## NEW CAR ASSESSMENT PROGRAM CRASH IMMINENT BRAKING SYSTEM CONFIRMATION TEST NCAP-DRI-CIB-20-03

2020 Ford F-150 4X4 SuperCrew

DYNAMIC RESEARCH, INC. 355 Van Ness Avenue, STE 200

**Final Report**

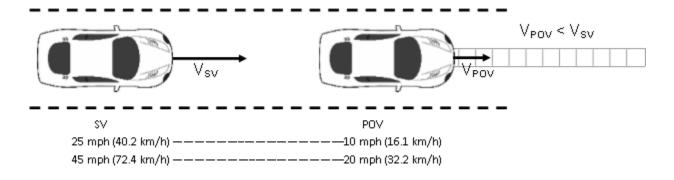
• This test evaluates the ability of the CIB system to detect and respond to a slowermoving lead vehicle traveling at a constant speed in the immediate forward path of the SV, as depicted in Figure 2.

Figure 2. Depiction of Test 2

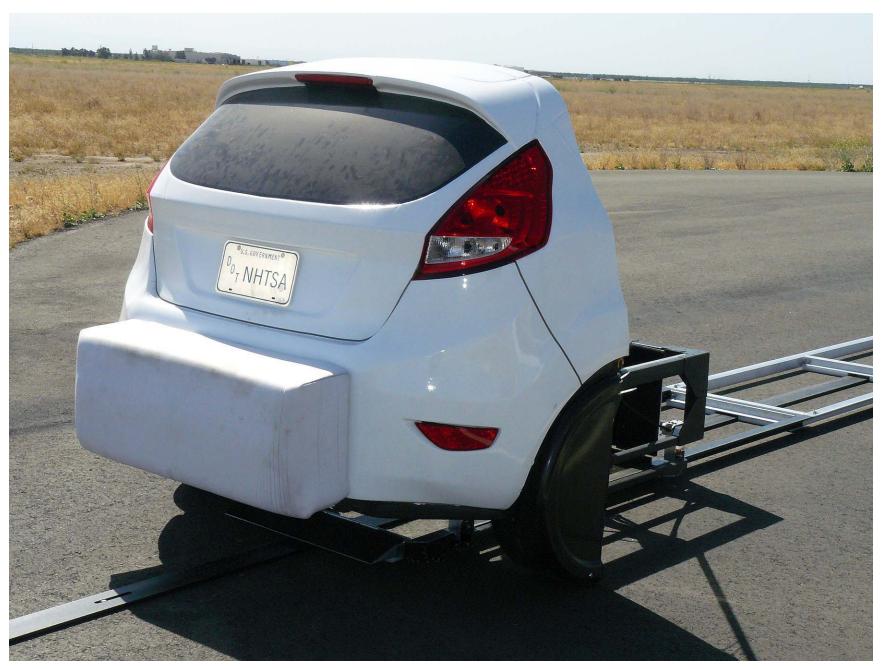
Figure A6. Rear View of Principal Other Vehicle (SSV)

CIB testing requires a POV that realistically represents typical vehicles, does not suffer damage or cause damage to a test vehicle in the event of collision, and can be accurately positioned and moved during the tests. The tests reported herein made use of the NHTSA developed Strikeable Surrogate Vehicle (SSV).

- Provide an accurate representation of a real vehicle to CIB sensors, including cameras and radar.
- Be resistant to damage and inflict little or no damage to the SV as a result of repeated SV-to-POV impacts.

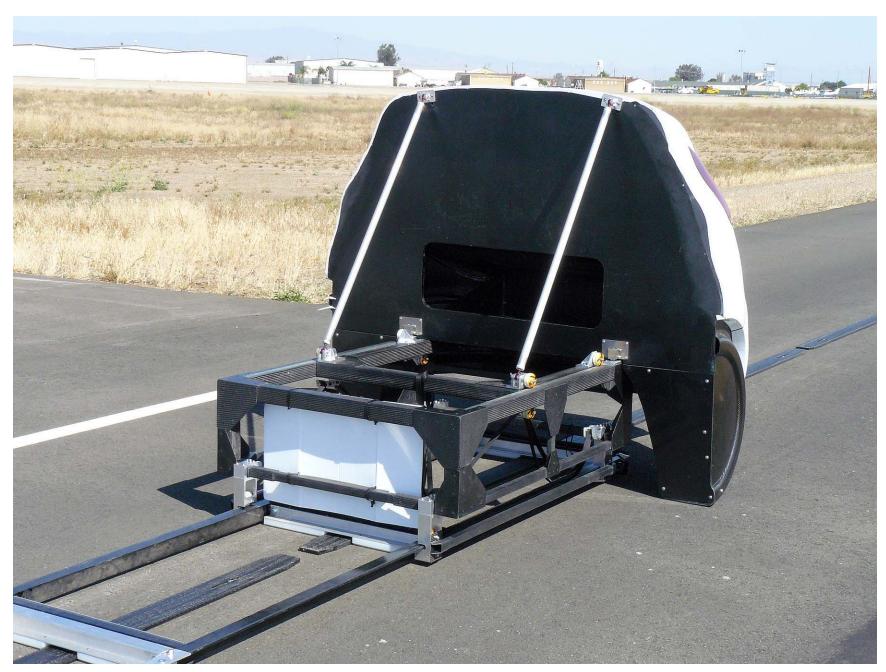
Figure A7. Load Frame/Slider of SSV

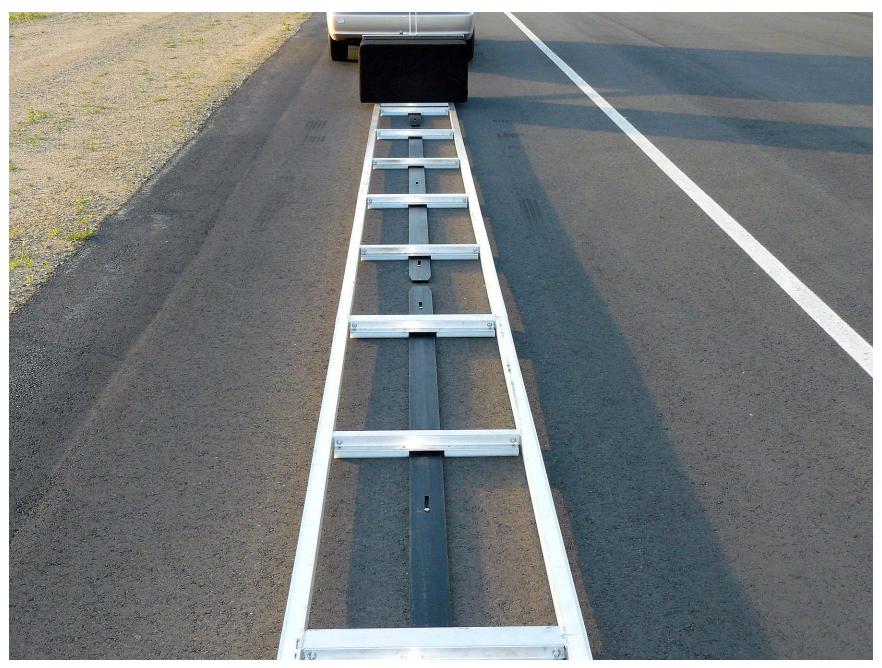
Figure A8. Two-Rail Track and Road-Based Lateral Restraint Track

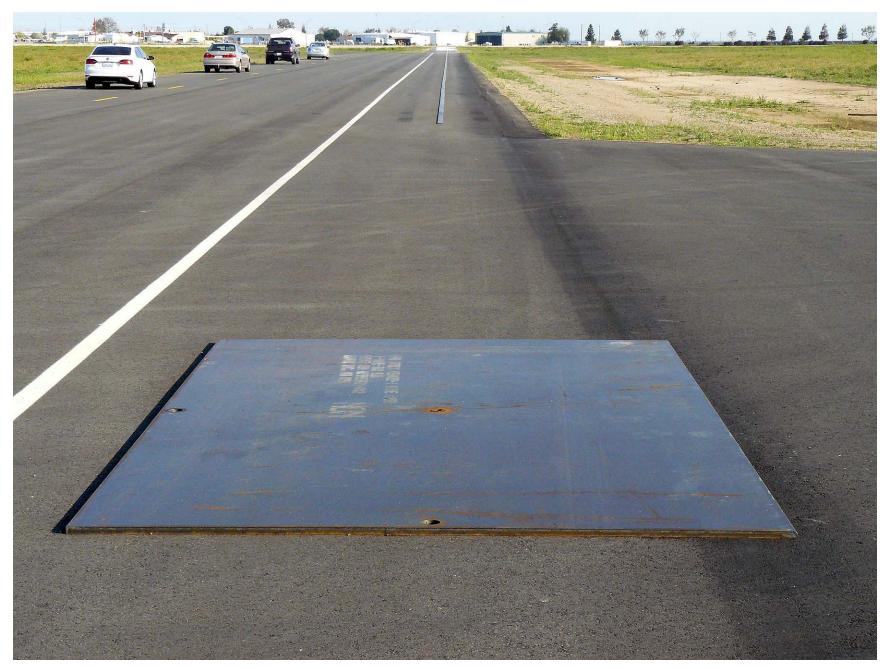
Figure A9. Steel Trench Plate

The false positive suppression test series evaluates the ability of a CIB system to differentiate a steel trench plate (STP) from an object presenting a genuine safety risk to the SV. Although the STP is large and metallic, it is designed to be driven over without risk of injury to the driver or damage to the SV. Therefore, in this scenario, the automatic braking available from CIB is not necessary and should be suppressed. The test condition is nearly equivalent to that previously defined for Test 1, the stopped POV condition, but with an STP in the SV forward path in lieu of a POV.

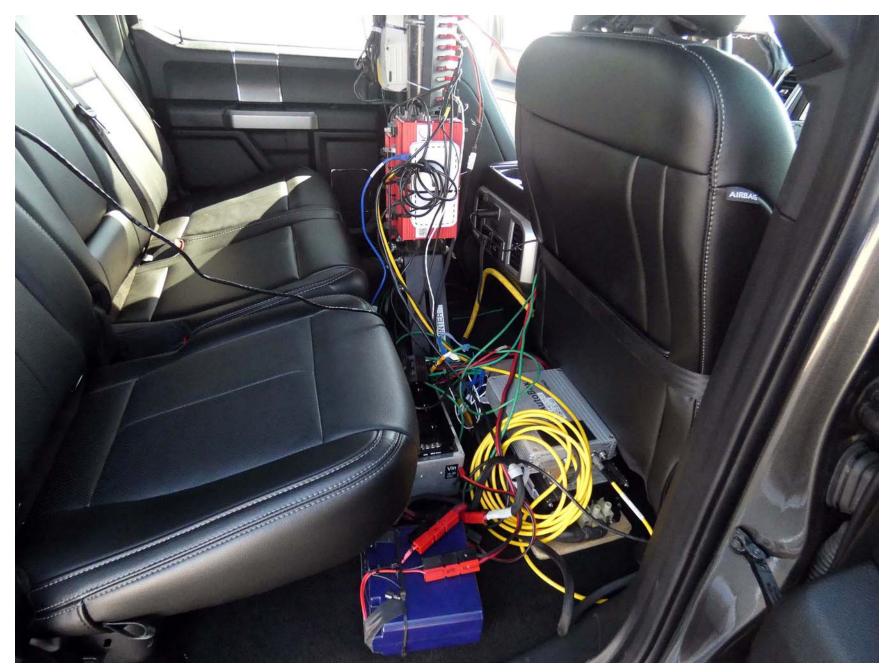
Figure A10. DGPS, Inertial Measurement Unit, and MicroAutoBox Installed in Subject Vehicle

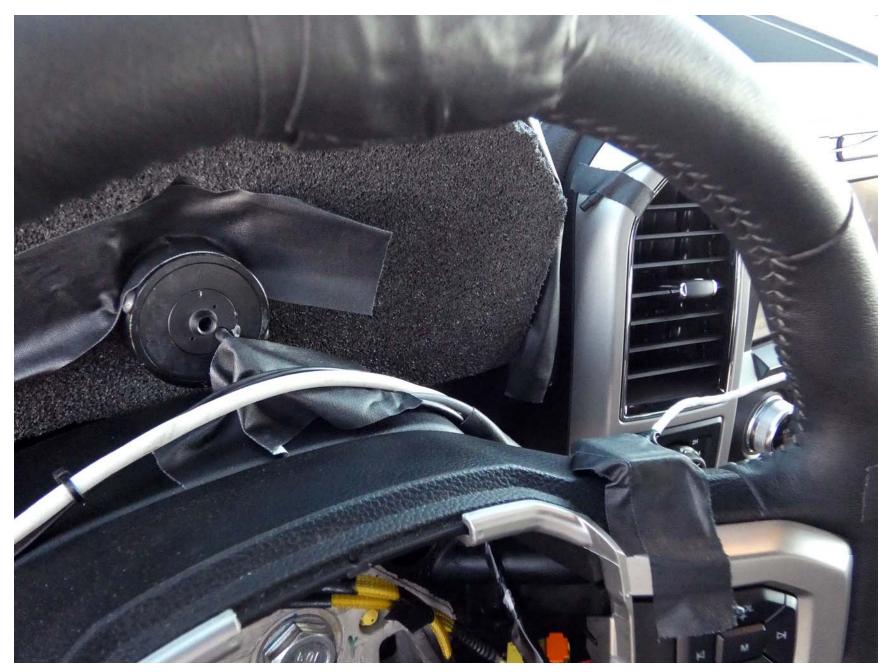
Figure A11. Sensors for Detecting Visual and Auditory Alerts

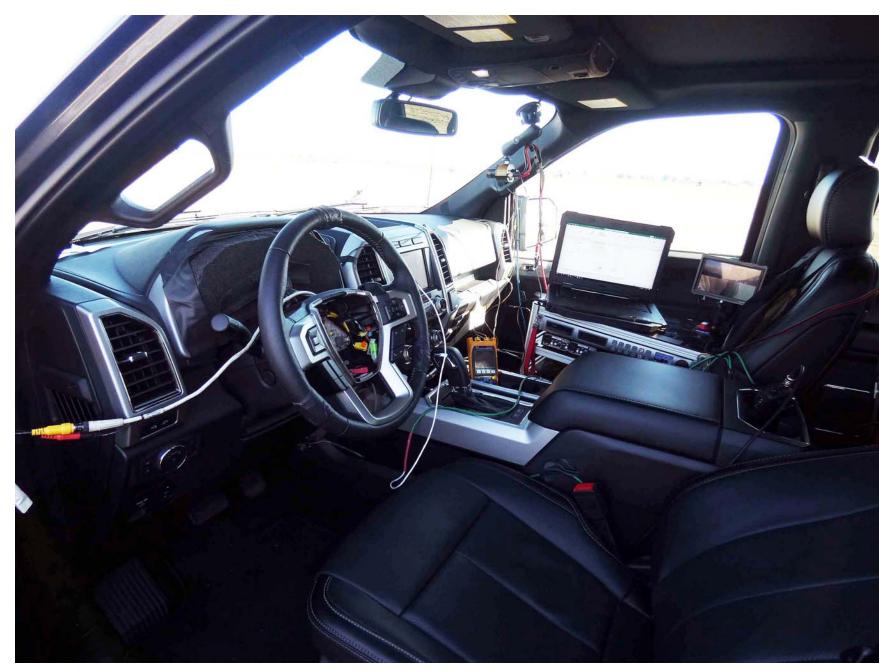
Figure A12. Computer Installed in Subject Vehicle

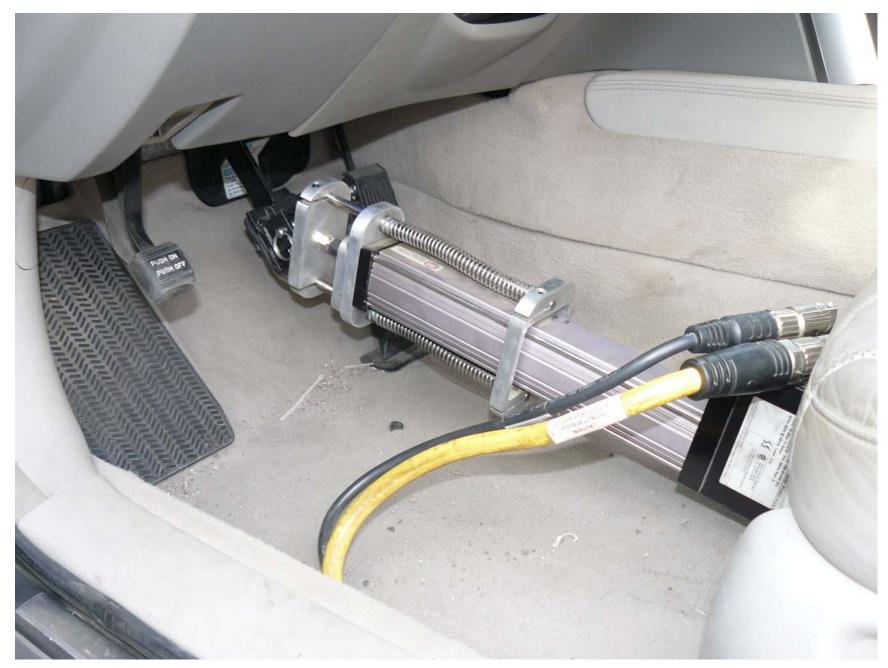
Figure A13. Brake Actuator Installed in POV System

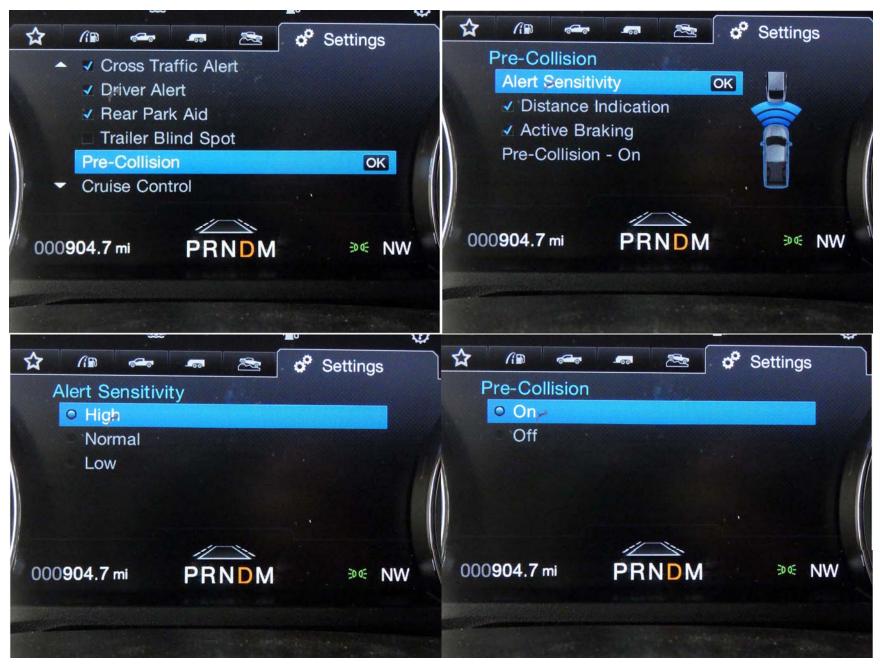
Figure A14. AEB Setup Menus

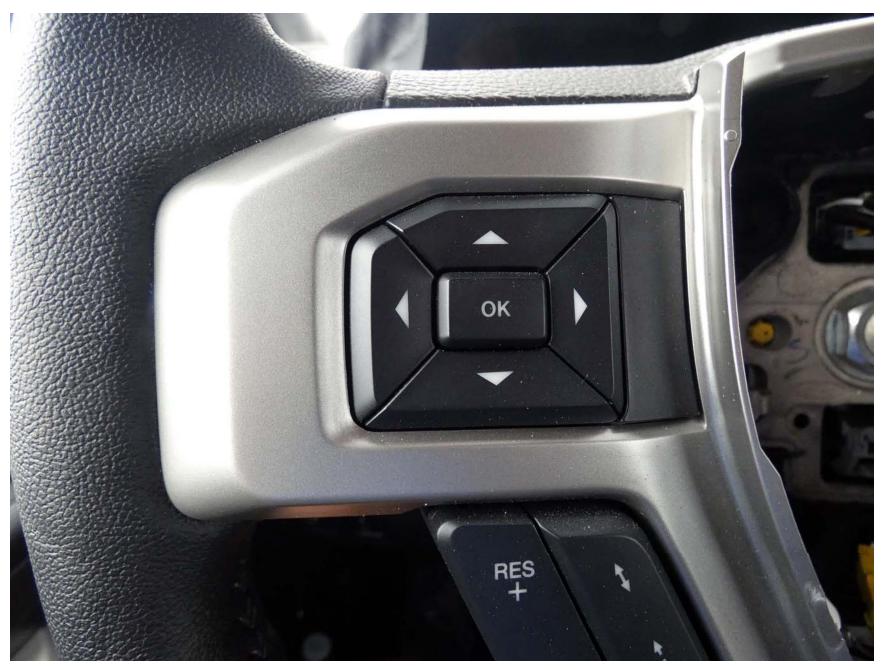
Figure A15. Controls for Changing Vehicle Parameters

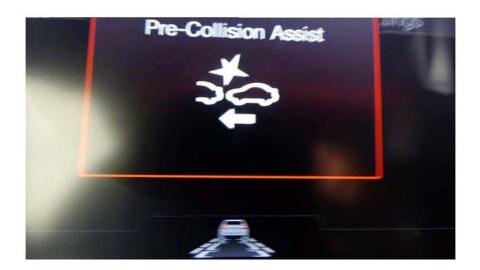
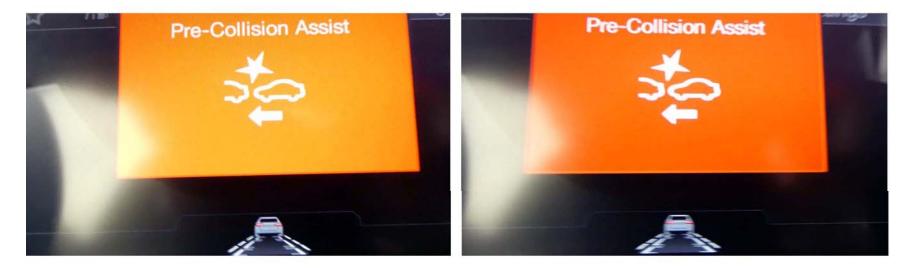
Figure A16. Visual Alerts

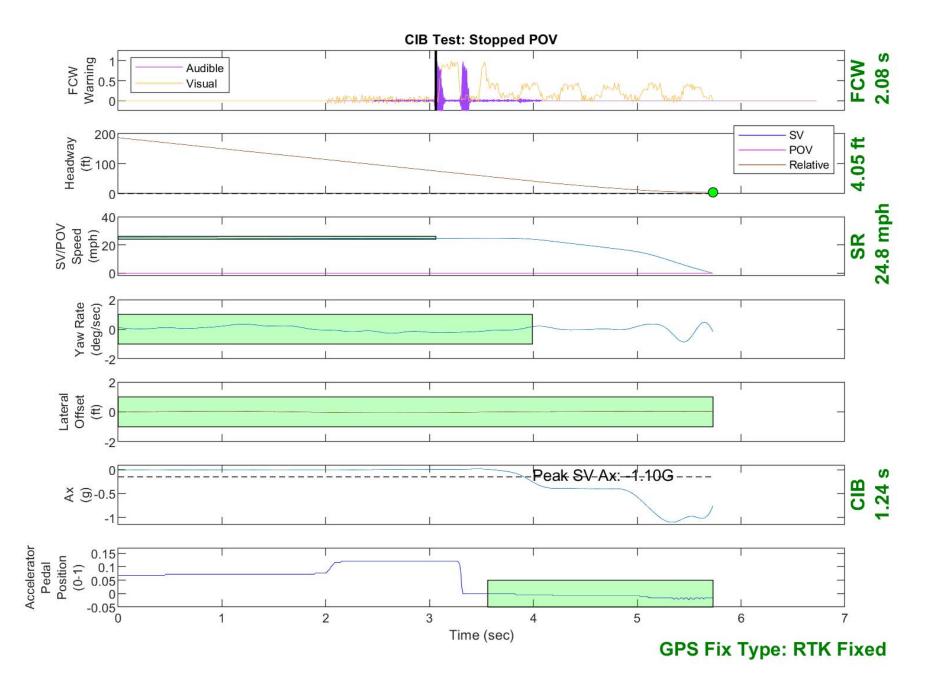
Figure D1. Example Time History for Stopped POV, Passing

Examples of time history plots for each test type (including passing, failing and invalid runs) are shown in Figure 1 through Figure 9. Figures 1 through 6 show passing runs for each of the 6 test types. Figures 7 and 8 show examples of invalid runs. Figure 9 shows an example of a valid test that failed the CIB requirements.

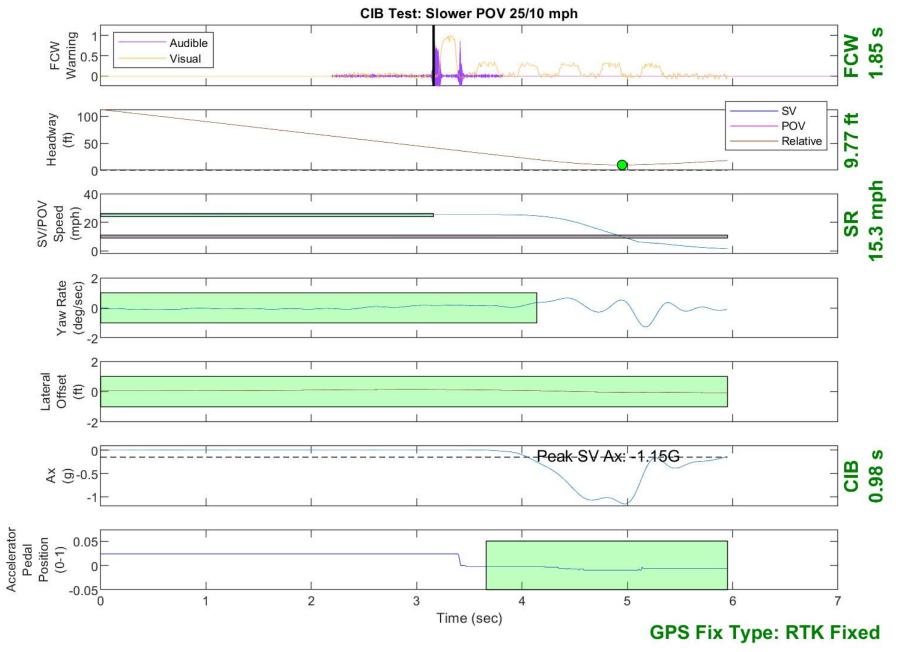
Figure D2. Example Time History for Slower POV 25 vs. 10, Passing

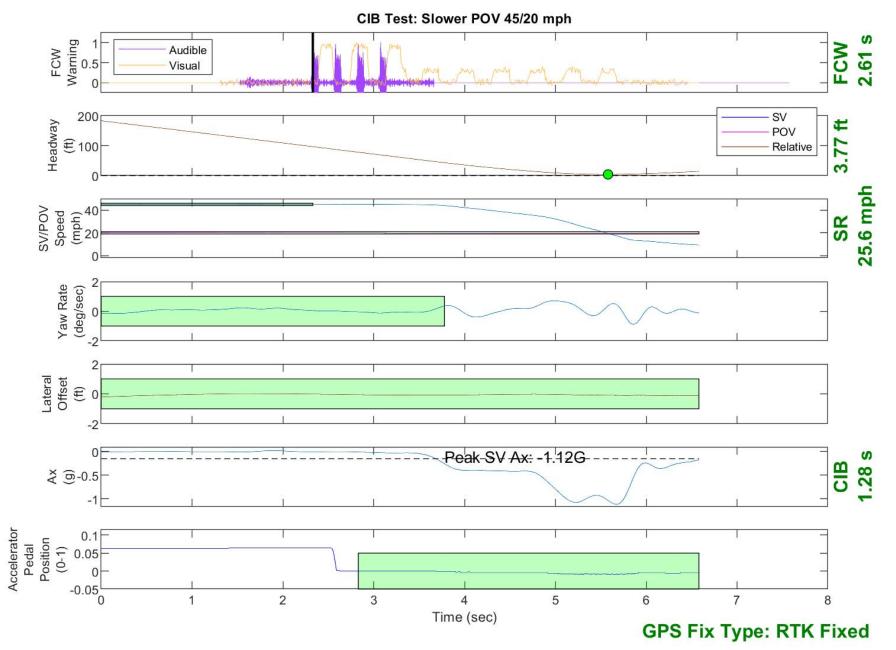
Figure D3. Example Time History for Slower POV 45 vs. 20, Passing

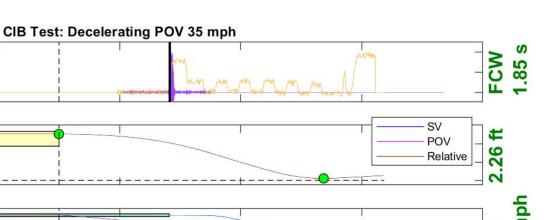
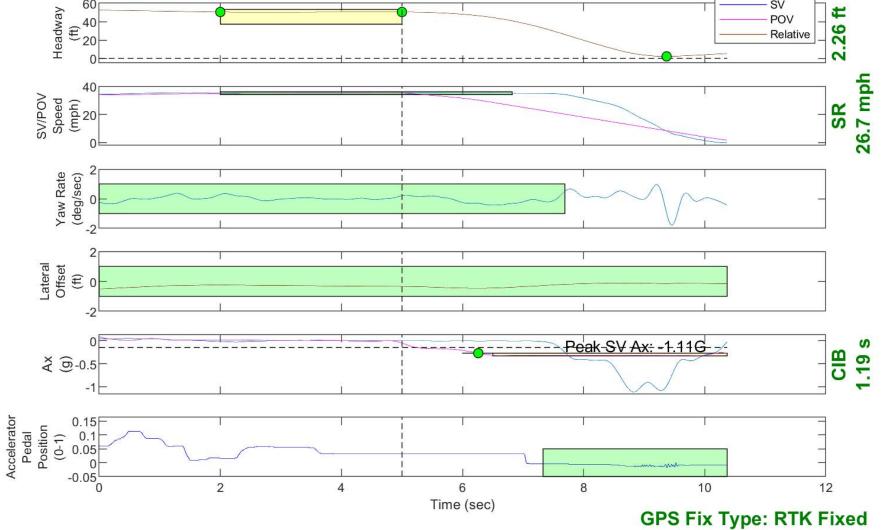
Figure D4. Example Time History for Decelerating POV 35, Passing

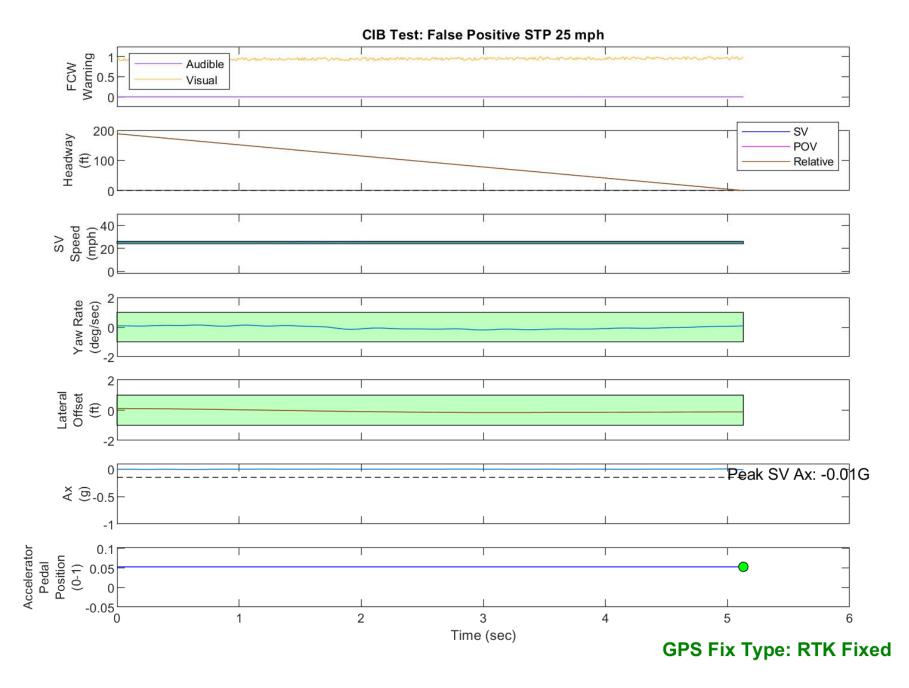
Figure D5. Example Time History for False Positive STP 25, Passing

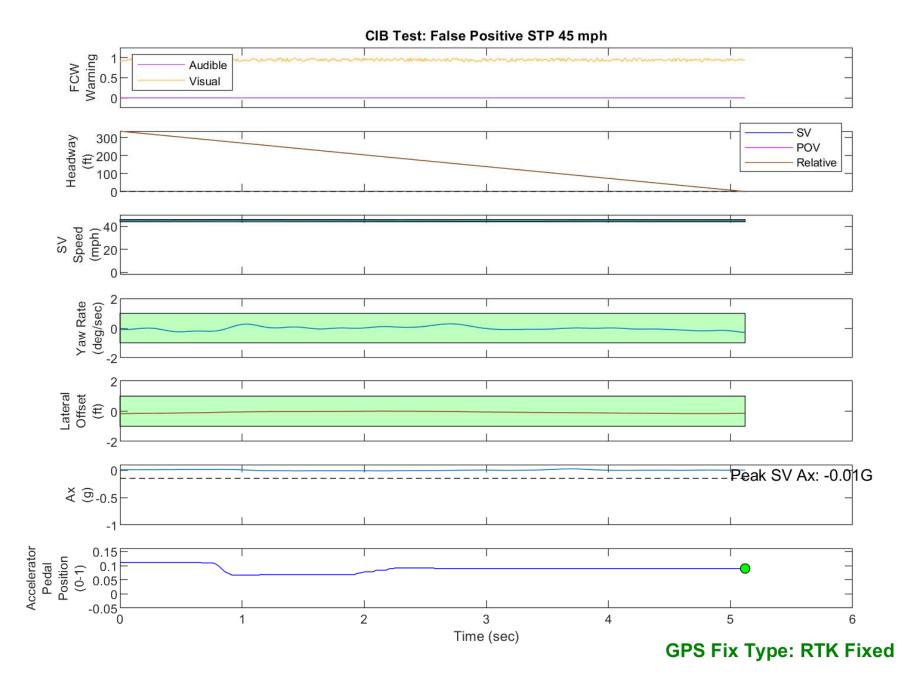
Figure D6. Example Time History for False Positive STP 45, Passing

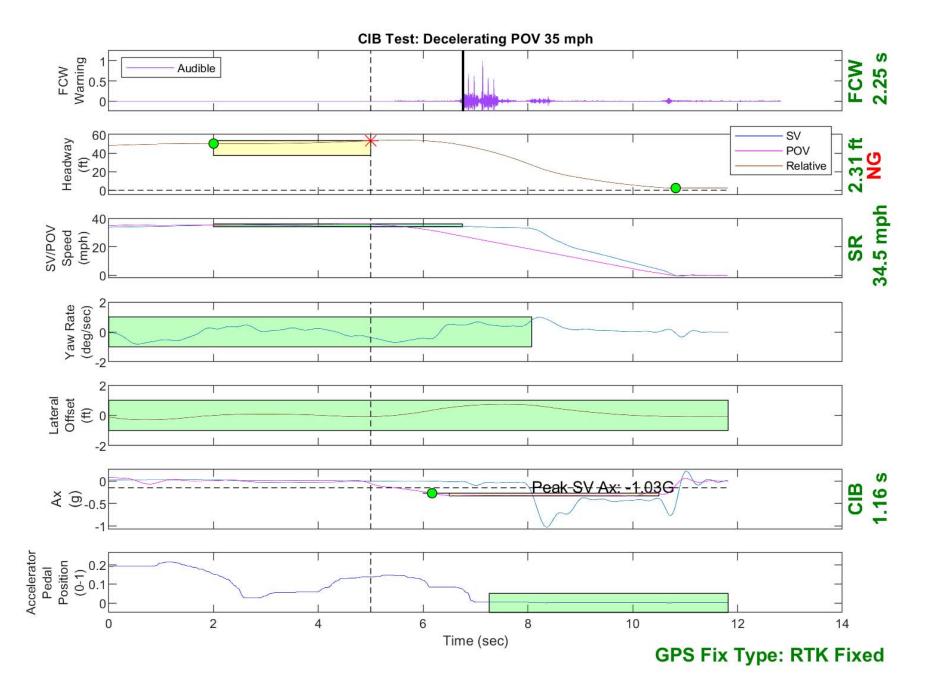
Figure D7. Example Time History Displaying Various Invalid Criteria

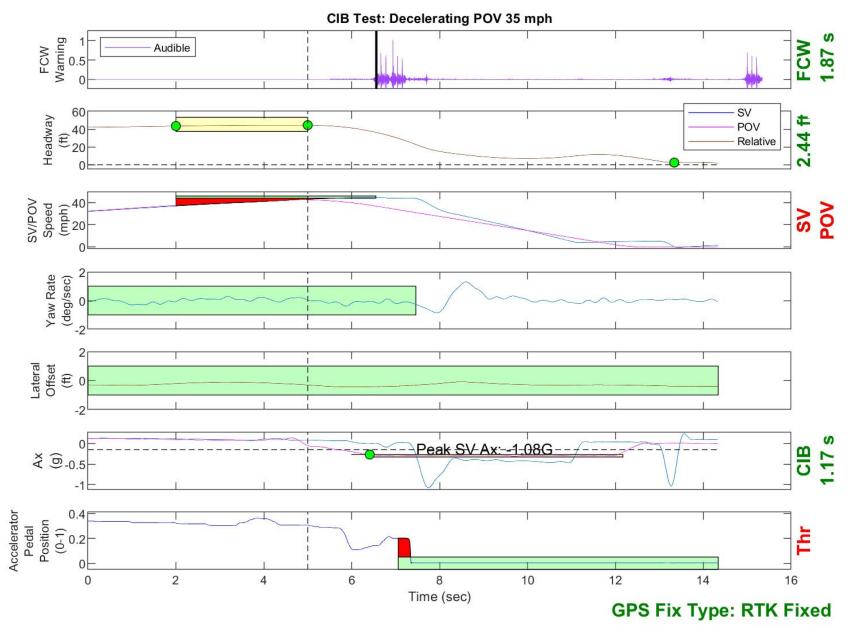
Figure D8. Example Time History Displaying Various Invalid Criteria

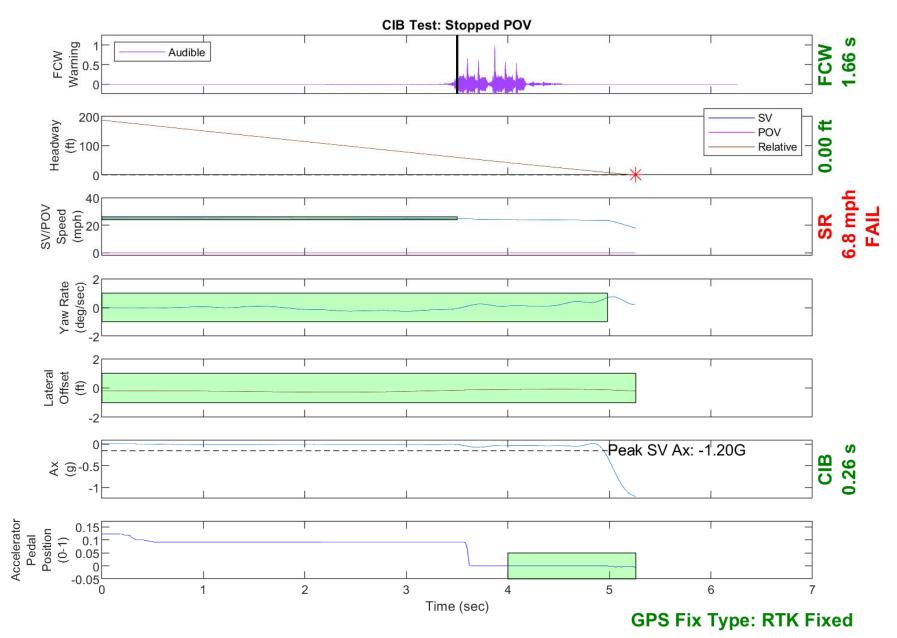
Figure D9. Example Time History for a Failed Run

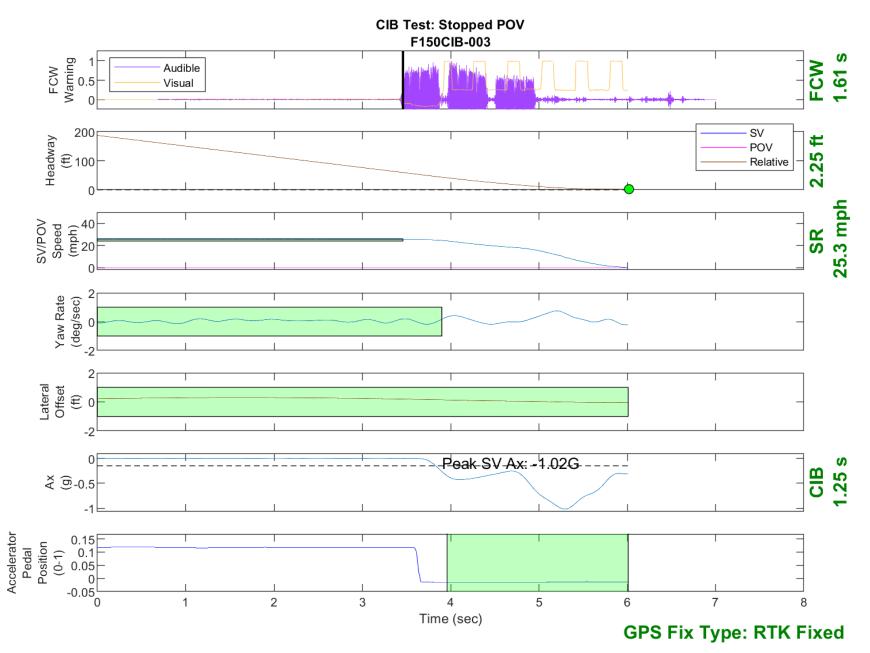
Figure D10. Time History for CIB Run 3, SV Encounters Stopped POV

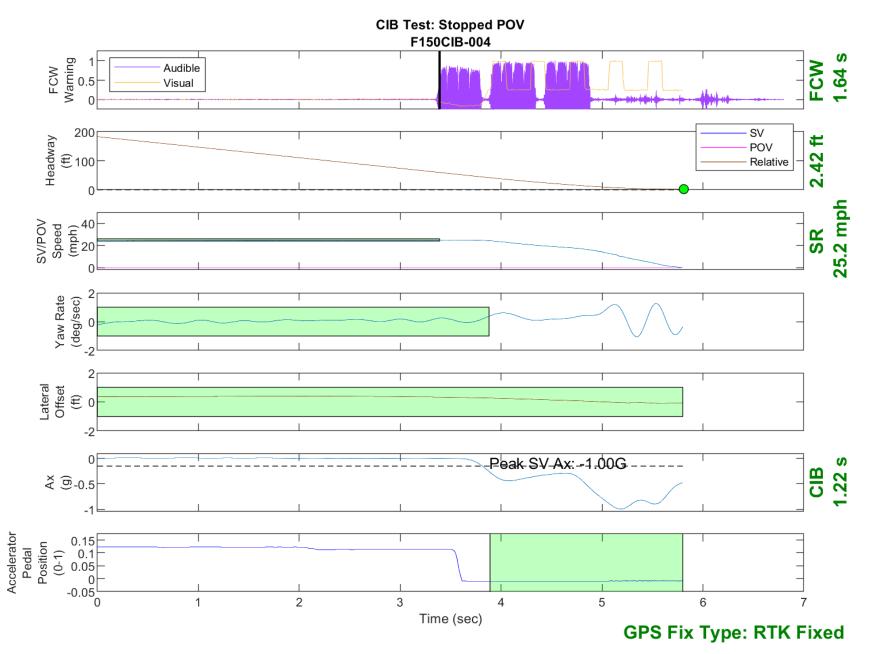
Figure D11. Time History for CIB Run 4, SV Encounters Stopped POV

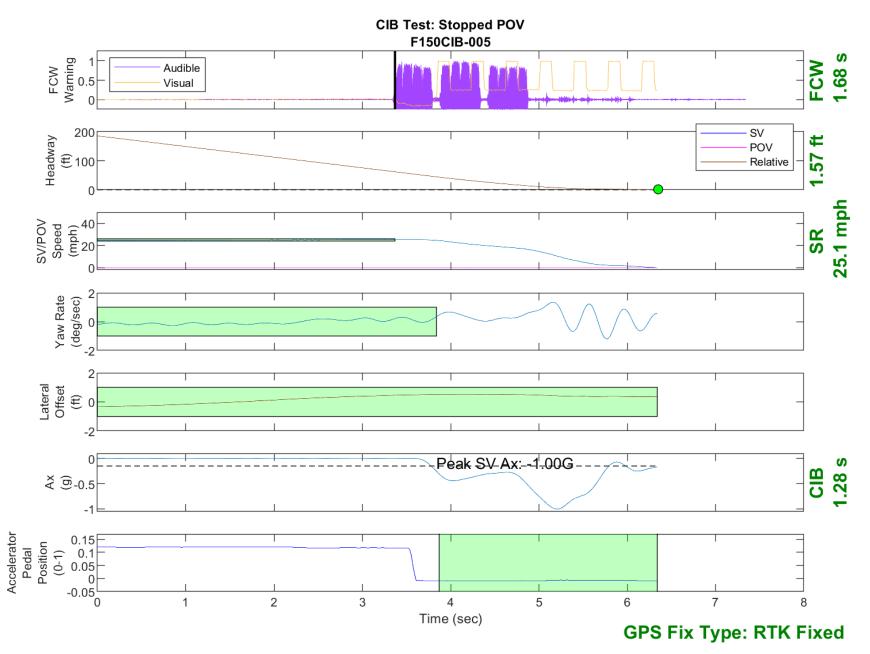
Figure D12. Time History for CIB Run 5, SV Encounters Stopped POV

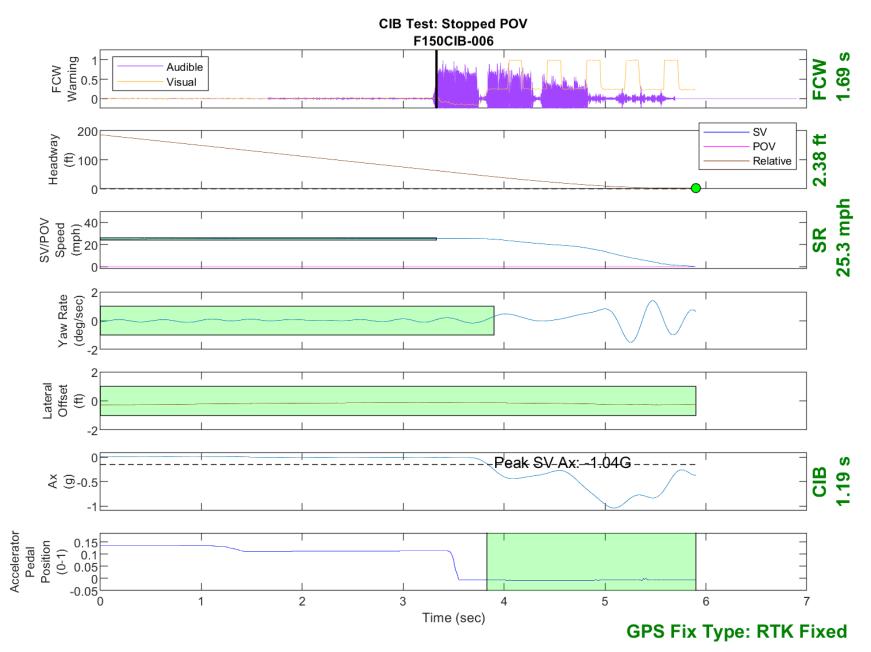
Figure D13. Time History for CIB Run 6, SV Encounters Stopped POV

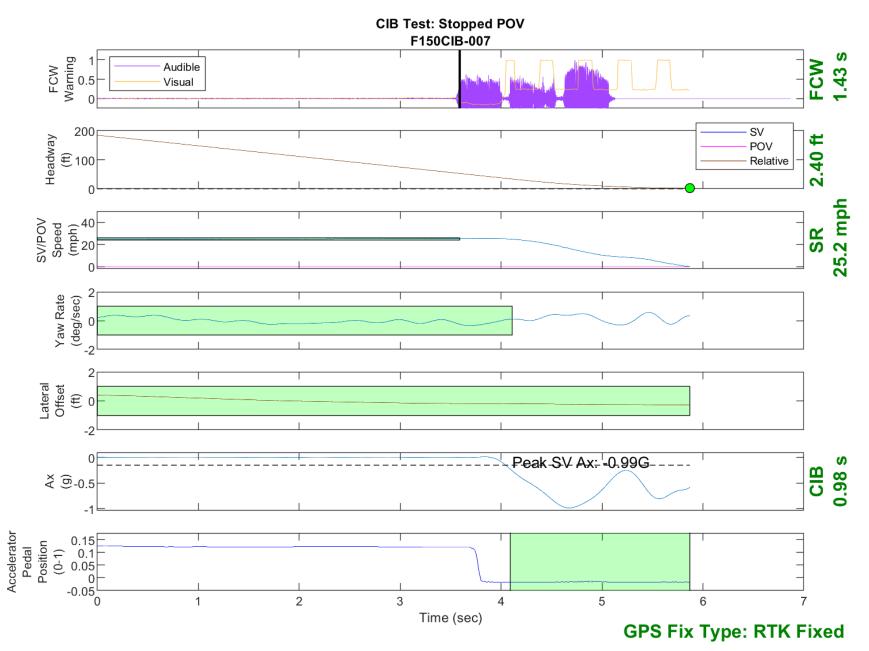
Figure D14. Time History for CIB Run 7, SV Encounters Stopped POV

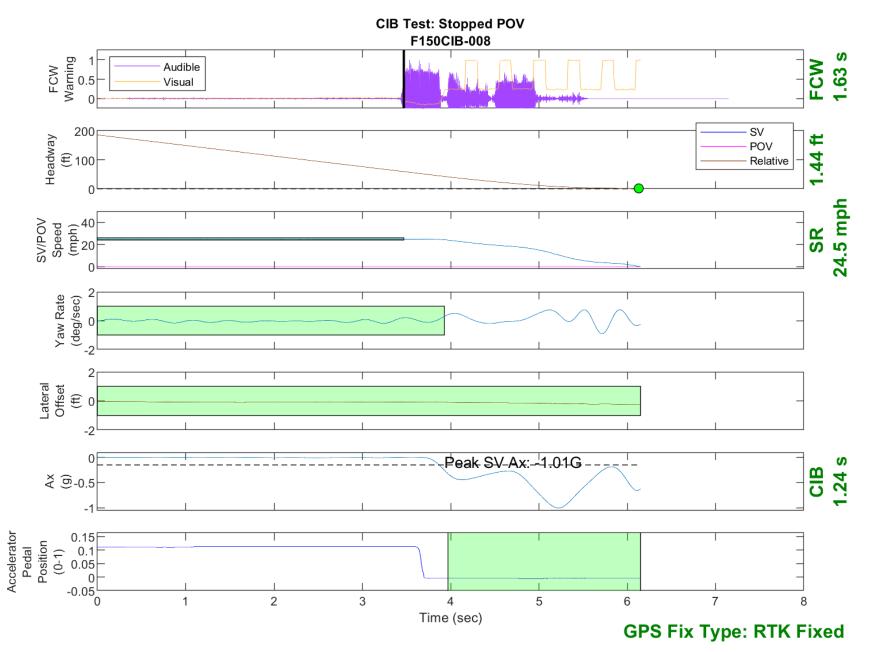
Figure D15. Time History for CIB Run 8, SV Encounters Stopped POV

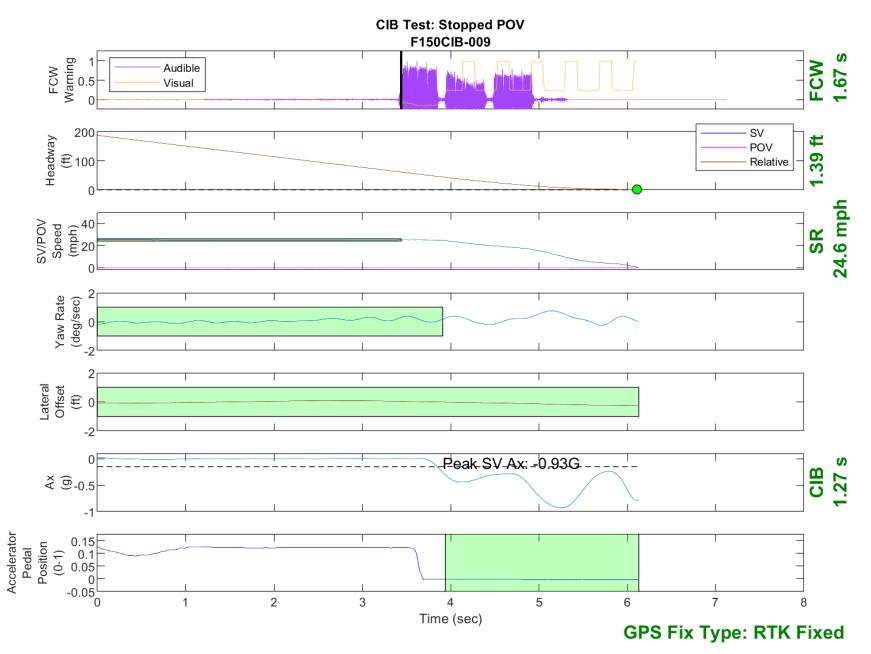
Figure D16. Time History for CIB Run 9, SV Encounters Stopped POV

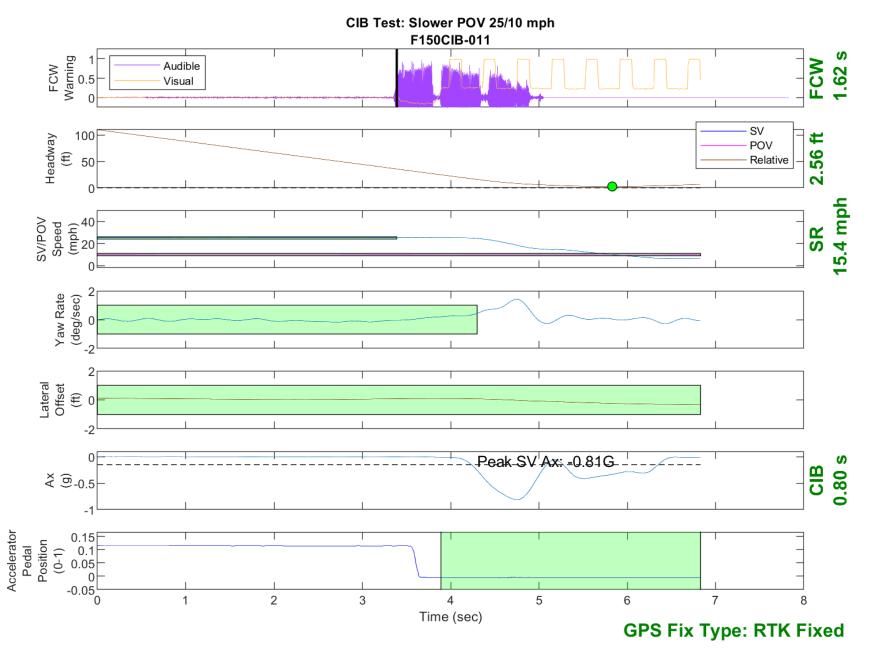
Figure D17. Time History for CIB Run 11, SV Encounters Slower POV, SV 25 mph, POV 10 mph

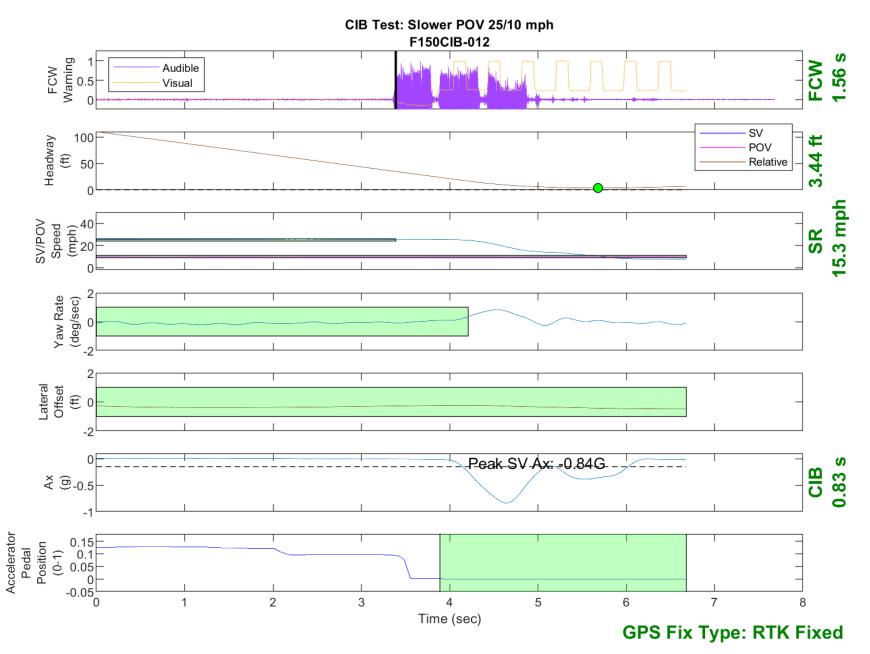
Figure D18. Time History for CIB Run 12, SV Encounters Slower POV, SV 25 mph, POV 10 mph

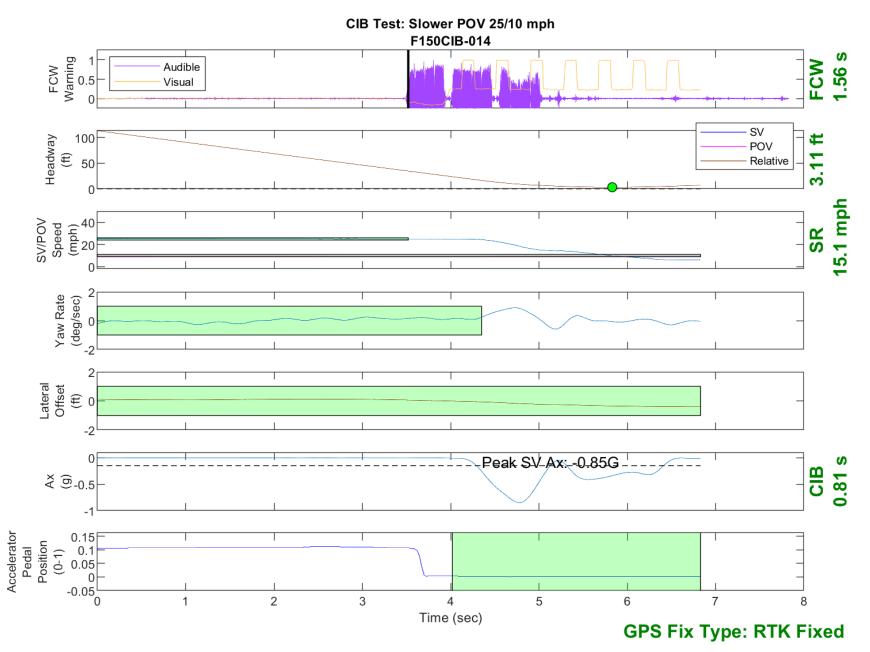
Figure D19. Time History for CIB Run 14, SV Encounters Slower POV, SV 25 mph, POV 10 mph

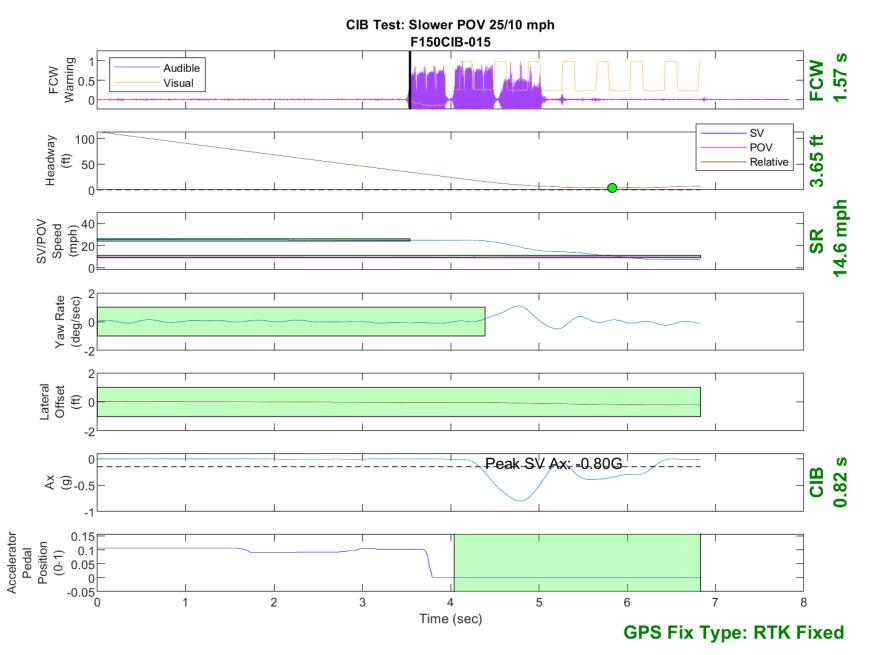
Figure D20. Time History for CIB Run 15, SV Encounters Slower POV, SV 25 mph, POV 10 mph

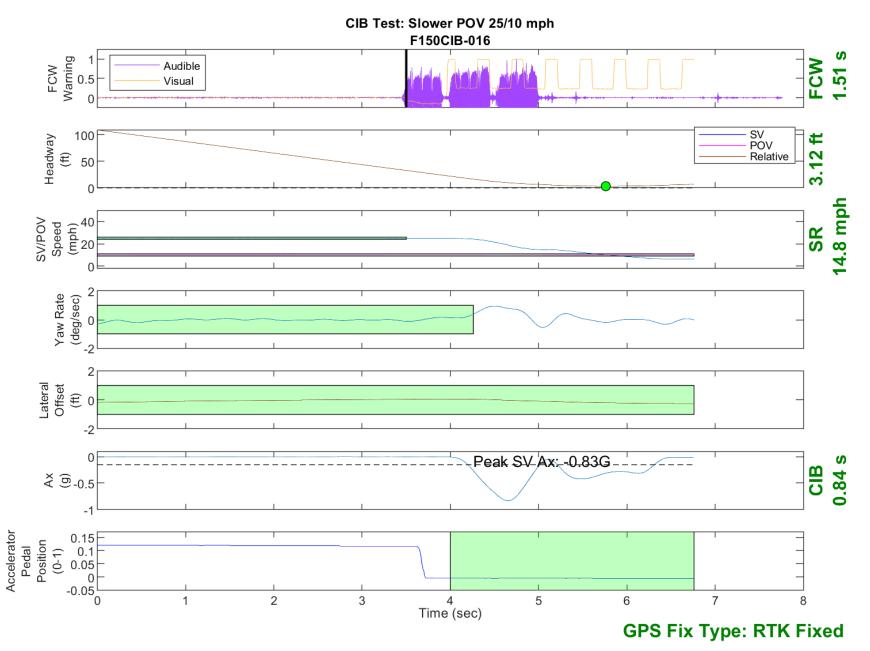
Figure D21. Time History for CIB Run 16, SV Encounters Slower POV, SV 25 mph, POV 10 mph

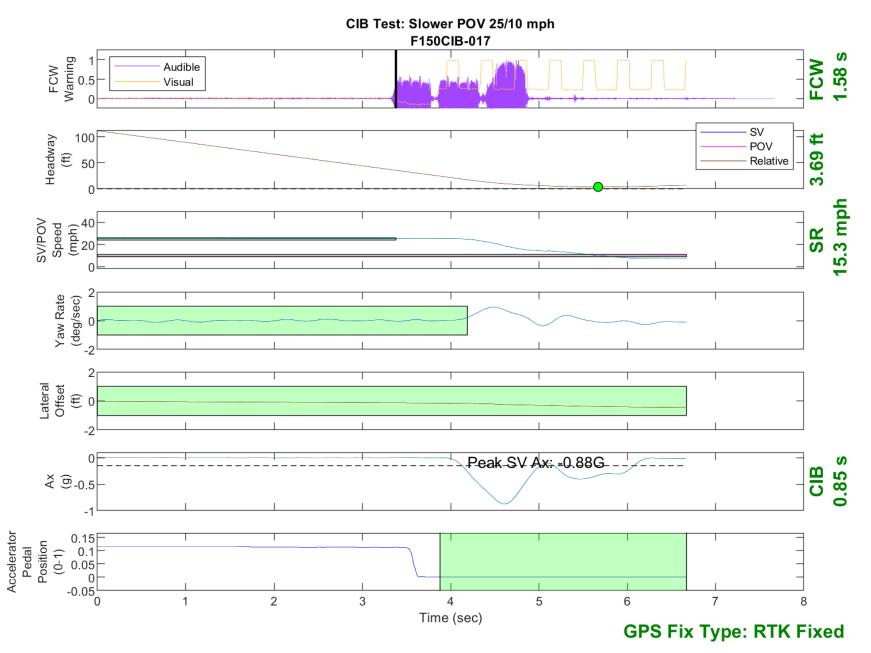
Figure D22. Time History for CIB Run 17, SV Encounters Slower POV, SV 25 mph, POV 10 mph

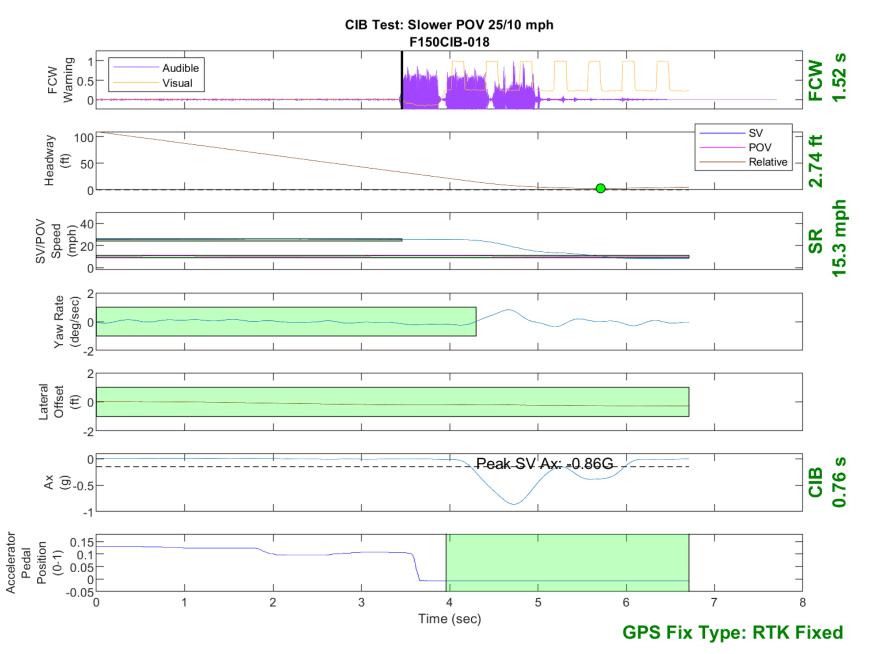
Figure D23. Time History for CIB Run 18, SV Encounters Slower POV, SV 25 mph, POV 10 mph

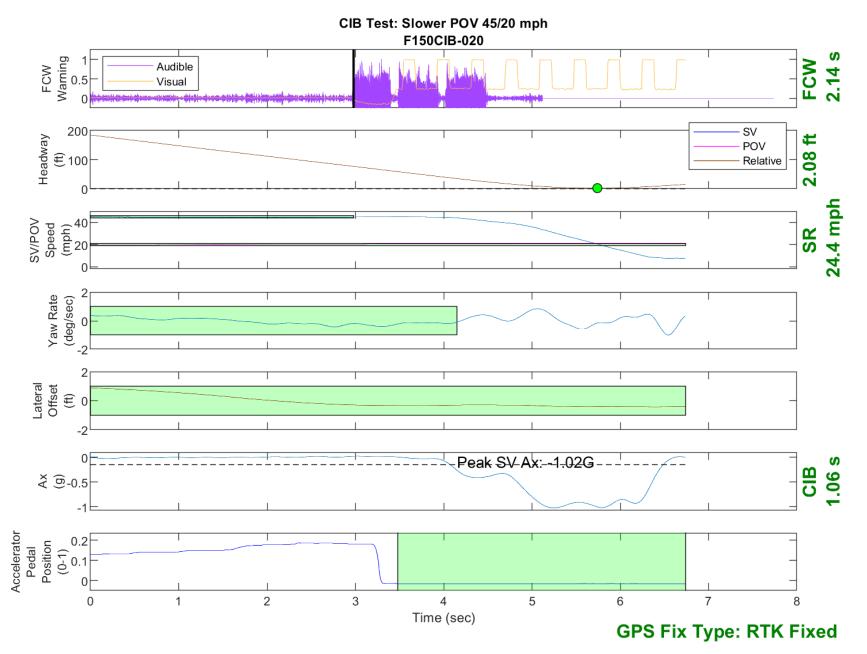
Figure D24. Time History for CIB Run 20, SV Encounters Slower POV, SV 45 mph, POV 20 mph

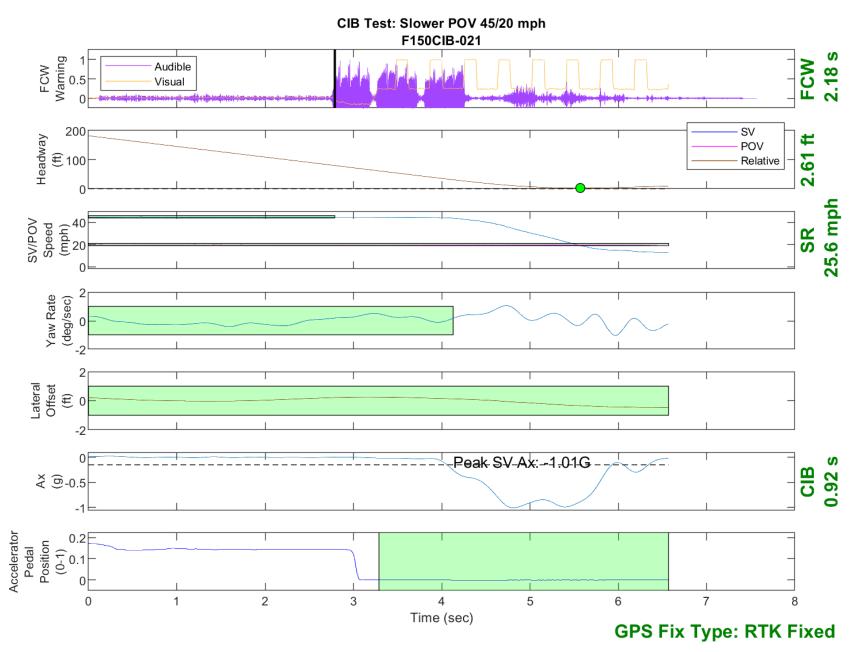
Figure D25. Time History for CIB Run 21, SV Encounters Slower POV, SV 45 mph, POV 20 mph

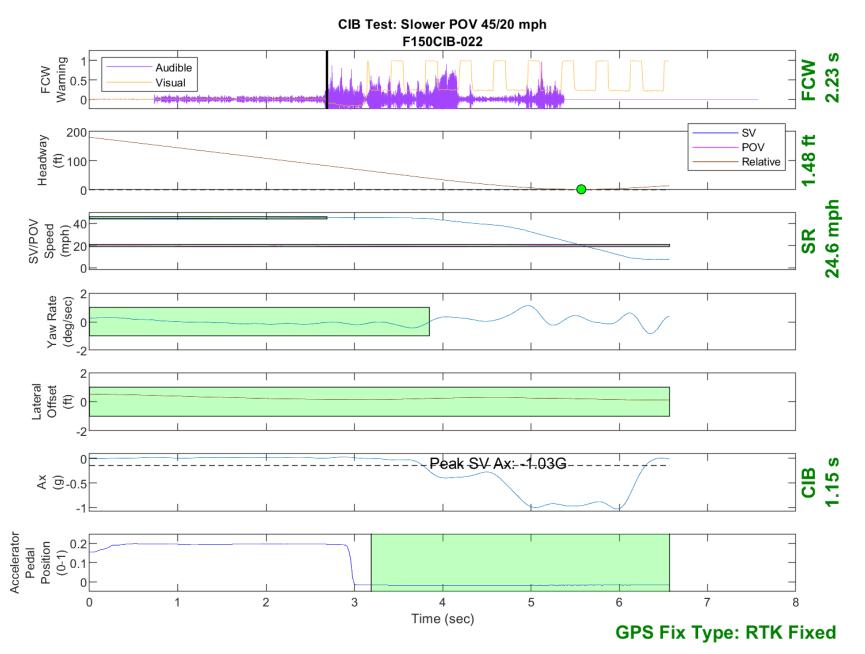
Figure D26. Time History for CIB Run 22, SV Encounters Slower POV, SV 45 mph, POV 20 mph

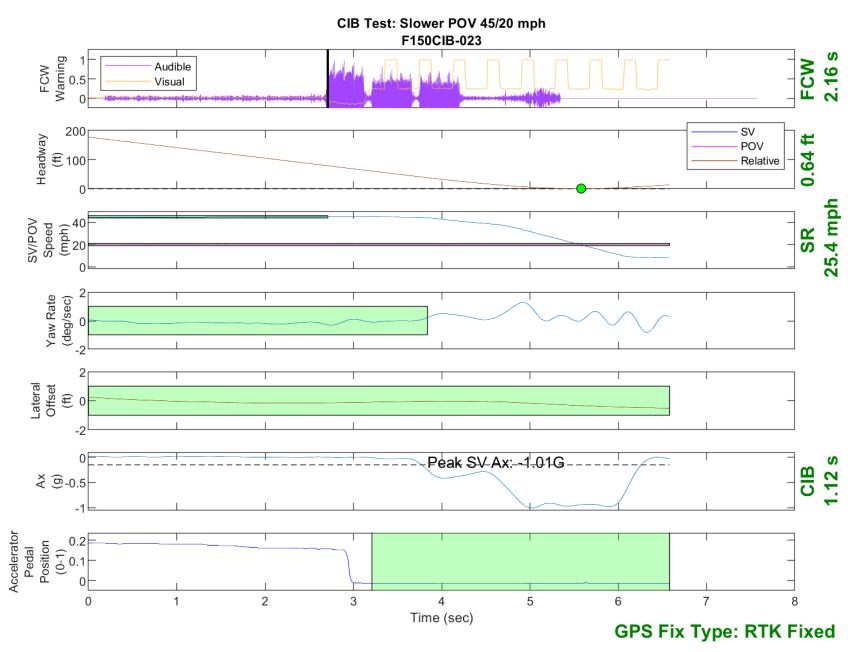
Figure D27. Time History for CIB Run 23, SV Encounters Slower POV, SV 45 mph, POV 20 mph
