## NEW CAR ASSESSMENT PROGRAM CRASH IMMINENT BRAKING SYSTEM CONFIRMATION TEST NCAP-DRI-CIB-20-03

2020 Ford F-150 4X4 SuperCrew

DYNAMIC RESEARCH, INC. 355 Van Ness Avenue, STE 200

**Final Report**

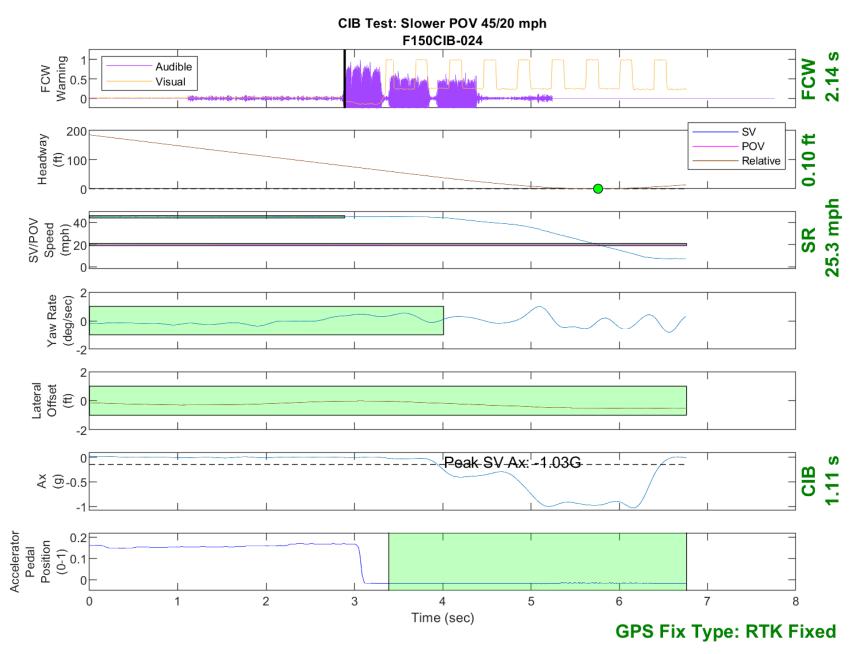
Figure D28. Time History for CIB Run 24, SV Encounters Slower POV, SV 45 mph, POV 20 mph

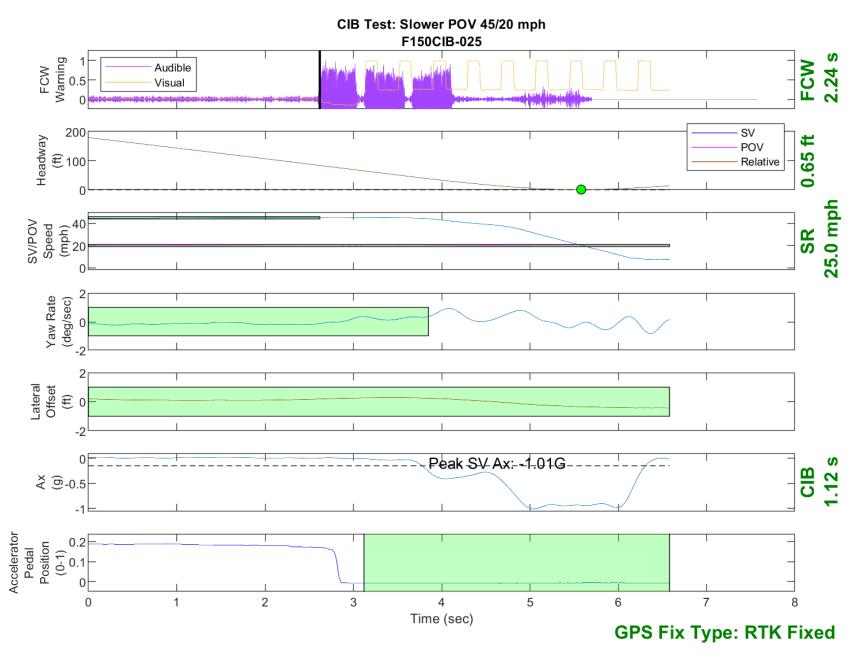
Figure D29. Time History for CIB Run 25, SV Encounters Slower POV, SV 45 mph, POV 20 mph

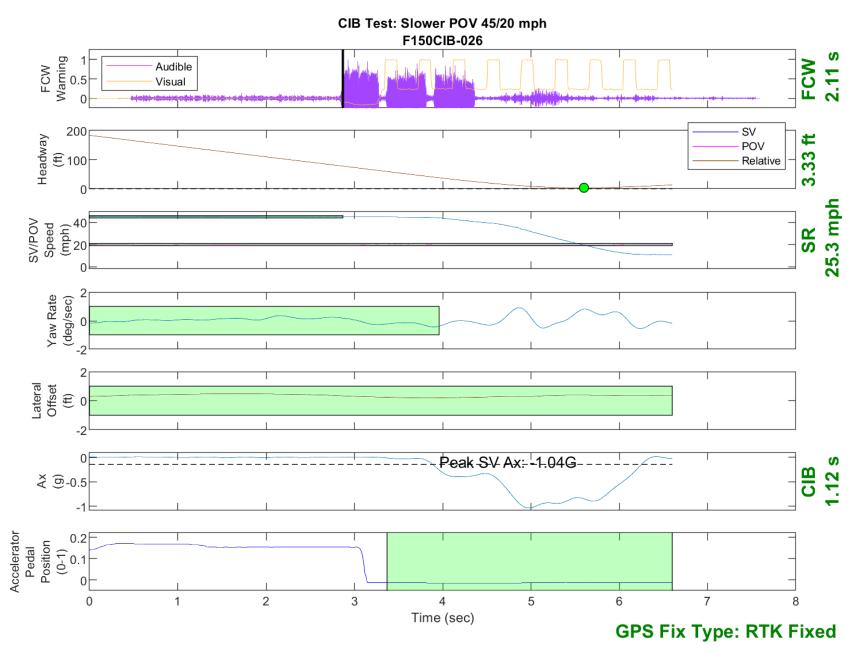
Figure D30. Time History for CIB Run 26, SV Encounters Slower POV, SV 45 mph, POV 20 mph

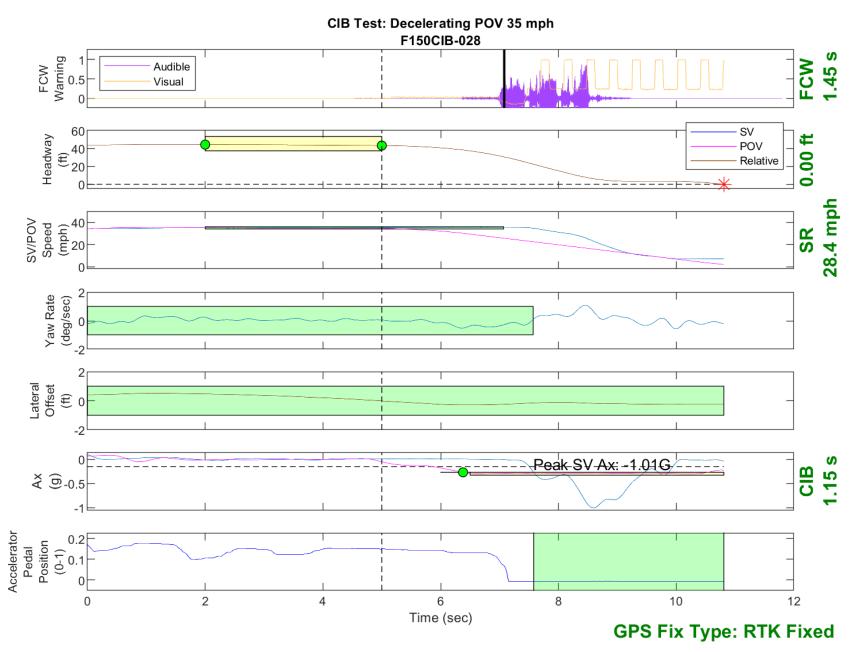
Figure D31. Time History for CIB Run 28, SV Encounters Decelerating POV, SV 35 mph, POV 35 mph

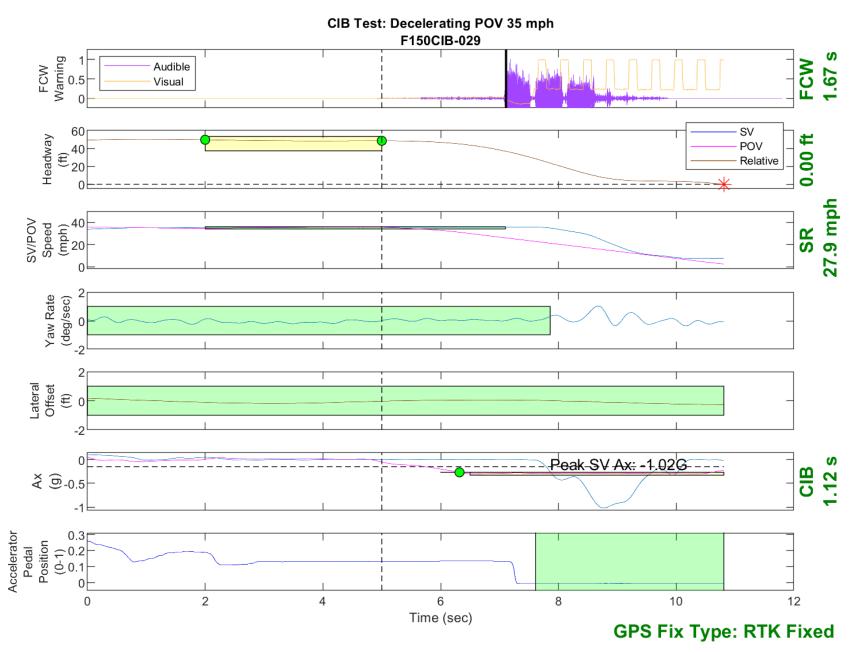
Figure D32. Time History for CIB Run 29, SV Encounters Decelerating POV, SV 35 mph, POV 35 mph

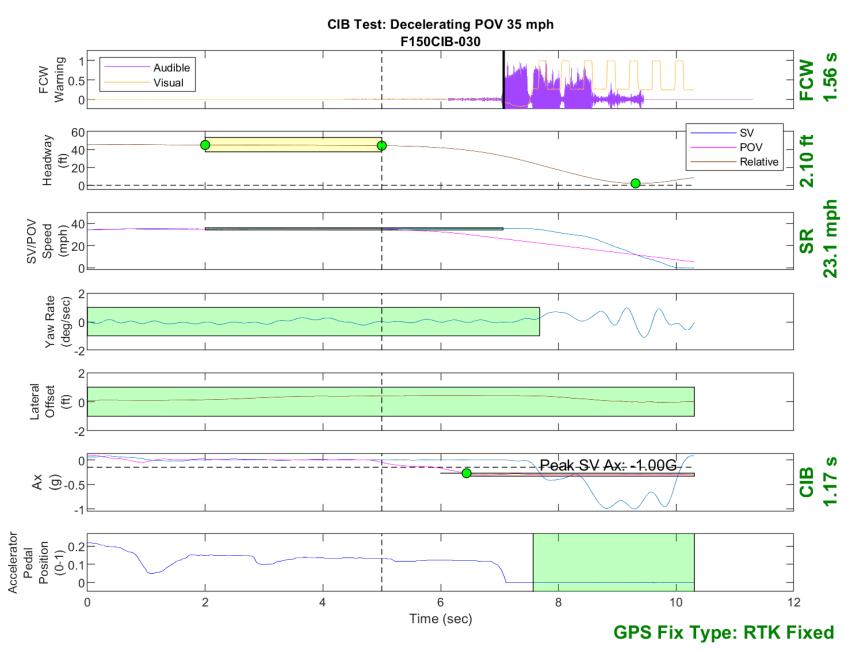
Figure D33. Time History for CIB Run 30, SV Encounters Decelerating POV, SV 35 mph, POV 35 mph

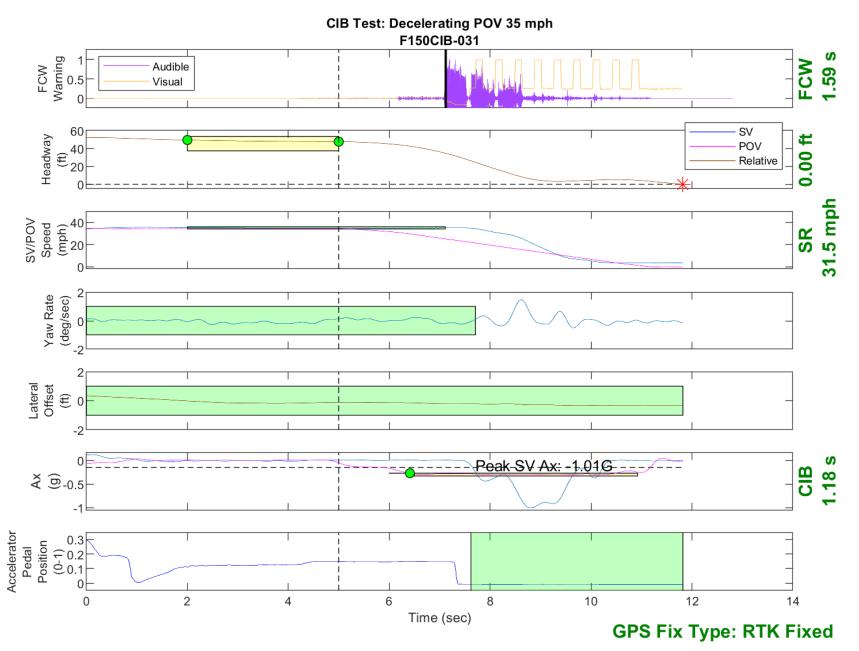
Figure D34. Time History for CIB Run 31, SV Encounters Decelerating POV, SV 35 mph, POV 35 mph

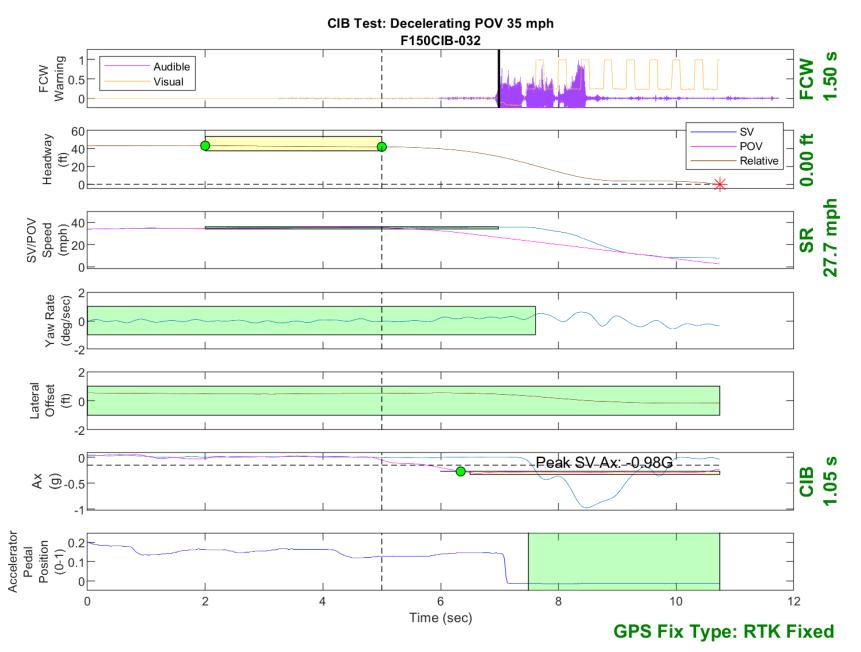
Figure D35. Time History for CIB Run 32, SV Encounters Decelerating POV, SV 35 mph, POV 35 mph

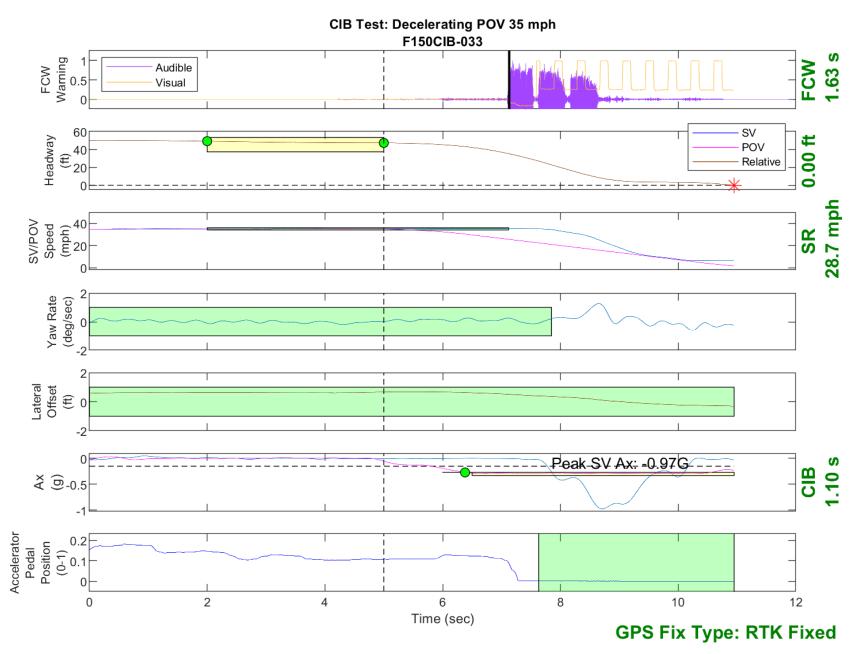
Figure D36. Time History for CIB Run 33, SV Encounters Decelerating POV, SV 35 mph, POV 35 mph

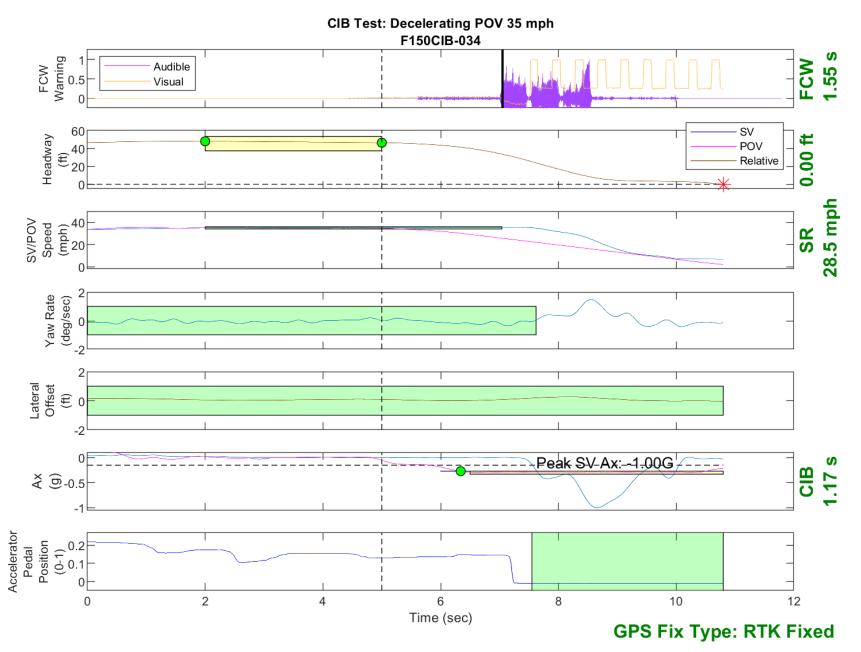
Figure D37. Time History for CIB Run 34, SV Encounters Decelerating POV, SV 35 mph, POV 35 mph

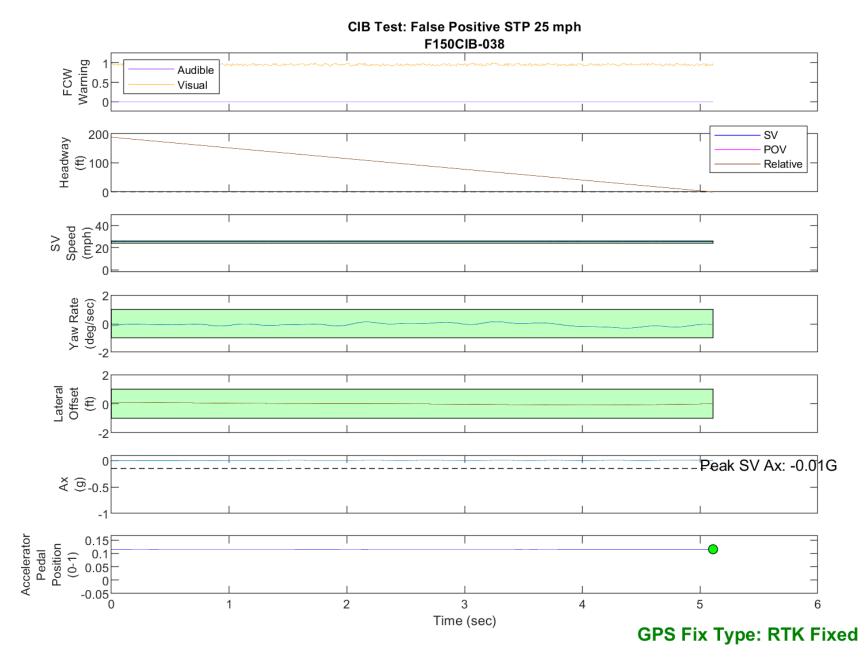
Figure D38. Time History for CIB Run 38, SV Encounters Steel Trench Plate, SV 25 mph

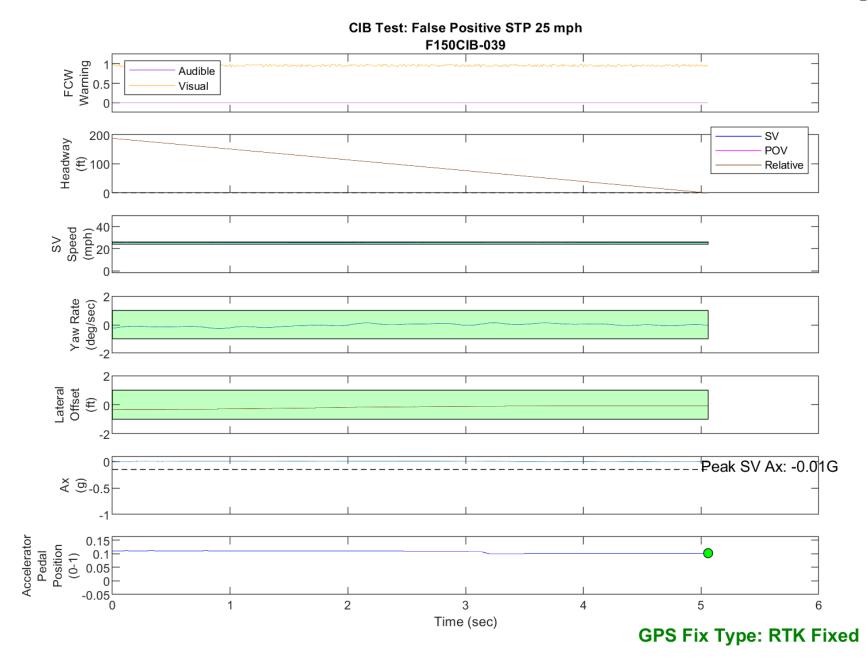
Figure D39. Time History for CIB Run 39, SV Encounters Steel Trench Plate, SV 25 mph

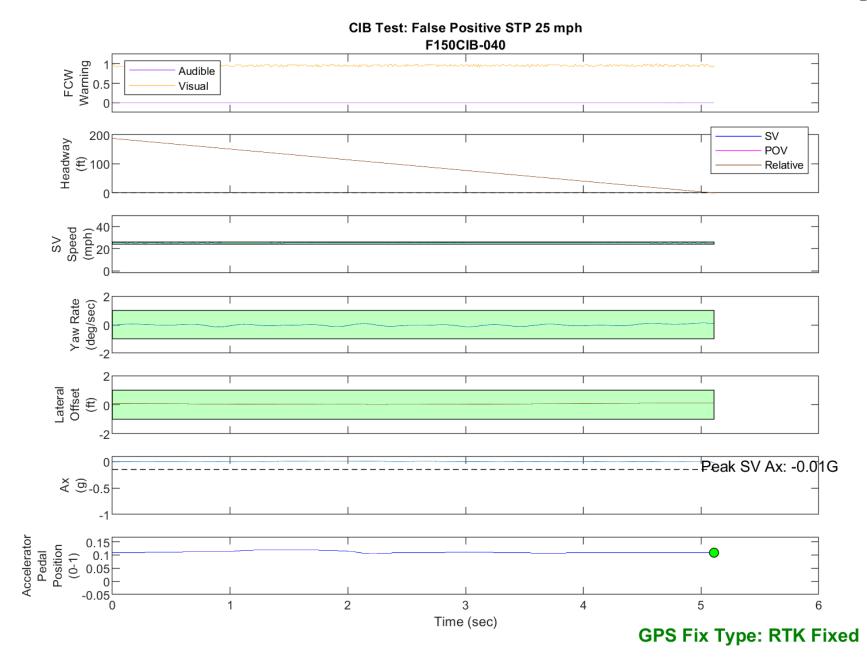
Figure D40. Time History for CIB Run 40, SV Encounters Steel Trench Plate, SV 25 mph

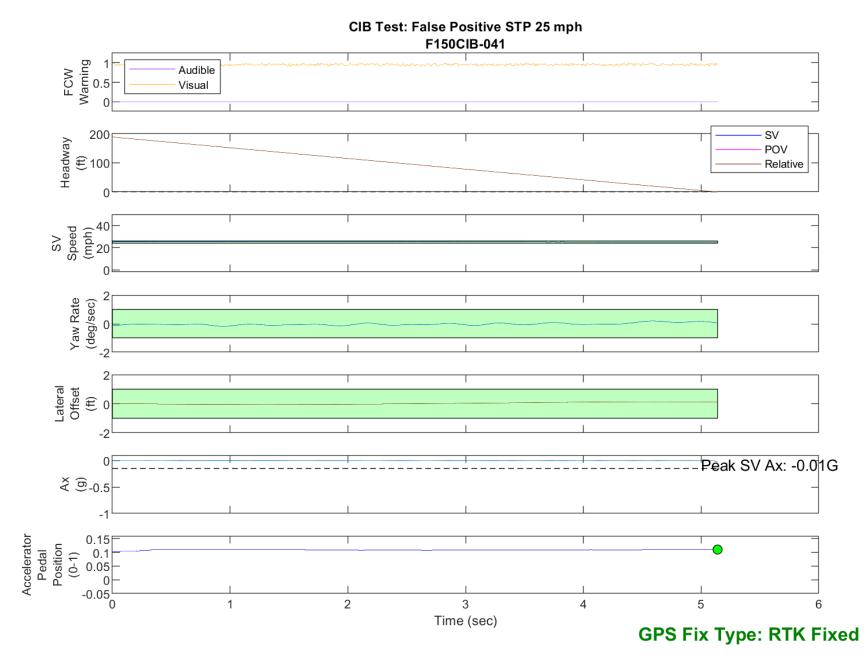
Figure D41. Time History for CIB Run 41, SV Encounters Steel Trench Plate, SV 25 mph

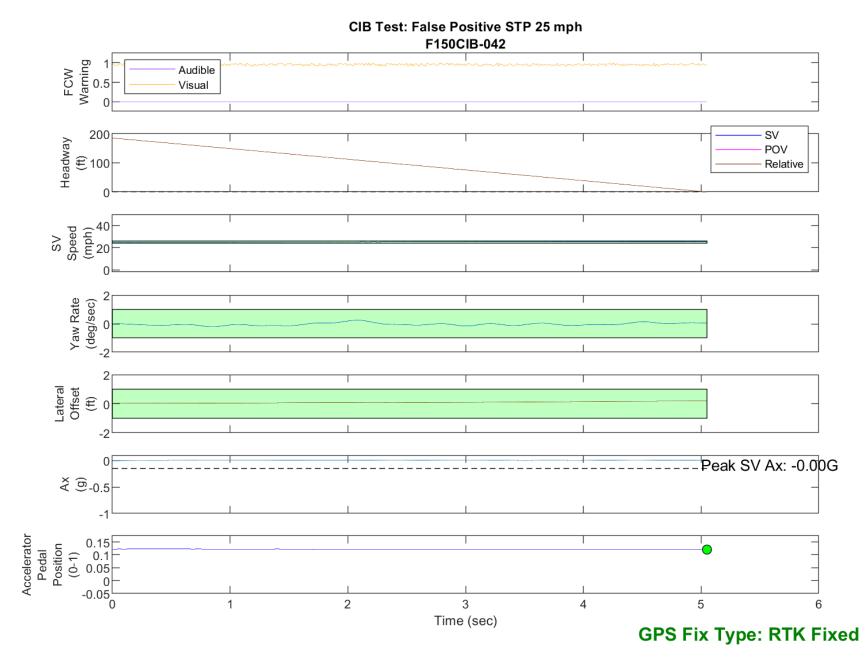
Figure D42. Time History for CIB Run 42, SV Encounters Steel Trench Plate, SV 25 mph

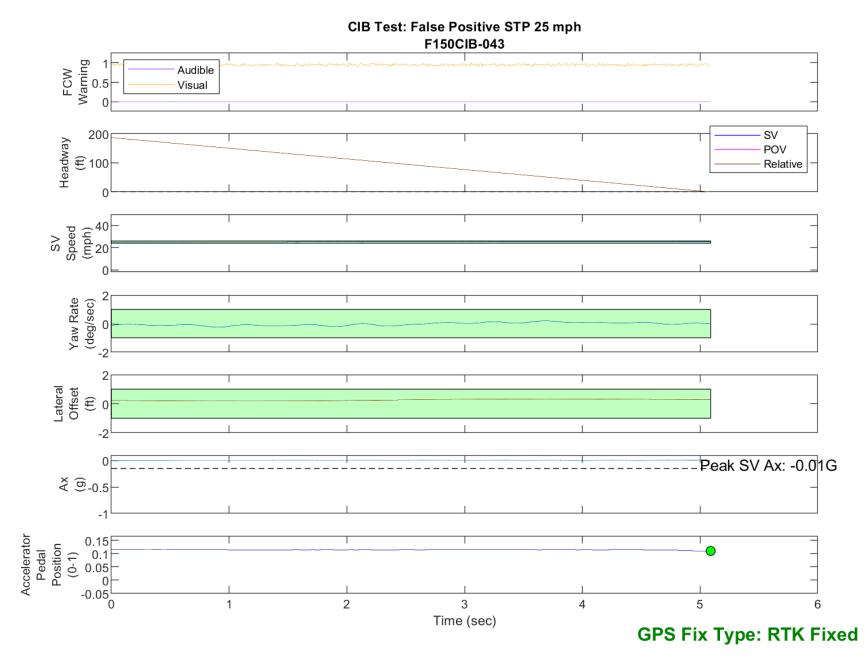
Figure D43. Time History for CIB Run 43, SV Encounters Steel Trench Plate, SV 25 mph

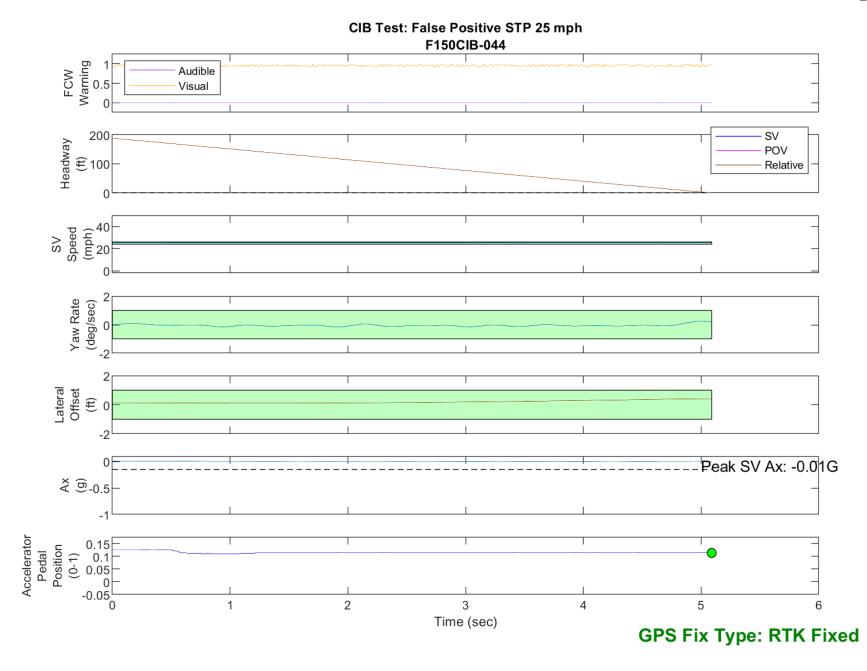
Figure D44. Time History for CIB Run 44, SV Encounters Steel Trench Plate, SV 25 mph

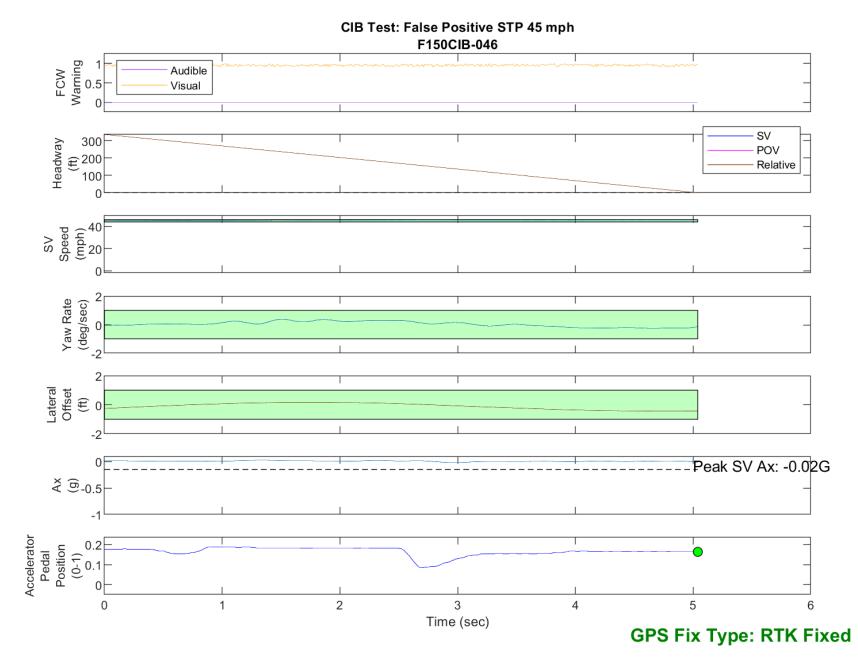
Figure D45. Time History for CIB Run 46, SV Encounters Steel Trench Plate, SV 45 mph

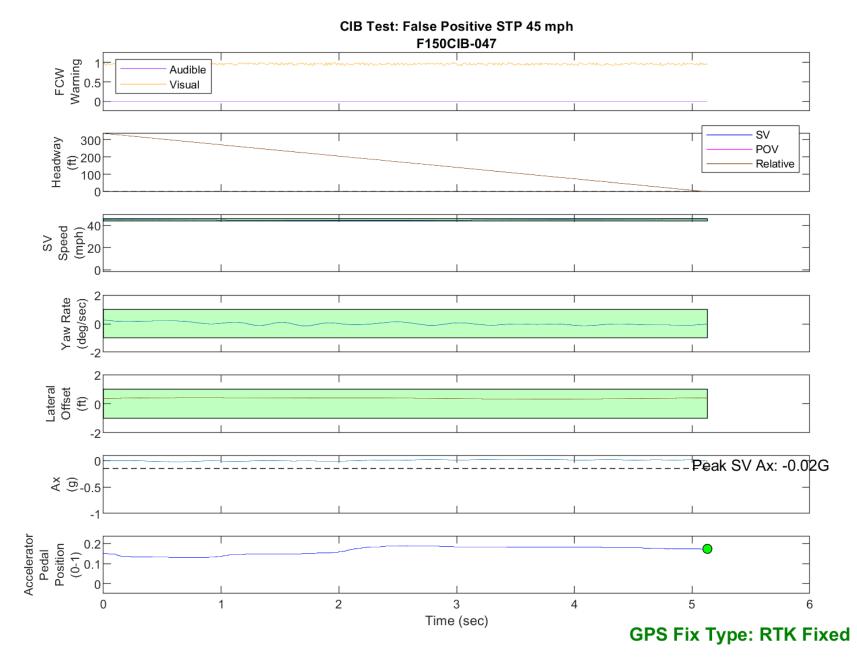
Figure D46. Time History for CIB Run 47, SV Encounters Steel Trench Plate, SV 45 mph

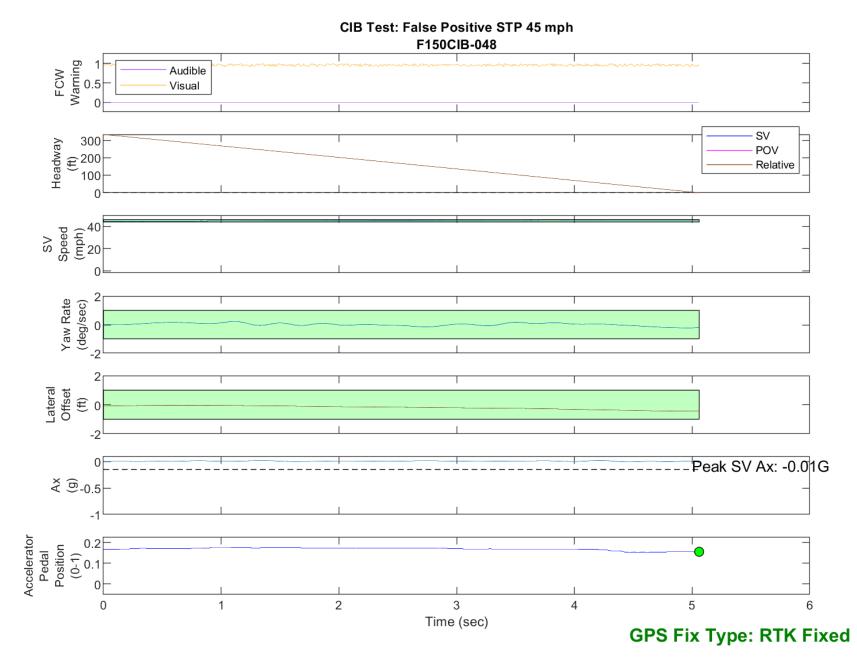
Figure D47. Time History for CIB Run 48, SV Encounters Steel Trench Plate, SV 45 mph

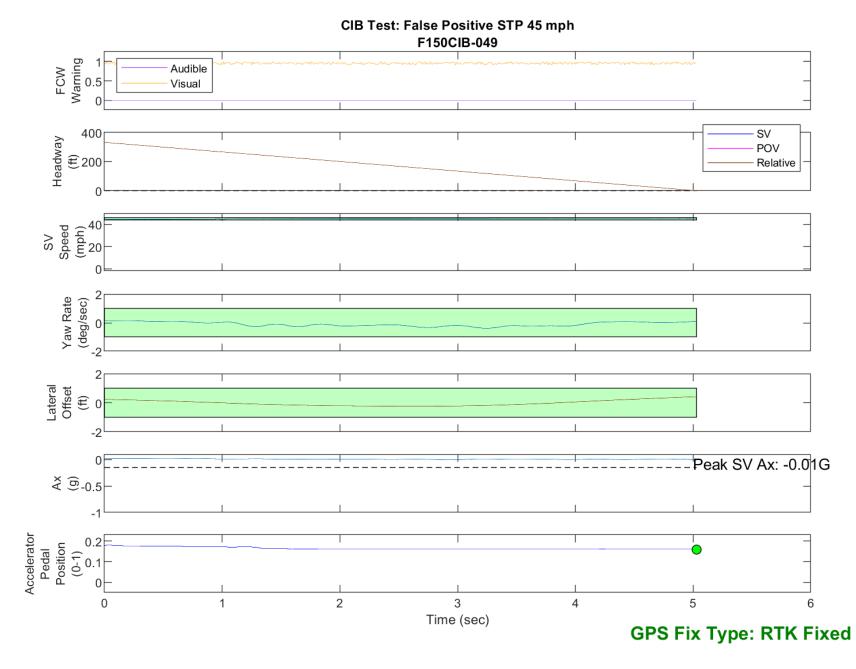
Figure D48. Time History for CIB Run 49, SV Encounters Steel Trench Plate, SV 45 mph

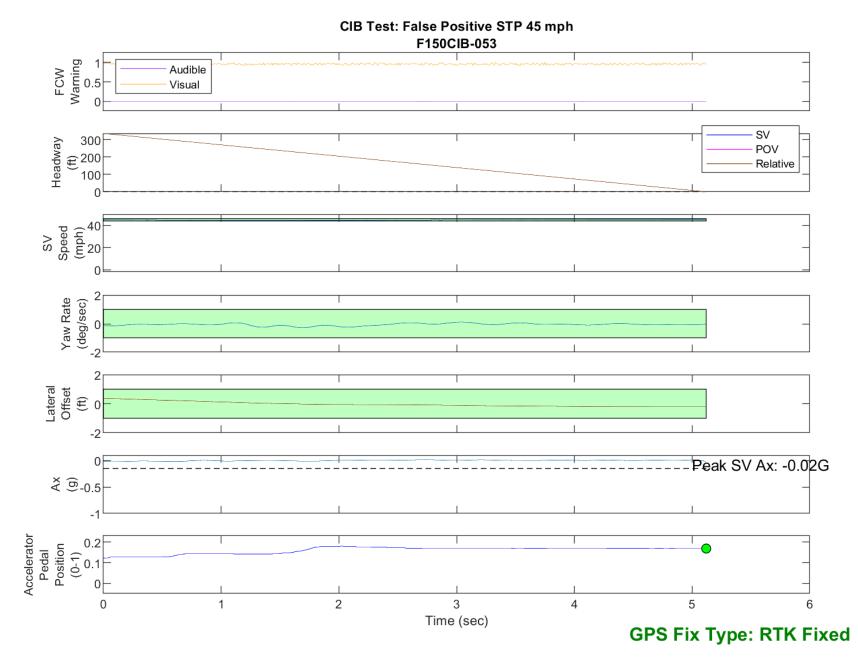
Figure D49. Time History for CIB Run 53, SV Encounters Steel Trench Plate, SV 45 mph

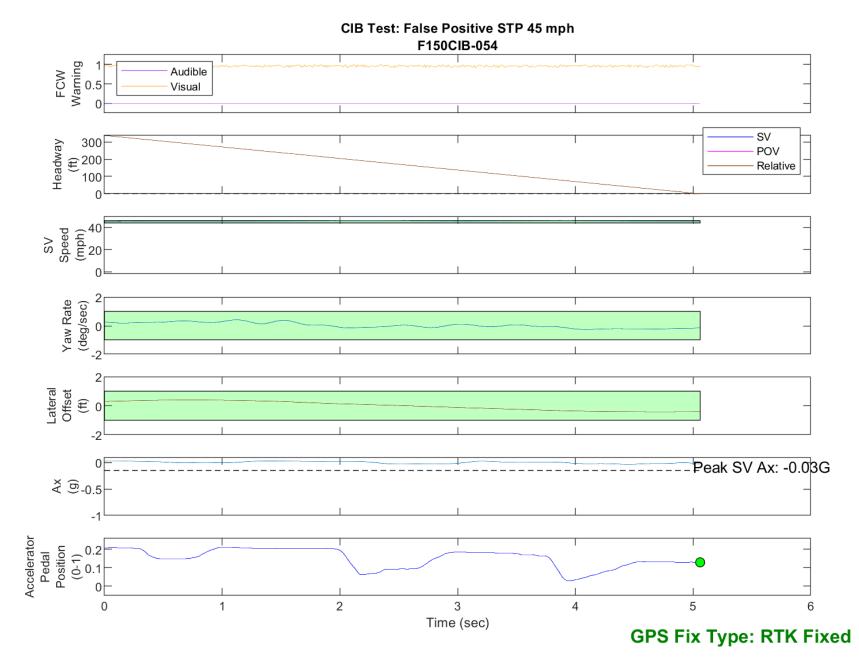
Figure D50. Time History for CIB Run 54, SV Encounters Steel Trench Plate, SV 45 mph

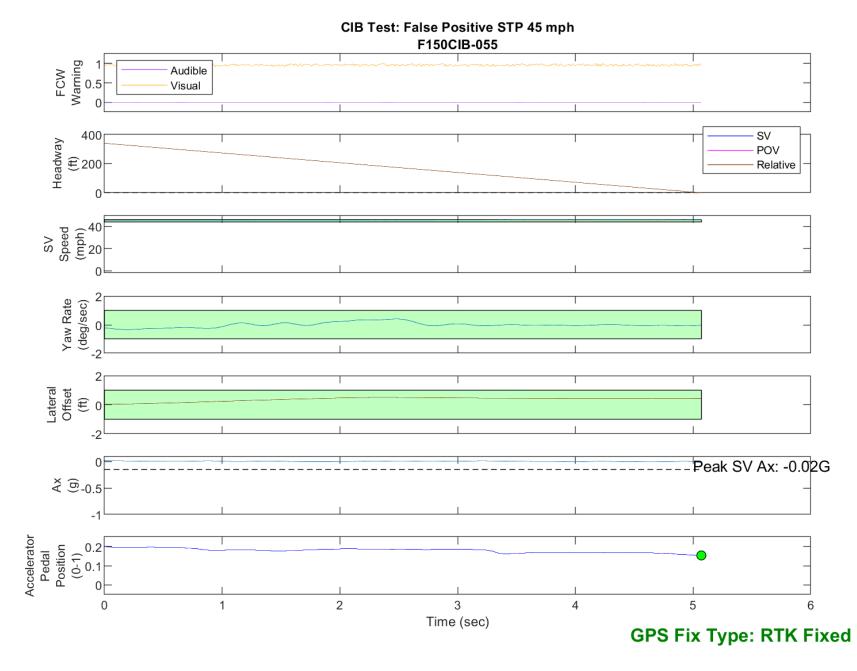
Figure D51. Time History for CIB Run 55, SV Encounters Steel Trench Plate, SV 45 mph
