NEW CAR ASSESSMENT PROGRAM FORWARD COLLISION WARNING CONFIRMATION TEST NCAP-DRI-FCW-20-15

2020 Mazda Mazda6 Sport

DYNAMIC RESEARCH, INC.

Final Report

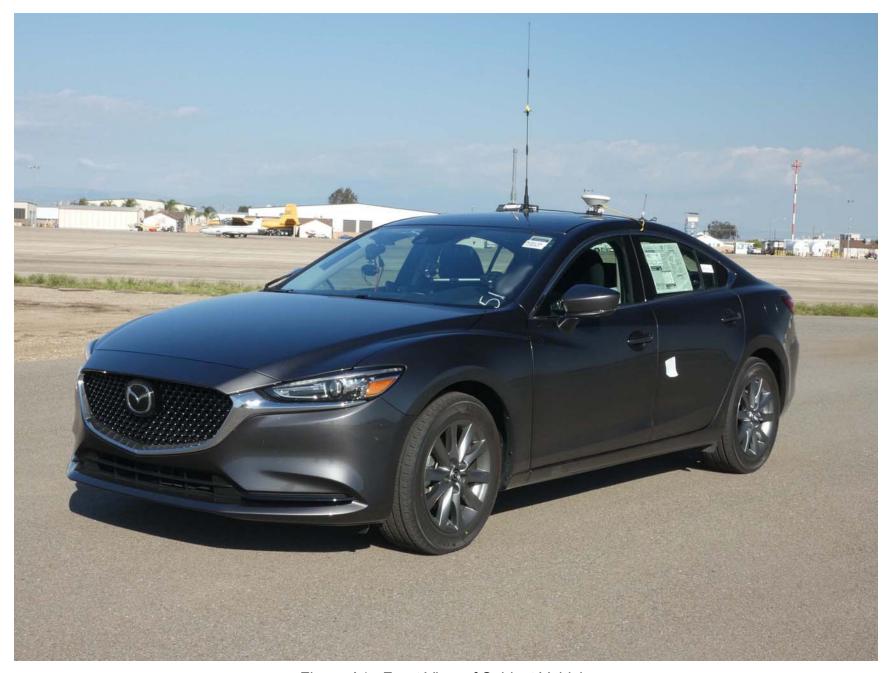
Figure A1. Front View of Subject Vehicle

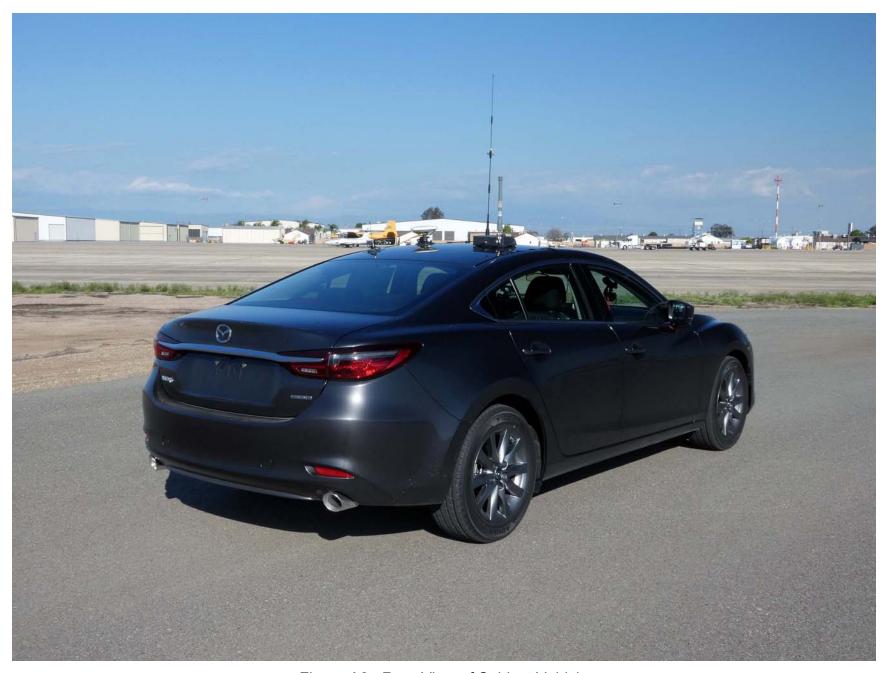
Figure A2. Rear View of Subject Vehicle

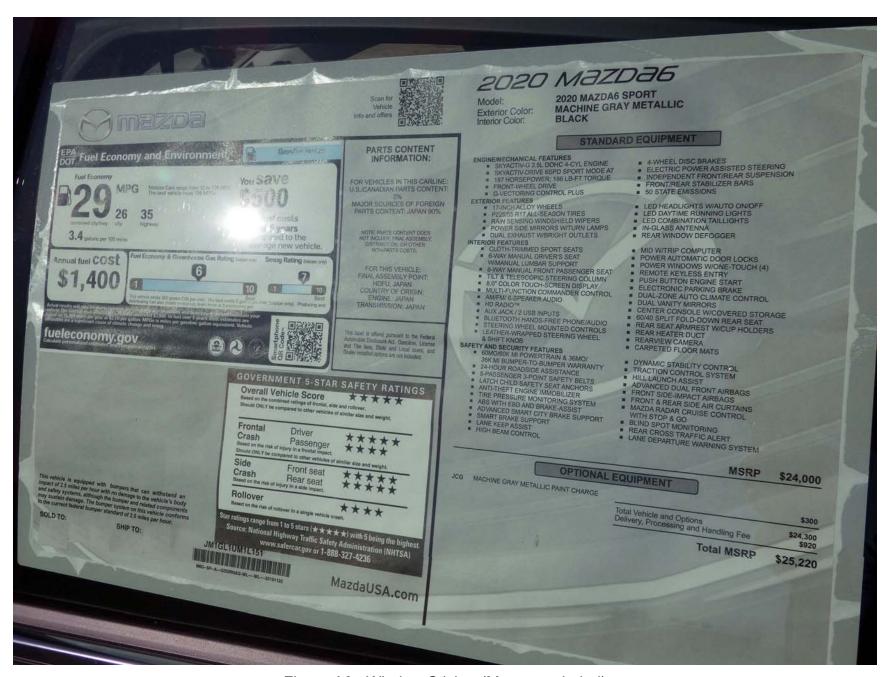
Figure A3. Window Sticker (Monroney Label)

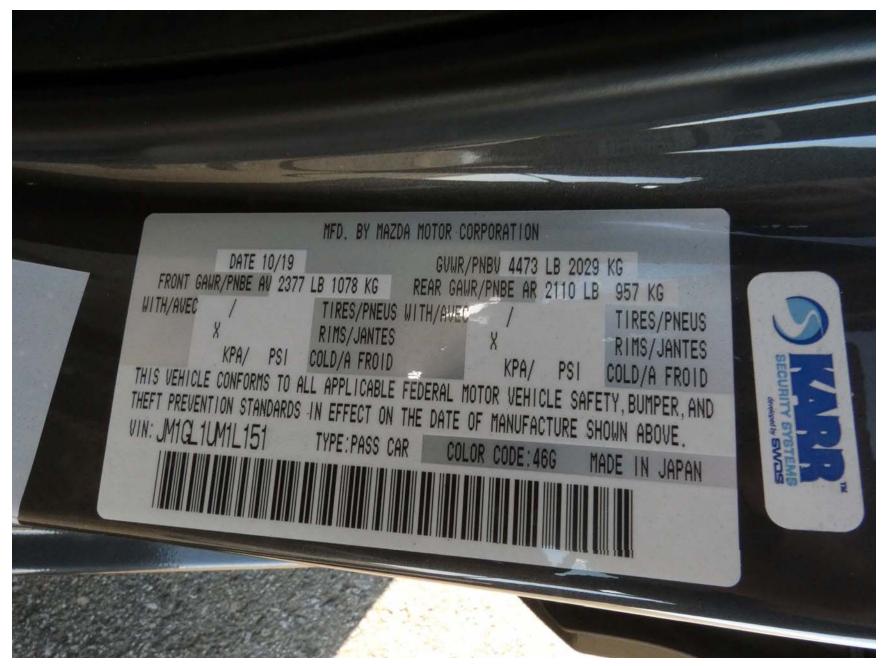
Figure A4. Vehicle Certification Label

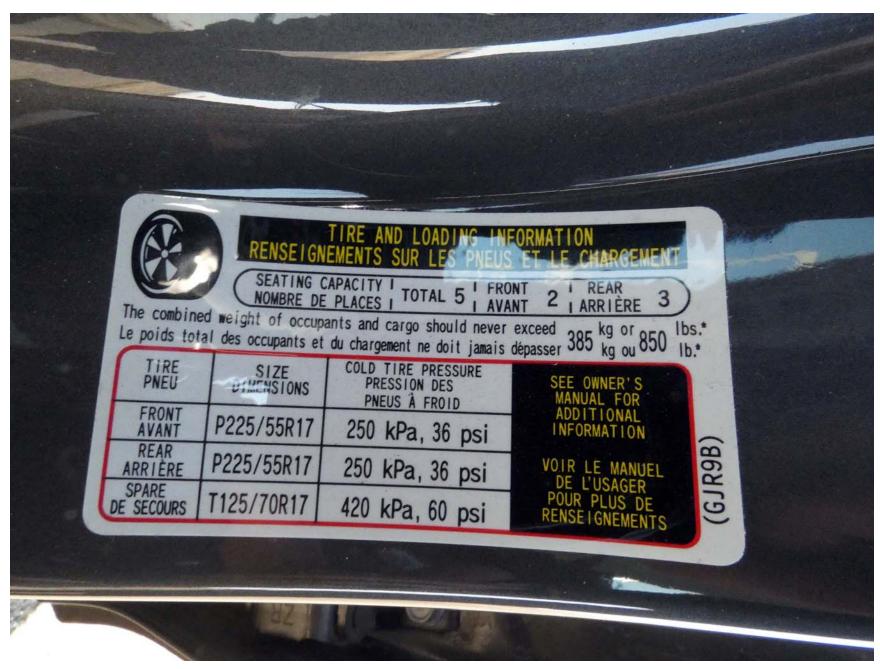
Figure A5. Tire Placard

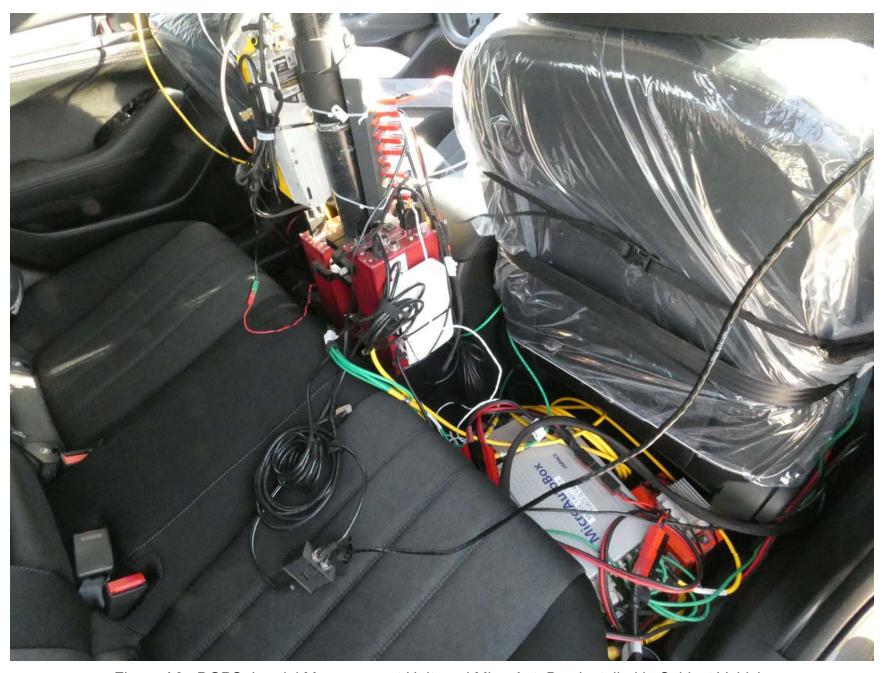
Figure A8. DGPS, Inertial Measurement Unit, and MicroAutoBox Installed in Subject Vehicle

Data Acquisition System	Acceleration, Roll, Yaw, and Pitch Rate, Forward and Lateral Velocity, Roll and Pitch Angle are sent over Ethernet to the MicroAutoBox. The Oxford IMUs are calibrated per the manufacturer's recommended schedule (listed above).			Base Board		549068
				I/O Board		588523

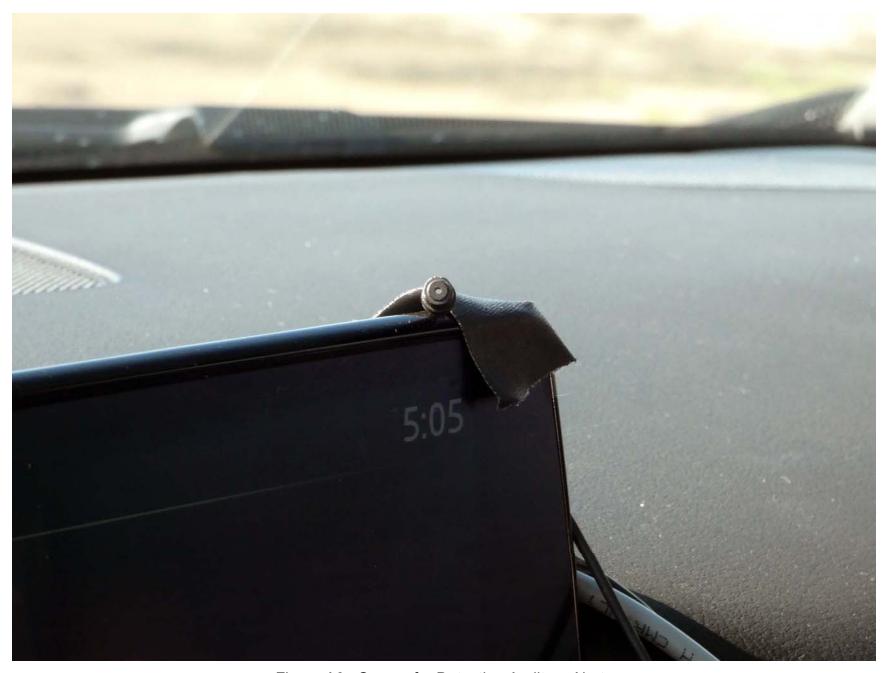
Figure A9. Sensor for Detecting Auditory Alerts

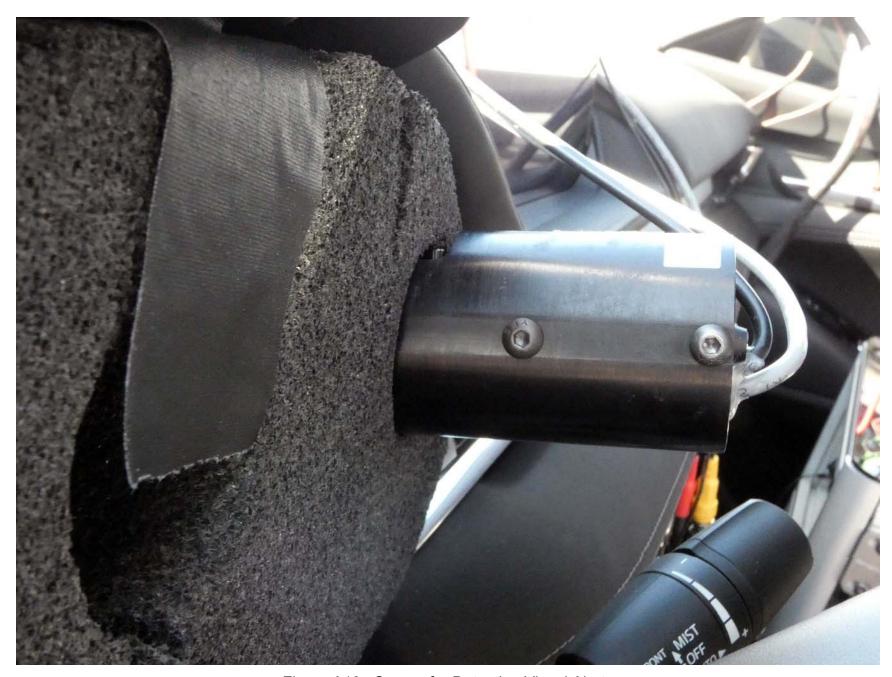
Figure A10. Sensor for Detecting Visual Alerts

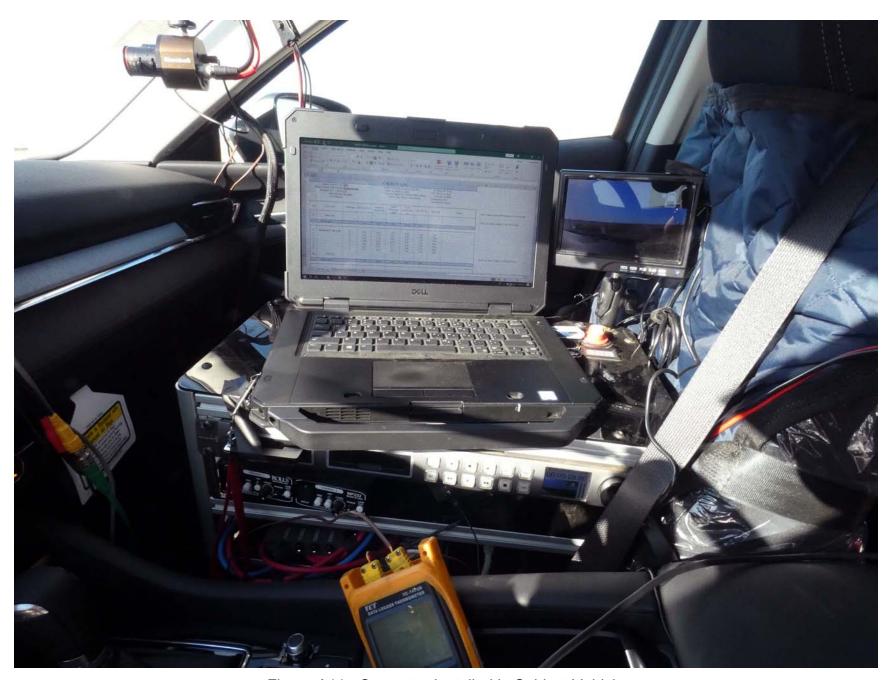
Figure A11. Computer Installed in Subject Vehicle

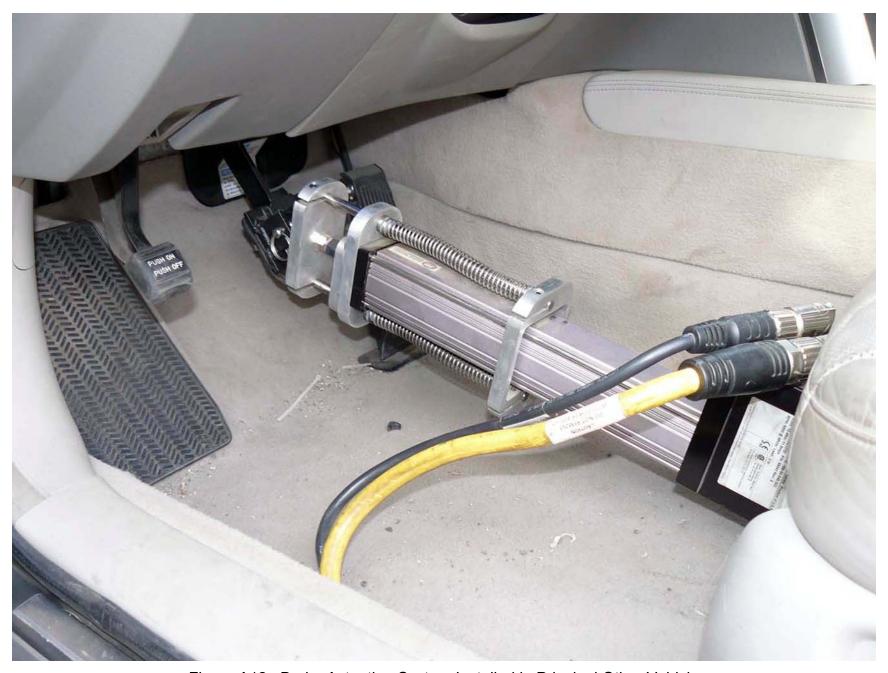
Figure A12. Brake Actuation System Installed in Principal Other Vehicle

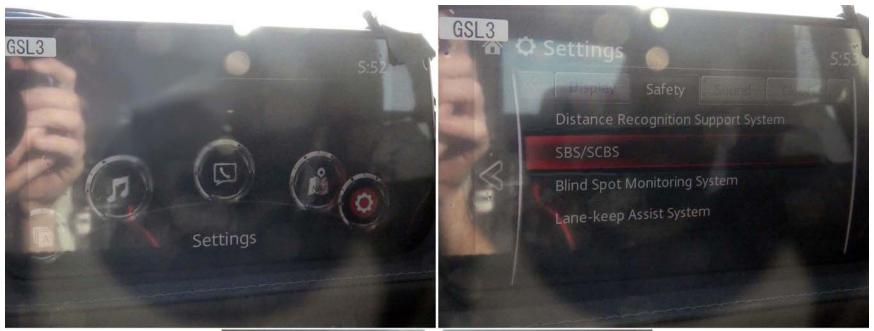
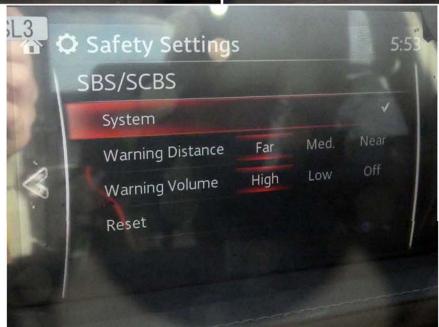
Figure A13. System Setting Menus

Is the vehicle equipped with a switch whose purpose is to render	X	Yes
FCW inoperable?		No
If yes, please provide a full description including the switch location a operation, any associated instrument panel indicator, etc.		
A touchscreen located in the center of the dash panel provides the settings (Appendix A, Figure A13). The hierarchy is:	<u>an int</u>	erface to
<u>Settings</u>		
Safety - Select SBS/SCBS		
System - Select on or off (check or unchec	<u>k)</u>	
When the SBS system is turned off, the SBS OFF indicator light When the engine is restarted, the system becomes operational.		<u>s on.</u>
Is the vehicle equipped with a control whose purpose is to adjust the range setting or otherwise influence the operation of FCW?	X	Yes No
If yes, please provide a full description.		
A touchscreen located in the center of the dash panel provides the settings (Appendix A, Figure A13). The hierarchy is:	an int	erface to

<u>Settings</u>		
Safety - Select SBS/SCBS		
Warning Distance- Select Far, Med., Near

Warning Volume- Select High, Low, Off

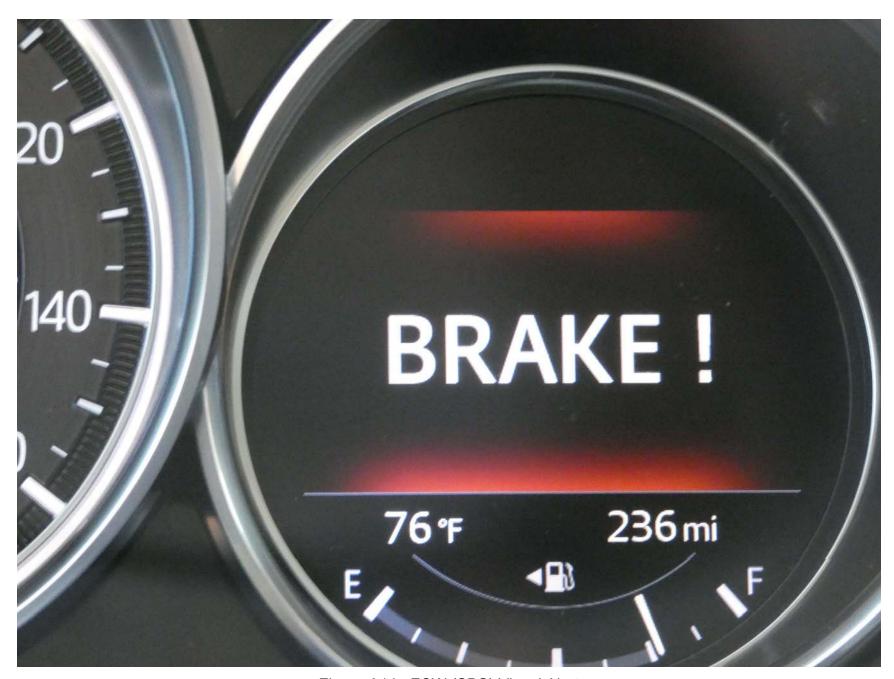
Figure A14. FCW (SBS) Visual Alert

<u>Visual warning, located in the instrument cluster: Symbol & Word, Red color, Flashes on/off. See Appendix A, Figure A14.</u>

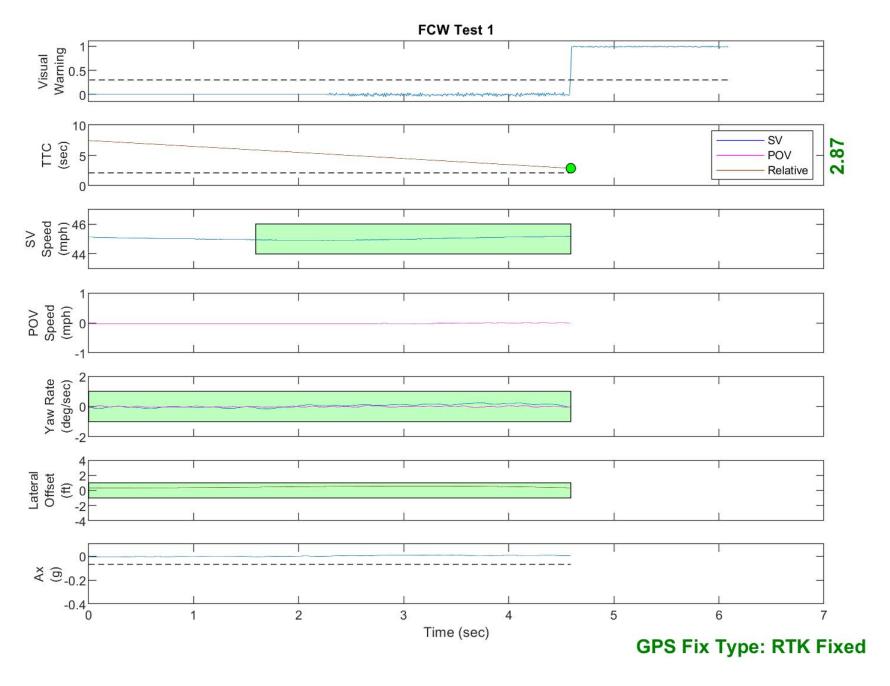
Figure D1. Example Time History for Test Type 1, Passing

Examples of time history plots for each test type (including passing, failing and invalid runs) are shown in Figure D1 through Figure D6. Actual time history data plots for the vehicle under consideration are provided subsequently.

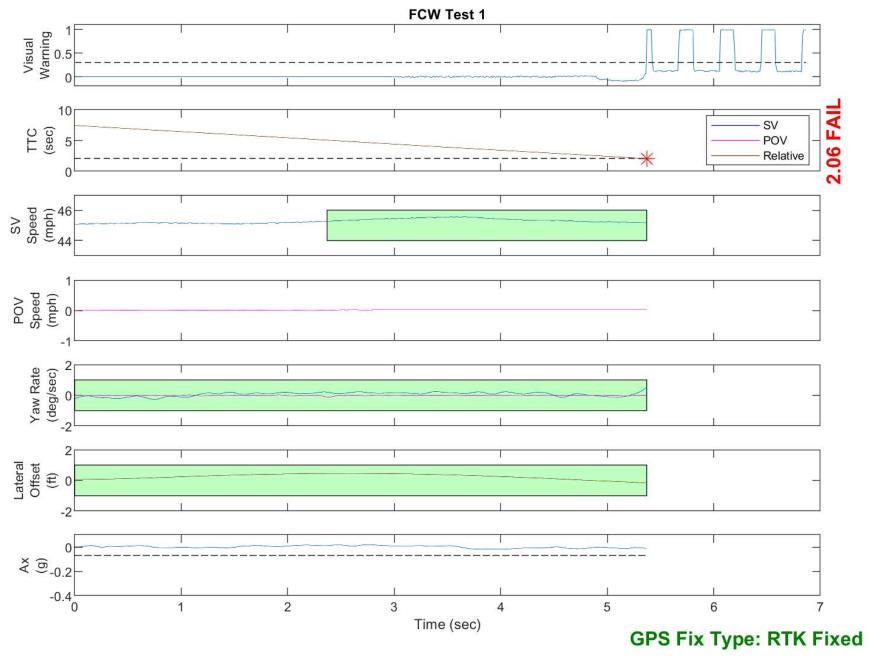
Figure D2. Example Time History for Test Type 1, Failing

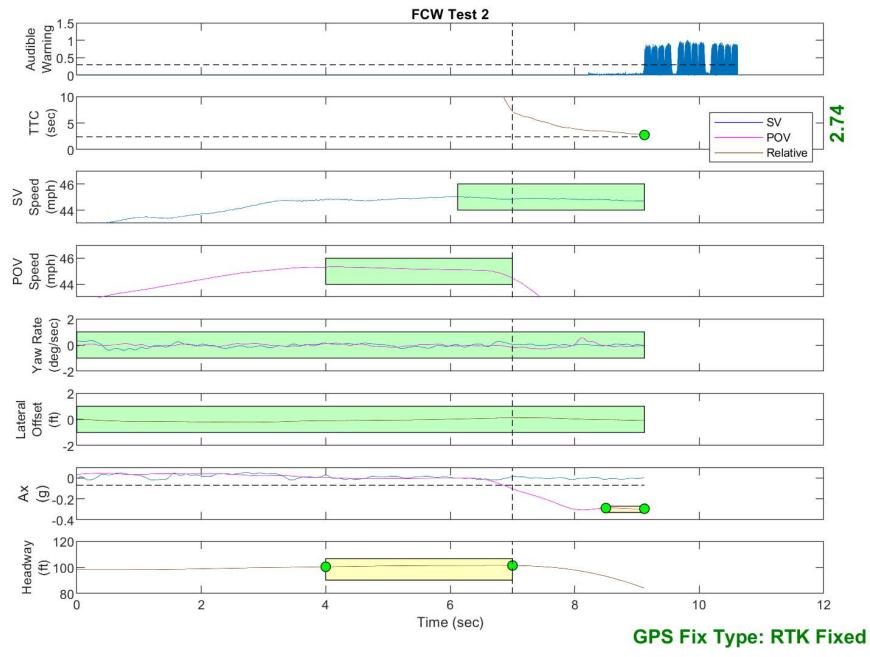
Figure D3. Example Time History for Test Type 2, Passing

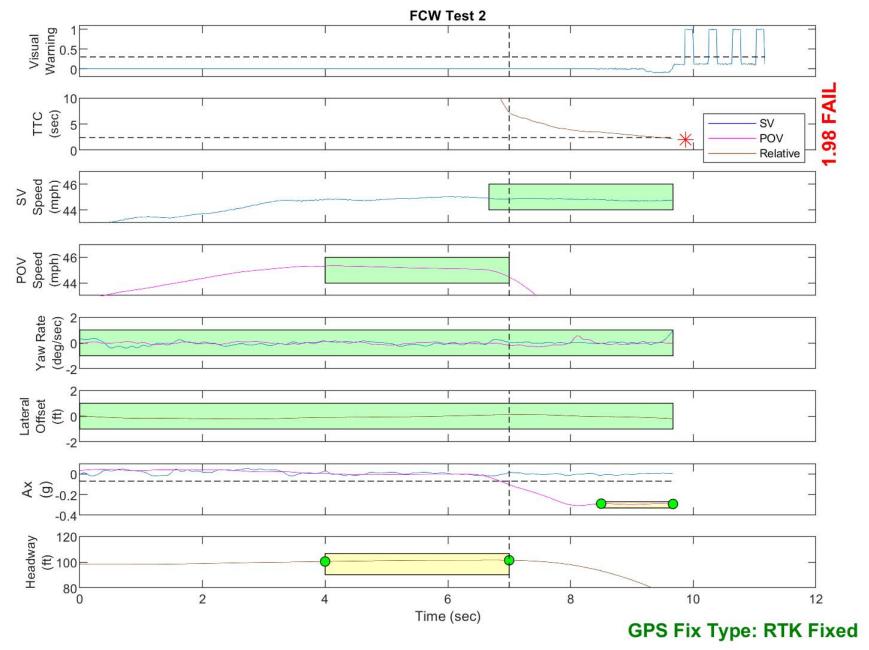
Figure D4. Example Time History for Test Type 2, Failing

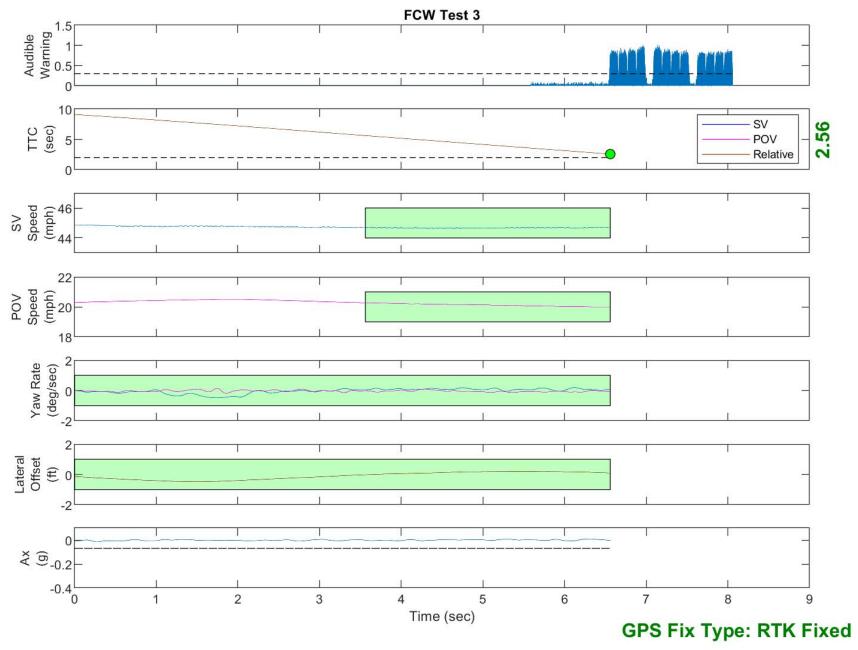
Figure D5. Example Time History for Test Type 3, Passing

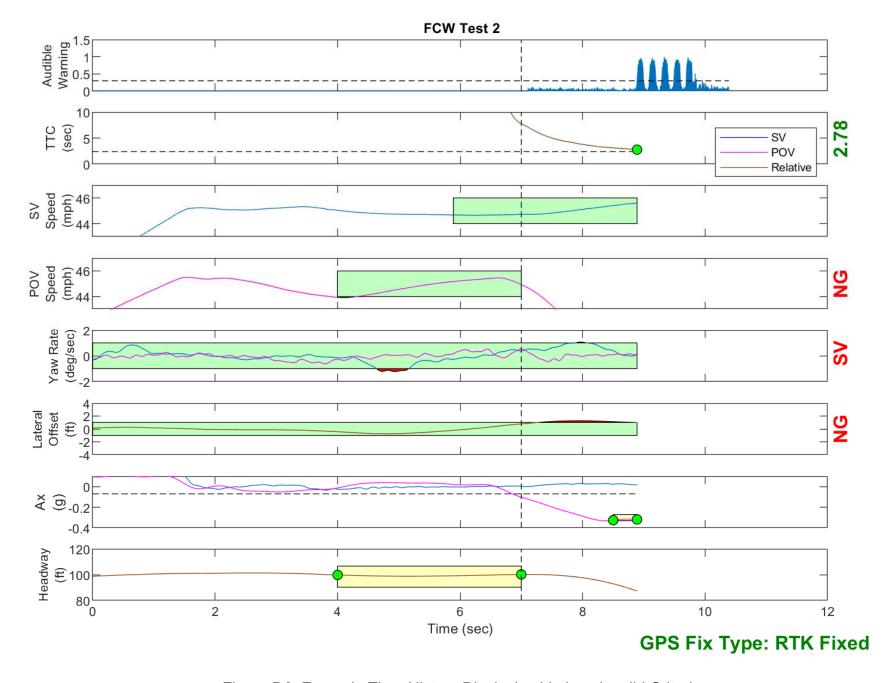
Figure D6. Example Time History Displaying Various Invalid Criteria

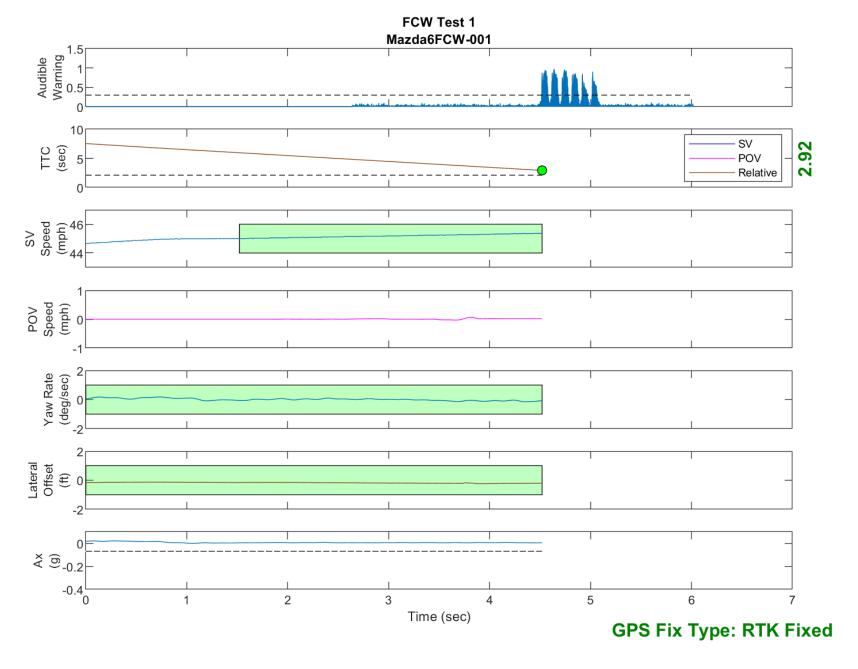
Figure D7. Time History for Run 1, FCW Test 1, Audible Warning

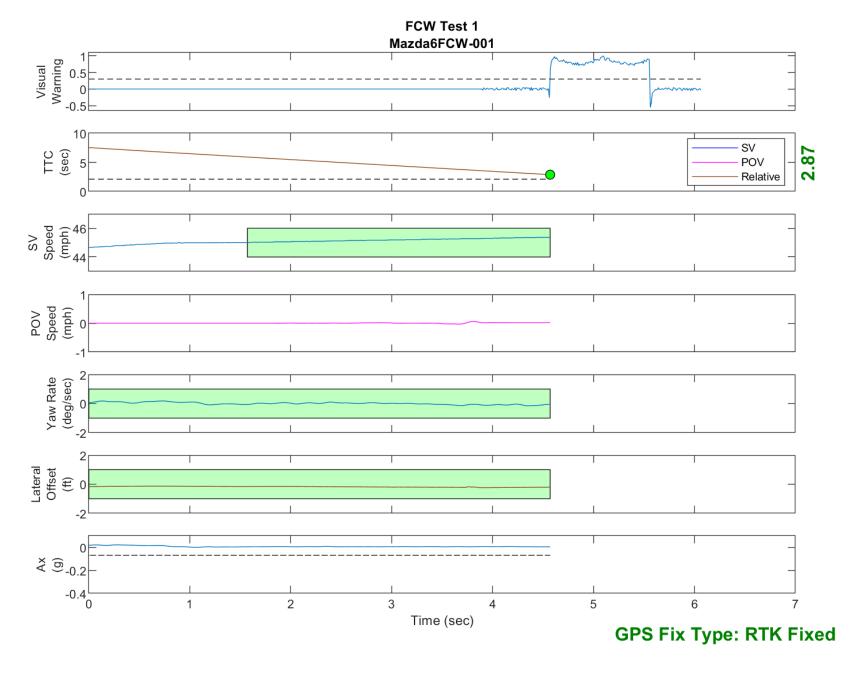
Figure D8. Time History for Run 1, FCW Test 1, Visual Warning

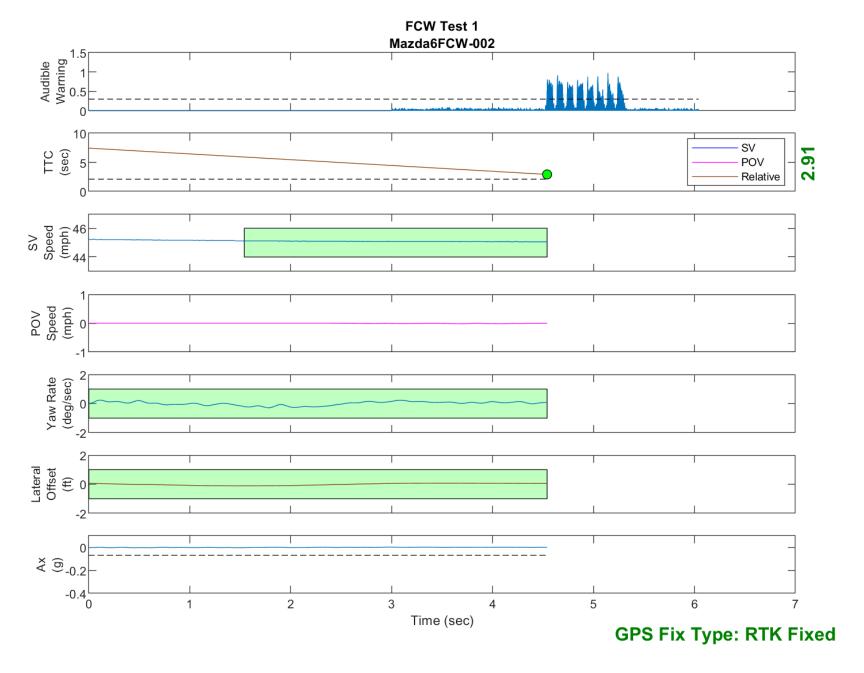
Figure D9. Time History for Run 2, FCW Test 1, Audible Warning

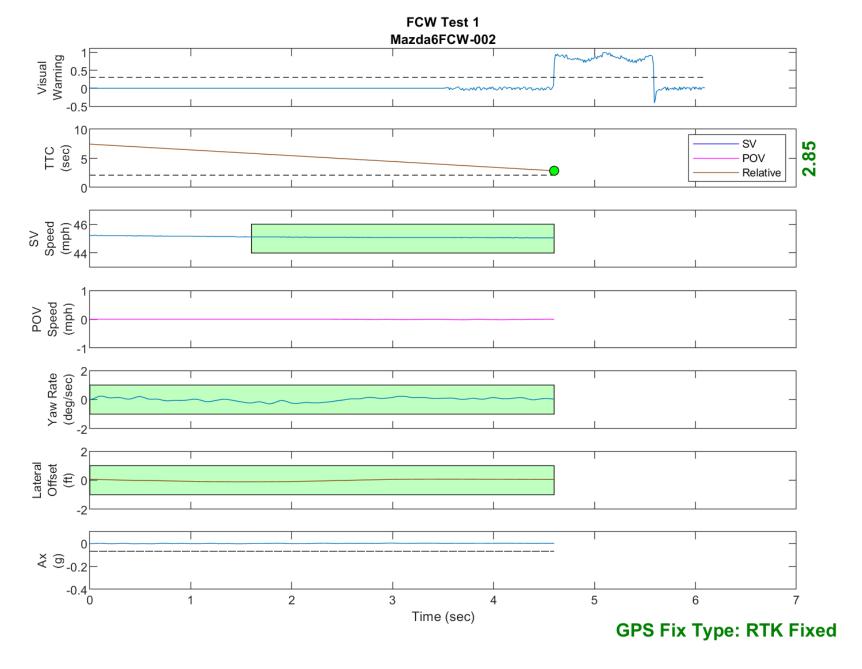
Figure D10. Time History for Run 2, FCW Test 1, Visual Warning

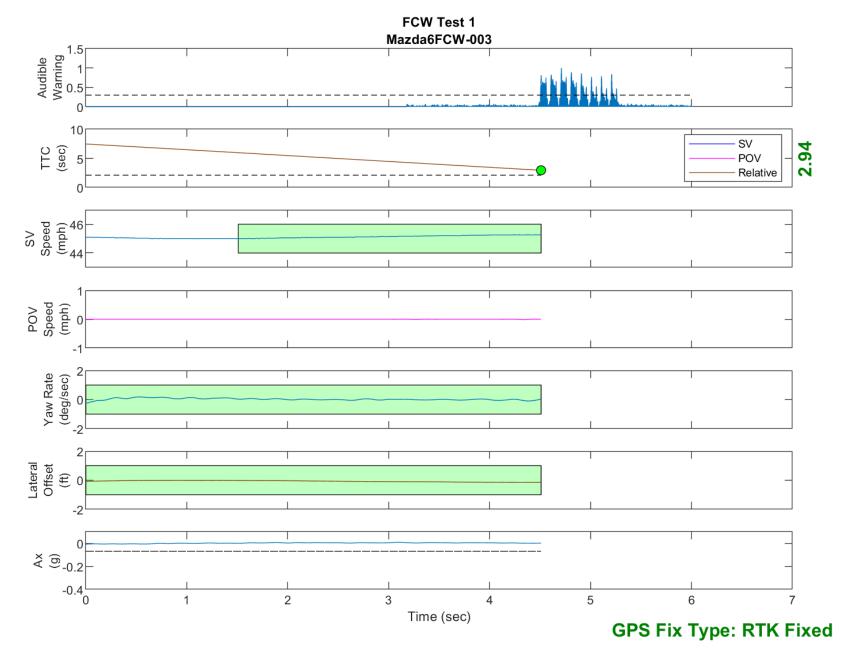
Figure D11. Time History for Run 3, FCW Test 1, Audible Warning

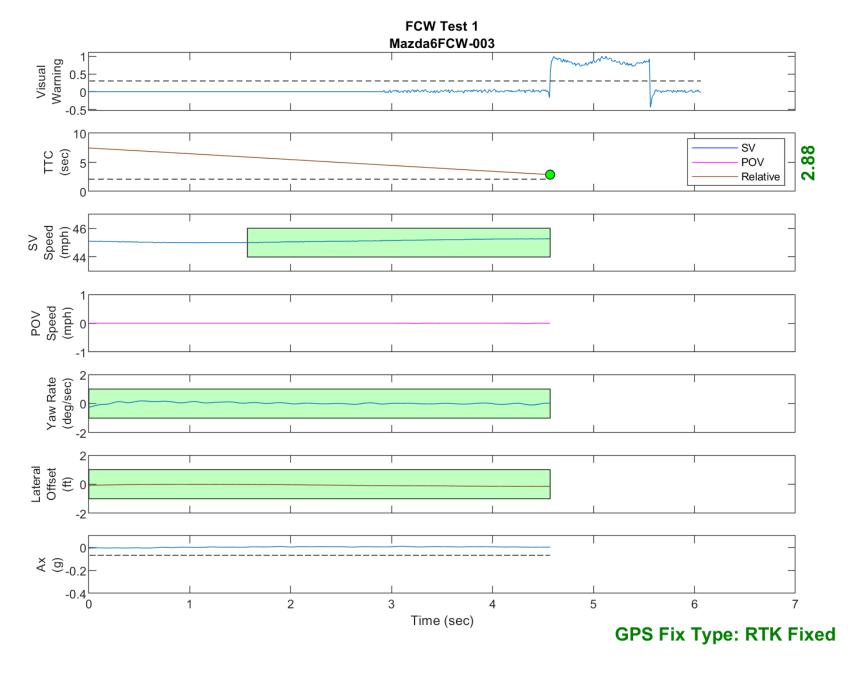
Figure D12. Time History for Run 3, FCW Test 1, Visual Warning

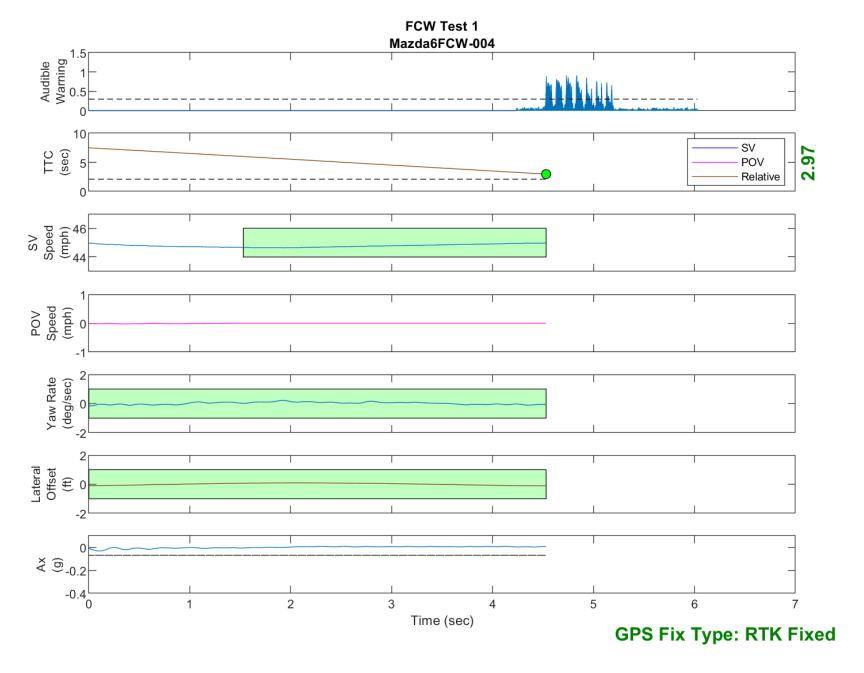
Figure D13. Time History for Run 4, FCW Test 1, Audible Warning

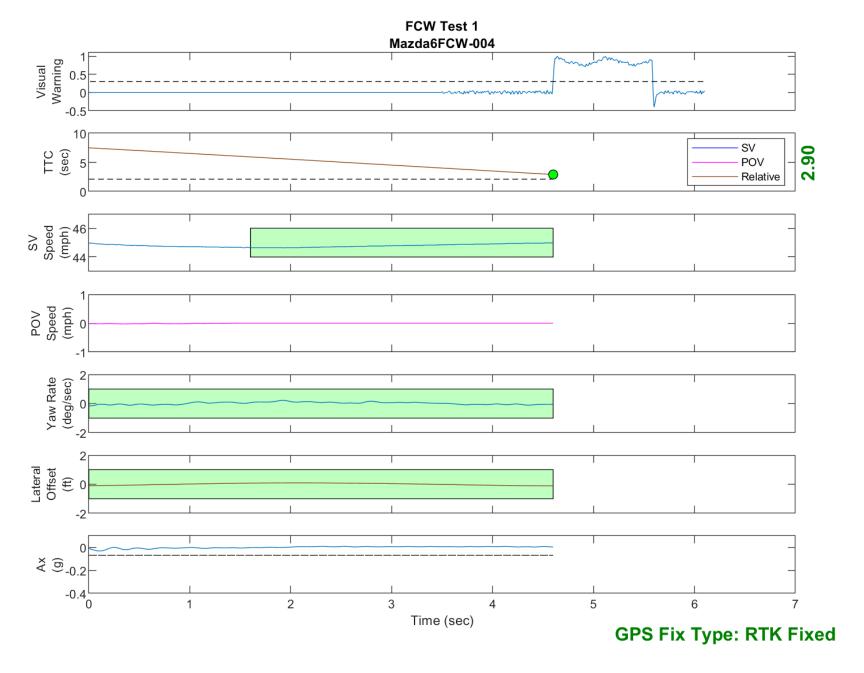
Figure D14. Time History for Run 4, FCW Test 1, Visual Warning

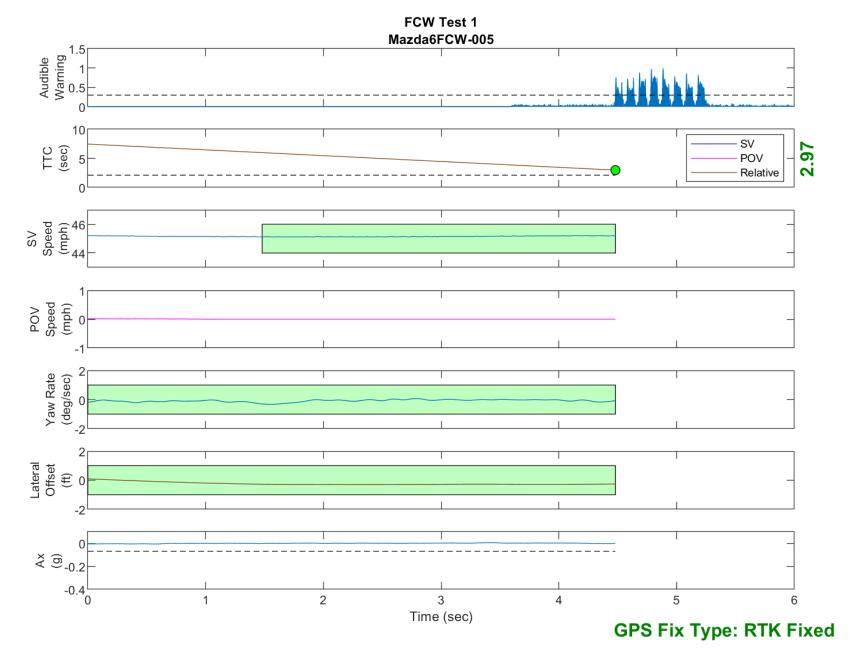
Figure D15. Time History for Run 5, FCW Test 1, Audible Warning

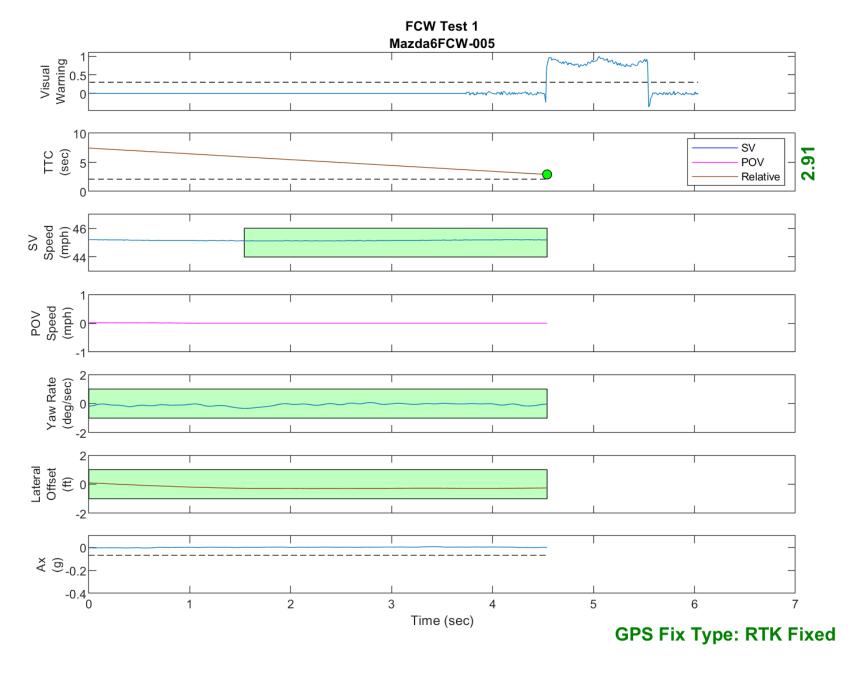
Figure D16. Time History for Run 5, FCW Test 1, Visual Warning

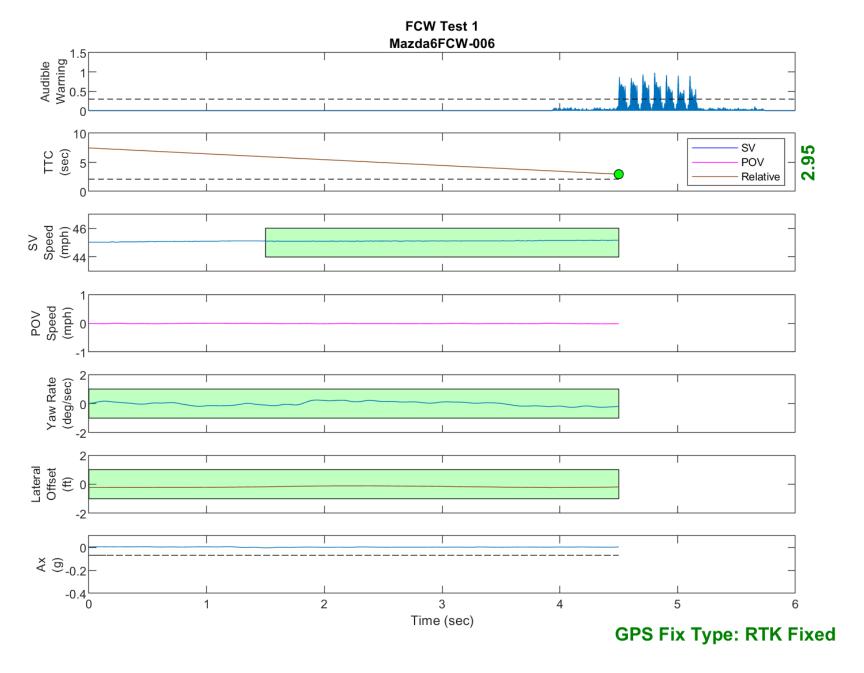
Figure D17. Time History for Run 6, FCW Test 1, Audible Warning

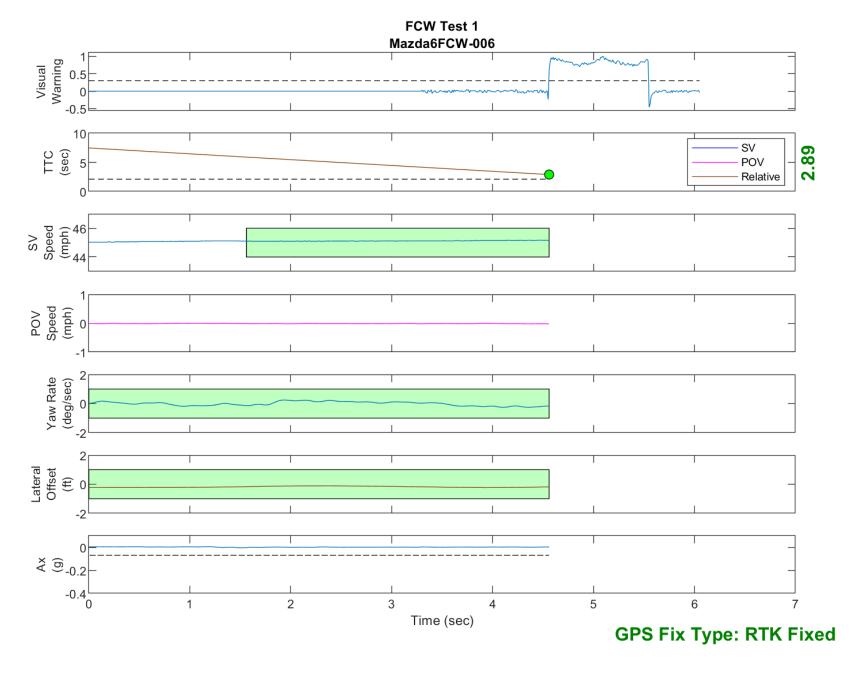
Figure D18. Time History for Run 6, FCW Test 1, Visual Warning

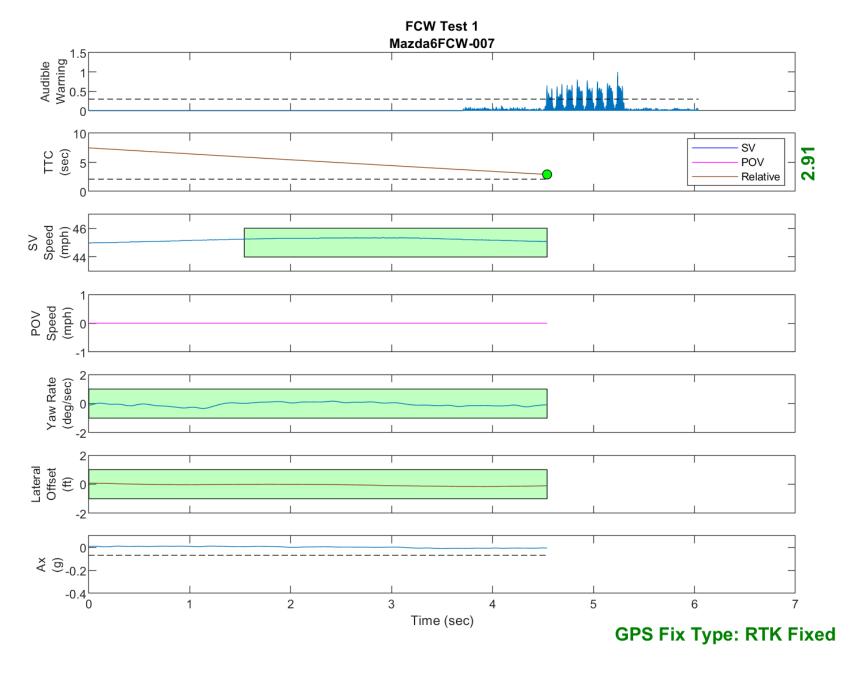
Figure D19. Time History for Run 7, FCW Test 1, Audible Warning

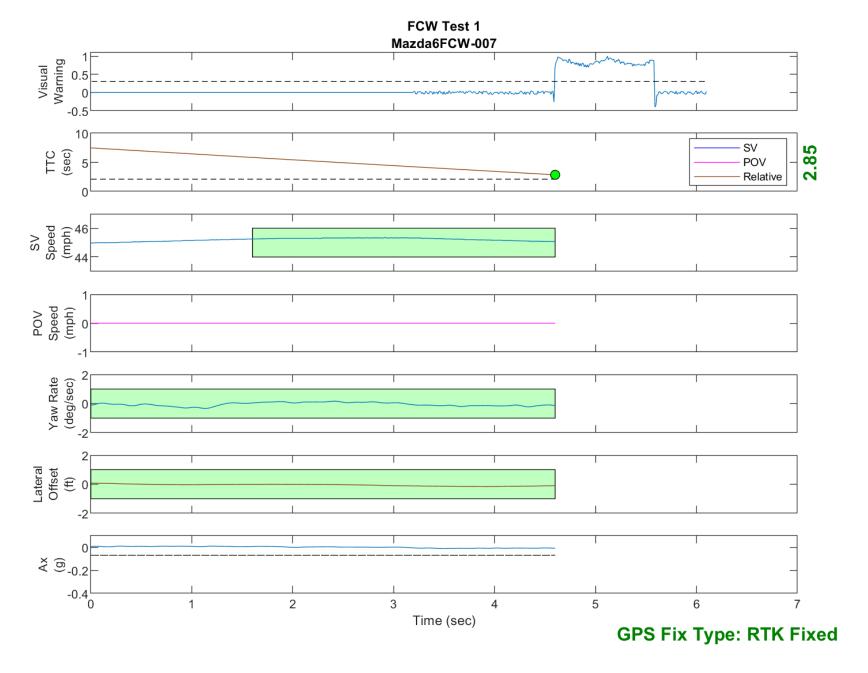
Figure D20. Time History for Run 7, FCW Test 1, Visual Warning

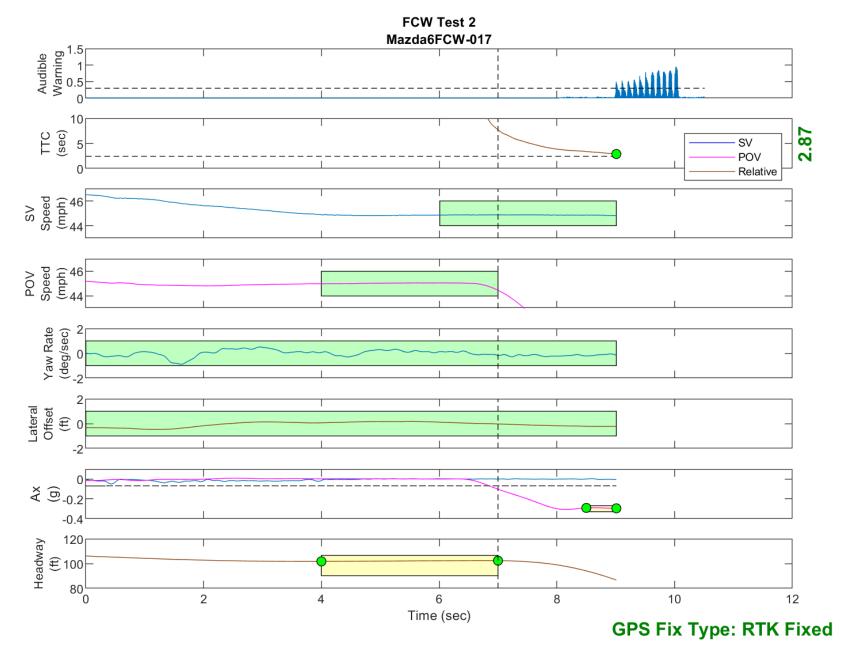
Figure D21. Time History for Run 17, FCW Test 2, Audible Warning

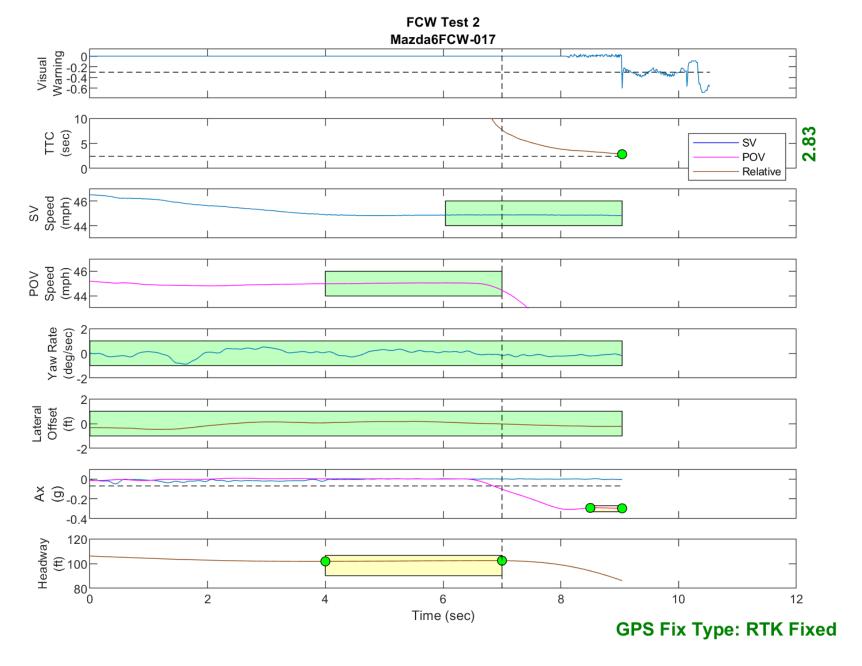
Figure D22. Time History for Run 17, FCW Test 2, Visual Warning

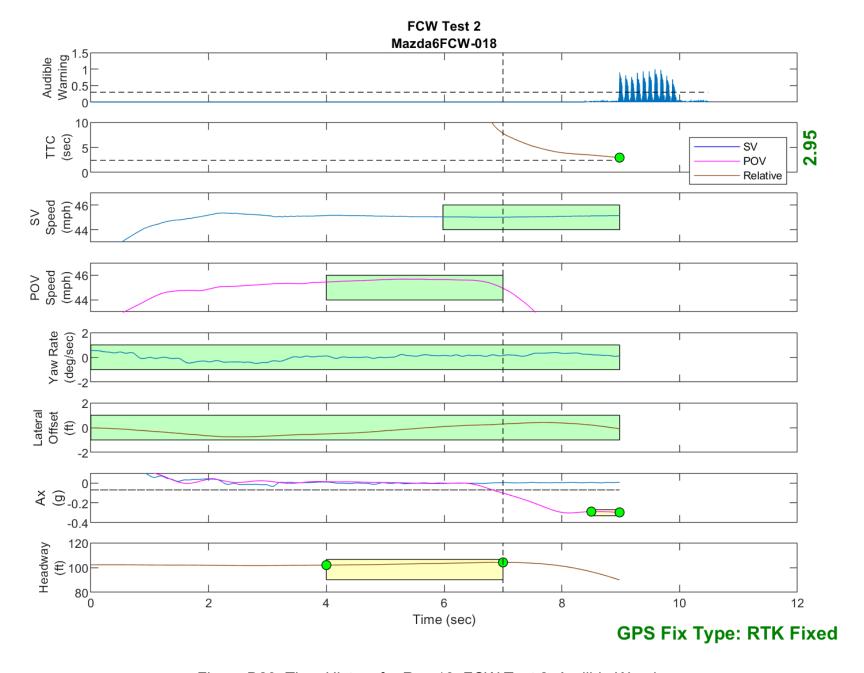
Figure D23. Time History for Run 18, FCW Test 2, Audible Warning

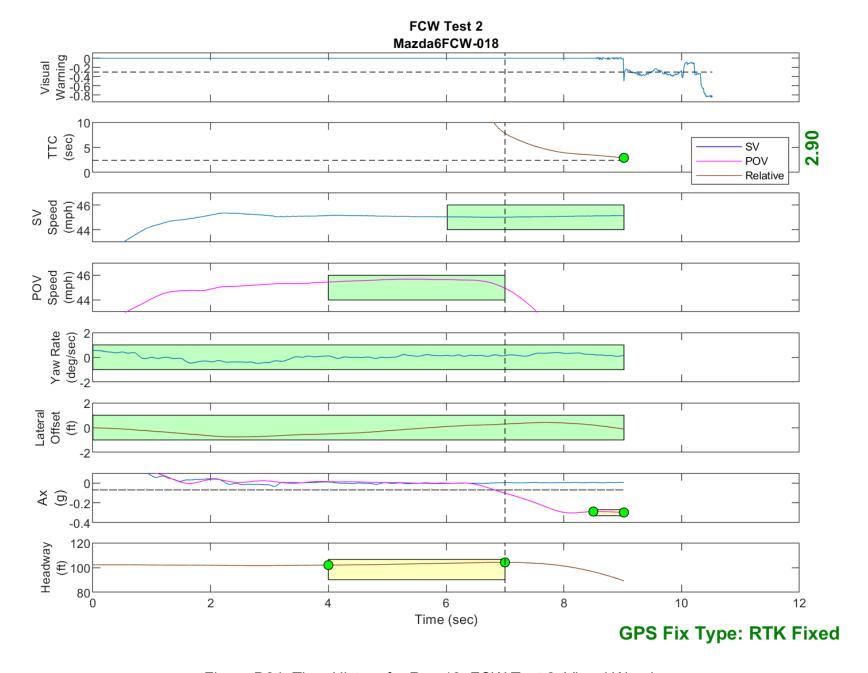
Figure D24. Time History for Run 18, FCW Test 2, Visual Warning

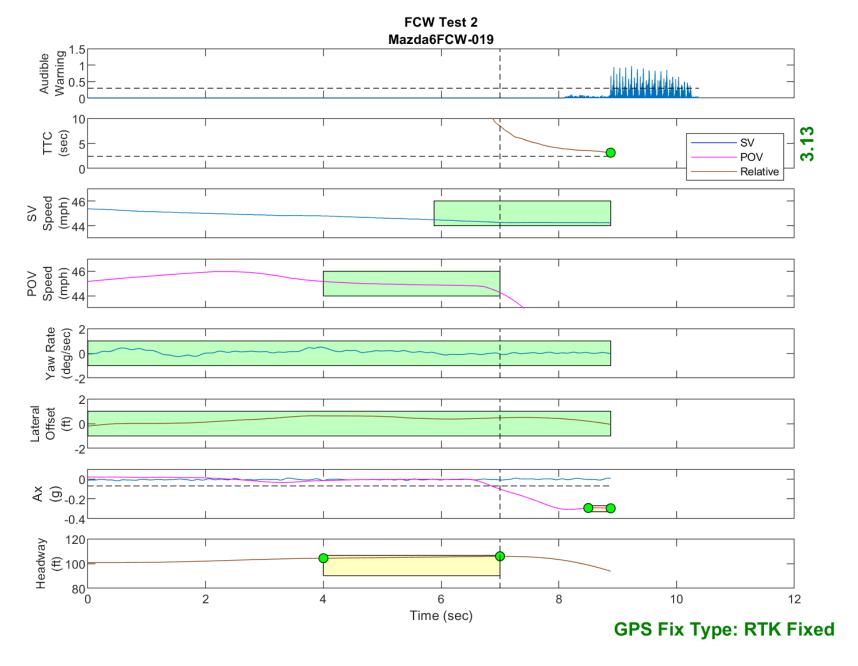
Figure D25. Time History for Run 19, FCW Test 2, Audible Warning

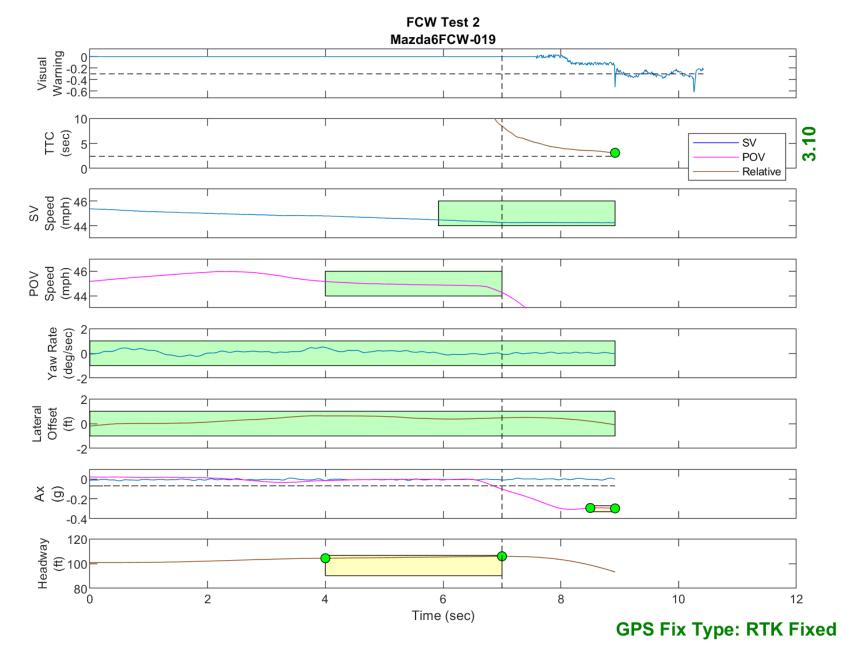
Figure D26. Time History for Run 19, FCW Test 2, Visual Warning
