NEW CAR ASSESSMENT PROGRAM FORWARD COLLISION WARNING CONFIRMATION TEST NCAP-DRI-FCW-20-15

2020 Mazda Mazda6 Sport

DYNAMIC RESEARCH, INC.

Final Report

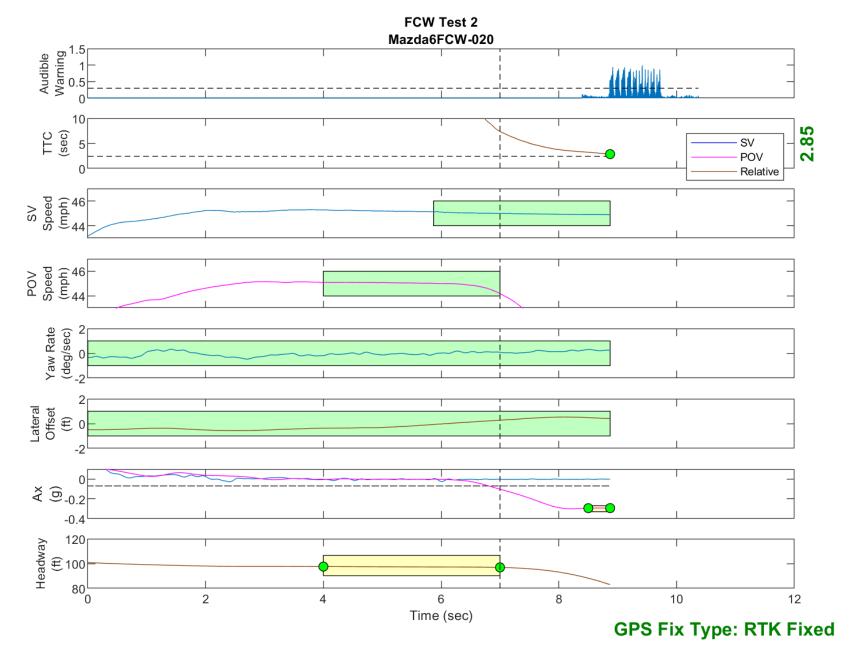
Figure D27. Time History for Run 20, FCW Test 2, Audible Warning

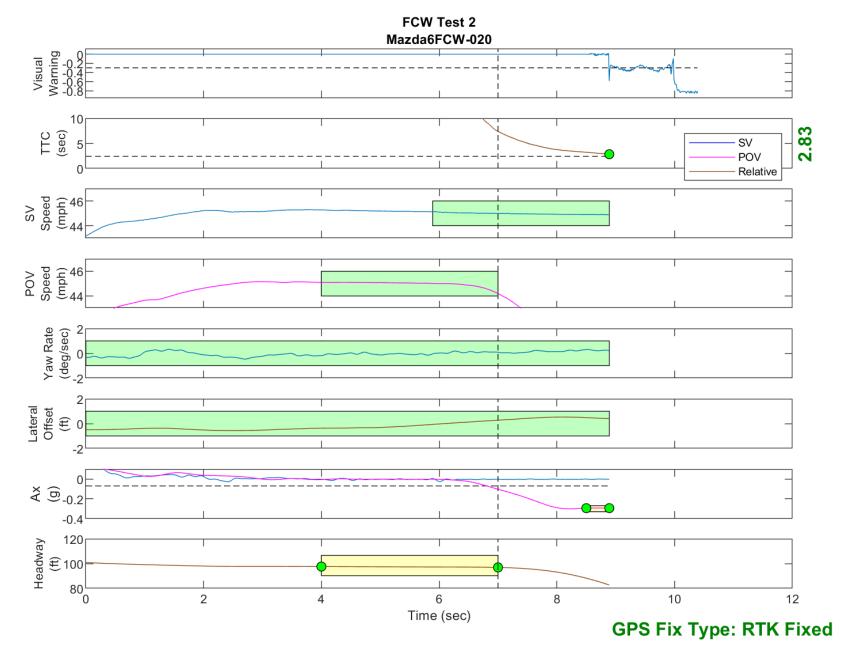
Figure D28. Time History for Run 20, FCW Test 2, Visual Warning

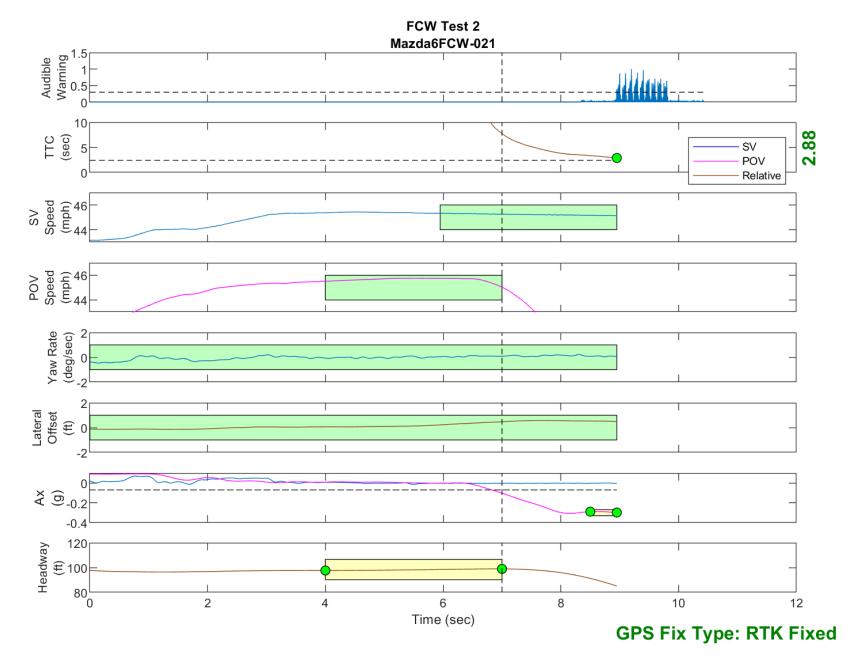
Figure D29. Time History for Run 21, FCW Test 2, Audible Warning

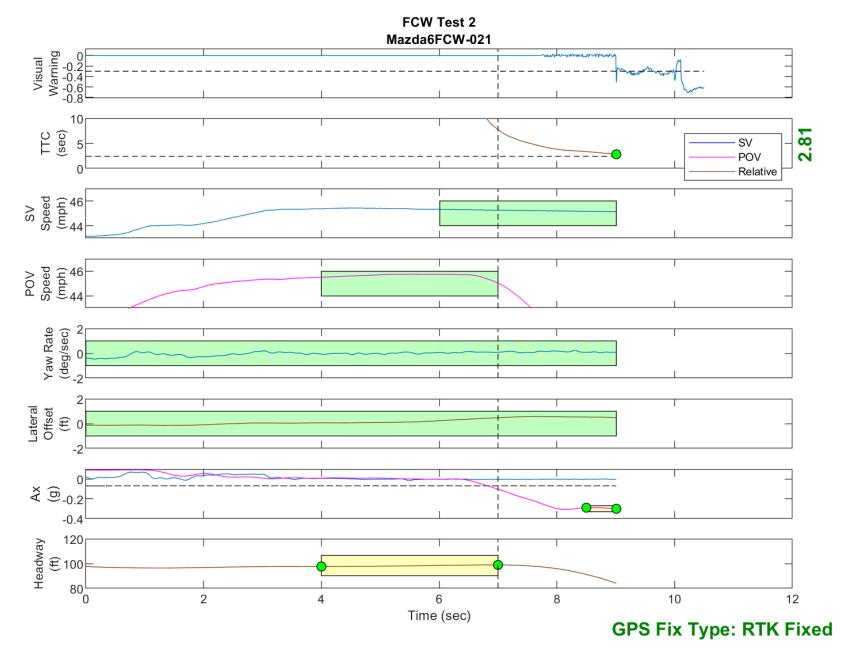
Figure D30. Time History for Run 21, FCW Test 2, Visual Warning

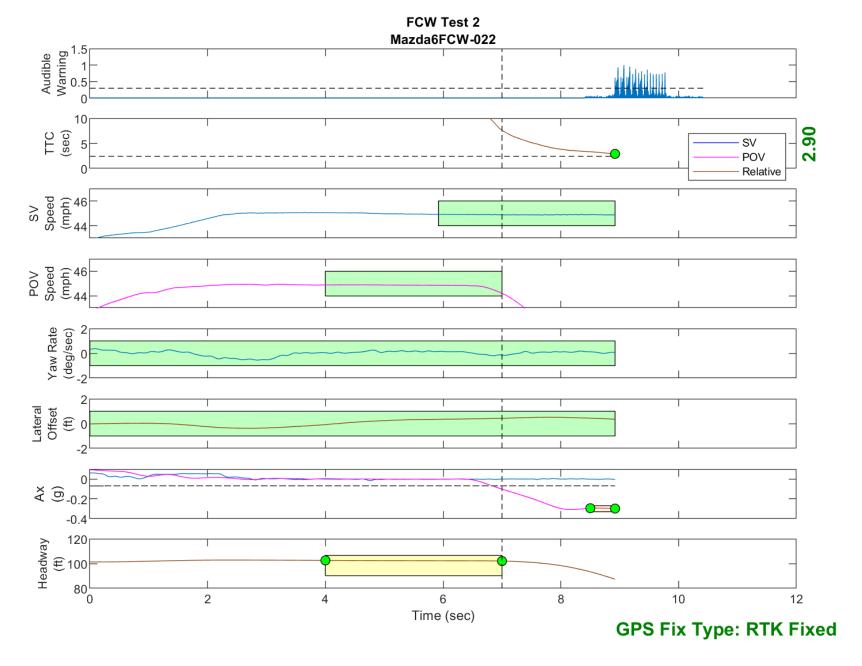
Figure D31. Time History for Run 22, FCW Test 2, Audible Warning

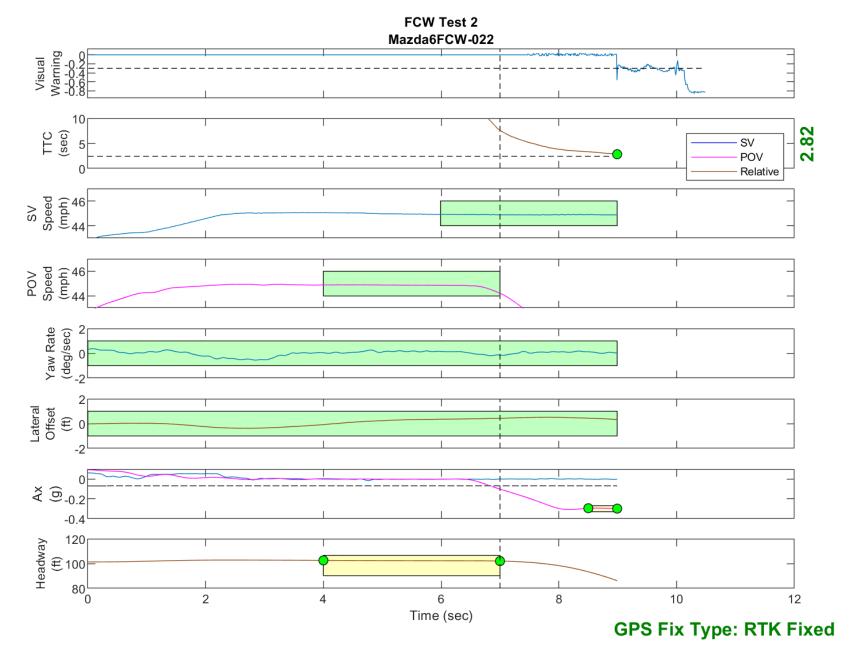
Figure D32. Time History for Run 22, FCW Test 2, Visual Warning

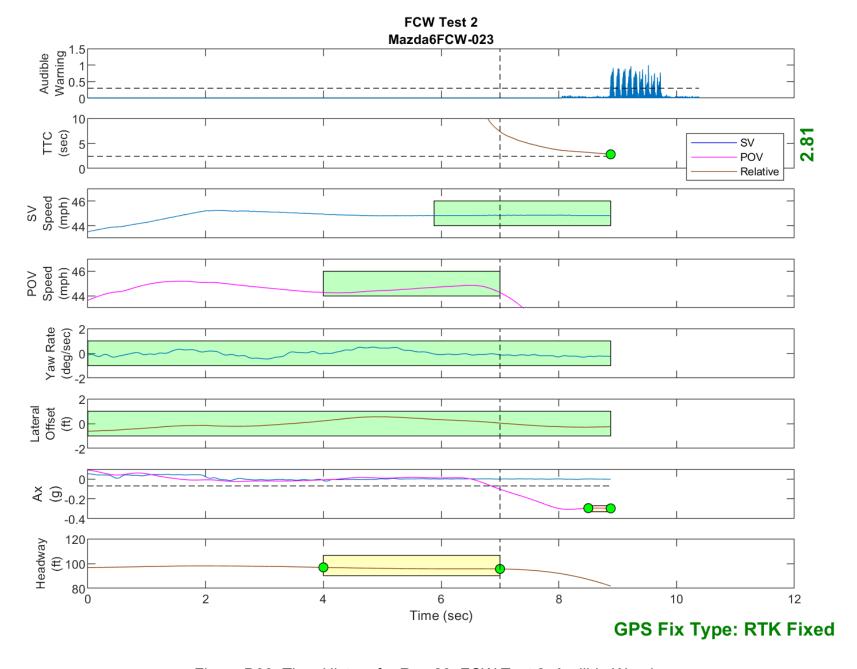
Figure D33. Time History for Run 23, FCW Test 2, Audible Warning

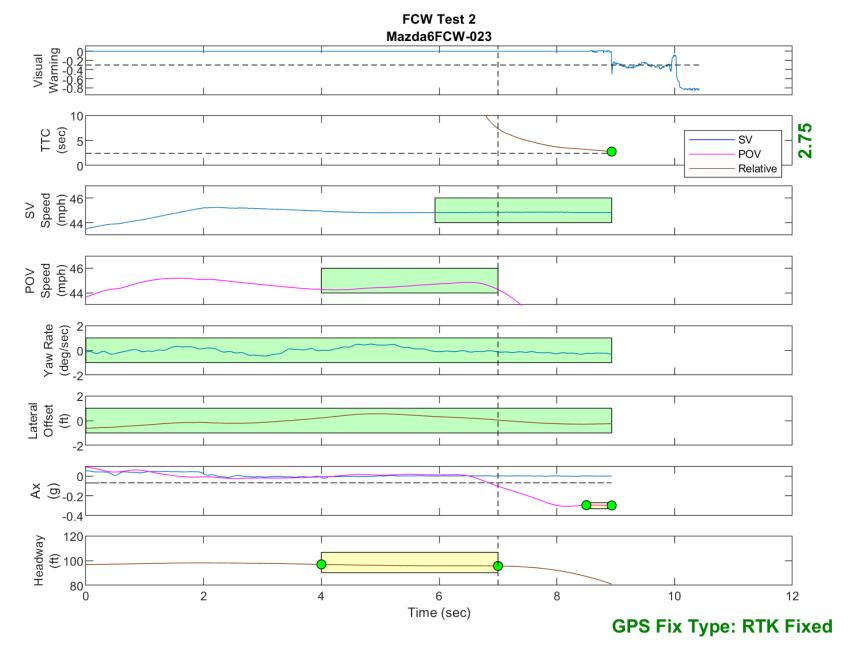
Figure D34. Time History for Run 23, FCW Test 2, Visual Warning

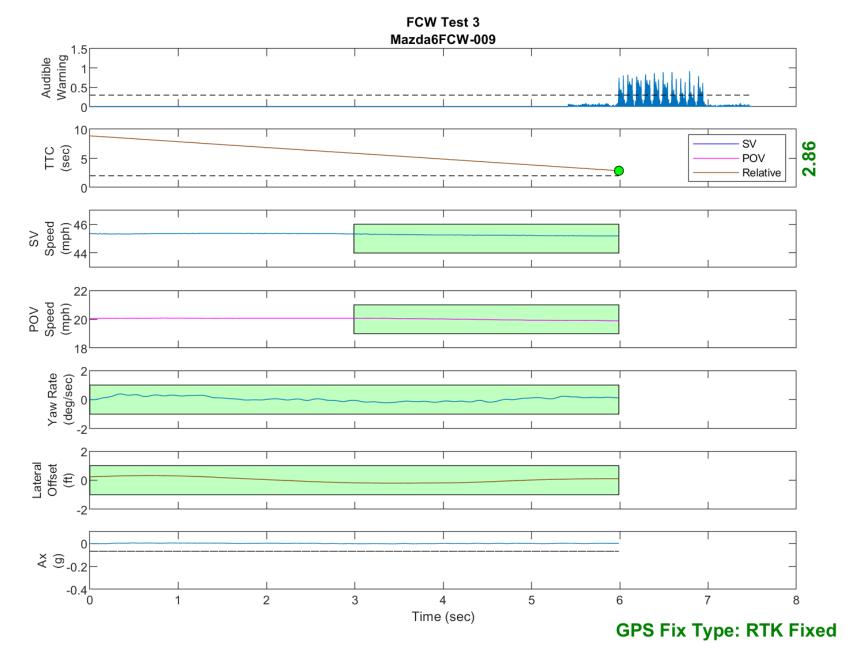
Figure D35. Time History for Run 9, FCW Test 3, Audible Warning

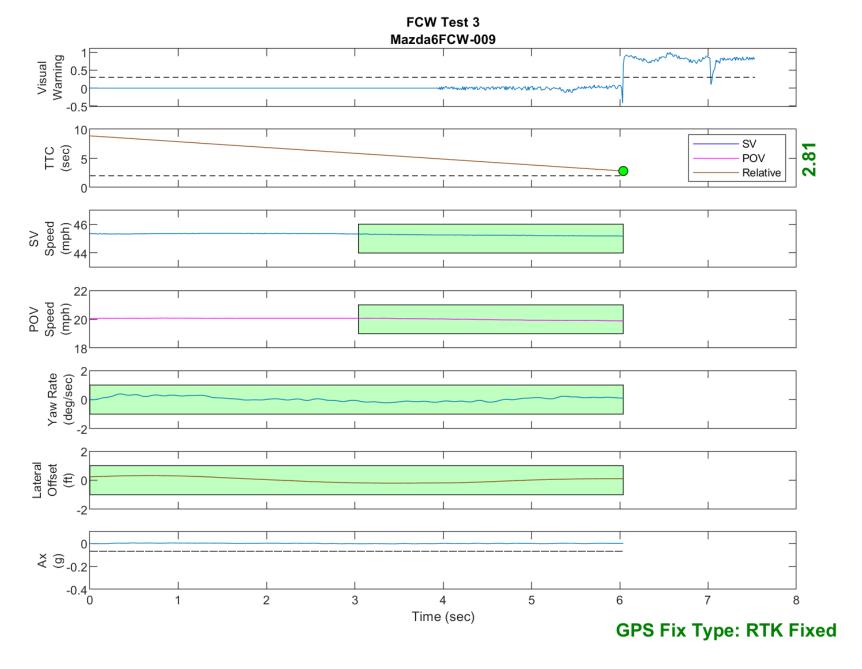
Figure D36. Time History for Run 9, FCW Test 3, Visual Warning

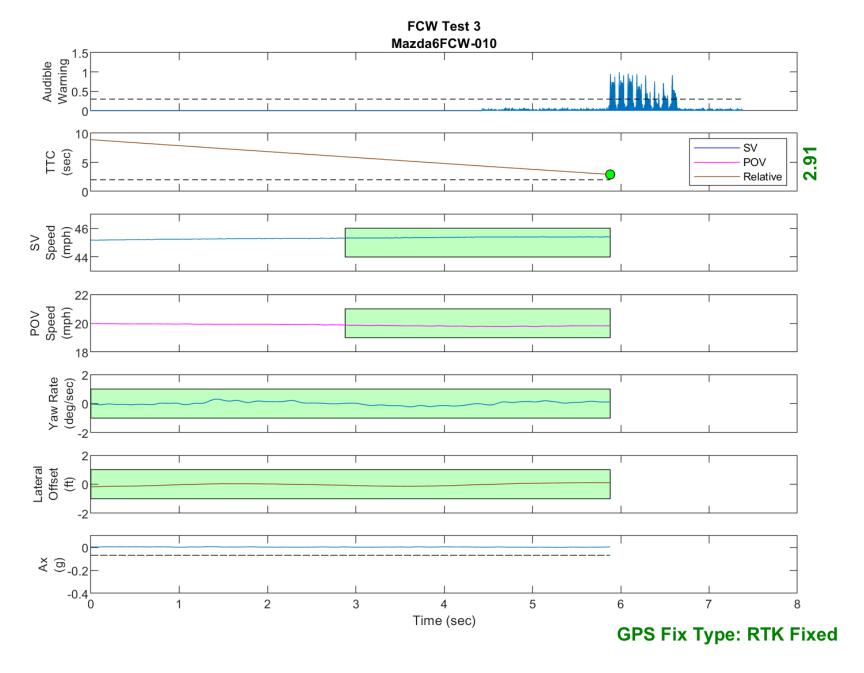
Figure D37. Time History for Run 10, FCW Test 3, Audible Warning

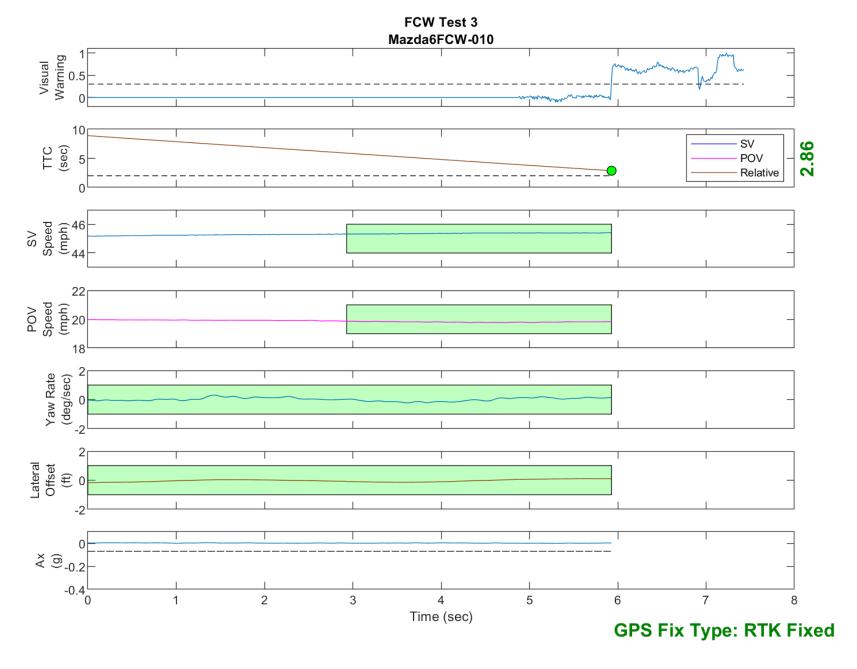
Figure D38. Time History for Run 10, FCW Test 3, Visual Warning

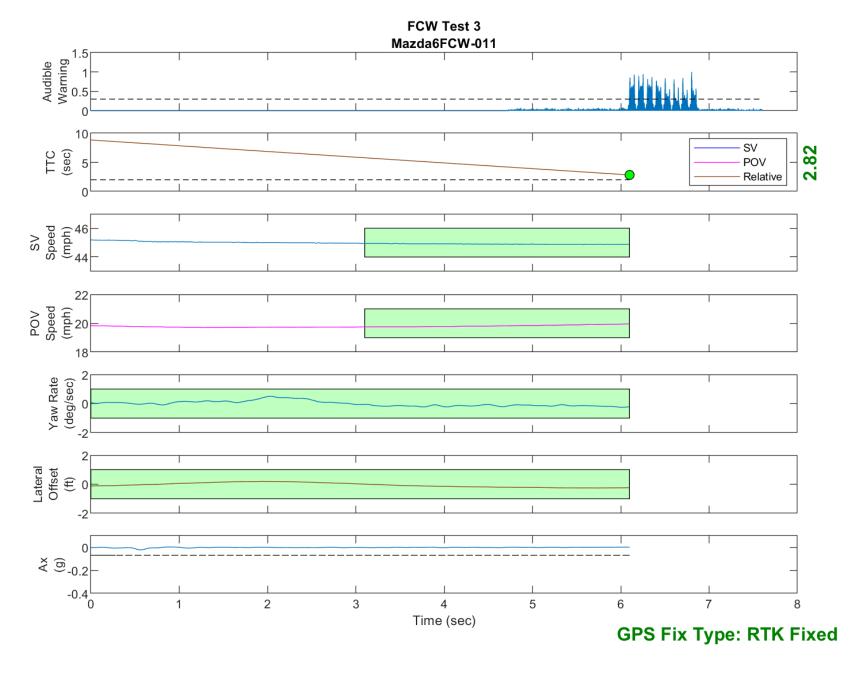
Figure D39. Time History for Run 11, FCW Test 3, Audible Warning

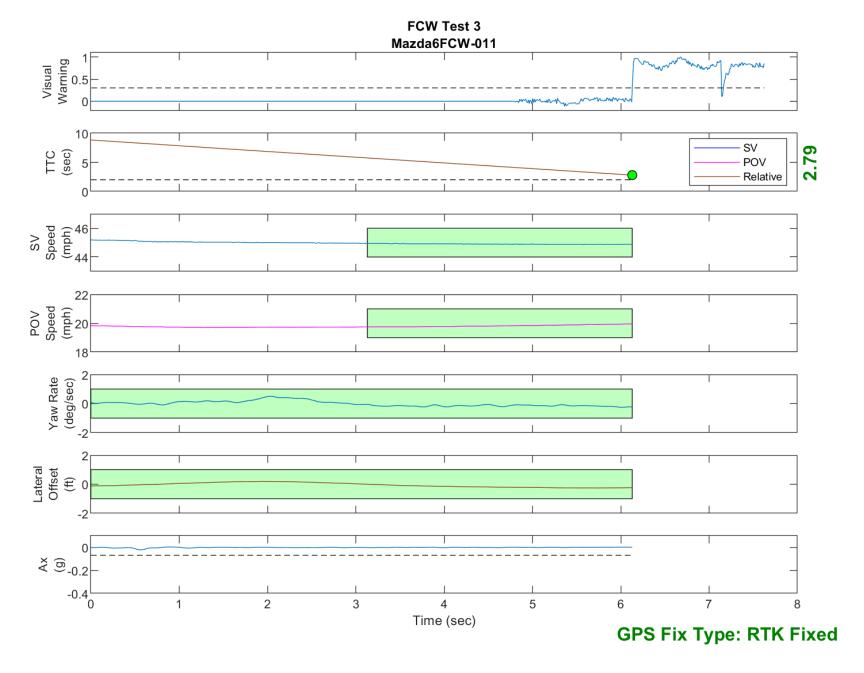
Figure D40. Time History for Run 11, FCW Test 3, Visual Warning

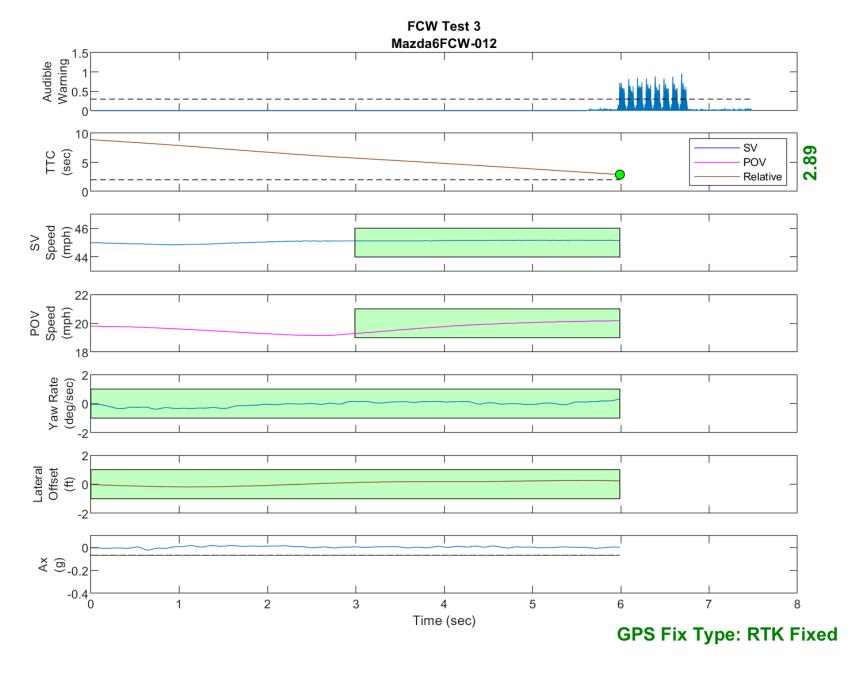
Figure D41. Time History for Run 12, FCW Test 3, Audible Warning

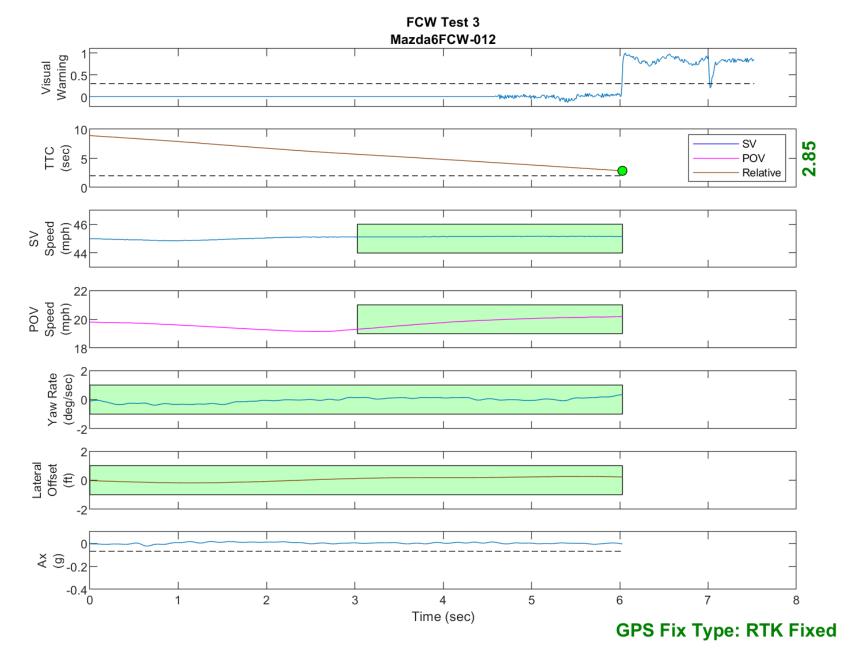
Figure D42. Time History for Run 12, FCW Test 3, Visual Warning

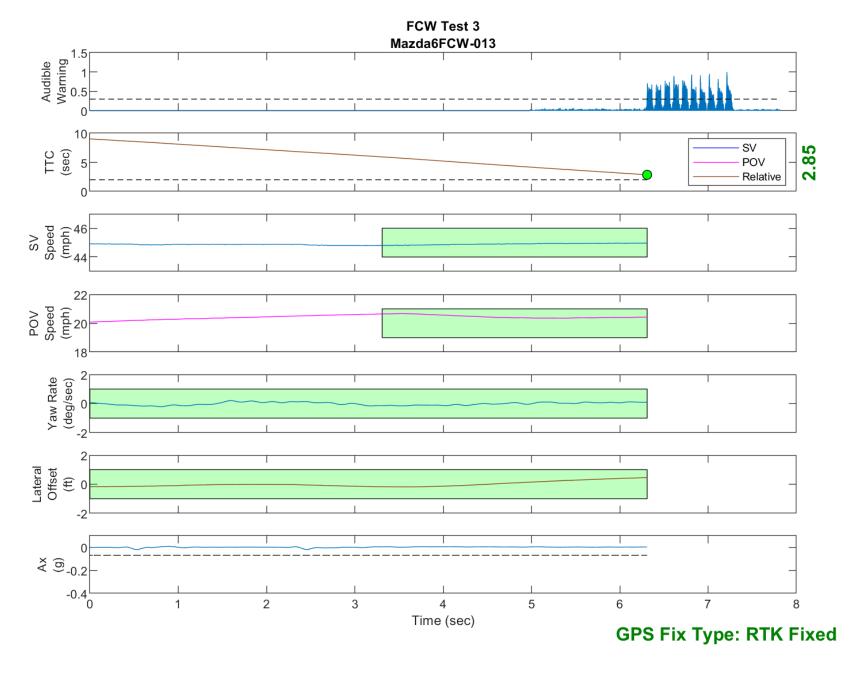
Figure D43. Time History for Run 13, FCW Test 3, Audible Warning

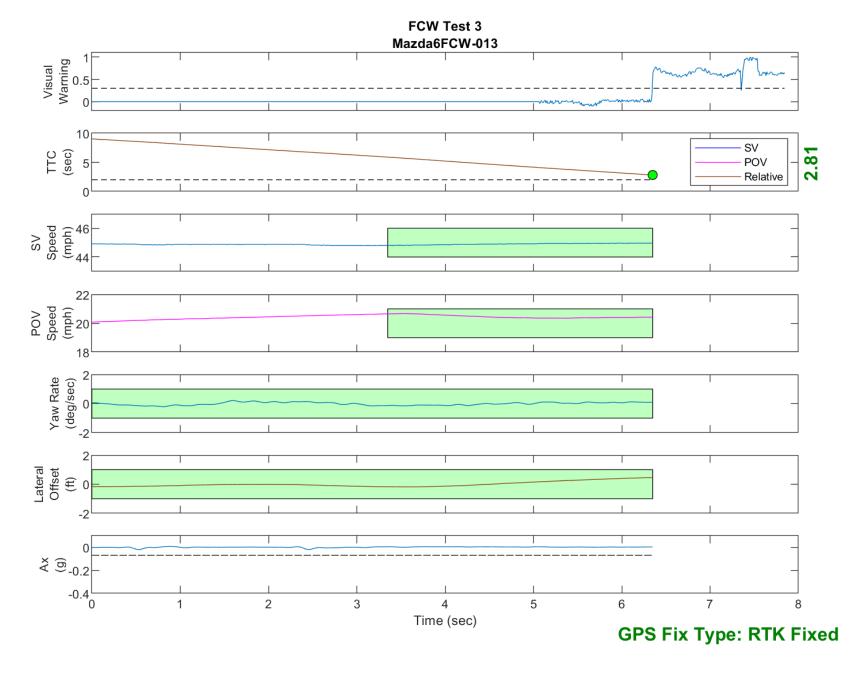
Figure D44. Time History for Run 13, FCW Test 3, Visual Warning

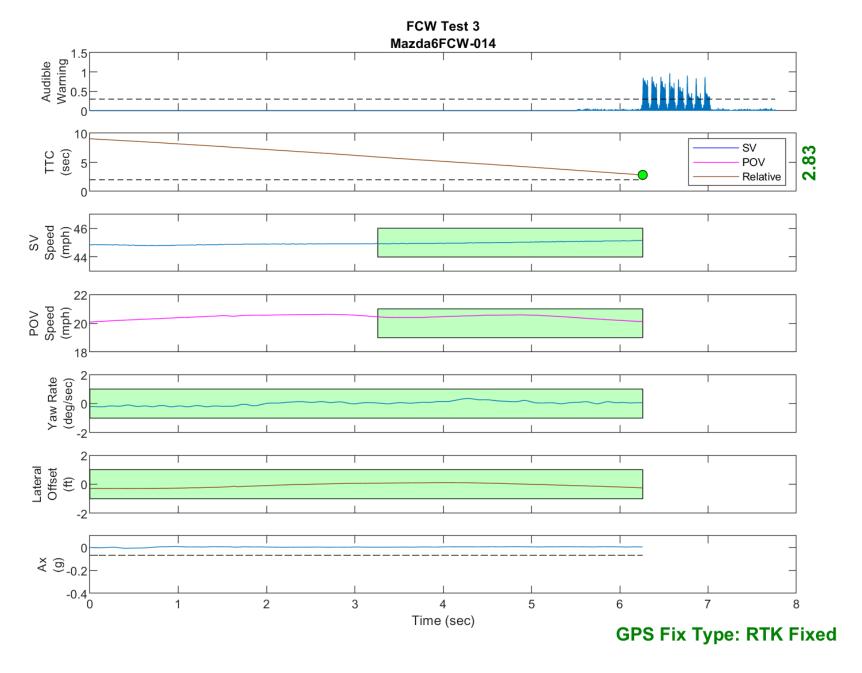
Figure D45. Time History for Run 14, FCW Test 3, Audible Warning

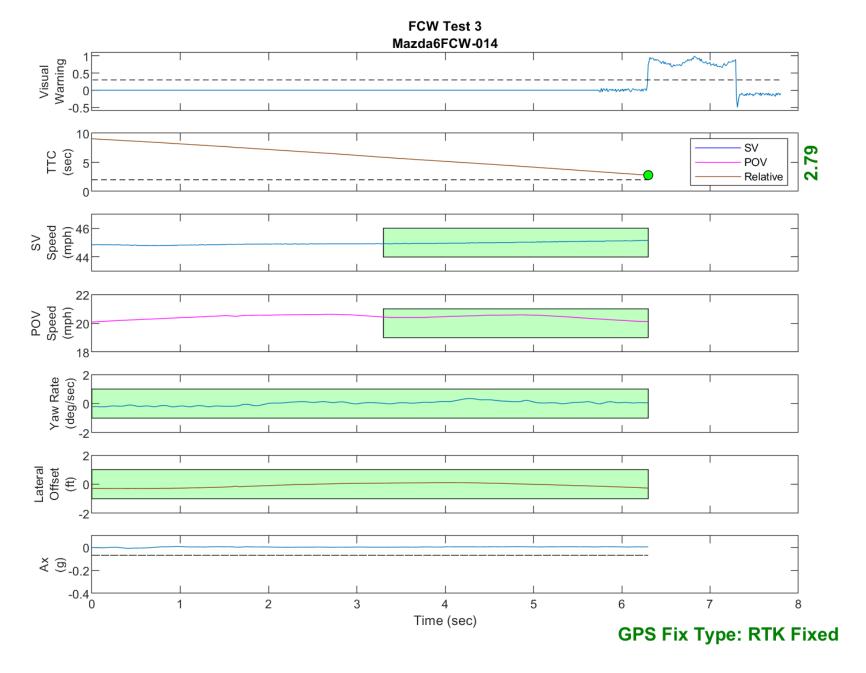
Figure D46. Time History for Run 14, FCW Test 3, Visual Warning

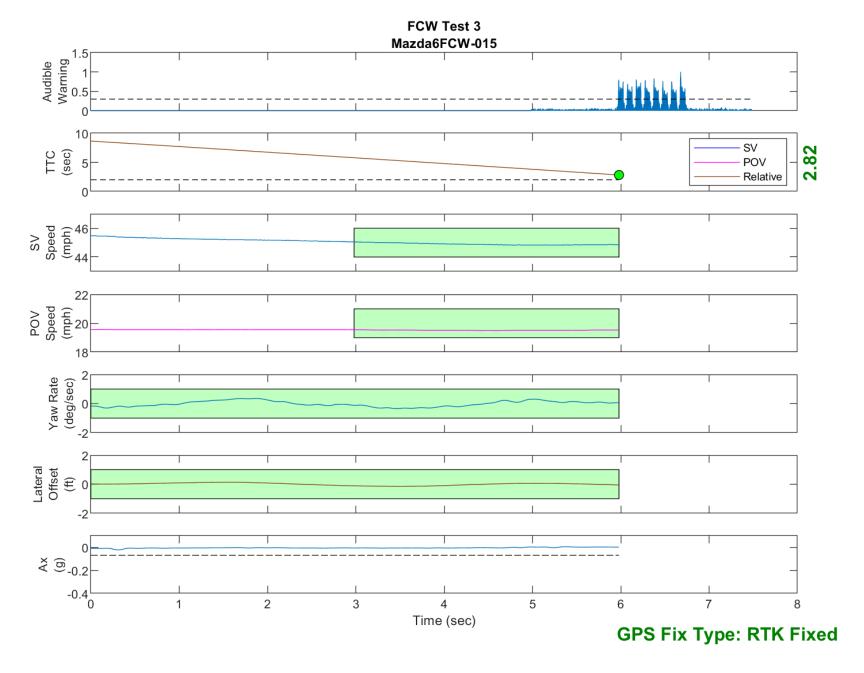
Figure D47. Time History for Run 15, FCW Test 3, Audible Warning

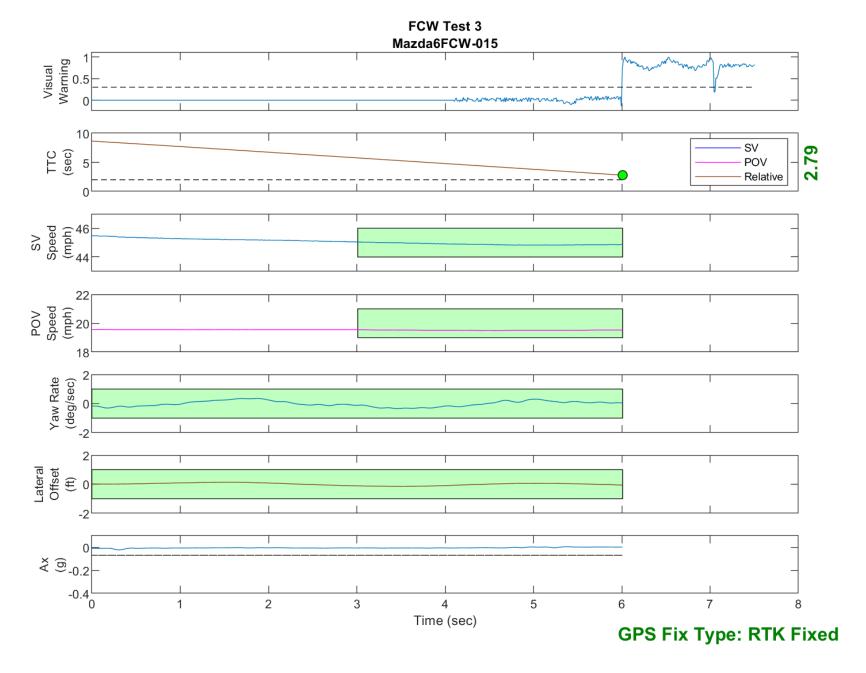
Figure D48. Time History for Run 15, FCW Test 3, Visual Warning
