NEW CAR ASSESSMENT PROGRAM CRASH IMMINENT BRAKING SYSTEM CONFIRMATION TEST NCAP-DRI-CIB-20-14

2020 Toyota Corolla LE

DYNAMIC RESEARCH, INC.

Final Report

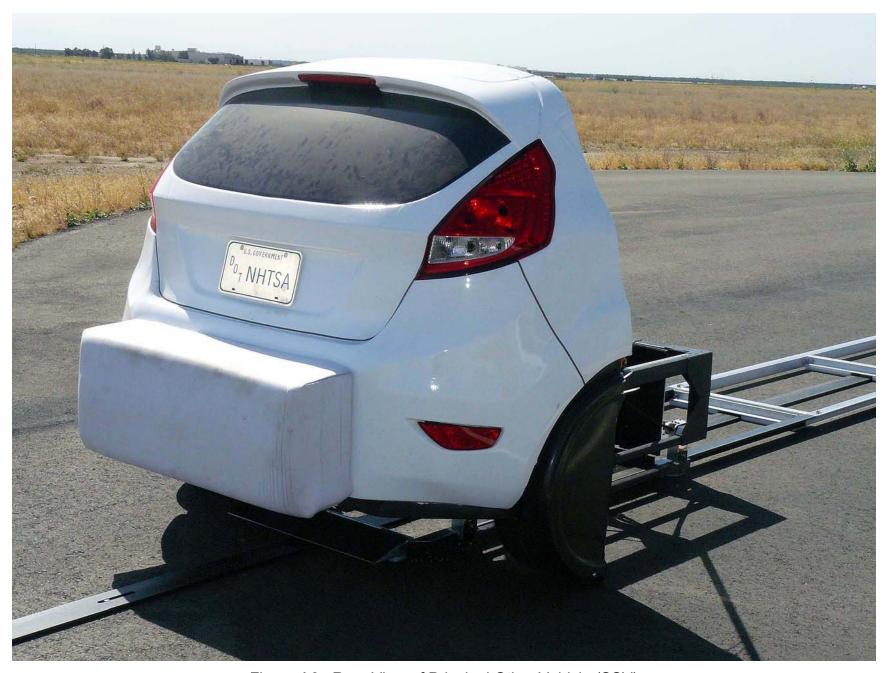
Figure A6. Rear View of Principal Other Vehicle (SSV)

CIB testing requires a POV that realistically represents typical vehicles, does not suffer damage or cause damage to a test vehicle in the event of collision, and can be accurately positioned and moved during the tests. The tests reported herein made use of the NHTSA developed Strikeable Surrogate Vehicle (SSV).

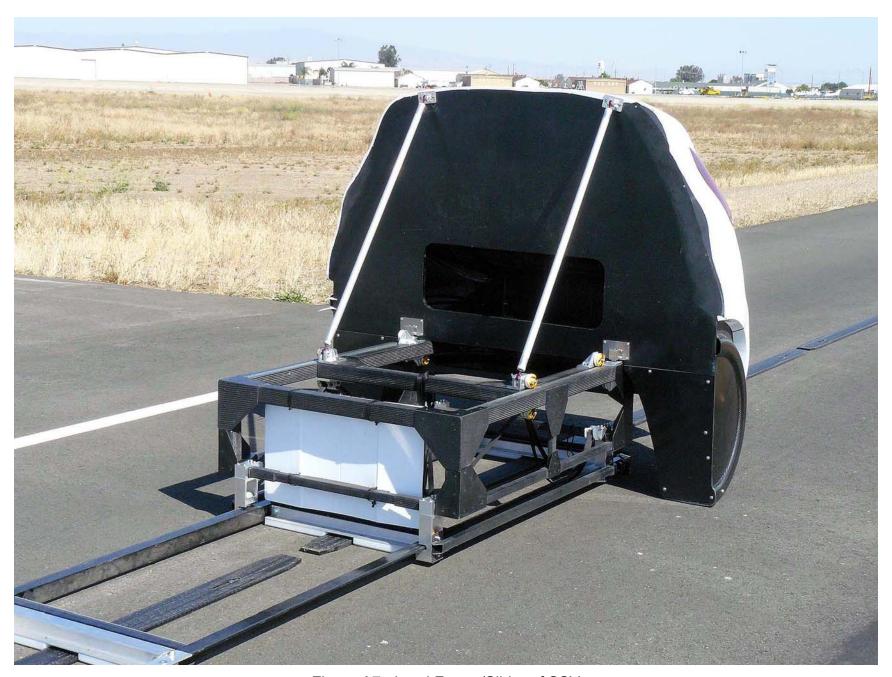
Figure A7. Load Frame/Slider of SSV

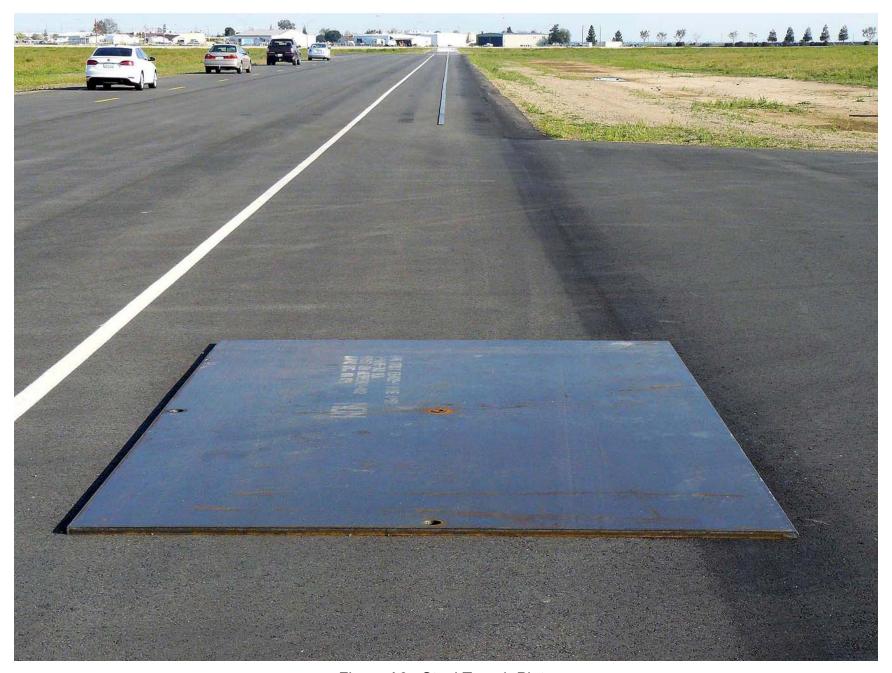
Figure A9. Steel Trench Plate

The false positive suppression test series evaluates the ability of a CIB system to differentiate a steel trench plate (STP) from an object presenting a genuine safety risk to the SV. Although the STP is large and metallic, it is designed to be driven over without risk of injury to the driver or damage to the SV. Therefore, in this scenario, the automatic braking available from CIB is not necessary and should be suppressed. The test condition is nearly equivalent to that previously defined for Test 1, the stopped POV condition, but with an STP in the SV forward path in lieu of a POV.

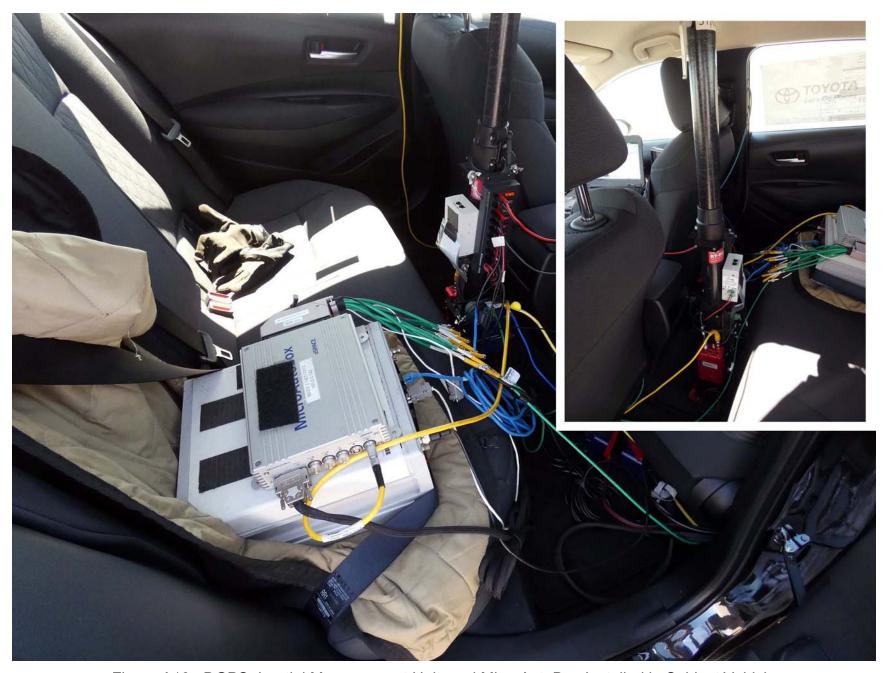
Figure A10. DGPS, Inertial Measurement Unit, and MicroAutoBox Installed in Subject Vehicle

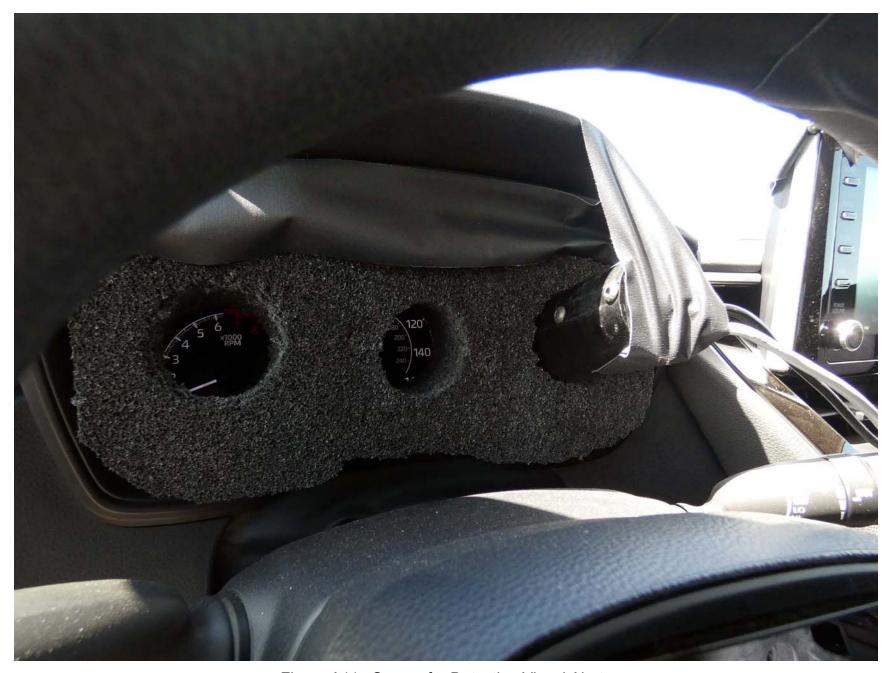
Figure A11. Sensor for Detecting Visual Alerts

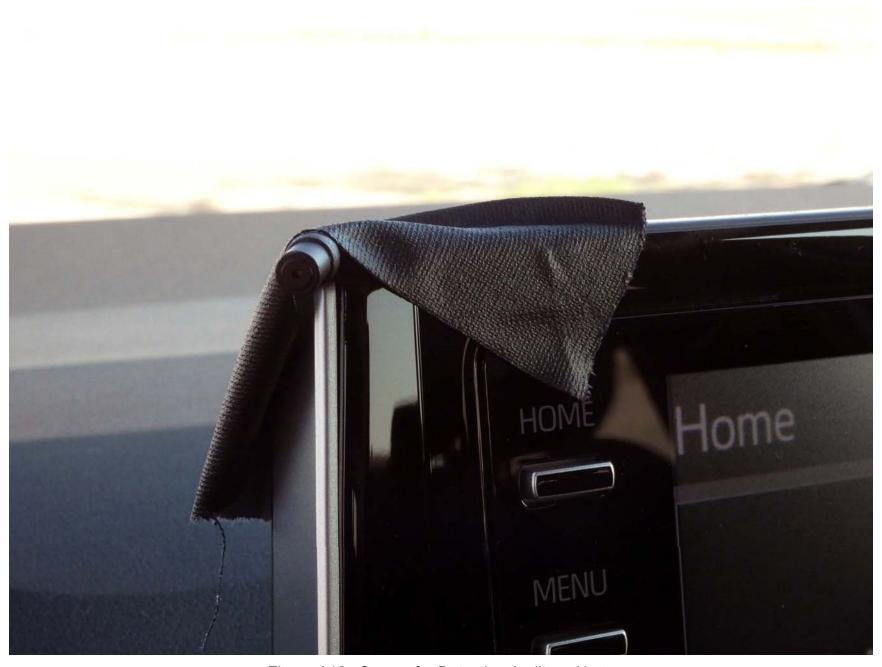
Figure A12. Sensor for Detecting Auditory Alerts

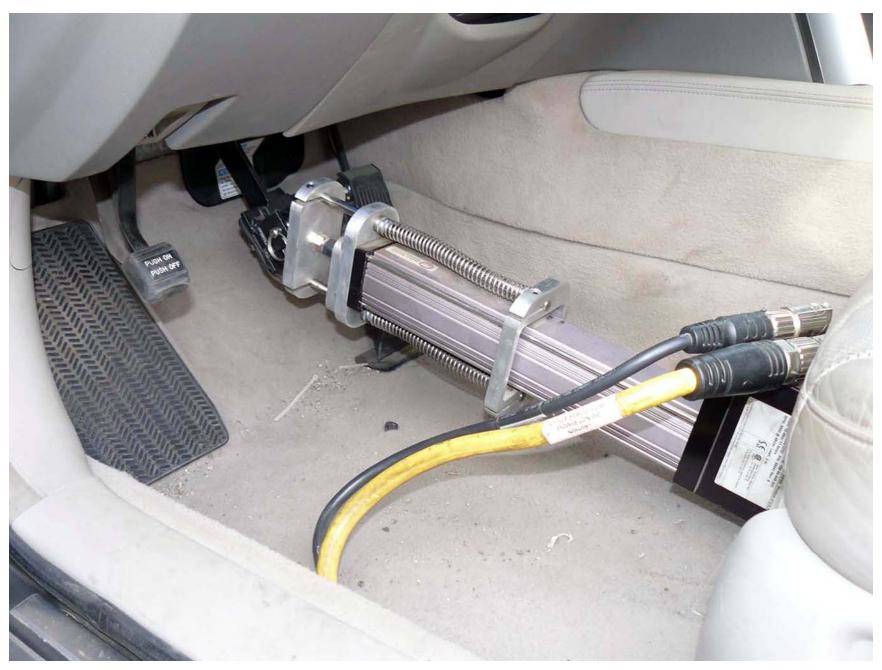
Figure A14. Brake Actuator Installed in POV System
