**NATIONAL TRANSPORTATION SAFETY BOARD
OFFICE OF HIGHWAY SAFETY
WASHINGTON, D.C.**

**SURVIVAL FACTORS GROUP CHAIRMAN'S
FACTUAL REPORT**

Location: 4600 block North State Route 25 in Rochester, Fulton County, Indiana
Vehicle: 2017 Toyota Tacoma pick-up truck
Operator: Private Operator
Pedestrian #1: 6-year-old male
Pedestrian #2: 9-year-old female
Pedestrian #3: 6-year-old male
Pedestrian #4: 11-year-old male
Date: October 30, 2018
Time: Approximately 7:12 a.m. EDT
NTSB#: **HWY19MH003**

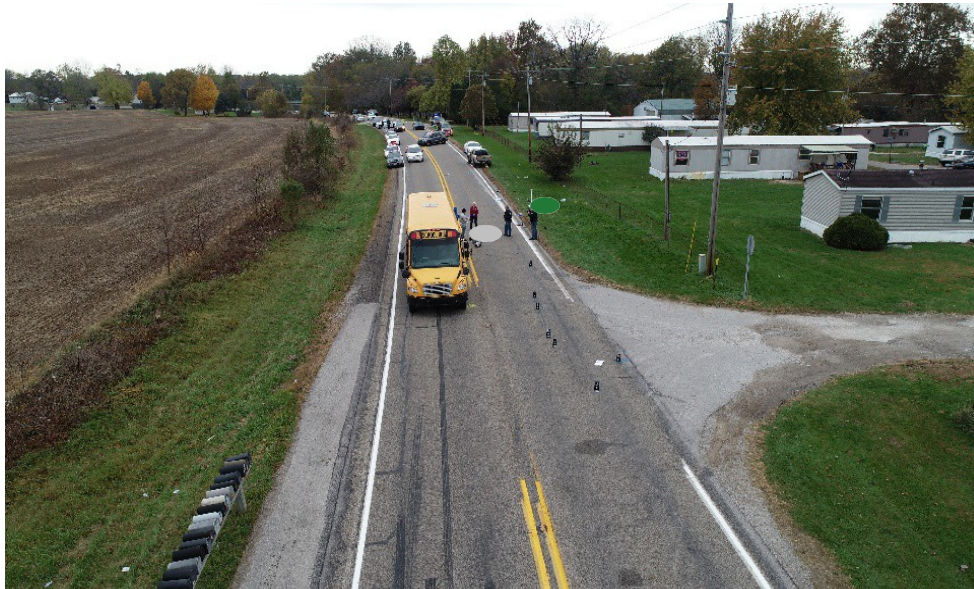
Figure 3: Incident school bus on the scene of the crash at the designated student pick-up location across from the mobile home park. (Photo provided by the Fulton County Sheriff's Office)

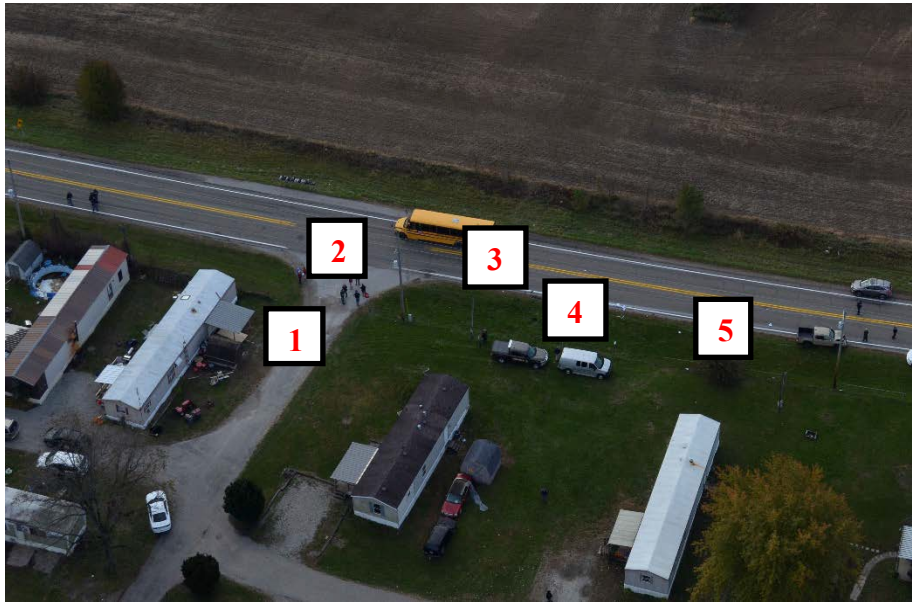
Figure 4: Aerial photograph of post-crash scene showing position of victims during crash sequence. (Photo provided by the Indiana State Police)

The 6-year-old male was positioned the farthest north of the four pedestrians when the group started walking cross the roadway. He was the first to be struck by the pick-up truck. Pedestrian #1 came to final rest in the southbound lane adjacent to the double yellow line approximately 45.6 feet south of the front bumper of the school bus. The victim was lying beside pedestrian #3 (Position #3). The pedestrian sustained fatal blunt force trauma to the head.

The 9-year old female was the second in the line of pedestrians. She came to final rest in the grassy area on the west side of the roadway approximately 78.8 feet south of the front bumper of the school bus. (Position #4). The victim sustained fatal multiple blunt force trauma to the head, torso, and extremities. Injuries sustained by the child were consistent with being run over by the striking vehicle.

The second 6-year-old male was found lying next to pedestrian #1 in the center of the southbound lane, 45.6 feet south of the front bumper of the bus. (Position #3). The victim had sustained fatal multiple blunt impact trauma to the head, torso and lower extremities and sustained a fractured neck.

The 11-year-old male was the last to be struck by the truck. He was positioned the farthest south as the pedestrians crossed the roadway. He sustained serious multiple blunt impact trauma to the torso and extremities. After being struck by the pick-up truck, the victim came to final rest lying in the grass adjacent to the roadway, behind the striking the vehicle, 130 feet south of the

front of the bus. **(Position #5)**. The victim was conscious and communicating with first responders immediately following the crash. He was flown by air ambulance to a hospital in Fort Wayne Indiana.

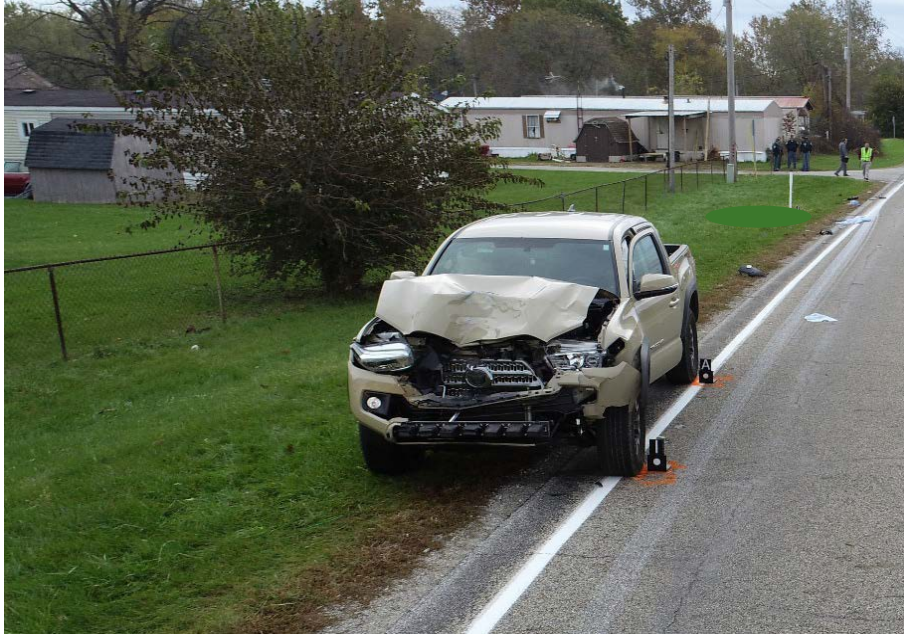
At the time of the crash, the 2017 Toyota Tacoma pick-up truck was occupied by the driver and three minor children. All the children were properly restrained in car seats in the rear seat of the truck and sustained no injury. The pick-up truck sustained extensive damage to the hood, front bumper, and radiator. A closer inspection of the truck's damage by the investigating officers revealed evidence that the 11-year-old male and the 9-year-old female, impacted the truck hood. The speed of the pick-up truck was approximately 41 miles per hour at impact. (See Vehicle Factors Group Chairman's report for additional information) **Figure 5** is a photograph of the damage to the striking vehicle caused by the impact with the victims.

Figure 5: Photograph of damage to striking pick-up truck (FCSO)

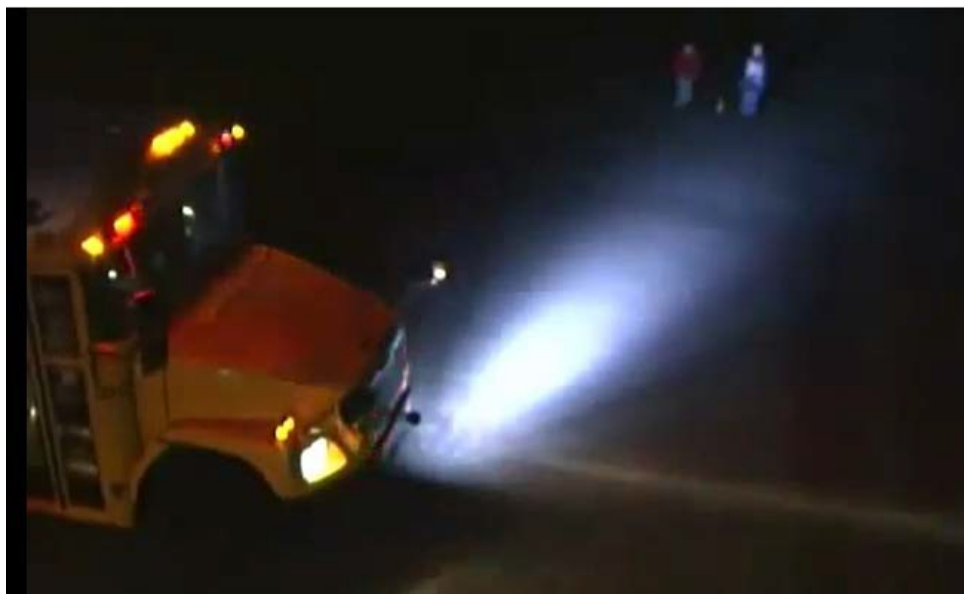
Figure 6 shows the Gardian Angel School Bus Lighting System in operation in a real-life dark environment. The photograph shows the beam of light extending across the opposing travel lane and illuminating the students standing at the edge of the roadway, across from the school bus.

Figure 6: Photograph of the Gardian Angel bus lighting system in operation (Photo provided by Gardian Angel LLC)

One solution is adding a supplemental lighting system to the school bus that would illuminate the students as they traverse the roadway. The Gardian Angel Lighting System is one such example of a supplemental lighting system. The school bus lighting system, which is comprised of three lights that include two red high intensity flashing strobe lights mounted on the hood of the bus which is in the line of sight of an approaching vehicle driver, two white lights at the bumper level and a 4" square light containing a 6 diode LED, white flood light which is mounted to the left corner of the bus's front bumper that provides 1000 lumens of light. The LED light is mounted at a 45-degree downward angle to prevent blinding the students as they approach the bus. The light creates a beam that extends beyond the 10-foot danger zone around the bus. The system is intended to provide three benefits.

- It illuminates the location and the path of the students for the school bus driver. The light extends to 18-20 feet out past the bus.
- It keeps the students 10 feet in front of the bus. The students are trained to stay within the projected beam of light.

- Motorist can see the students as they cross the roadway without any visual obstruction caused by the other lights on the bus.

The Gardian Angel School Bus Lighting System can be installed on Type A, C and D school buses. The lighting system is available in kits to facilitate installation by transportation maintenance personnel and available for purchase from a major school bus parts distributor. Typically, installation takes under 30 minutes to complete. The system is connected to the existing wiring harness so that activation occurs simultaneously with the activation of the bus warning lights. This alleviates the need for additional training for the bus driver or the possibility of a driver forgetting to use the system. The lights have a 52,000-hour life expectancy. At the time of this investigation, the cost of the Gardian Angel Lighting System ranged from \$119.00 to \$379.00, dependent upon a school district's requirement for additional equipment; such as an additional LED light to illuminate both sides of the bus. This allows the system to be used regardless of which side of the roadway the student is on to await boarding. The Gardian Angel Lighting System has met the current federal standards and complies with Society of Automotive Engineers (SAE) and U.S. Department of Transportation (DOT) guidelines. Currently, the lighting system has been approved for use in 22 states.¹⁶
