**NEW CAR ASSESSMENT PROGRAM  
CRASH IMMINENT BRAKING SYSTEM CONFIRMATION TEST  
NCAP-DRI-CIB-20-11**

**2020 Mazda Mazda6 Sport**

**DYNAMIC RESEARCH, INC.**

**Final Report**

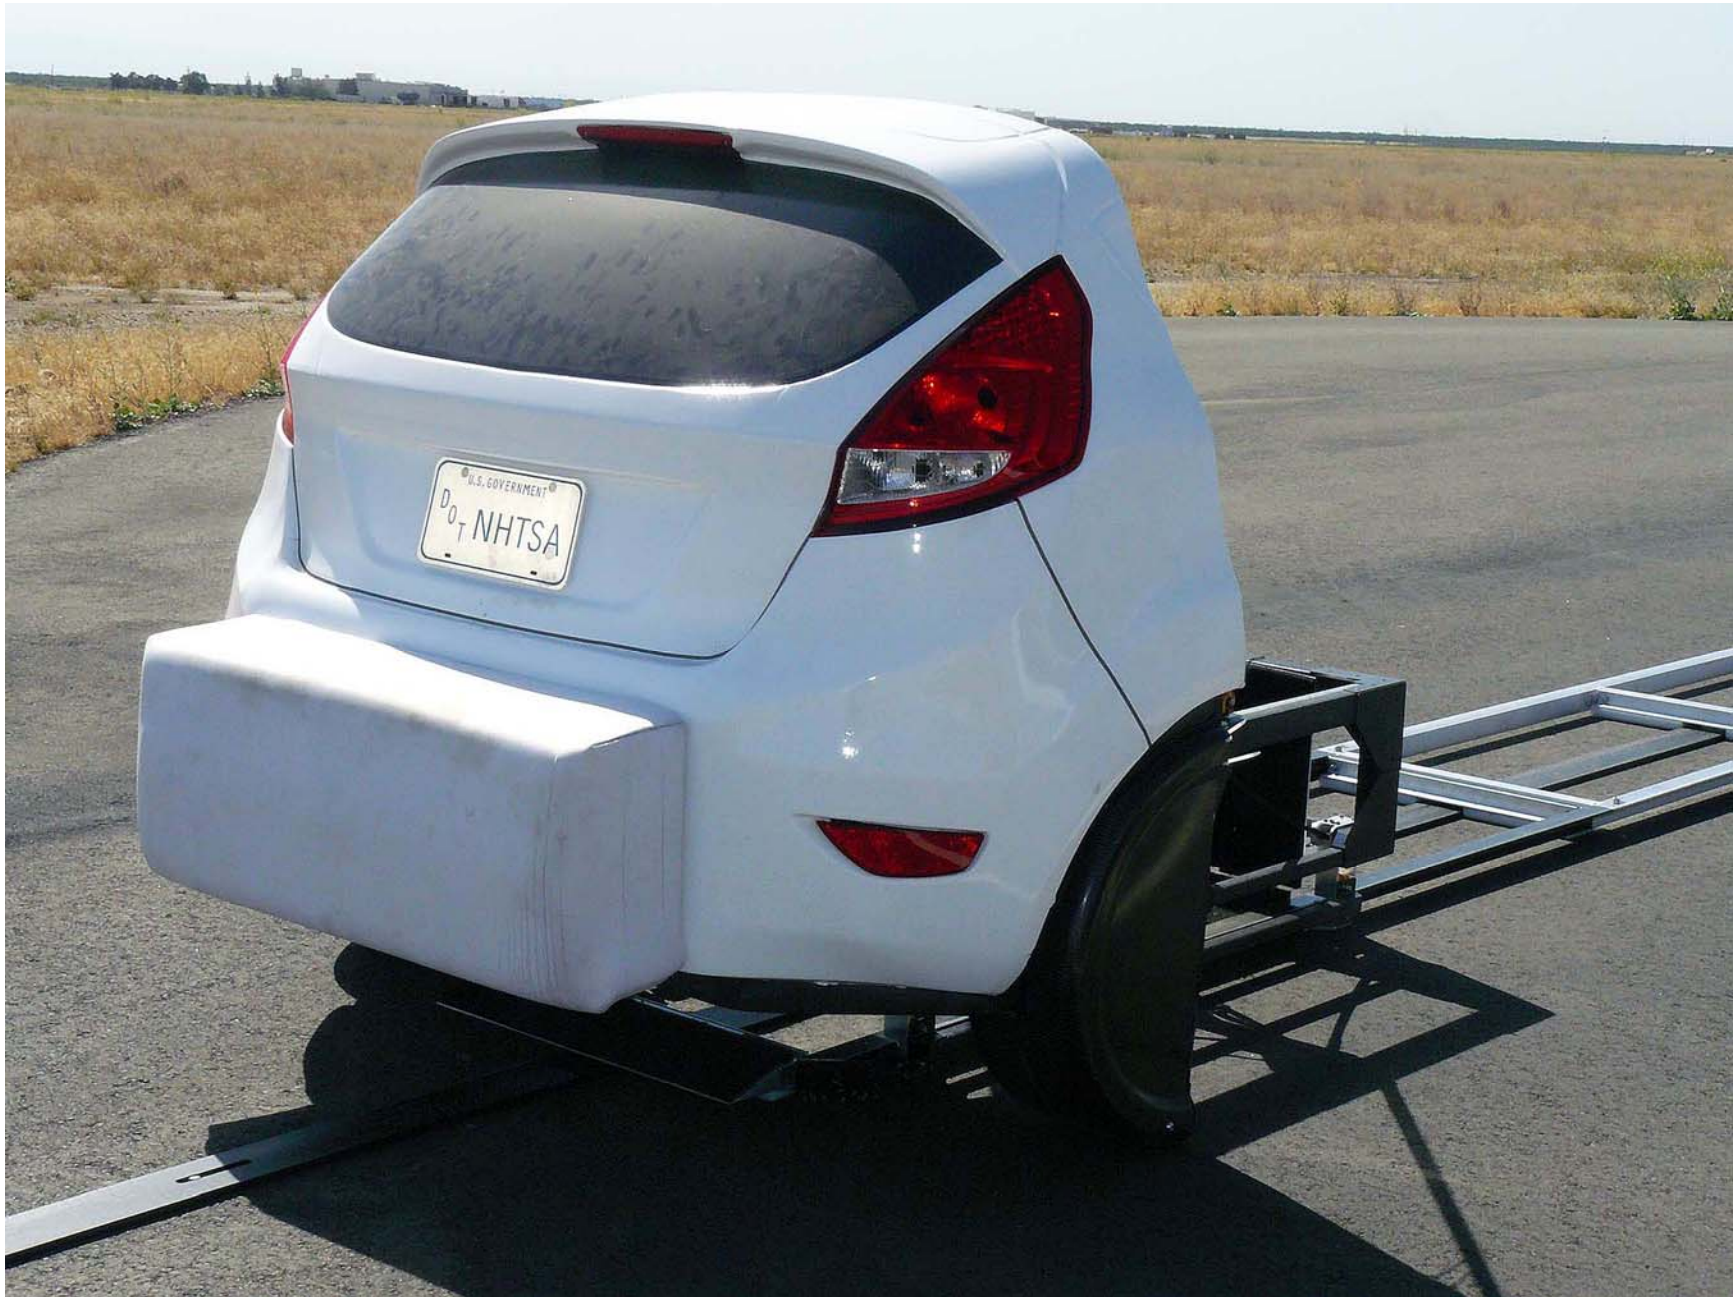
Figure A6. Rear View of Principal Other Vehicle (SSV)

CIB testing requires a POV that realistically represents typical vehicles, does not suffer damage or cause damage to a test vehicle in the event of collision, and can be accurately positioned and moved during the tests. The tests reported herein made use of the NHTSA developed Strikeable Surrogate Vehicle (SSV).

- Provide an accurate representation of a real vehicle to DBS sensors, including cameras and radar.
- Be resistant to damage and inflict little or no damage to the SV as a result of repeated SV-to-POV impacts.

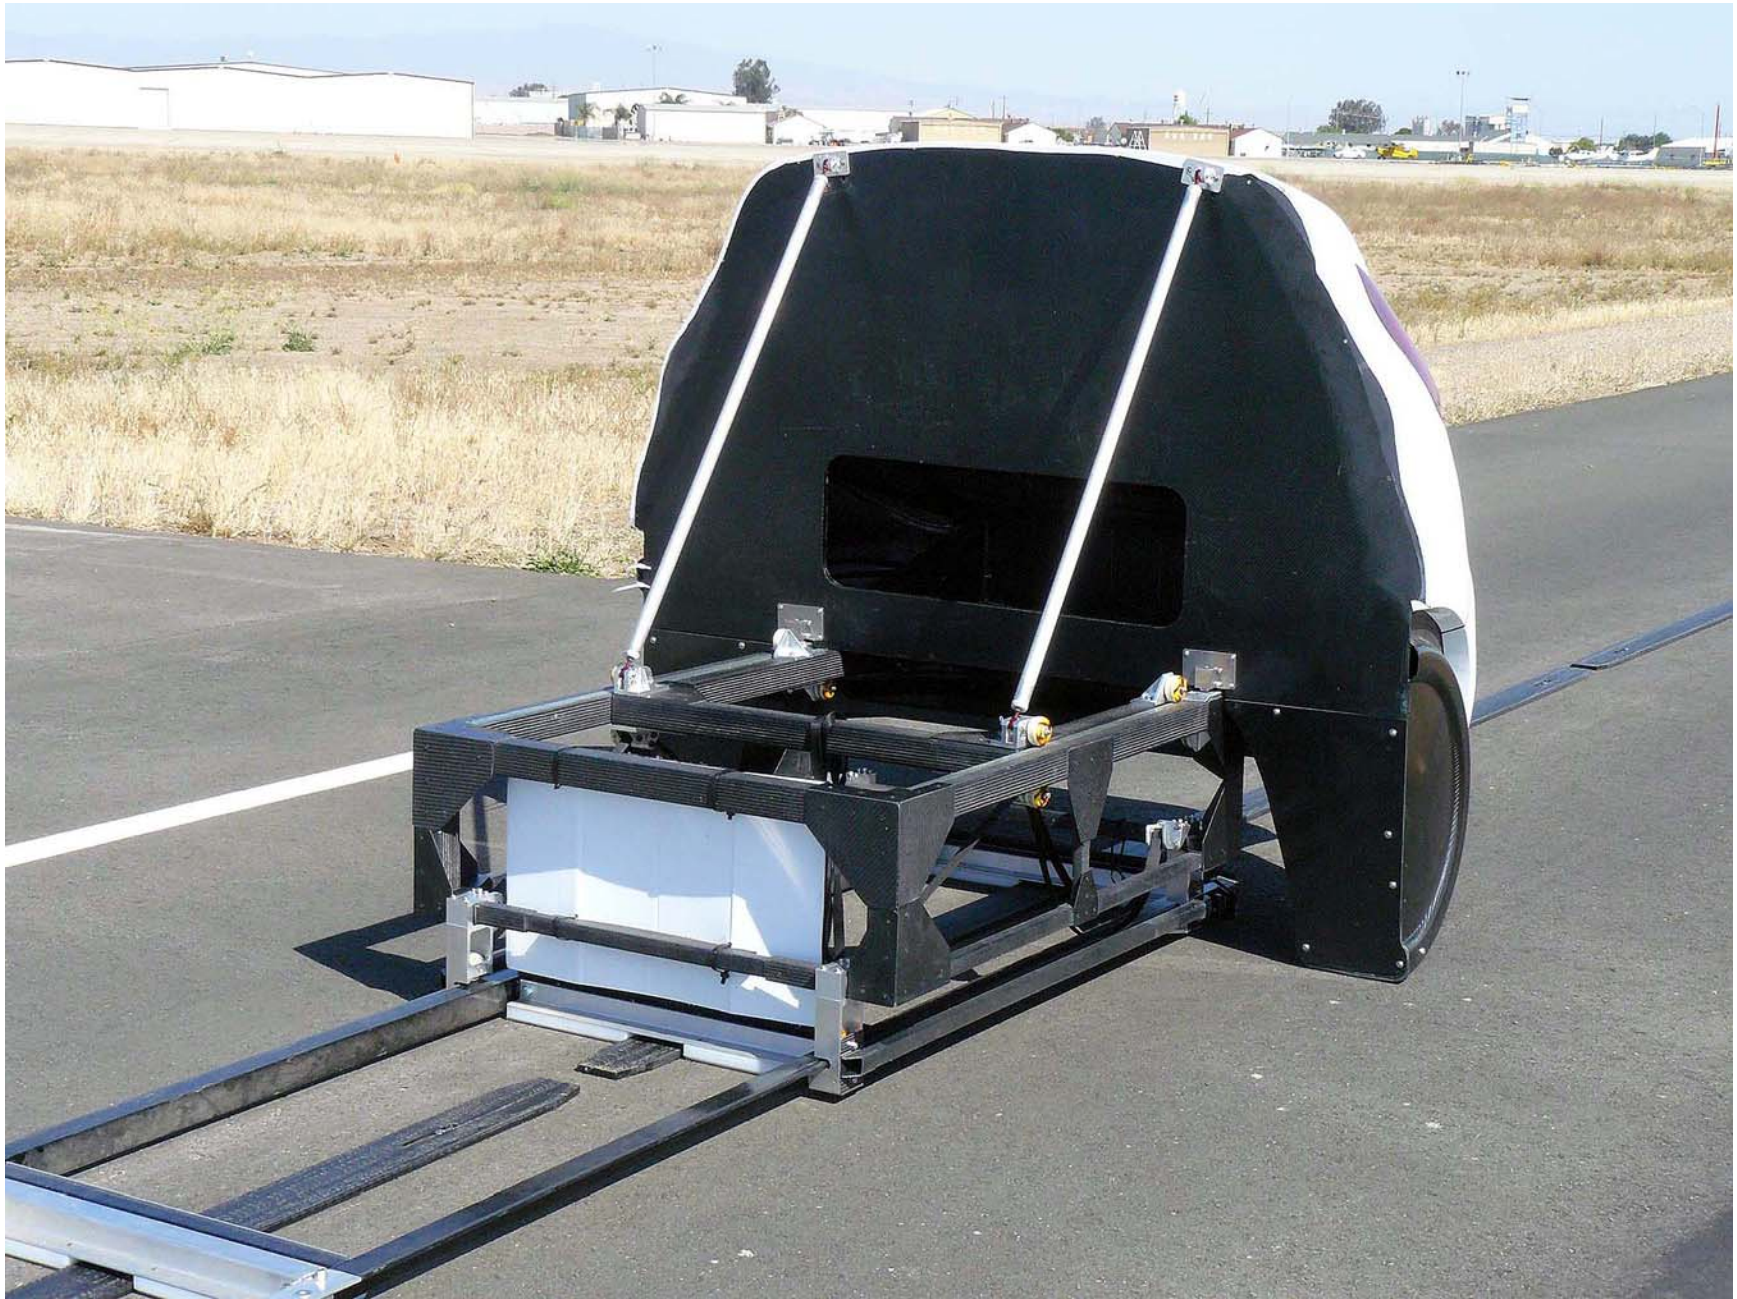
Figure A7. Load Frame/Slider of SSV

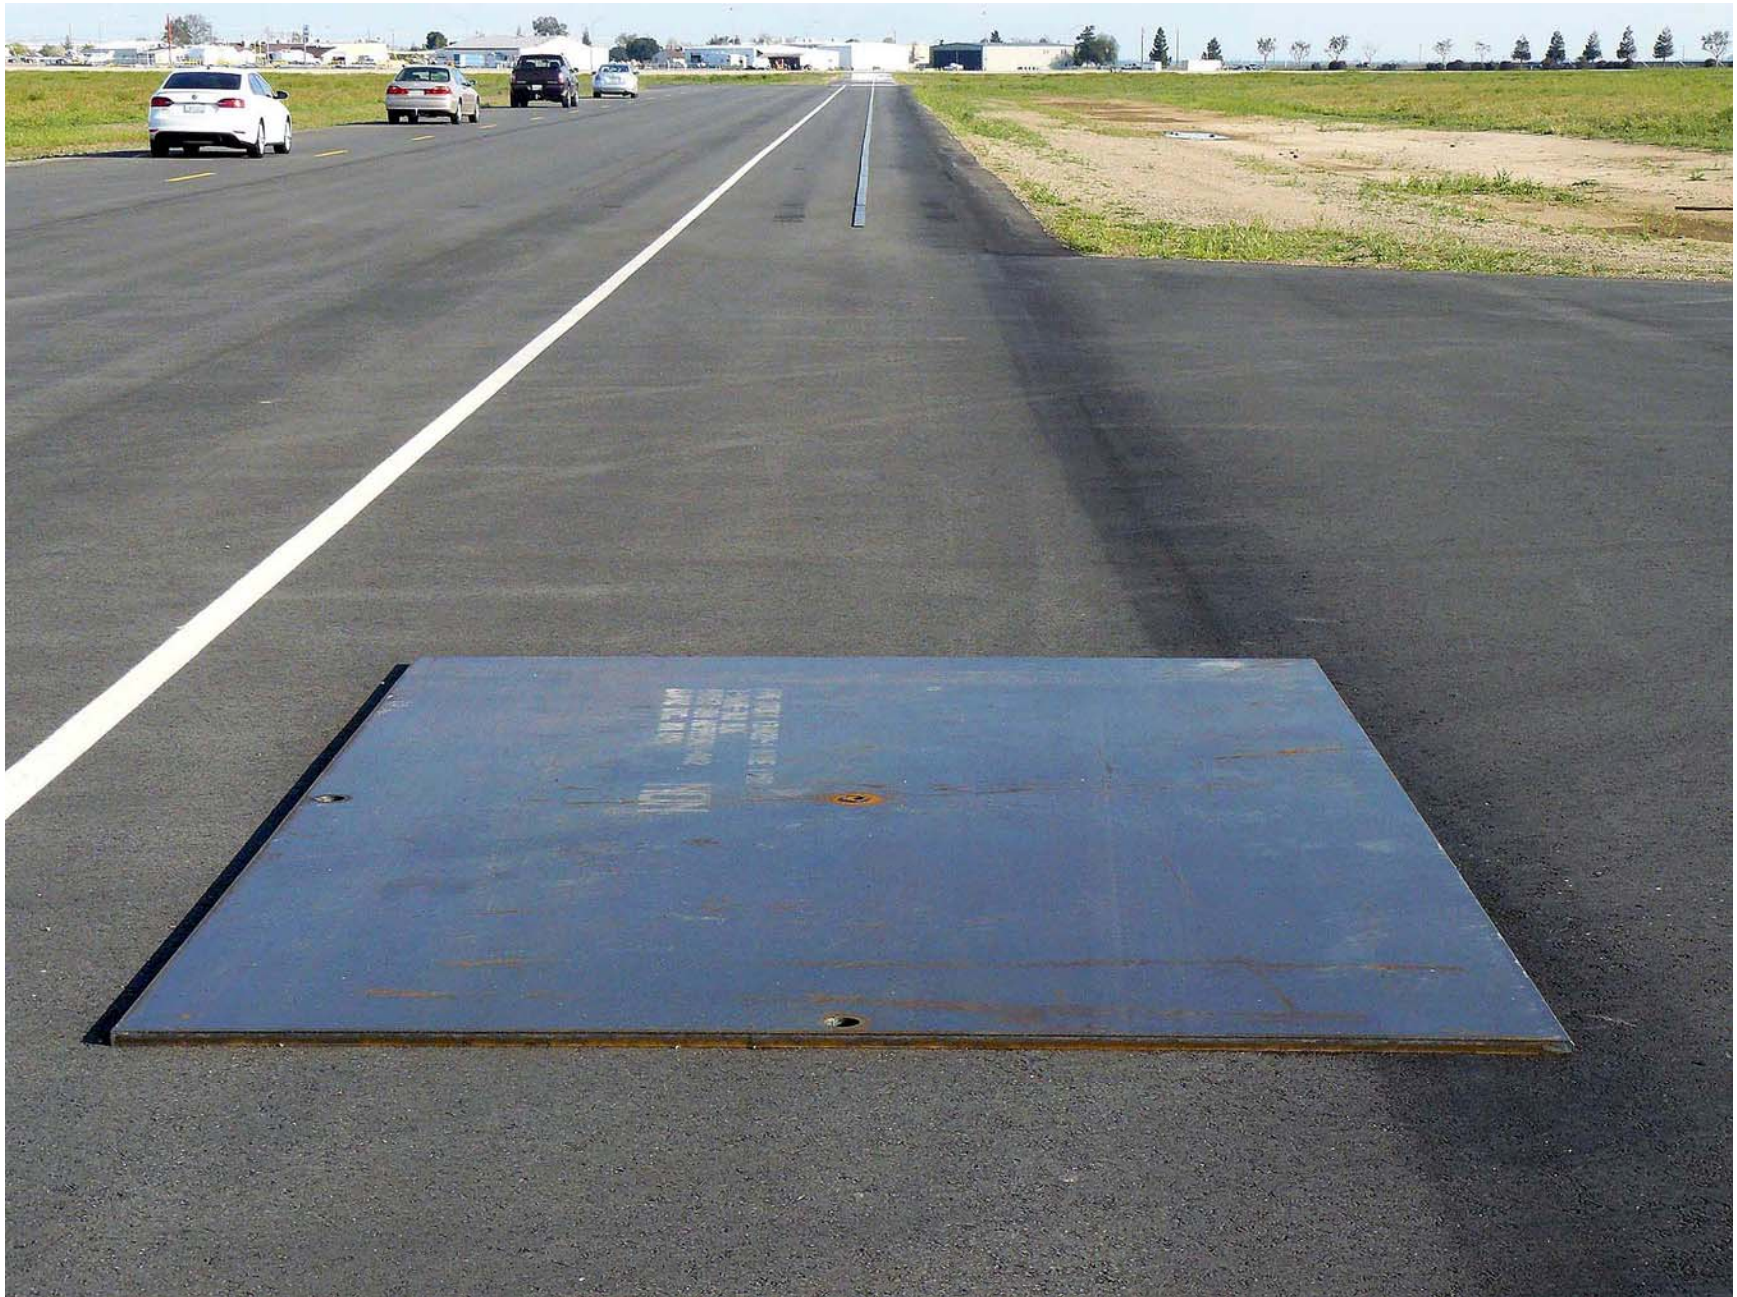
Figure A9. Steel Trench Plate

The false positive suppression test series evaluates the ability of a CIB system to differentiate a steel trench plate (STP) from an object presenting a genuine safety risk to the SV. Although the STP is large and metallic, it is designed to be driven over without risk of injury to the driver or damage to the SV. Therefore, in this scenario, the automatic braking available from CIB is not necessary and should be suppressed. The test condition is nearly equivalent to that previously defined for Test 1, the stopped POV condition, but with an STP in the SV forward path in lieu of a POV.

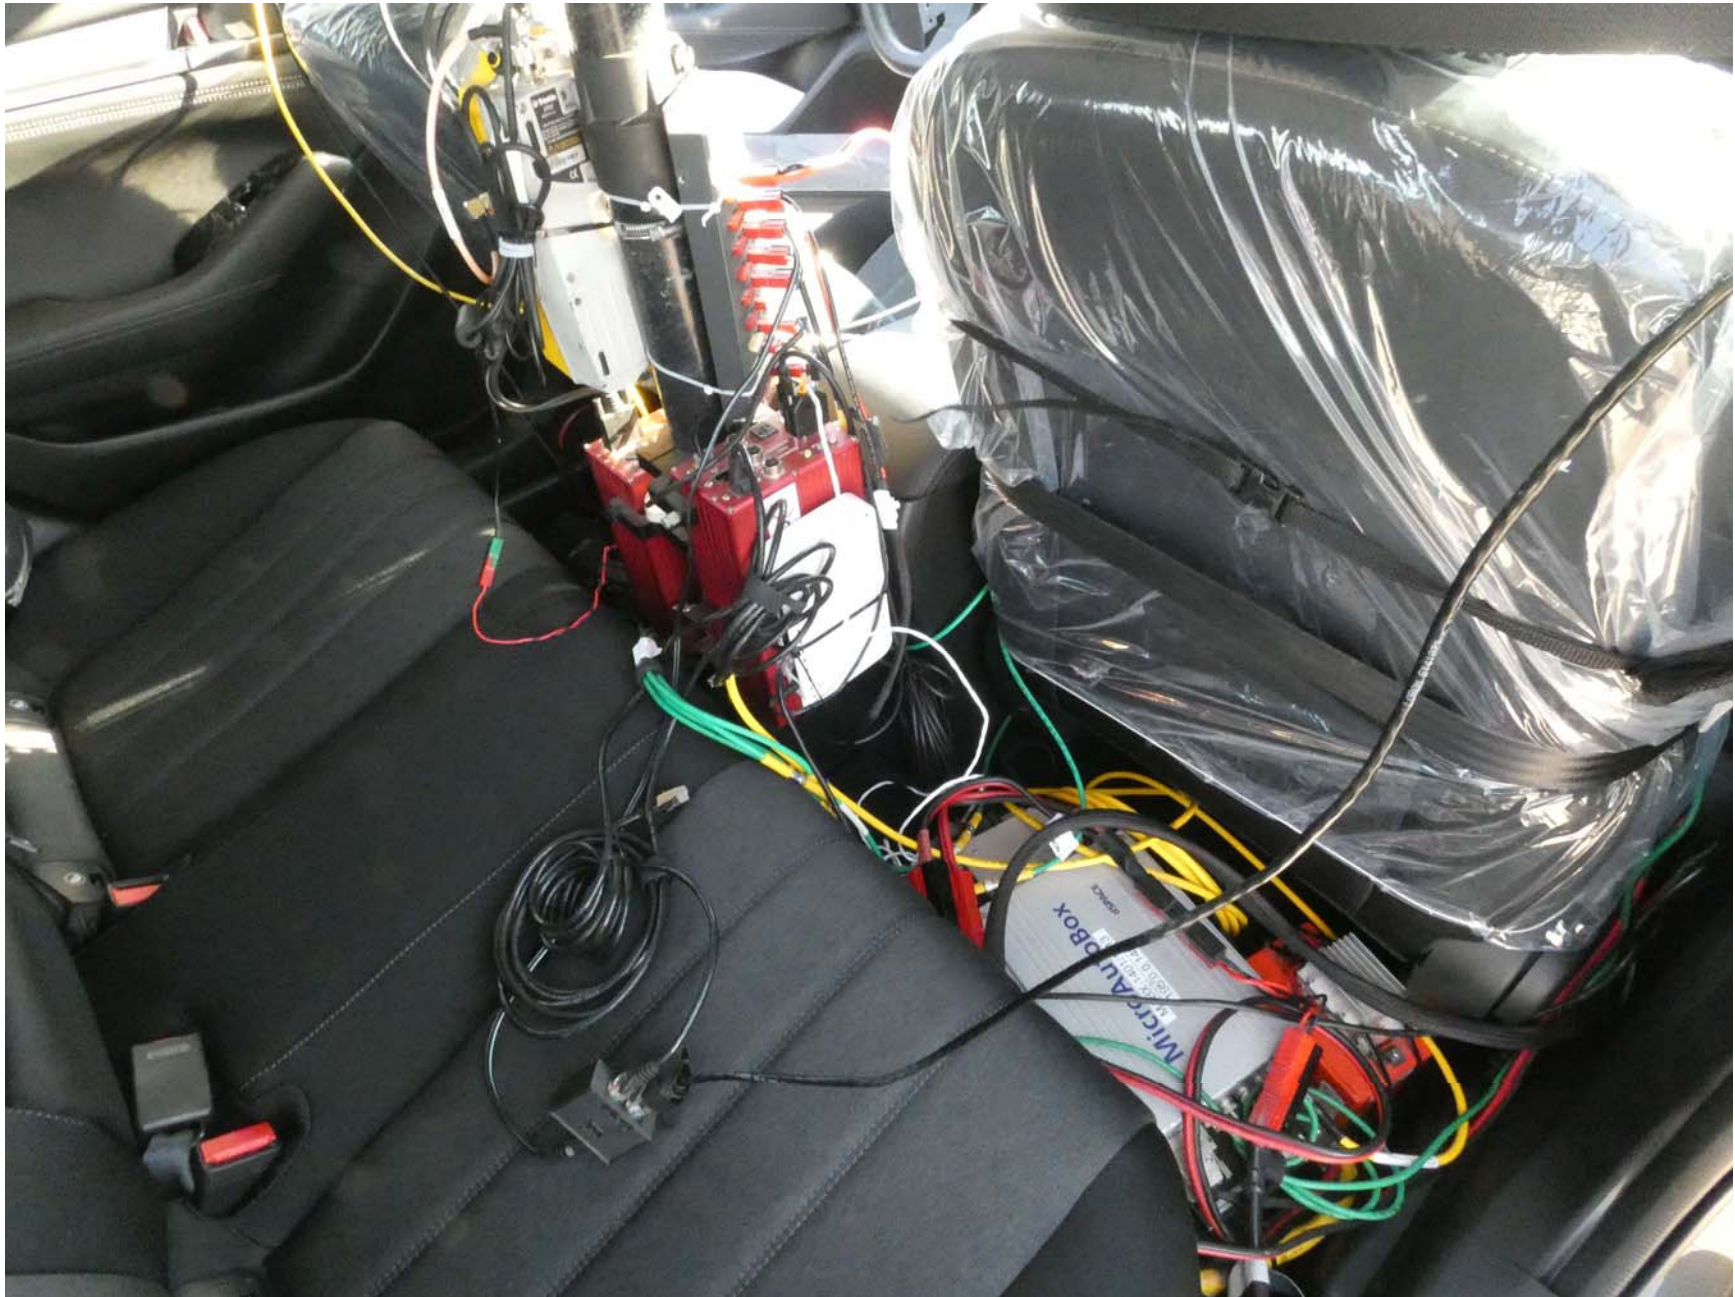
Figure A10. DGPS, Inertial Measurement Unit, and MicroAutoBox Installed in Subject Vehicle

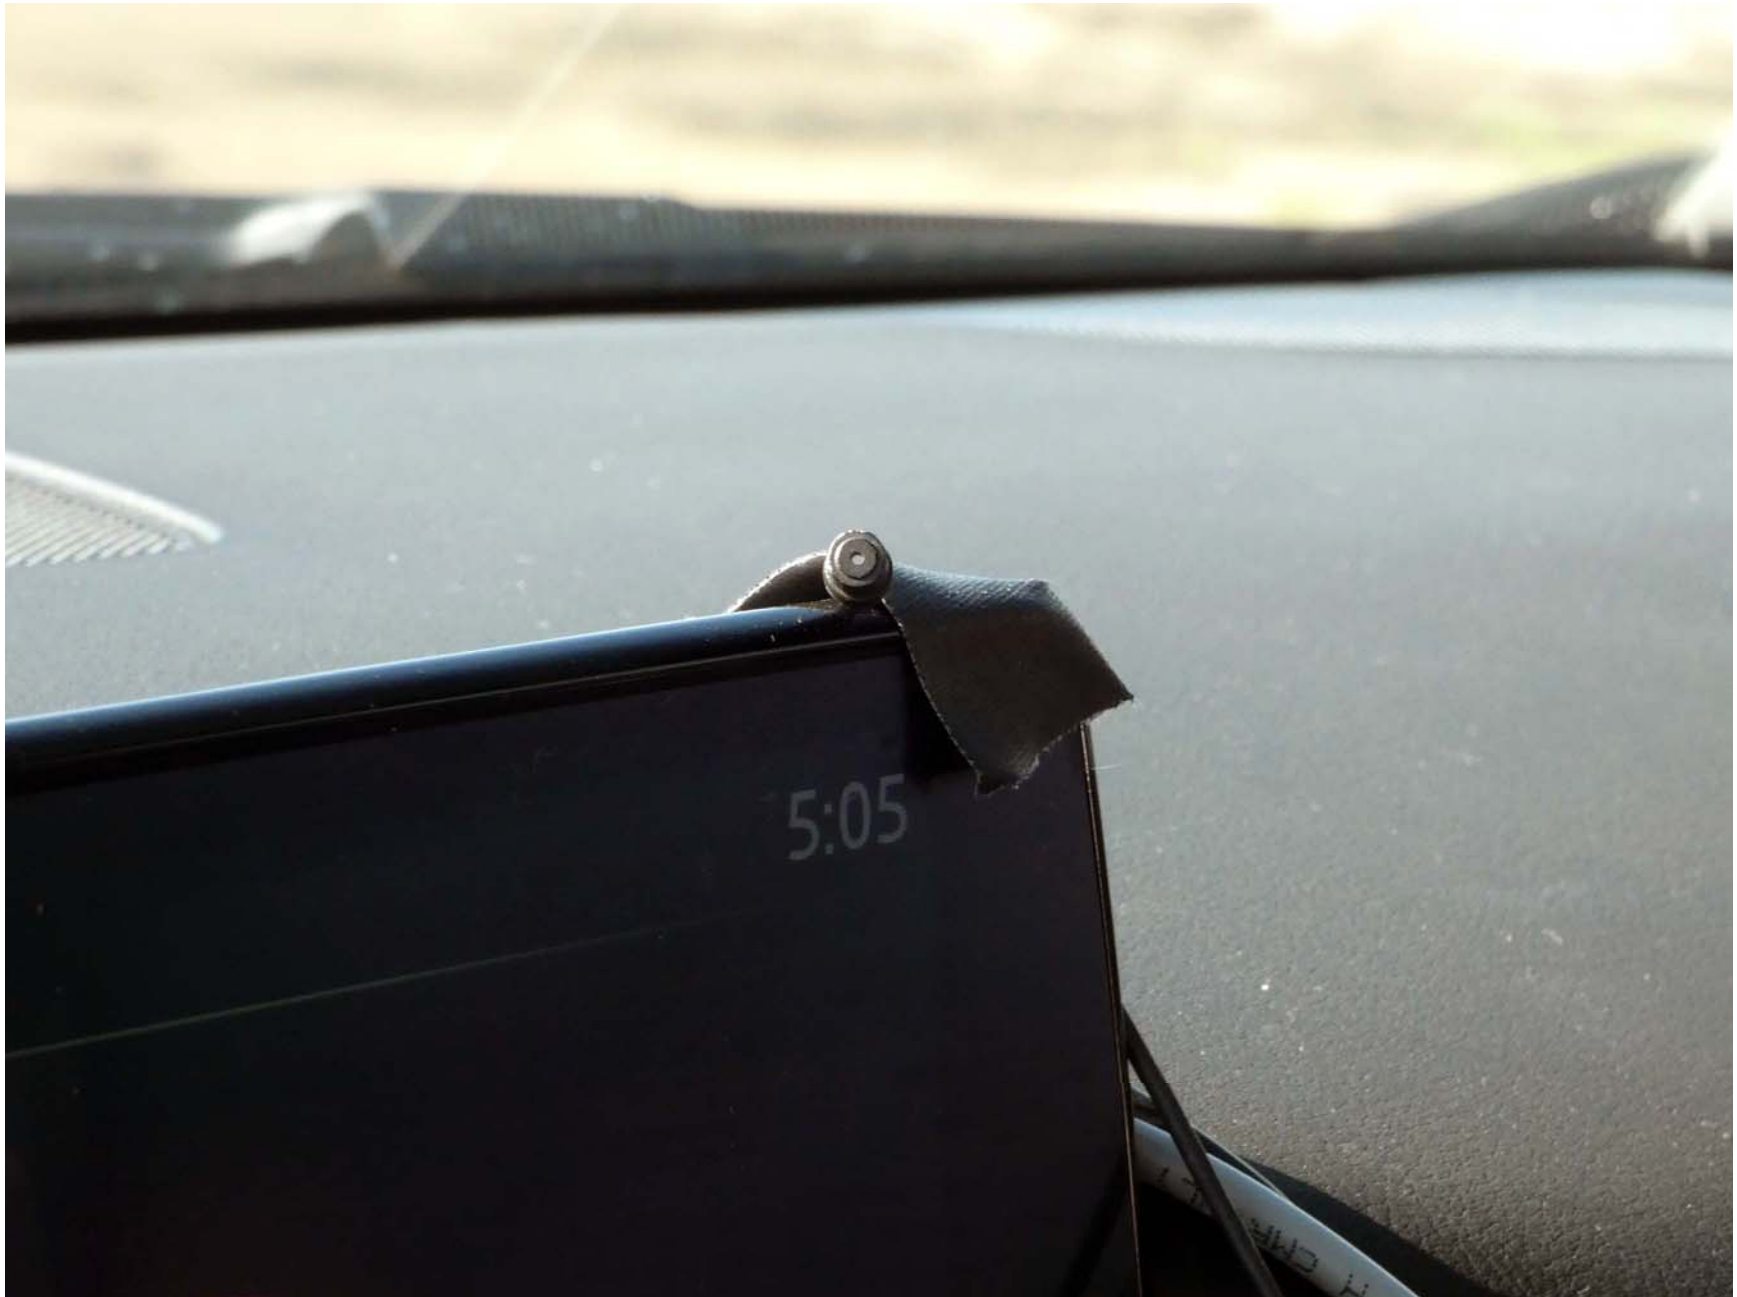
Figure A11. Sensor for Detecting Auditory Alerts

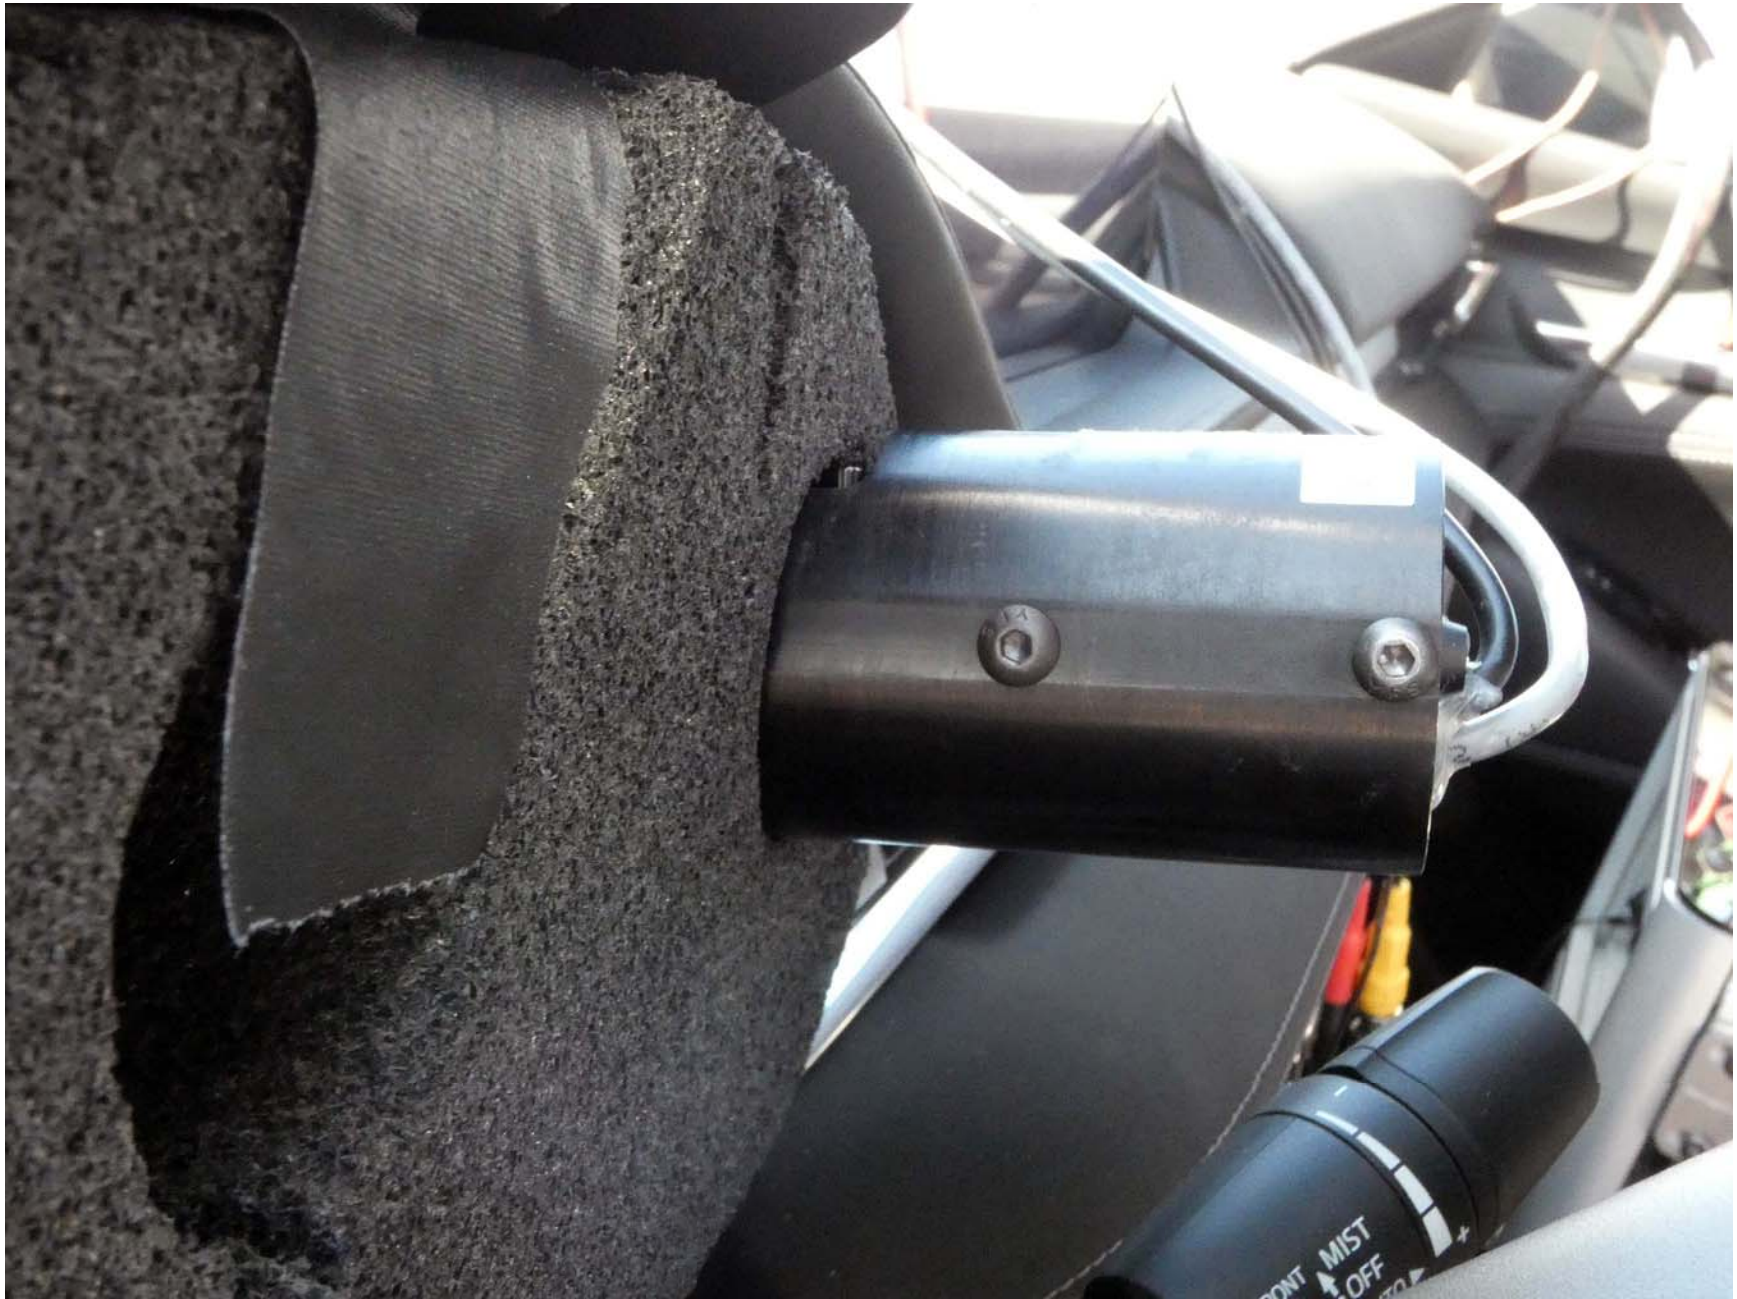
Figure A12. Sensor for Detecting Visual Alerts

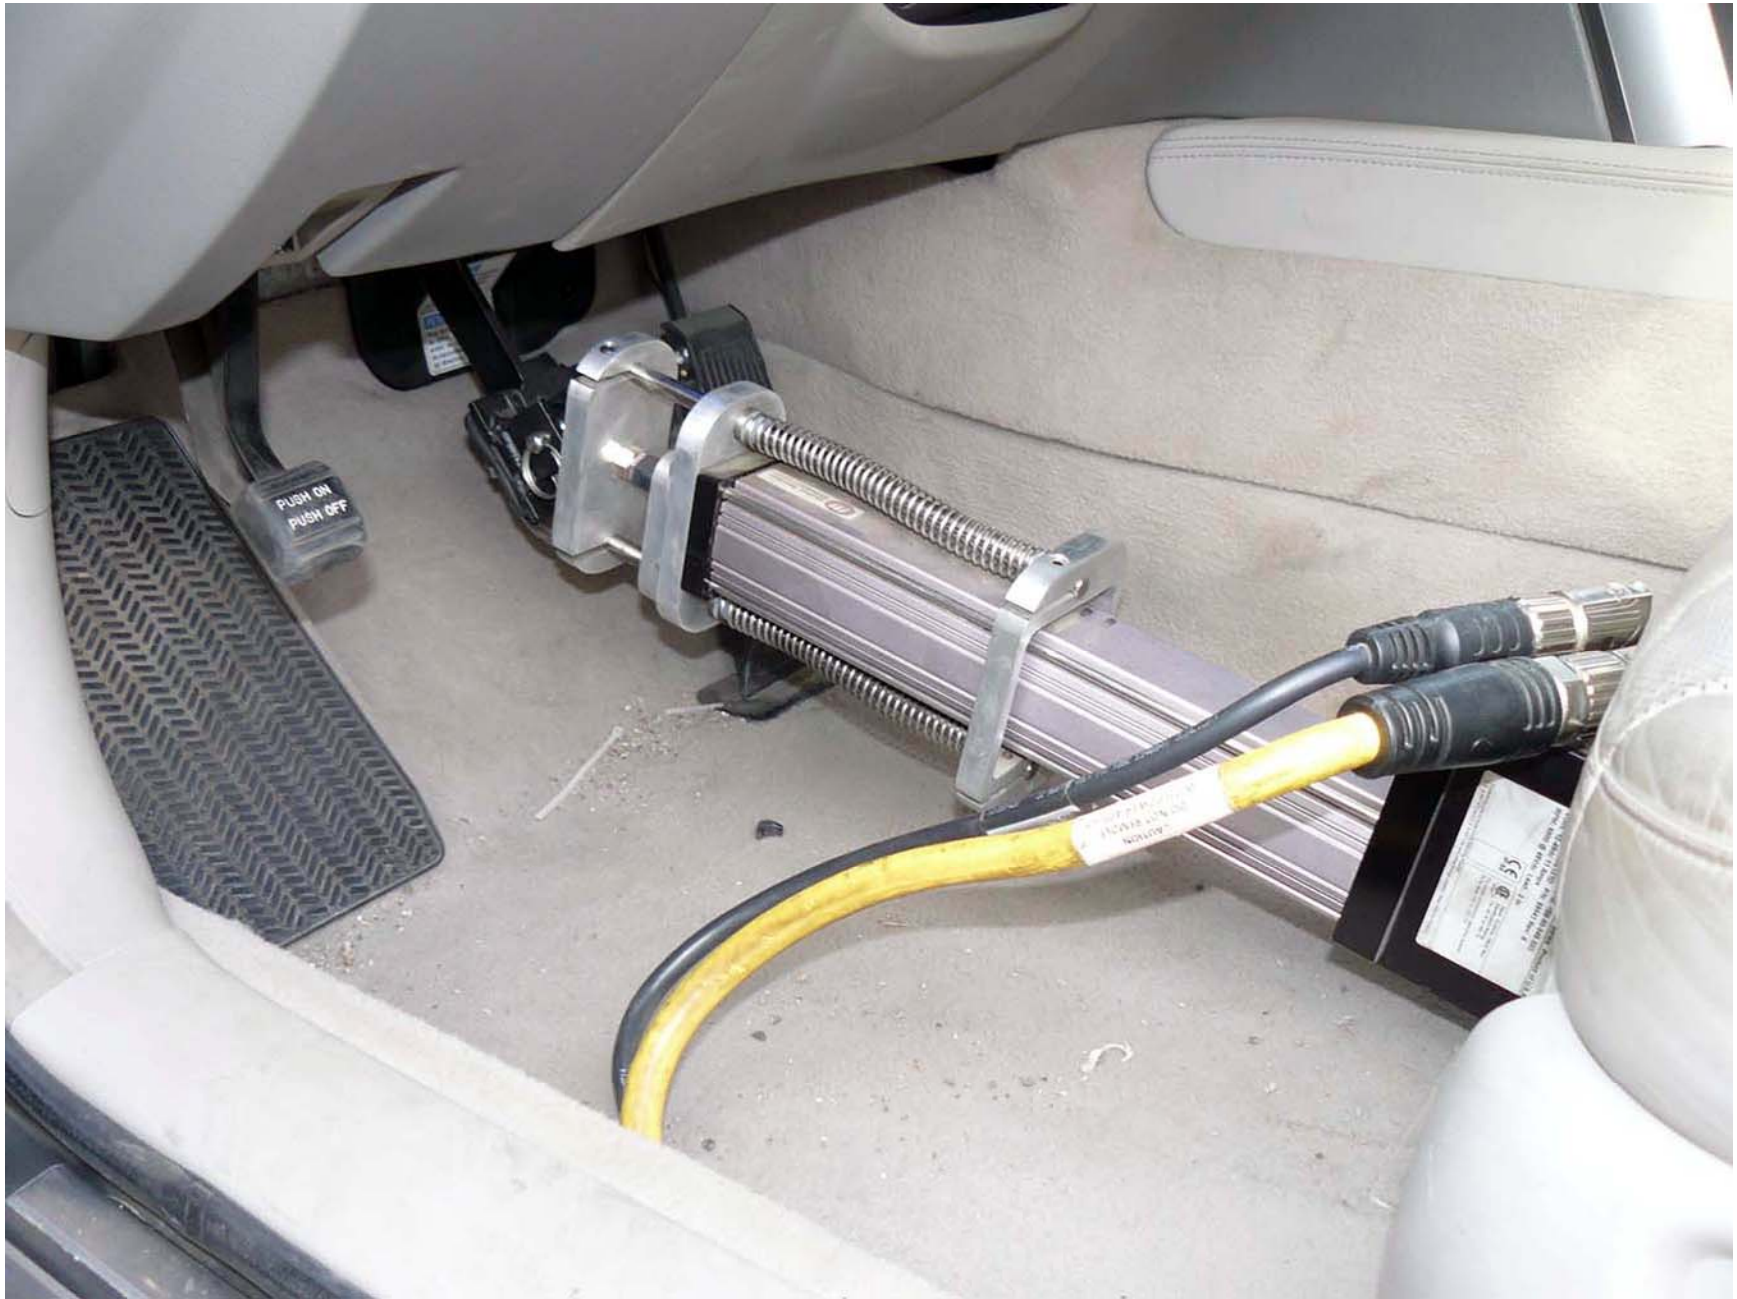
Figure A14. Brake Actuator Installed in POV System
