# NEW CAR ASSESSMENT PROGRAM CRASH IMMINENT BRAKING SYSTEM CONFIRMATION TEST NCAP-DRI-CIB-20-13

2020 Subaru Outback Premium/LDD

#### DYNAMIC RESEARCH, INC.

#### **Final Report**

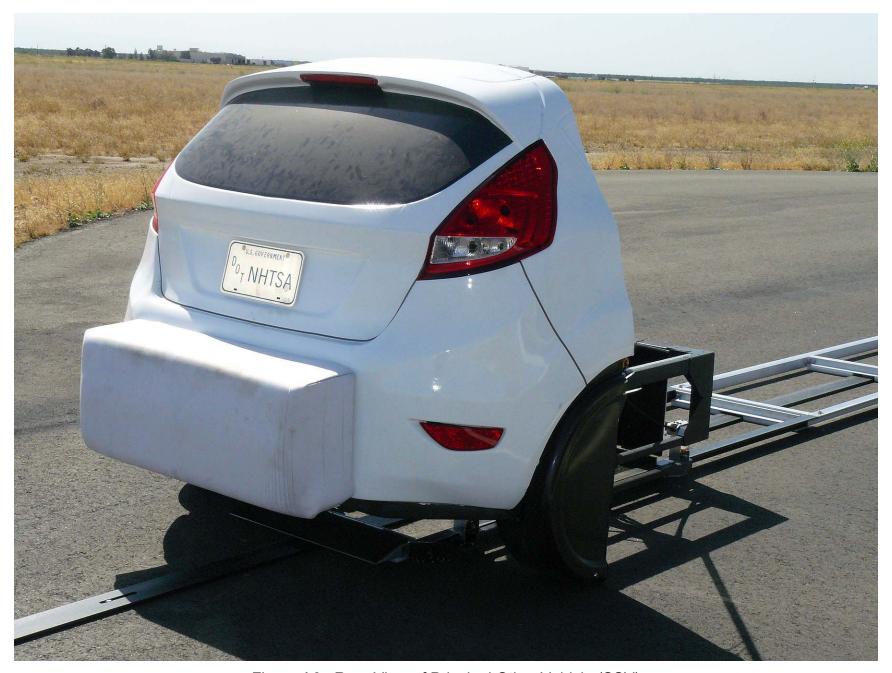
Figure A6. Rear View of Principal Other Vehicle (SSV)

CIB testing requires a POV that realistically represents typical vehicles, does not suffer damage or cause damage to a test vehicle in the event of collision, and can be accurately positioned and moved during the tests. The tests reported herein made use of the NHTSA developed Strikeable Surrogate Vehicle (SSV).

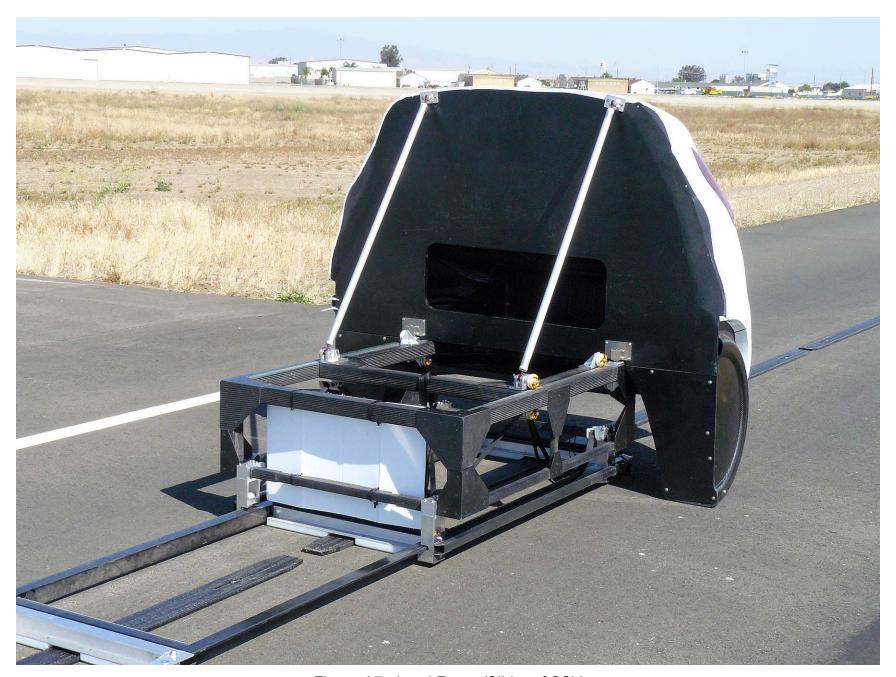
Figure A7. Load Frame/Slider of SSV

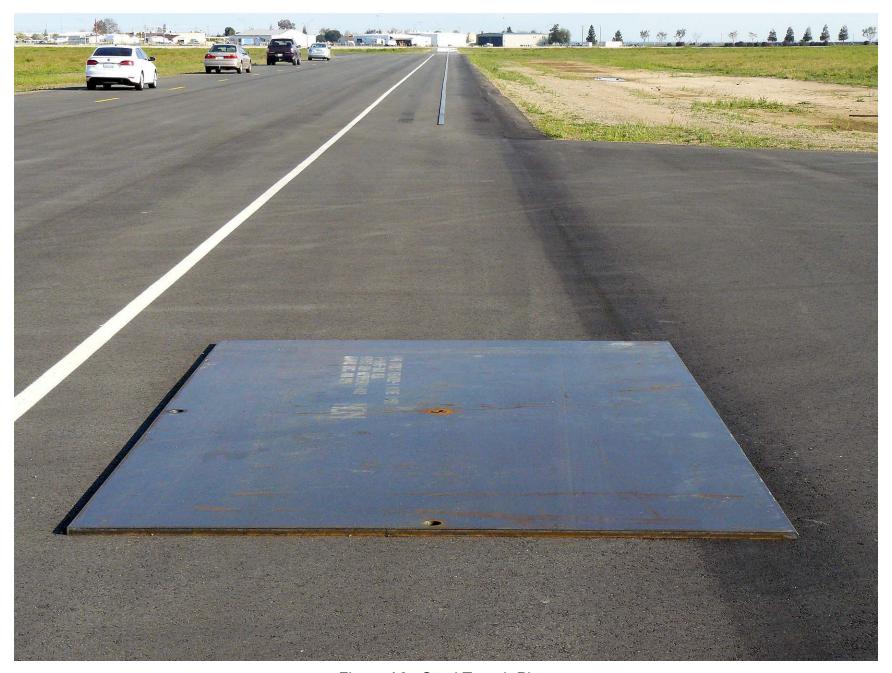
Figure A9. Steel Trench Plate

The false positive suppression test series evaluates the ability of a CIB system to differentiate a steel trench plate (STP) from an object presenting a genuine safety risk to the SV. Although the STP is large and metallic, it is designed to be driven over without risk of injury to the driver or damage to the SV. Therefore, in this scenario, the automatic braking available from CIB is not necessary and should be suppressed. The test condition is nearly equivalent to that previously defined for Test 1, the stopped POV condition, but with an STP in the SV forward path in lieu of a POV.

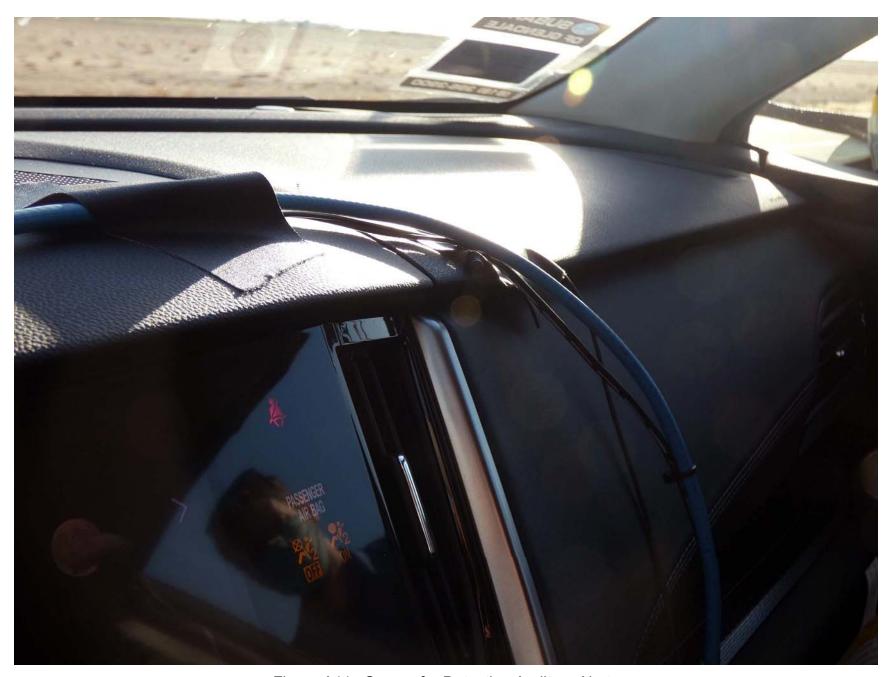
Figure A11. Sensor for Detecting Auditory Alerts

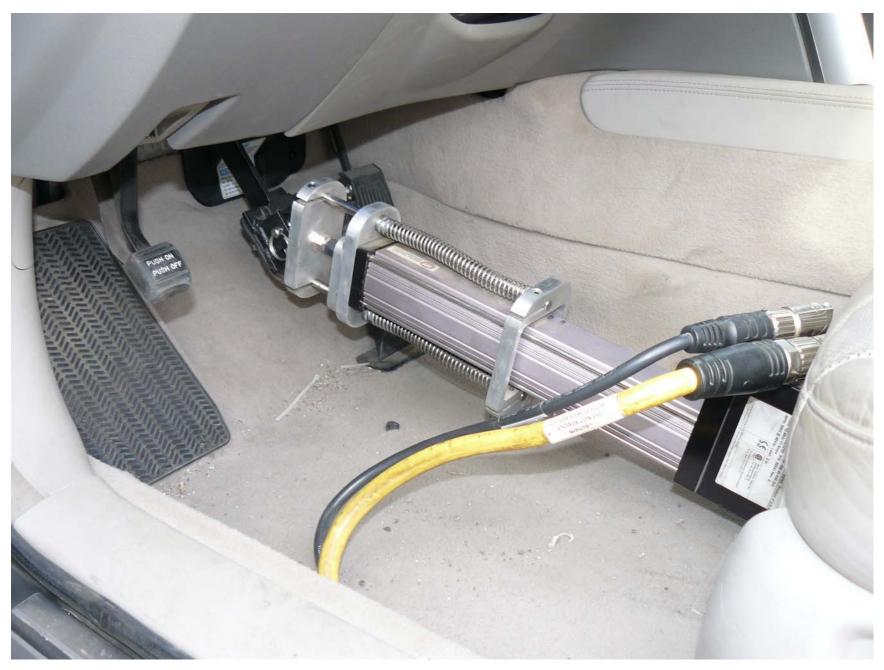
Figure A14. Brake Actuator Installed in POV System

In some cases, the subject vehicle is also equipped with an automatic braking system (E-brake) for the purpose of slowing the subject vehicle before impact with the SSV in cases where the subject vehicle is likely to fail a test. The system fires when TTC is below 0.7 sec. It is typically enabled when an SV has already impacted the SSV one or two times.

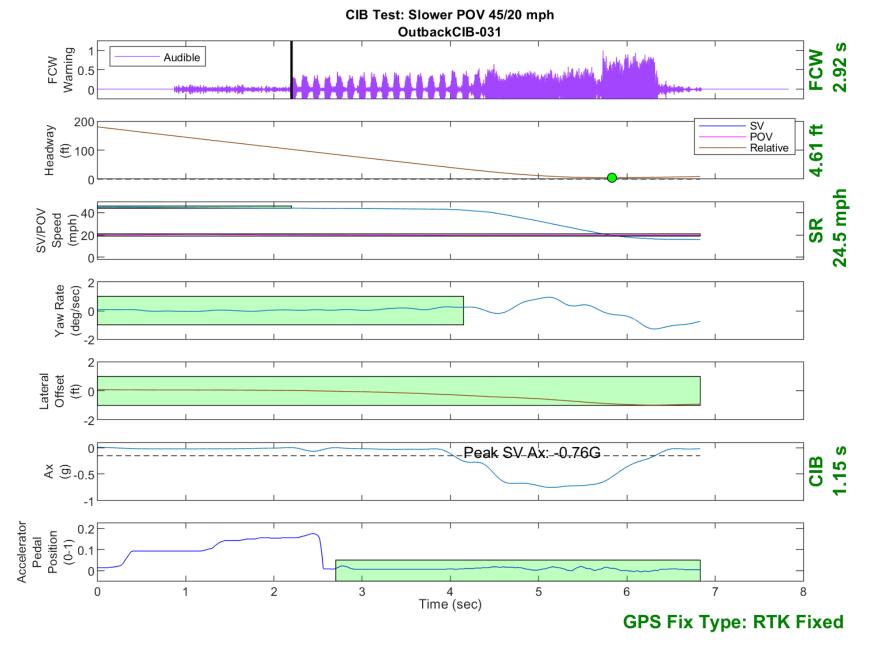
Figure D26. Time History for CIB Run 31, SV Encounters Slower POV, SV 45 mph, POV 20 mph

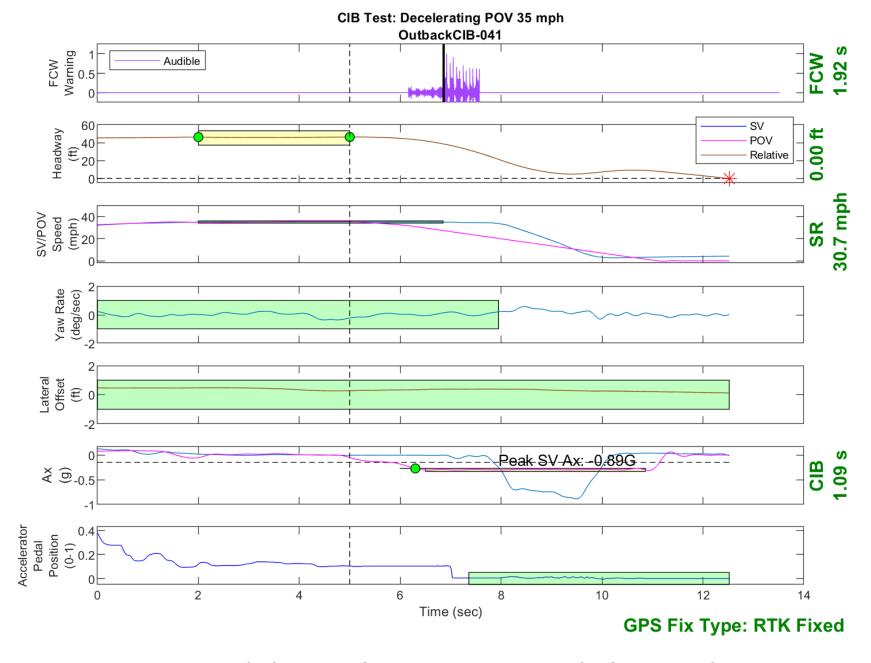
Figure D30. Time History for CIB Run 41, SV Encounters Decelerating POV, SV 35 mph, POV 35 mph

The SV ignition was cycled prior to each test run. For this test scenario, both the POV and SV were driven at a constant 35.0 mph (56.3 km/h) in the center of the lane, with a headway of 45.3 ft (13.8 m)  $\pm$  8 ft (2.4 m). Once these conditions were met, the POV tow vehicle brakes were applied to achieve 0.3  $\pm$  0.03 g of deceleration. The test concluded when either:

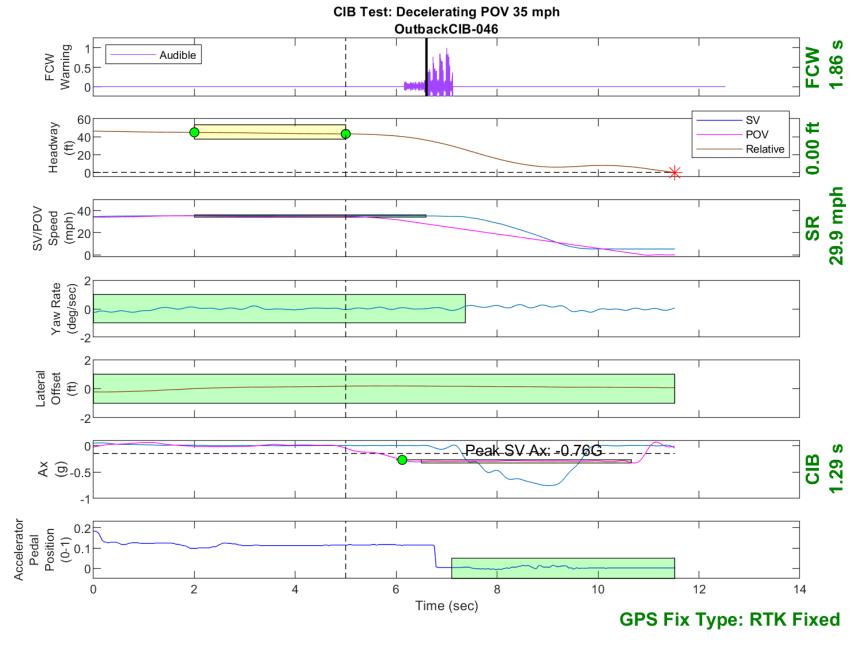
Figure D35. Time History for CIB Run 46, SV Encounters Decelerating POV, SV 35 mph, POV 35 mph
