**NEW CAR ASSESSMENT PROGRAM
CRASH IMMINENT BRAKING SYSTEM CONFIRMATION TEST
NCAP-DRI-CIB-20-13**

2020 Subaru Outback Premium/LDD

DYNAMIC RESEARCH, INC.

Final Report

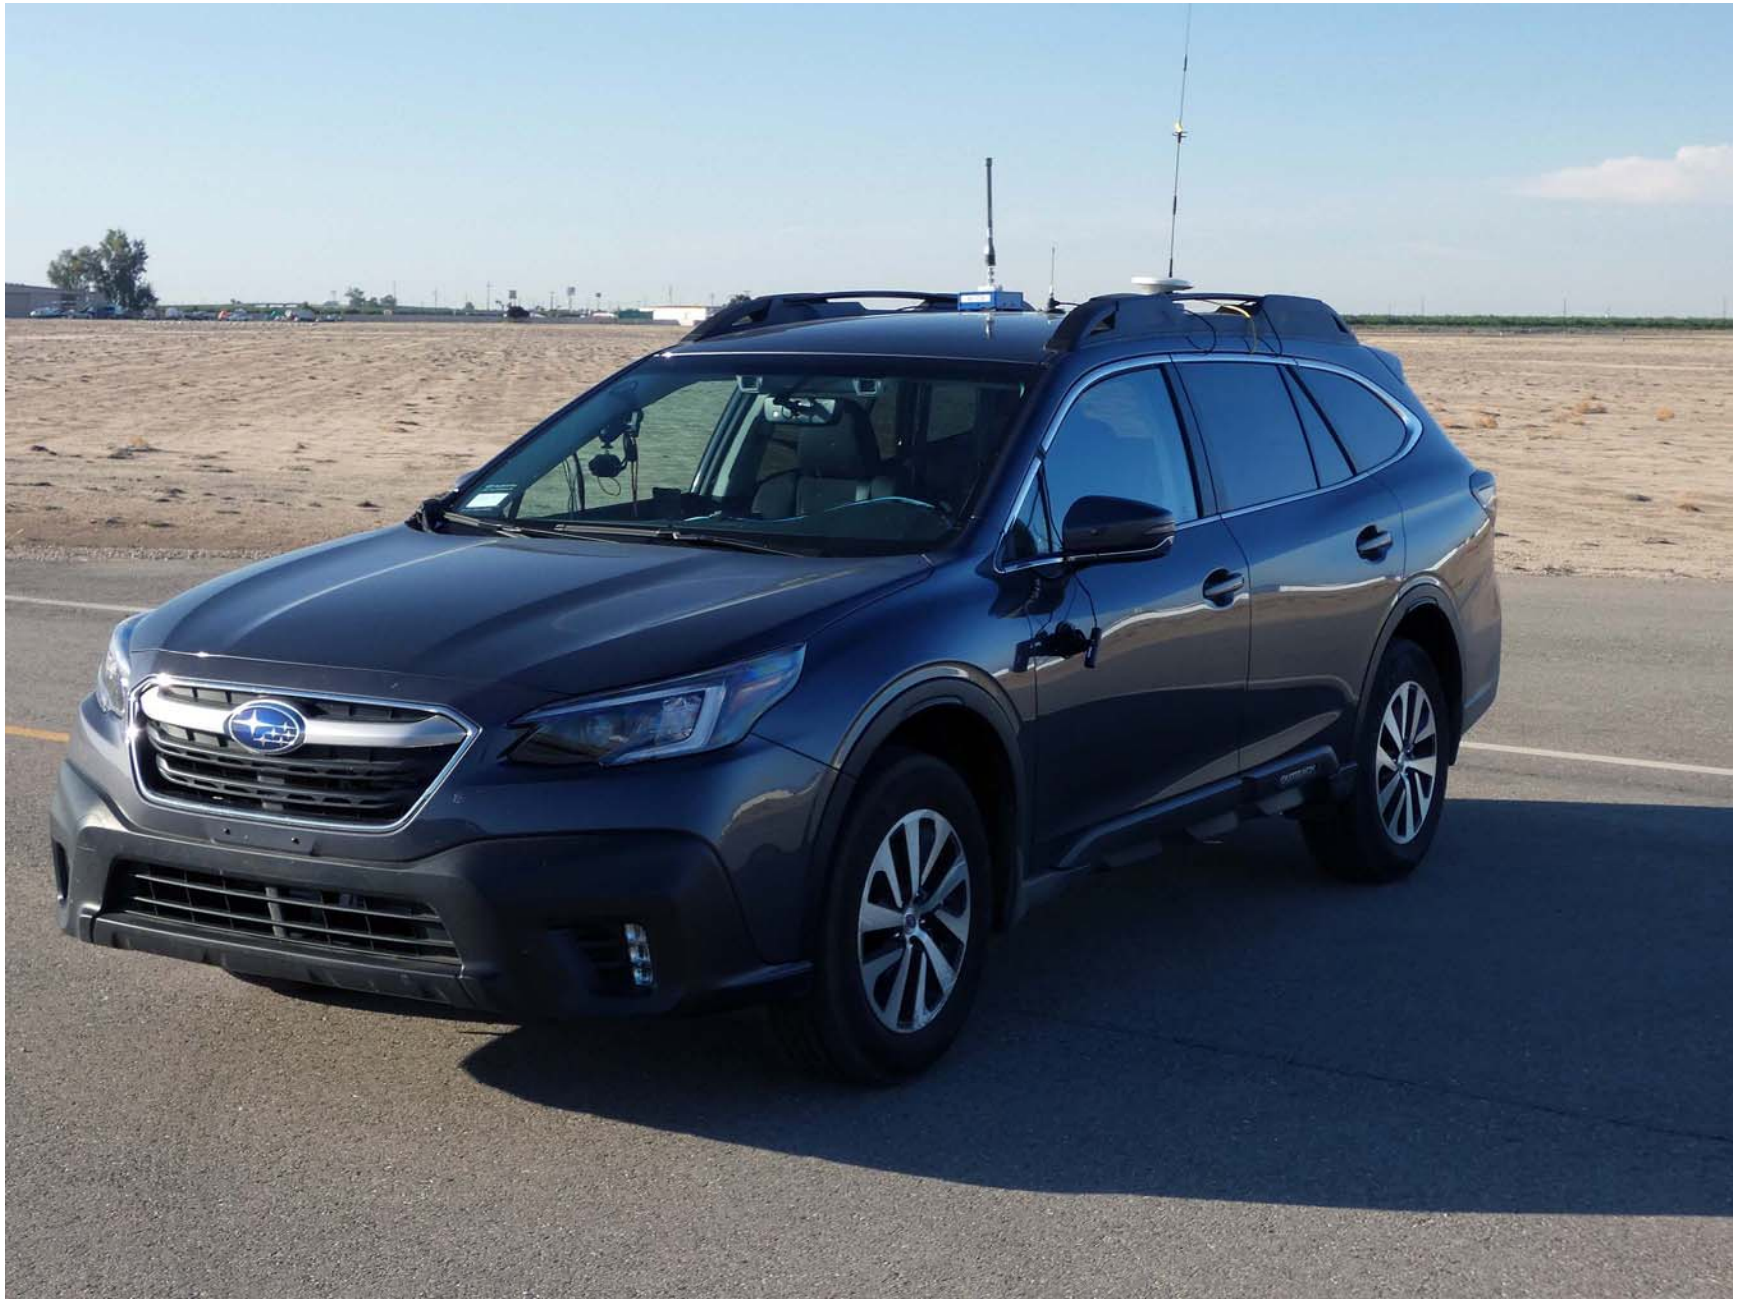
Figure A1. Front View of Subject Vehicle

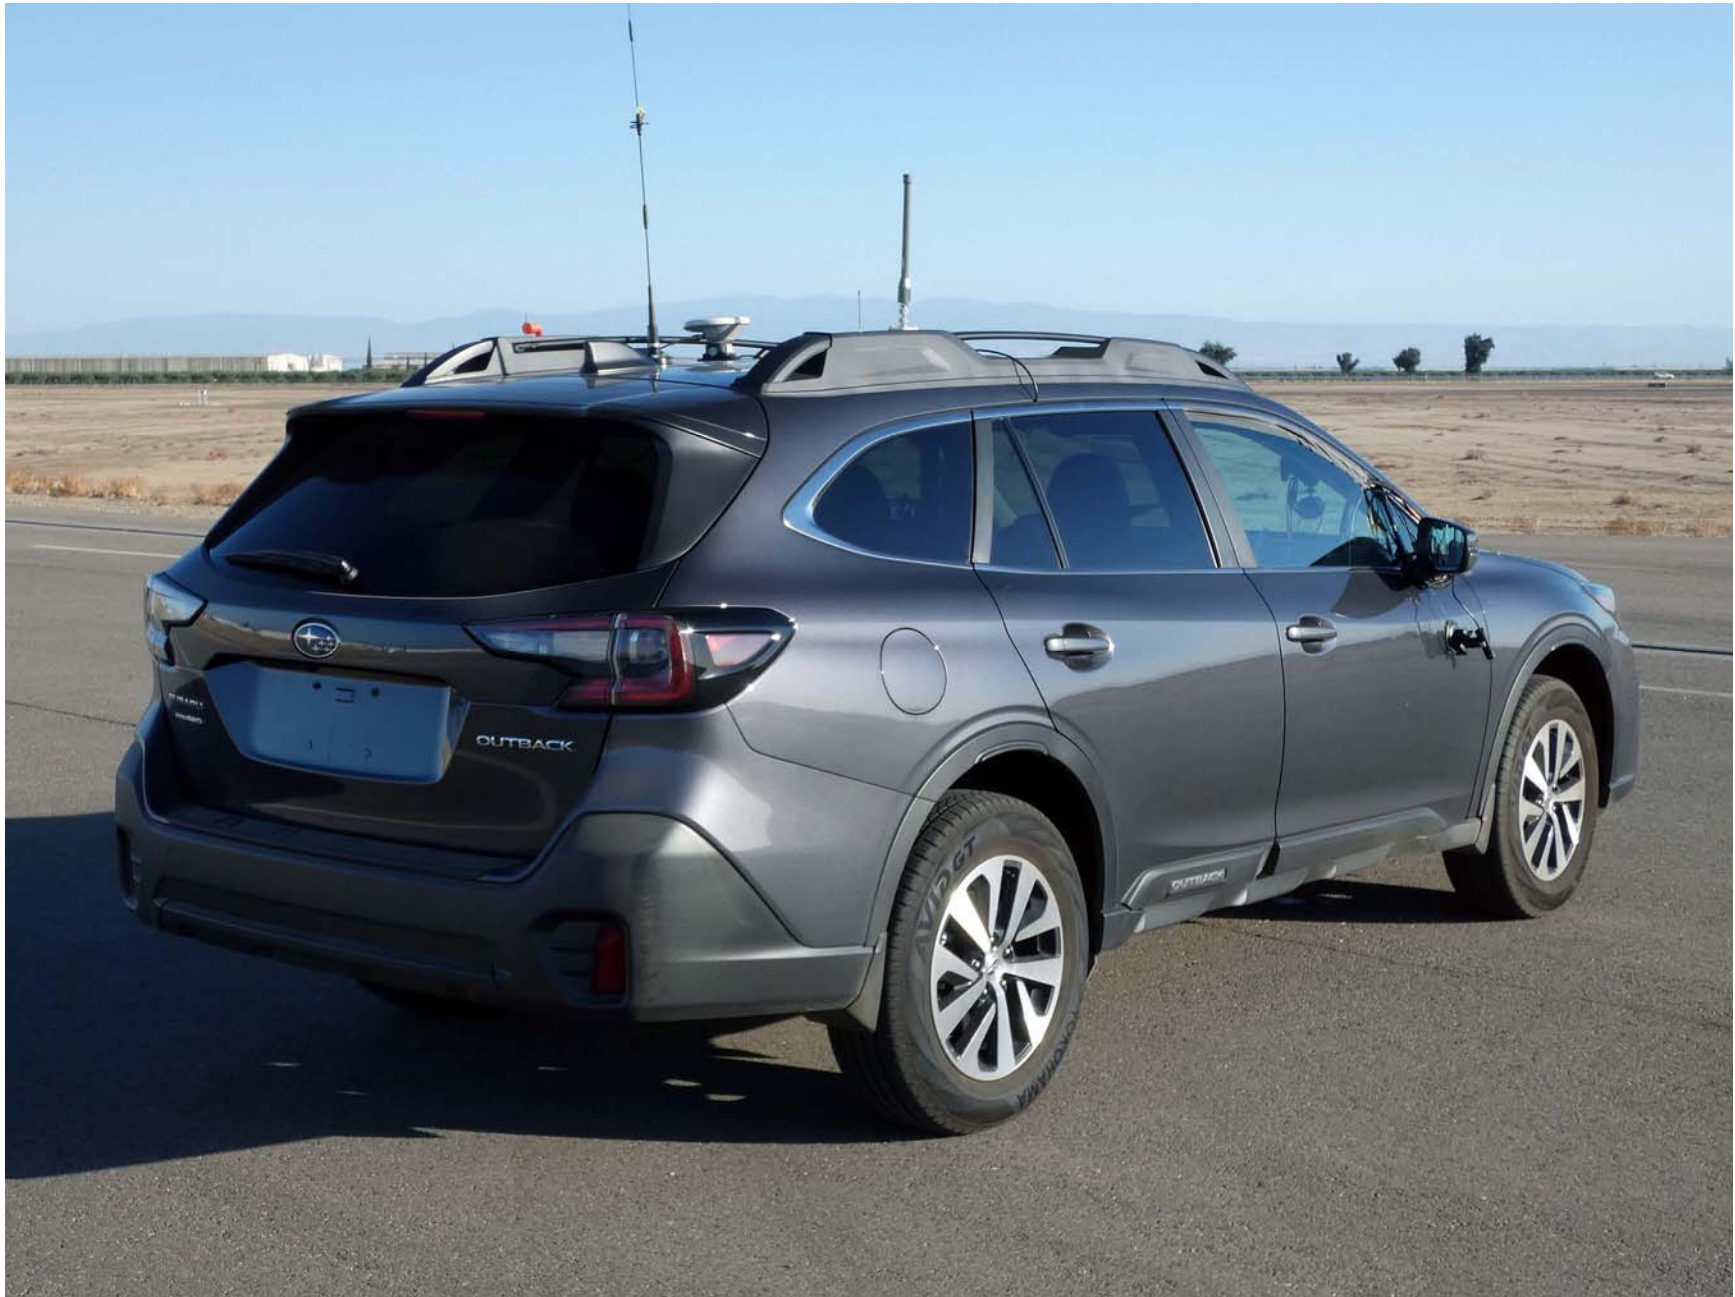
Figure A2. Rear View of Subject Vehicle

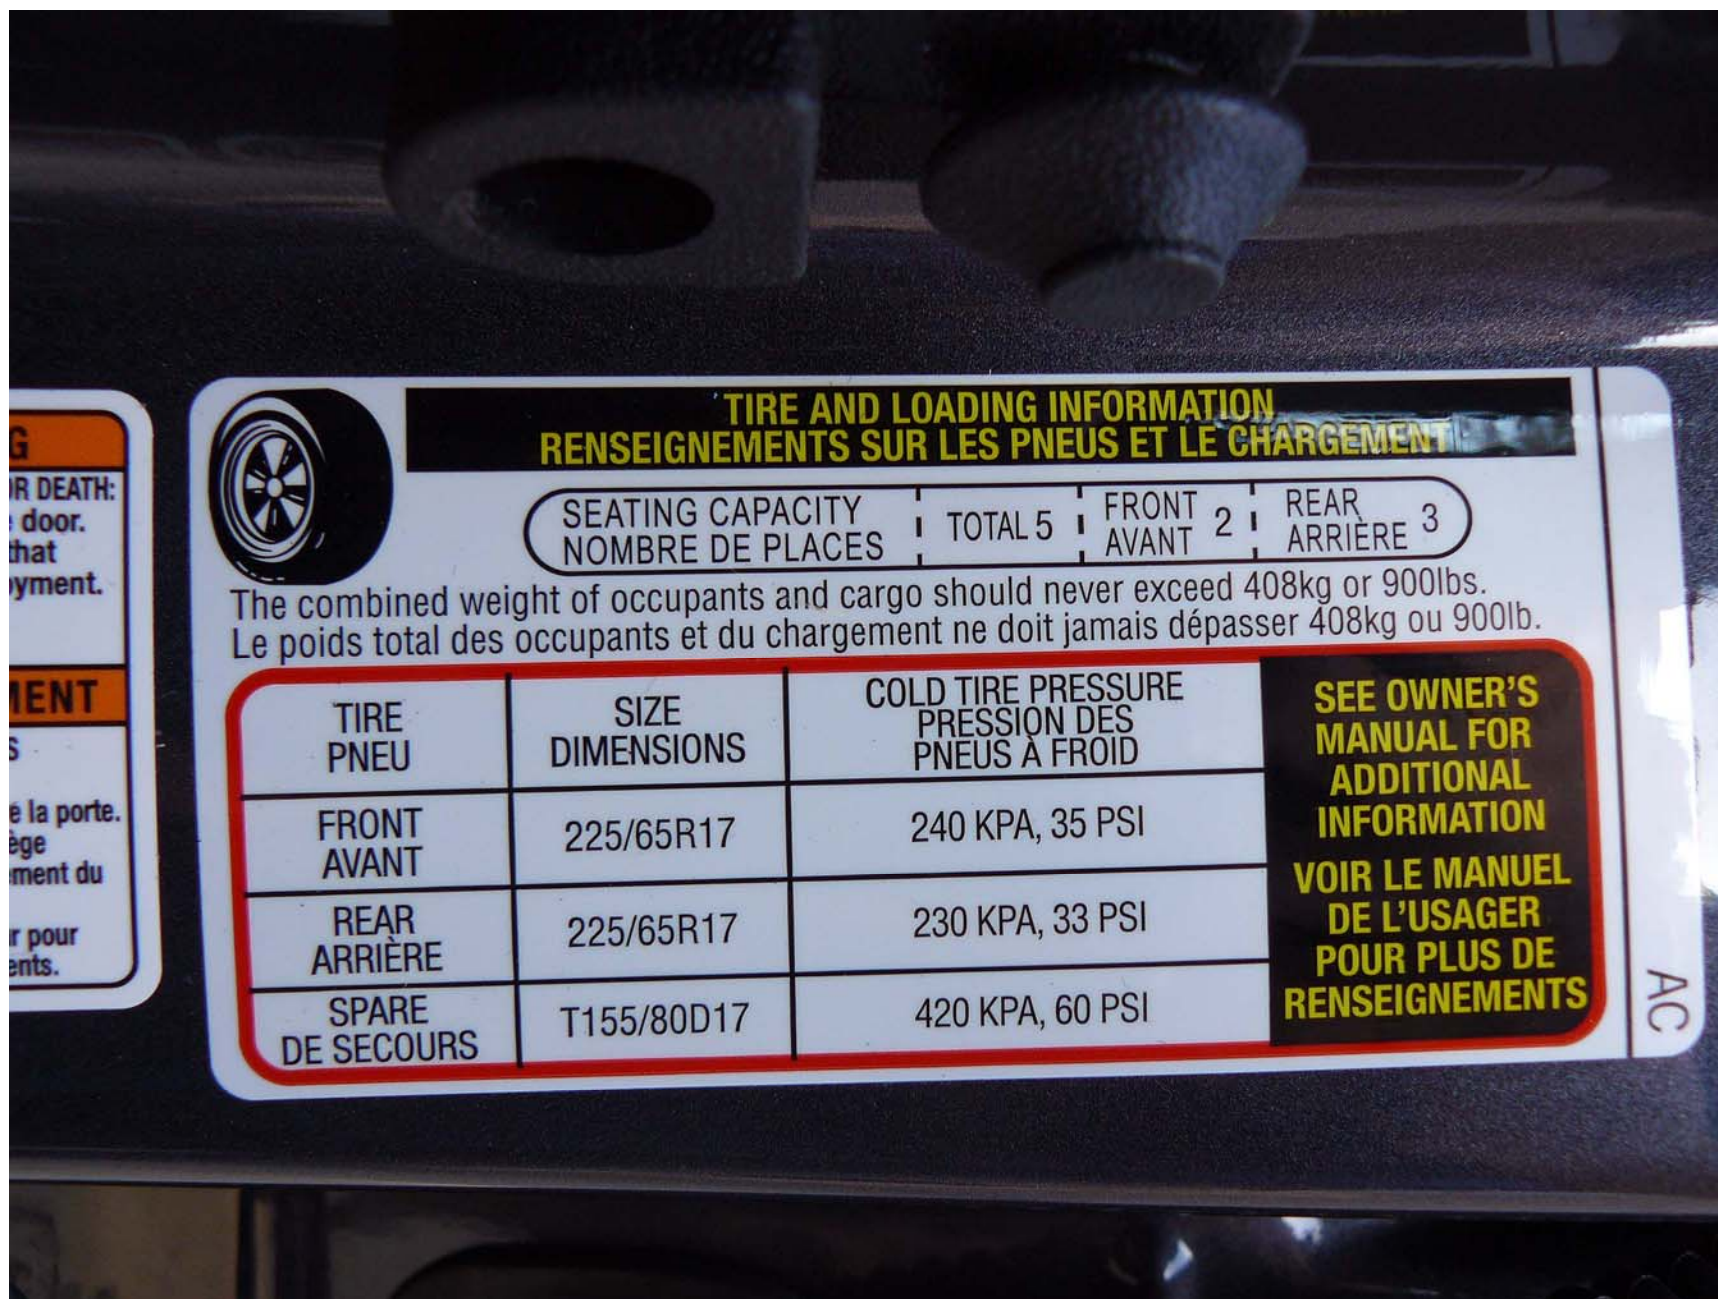
Figure A5. Tire Placard

Recommended cold tire pressure: Front: 240 kPa (35 psi)

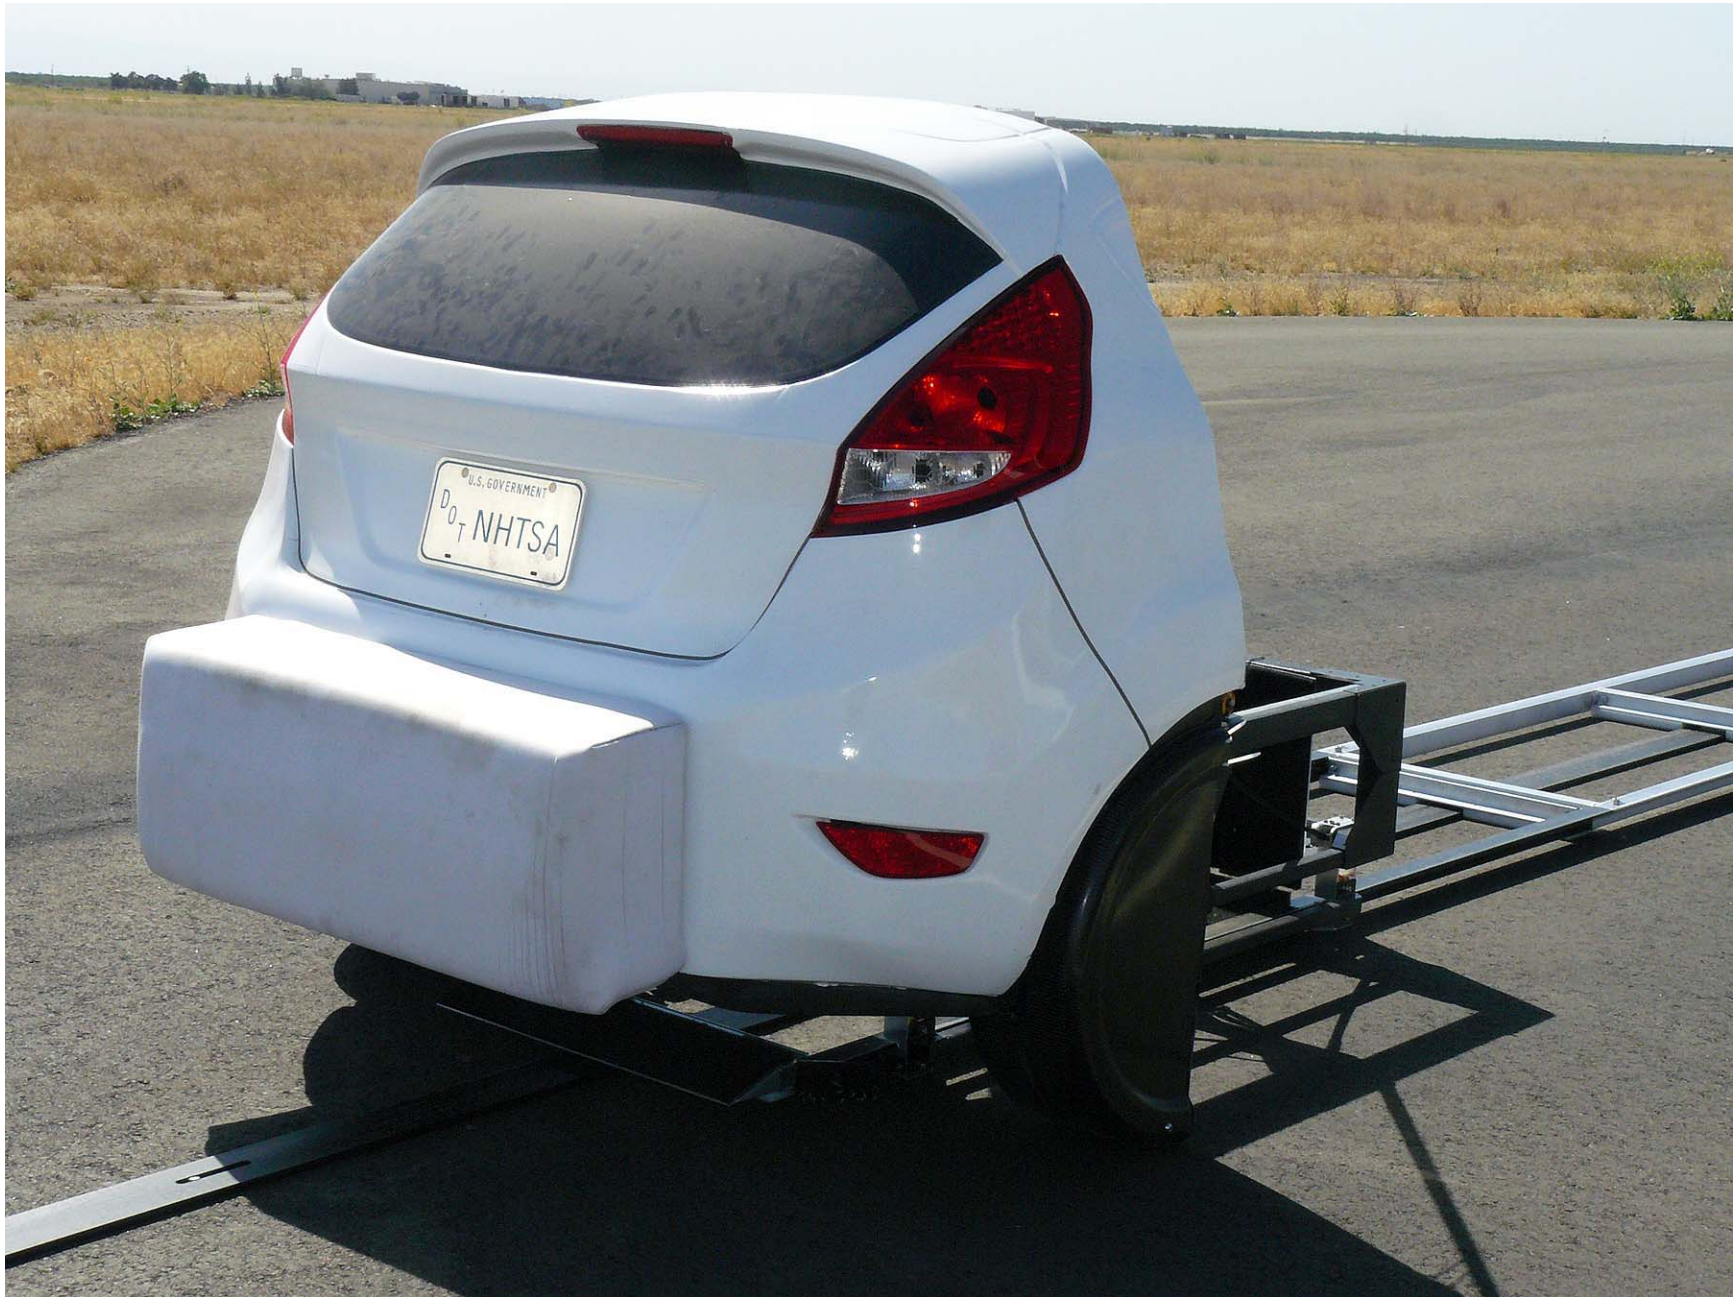
Figure A6. Rear View of Principal Other Vehicle (SSV)

CIB testing requires a POV that realistically represents typical vehicles, does not suffer damage or cause damage to a test vehicle in the event of collision, and can be accurately positioned and moved during the tests. The tests reported herein made use of the NHTSA developed Strikeable Surrogate Vehicle (SSV).

- Provide an accurate representation of a real vehicle to CIB sensors, including cameras and radar.
- Be resistant to damage and inflict little or no damage to the SV as a result of repeated SV-to-POV impacts.

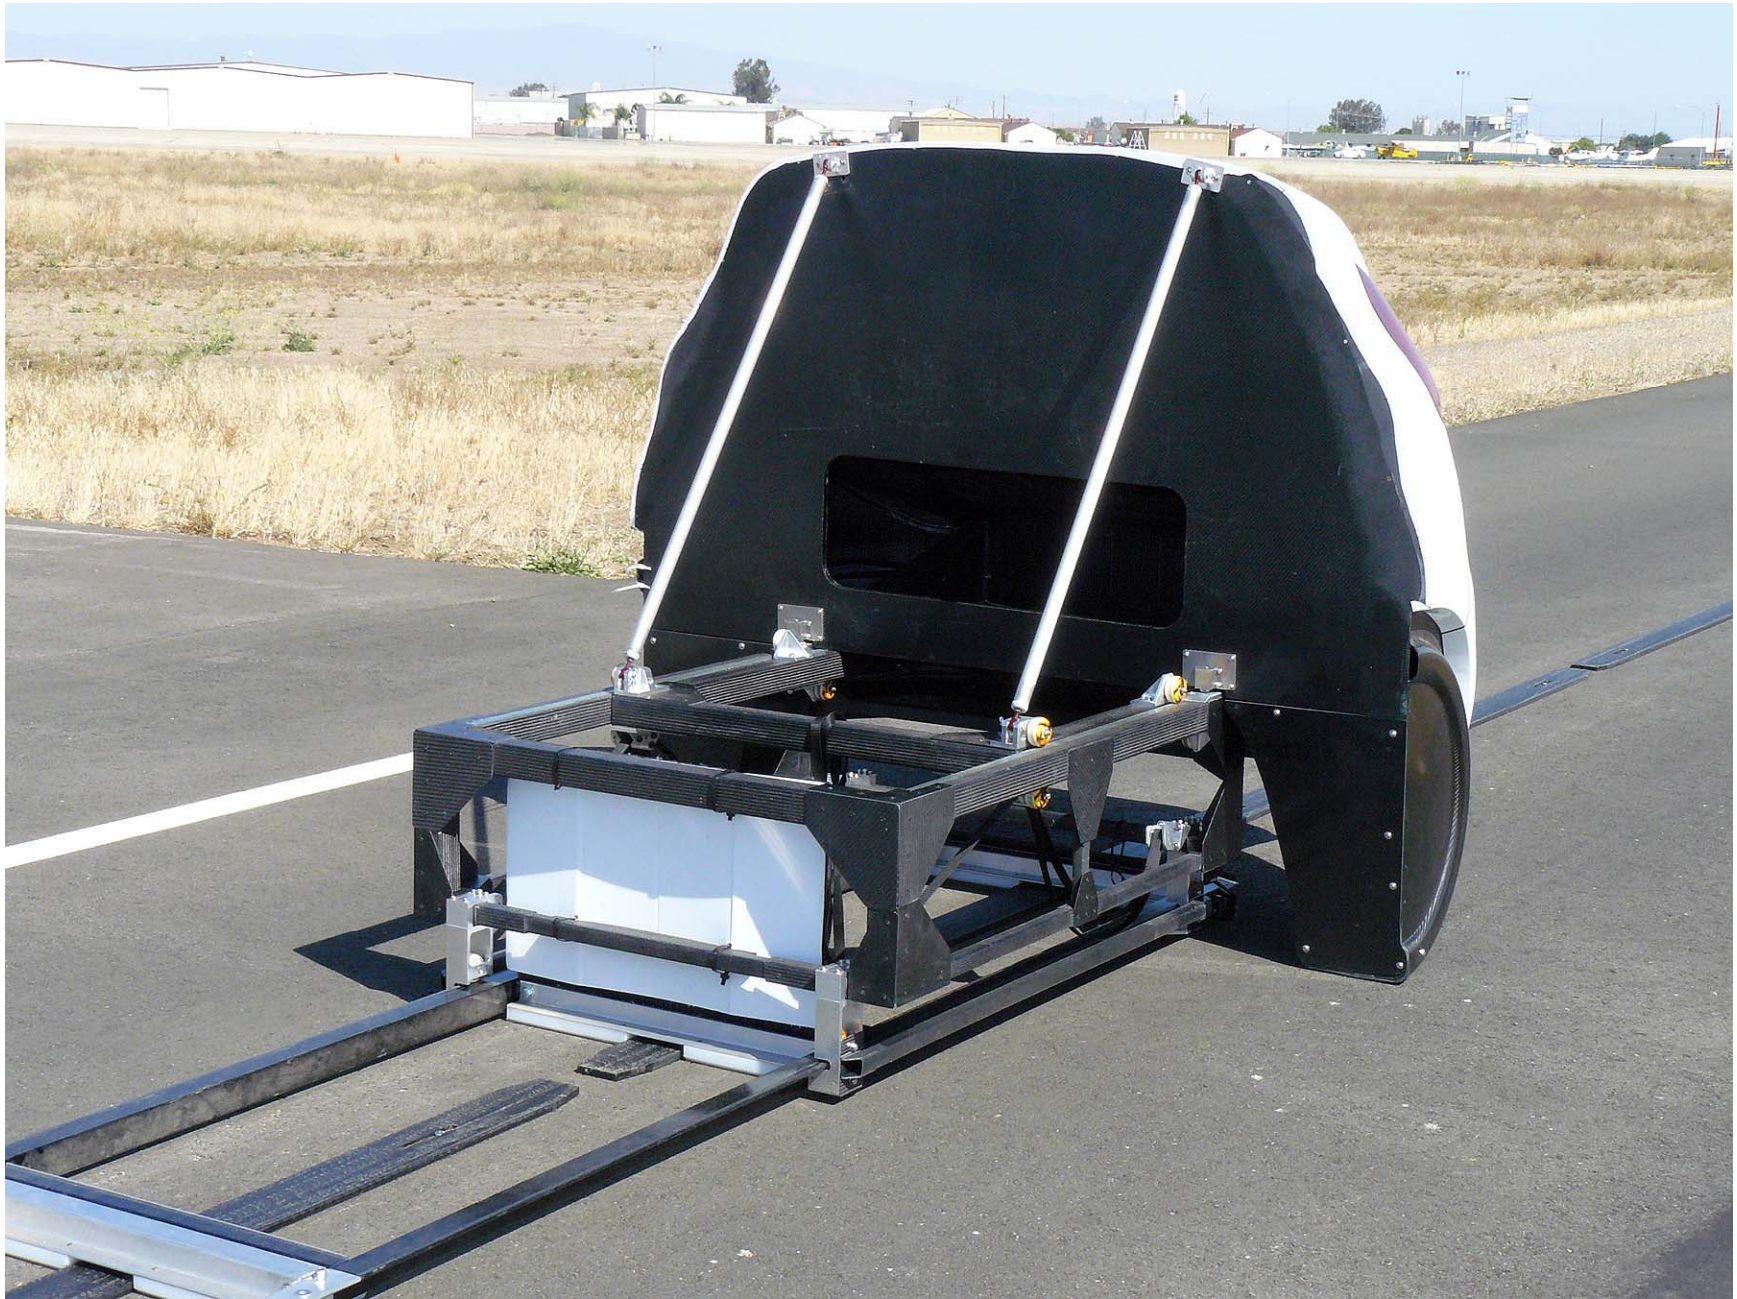
Figure A7. Load Frame/Slider of SSV

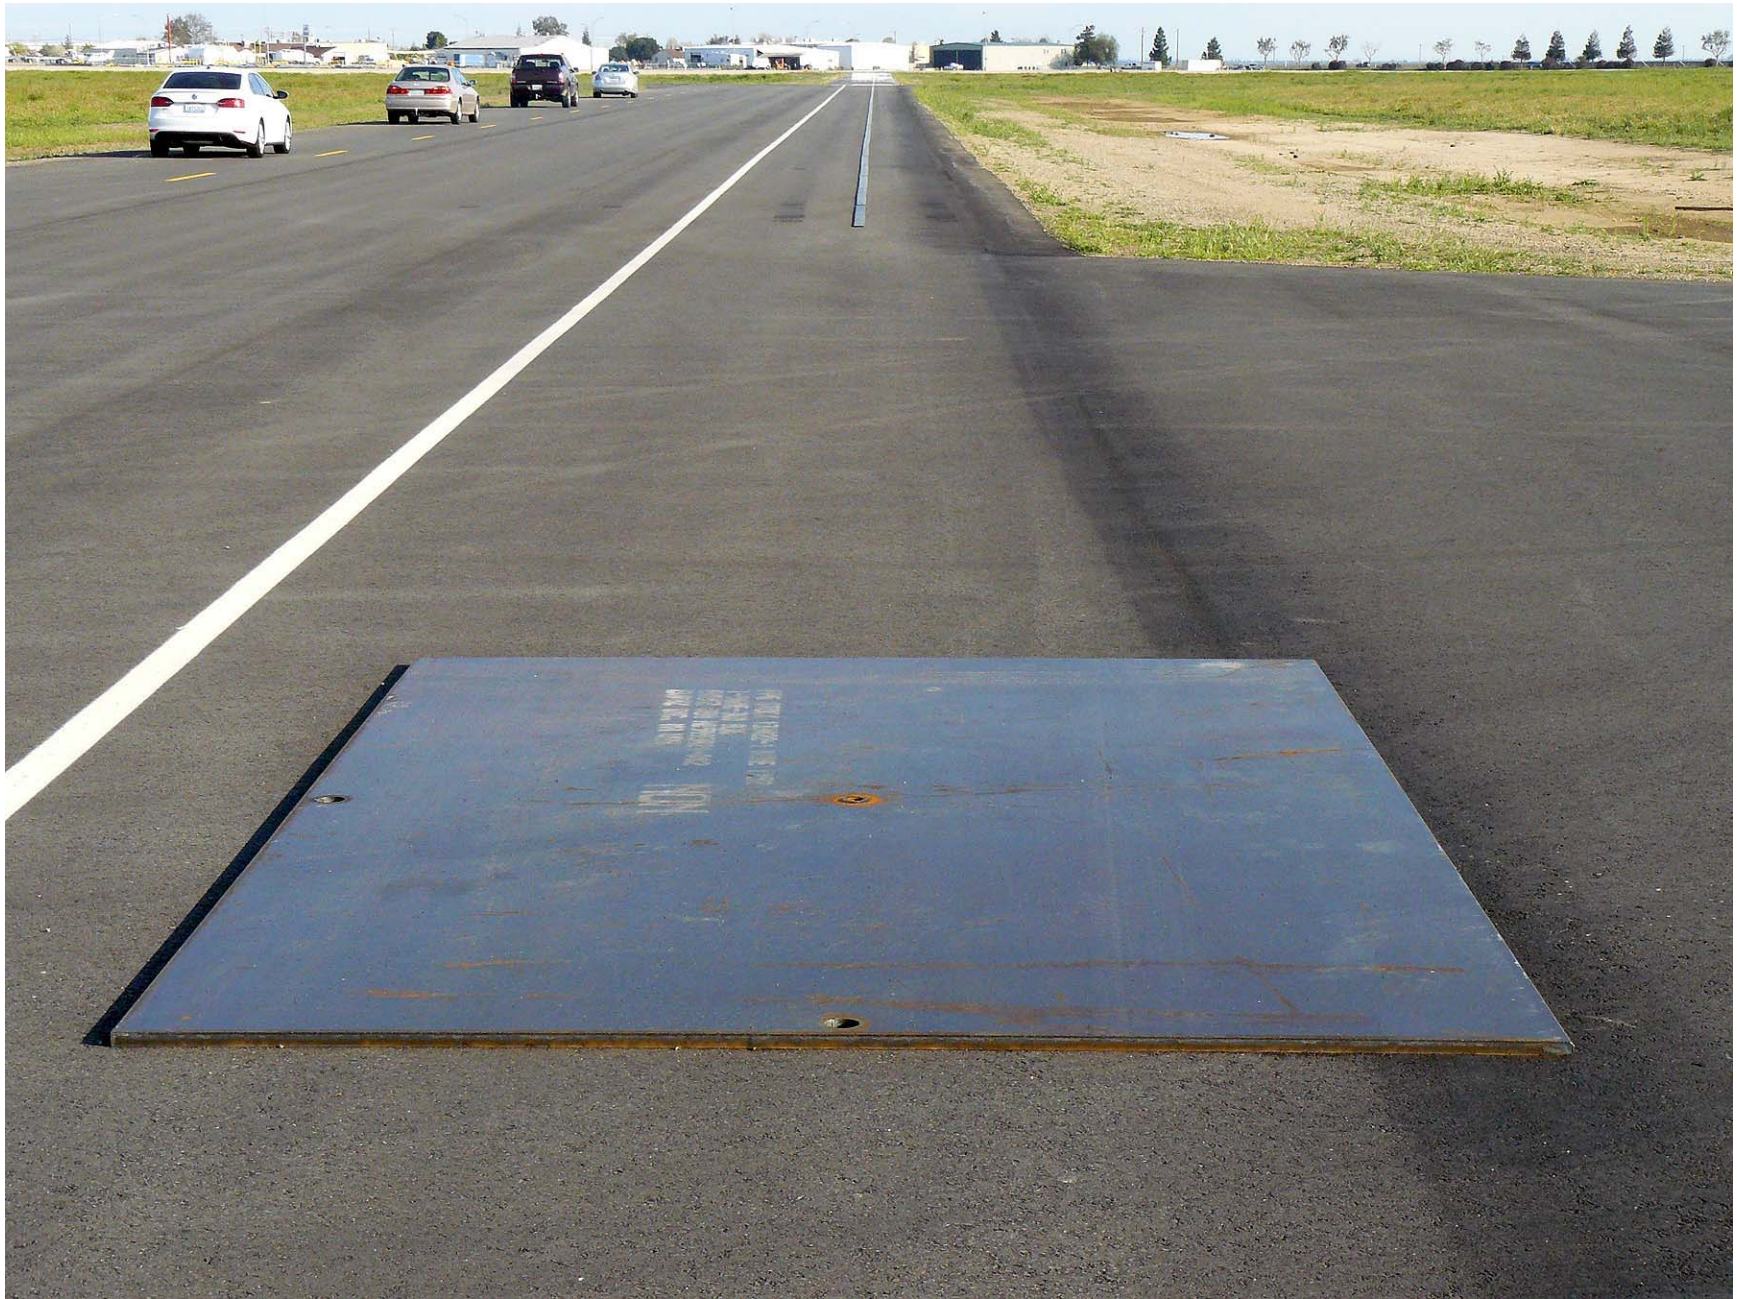
Figure A9. Steel Trench Plate

The false positive suppression test series evaluates the ability of a CIB system to differentiate a steel trench plate (STP) from an object presenting a genuine safety risk to the SV. Although the STP is large and metallic, it is designed to be driven over without risk of injury to the driver or damage to the SV. Therefore, in this scenario, the automatic braking available from CIB is not necessary and should be suppressed. The test condition is nearly equivalent to that previously defined for Test 1, the stopped POV condition, but with an STP in the SV forward path in lieu of a POV.

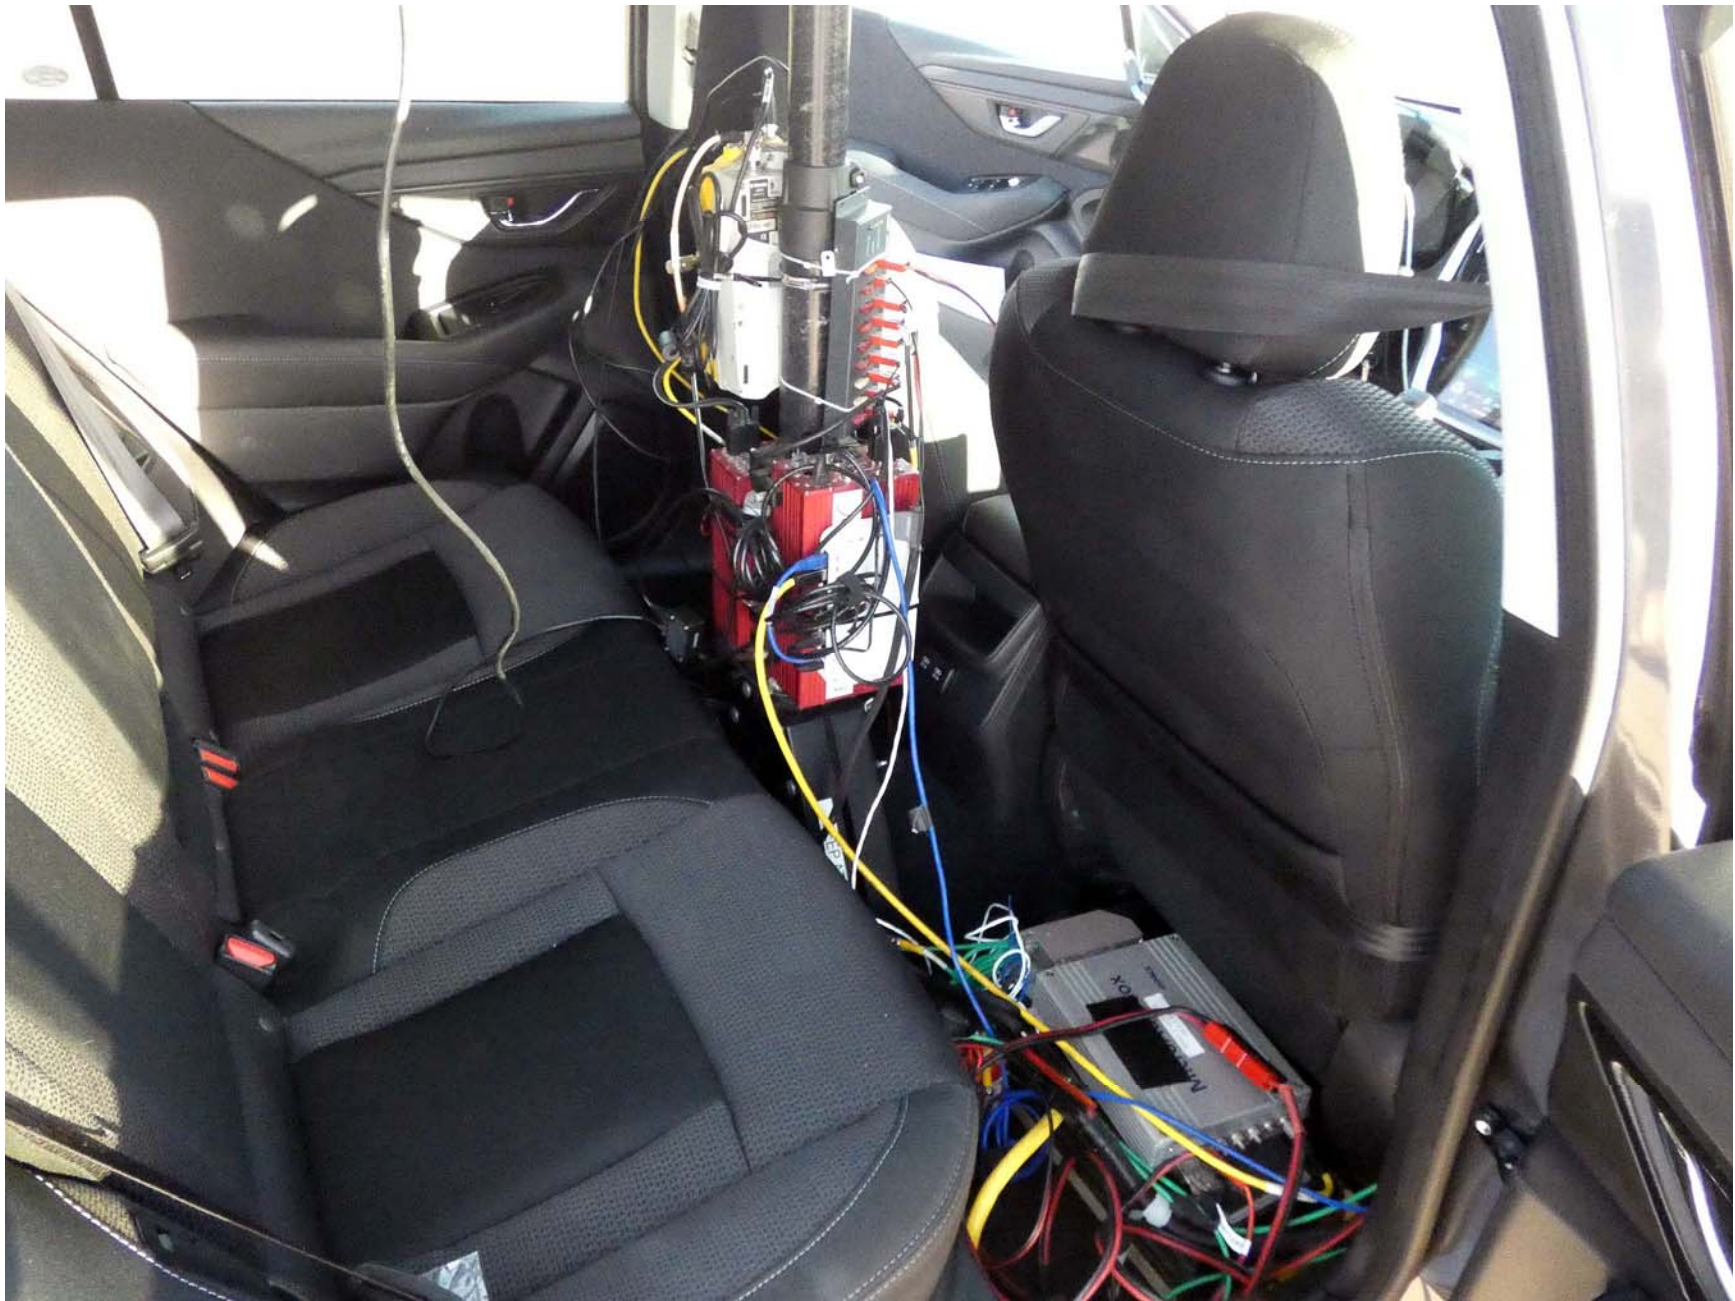
Figure A10. DGPS, Inertial Measurement Unit, and MicroAutoBox Installed in Subject Vehicle

Table 2 lists the sensors, signal conditioning, and data acquisition equipment used for these tests.

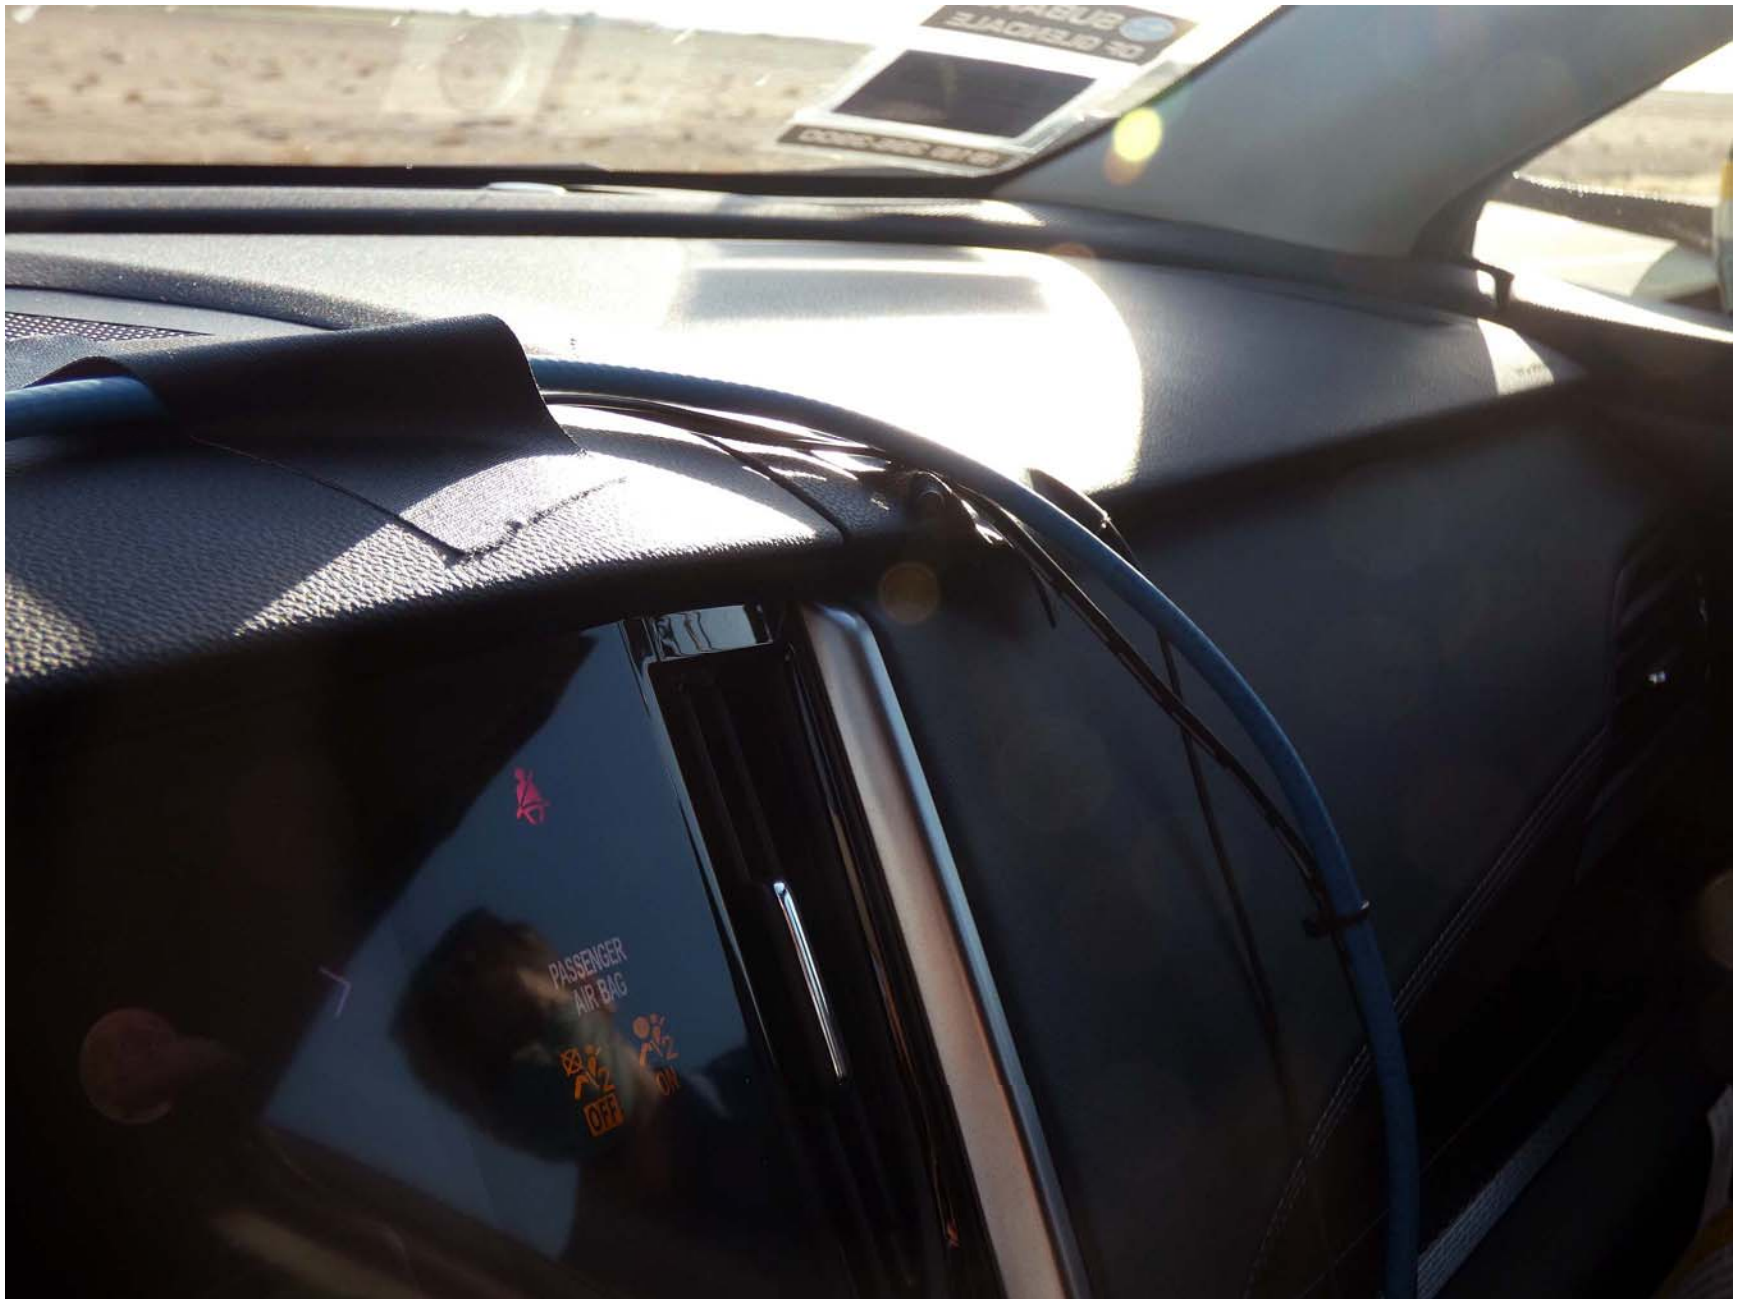
Figure A11. Sensor for Detecting Auditory Alerts

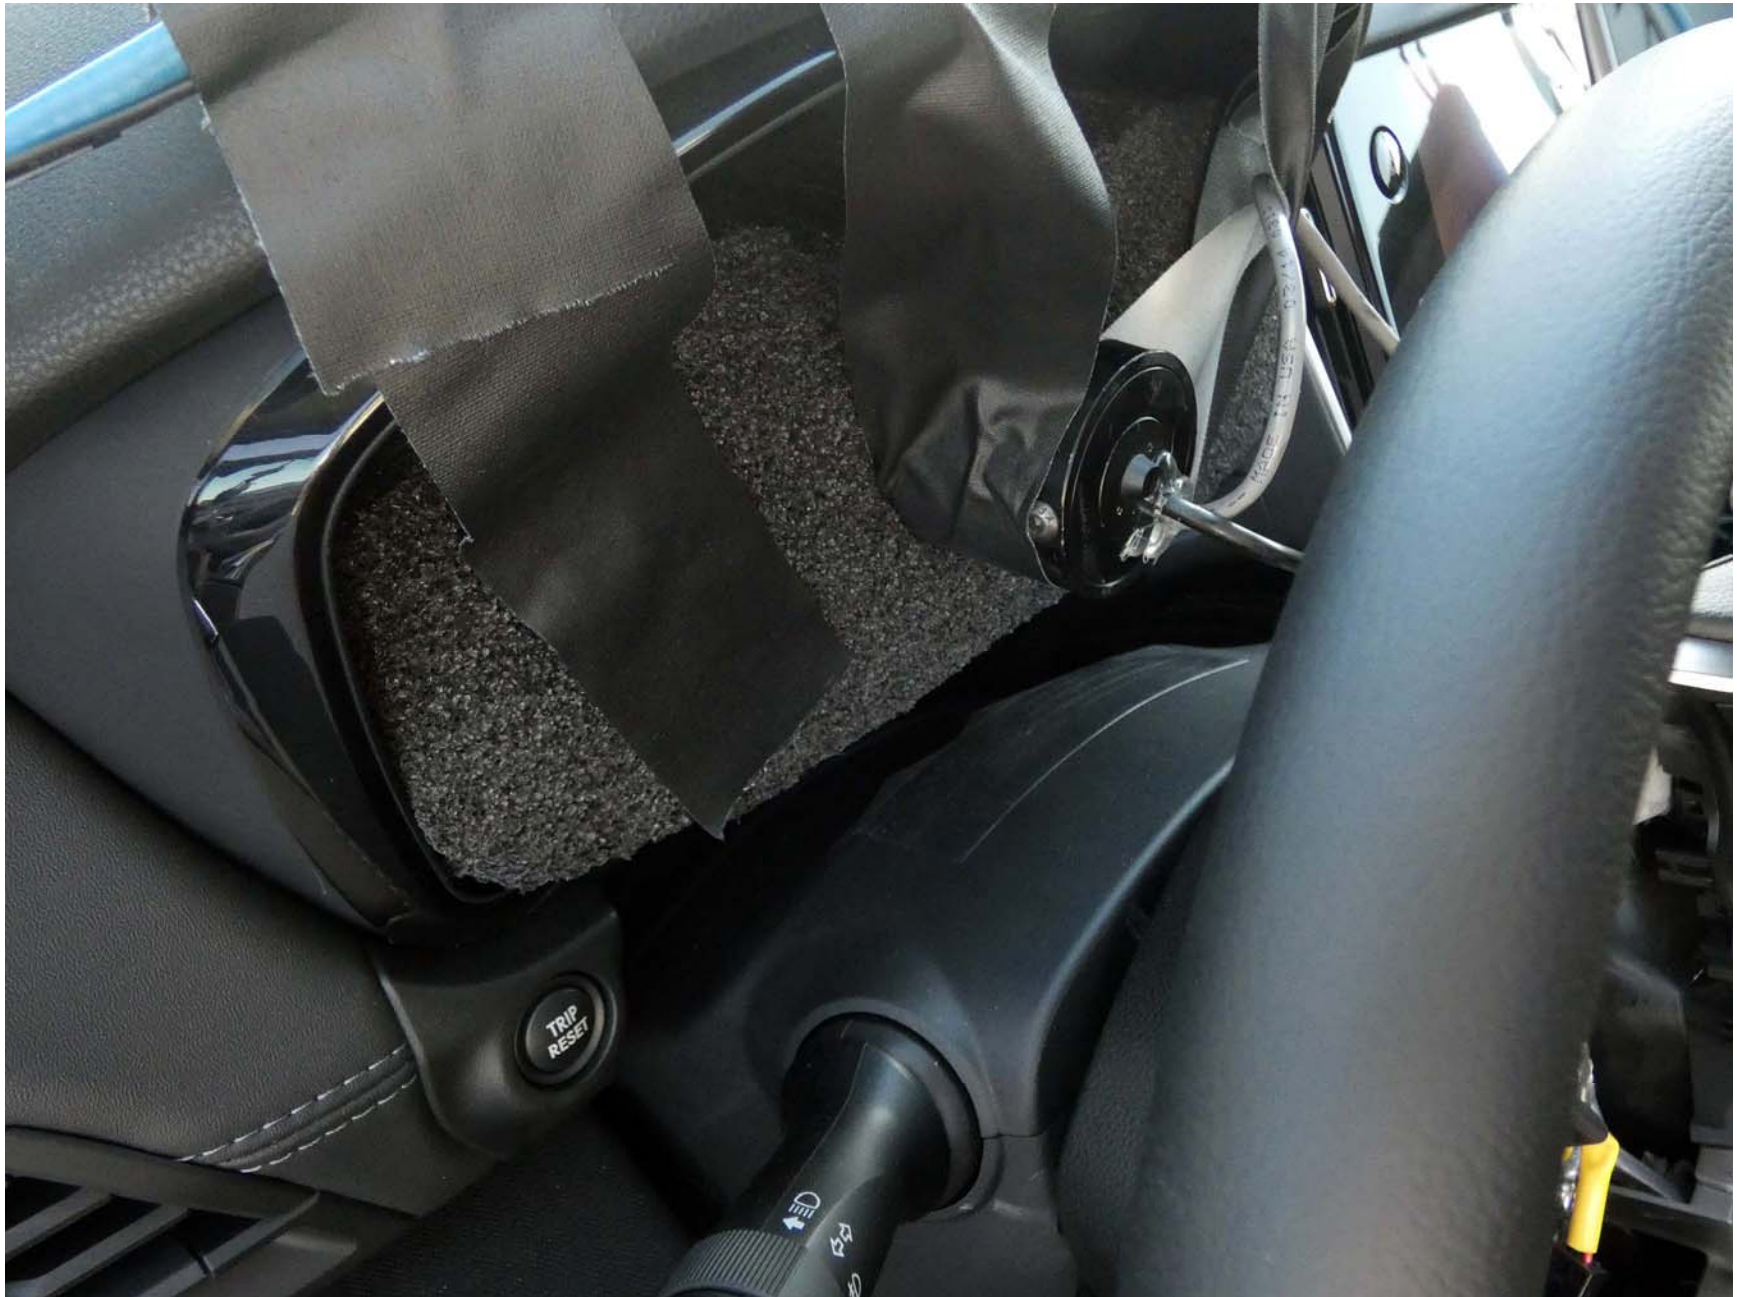
Figure A12. Sensor for Detecting Visual Alerts

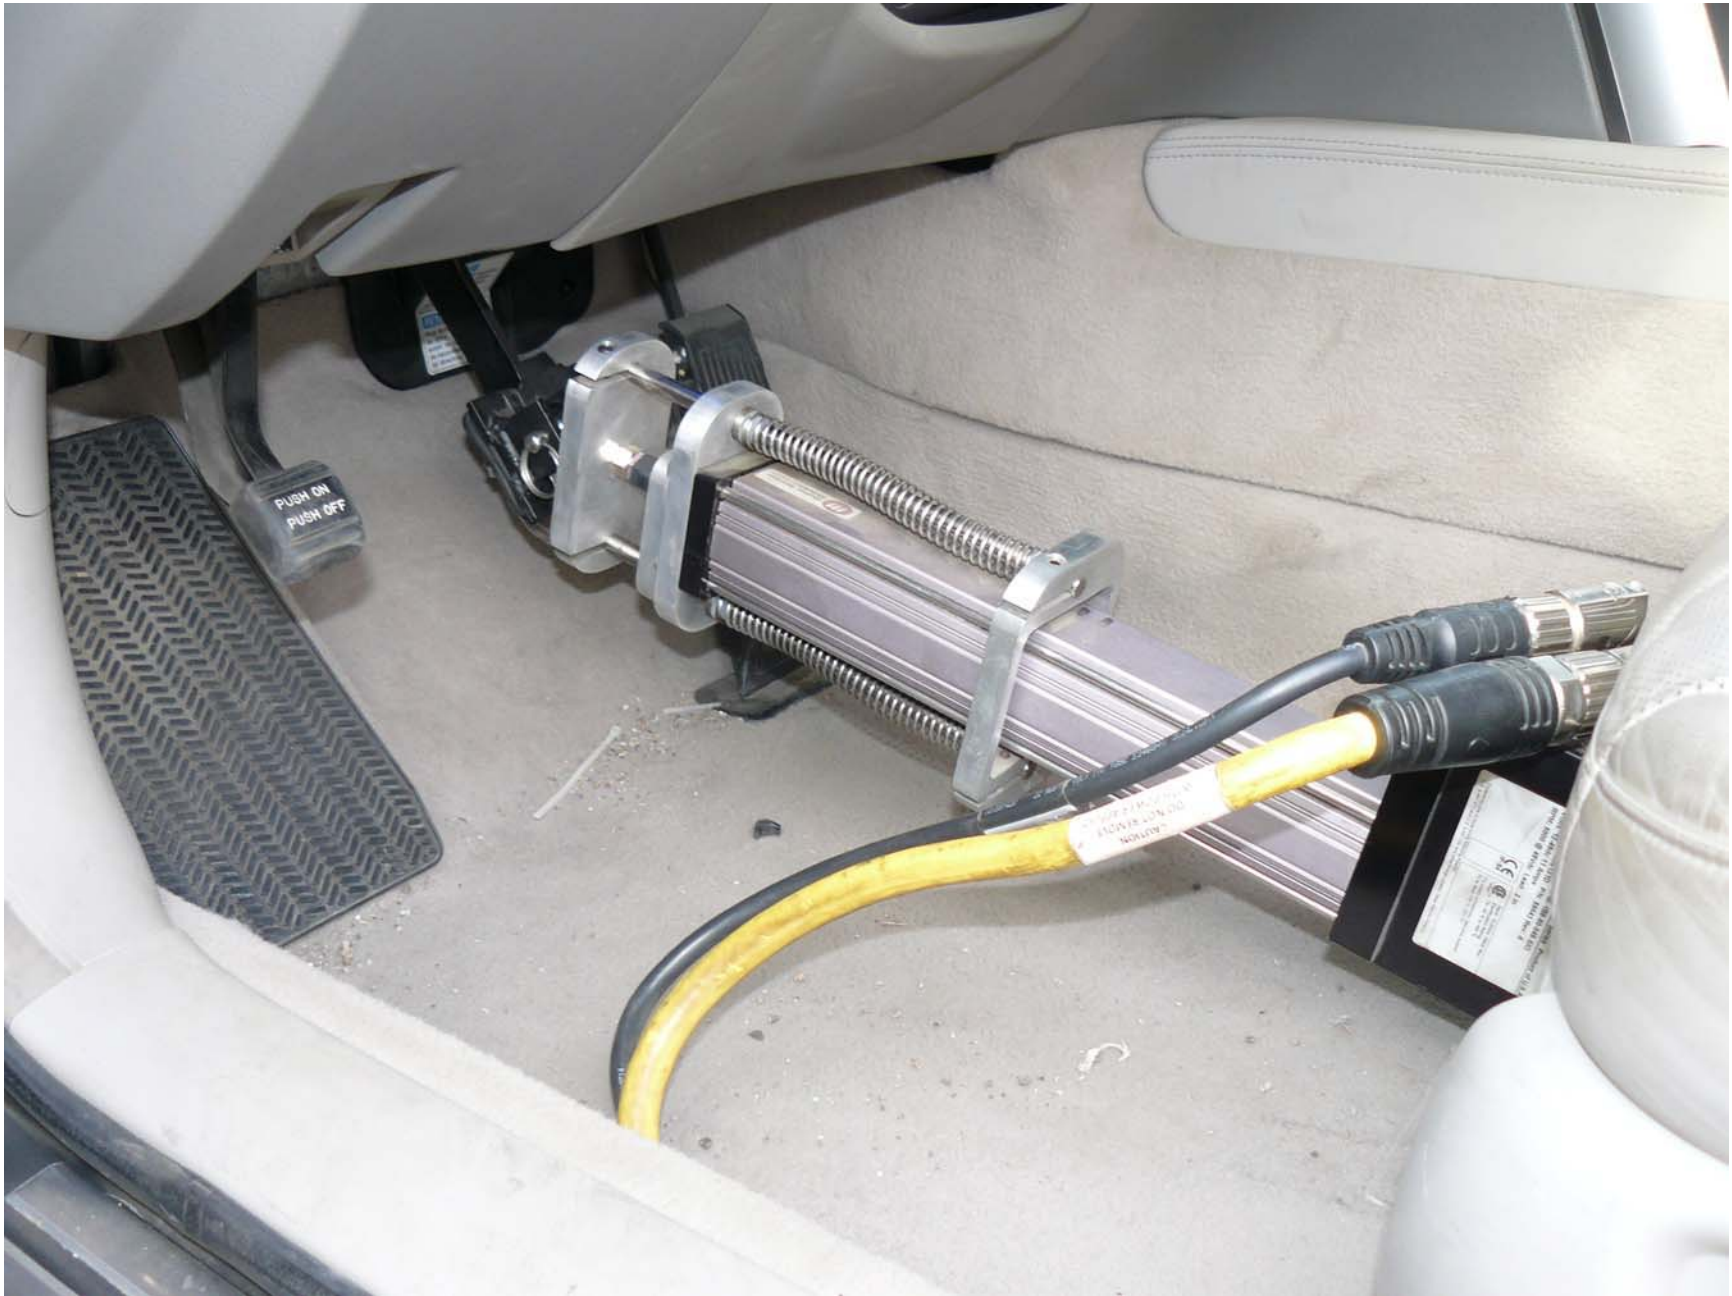
Figure A14. Brake Actuator Installed in POV System

In some cases, the subject vehicle is also equipped with an automatic braking system (E-brake) for the purpose of slowing the subject vehicle before impact with the SSV in cases where the subject vehicle is likely to fail a test. The system fires when TTC is below 0.7 sec. It is typically enabled when an SV has already impacted the SSV one or two times.
