**NEW CAR ASSESSMENT PROGRAM
CRASH IMMINENT BRAKING SYSTEM CONFIRMATION TEST
NCAP-DRI-CIB-20-13**

2020 Subaru Outback Premium/LDD

DYNAMIC RESEARCH, INC.

Final Report

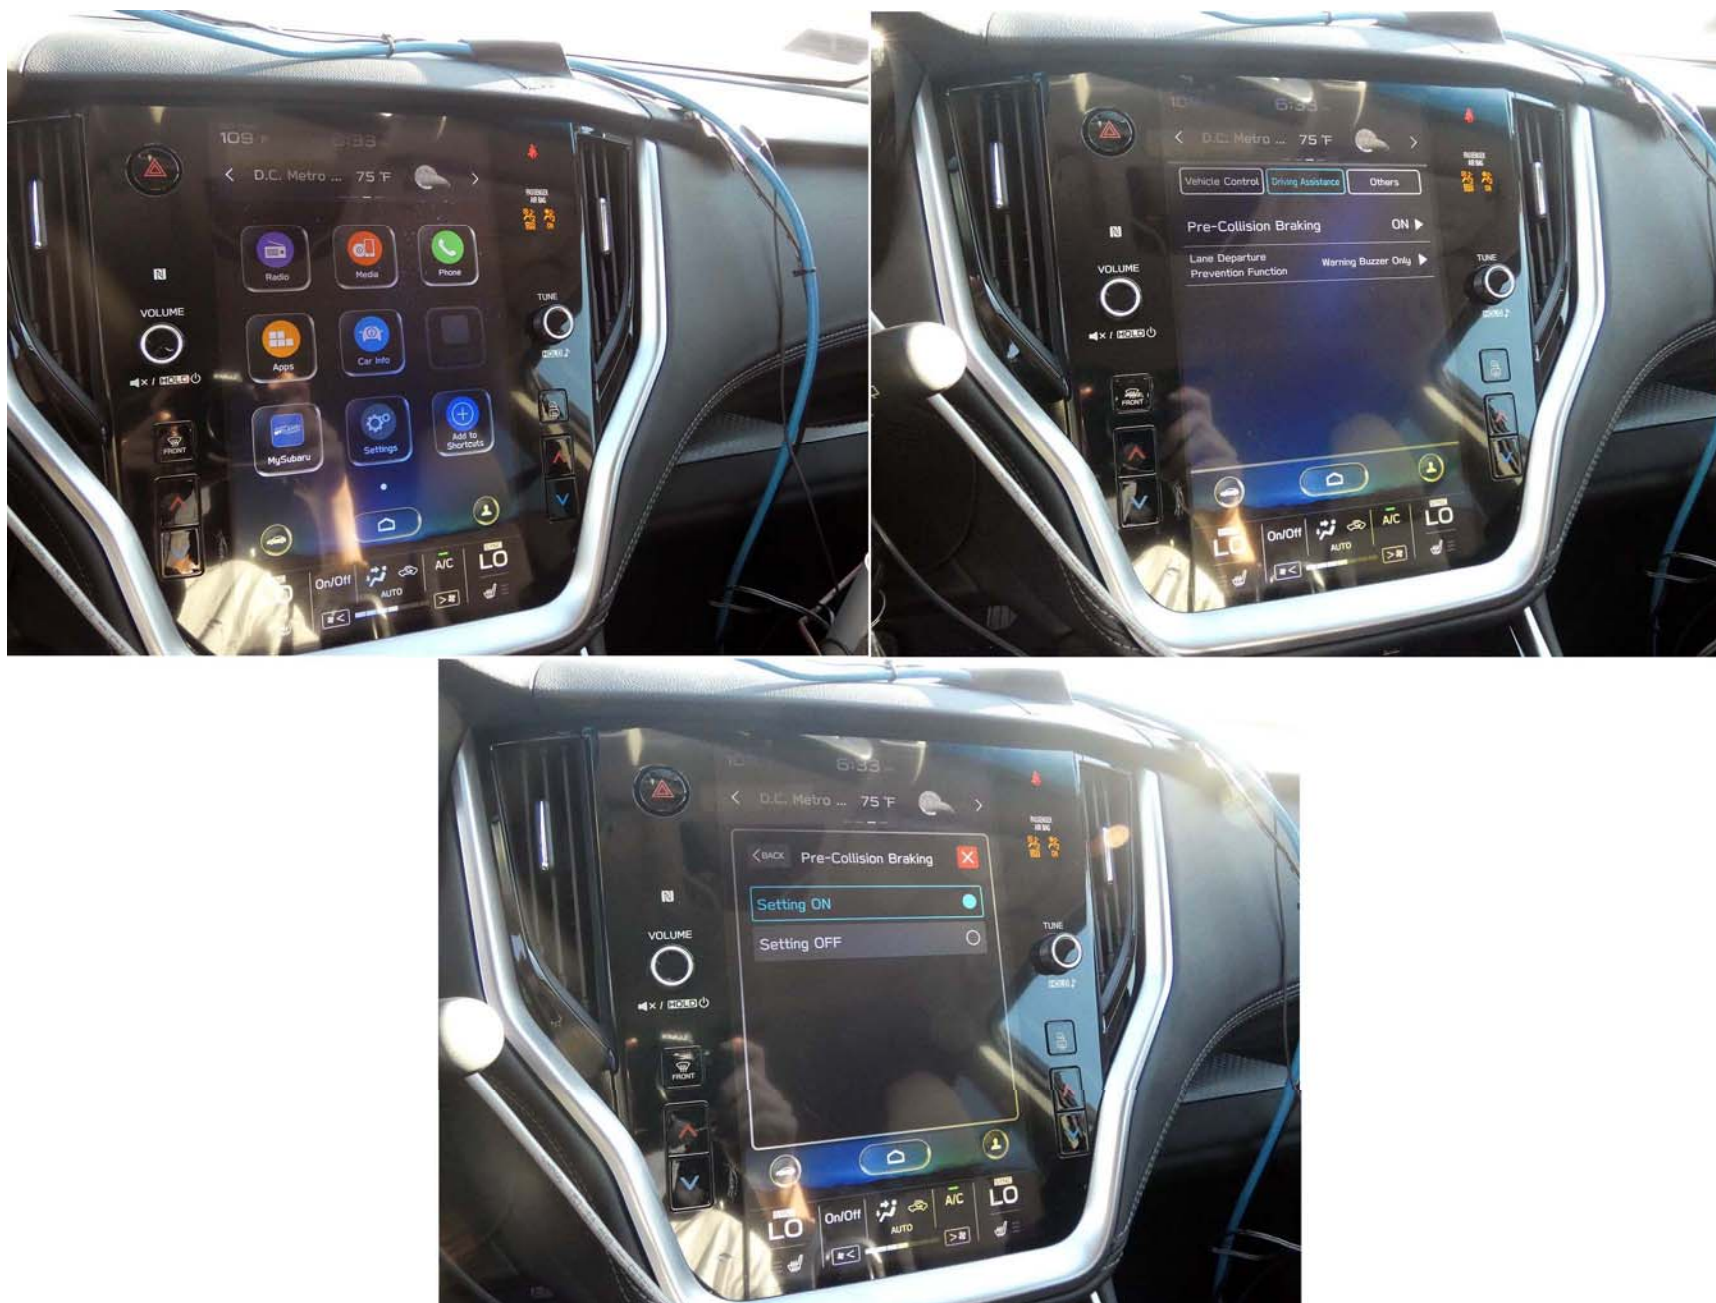
Figure A15. System Setup Menus

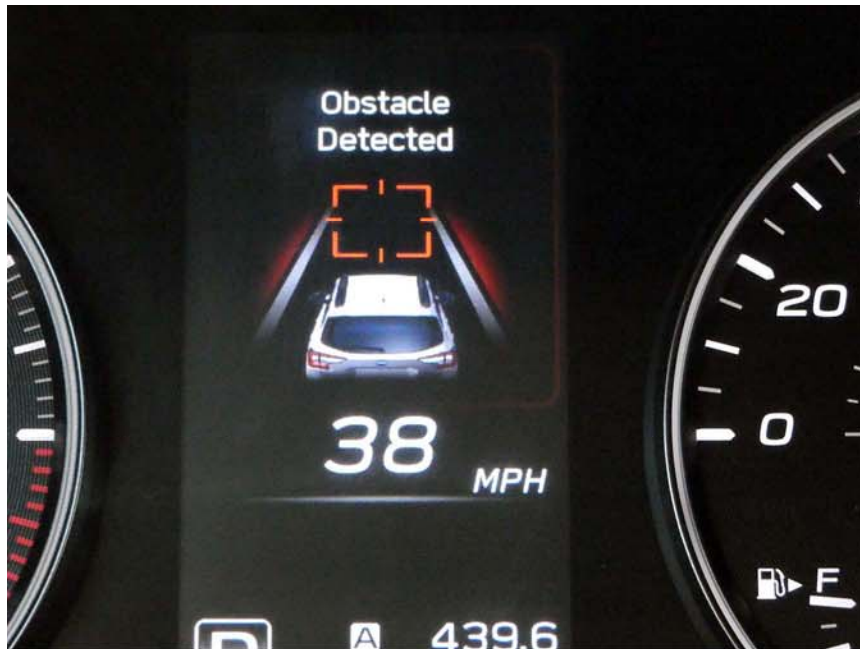
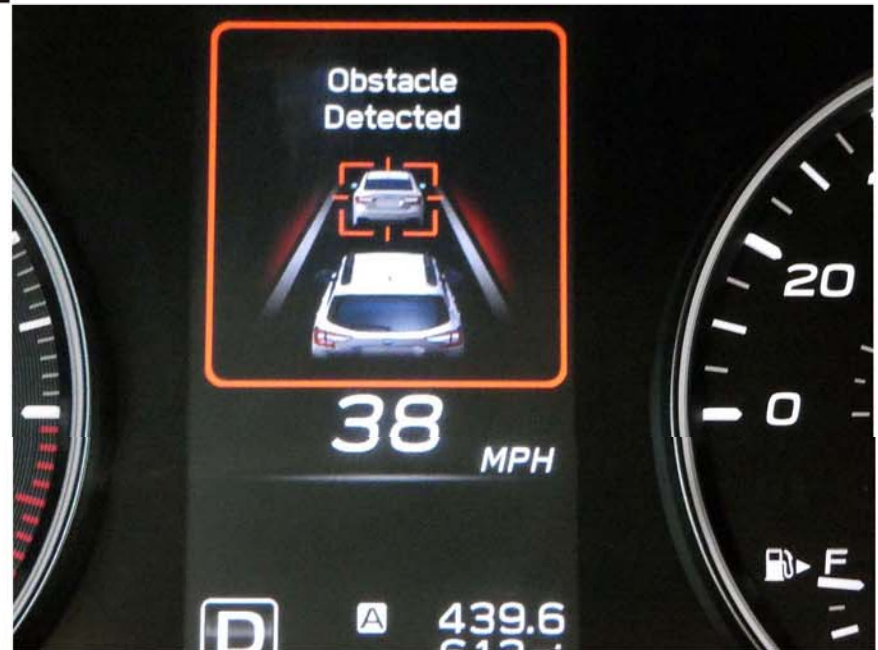
Figure A16. Visual Alerts

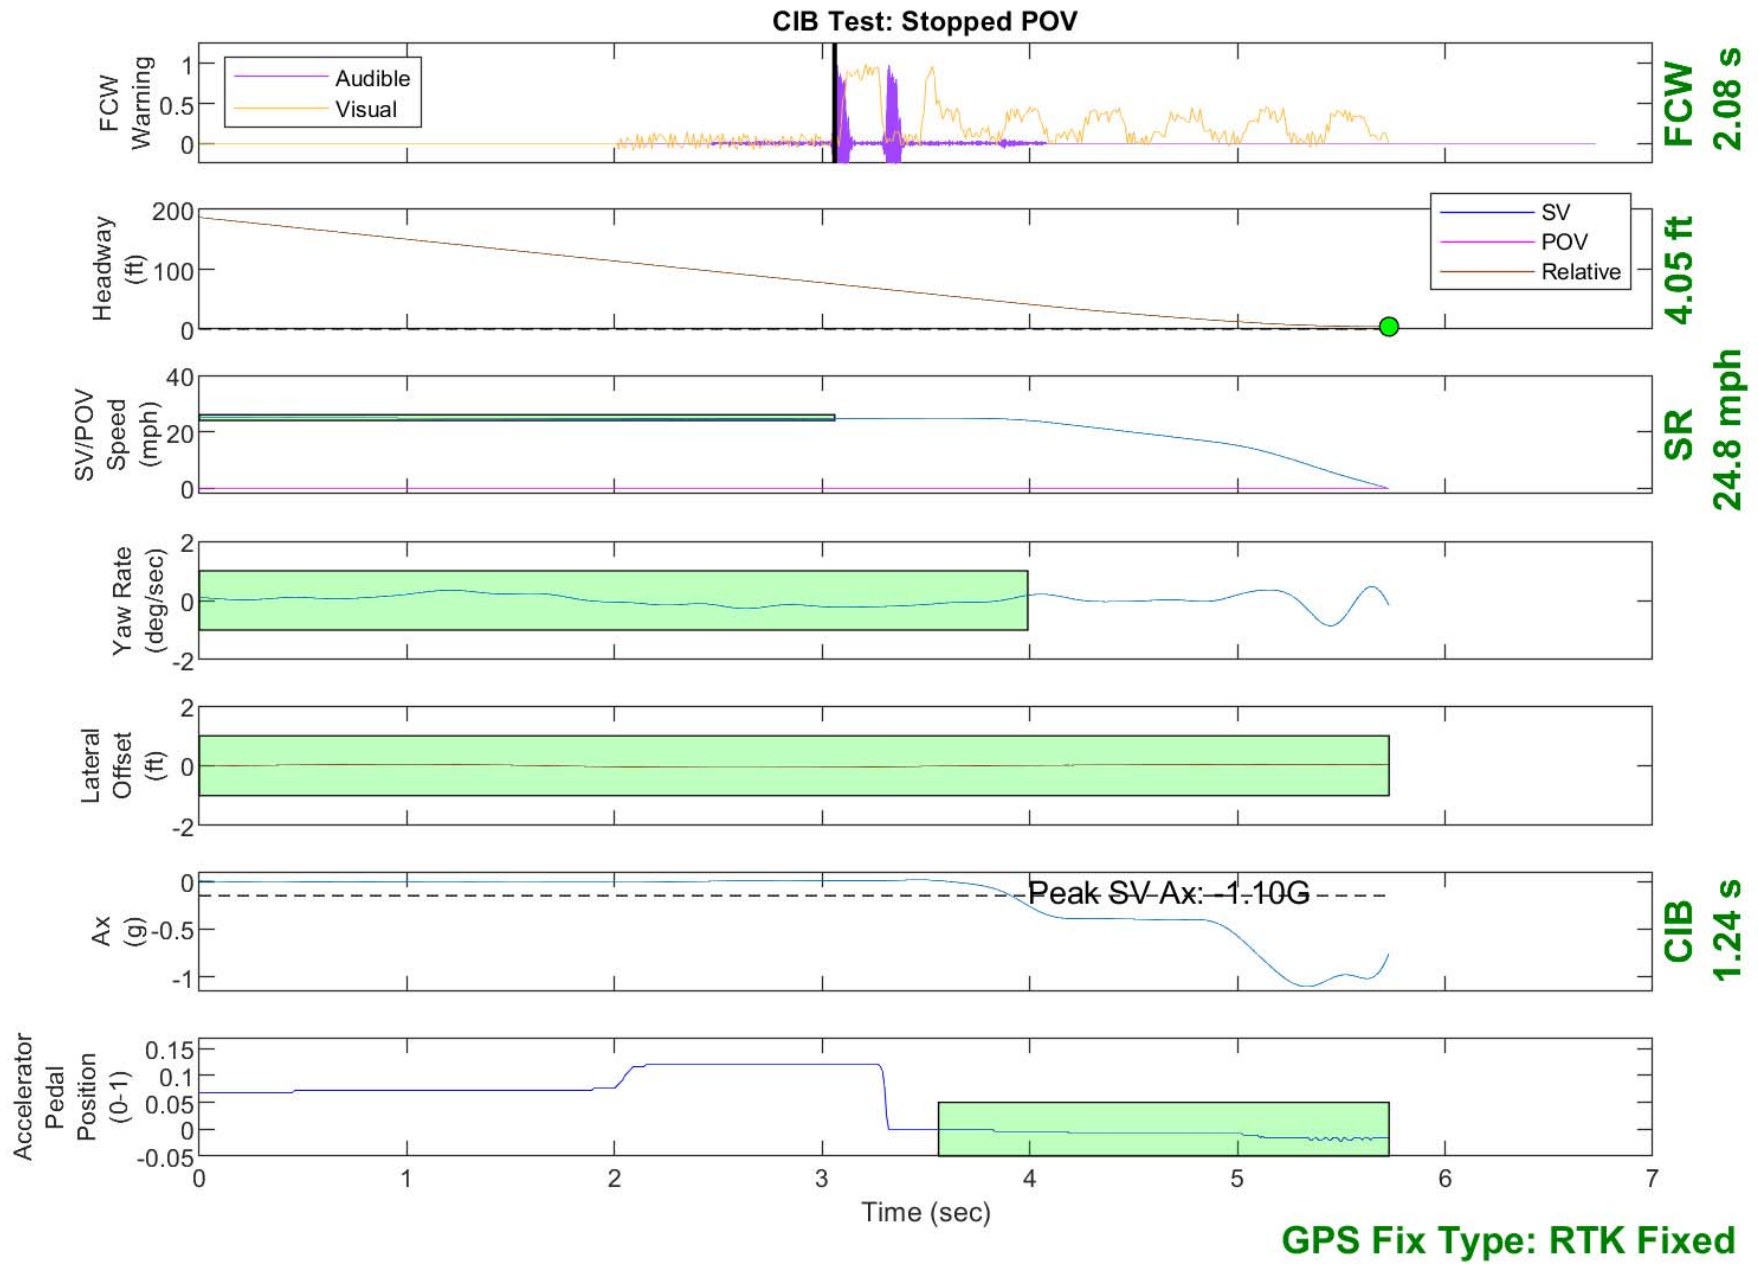
Figure D1. Example Time History for Stopped POV, Passing

Examples of time history plots for each test type (including passing, failing and invalid runs) are shown in Figure D1 through Figure D9. Figures D1 through D6 show passing runs for each of the 6 test types. Figures D7 and D8 show examples of invalid runs. Figure D9 shows an example of a valid test that failed the CIB requirements.

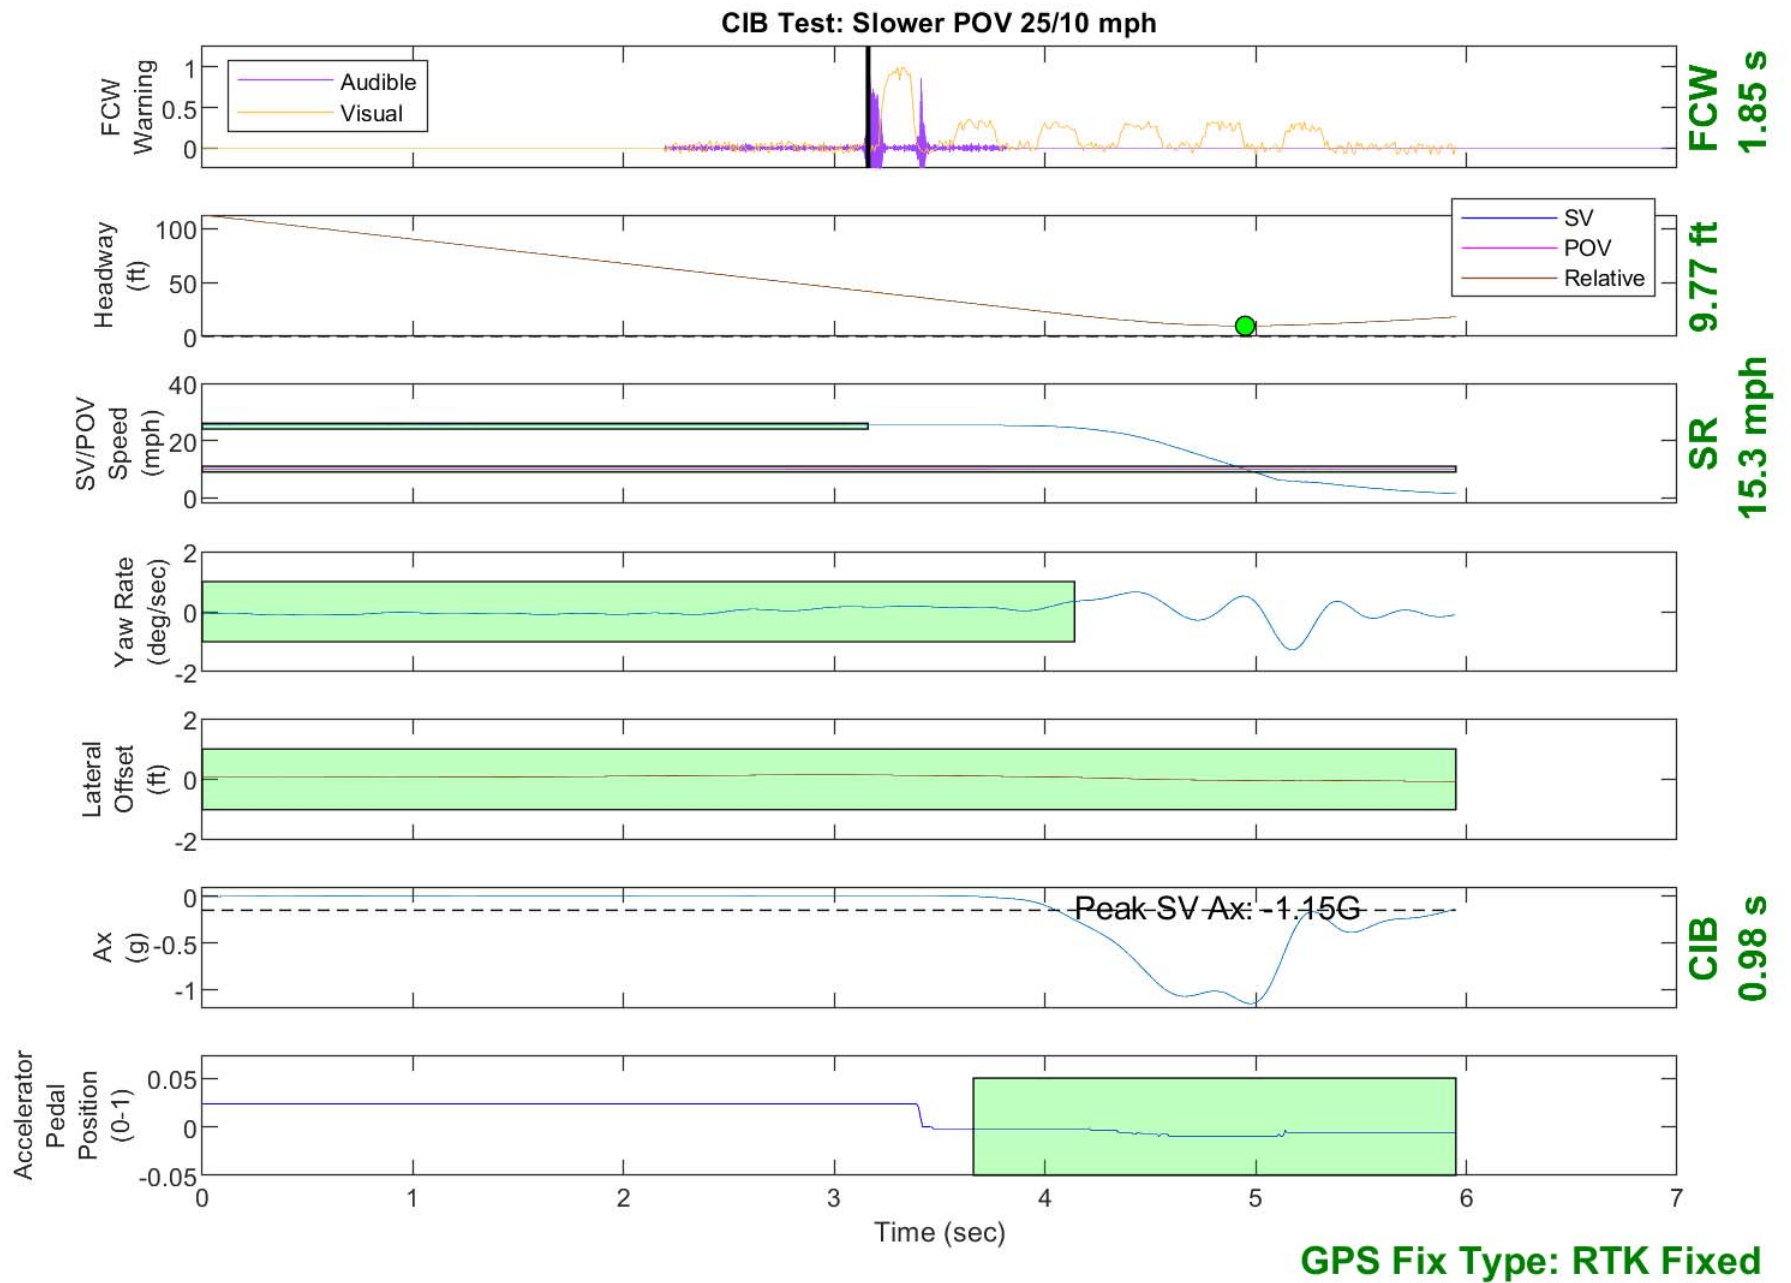
Figure D2. Example Time History for Slower POV 25 vs. 10, Passing

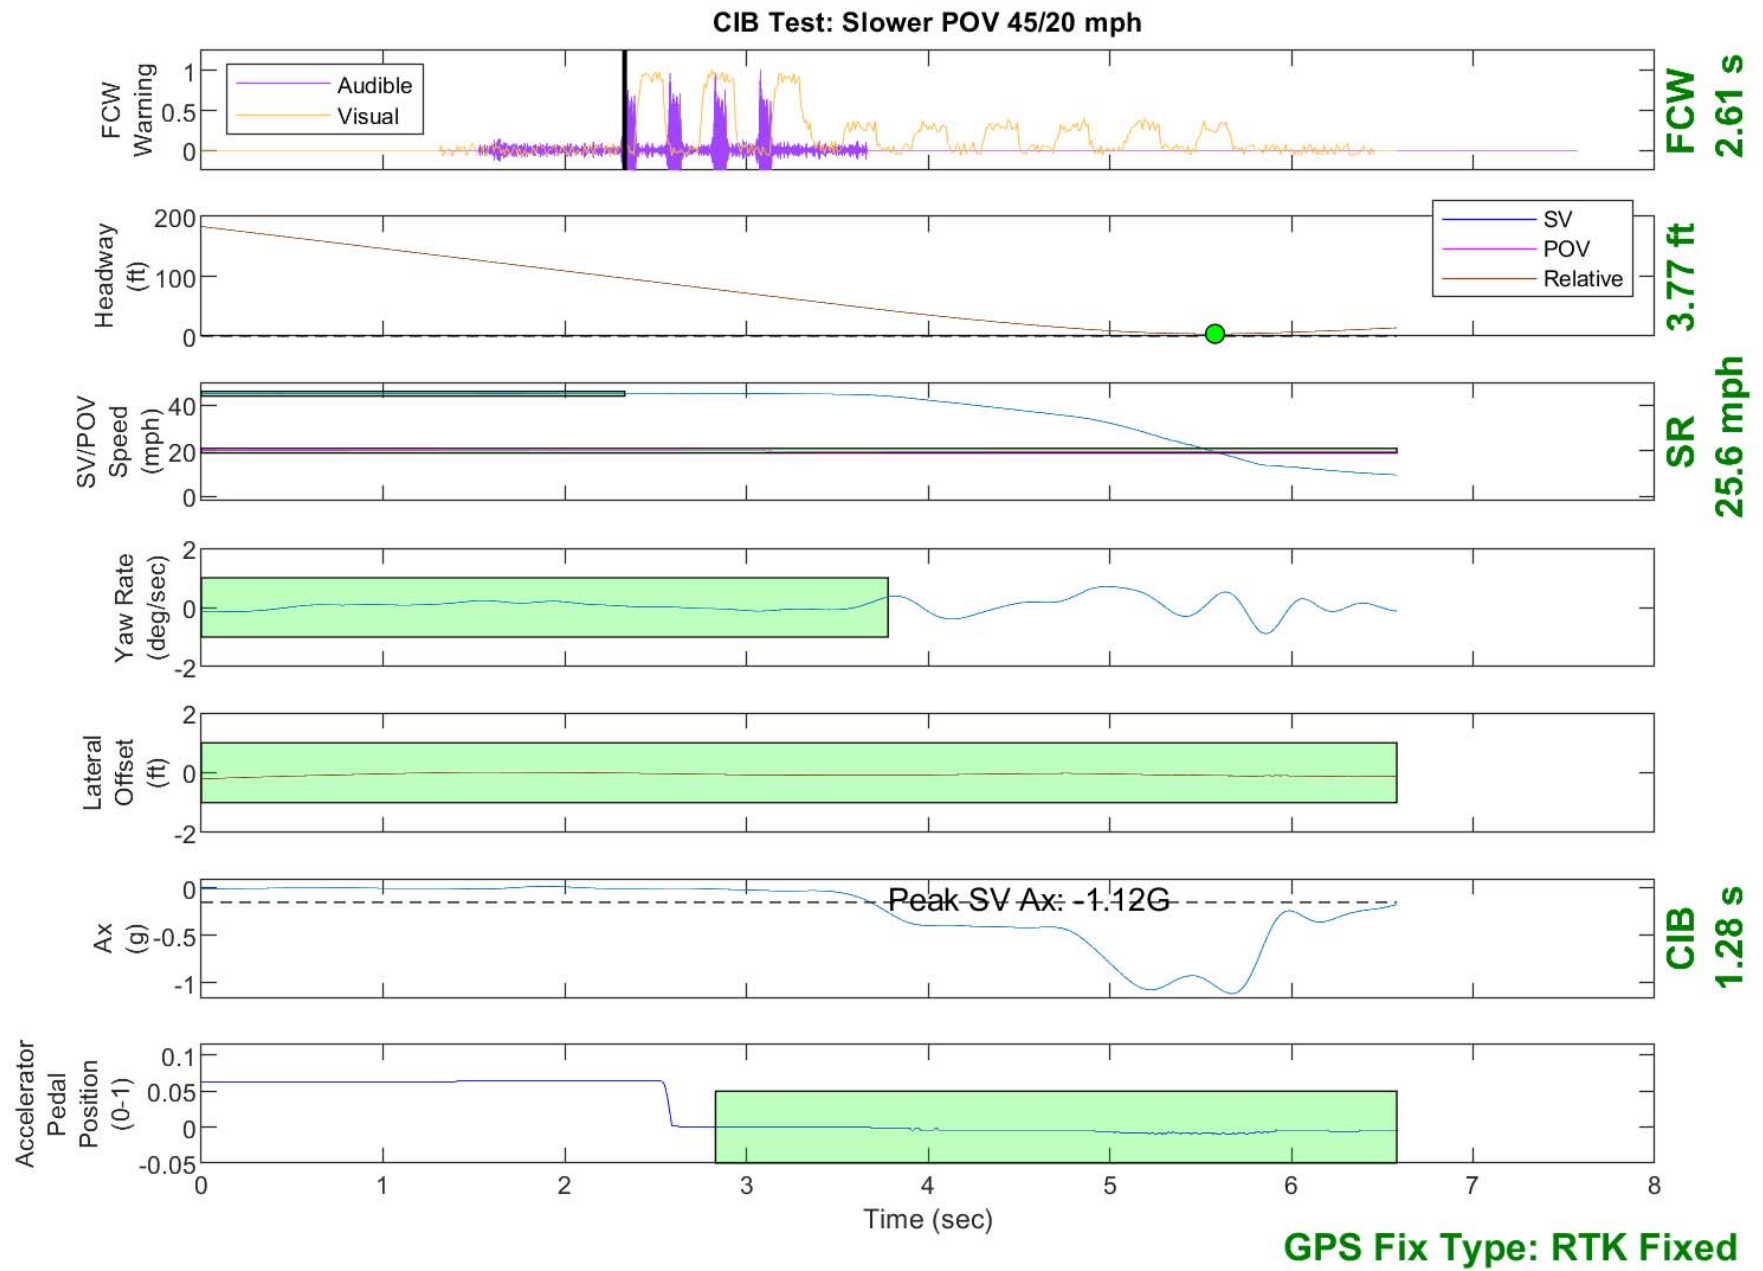
Figure D3. Example Time History for Slower POV 45 vs. 20, Passing

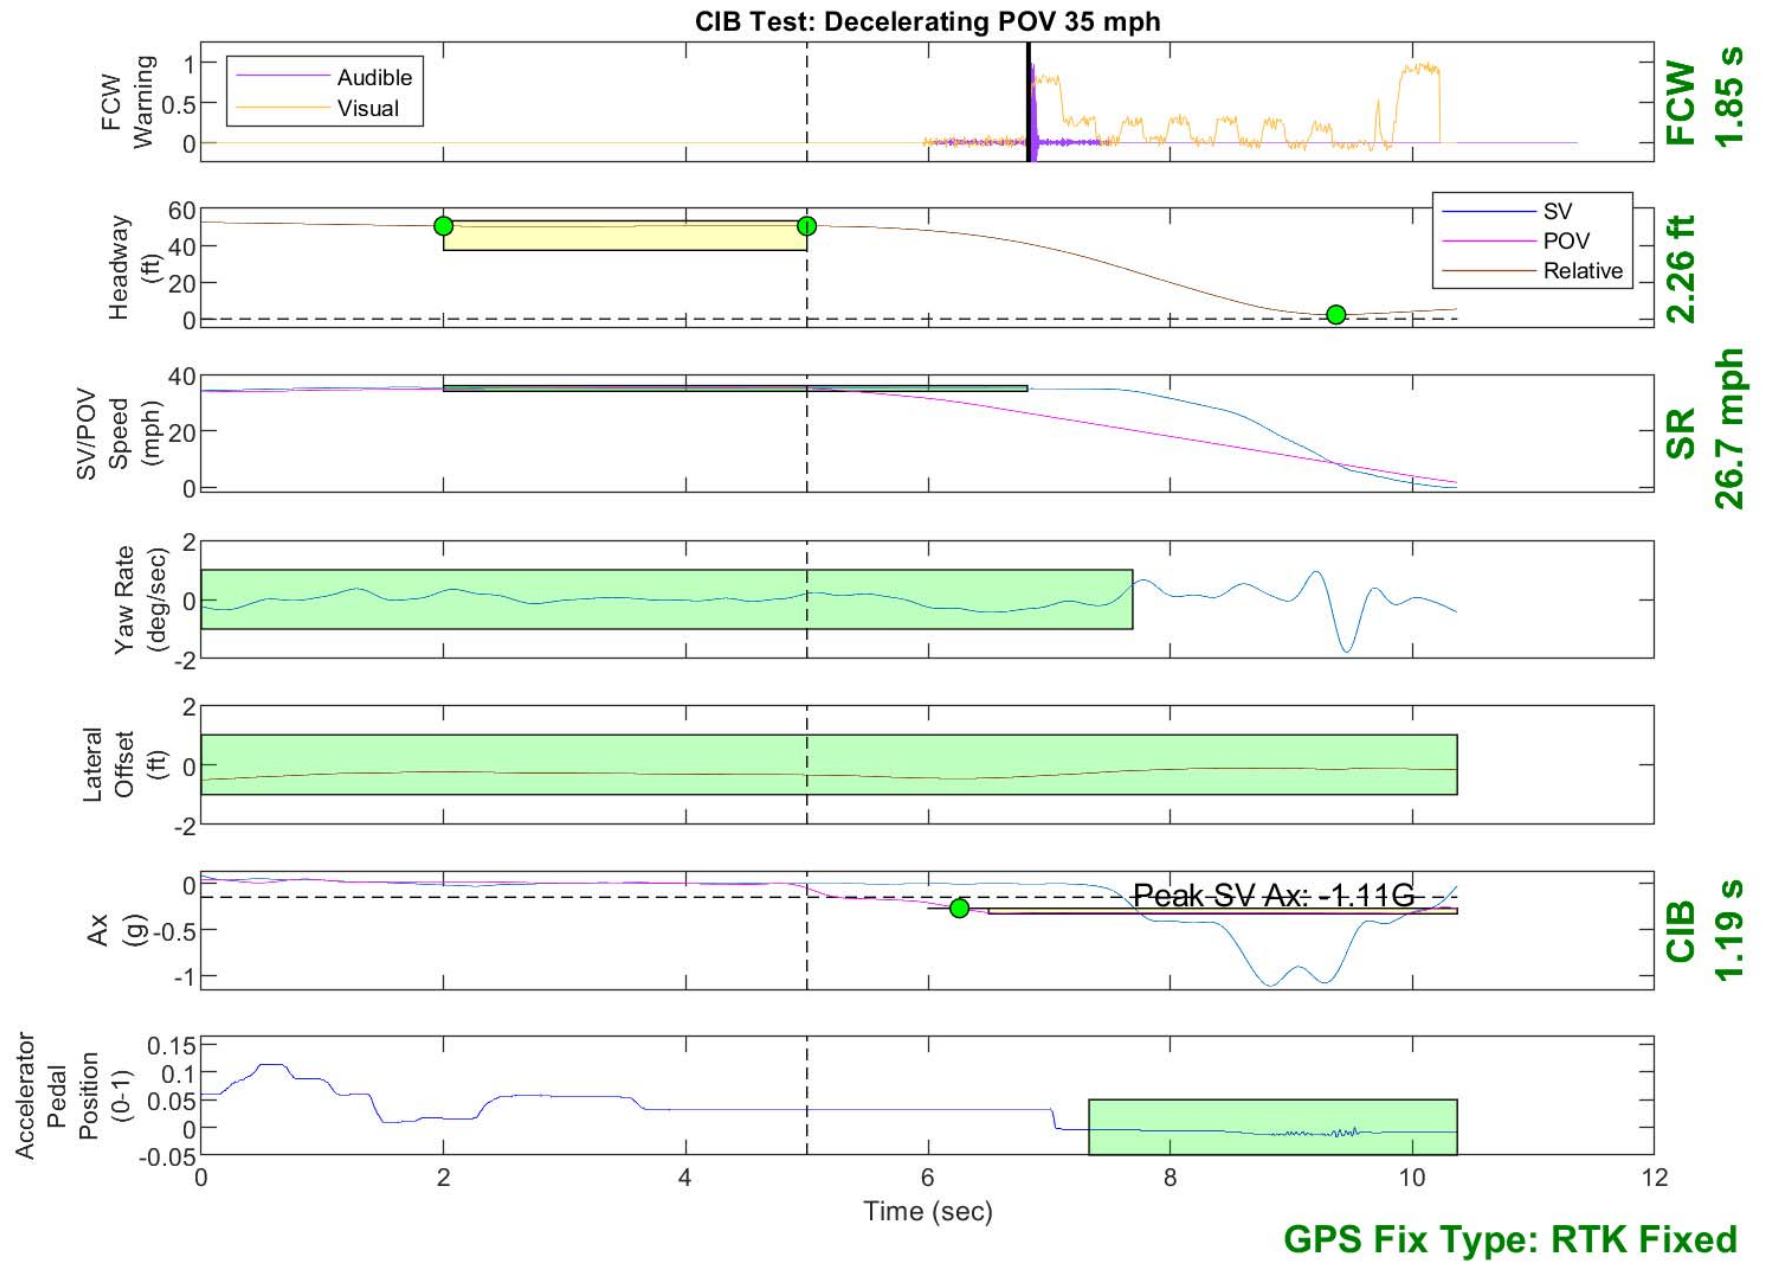
Figure D4. Example Time History for Decelerating POV 35, Passing

The SV ignition was cycled prior to each test run. For this test scenario, both the POV and SV were driven at a constant 35.0 mph (56.3 km/h) in the center of the lane, with a headway of 45.3 ft (13.8 m) ± 8 ft (2.4 m). Once these conditions were met, the POV tow vehicle brakes were applied to achieve 0.3 ± 0.03 g of deceleration. The test concluded when either:

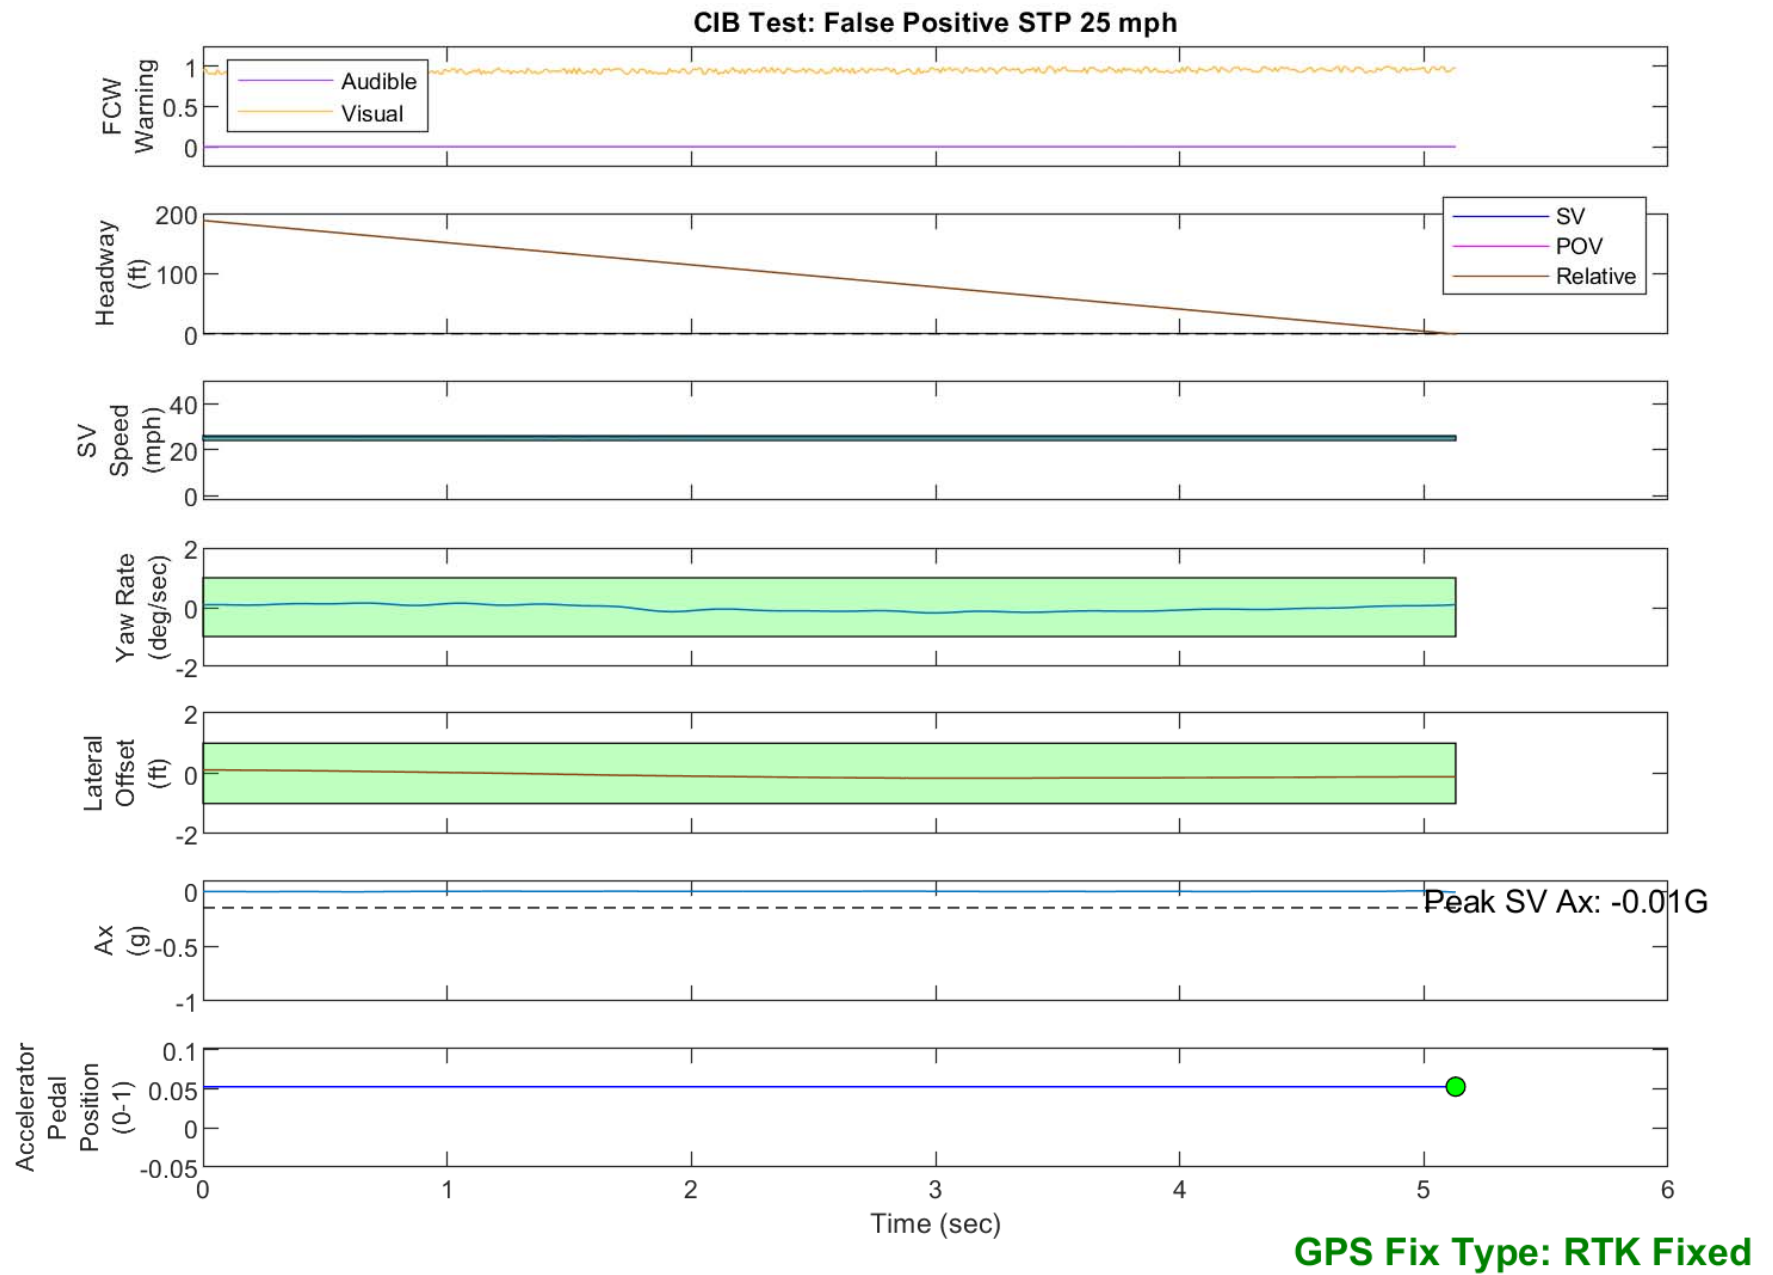
Figure D5. Example Time History for False Positive STP 25, Passing

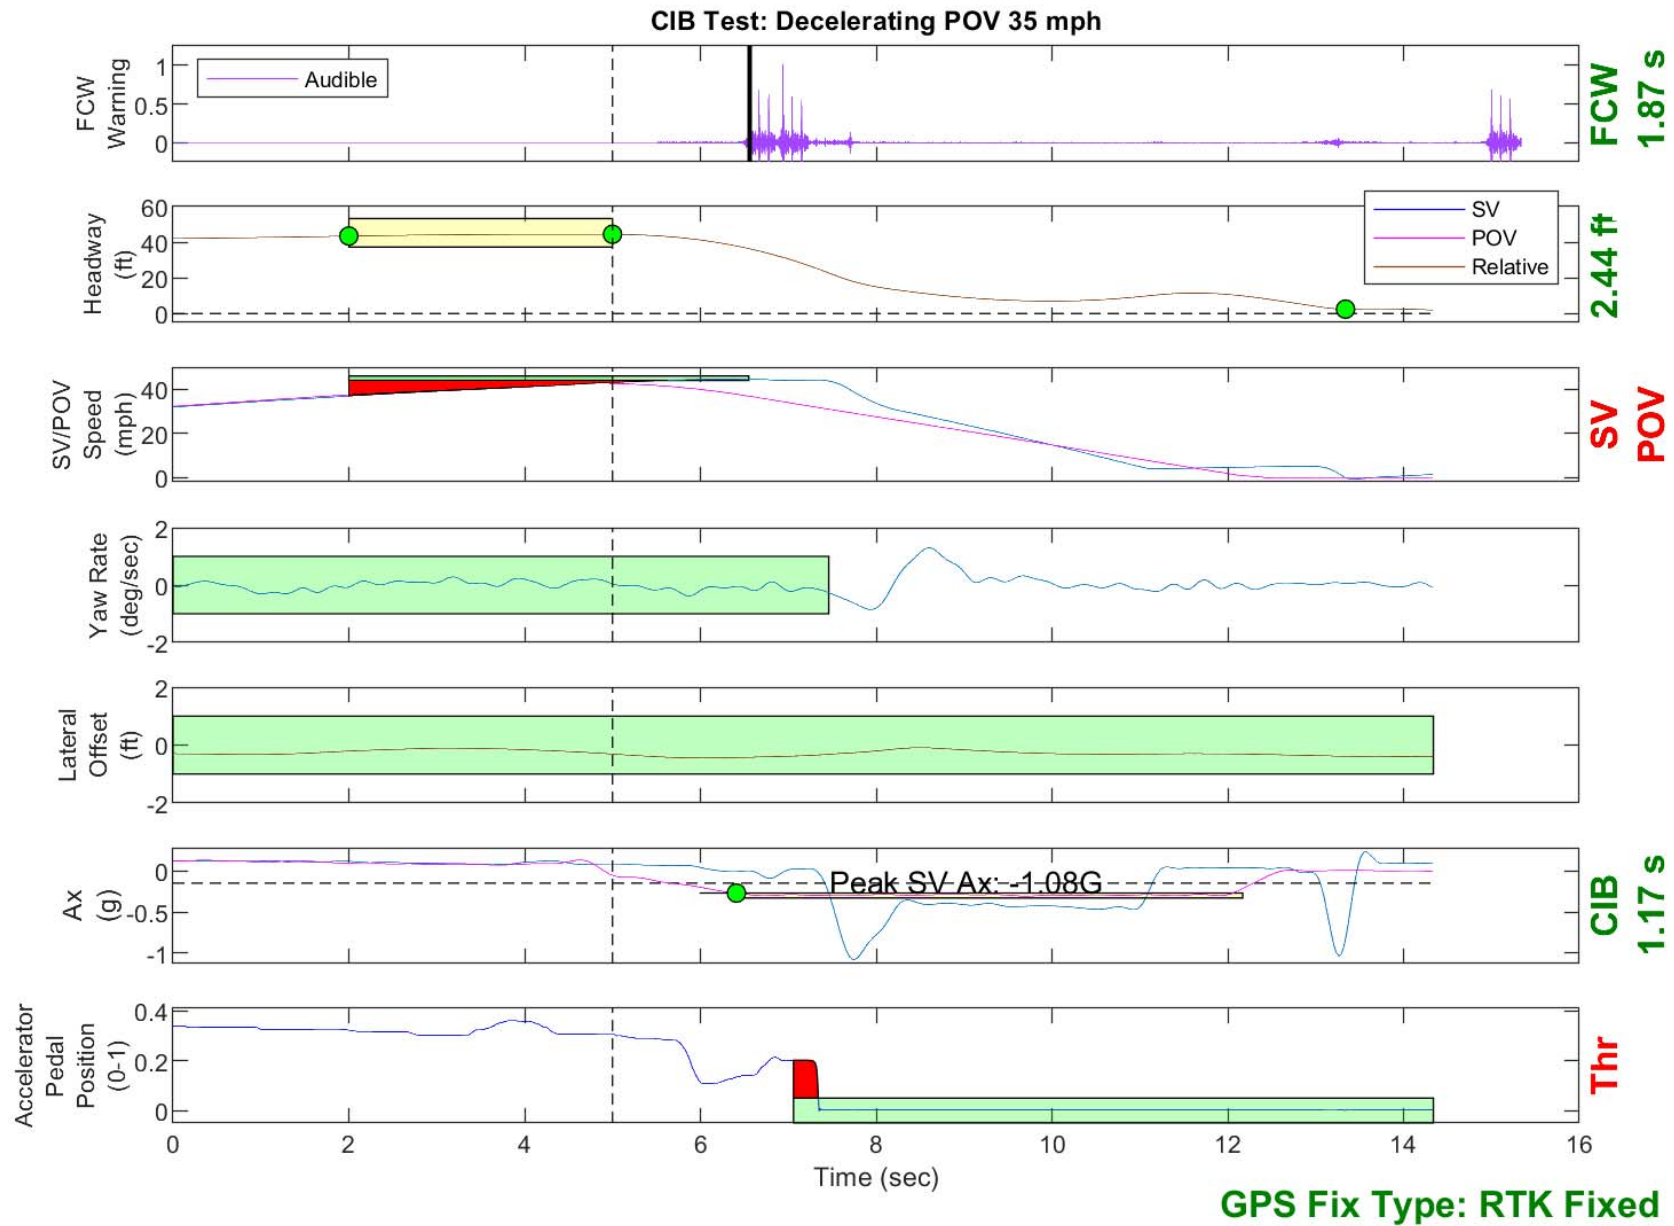
Figure D8. Example Time History Displaying Various Invalid Criteria

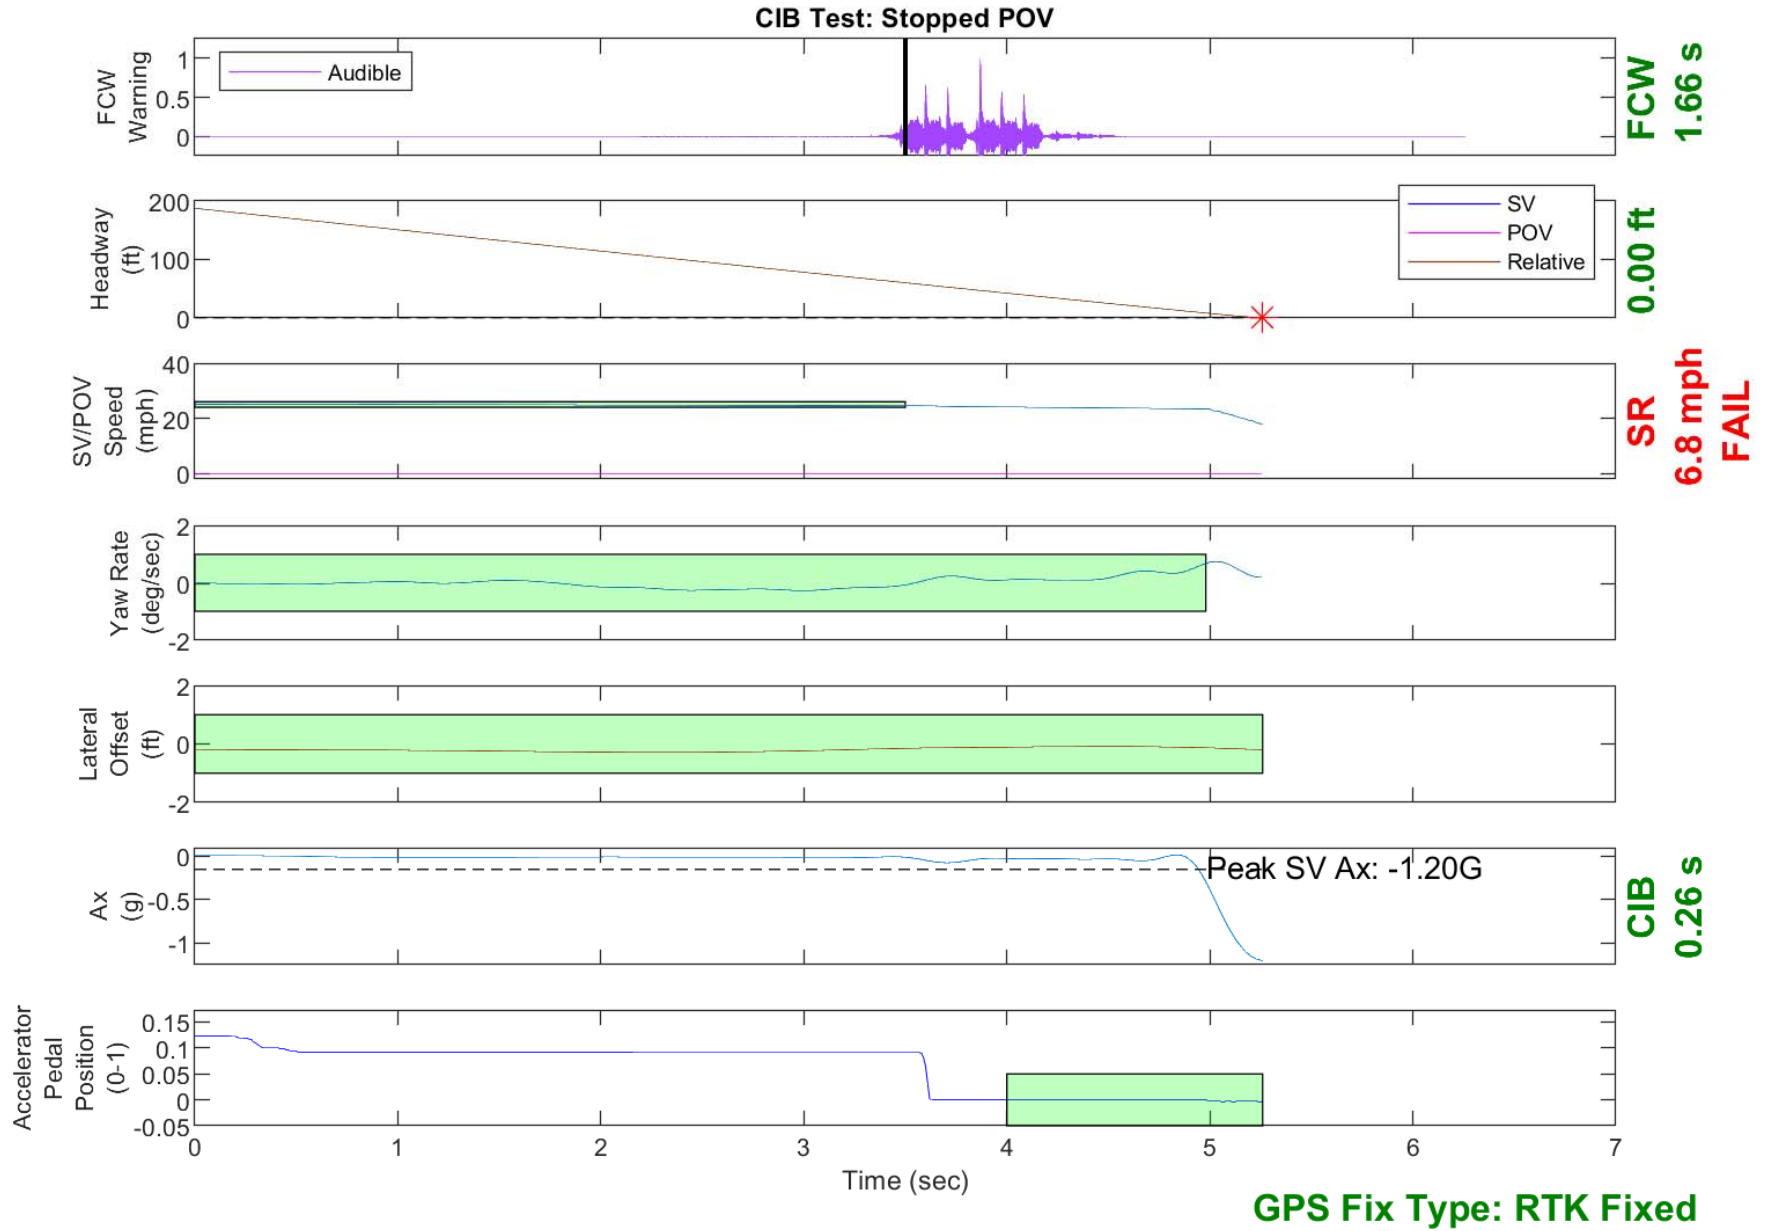
Figure D9. Example Time History for a Failed Run
