**NEW CAR ASSESSMENT PROGRAM  
FORWARD COLLISION WARNING CONFIRMATION TEST  
NCAP-DRI-FCW-20-21**

**2020 Mercedes-Benz GLC 300 4Matic SUV**

**DYNAMIC RESEARCH, INC.**

**Final Report**

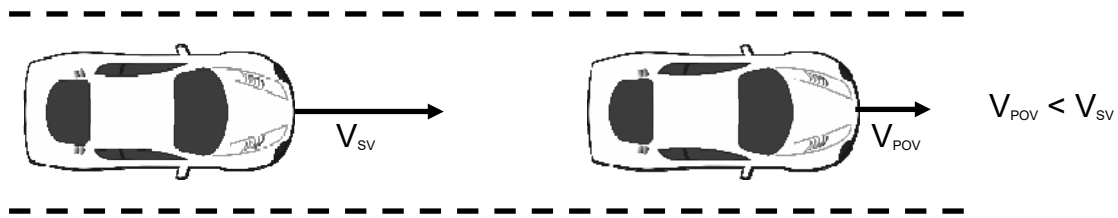
Figure 3. Depiction of Test 3

This test examines the ability of the FCW system to recognize a slower lead vehicle being driven with a constant speed and to issue a timely alert. As depicted in Figure 3, the scenario was conducted with a closing speed equal to 25.0 mph (40.2 km/h).

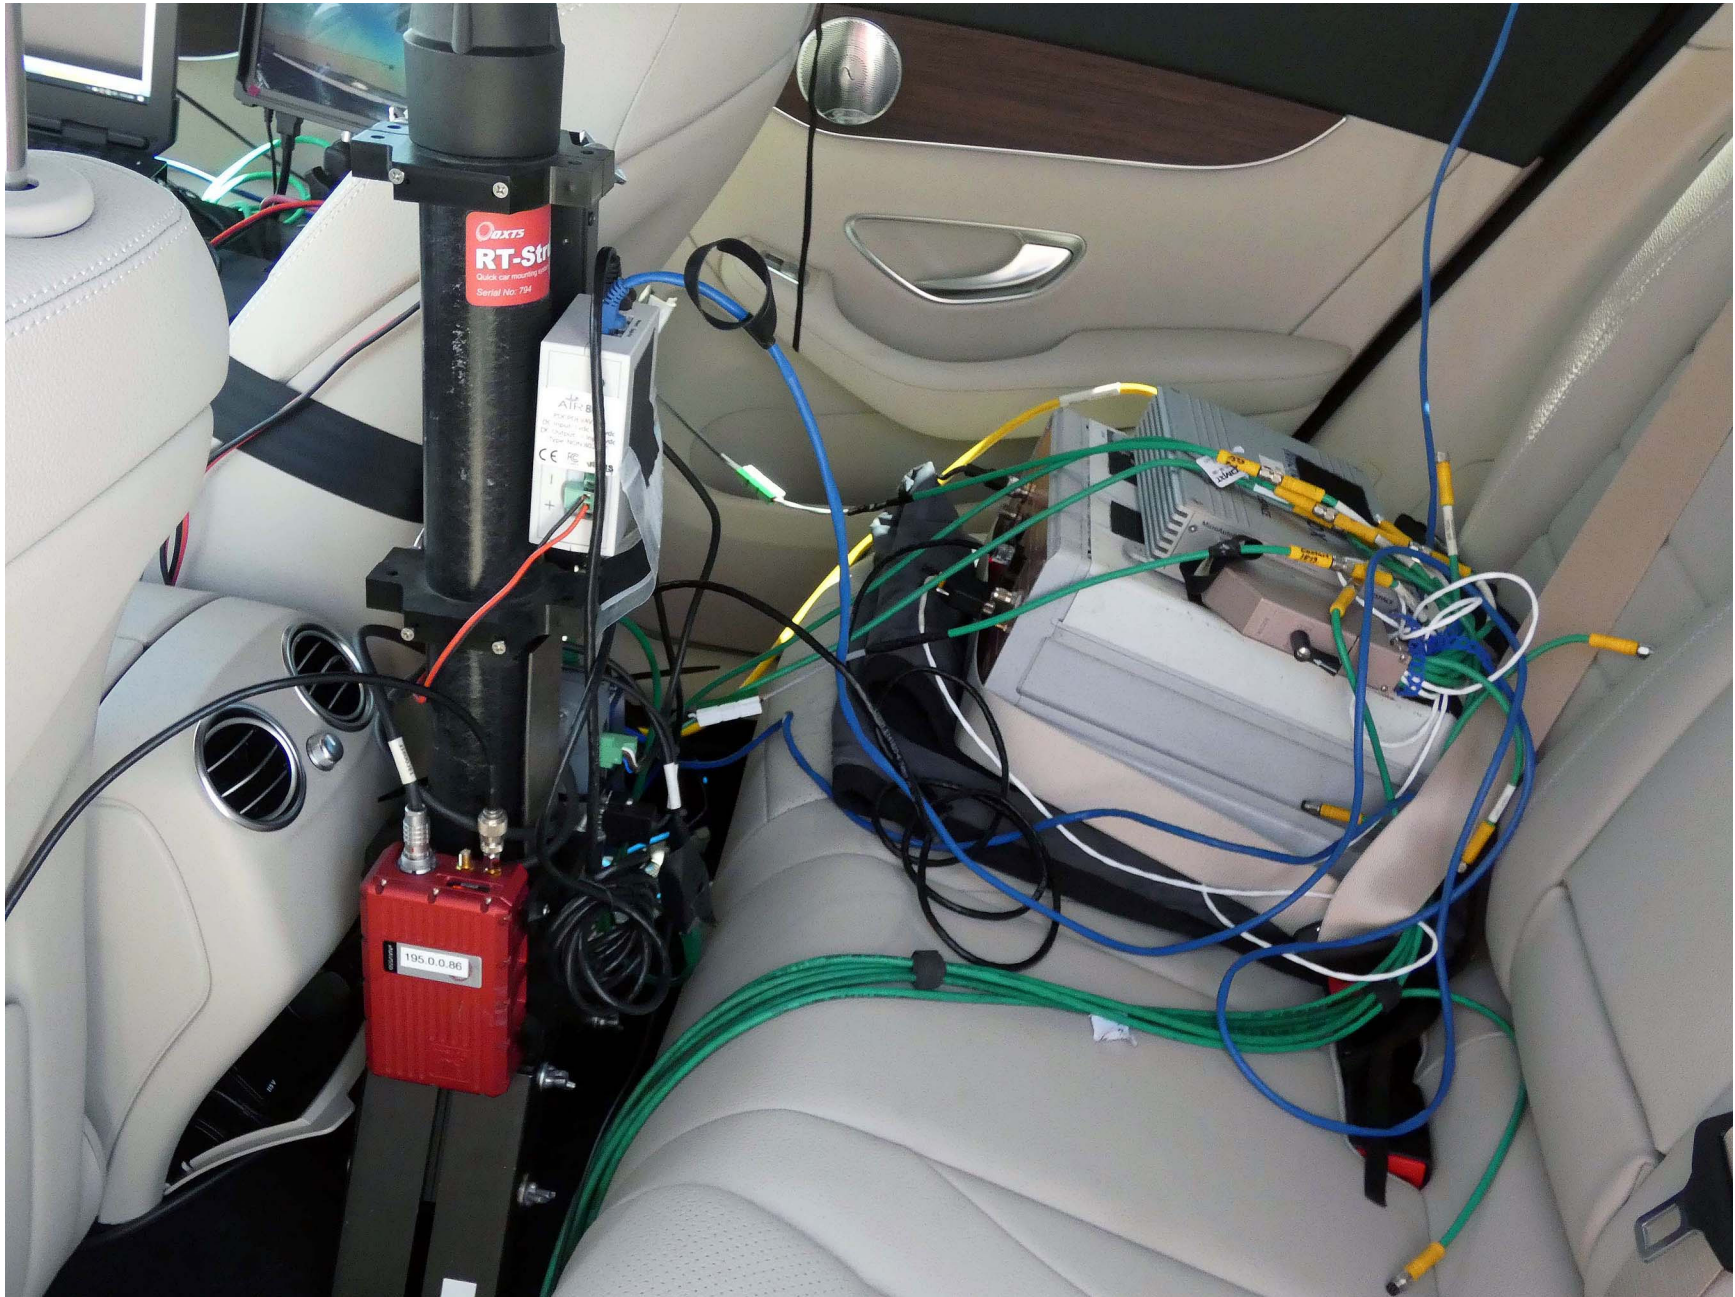
Figure A8. DGPS, Inertial Measurement Unit, and MicroAutoBox Installed in Subject Vehicle

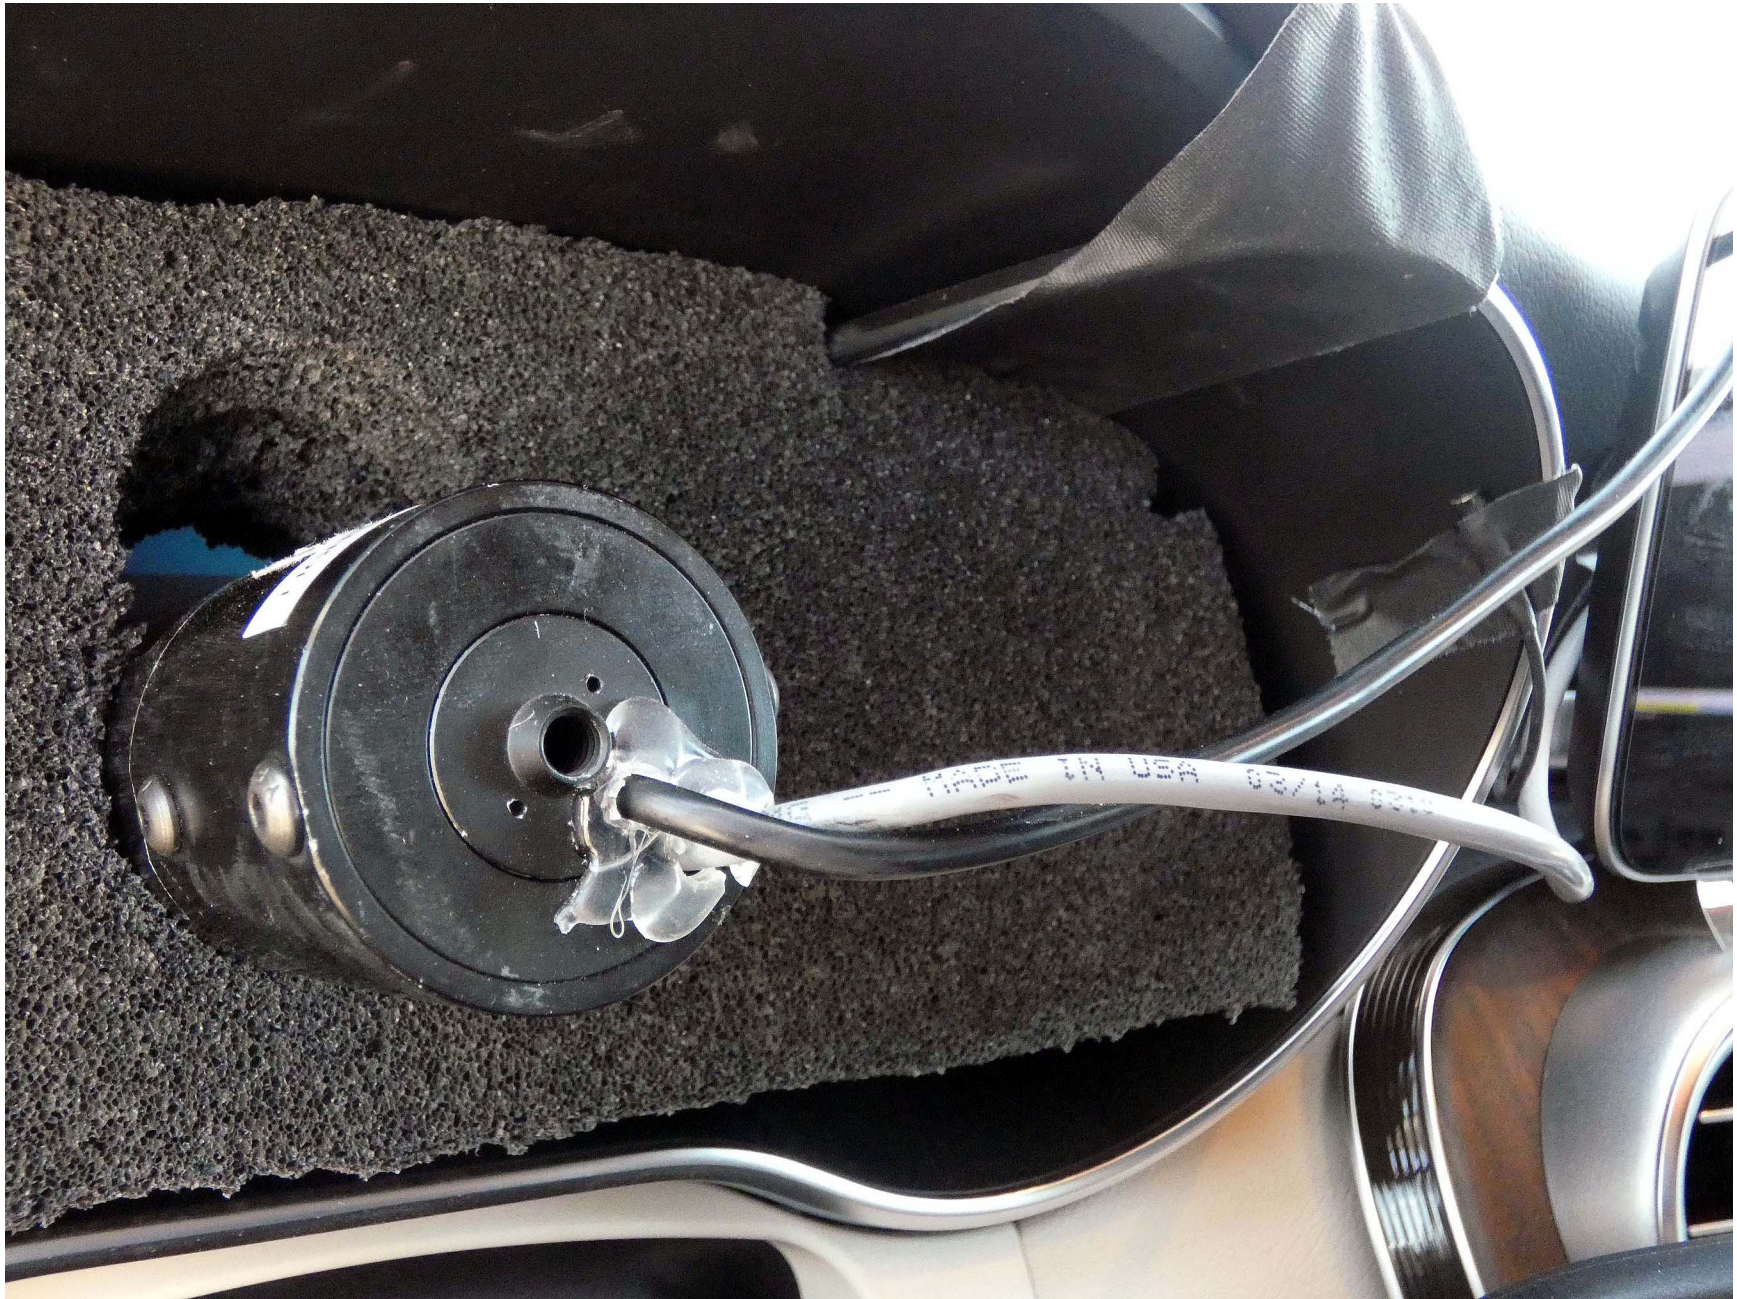
Figure A9. Sensors for Detecting Auditory and Visual Alerts

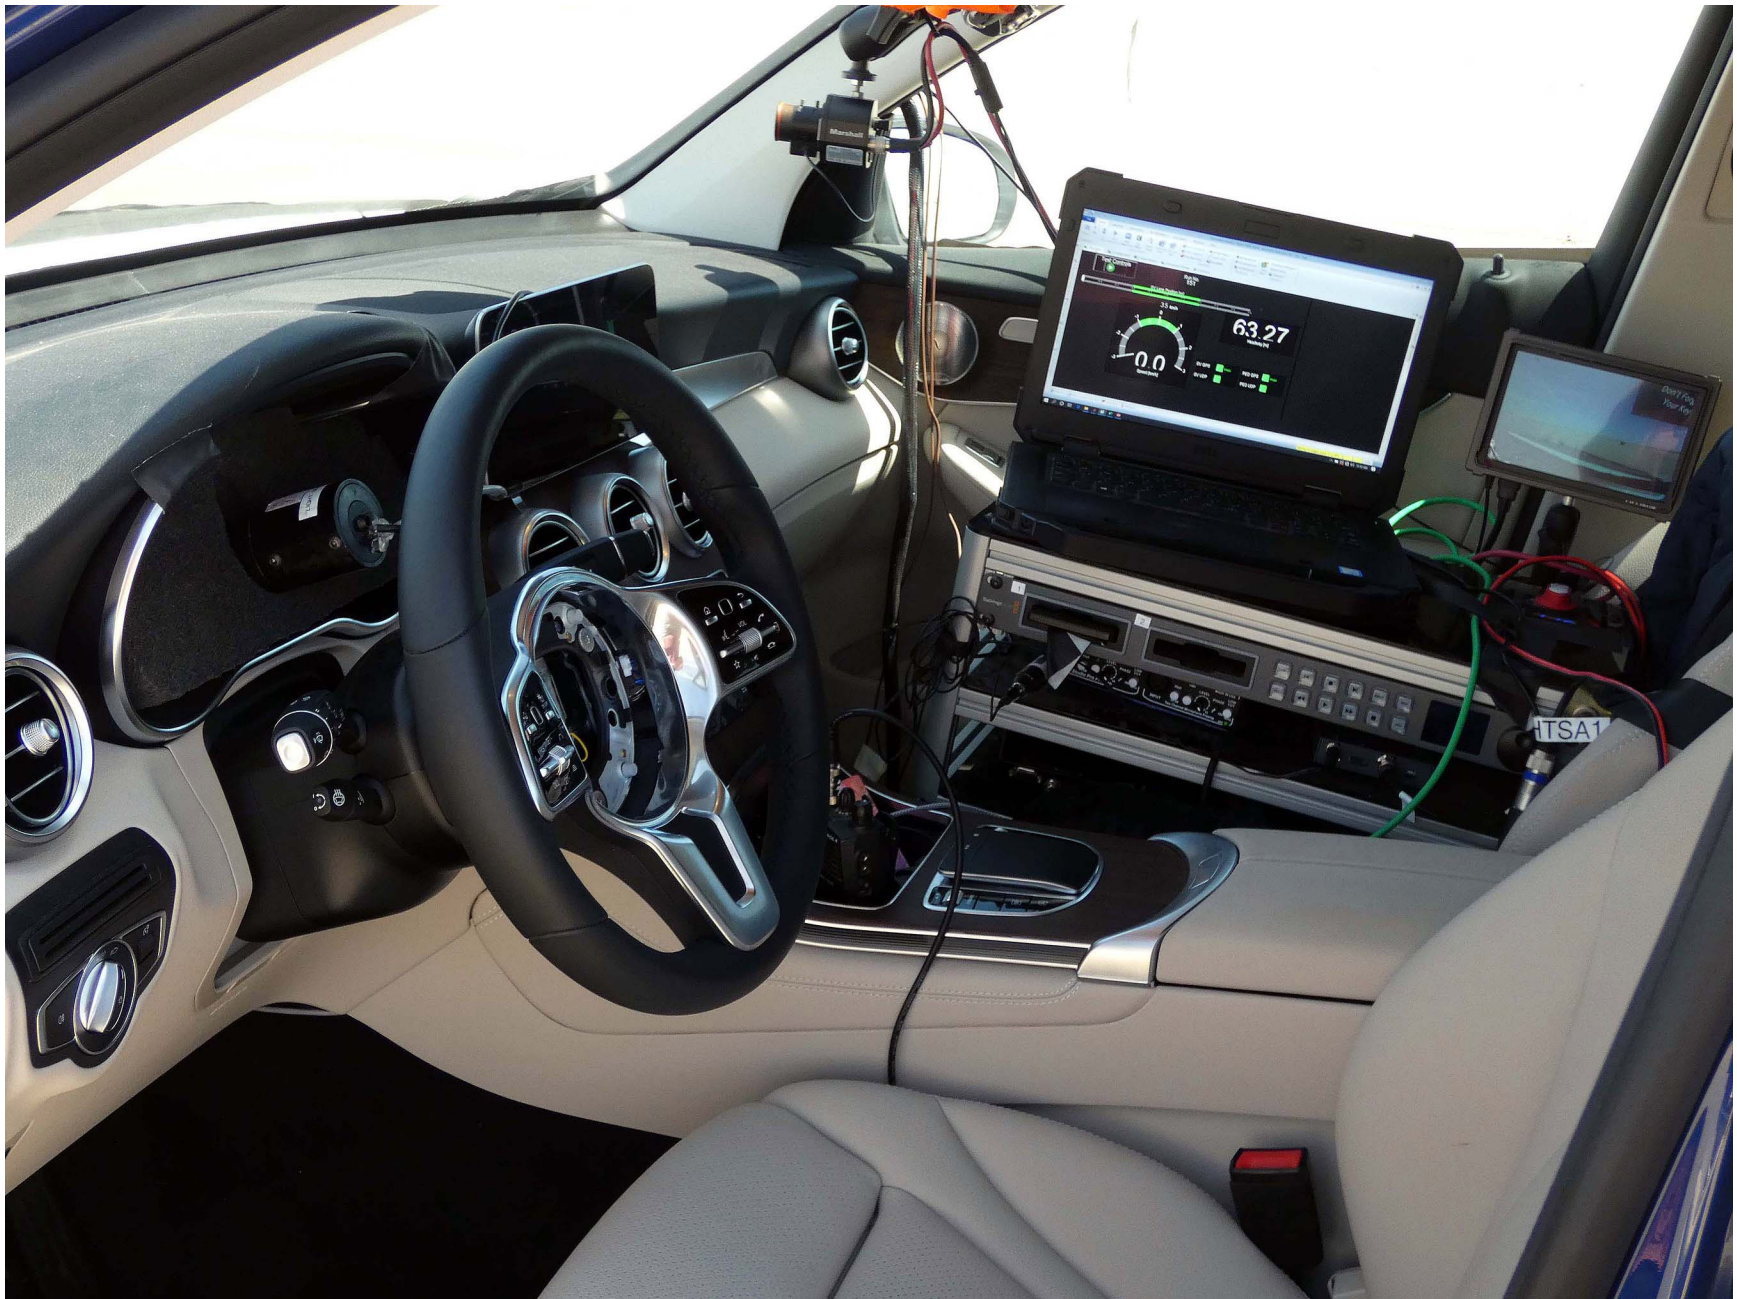
Figure A10. Computer Installed in Subject Vehicle

Table 1 lists the sensors, signal conditioning, and data acquisition equipment used for these tests.

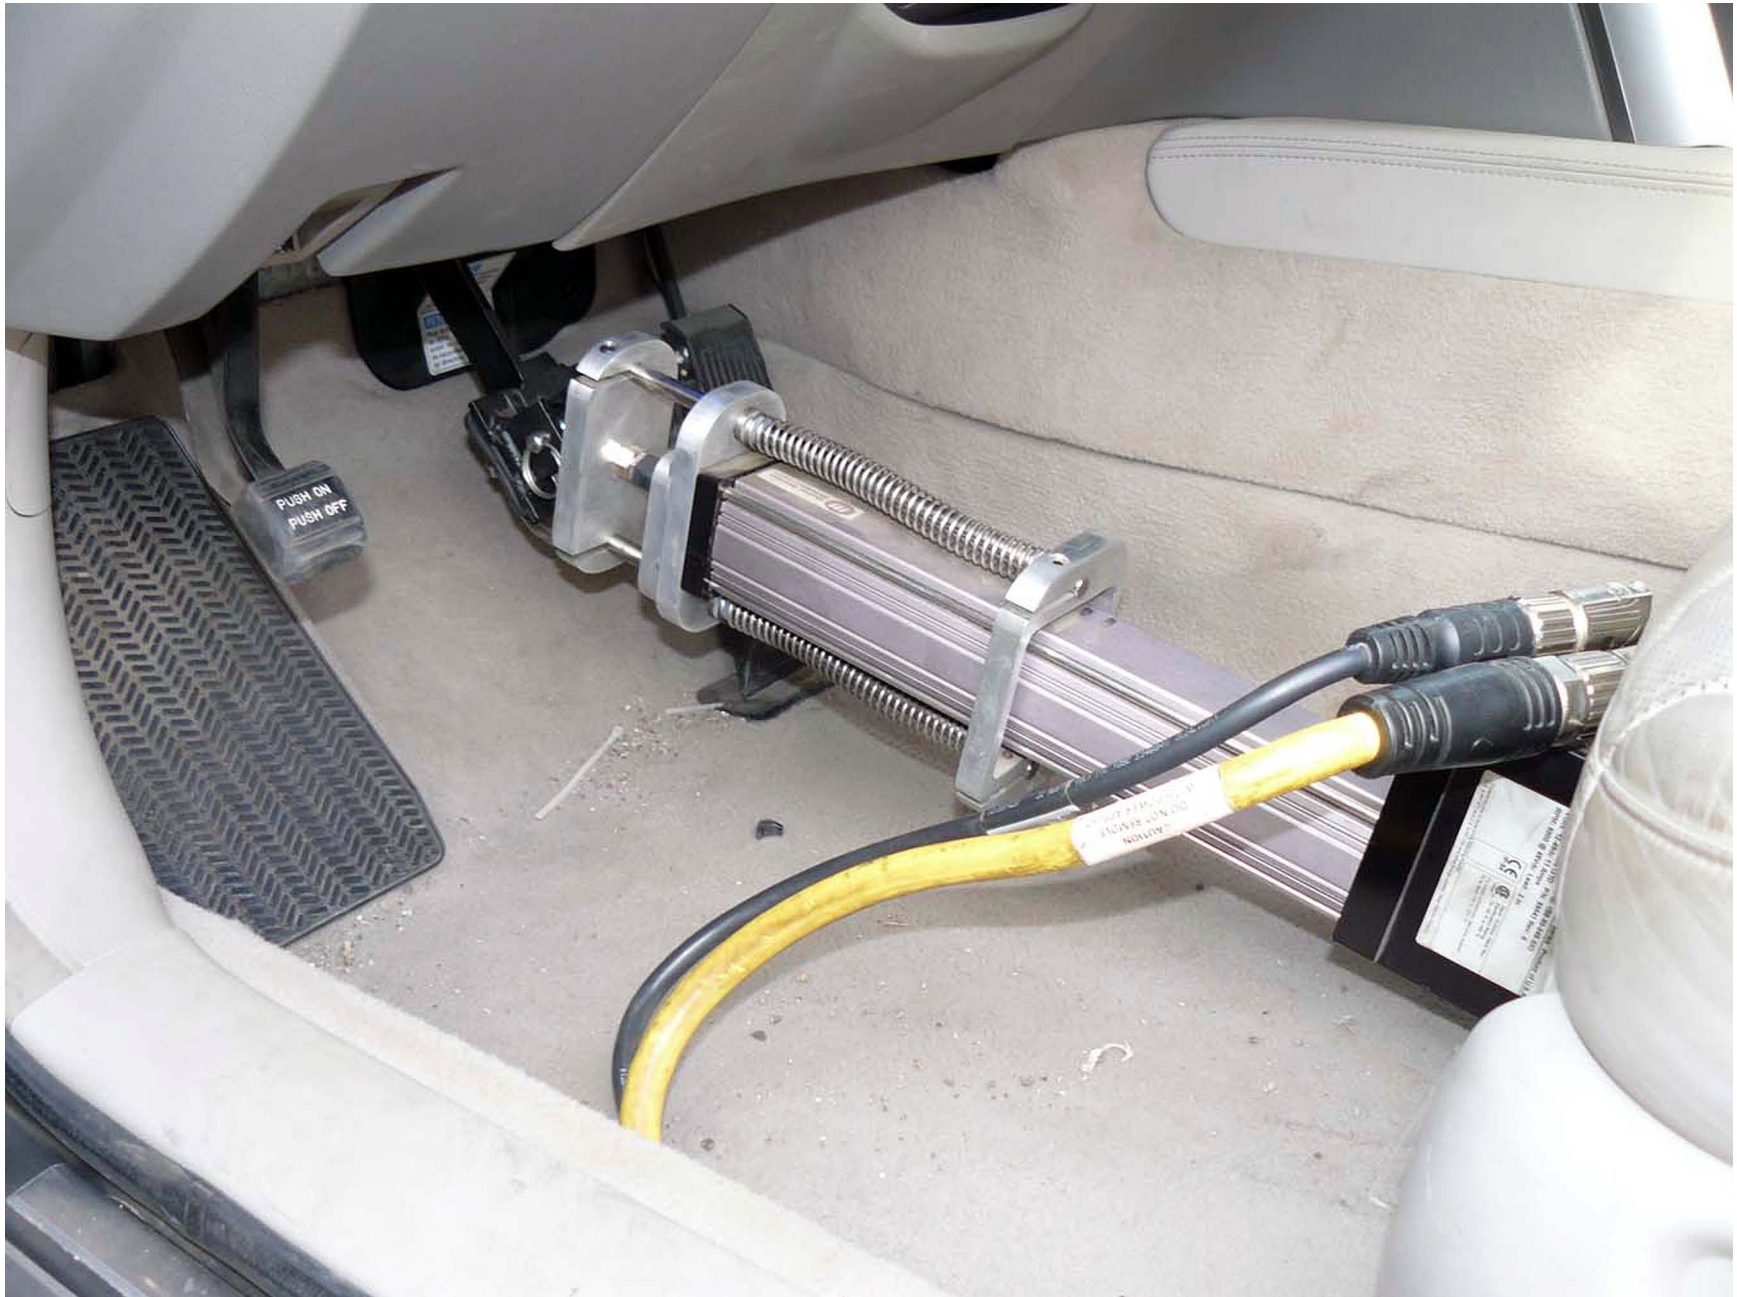
Figure A11. Brake Actuation System Installed in Principal Other Vehicle

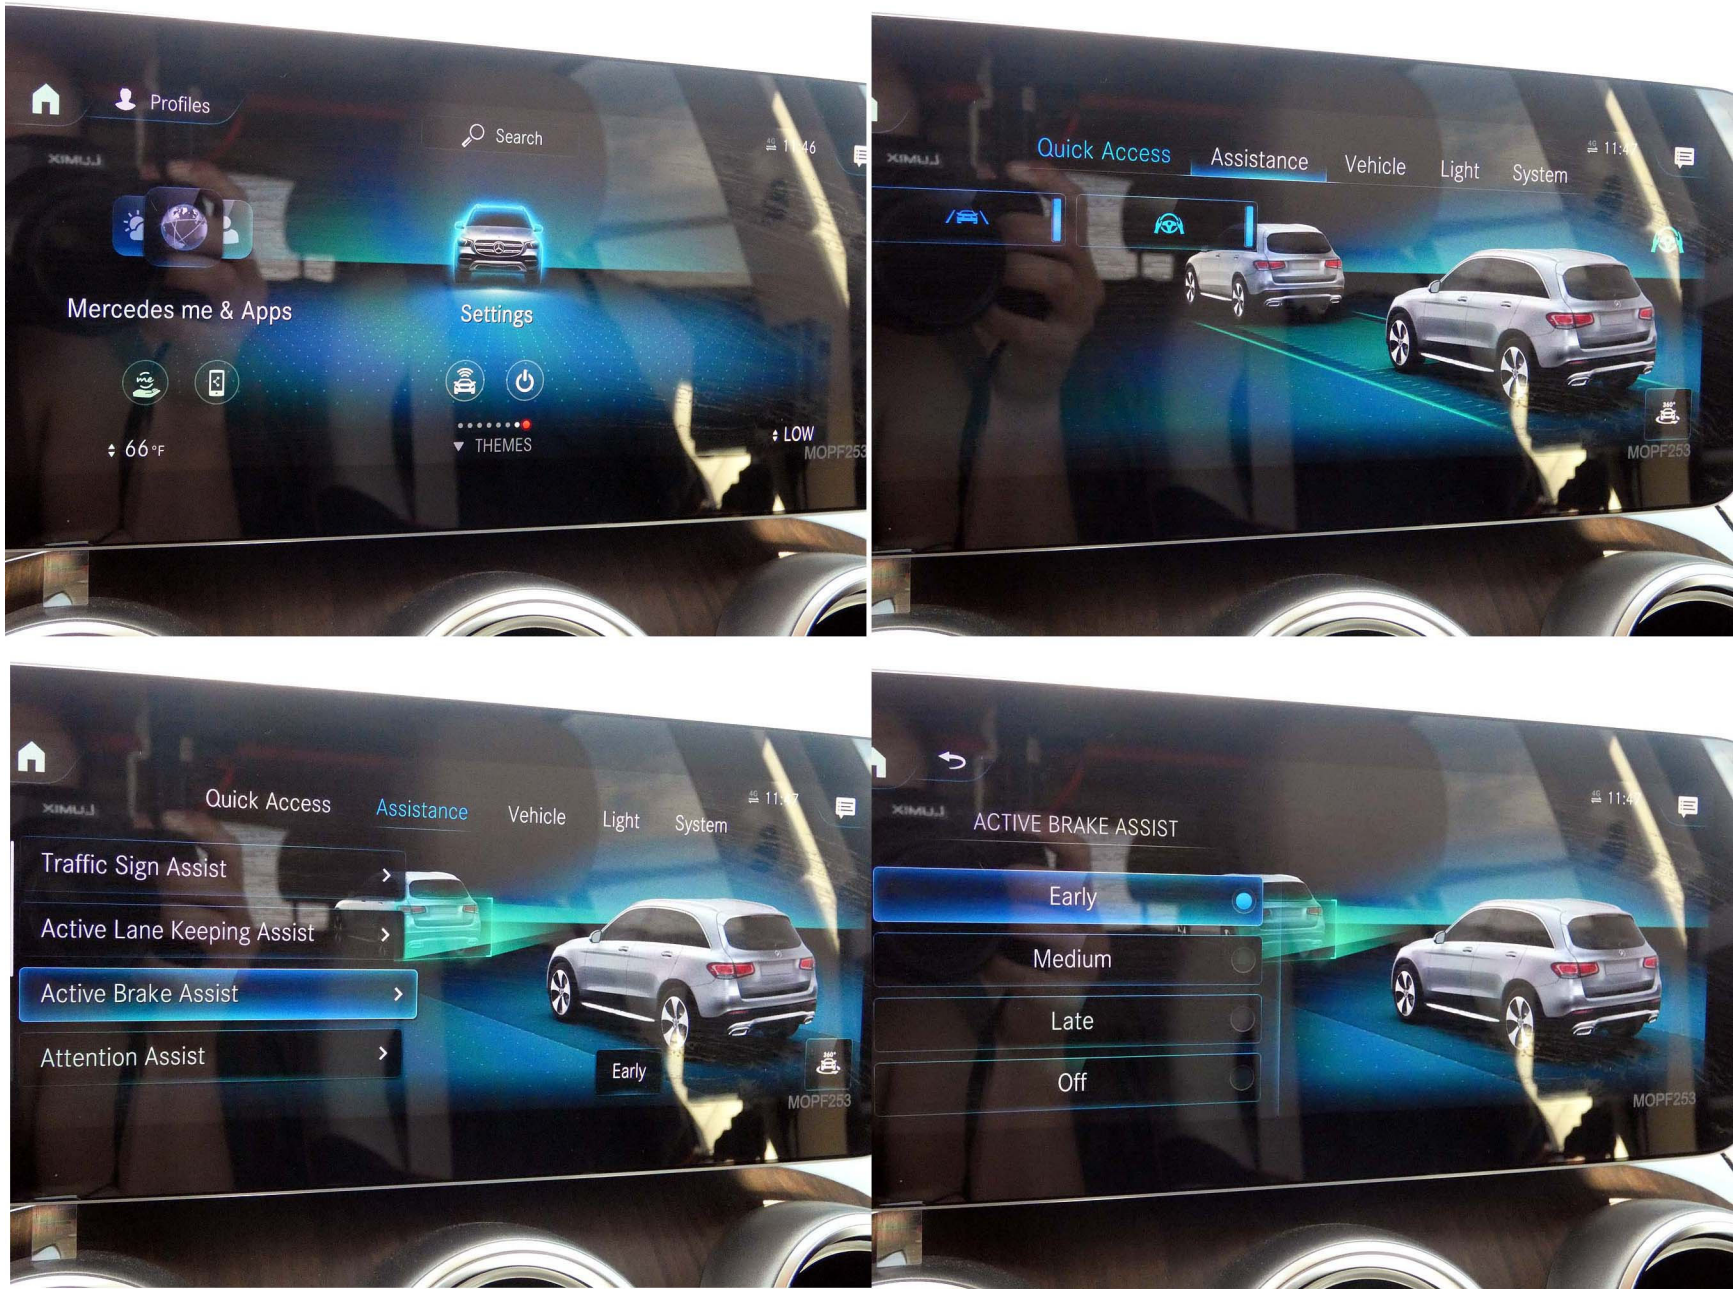
Figure A12. System Setup Menus

Controls on the right side of the steering wheel or a touch pad located in the center console can be used to interact with the multimedia system menus.

The hierarchy is:

Settings

Assistance

Active Brake Assist.

Select "Off" to disable

See Appendix A, Figures A12 and A13

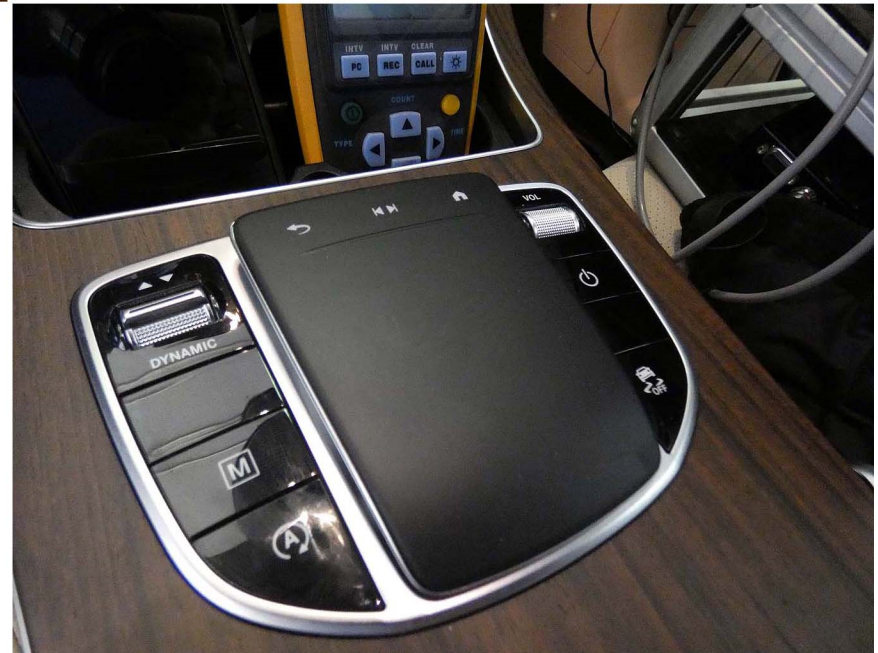
Figure A13. Controls for Changing System Parameters

The sensitivity of the system can be adjusted. Controls on the right side of the steering wheel or a touch pad located in the center console can be used to interact with the multimedia system menus. The hierarchy is:

Select Early – Medium (default) – Late – Off

See Appendix A, Figures A12 and A13
