**NEW CAR ASSESSMENT PROGRAM
CRASH IMMINENT BRAKING SYSTEM CONFIRMATION TEST
NCAP-DRI-CIB-20-08**

2020 Kia Optima EX

DYNAMIC RESEARCH, INC.
355 Van Ness Avenue, STE 200
Torrance, California 90501

Final Report

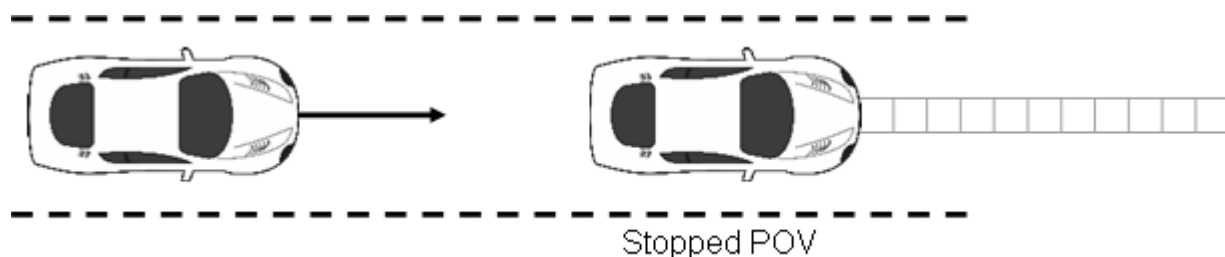
This test evaluates the ability of the CIB system to detect and respond to a stopped lead vehicle in the immediate forward path of the SV, as depicted in Figure 1.

Figure 1. Depiction of Test 1

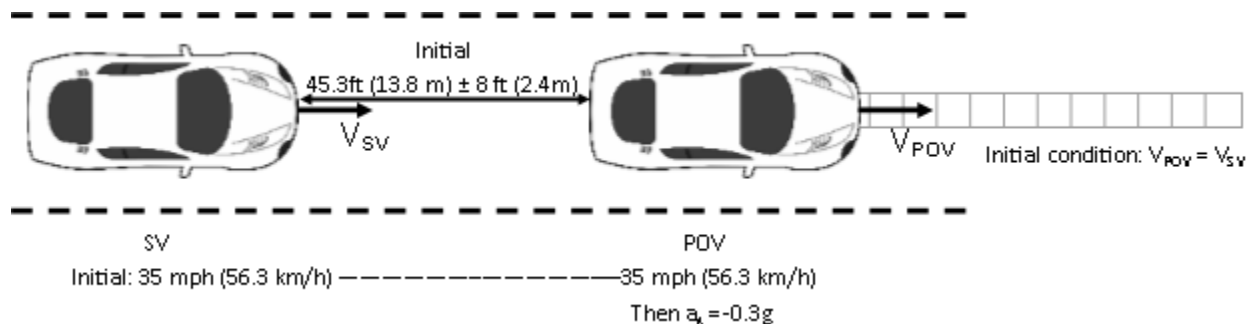
This test evaluates the ability of the CIB system to detect and respond to a lead vehicle slowing with a constant deceleration in the immediate forward path of the SV, as depicted in Figure 3.

Figure 3. Depiction of Test 3 with POV Decelerating

The SV ignition was cycled prior to each test run. For this test scenario, both the POV and SV were driven at a constant 35.0 mph (56.3 km/h) in the center of the lane, with a headway of 45.3 ft (13.8 m) \pm 8 ft (2.4 m). Once these conditions were met, the POV tow vehicle brakes were applied to achieve 0.3 \pm 0.03 g of deceleration. The test concluded when either:

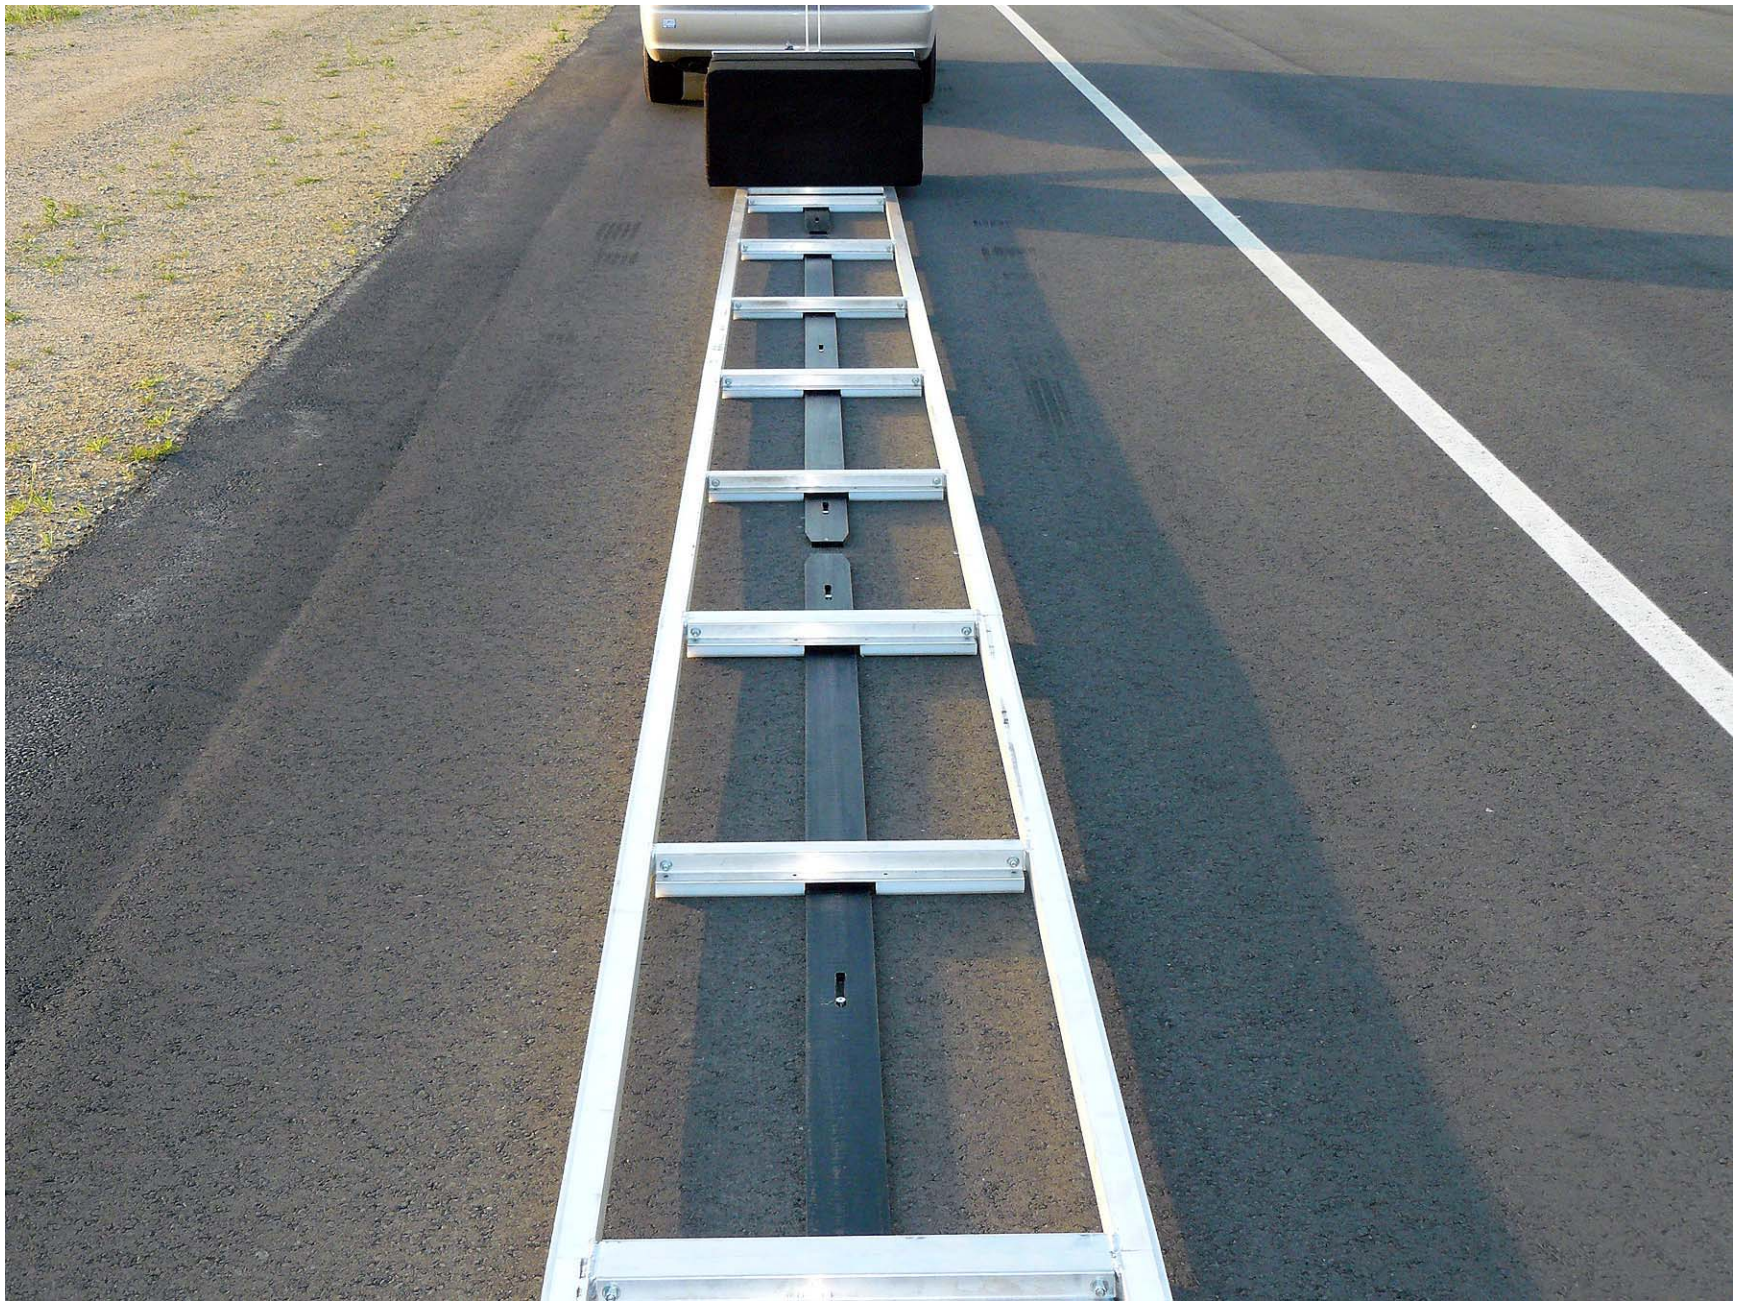
Figure A8. Two-Rail Track and Road-Based Lateral Restraint Track

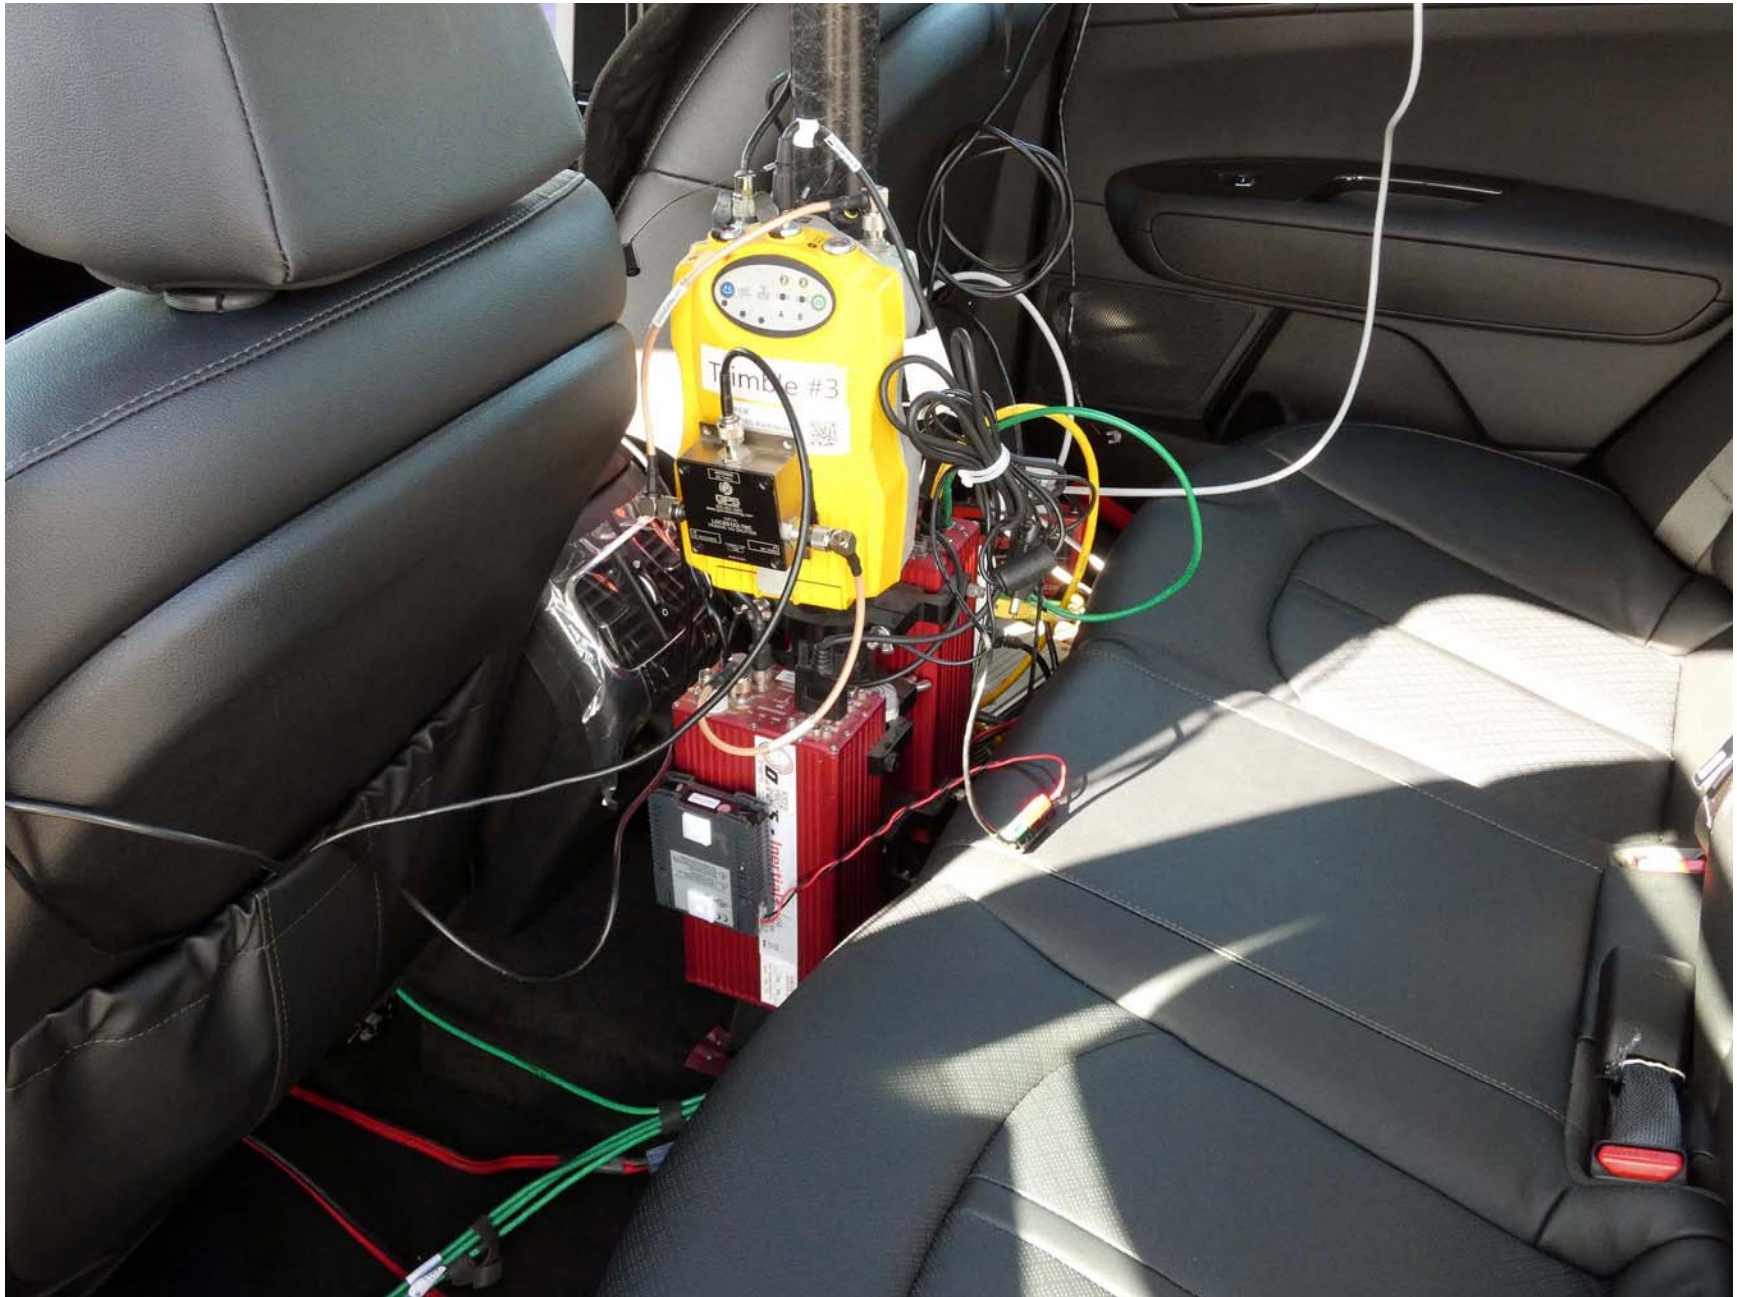
Figure A10. DGPS, Inertial Measurement Unit, and MicroAutoBox Installed in Subject Vehicle

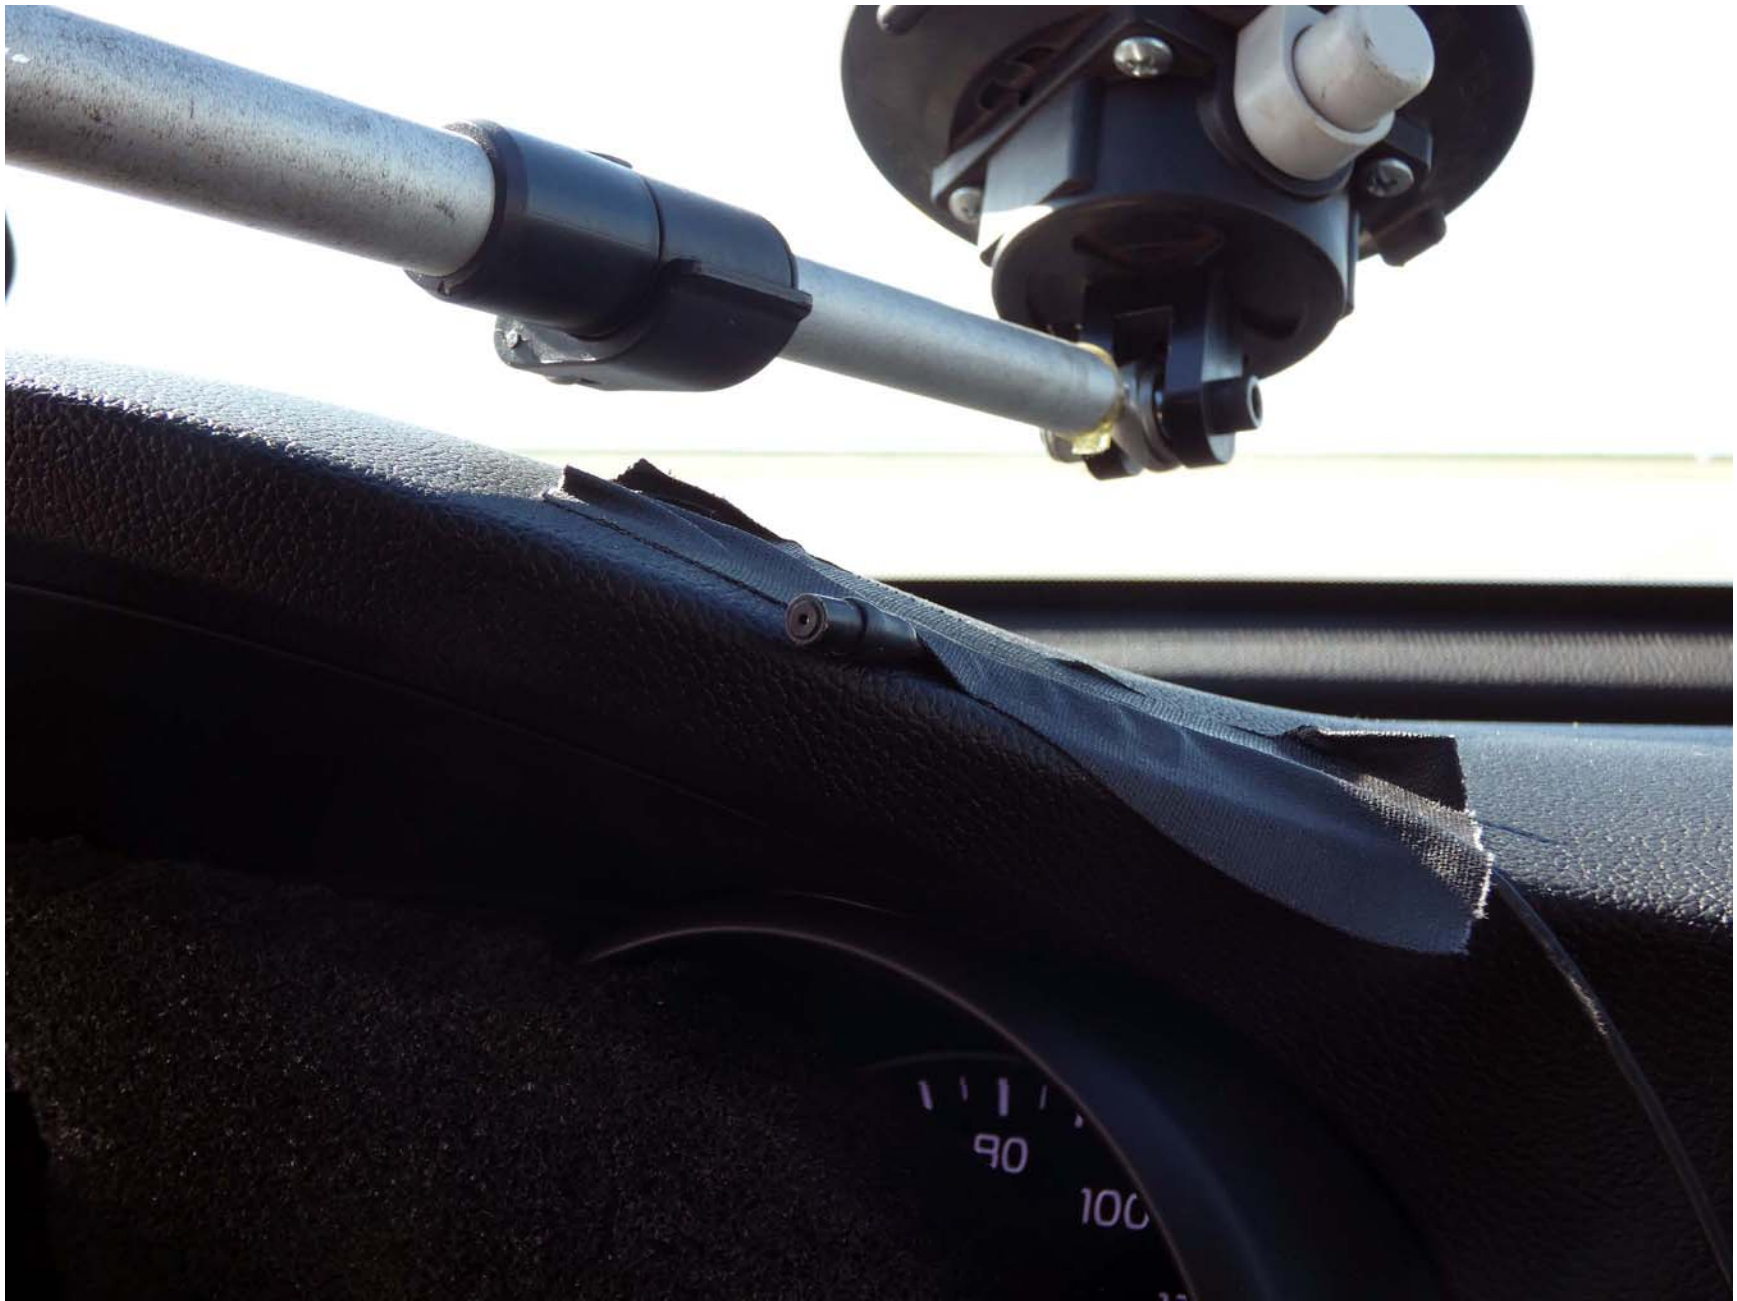
Figure A11. Sensor for Detecting Auditory Alerts

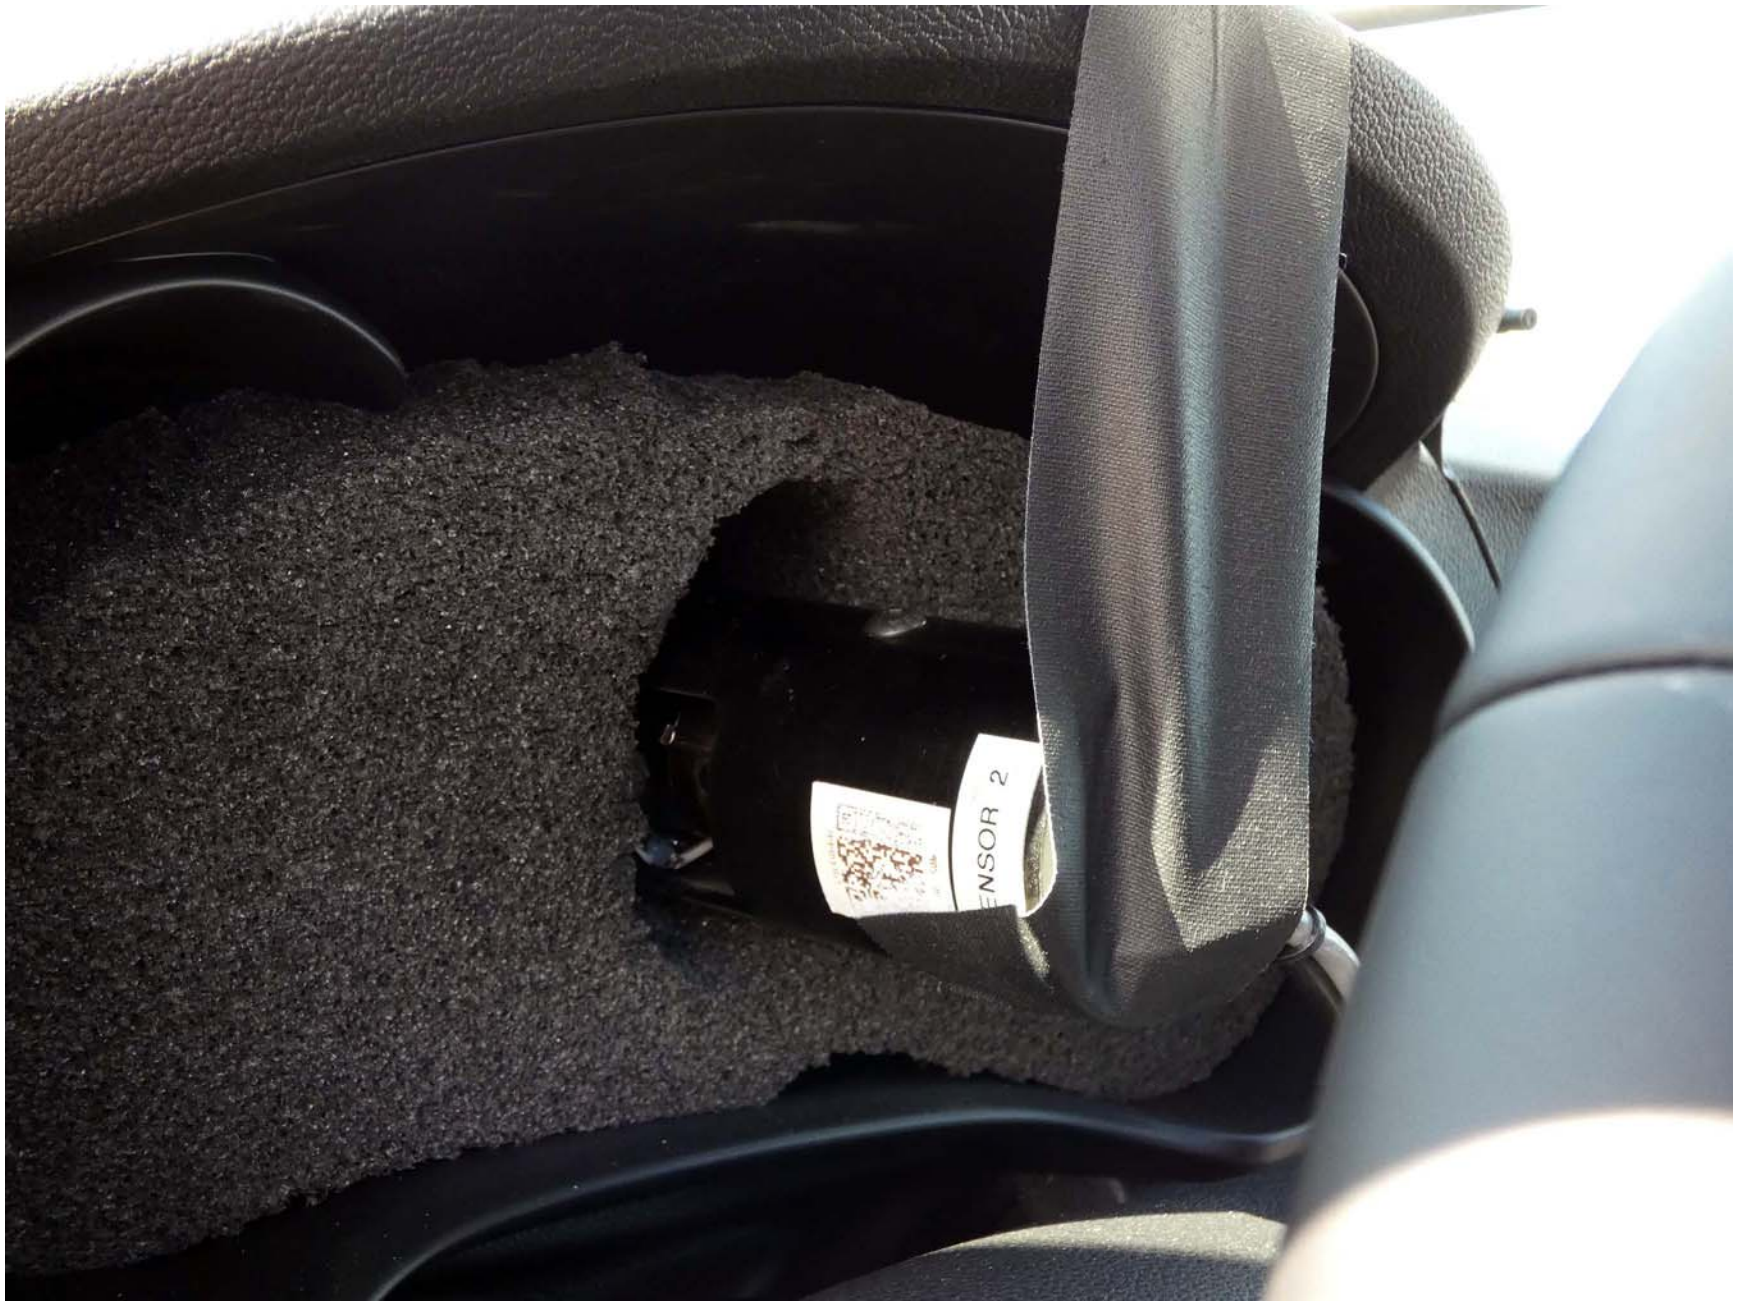
Figure A12. Sensor for Detecting Visual Alerts

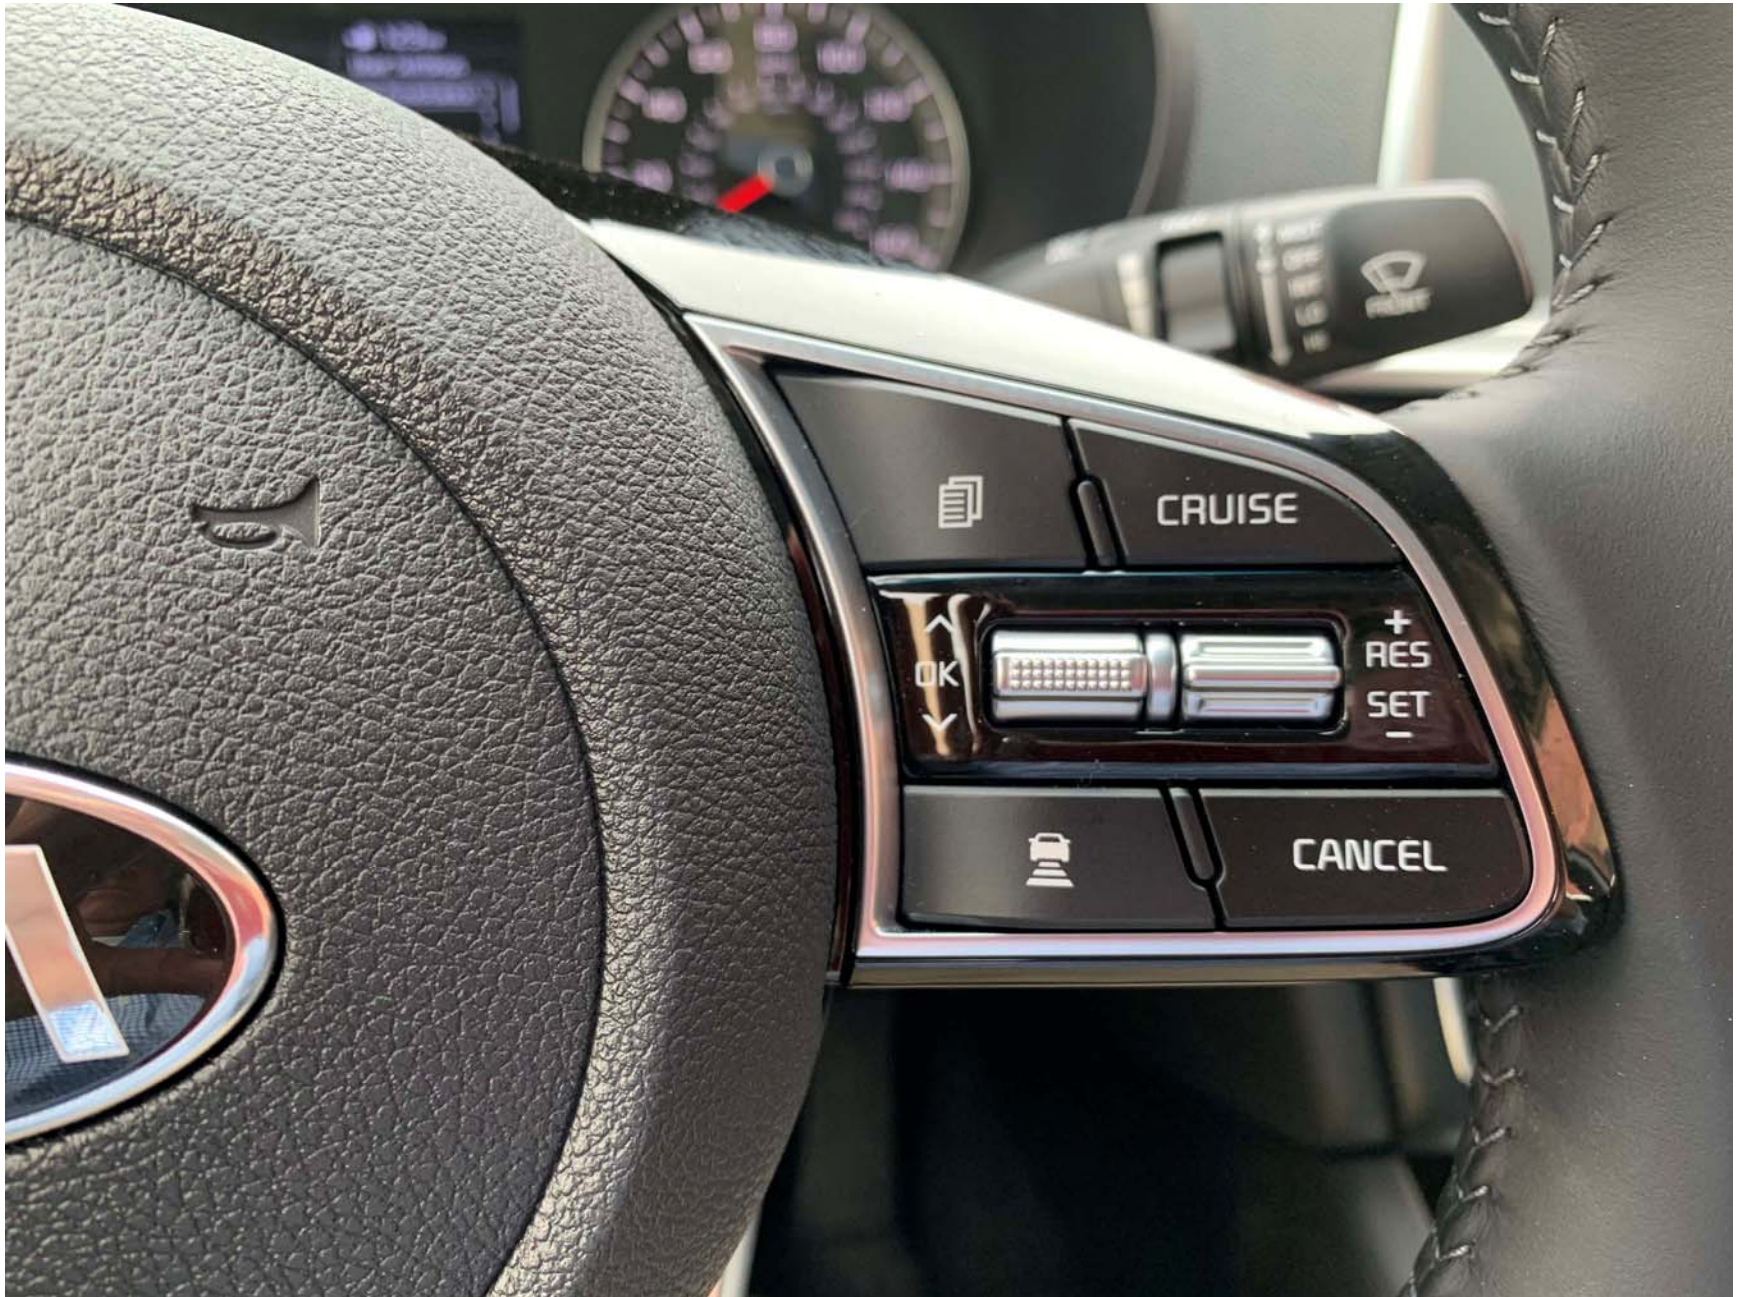
Figure A14. AEB Setup Menus

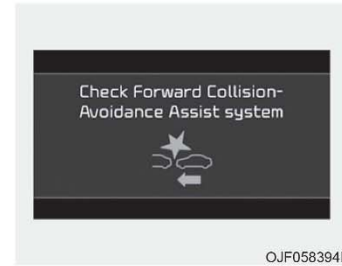
System malfunction

- When the FCA is not working properly, the FCA warning light (⚠) will illuminate and the warning message will appear for a few seconds. After the message disappears, the master warning light (⚠) will illuminate. In this case, have the vehicle inspected by an authorized Kia dealer.
- The FCA warning message may appear along with the illumination of the ESC warning light.
