**NEW CAR ASSESSMENT PROGRAM
CRASH IMMINENT BRAKING SYSTEM CONFIRMATION TEST
NCAP-DRI-CIB-20-08**

2020 Kia Optima EX

DYNAMIC RESEARCH, INC.
355 Van Ness Avenue, STE 200
Torrance, California 90501

Final Report

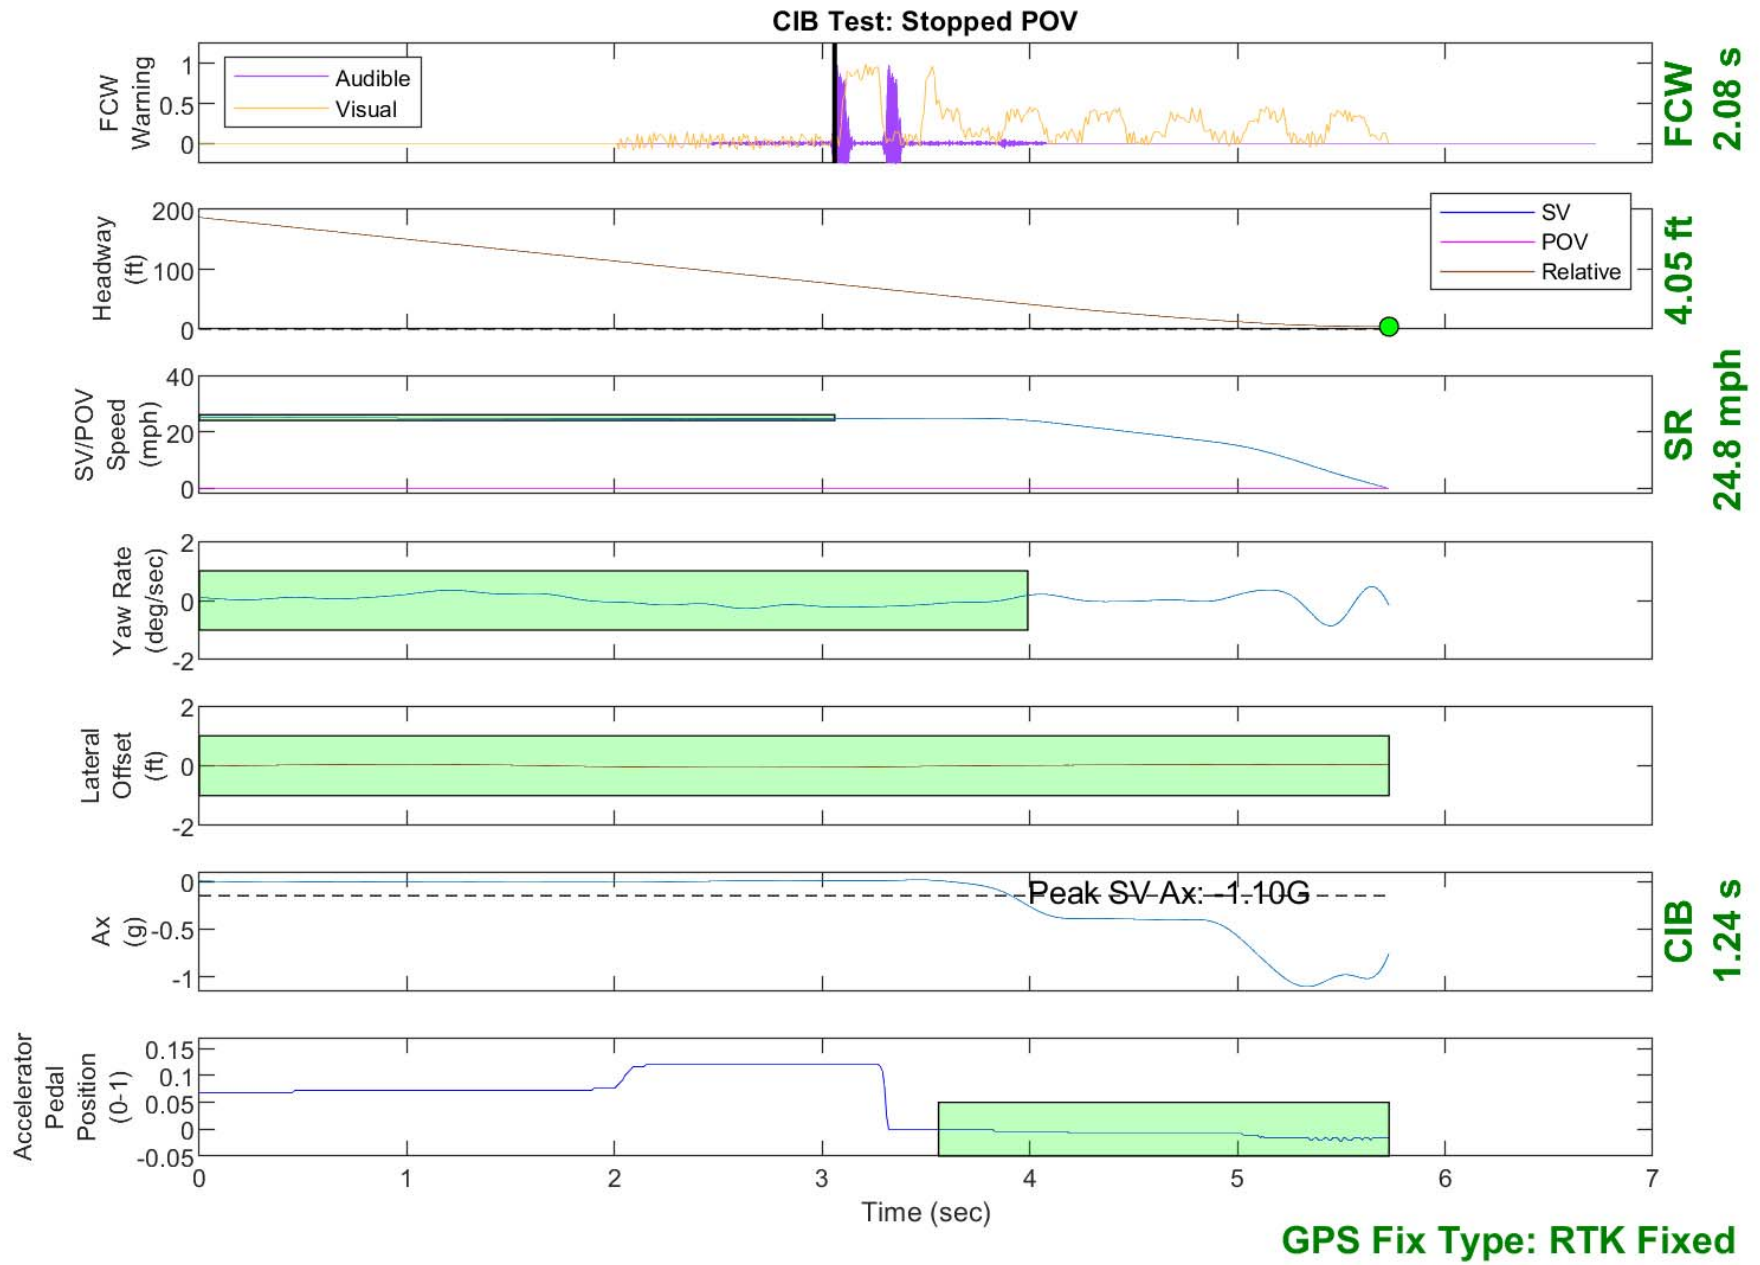
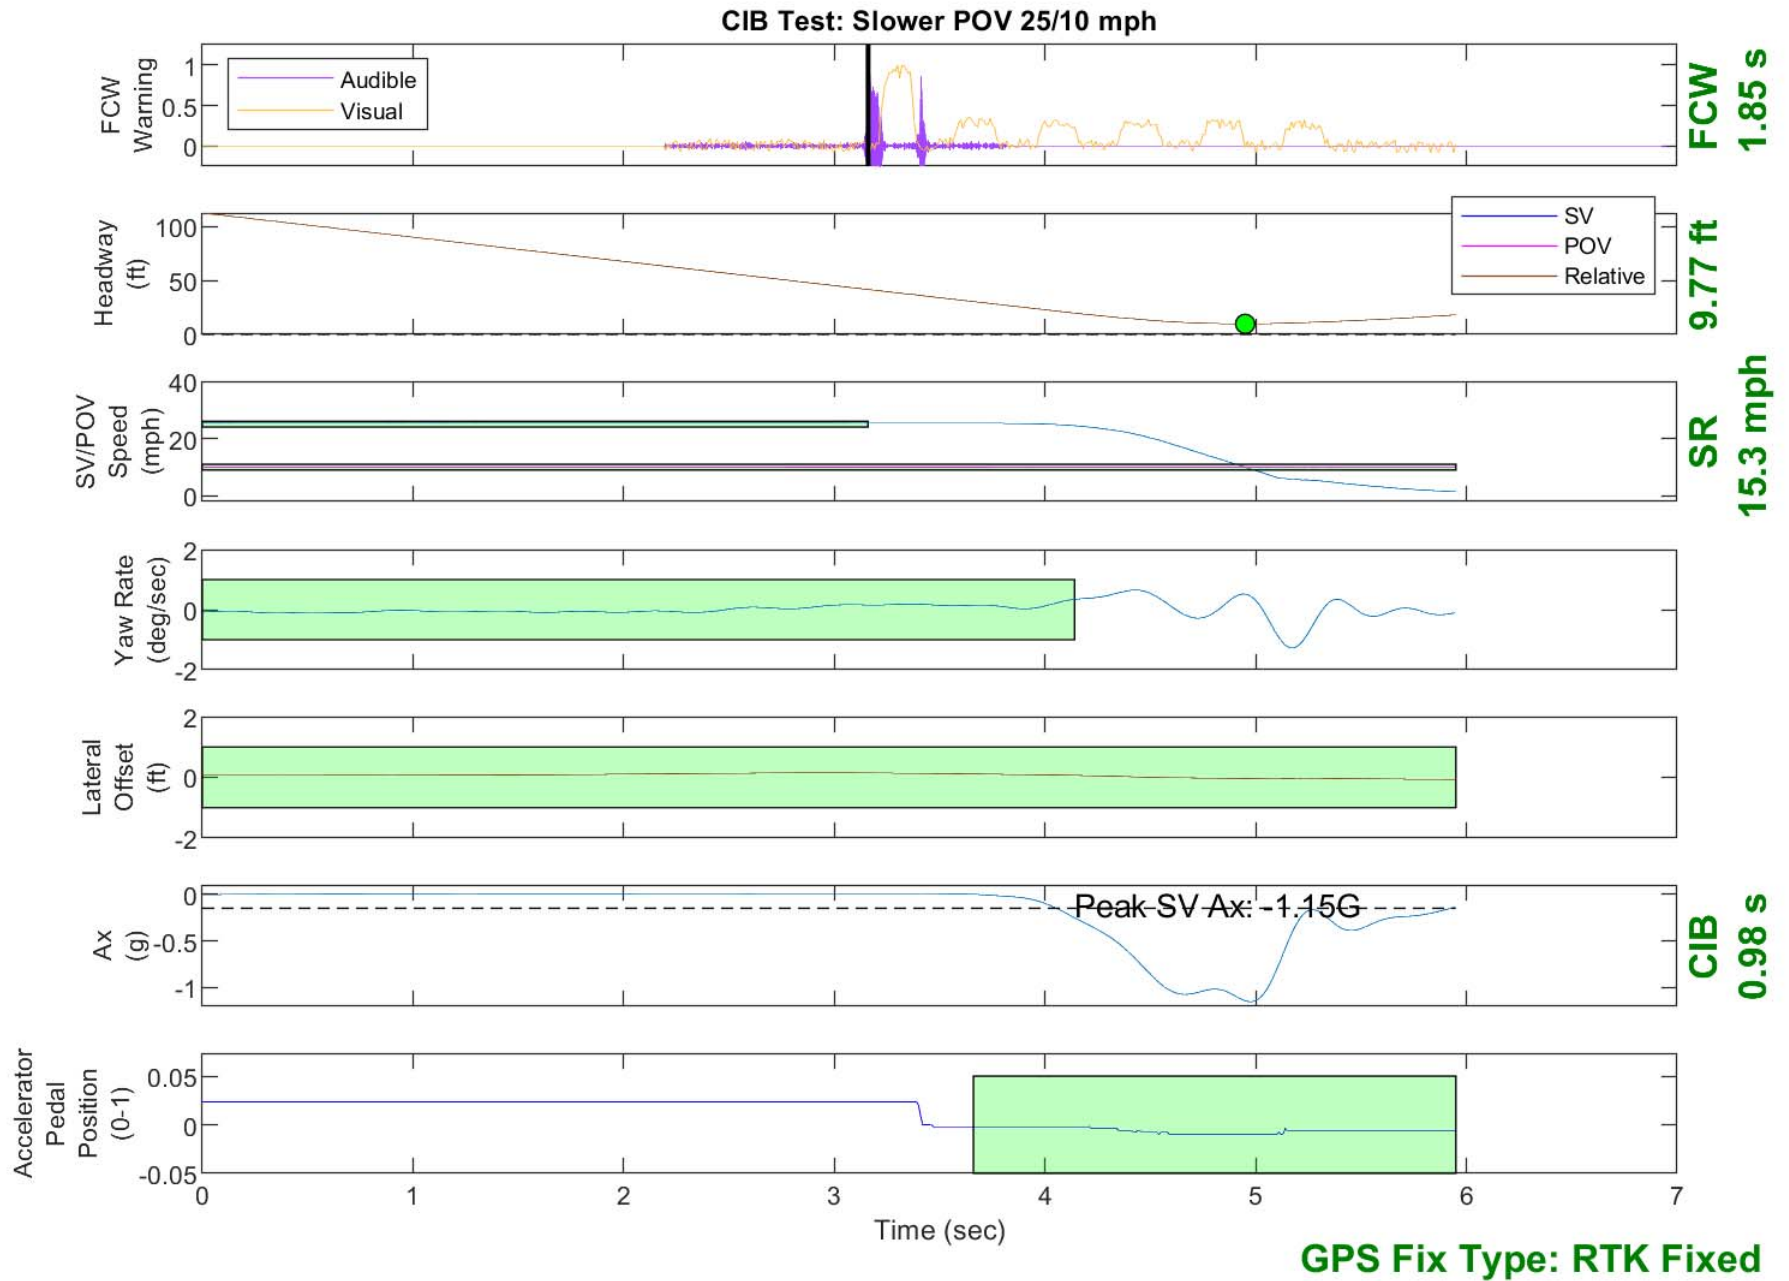
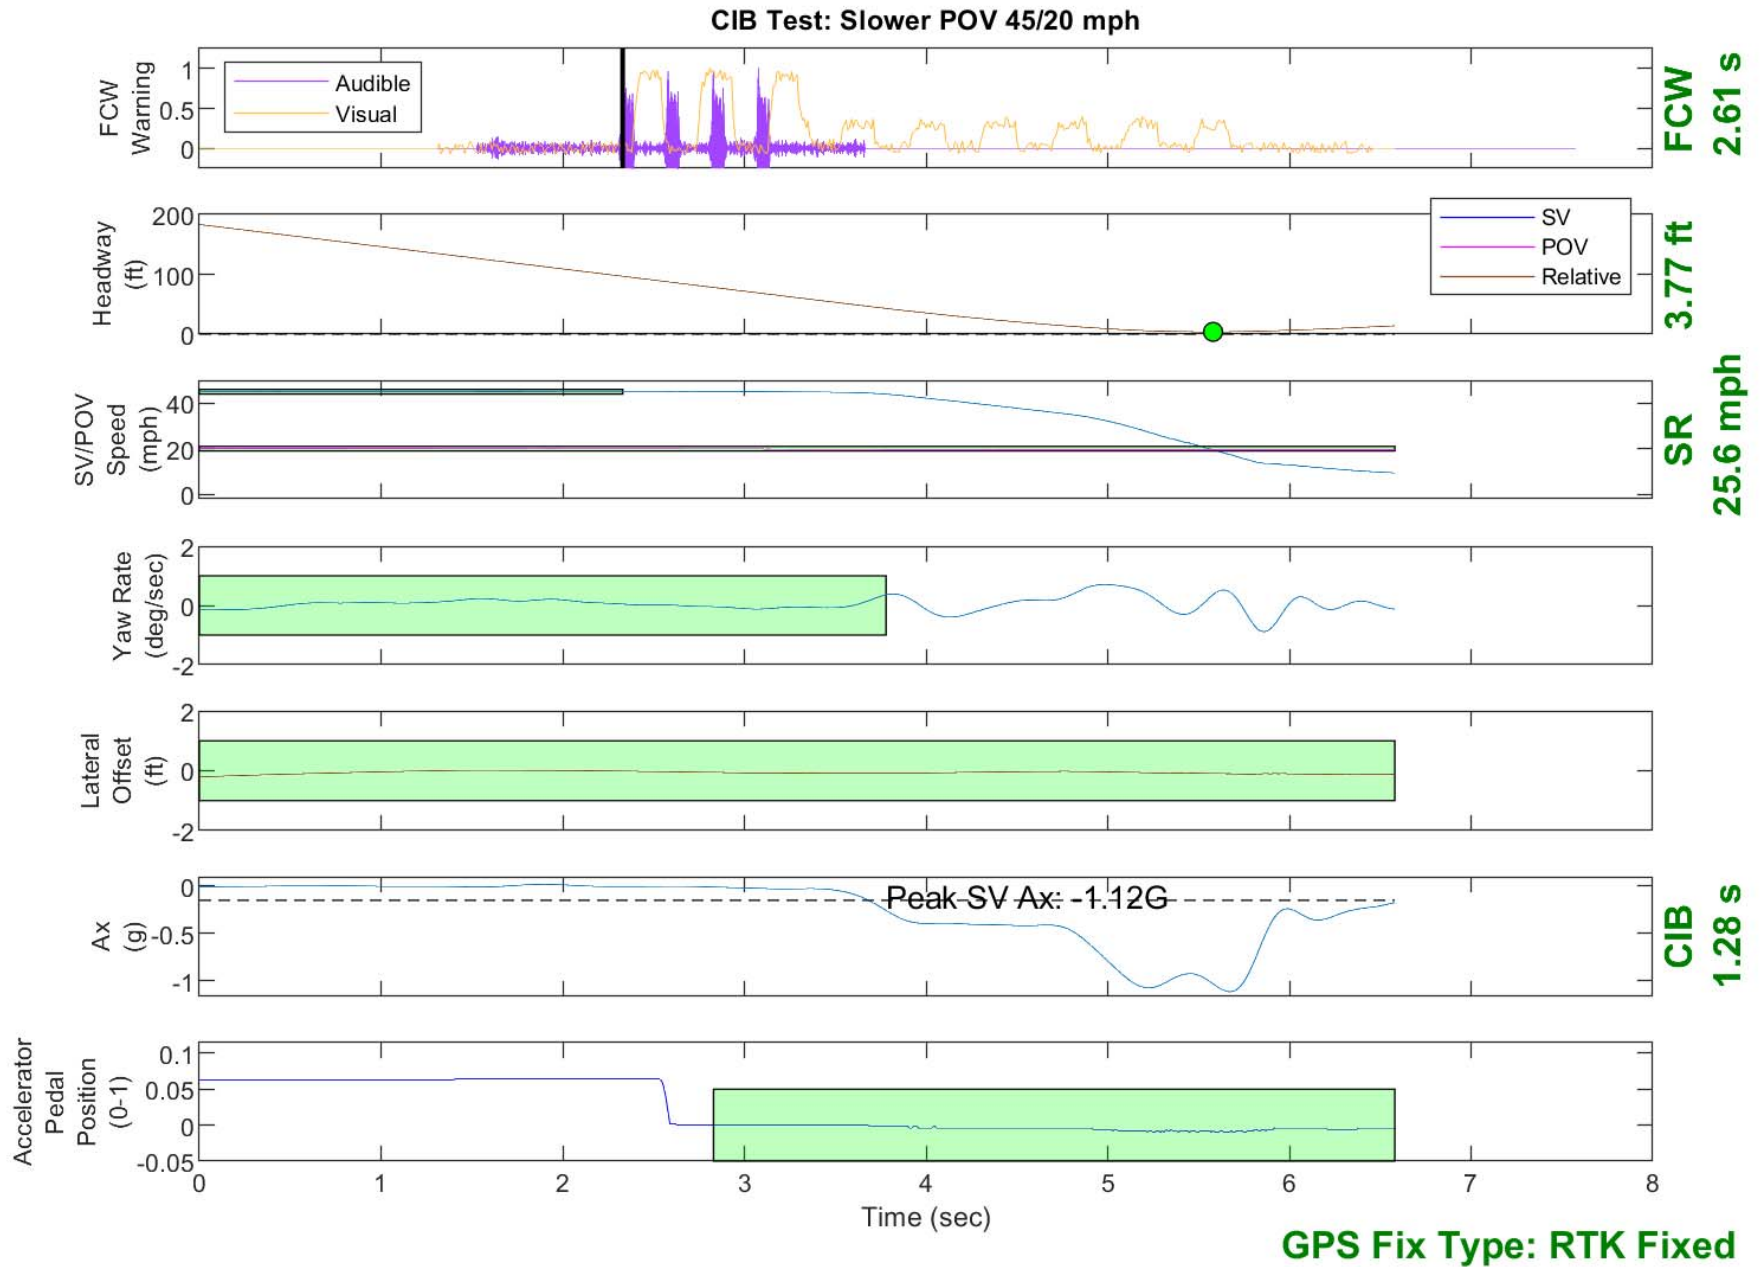
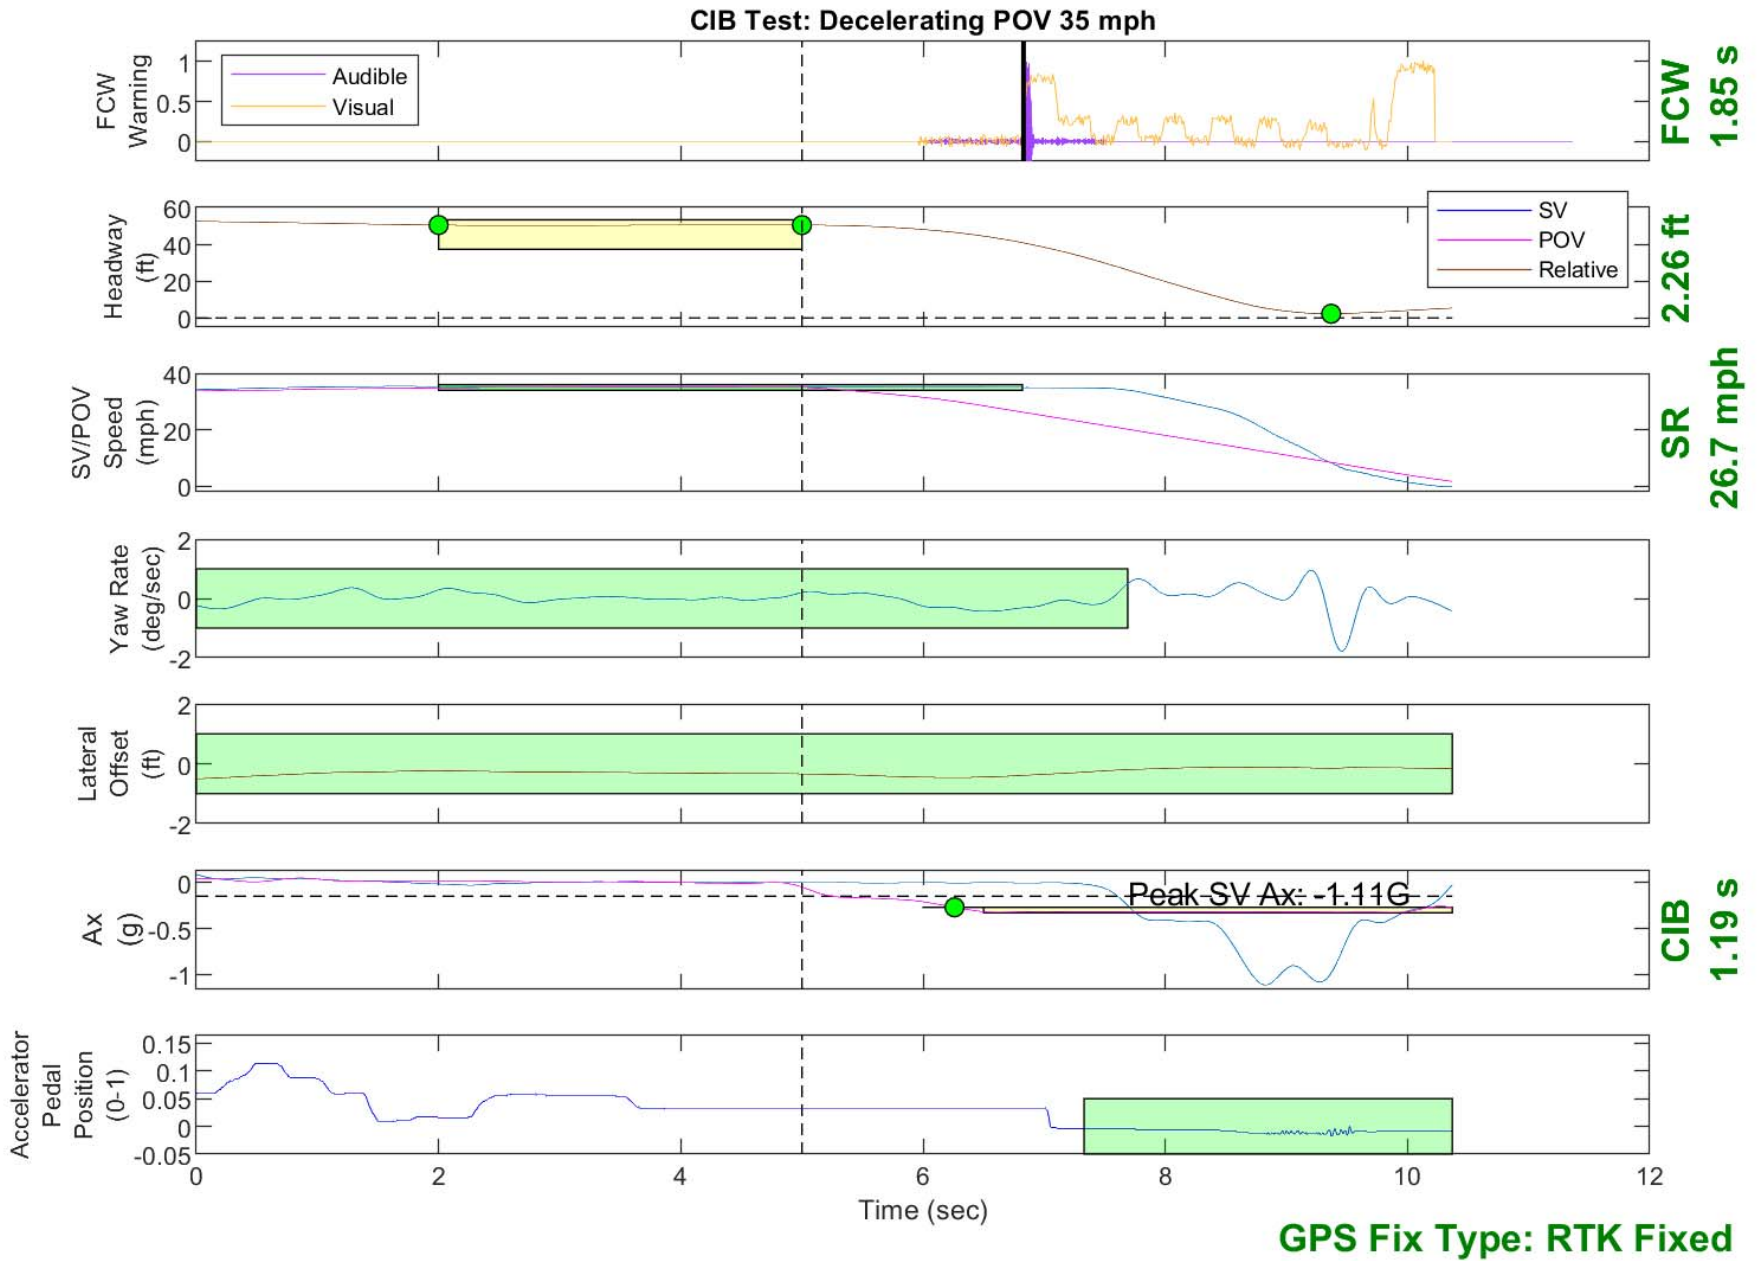
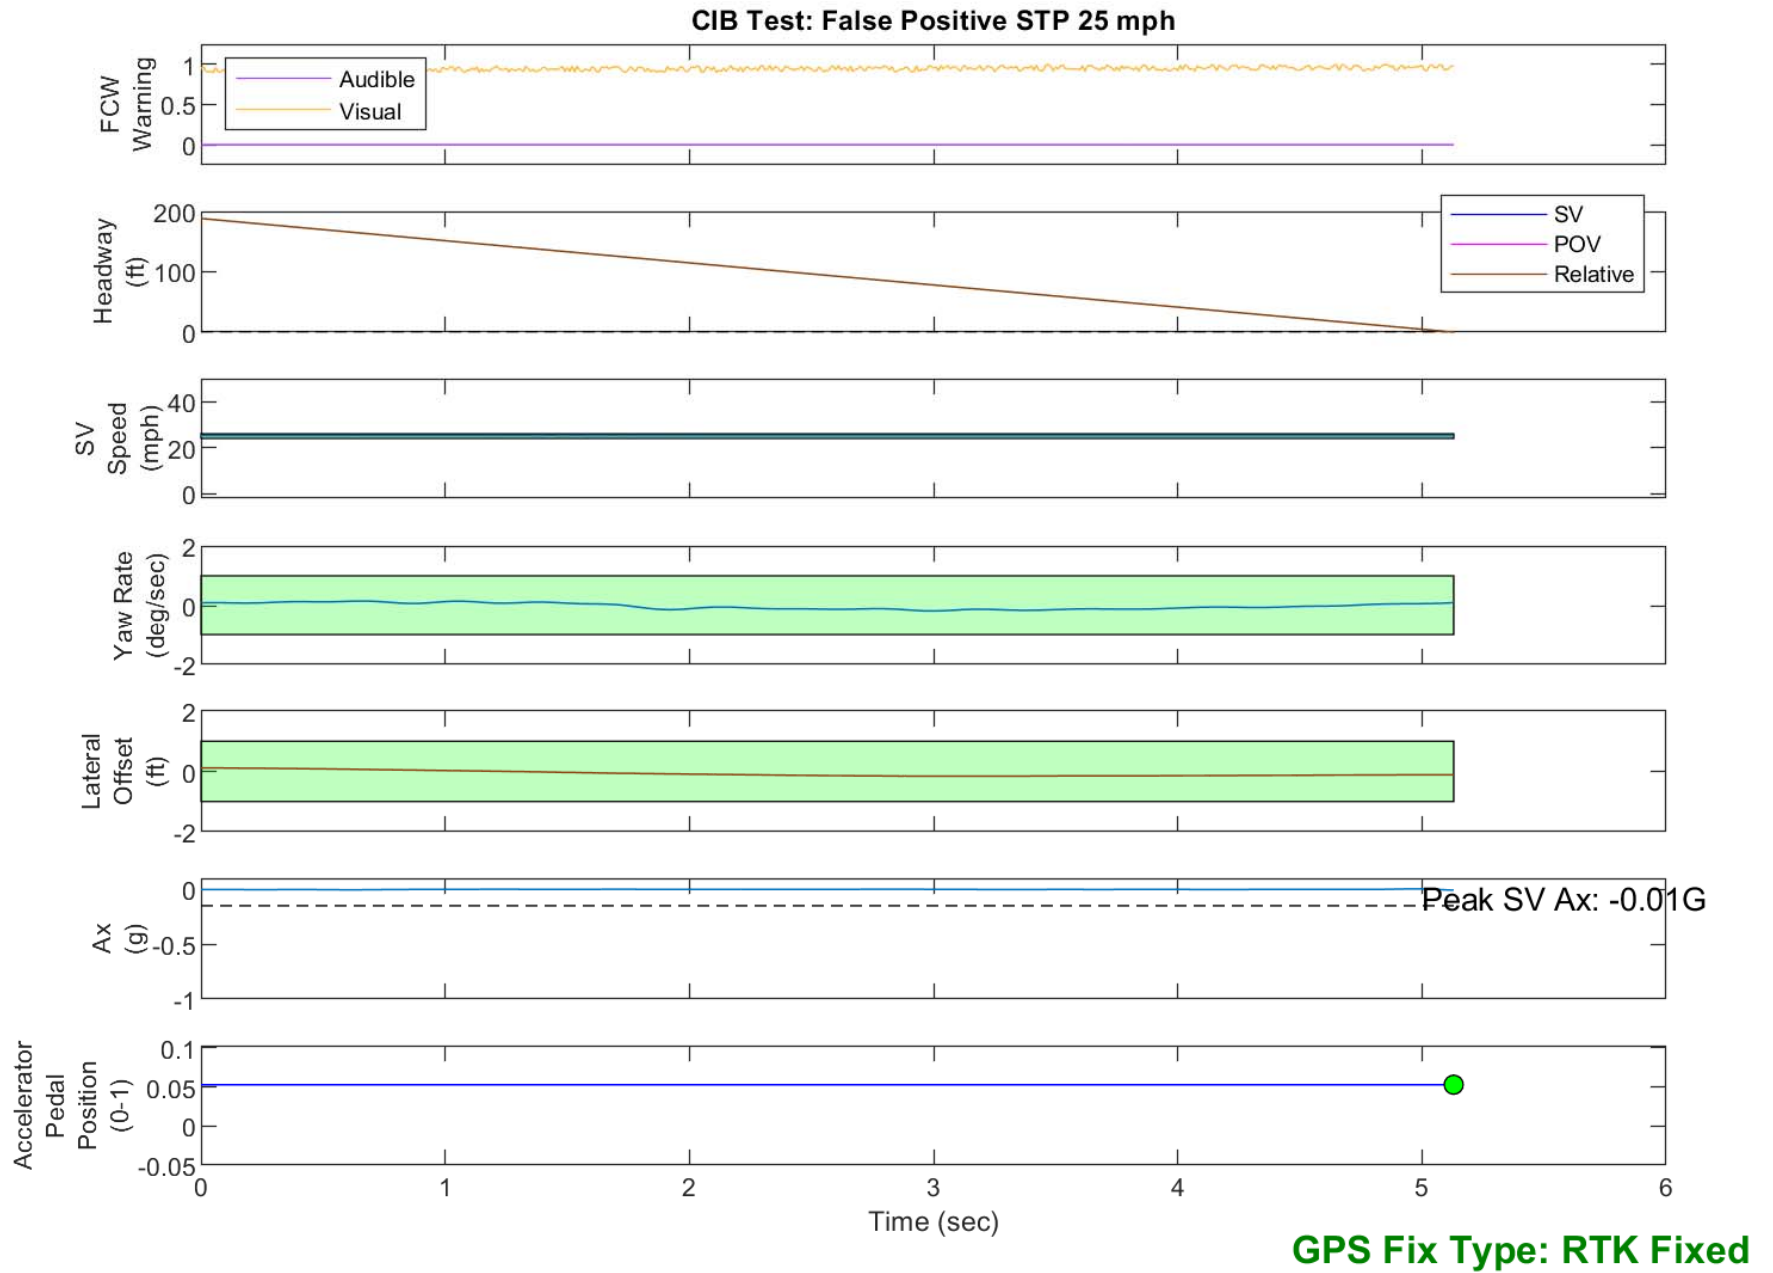
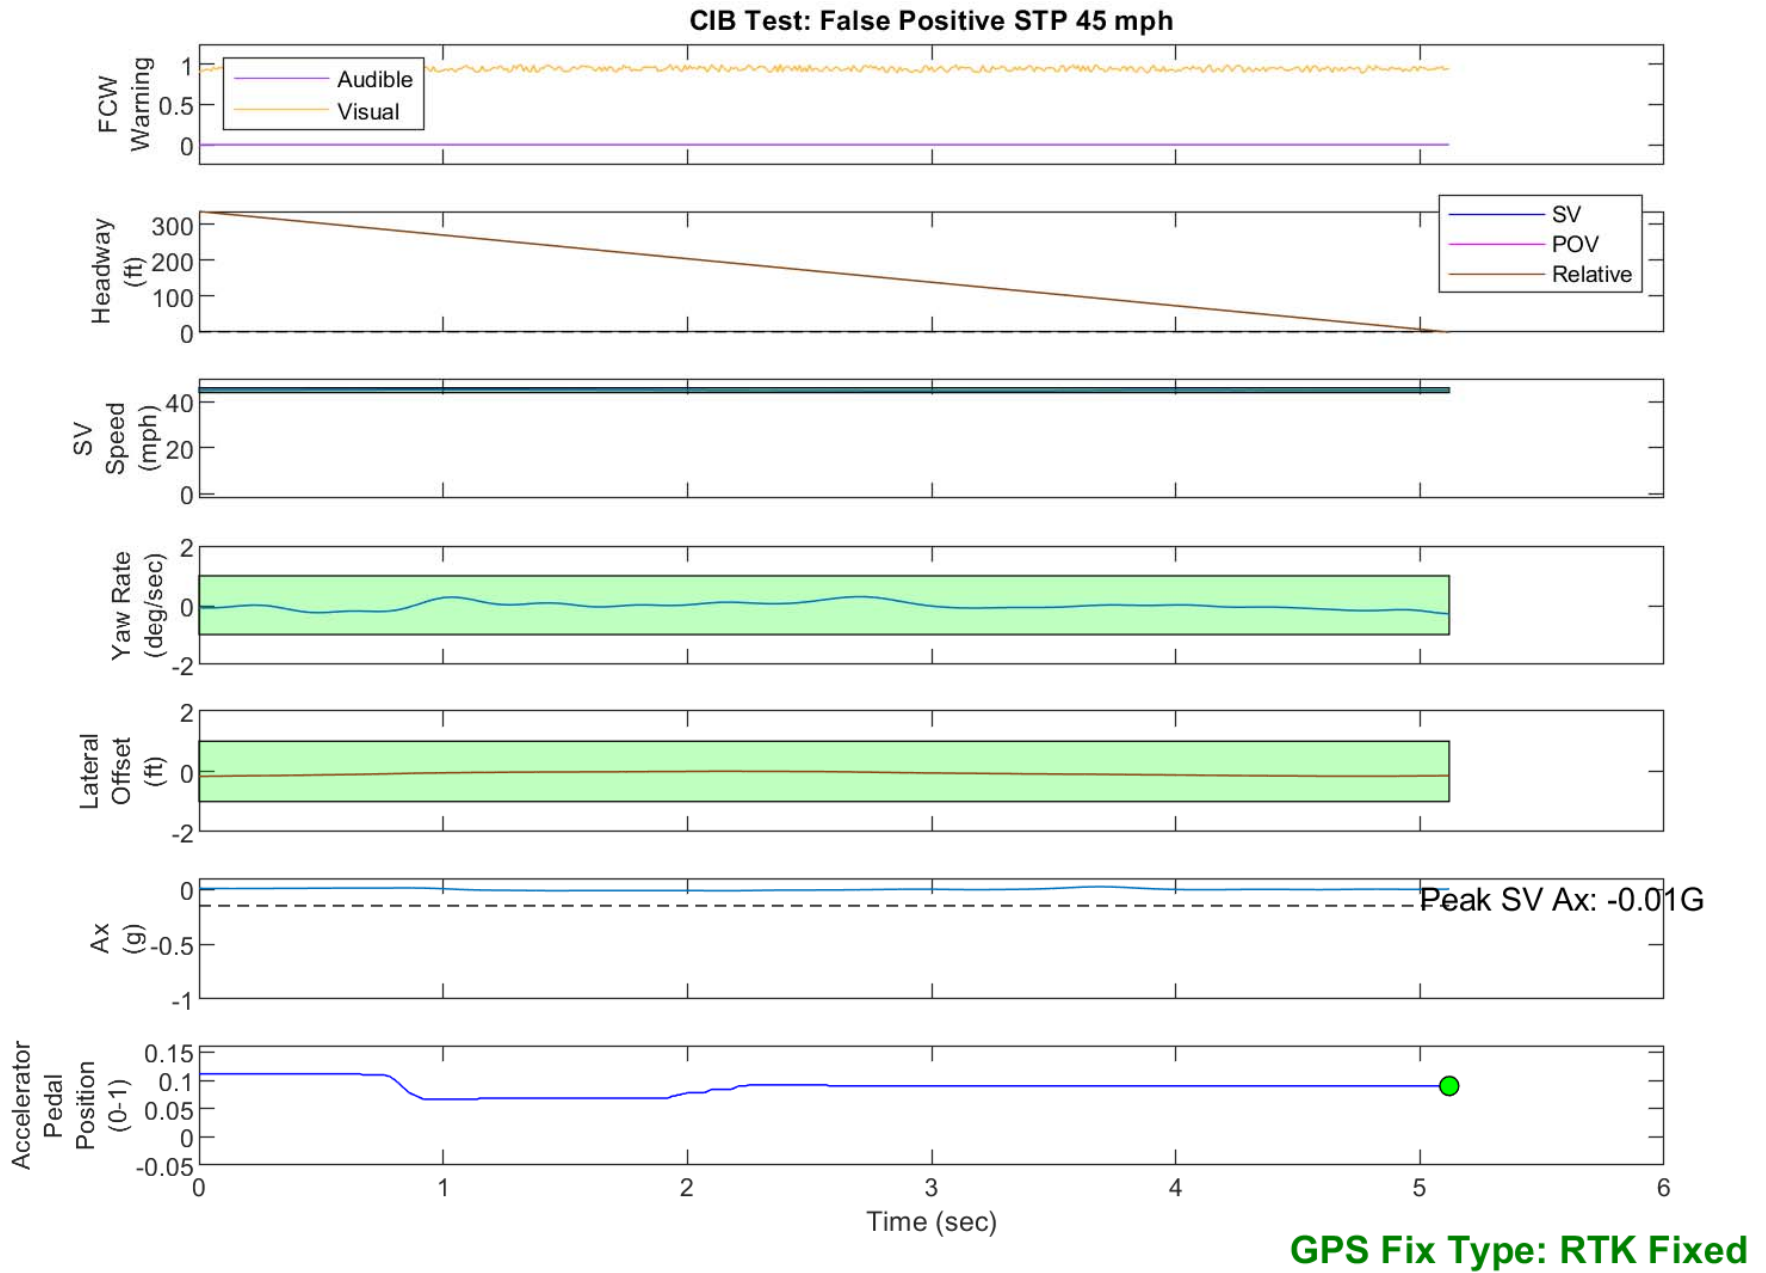
Figure D1. Example Time History for Stopped POV, Passing

Figure D2. Example Time History for Slower POV 25 vs. 10, Passing

Figure D3. Example Time History for Slower POV 45 vs. 20, Passing

Figure D4. Example Time History for Decelerating POV 35, Passing

Figure D5. Example Time History for False Positive STP 25, Passing

Figure D6. Example Time History for False Positive STP 45, Passing

Examples of time history plots for each test type (including passing, failing and invalid runs) are shown in Figure 1 through Figure 9. Figures 1 through 6 show passing runs for each of the 6 test types. Figures 7 and 8 show examples of invalid runs. Figure 9 shows an example of a valid test that failed the CIB requirements.

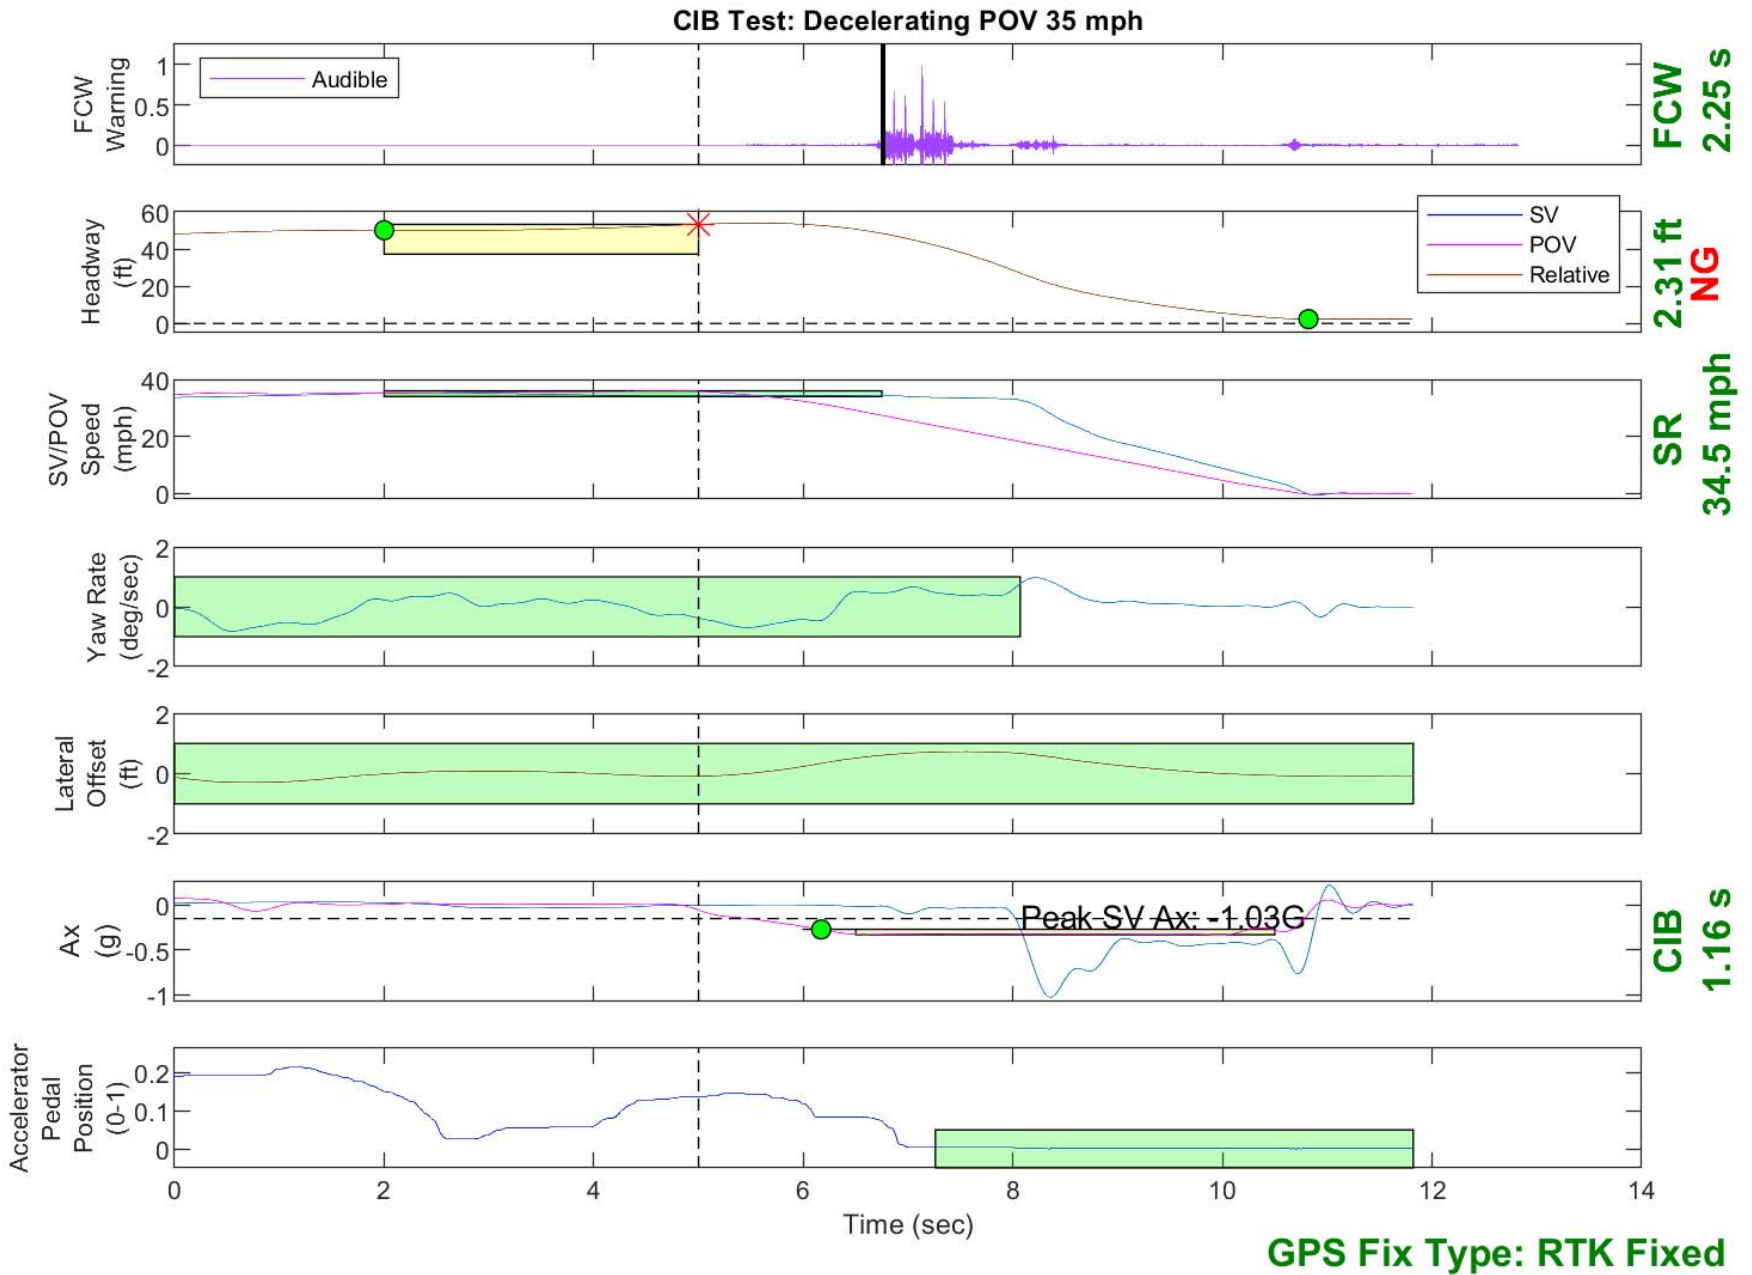
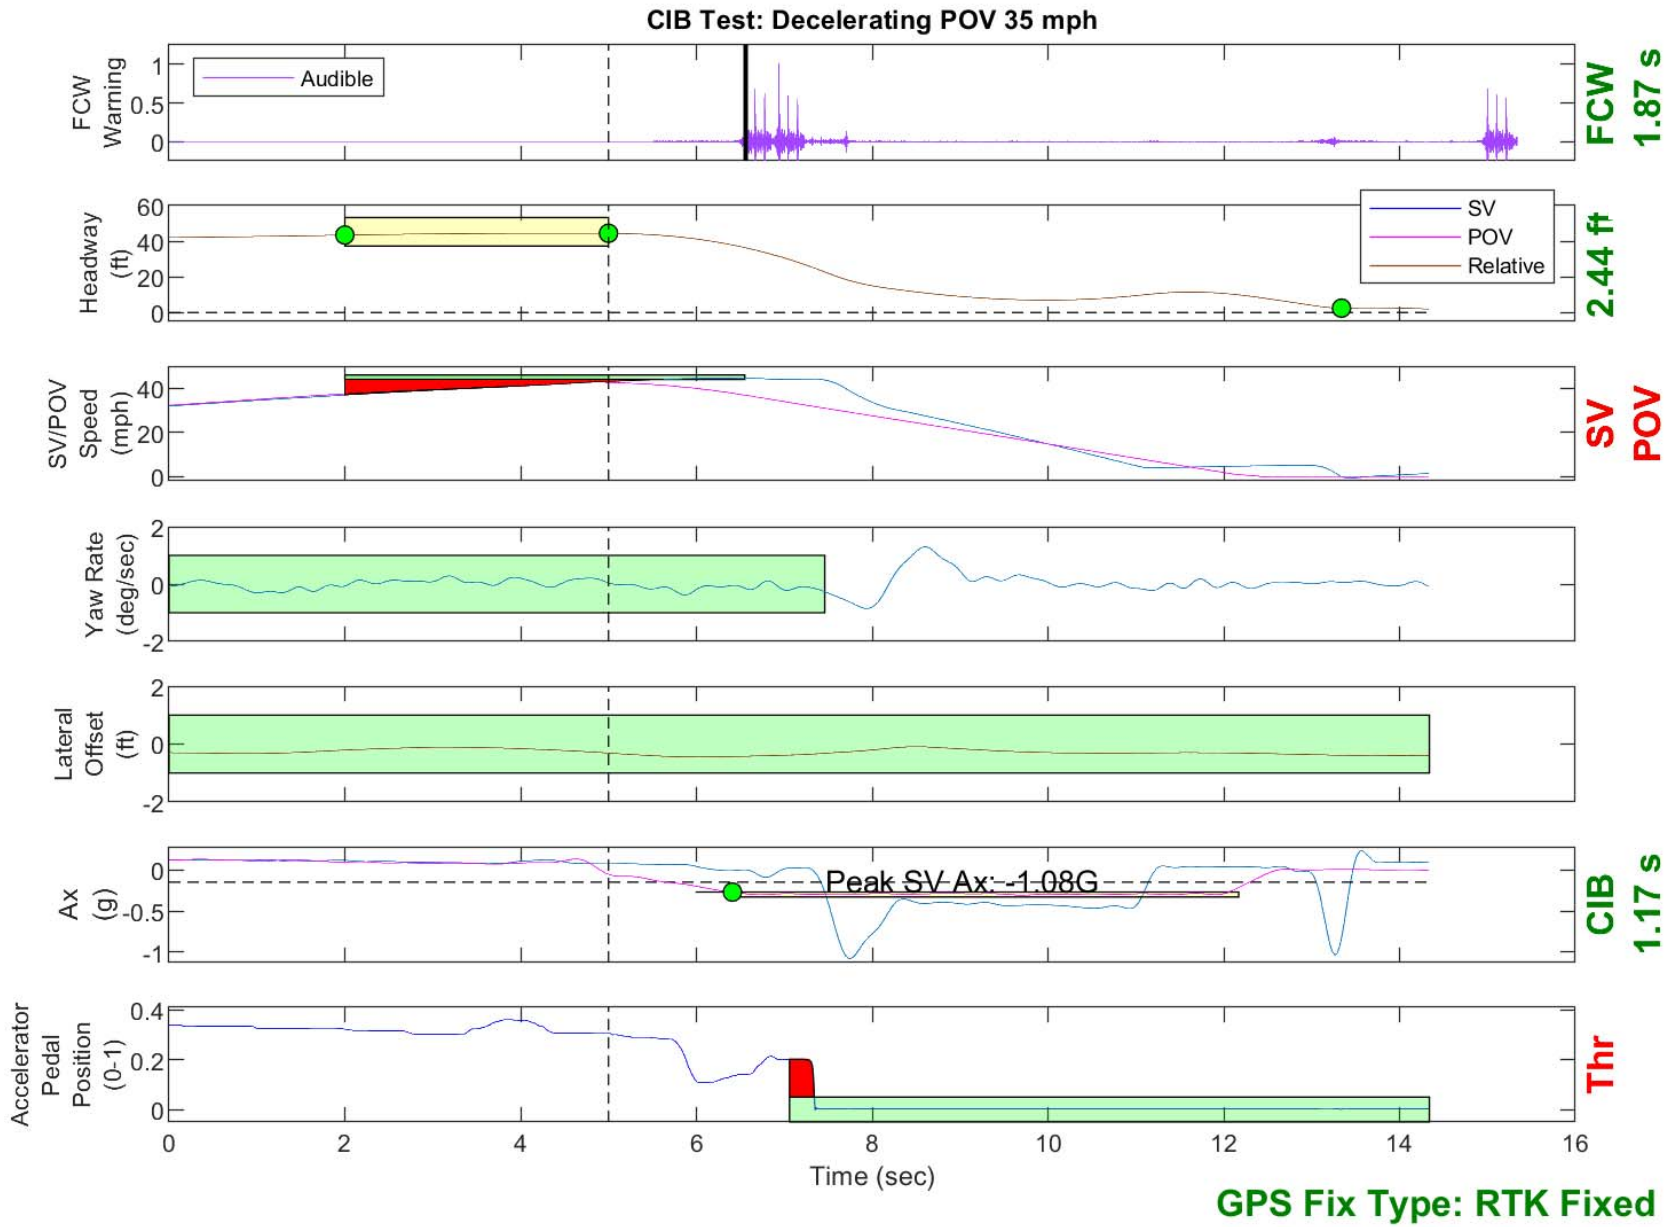
Figure D7. Example Time History Displaying Various Invalid Criteria

Figure D8. Example Time History Displaying Various Invalid Criteria

Some of the time history plot figures contain either green or yellow envelopes and/or black threshold lines. These envelopes and thresholds are used to programmatically and visually determine the validity of a given test run. Envelope and threshold exceedances are indicated with either red shading or red asterisks, and red text is placed to the right side of the plot indicating the type of exceedance. Such exceedances indicate either that the test was invalid or that the requirements of the test were not met (i.e., failure of the AEB system).
