**NEW CAR ASSESSMENT PROGRAM
CRASH IMMINENT BRAKING SYSTEM CONFIRMATION TEST
NCAP-DRI-CIB-20-08**

2020 Kia Optima EX

DYNAMIC RESEARCH, INC.
355 Van Ness Avenue, STE 200
Torrance, California 90501

Final Report

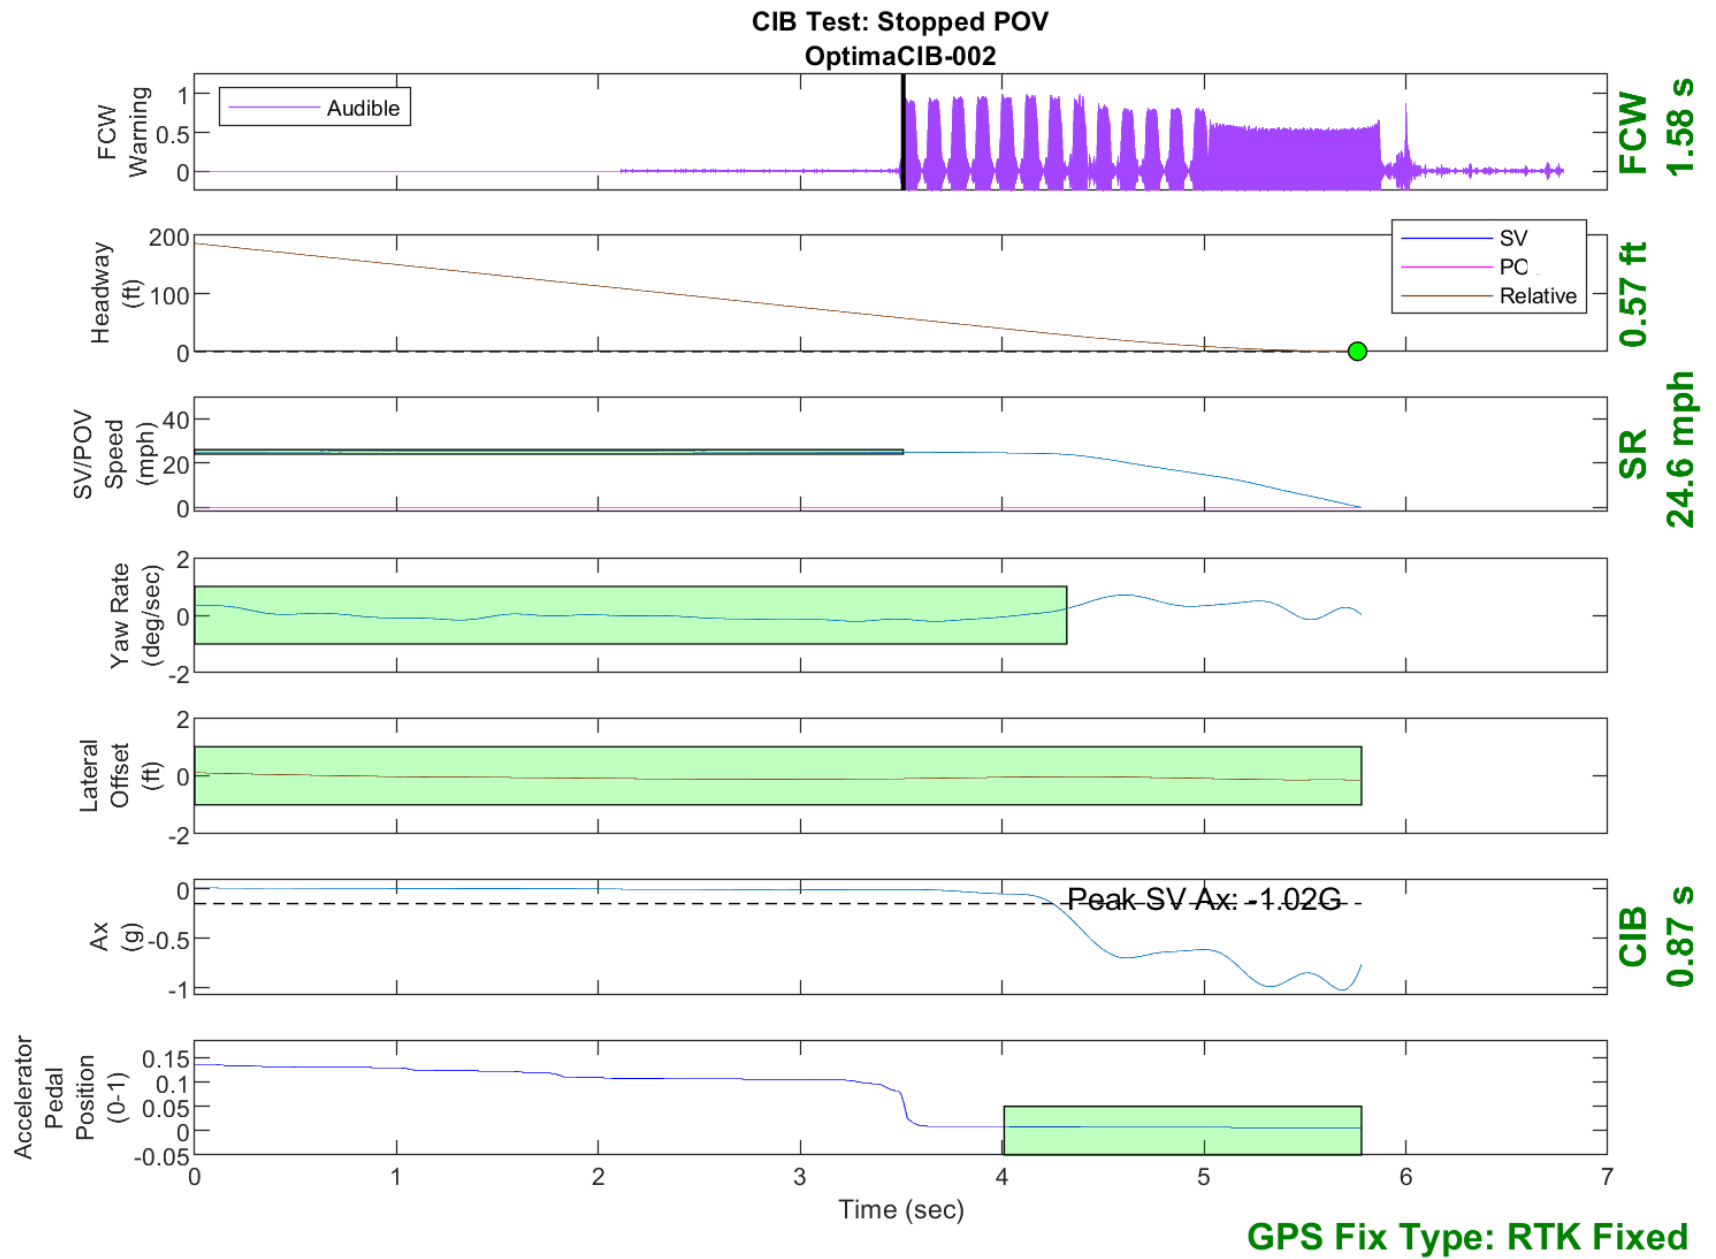
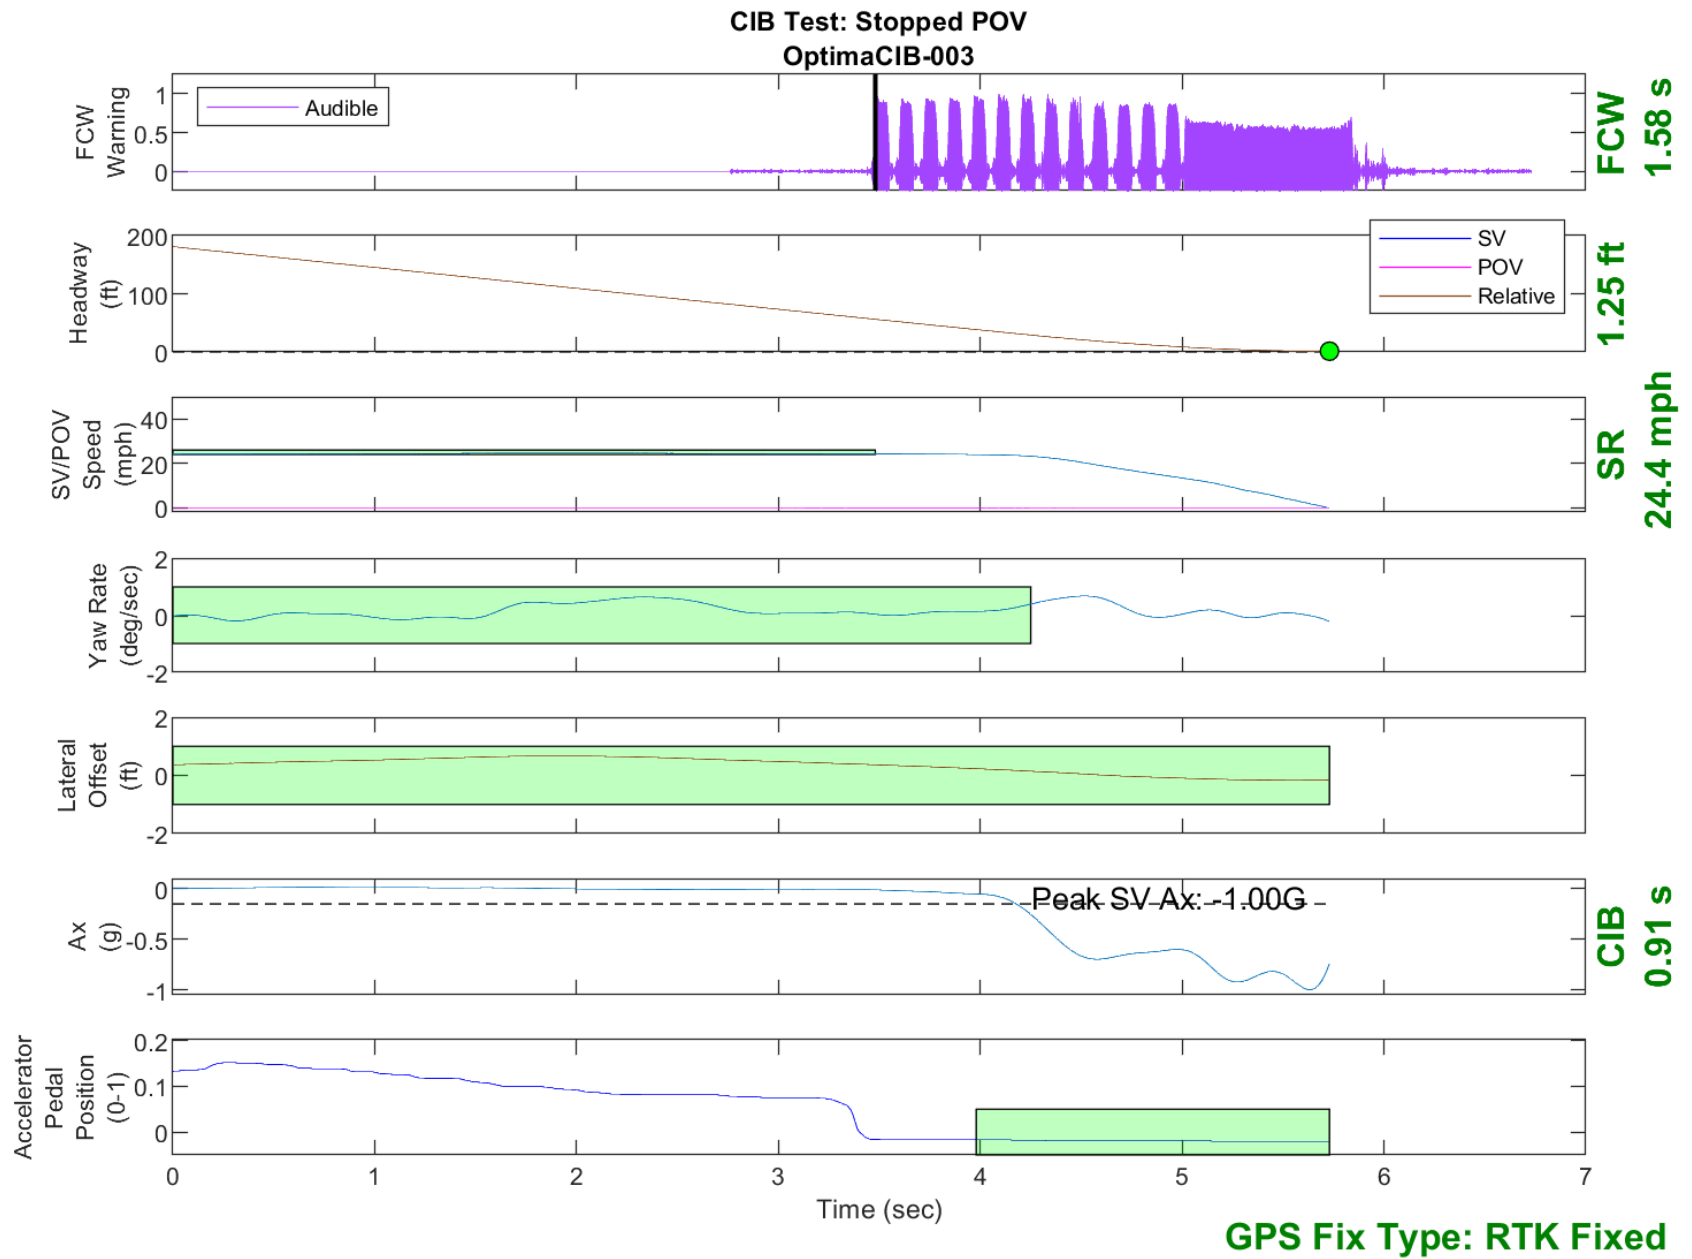
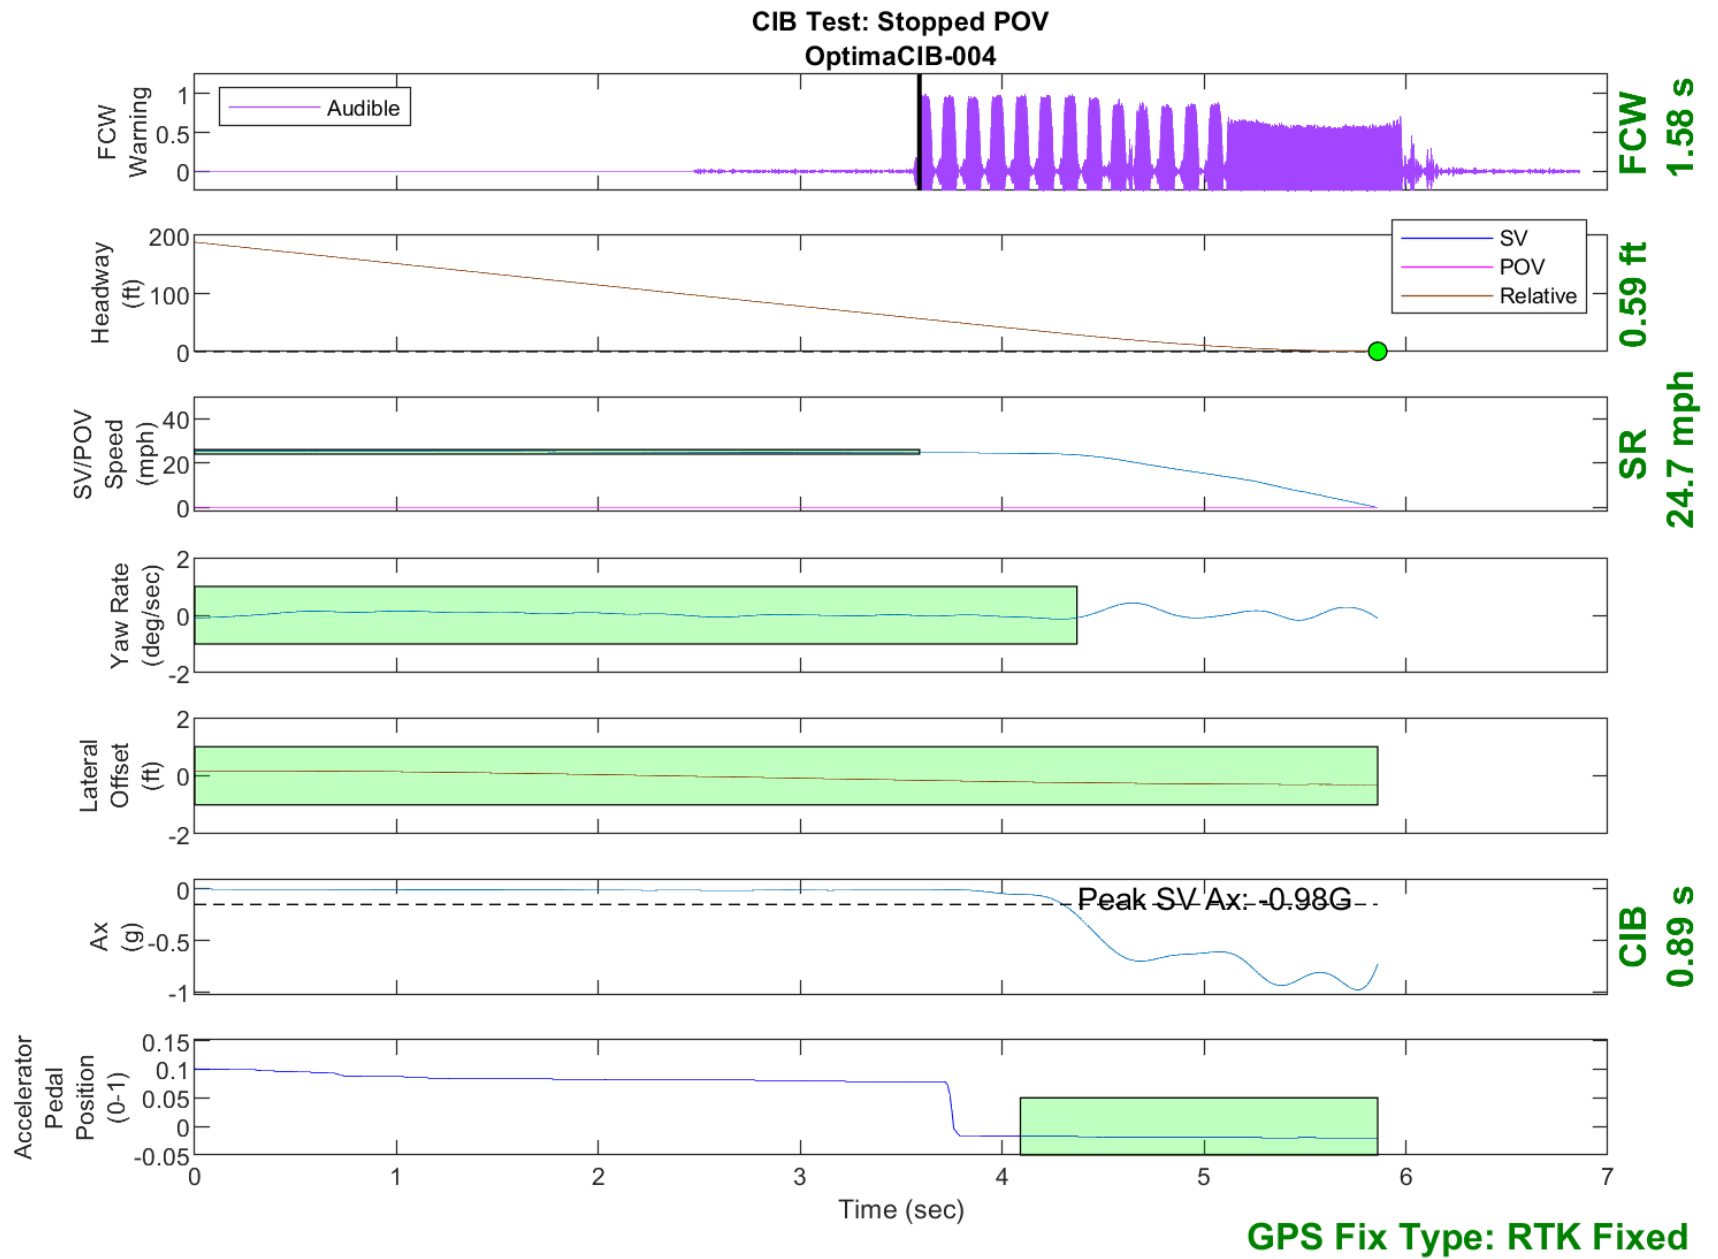
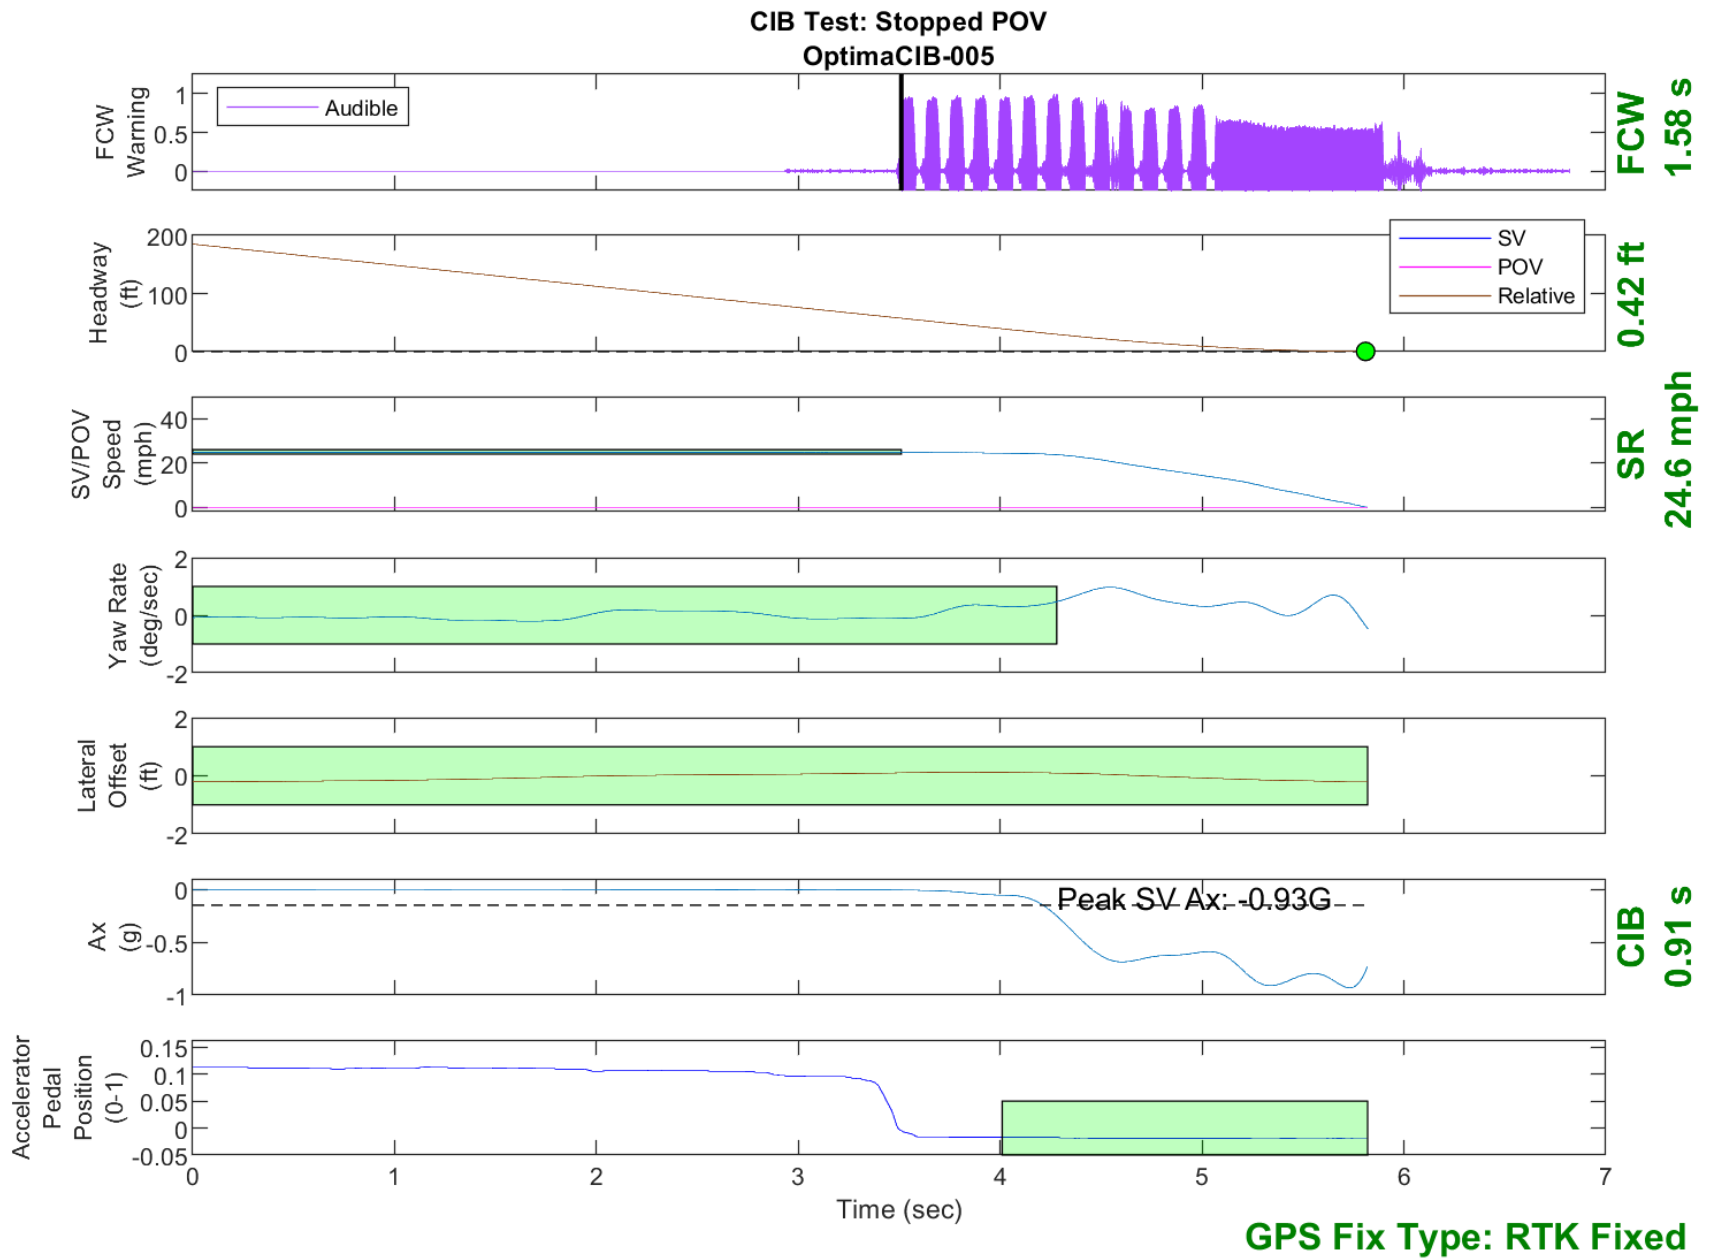
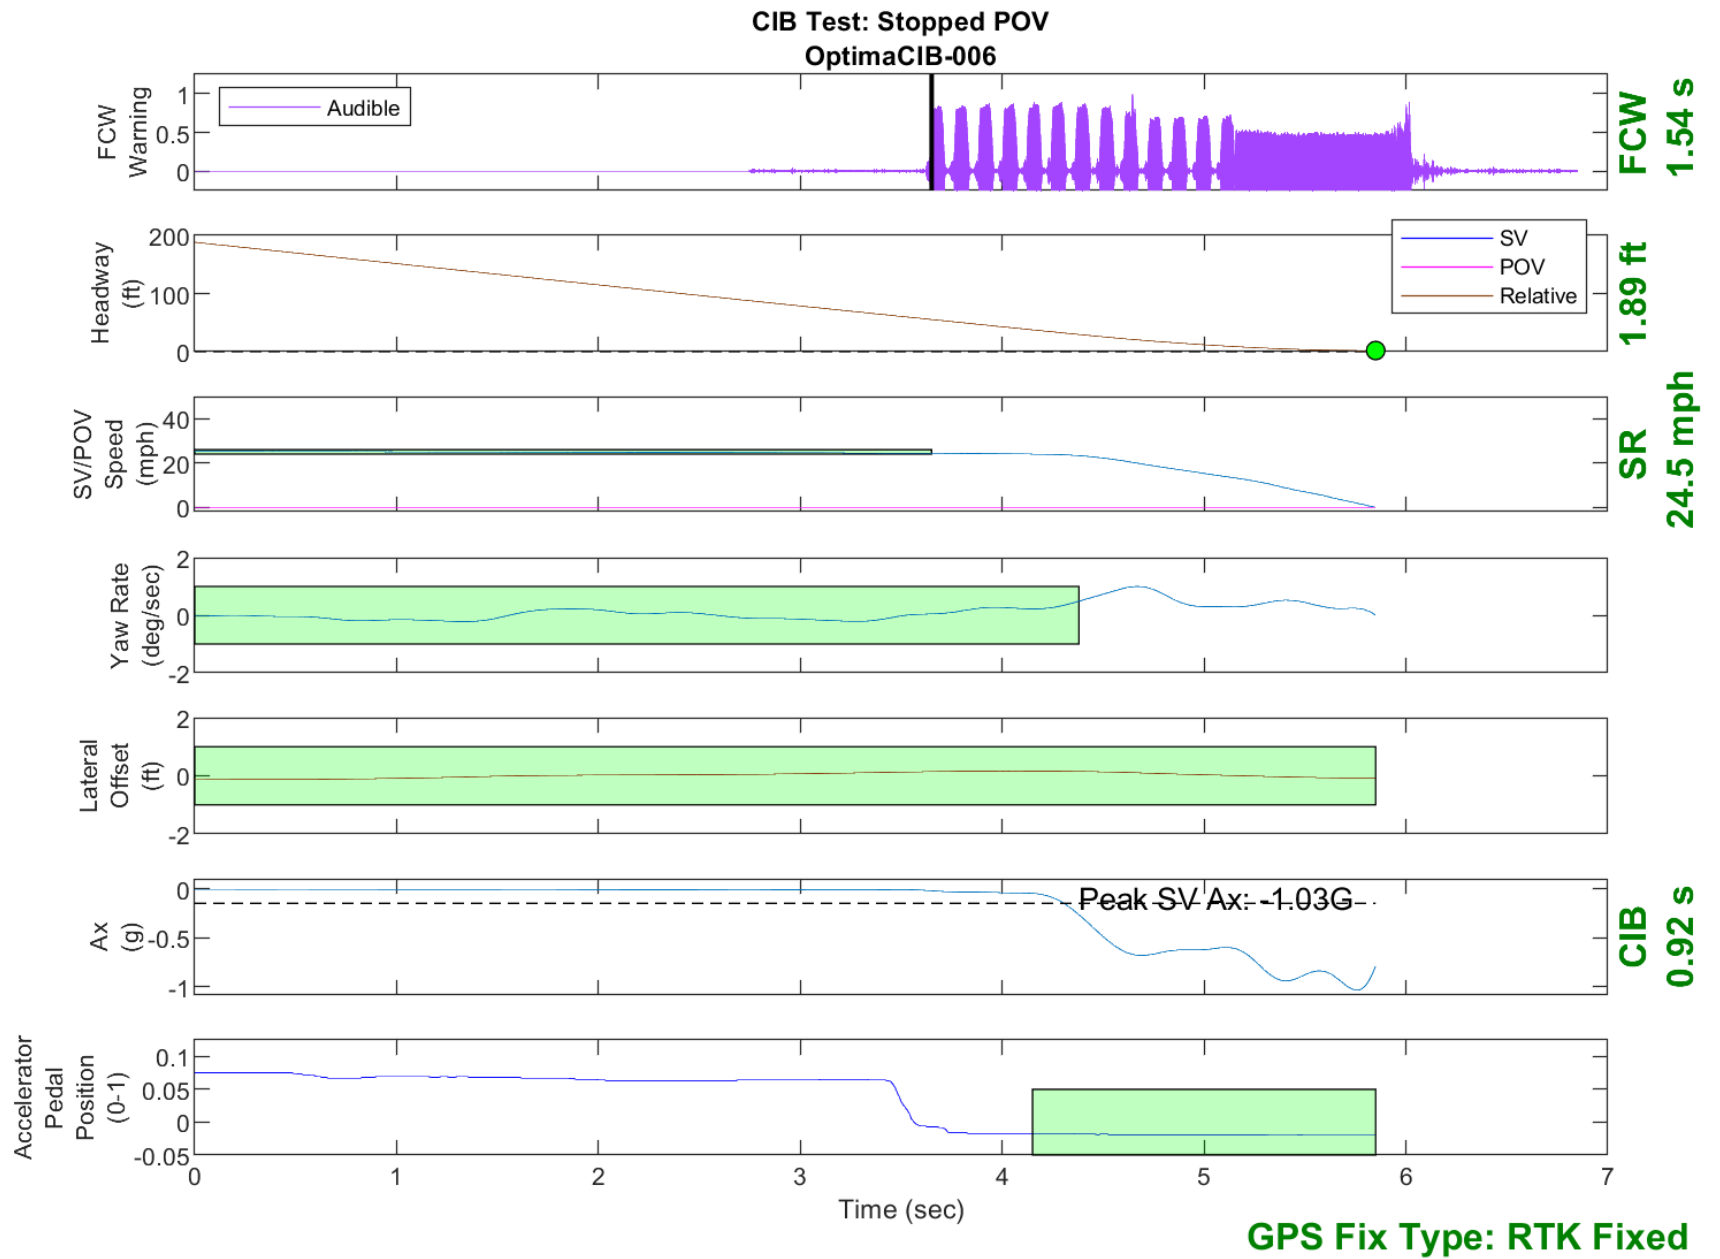
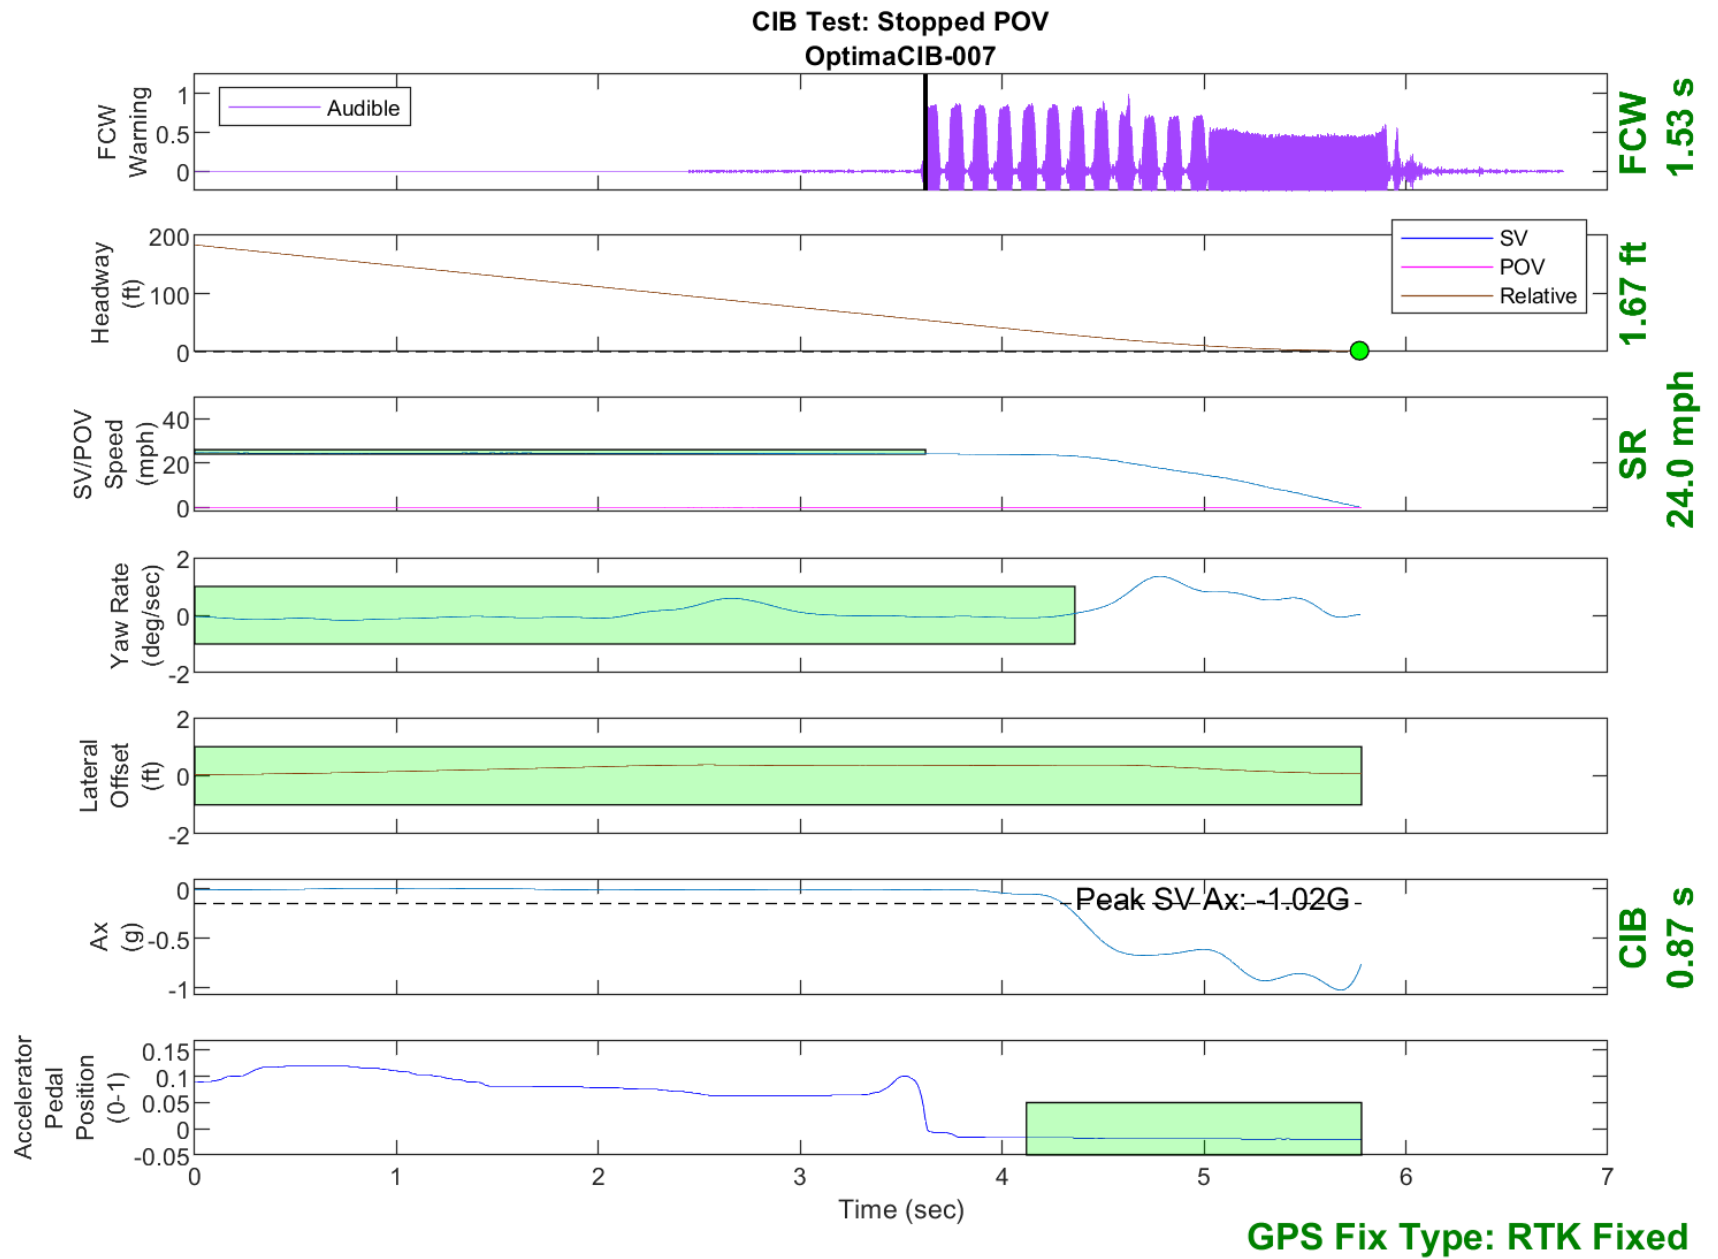
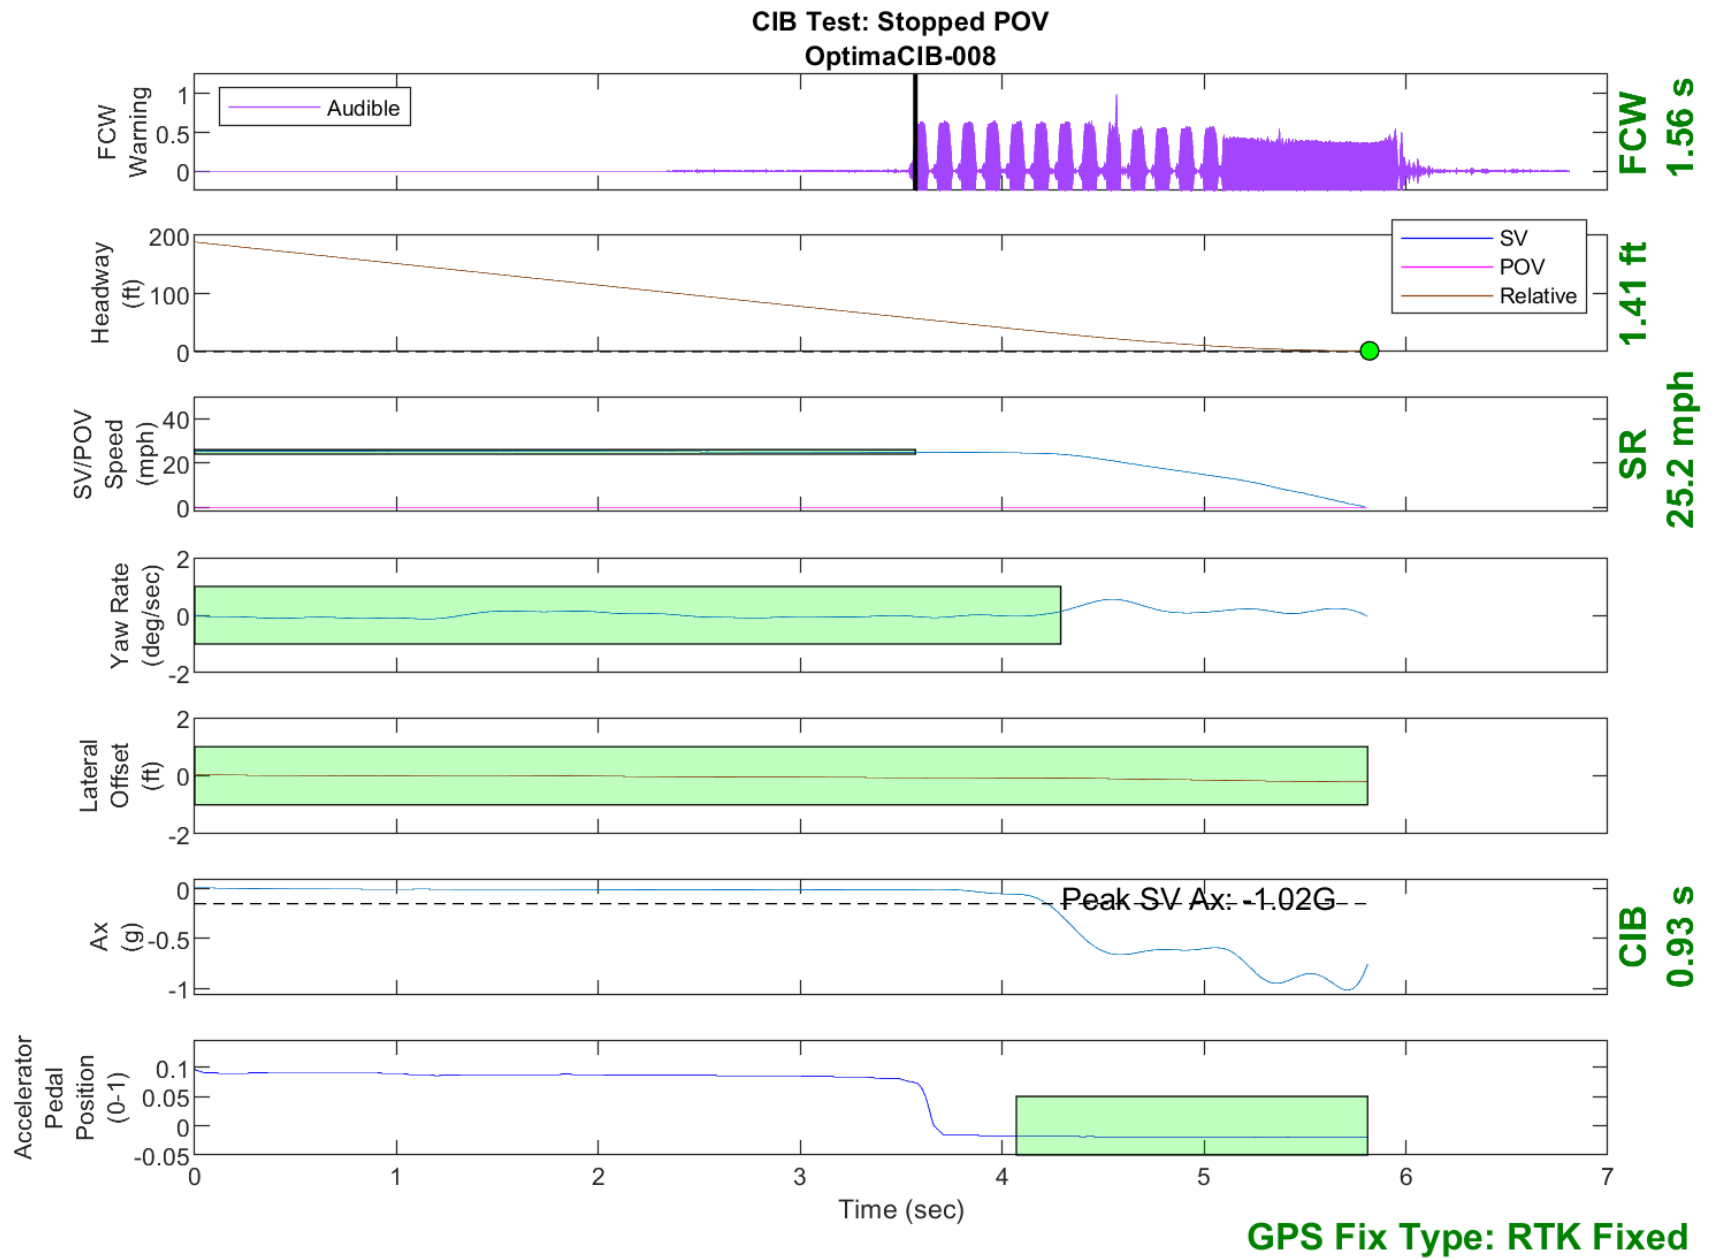
Figure D10. Time History for CIB Run 2, SV Encounters Stopped POV

Figure D11. Time History for CIB Run 3, SV Encounters Stopped POV

Figure D12. Time History for CIB Run 4, SV Encounters Stopped POV

Figure D13. Time History for CIB Run 5, SV Encounters Stopped POV

Figure D14. Time History for CIB Run 6, SV Encounters Stopped POV

Figure D15. Time History for CIB Run 7, SV Encounters Stopped POV

Figure D16. Time History for CIB Run 8, SV Encounters Stopped POV

Run	Test Type	Valid Run?	FCW TTC (s)	Min. Distance (ft)	Speed Reduction (mph)	Peak Decel. (g)	CIB TTC (s)	Pass/Fail	Notes
1	Static Run								
2	Stopped POV	Y	1.58	0.57	24.6	1.02	0.87	Pass	
3		Y	1.58	1.25	24.4	1.00	0.91	Pass	
4		Y	1.58	0.59	24.7	0.98	0.89	Pass	
5		Y	1.58	0.42	24.6	0.93	0.91	Pass	
6		Y	1.54	1.89	24.5	1.03	0.92	Pass	
7		Y	1.53	1.67	24.0	1.02	0.87	Pass	
8		Y	1.56	1.41	25.2	1.02	0.93	Pass	
9	Static Run								
10	Slower POV, 25 vs 10	Y	1.46	2.90	14.5	0.95	0.70	Pass	
11		Y	1.29	3.08	14.7	0.98	0.69	Pass	
12		Y	1.38	2.13	13.8	0.95	0.61	Pass	
13		Y	1.51	3.00	14.8	0.97	0.68	Pass	
14		Y	1.38	3.51	14.6	0.94	0.72	Pass
