**NEW CAR ASSESSMENT PROGRAM
CRASH IMMINENT BRAKING SYSTEM CONFIRMATION TEST
NCAP-DRI-CIB-20-08**

2020 Kia Optima EX

DYNAMIC RESEARCH, INC.
355 Van Ness Avenue, STE 200
Torrance, California 90501

Final Report

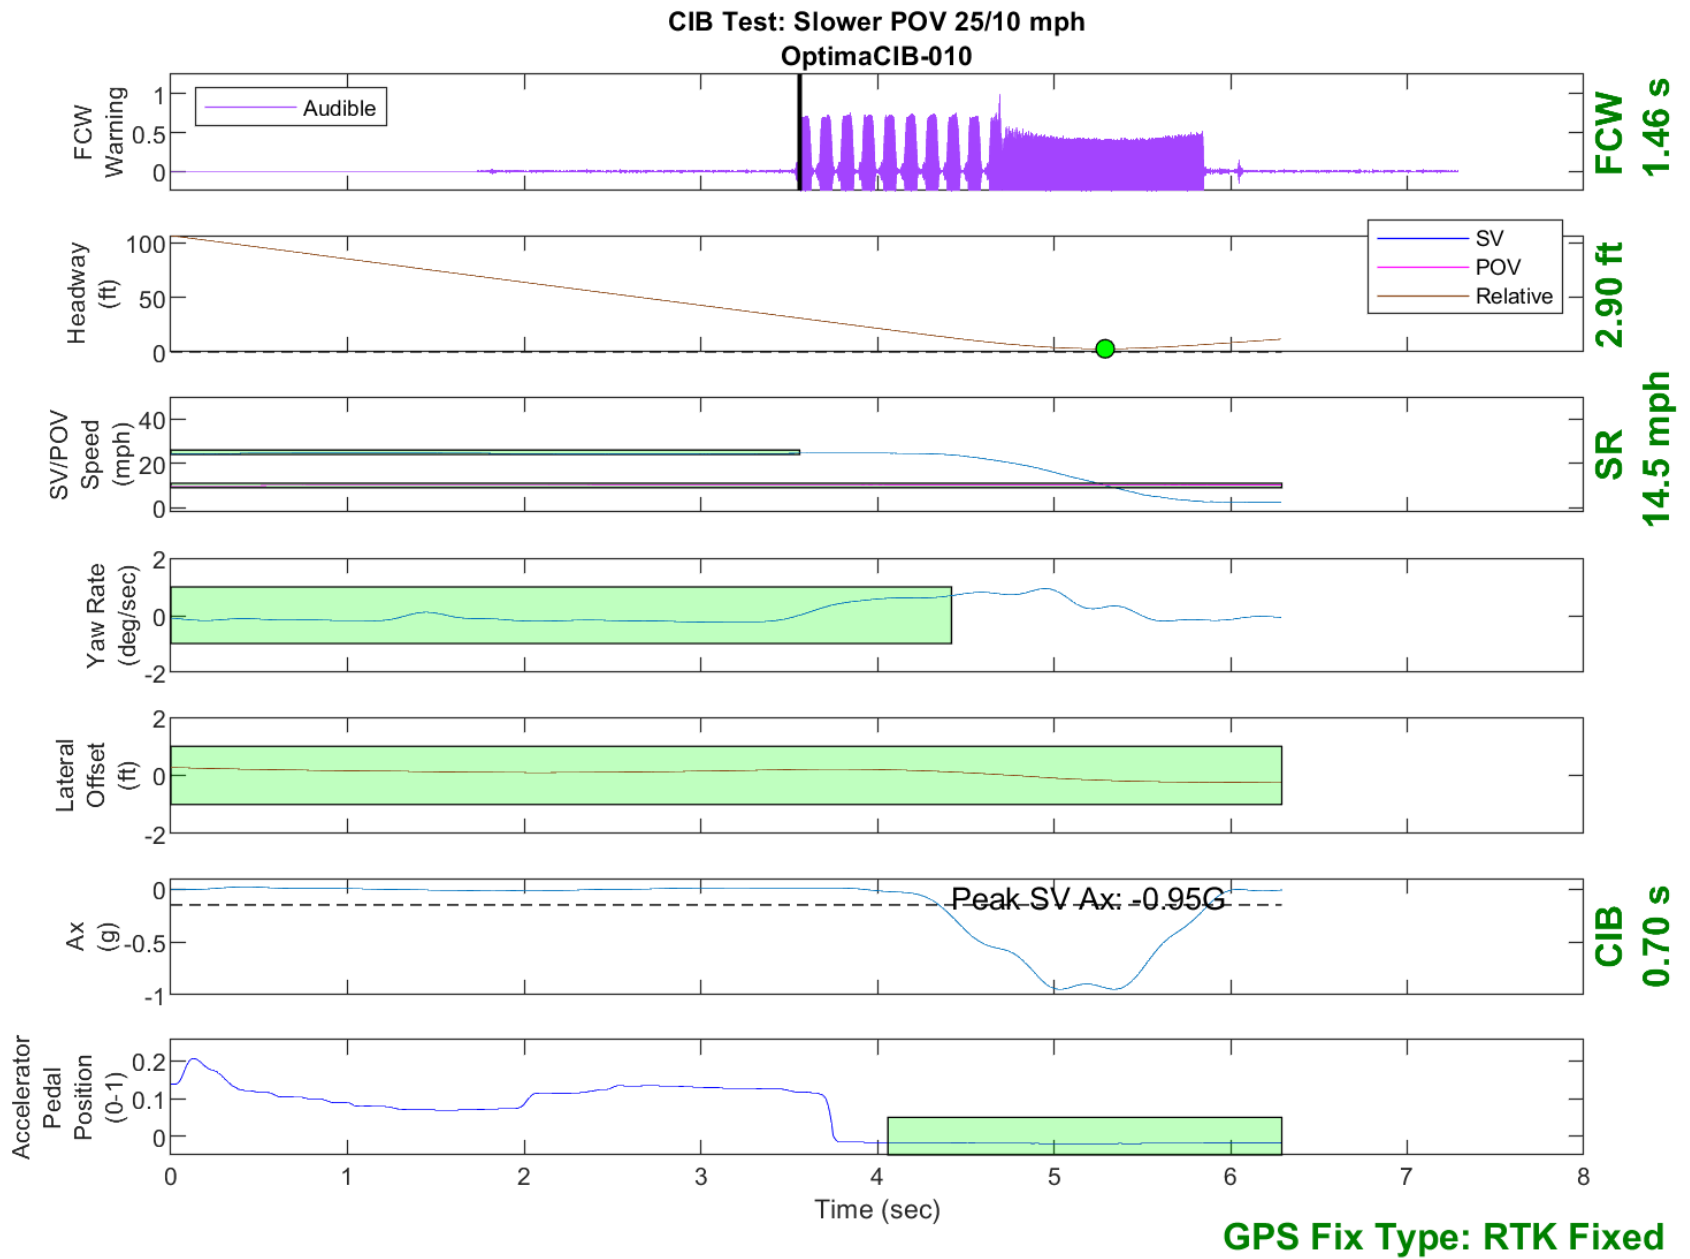
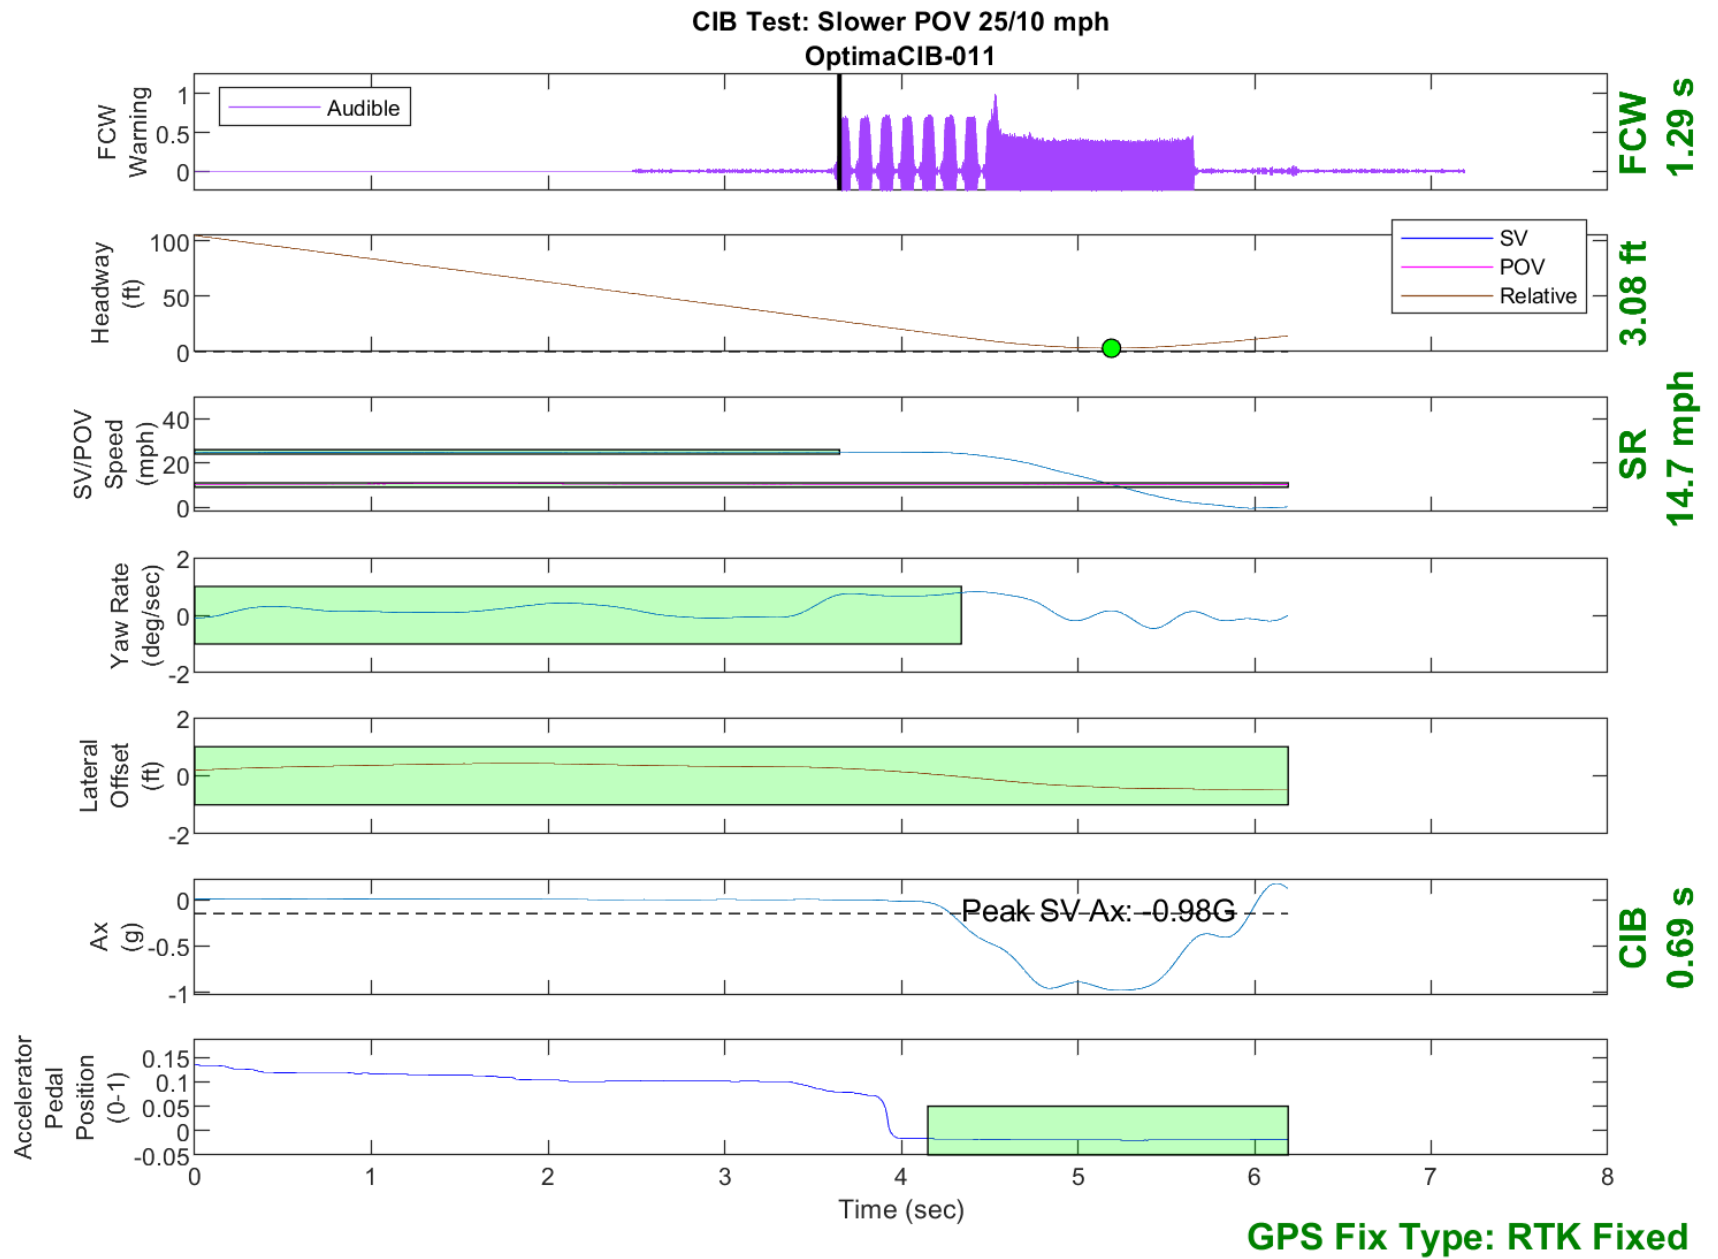
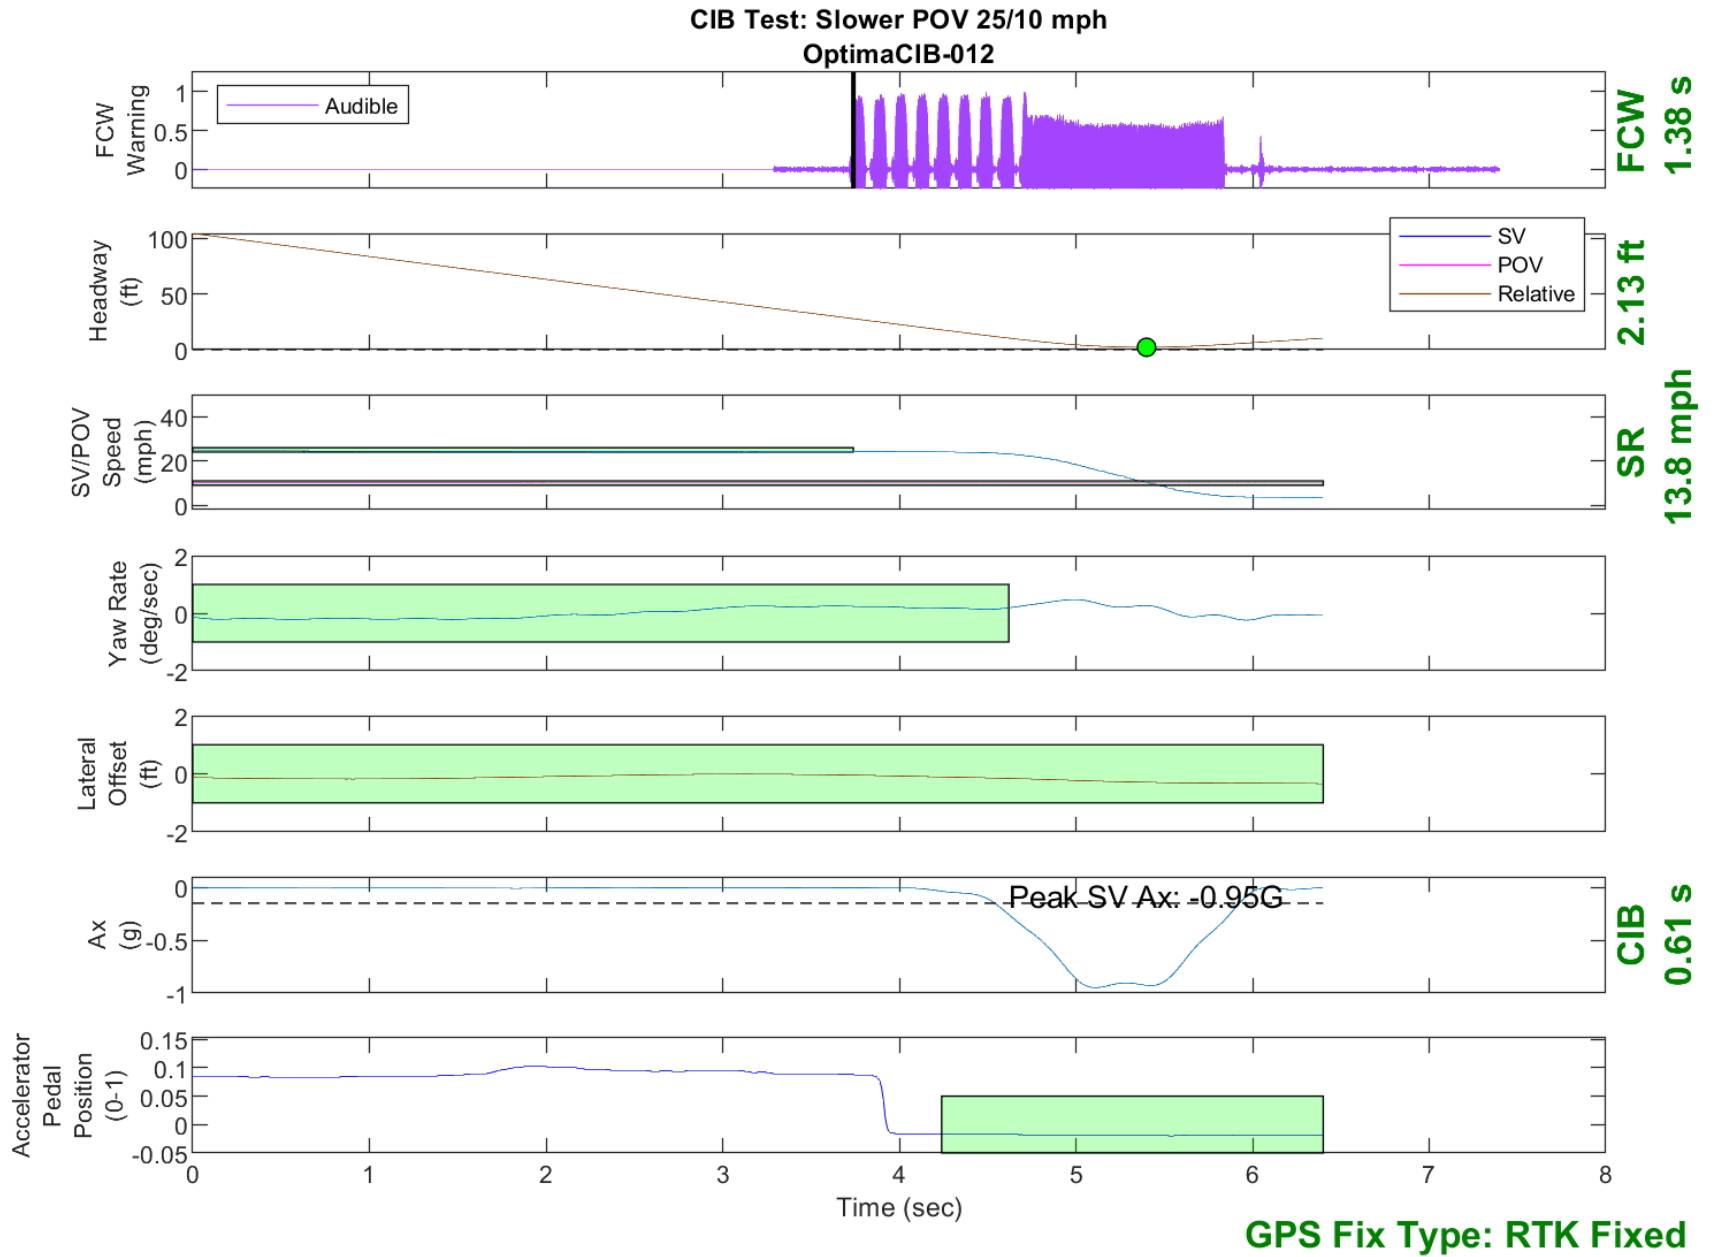
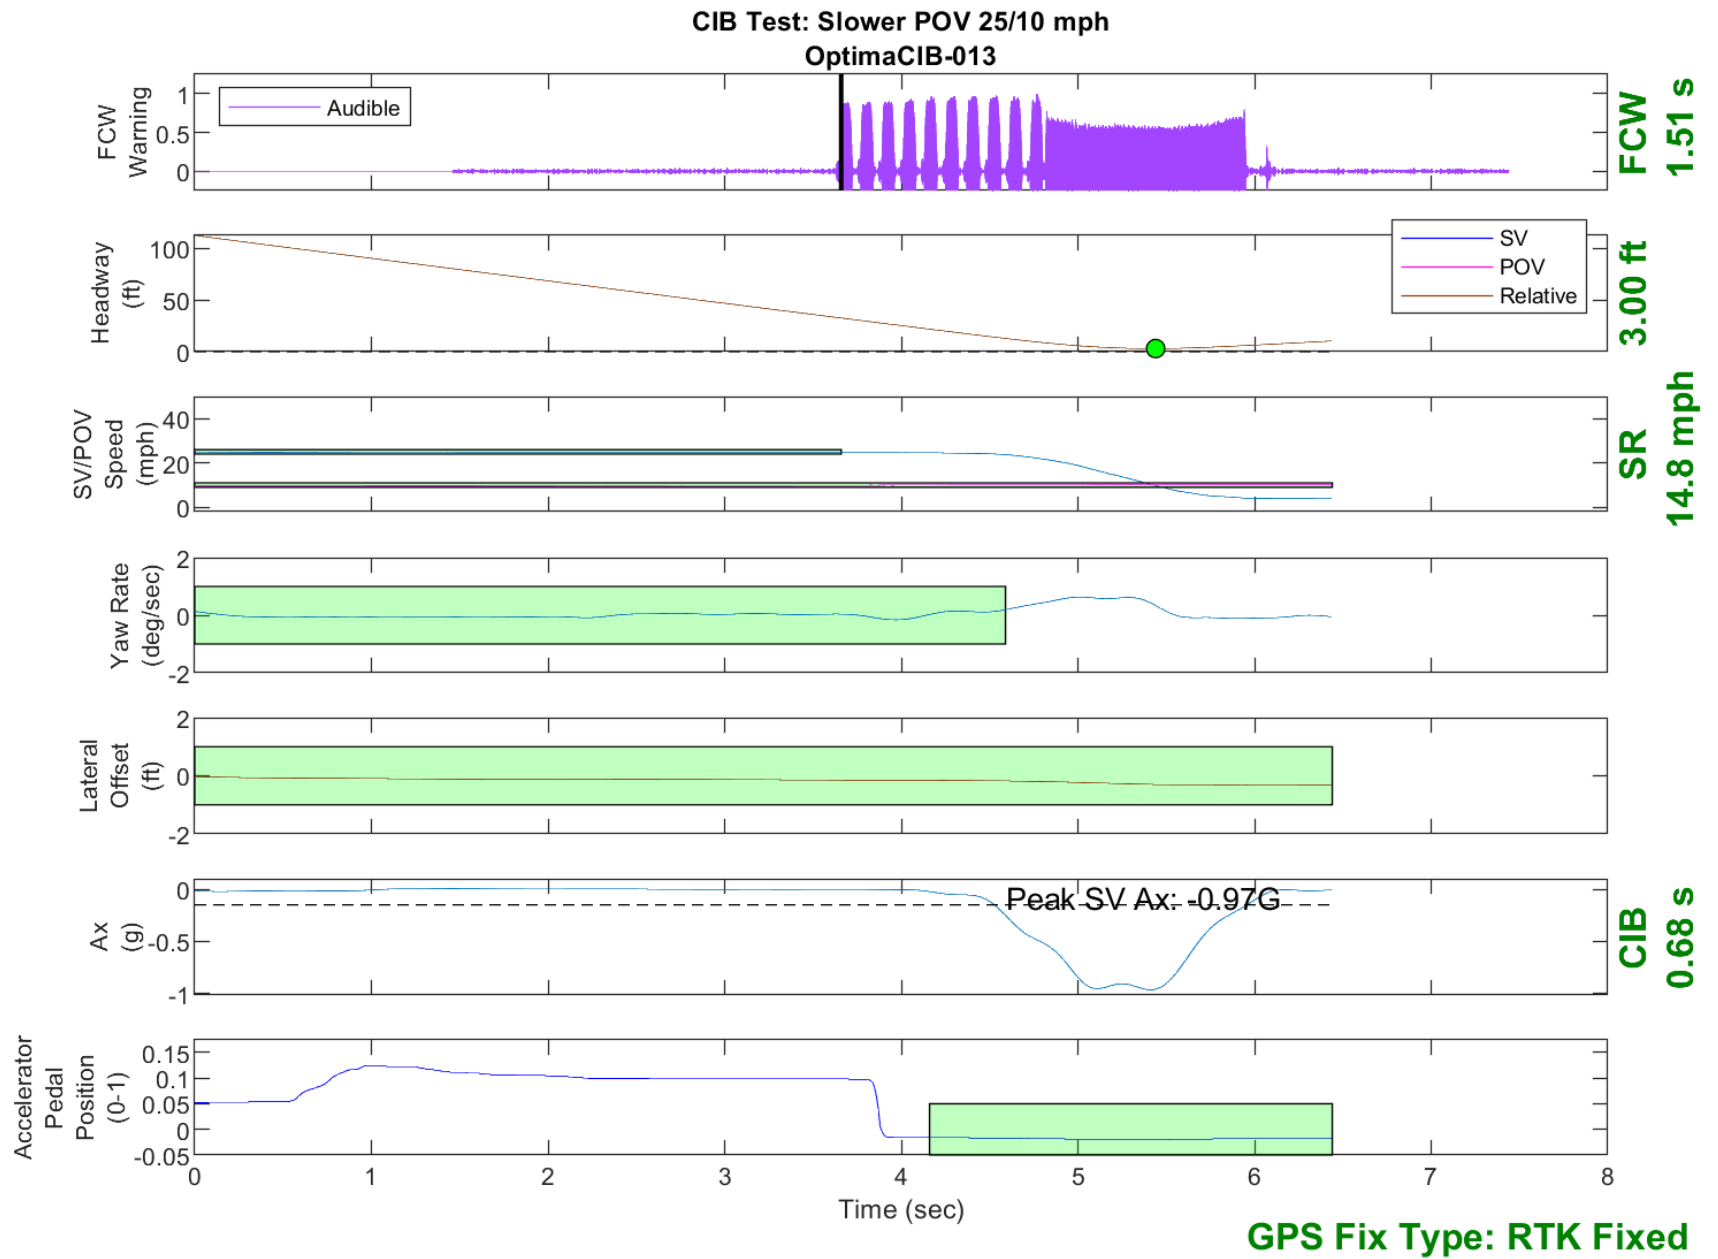
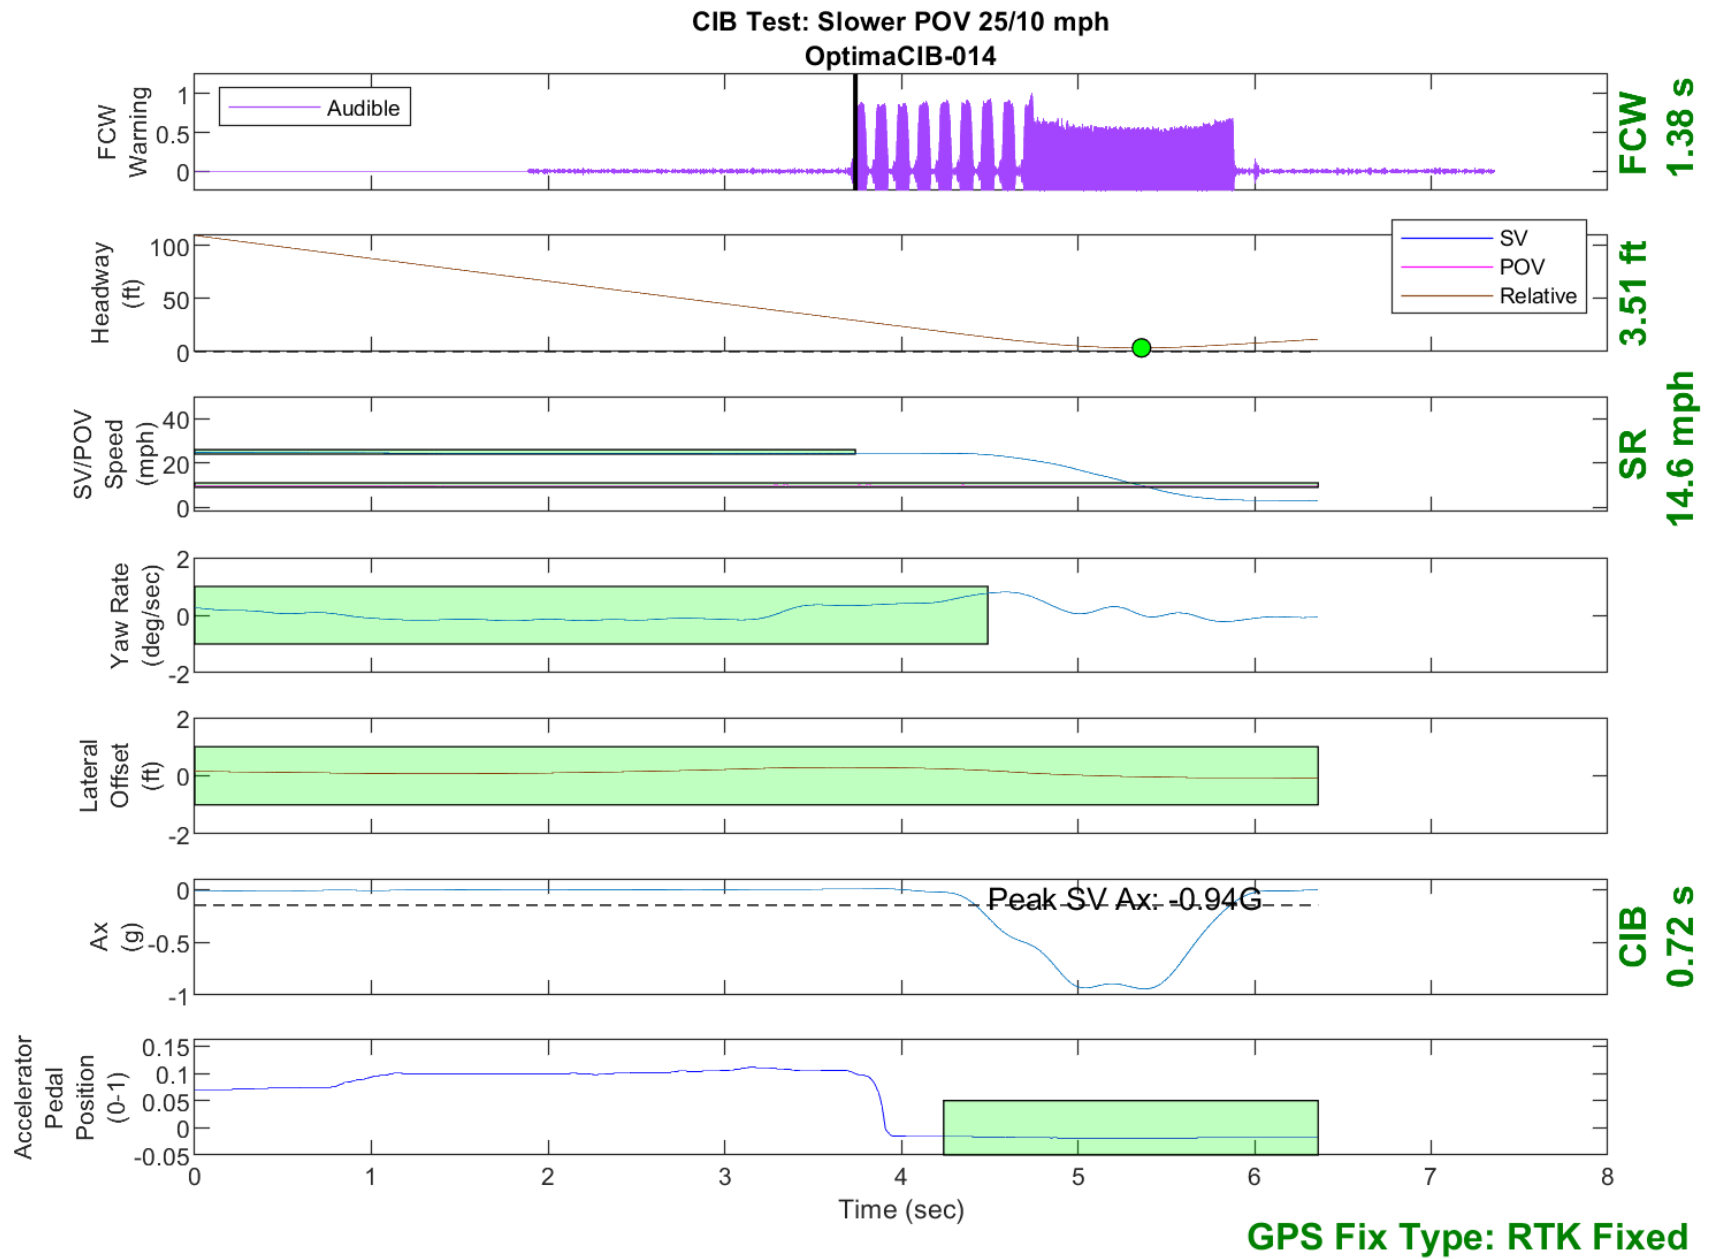
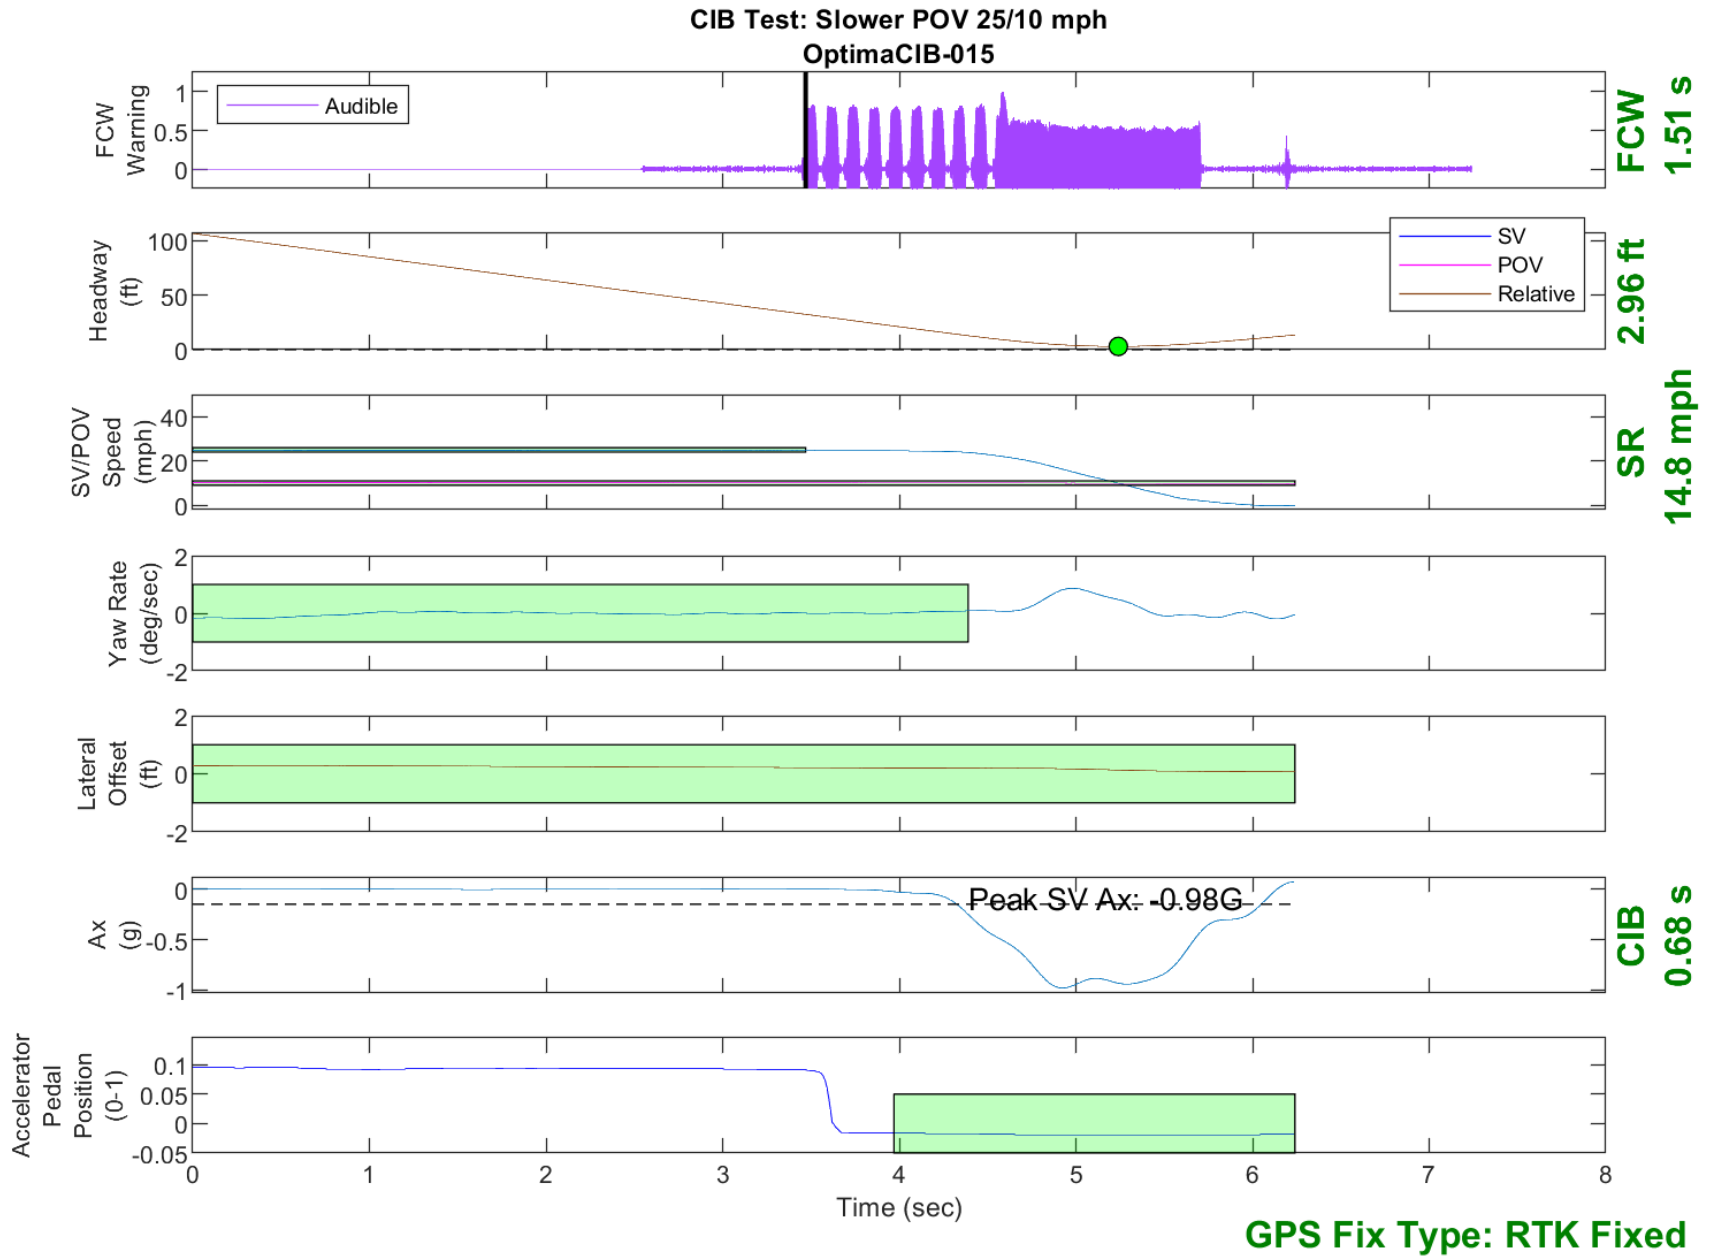
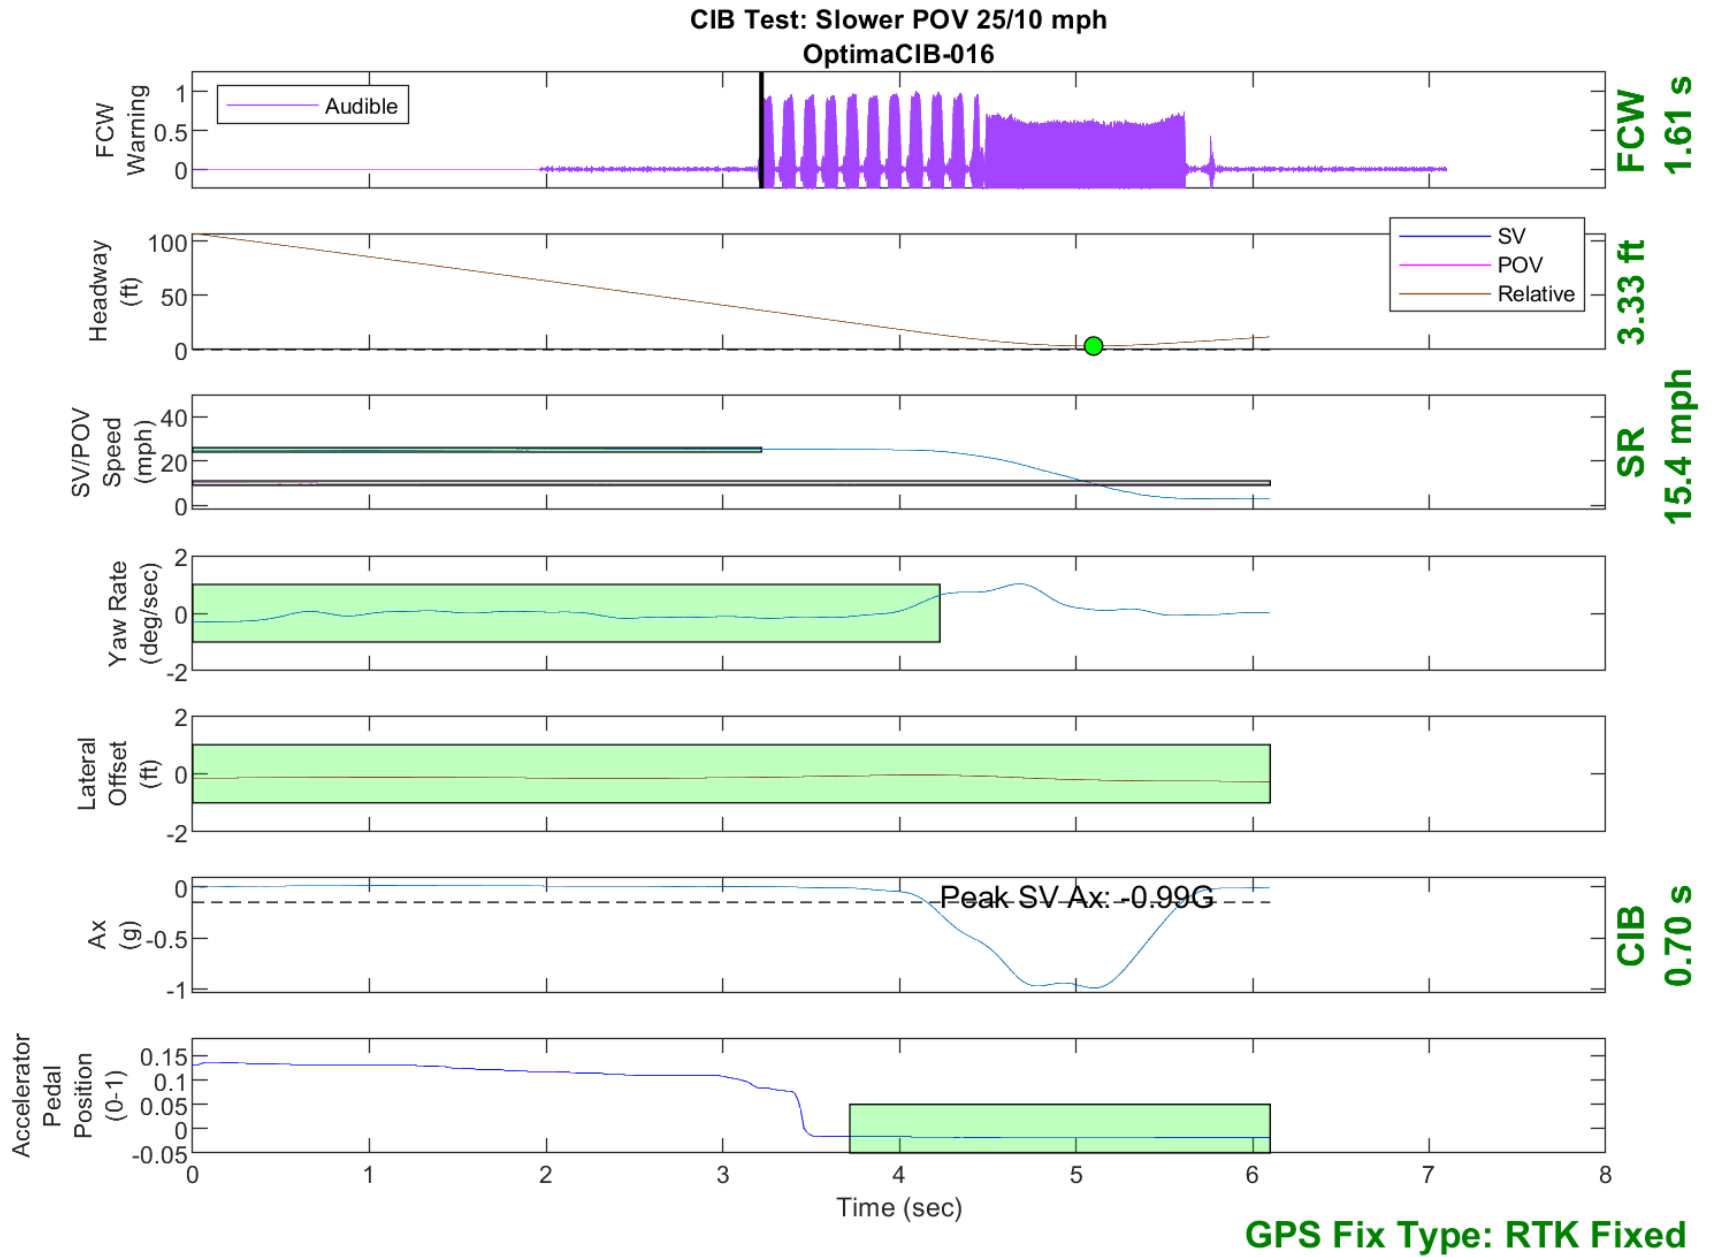
Figure D17. Time History for CIB Run 10, SV Encounters Slower POV, SV 25 mph, POV 10 mph

Figure D18. Time History for CIB Run 11, SV Encounters Slower POV, SV 25 mph, POV 10 mph

Figure D19. Time History for CIB Run 12, SV Encounters Slower POV, SV 25 mph, POV 10 mph

Figure D20. Time History for CIB Run 13, SV Encounters Slower POV, SV 25 mph, POV 10 mph

Figure D21. Time History for CIB Run 14, SV Encounters Slower POV, SV 25 mph, POV 10 mph

Figure D22. Time History for CIB Run 15, SV Encounters Slower POV, SV 25 mph, POV 10 mph

Figure D23. Time History for CIB Run 16, SV Encounters Slower POV, SV 25 mph, POV 10 mph

Run	Test Type	Valid Run?	FCW TTC (s)	Min. Distance (ft)	Speed Reduction (mph)	Peak Decel. (g)	CIB TTC (s)	Pass/Fail	Notes
1	Static Run								
2	Stopped POV	Y	1.58	0.57	24.6	1.02	0.87	Pass	
3		Y	1.58	1.25	24.4	1.00	0.91	Pass	
4		Y	1.58	0.59	24.7	0.98	0.89	Pass	
5		Y	1.58	0.42	24.6	0.93	0.91	Pass	
6		Y	1.54	1.89	24.5	1.03	0.92	Pass	
7		Y	1.53	1.67	24.0	1.02	0.87	Pass	
8		Y	1.56	1.41	25.2	1.02	0.93	Pass	
9	Static Run								
10	Slower POV, 25 vs 10	Y	1.46	2.90	14.5	0.95	0.70	Pass	
11		Y	1.29	3.08	14.7	0.98	0.69	Pass	
12		Y	1.38	2.13	13.8	0.95	0.61	Pass	
13		Y	1.51	3.00	14.8	0.97	0.68	Pass	
14		Y	1.38	3.51	14.6	0.94	0.72	Pass

Run	Test Type	Valid Run?	FCW TTC (s)	Min. Distance (ft)	Speed Reduction (mph)	Peak Decel. (g)	CIB TTC (s)	Pass/Fail	Notes
15		Y	1.51	2.96	14.8	0.98	0.68	Pass	
16		Y	1.61	3.33	15.4	0.99	0.70	Pass	
17	Static Run								
18	Slower POV, 45 vs 20	Y	2.65	0.00	7.7	1.10	0.73	Fail	Vehicle CIB activated at TTC shown. Driver applied additional brakes at last moment. Last minute brake actuator turned on
19		Y	2.70	3.67	25.3	0.98	0.90	Pass	
20		Y	2.71	4.02	24.7	1.00	0.90	Pass	
21		N							POV speed
22		Y	2.64	5.04	24.8	0.98	0.94	Pass	
23		Y	2.63	4.92	24.8	1.00	0.95	Pass	
24		Y	2.64	5.38	24.5	1.04	0.92	Pass	
25		Y	2.71	5.03	25.4	0.99	0.94	Pass	
26	Static run								
27	Decelerating POV, 35	Y	1.83	0.00	21.6	0.92	1.31	Pass	
28		Y	1.79	1.90	27.1	1.07	1.13	Pass	
29		Y	1.82	0.00	23.0	0.93	1.27	Pass
