**NEW CAR ASSESSMENT PROGRAM
CRASH IMMINENT BRAKING SYSTEM CONFIRMATION TEST
NCAP-DRI-CIB-20-08**

2020 Kia Optima EX

DYNAMIC RESEARCH, INC.
355 Van Ness Avenue, STE 200
Torrance, California 90501

Final Report

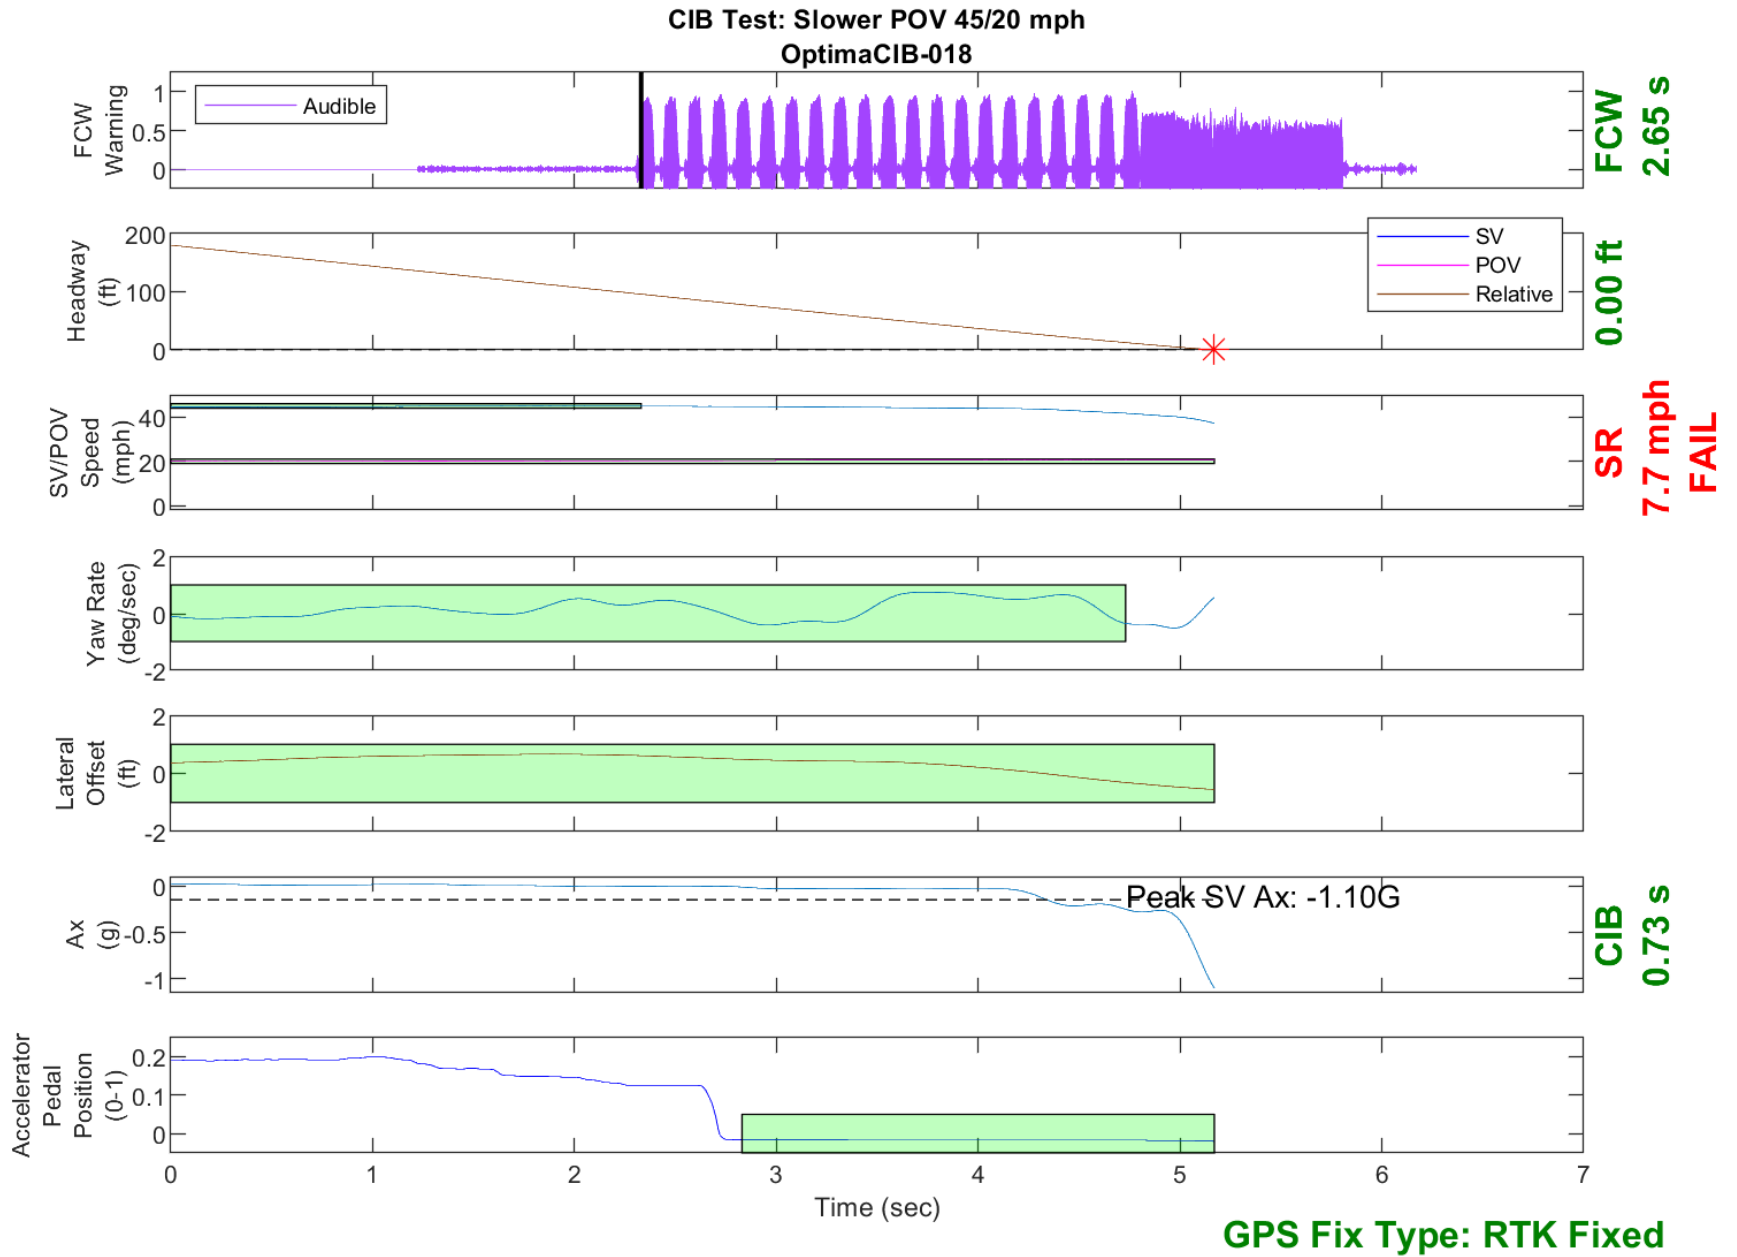
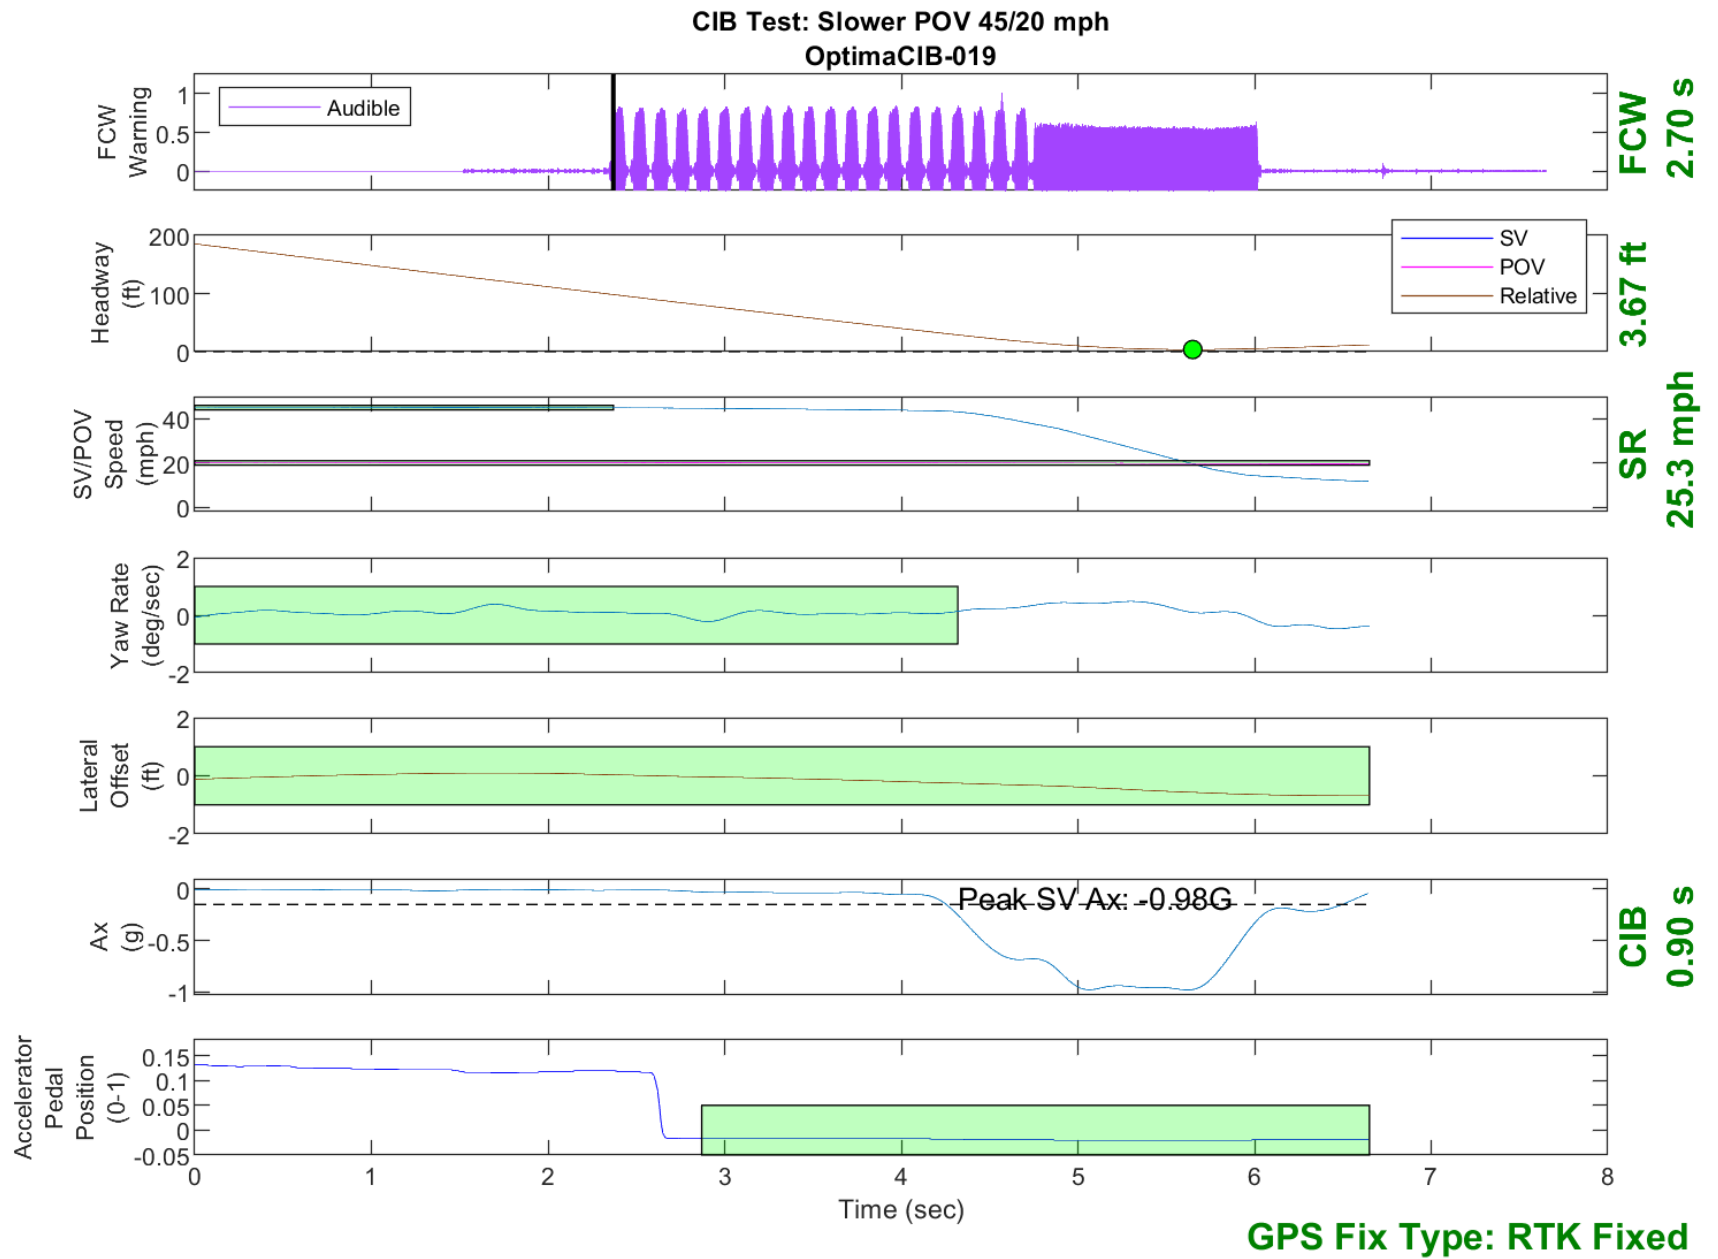
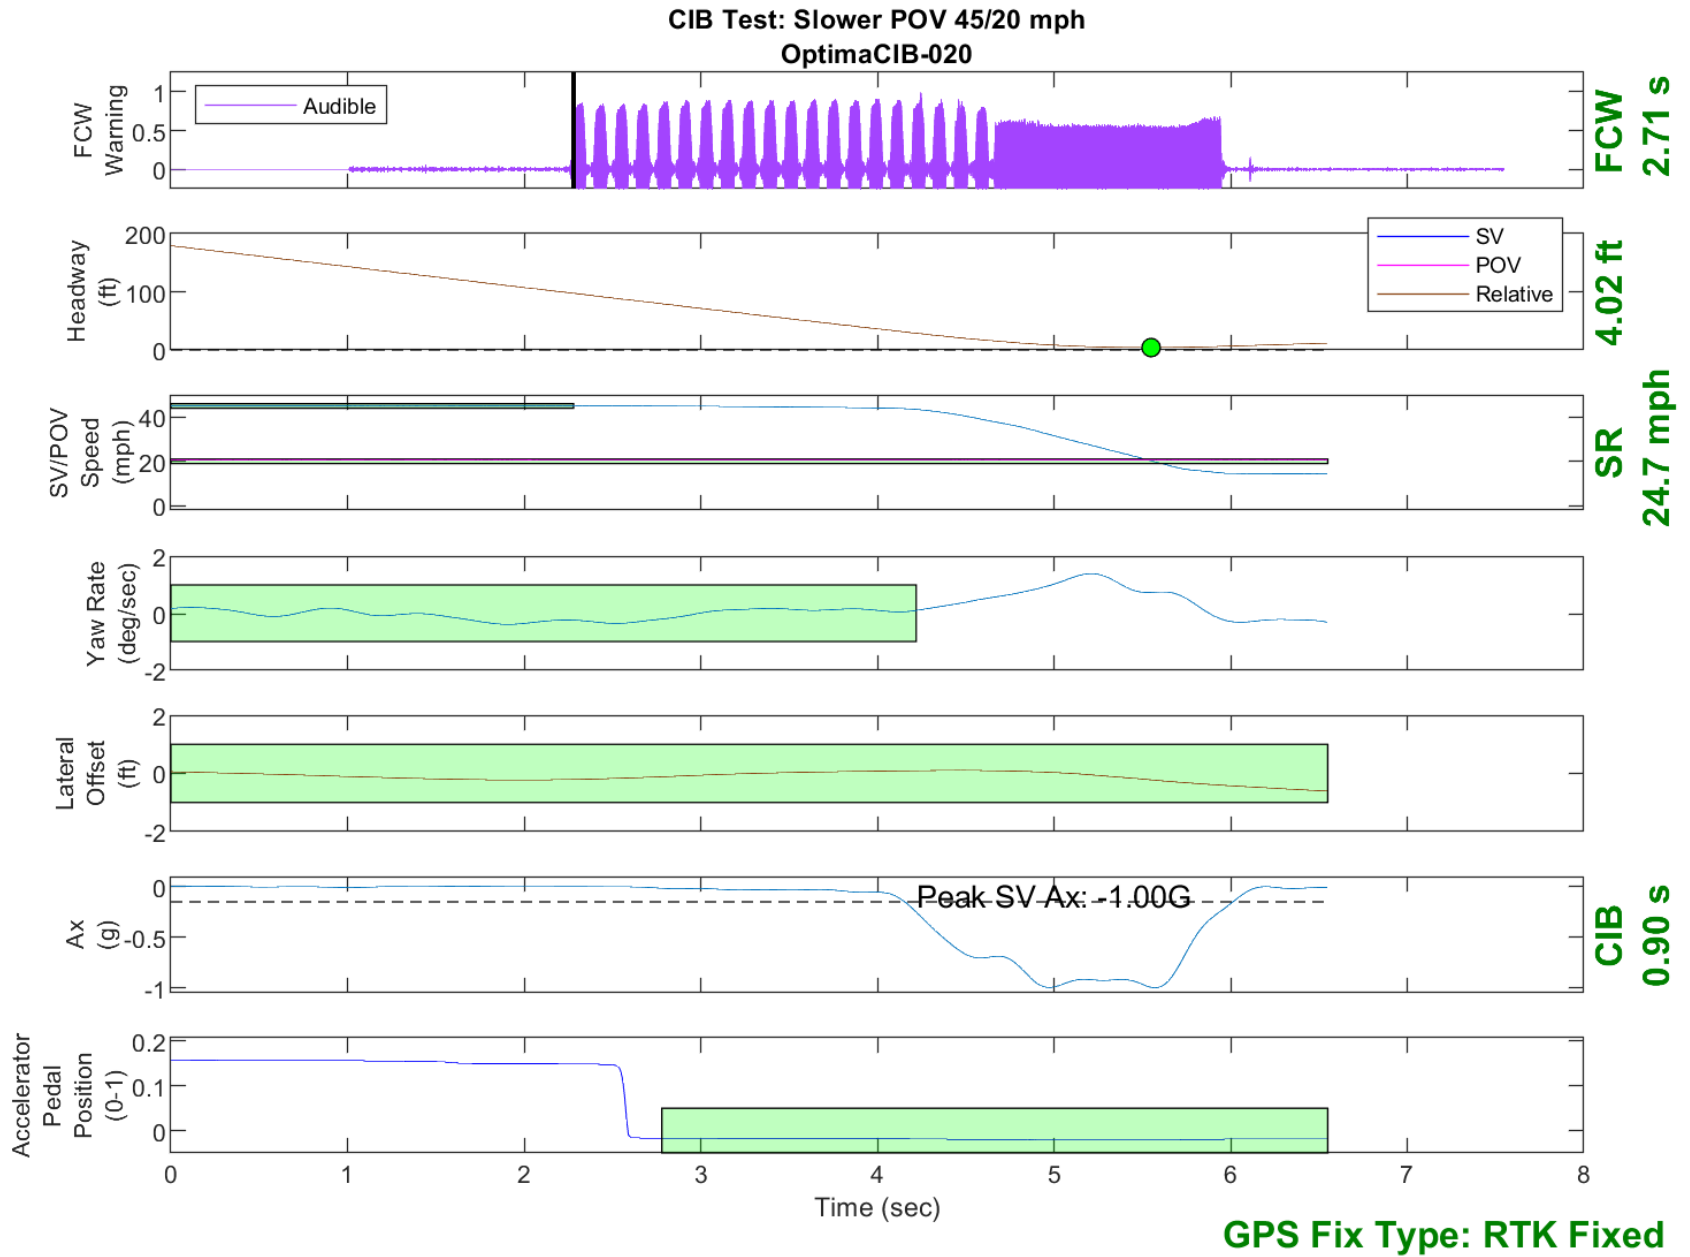
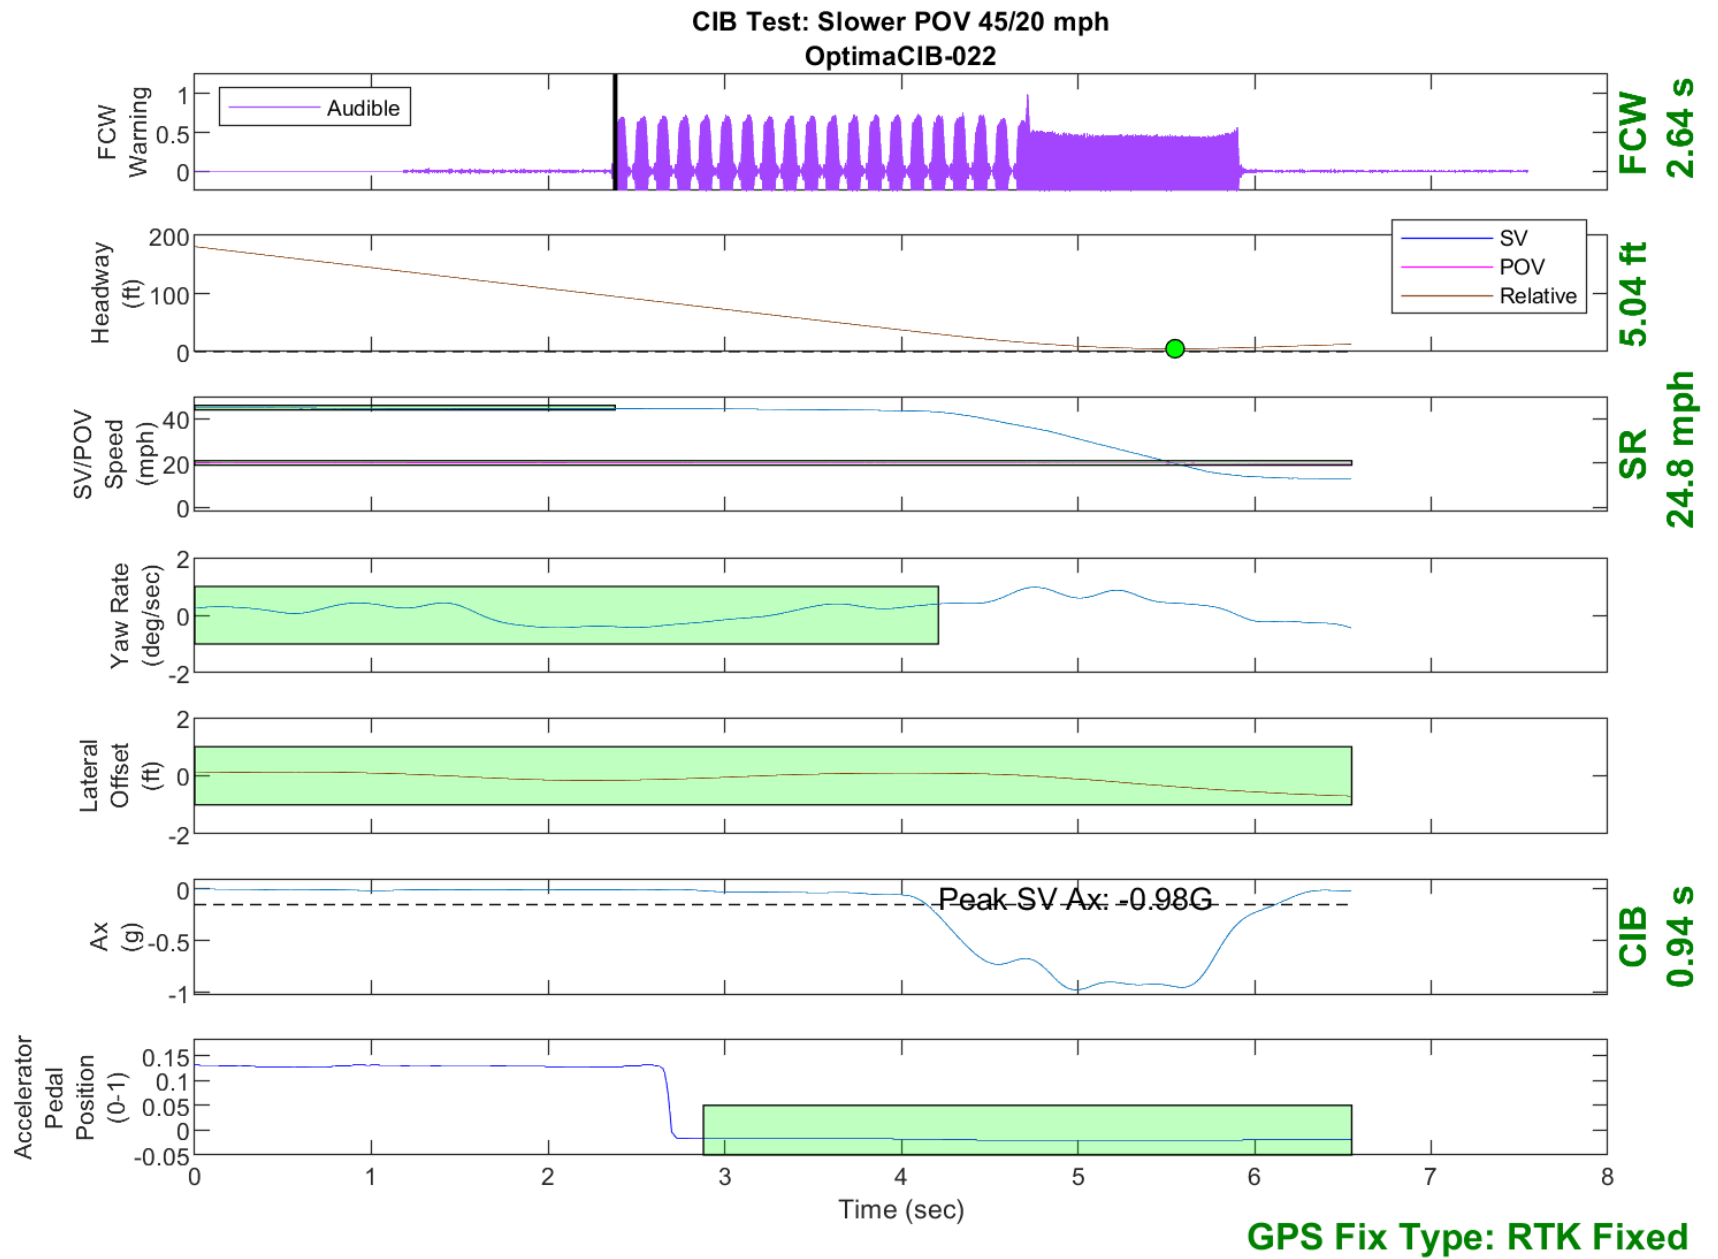
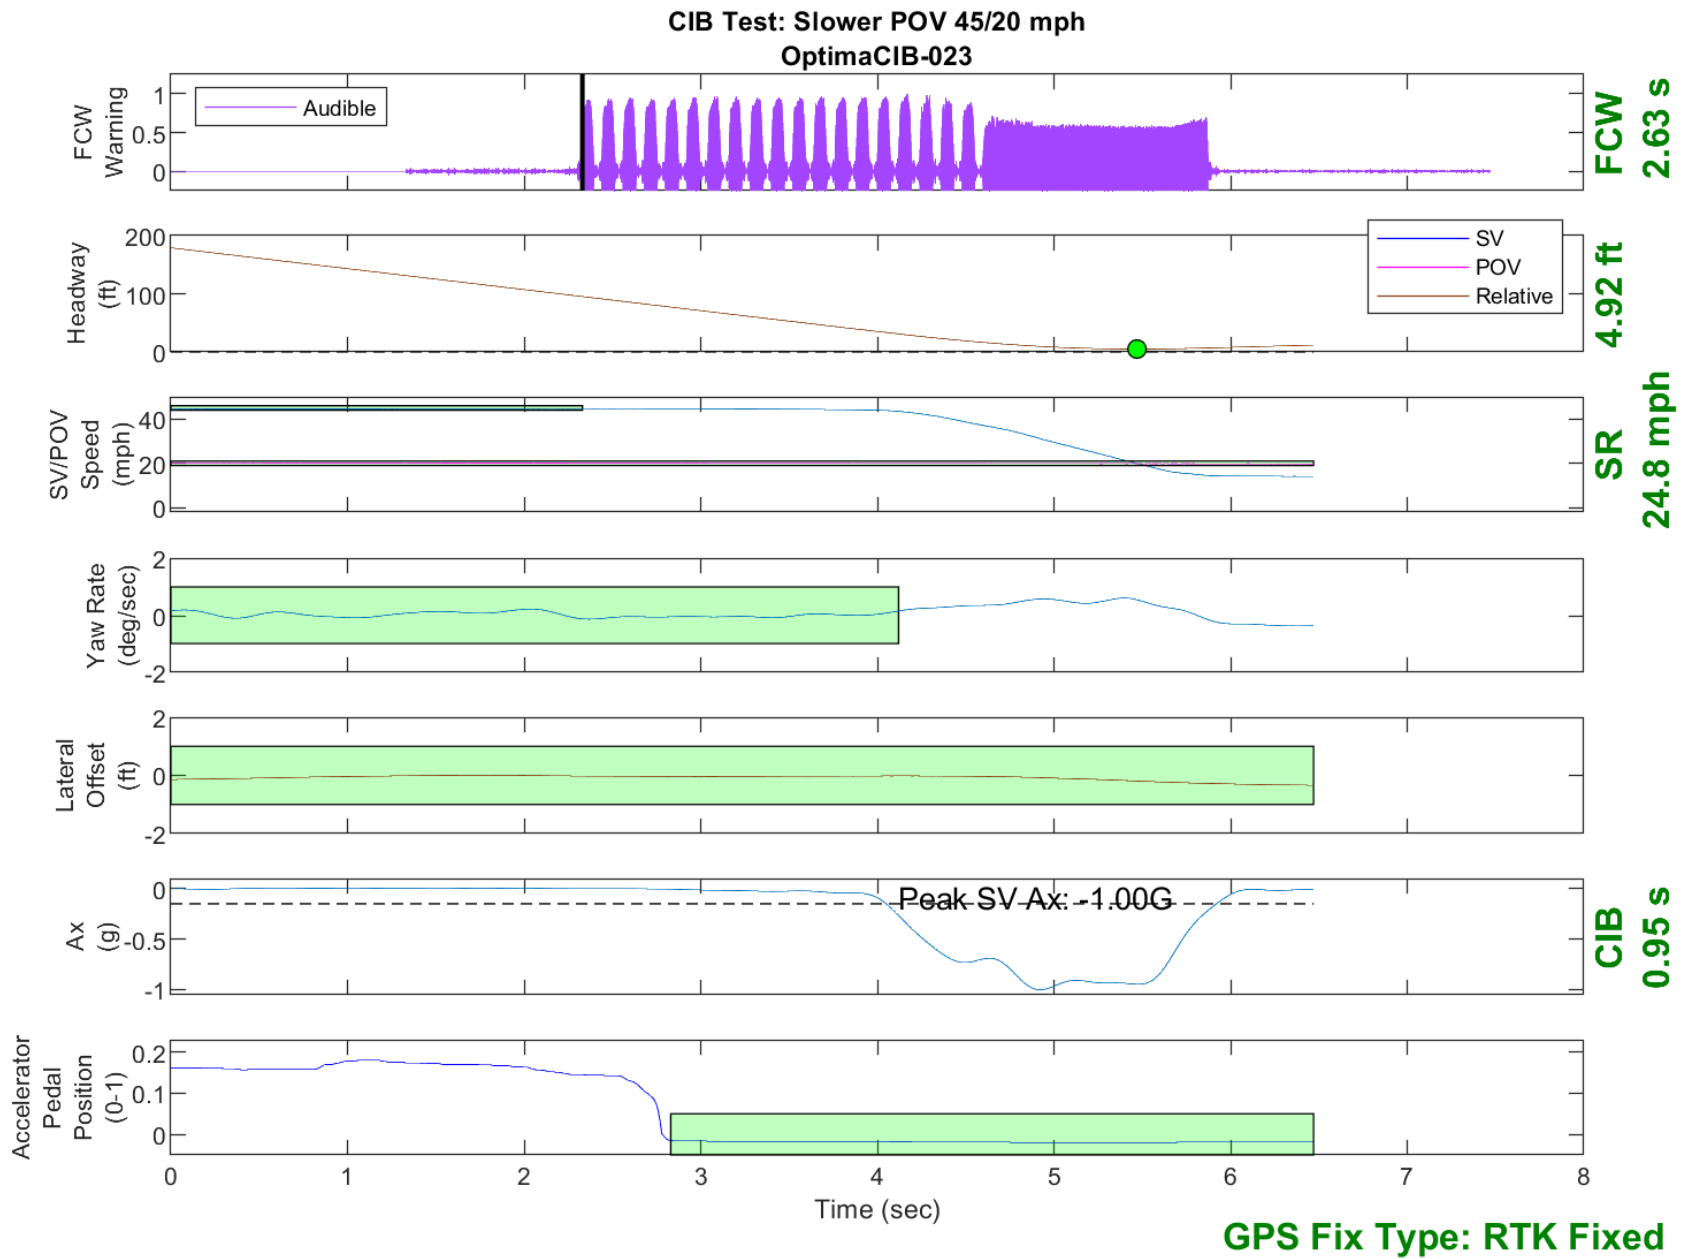
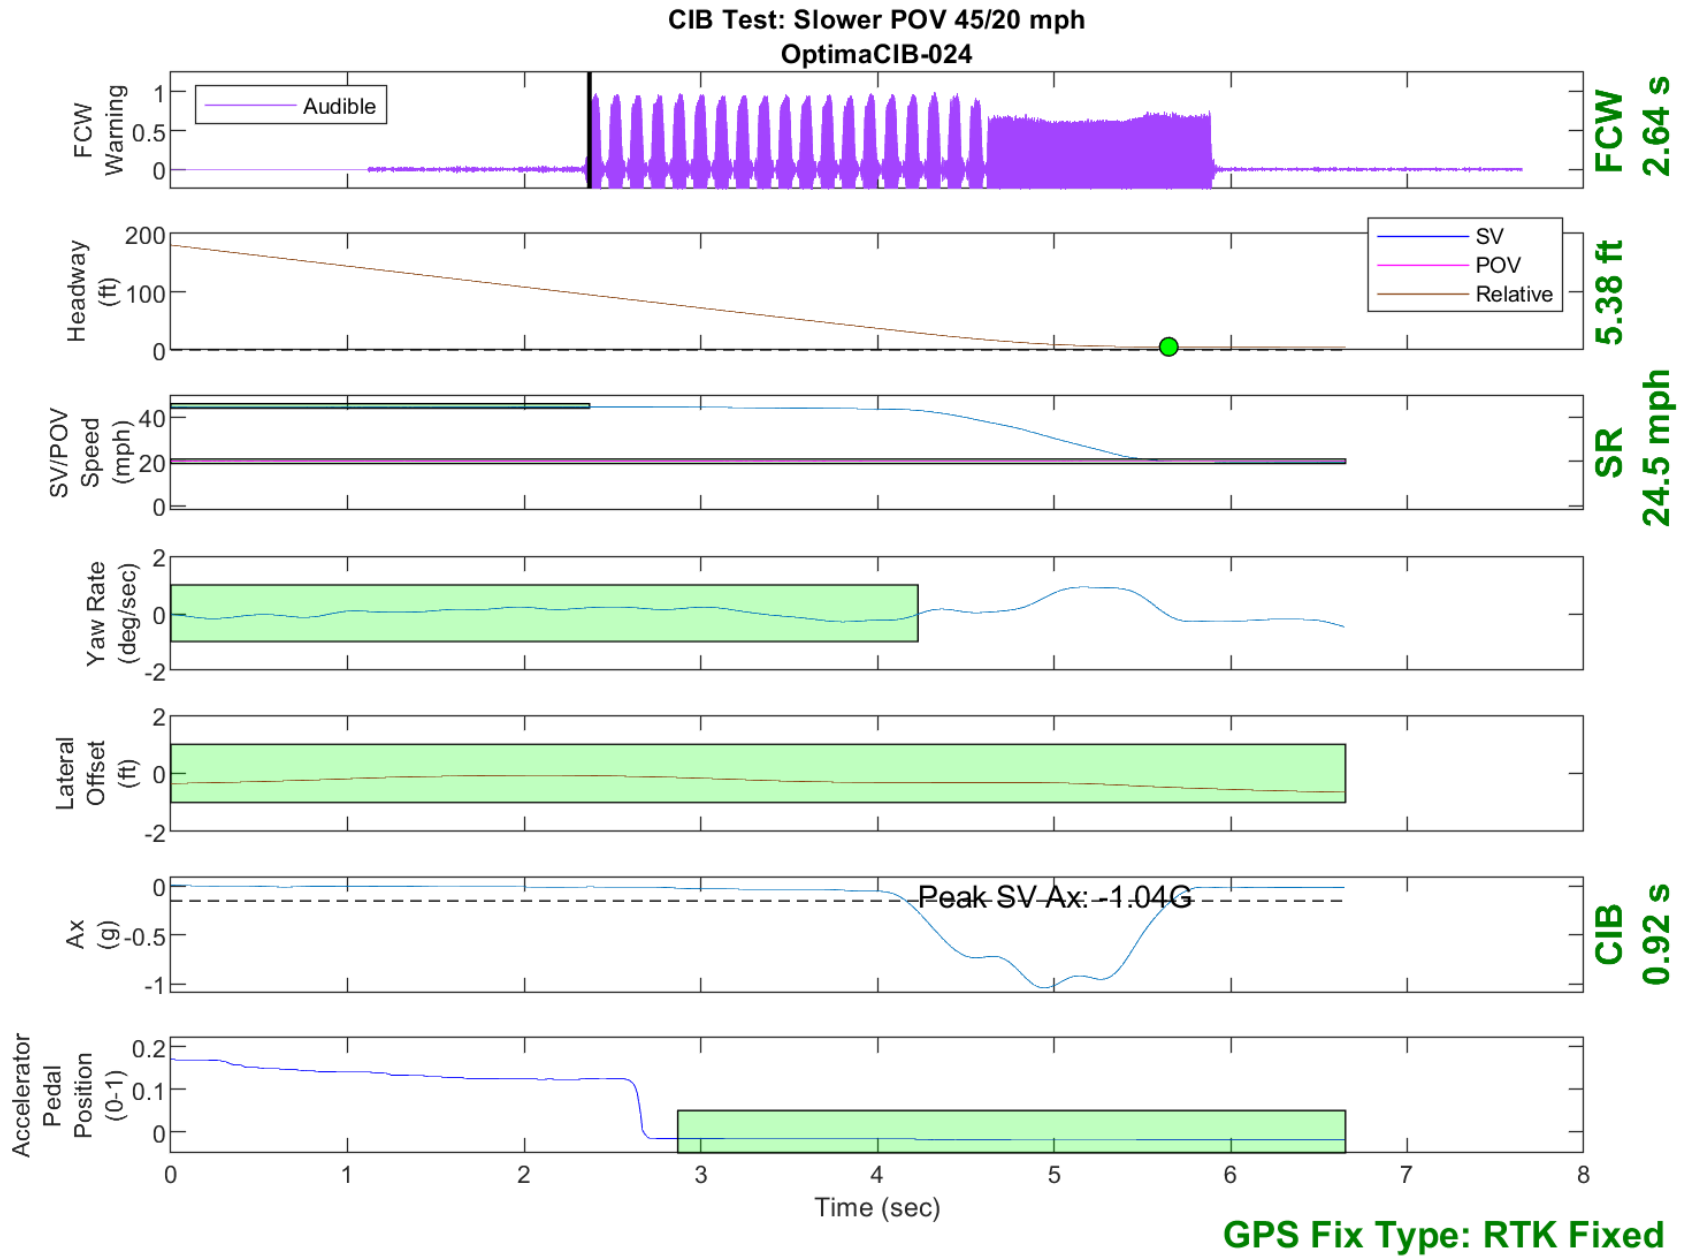
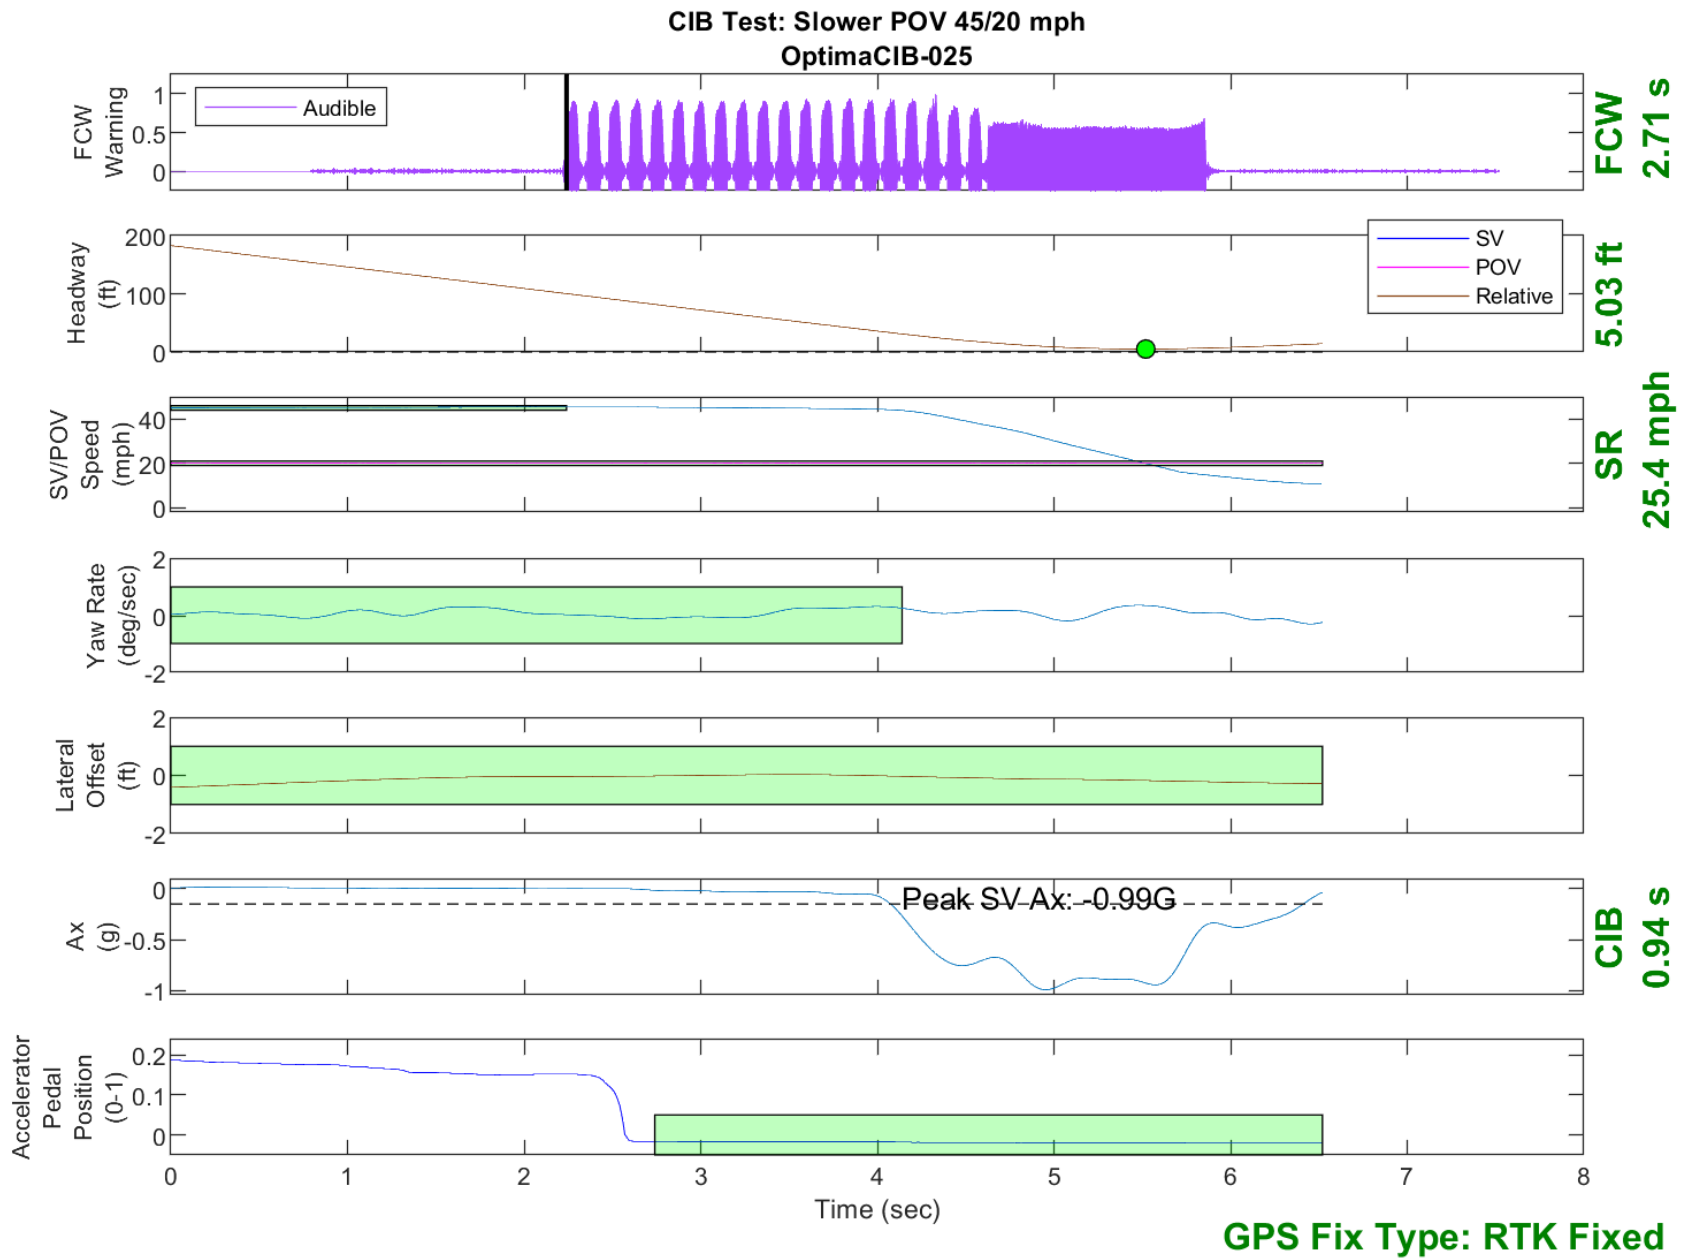
Figure D24. Time History for CIB Run 18, SV Encounters Slower POV, SV 45 mph, POV 20 mph

Figure D25. Time History for CIB Run 19, SV Encounters Slower POV, SV 45 mph, POV 20 mph

Figure D26. Time History for CIB Run 20, SV Encounters Slower POV, SV 45 mph, POV 20 mph

Figure D27. Time History for CIB Run 22, SV Encounters Slower POV, SV 45 mph, POV 20 mph

Figure D28. Time History for CIB Run 23, SV Encounters Slower POV, SV 45 mph, POV 20 mph

Figure D29. Time History for CIB Run 24, SV Encounters Slower POV, SV 45 mph, POV 20 mph

Figure D30. Time History for CIB Run 25, SV Encounters Slower POV, SV 45 mph, POV 20 mph

Run	Test Type	Valid Run?	FCW TTC (s)	Min. Distance (ft)	Speed Reduction (mph)	Peak Decel. (g)	CIB TTC (s)	Pass/Fail	Notes
15		Y	1.51	2.96	14.8	0.98	0.68	Pass	
16		Y	1.61	3.33	15.4	0.99	0.70	Pass	
17	Static Run								
18	Slower POV, 45 vs 20	Y	2.65	0.00	7.7	1.10	0.73	Fail	Vehicle CIB activated at TTC shown. Driver applied additional brakes at last moment. Last minute brake actuator turned on
19		Y	2.70	3.67	25.3	0.98	0.90	Pass	
20		Y	2.71	4.02	24.7	1.00	0.90	Pass	
21		N							POV speed
22		Y	2.64	5.04	24.8	0.98	0.94	Pass	
23		Y	2.63	4.92	24.8	1.00	0.95	Pass	
24		Y	2.64	5.38	24.5	1.04	0.92	Pass	
25		Y	2.71	5.03	25.4	0.99	0.94	Pass	
26	Static run								
27	Decelerating POV, 35	Y	1.83	0.00	21.6	0.92	1.31	Pass	
28		Y	1.79	1.90	27.1	1.07	1.13	Pass	
29		Y	1.82	0.00	23.0	0.93	1.27	Pass
