**NEW CAR ASSESSMENT PROGRAM
CRASH IMMINENT BRAKING SYSTEM CONFIRMATION TEST
NCAP-DRI-CIB-20-08**

2020 Kia Optima EX

DYNAMIC RESEARCH, INC.
355 Van Ness Avenue, STE 200
Torrance, California 90501

Final Report

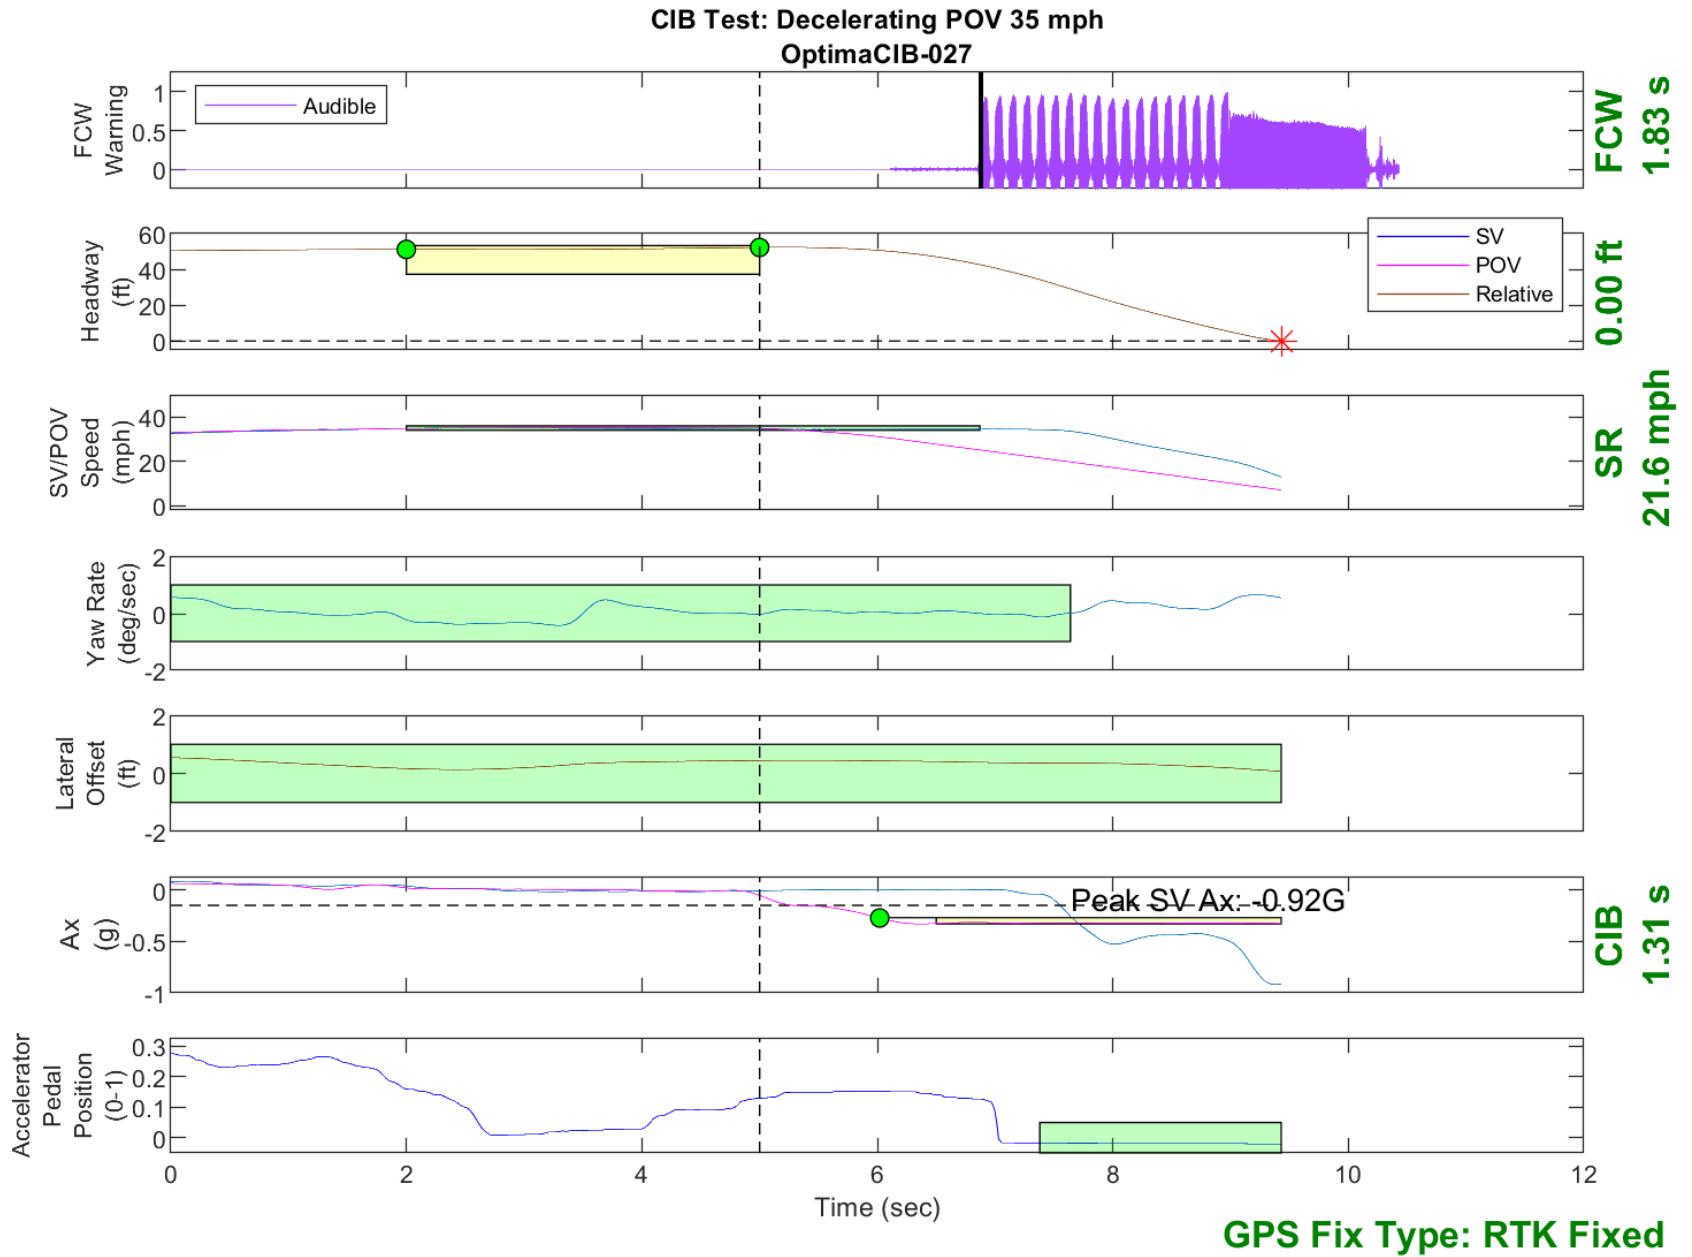
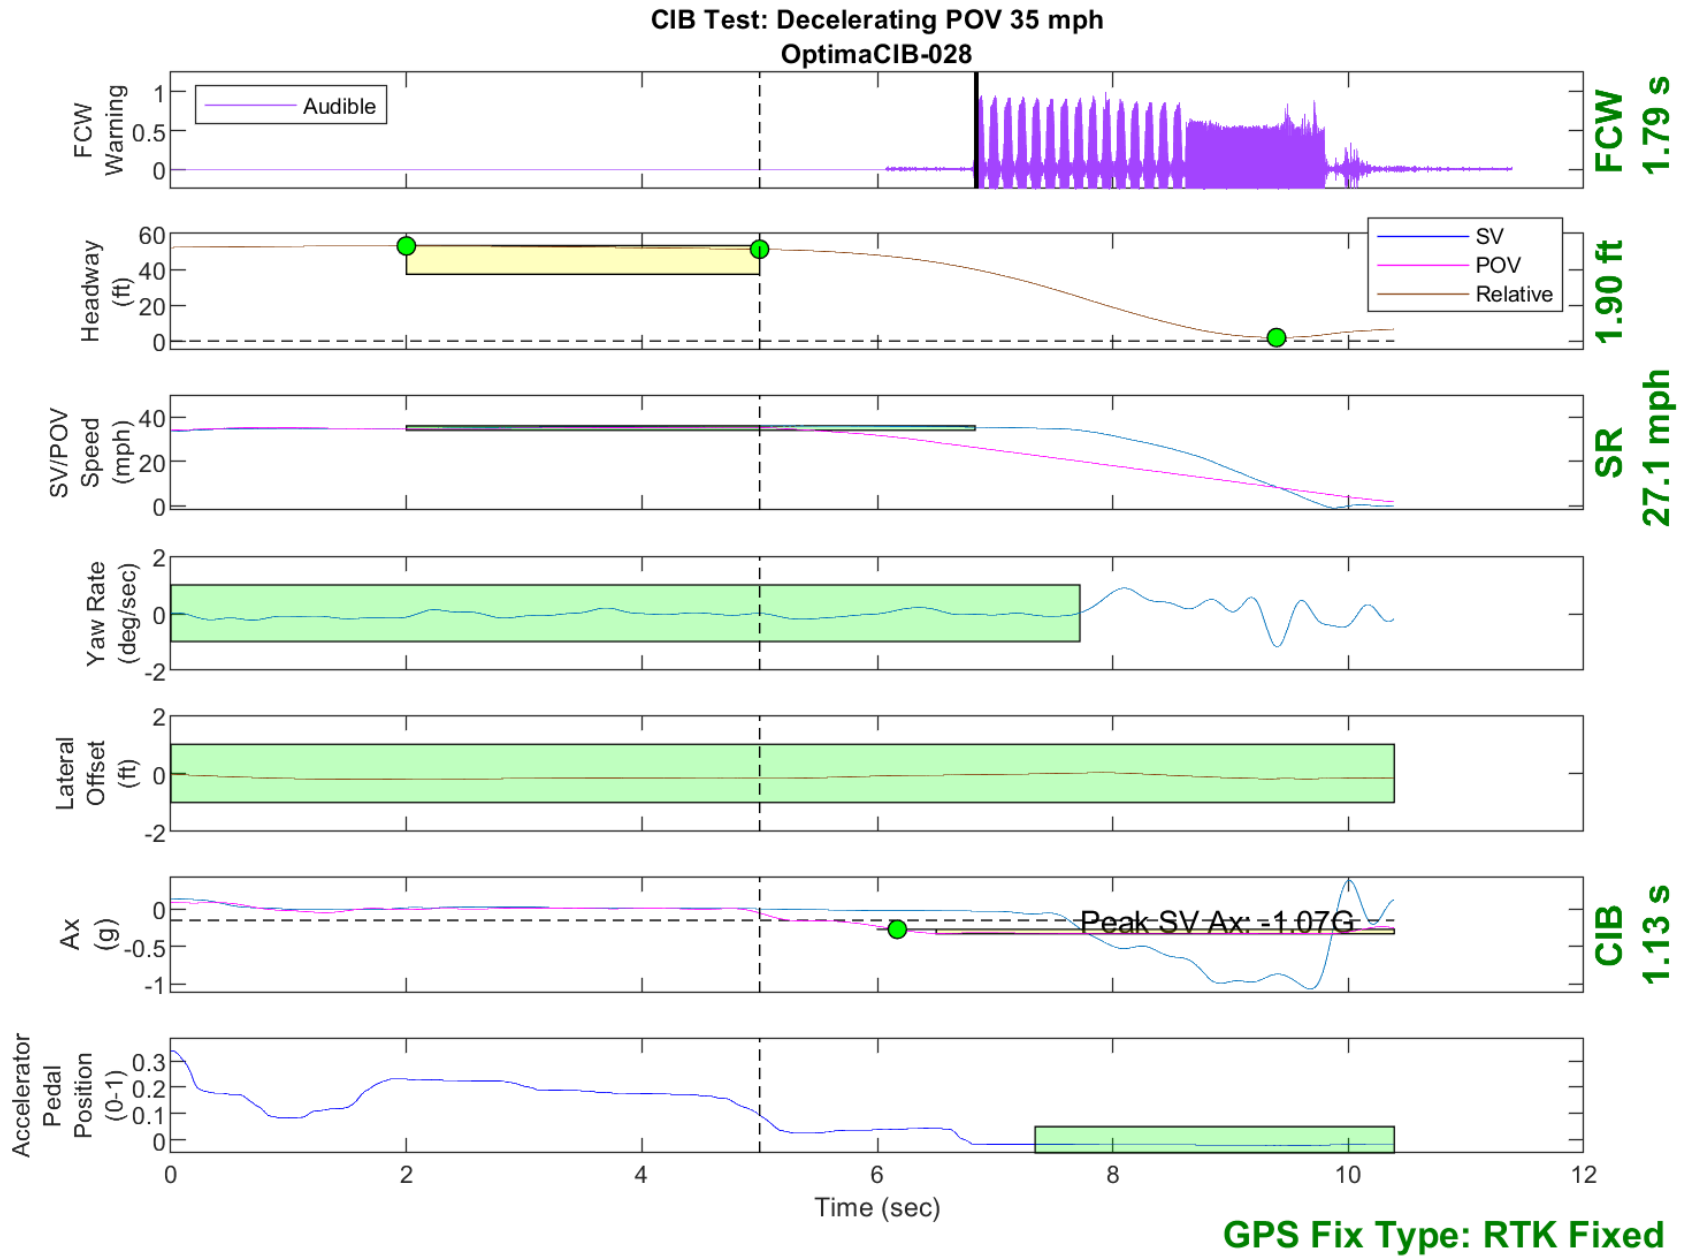
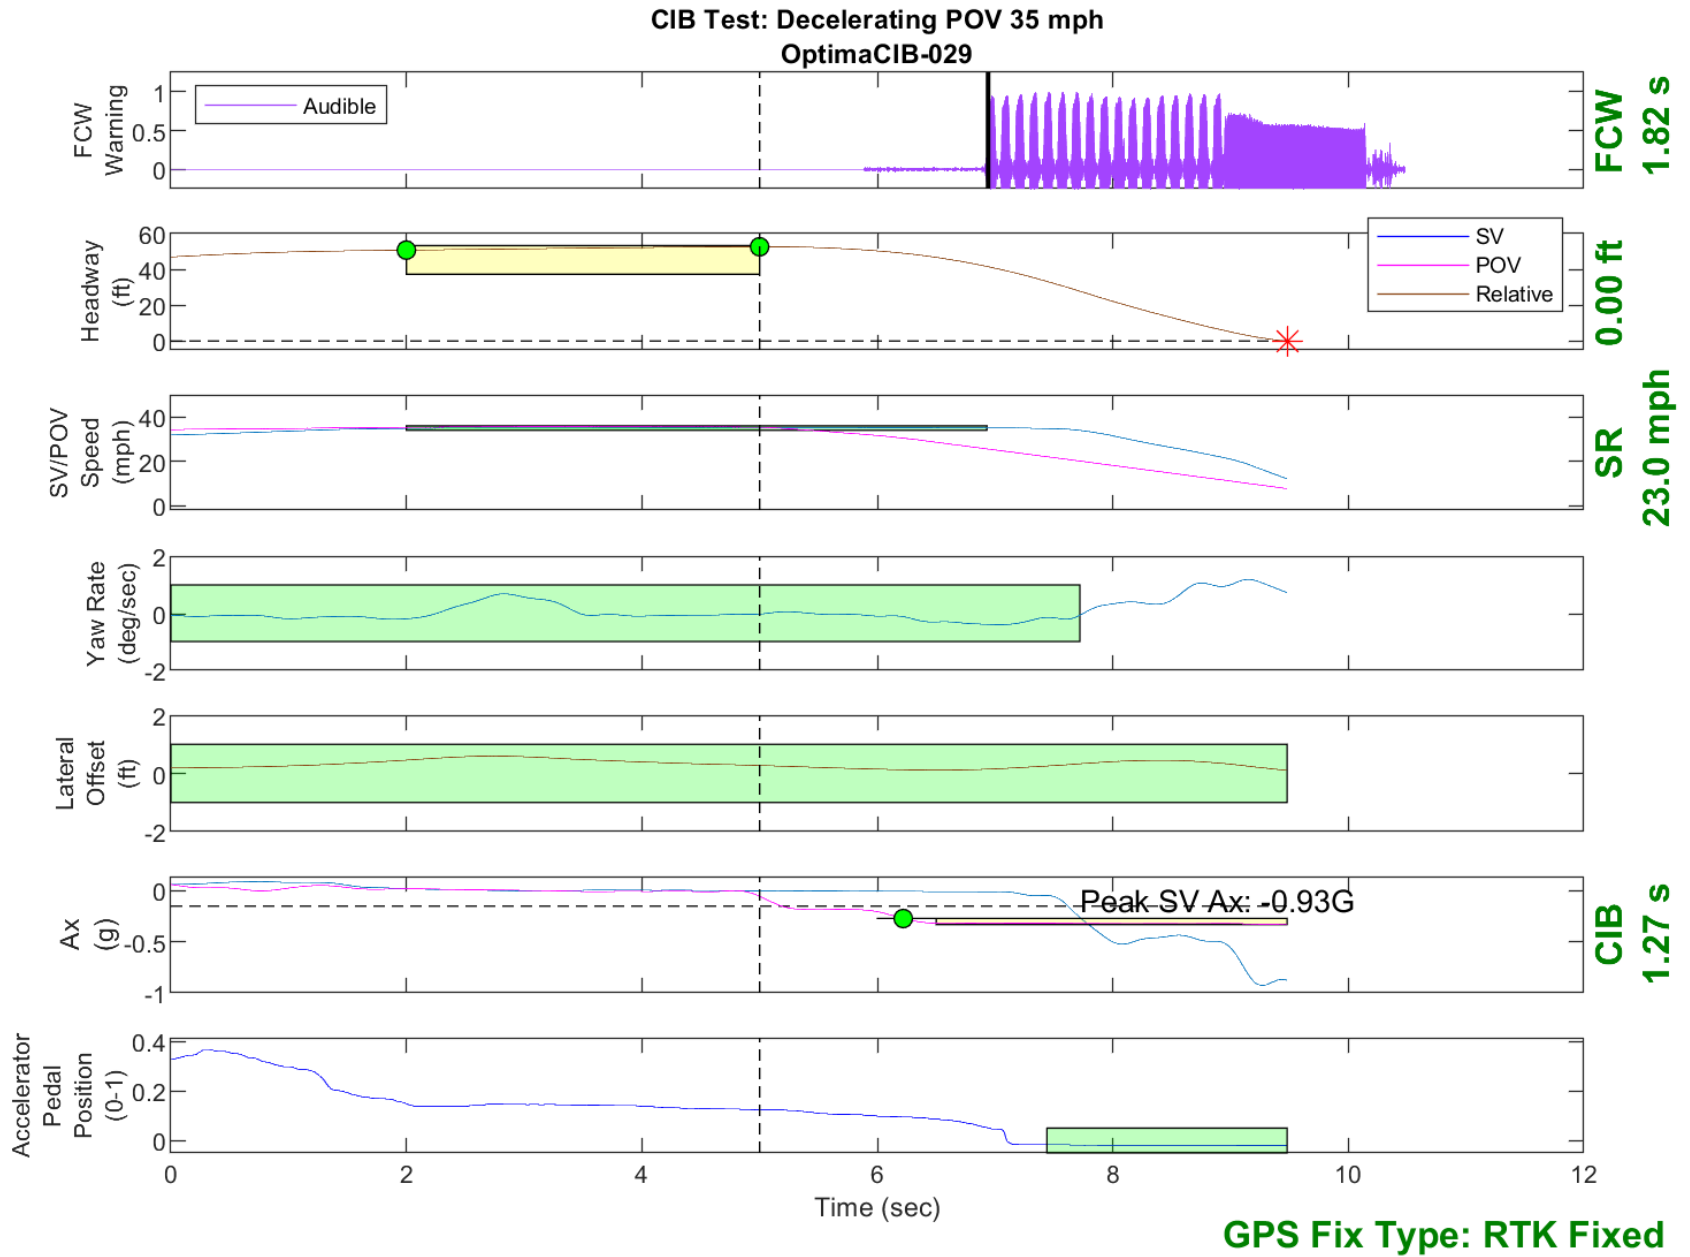
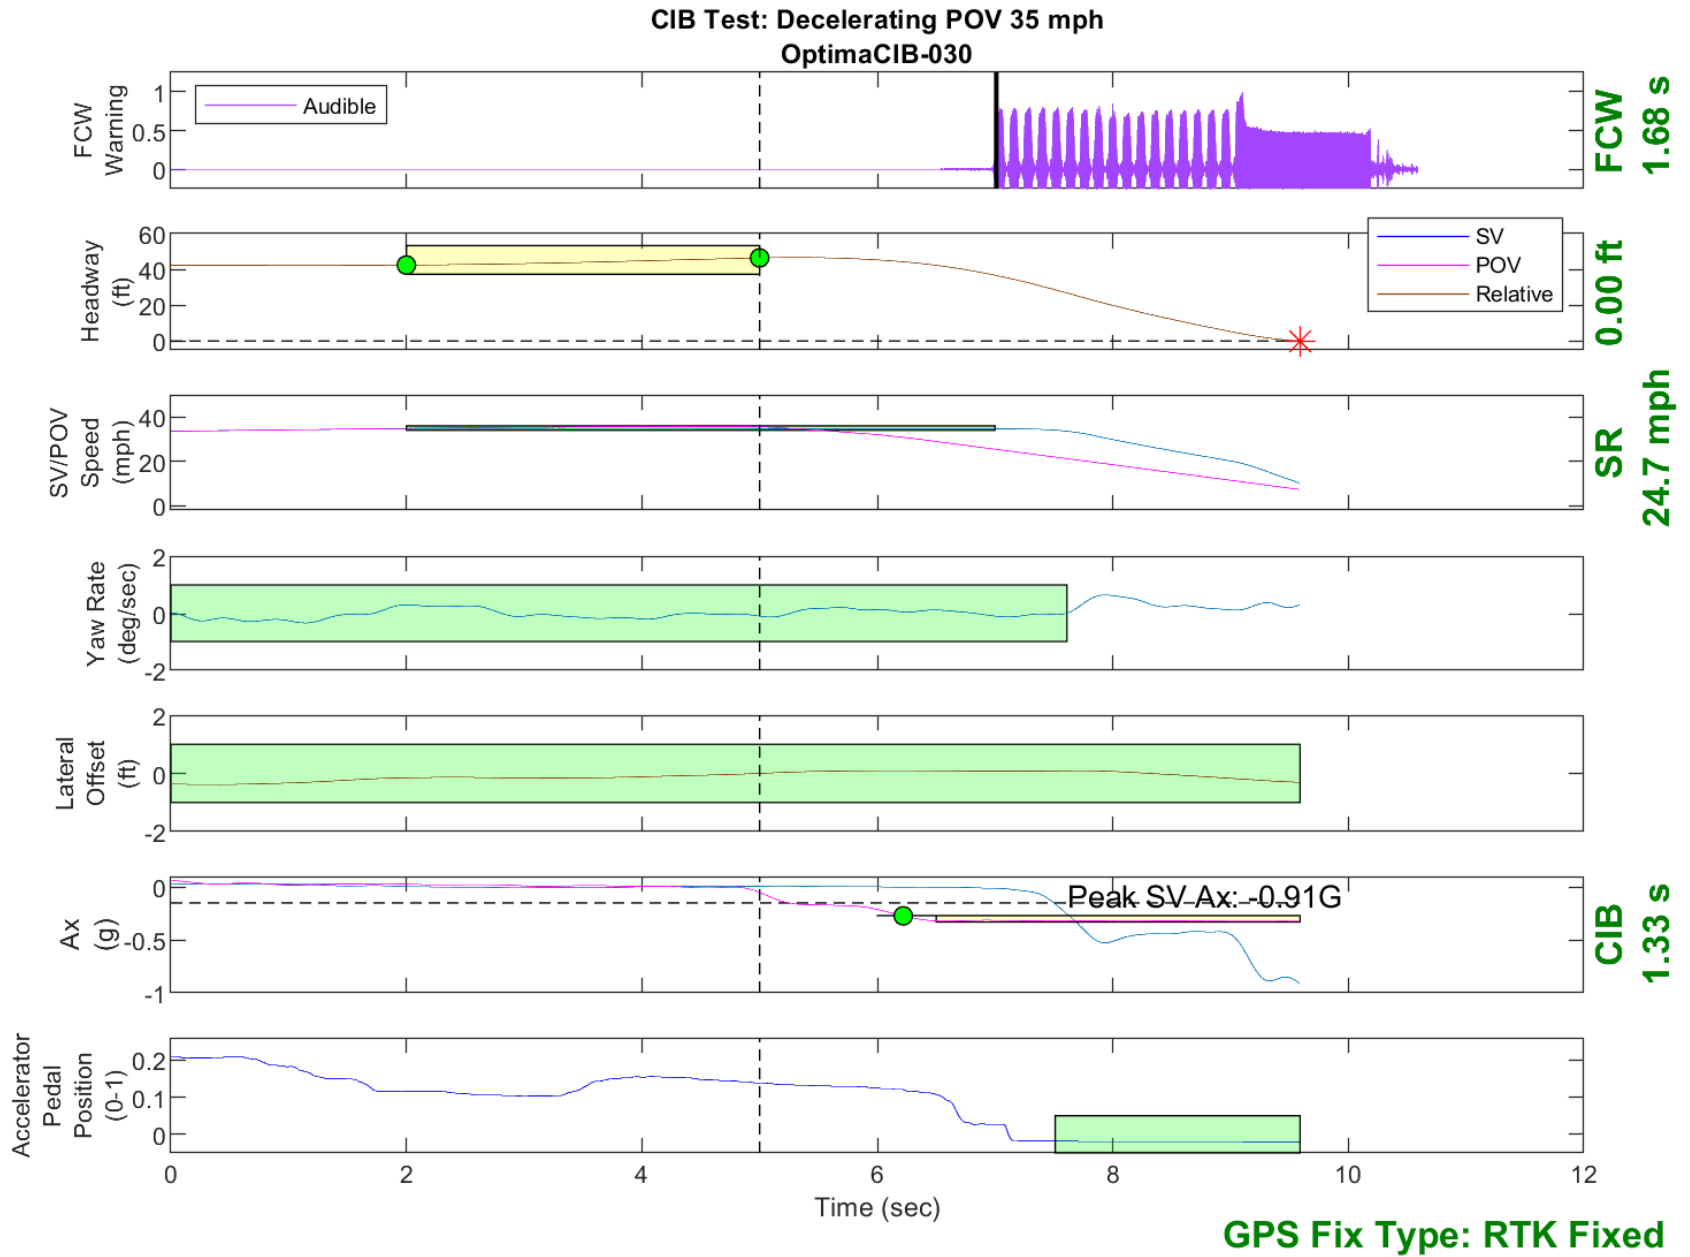
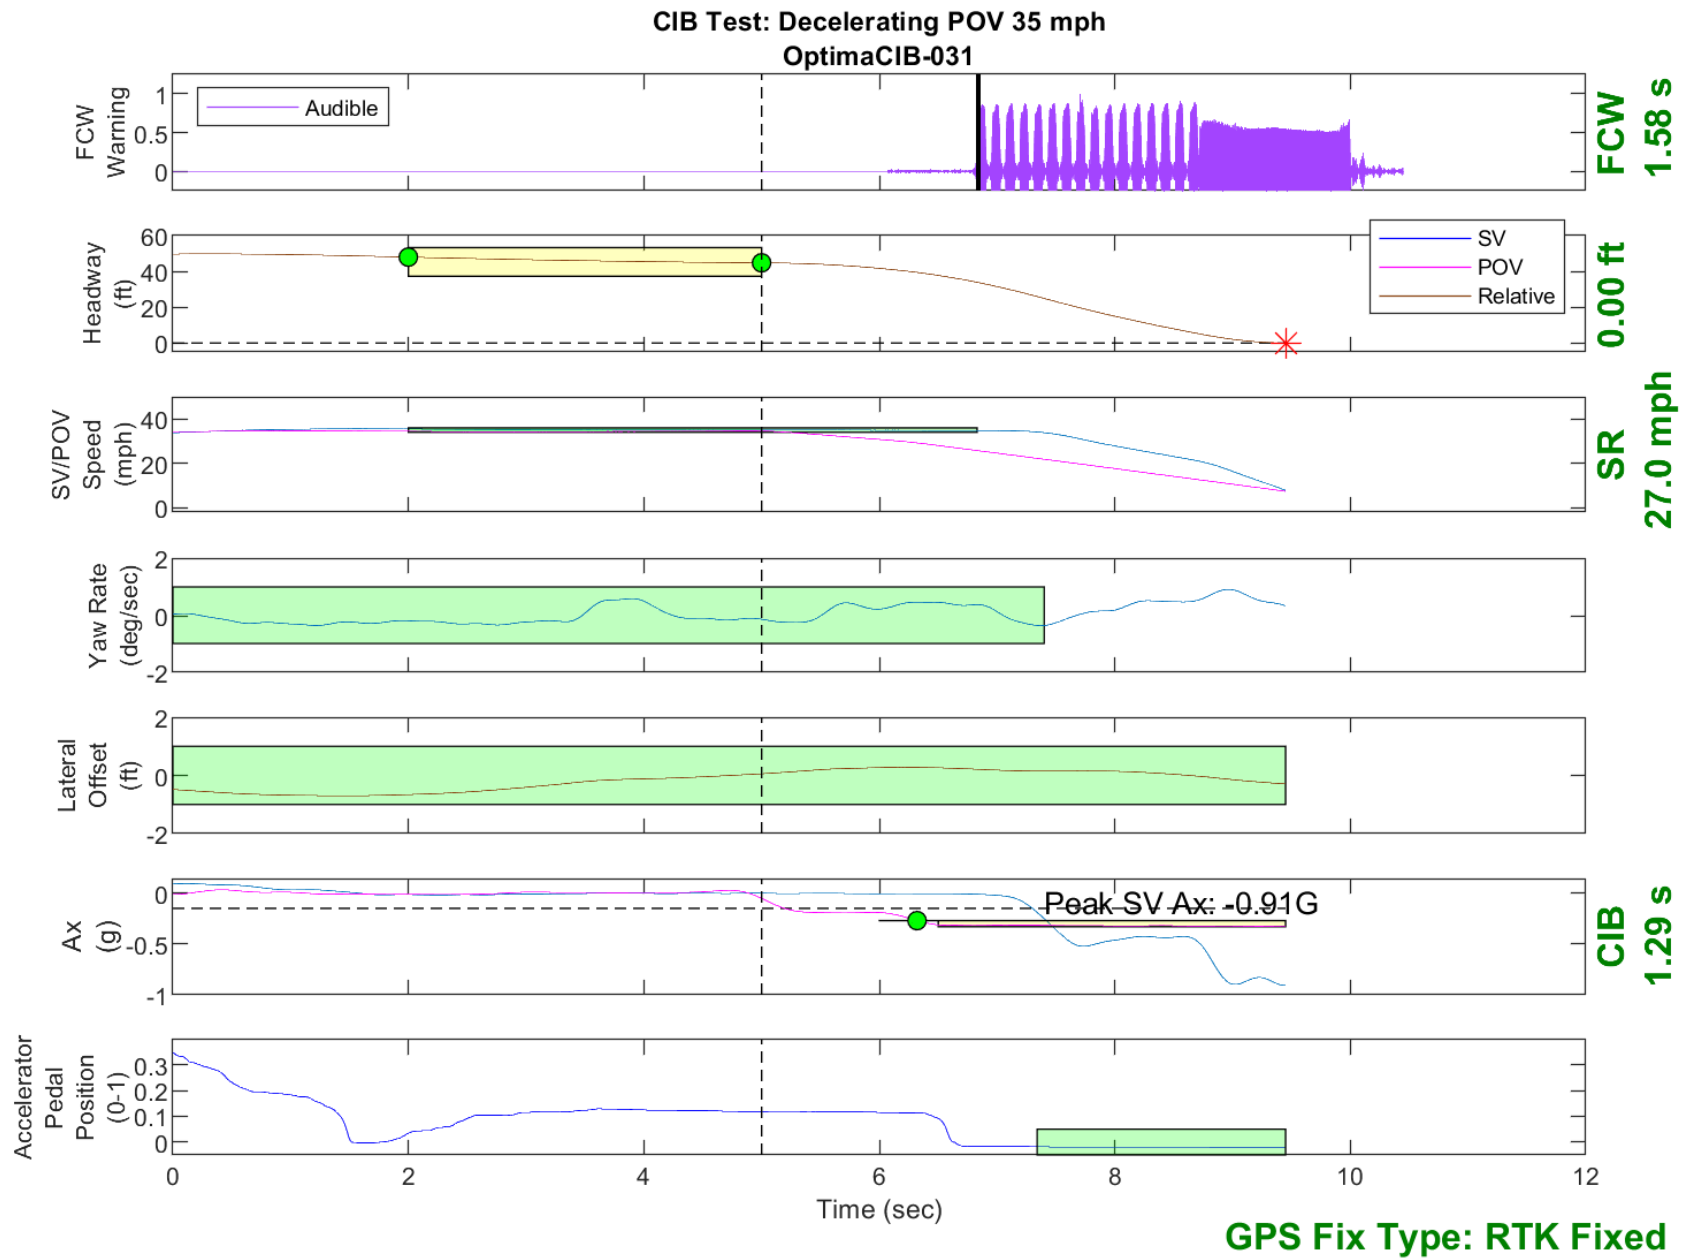
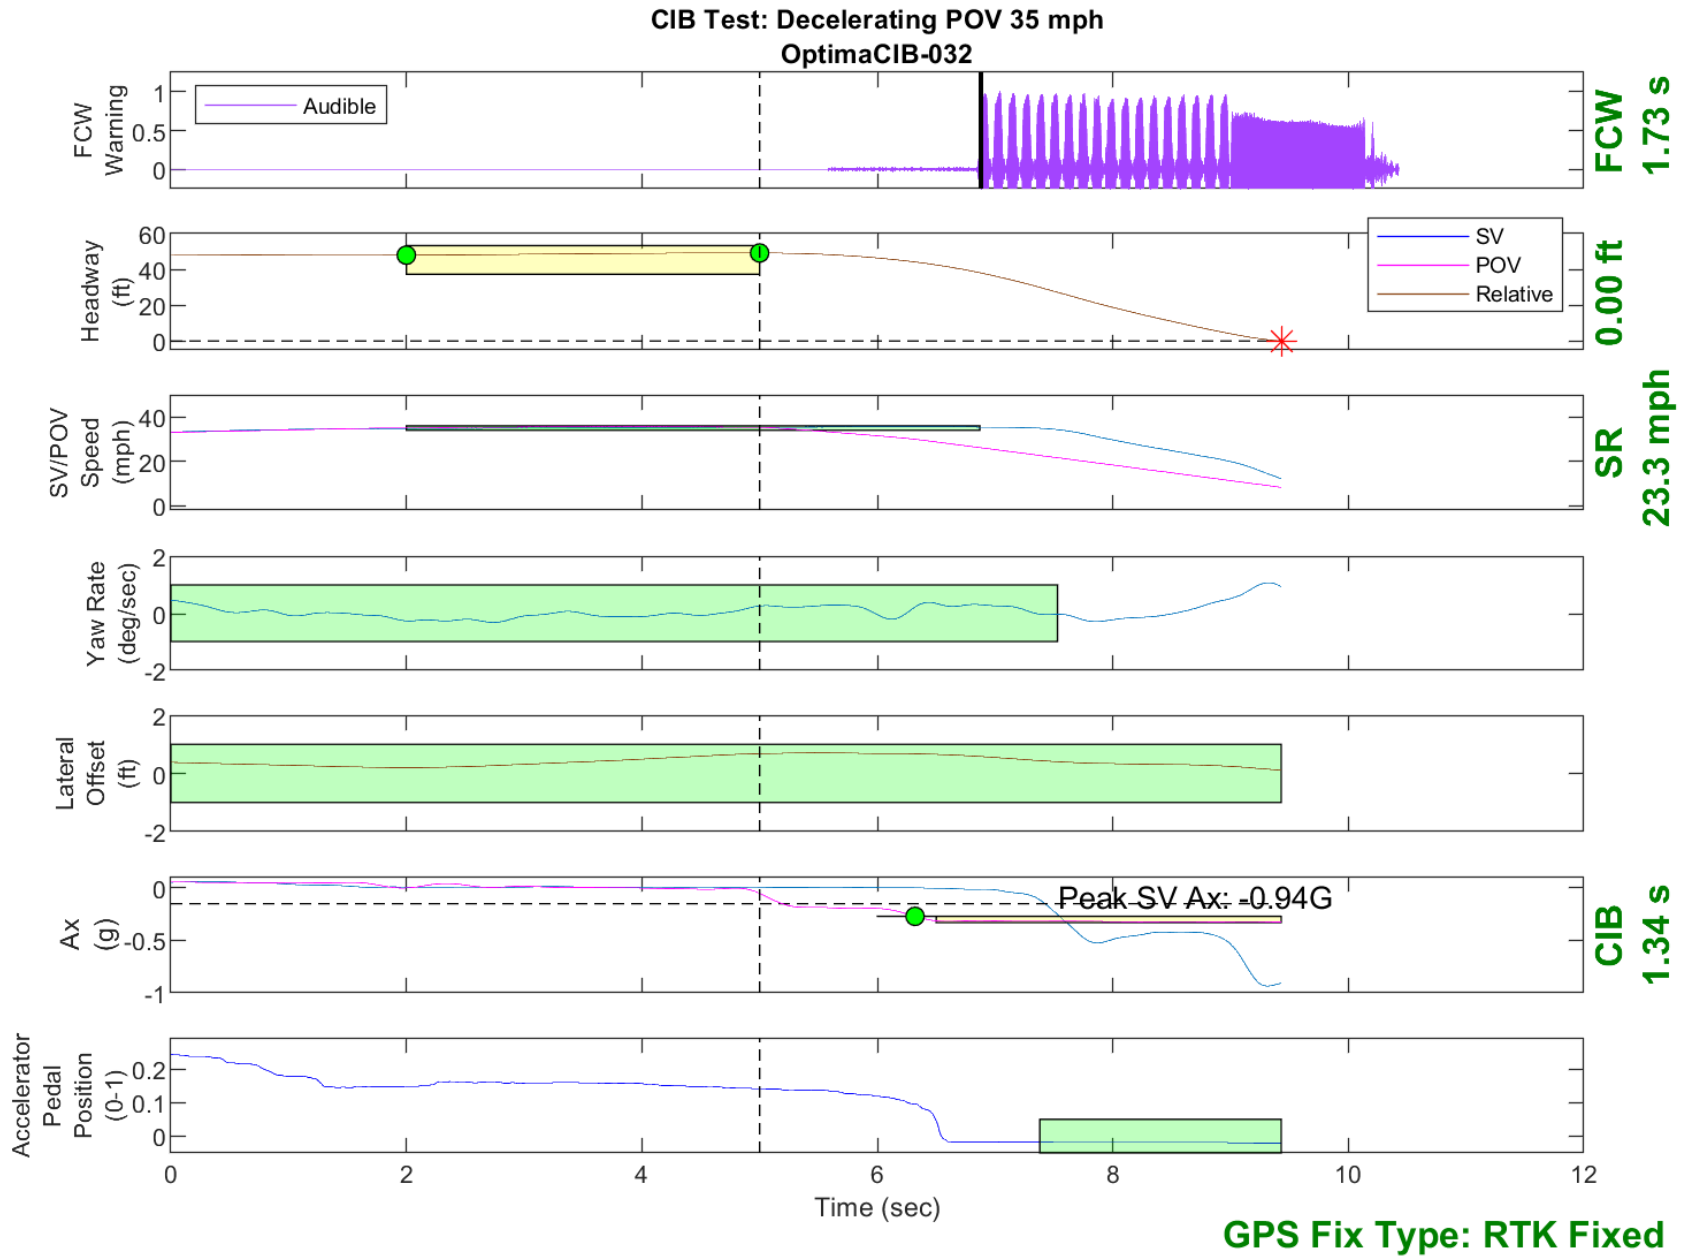
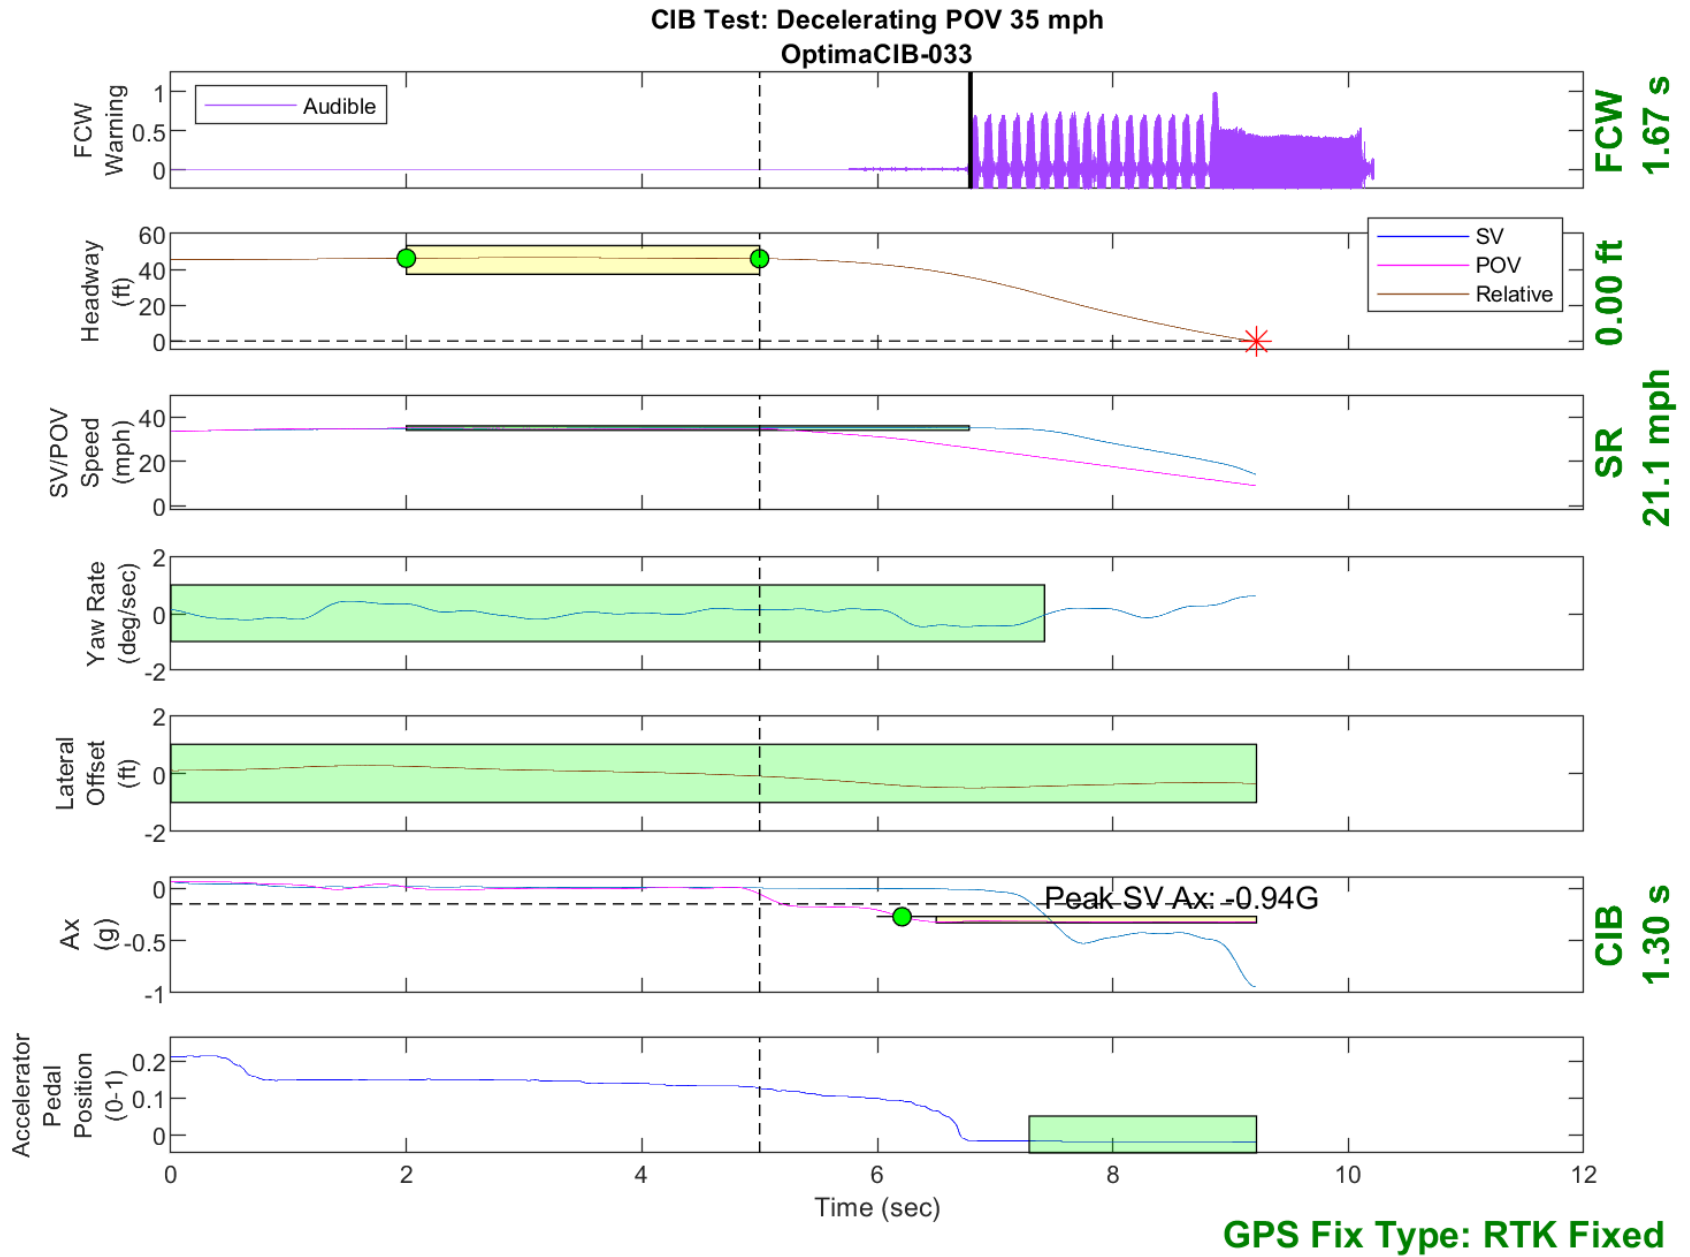
Figure D31. Time History for CIB Run 27, SV Encounters Decelerating POV, SV 35 mph, POV 35 mph

Figure D32. Time History for CIB Run 28, SV Encounters Decelerating POV, SV 35 mph, POV 35 mph

Figure D33. Time History for CIB Run 29, SV Encounters Decelerating POV, SV 35 mph, POV 35 mph

Figure D34. Time History for CIB Run 30, SV Encounters Decelerating POV, SV 35 mph, POV 35 mph

Figure D35. Time History for CIB Run 31, SV Encounters Decelerating POV, SV 35 mph, POV 35 mph

Figure D36. Time History for CIB Run 32, SV Encounters Decelerating POV, SV 35 mph, POV 35 mph

Figure D37. Time History for CIB Run 33, SV Encounters Decelerating POV, SV 35 mph, POV 35 mph

Run	Test Type	Valid Run?	FCW TTC (s)	Min. Distance (ft)	Speed Reduction (mph)	Peak Decel. (g)	CIB TTC (s)	Pass/Fail	Notes
15		Y	1.51	2.96	14.8	0.98	0.68	Pass	
16		Y	1.61	3.33	15.4	0.99	0.70	Pass	
17	Static Run								
18	Slower POV, 45 vs 20	Y	2.65	0.00	7.7	1.10	0.73	Fail	Vehicle CIB activated at TTC shown. Driver applied additional brakes at last moment. Last minute brake actuator turned on
19		Y	2.70	3.67	25.3	0.98	0.90	Pass	
20		Y	2.71	4.02	24.7	1.00	0.90	Pass	
21		N							POV speed
22		Y	2.64	5.04	24.8	0.98	0.94	Pass	
23		Y	2.63	4.92	24.8	1.00	0.95	Pass	
24		Y	2.64	5.38	24.5	1.04	0.92	Pass	
25		Y	2.71	5.03	25.4	0.99	0.94	Pass	
26	Static run								
27	Decelerating POV, 35	Y	1.83	0.00	21.6	0.92	1.31	Pass	
28		Y	1.79	1.90	27.1	1.07	1.13	Pass	
29		Y	1.82	0.00	23.0	0.93	1.27	Pass

Run	Test Type	Valid Run?	FCW TTC (s)	Min. Distance (ft)	Speed Reduction (mph)	Peak Decel. (g)	CIB TTC (s)	Pass/Fail	Notes
30		Y	1.68	0.00	24.7	0.91	1.33	Pass	
31		Y	1.58	0.00	27.0	0.91	1.29	Pass	
32		Y	1.73	0.00	23.3	0.94	1.34	Pass	
33		Y	1.67	0.00	21.1	0.94	1.30	Pass	
34	Static Run								
35	STP - Static Run								
36	STP False Positive, 25	Y				0.02		Pass	
37		Y				0.01		Pass	
38		Y				0.01		Pass	
39		Y				0.01		Pass	
40		Y				0.02		Pass	
41		Y				0.01		Pass	
42		Y				0.02		Pass	
43	STP - Static Run
