**NEW CAR ASSESSMENT PROGRAM
CRASH IMMINENT BRAKING SYSTEM CONFIRMATION TEST
NCAP-DRI-CIB-20-08**

2020 Kia Optima EX

DYNAMIC RESEARCH, INC.
355 Van Ness Avenue, STE 200
Torrance, California 90501

Final Report

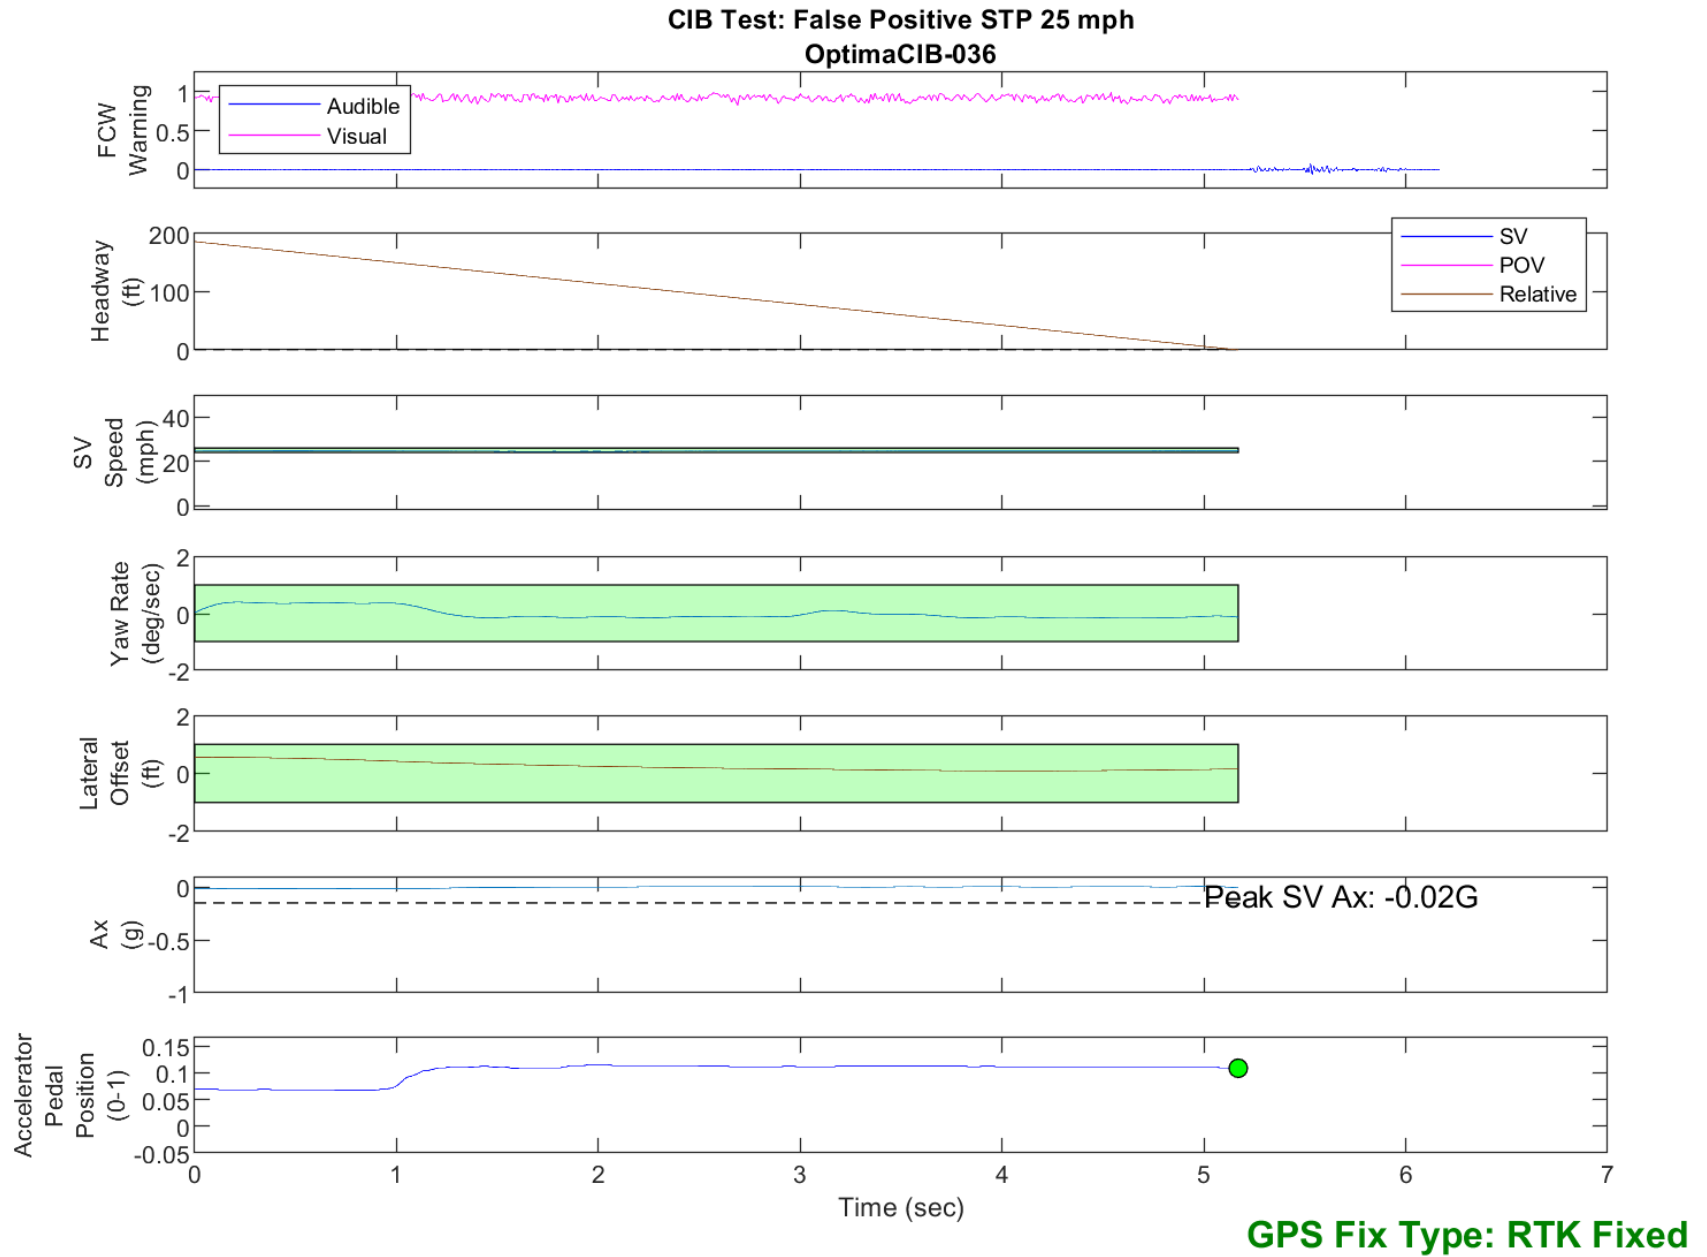
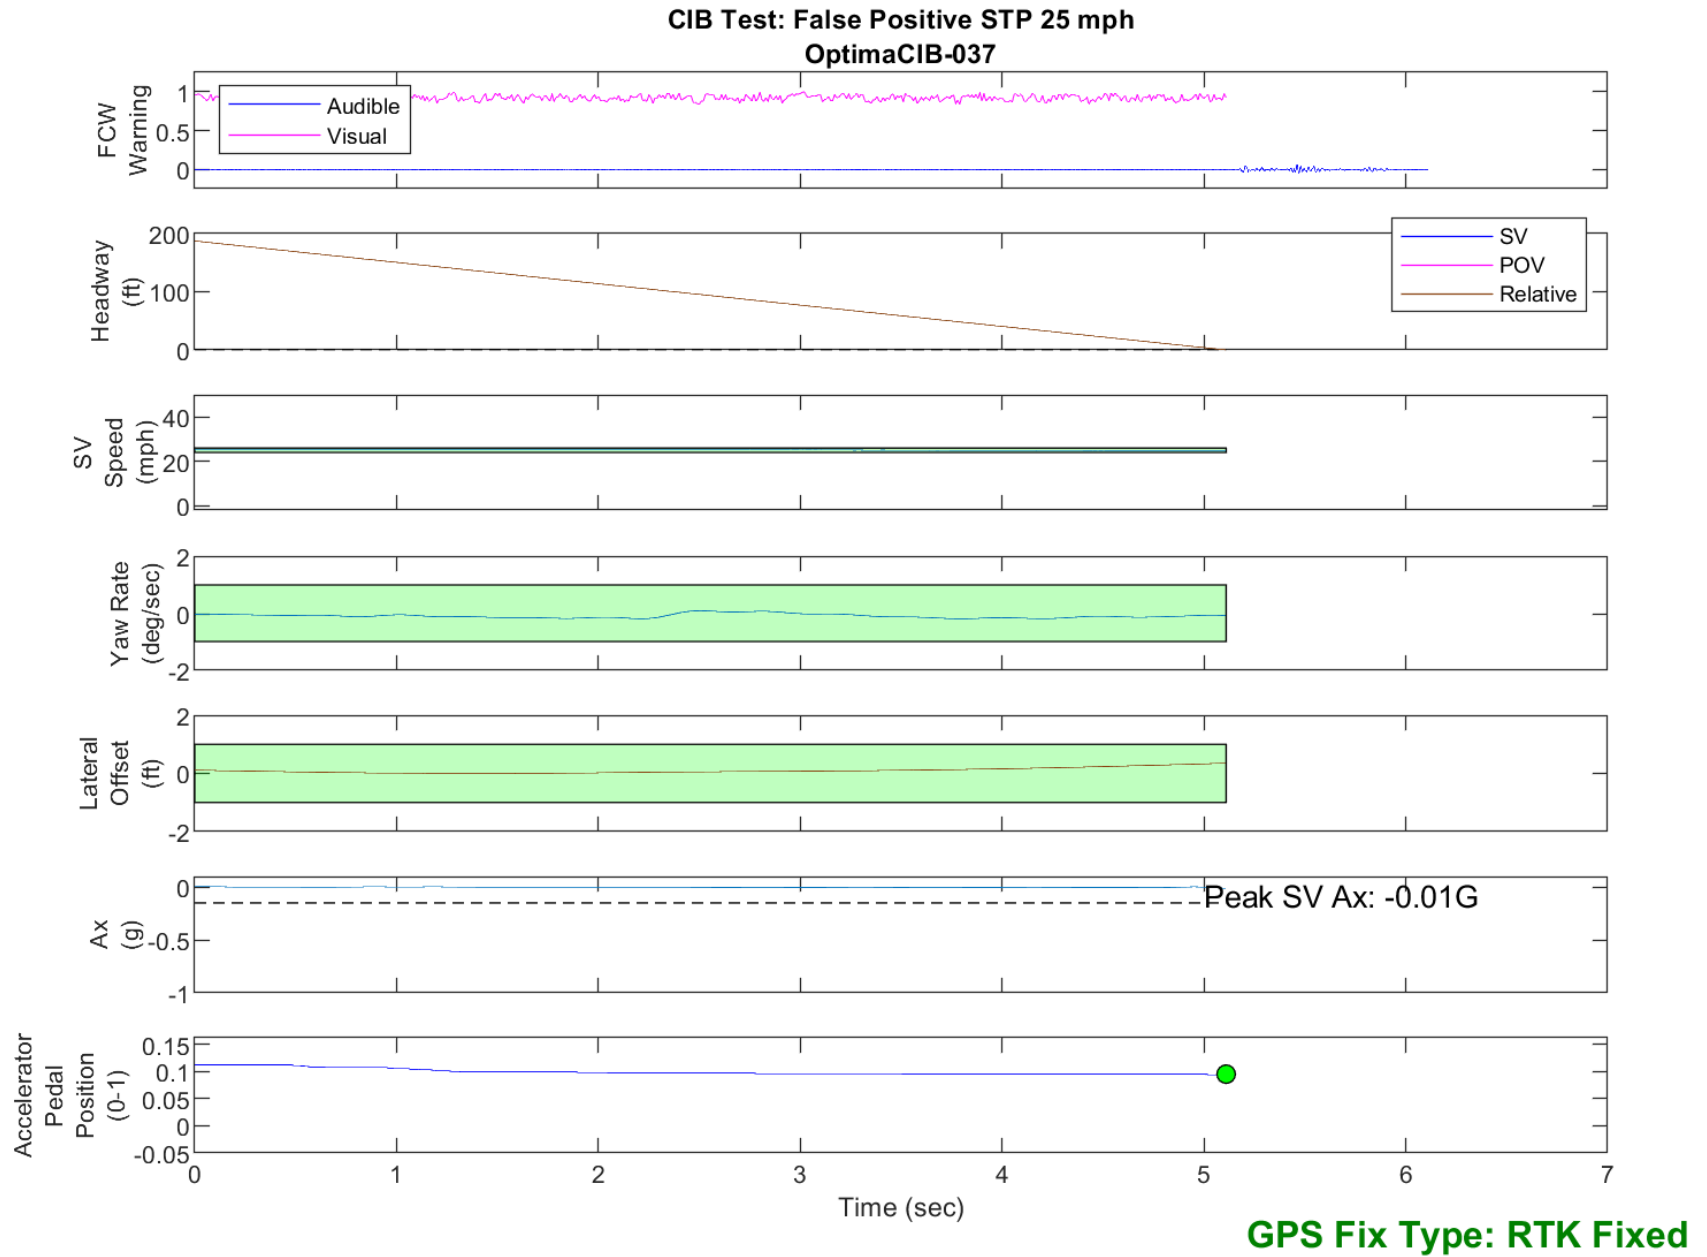
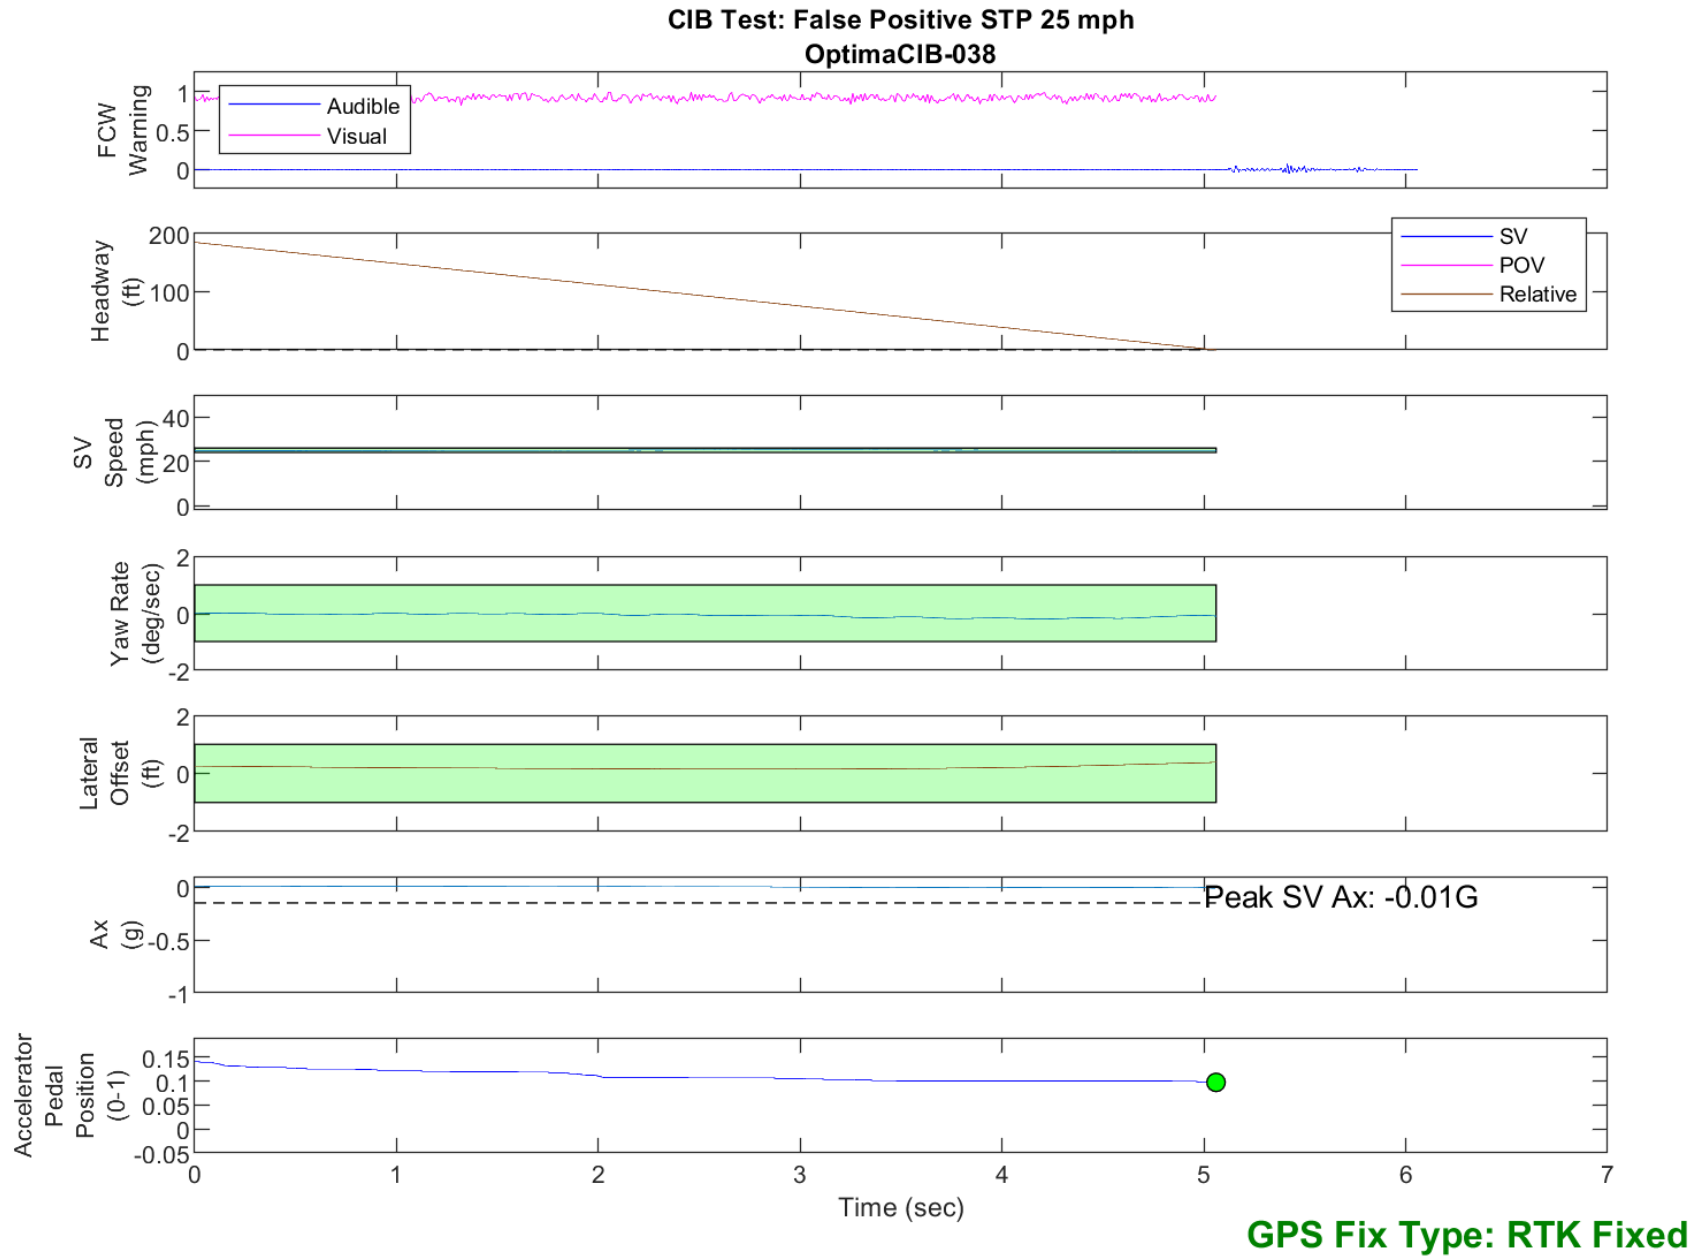
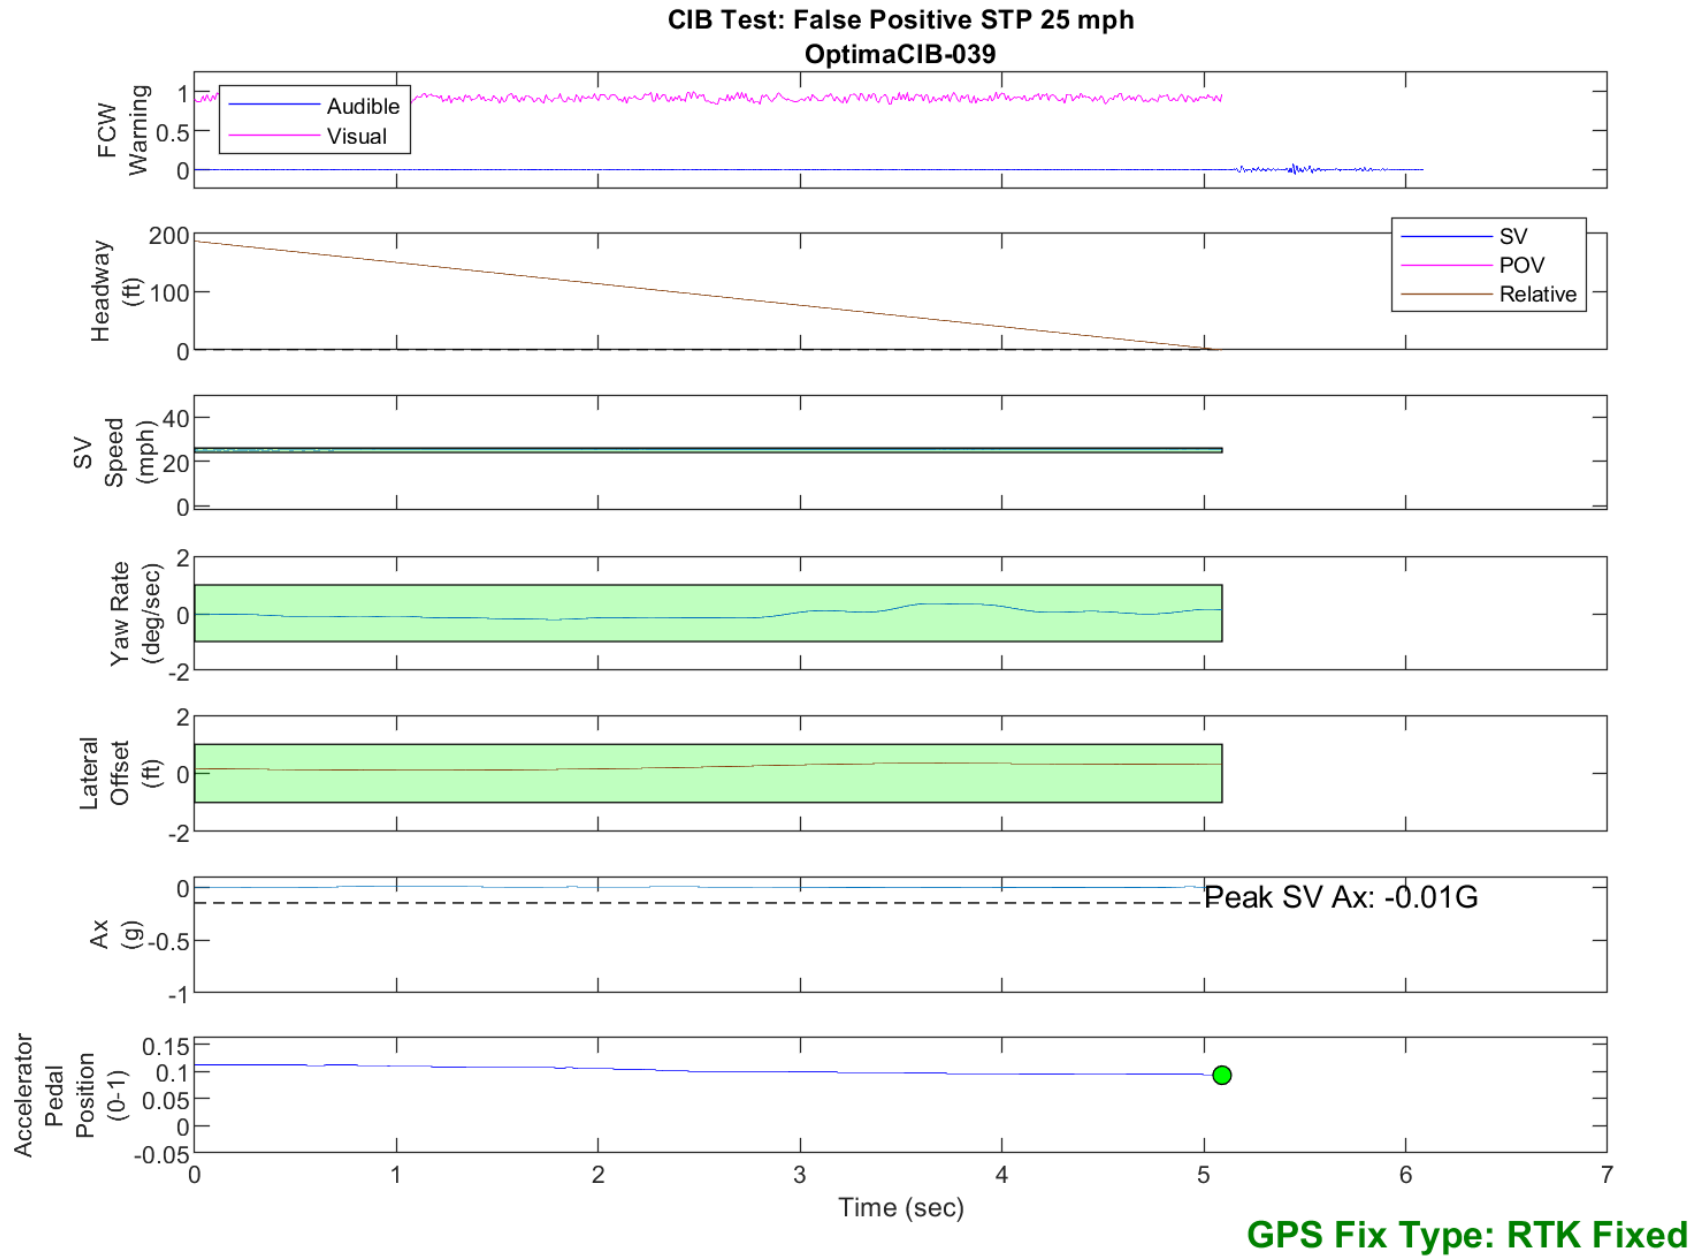
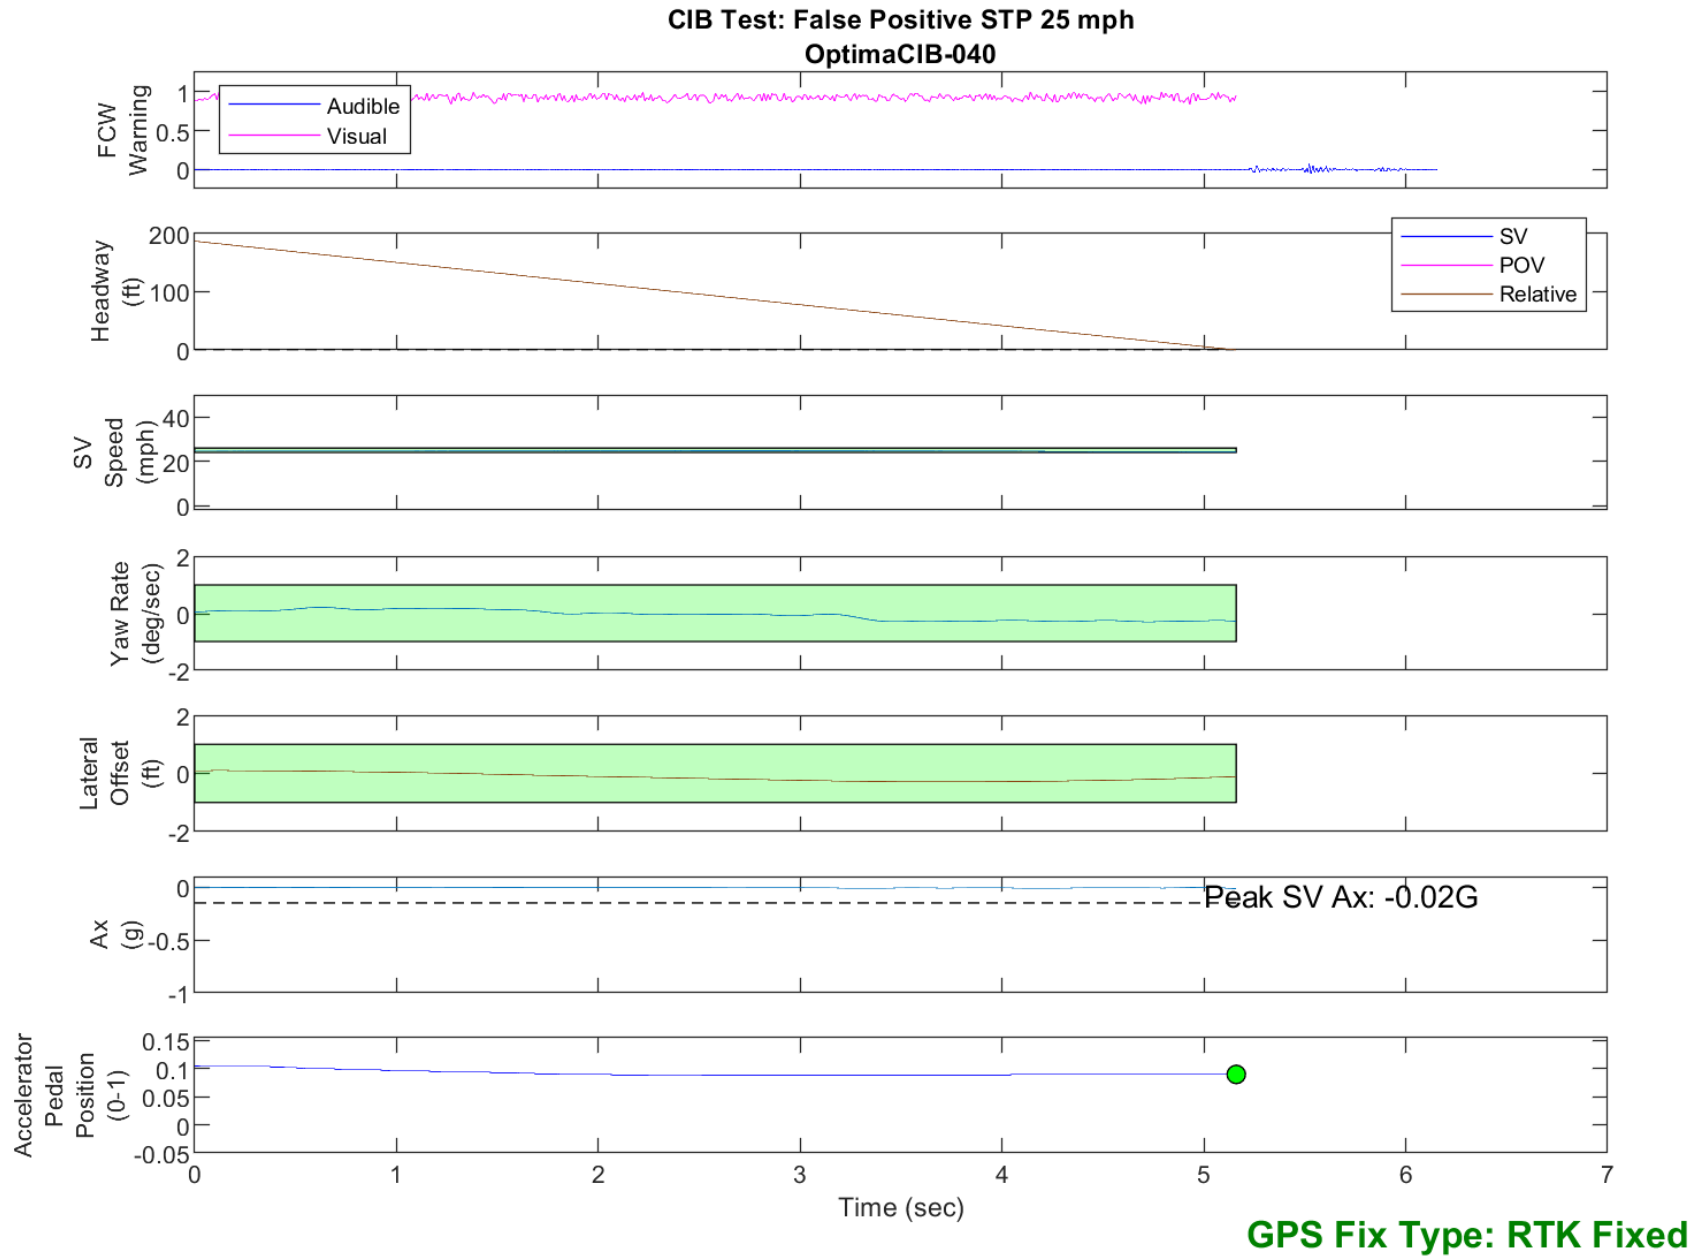
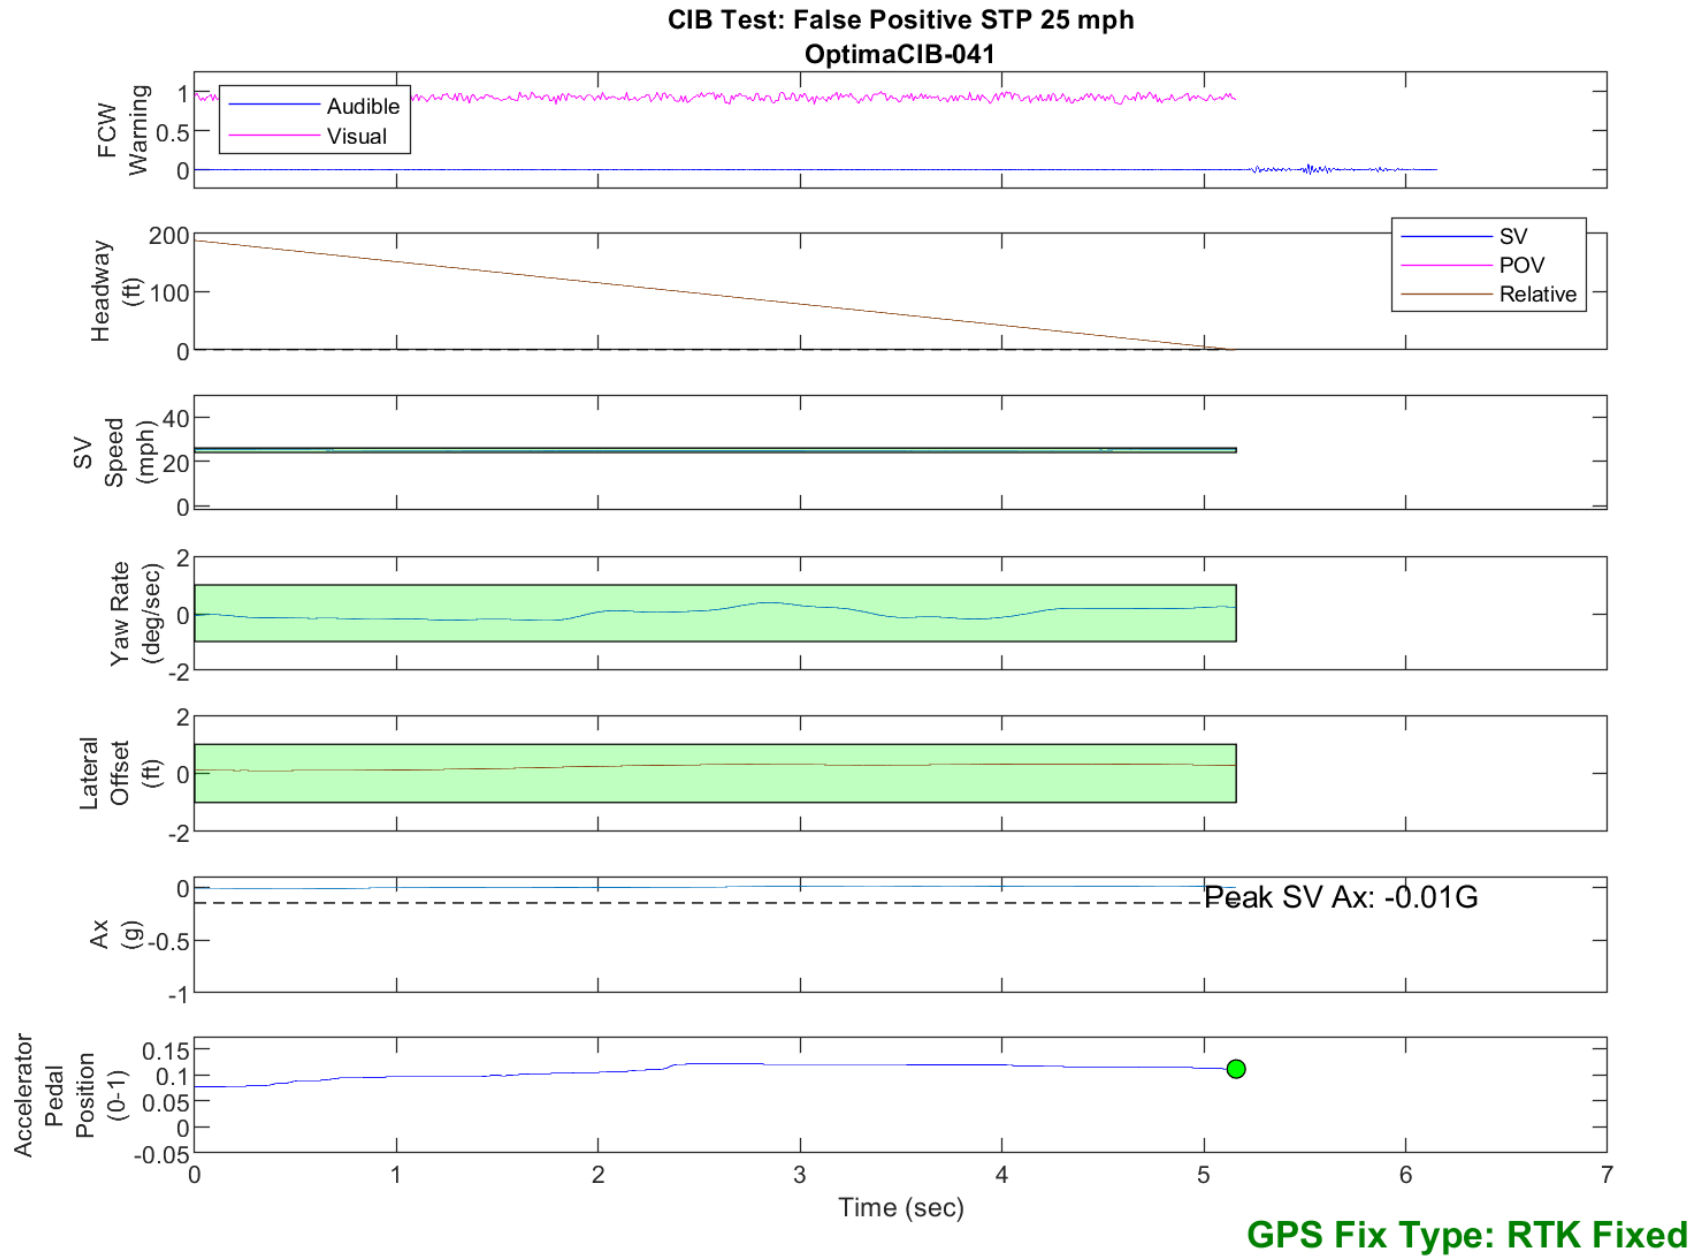
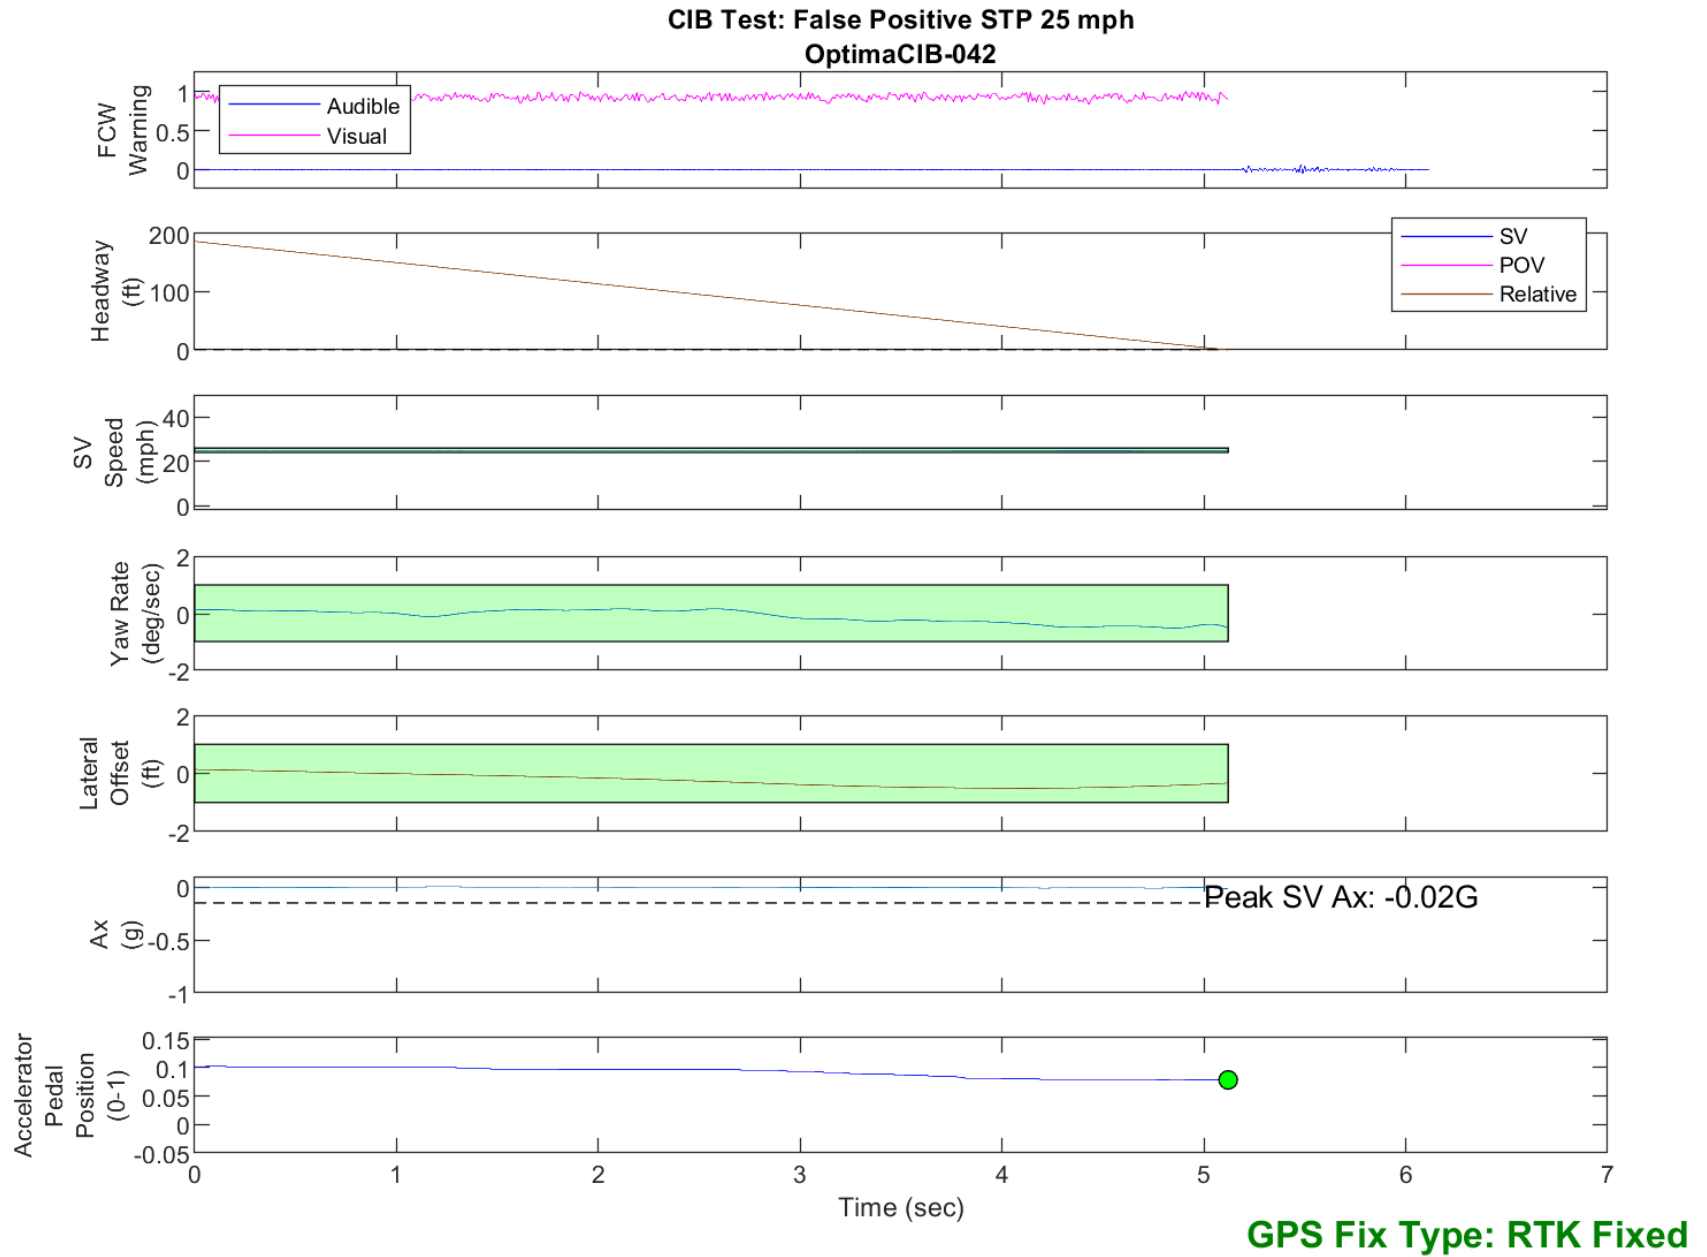
Figure D38. Time History for CIB Run 36, SV Encounters Steel Trench Plate, SV 25 mph

Figure D39. Time History for CIB Run 37, SV Encounters Steel Trench Plate, SV 25 mph

Figure D40. Time History for CIB Run 38, SV Encounters Steel Trench Plate, SV 25 mph

Figure D41. Time History for CIB Run 39, SV Encounters Steel Trench Plate, SV 25 mph

Figure D42. Time History for CIB Run 40, SV Encounters Steel Trench Plate, SV 25 mph

Figure D43. Time History for CIB Run 41, SV Encounters Steel Trench Plate, SV 25 mph

Figure D44. Time History for CIB Run 42, SV Encounters Steel Trench Plate, SV 25 mph

Run	Test Type	Valid Run?	FCW TTC (s)	Min. Distance (ft)	Speed Reduction (mph)	Peak Decel. (g)	CIB TTC (s)	Pass/Fail	Notes
30		Y	1.68	0.00	24.7	0.91	1.33	Pass	
31		Y	1.58	0.00	27.0	0.91	1.29	Pass	
32		Y	1.73	0.00	23.3	0.94	1.34	Pass	
33		Y	1.67	0.00	21.1	0.94	1.30	Pass	
34	Static Run								
35	STP - Static Run								
36	STP False Positive, 25	Y				0.02		Pass	
37		Y				0.01		Pass	
38		Y				0.01		Pass	
39		Y				0.01		Pass	
40		Y				0.02		Pass	
41		Y				0.01		Pass	
42		Y				0.02		Pass	
43	STP - Static Run
