**NEW CAR ASSESSMENT PROGRAM
CRASH IMMINENT BRAKING SYSTEM CONFIRMATION TEST
NCAP-DRI-CIB-20-08**

2020 Kia Optima EX

DYNAMIC RESEARCH, INC.
355 Van Ness Avenue, STE 200
Torrance, California 90501

Final Report

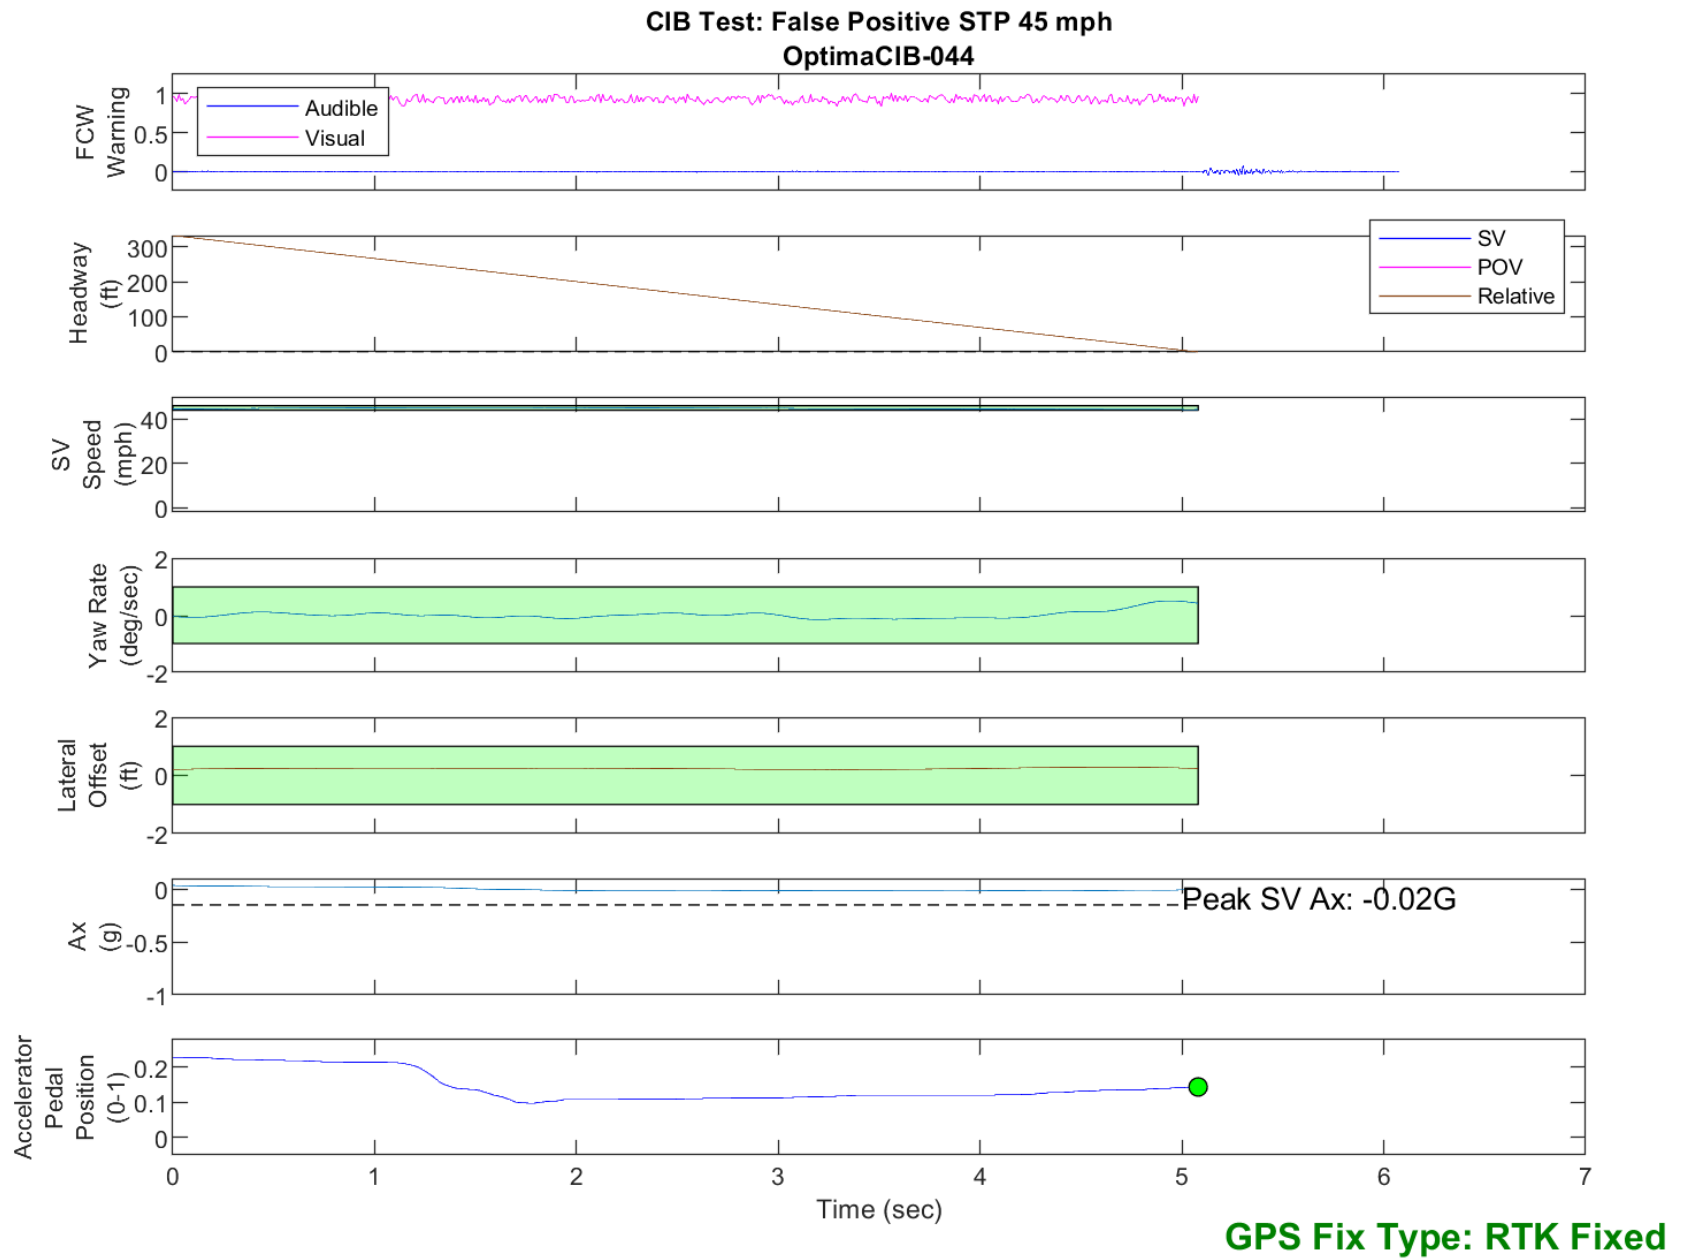
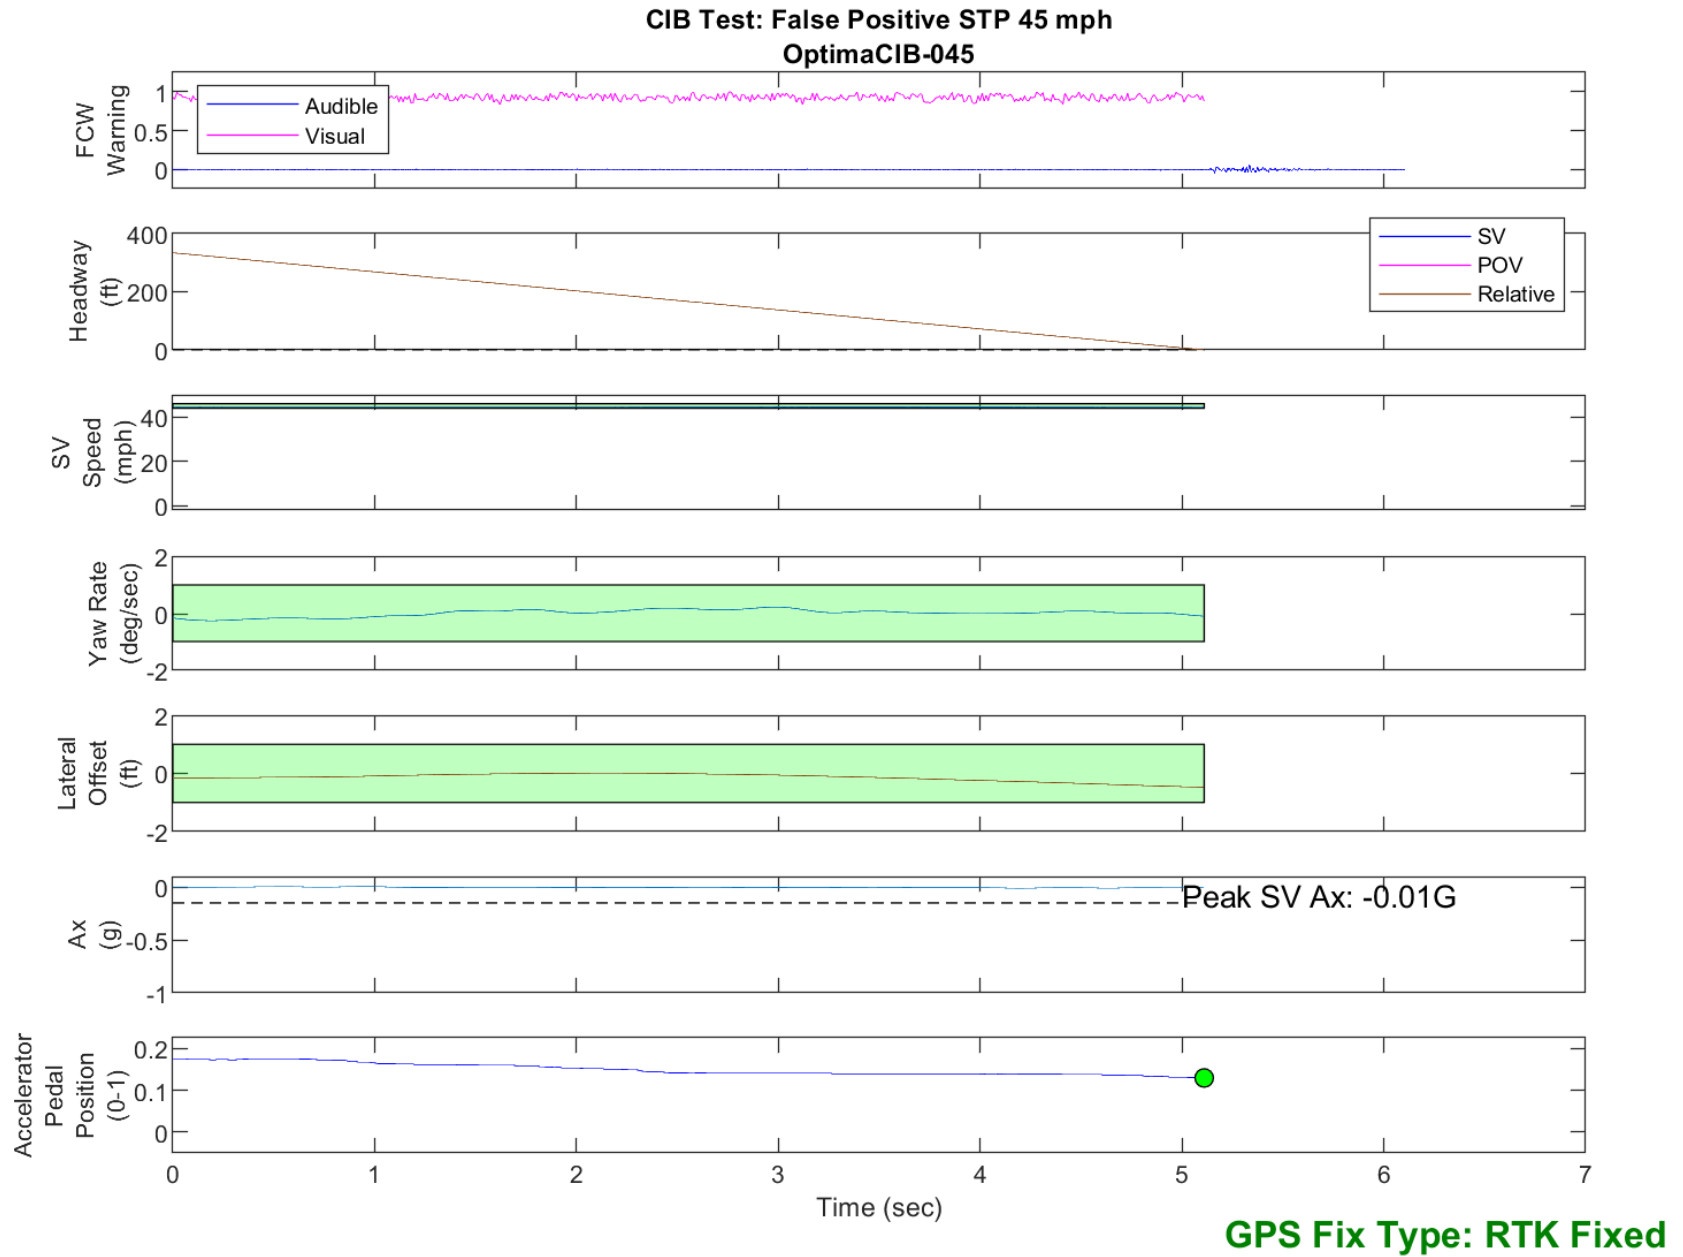
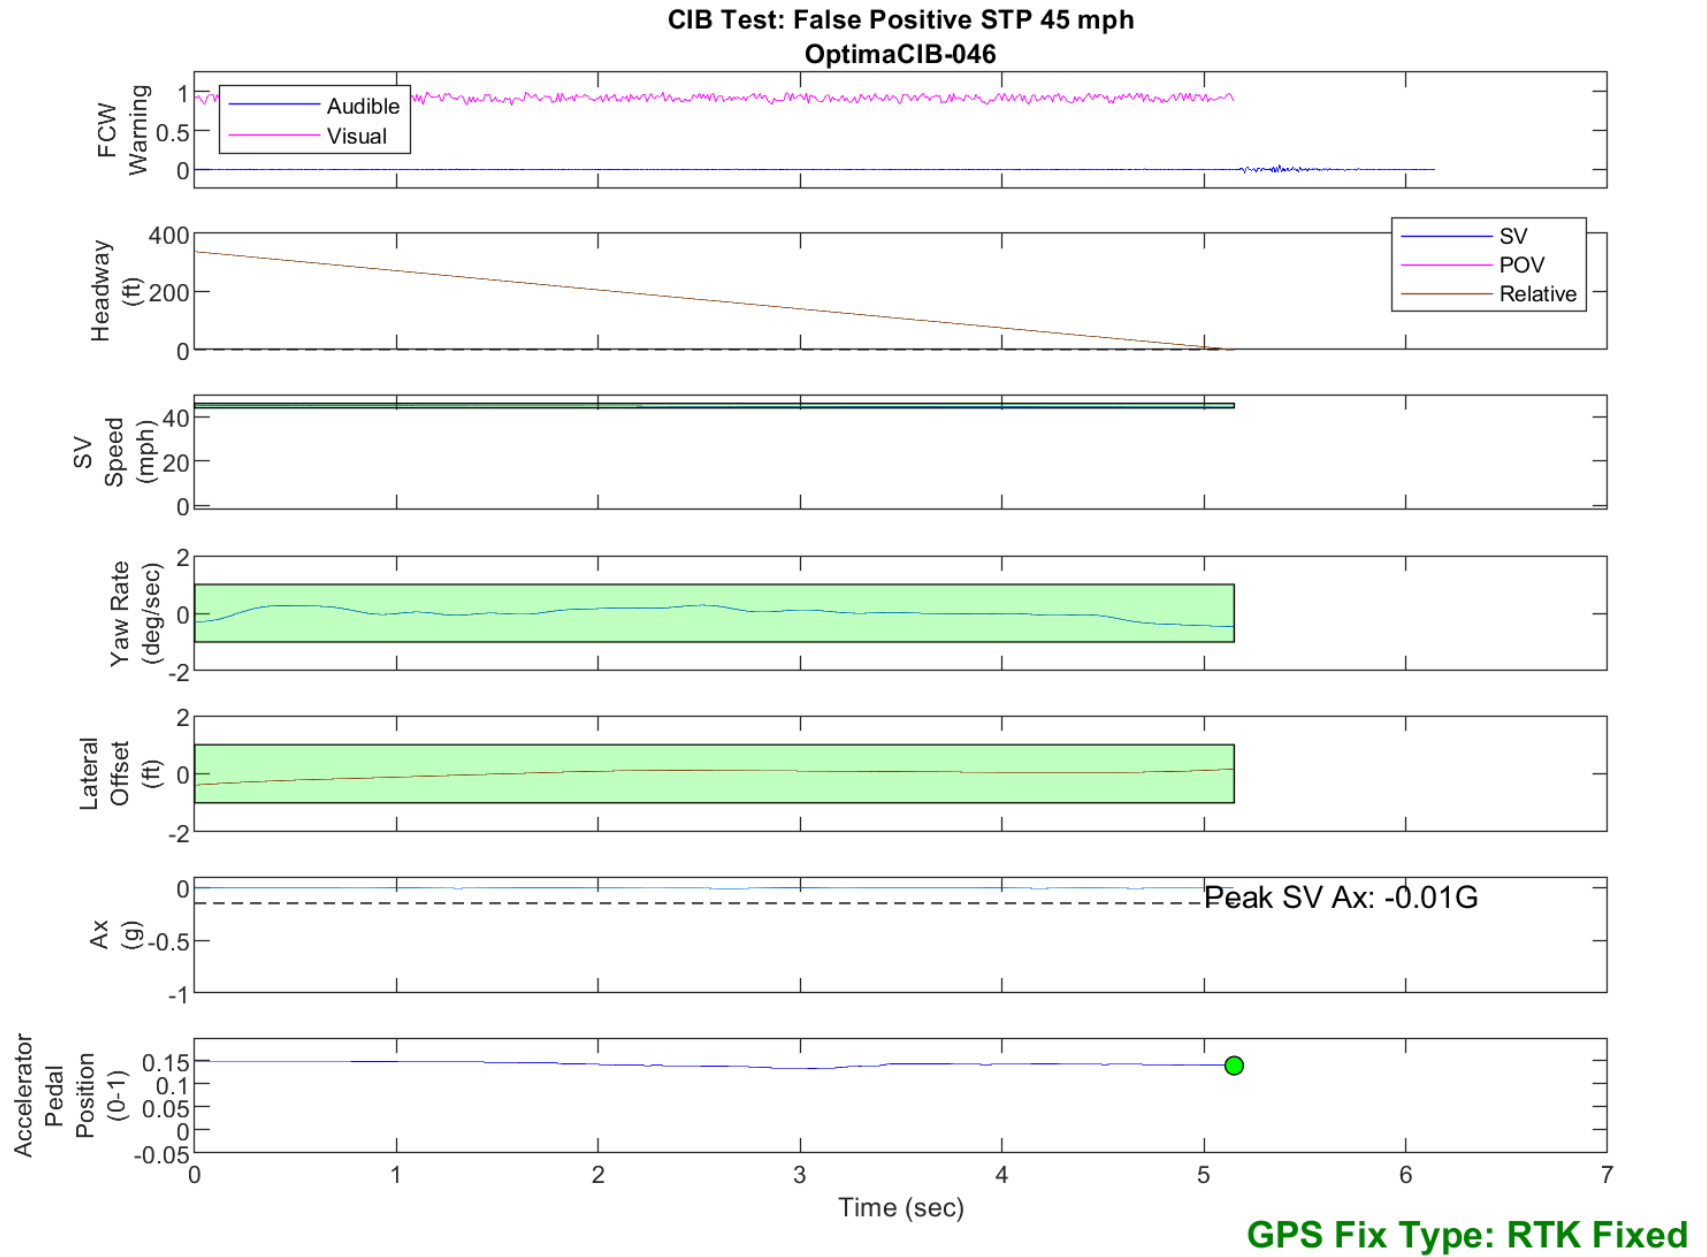
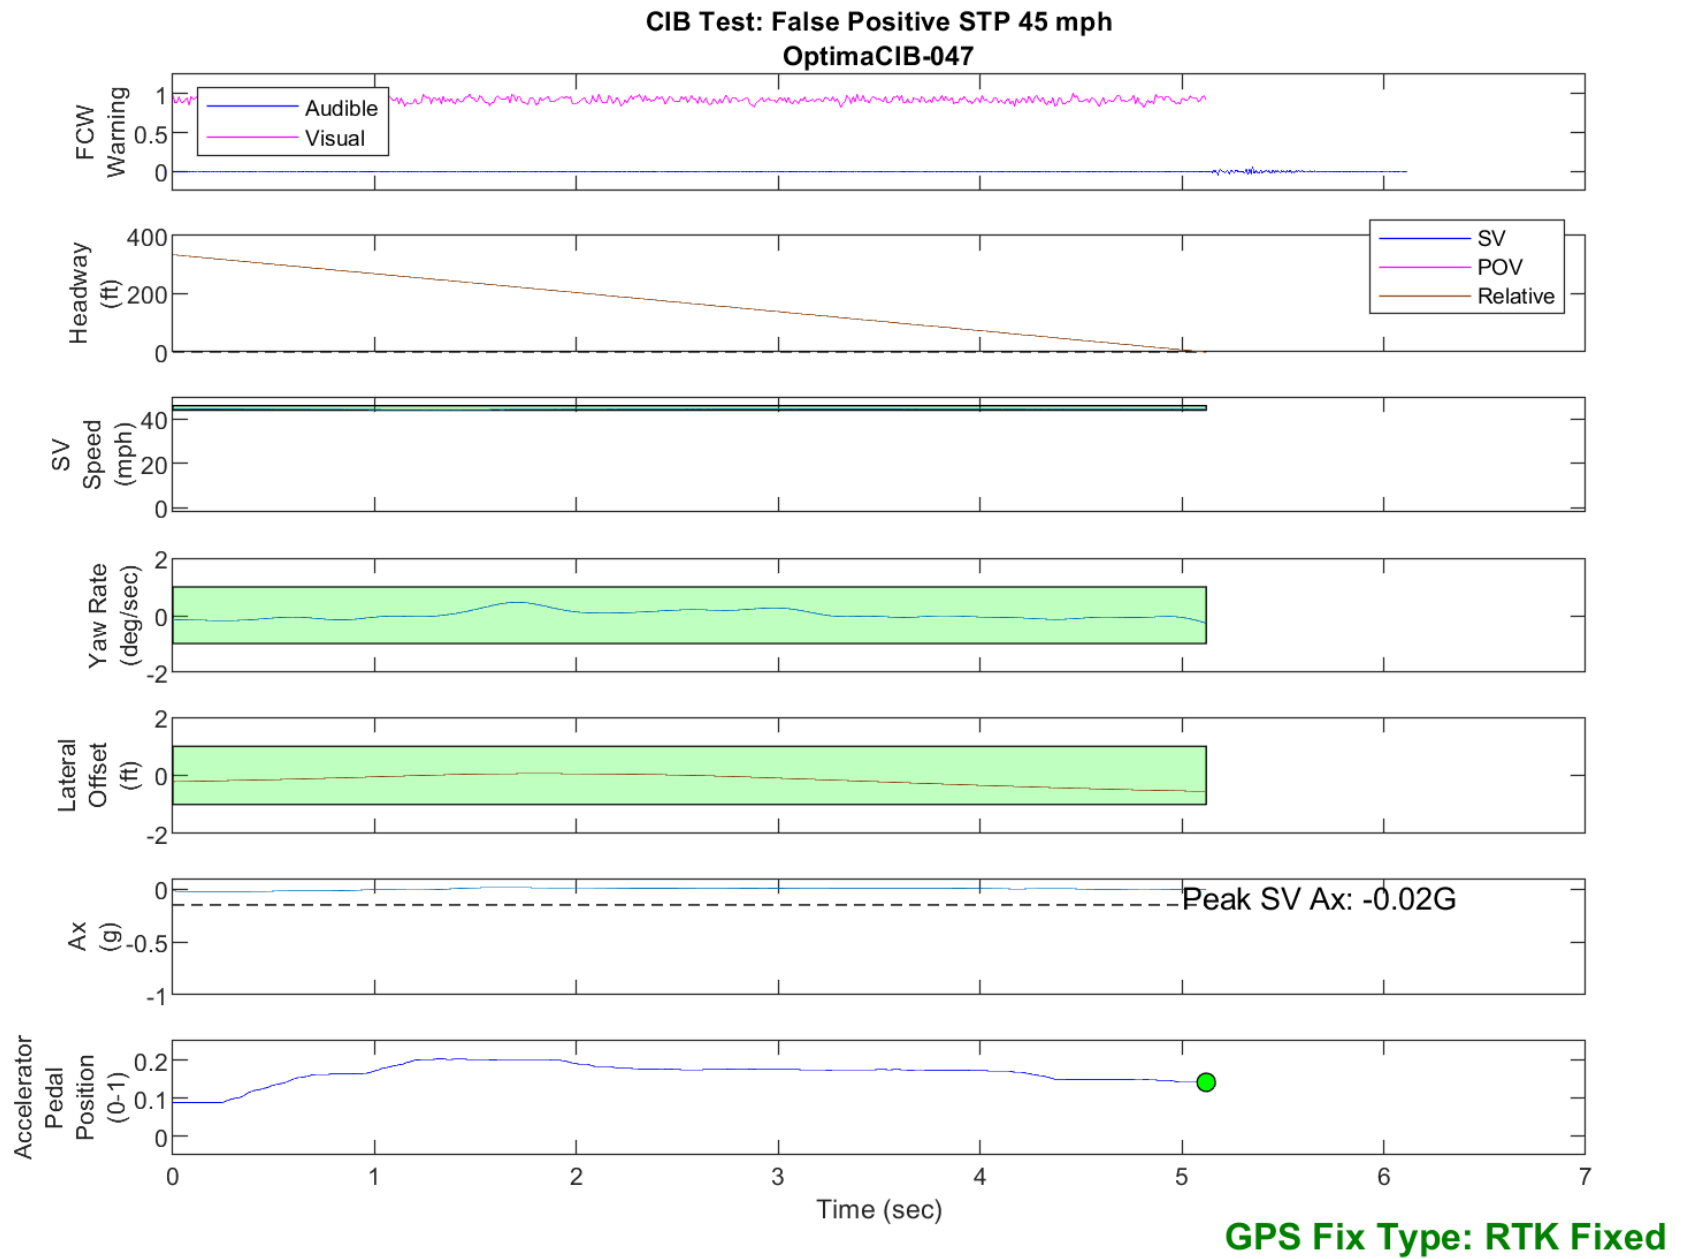
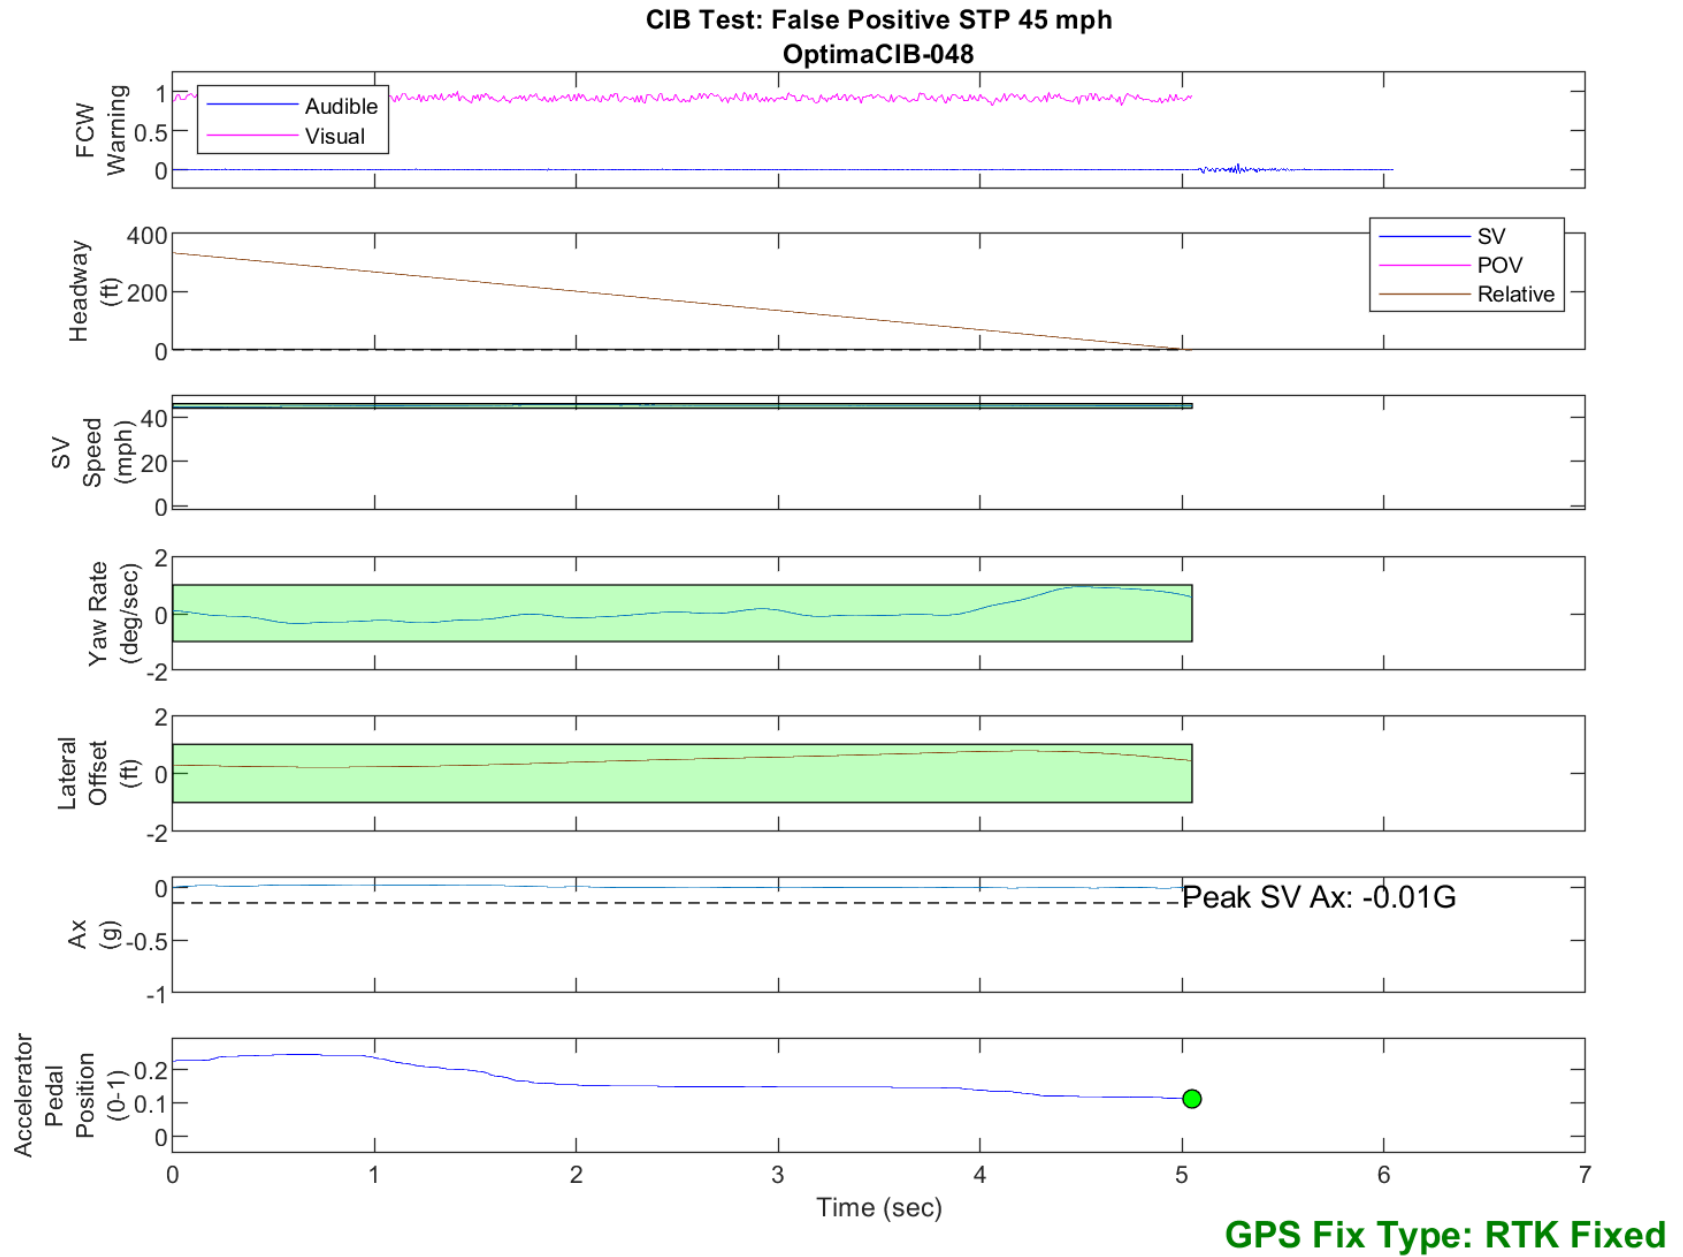
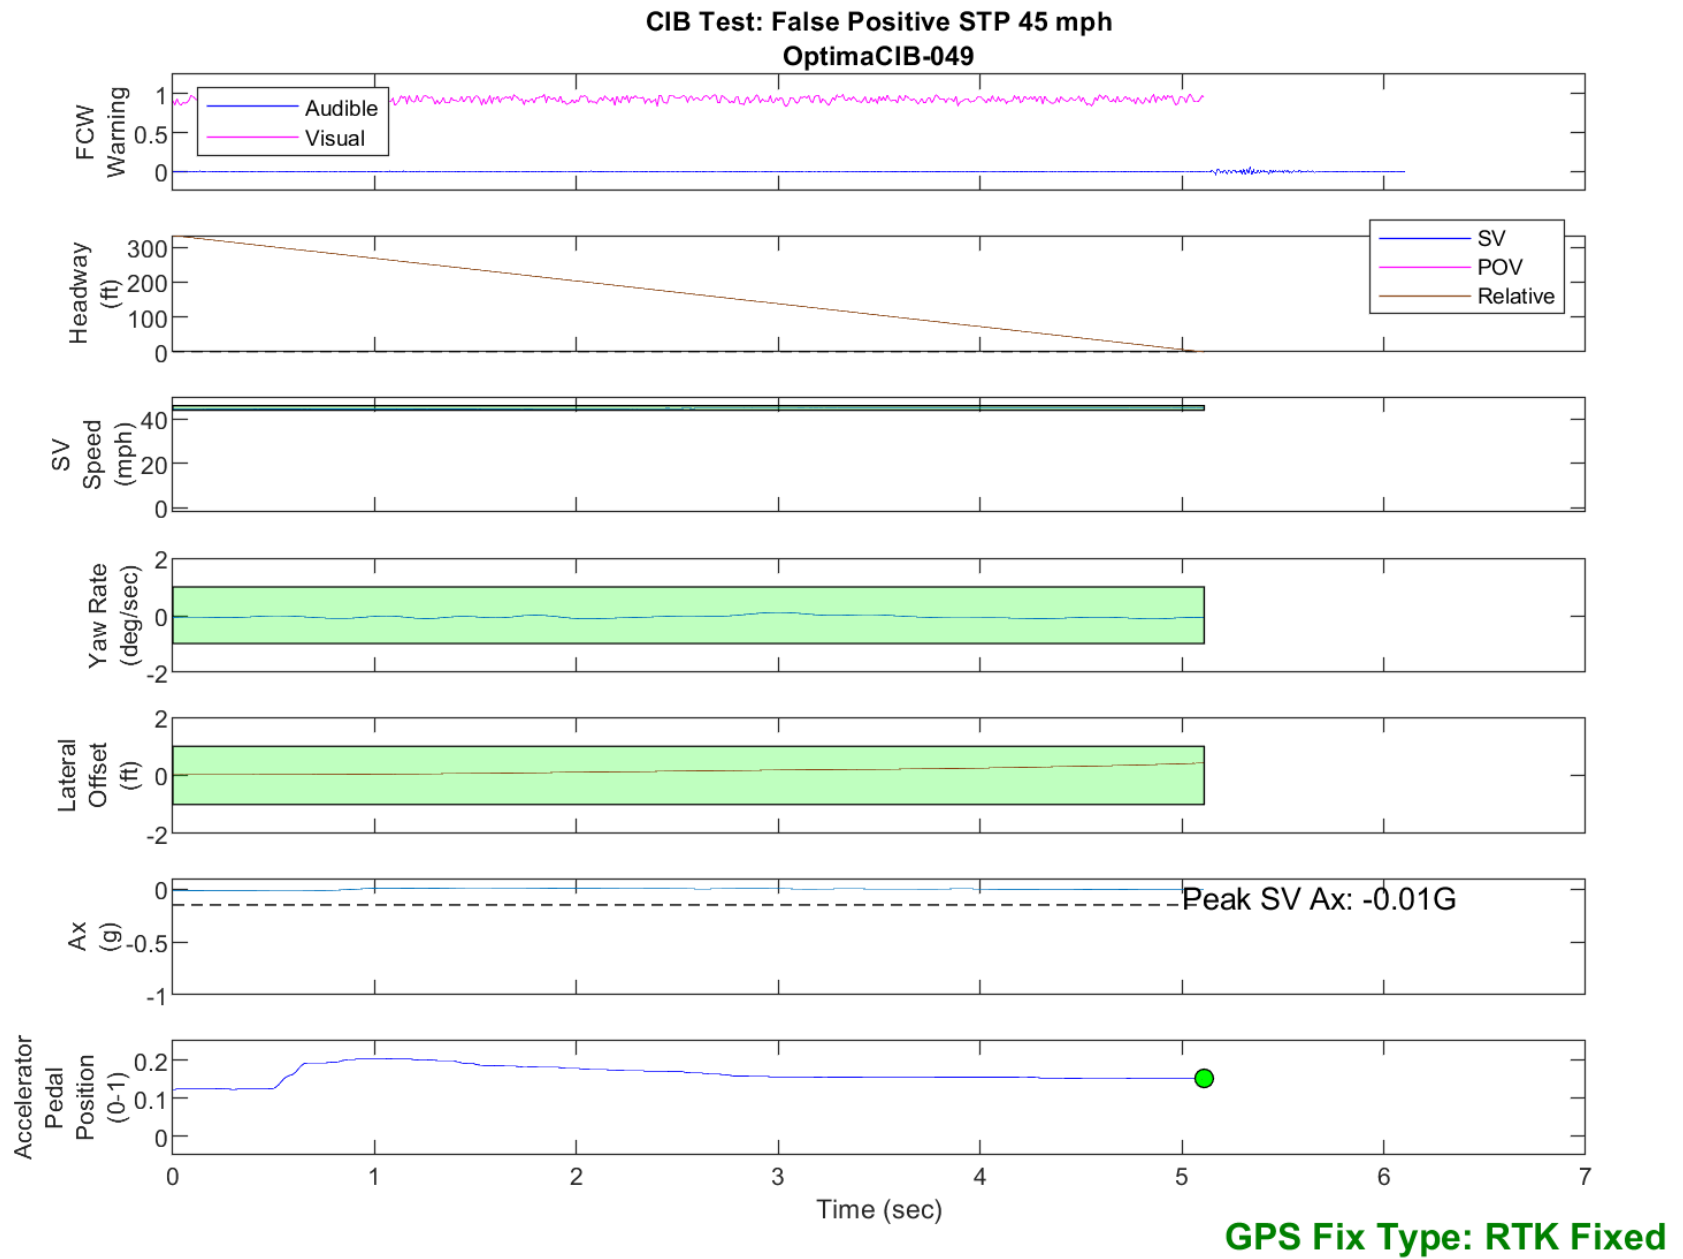
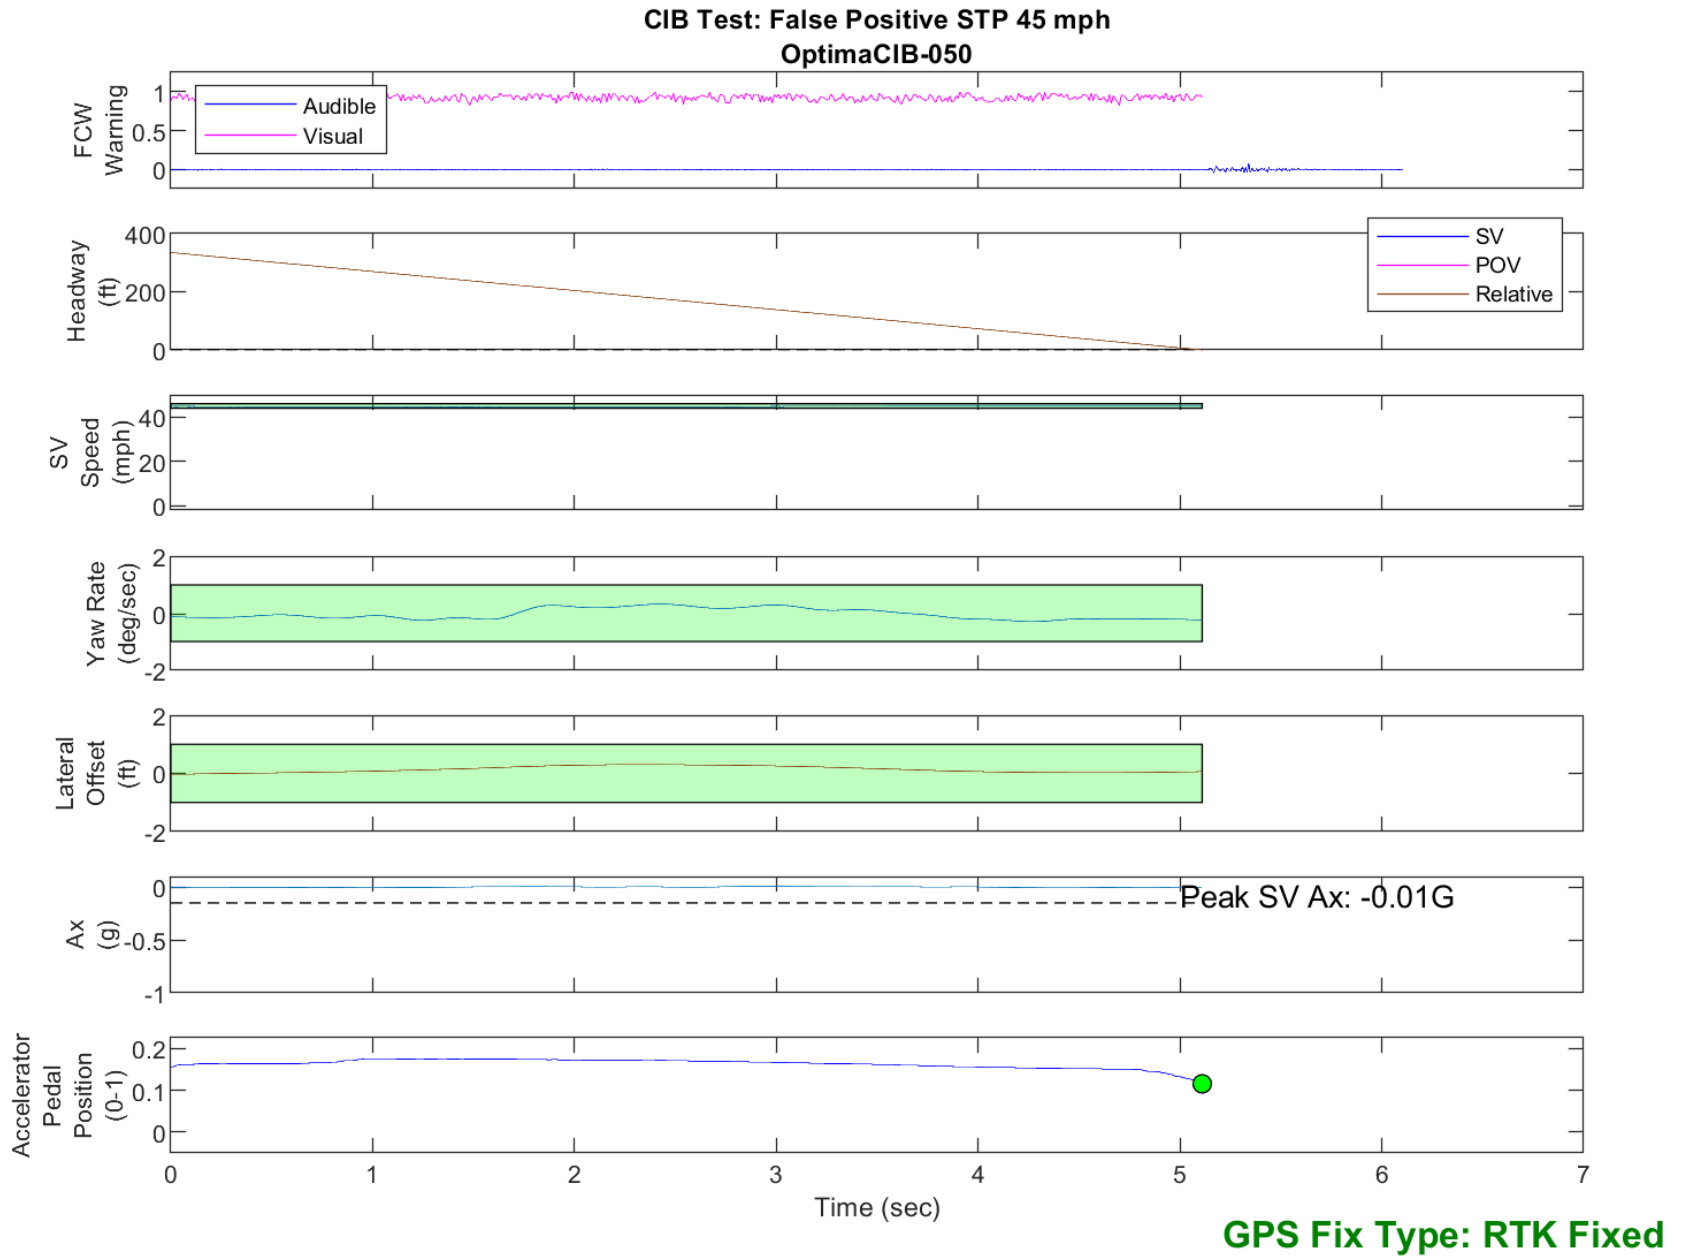
Figure D45. Time History for CIB Run 44, SV Encounters Steel Trench Plate, SV 45 mph

Figure D46. Time History for CIB Run 45, SV Encounters Steel Trench Plate, SV 45 mph

Figure D47. Time History for CIB Run 46, SV Encounters Steel Trench Plate, SV 45 mph

Figure D48. Time History for CIB Run 47, SV Encounters Steel Trench Plate, SV 45 mph

Figure D49. Time History for CIB Run 48, SV Encounters Steel Trench Plate, SV 45 mph

Figure D50. Time History for CIB Run 49, SV Encounters Steel Trench Plate, SV 45 mph

Figure D51. Time History for CIB Run 50, SV Encounters Steel Trench Plate, SV 45 mph

Run	Test Type	Valid Run?	FCW TTC (s)	Min. Distance (ft)	Speed Reduction (mph)	Peak Decel. (g)	CIB TTC (s)	Pass/Fail	Notes
44	STP False Positive, 45	Y				0.02		Pass	
45		Y				0.01		Pass	
46		Y				0.01		Pass	
47		Y				0.02		Pass	
48		Y				0.01		Pass	
49		Y				0.01		Pass	
50		Y				0.01		Pass	
51	STP - Static Run
