**REPORT NUMBER: SINCAP-CAL-20-012**

**NEW CAR ASSESSMENT PROGRAM (NCAP)  
MOVING DEFORMABLE BARRIER SIDE IMPACT TEST**

**Toyota Motor Manufacturing, Texas, INC  
2020 Toyota Tacoma Extended Cab  
Truck**

**NHTSA No: M20205105**

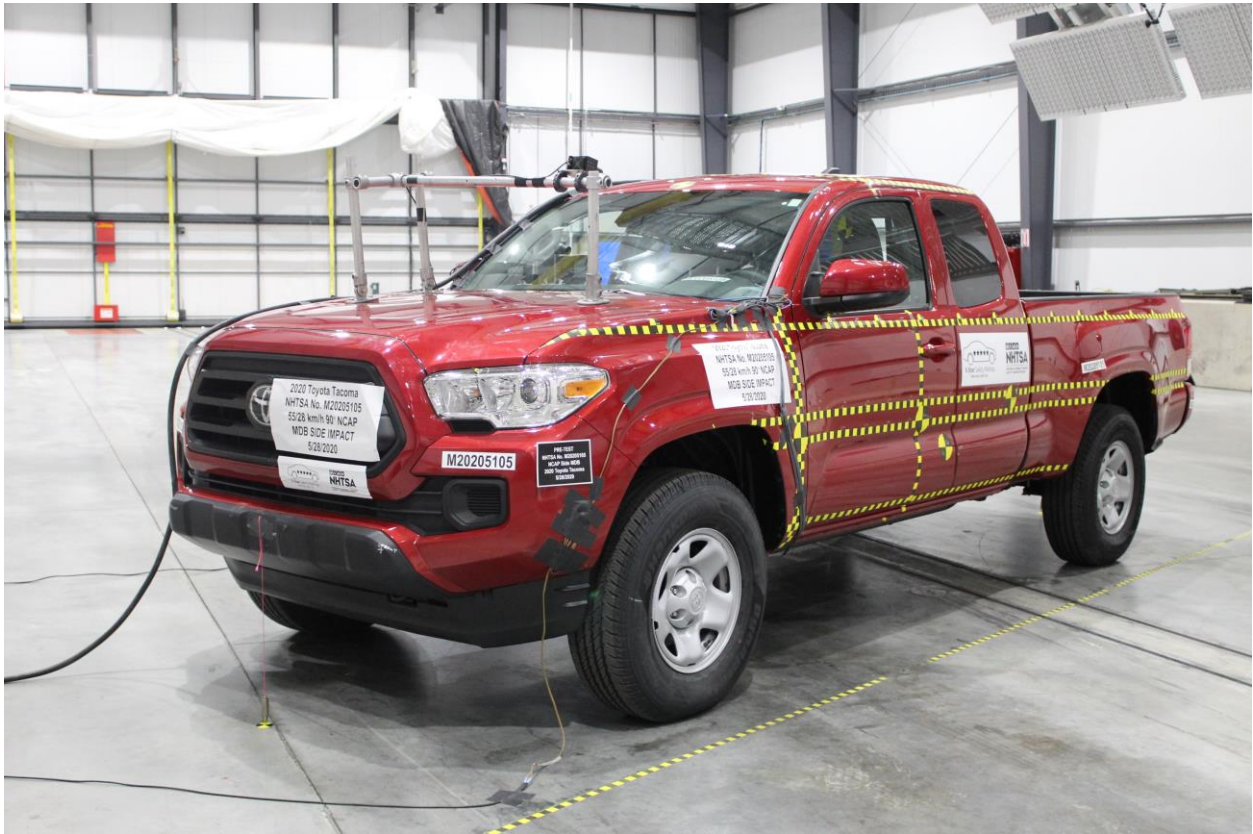
**Figure A-5: Pre-Test Left Front  $\frac{3}{4}$  View of Test Vehicle**

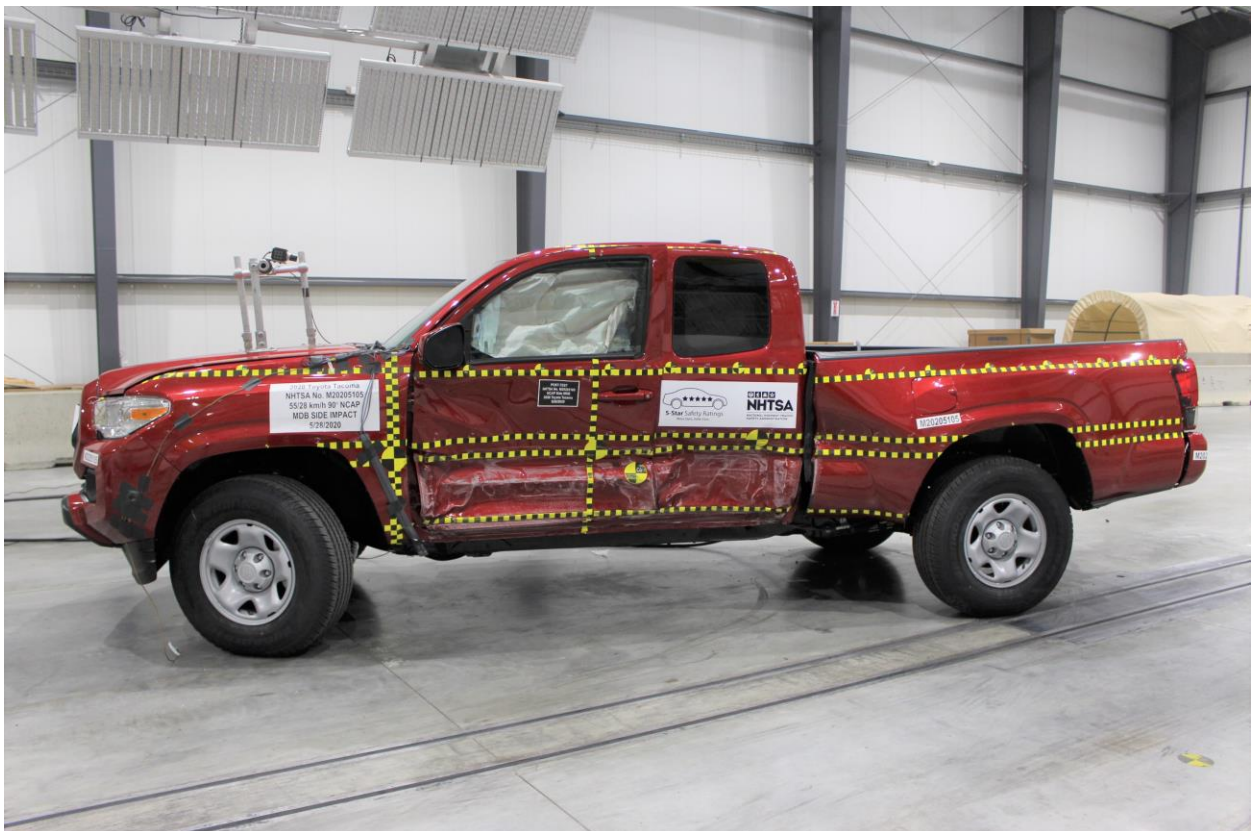
**Figure A-8: Post-Test Left Side View of Test Vehicle**

Critical Areas of Performance	Observations and Conclusions
Pillar Performance	B-Pillar Buckled
Sill Separation	None
Windshield Damage	None
Side Window Damage	None
Other Notable Effects	None

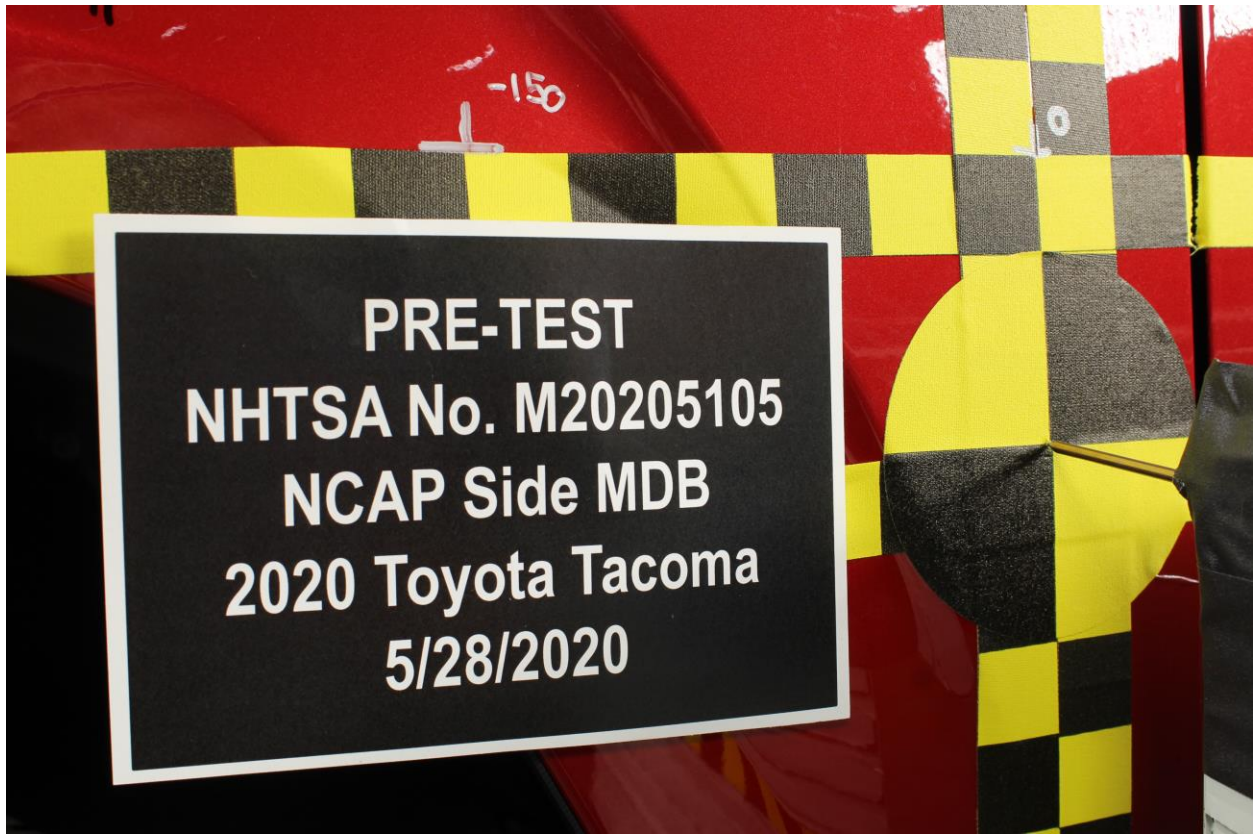
**Figure A-19: Pre-Test Close-up View of Impact Point Target**

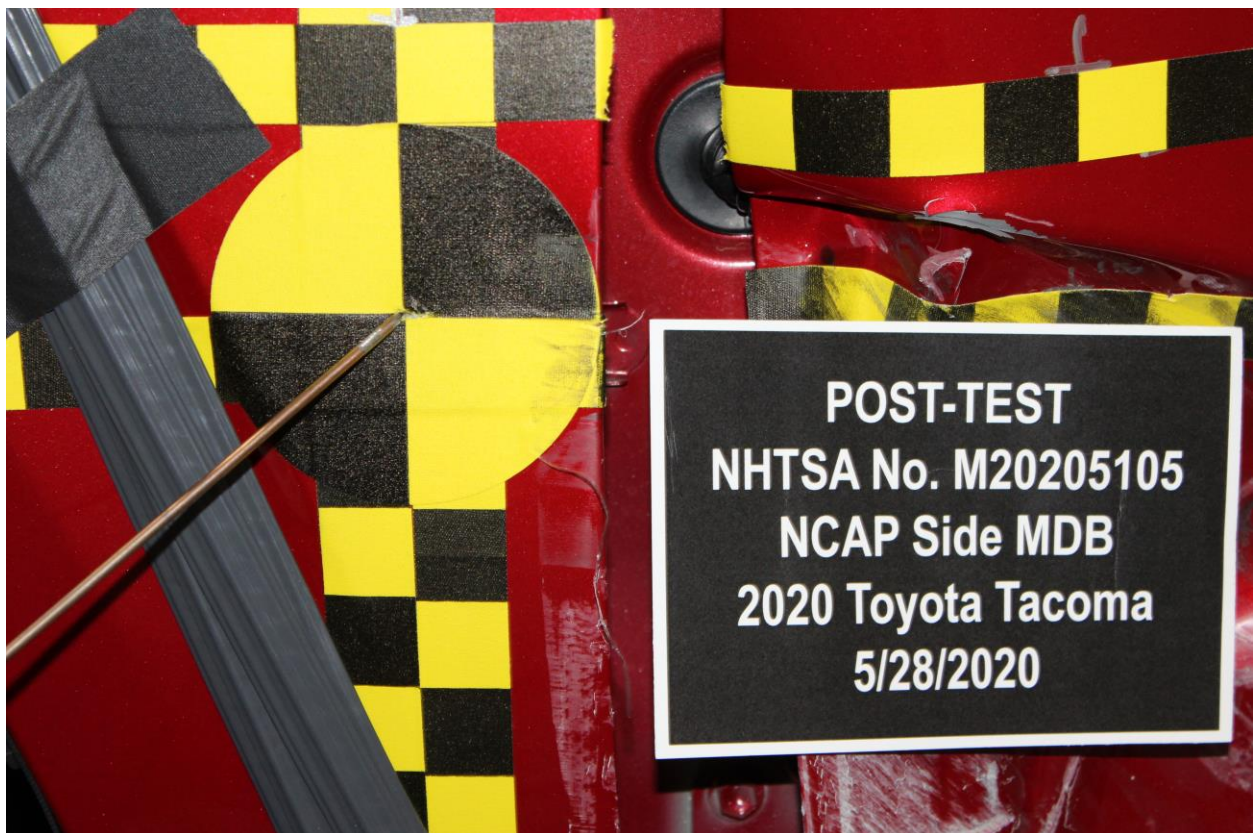
**Figure A-20: Post-Test Close-up View of Impact Point Target**

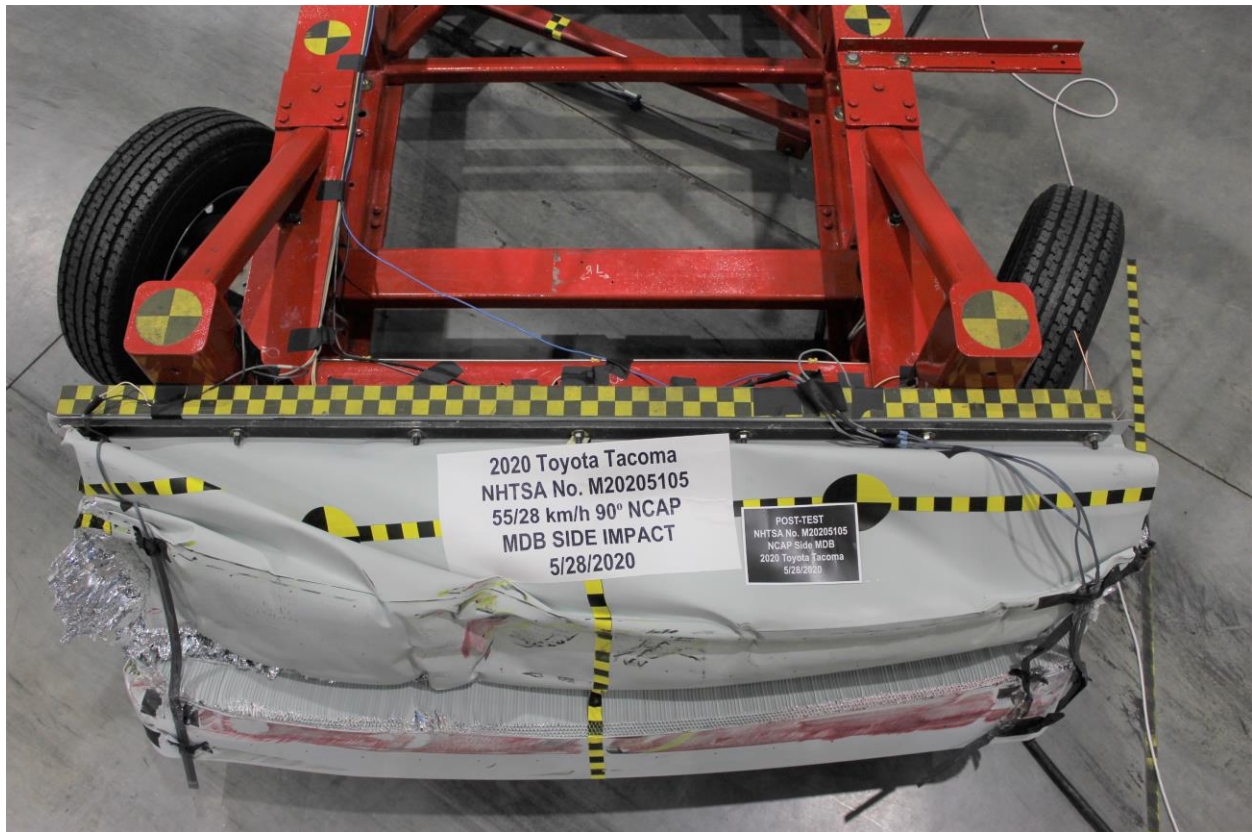
**Figure A-87: Post-Test Top View of MDB Impactor Face**

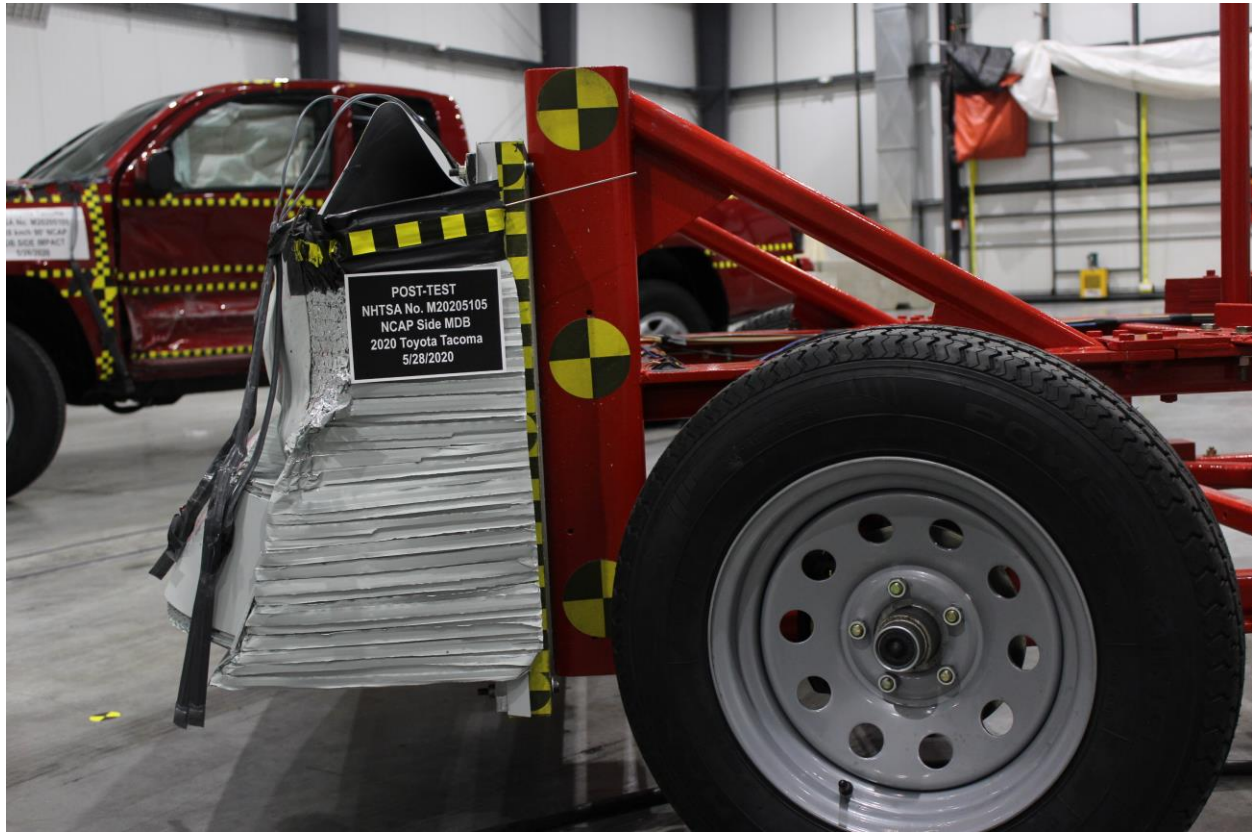
**Figure A-89: Post-Test Left Side View of MDB Impactor Face**

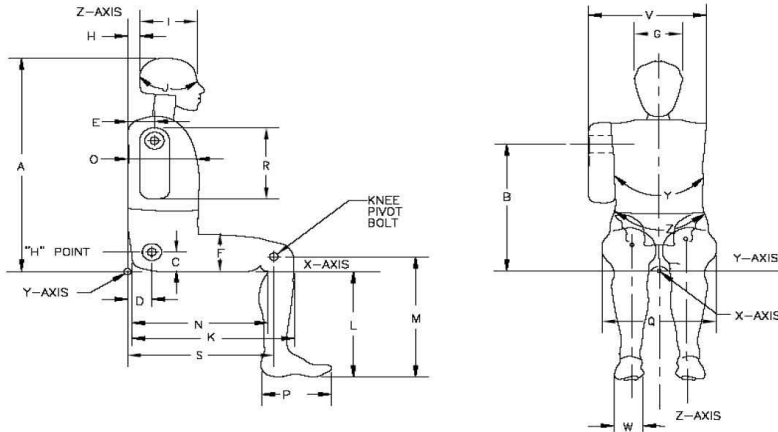
Symbol	Description	Specification (mm)		Result (mm)	Pass/Fail
A	Sitting Height	772	788	779	Pass
B	Shoulder Pivot Height	437	453	446	Pass
C	H-point Height	79	89	85	Pass
D	H-point from seatback	141	151	146	Pass
E	Shoulder Pivot from Backline	97	107	103	Pass
F	Thigh Clearance	119	135	125	Pass
G	Head Breadth	140	148	144	Pass
H	Head Back from Backline	40	46	43	Pass
I	Head Depth	178	188	183	Pass
J	Head Circumference	541	551	547	Pass
K	Buttock to Knee Length	514	540	537	Pass
L	Popliteal Height	343	369	357	Pass
M	Knee Pivot to floor height	392	409	405	Pass
N	Buttock Popliteal Length	416	442	433	Pass
O	Chest Depth w/o jacket	195	211	205	Pass
P	Foot Length	216	232	224	Pass
Q	Hip Breadth (w/pelvic plugs)	313	323	319	Pass
R	Arm Length	249	259	255	Pass
S	Knee Joint to seatback	477	493	487	Pass
V	Shoulder Width	341	357	346	Pass
W	Foot Width	78	94	85	Pass
Y	Chest Circumference w/jacket	851	881	867	Pass
Z	Waist Circumference	761	791	781	Pass

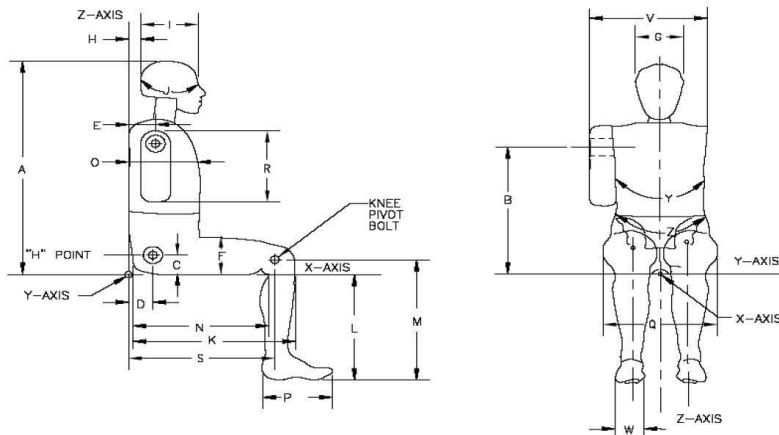
Symbol	Description	Specification (mm)		Result (mm)	Pass/Fail
A	Sitting Height	772	788	779	Pass
B	Shoulder Pivot Height	437	453	446	Pass
C	H-point Height	79	89	84	Pass
D	H-point from seatback	141	151	146	Pass
E	Shoulder Pivot from Backline	97	107	103	Pass
F	Thigh Clearance	119	135	127	Pass
G	Head Breadth	140	148	144	Pass
H	Head Back from Backline	40	46	43	Pass
I	Head Depth	178	188	183	Pass
J	Head Circumference	541	551	547	Pass
K	Buttock to Knee Length	514	540	537	Pass
L	Popliteal Height	343	369	357	Pass
M	Knee Pivot to floor height	392	409	403	Pass
N	Buttock Popliteal Length	416	442	433	Pass
O	Chest Depth w/o jacket	195	211	205	Pass
P	Foot Length	216	232	224	Pass
Q	Hip Breadth (w/pelvic plugs)	313	323	319	Pass
R	Arm Length	249	259	255	Pass
S	Knee Joint to seatback	477	493	487	Pass
V	Shoulder Width	341	357	346	Pass
W	Foot Width	78	94	85	Pass
Y	Chest Circumference w/jacket	851	881	867	Pass
Z	Waist Circumference	761	791	781	Pass
