REPORT NUMBER: SPNCAP-CAL-20-012

**NEW CAR ASSESSMENT PROGRAM (NCAP)
SIDE IMPACT POLE TEST**

**Toyota Motor Manufacturing, Texas, INC.
2020 Toyota Tacoma Extended Cab
Truck**

FINAL REPORT

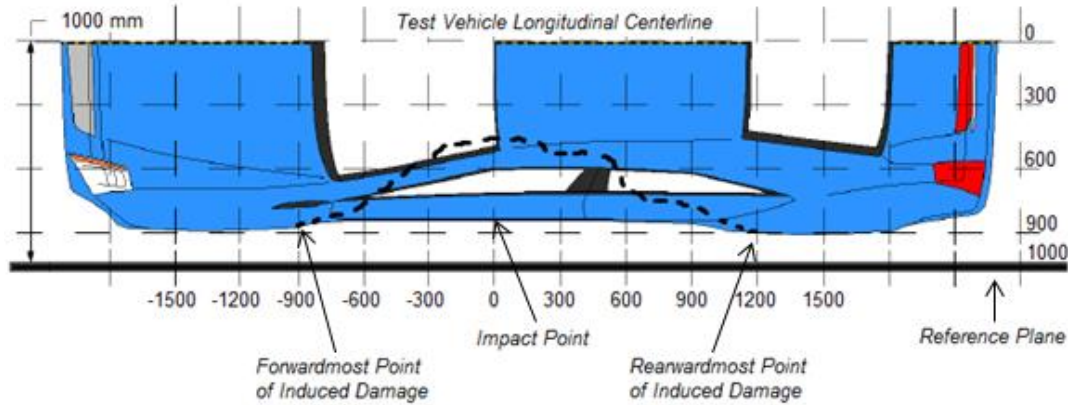
Overhead View

For guidance regarding damage profile distance measurements, please refer to the latest version of the *NHTSA Test Reference Guide, Volume 1: Vehicle Tests*.

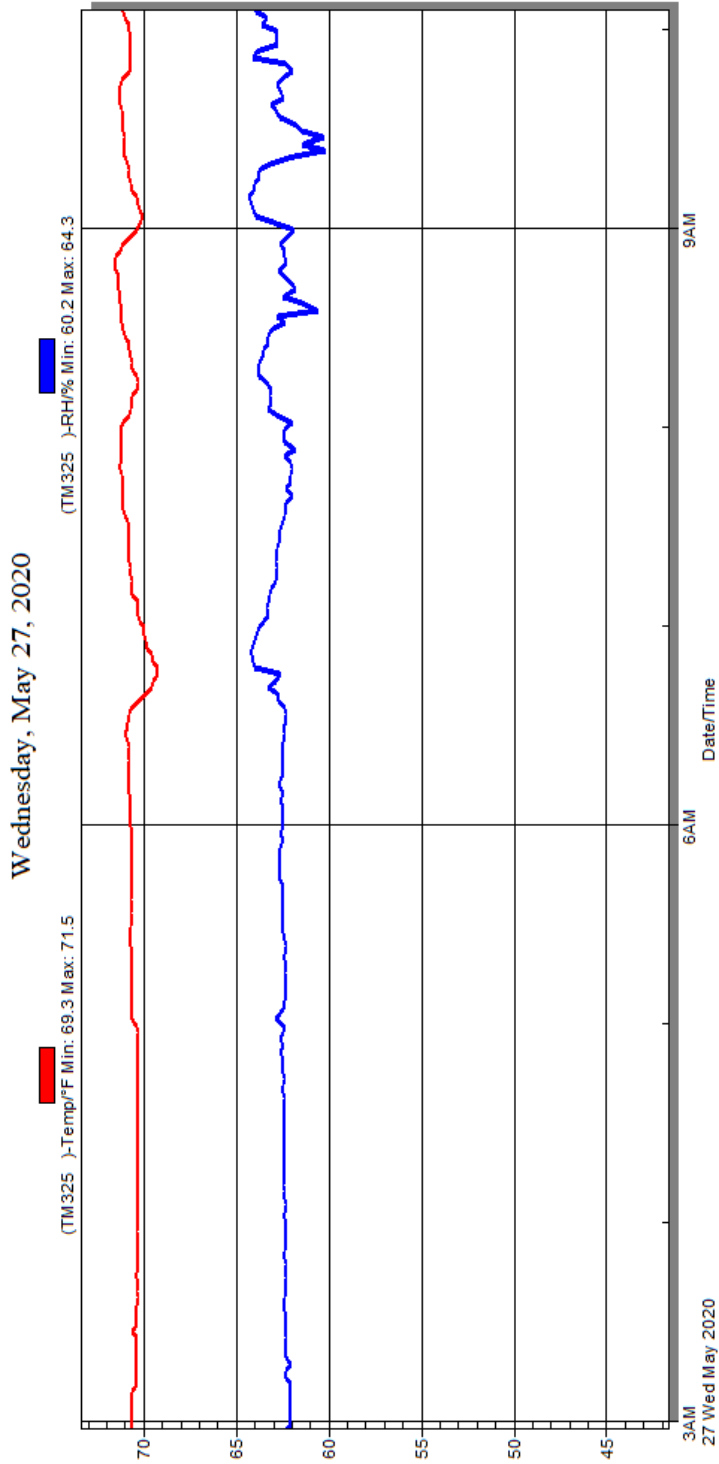
Temperature and Humidity Stabilization Chart / Data for Dummies and Test Vehicle

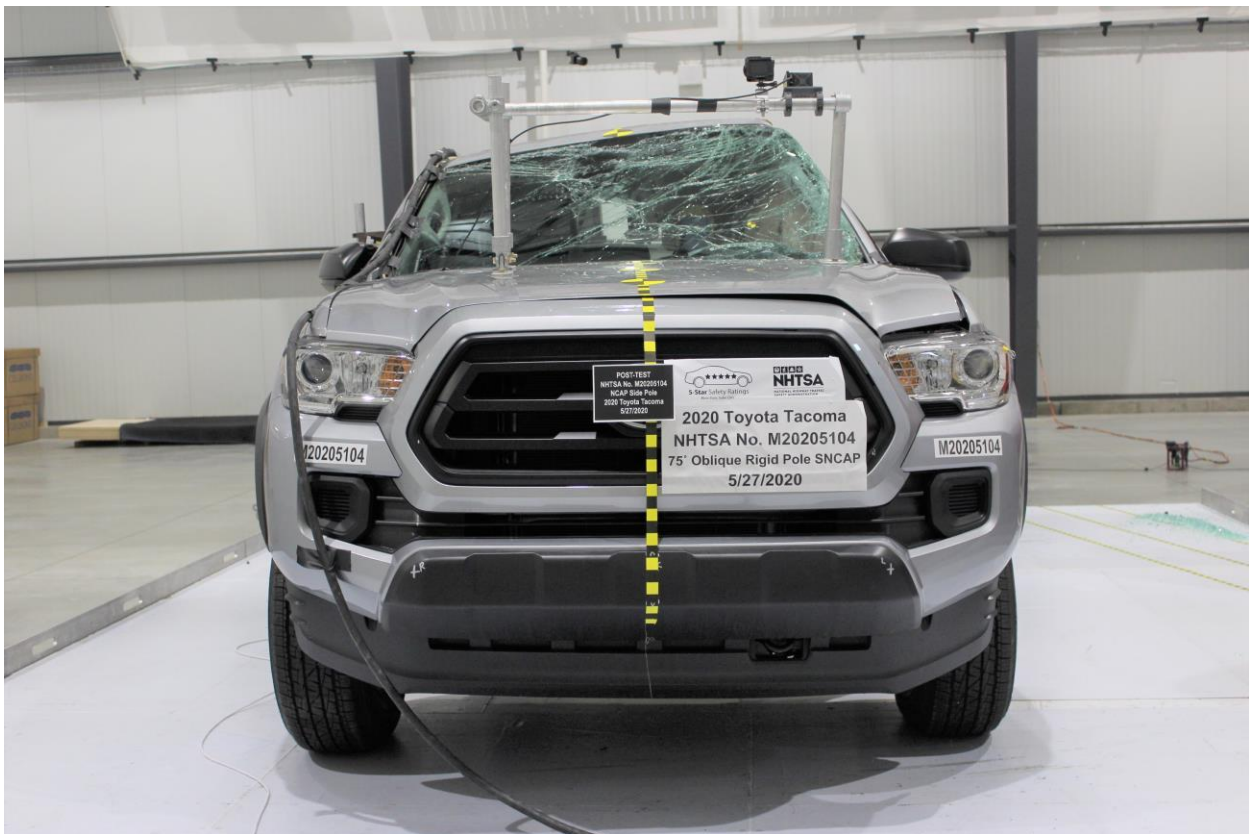
Figure A-4: Post-Test Frontal View of Test Vehicle

Critical Areas of Performance	Observations and Conclusions
Pillar Performance	A-Pillar Buckled
Sill Separation	None
Windshield Damage	Cracks Throughout
Side Window Damage	Driver Window Shattered
Other Notable Effects	Truck bed shifted during event a substantial amount

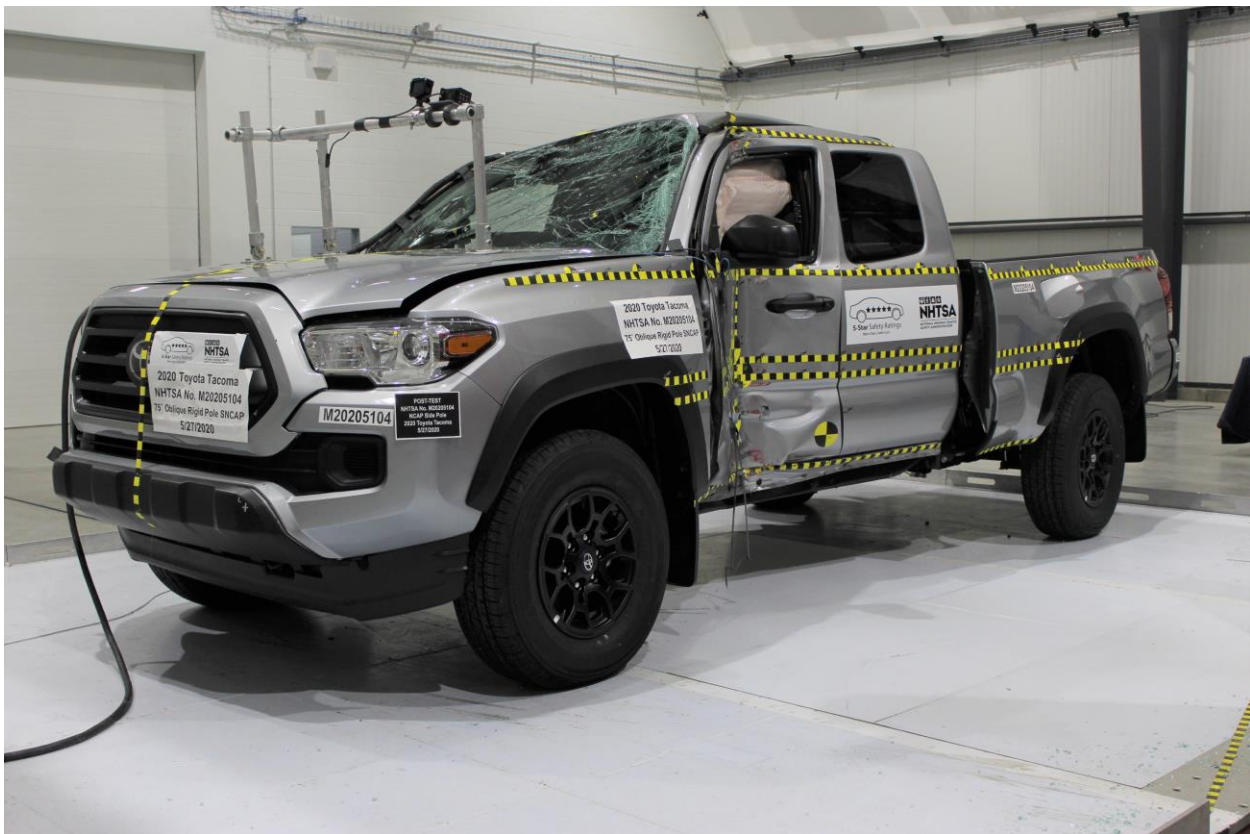
Figure A-6: Post-Test Left Front ¾ View of Test Vehicle

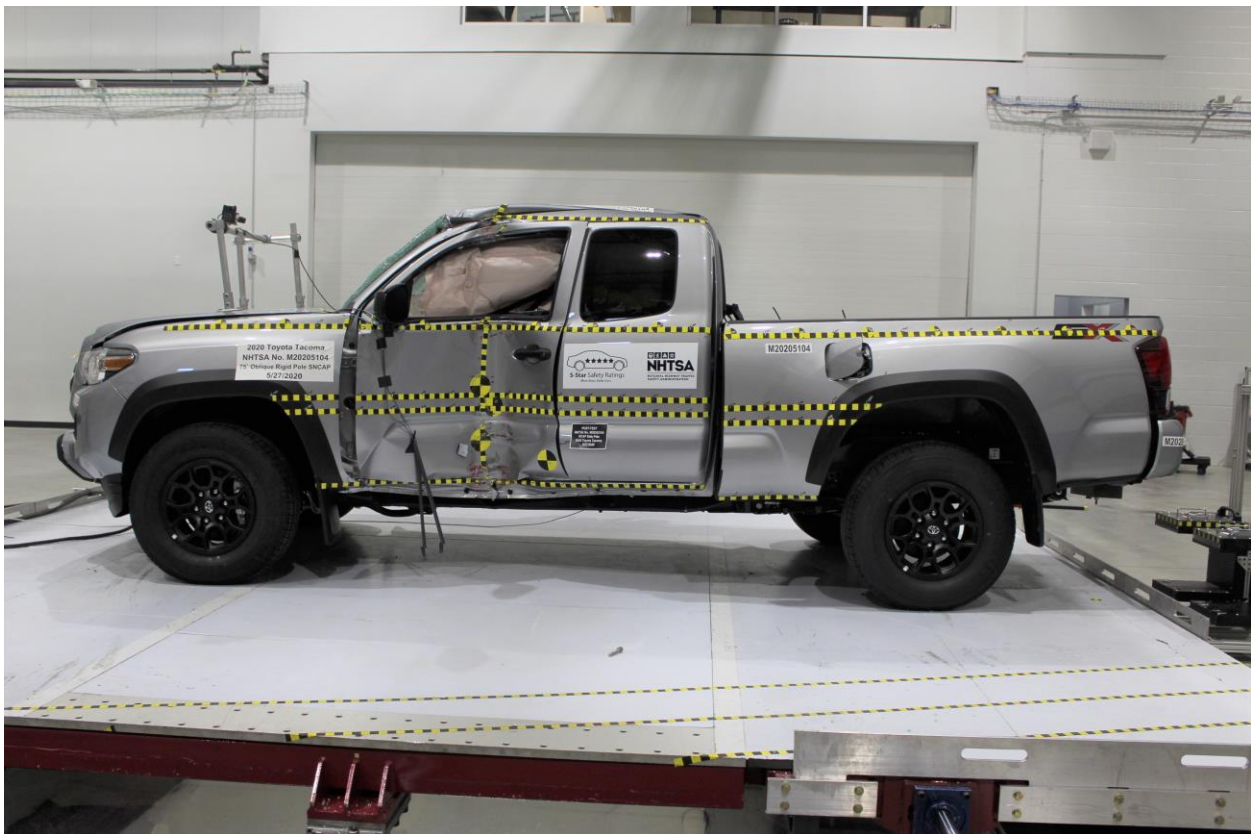
Figure A-8: Post-Test Left Side View of Test Vehicle

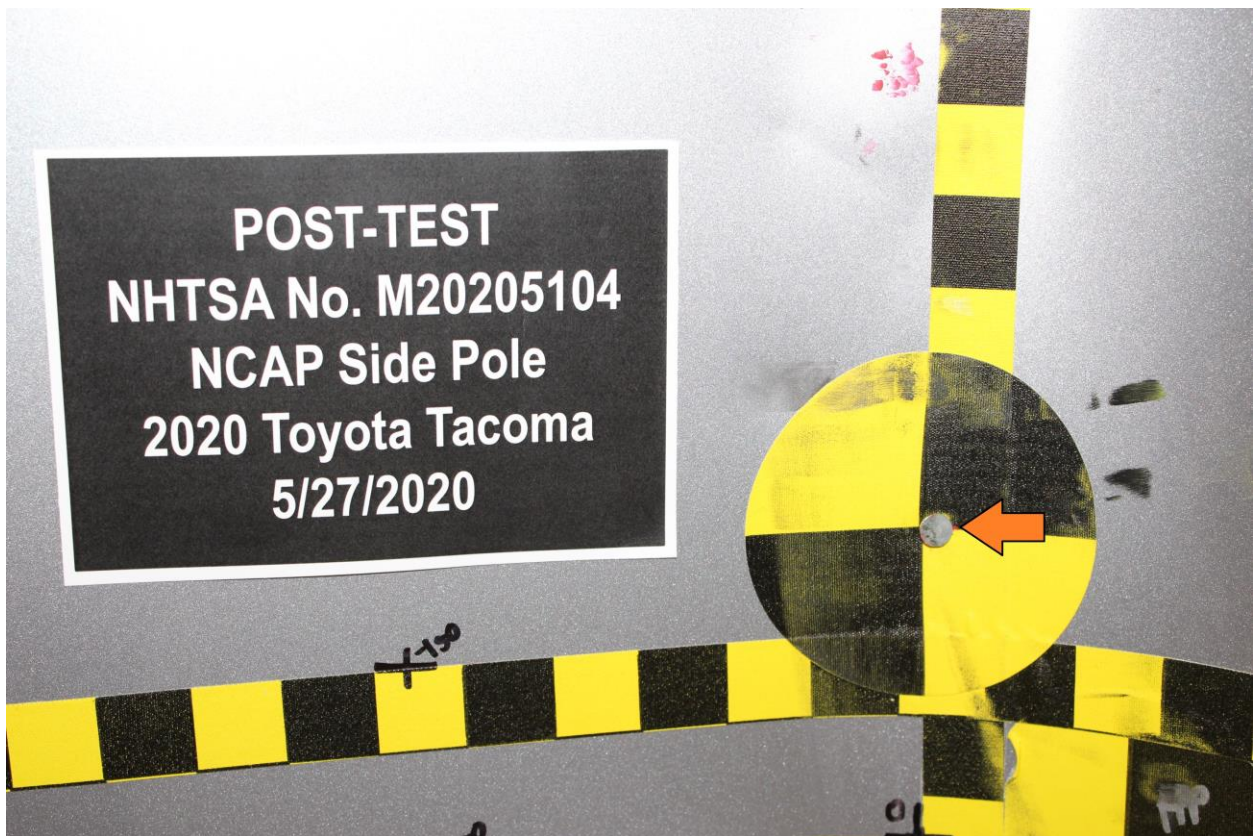
Figure A-20: Post-Test Close-Up View of Impact Point Target Showing Impact Location

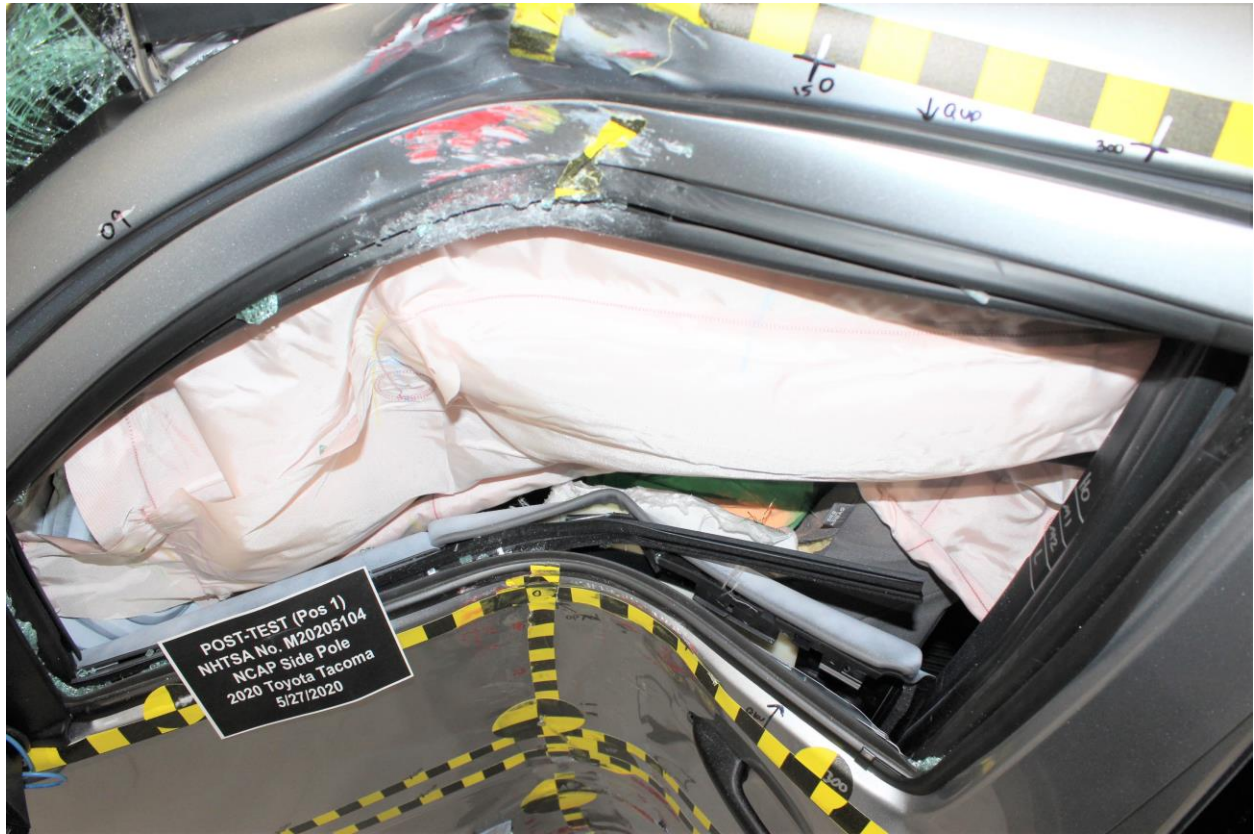
Figure A-41: Post-Test Dummy and Door Clearance View

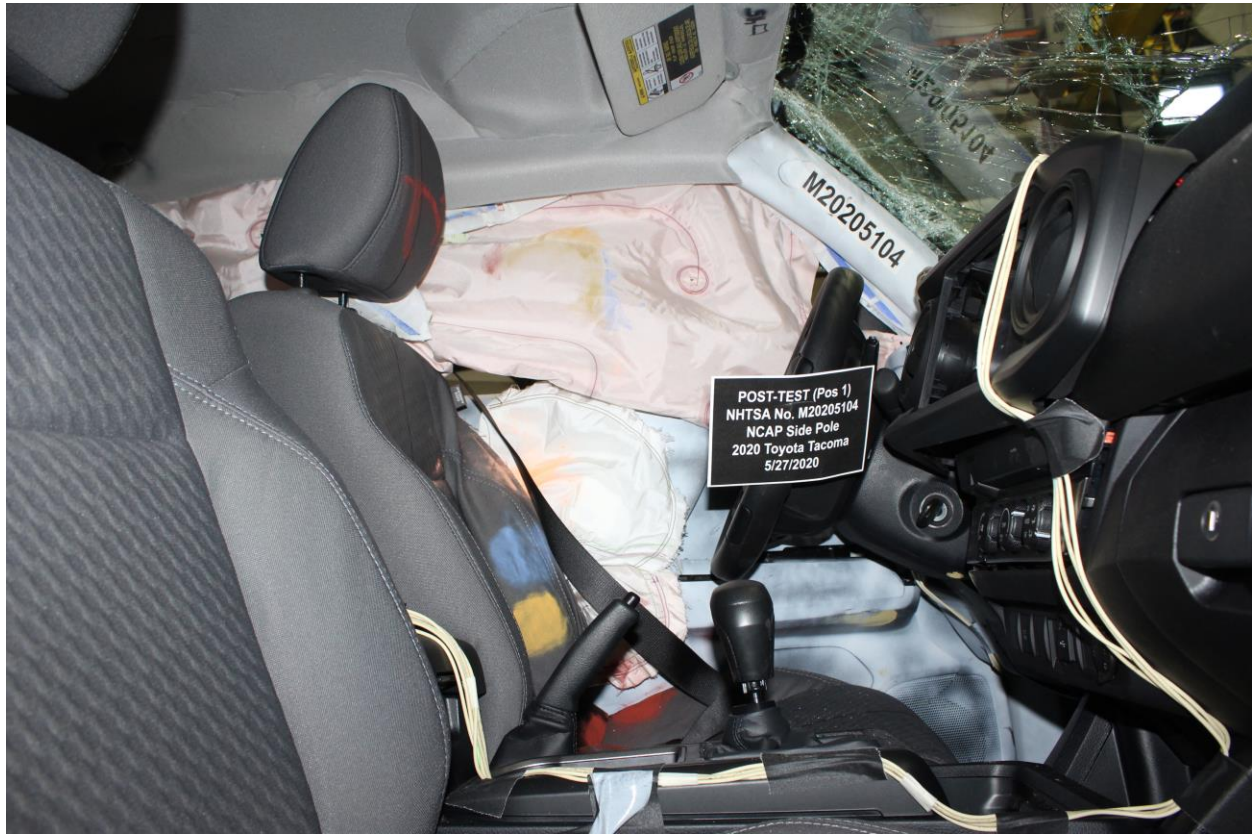
Figure A-45: Post-Test Inner Door Panel View Showing Dummy Contact Location

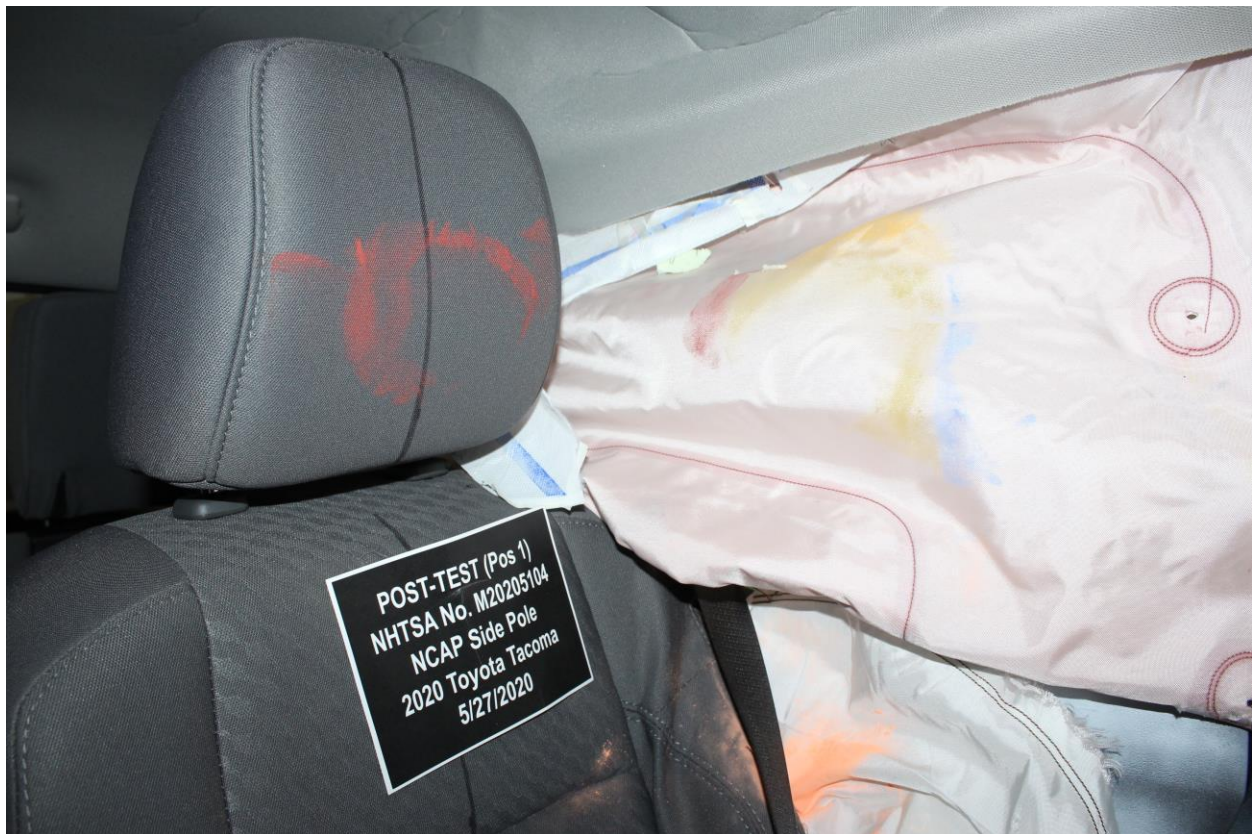
Figure A-46: Post-Test Dummy Close-Up Head Contact with Vehicle Interior View

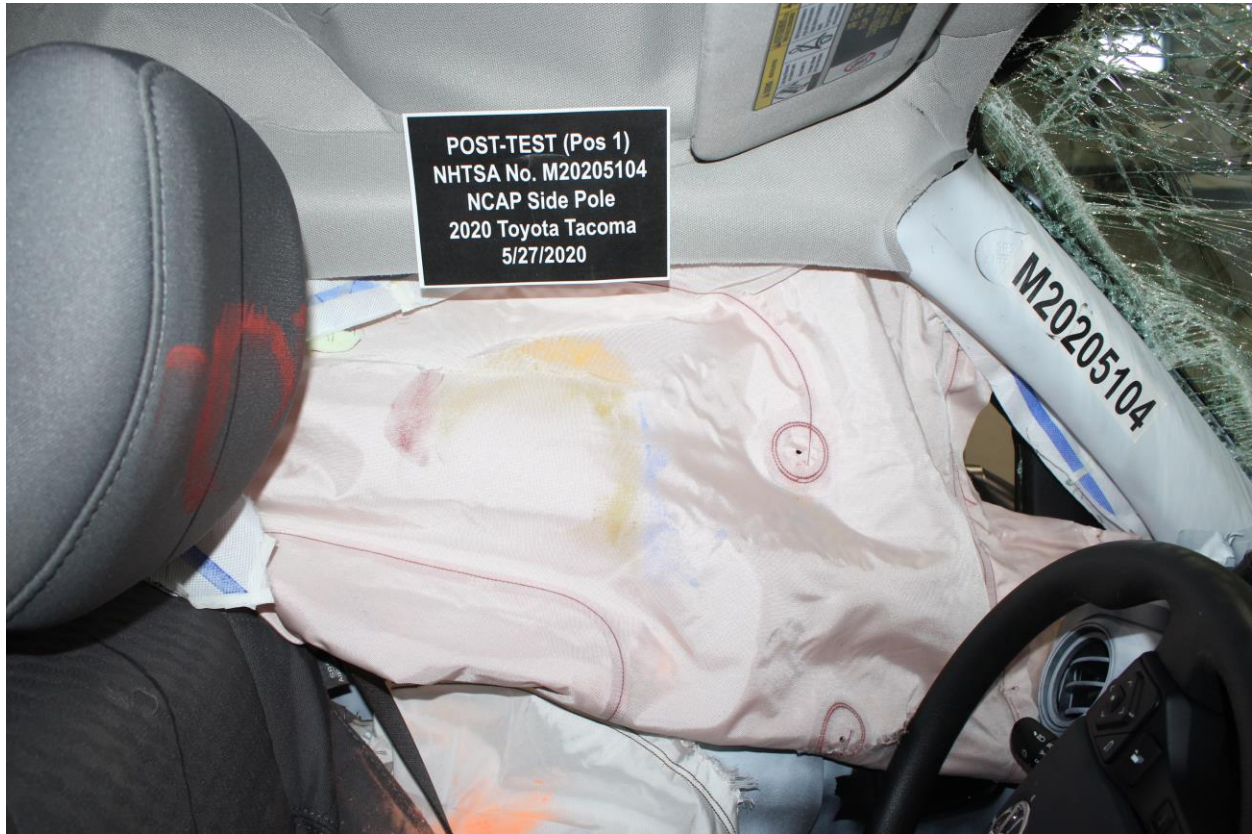
Figure A-47: Post-Test Dummy Close-Up Head Contact with Side Airbag View

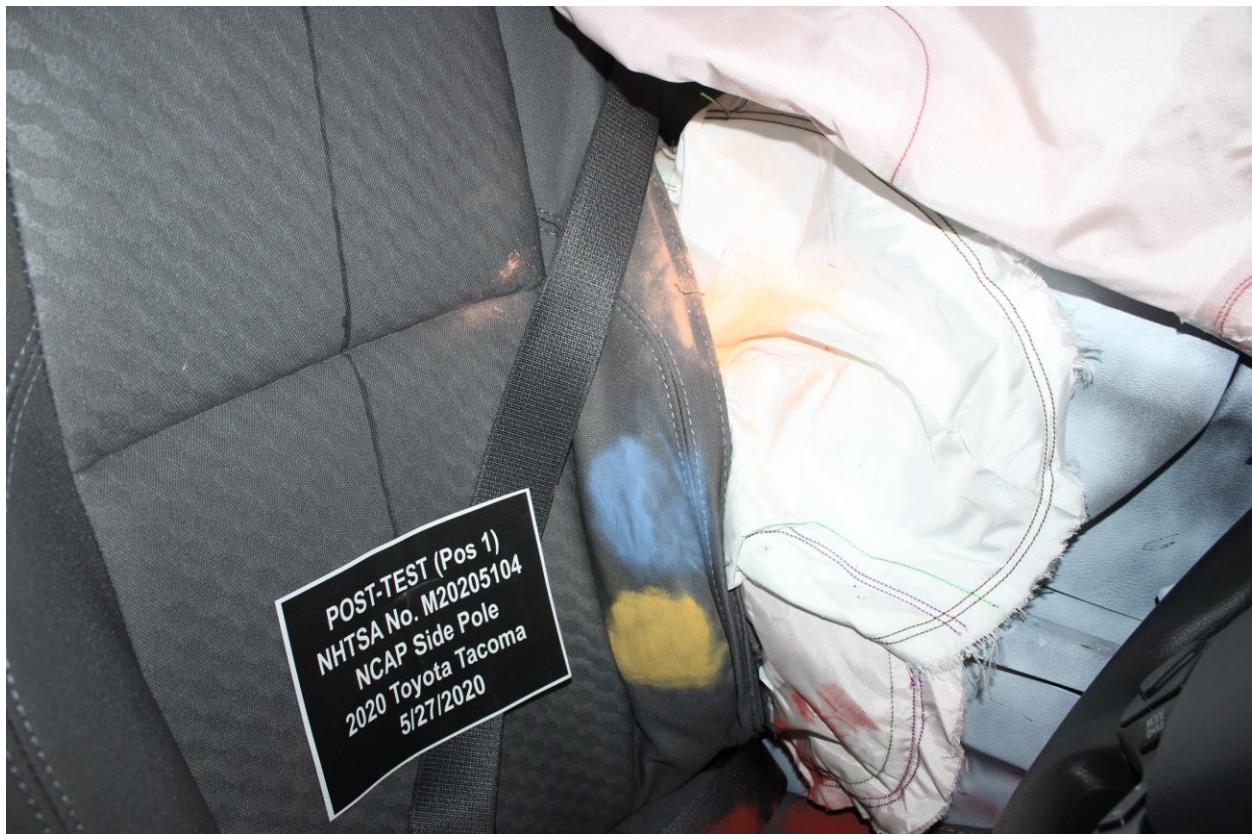
Figure A-48: Post-Test Dummy Close-Up Torso Contact with Vehicle Interior View

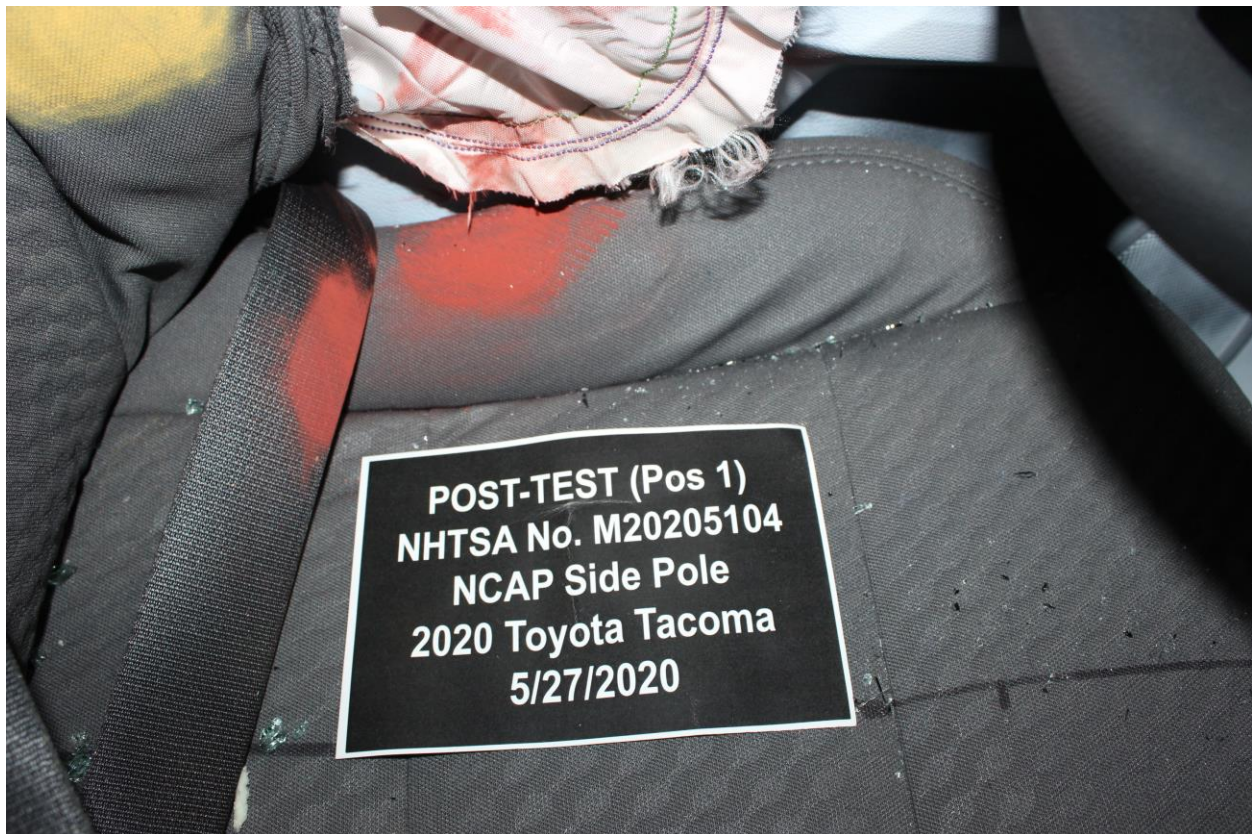
Figure A-50: Post-Test Dummy Close-Up Pelvis Contact with Vehicle Interior View

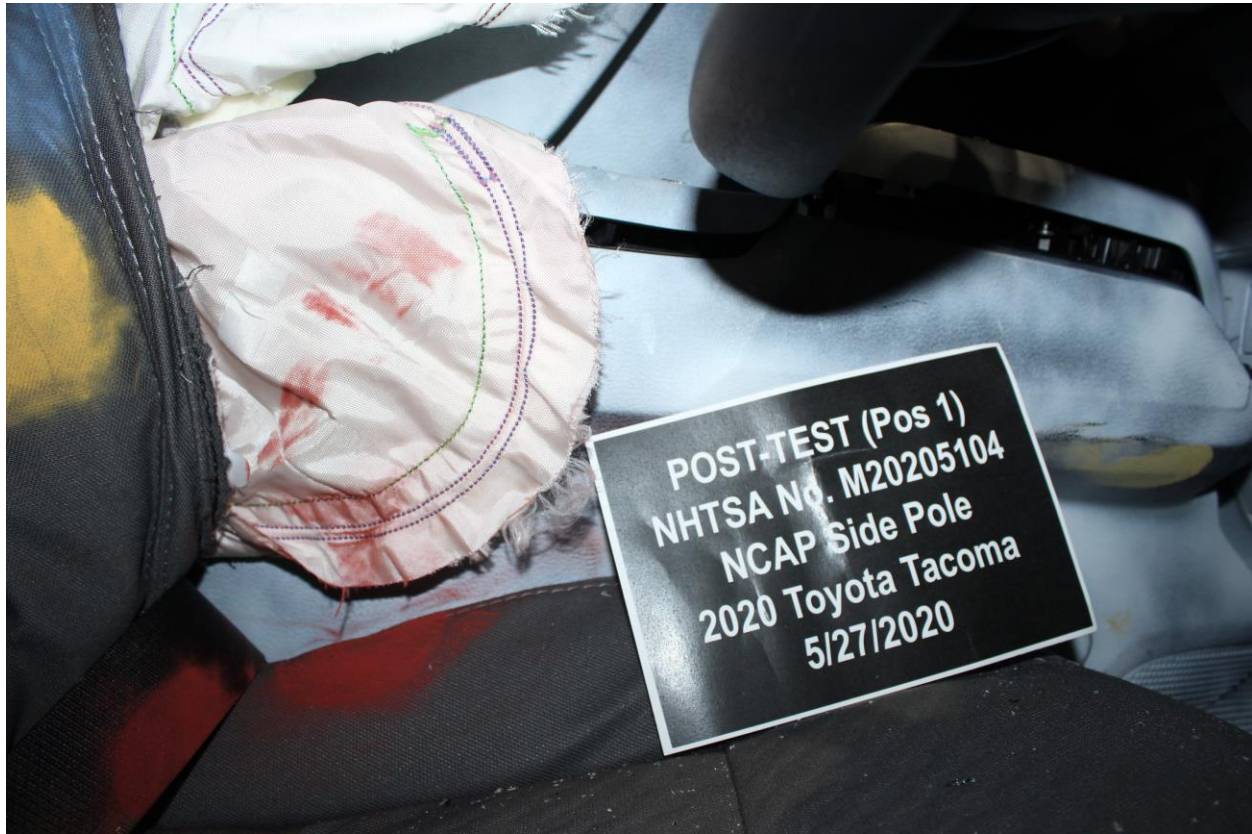
Figure A-51: Post-Test Dummy Close-Up Pelvis Contact with Side Airbag View

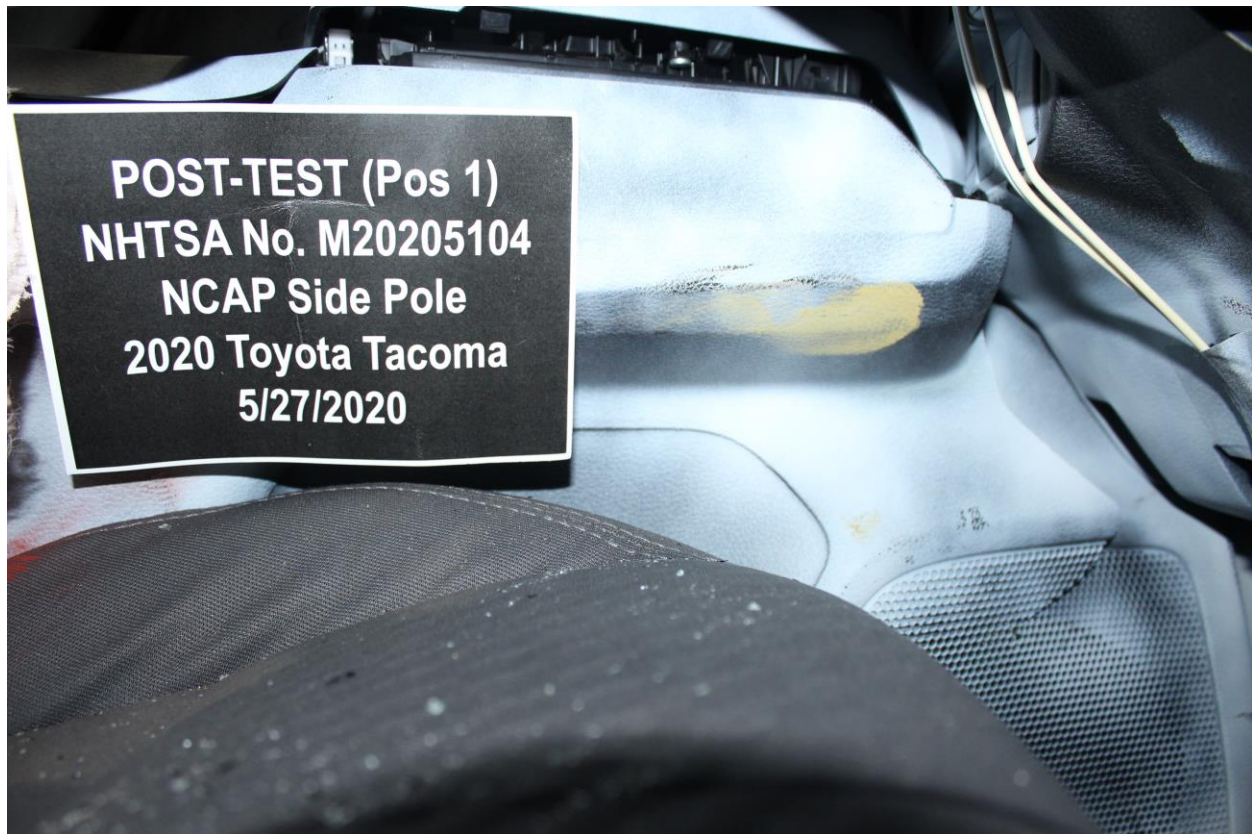
Figure A-52: Post-Test Dummy Close-Up Knee Contact with Vehicle Interior View

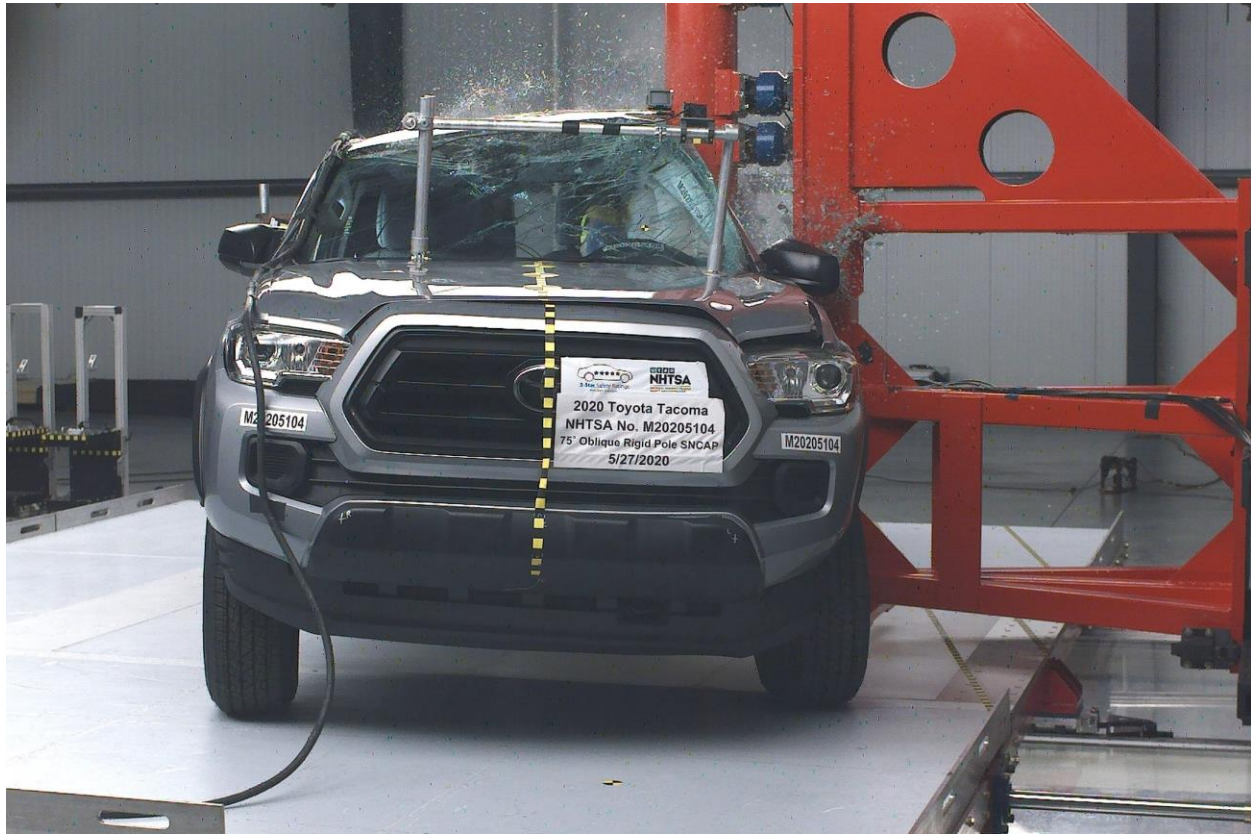
Figure A-68: Impact Event

A rigid pole side impact test was conducted on a 2020 Toyota Tacoma Extended Cab Truck. The subject vehicle was towed into the rigid pole at an angle of 75° and a velocity of 32.28 km/h. The test was conducted by Calspan Corporation's Transportation Test Operations facility in Buffalo, New York on May 27, 2020. Pre-test and post-test photographs of the test vehicle and side impact dummy (SID-IIs) are included in Appendix A of this report.

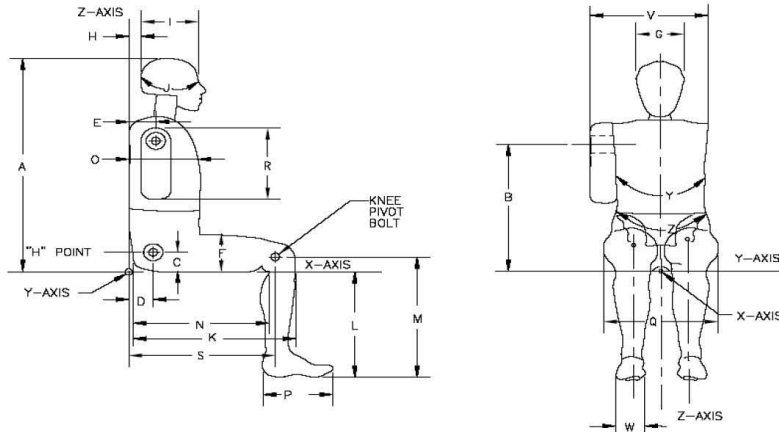
Symbol	Description	Specification (mm)		Result (mm)	Pass/Fail
A	Sitting Height	772	788	780	Pass
B	Shoulder Pivot Height	437	453	450	Pass
C	H-point Height	79	89	85	Pass
D	H-point from seatback	141	151	145	Pass
E	Shoulder Pivot from Backline	97	107	104	Pass
F	Thigh Clearance	119	135	125	Pass
G	Head Breadth	140	148	144	Pass
H	Head Back from Backline	40	46	43	Pass
I	Head Depth	178	188	186	Pass
J	Head Circumference	541	551	545	Pass
K	Buttock to Knee Length	514	540	532	Pass
L	Popliteal Height	343	369	360	Pass
M	Knee Pivot to floor height	392	409	402	Pass
N	Buttock Popliteal Length	416	442	432	Pass
O	Chest Depth w/o jacket	195	211	206	Pass
P	Foot Length	216	232	221	Pass
Q	Hip Breadth (w/pelvic plugs)	313	323	319	Pass
R	Arm Length	249	259	253	Pass
S	Knee Joint to seatback	477	493	485	Pass
V	Shoulder Width	341	357	352	Pass
W	Foot Width	78	94	84	Pass
Y	Chest Circumference w/jacket	851	881	870	Pass
Z	Waist Circumference	761	791	772	Pass

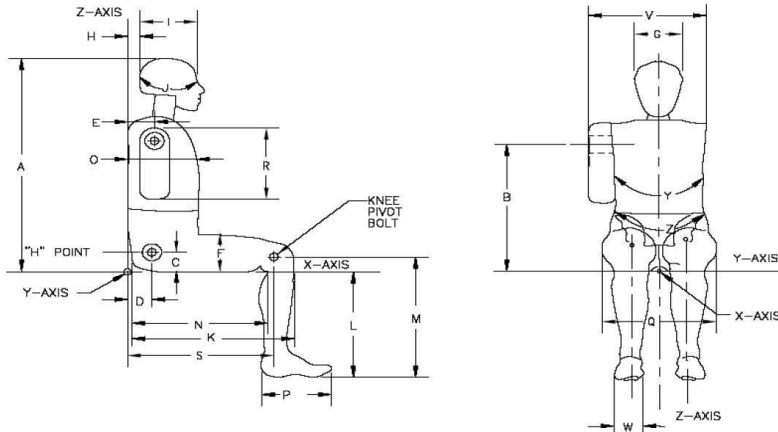
Symbol	Description	Specification (mm)		Result (mm)	Pass/Fail
A	Sitting Height	772	788	782	Pass
B	Shoulder Pivot Height	437	453	449	Pass
C	H-point Height	79	89	86	Pass
D	H-point from seatback	141	151	145	Pass
E	Shoulder Pivot from Backline	97	107	102	Pass
F	Thigh Clearance	119	135	126	Pass
G	Head Breadth	140	148	145	Pass
H	Head Back from Backline	40	46	43	Pass
I	Head Depth	178	188	187	Pass
J	Head Circumference	541	551	544	Pass
K	Buttock to Knee Length	514	540	533	Pass
L	Popliteal Height	343	369	361	Pass
M	Knee Pivot to floor height	392	409	401	Pass
N	Buttock Popliteal Length	416	442	433	Pass
O	Chest Depth w/o jacket	195	211	207	Pass
P	Foot Length	216	232	220	Pass
Q	Hip Breadth (w/pelvic plugs)	313	323	318	Pass
R	Arm Length	249	259	254	Pass
S	Knee Joint to seatback	477	493	484	Pass
V	Shoulder Width	341	357	352	Pass
W	Foot Width	78	94	83	Pass
Y	Chest Circumference w/jacket	851	881	875	Pass
Z	Waist Circumference	761	791	773	Pass
