REPORT NUMBER: SideNCAPMDB-MGA-20-022

**NEW CAR ASSESSMENT PROGRAM (NCAP)
Moving Deformable Barrier Side Impact Test**

**GENERAL MOTORS LLC
2020 Cadillac CT5 Luxury 4-Door Sedan
NHTSA No.: M20200105**

**MGA RESEARCH CORPORATION
5000 Warren Road
Burlington, WI 53105**

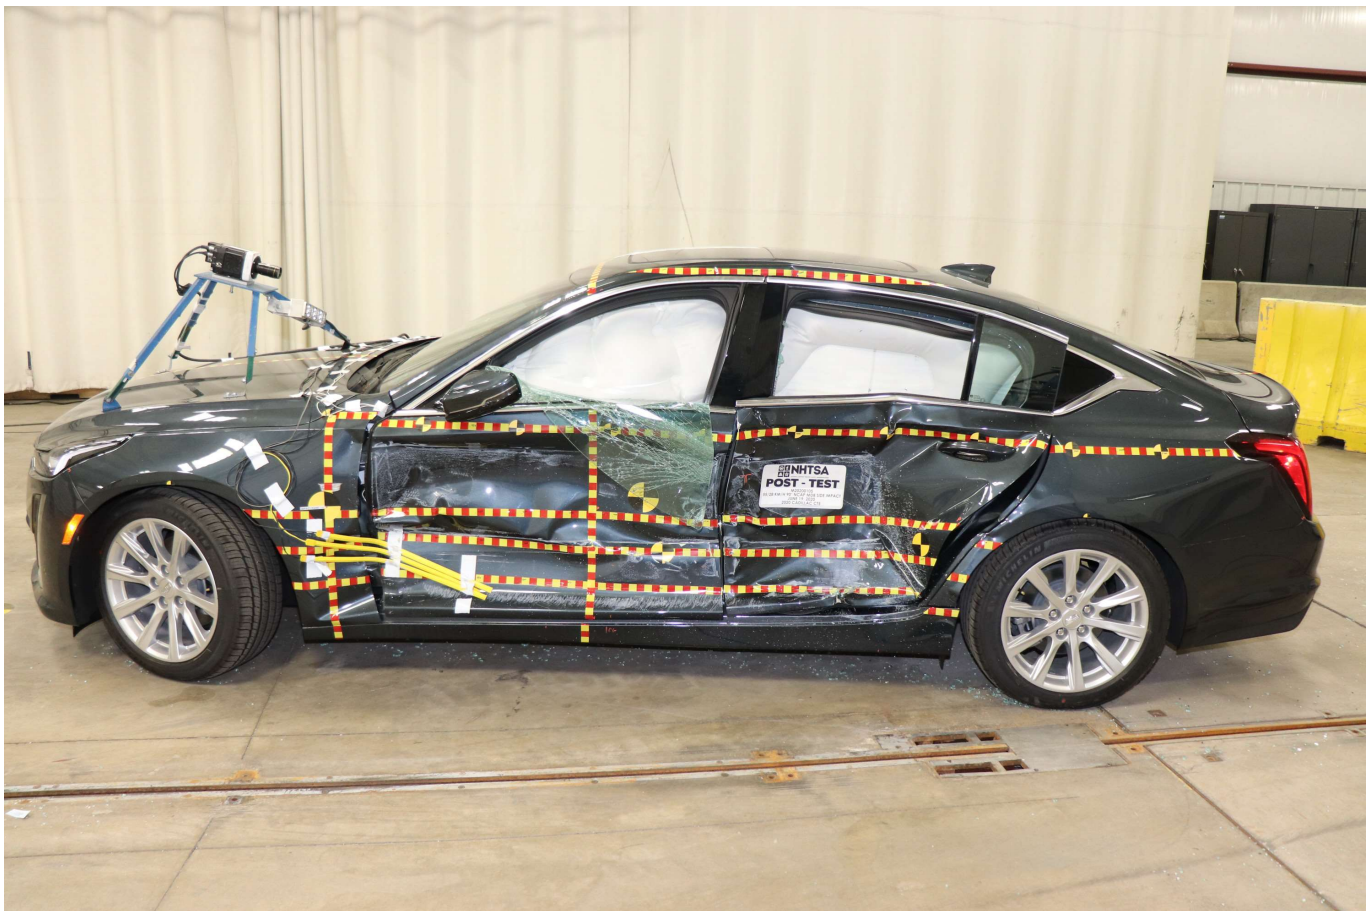
Photo No. 008 - Post-Test Left Side View of Test Vehicle

Critical Areas of Performance	Observations and Conclusions
Pillar Performance	No Separation
Sill Separation	None
Windshield Damage	None
Side Window Damage	LF, LR windows broken
Other Notable Effects	None

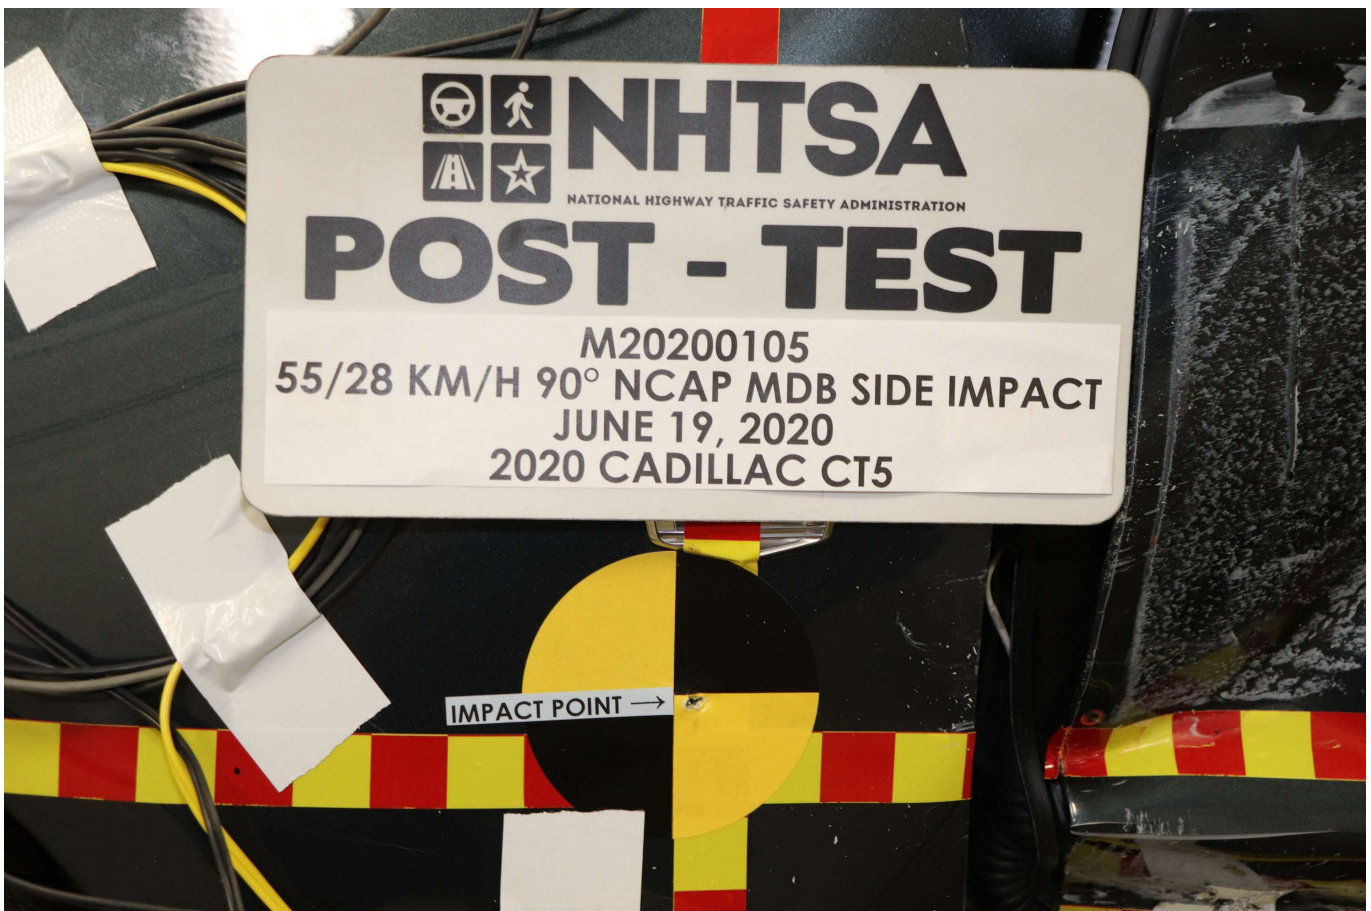
Photo No. 020 - Post-Test Close-Up View of Impact Point Target

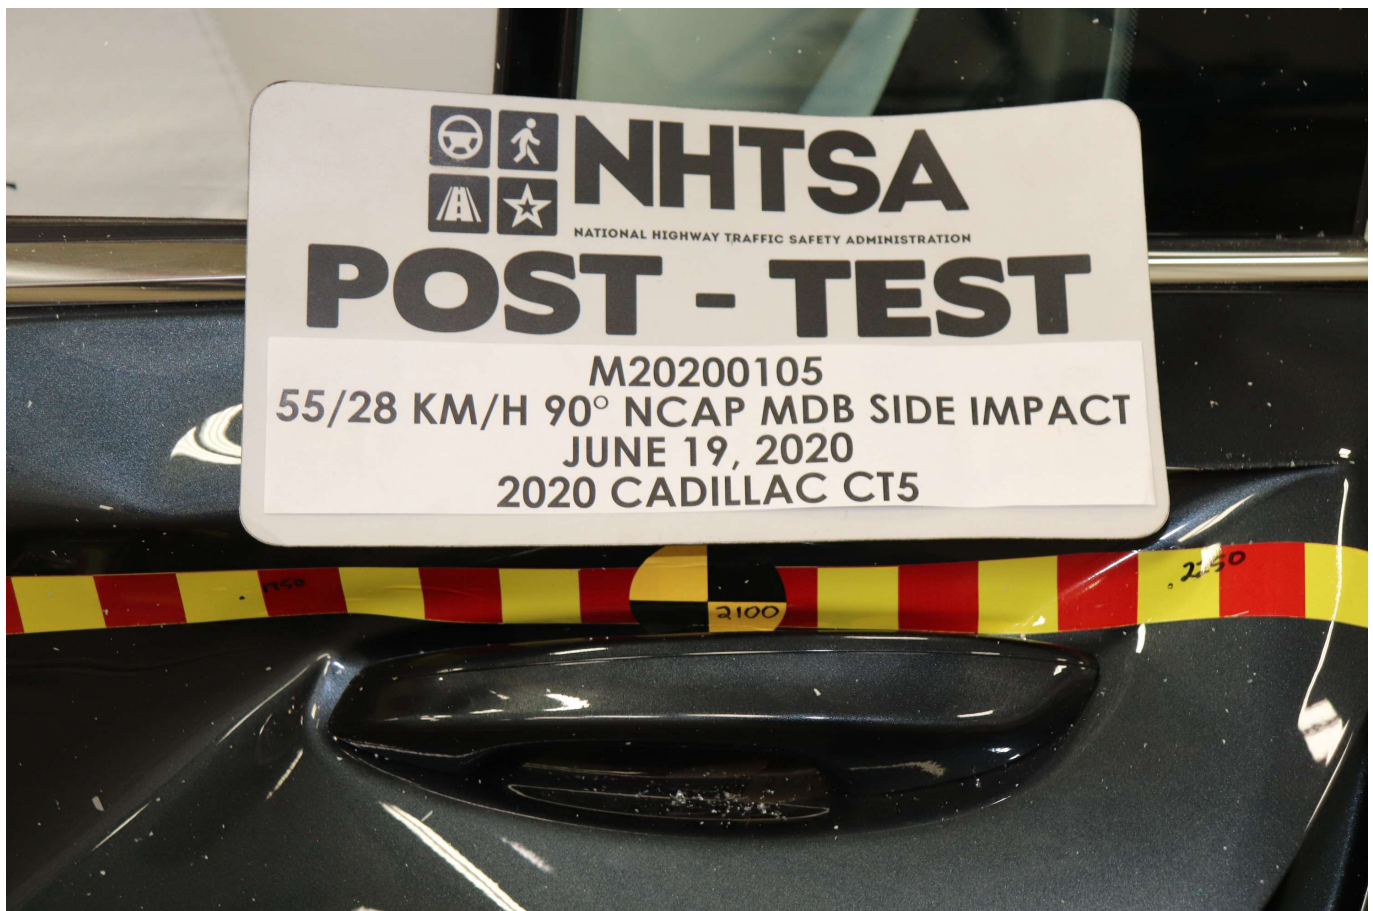
Photo No. 024 - Post-Test Left Rear Door Latch Close-Up

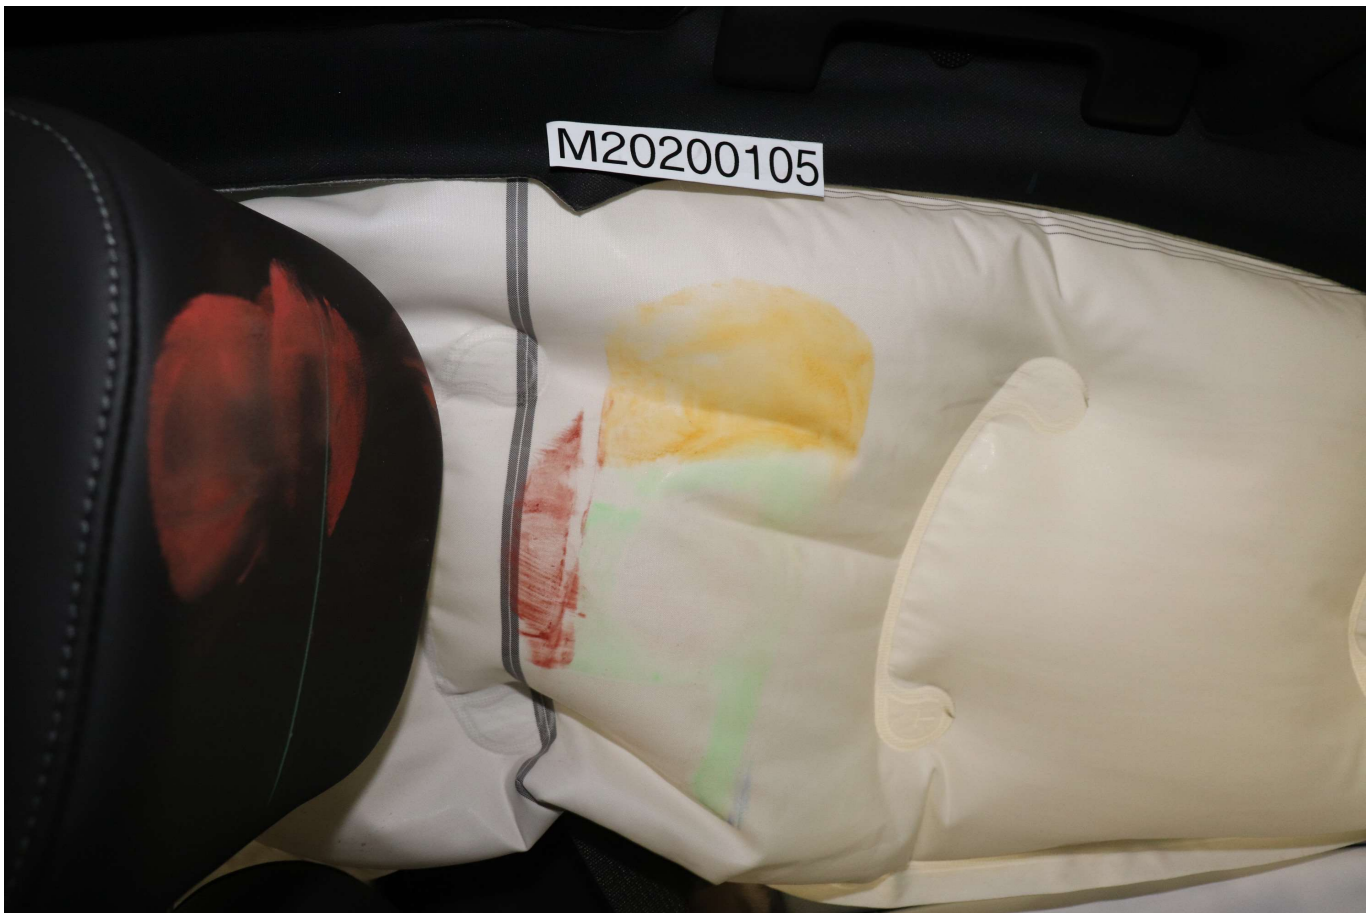
Photo No. 049 - Post-Test Driver Dummy Close-up Head Contact with Side Airbag View

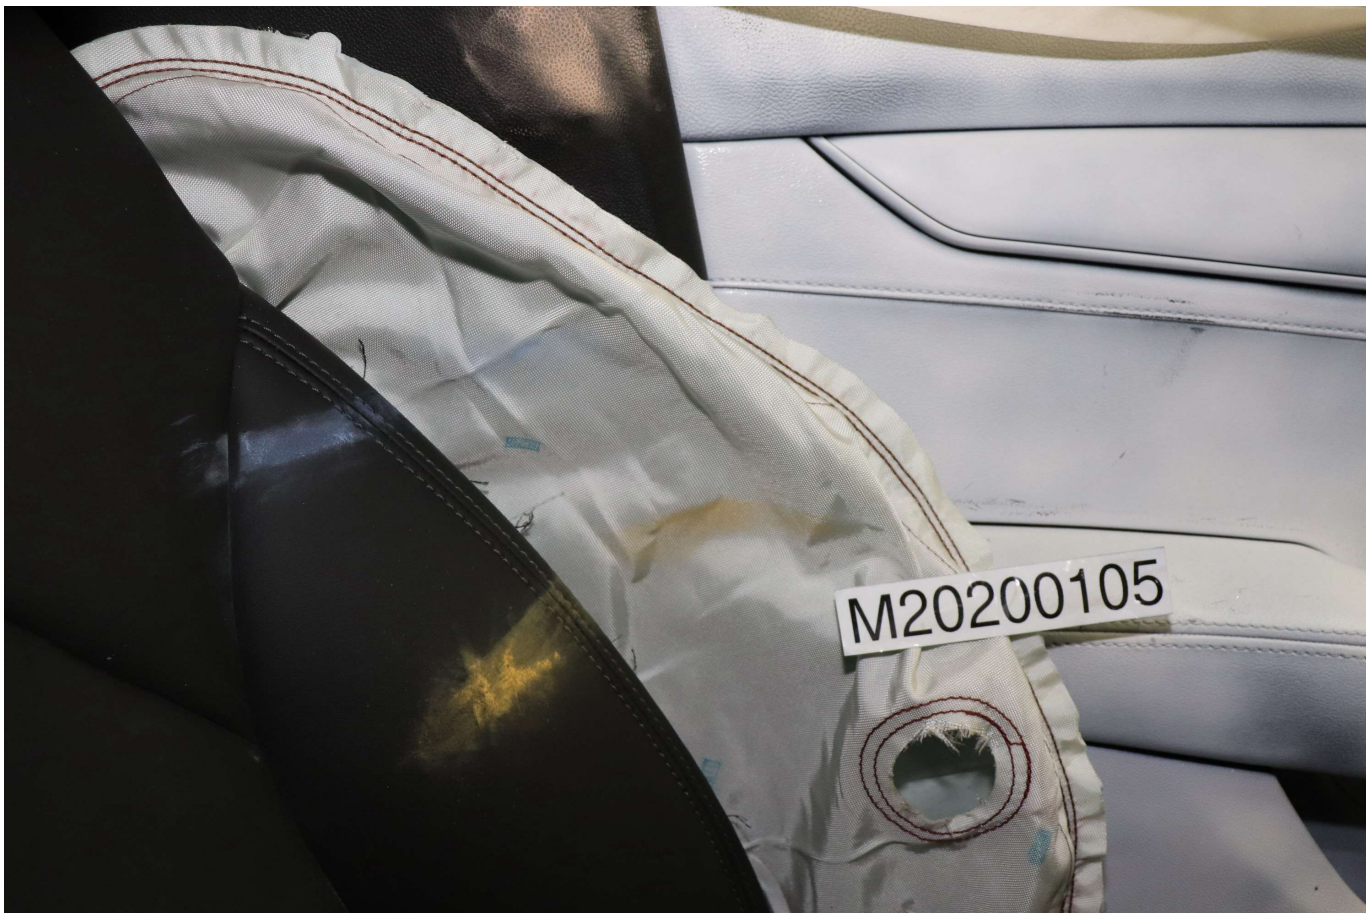
Photo No. 051 - Post-Test Driver Dummy Close-up Torso Contact with Side Airbag View

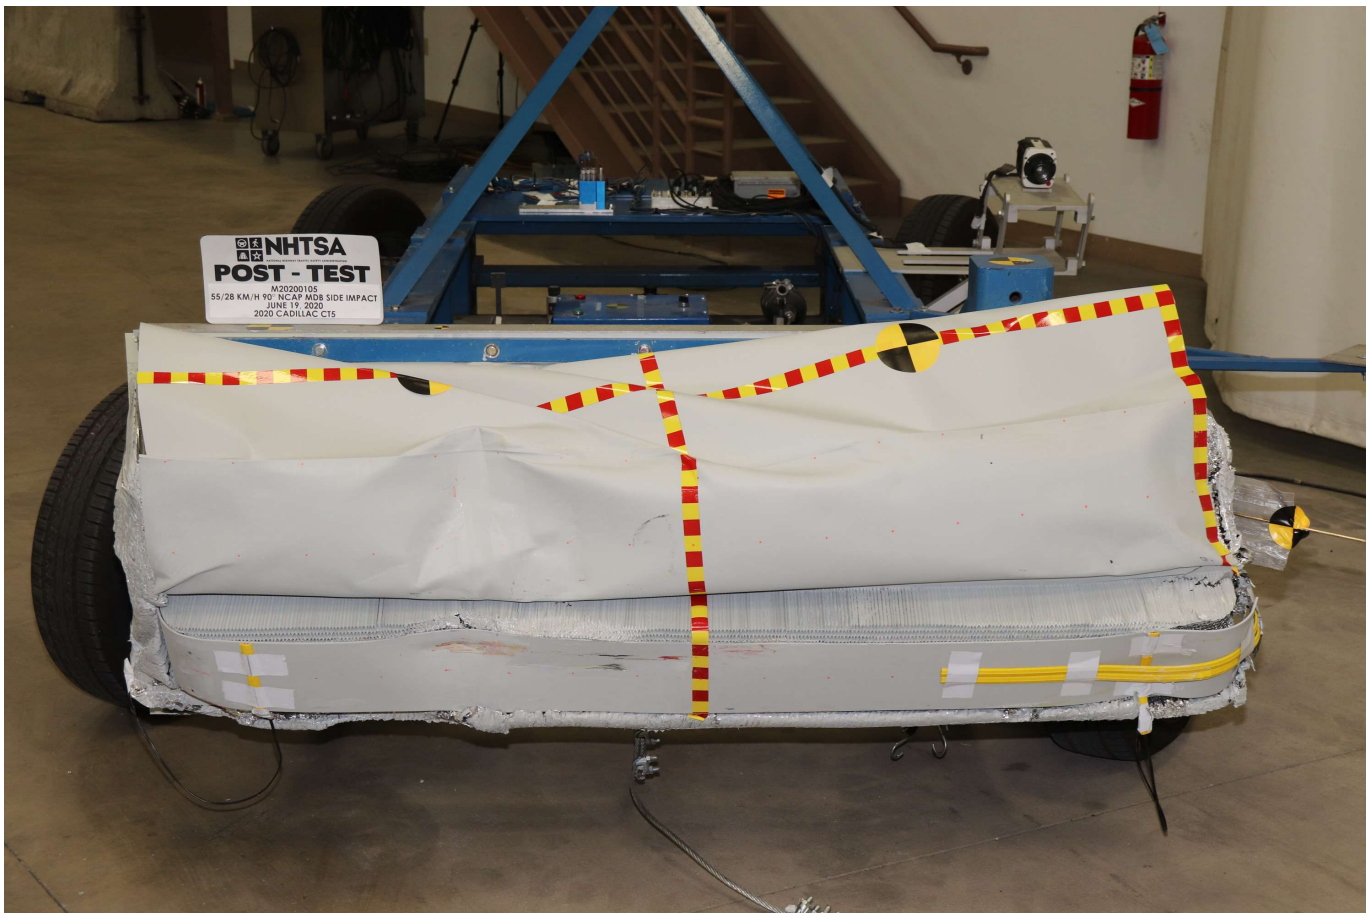
Photo No. 085 - Post-Test Front View of MDB Impactor Face
