**REPORT NUMBER: SideNCAPPole-MGA-20-021**

**NEW CAR ASSESSMENT PROGRAM (NCAP)  
Side Impact Pole Test**

**GENERAL MOTORS LLC  
2020 Cadillac CT5 Luxury 4-Door Sedan  
NHTSA No.: M20200104**

**FINAL REPORT**

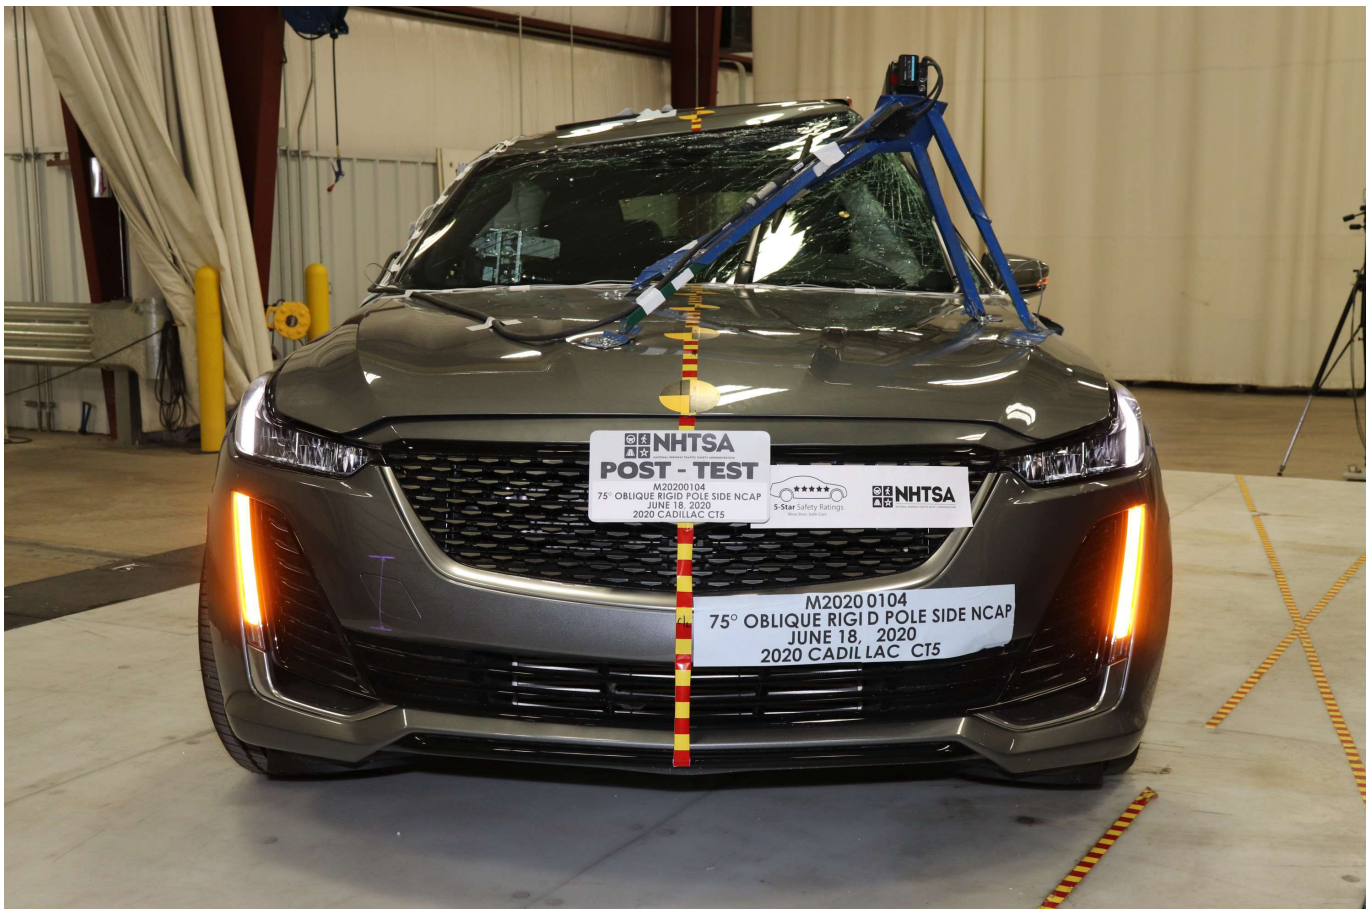
Photo No. 004 - Post-Test Frontal View of Test Vehicle

Critical Areas of Performance	Observations and Conclusions
Pillar Performance	No Separation
Sill Separation	None
Windshield Damage	Cracked
Side Window Damage	LF window cracked
Other Notable Effects	None

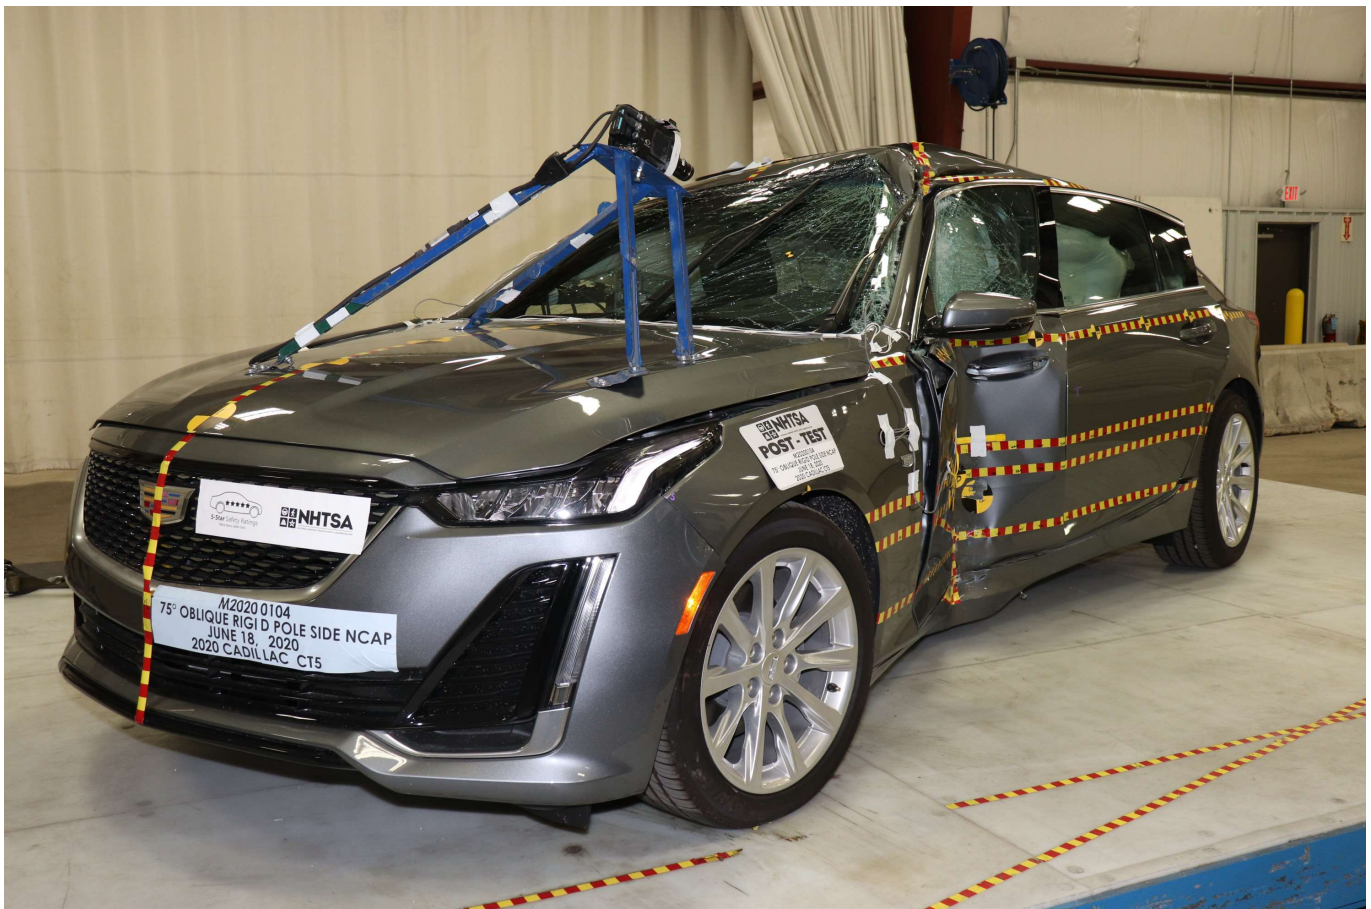
Photo No. 006 - Post-Test Left Front Three-Quarter View of Test Vehicle

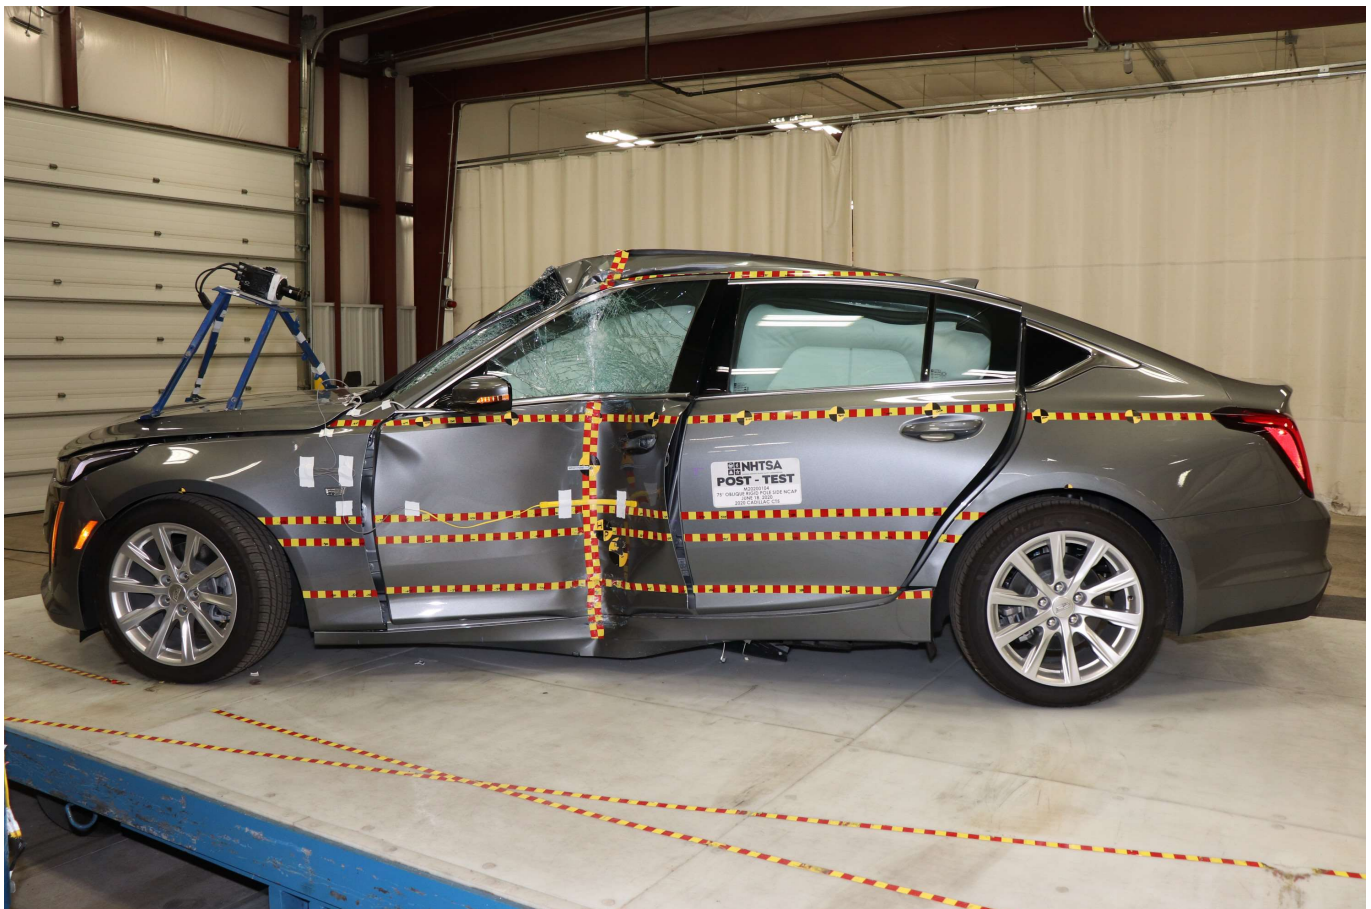
Photo No. 008 - Post-Test Left Side View of Test Vehicle

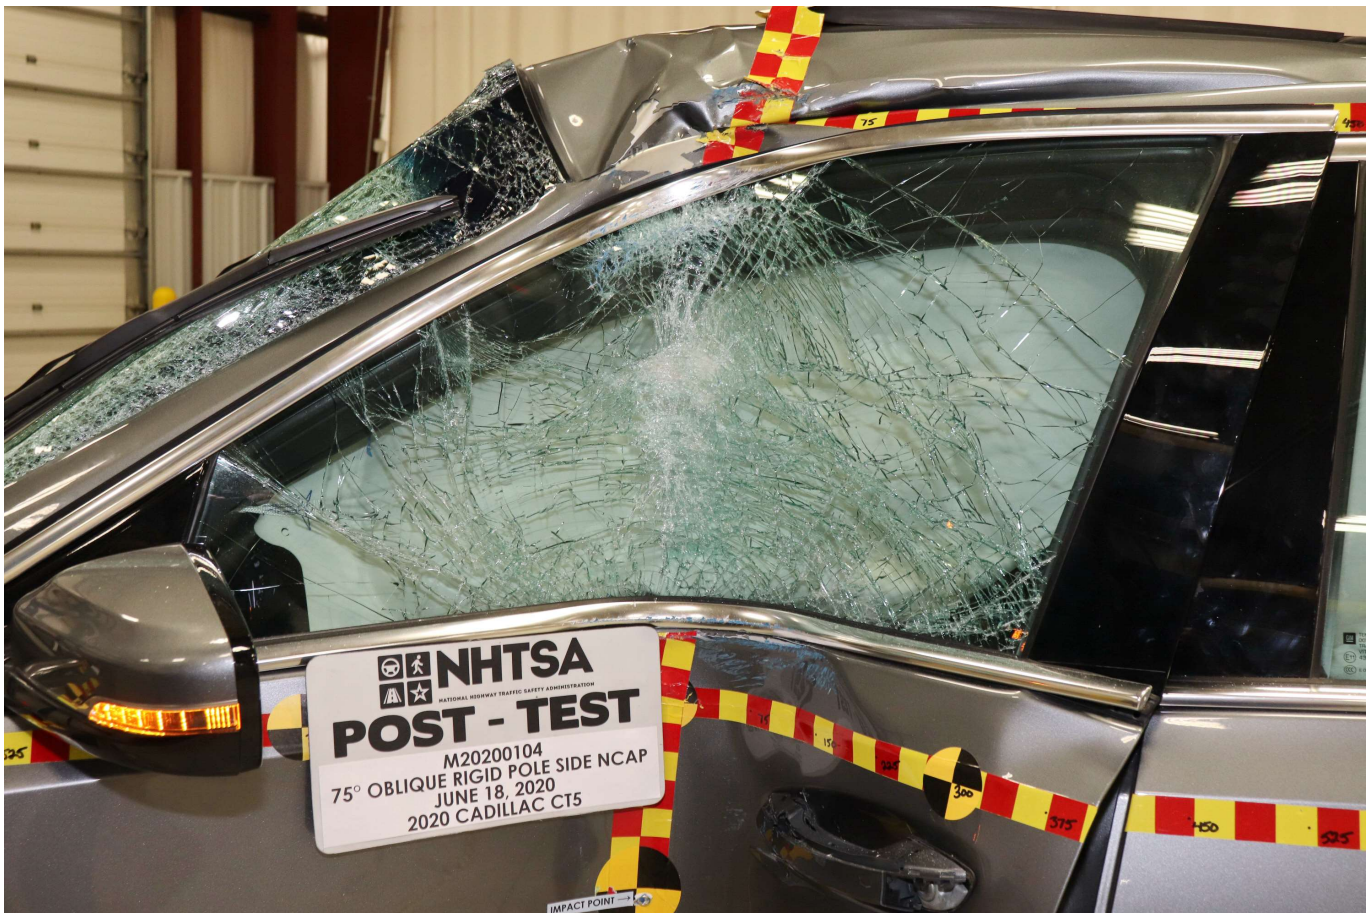
Photo No. 025 - Post-Test Left Side View of Dummy Shoulder and Door Top View

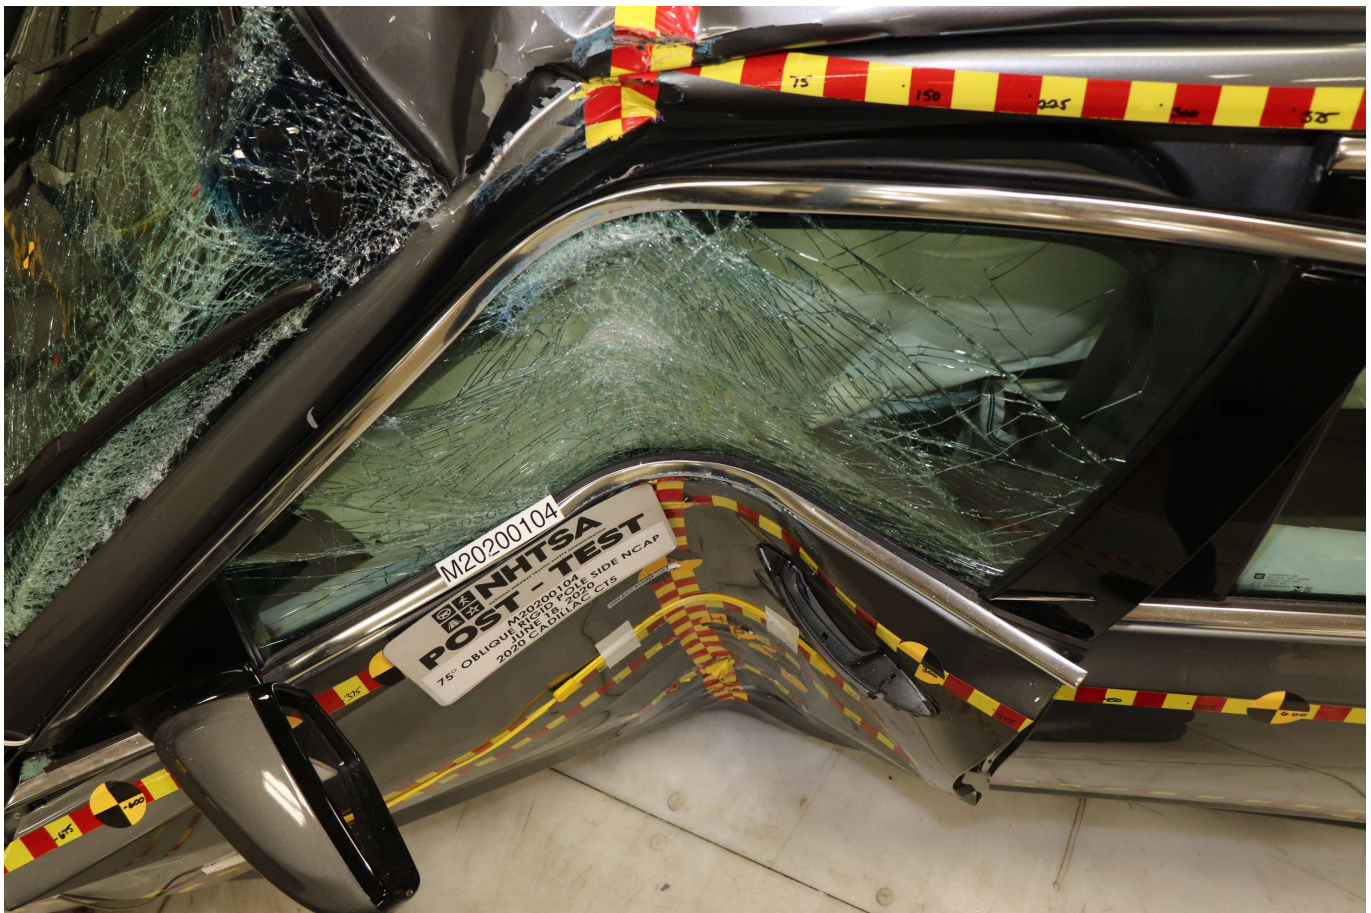
Photo No. 041 - Post-Test Dummy and Door Clearance View

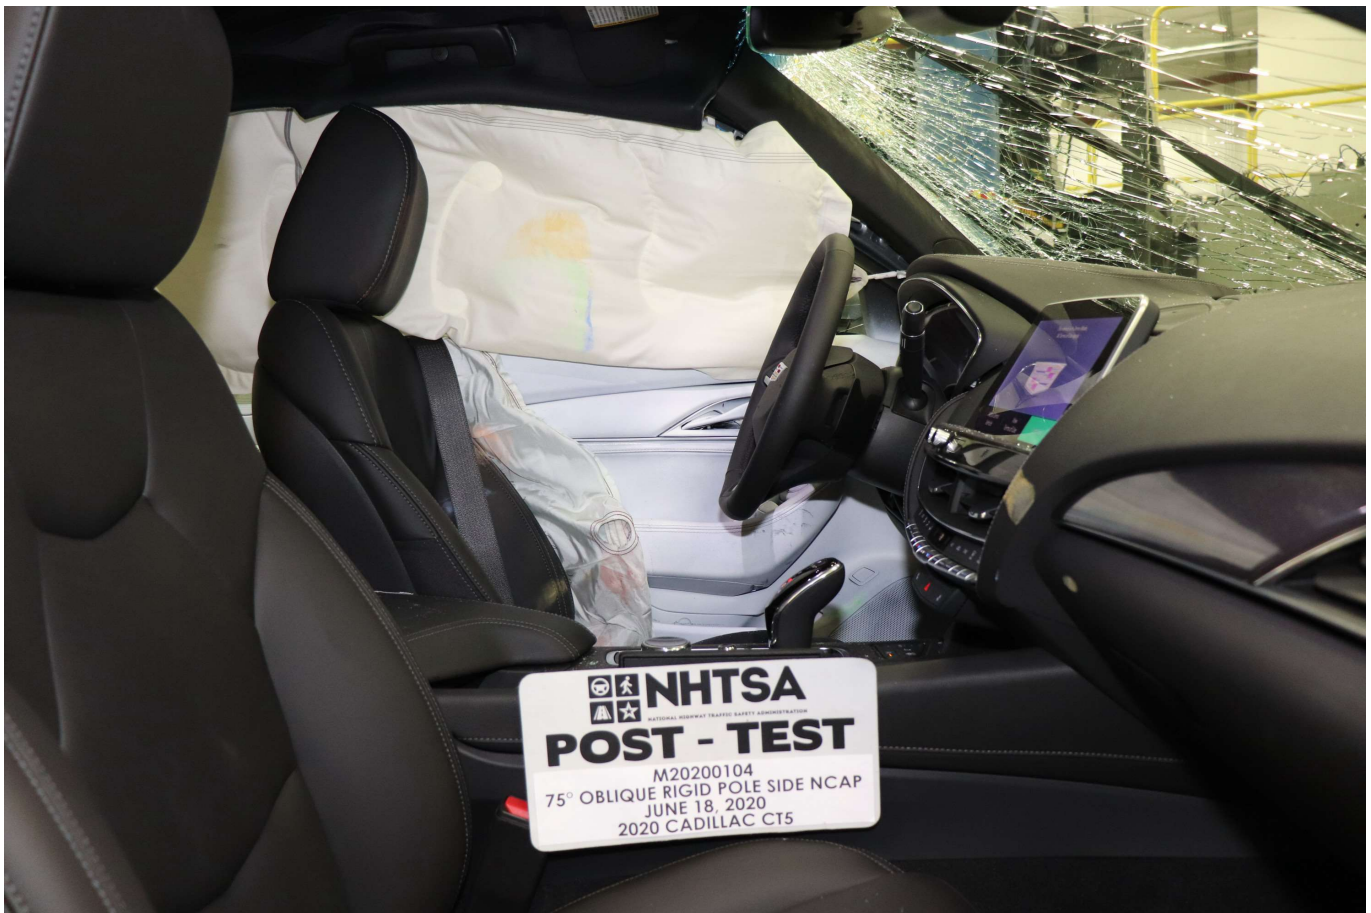
Photo No. 045 - Post-Test Inner Door Panel View Showing Dummy Contact Location

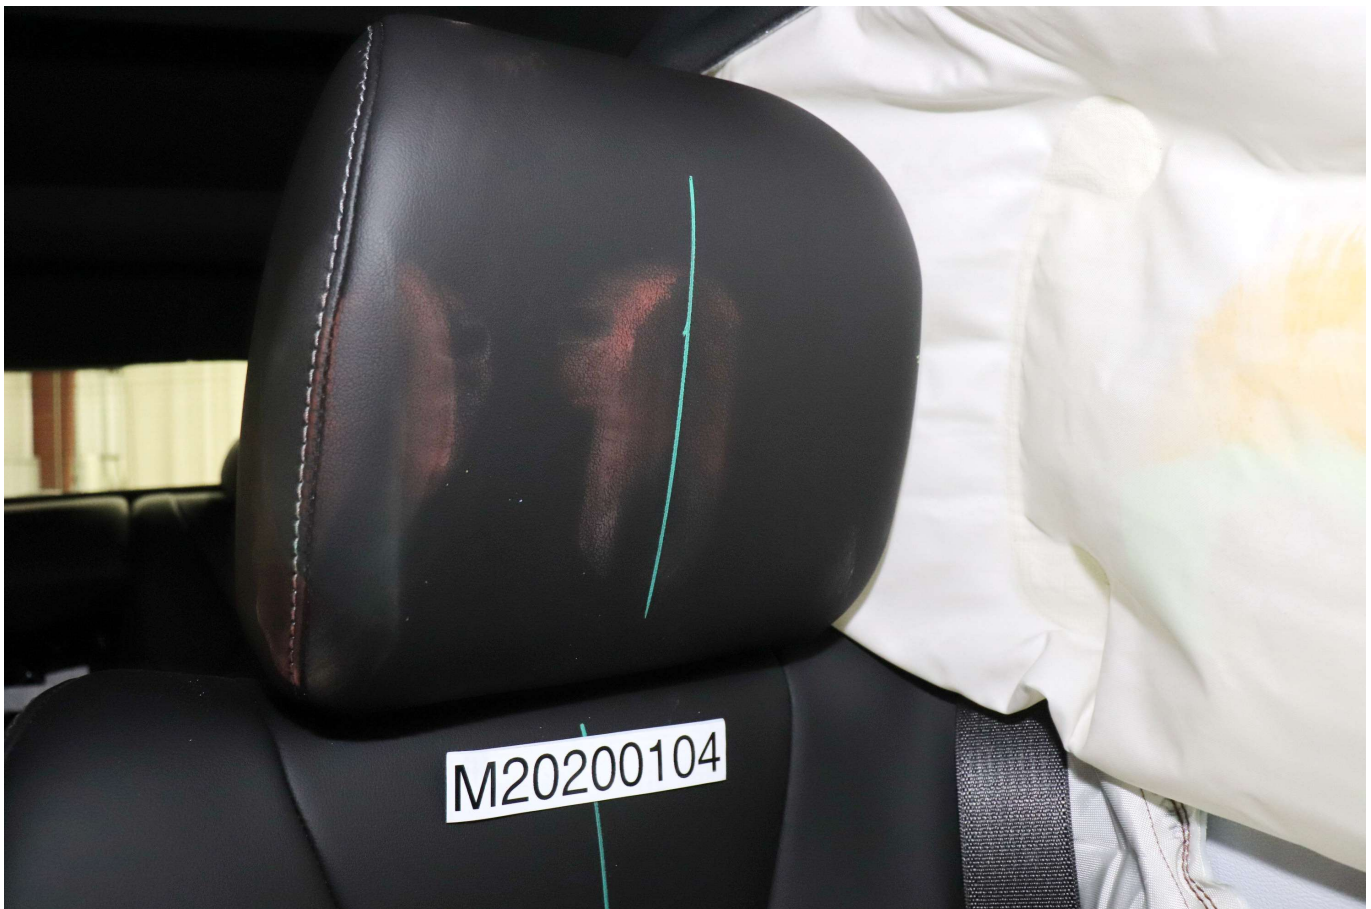
Photo No. 046 - Post-Test Dummy Close-Up Head Contact with Vehicle Interior View

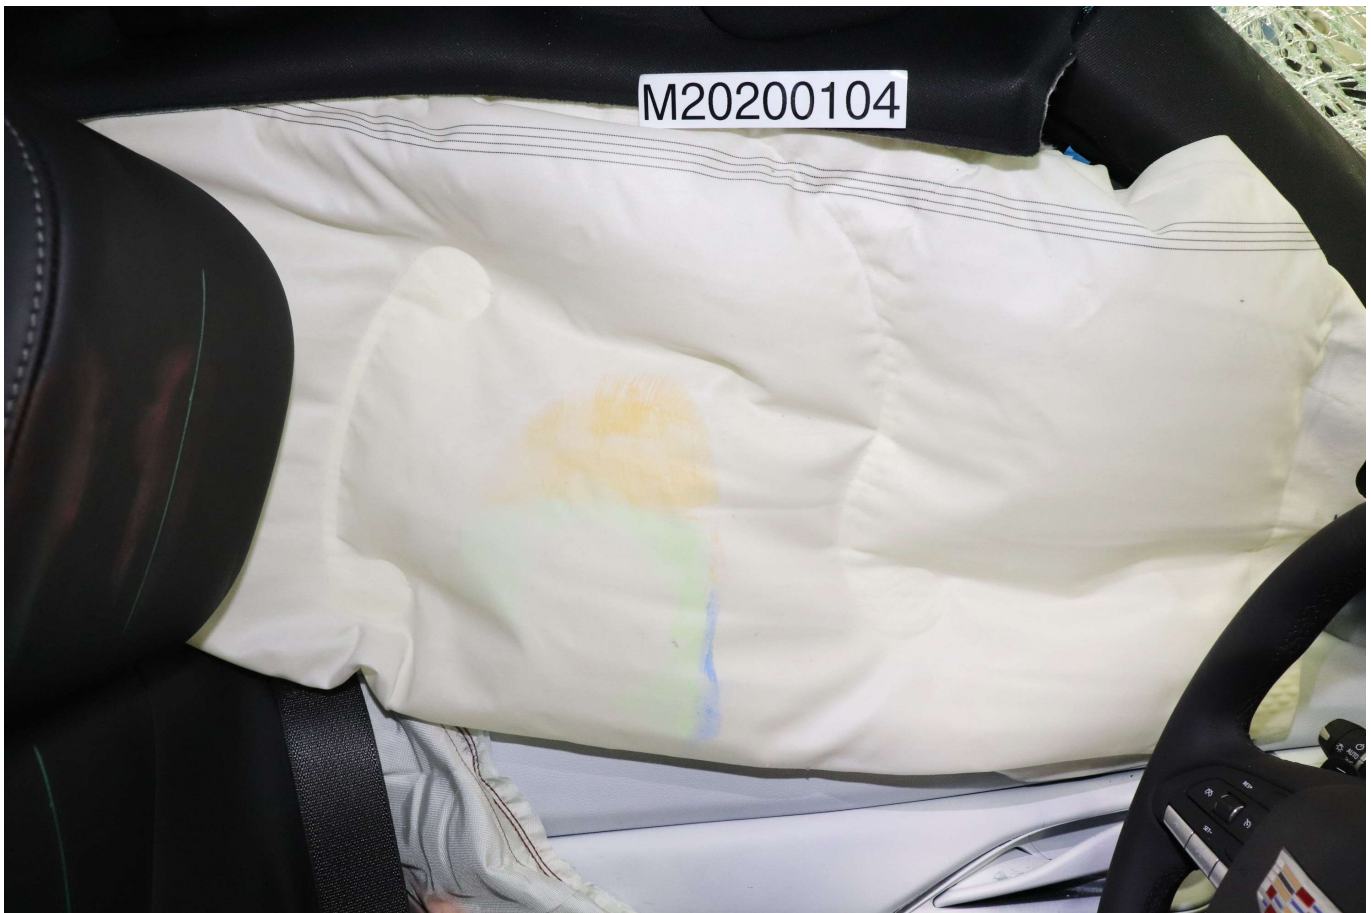
Photo No. 047 - Post-Test Dummy Close-Up Head Contact with Side Air Bag View

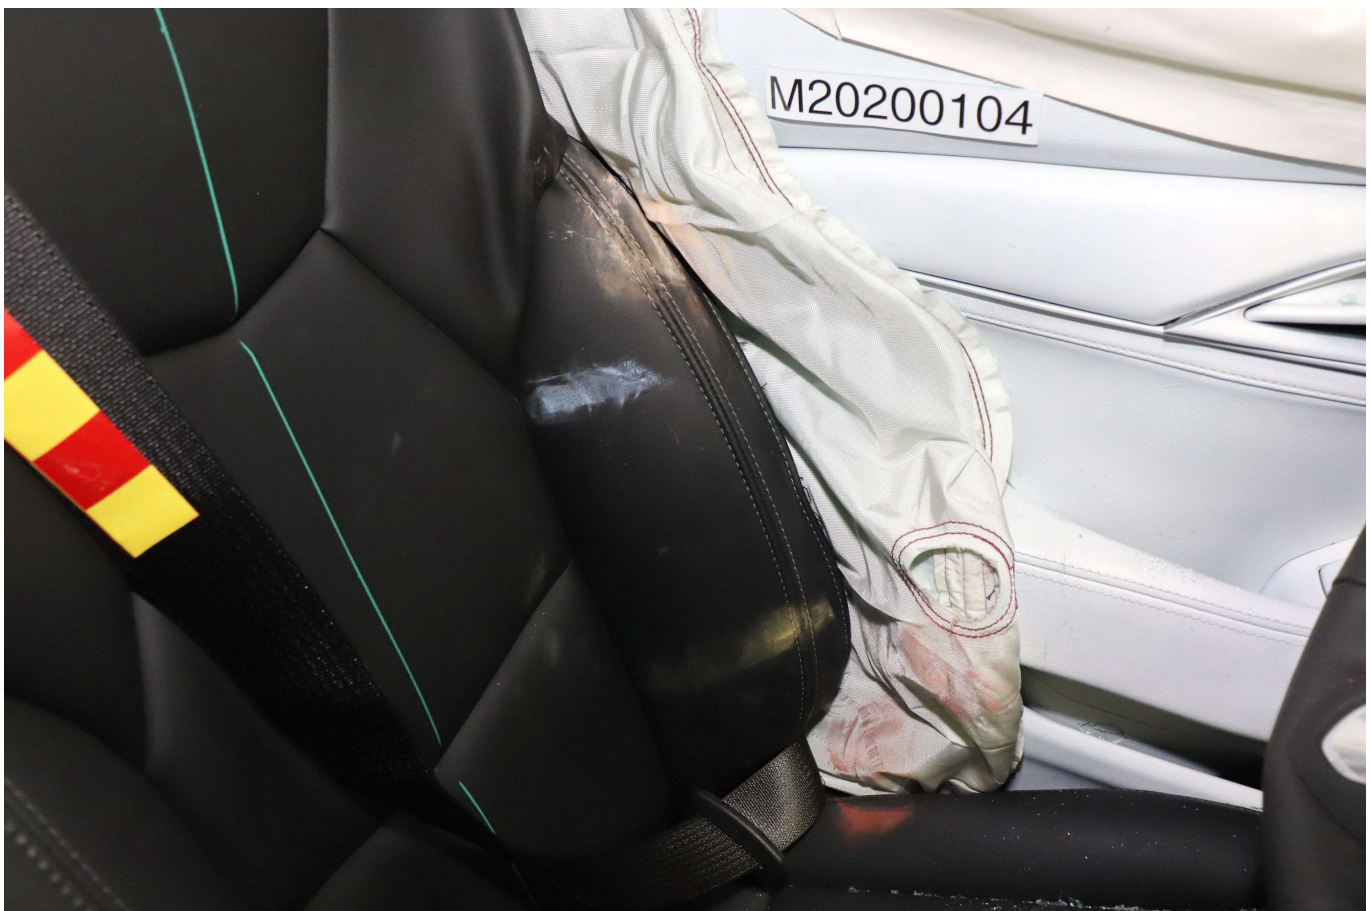
Photo No. 048 - Post-Test Dummy Close-Up Torso Contact with Vehicle Interior View

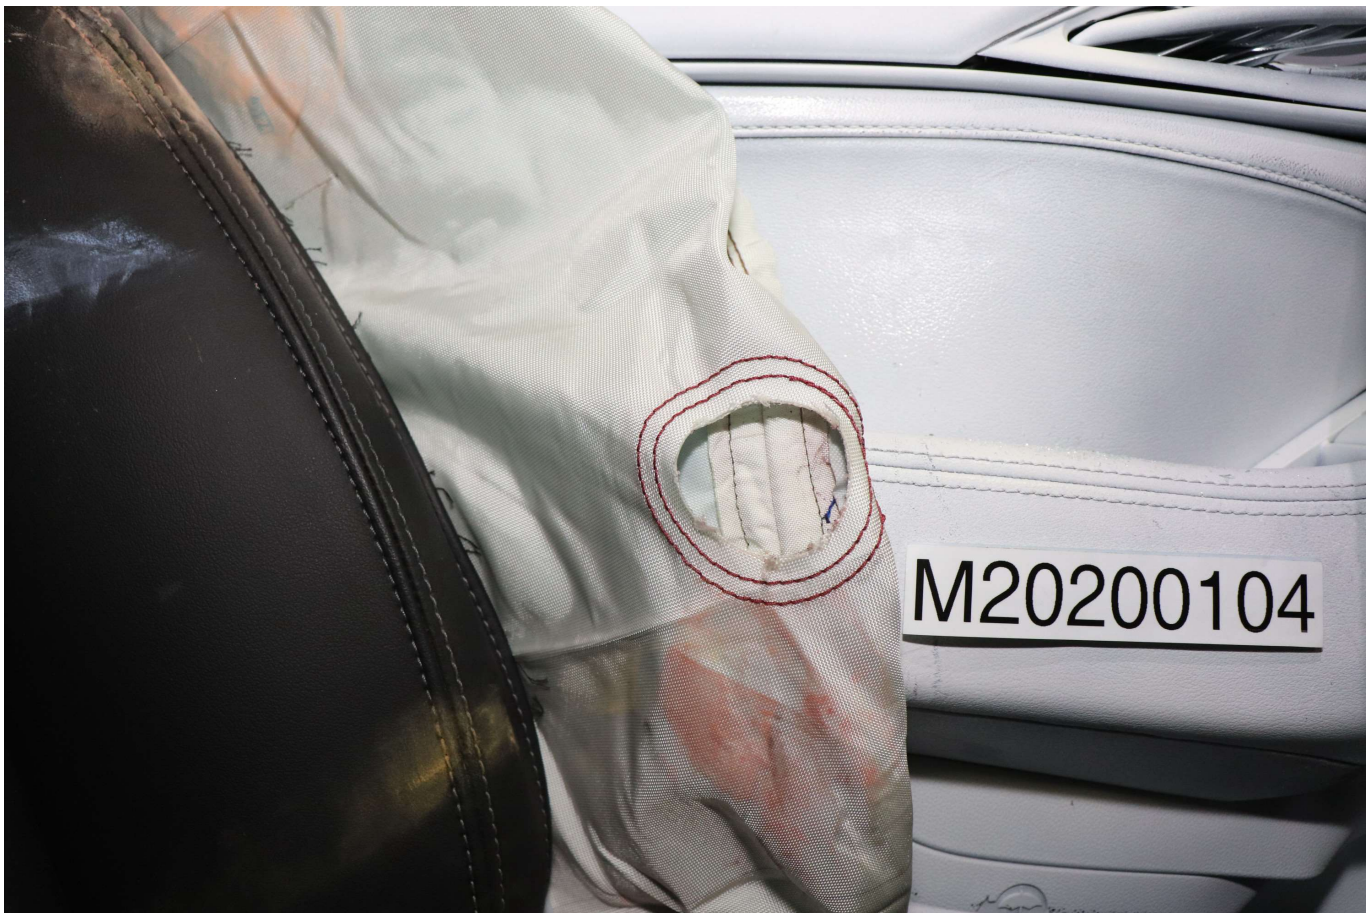
Photo No. 049 - Post-Test Dummy Close-Up Torso Contact with Side Air Bag View

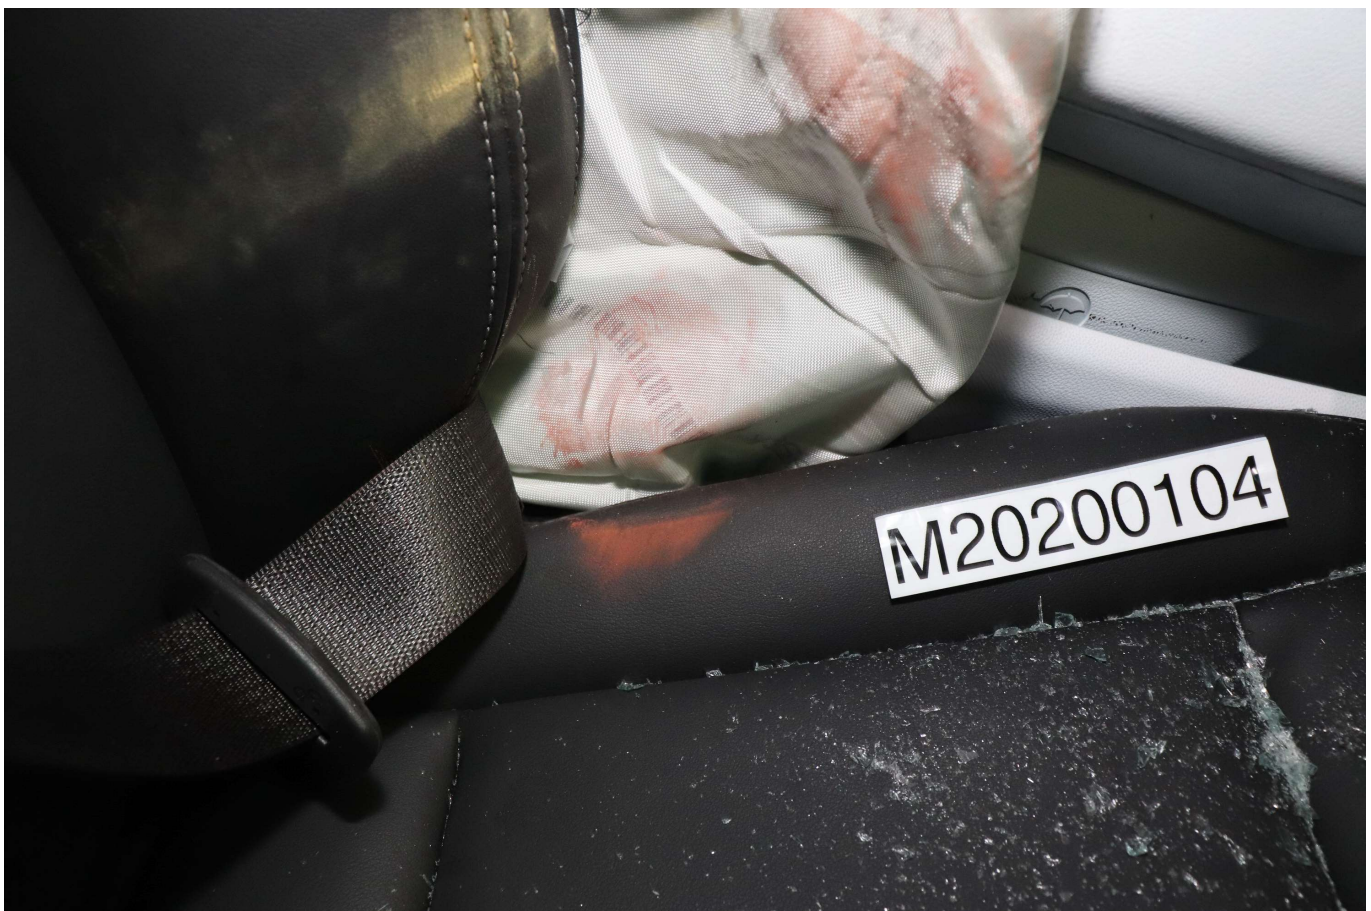
Photo No. 050 - Post-Test Dummy Close-Up Pelvis Contact with Vehicle Interior View

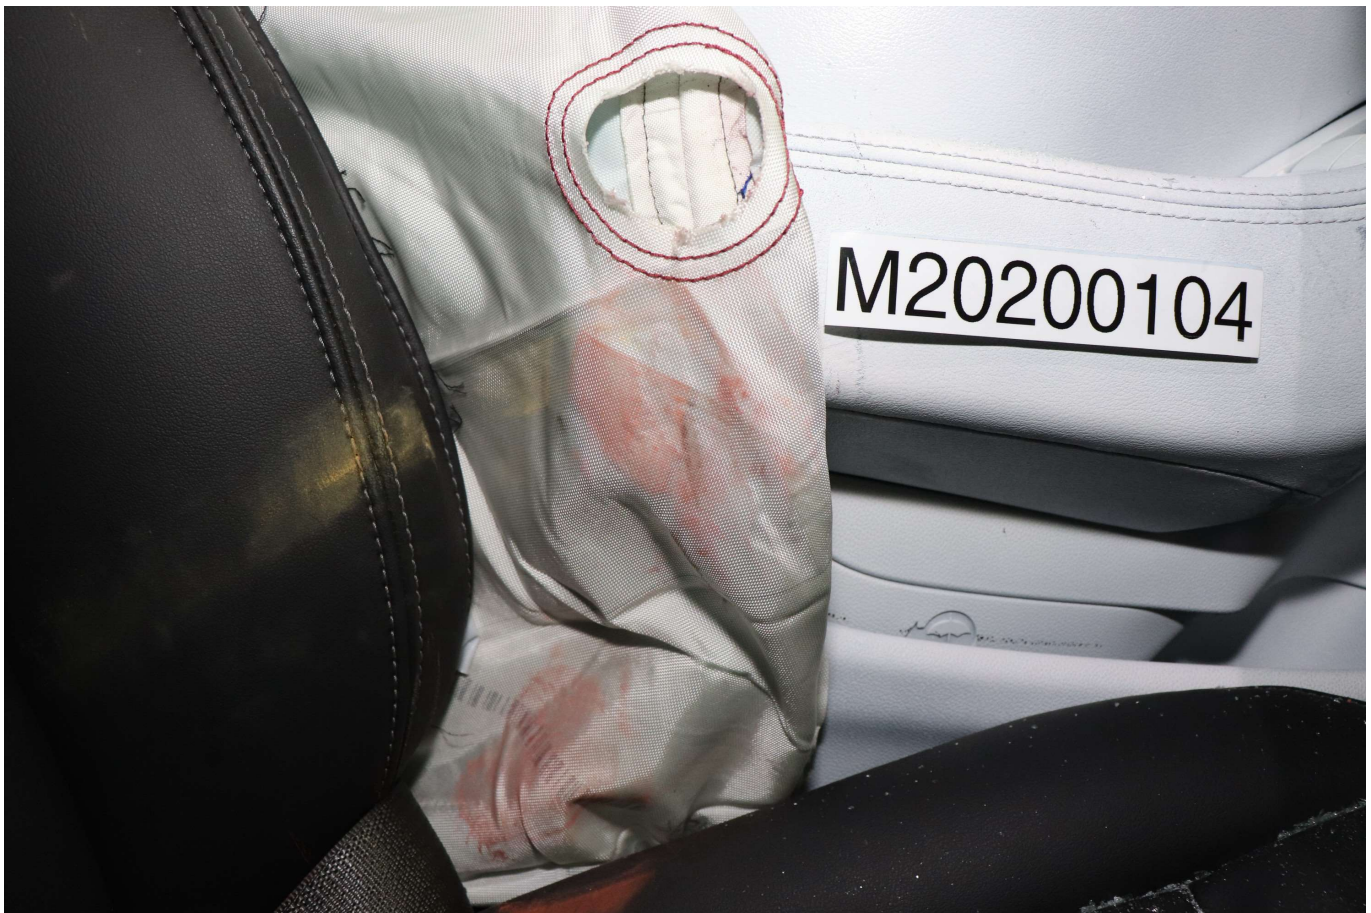
Photo No. 051 - Post-Test Dummy Close-Up Pelvis Contact with Side Air Bag View

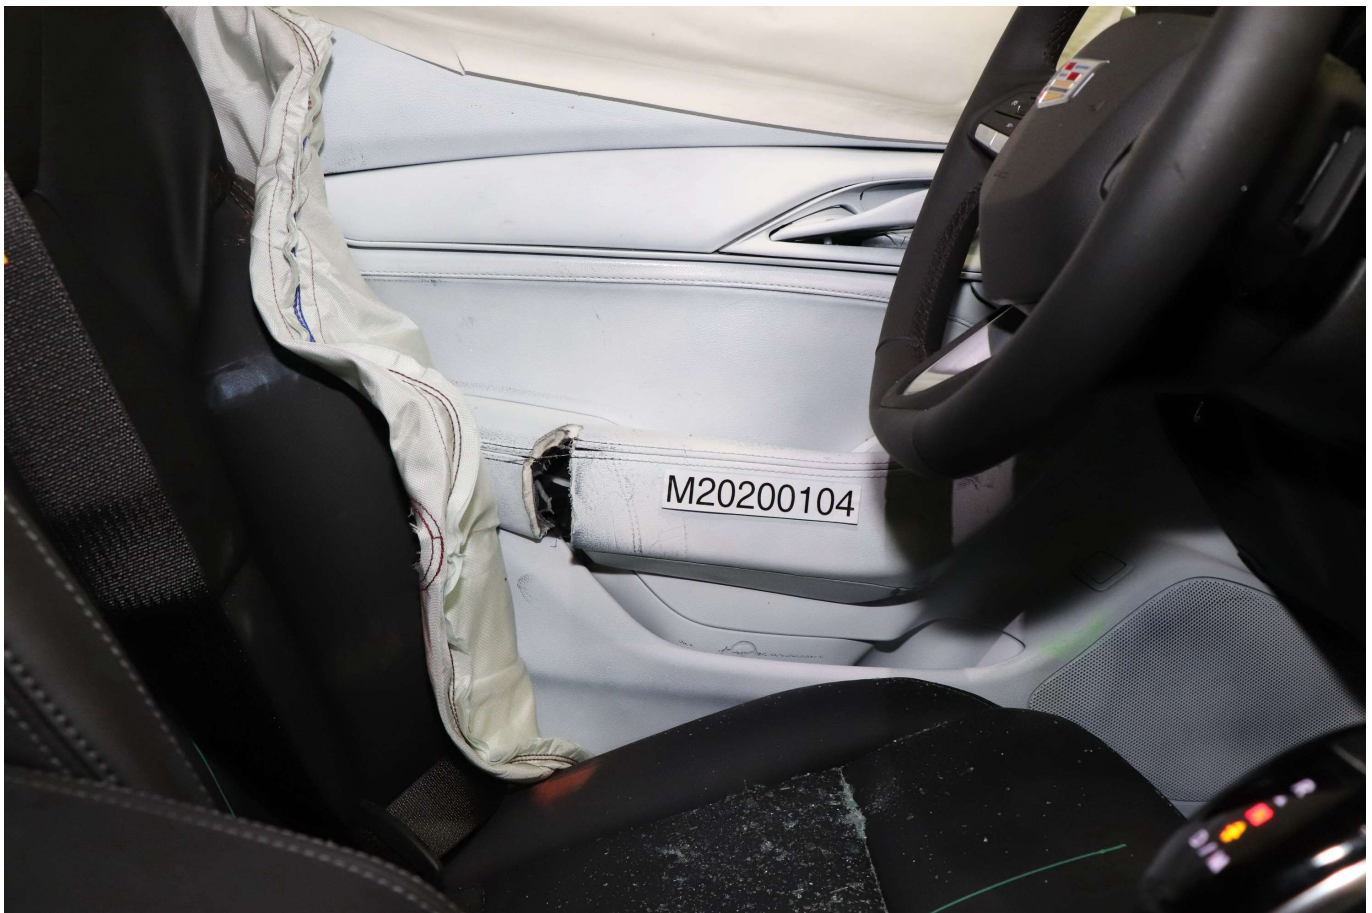
Photo No. 073 - Post-Test View of Shattered Vehicle Inner Door Panel
