**REPORT NUMBER: NCAP-MGA-20-020**

**NEW CAR ASSESSMENT PROGRAM (NCAP)  
Frontal Barrier Impact Test**

**GENERAL MOTORS LLC  
2020 Cadillac CT5 Luxury AWD 4-Door Sedan  
NHTSA No.: M20200103**

**MGA RESEARCH CORPORATION  
5000 Warren Road  
Burlington, WI 53105**

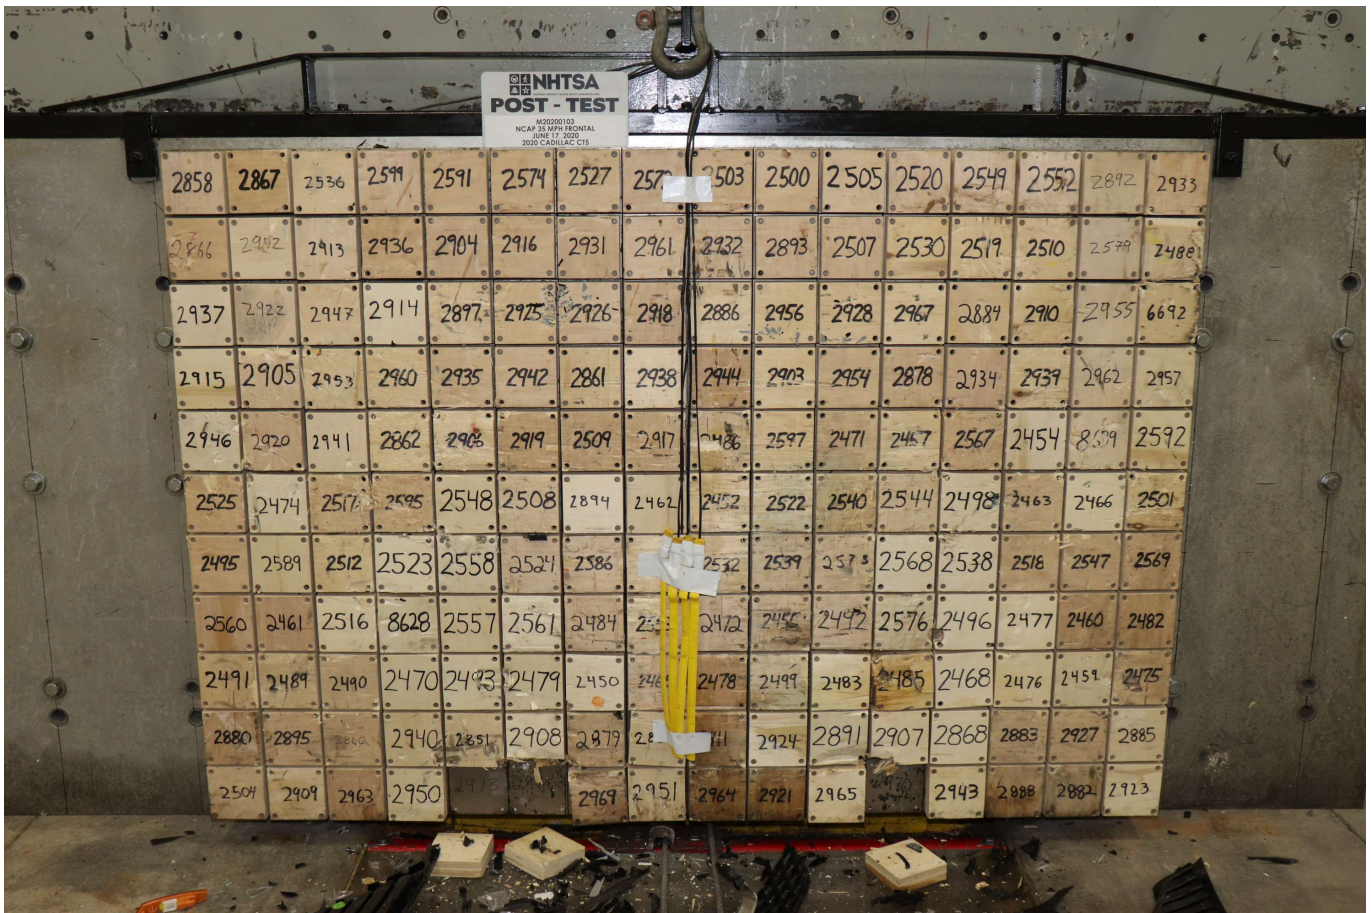
Photo No. 003 - Post-Test Load Cell Wall

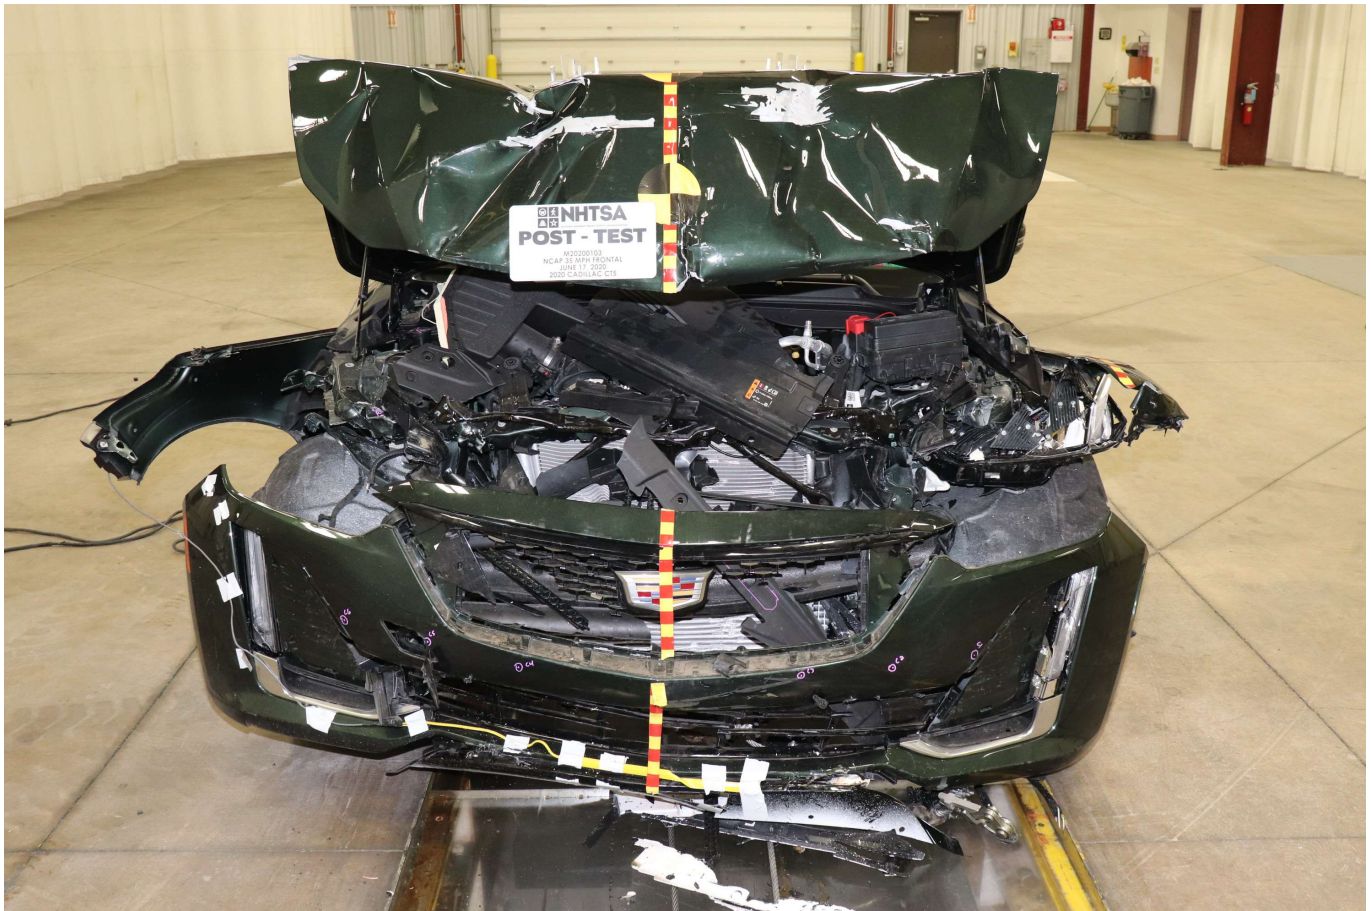
Photo No. 009 - Post-Test Front View of Test Vehicle

The maximum static crush of the vehicle was 505 mm located to the left of vehicle centerline and both the driver and passenger side doors remained closed during the impact event and were operable after the impact.

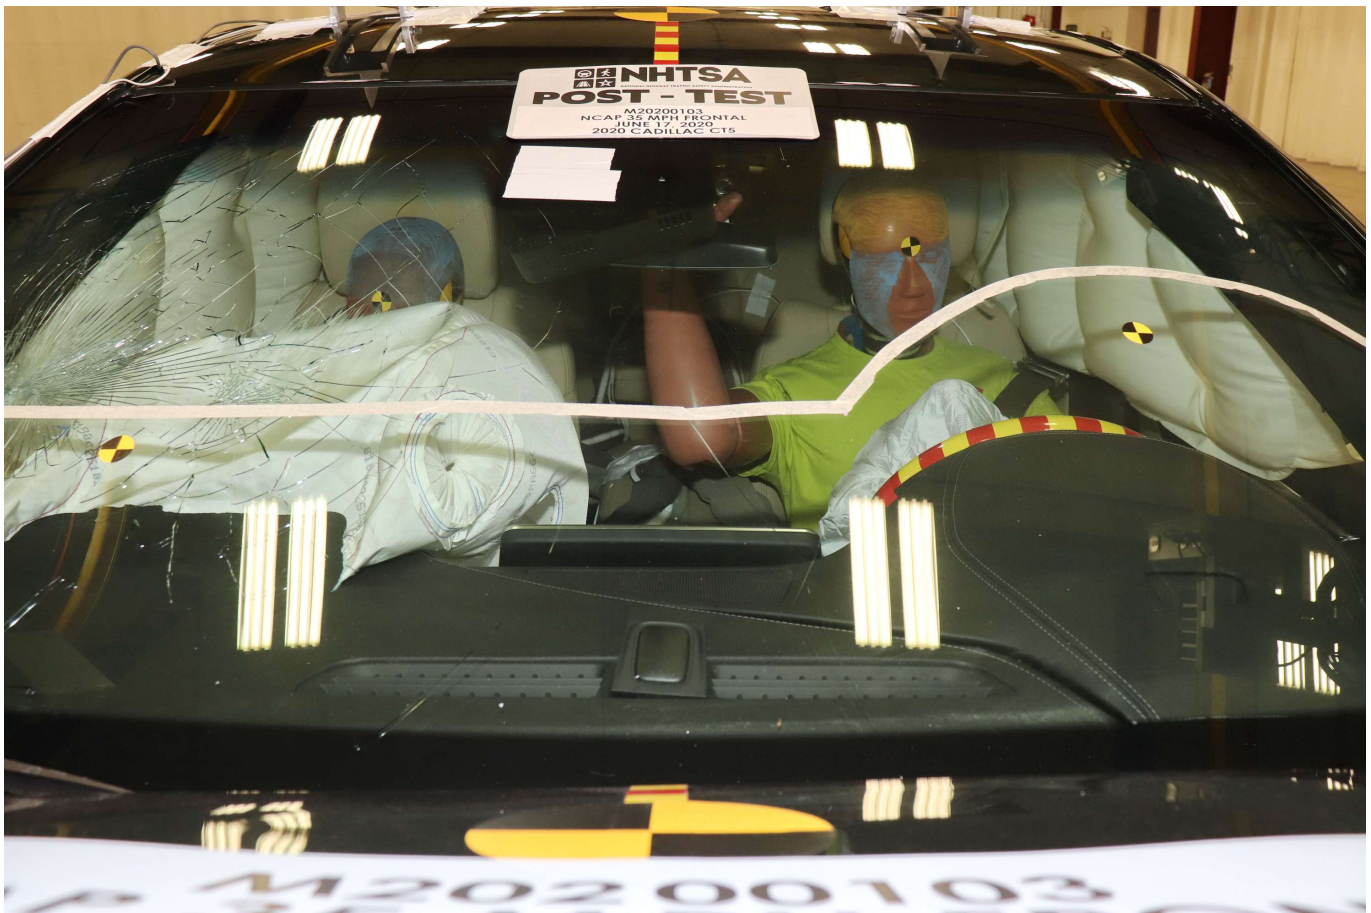
Photo No. 019 - Post-Test Windshield View

There was 100 percent windshield retention and no intrusion into the protected zone of the windshield during the event. There was no Stoddard Solvent leakage after the event or during any phase of the static rollover.

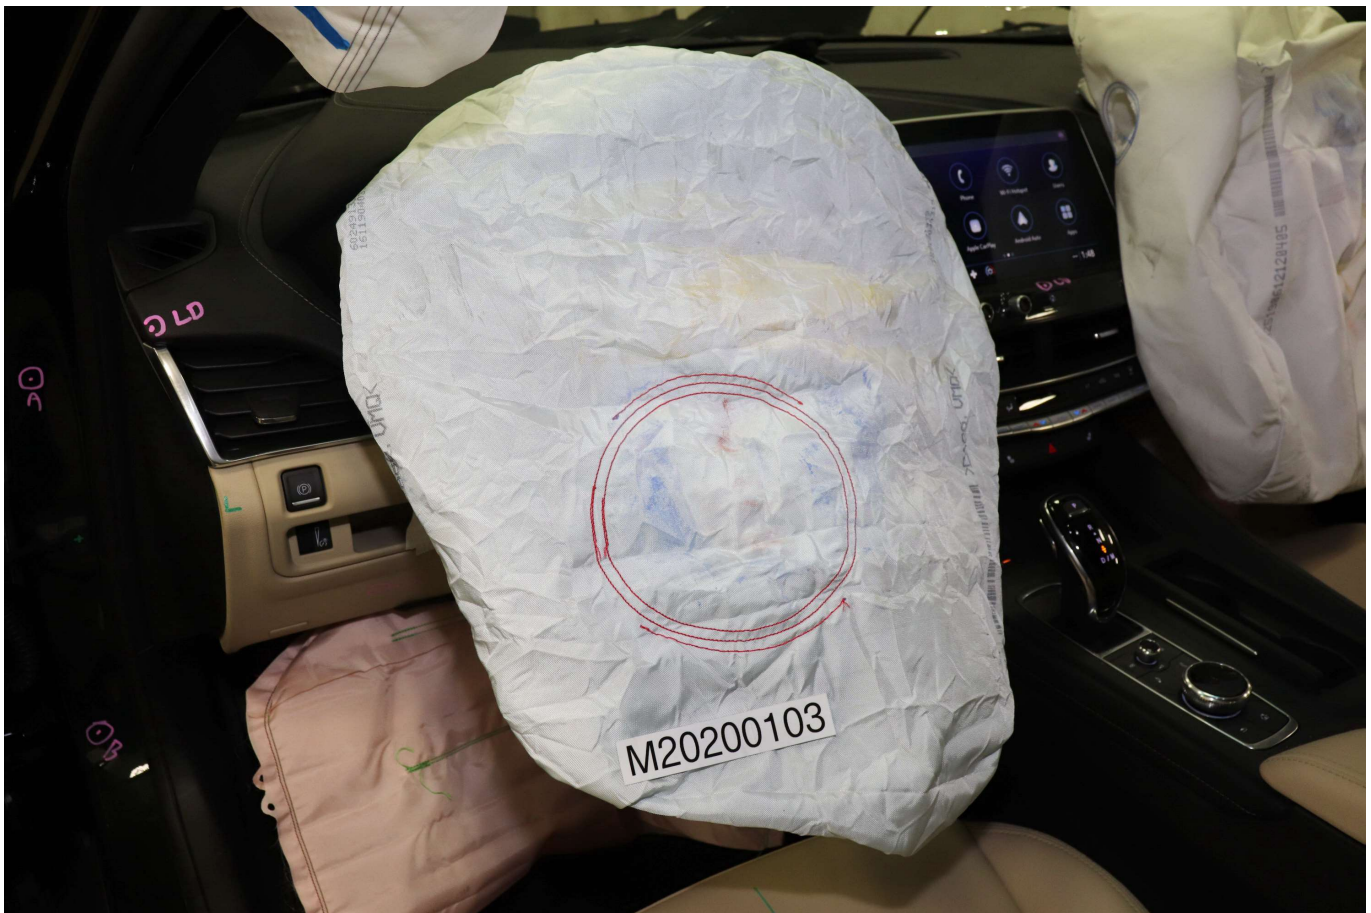
Photo No. 049 - Post-Test Driver Dummy Contact with Airbag

The driver's visible contact points were as follows: The driver's head contacted the airbag. The driver's head also contacted the headrest. The driver's knees contacted the knee airbag.

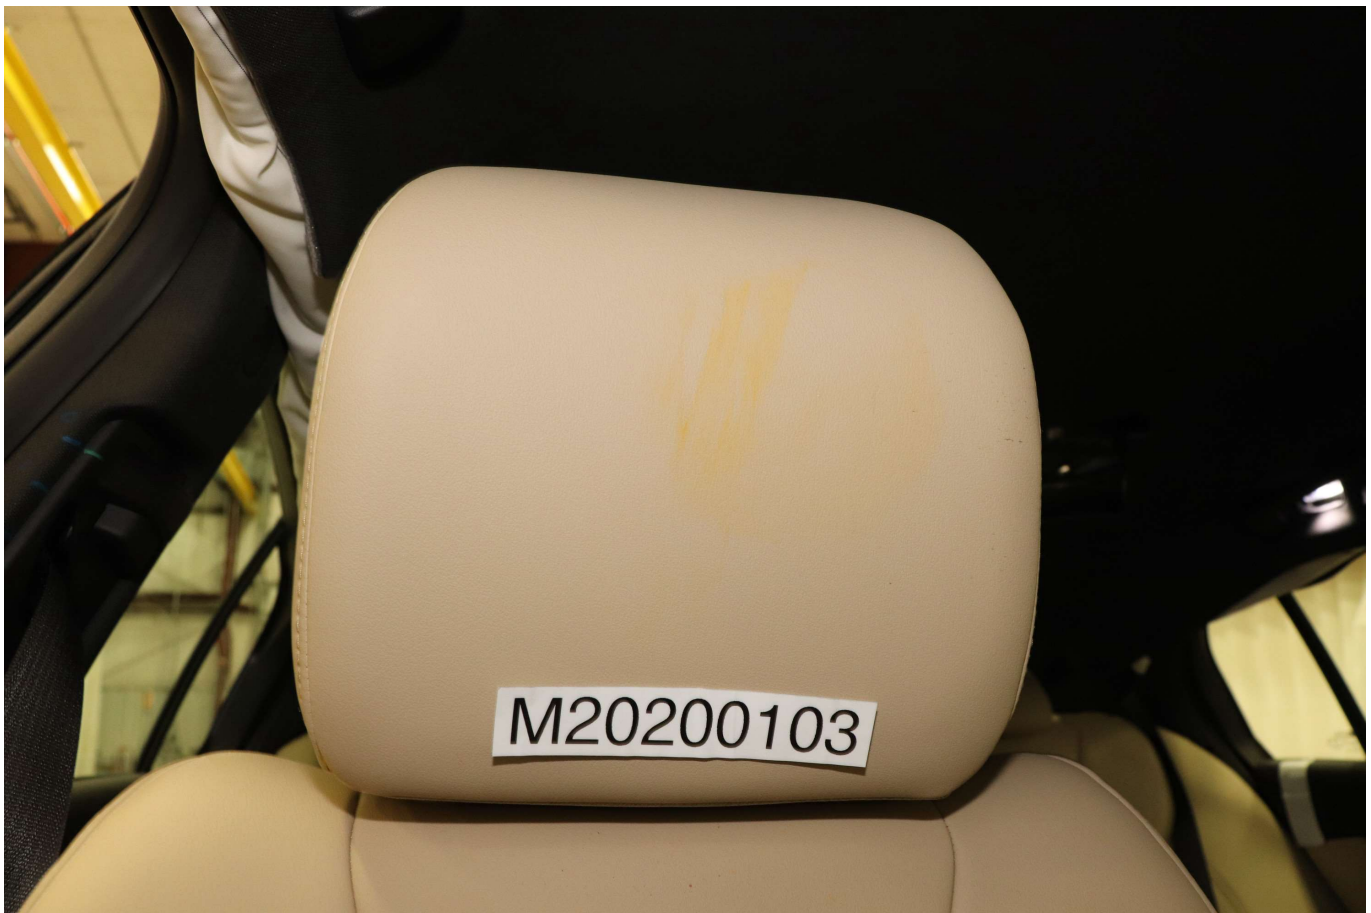
Photo No. 073 - Post-Test Passenger Dummy Contact with Headrest

The passenger's visible contact points were as follows: The passenger's head contacted the airbag. The passenger's head also contacted the headrest. The passenger's knees contacted the knee airbag.

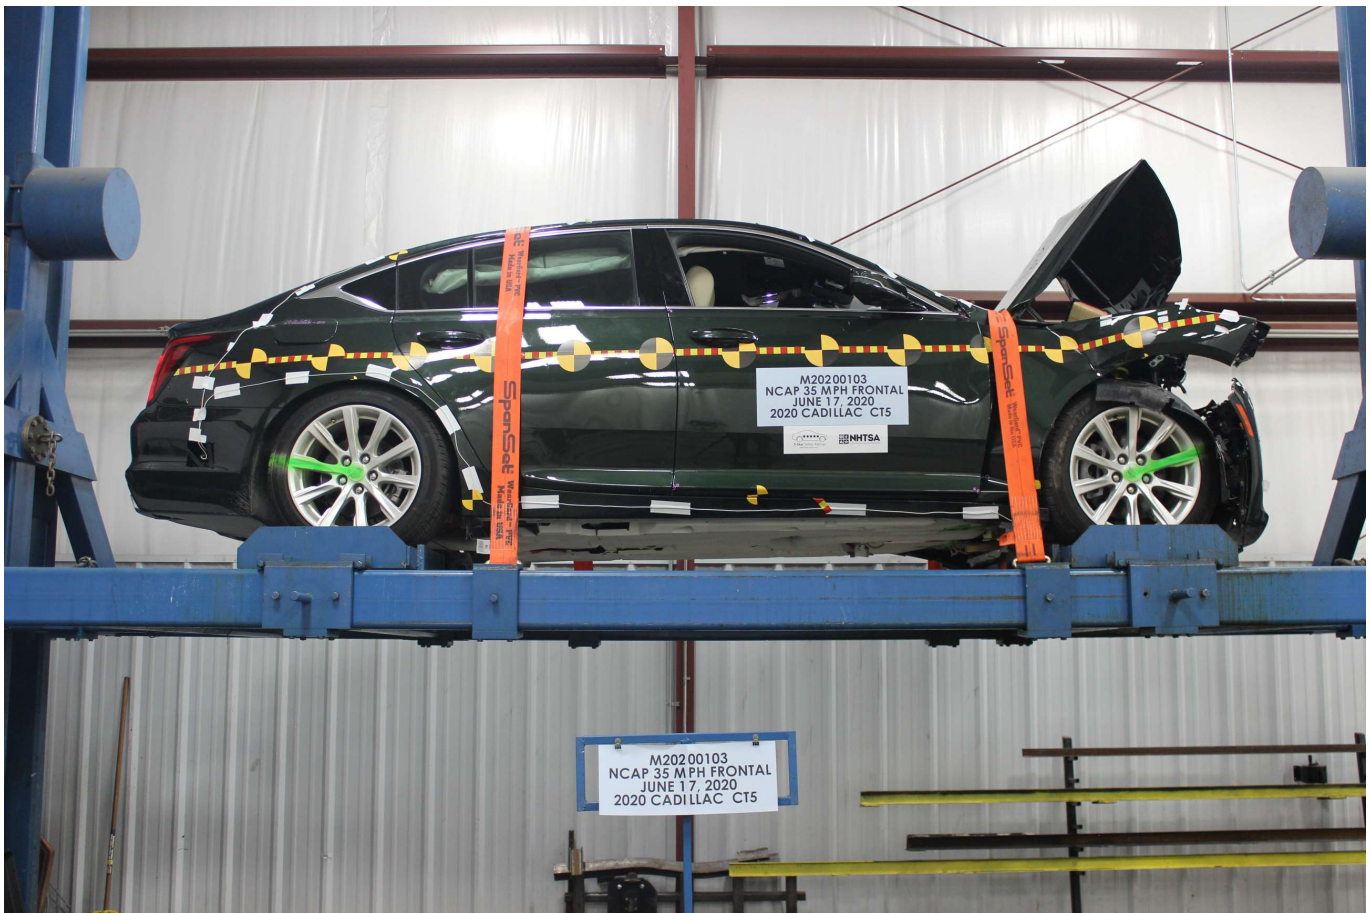
Photo No. 077 - Vehicle at 0 Degrees on Static Rollover Device

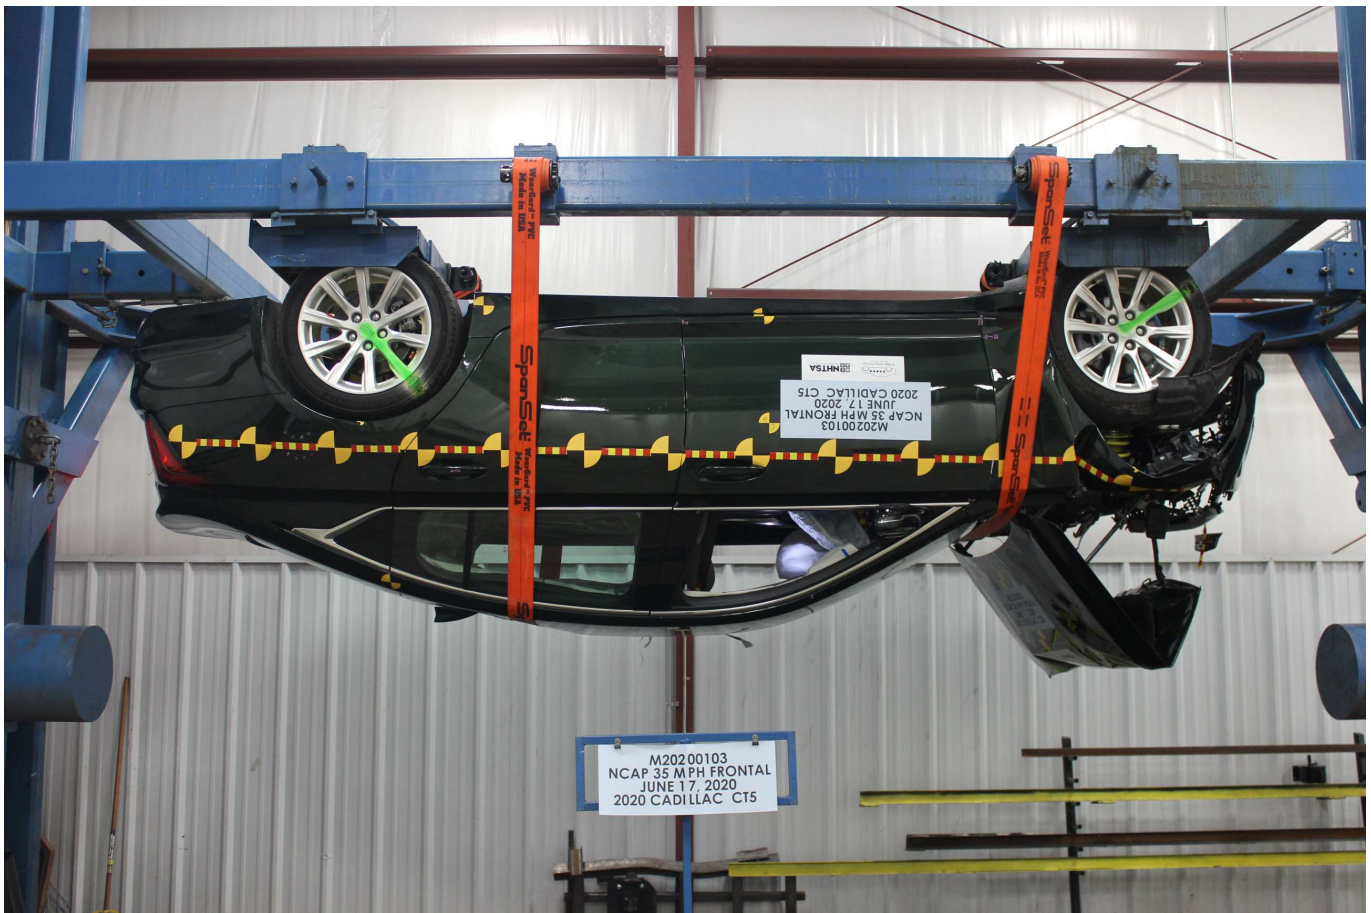
Photo No. 079 - Vehicle at 180 Degrees on Static Rollover Device

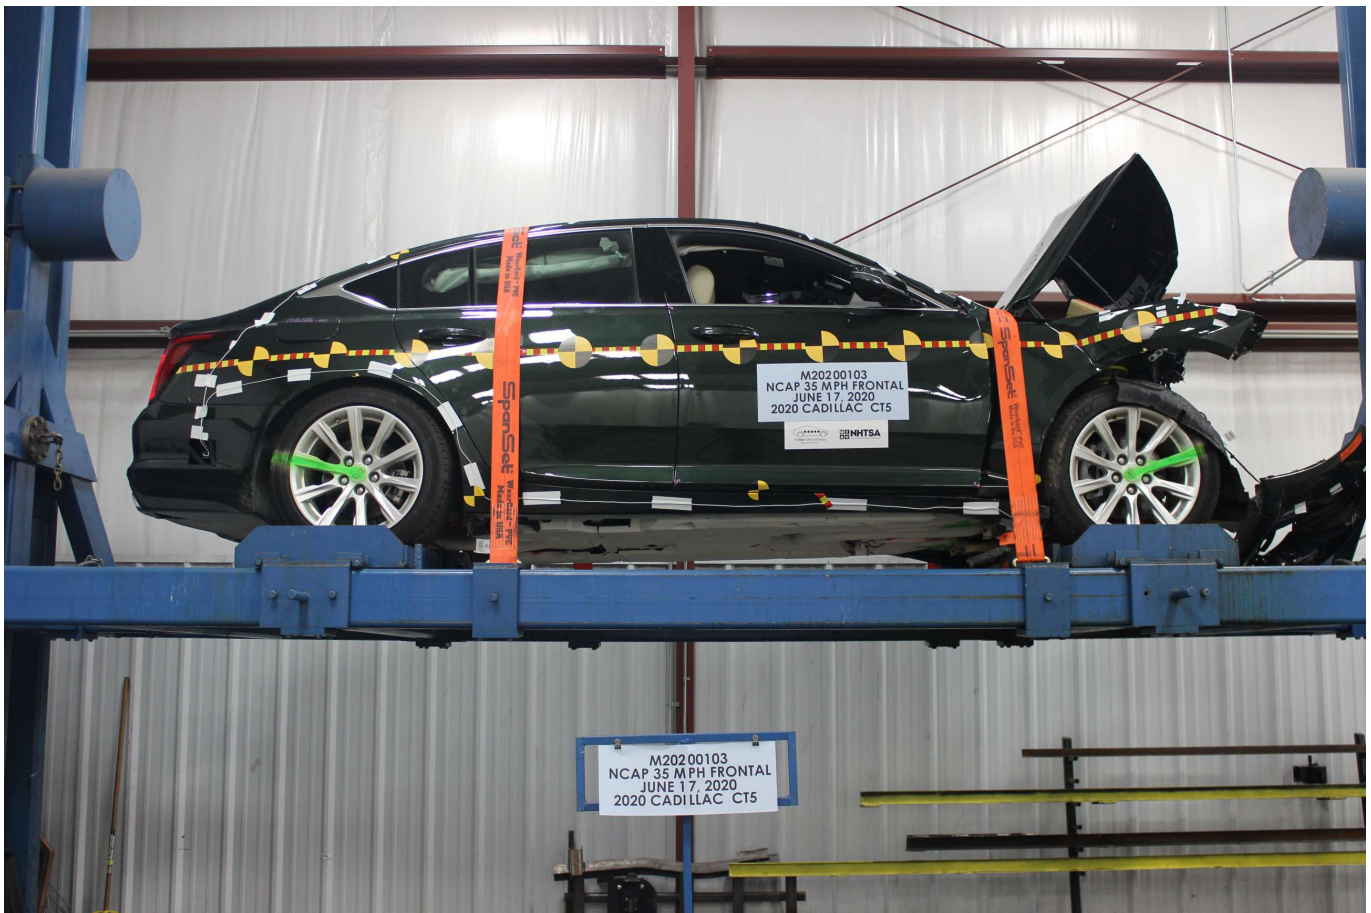
Photo No. 081 - Vehicle at 360 Degrees on Static Rollover Device
