**NEW CAR ASSESSMENT PROGRAM (NCAP)  
Moving Deformable Barrier Side Impact Test**

**NISSAN MOTOR CO., LTD.  
2020 Nissan Titan S Crew Cab  
NHTSA No.: M20205214**

**FINAL REPORT**

| <b>4. Title and Subtitle</b><br>Final Report of New Car Assessment Program<br>Side Impact MDB Testing of 2020 Nissan Titan S Crew Cab,<br>NHTSA No.: M20205214 | | <b>5. Report Date</b><br>September 28, 2020 |

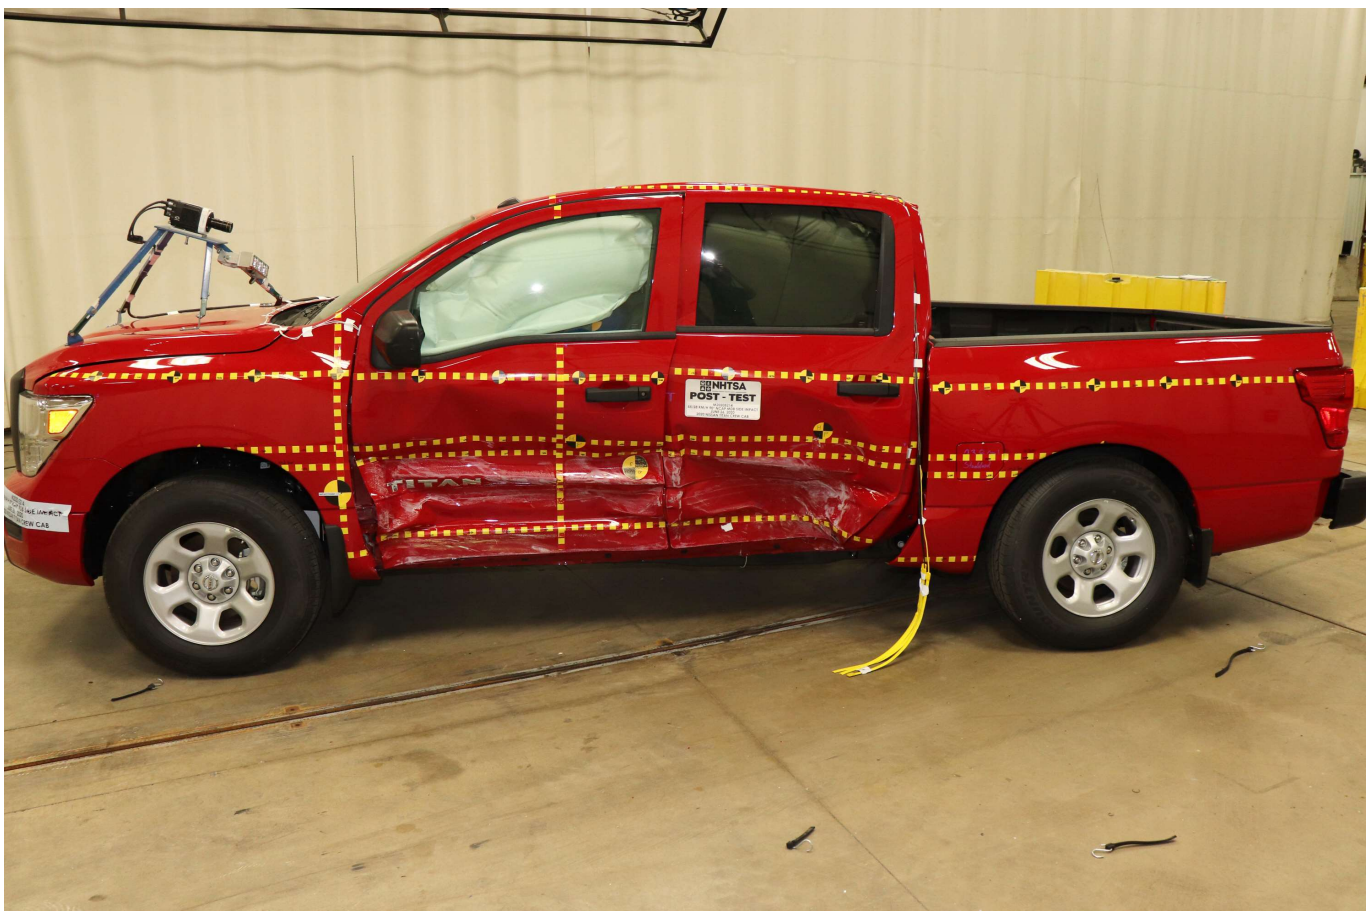
Photo No. 008 - Post-Test Left Side View of Test Vehicle

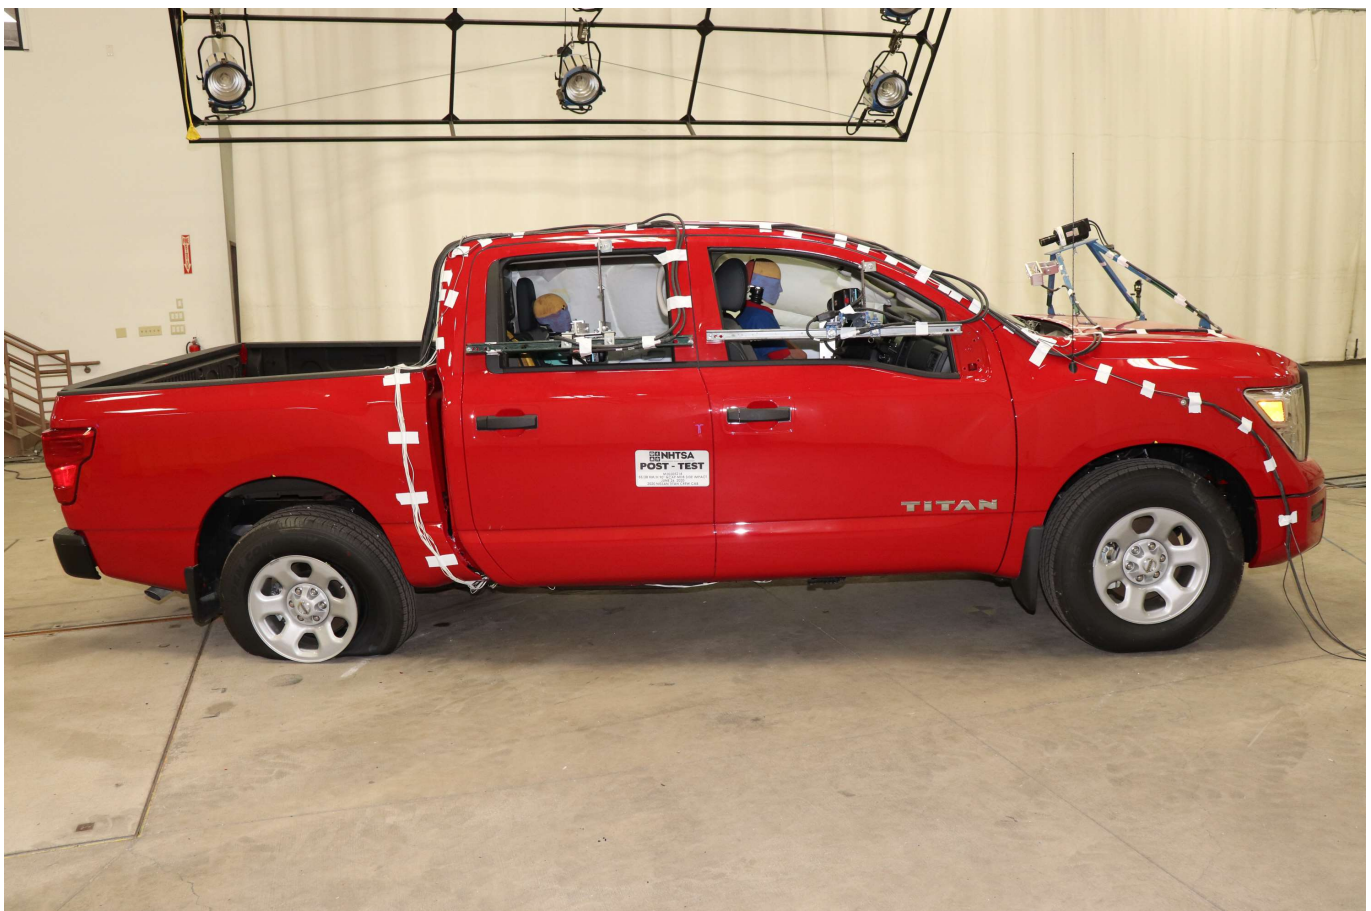
Photo No. 014 - Post-Test Right Side View of Test Vehicle

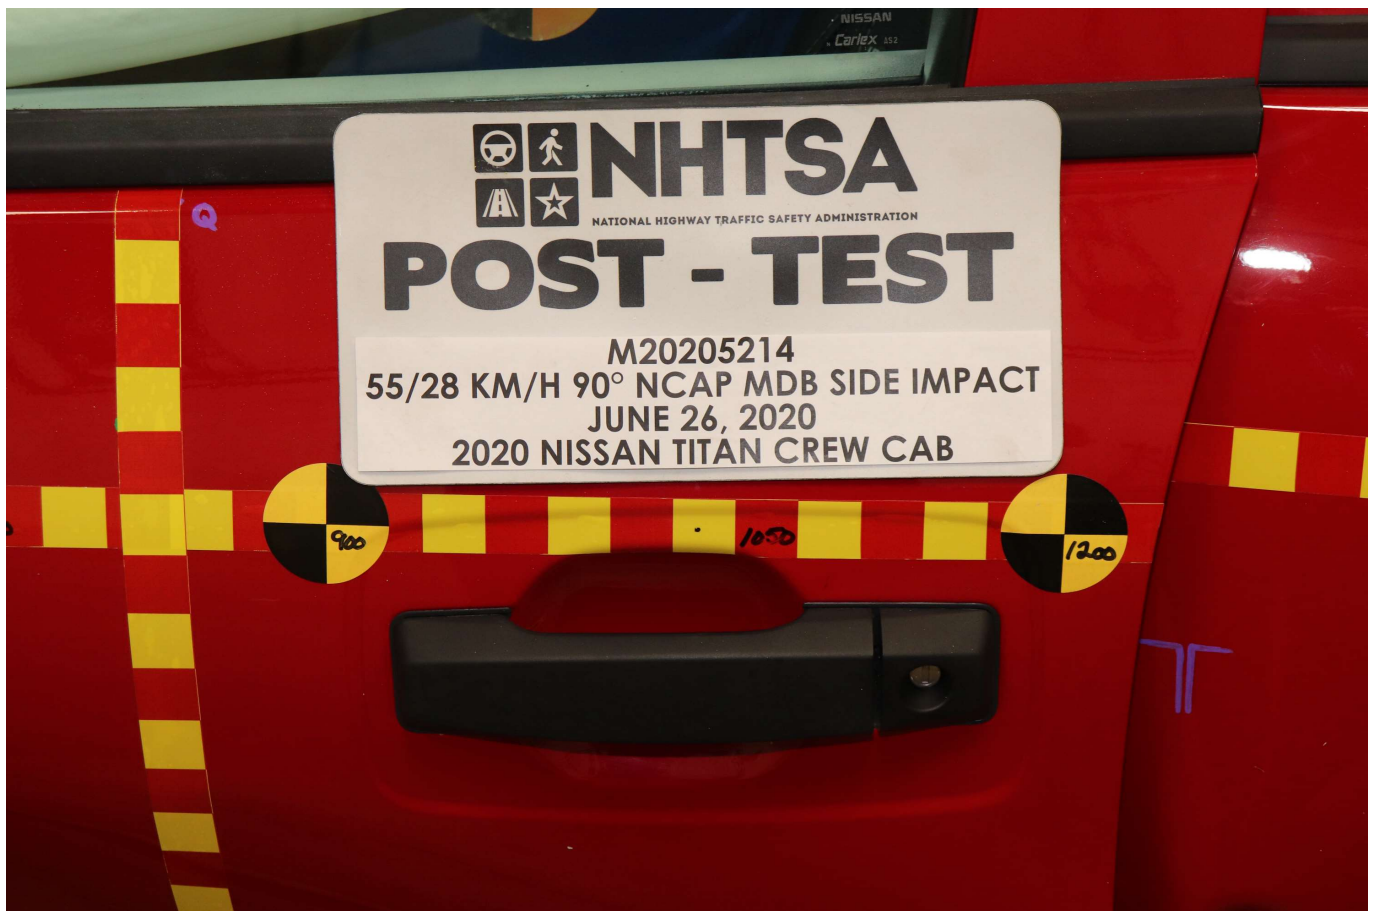
Photo No. 022 - Post-Test Left Front Door Latch Close-Up

The two doors on the struck side of the vehicle did not separate from the body at the hinges or latches and the opposite door(s) did not open during the side impact event.

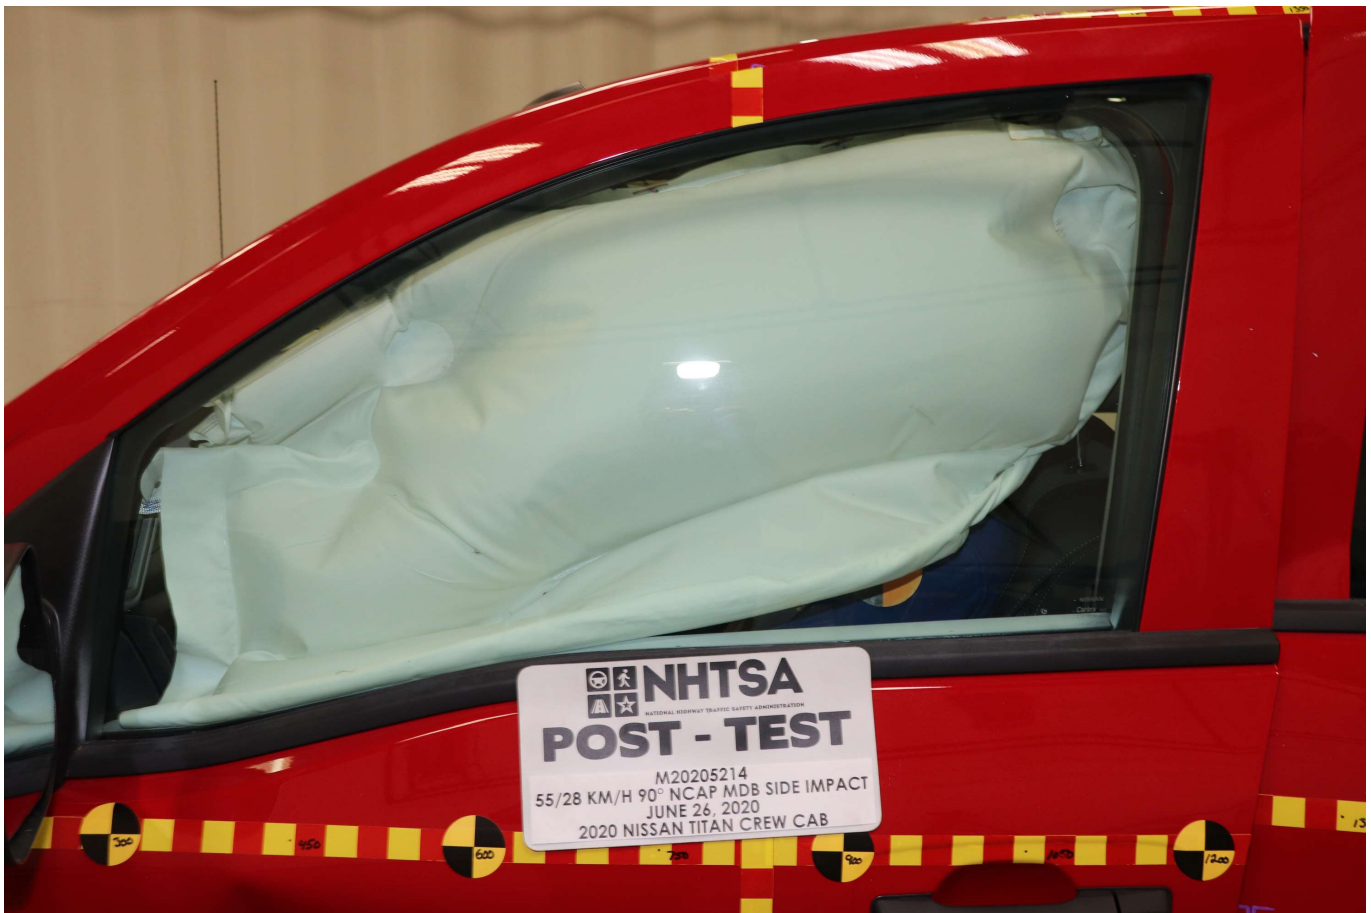
Photo No. 029 - Post-Test Left Side View of Driver Dummy Shoulder and Door Top View

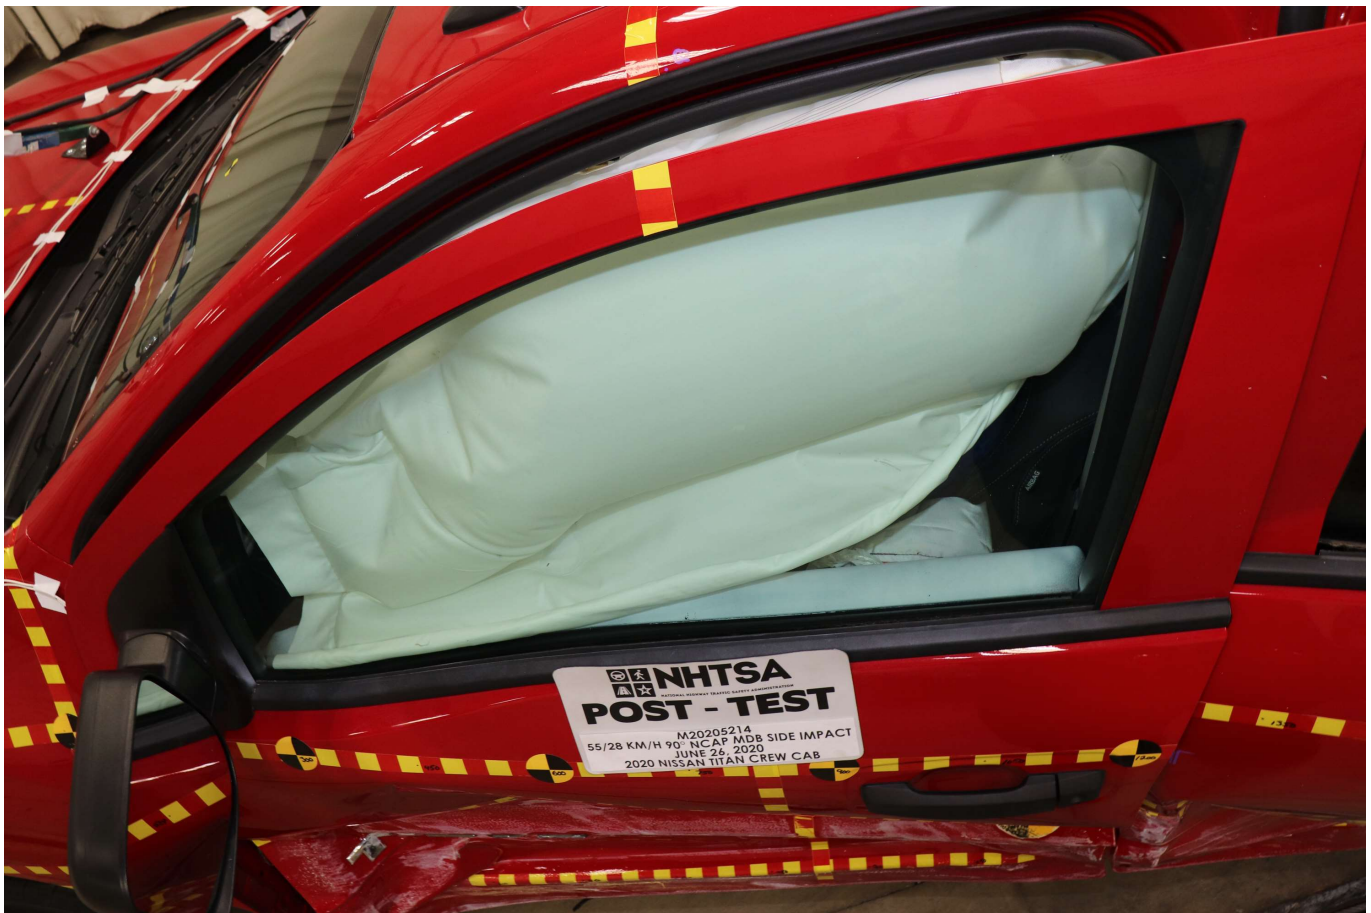
Photo No. 043 - Post-Test Driver Dummy and Door Clearance View

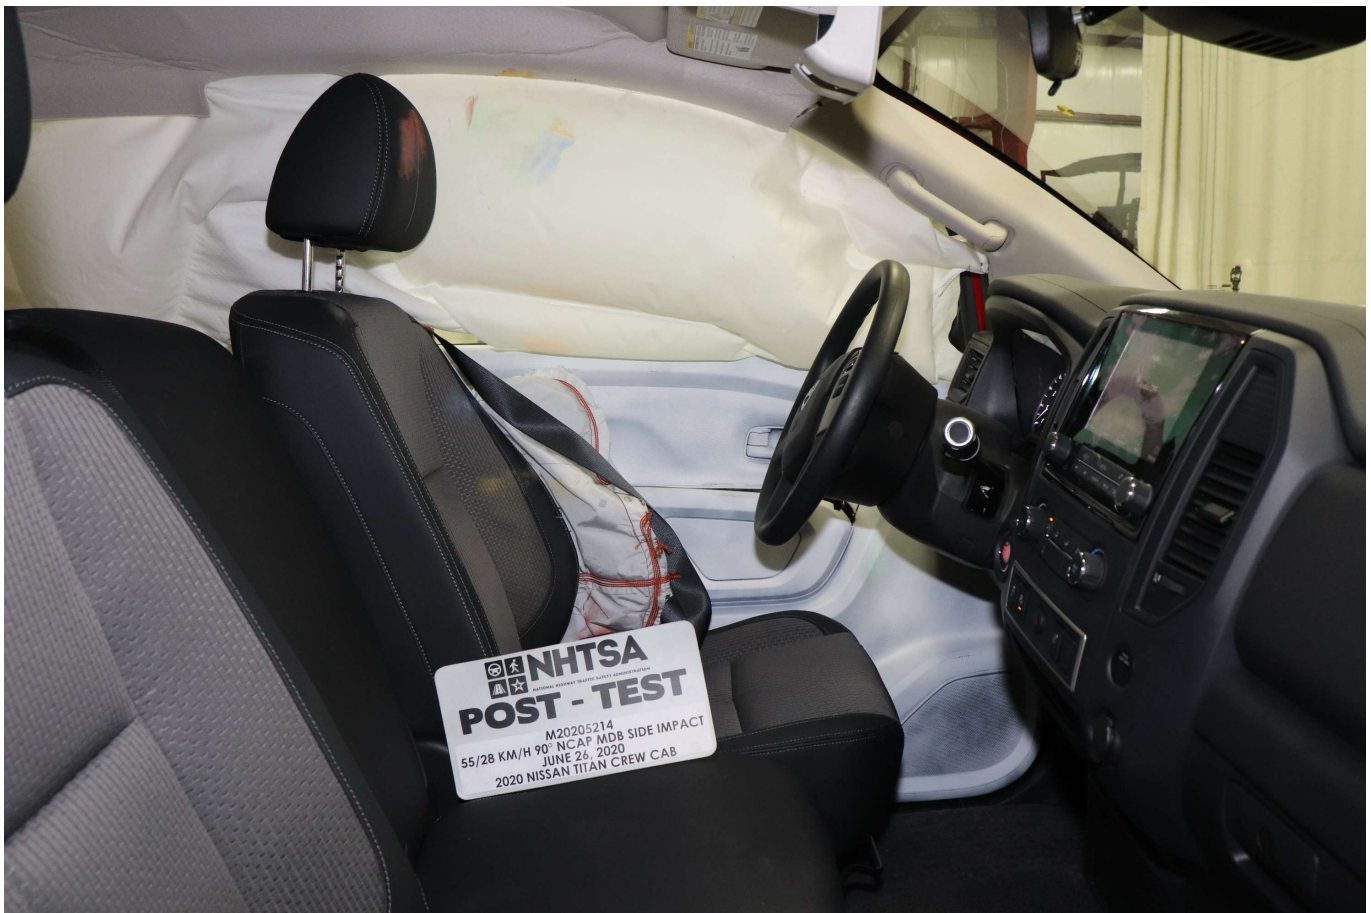
Photo No. 047 - Post-Test Driver Inner Door Panel View

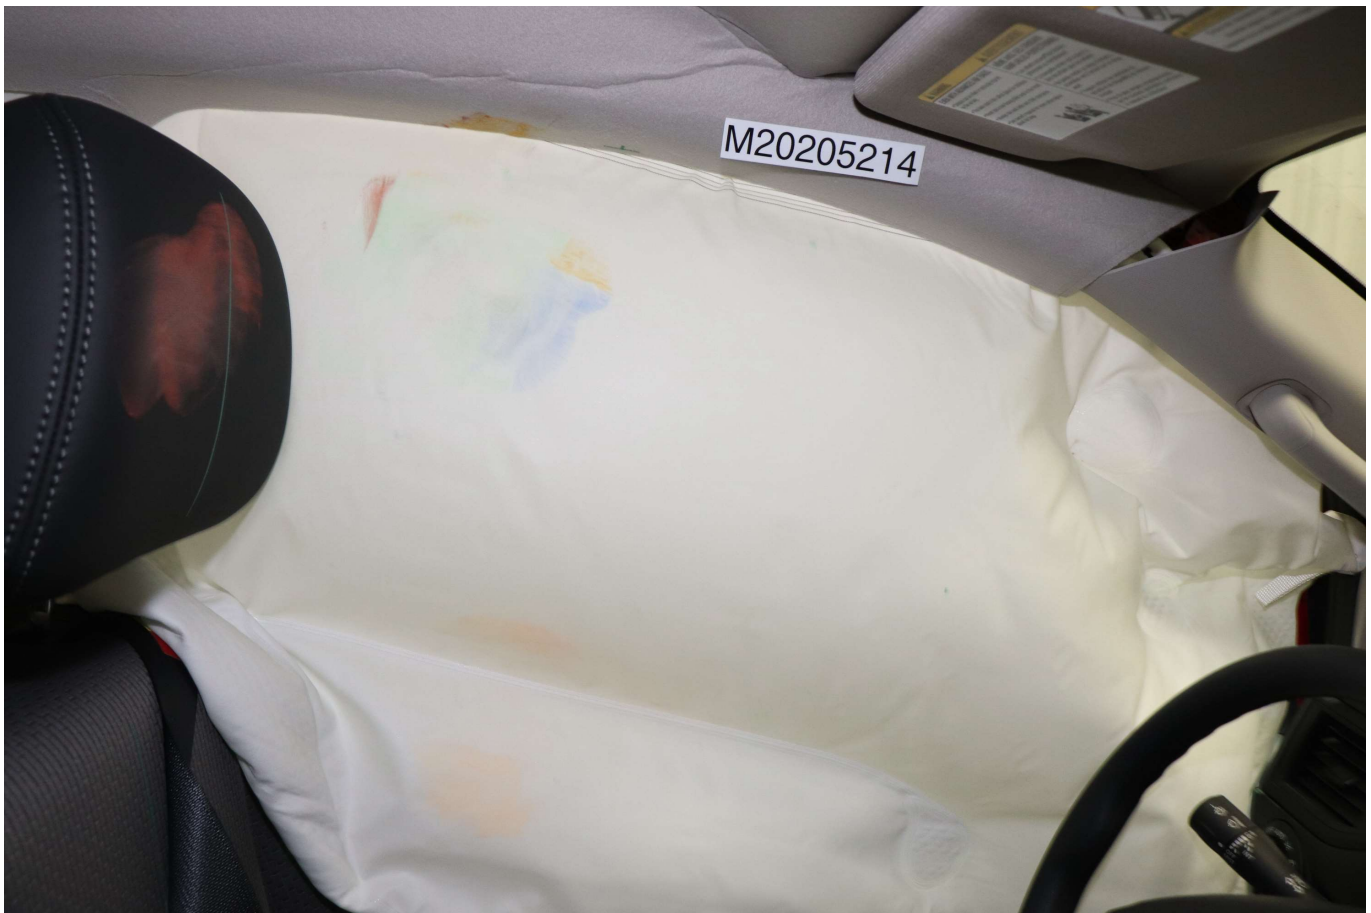
Photo No. 049 - Post-Test Driver Dummy Close-up Head Contact with Side Airbag View

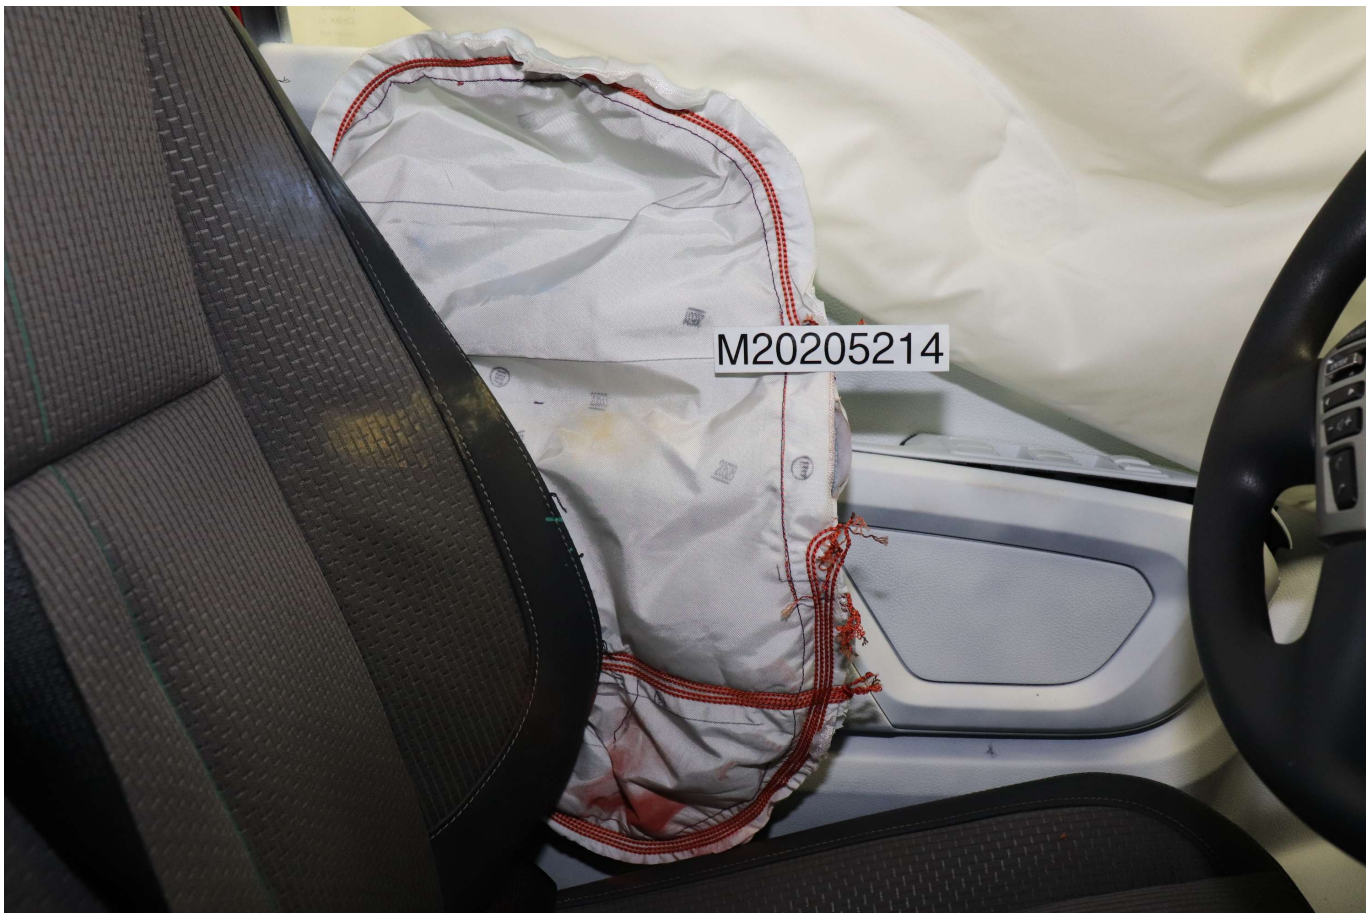
Photo No. 051 - Post-Test Driver Dummy Close-up Torso Contact with Side Airbag View

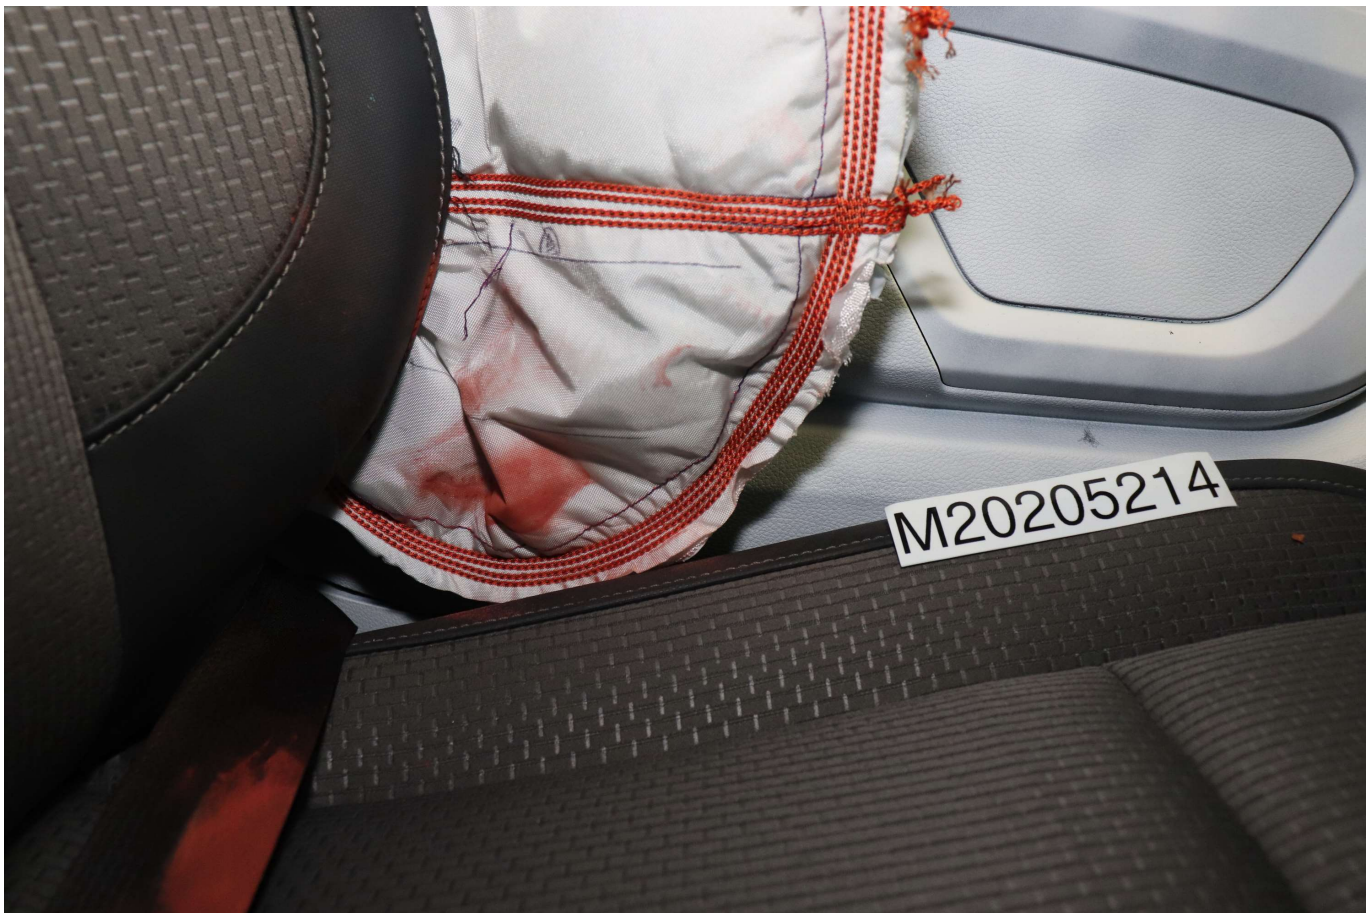
Photo No. 053 - Post-Test Driver Dummy Close-up Pelvis Contact with Side Airbag View

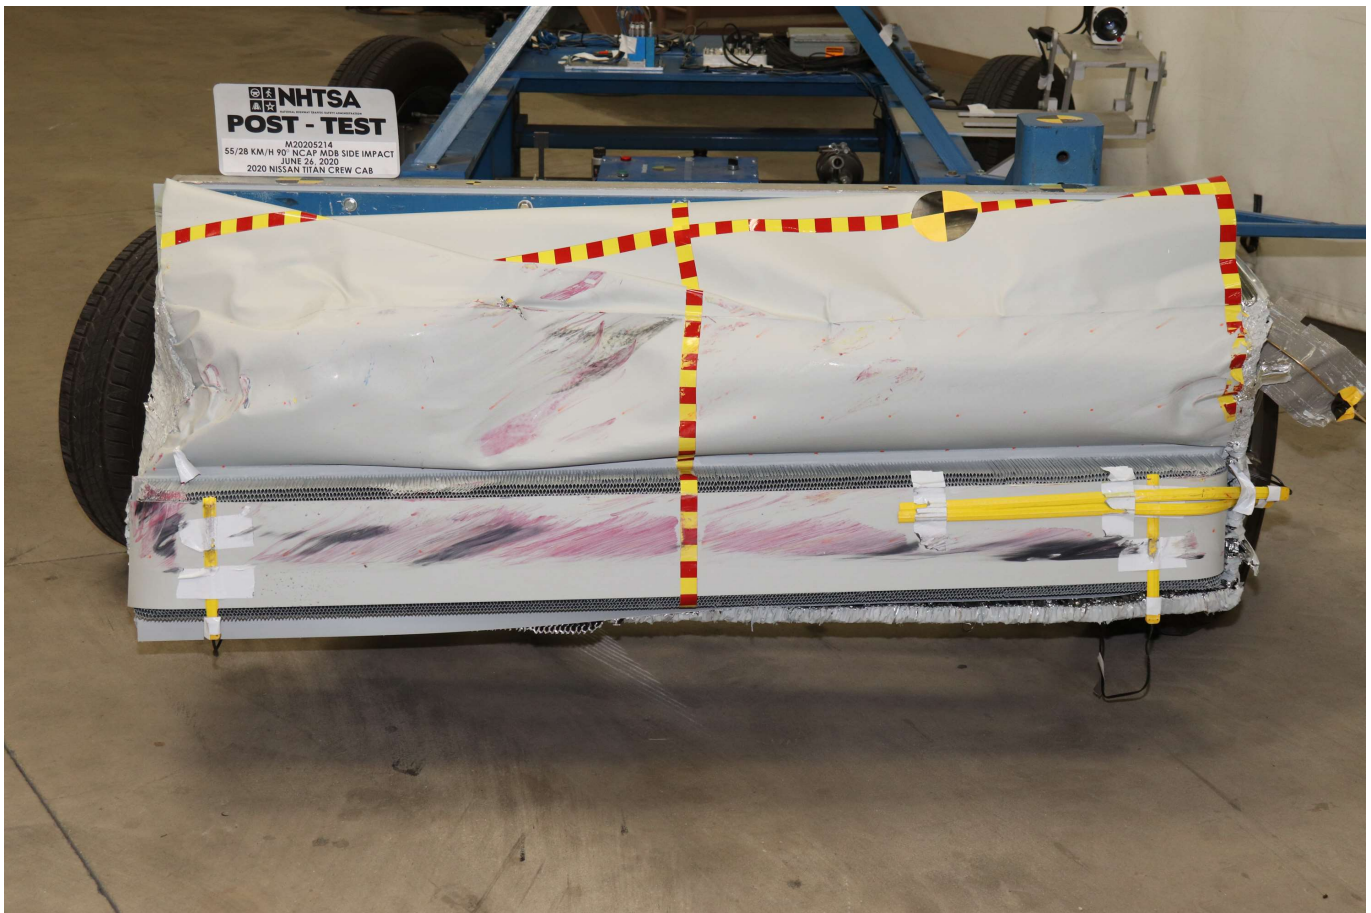
Photo No. 085 - Post-Test Front View of MDB Impactor Face

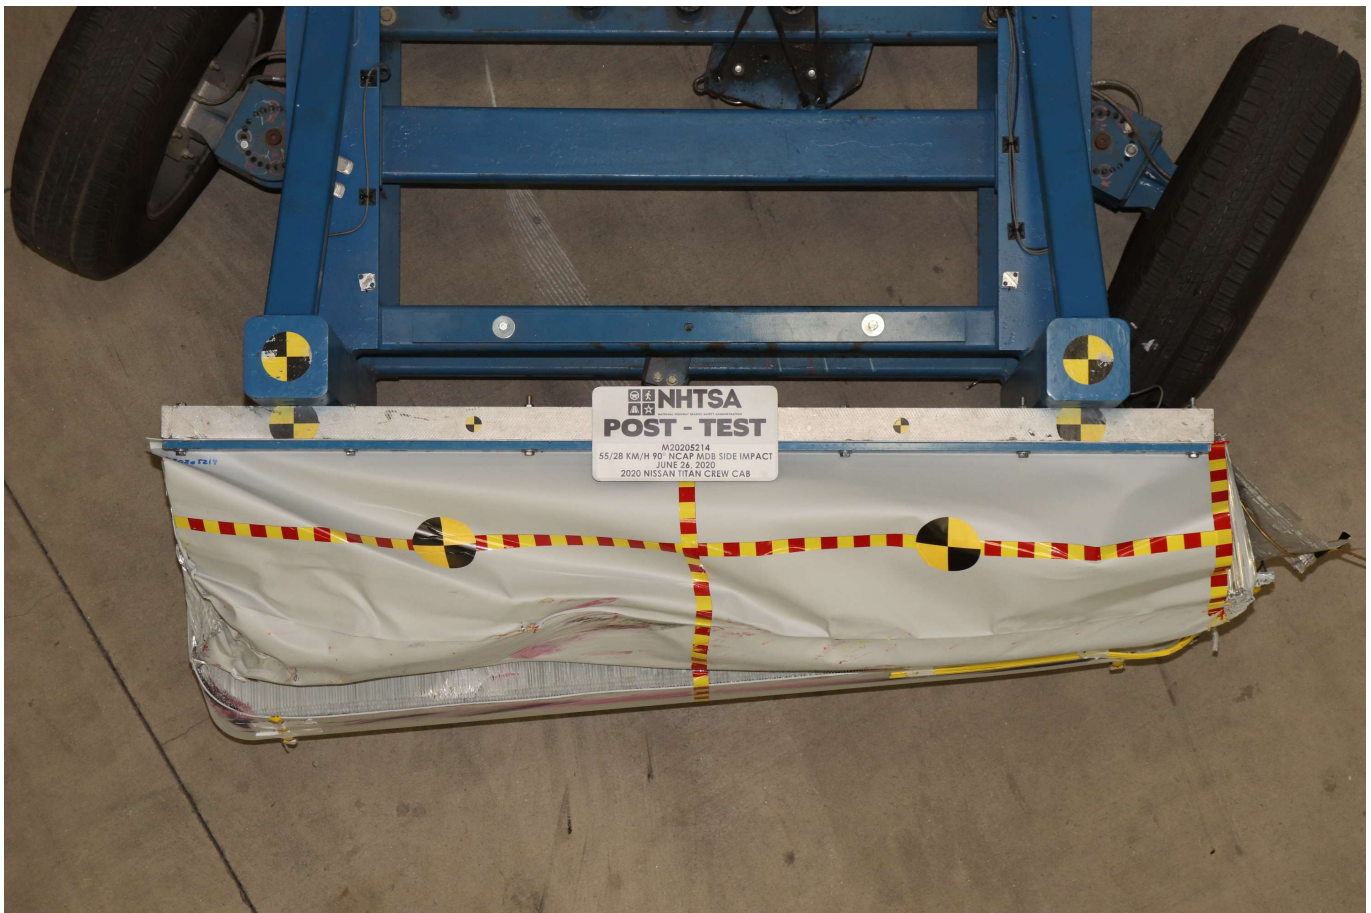
Photo No. 087 - Post-Test Top View of MDB Impactor Face

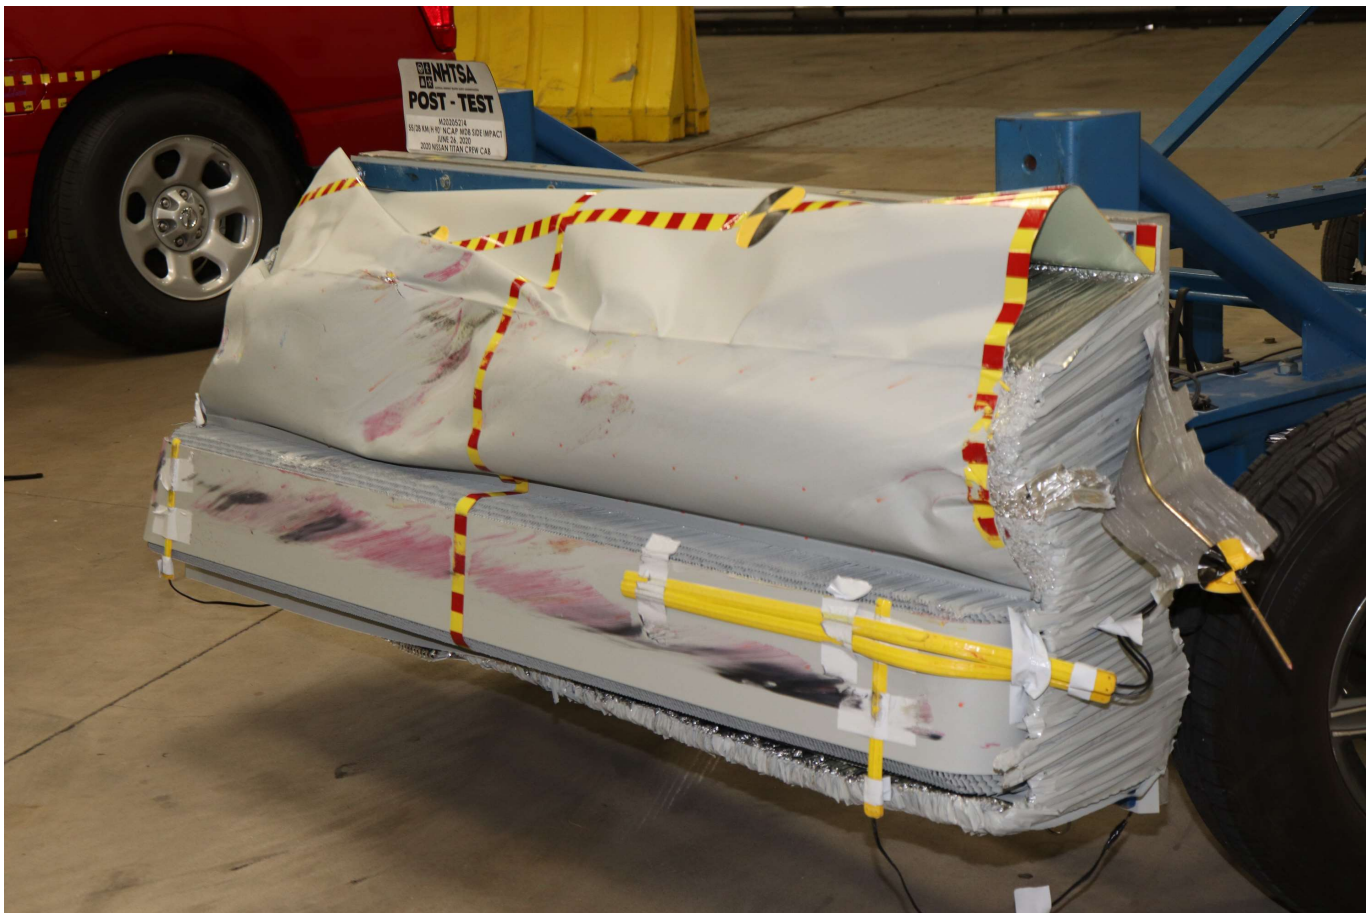
Photo No. 089 - Post-Test Left Side View of MDB Impactor Face

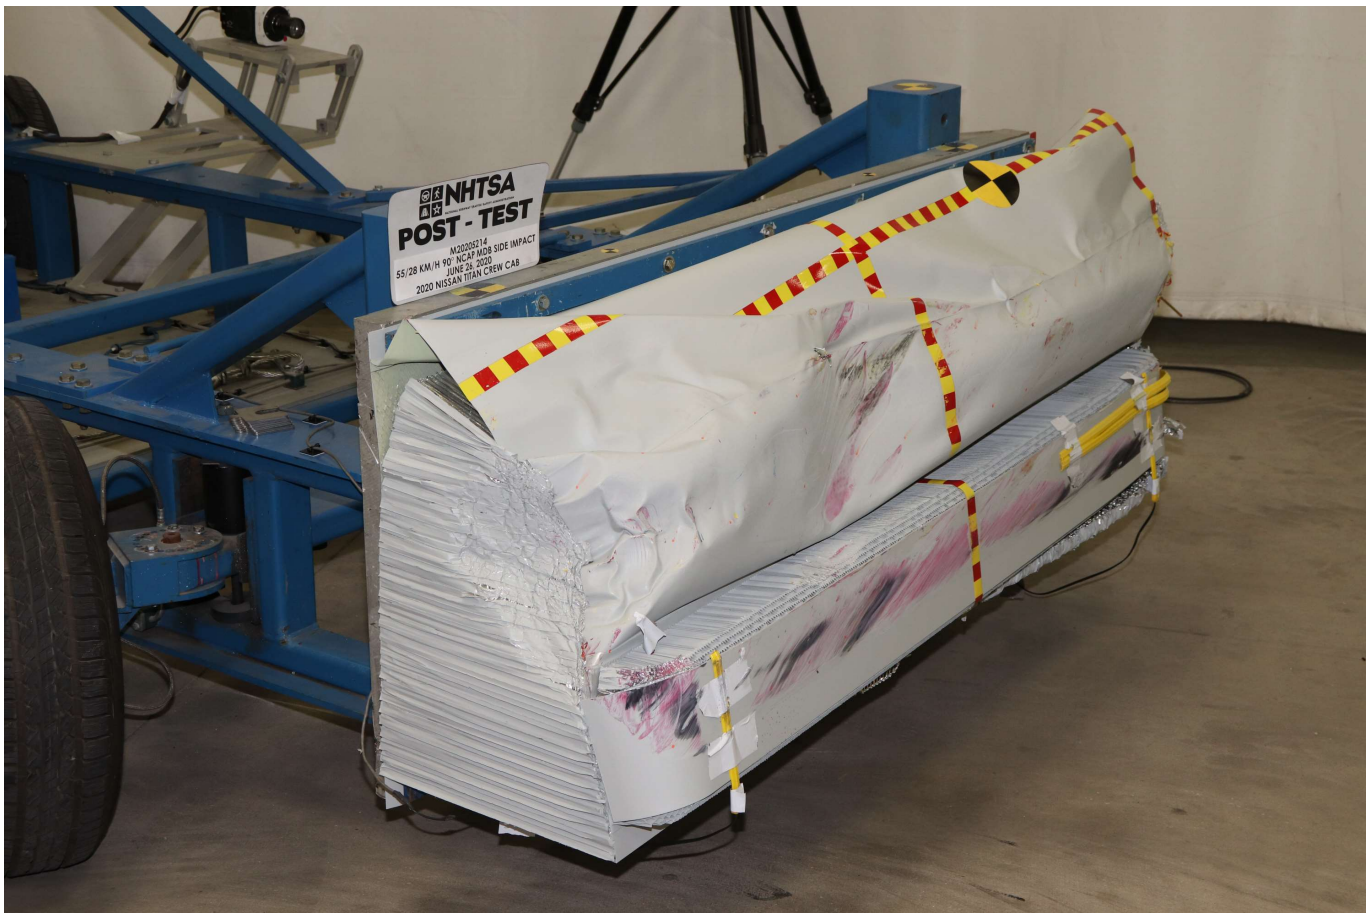
Photo No. 091 - Post-Test Right Side View of MDB Impactor Face
