REPORT NUMBER: SPNCAP-CAL-20-011

**NEW CAR ASSESSMENT PROGRAM (NCAP)
SIDE IMPACT POLE TEST**

**Nissan Motor Co. LTD.
2020 Nissan LEAF PLUS (62 kWh Battery)
Five Door Hatchback**

FINAL REPORT

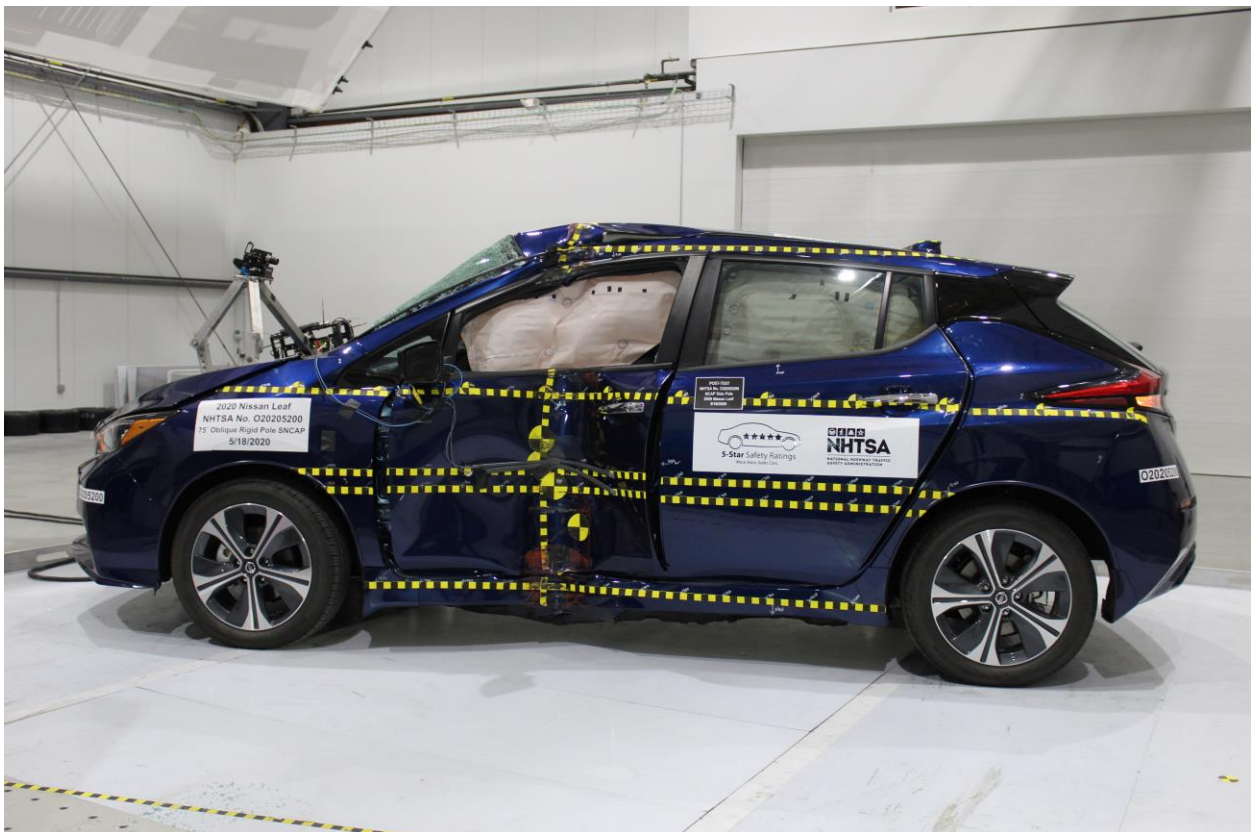
Figure A-8: Post-Test Left Side View of Test Vehicle

Critical Areas of Performance	Observations and Conclusions
Pillar Performance	A-Pillar Buckled
Sill Separation	None
Windshield Damage	Cracks Throughout
Side Window Damage	Driver Window Shattered
Other Notable Effects	None

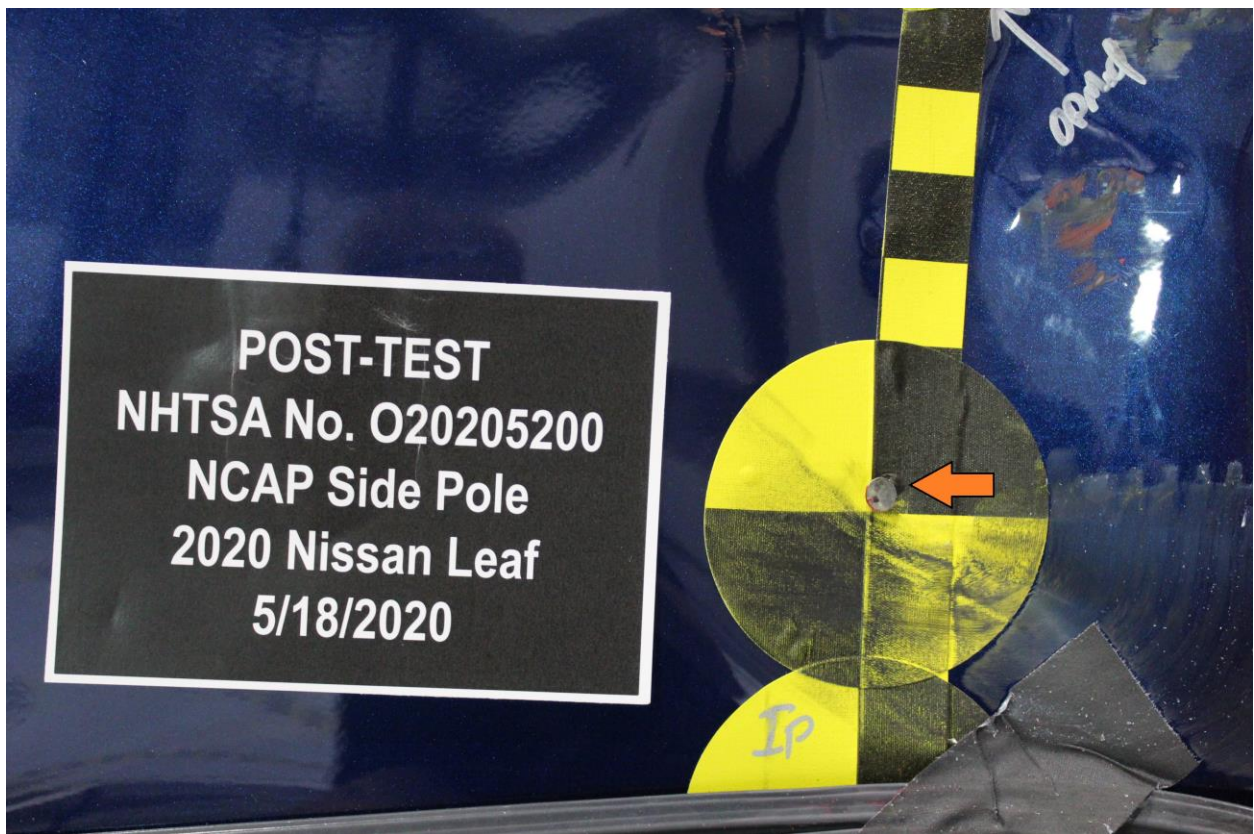
Figure A-20: Post-Test Close-Up View of Impact Point Target Showing Impact Location

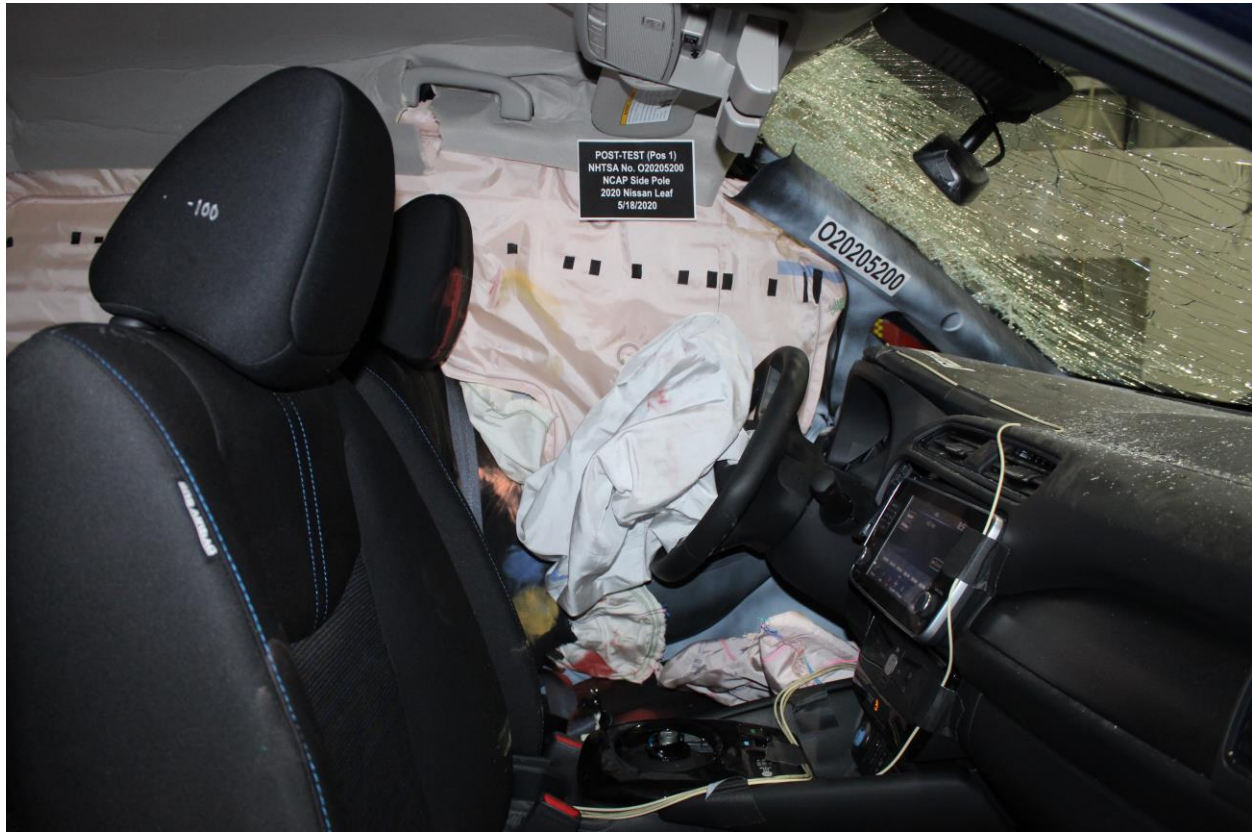
Figure A-45: Post-Test Inner Door Panel View Showing Dummy Contact Location

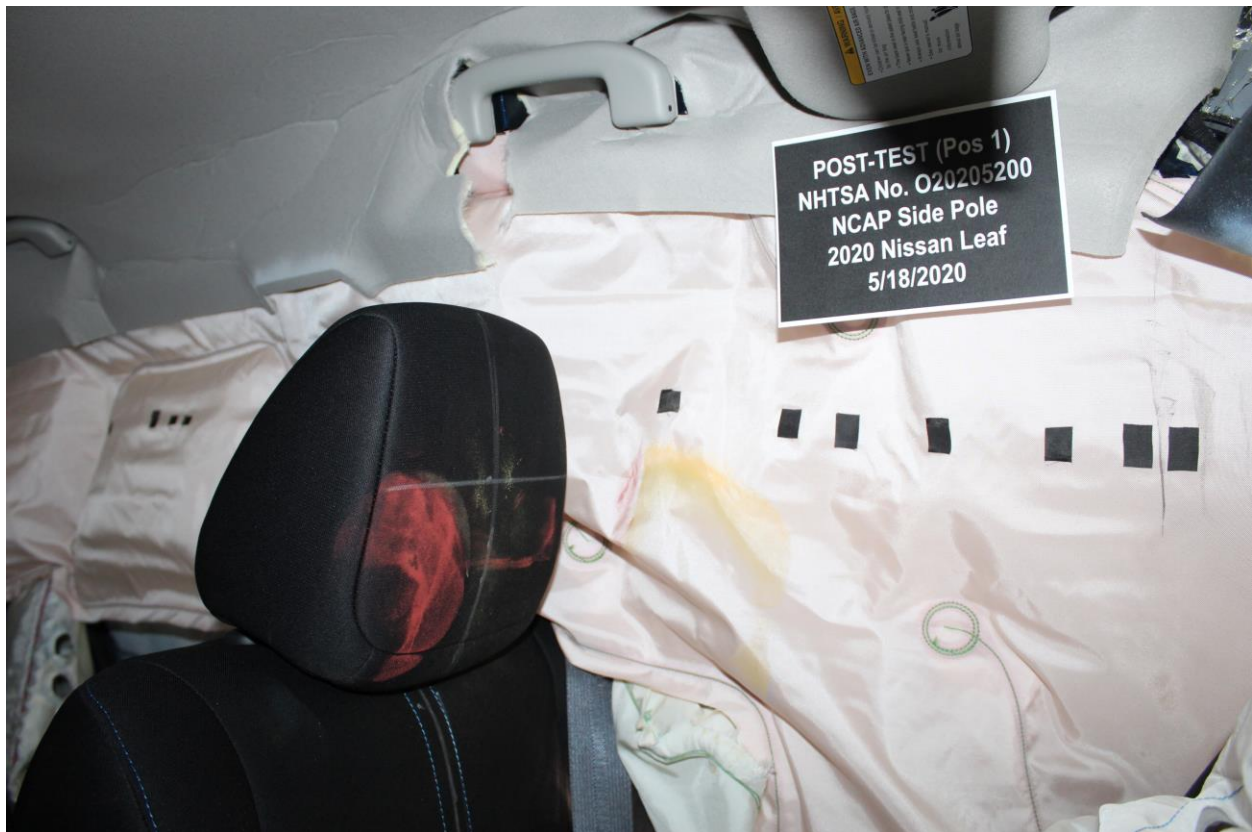
Figure A-46: Post-Test Dummy Close-Up Head Contact with Vehicle Interior View

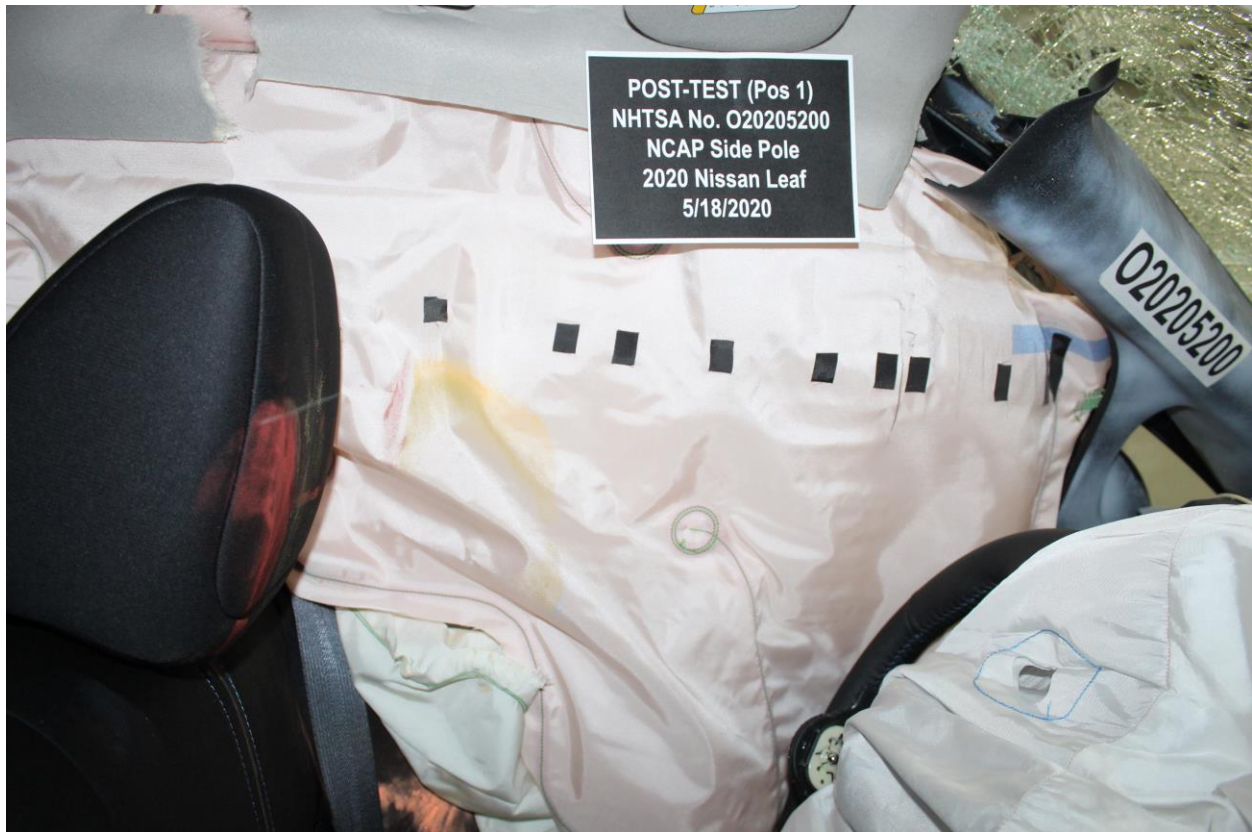
Figure A-47: Post-Test Dummy Close-Up Head Contact with Side Airbag View

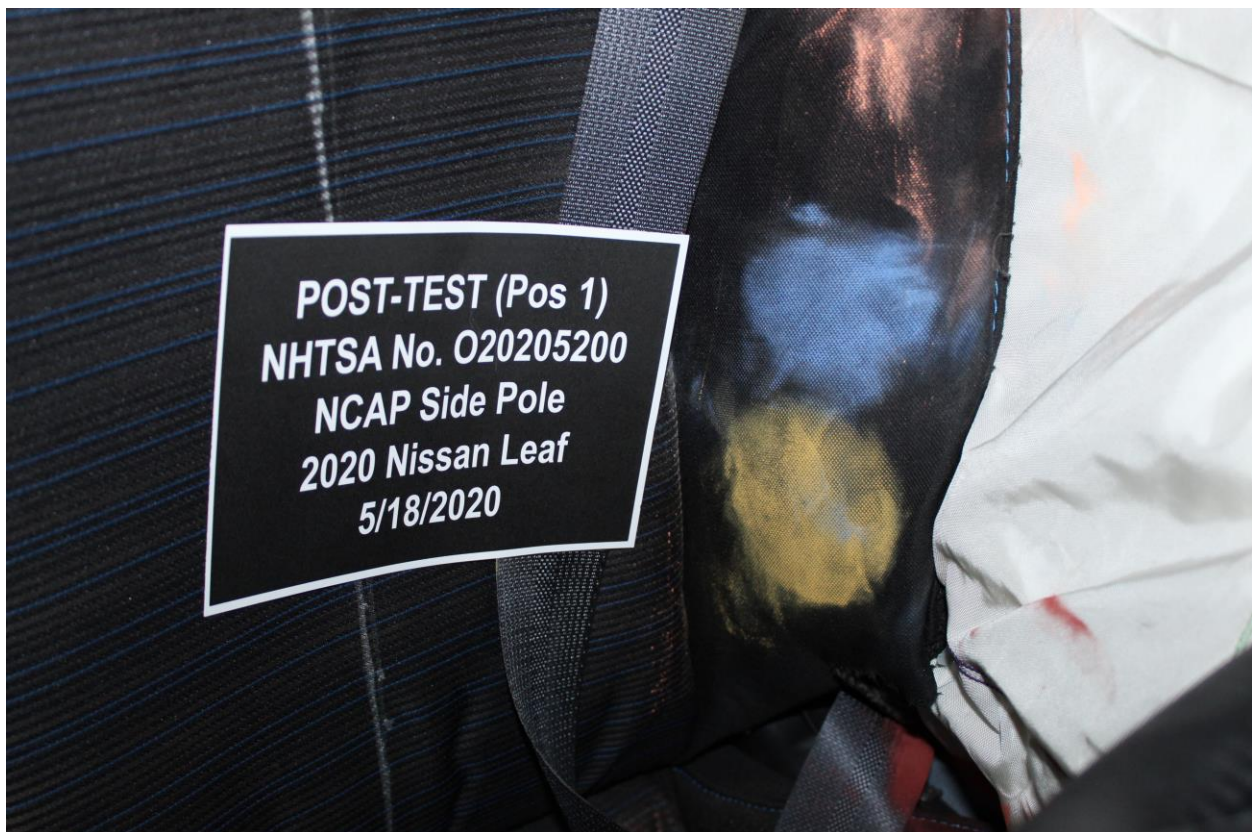
Figure A-48: Post-Test Dummy Close-Up Torso Contact with Vehicle Interior View

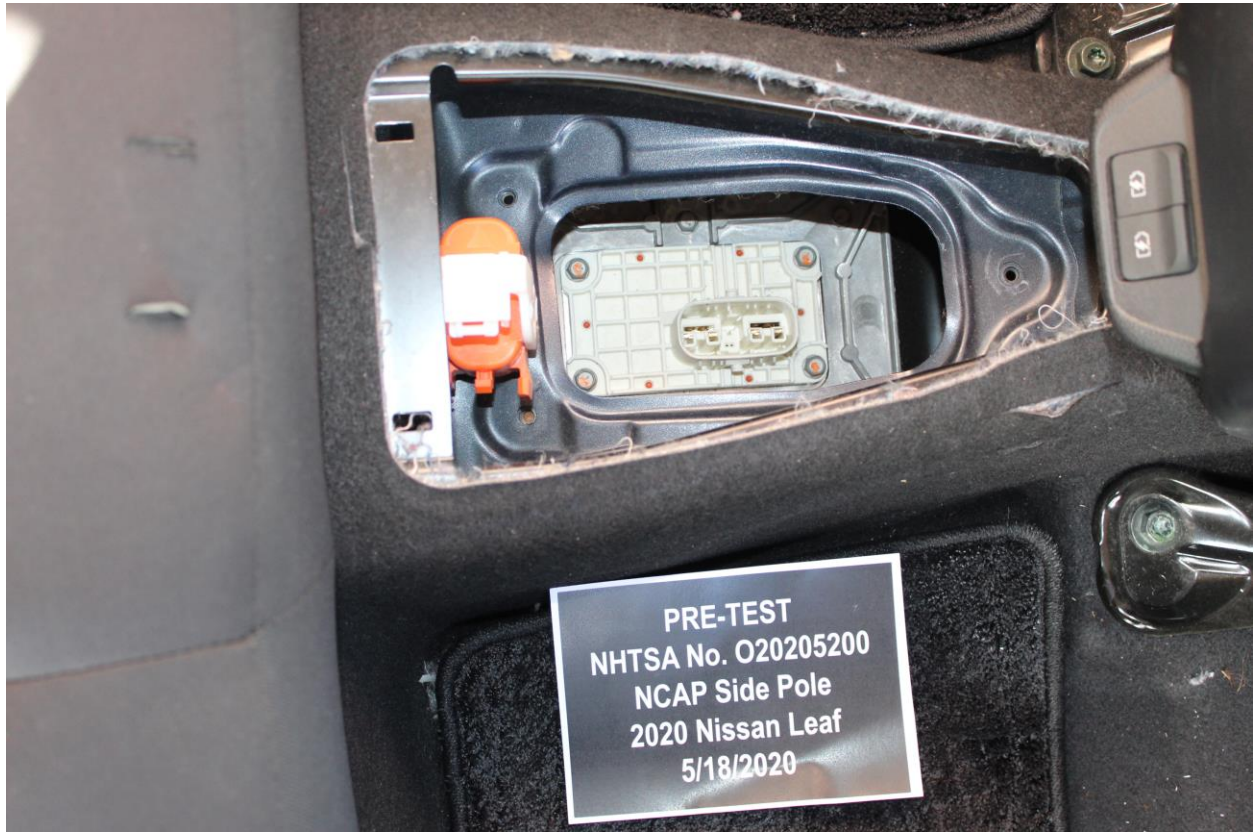
Figure 305-7: Manual High Voltage Service Disconnect Removed (Show Plug)

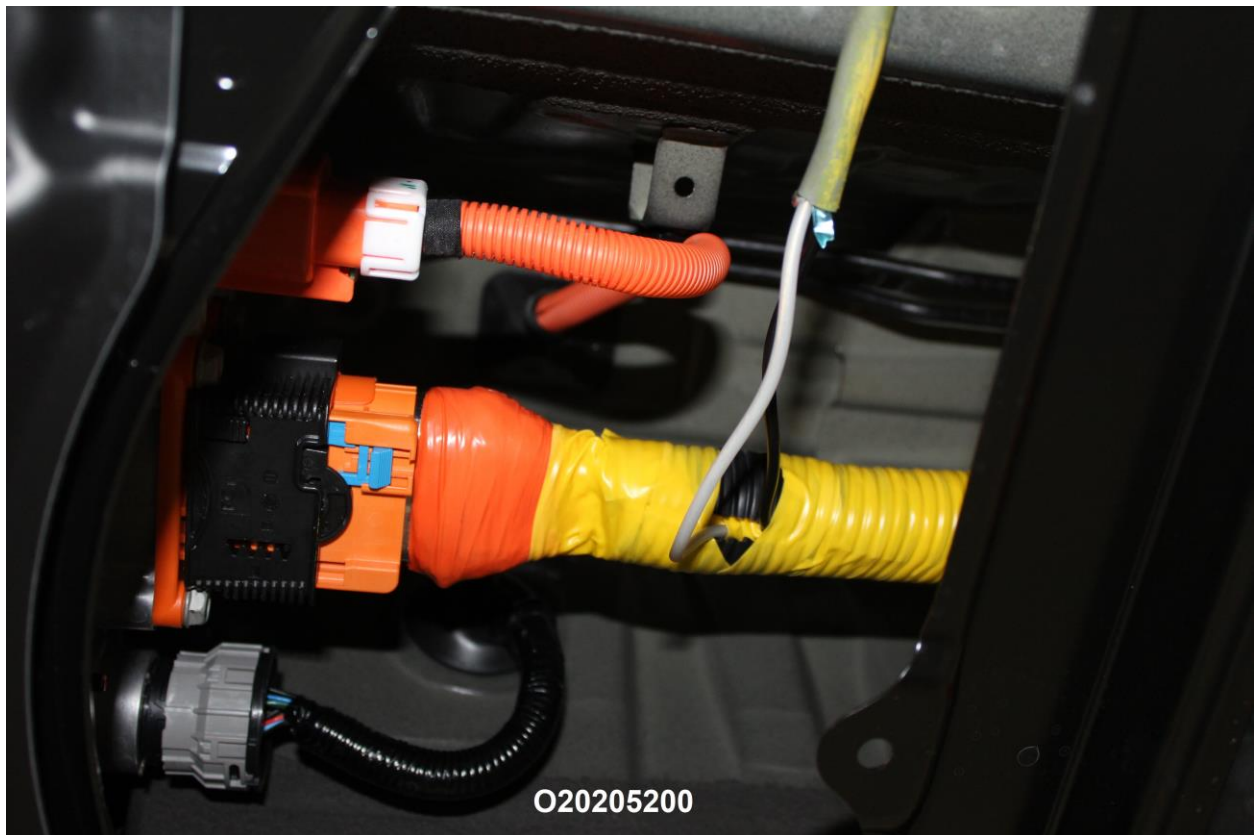
Figure 305-22: Pre-Impact View of High Voltage Leads Attached
