REPORT NUMBER: SideNCAPPole-MGA-20-026

**NEW CAR ASSESSMENT PROGRAM (NCAP)
Side Impact Pole Test**

**FCA US LLC
2020 Dodge Challenger SXT 2-Door Coupe
NHTSA No.: M20200304**

FINAL REPORT

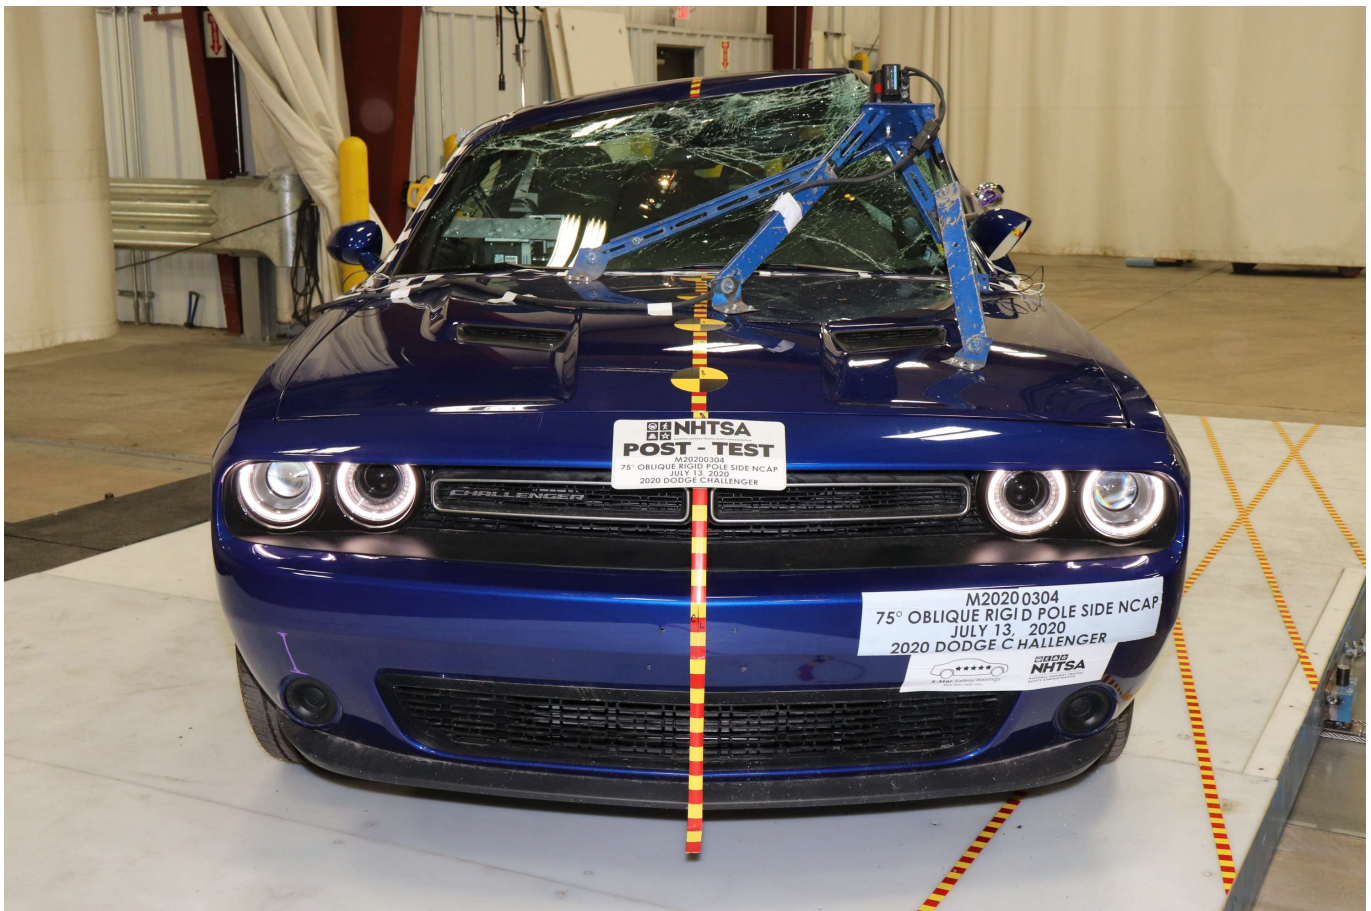
Photo No. 004 - Post-Test Frontal View of Test Vehicle

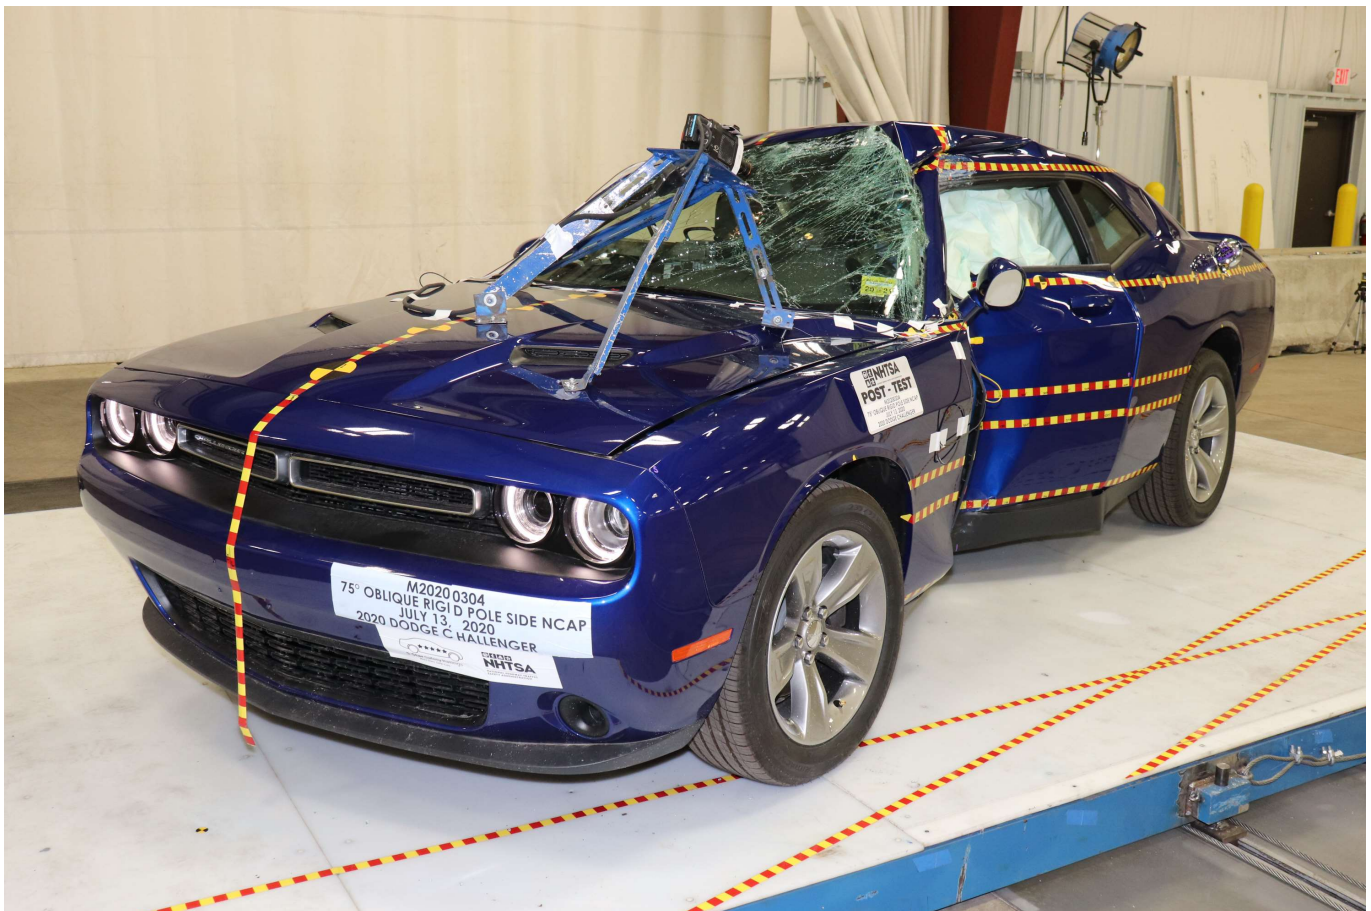
Photo No. 006 - Post-Test Left Front Three-Quarter View of Test Vehicle

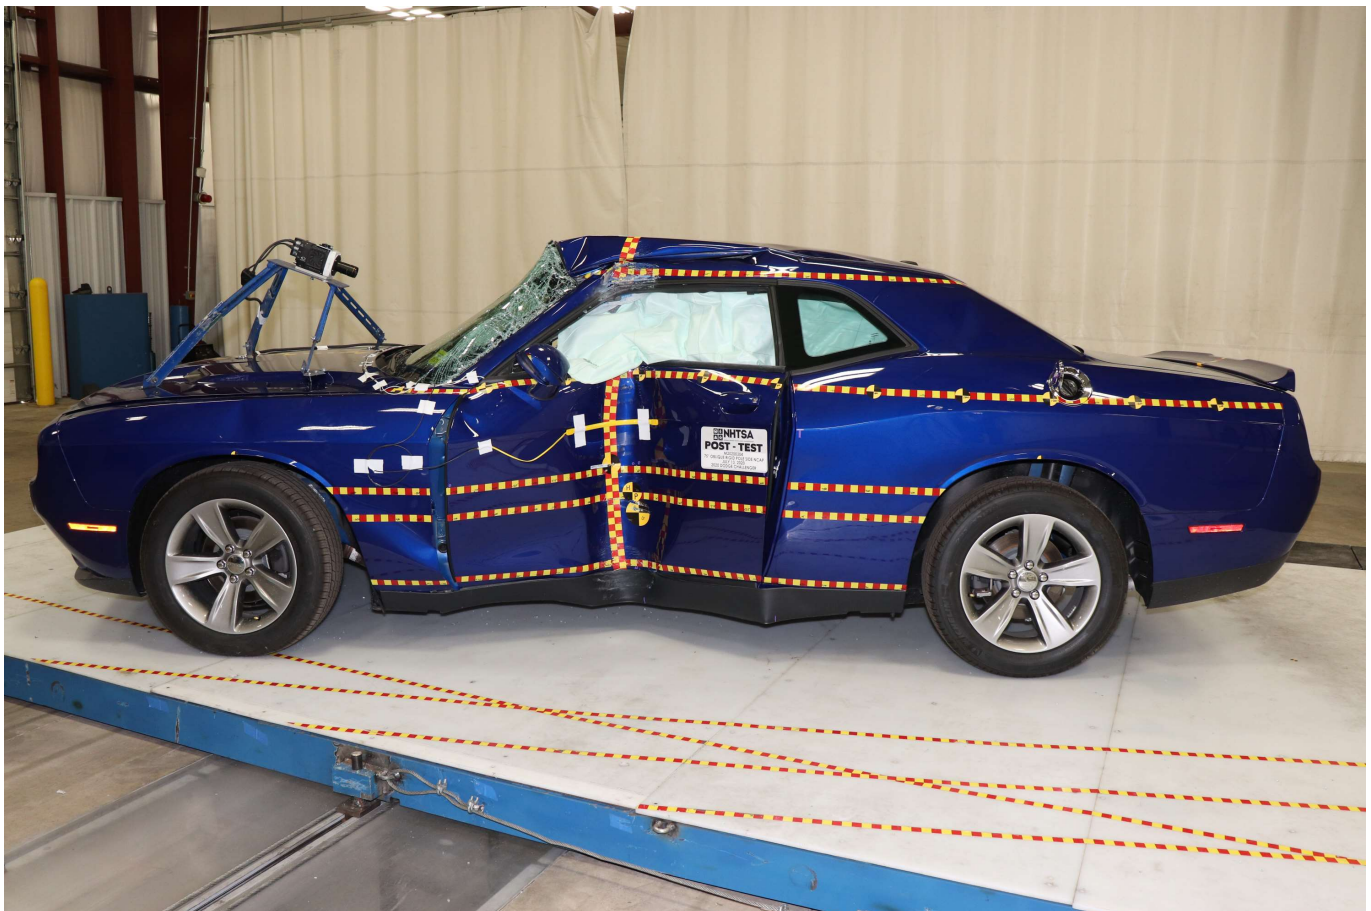
Photo No. 008 - Post-Test Left Side View of Test Vehicle

Critical Areas of Performance	Observations and Conclusions
Pillar Performance	No Separation
Sill Separation	No Separation
Windshield Damage	Cracked
Side Window Damage	LF Window Broken
Other Notable Effects	None

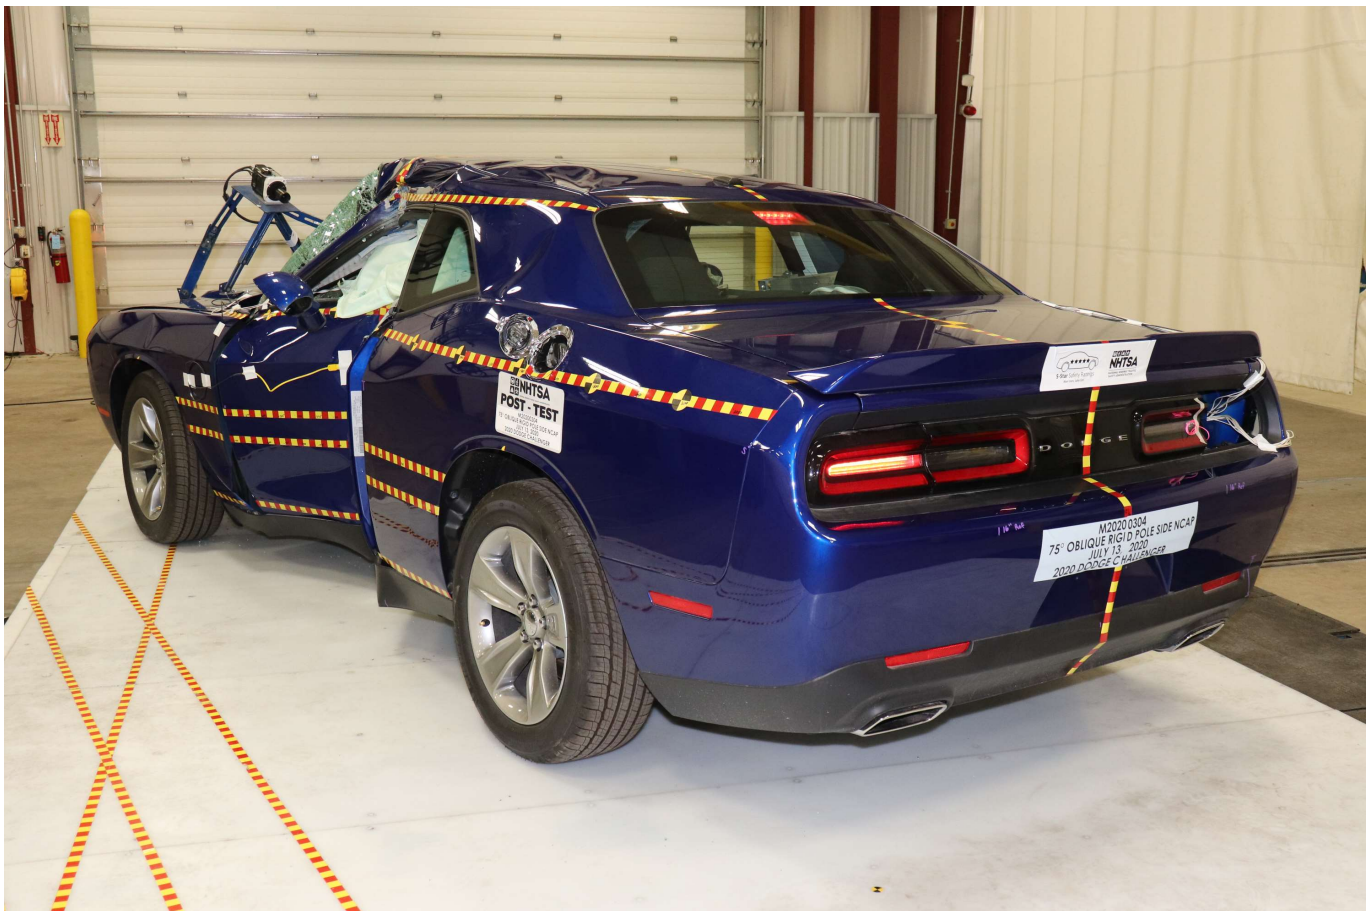
Photo No. 010 - Post-Test Left Rear Three-Quarter View of Test Vehicle

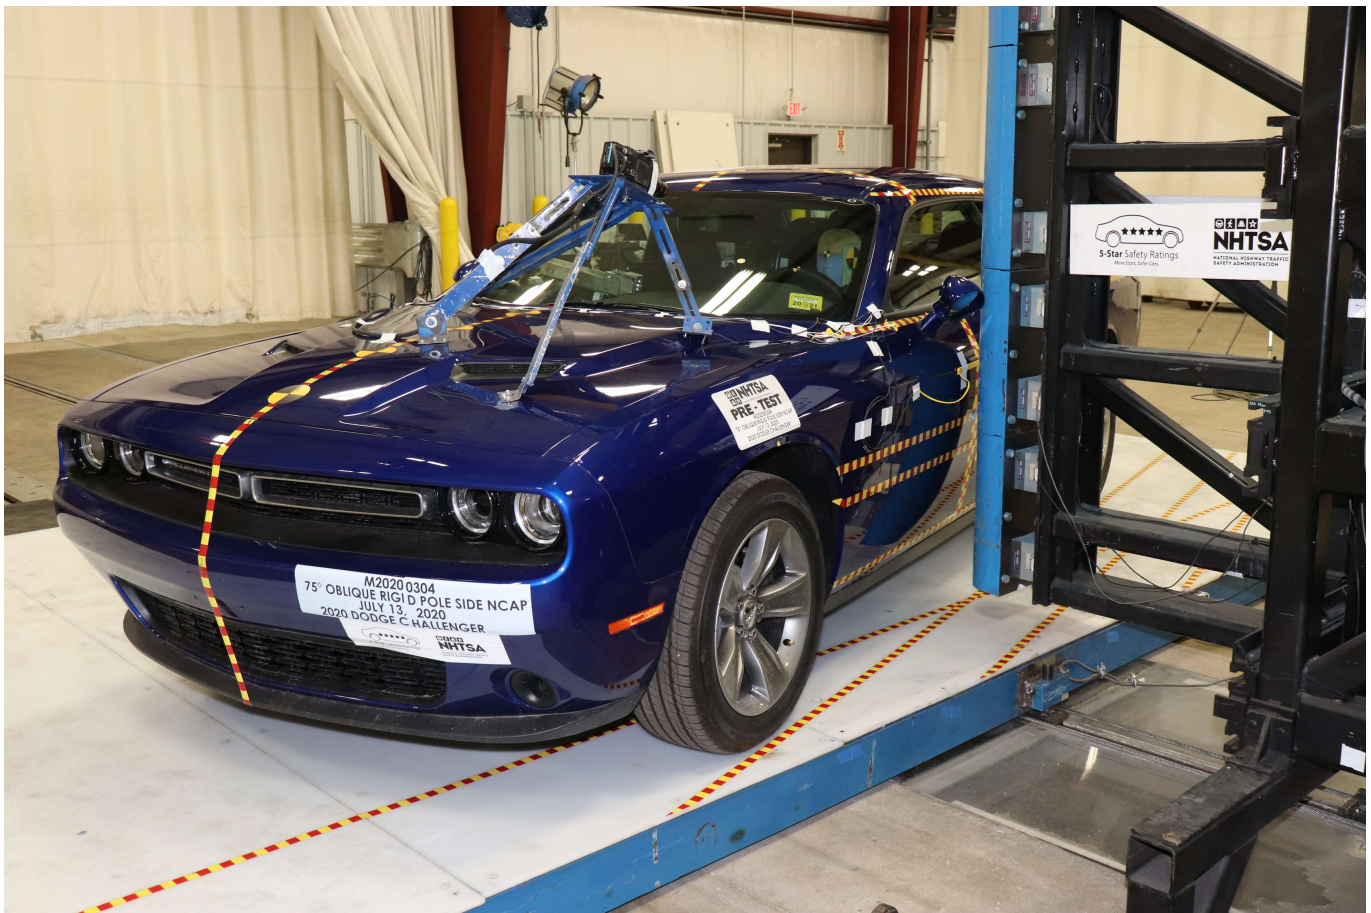
Photo No. 017 - Pre-Test Left Side View of Pole Positioned Against Side of Vehicle

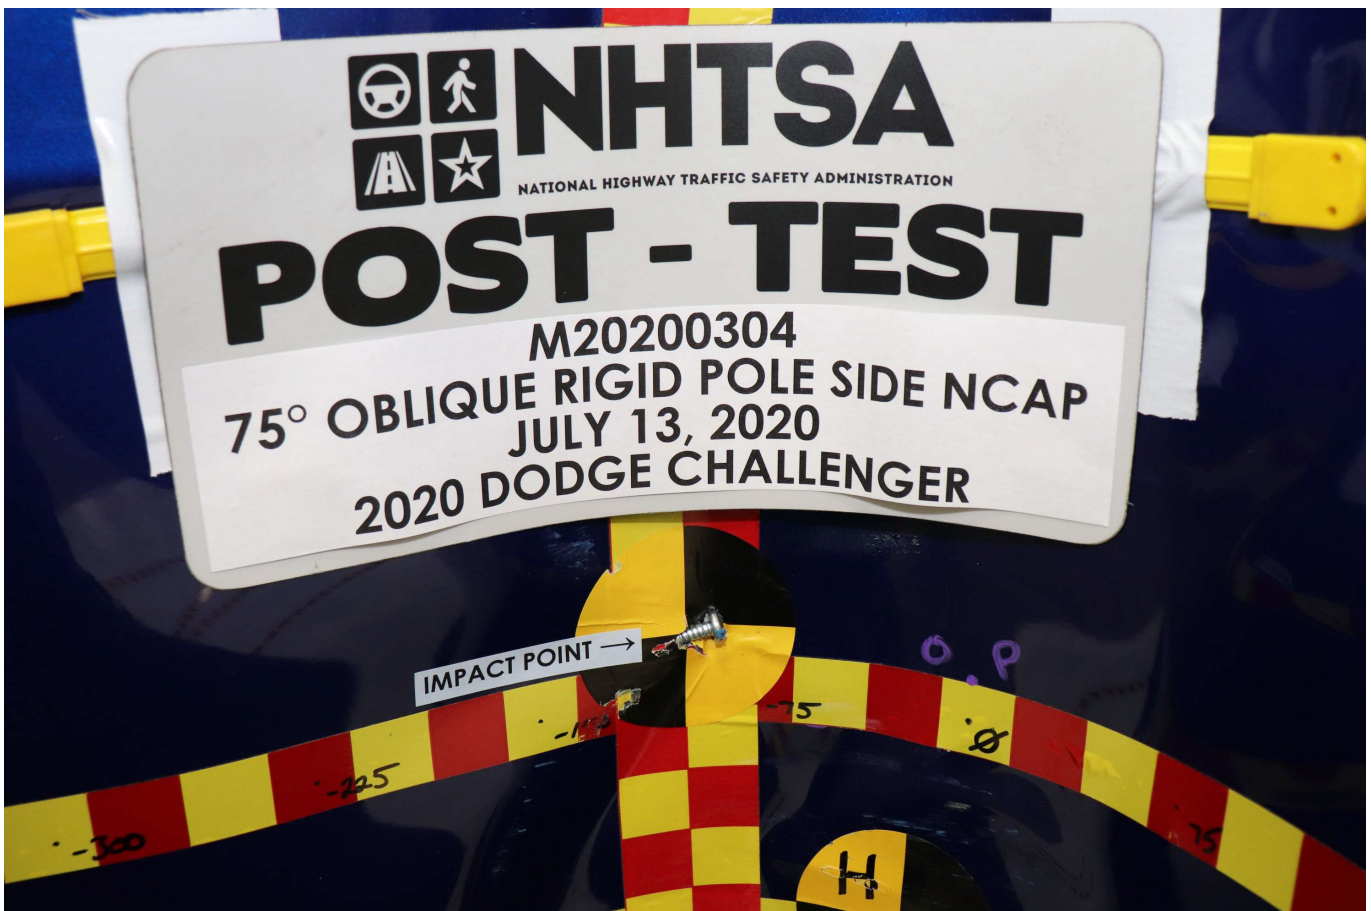
Photo No. 020 - Post-Test Close-Up View of Impact Point Target Showing Impact Location

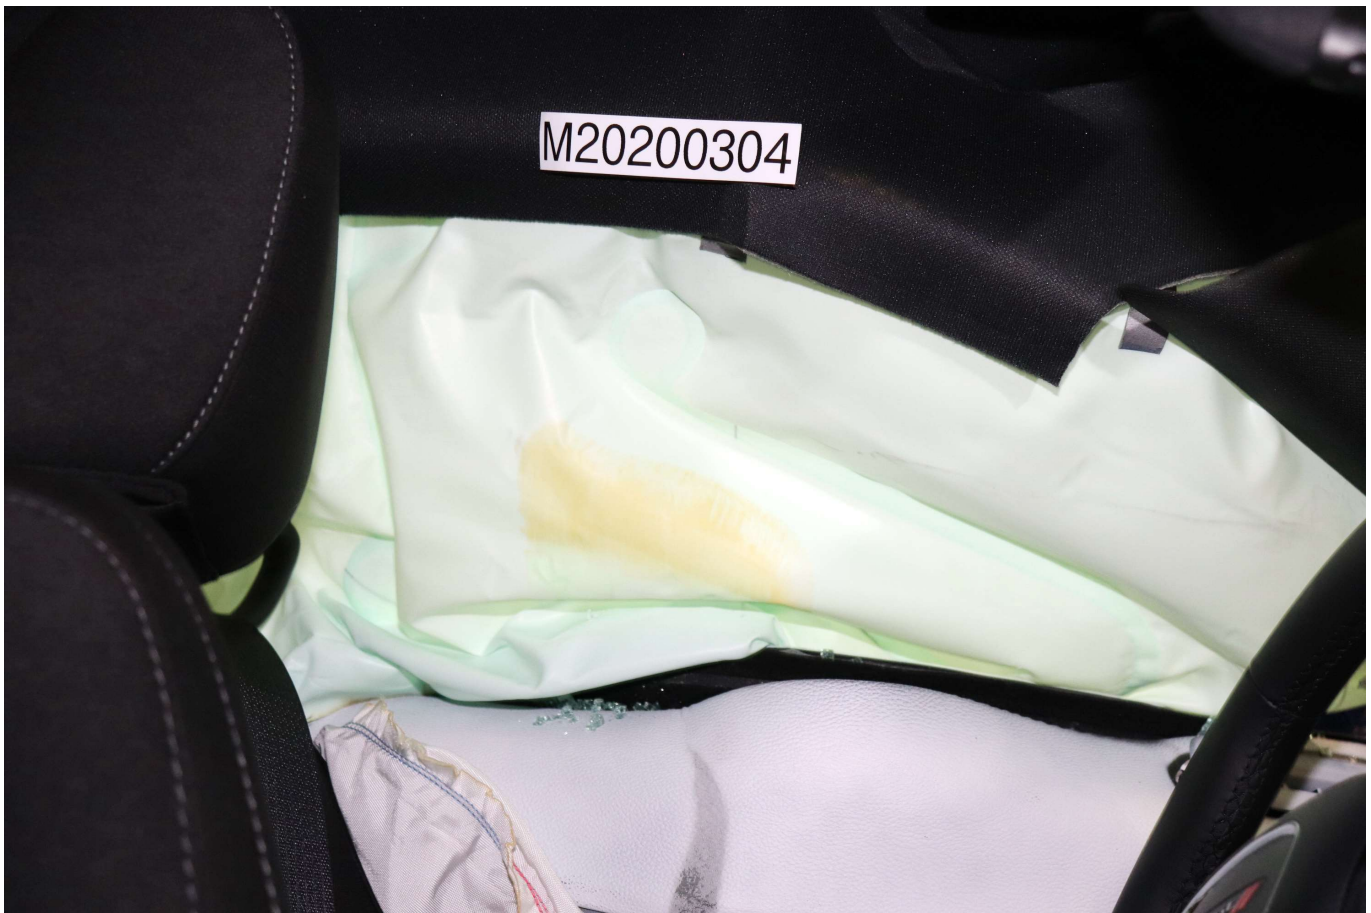
Photo No. 047 - Post-Test Dummy Close-Up Head Contact with Side Air Bag View

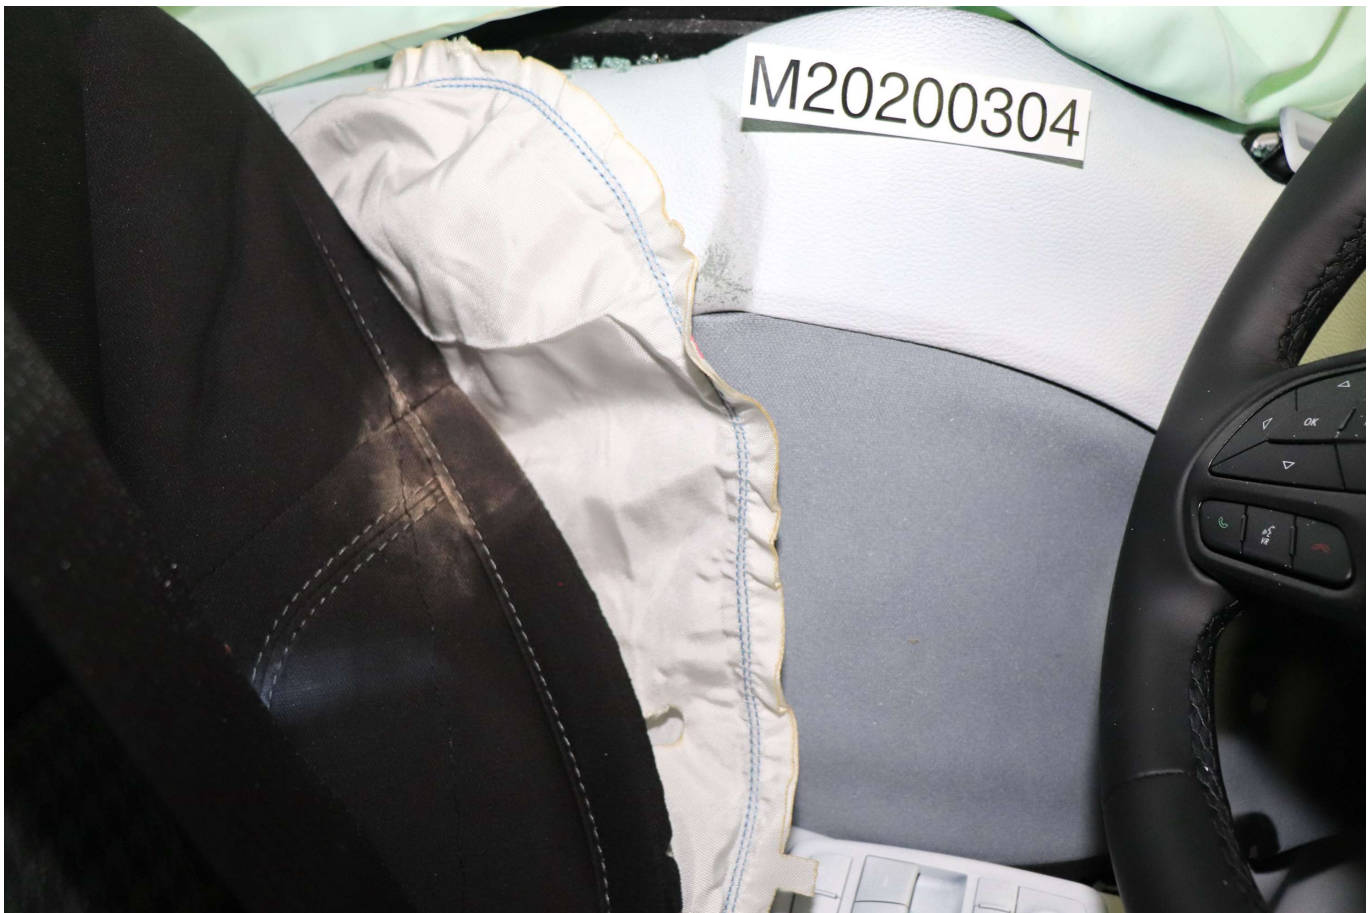
Photo No. 049 - Post-Test Dummy Close-Up Torso Contact with Side Air Bag View

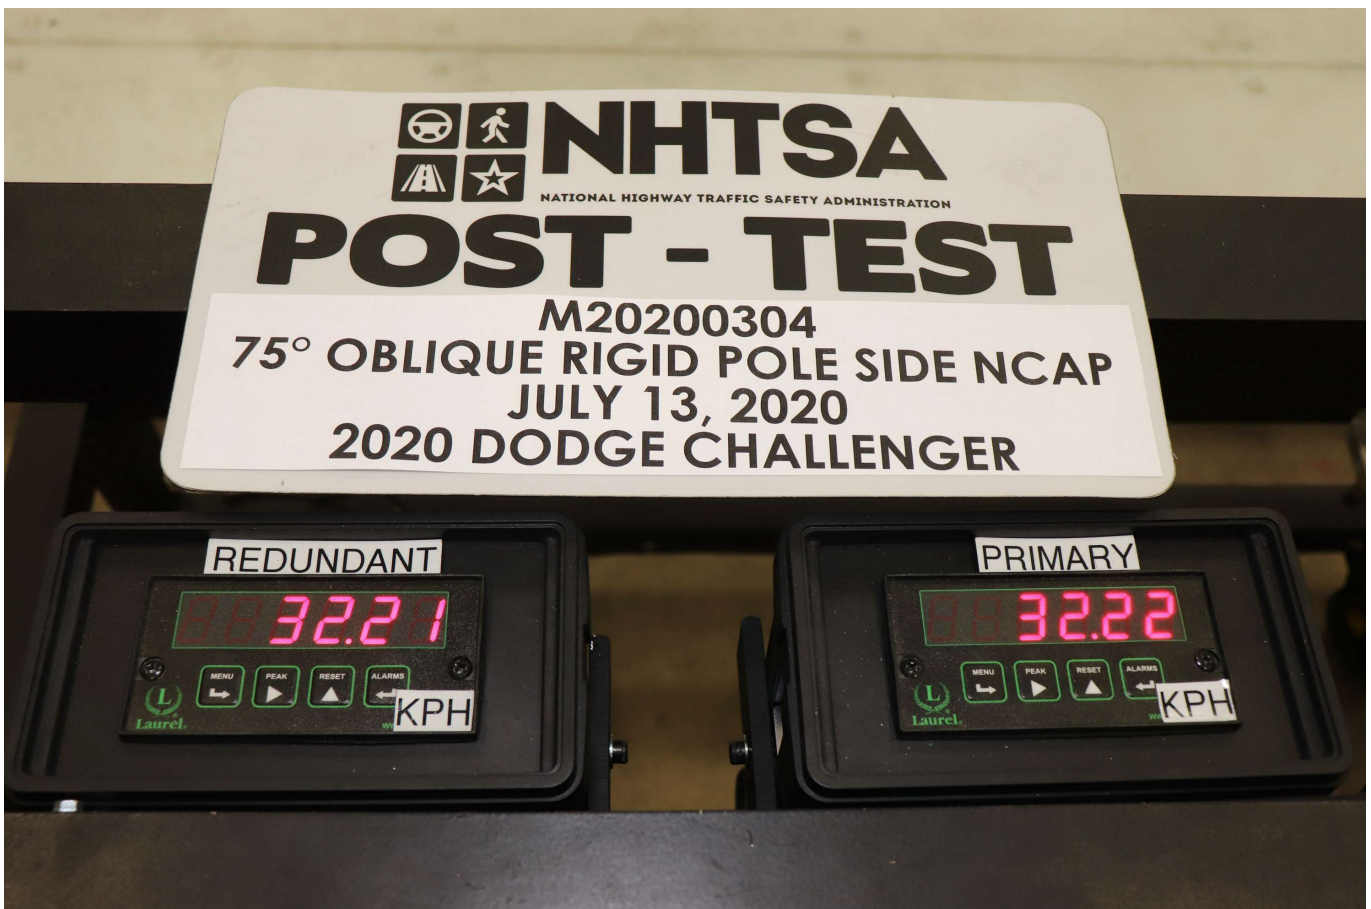
Photo No. 064 - Post-Test Primary and Redundant Speed Trap Read-Out

A rigid pole side impact test was conducted on a 2020 Dodge Challenger SXT 2-Door Coupe. The subject vehicle was towed into the rigid pole at an angle of 75° and a velocity of 32.22 km/h. The test was conducted by MGA Research Corporation in Burlington, Wisconsin on July 13, 2020. Pre-test and post-test photographs of the test vehicle and side impact dummy (SID-IIs) are included in Appendix A of this report.

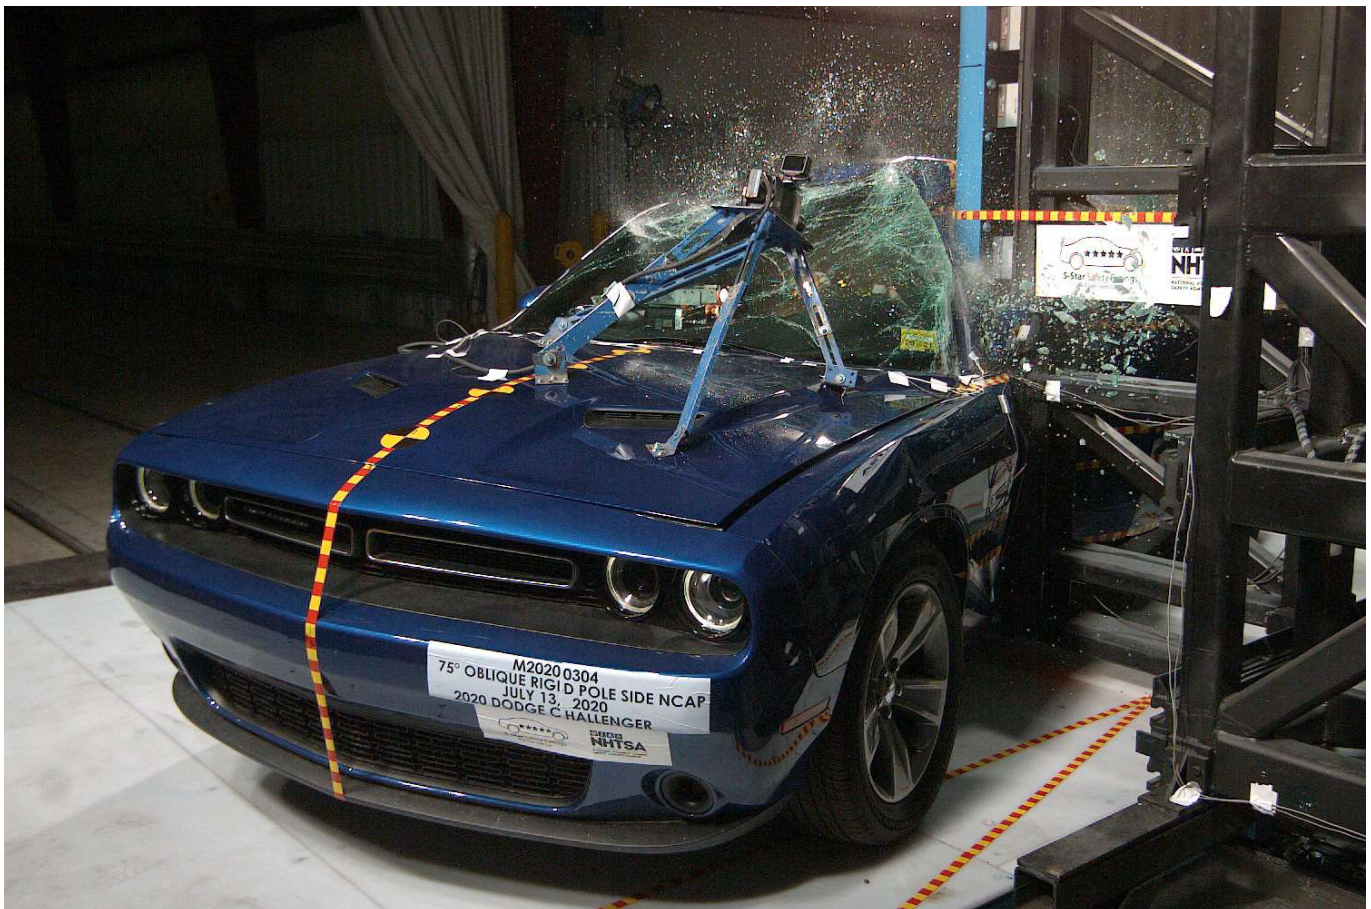
Photo No. 070 - Impact Event

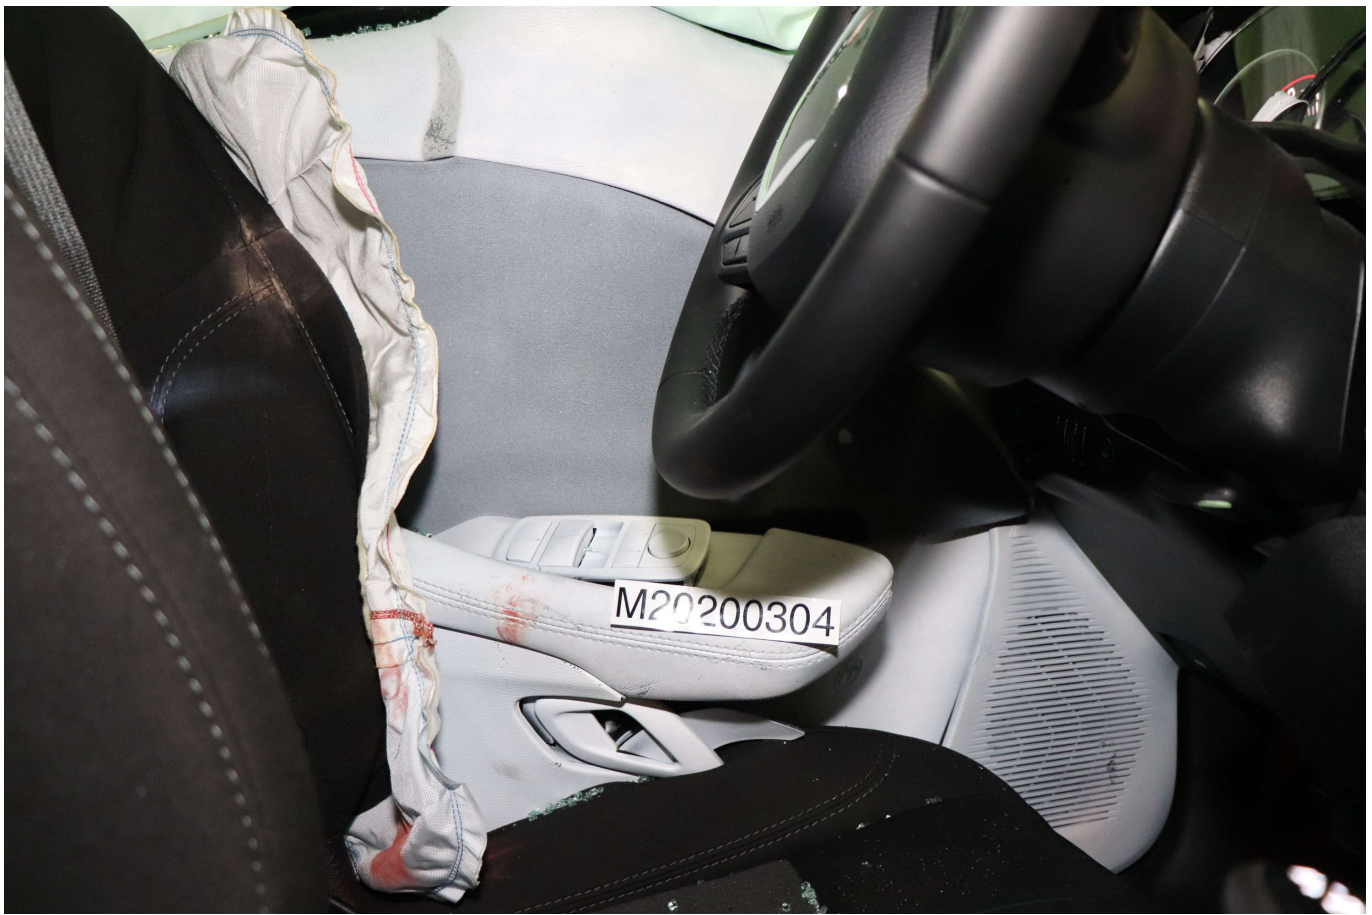
Photo No. 073 - Post-Test View of Shattered Vehicle Inner Door Panel
