REPORT NUMBER: TWG-TRC-19-03

NEW CAR ASSESSMENT PROGRAM (NCAP)  
Side Airbag Out-of-Position Test

GENERAL MOTORS LLC  
2019 Cadillac XT4 SUV

NHTSA NUMBER: M20190102TWG2  
TRC TEST NUMBER: 190710-2

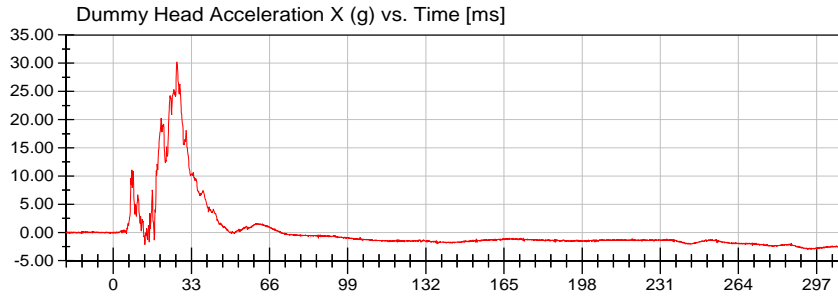
30.26 g at 26.80 ms

-2.96 g at 292.96 ms

Channel	Unit	CFC	Maximum	Time (ms)	Minimum	Time (ms)
Head X	G	1000	30.26	26.80	-2.96	292.96
Head Y	G	1000	14.16	32.88	-20.87	8.72
Head Z	G	1000	18.07	7.44	-6.72	13.68
Head Resultant	G	1000	33.35	26.88		
Head Red X	G	1000	31.15	26.80	-3.18	295.04
Head Red Y	G	1000	14.73	32.80	-21.28	8.64
Head Red Z	G	1000	17.92	7.44	-7.68	13.68
Head Red Resultant	G	1000	34.27	27.04		
Upper Neck X	N	1000	53.62	25.28	-179.65	16.48
Upper Neck Y	N	1000	430.87	22.40	-73.46	145.28
Upper Neck Z	N	1000	105.13	96.24	-875.85	11.20
Upper Neck Resultant	N	1000	888.13	11.20		
Upper Neck X	Nm	600	26.53	17.20	-11.79	52.72
Upper Neck Y	Nm	600	8.48	23.52	-13.60	39.52
Upper Neck Z	Nm	600	5.08	158.56	-6.27	84.40
Upper Neck Resultant	Nm	600	28.86	17.04		
Lower Neck X	N	1000	138.92	12.88	-242.13	21.44
Lower Neck Y	N	1000	424.93	15.76	-91.89	282.96
Lower Neck Z	N	1000	94.61	238.72	-752.92	13.04
Lower Neck Resultant	N	1000	811.16	13.04		
Lower Neck X	Nm	600	17.84	146.32	-49.12	37.44

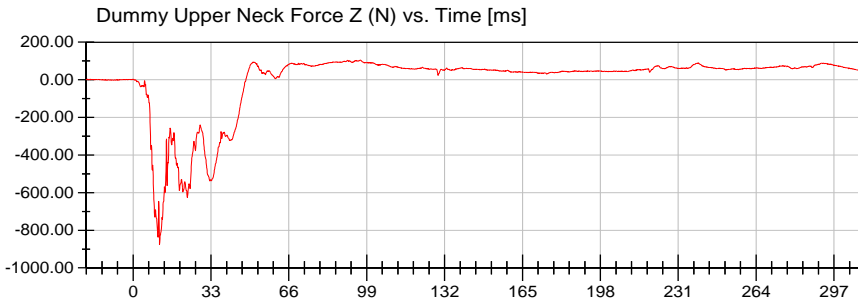
105.13 N at 96.24 ms

-875.85 N at 11.20 ms

Measurement Description	Units	Passenger ATD SID-IIs	
		IARV	Result
Head Injury Criteria (HIC15)	N/A	779	35
Nij	N/A	1	0.30
Upper Neck Tension	N	2070	105.1
Upper Neck Compression	N	2520	-875.9
Thorax Compression	mm	34	
Thorax Compression rate	m/sec	8.2

Injury Criteria	Value	Time (ms)
Upper Neck NTF	0.05	115.92
Upper Neck NTE	0.19	49.60
Upper Neck NCF	0.21	22.96
Upper Neck NCE	0.30	34.08
Peak Tension <sup>1</sup>	105.13	96.24
Peak Compression	-875.85	11.20
