REPORT NUMBER: TWG-CAL-19-04

**NEW CAR ASSESSMENT PROGRAM (NCAP)**  
SIDE AIRBAG OUT-OF-POSITION INJURY TESTING

**Ford Motor Company**  
**2019 Ford Edge**

NHTSA NUMBER: M20190202TWG2  
CALSPAN TEST NUMBER: CT2019-04

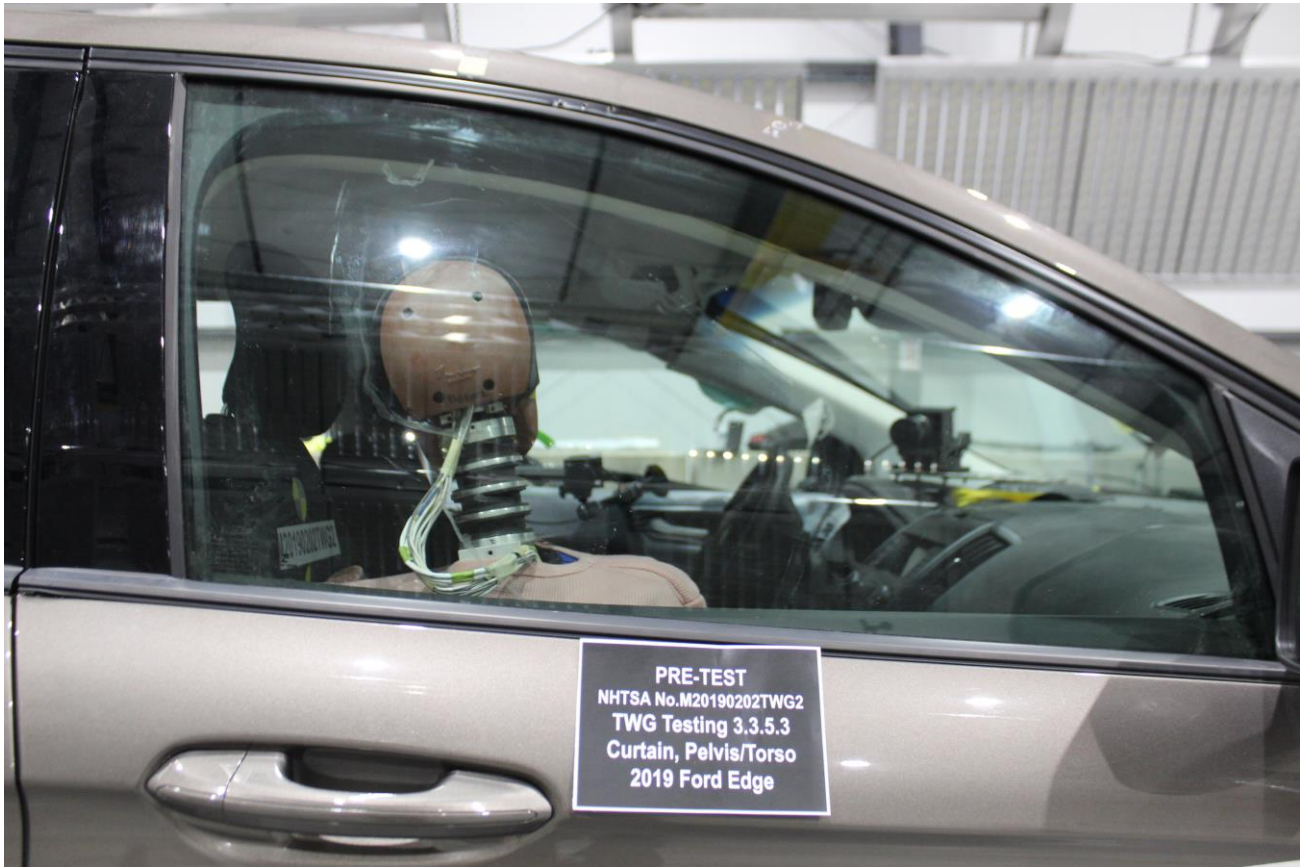
**Figure A-11: Pre-Test SID-IIs Right Side View**

PRE-TEST  
NHTSA No.M20190202TWG2  
TWG Testing 3.3.5.3  
Curtain, Pelvis/Torso  
2019 Ford Edge

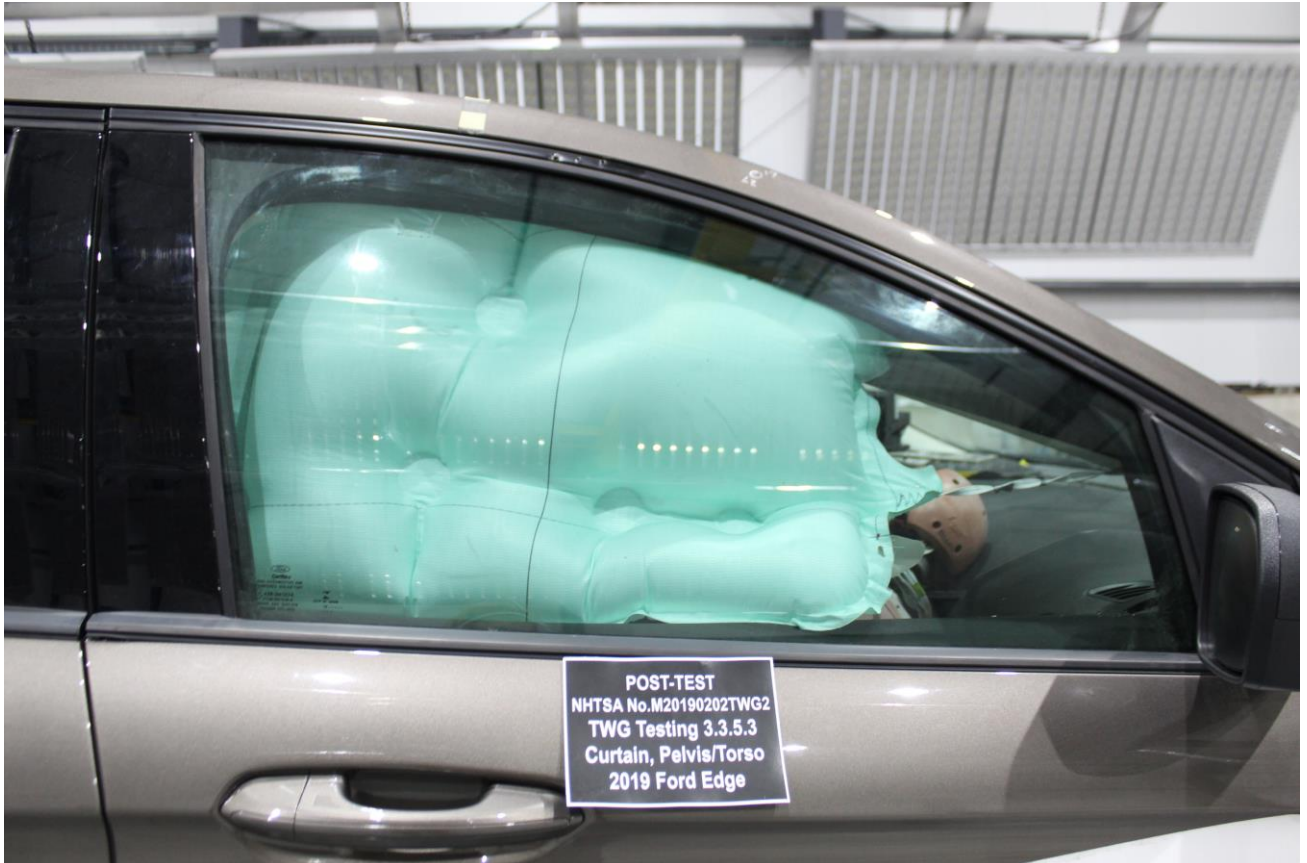
**Figure A-12: Post-Test SID-IIs Right Side View**

POST-TEST  
NHTSA No.M20190202TWG2  
TWG Testing 3.3.5.3  
Curtain, Pelvis/Torso  
2019 Ford Edge
