**REPORT NUMBER: TWG-KAR-19-001**

**SIDE AIRBAG OCCUPANT RISK PROGRAM  
OCCUPANT OUT-OF-POSITION TESTS**

**FCA US LLC  
2019 DODGE GRAND CARAVAN 5-DOOR MINIVAN**

**NHTSA NUMBER: M20190304TWG2**

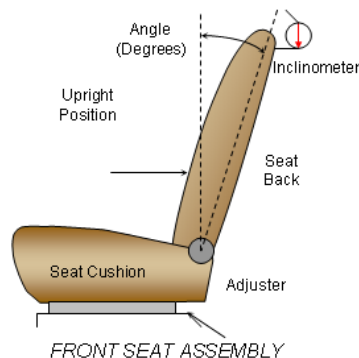
The passenger seat back is positioned per section 3.3.3.2 of the TWG recommendation in the Recommended Procedures for Evaluating Occupant Injury Risk from Deploying Side Airbags. Seat back angle is measured at the headrest post.

Seating Position	Degrees
Passenger Seat	8.4

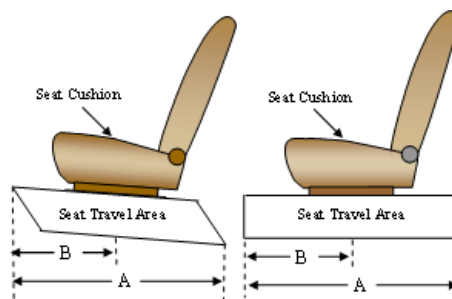
The passenger seat track travel is set per section 3.3.3.2 of the TWG recommendation in the Recommended Procedures for Evaluating Occupant Injury Risk from Deploying Side Airbags. The first or forward most position is counted as zero (0)

Seating Position	Total Fore-Aft Travel		Placed in Position	
	mm	Detents	mm	Detents
Passenger Seat	220	33	117	18

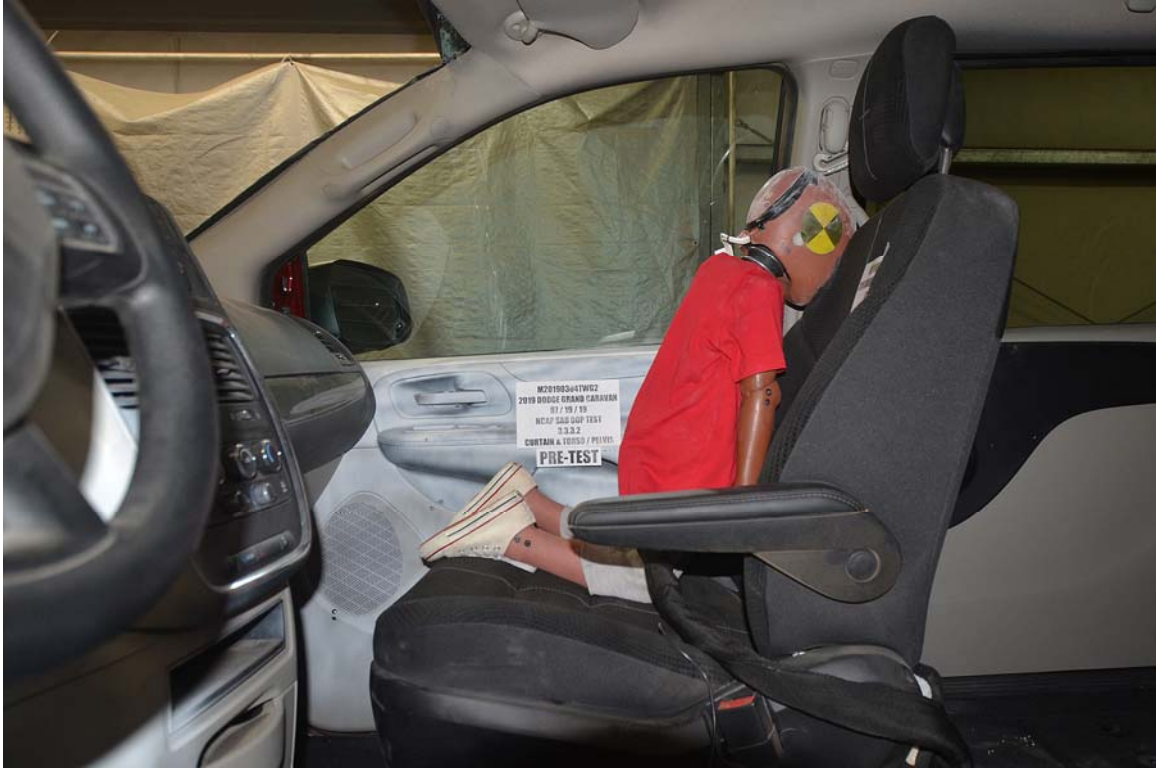
FIGURE 7. Pre-Test Dummy Position, Left View

A 3-year old anthropomorphic test device (ATD) was placed in the right front passenger seating position, along the outboard edge of the seat cushion, kneeling and facing rearward according to the dummy placement instructions (3.3.3.2) in the July 2003 Revision of the Technical Working Group's 'Recommended Procedures for Evaluating Occupant Injury Risk from Deploying Side Airbags'.

Orientation of the 3-year old dummy was with the dummy facing rearward. The seat is set at the 117 mm from the full forward position. The seat was not tested in the rearmost position in order to maximize the interaction and contact between the dummy and airbag. The dummy is placed on the along the outboard edge of the seat cushion, kneeling and facing rearward. The vertical centerline of the dummy's sternum was aligned as close as possible with the leading edge of the seat back bolster. The sternum contacted the seat. The dummy's head was placed in between the seat bolster and b-pillar trim to maximize contact between the sternum and the seatback. The head remained in a neutral orientation while in this position. This orientation complies with section 3.3.3.2 of the Technical Working Group (TWG) recommendation in the Recommended Procedures for Evaluating Occupant Injury Risk from Deploying Side Airbags.

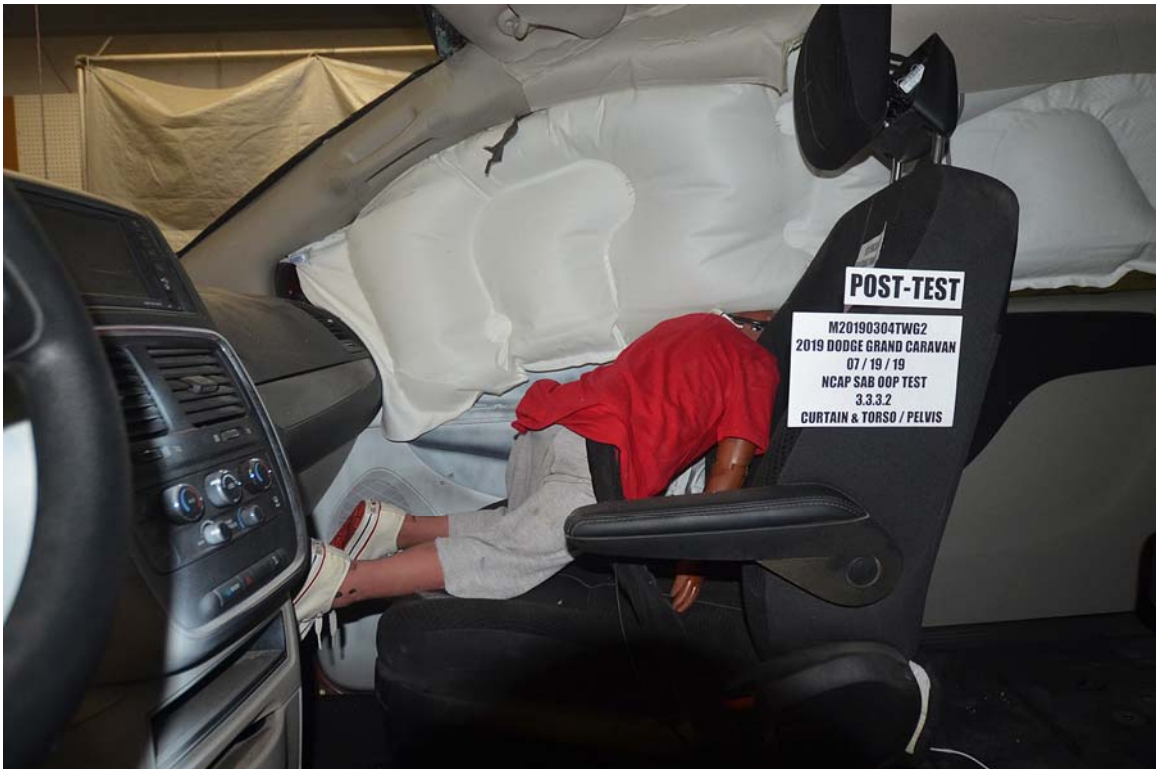
FIGURE 8. Post-Test Dummy Position, Left View

The 3-year old dummy's visible contact points were as follows: The ATD's head contacted the curtain airbag and seatback. The ATD's torso contacted the torso/pelvis airbag, seat pan, and seatback. The ATD's pelvis contacted the torso/pelvis airbag, seat pan, and door panel. The ATD's left knee contacted the seat pan and door panel. The ATD's right knee contacted the seat pan.

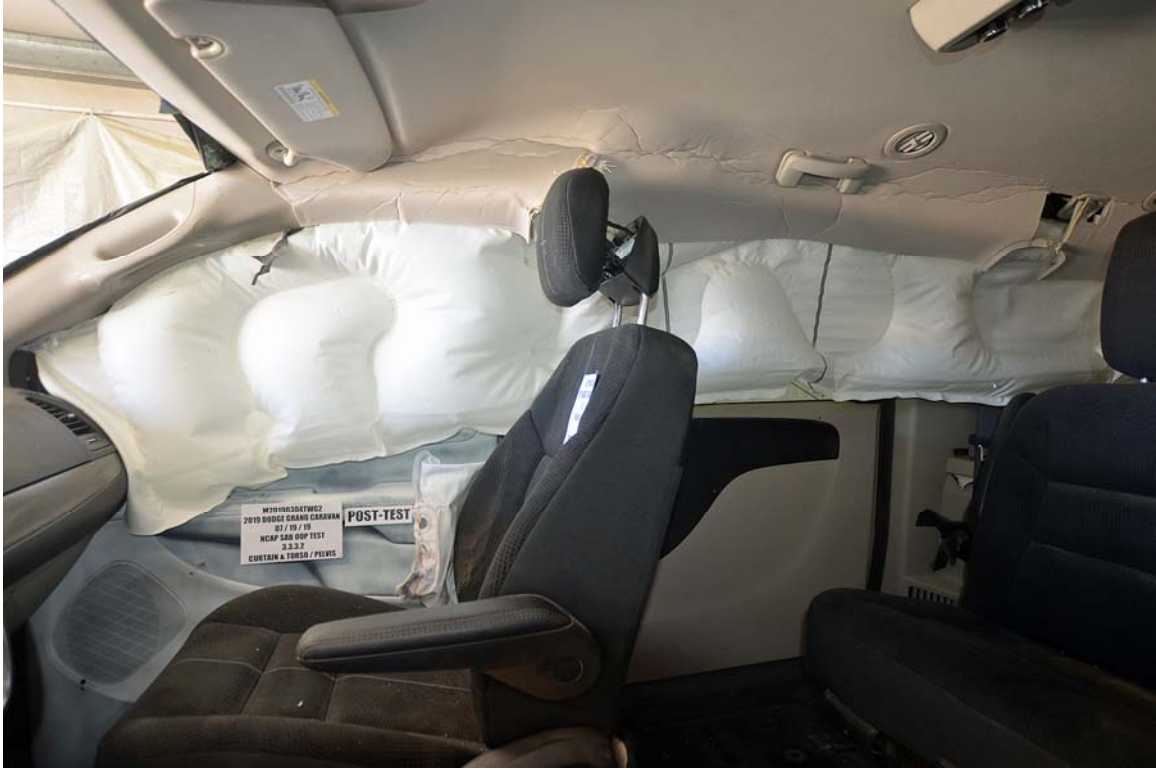
FIGURE 17. Post-Test Airbags, Left Side View

The effects of a roof mounted curtain airbag and a seat mounted torso/pelvis airbag deployment in a 2019 Dodge Grand Caravan 5-door minivan with an out-of-position Hybrid III 3-year old crash test dummy were evaluated. The test was performed at Applus+ IDIADA KARCO Engineering, LLC. on July 19, 2019. Pre- and post-test photographs of the vehicle and dummy can be found in Appendix A.

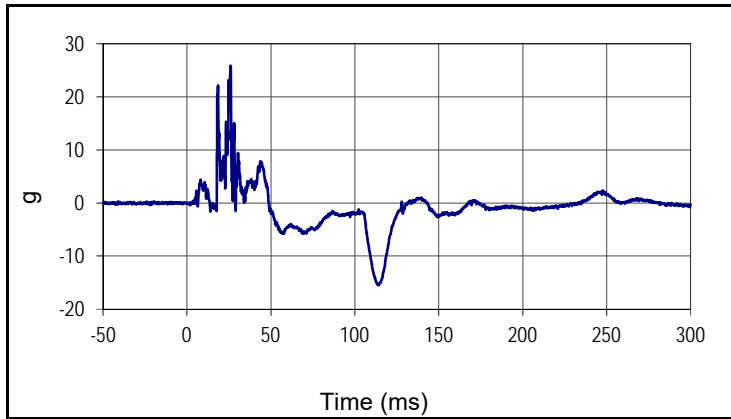
Curve Description			
3 Year Old Head Acceleration X			
Plot No.		SAE Class	Units
001		1000	g
Max	Time	Min	Time
25.9	26.0	-15.5	114.3

Location	Axis	Units	3 Year Old			
			Max	Time	Min	Time
Head CG	X	g	25.9	26.0	-15.5	114.3
Head CG	Y	g	12.1	49.6	-56.4	18.1
Head CG	Z	g	48.0	18.1	-8.7	19.5
Head CG Resultant	N/A	g	76.9	18.1		
Chest Deflection	X	mm	1.3	20.6	-13.0	10.2
Chest Deflection Rate	X	m/s	3.1	13.9	-4.4	9.4

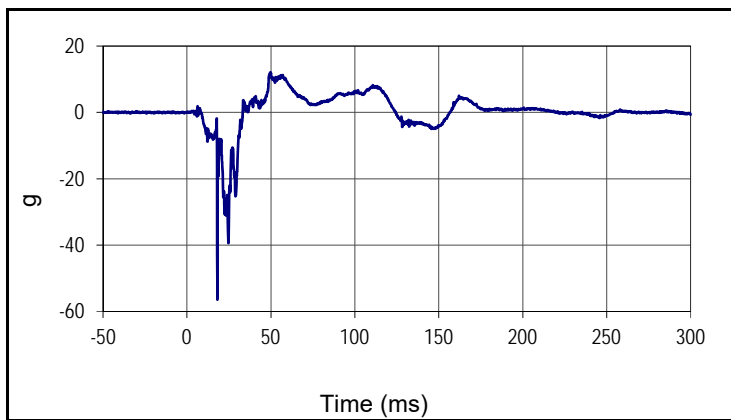
Curve Description			
3 Year Old Head Acceleration Y			
Plot No.		SAE Class	Units
002		1000	g
Max	Time	Min	Time
12.1	49.6	-56.4	18.1

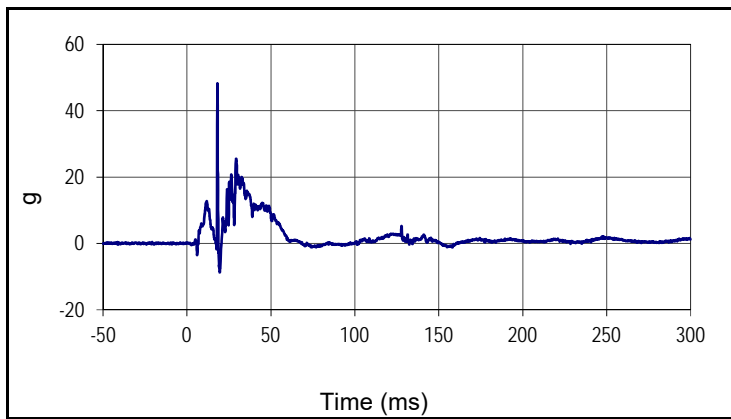
Curve Description			
3 Year Old Head Acceleration Z			
Plot No.		SAE Class	Units
003		1000	g
Max	Time	Min	Time
48.0	18.1	-8.7	19.5

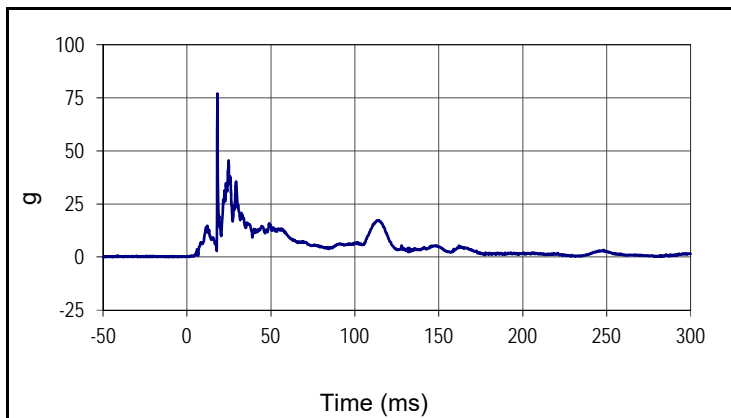
Curve Description			
3 Year Old Head Acceleration Resultant			
Plot No.		SAE Class	Units
004		1000	g
Max	Time	Min	Time
76.9	18.1	0.0	1.4

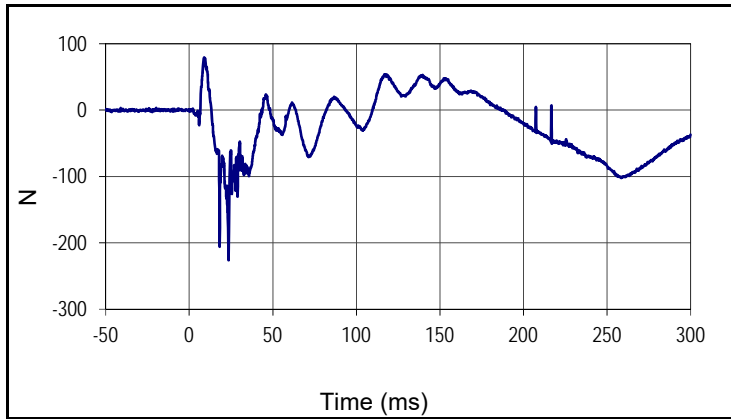
Curve Description			
3 Year Old Upper Neck Force X			
Plot No.		SAE Class	Units
005		1000	N
Max	Time	Min	Time
79.3	9.0	-226.1	23.6

Location	Axis	Units	3 Year Old			
			Max	Time	Min	Time
Neck Force	X	N	79.3	9.0	-226.1	23.6
Neck Force	Y	N	348.2	29.0	-211.2	14.1
Neck Force	Z	N	544.6	30.1	-462.4	18.9
Neck Force Resultant	N/A	N	615.0	32.2		
Neck Moment	X	Nm	17.1	43.6	-27.1	22.8
Neck Moment	Y	Nm	3.5	9.3	-9.8	23.2
Neck Moment	Z	Nm	3.8	141.8	-5.8	38.9
Neck Moment Resultant	N/A	Nm	28.9	22.8

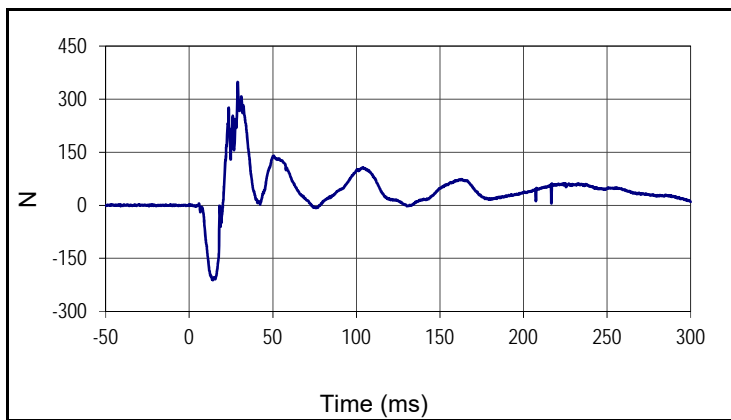
Curve Description			
3 Year Old Upper Neck Force Y			
Plot No.		SAE Class	Units
006		1000	N
Max	Time	Min	Time
348.2	29.0	-211.2	14.1

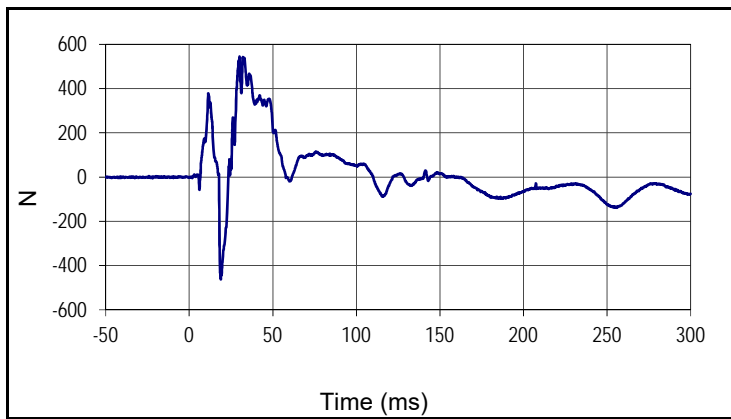
Curve Description			
3 Year Old Upper Neck Force Z			
Plot No.		SAE Class	Units
007		1000	N
Max	Time	Min	Time
544.6	30.1	-462.4	18.9

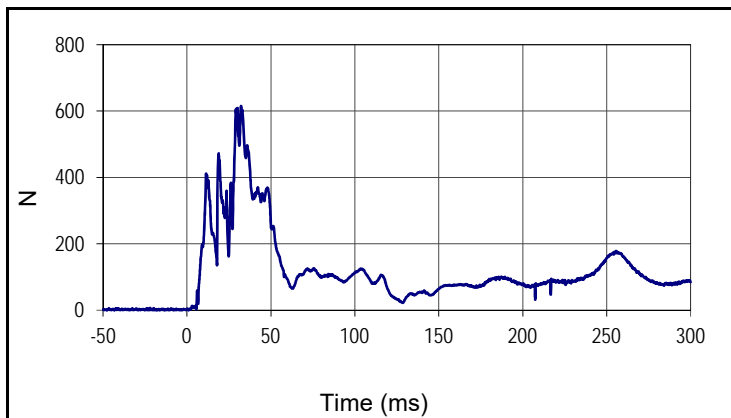
Curve Description			
3 Year Old Upper Neck Force Resultant			
Plot No.		SAE Class	Units
008		1000	N
Max	Time	Min	Time
615.0	32.2	0.3	1.1

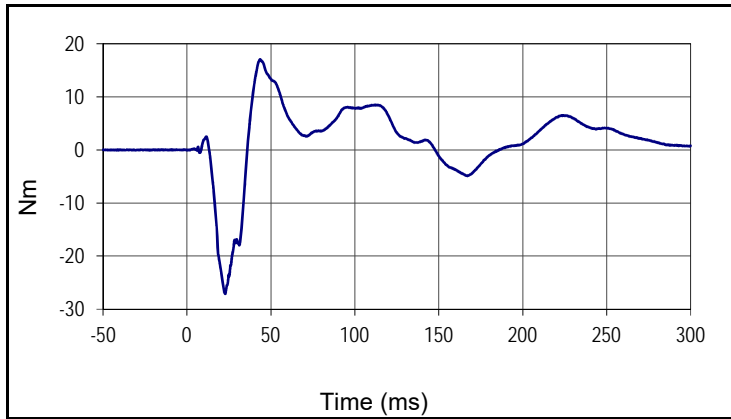
Curve Description			
3 Year Old Upper Neck Moment X			
Plot No.		SAE Class	Units
009		600	Nm
Max	Time	Min	Time
17.1	43.6	-27.1	22.8

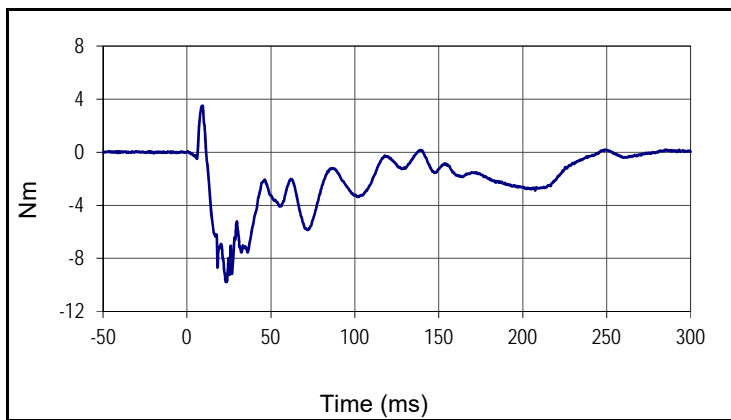
Curve Description			
3 Year Old Upper Neck Moment Y			
Plot No.		SAE Class	Units
010		600	Nm
Max	Time	Min	Time
3.5	9.3	-9.8	23.2

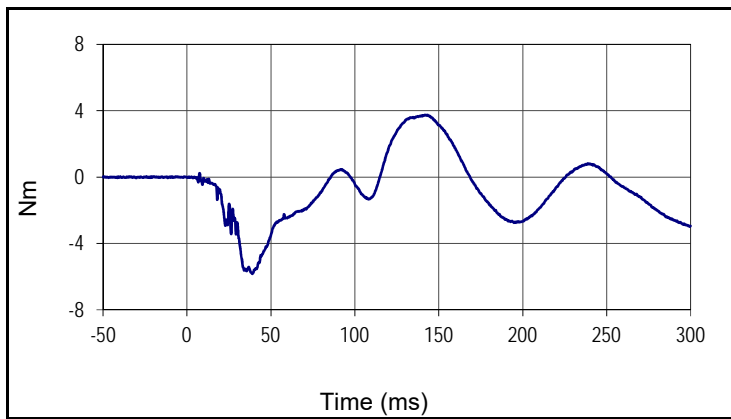
Curve Description			
3 Year Old Upper Neck Moment Z			
Plot No.		SAE Class	Units
011		600	Nm
Max	Time	Min	Time
3.8	141.8	-5.8	38.9

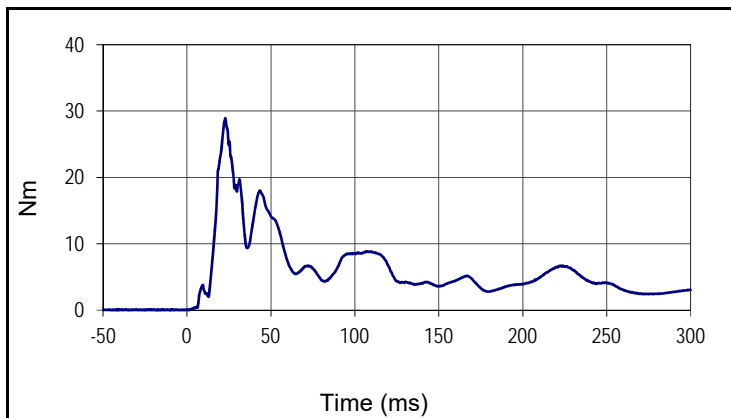
Curve Description			
3 Year Old Upper Neck Moment Resultant			
Plot No.		SAE Class	Units
012		1000	Nm
Max	Time	Min	Time
28.9	22.8	0.0	1.4

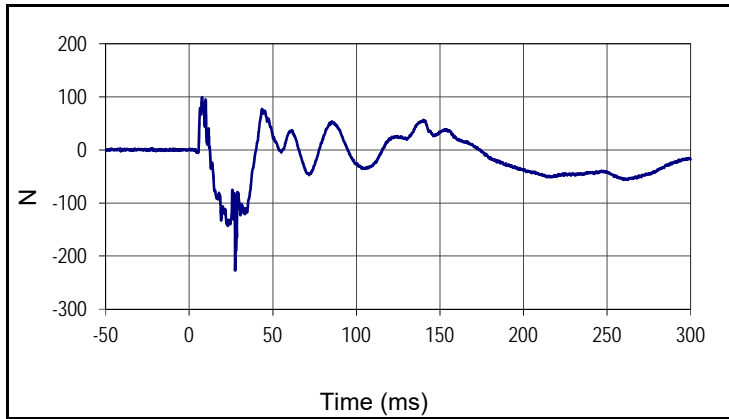
Curve Description			
3 Year Old Lower Neck Force X			
Plot No.		SAE Class	Units
013		1000	N
Max	Time	Min	Time
99.3	7.7	-227.3	27.5

Location	Axis	Units	3 Year Old			
			Max	Time	Min	Time
Neck Force	X	N	99.3	7.7	-227.3	27.5
Neck Force	Y	N	315.9	32.0	-359.0	11.9
Neck Force	Z	N	707.9	29.4	-871.2	27.5
Neck Force Resultant	N/A	N	904.1	27.5		
Neck Moment	X	Nm	31.3	49.1	-30.6	15.3
Neck Moment	Y	Nm	7.4	260.6	-6.6	9.9
Neck Moment	Z	Nm	3.5	136.1	-8.5	36.8
Neck Moment Resultant	N/A	Nm	32.1	49.0

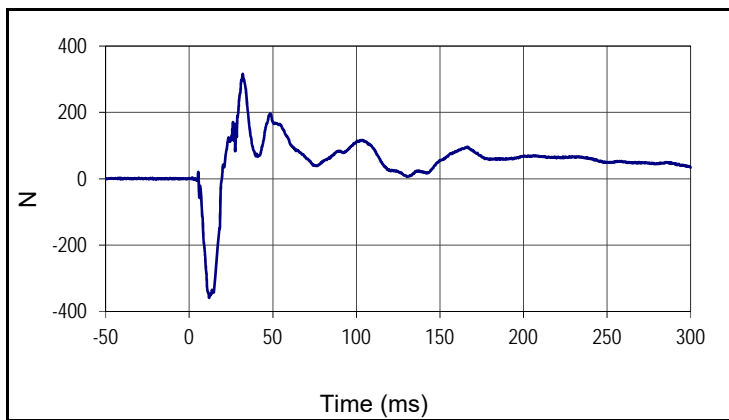
Curve Description			
3 Year Old Lower Neck Force Y			
Plot No.		SAE Class	Units
014		1000	N
Max	Time	Min	Time
315.9	32.0	-359.0	11.9

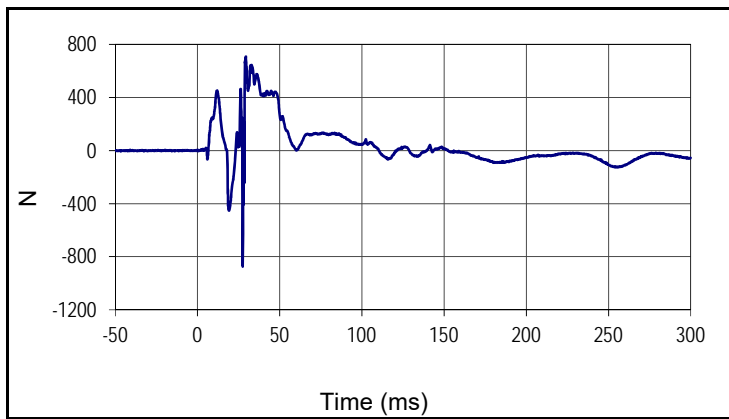
Curve Description			
3 Year Old Lower Neck Force Z			
Plot No.		SAE Class	Units
015		1000	N
Max	Time	Min	Time
707.9	29.4	-871.2	27.5

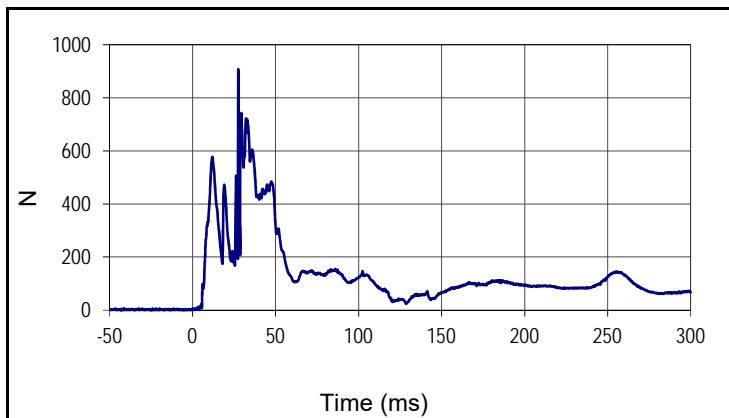
Curve Description			
3 Year Old Lower Neck Force Resultant			
Plot No.		SAE Class	Units
016		1000	N
Max	Time	Min	Time
904.1	27.5	0.7	1.5

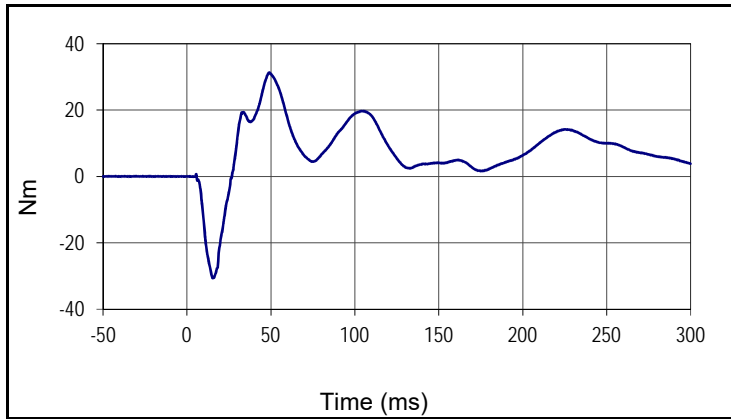
Curve Description			
3 Year Old Lower Neck Moment X			
Plot No.		SAE Class	Units
017		600	Nm
Max	Time	Min	Time
31.3	49.1	-30.6	15.3

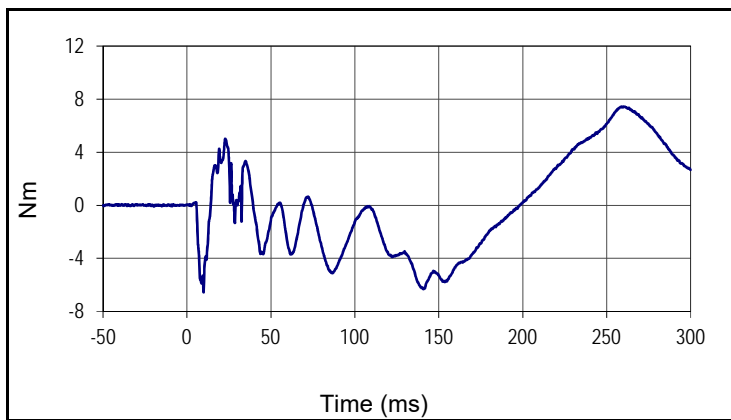
Curve Description			
3 Year Old Lower Neck Moment Y			
Plot No.		SAE Class	Units
018		600	Nm
Max	Time	Min	Time
7.4	260.6	-6.6	9.9

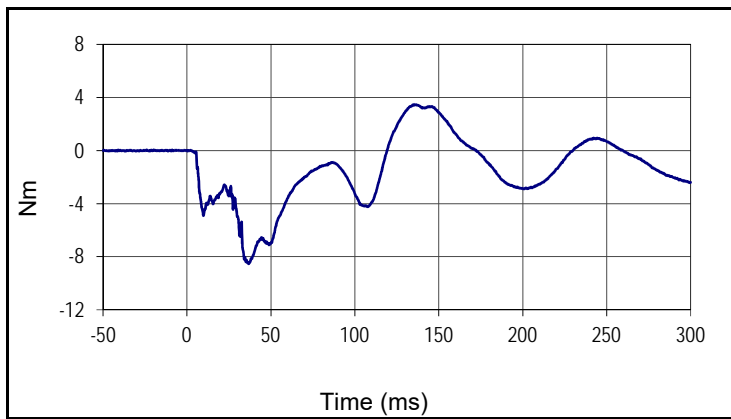
Curve Description			
3 Year Old Lower Neck Moment Z			
Plot No.		SAE Class	Units
019		600	Nm
Max	Time	Min	Time
3.5	136.1	-8.5	36.8

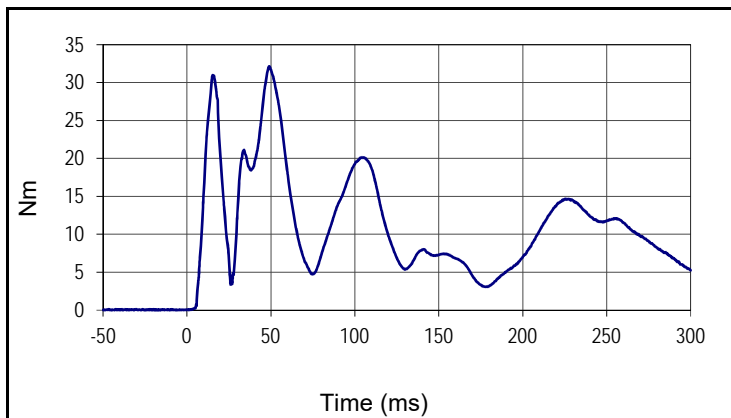
Curve Description			
3 Year Old Lower Neck Moment Resultant			
Plot No.		SAE Class	Units
020		600	Nm
Max	Time	Min	Time
32.1	49.0	0.0	1.0

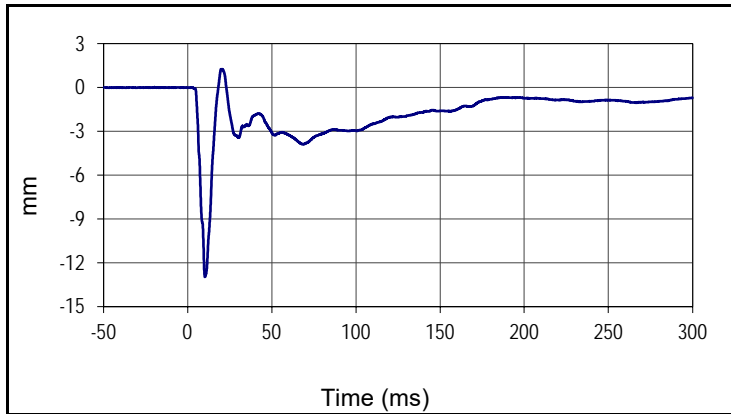
Curve Description			
3 Year Old Chest Displacement X			
Plot No.		SAE Class	Units
021		600	mm
Max	Time	Min	Time
1.3	20.6	-13.0	10.2

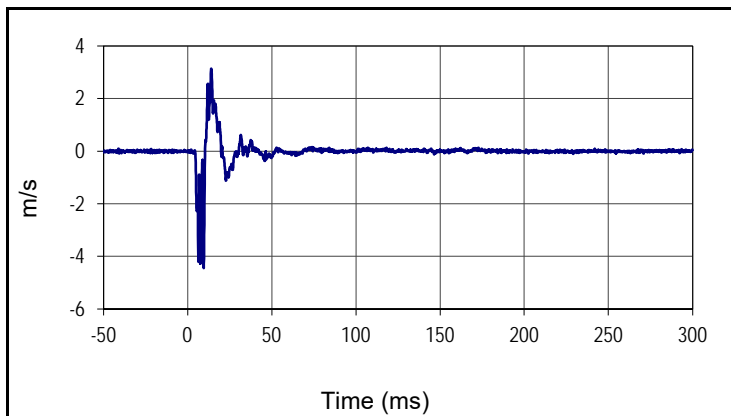
Curve Description			
3 Year Old Chest Deflection Rate			
Plot No.		SAE Class	Units
022		600	m/s
Max	Time	Min	Time
3.1	13.9	-4.4	9.4

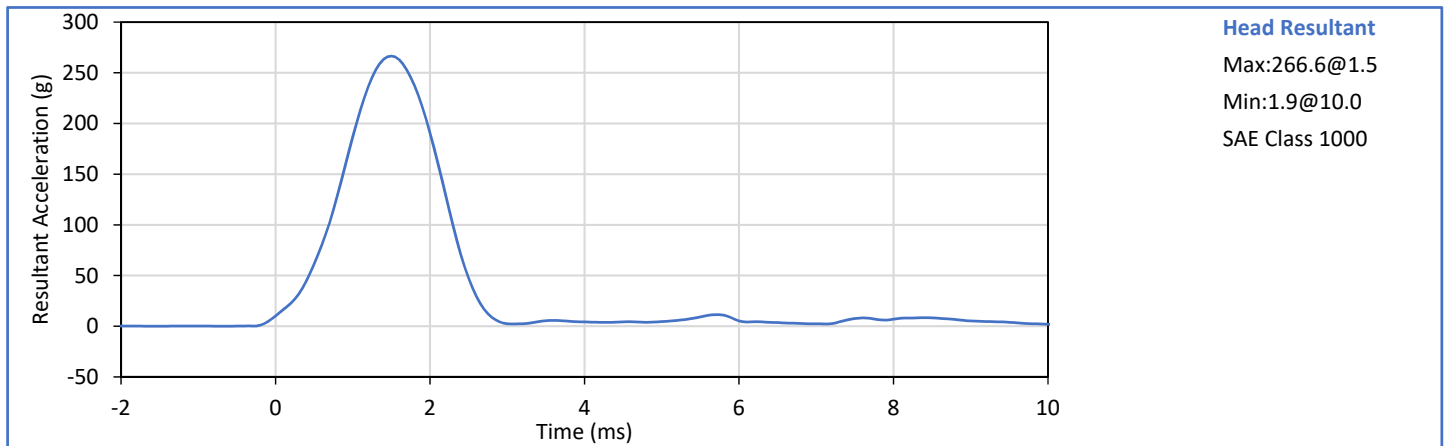
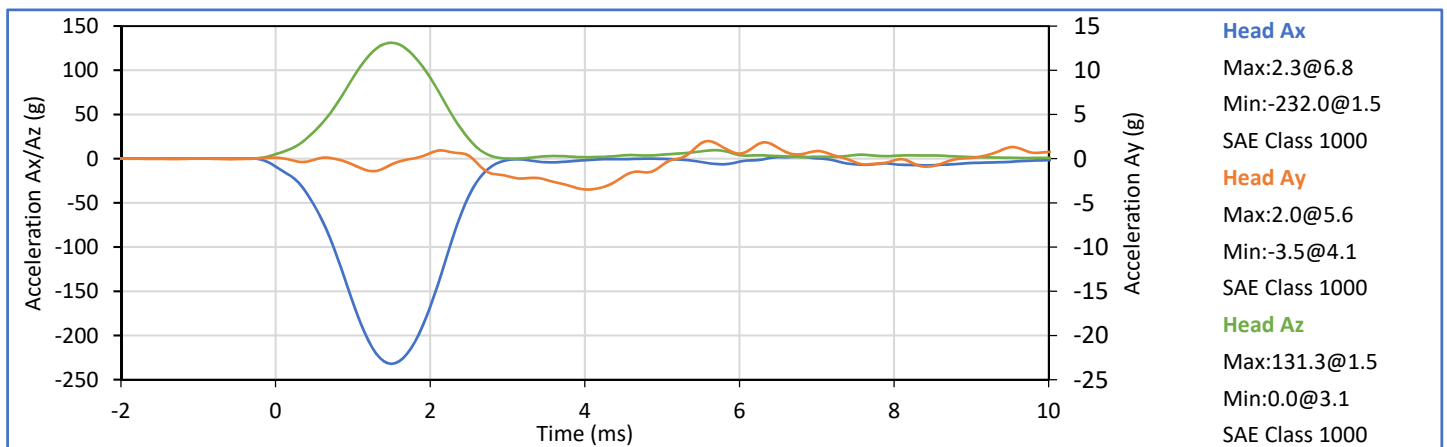
Tested Parameter	Units	Spec. Low	Spec. High	Result	Pass/Fail
Laboratory Temperature	°C	18.9	25.6	21.1	Pass
Laboratory Humidity	%	10	70	29	Pass
Peak Resultant Acceleration	g	250.0	280.0	266.6	Pass
Peak Lateral Acceleration	g	-15.0	15.0	-3.5	Pass
Oscillations After Main Pulse	%	0.0	10.0	4.3	Pass
Is Acceleration Unimodal?	Yes/No	Yes		Yes	Pass
<b>Overall Test Results</b>					<b>Pass</b>

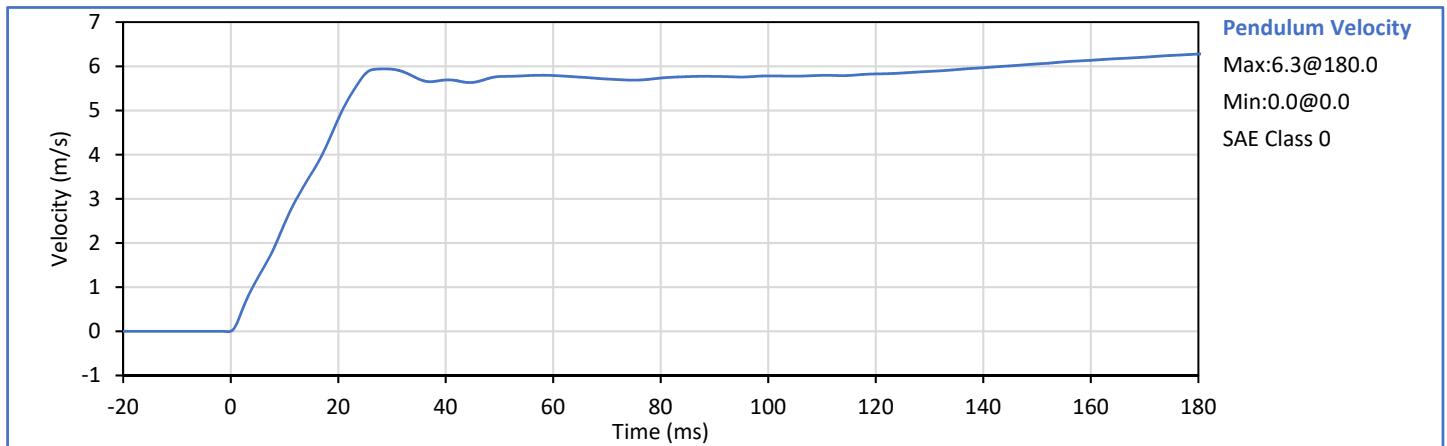
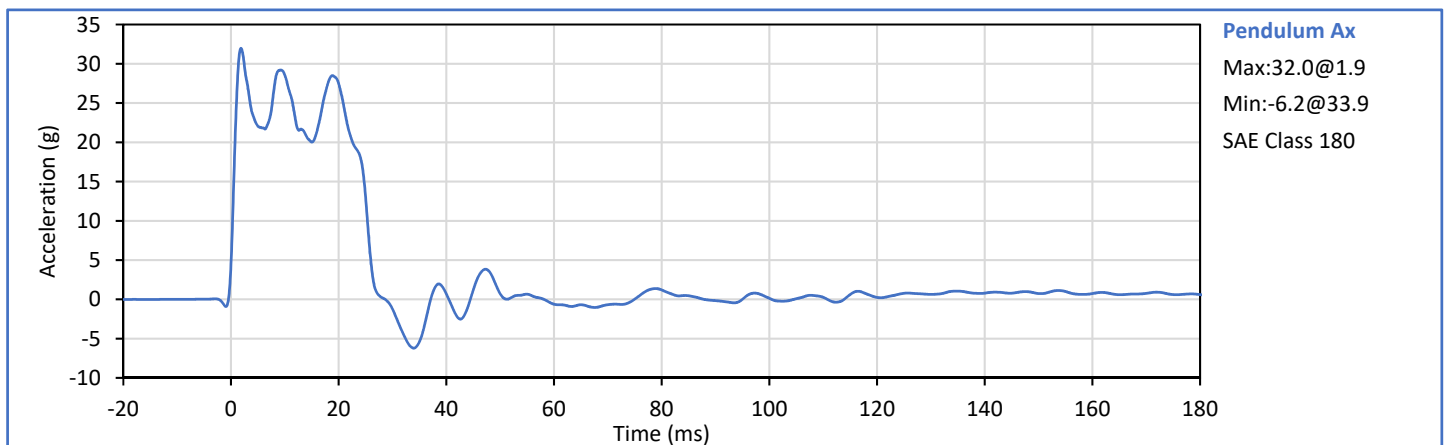
Tested Parameter	Units	Spec. Low	Spec. High	Result	Pass/Fail
Laboratory Temperature	°C	20.6	22.2	21.1	Pass
Laboratory Humidity	%	10	70	31	Pass
Pendulum Velocity	m/s	5.40	5.60	5.55	Pass
Pendulum Velocity at 10 ms	m/s	2.00	2.70	2.44	Pass
Pendulum Velocity at 15 ms	m/s	3.00	4.00	3.57	Pass
Pendulum Velocity at 20 ms	m/s	4.00	5.10	4.81	Pass
Peak Moment in Rotation	Nm	42.0	53.0	46.0	Pass
	deg	70.0	82.0	76.1	Pass
Positive Moment Decay to 10 Nm	ms	60.0	80.0	71.1	Pass
Overall Test Results					Pass

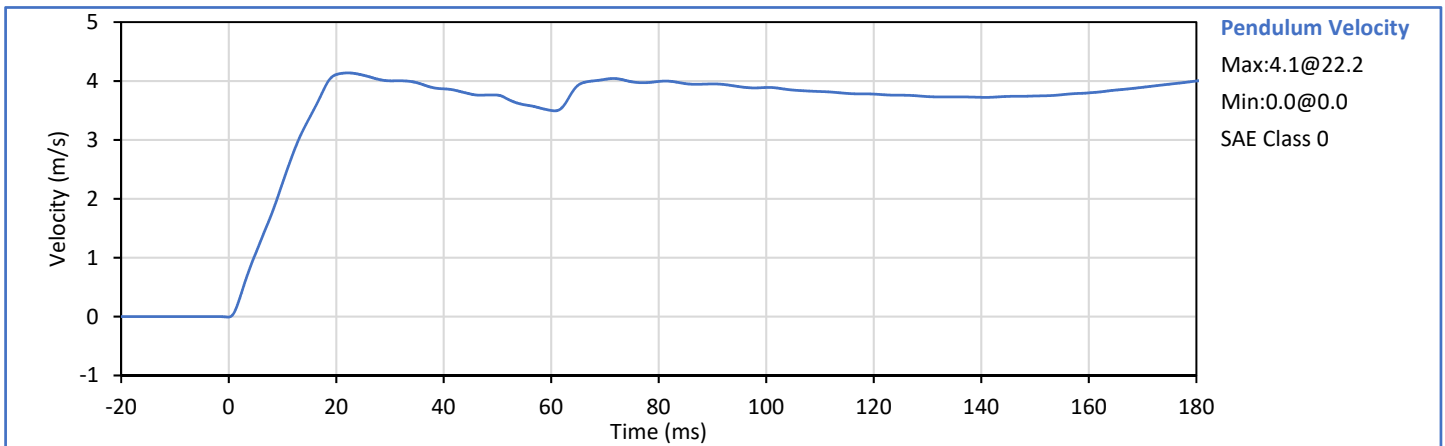
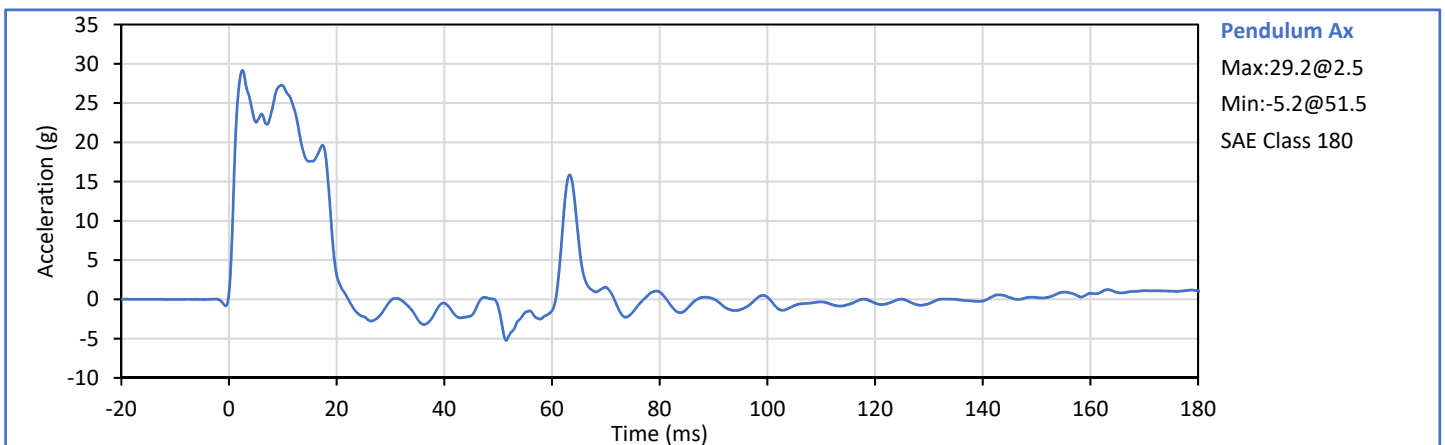
Tested Parameter	Units	Spec. Low	Spec. High	Result	Pass/Fail
Laboratory Temperature	°C	20.6	22.2	21.1	Pass
Laboratory Humidity	%	10	70	31	Pass
Pendulum Velocity	m/s	3.55	3.75	3.73	Pass
Pendulum Velocity at 6 ms	m/s	1.00	1.40	1.30	Pass
Pendulum Velocity at 10 ms	m/s	1.90	2.50	2.27	Pass
Pendulum Velocity at 14 ms	m/s	2.80	3.50	3.20	Pass
Peak Moment in Rotation	Nm	-53.3	-43.7	-45.4	Pass
	deg	83.0	93.0	86.2	Pass
Positive Moment Decay to -10 Nm	ms	60.0	80.0	65.2	Pass
Overall Test Results					Pass
