**REPORT NUMBER: TWG-KAR-19-004**

**SIDE AIRBAG OCCUPANT RISK PROGRAM  
OCCUPANT OUT-OF-POSITION TESTS**

**BAYERISCHE MOTOREN WERKE AG  
2019 BMW X3 SDRIVE30I 5-DOOR MPV**

**NHTSA NUMBER: M20194102TWG2**

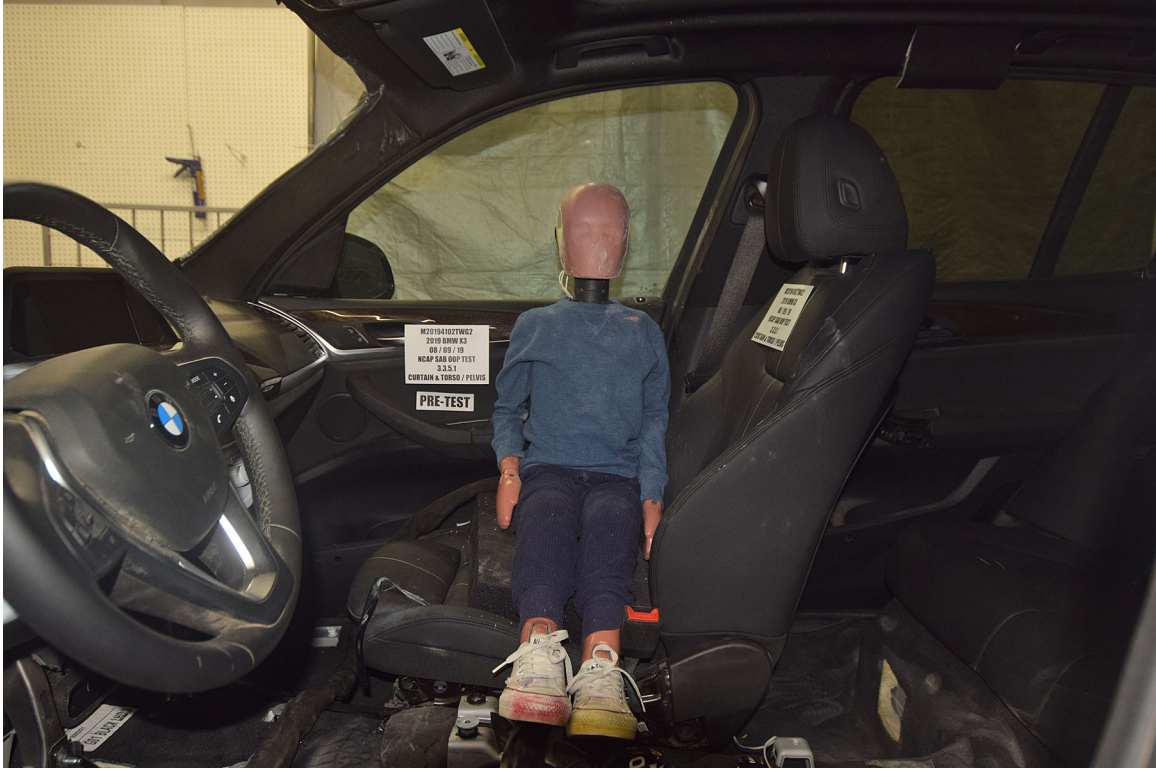
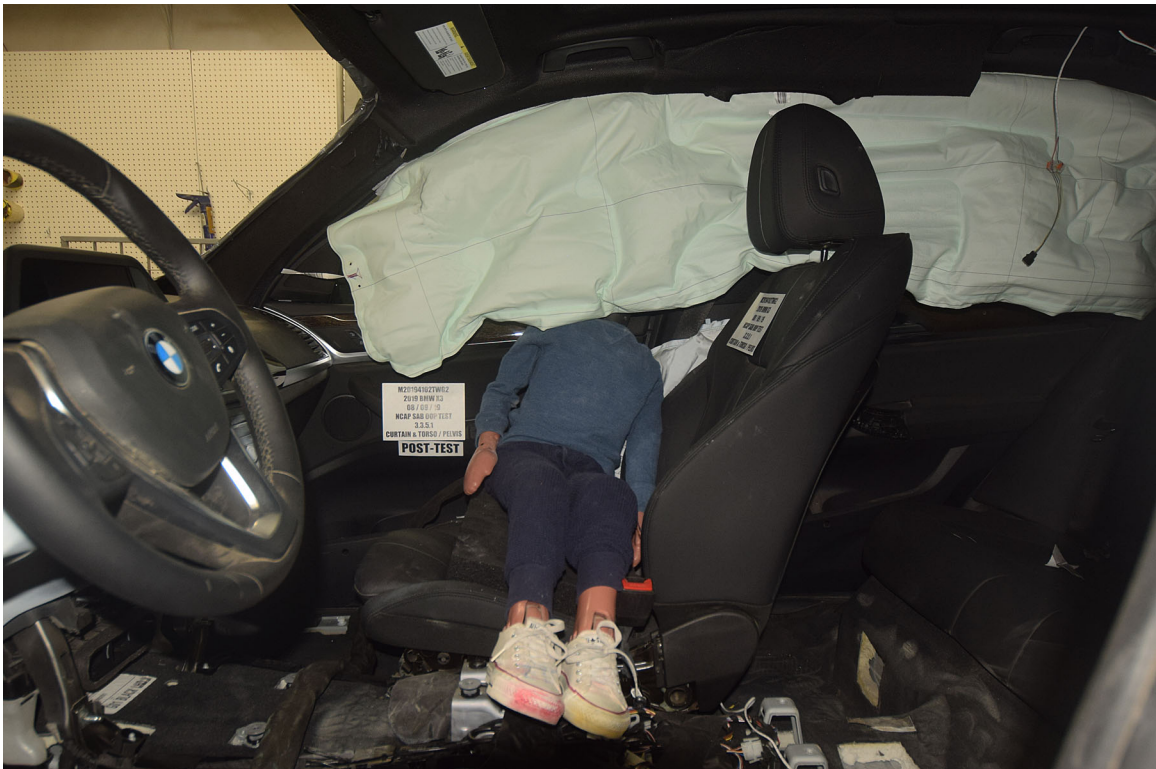
FIGURE 7. Pre-Test Dummy Position, Left View

FIGURE 8. Post-Test Dummy Position, Left View

A 6-year old anthropomorphic test device (ATD) was placed in the right front passenger seating position with its arms hanging at its sides on a foam block, facing inboard with its legs extended according to the dummy placement instructions (3.3.5.1) in the July 2003 Revision of the Technical Working Group's 'Recommended Procedures for Evaluating Occupant Injury Risk from Deploying Side Airbags'.

The 6-year old dummy's visible contact points were as follows: The ATD's head contacted the window.

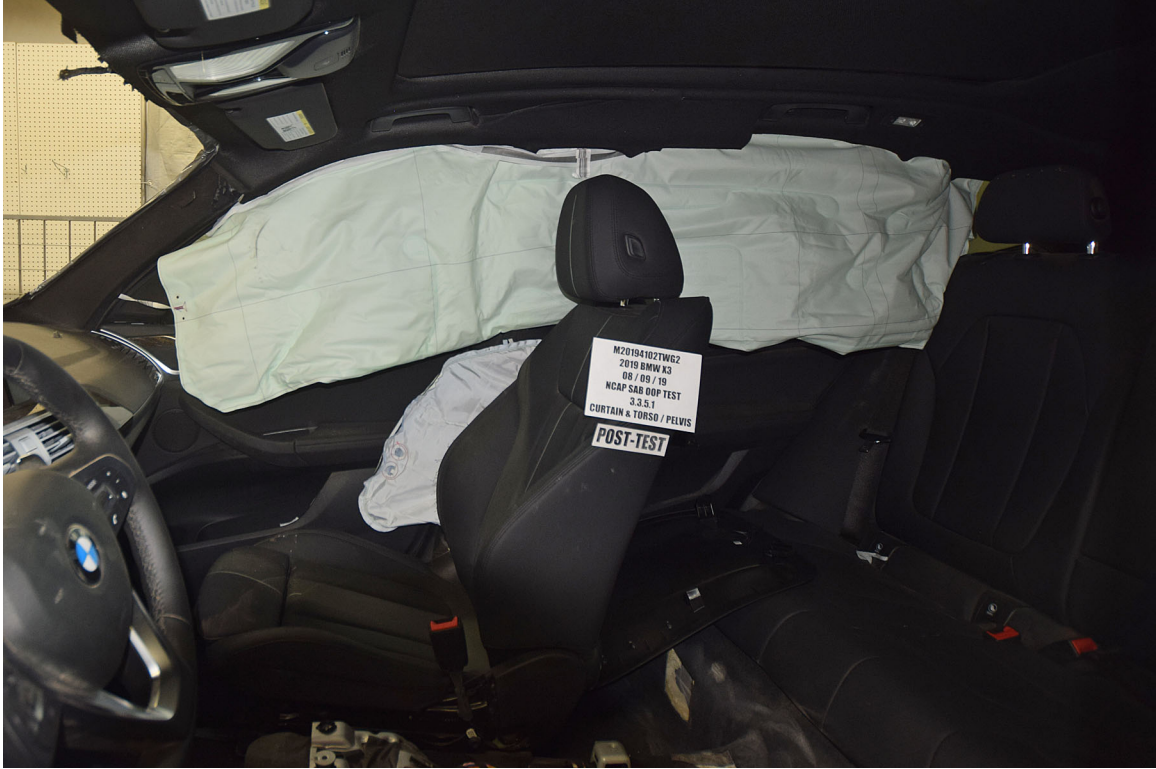
FIGURE 17. Post-Test Airbags, Left Side View

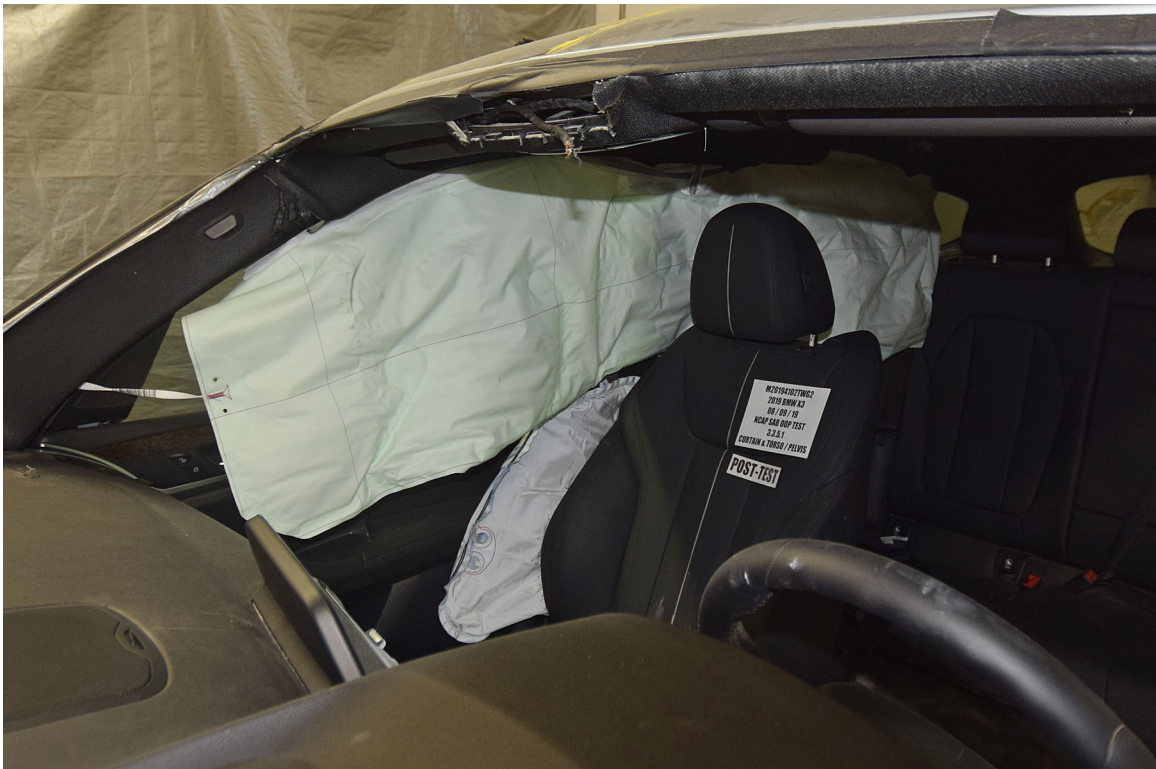
FIGURE 18. Post-Test Airbags, Left Front  $\frac{3}{4}$  View
