REPORT NUMBER: TWG-TRC-19-01

NEW CAR ASSESSMENT PROGRAM (NCAP)
Side Airbag Out-of-Position Test

BAYERISCHE MOTOREN WERKE AG
2019 BMW X5 5-DR SUV

NHTSA NUMBER: M20194105TWG2
TRC TEST NUMBER: 190709-1

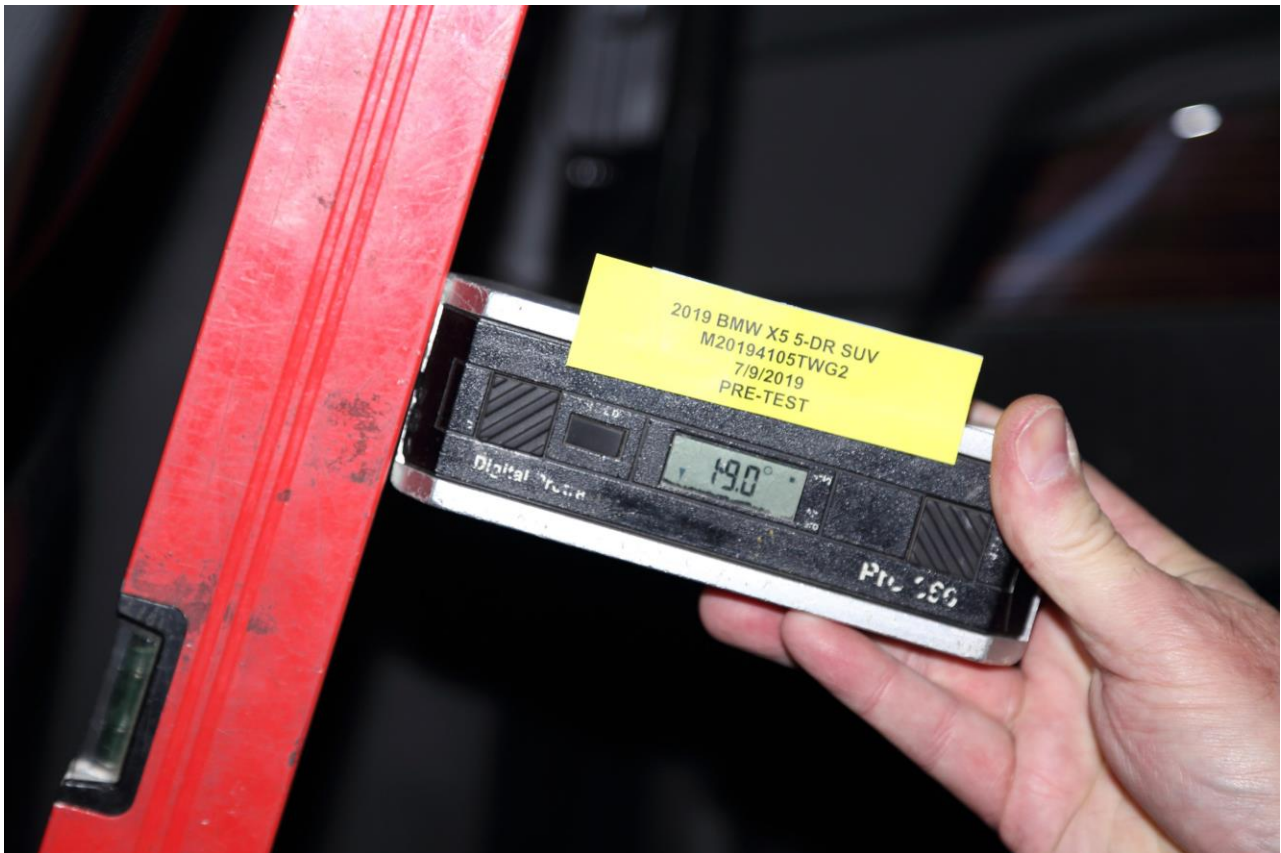
Figure A-8 Pre-Test Vehicle Seat Back Angle

OEM Back Angle Design Position	19.0 degrees measured across seat back
Method of Measuring Back Angle Position	Inclinometer on straight edge across seat back
Seat Back Angle Position Per TWG Guidelines	Per OEM Form 1
Reason for Deviation from TWG Guidelines	No deviations
