REPORT NUMBER: TWG-TRC-19-01

NEW CAR ASSESSMENT PROGRAM (NCAP)  
Side Airbag Out-of-Position Test

BAYERISCHE MOTOREN WERKE AG  
2019 BMW X5 5-DR SUV

NHTSA NUMBER: M20194105TWG3  
TRC TEST NUMBER: 190709-1

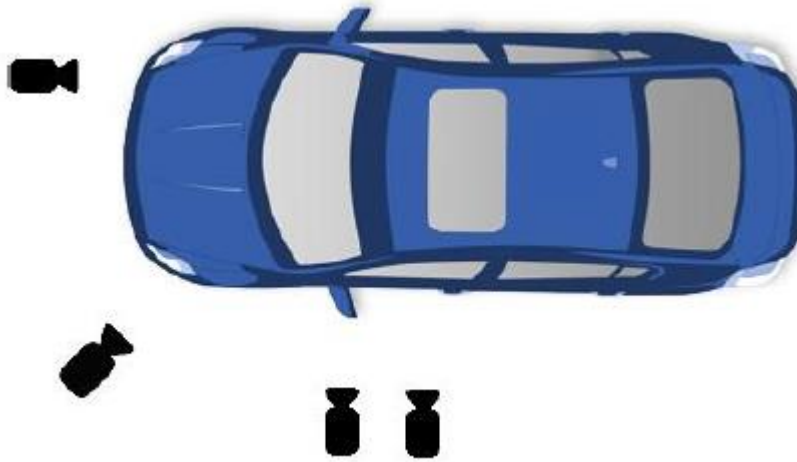
**CAMERA SETUP DIAGRAM FOR SAB OOP TESTS**

No.	Camera View	Location (mm) <sup>1</sup>			Lens (mm)	Speed (fps)
		X	Y	Z		
1	Left View	-3417	-2357	-1470	20	1000
2	Oblique View	2111	-1927	-1527	20	1000
3	Front View	1758	1104	-751	20	1000
4	Real Time	--- <sup>2</sup>	--- <sup>2</sup>	--- <sup>2</sup>	--- <sup>2</sup>	--- <sup>2</sup>

<sup>1</sup>+X forward of vehicle, +Y right of vehicle, +Z into ground

Three high-speed cameras were used to record the air bag deployment event. High speed images were recorded at rates of 1,000 frames per second. Cameras were placed relative to the position 3 and were positioned to capture the deployment event from the side, the front, and the oblique views.

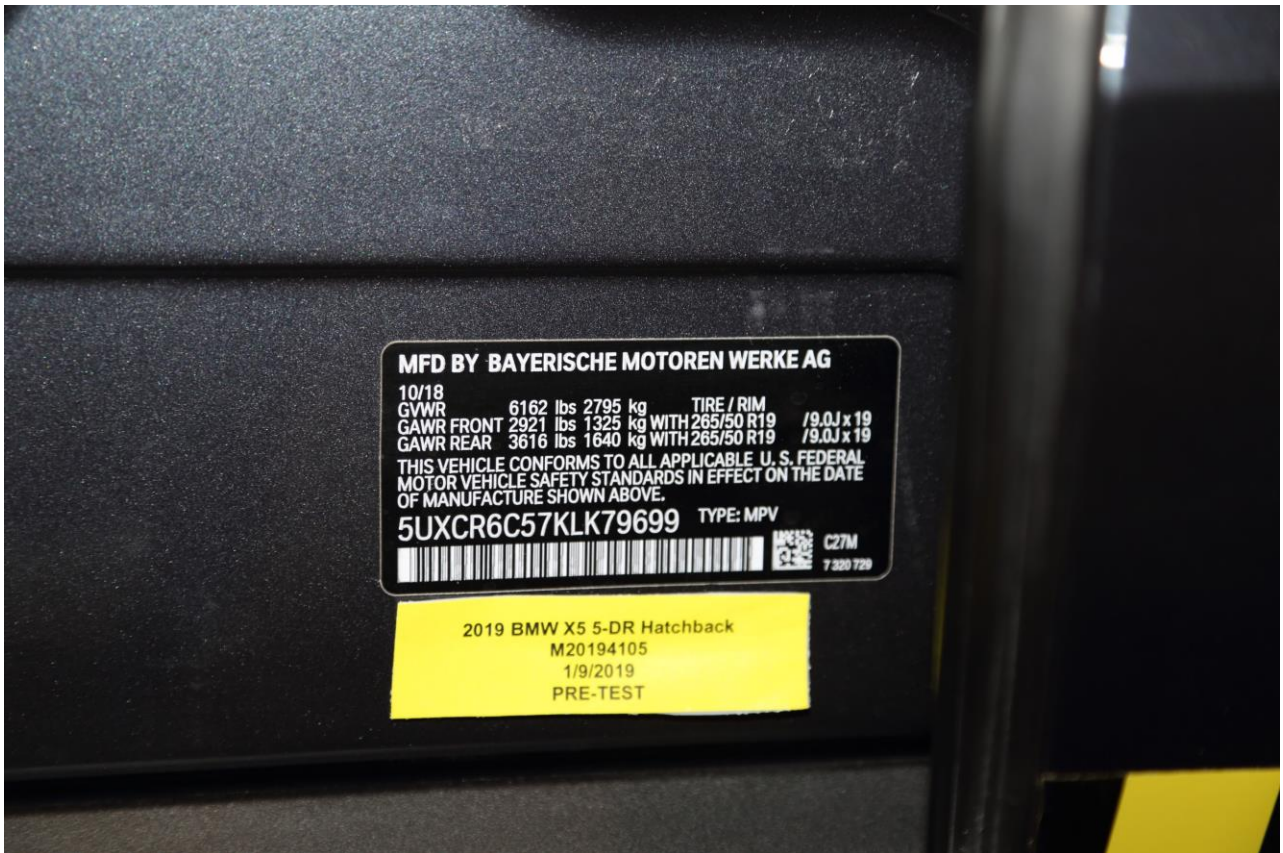
Figure A-2 Vehicle Certification Label

**MFD BY BAYERISCHE MOTOREN WERKE AG**  
10/18  
GVWR 6162 lbs 2795 kg TIRE / RIM  
GAWR FRONT 2921 lbs 1325 kg WITH 265/50 R19 /9.0J x 19  
GAWR REAR 3616 lbs 1640 kg WITH 265/50 R19 /9.0J x 19  
THIS VEHICLE CONFORMS TO ALL APPLICABLE U. S. FEDERAL  
MOTOR VEHICLE SAFETY STANDARDS IN EFFECT ON THE DATE  
OF MANUFACTURE SHOWN ABOVE.  
**5UXCR6C57KLK79699** TYPE: MPV  
C27M  
7 320 729

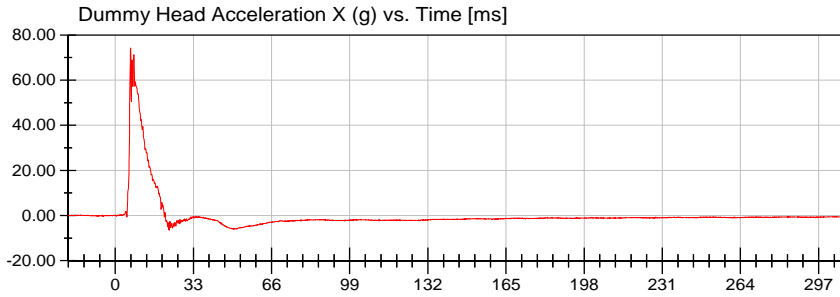
74.22 g at 6.48 ms

-6.58 g at 22.72 ms

CFC\_1000

Channel	Unit	CFC	Maximum	Time (ms)	Minimum	Time (ms)
Head X	G	1000	74.22	6.48	-6.58	22.72
Head Y	G	1000	53.99	6.00	-5.78	28.88
Head Z	G	1000	11.83	7.60	-10.13	6.40
Head Resultant	G	1000	85.53	6.48		
Head Red X	G	1000	74.13	6.48	-6.81	22.72
Head Red Y	G	1000	54.18	6.00	-5.70	28.88
Head Red Z	G	1000	11.32	7.60	-9.84	6.40
Head Red Resultant	G	1000	85.47	6.48		
Upper Neck X	N	1000	4.35	4.96	-218.68	11.28
Upper Neck Y	N	1000	22.72	9.76	-142.41	21.60
Upper Neck Z	N	1000	559.70	9.84	-73.96	6.16
Upper Neck Resultant	N	1000	582.74	10.40		
Upper Neck X	Nm	600	3.93	60.00	-13.94	24.48
Upper Neck Y	Nm	600	5.52	34.40	-8.84	11.84
Upper Neck Z	Nm	600	3.98	92.80	-6.65	29.52
Upper Neck Resultant	Nm	600	15.34	24.16		
Lower Neck X	N	1000	59.26	64.64	-553.53	22.00
Lower Neck Y	N	1000	229.57	19.76	-0.71	5.36
Lower Neck Z	N	1000	269.36	92.48	-556.67	34.64
Lower Neck Resultant	N	1000	768.77	22.24		
Lower Neck X	Nm	600	2.11	7.76	-9.08	18.80

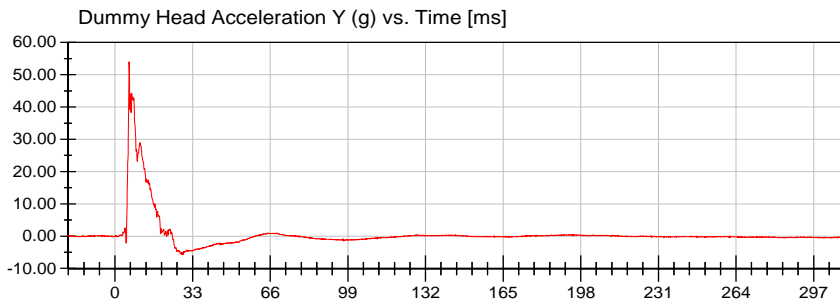
53.99 g at 6.00 ms

-5.78 g at 28.88 ms

CFC\_1000

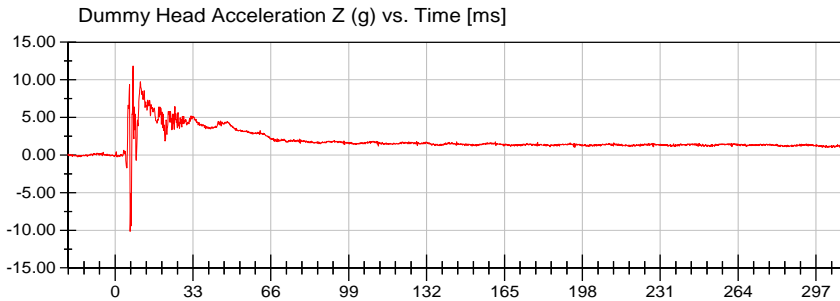
11.83 g at 7.60 ms

-10.13 g at 6.40 ms

CFC\_1000

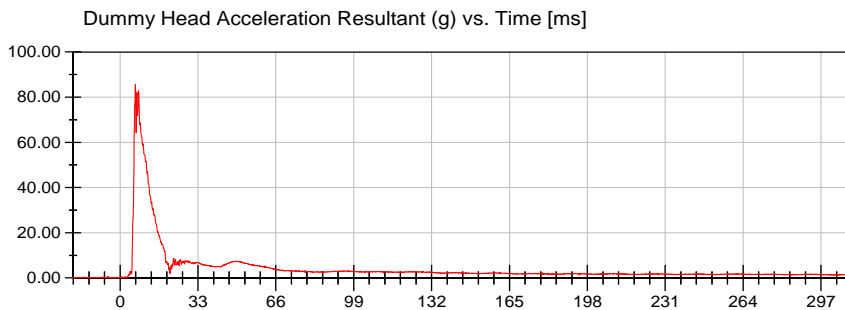
85.53 g at 6.48 ms

0.03 g at -19.52 ms

CFC\_1000

HIC15	T1 (ms)	T2 (ms)	HIC36	T1 (ms)	T2 (ms)
200	5.68	12.80	200	5.68	12.80

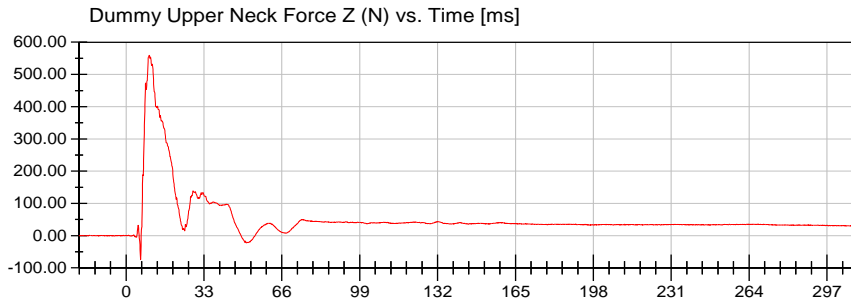
559.70 N at 9.84 ms

-73.96 N at 6.16 ms

CFC\_1000

Injury Criteria	Value	Time (ms)
Upper Neck NTF	0.14	32.56
Upper Neck NTE	0.57	11.20
Upper Neck NCF	0.01	49.12
Upper Neck NCE	0.07	6.16
Peak Tension	559.70	9.84
Peak Compression	-73.96	6.16

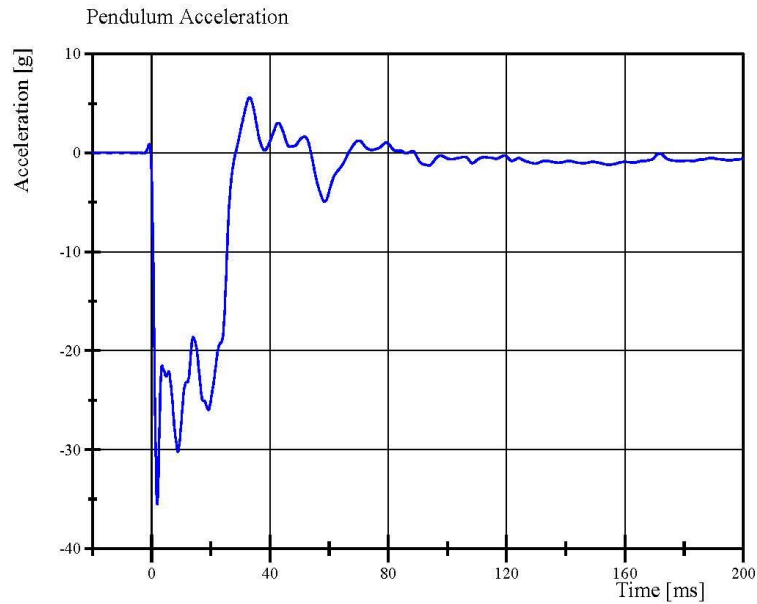
HIII 3YO Serial No. 040 Certification No. 9-2

Filter Class: CFC\_180  
Max: 5.6 g at 33.1 ms  
Min: -35.5 g at 1.9 ms

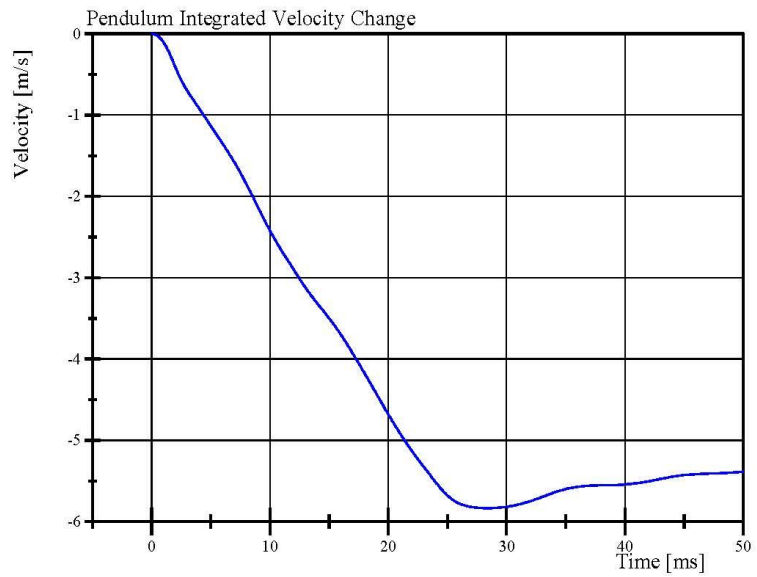
Filter Class: CFC\_180  
Max: 0.0 m/s at 0.0 ms  
Min: -5.8 m/s at 28.4 ms

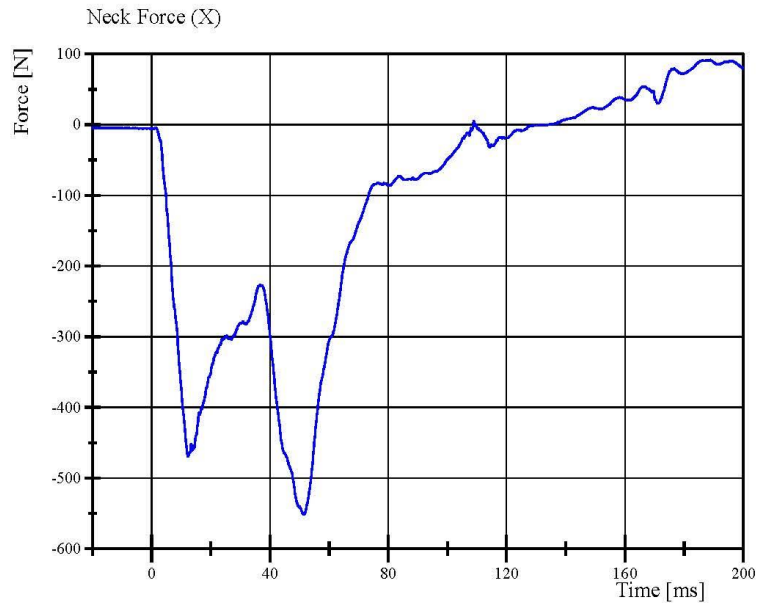
HIII 3YO Serial No. 040 Certification No. 9-2

Filter Class: CFC\_1000  
Max: 91.5 N at 188.8 ms  
Min: -551.4 N at 51.4 ms

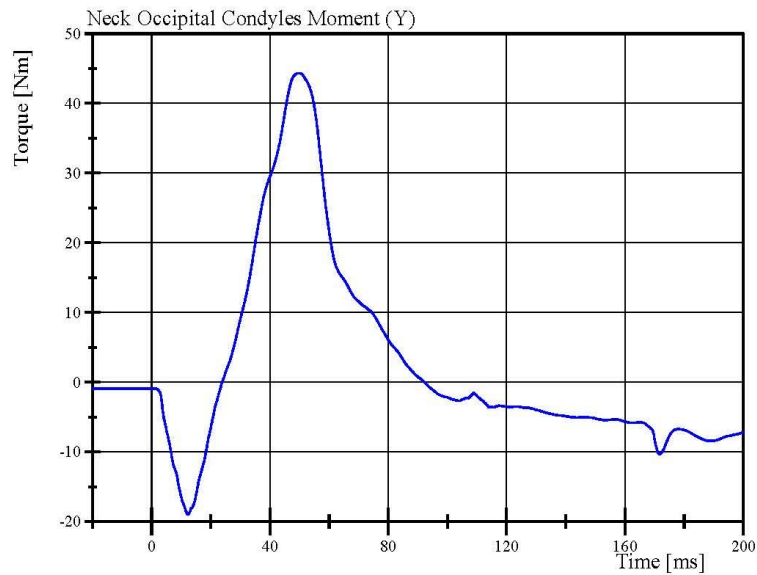
Filter Class: CFC\_600  
Max: 44.4 Nm at 49.8 ms  
Min: -19.0 Nm at 12.3 ms

Test Parameter	Specification	Test Results	Pass
Temperature	20.6 - 22.2 °C	20.8 °C	Yes
Relative Humidity	10 - 70 %	58 %	Yes
Pendulum Impact Velocity	5.40 - 5.60 m/s	5.599 m/s	Yes
Pendulum Integrated Velocity Change at 10 ms	(-2.0) - (-2.7) m/s	-2.42 m/s	Yes
Pendulum Integrated Velocity Change at 15 ms	(-3.0) - (-4.0) m/s	-3.49 m/s	Yes
Pendulum Integrated Velocity Change at 20 ms	(-4.0) - (-5.1) m/s	-4.68 m/s	Yes
Total Headform D-Plane Rotation	(-70) - (-82) °	-79.2 °	Yes
Peak Neck Occipital Condyles Moment	42 - 53 Nm	44.4 Nm	Yes
Neck Occipital Condyles Moment Decay to 10 Nm	60 - 80 ms	74.6 ms	Yes

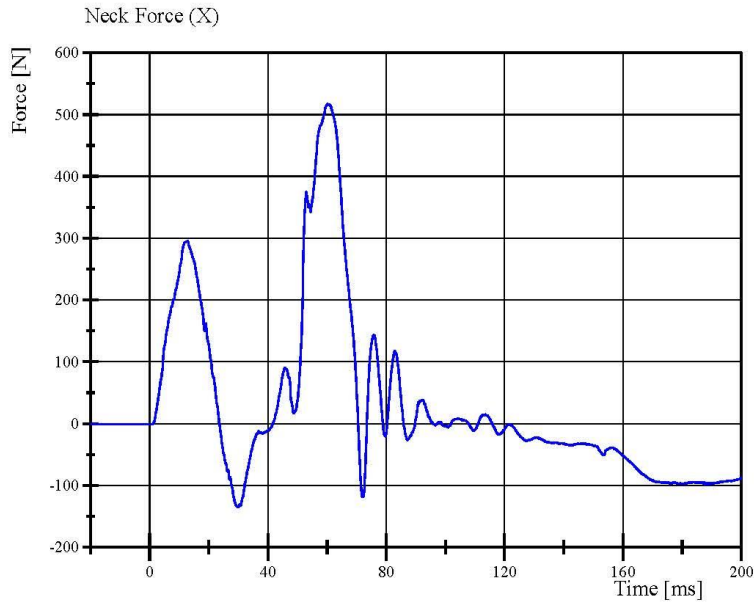
HIII 3YO Serial No. 040 Certification No. 9-1

Filter Class: CFC\_1000  
Max: 516.7 N at 60.2 ms  
Min: -134.7 N at 30.1 ms

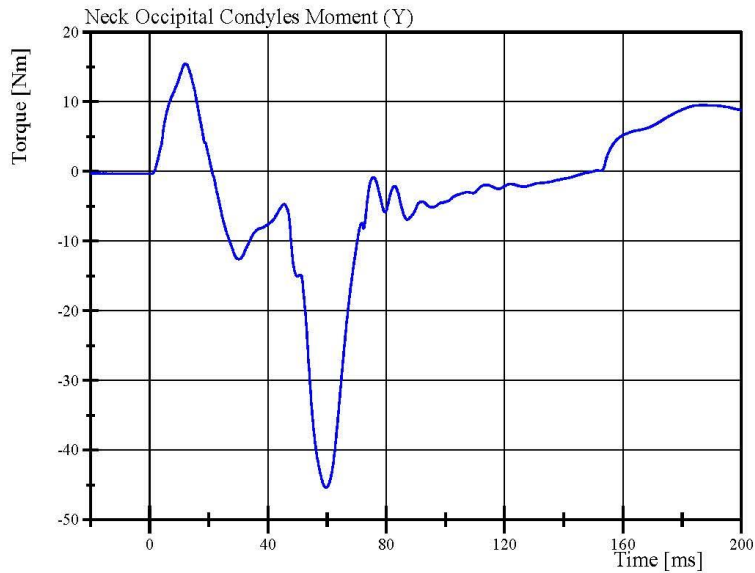
Filter Class: CFC\_600  
Max: 15.4 Nm at 12.0 ms  
Min: -45.4 Nm at 59.7 ms

Test Parameter	Specification	Test Results	Pass
Temperature	20.6 - 22.2 °C	21.0 °C	Yes
Relative Humidity	10 - 70 %	60 %	Yes
Pendulum Impact Velocity	(-3.55) - (-3.75) m/s	-3.745 m/s	Yes
Pendulum Integrated Velocity Change at 6 ms	1.0 - 1.4 m/s	1.25 m/s	Yes
Pendulum Integrated Velocity Change at 10 ms	1.9 - 2.5 m/s	2.26 m/s	Yes
Pendulum Integrated Velocity Change at 14 ms	2.8 - 3.5 m/s	3.19 m/s	Yes
Total Headform D-Plane Rotation	83 - 93 °	88.6 °	Yes
Peak Neck Occipital Condyles Moment Neck Occipital Condyles Moment	(-43.7) - (-53.3) Nm	-45.39 Nm	Yes
Decay to 10 Nm	60 - 80 ms	70.2 ms	Yes
