**REPORT NUMBER: TWG-MGA-19-002**

**SIDE AIRBAG OUT-OF-POSITION INJURY  
TECHNICAL WORKING GROUP**

**NISSAN MOTOR CO., LTD.  
2019 Nissan Murano S 5-Door SUV  
NHTSA No.: M20195211TWG3**

**FINAL REPORT**

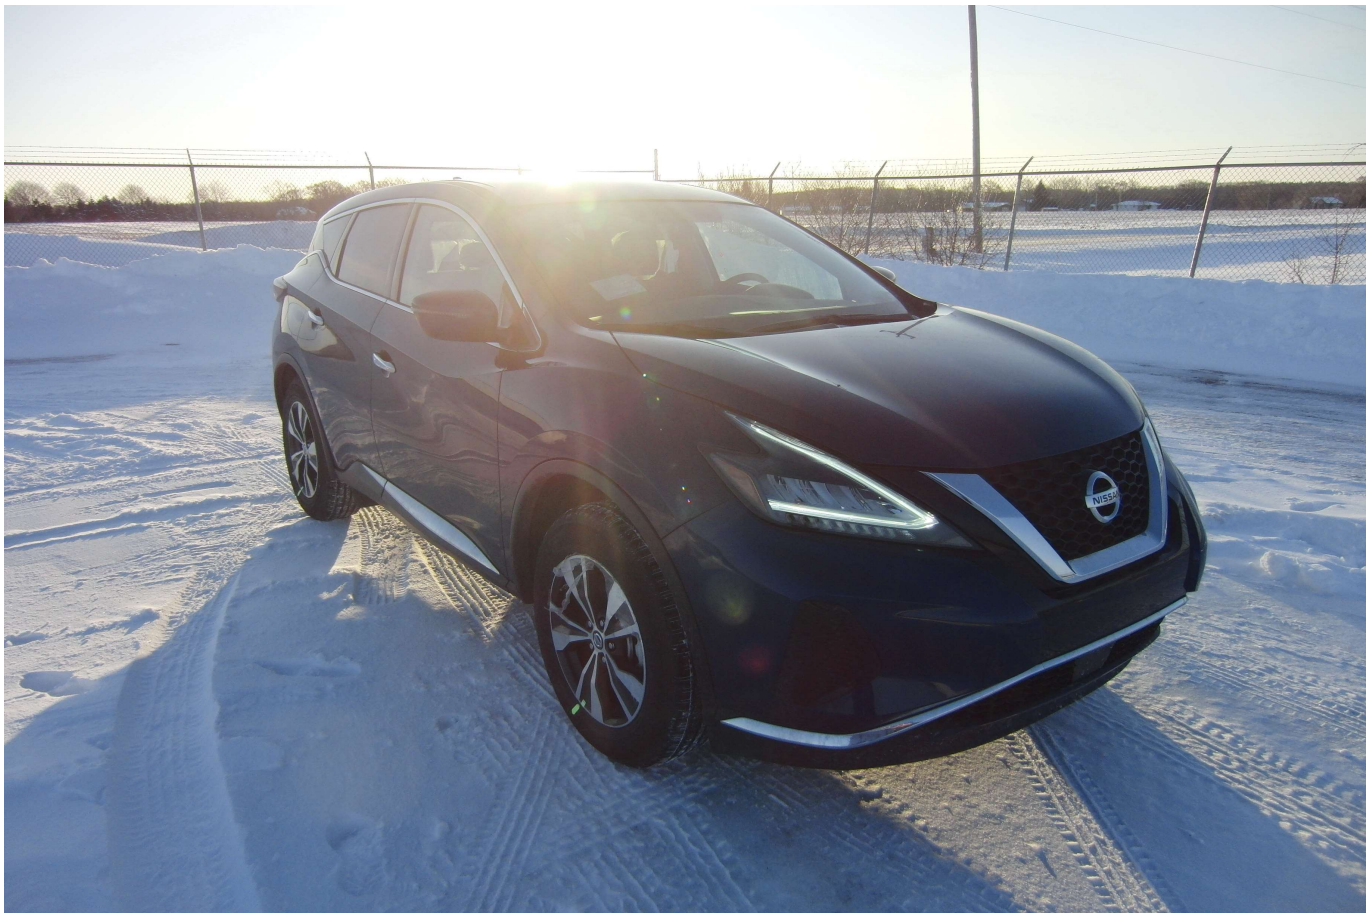
Photo No. 001 - Right Front Three-Quarter View of Vehicle, As Delivered

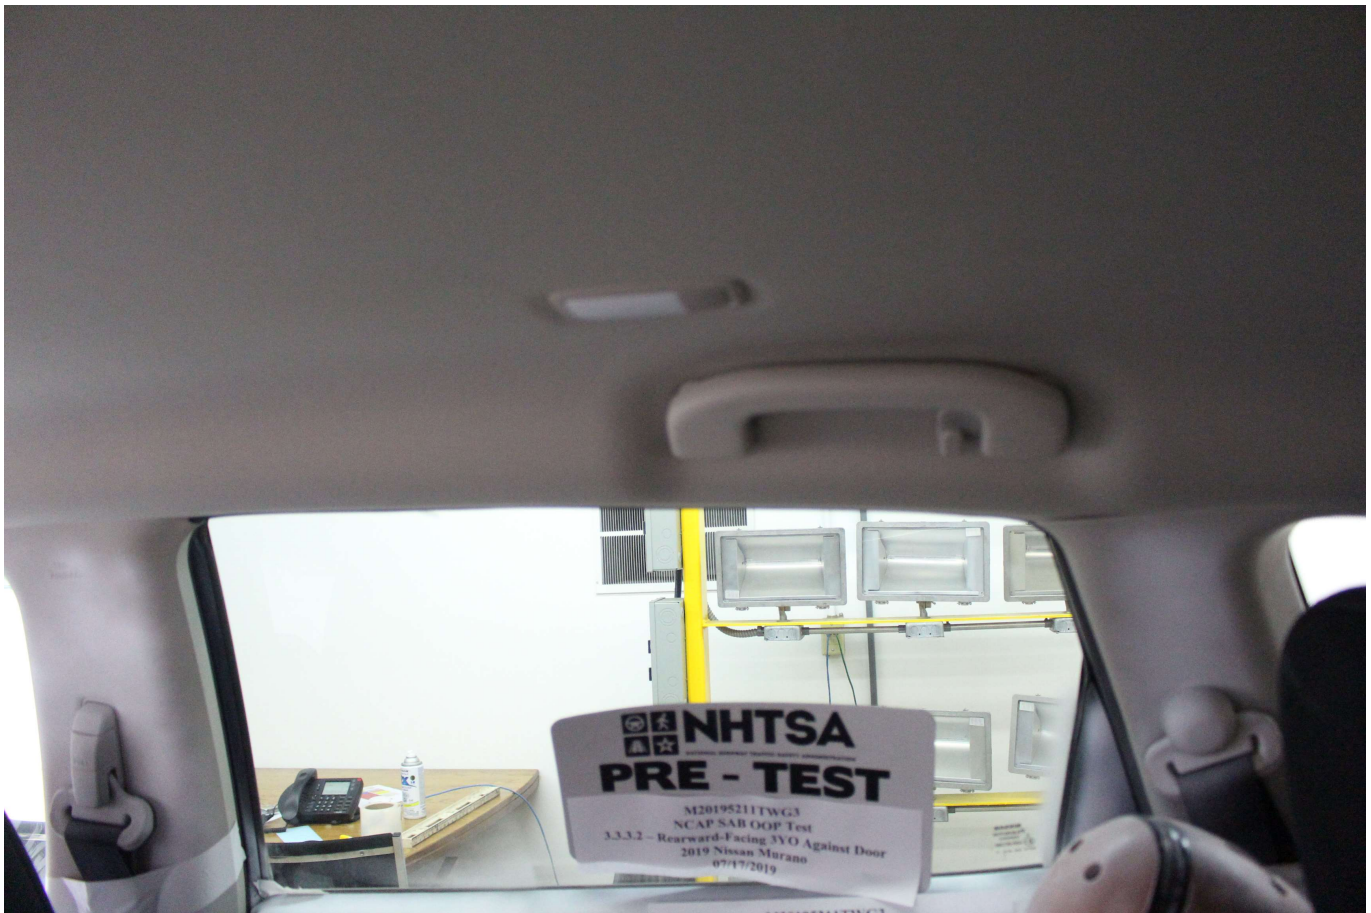
Photo No. 005 - Pre-Test Vehicle Location of Air Bag 1

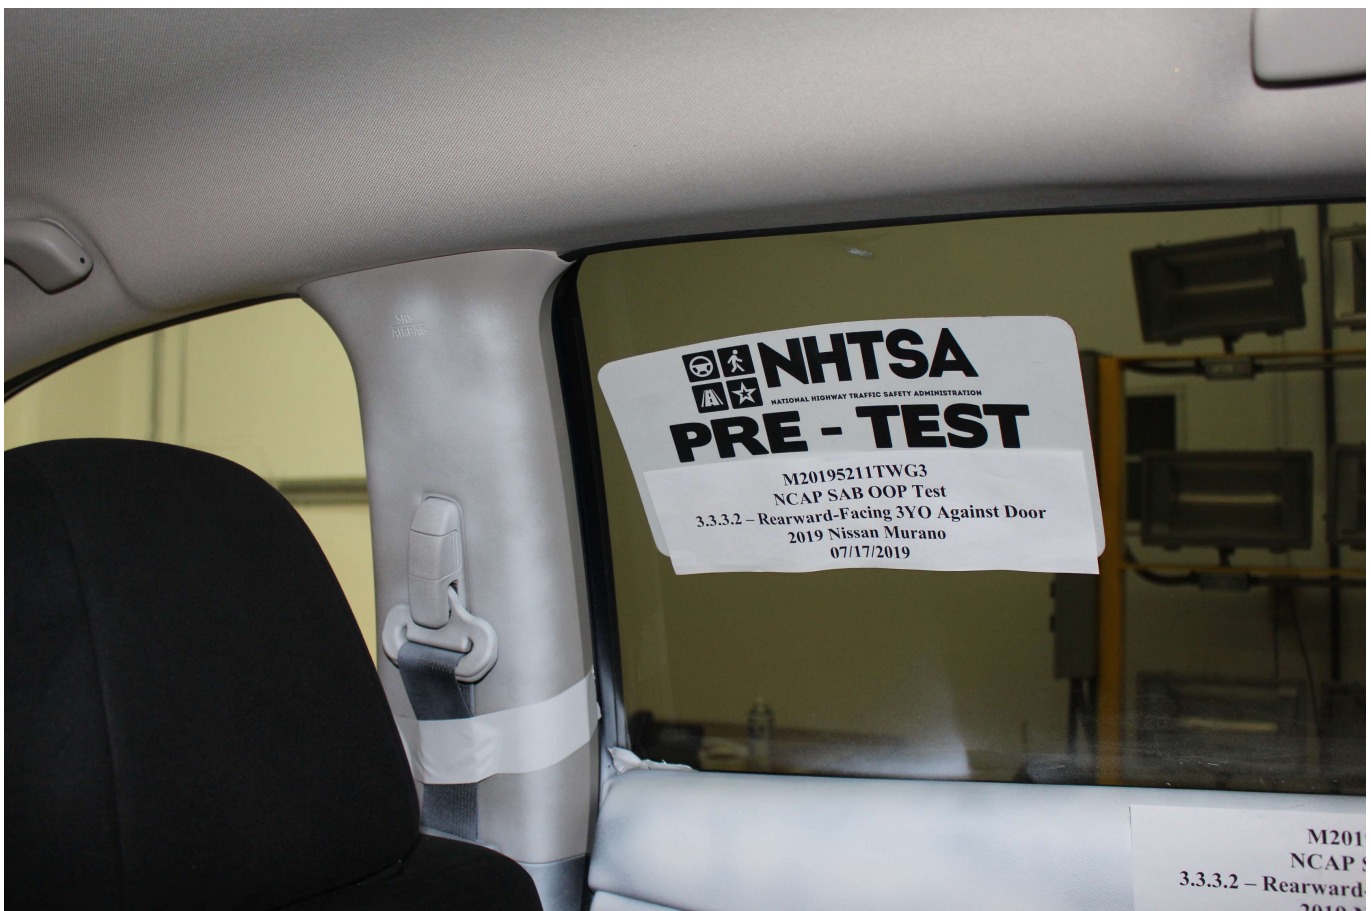
Photo No. 006 - Pre-Test Vehicle Location of Air Bag 2

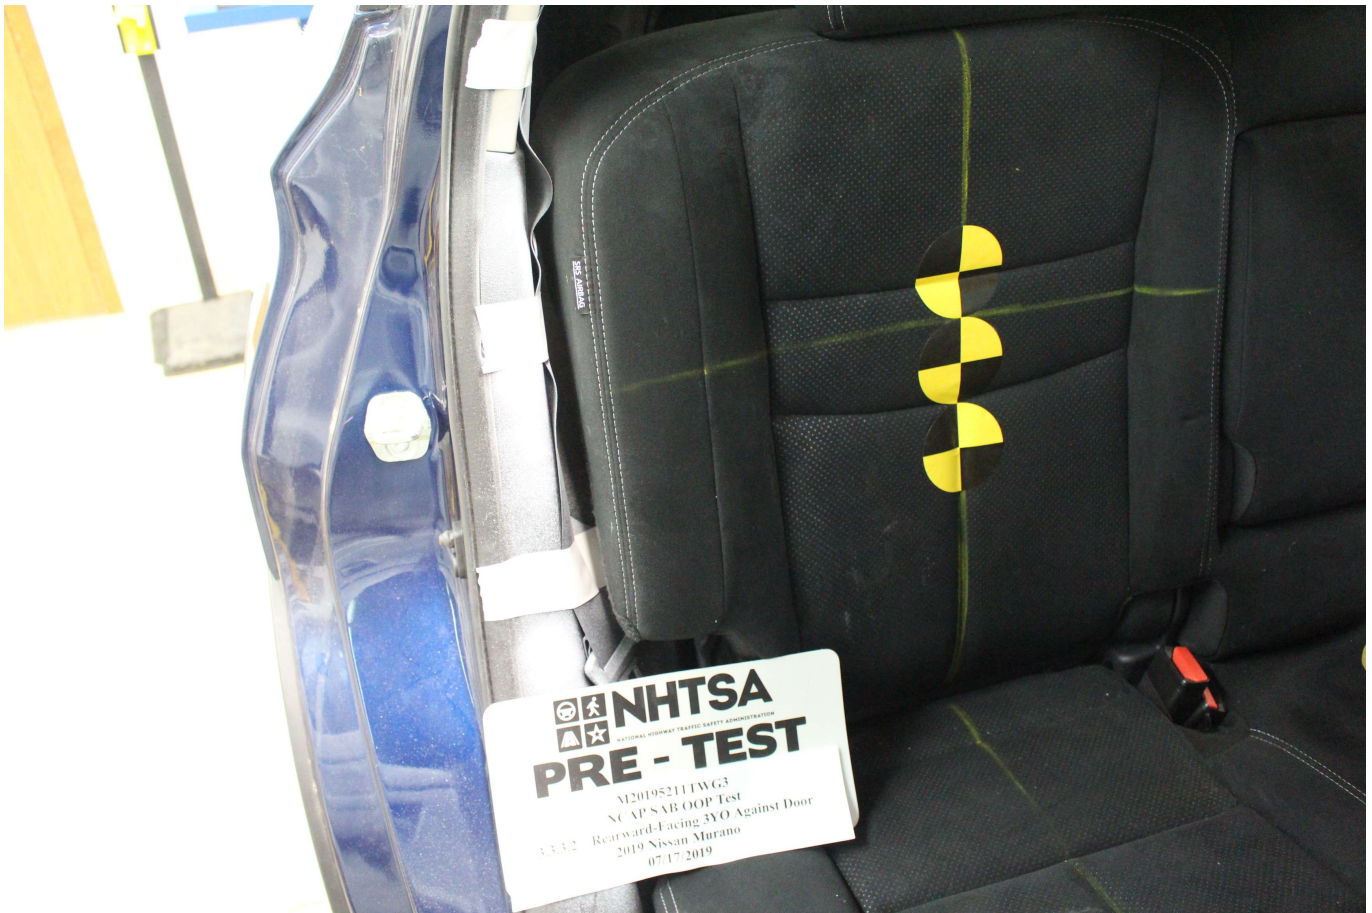
Photo No. 007 - Pre-Test Vehicle Location of Air Bag 3

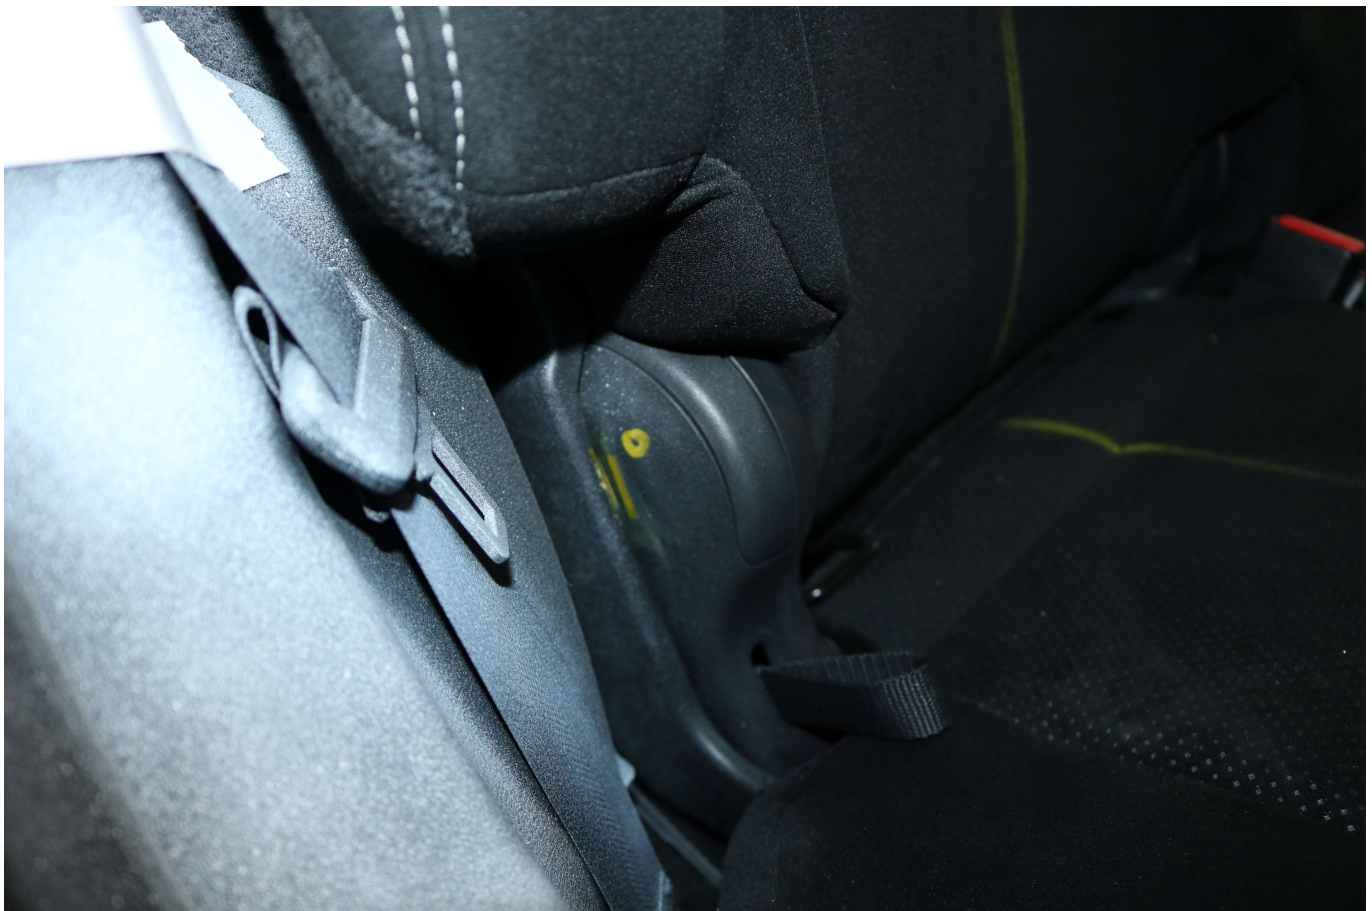
Photo No. 008 - Pre-Test Vehicle Seat Back Angle

| Seat | Total Seat Back Angle Range | | Test Position from Vertical | |
|---|---|---|---|---|
| Right Rear Passenger Seat | 23.8 | 13 | -3.5 | 0 |
| Method of Measuring Back Angle Position | Angle measured on outboard headrest post | | | |

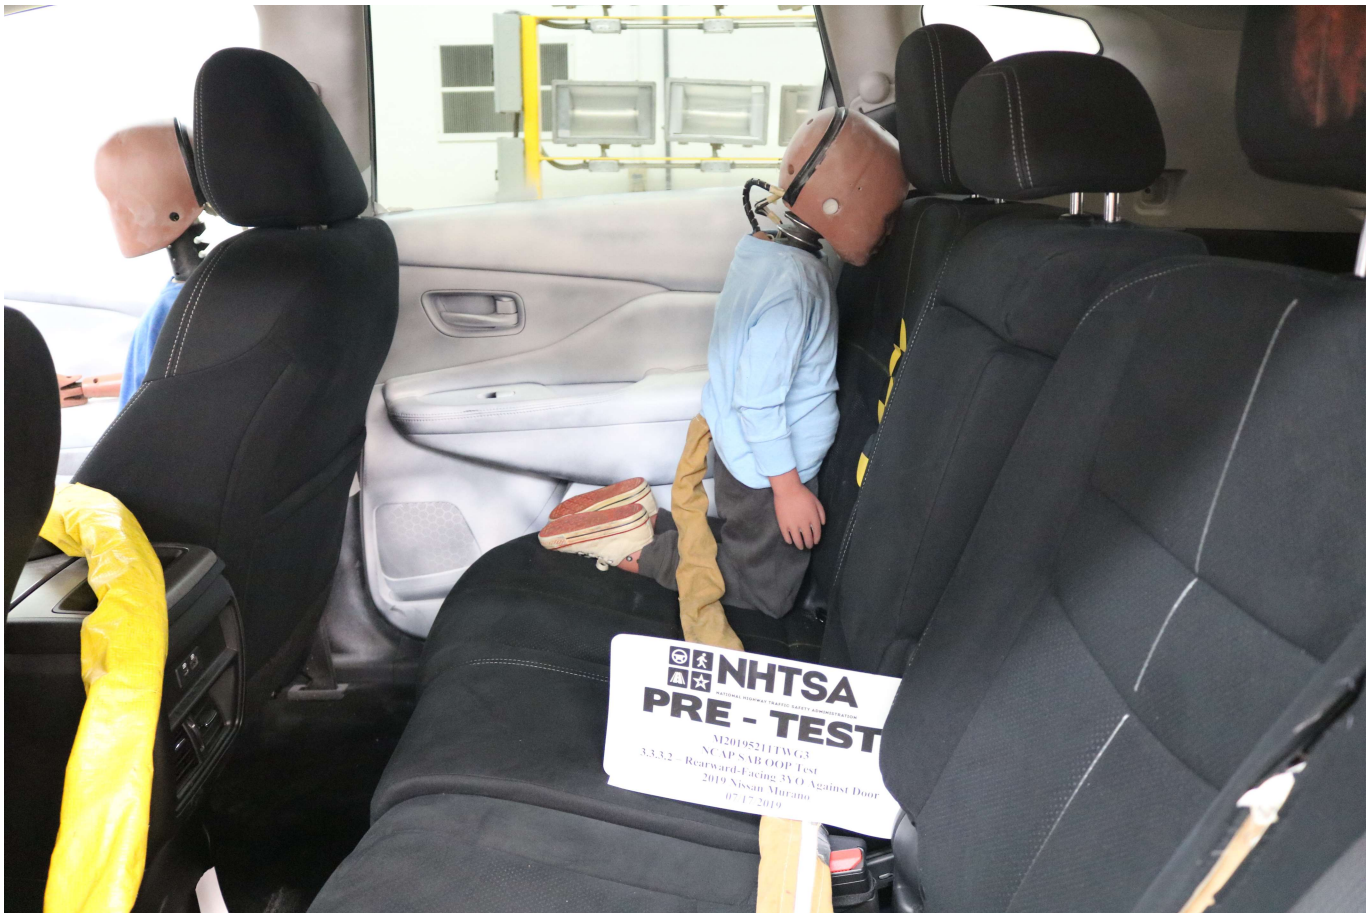
Photo No. 009 - Pre-Test Dummy Left Side View

The Hybrid III 3-Year-Old child dummy was placed in the right rear passenger seat along the outboard edge of the seat cushion, kneeling and facing rearward. The vertical centerline of the dummy's sternum was aligned as close as possible with the leading edge of the seatback bolster. The sternum contacted with seat. The dummy's head was placed in between the seat bolster and pillar/side trim to maximize contact between the sternum and seatback. The head remained in its neutral orientation. The outboard leg was positioned at the outboard edge of the seat cushion and parallel to the seat centerline and remained on the cushion. The outboard knee and lower leg was slid toward the seatback/seat cushion junction until the top edge of the upper rib was aligned horizontally with the top edge of the airbag module. The inboard leg was aligned parallel to the centerline of the seat cushion. The inboard knee and lower leg was slid toward the seat bight until a line drawn through both shoulder bolts was perpendicular to the vehicle centerline. The inboard arm was rotated towards the seatback until the thumb contacts the seatback. The outboard arm and hand was rotated to hang down as close to vertical as possible.

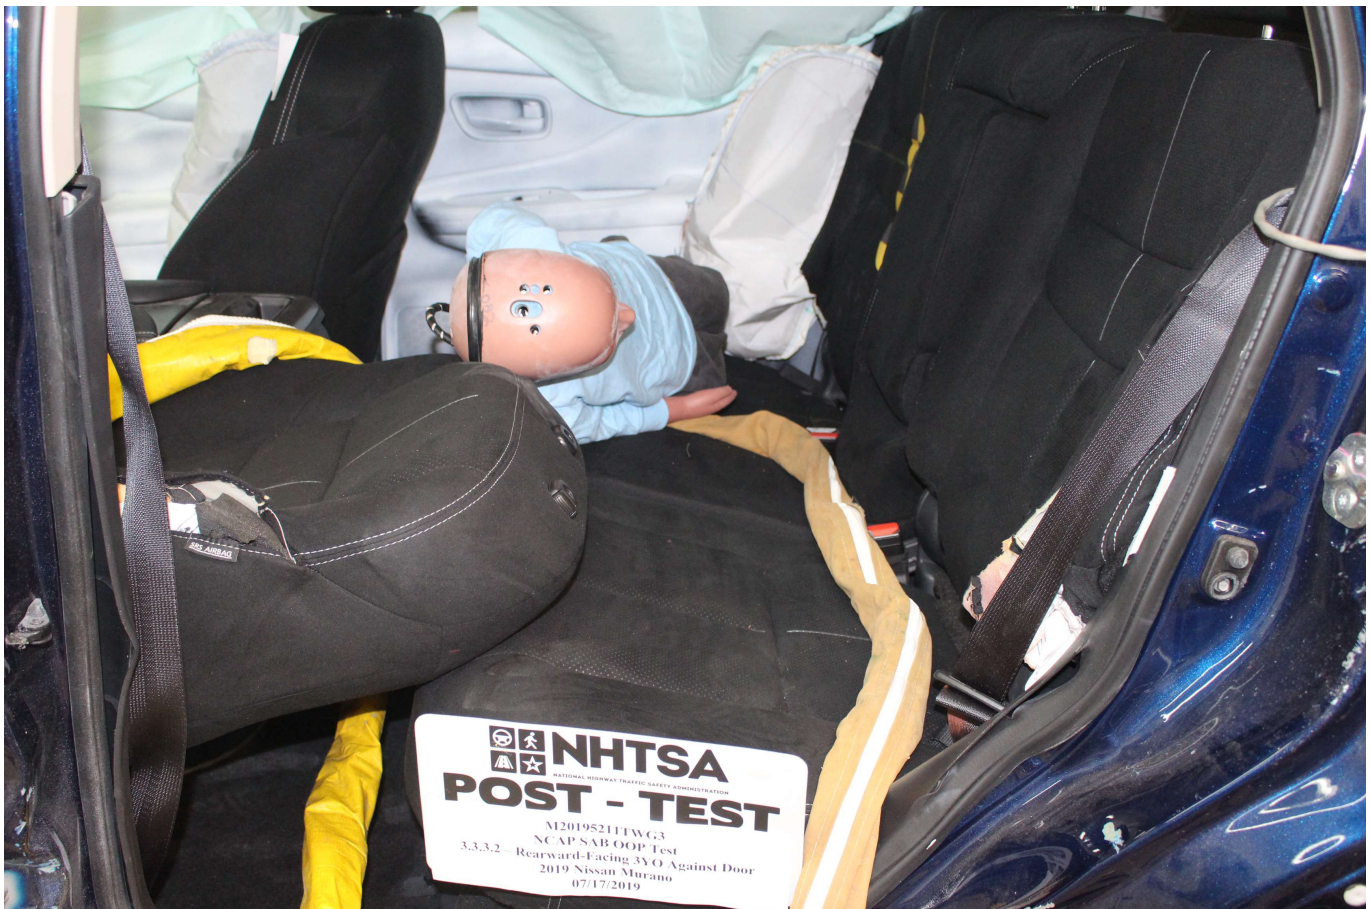
Photo No. 010 - Post-Test Dummy Left Side View

- Side curtain airbag to top of head
- Side torso/pelvis airbag to face and torso/pelvis

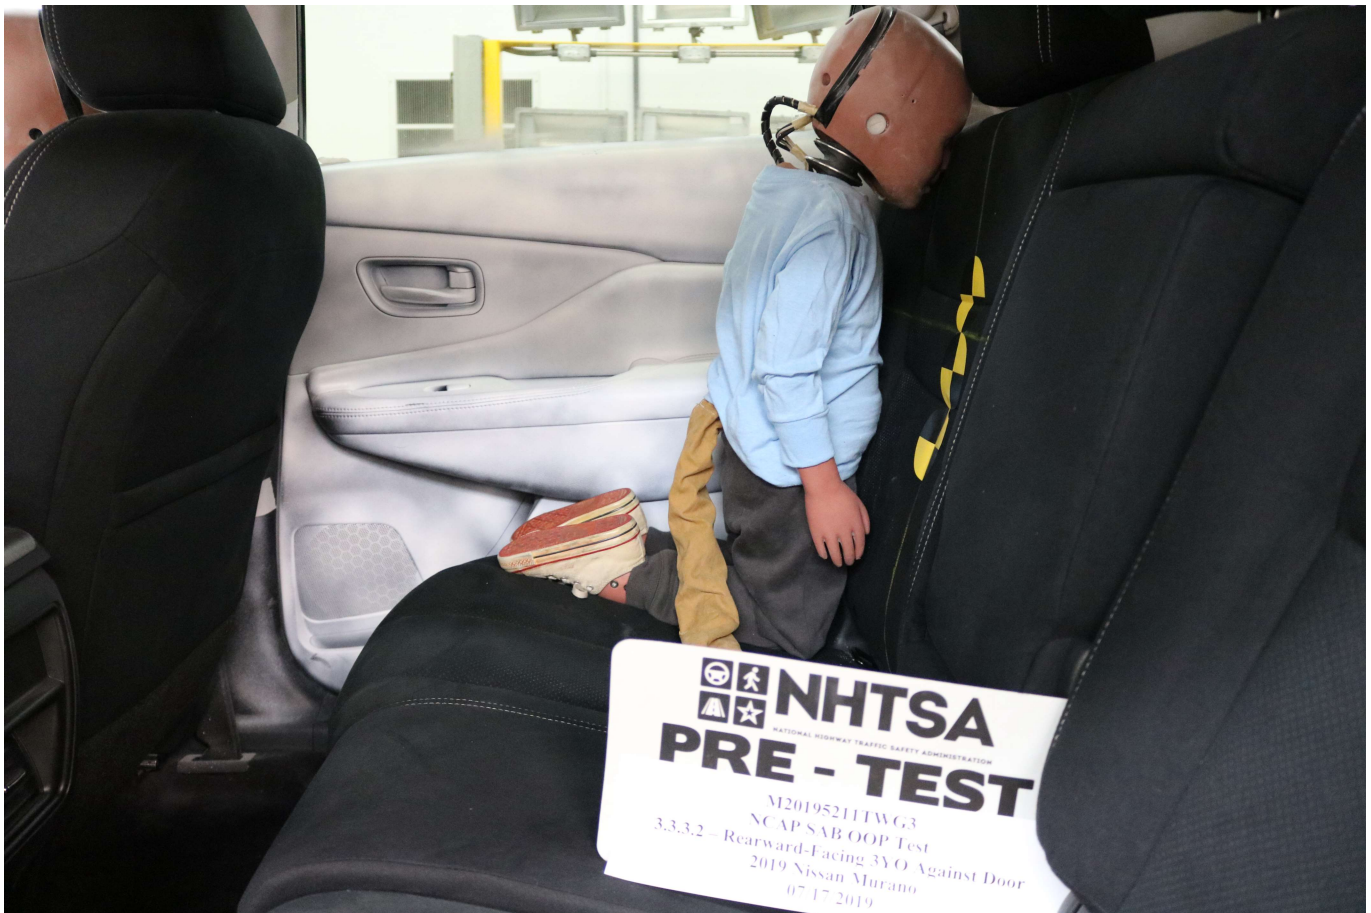
Photo No. 011 - Pre-Test Dummy Left Side Close-up View

The dummy's skullcap seam was covered with 4mm electrical tape to prevent the airbag from getting caught in the seam. The dummy's head skin was cleaned with alcohol and dusted with baby powder to achieve acceptable frictional characteristics.

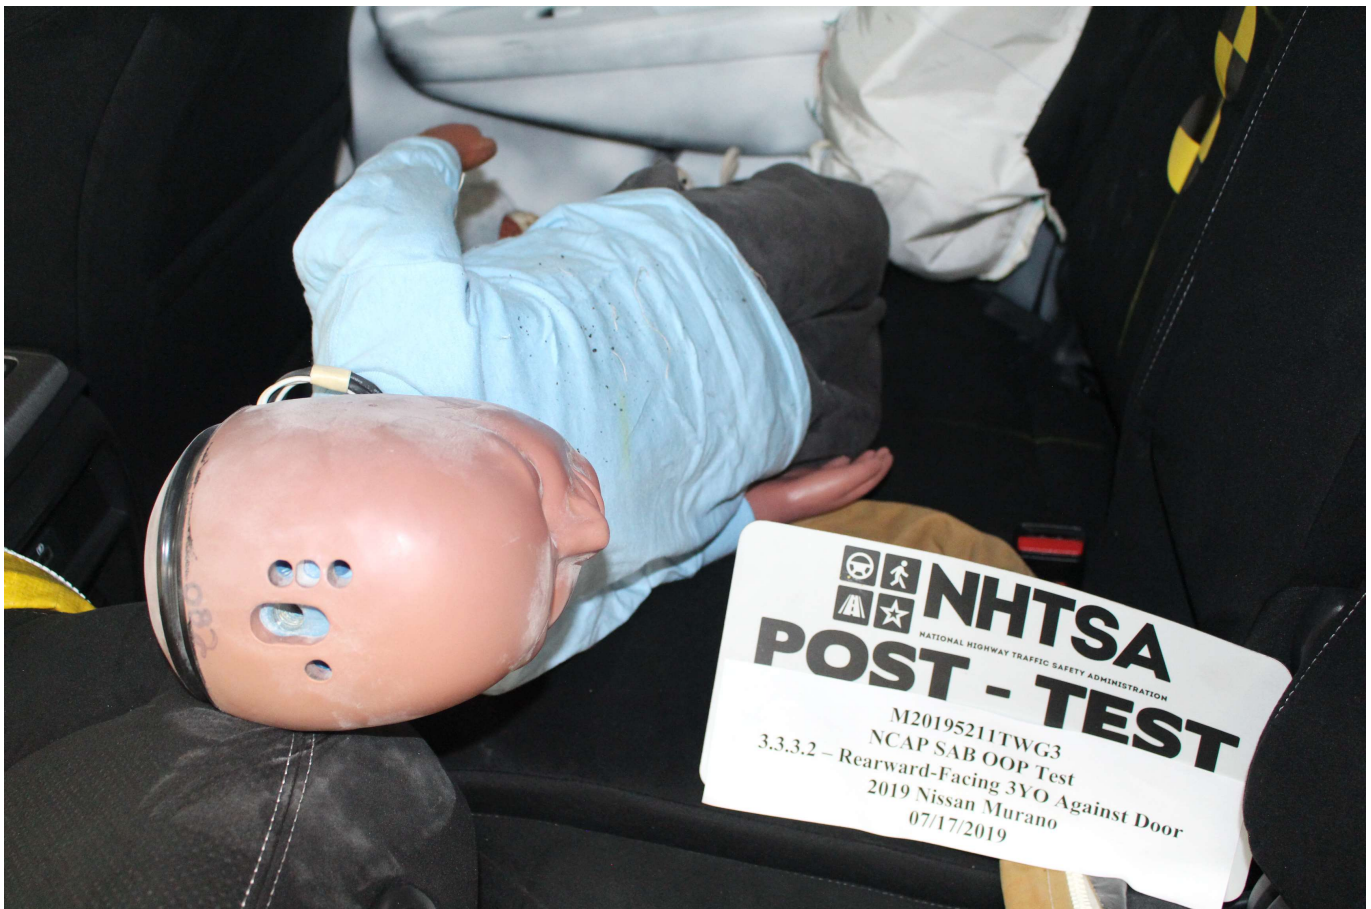
Photo No. 012 - Post-Test Dummy Left Side Close-up View

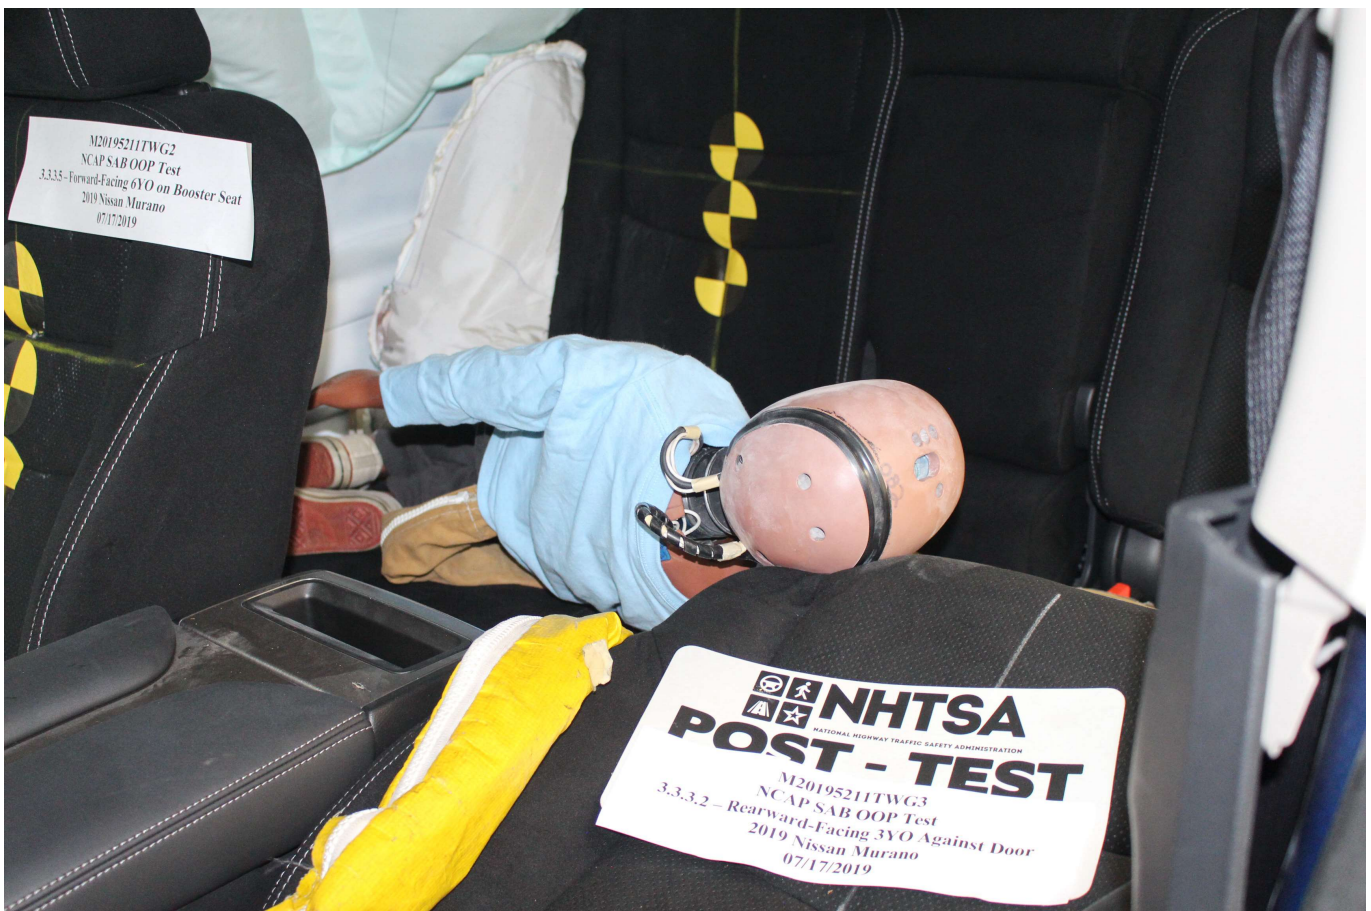
Photo No. 014 - Post-Test Dummy Left Three-Quarter Front View

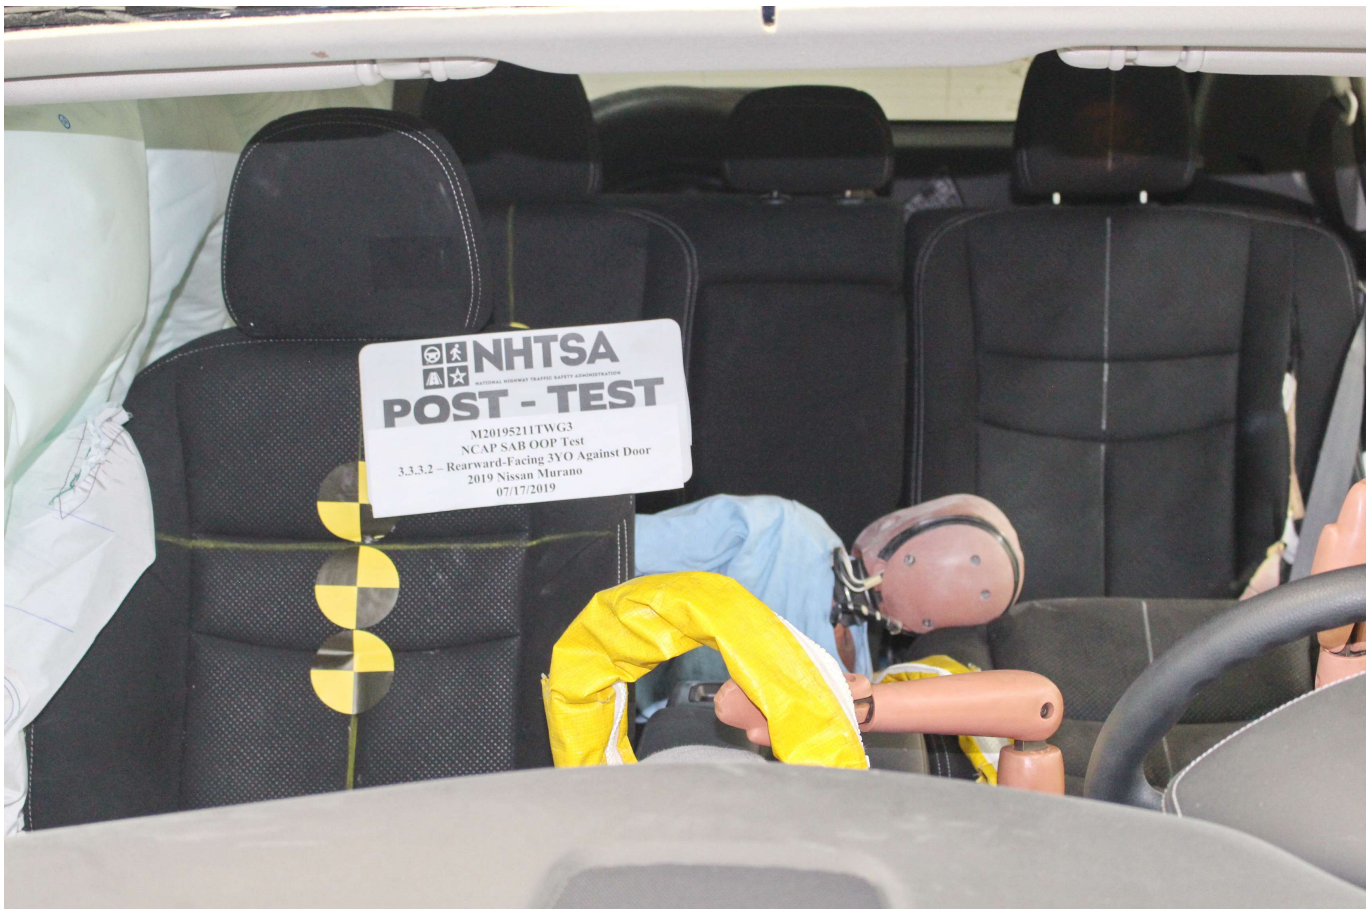
Photo No. 018 - Post-Test Dummy Front View

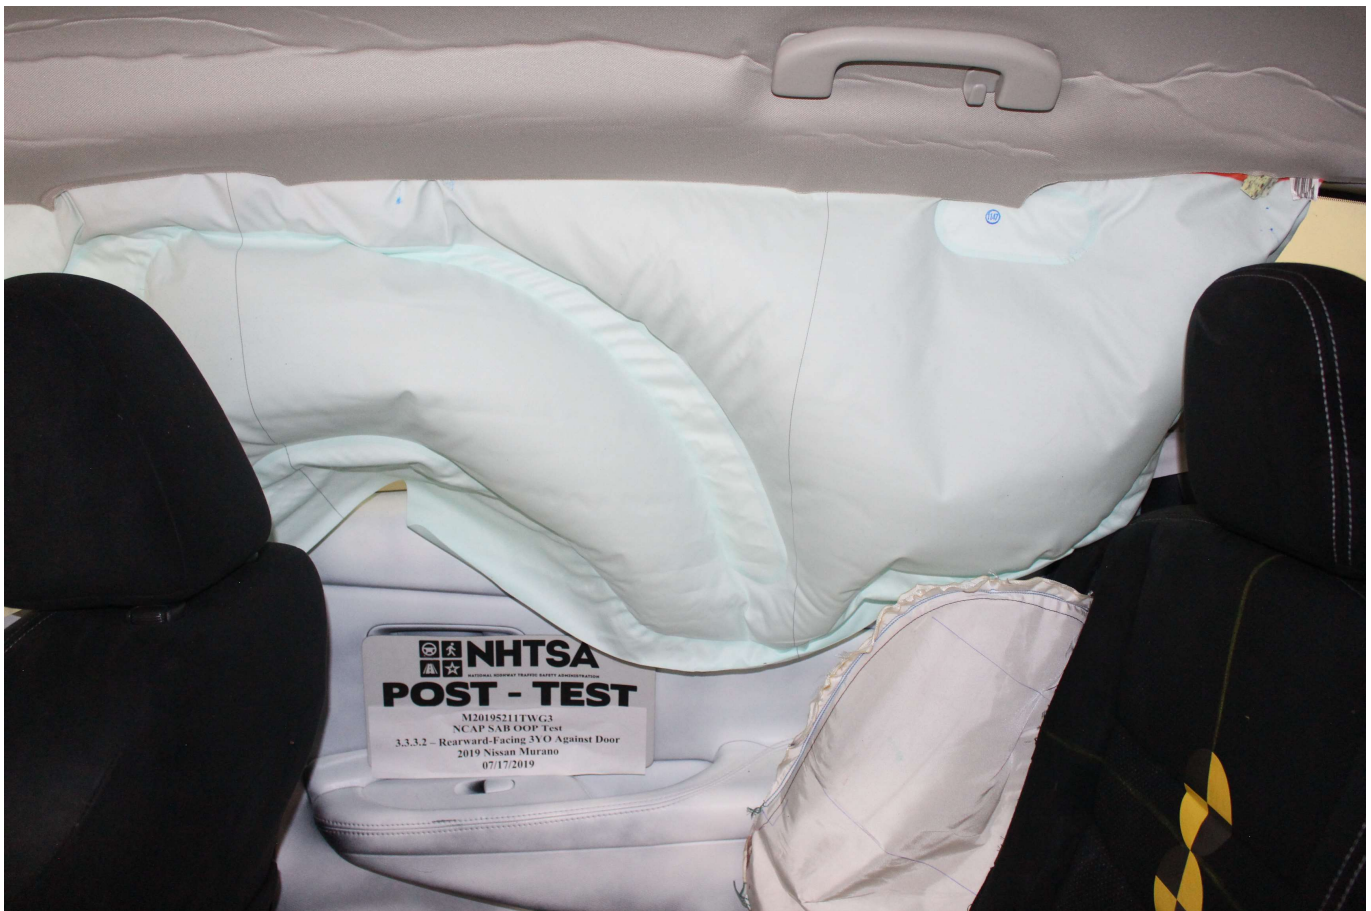
Photo No. 026 - Post-Test Curtain Air Bag Left Side View

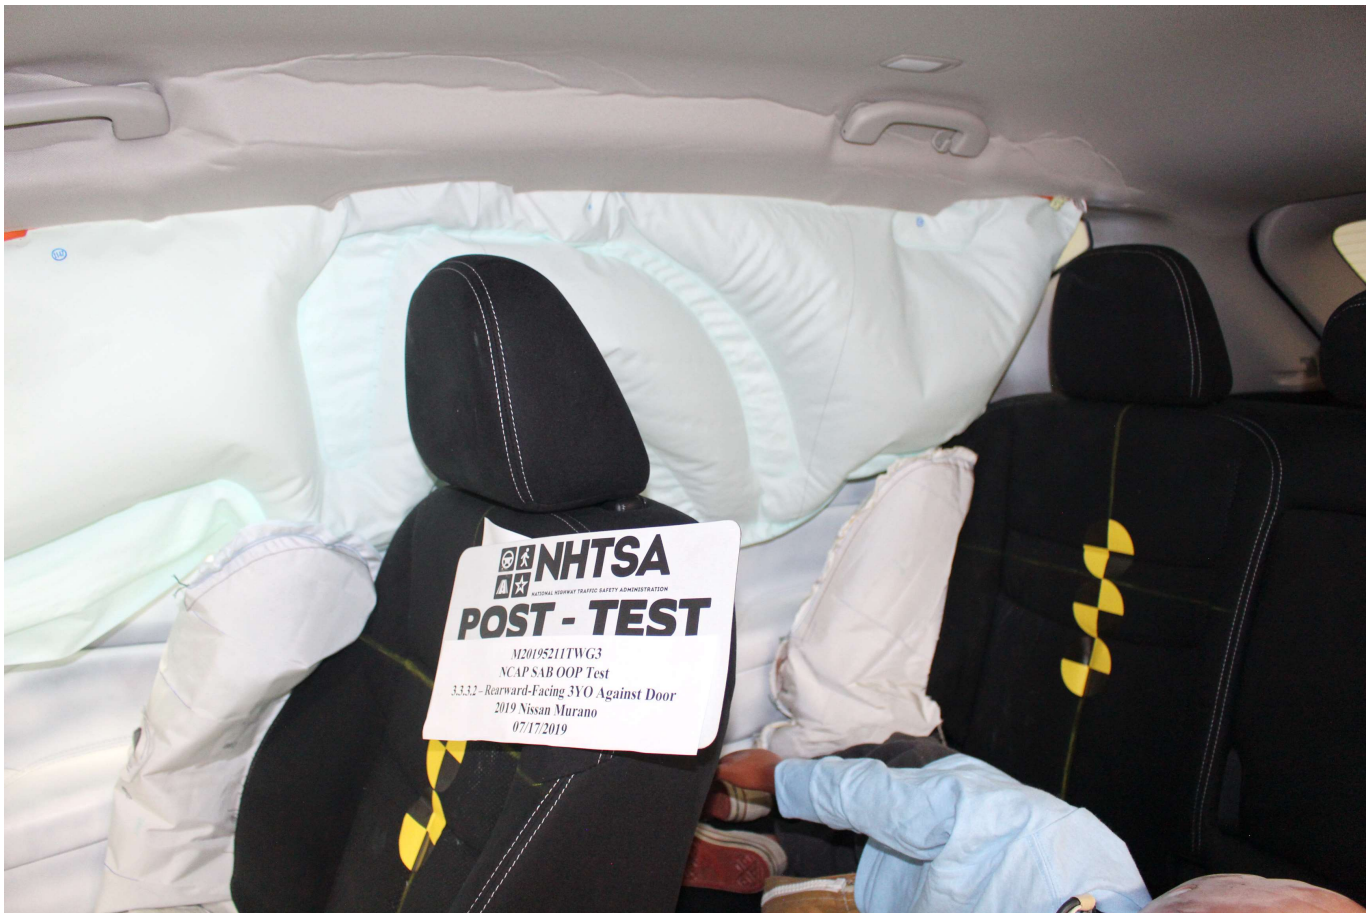
Photo No. 027 - Post-Test Curtain Air Bag Left Three-Quarter Front View

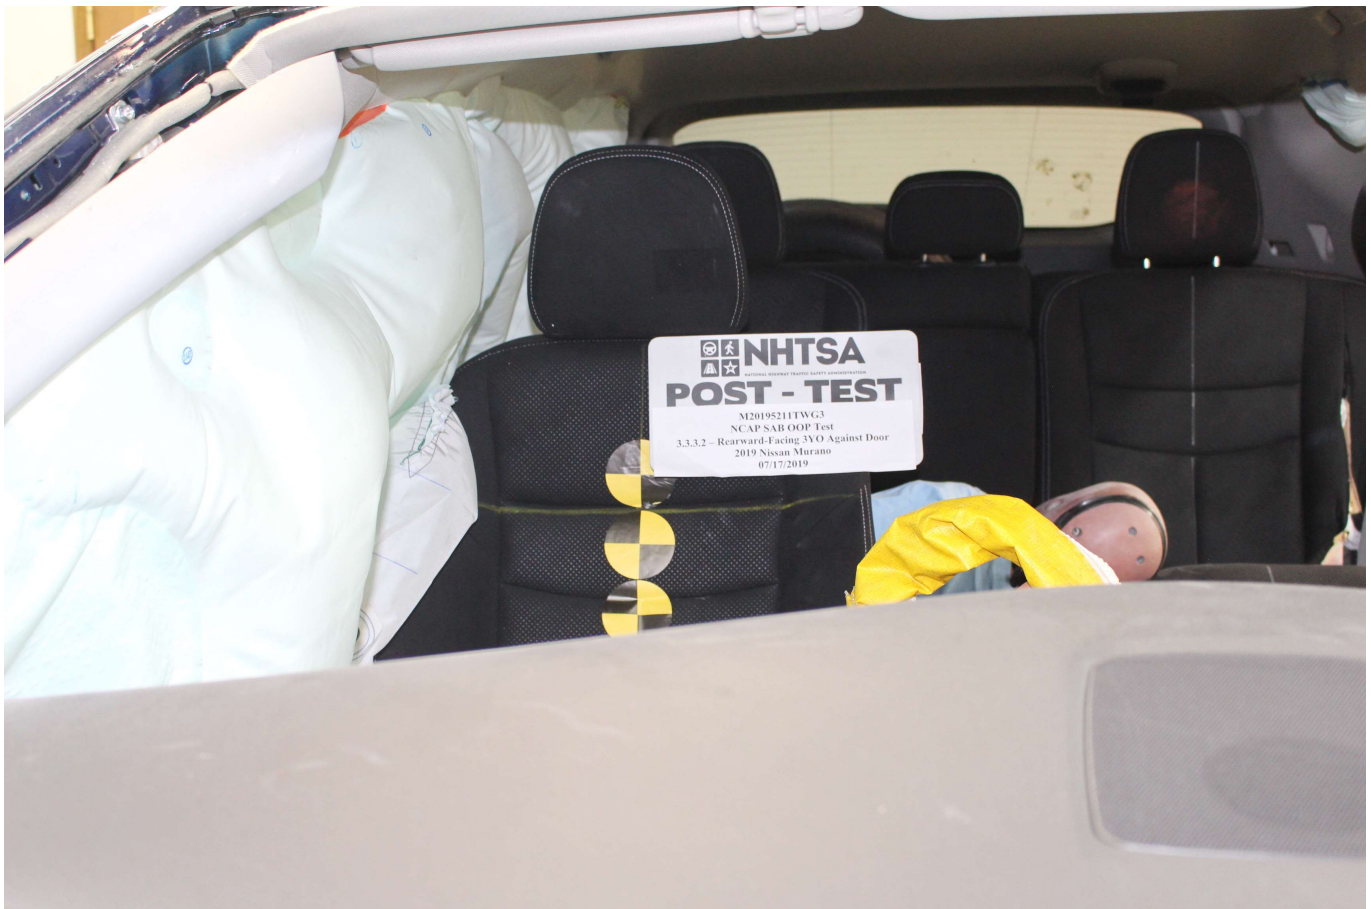
Photo No. 028 - Post-Test Curtain Air Bag Front View

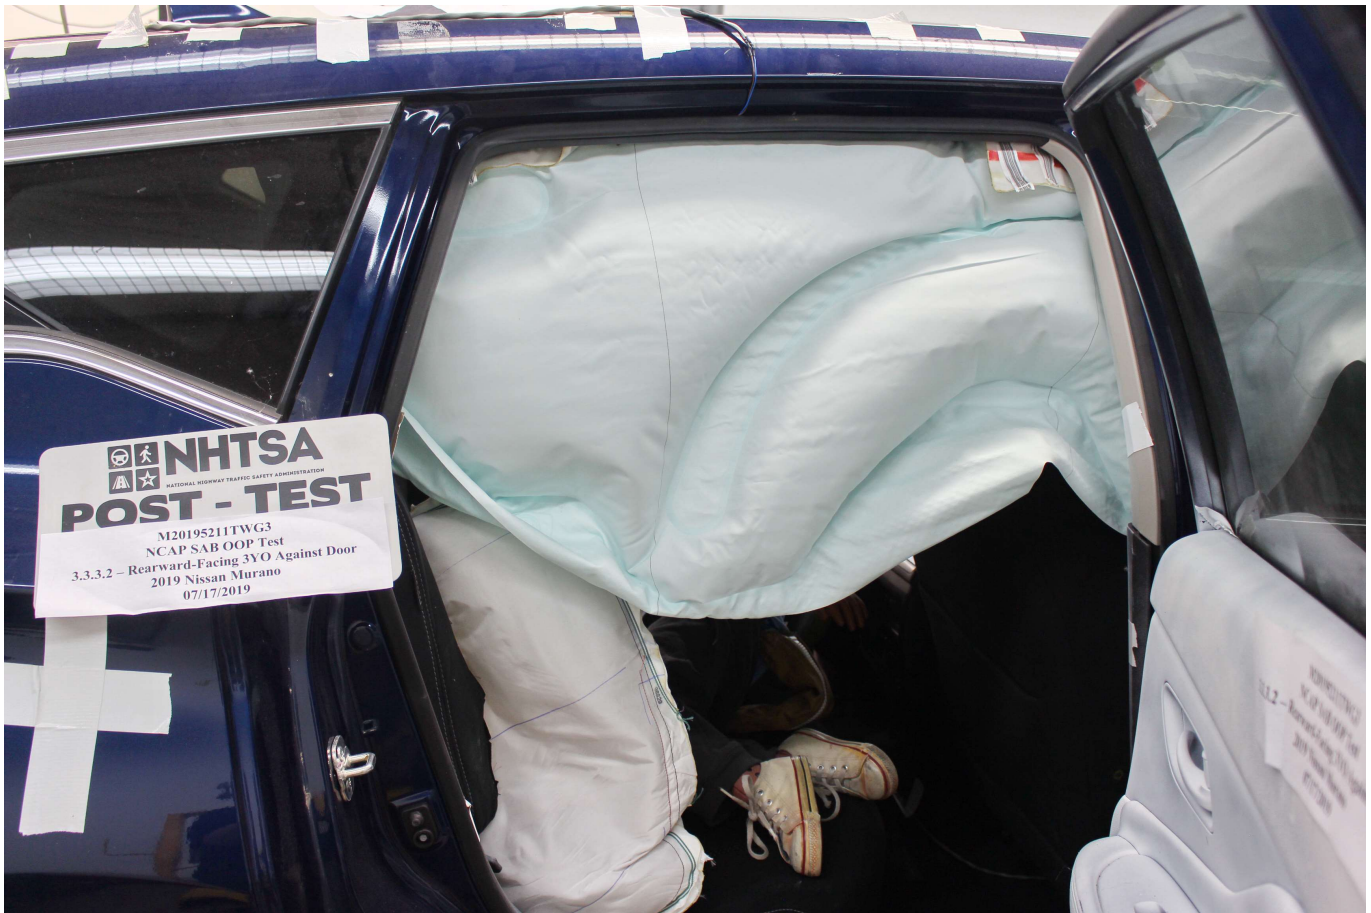
Photo No. 029 - Post-Test Curtain Air Bag Right Side View (Door Open)
