REPORT NUMBER: TWG-TRC-19-02

NEW CAR ASSESSMENT PROGRAM (NCAP)
Side Airbag Out-of-Position Test

NISSAN MOTOR CO., LTD.
2019 Infiniti QX50 SUV

NHTSA NUMBER: M20195215TWG2
TRC TEST NUMBER: 190710-1

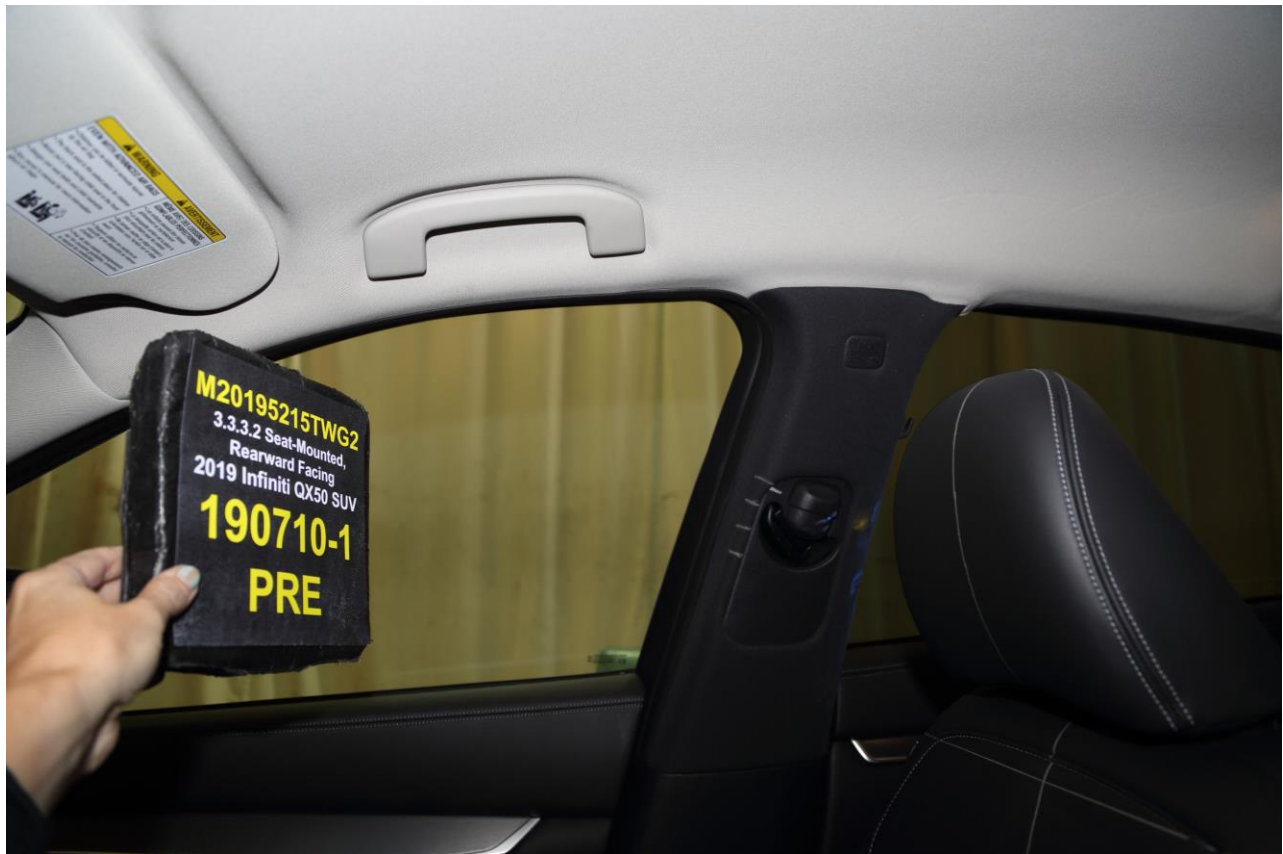
Figure A-5 Pre-Test Vehicle Location of Air Bag 1

Seating Position:	P2	Right Front Seating Position
Test Section:	3.3.3.2	Seat-Mounted, Rearward Facing
Airbag 1:	Seat	Seat mounted – outside seam
Airbag 2:	Side Rail	Side curtain airbag
Booster Block:	N/A	N/A
ATD Type/Serial No.:	Hybrid III 3-Year-Old	040
Vehicle	Infiniti	QX50
Previous Crash Test	MDB	3/21/2019 and M20195215

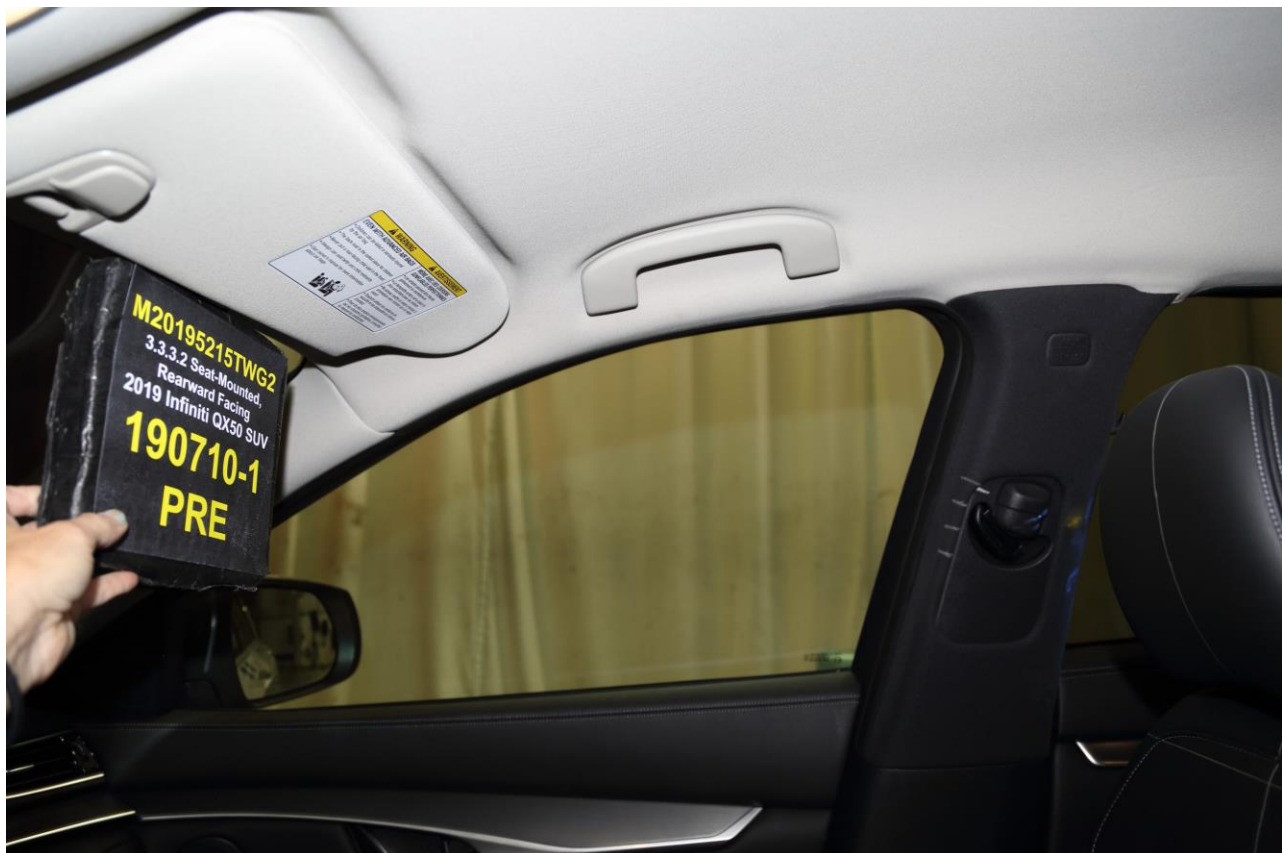
Figure A-6 Pre-Test Vehicle Location of Air Bag 2

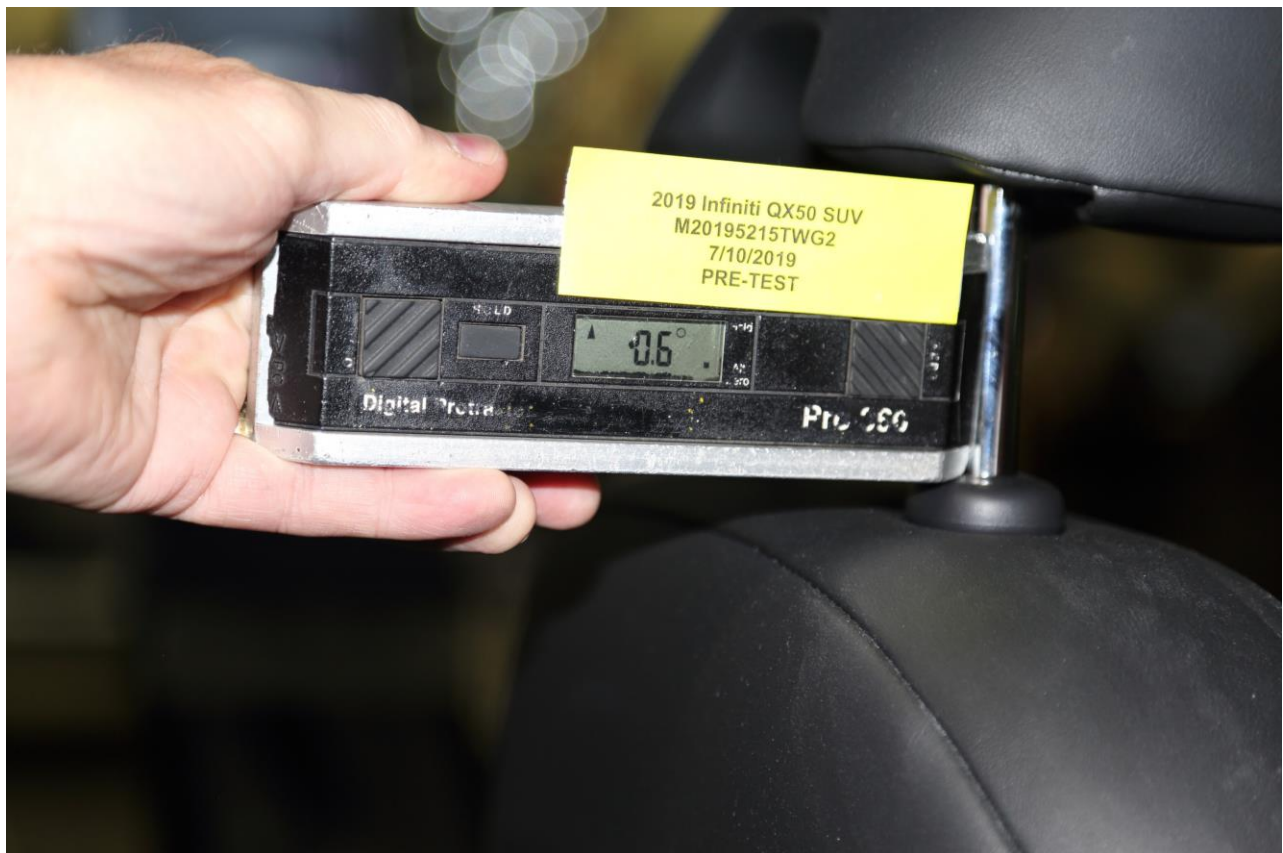
Figure A-8 Pre-Test Vehicle Seat Back Angle

OEM Back Angle Design Position	965 mm as measured from outboard headrest post to rear striker face
Method of Measuring Back Angle Position	As per OEM instruction
Seat Back Angle Position Per TWG Guidelines	Manufacturer design angle
Reason for Deviation from TWG Guidelines	No deviations

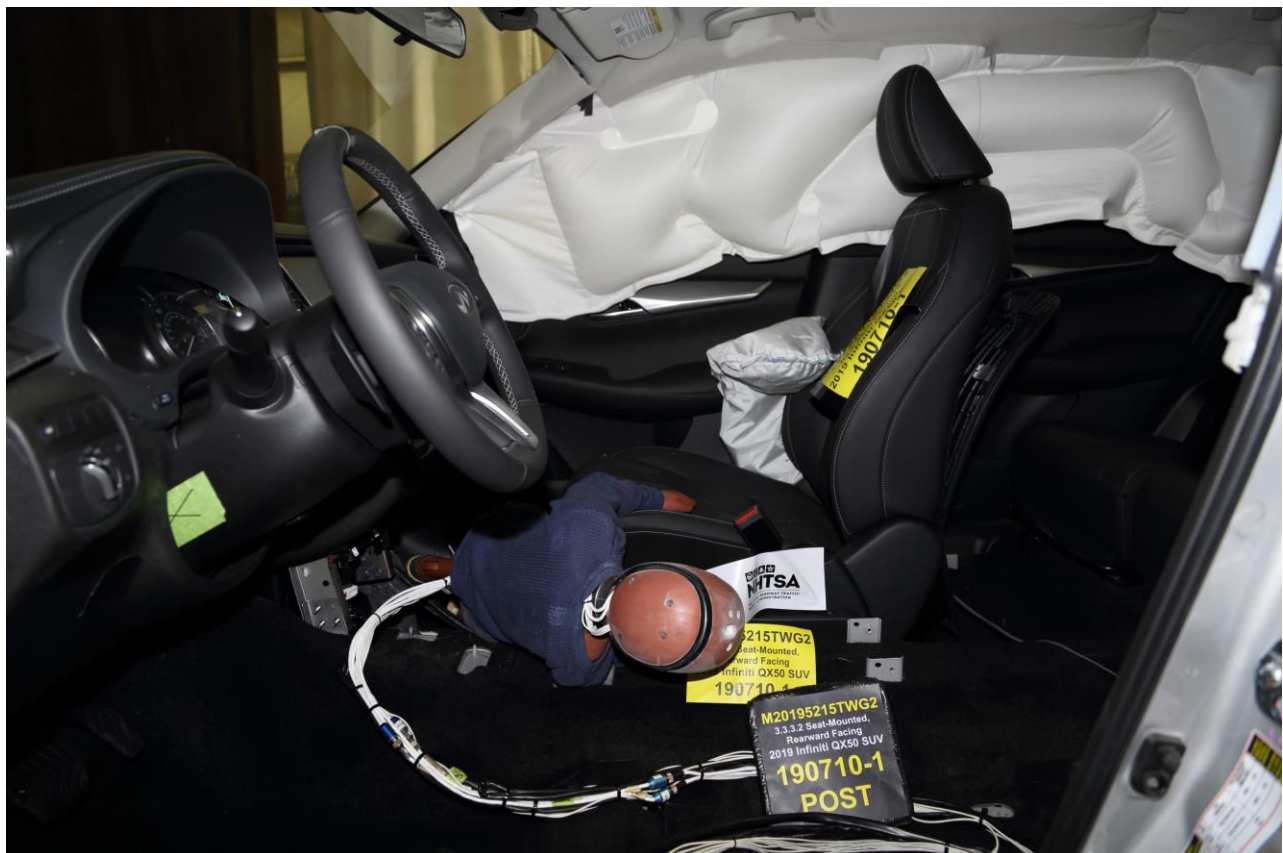
Figure A-10 Post-Test Dummy Left Side View

Head	None Visible
Upper Torso	None Visible
Lower Torso	None Visible
Knee	None Visible

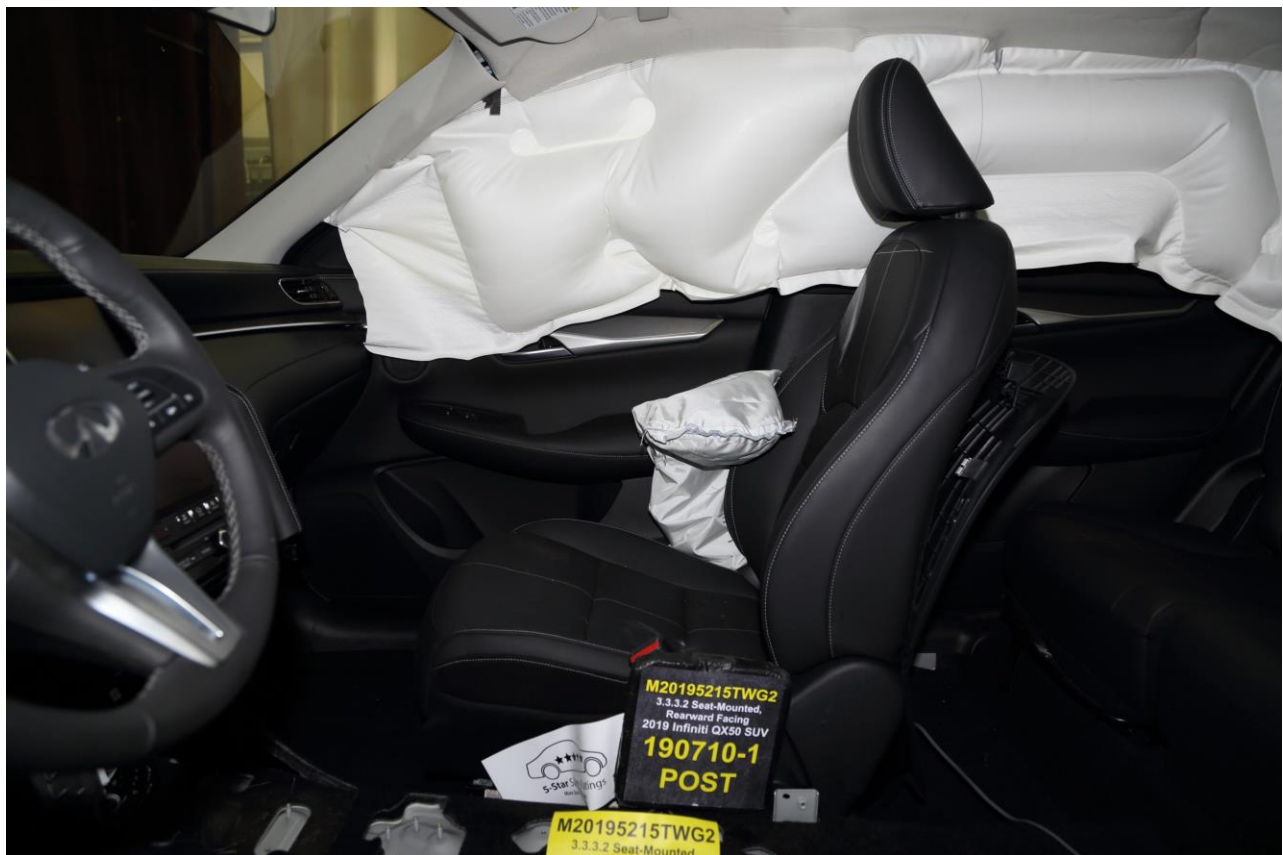
Figure A-26 Post-Test Curtain Air Bag Left Side View
