REPORT NUMBER: TWG-KAR-19-003

**SIDE AIRBAG OCCUPANT RISK PROGRAM
OCCUPANT OUT-OF-POSITION TESTS**

**HYUNDAI MOTOR COMPANY
2019 HYUNDAI KONA SE 5-DOOR MPV**

FINAL REPORT

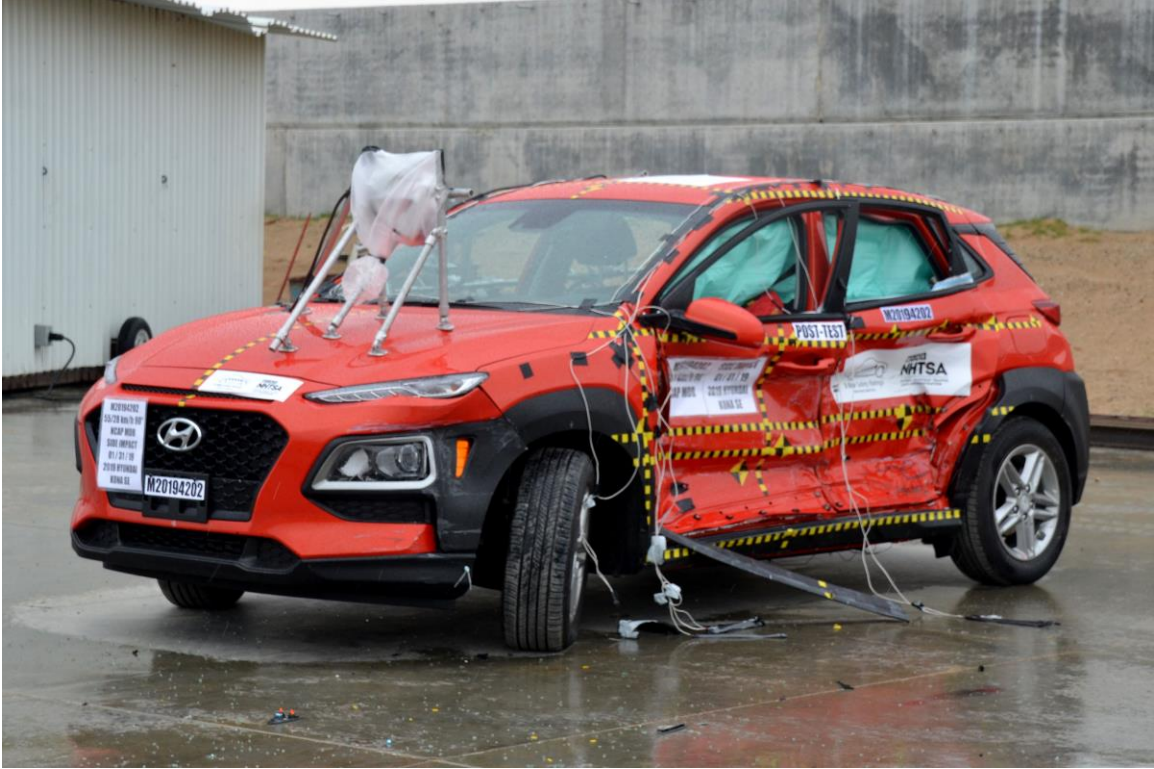
FIGURE 3. Post-Test Left Front 3/4 View of NCAP Side MDB Impact Test

*Vehicle underwent New Car Assessment Program Side MDB Impact Testing on January 31, 2019.

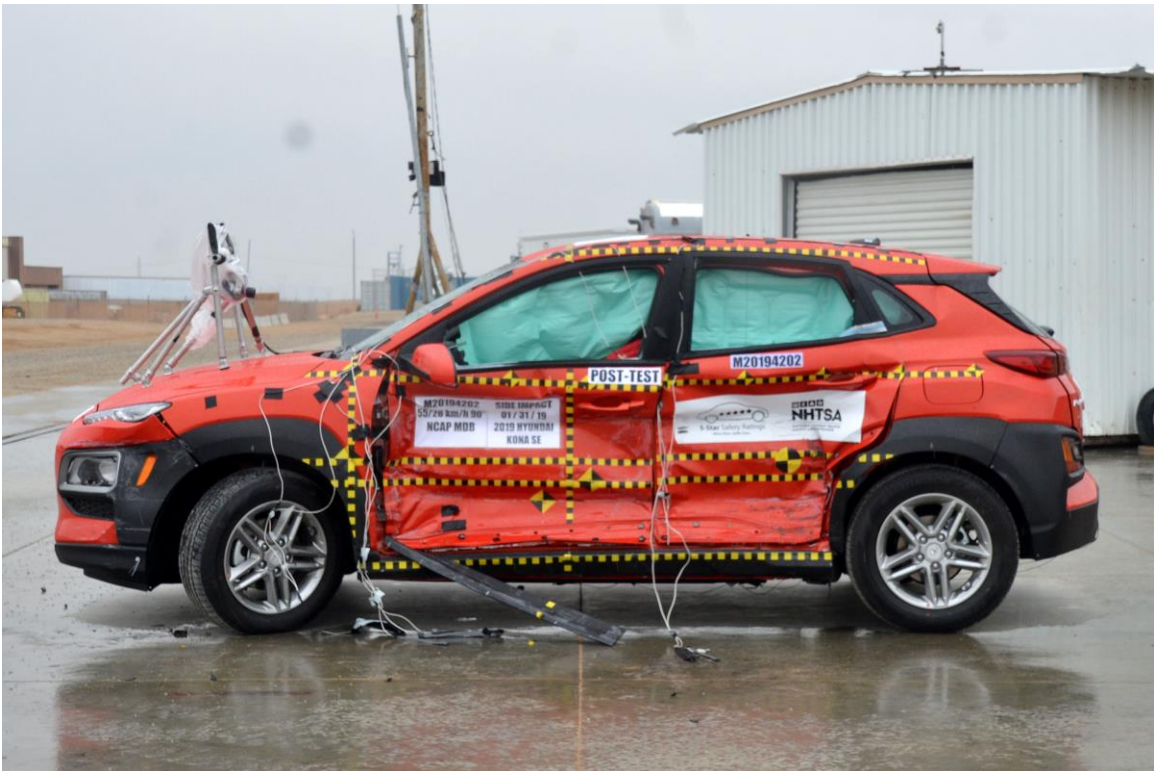
FIGURE 4. Post-Test Left Side View of NCAP Side MDB Impact Test

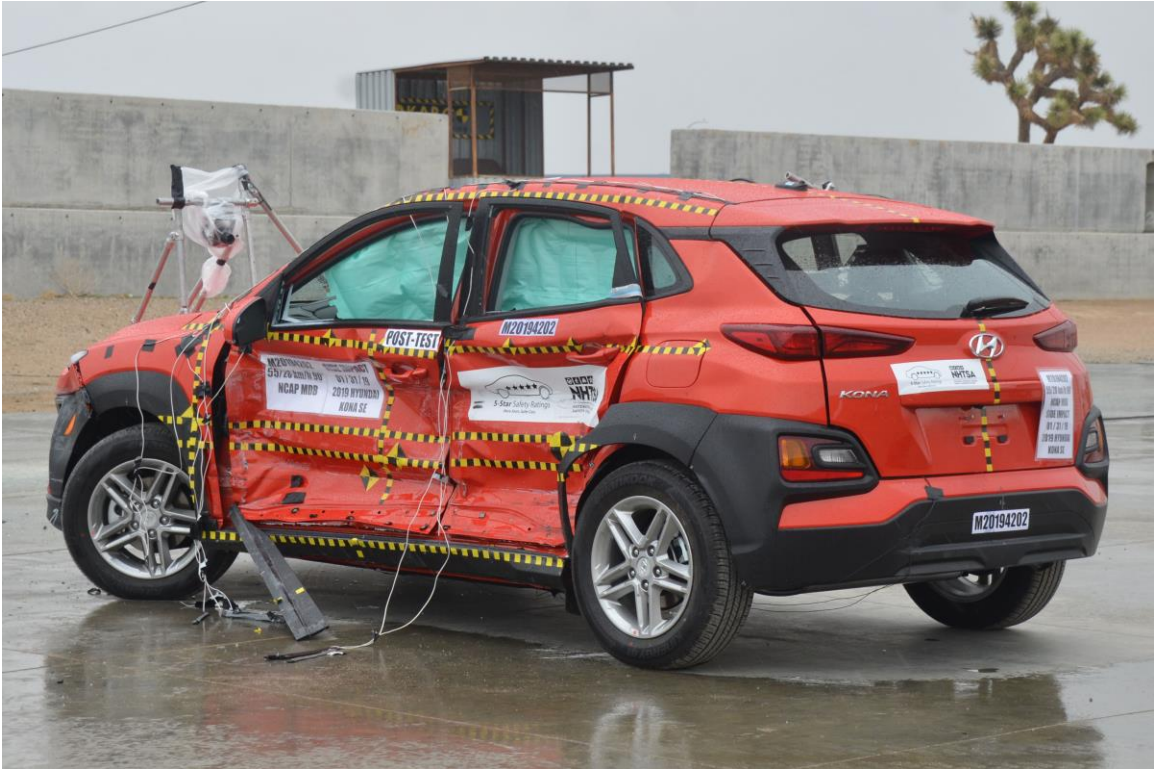
FIGURE 5. Post-Test Left Rear $\frac{3}{4}$ View of NCAP Side MDB Impact Test

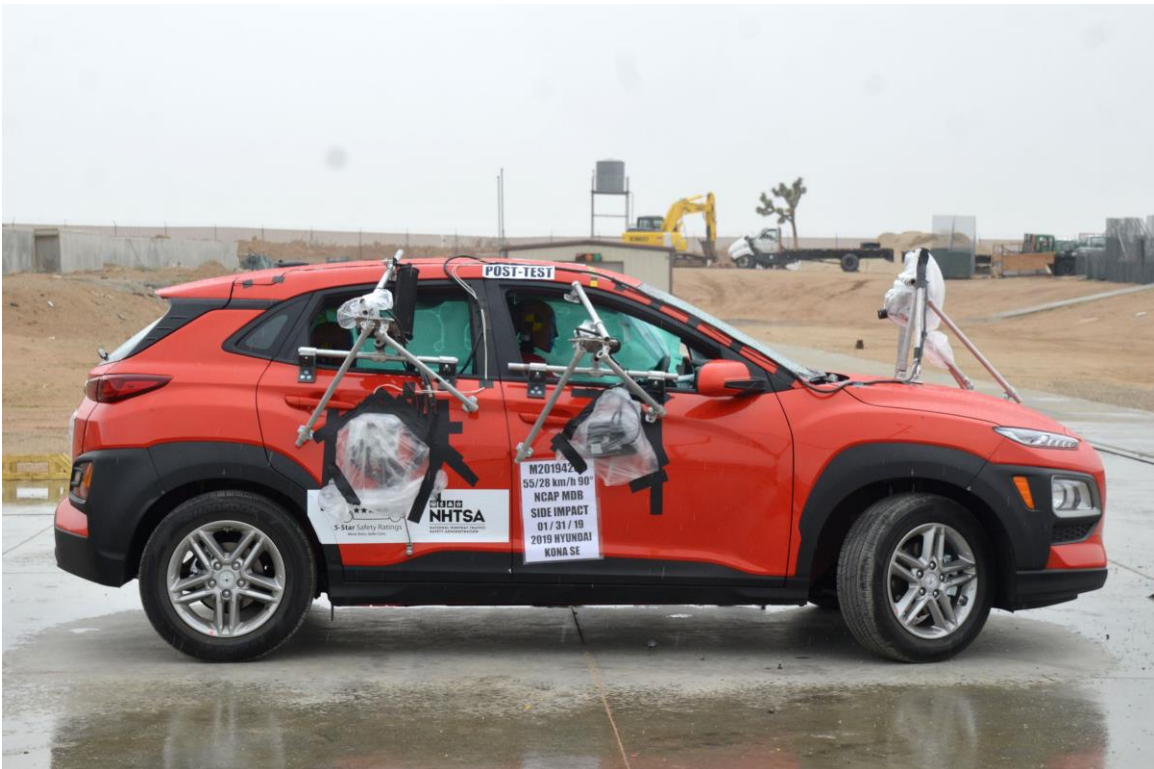
FIGURE 6. Post-Test Right Side View of NCAP Side MDB Impact Test

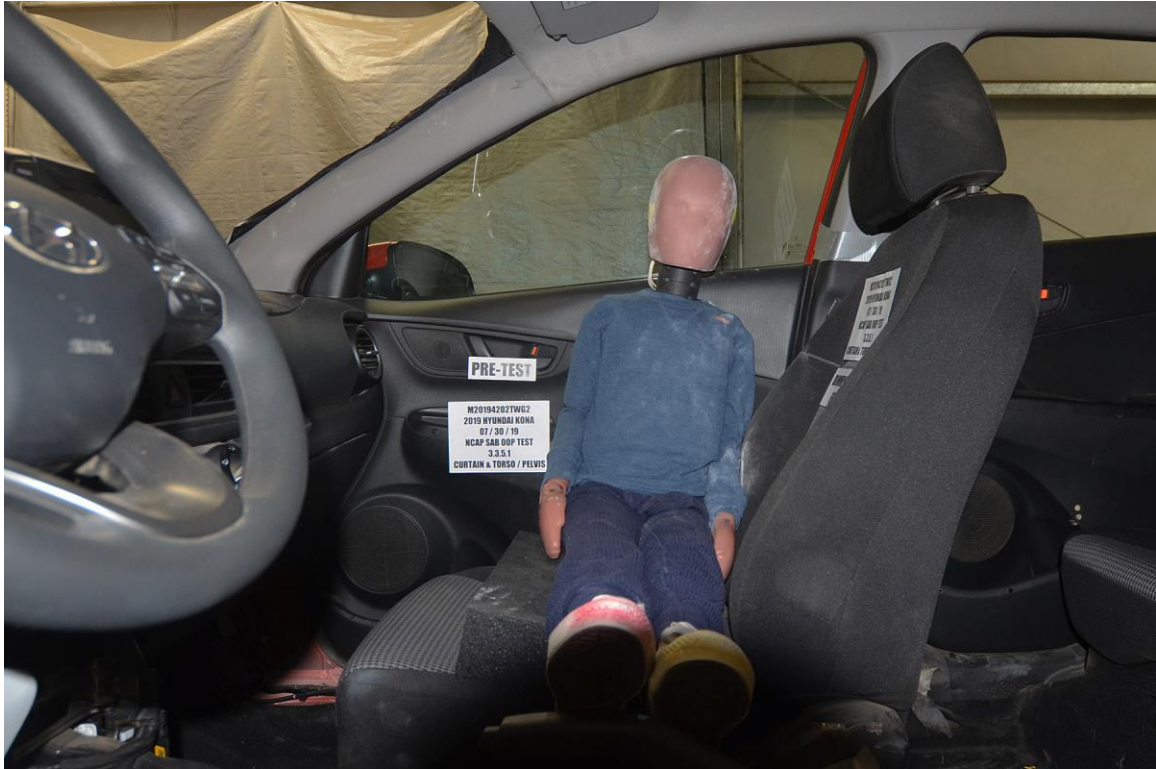
FIGURE 7. Pre-Test Dummy Position, Left View

Orientation of the 6-year old dummy was with the dummy facing inboard. The seat is set 20 mm from the full forward position. The seat was not tested in the rearmost position in order to maximize the interaction and contact between the dummy and airbag. The dummy was placed with its arms hanging at its sides on the foam block facing inboard with its legs extended. The dummy's pelvis is slid outboard until contact is made with the door panel while keeping the head in a neutral orientation. The center of gravity of the head is centered in the deployment trajectory of the airbag. The dummy's arms are bent at the elbow until the fingers just touch the booster seat. This orientation complies with section 3.3.5.1 of the Technical Working Group (TWG) recommendation in the Recommended procedures for Evaluating Occupant Injury Risk from Deploying Side Airbags.

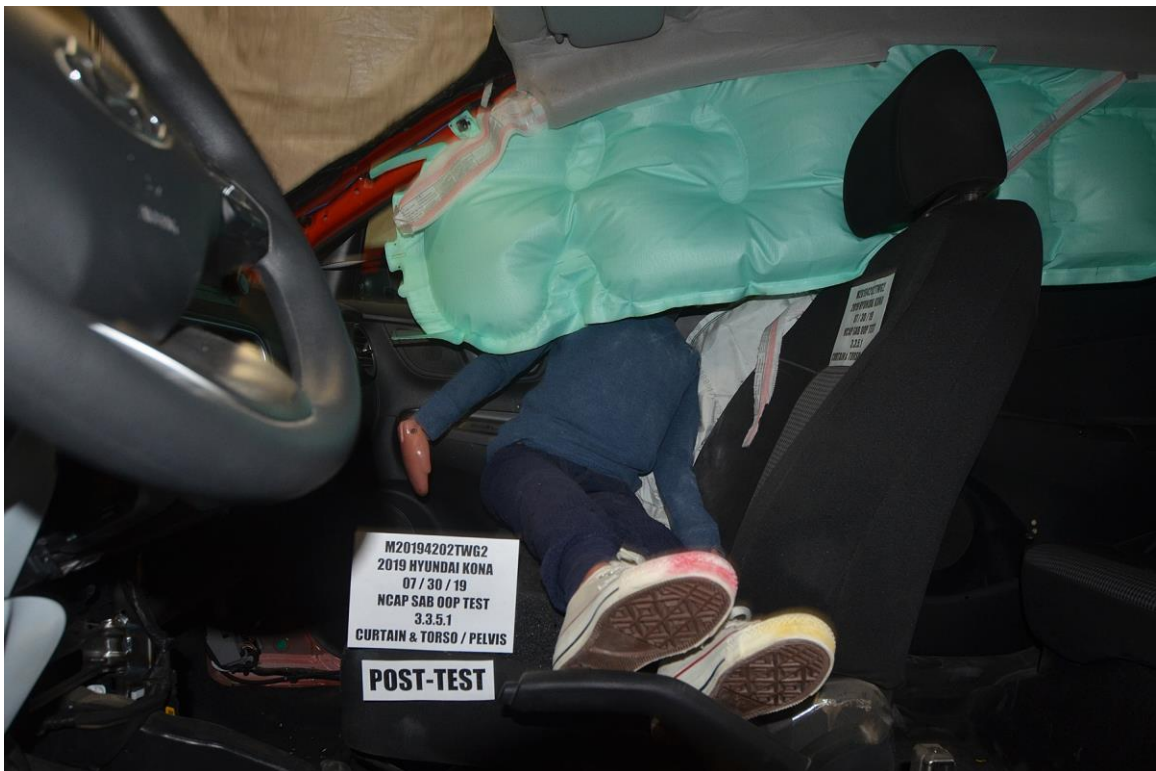
FIGURE 8. Post-Test Dummy Position, Left View

The 6-year old dummy's visible contact points were as follows: The ATD's head contacted the curtain airbag. The ATD's torso contacted the torso/pelvis and curtain airbag.

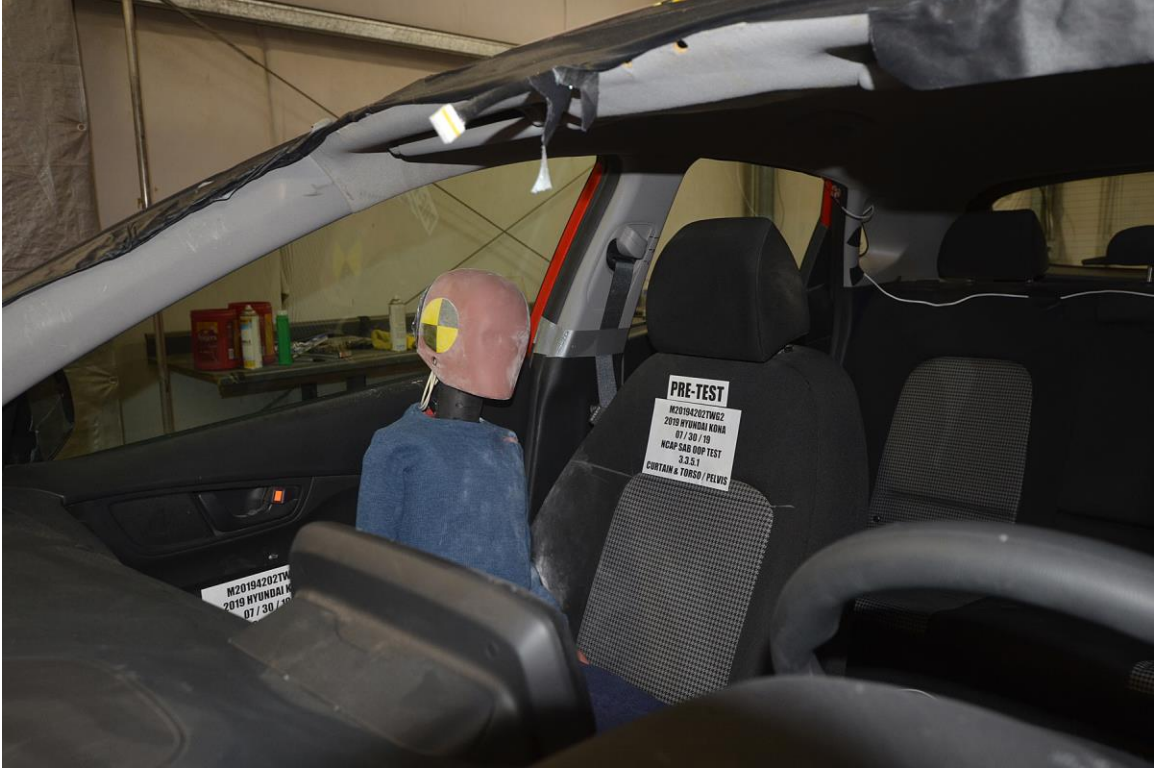
FIGURE 9. Pre-Test Dummy Position, $\frac{3}{4}$ View

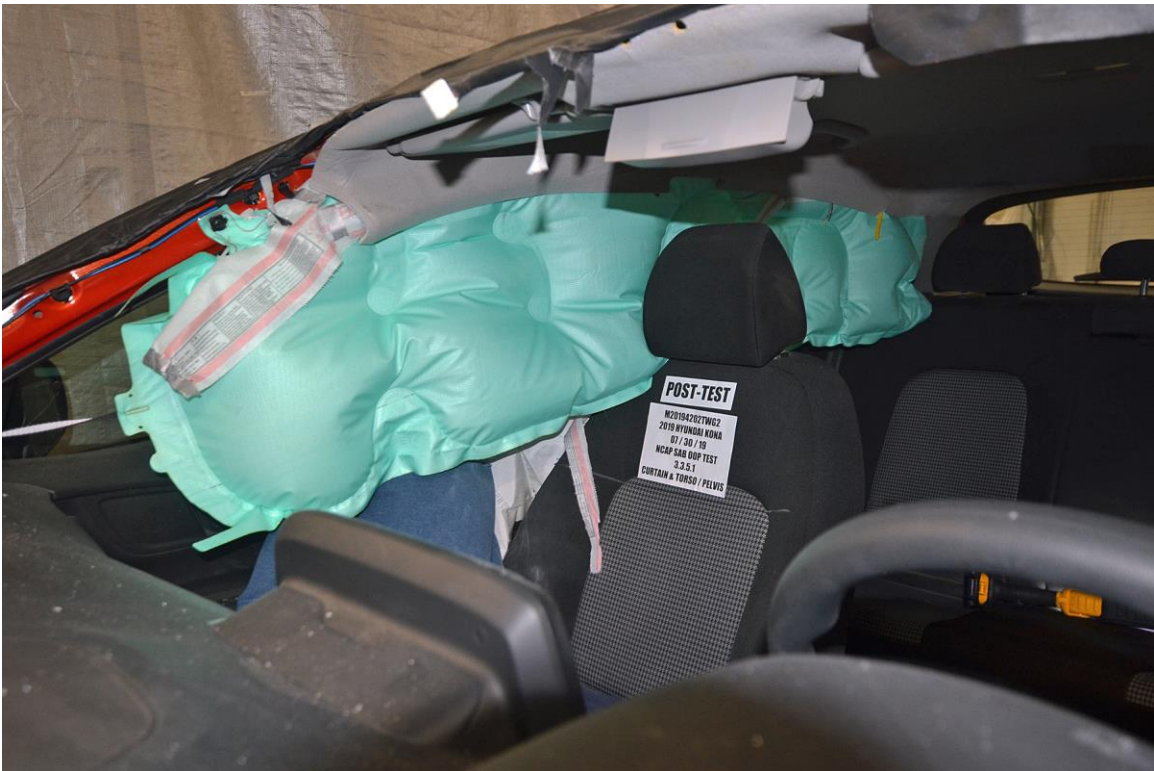
FIGURE 10. Post-Test Dummy Position, $\frac{3}{4}$ View

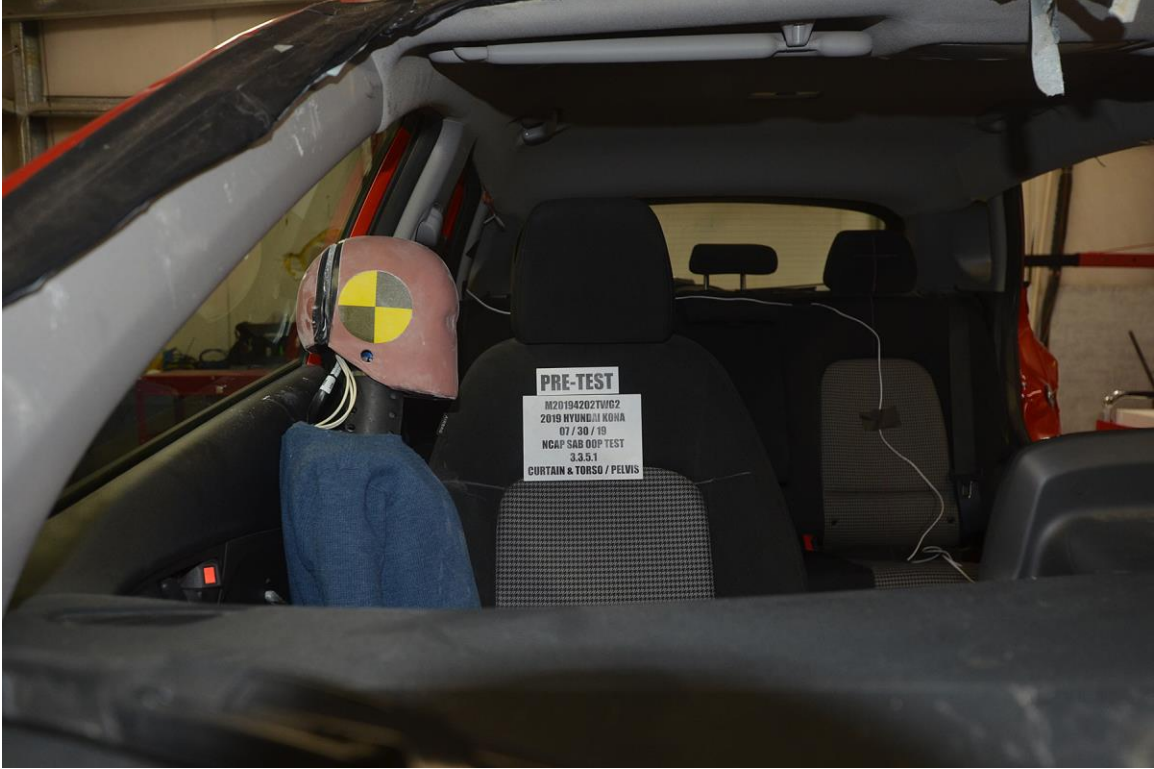
FIGURE 11. Pre-Test Dummy Position, Front View

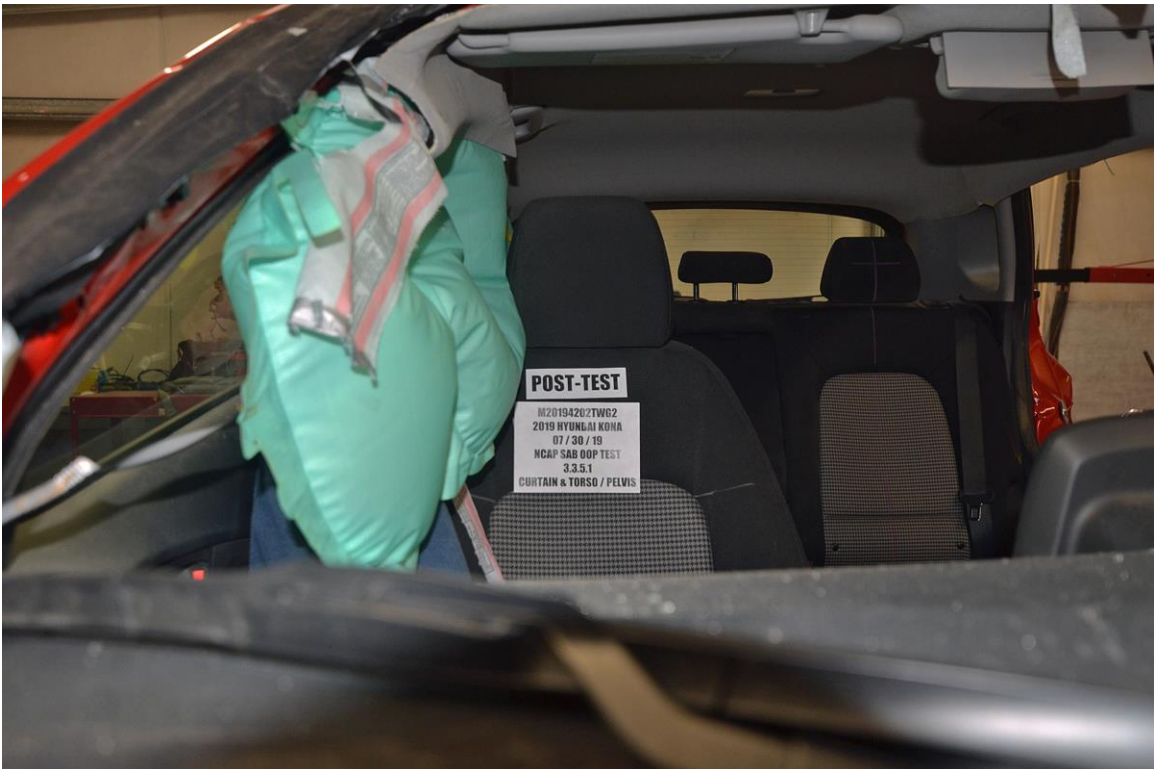
FIGURE 12. Post-Test Dummy Position, Front View

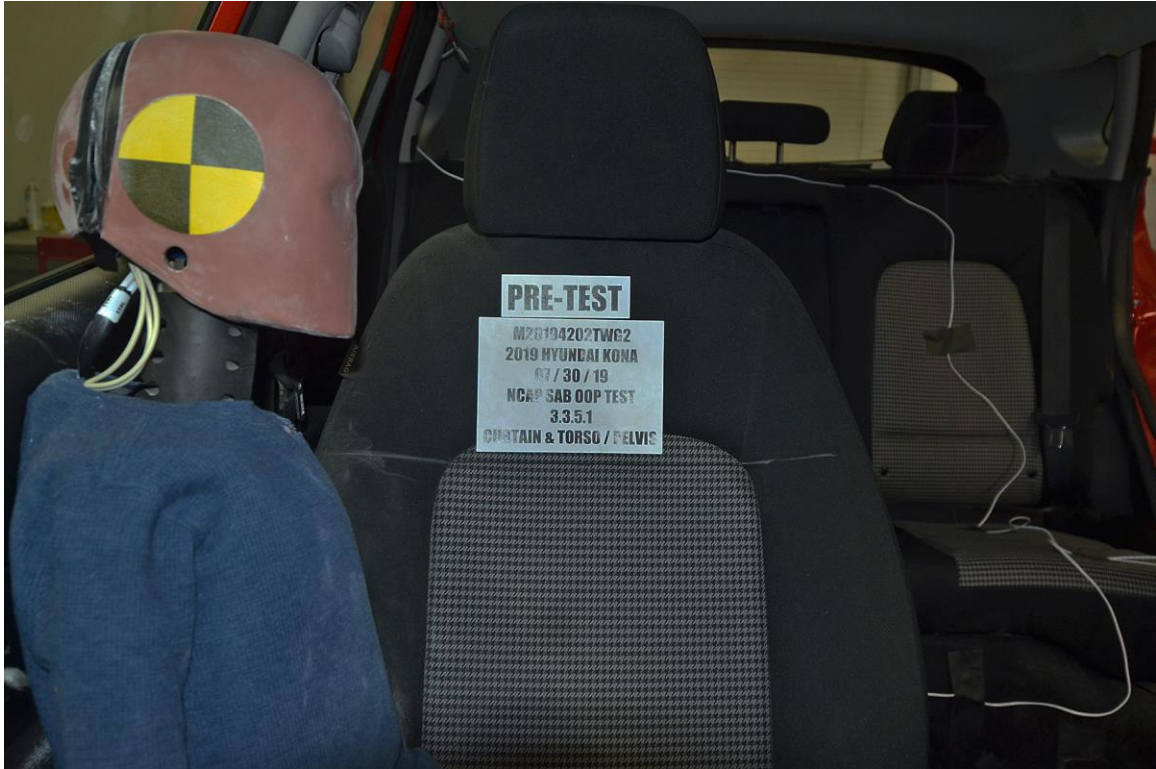
FIGURE 13. Pre-Test Dummy Position, Close-Up Front View

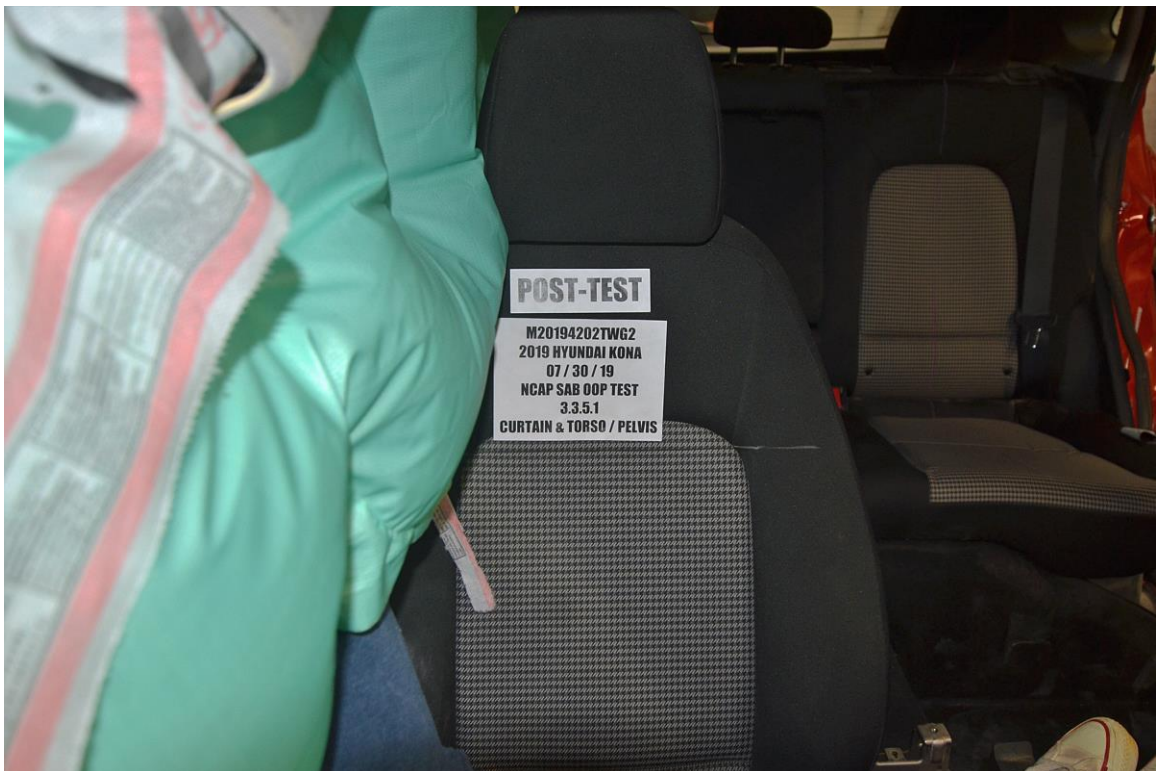
FIGURE 14. Post-Test Dummy Position, Close-Up Front View

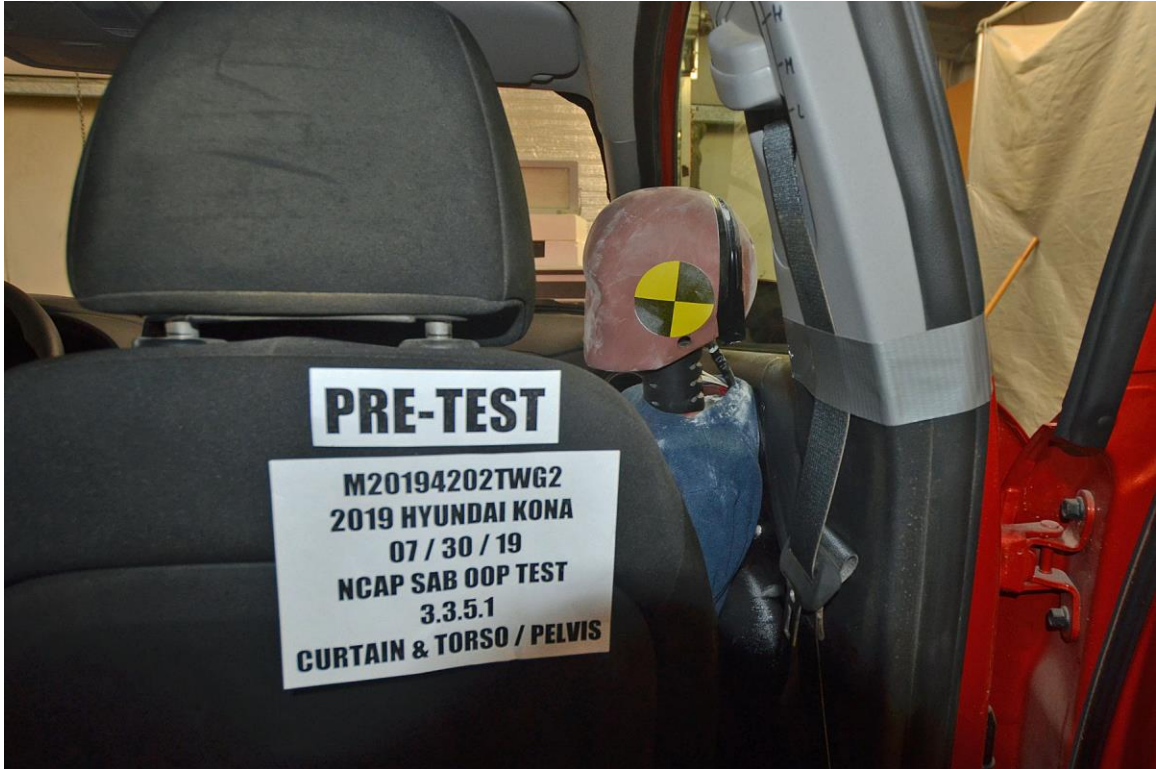
FIGURE 15. Pre-Test Dummy Position, Close-Up Rear View

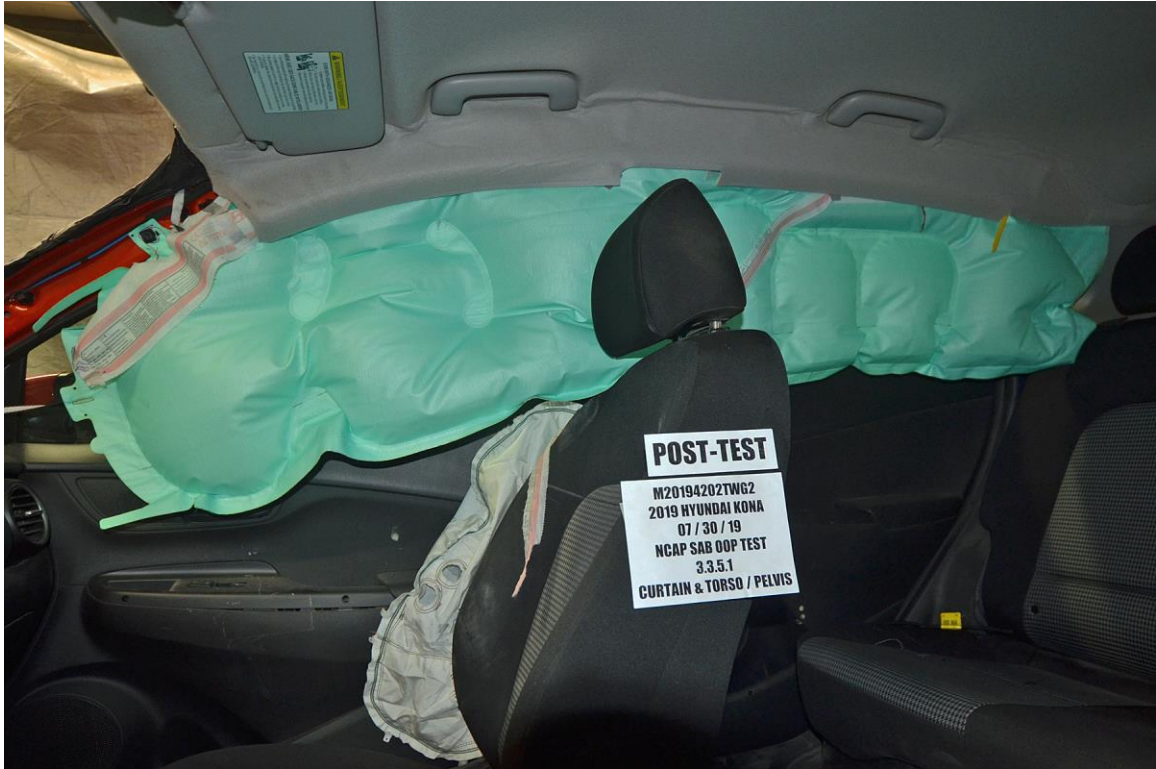
FIGURE 17. Post-Test Airbags, Left Side View

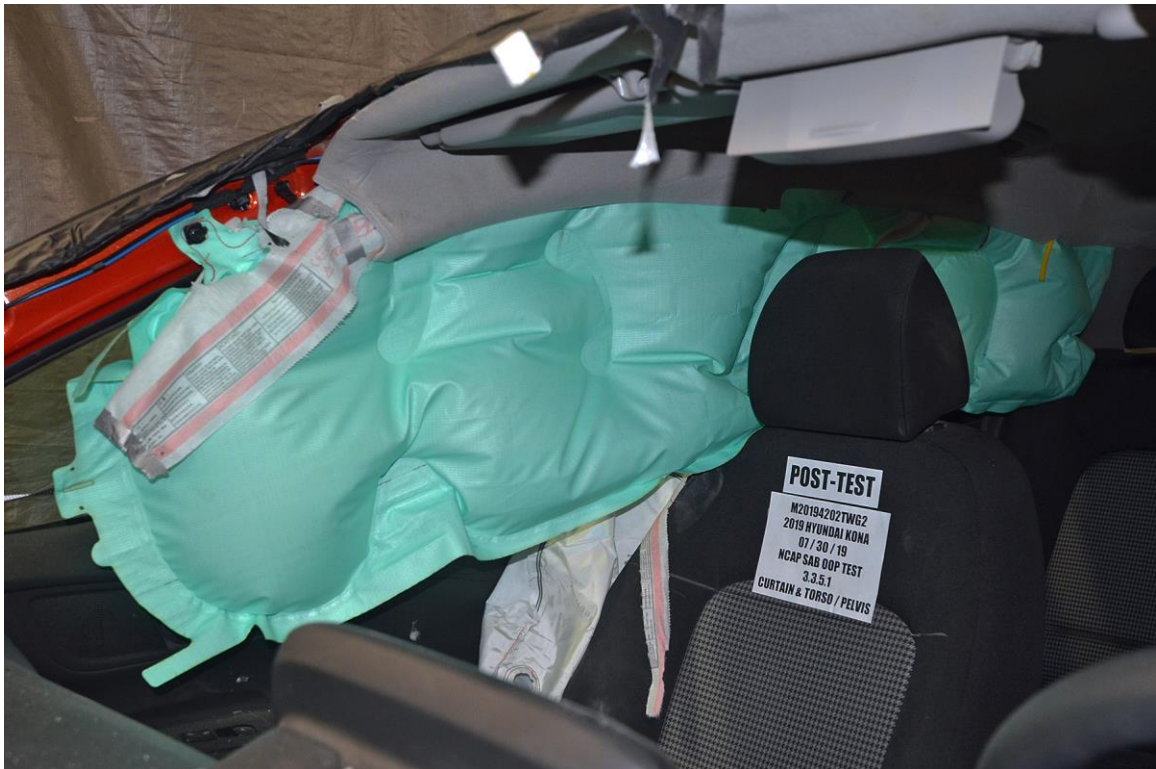
FIGURE 18. Post-Test Airbags, Left Front $\frac{3}{4}$ View
