REPORT NUMBER: SPNCAP-CAL-20-013

**NEW CAR ASSESSMENT PROGRAM (NCAP)
SIDE IMPACT POLE TEST**

**Toyota Motor Manufacturing, Indiana Inc.
2020 Toyota Highlander L
SUV**

NHTSA No: M20205101

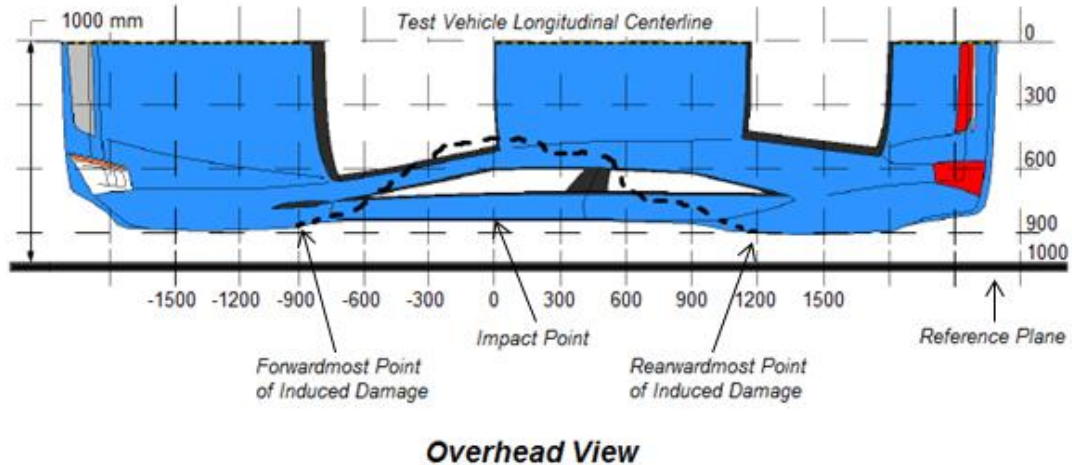
**DATA SHEET NO. 11
VEHICLE DAMAGE PROFILE DISTANCES**

For guidance regarding damage profile distance measurements, please refer to the latest version of the *NHTSA Test Reference Guide, Volume 1: Vehicle Tests*.

DPD	Distance From Impact Point (mm)	Level	Post-Test (mm)	Pre-Test (mm)	Crush (mm)
1	-750	3	32	37	-5
2	-300	3	226	45	181
3	150	3	387	43	344
4	600	3	107	51	56
5	1050	3	89	64	25
6	1500	3	4	34	-30

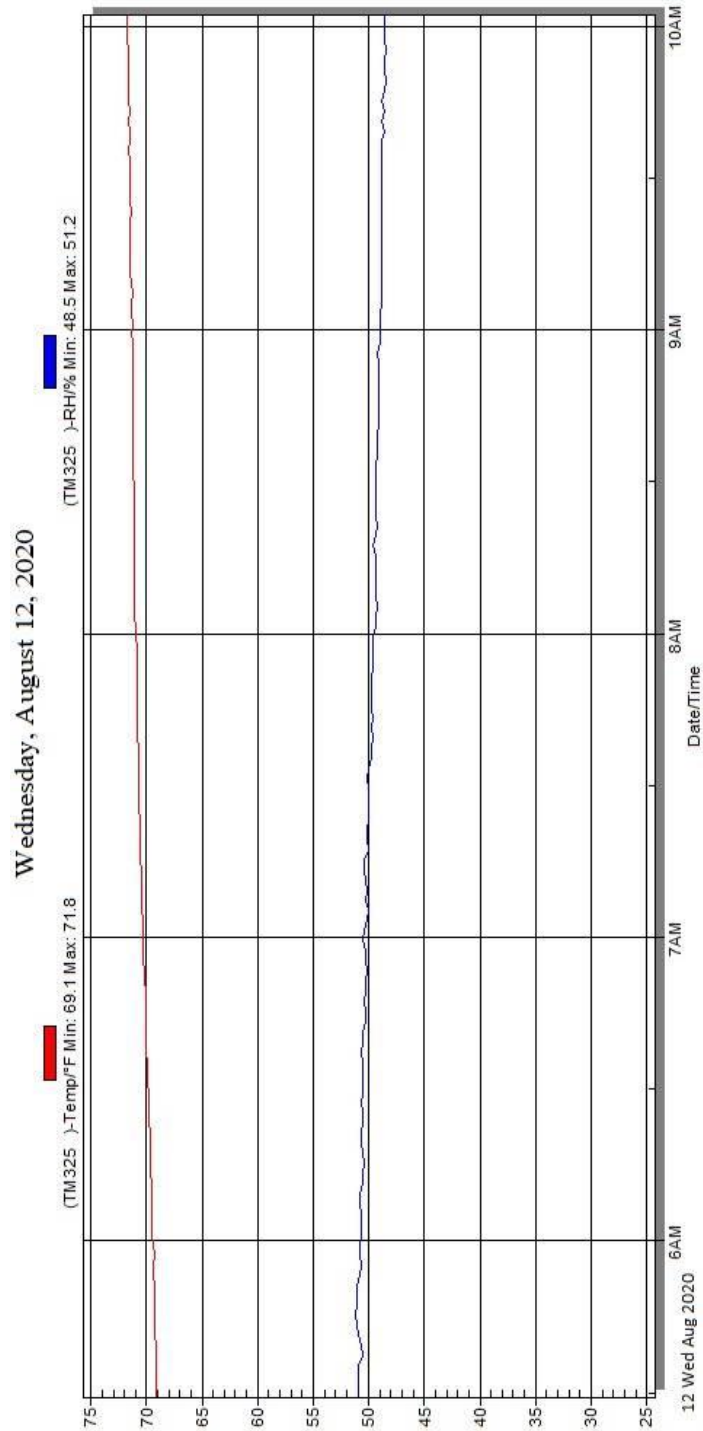
Temperature and Humidity Stabilization Chart / Data for Dummies and Test Vehicle

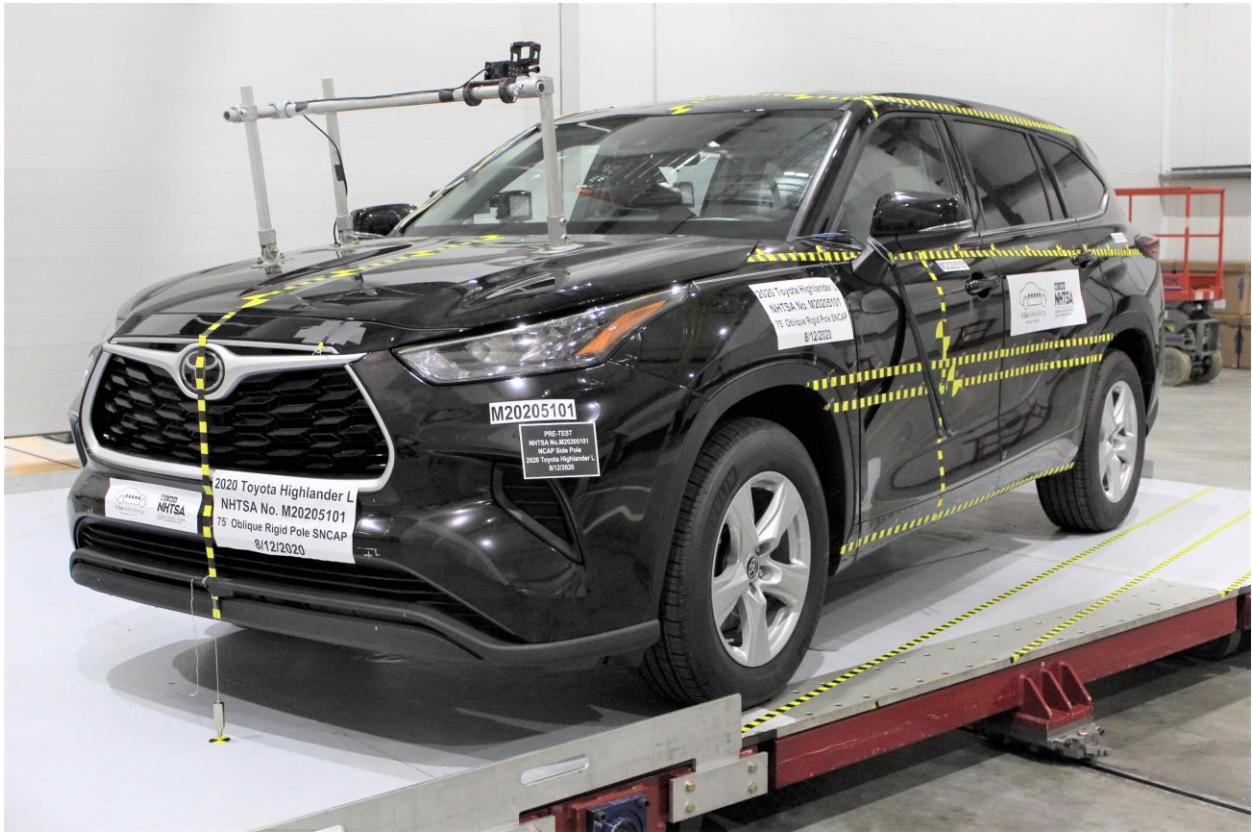
Figure A-4: Post-Test Frontal View of Test Vehicle

Critical Areas of Performance	Observations and Conclusions
Pillar Performance	A-Pillar Buckled
Sill Separation	None
Windshield Damage	Cracks throughout with separation along A-Pillar and Roof
Side Window Damage	Driver Window Shattered
Other Notable Effects	None

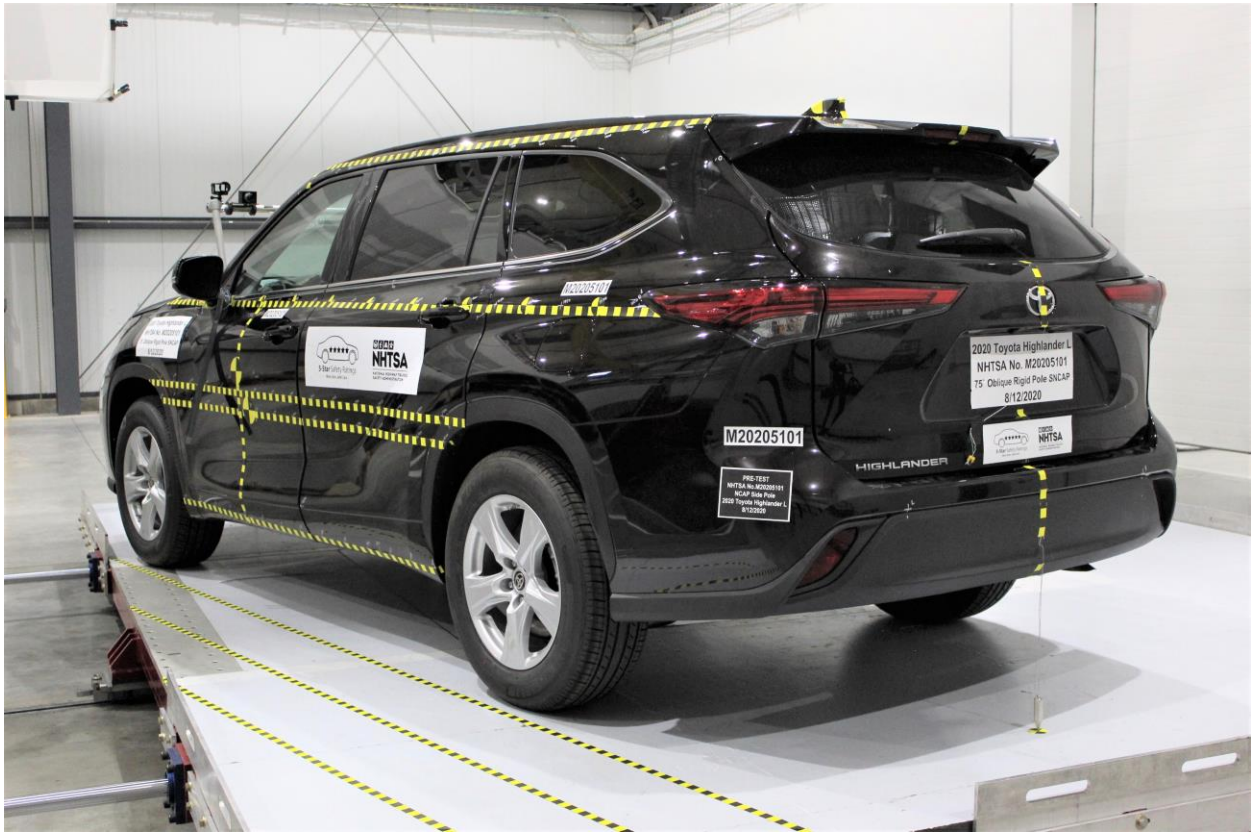
Figure A-8: Post-Test Left Side View of Test Vehicle

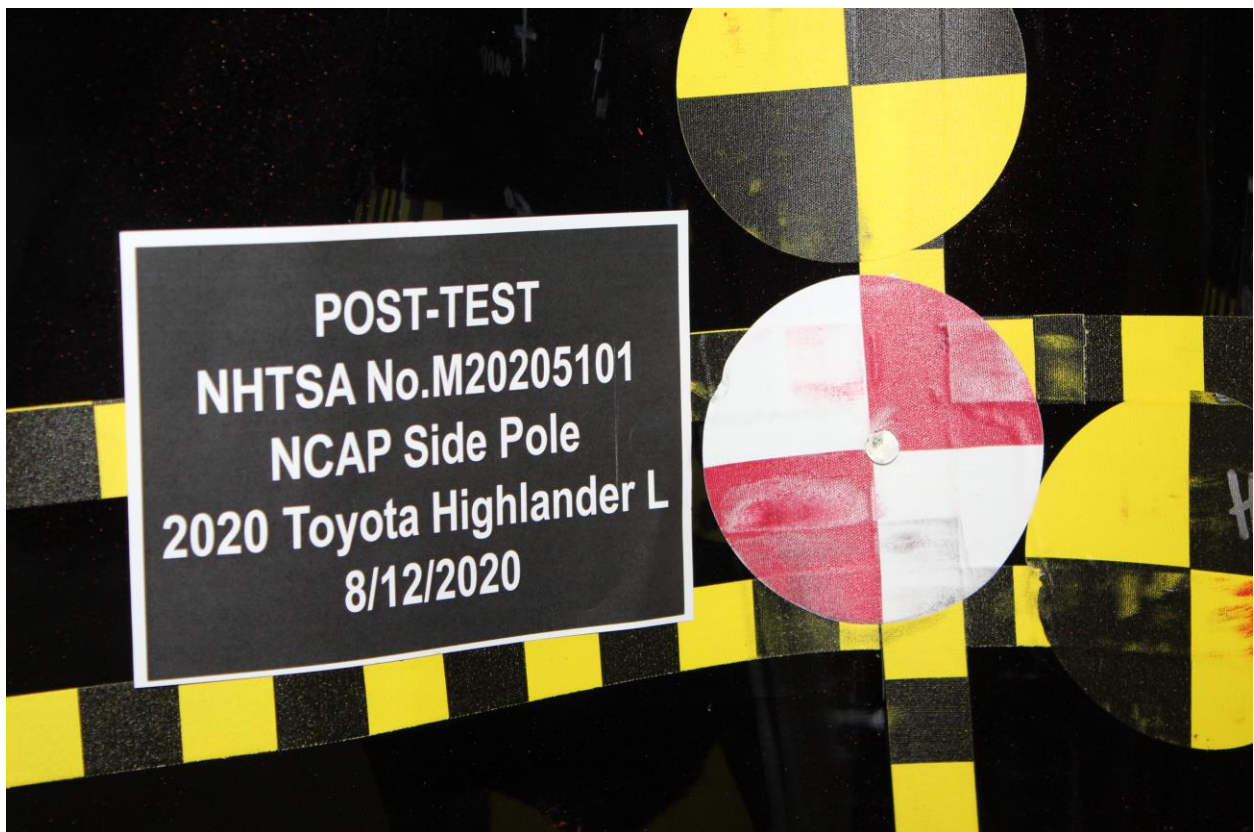
Figure A-20: Post-Test Close-Up View of Impact Point Target Showing Impact Location

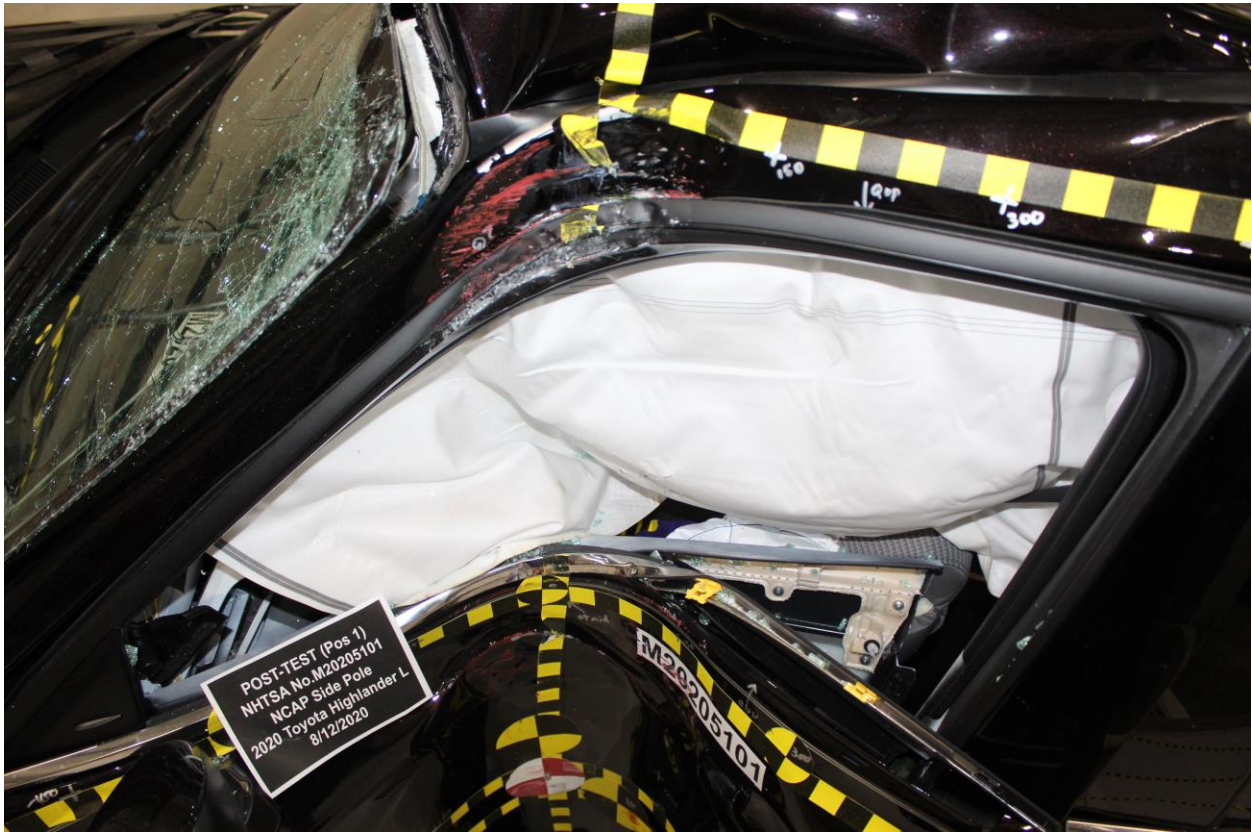
Figure A-41: Post-Test Dummy and Door Clearance View

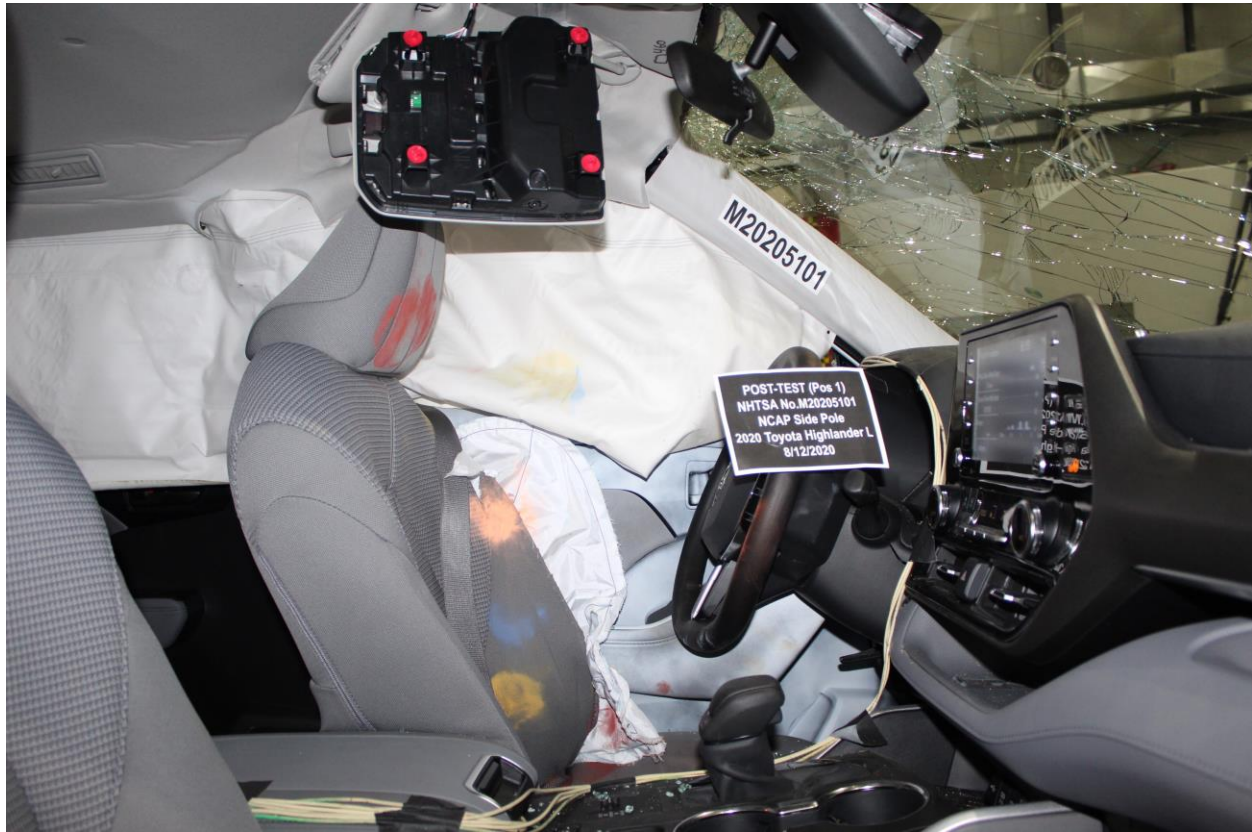
Figure A-45: Post-Test Inner Door Panel View Showing Dummy Contact Location

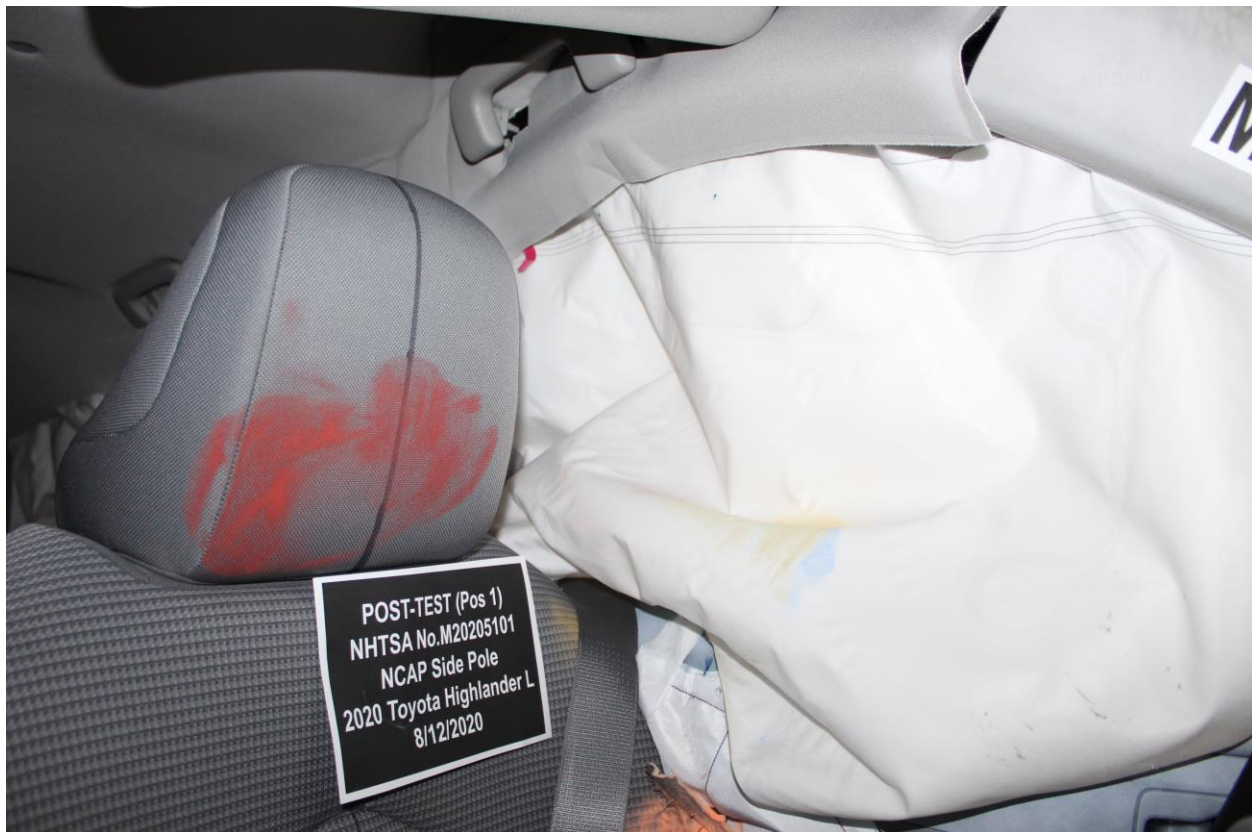
Figure A-46: Post-Test Dummy Close-Up Head Contact with Vehicle Interior View

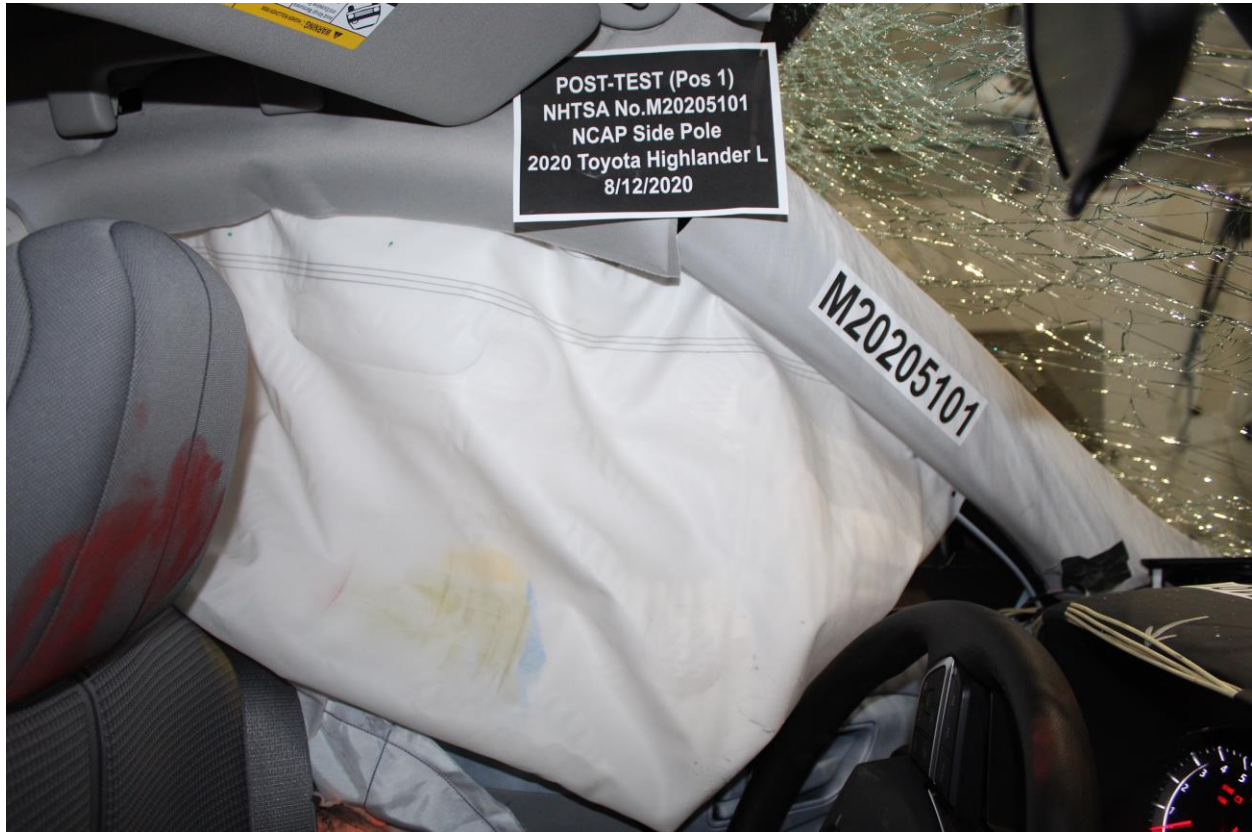
Figure A-47: Post-Test Dummy Close-Up Head Contact with Side Airbag View

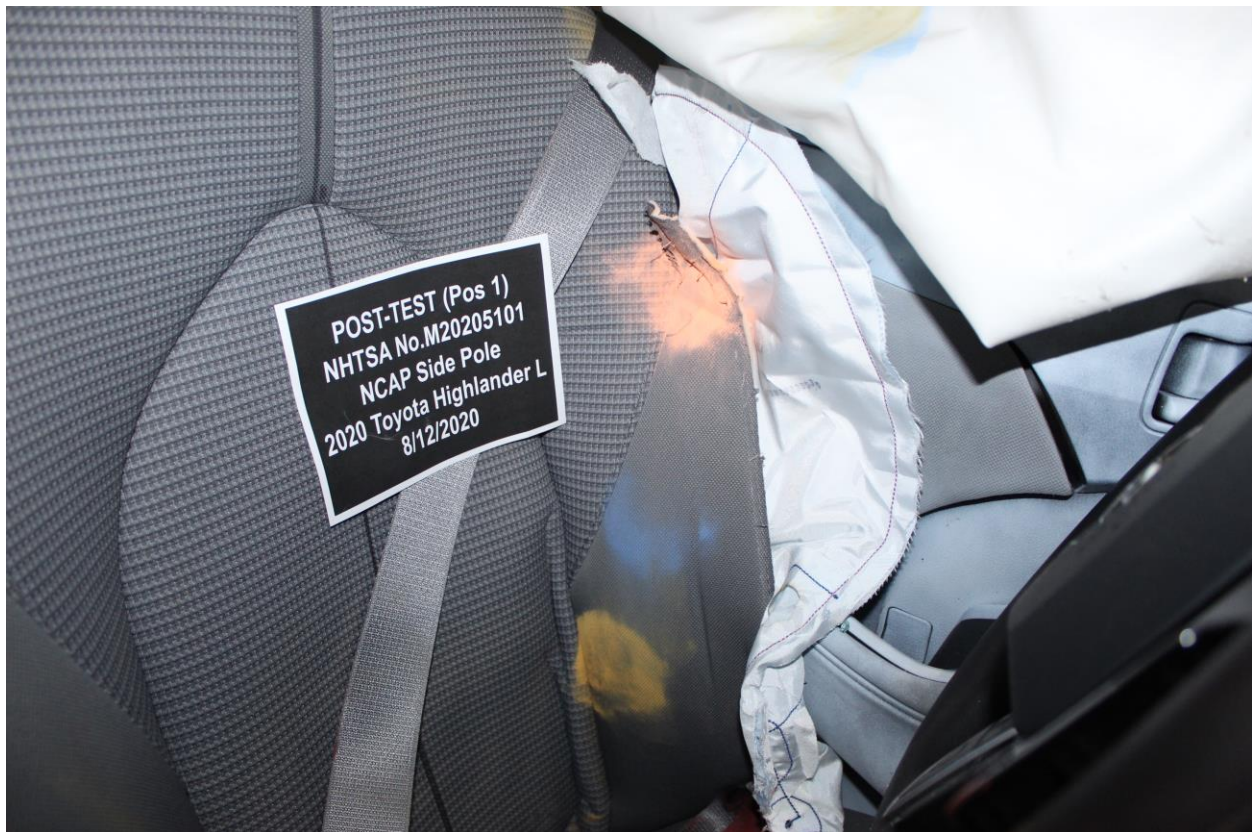
Figure A-48: Post-Test Dummy Close-Up Torso Contact with Vehicle Interior View

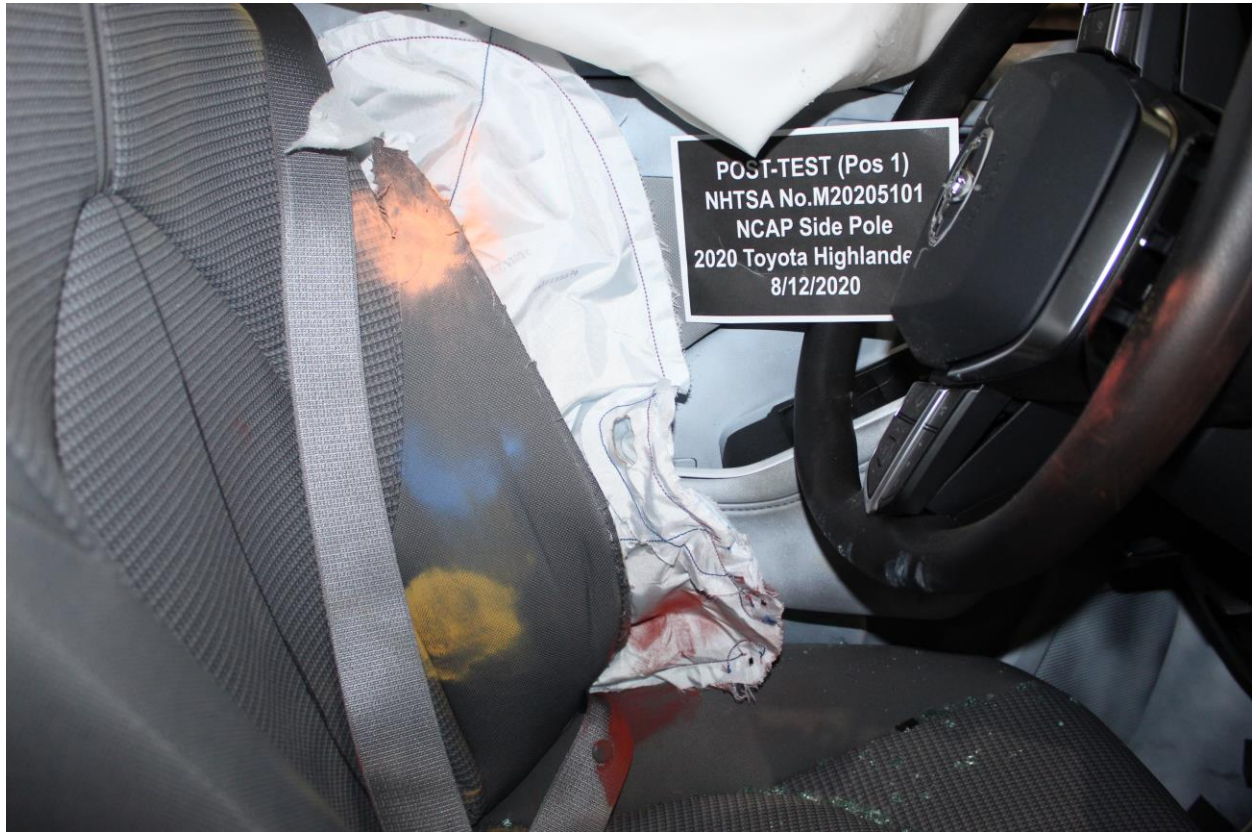
Figure A-49: Post-Test Dummy Close-Up Torso Contact with Side Airbag View

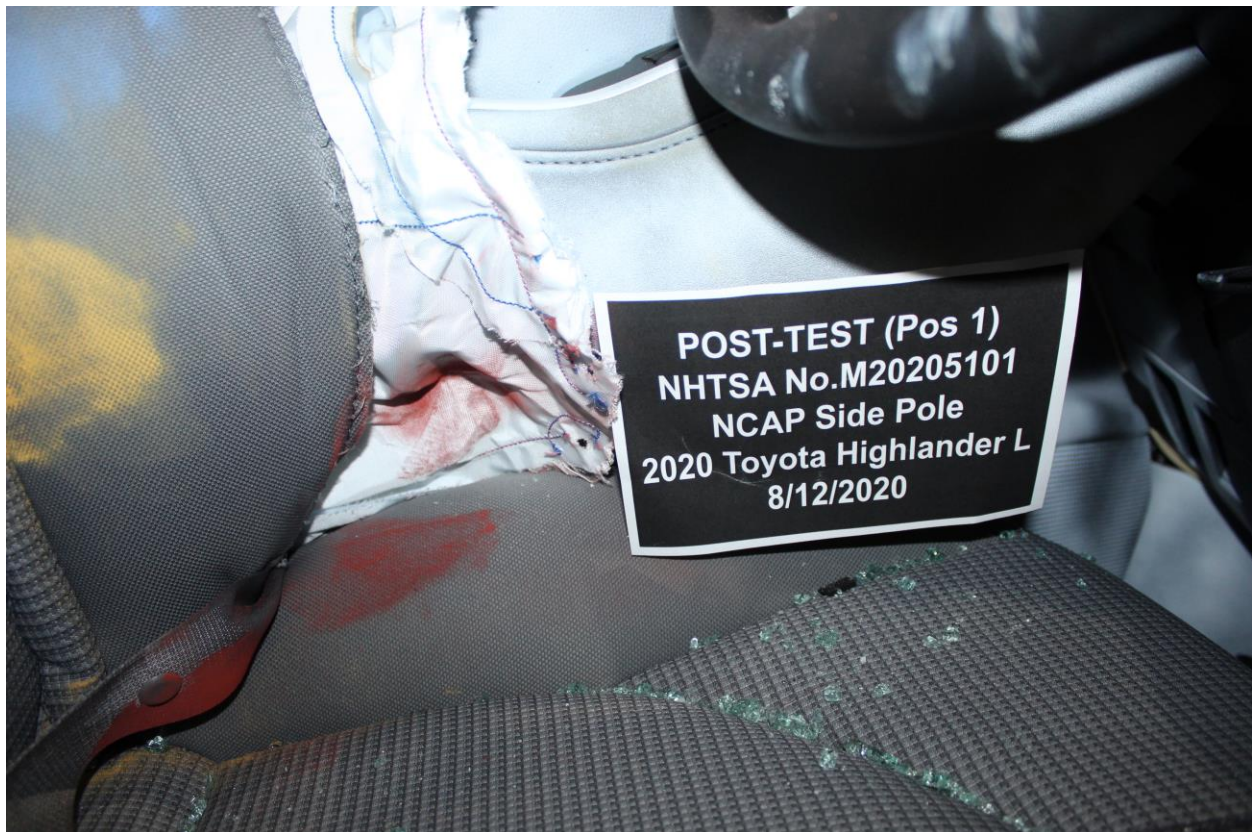
Figure A-50: Post-Test Dummy Close-Up Pelvis Contact with Vehicle Interior View

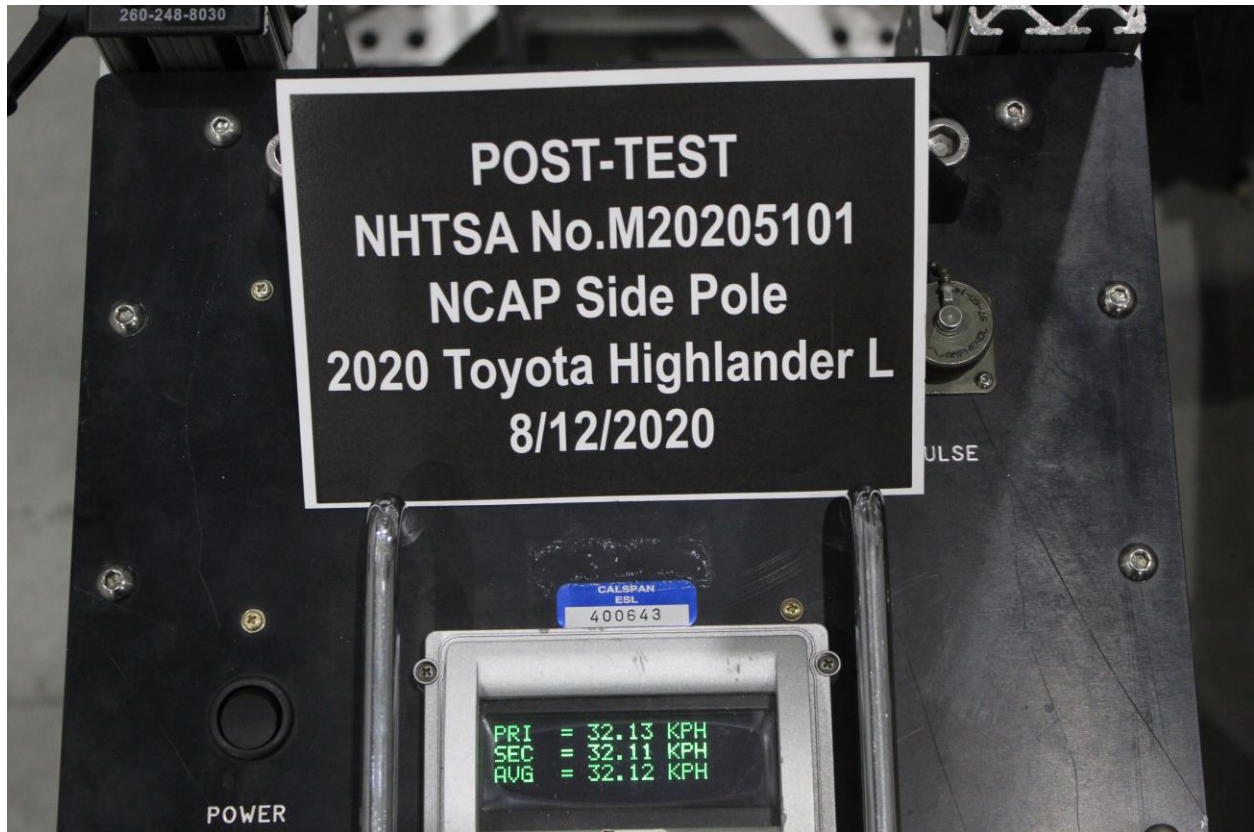
Figure A-62: Post-Test Primary and Redundant Speed Trap Read-Out

A rigid pole side impact test was conducted on a 2020 Toyota Highlander SUV. The subject vehicle was towed into the rigid pole at an angle of 75° and a velocity of 32.13 km/h. The test was conducted by Calspan Corporation's Transportation Test Operations facility in Buffalo, New York on August 12, 2020. Pre-test and post-test photographs of the test vehicle and side impact dummy (SID-IIs) are included in Appendix A of this report.

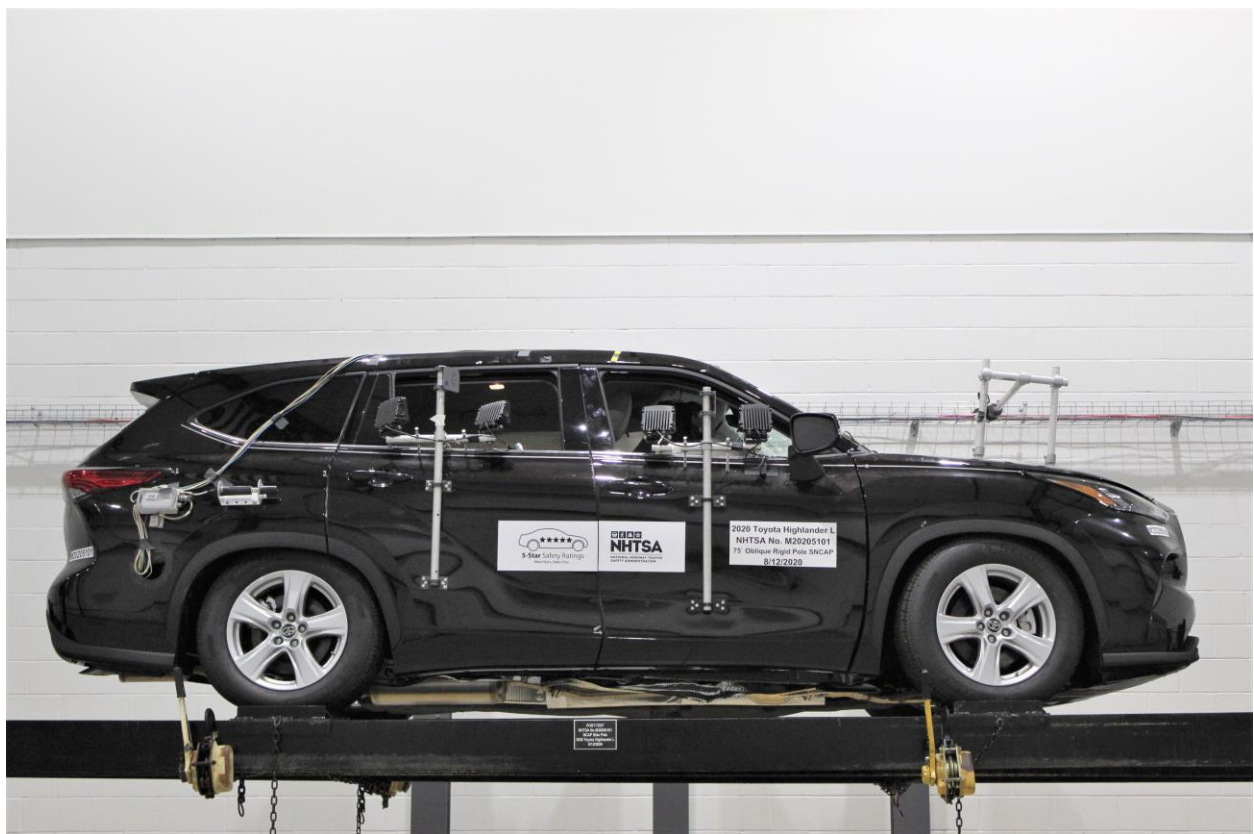
Figure A-63: FMVSS No. 301 Static Rollover 0 Degrees

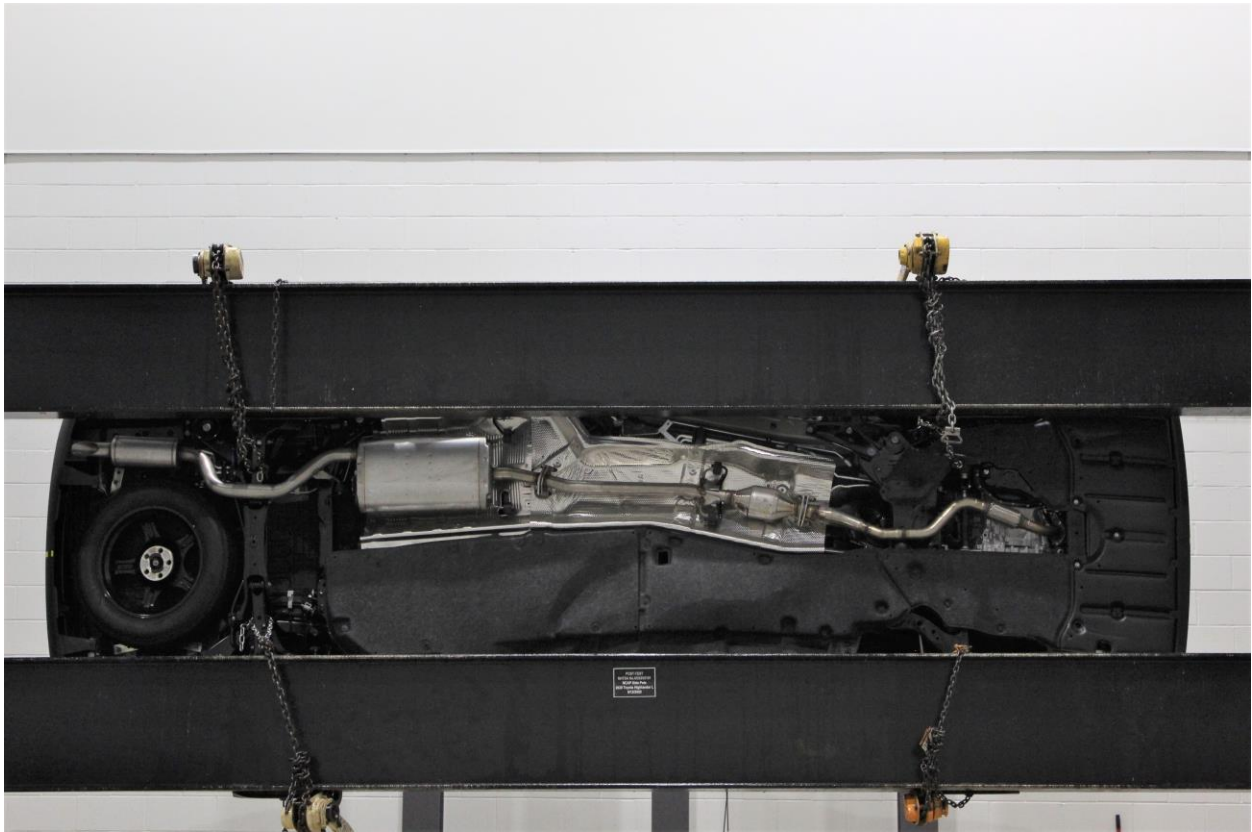
Figure A-64: FMVSS No. 301 Static Rollover 90 Degrees

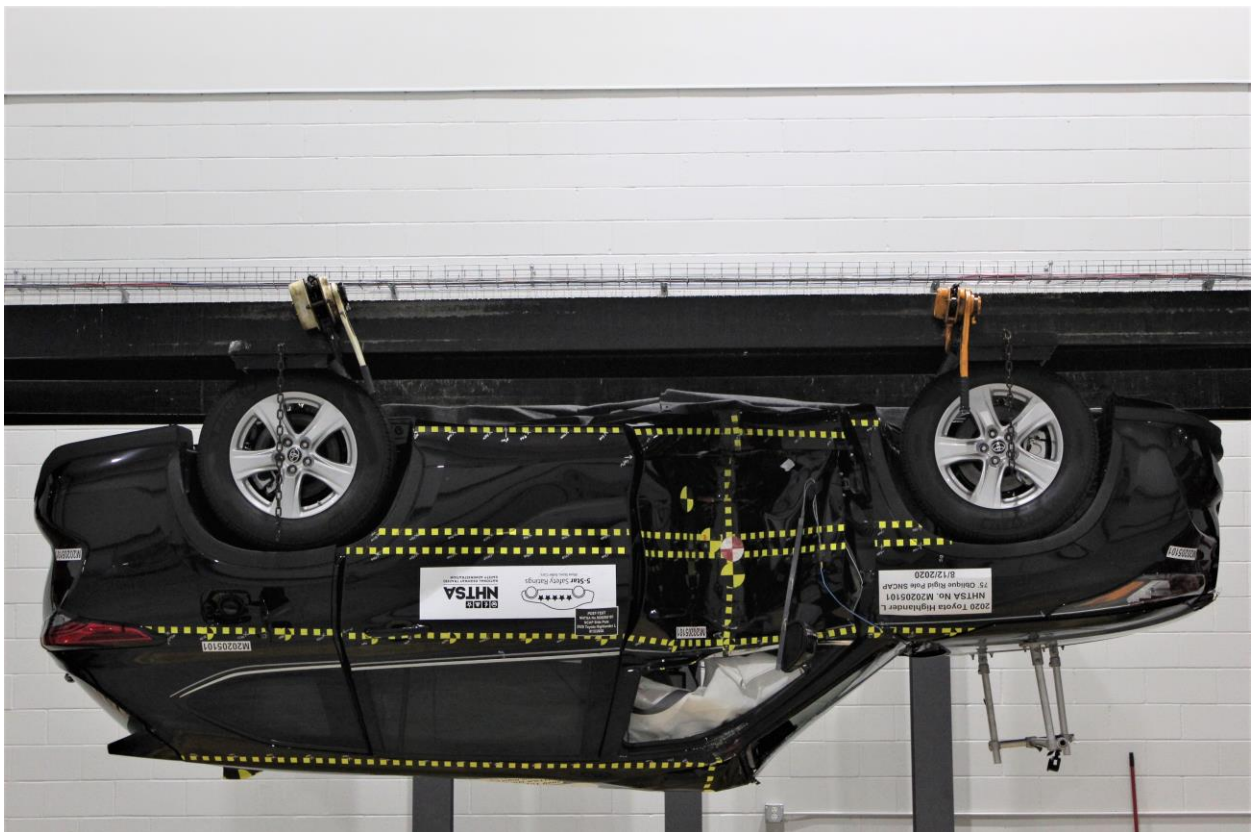
Figure A-65: FMVSS No. 301 Static Rollover 180 Degrees

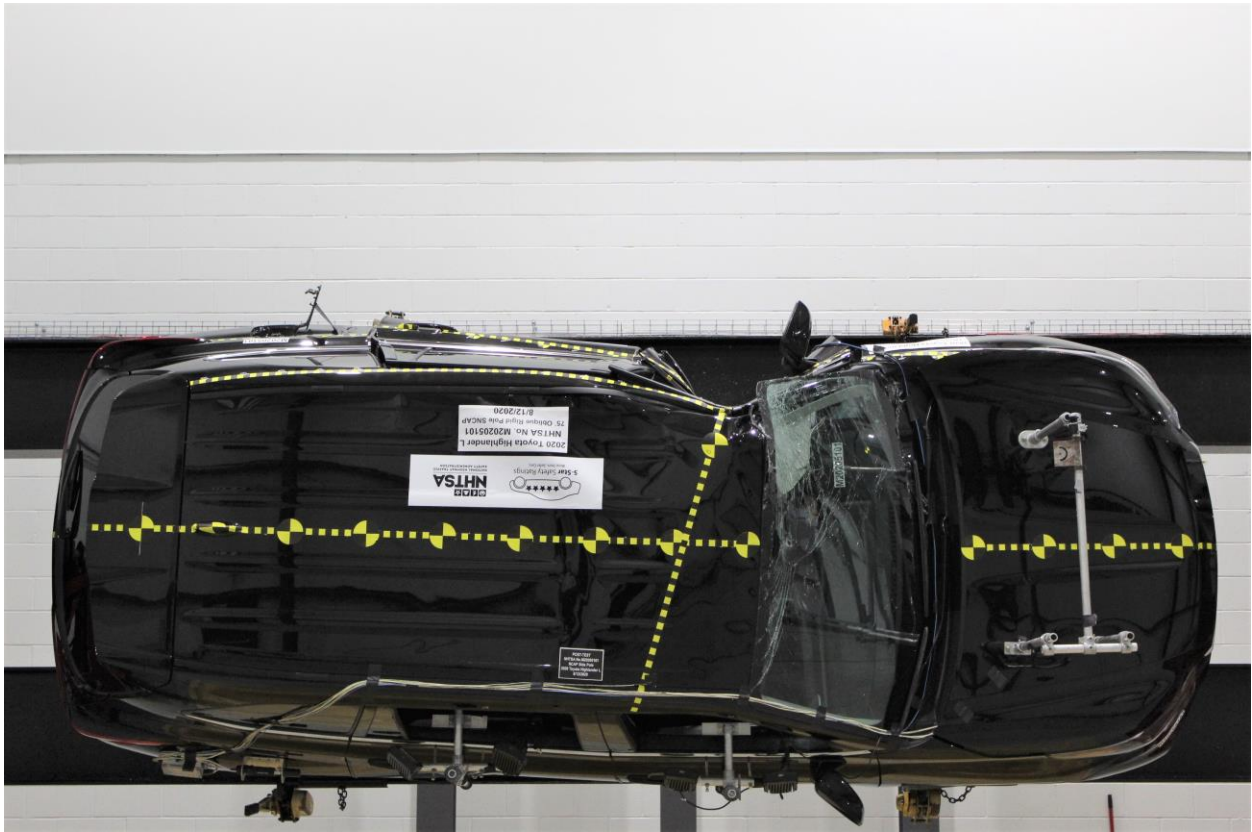
Figure A-66: FMVSS No. 301 Static Rollover 270 Degrees

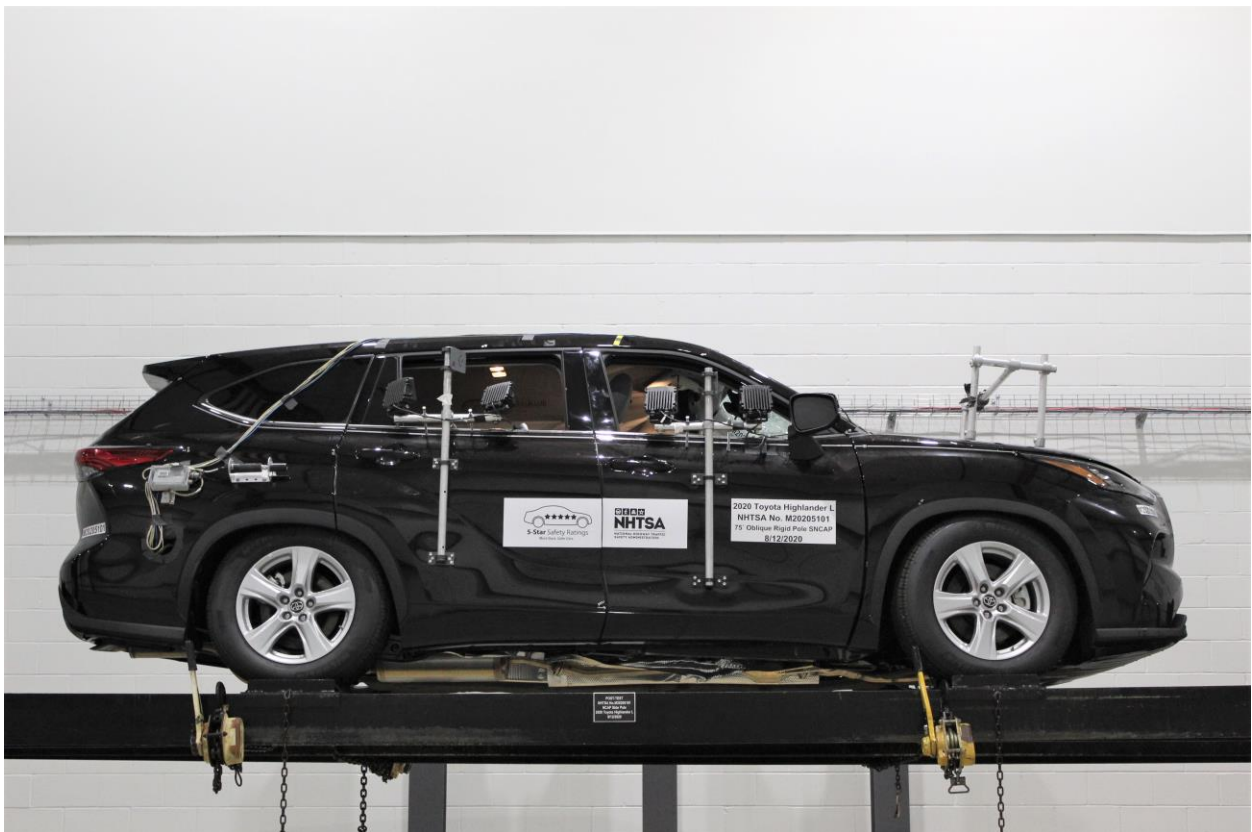
Figure A-67: FMVSS No. 301 Static Rollover 360 Degrees

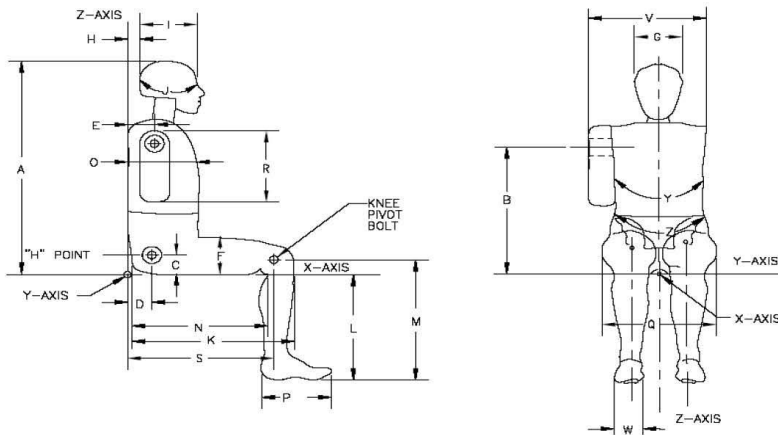
Symbol	Description	Specification (mm)		Result (mm)	Pass/Fail
A	Sitting Height	772	788	779	Pass
B	Shoulder Pivot Height	437	453	446	Pass
C	H-point Height	79	89	84	Pass
D	H-point from seatback	141	151	146	Pass
E	Shoulder Pivot from Backline	97	107	104	Pass
F	Thigh Clearance	119	135	127	Pass
G	Head Breadth	140	148	144	Pass
H	Head Back from Backline	40	46	44	Pass
I	Head Depth	178	188	184	Pass
J	Head Circumference	541	551	547	Pass
K	Buttock to Knee Length	514	540	533	Pass
L	Popliteal Height	343	369	357	Pass
M	Knee Pivot to floor height	392	409	402	Pass
N	Buttock Popliteal Length	416	442	433	Pass
O	Chest Depth w/o jacket	195	211	206	Pass
P	Foot Length	216	232	225	Pass
Q	Hip Breadth (w/pelvic plugs)	313	323	319	Pass
R	Arm Length	249	259	255	Pass
S	Knee Joint to seatback	477	493	486	Pass
V	Shoulder Width	341	357	346	Pass
W	Foot Width	78	94	85	Pass
Y	Chest Circumference w/jacket	851	881	867	Pass
Z	Waist Circumference	761	791	781	Pass
