REPORT NUMBER: SINCAP-CAL-20-013

NEW CAR ASSESSMENT PROGRAM (NCAP) MOVING DEFORMABLE BARRIER SIDE IMPACT TEST

> Toyota Motor Manufacturing Indiana, Inc. 2020 Toyota Highlander Five Door SUV

> > NHTSA No: M20205102

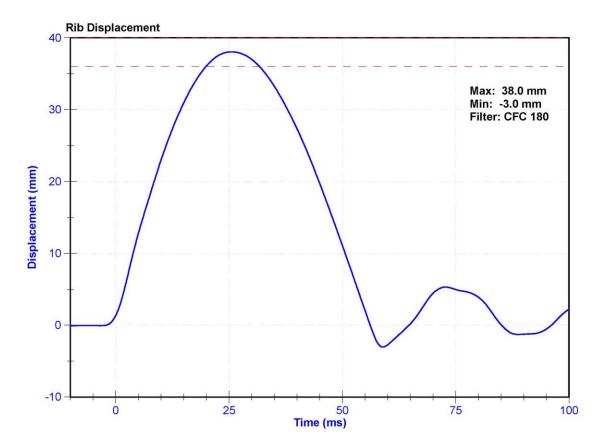
Certification Report ES-2re Lower Rib Drop 3 m/s - CFR 572

Results					
Test Parameter	Minimum Specification	Maximum Specification	Unit	Result	Pass/Fail
Temperature	20.6	22.2	°C	21.6	Pass
Humidity	10	70	%	60.7	Pass
Rib Displacement	36	40	mm	38.0	Pass
