**REPORT NUMBER: NCAP-CAL-20-016**

**NEW CAR ASSESSMENT PROGRAM (NCAP)  
FRONTAL BARRIER IMPACT TEST**

**Toyota Motor Manufacturing, Indiana, INC  
2020 Toyota Highlander  
Five Door SUV**

**NHTSA No: M20205100**

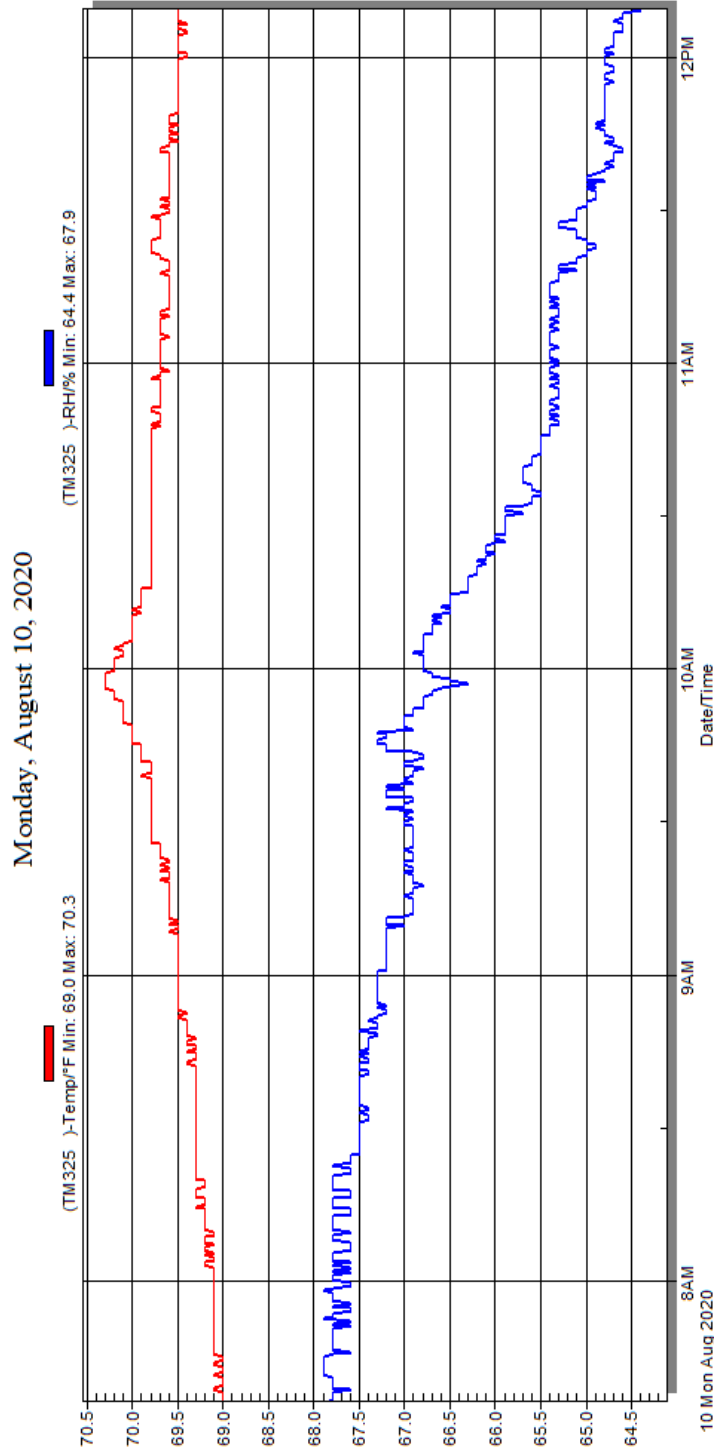
**Temperature and Humidity Stabilization Chart/Data for Dummies and Test Vehicle**

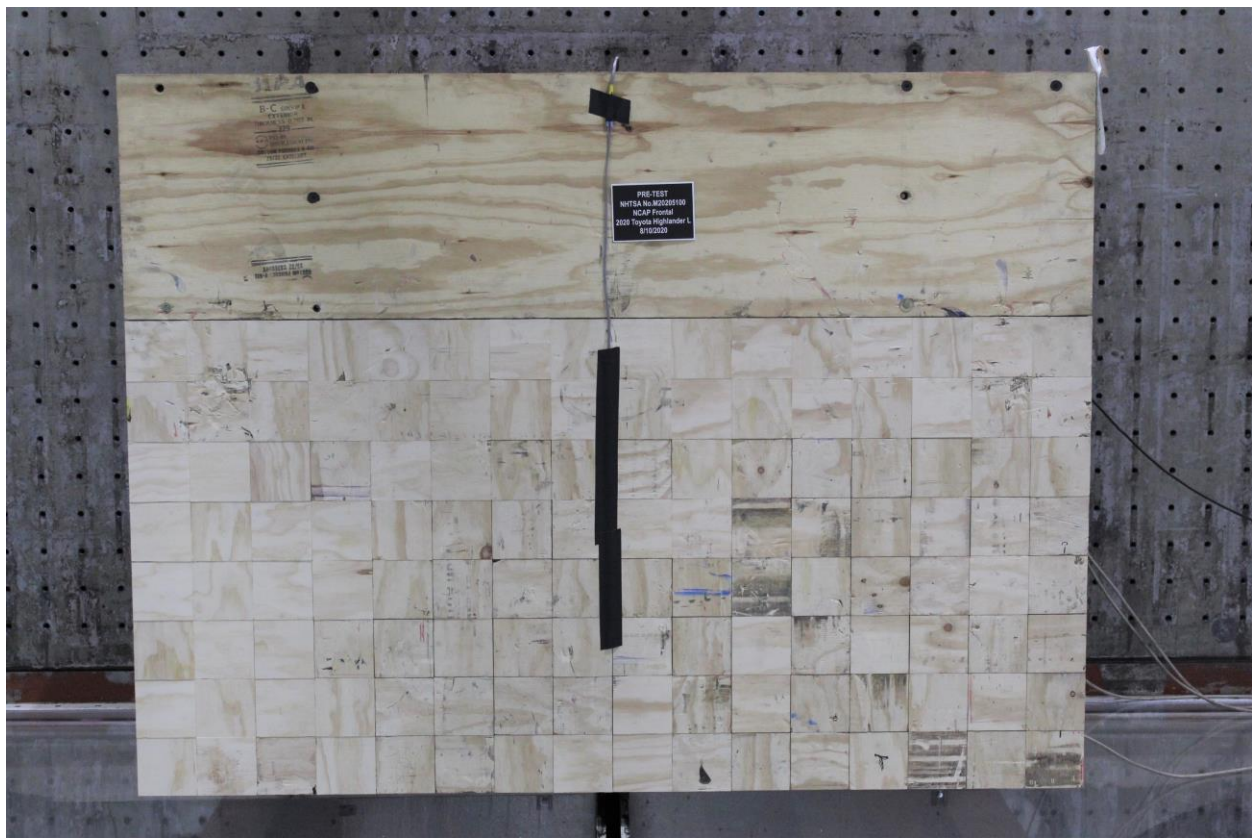
**Figure A-2: Pre-Test Load Cell Wall**

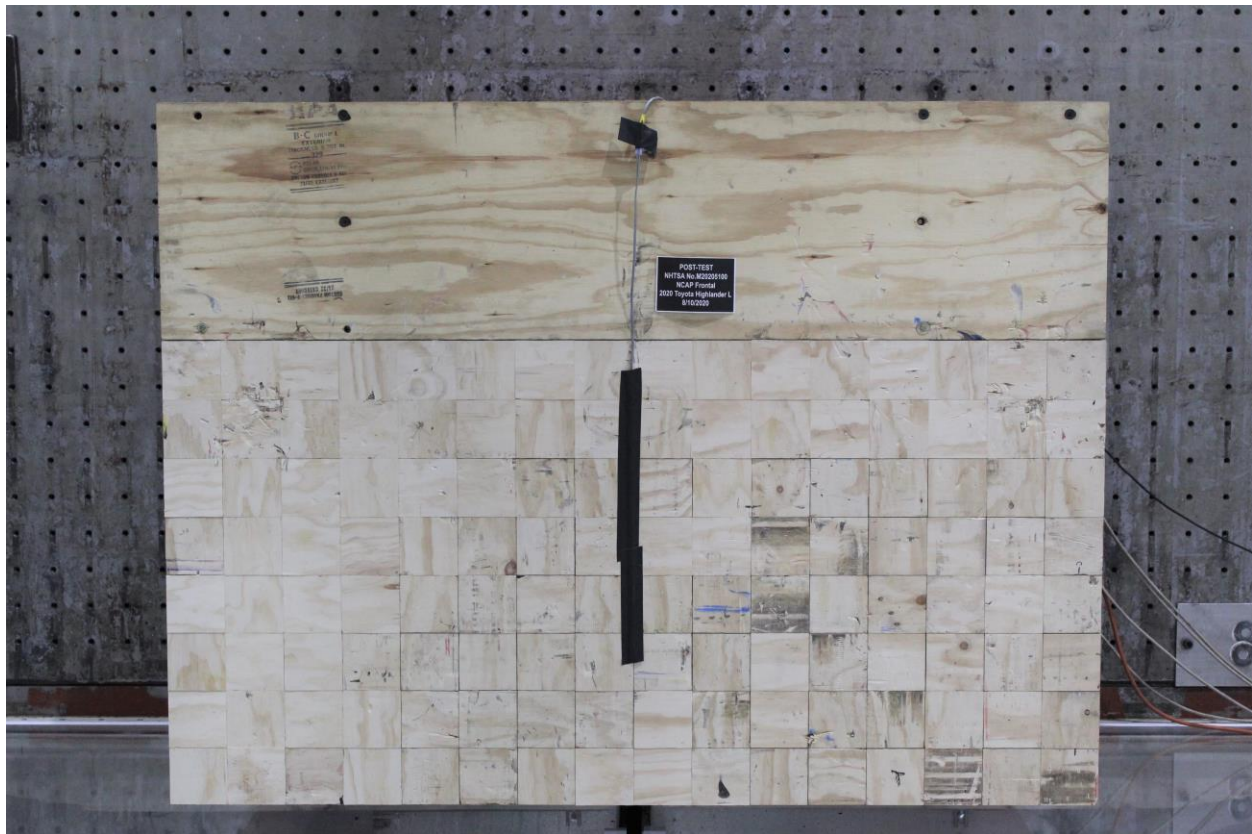
**Figure A-3: Post-Test Load Cell Wall**

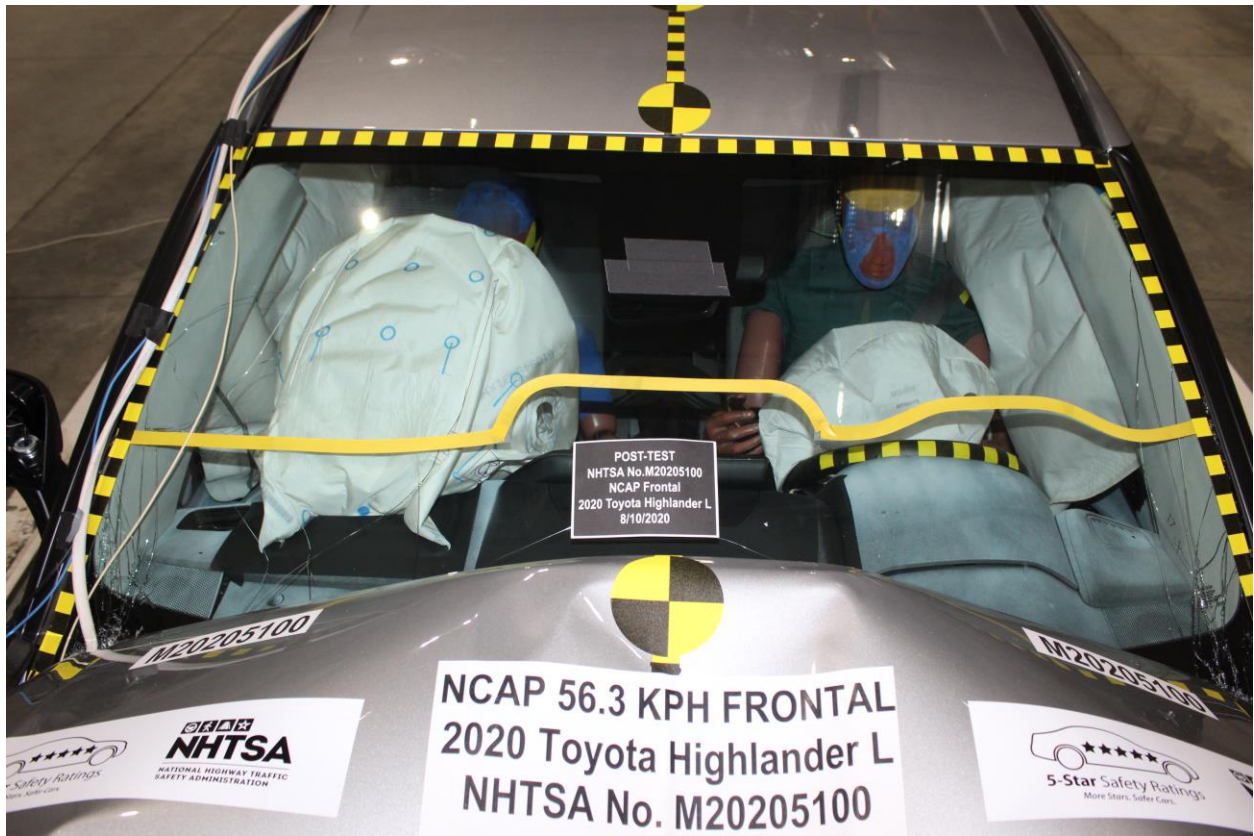
Figure A-19: Post-Test Windshield View

Critical Areas of Performance	Observations and Conclusions
Windshield Damage	Corners of hood penetrated windshield, cracks throughout
Window Damage	None
Other	None

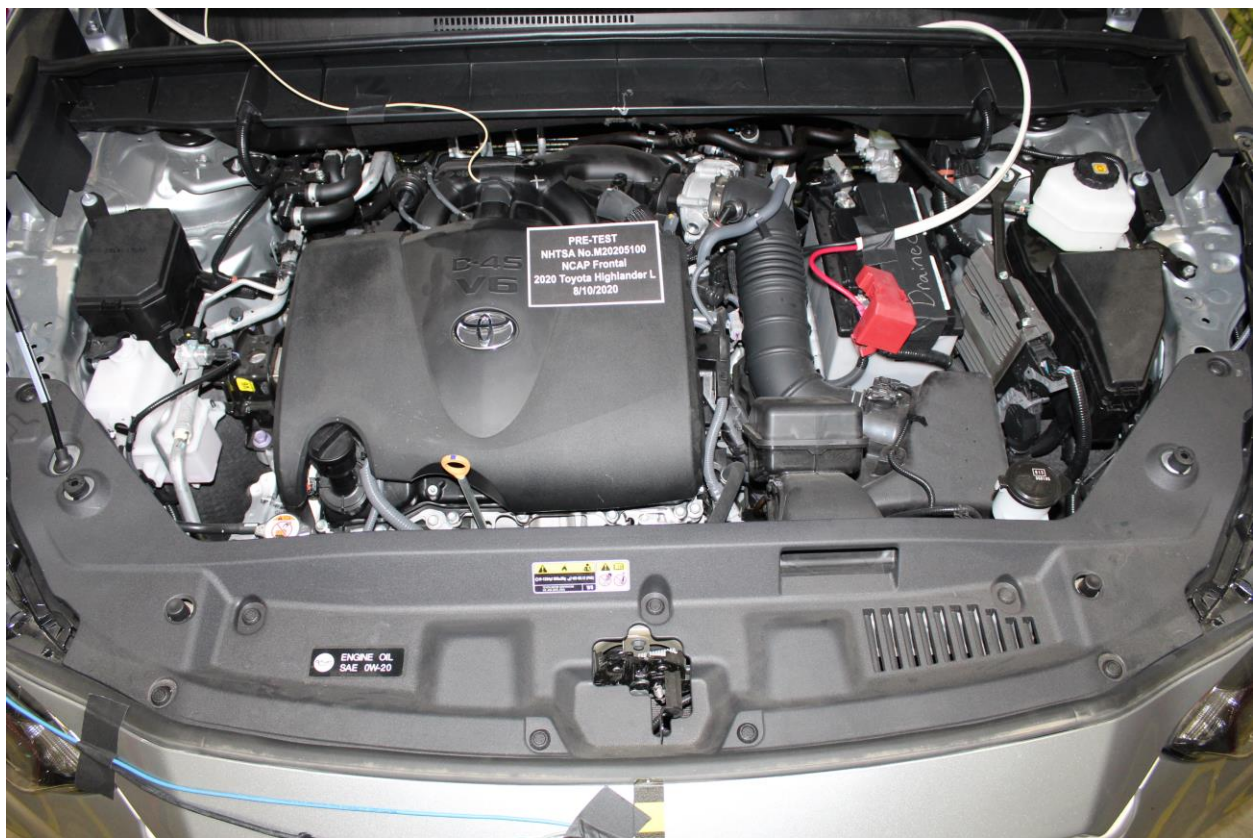
Figure A-20: Pre-Test Engine Compartment View
