**REPORT NUMBER: SINCAP-KAR-20-019**

**NEW CAR ASSESSMENT PROGRAM (NCAP)  
MOVING DEFORMABLE BARRIER SIDE IMPACT TEST**

**NISSAN MOTOR CO., LTD.  
2020 NISSAN KICKS 5-DOOR SUV**

**FINAL REPORT**

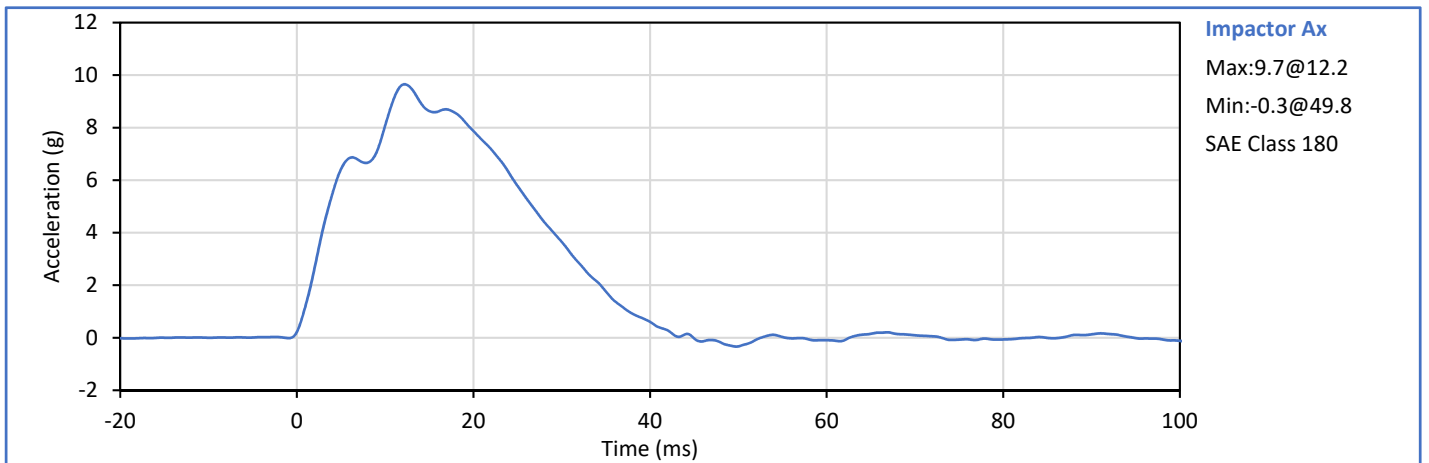
Tested Parameter	Units	Spec. Low	Spec. High	Result	Pass/Fail
Laboratory Temperature	°C	20.6	22.2	21.4	Pass
Laboratory Relative Humidity	%	10	70	27	Pass
Impactor Velocity	m/s	4.20	4.40	4.36	Pass
Peak Impactor Ax	g	7.5	10.5	9.7	Pass
Overall Test Results					Pass

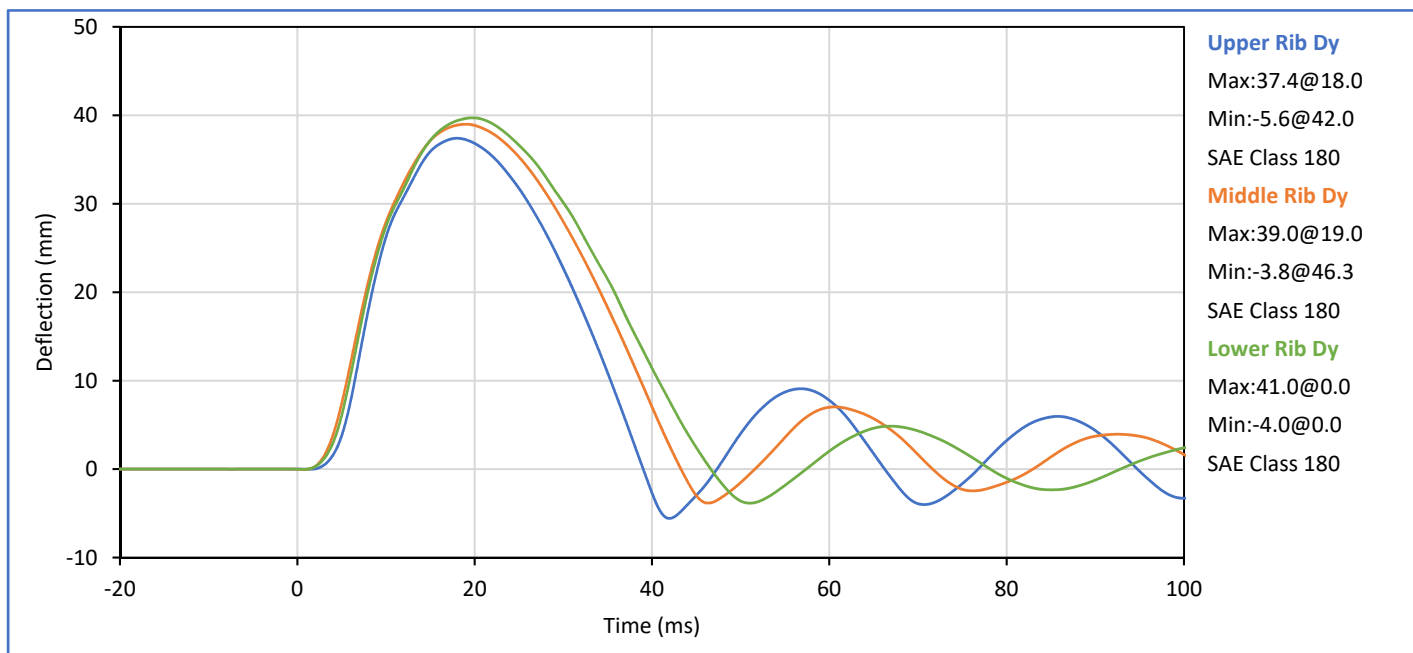
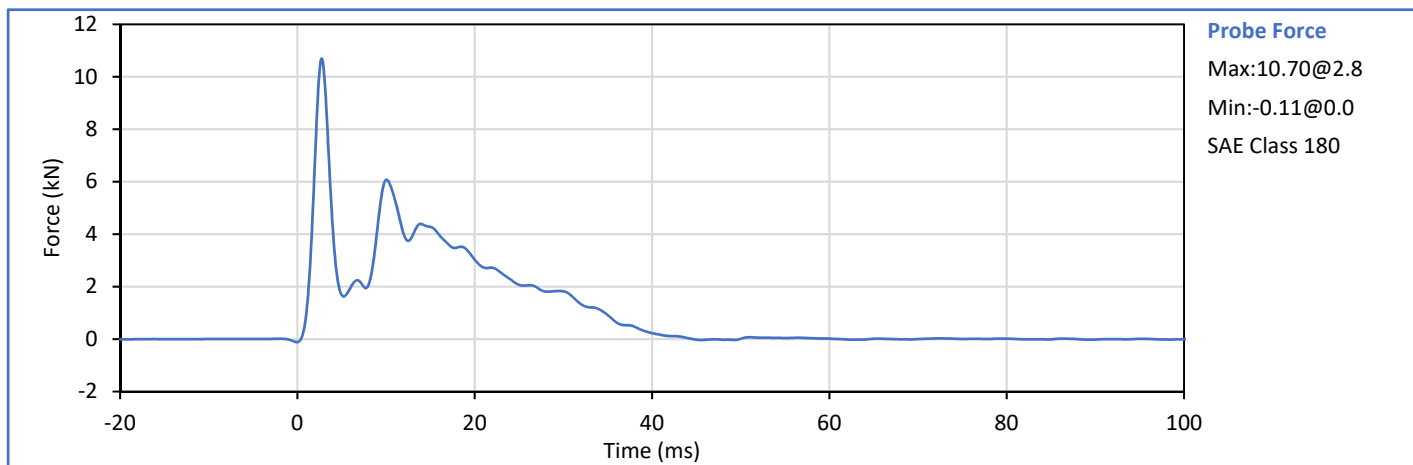
Tested Parameter	Units	Spec. Low	Spec. High	Result	Pass/Fail
Laboratory Temperature	°C	20.6	22.2	21.4	Pass
Laboratory Relative Humidity	%	10	70	27	Pass
Impactor Velocity	m/s	5.40	5.60	5.52	Pass
Peak Upper Rib Dy	mm	34.0	41.0	37.4	Pass
Peak Middle Rib Dy	mm	37.0	45.0	39.0	Pass
Peak Lower Rib Dy	mm	37.0	44.0	39.7	Pass
Peak Impactor Force After 6 ms	kN	5.10	6.20	6.08	Pass
Overall Test Results					Pass

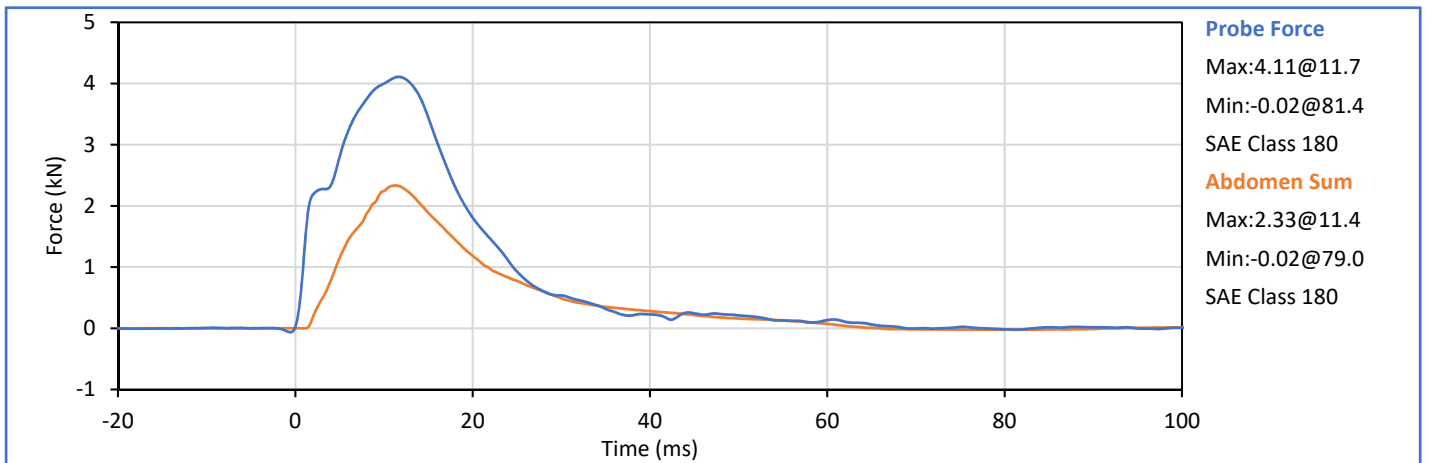
Tested Parameter	Units	Spec. Low	Spec. High	Result	Pass/Fail
Laboratory Temperature	°C	20.6	22.2	21.1	Pass
Laboratory Relative Humidity	%	10	70	27	Pass
Impactor Velocity	m/s	3.90	4.10	4.01	Pass
Peak Impactor Force	kN	4.00	4.80	4.11	Pass
Time of Peak Impactor Force	ms	10.6	13.0	11.7	Pass
Sum of Abdomen Forces	kN	2.20	2.70	2.33	Pass
Time of Peak Sum Abdomen Force	ms	10.0	12.3	11.4	Pass
Overall Test Results					Pass
