REPORT NUMBER: NCAP-CAL-20-017

**NEW CAR ASSESSMENT PROGRAM (NCAP)
FRONTAL BARRIER IMPACT TEST**

**FCA US LLC
2020 Chrysler Pacifica Hybrid
Five Door Minivan**

NHTSA No: M20200316

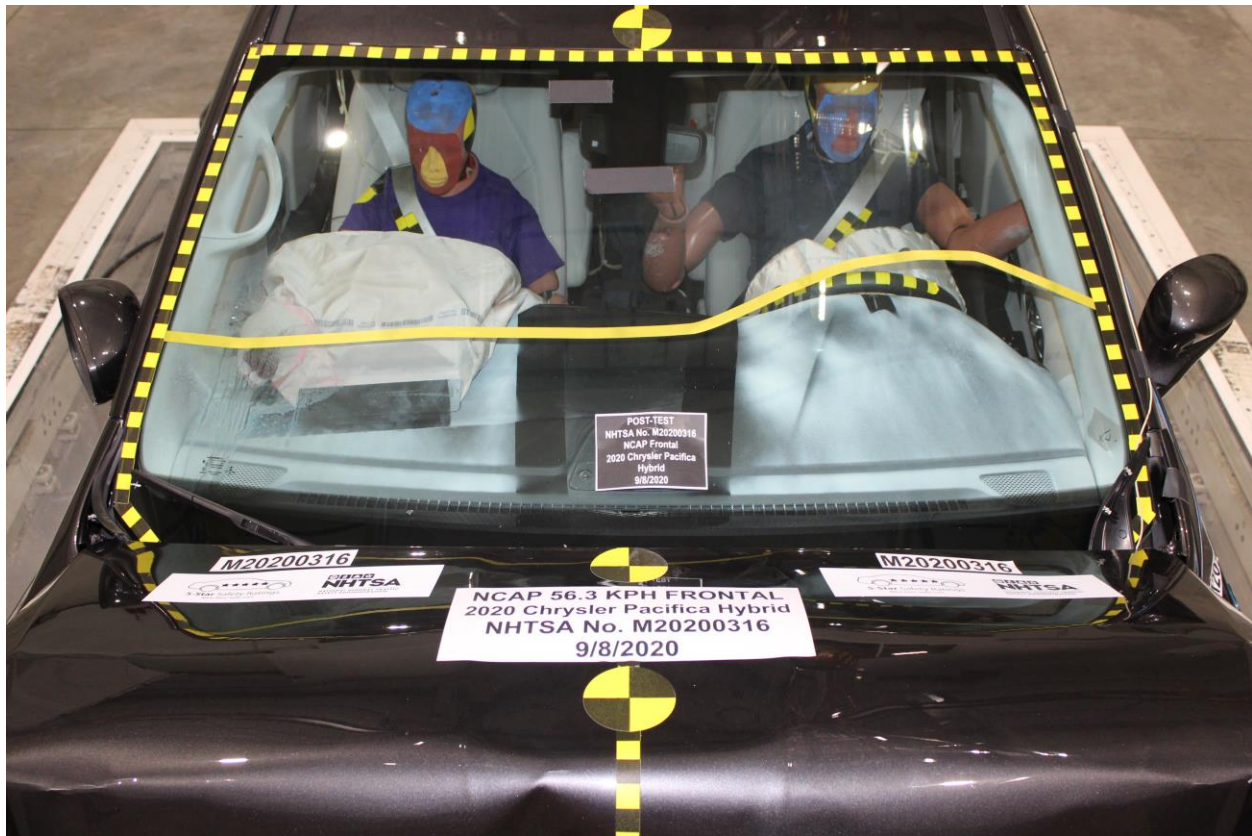
Figure A-19: Post-Test Windshield View

Critical Areas of Performance	Observations and Conclusions
Windshield Damage	None
Window Damage	None
Other	None
