EVALUATION OF INFLATABLE BOOSTER SEATS

A comparison of performance in rear seats of vehicles undergoing crash tests and the CMVSS 213.2 type sled test

Part 2: GoBooster®

Crashworthiness Research Division (ASFBD)
Motor Vehicle Standards, Research & Development
Road Safety & Motor Vehicle Regulations
Transport Canada

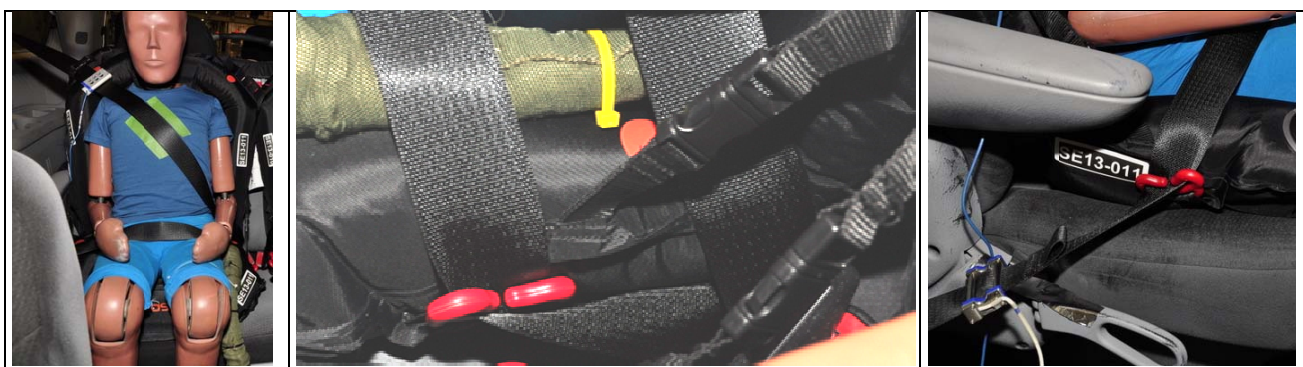
FIGURE 3 PRE-TEST POSITION OF HYBRID III 10 - YEAR-OLD PLACED ON THE GOBOOSTER® IN DODGE GRAND CARAVAN

Behind the right front passenger: An instrumented Hybrid III 10 - year-old ATD was placed on a GoBooster® booster seat as per manufacturer instructions¹. The lower spine of the ATD was set to 0 degrees, which represents a relaxed. Pre-test position of the lap and torso belt displayed good fit though the seatbelt was difficult to route through guides. The centre photo of Figure 3 displays the inboard belt routing. Note how the lap portion of the belt must be brought forward to be routed through the guide. The right most photo displays the outboard routing.

¹ PICTOGRAM INSTRUCTING THAT THE SHOULDER PORTION OF THE SEAT BELT BE TUCKED BETWEEN THE SEATBACK AND CUSHION OF THE BOOSTER SEAT WAS NOT CORRECTLY INTERPRETED BY THE TECHNICIAN. IN BOTH INSTALLATIONS THE SHOULDER BELT PATH WAS FORWARD OF THE BOOSTER SEAT CUSHION/BACK JUNCTION BUT INBOARD OF CONNECTING STRAP.

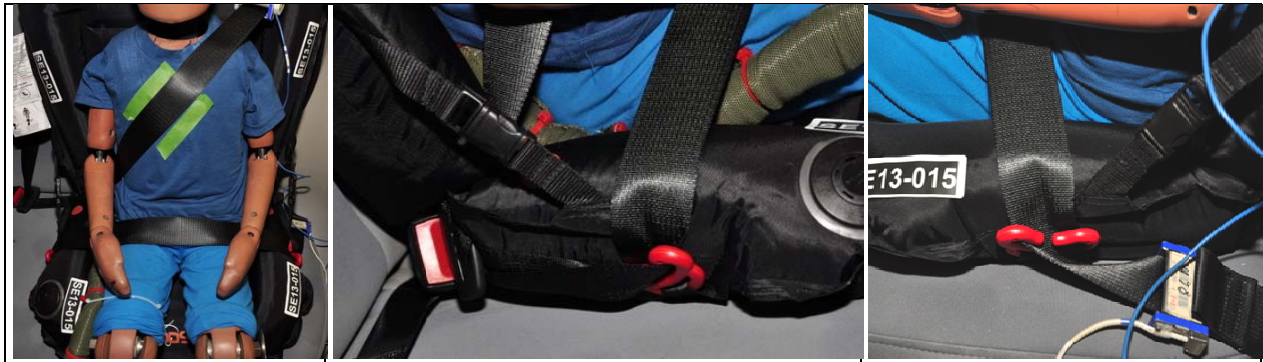
FIGURE 5 PRE-TEST POSITION OF HYBRID III 6 - YEAR-OLD PLACED ON THE GOBOOSTER® IN THE FORD FIESTA

Behind the driver: An instrumented Hybrid III 6 - year-old ATD was placed on a GoBooster® booster seat as per manufacturer instructions. The dummy was seated upright and a shield was positioned over the front region of the pelvis to prevent the lap belt from penetrating the space between the pelvis and upper femurs. Pre-test position of the lap displayed good fit though the seatbelt was difficult to route through the guides shown in Figure 5.

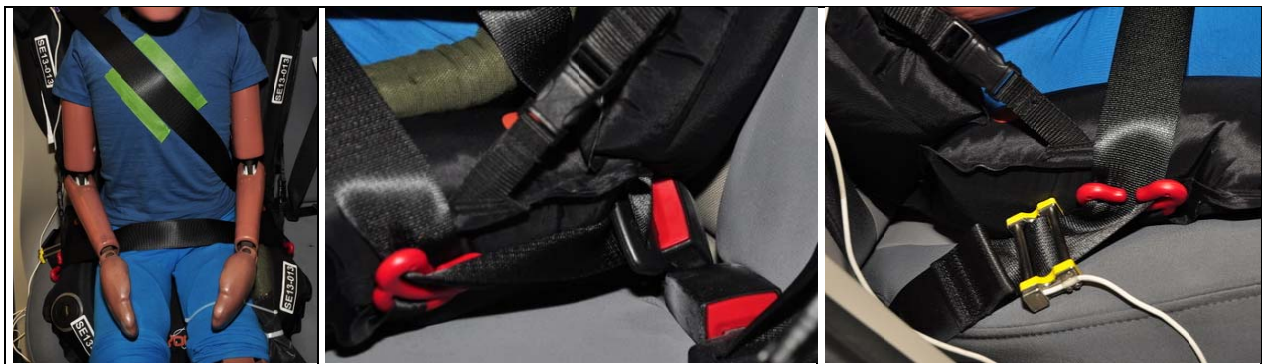
FIGURE 6 PRE-TEST POSITION OF HYBRID III 10 - YEAR-OLD PLACED ON THE GOBOOSTER® IN THE FORD FIESTA

Behind the right front passenger: An instrumented Hybrid III 10-year-old ATD was placed on a GoBooster® booster seat as per manufacturer instructions. The lower spine of the ATD was set to 0 degrees, which represents a relaxed position. Pre-test position of the lap belt displayed good fit though the seatbelt was difficult to route through the guides shown in Figure 6.

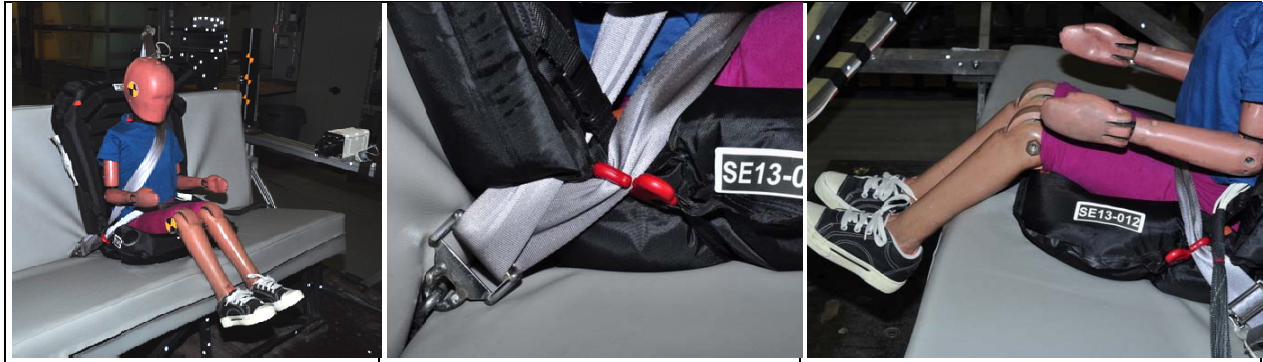
FIGURE 7 PRE-TEST POSITION OF HYBRID III 6-YEAR OLD ON COMPLIANCE TEST BENCH

A Hybrid III 6-year-old was placed on the GoBooster® booster seat and on the CMVSS 213 sled bench as per manufacturer instructions. The lap and torso belt was applied and tightened as per the CMVSS 213.2 test protocol. Pre-test photos are presented in Figure 7 below. Two CMVSS 213 tests were conducted.

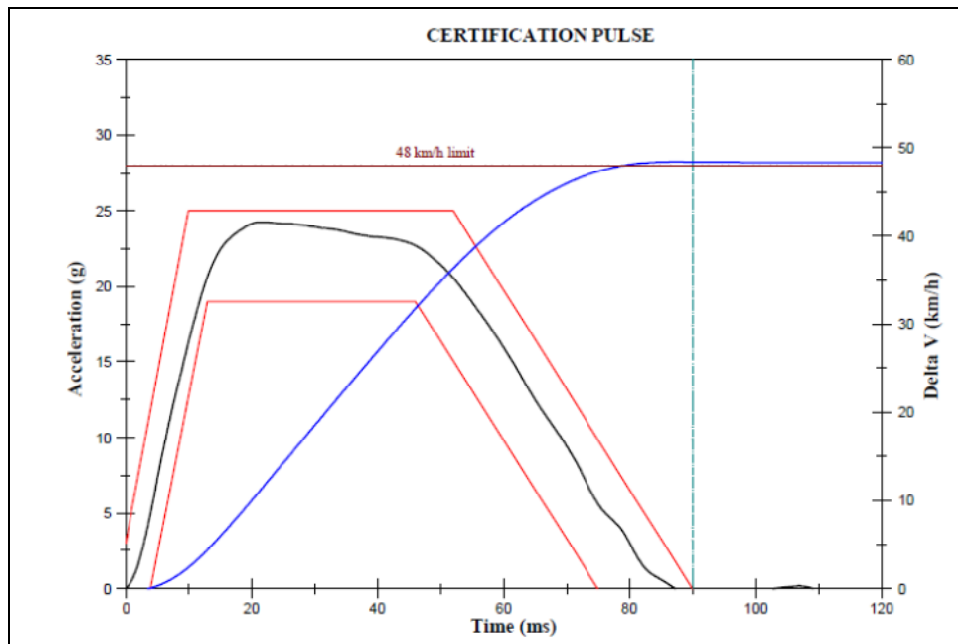
FIGURE 8 ACCELERATION PULSE AND DELTA V

The compliance pulse for test one produced a peak change in velocity of 48.4 km/h at 87.3 ms and peak acceleration of 24.3 g at 21.6 ms; test two produced a peak change in velocity of 49.1 km/h at 90 ms and peak acceleration of 24.3 g at 21.8 ms.

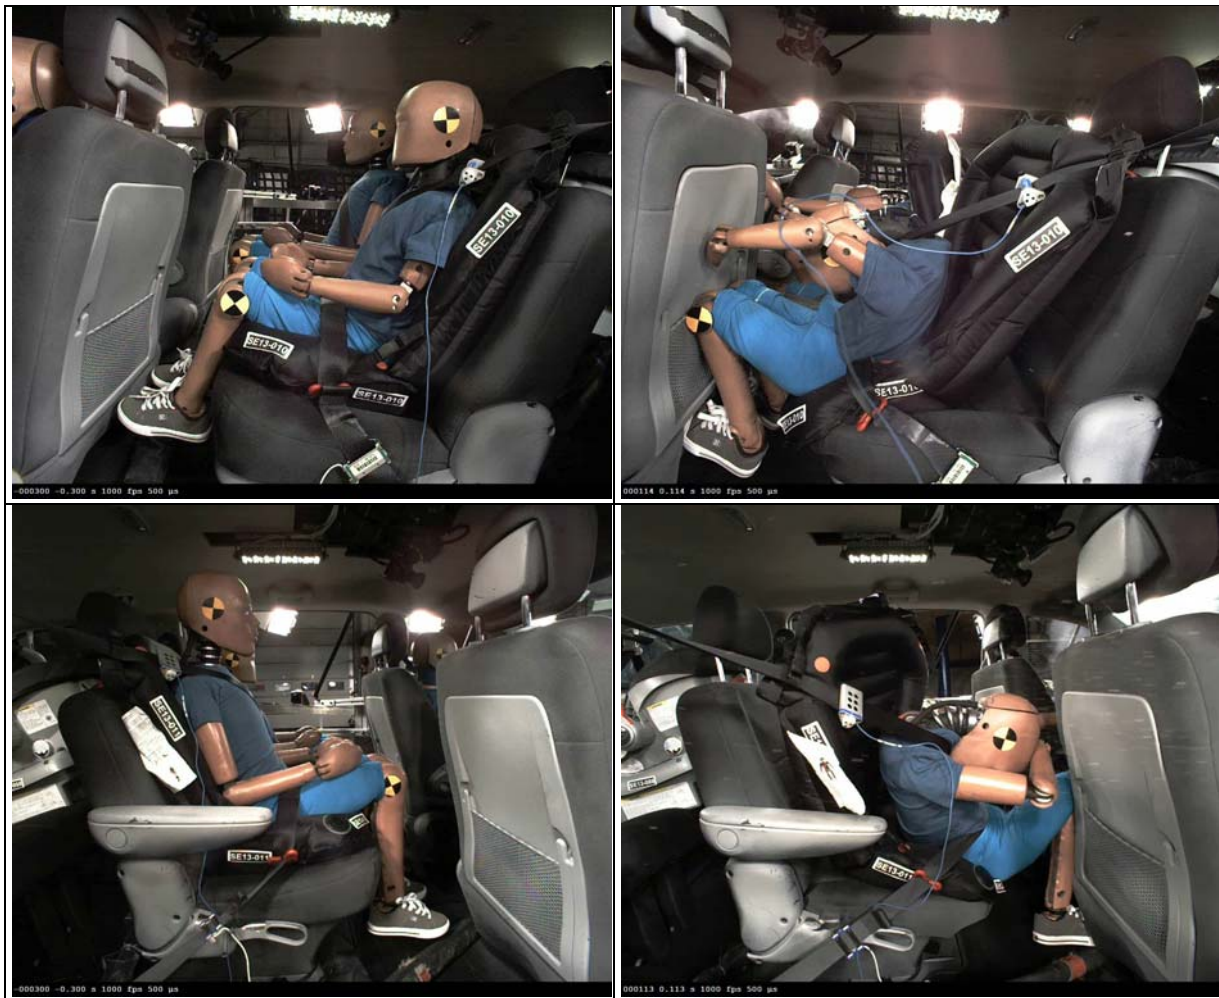
FIGURE 9 FREEZE FRAME IMAGES OF 6-YEAR-OLD PRIOR TO IMPACT (TOP LEFT) AND AT MAXIMUM EXCURSION (TOP RIGHT); 10-YEAR-OLD PRIOR TO IMPACT (BOTTOM LEFT) AND AT MAXIMUM EXCURSION (BOTTOM RIGHT) DURING FFRB TEST AT 40 KM/H.

The left views of Figure 9 illustrate the position of each dummy as the vehicle is accelerated down the ramp towards the barrier. In the top right image the 6-year old has slid off the front edge of the vehicle seat cushion together with the booster seat. The lap belt has penetrated the abdomen and the dummy is suspended by the rib cage. In the bottom right image the 10-year-old has slid to the front edge of the seat. The lap belt has penetrated the abdominal region.

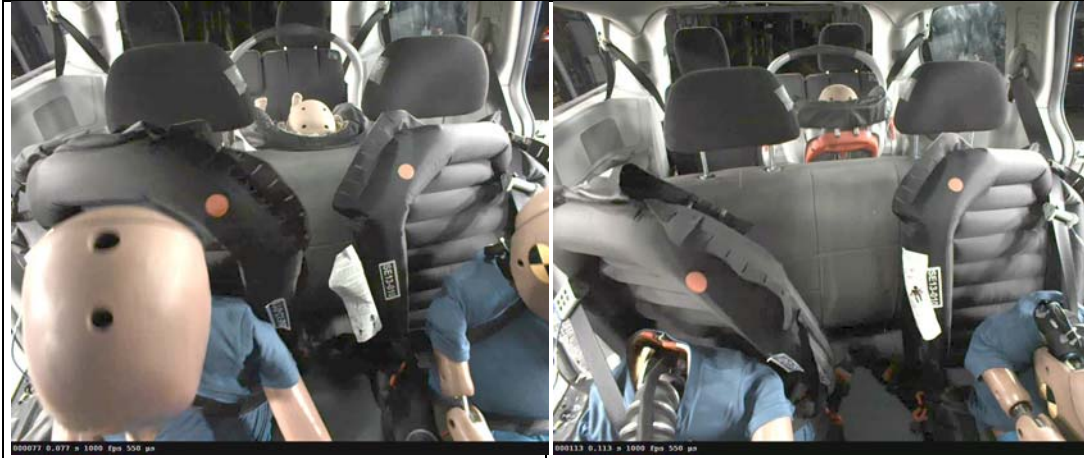
FIGURE 10 FRONTAL VIEWS OBTAINED DURING FORWARD EXCURSION SHOWING SHOULDER BELT LOADING OF THE NECK AND INBOARD AXILLAE FOR BOTH THE 6 AND 10-YEAR-OLD ATDS.

Figure 10 displays the position of the shoulder belt with respect to the neck as the dummies slid towards the front edge of the seat and slipped underneath the lap belts. Both shoulder belts loaded the neck and inboard axilla of each ATD.

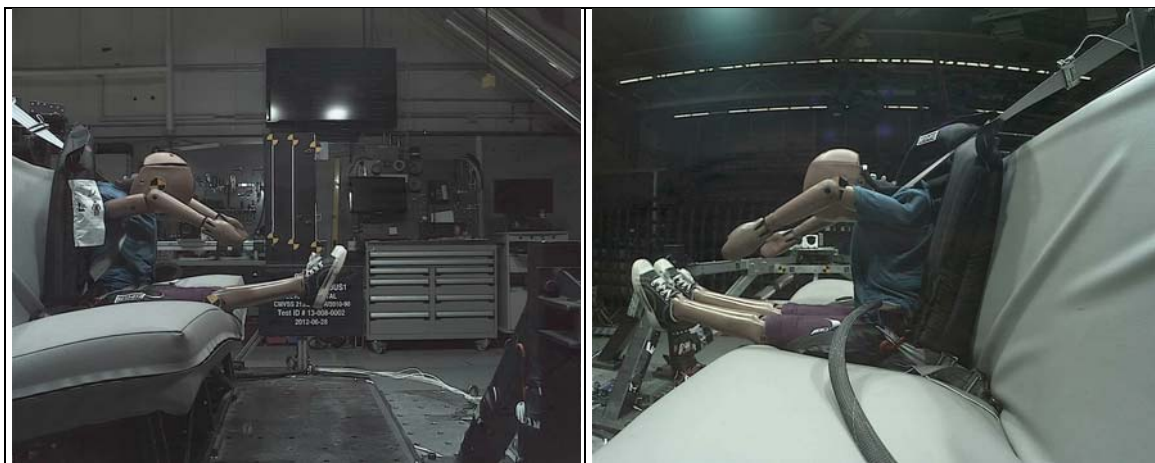
FIGURE 13 MOTION OF HYBRID III 6-YEAR-OLD AND THE GOBOOSTER DURING THE CMVSS 213 COMPLIANCE TEST.

Kinematic response for the Hybrid III 6-year-old was significantly different when evaluated on the CMVSS 213 bench. As can be seen from left and right side images obtained at peak excursion and shown in Figure 13, the ATD remained upright and there was very little forward displacement of the ATD or booster cushion with respect to the bench.

The GoBooster met all excursion requirements but failed to meet the peak chest acceleration clip requirement of 60 g in both compliance tests.
