**REPORT NUMBER: NCAP-KAR-20-027**

**NEW CAR ASSESSMENT PROGRAM (NCAP)  
FRONTAL BARRIER IMPACT TEST**

**NISSAN MOTOR CO., LTD.  
2020 NISSAN KICKS 5-DOOR SUV**

**FINAL REPORT**

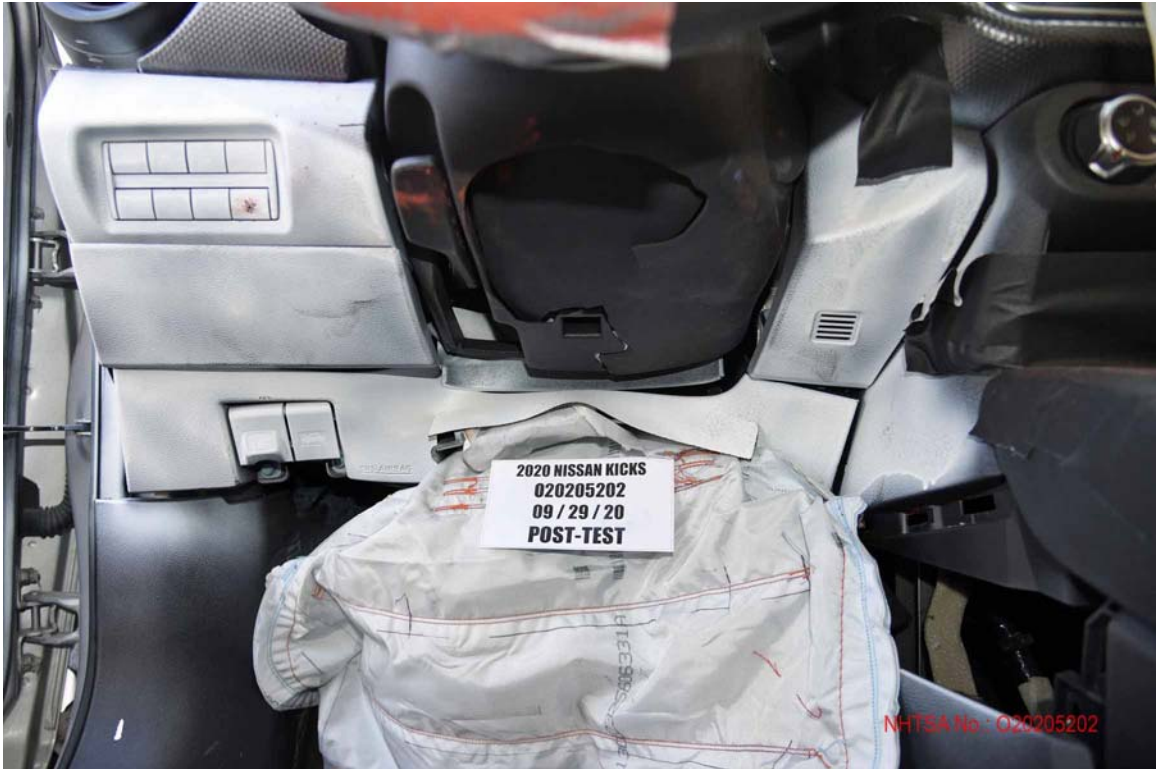
FIGURE 45. Post-Test Driver's Side Knee Bolster

The driver's visible contact points were as follows: the driver ATD's head contacted the frontal airbag and headrest. The upper torso contacted the frontal airbag. Both the left and right knees contacted the knee airbag.
