**REPORT NUMBER: NCAP-MGA-21-007**

**NEW CAR ASSESSMENT PROGRAM (NCAP)  
Frontal Barrier Impact Test**

**GM KOREA COMPANY  
2021 Chevrolet Trailblazer AWD LT 5-Door SUV  
NHTSA No.: O20210100**

**FINAL REPORT**

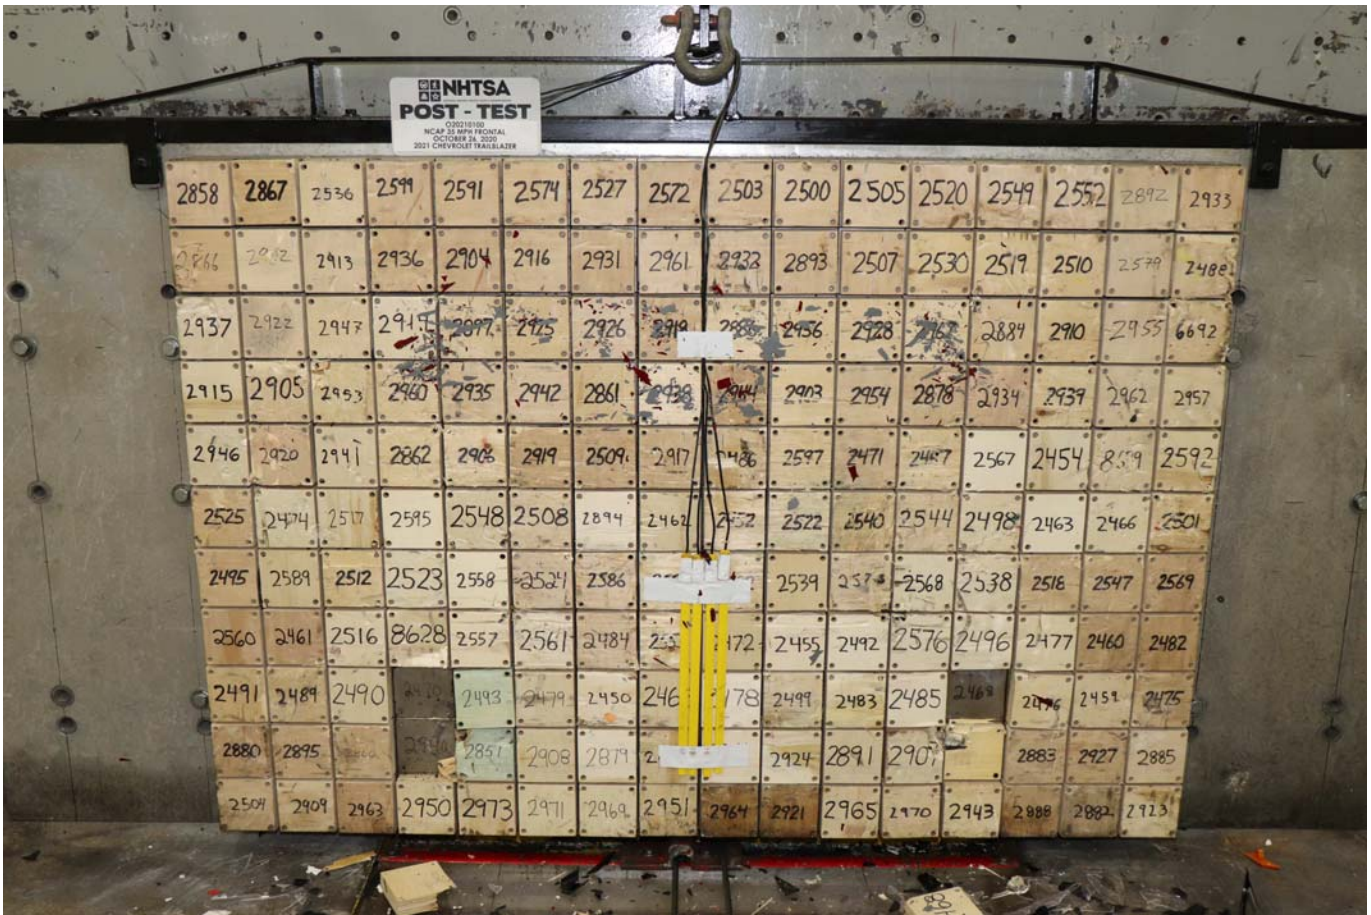
Photo No. 003 - Post-Test Load Cell Wall

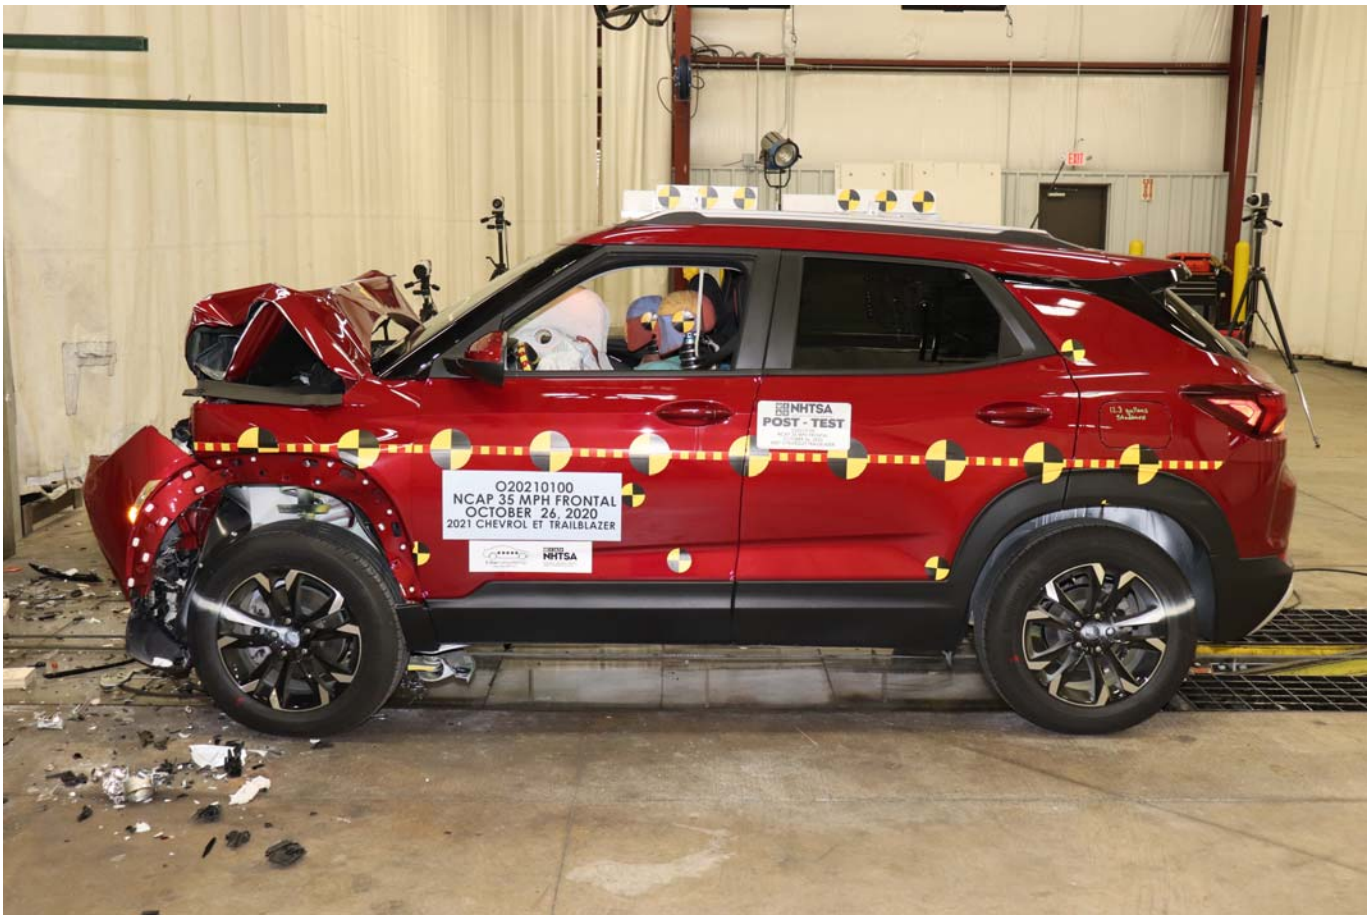
Photo No. 011 - Post-Test Left View of Test Vehicle

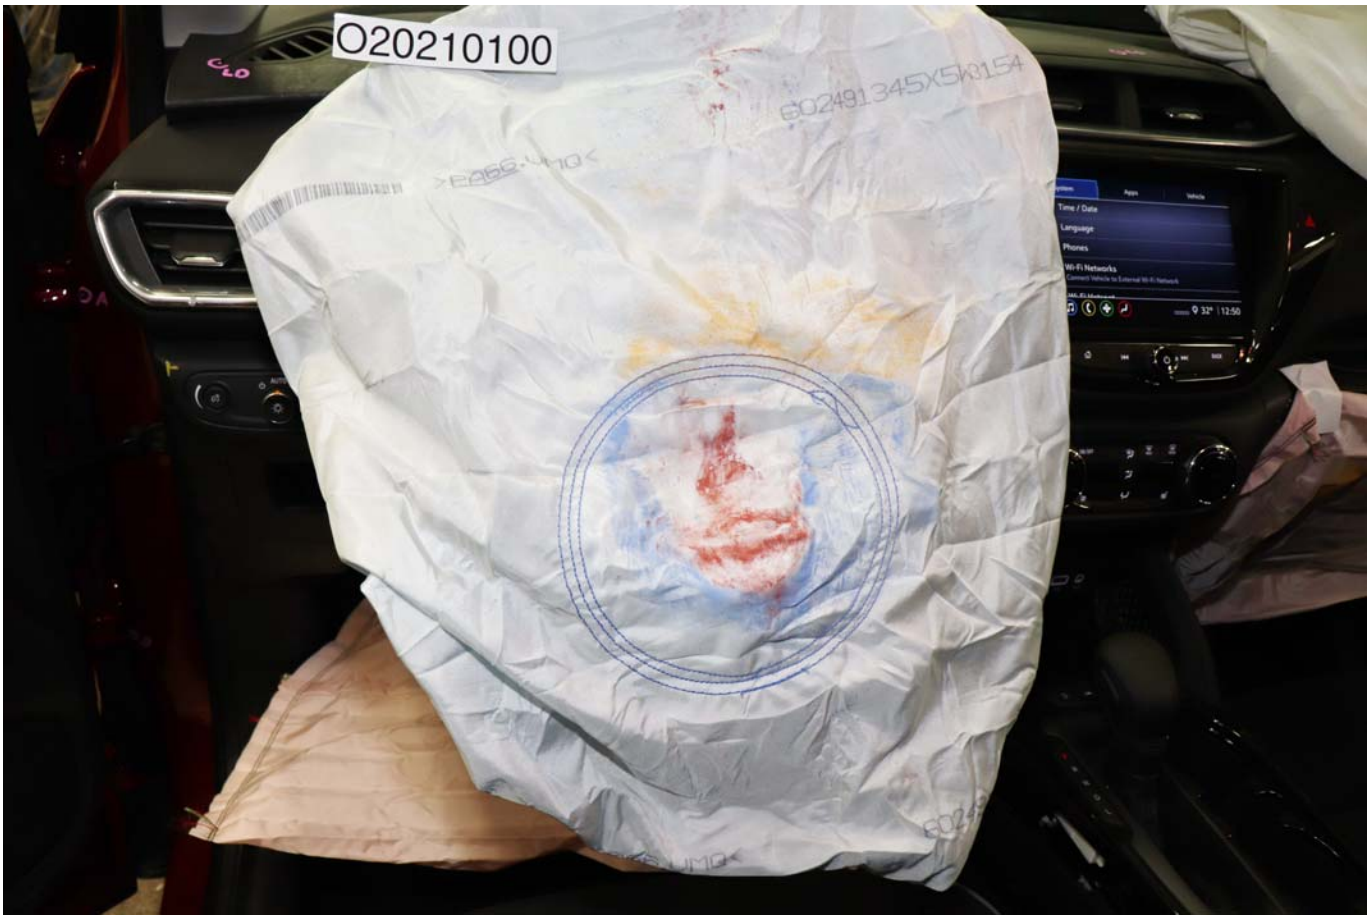
Photo No. 049 - Post-Test Driver Dummy Contact with Airbag

The driver's visible contact points were as follows: The driver's head contacted the airbag. The driver's head also contacted the headrest. The driver's knees contacted the knee airbag.

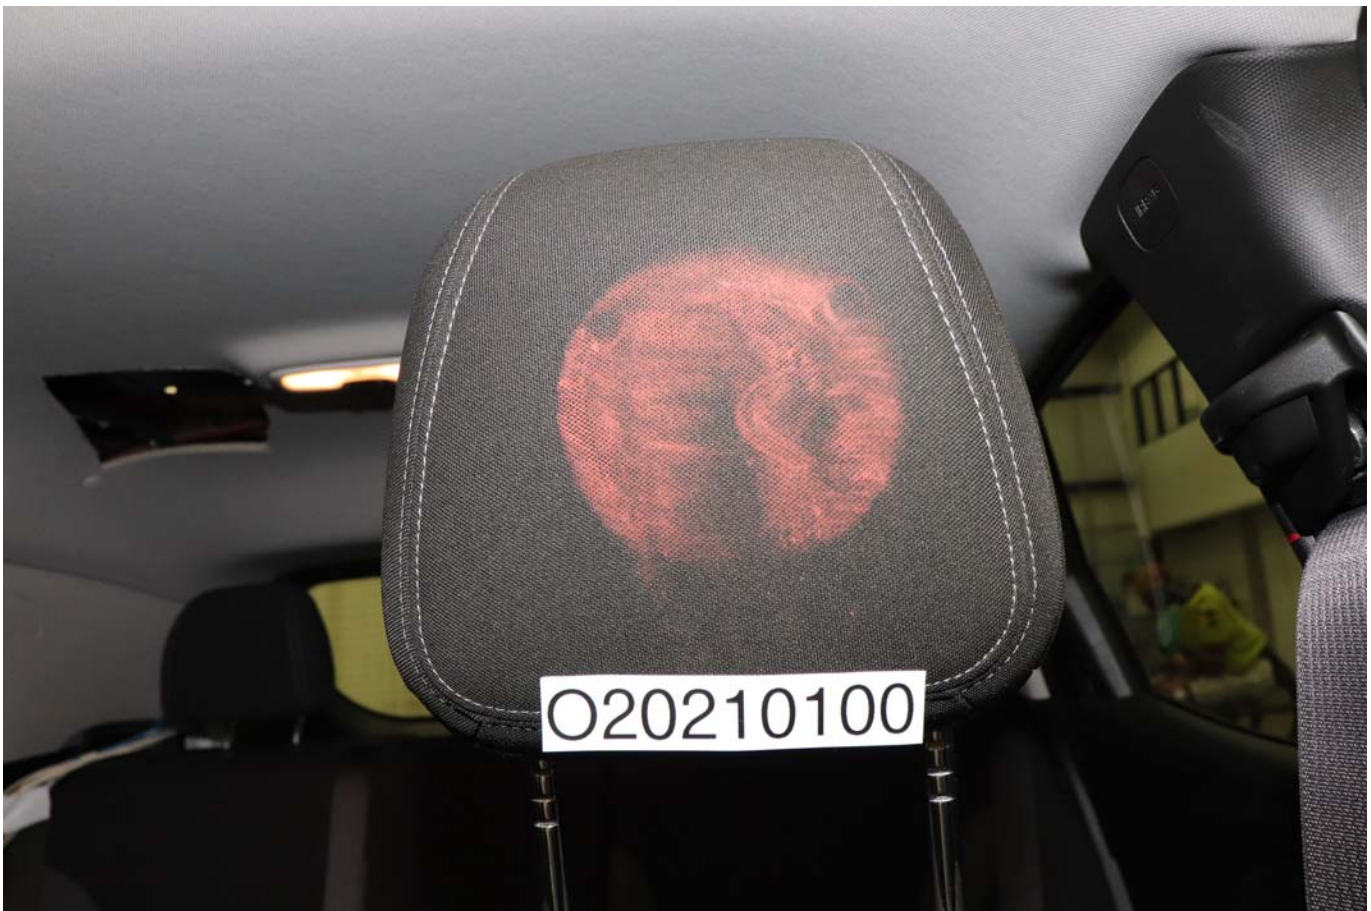
Photo No. 050 - Post-Test Driver Dummy Contact with Headrest

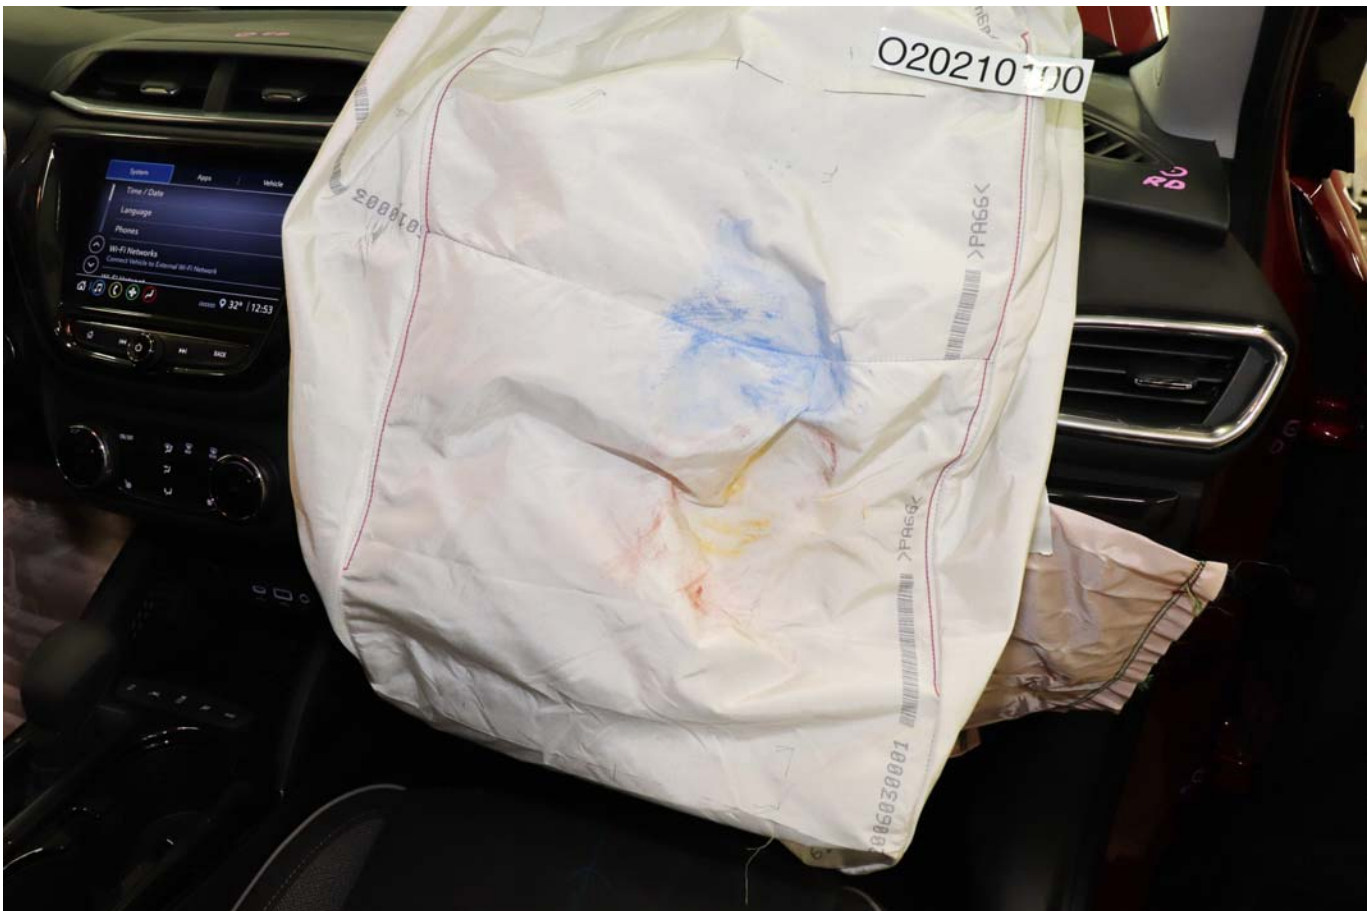
Photo No. 072 - Post-Test Passenger Dummy Contact with Airbag

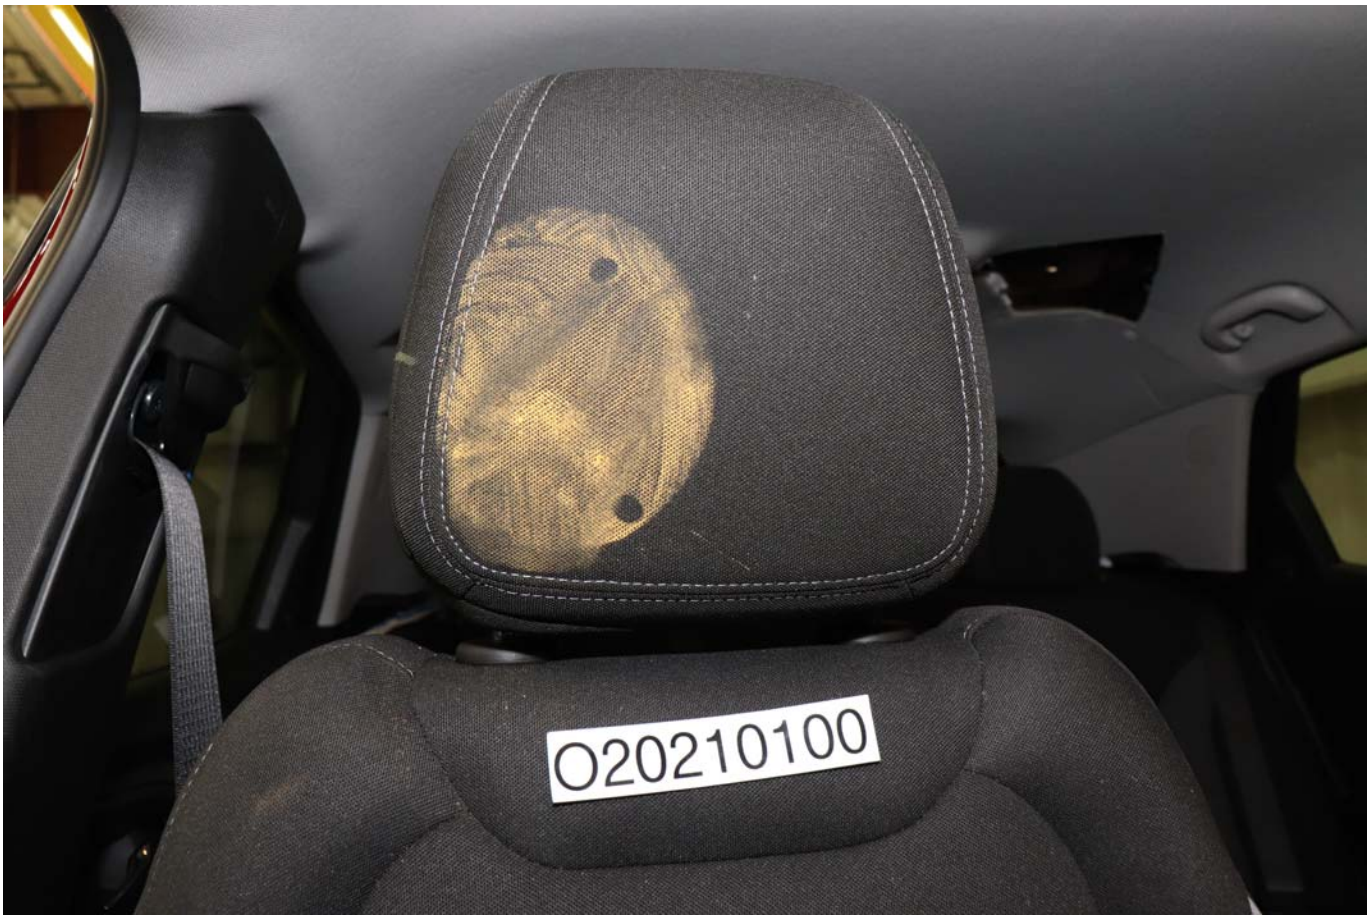
Photo No. 073 - Post-Test Passenger Dummy Contact with Headrest
