**REPORT NUMBER: NCAP-MGA-21-005**

**NEW CAR ASSESSMENT PROGRAM (NCAP)  
Frontal Barrier Impact Test**

**KIA MOTORS MANUFACTURING GEORGIA, INC.  
2021 Kia K5 LXS 4-Door Sedan  
NHTSA No.: O20214203**

**FINAL REPORT**

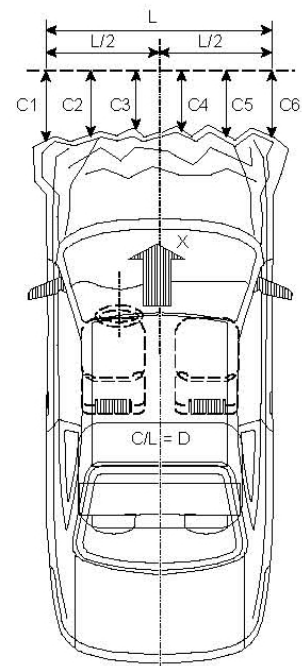
**CRUSH PROFILE**

Collision Deformation Classification:	<u>12FDEW3</u>
Midpoint of Damage:	<u>Centerline</u>
Damage Region Length (mm):	<u>1400</u>
Impact Mode:	<u>Frontal</u>

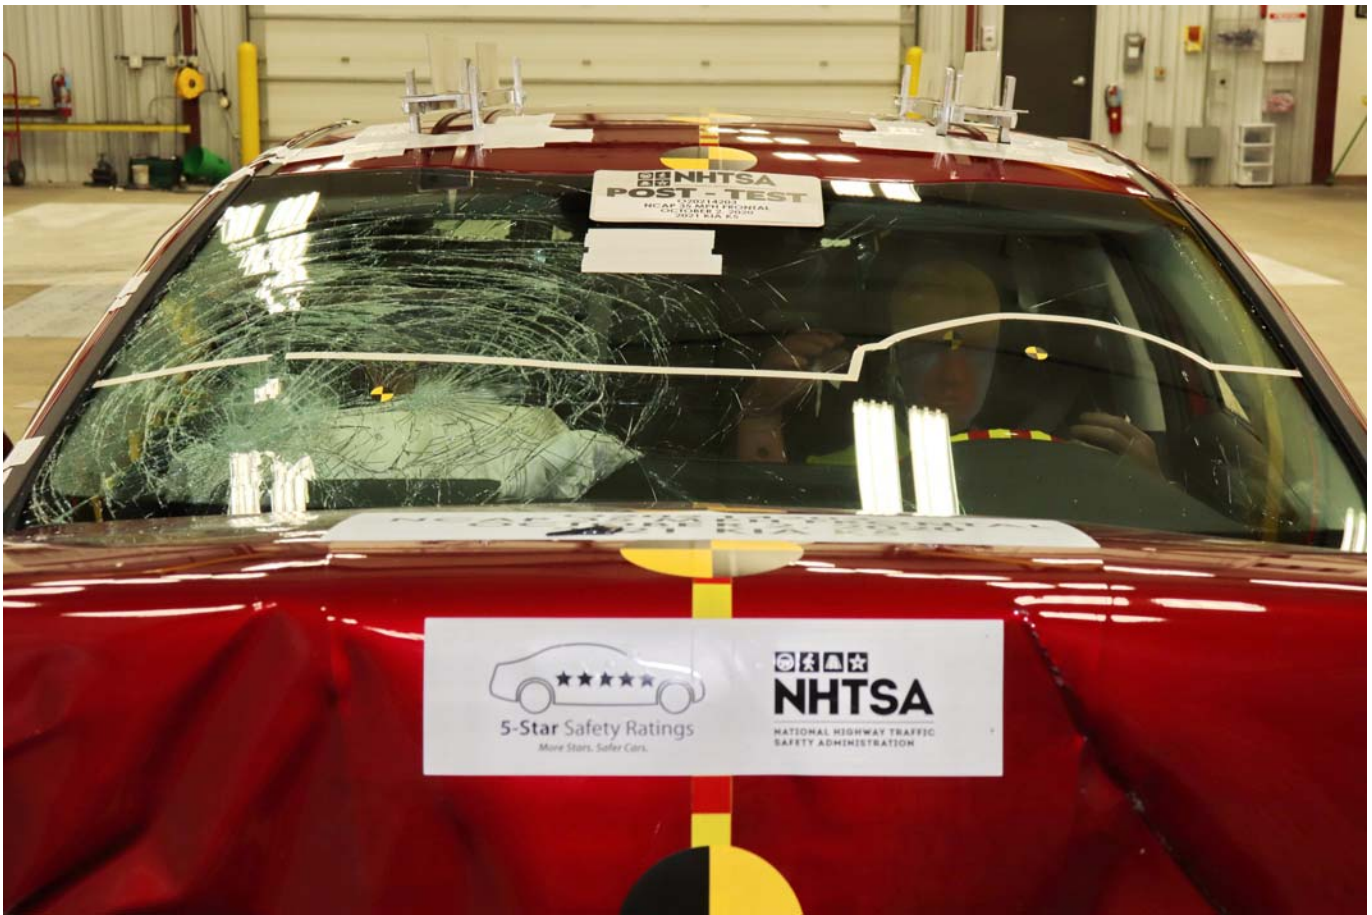
Photo No. 019 - Post-Test Windshield View

There was 100 percent windshield retention and no intrusion into the protected zone of the windshield during the event. There was no Stoddard Solvent leakage after the event or during any phase of the static rollover.

Critical Areas of Performance	Observations and Conclusions
Windshield Damage	Cracked
Window Damage	None
Other Notable Effects	None

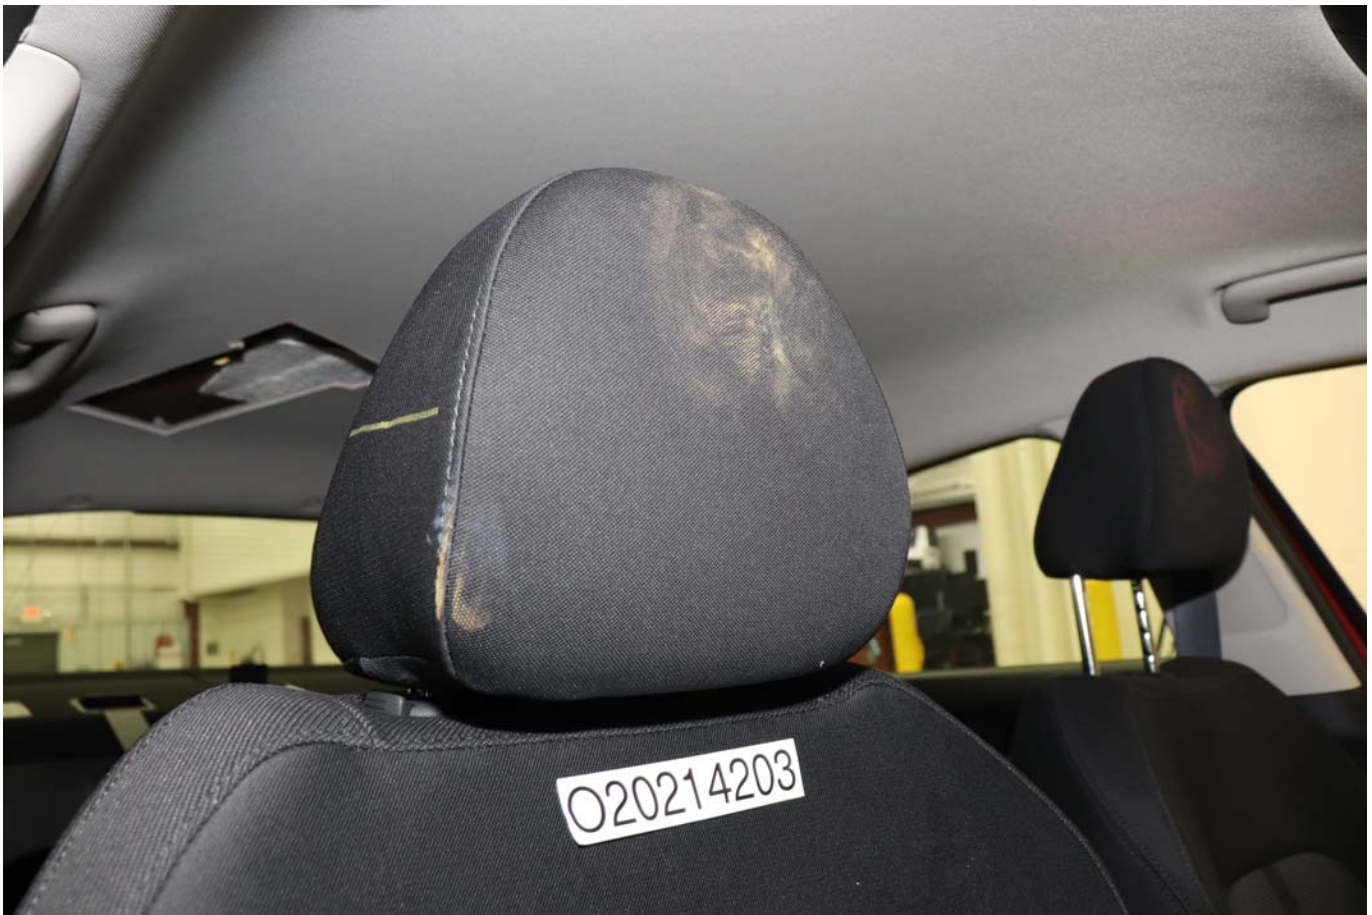
Photo No. 073 - Post-Test Passenger Dummy Contact with Headrest

The passenger's visible contact points were as follows: The passenger's head contacted the airbag. The passenger's head also contacted the headrest.
