**REPORT NUMBER: SideNCAPPole-MGA-21-001**

**NEW CAR ASSESSMENT PROGRAM (NCAP)  
Side Impact Pole Test**

**KIA MOTORS CORPORATION  
2021 Kia Seltos S 5-Door SUV  
NHTSA No.: O20214201**

**FINAL REPORT**

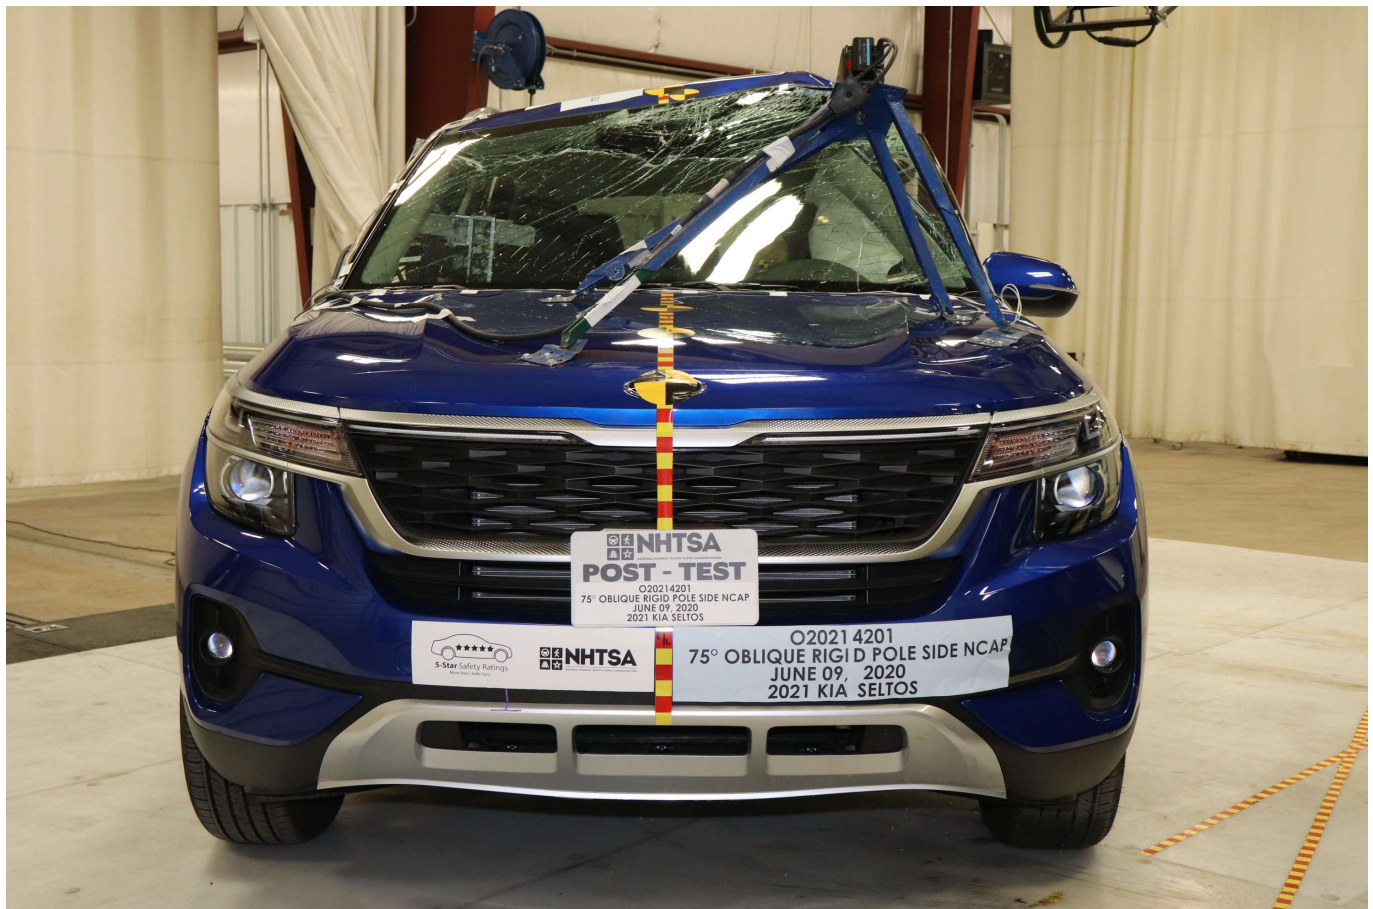
Photo No. 004 - Post-Test Frontal View of Test Vehicle

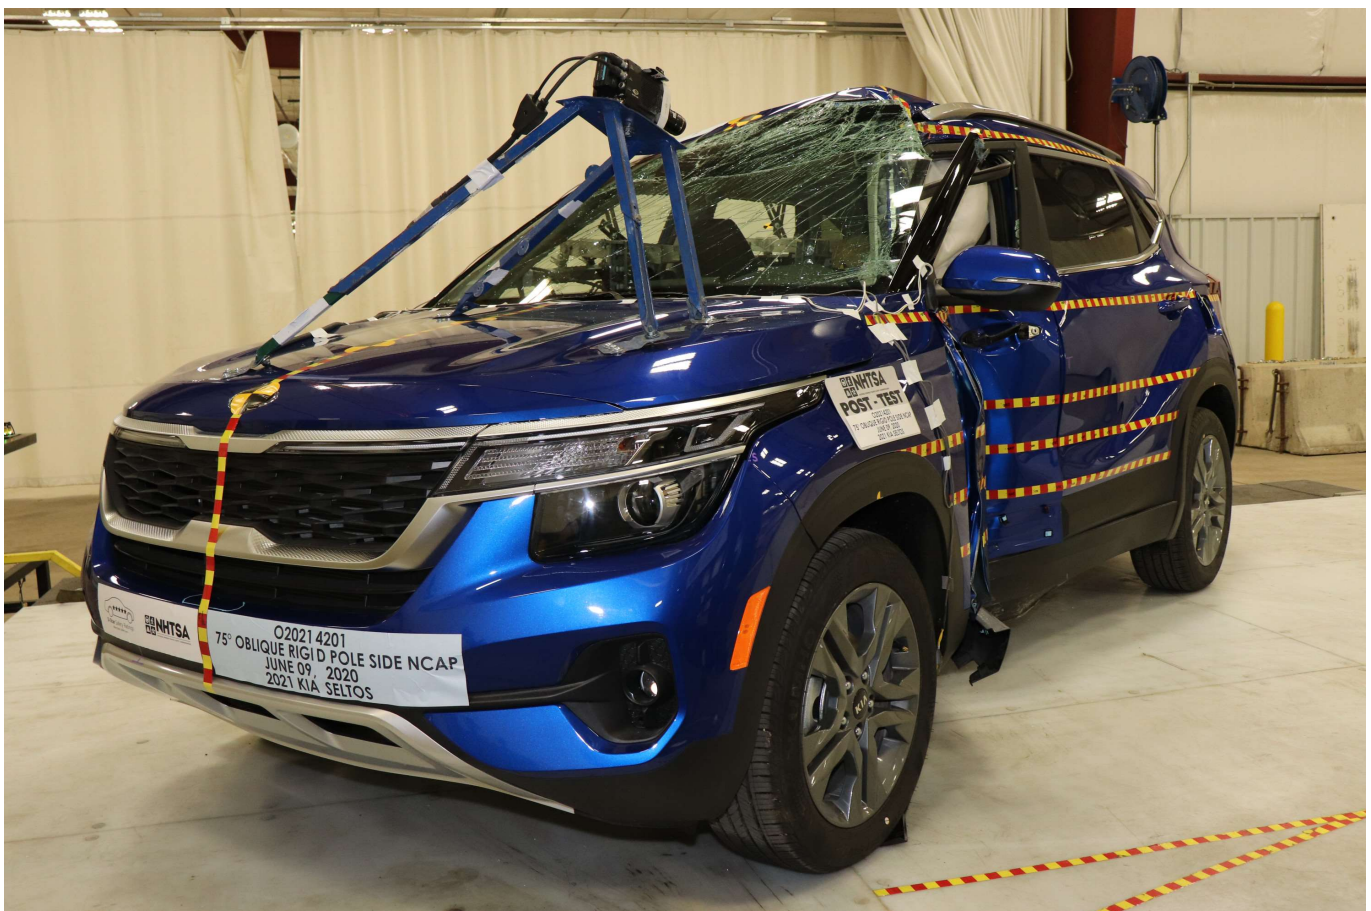
Photo No. 006 - Post-Test Left Front Three-Quarter View of Test Vehicle

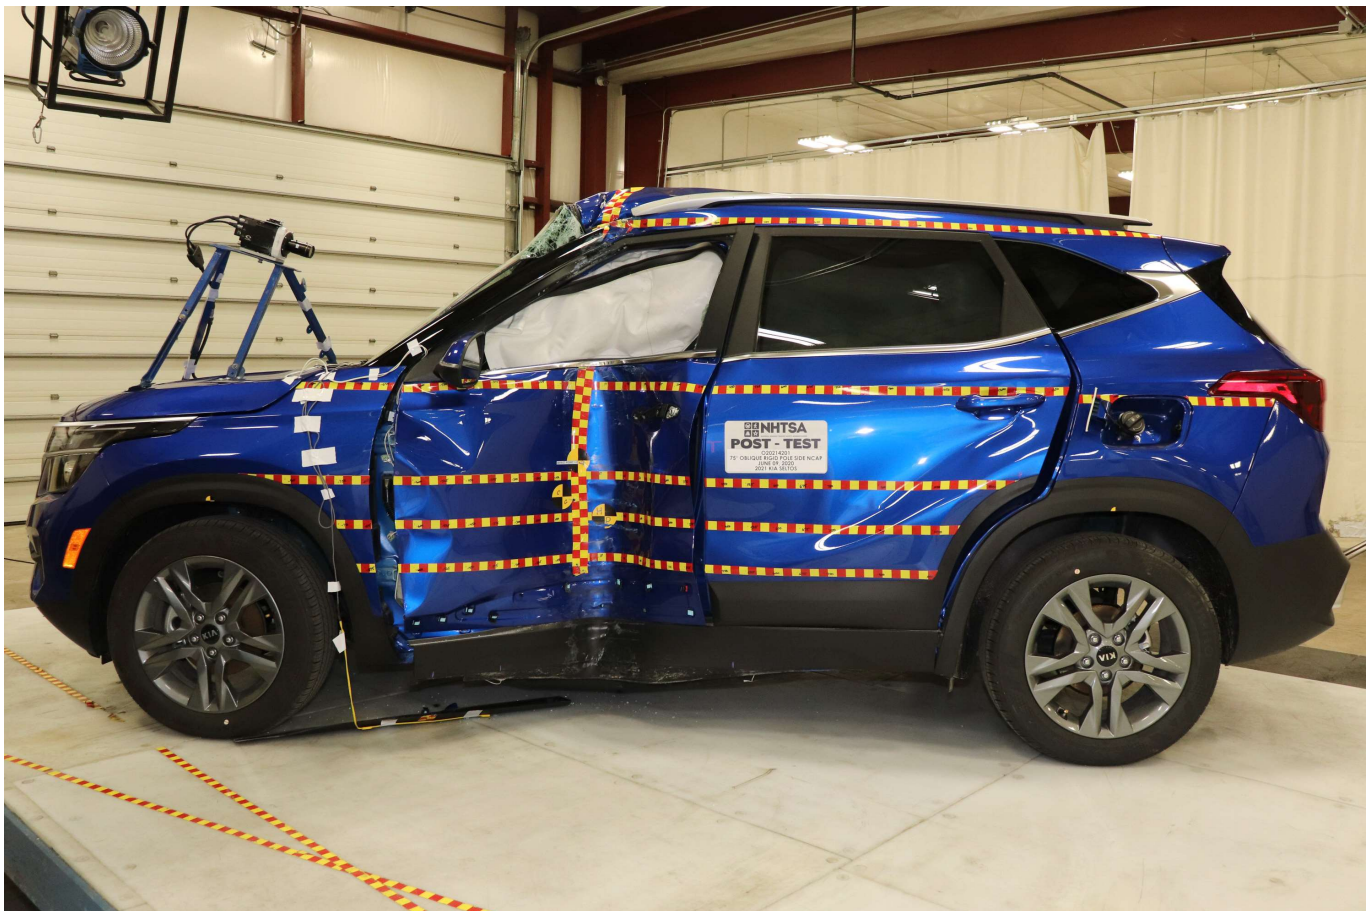
Photo No. 008 - Post-Test Left Side View of Test Vehicle

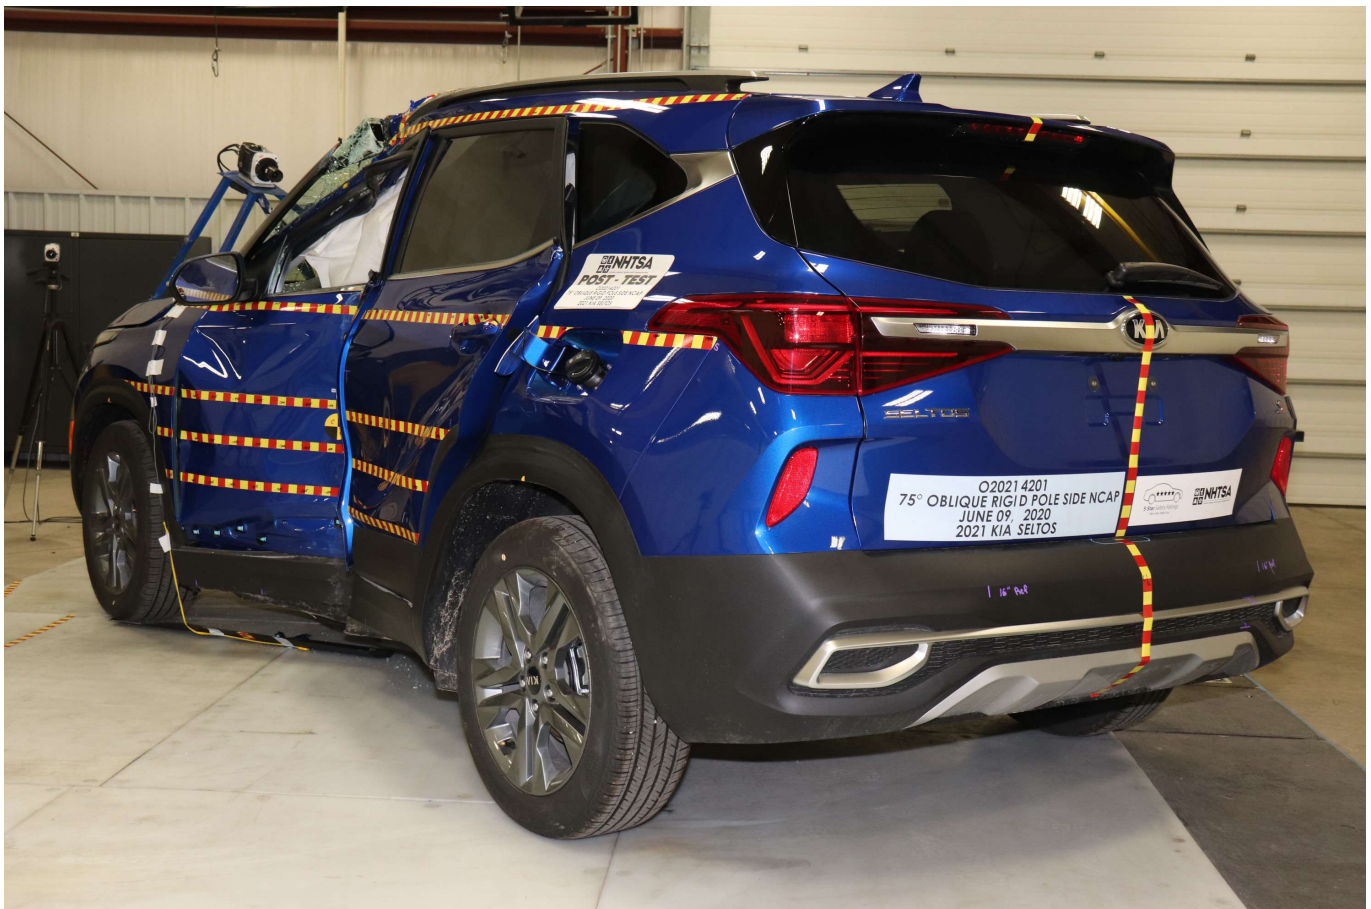
Photo No. 010 - Post-Test Left Rear Three-Quarter View of Test Vehicle

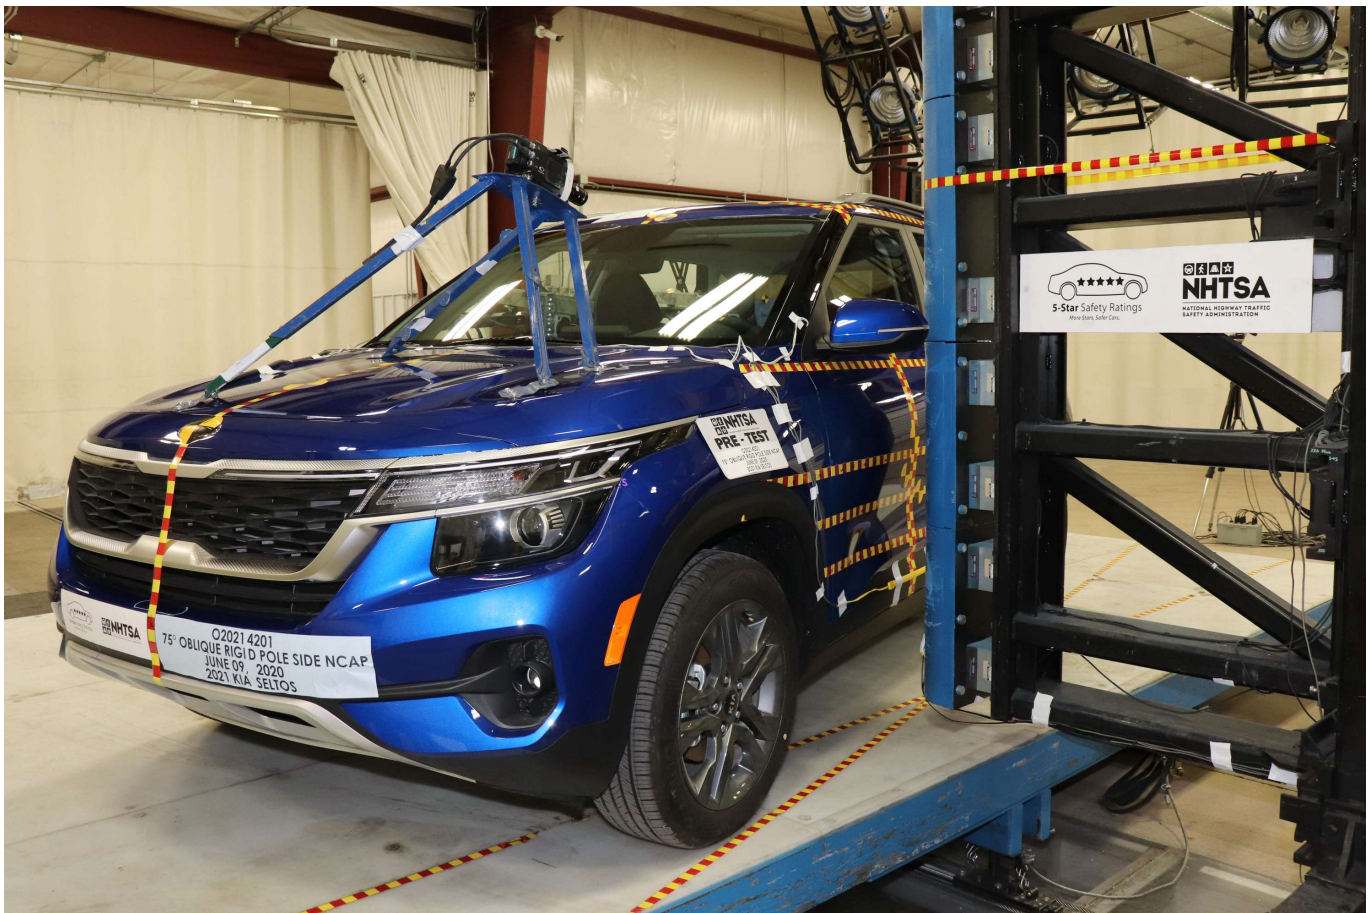
Photo No. 017 - Pre-Test Left Side View of Pole Positioned Against Side of Vehicle

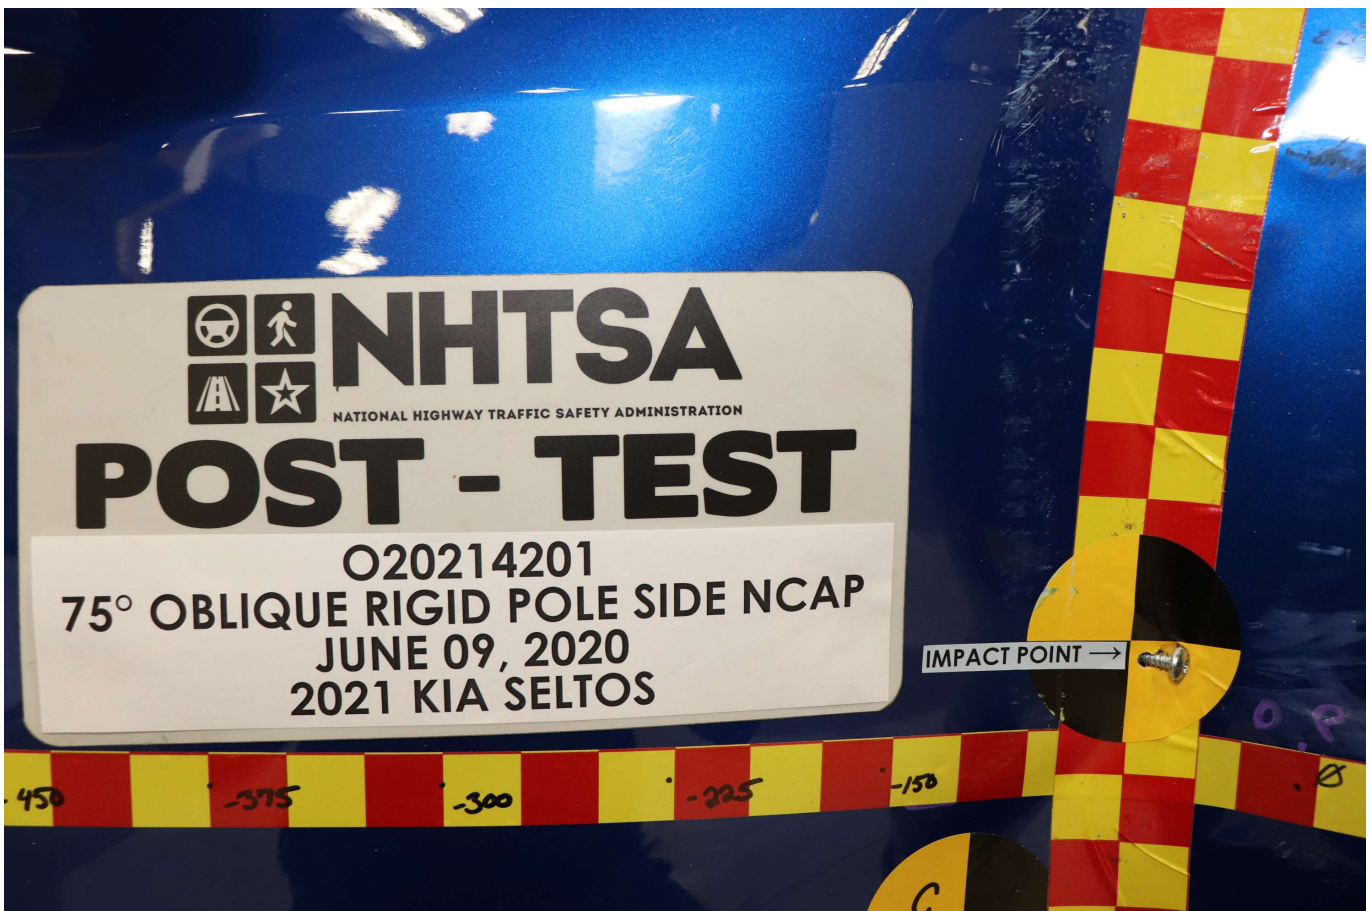
Photo No. 020 - Post-Test Close-Up View of Impact Point Target Showing Impact Location

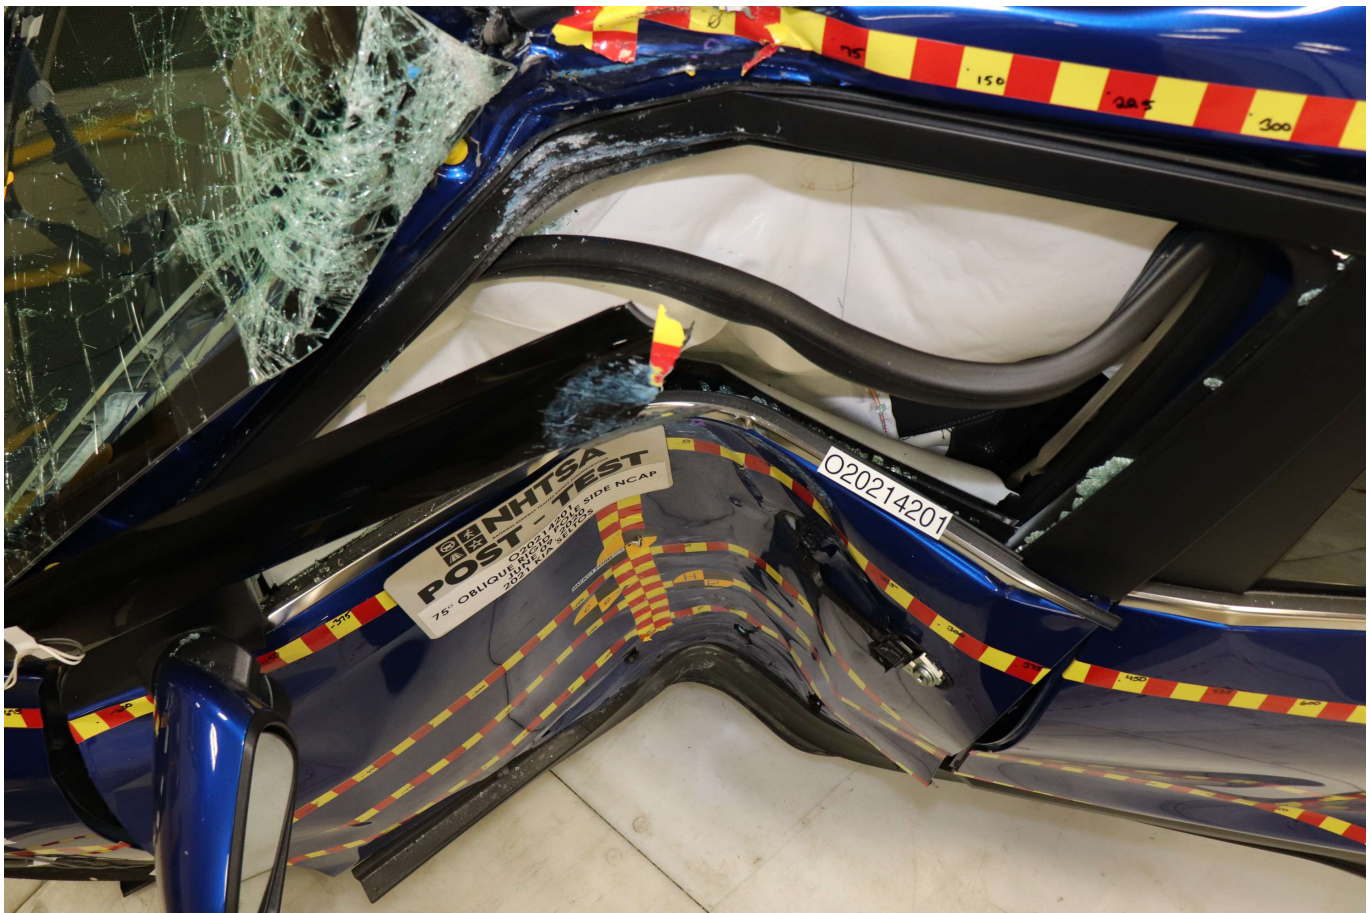
Photo No. 041 - Post-Test Dummy and Door Clearance View

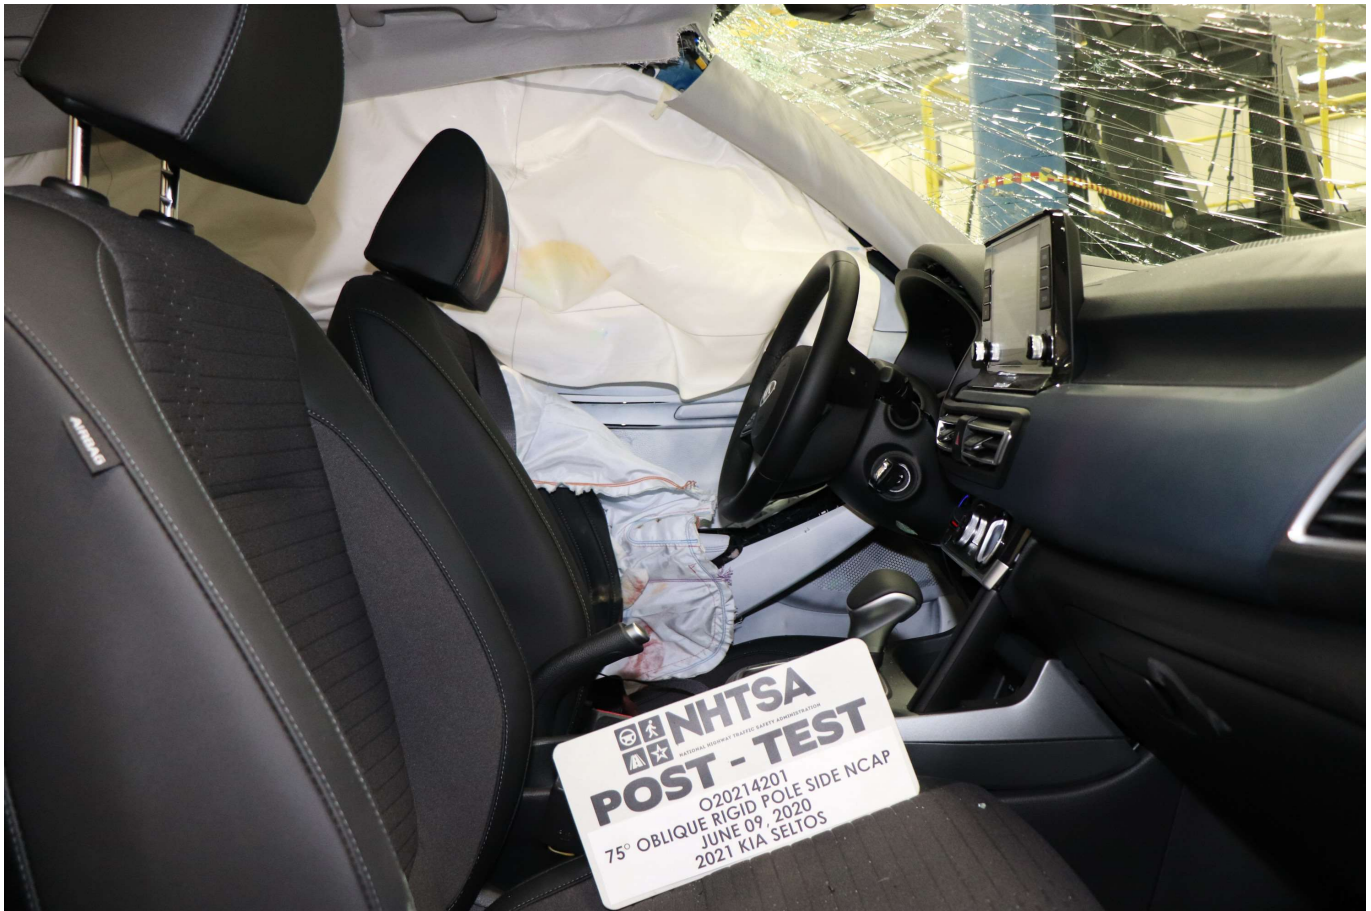
Photo No. 045 - Post-Test Inner Door Panel View Showing Dummy Contact Location

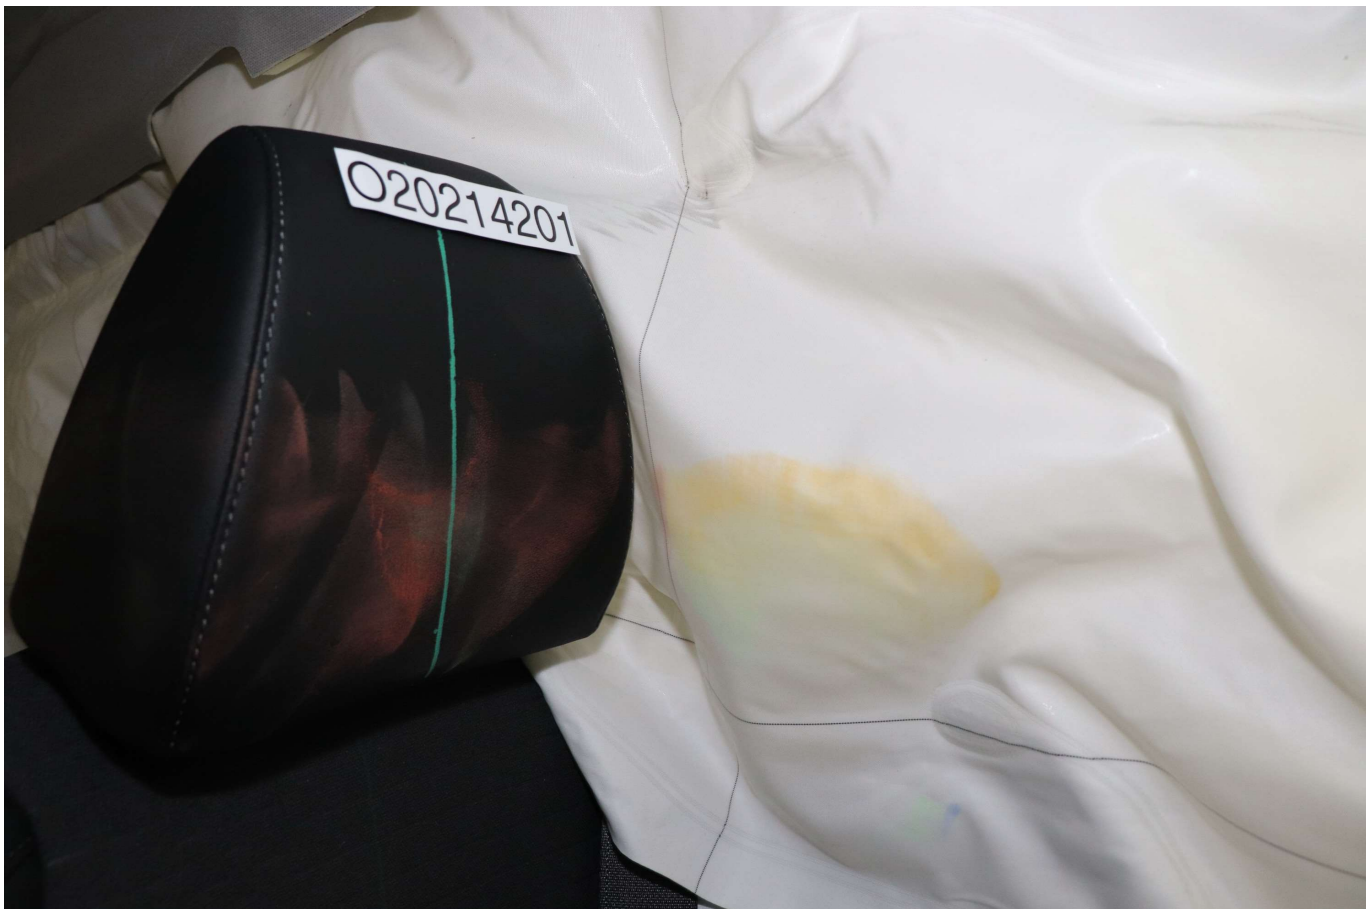
Photo No. 046 - Post-Test Dummy Close-Up Head Contact with Vehicle Interior View

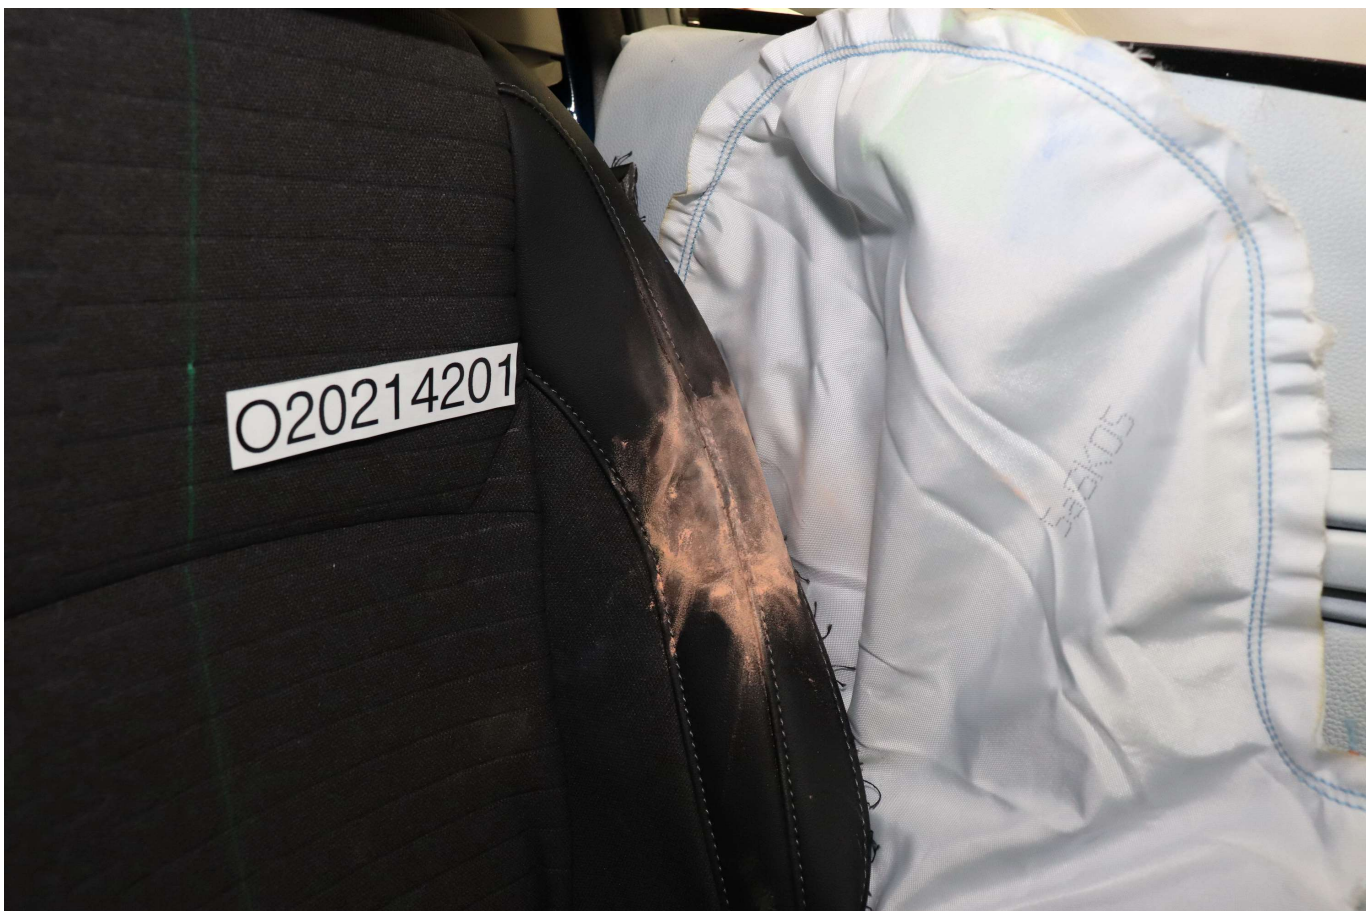
Photo No. 048 - Post-Test Dummy Close-Up Torso Contact with Vehicle Interior View

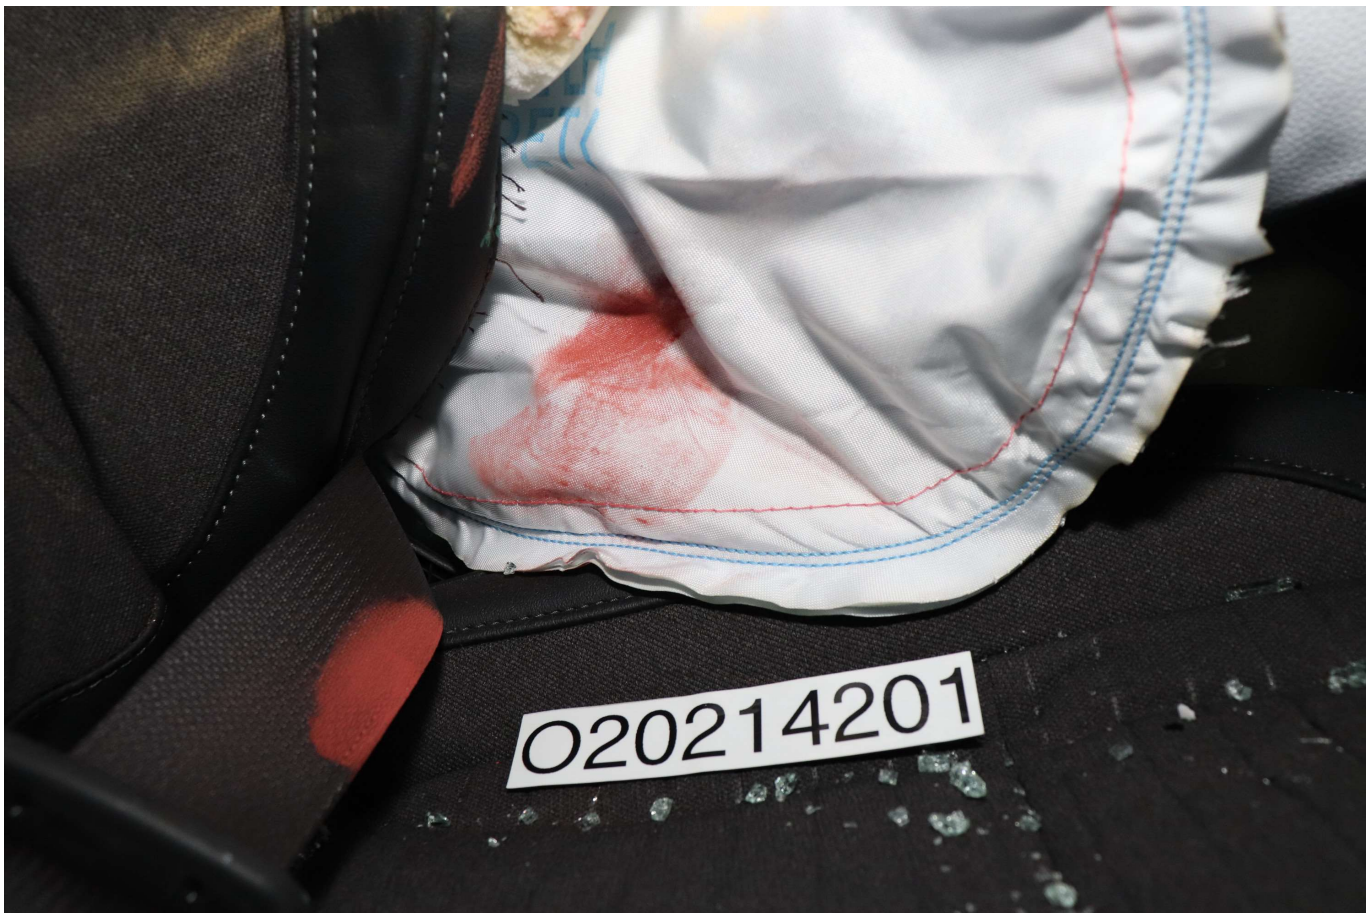
Photo No. 051 - Post-Test Dummy Close-Up Pelvis Contact with Side Air Bag View

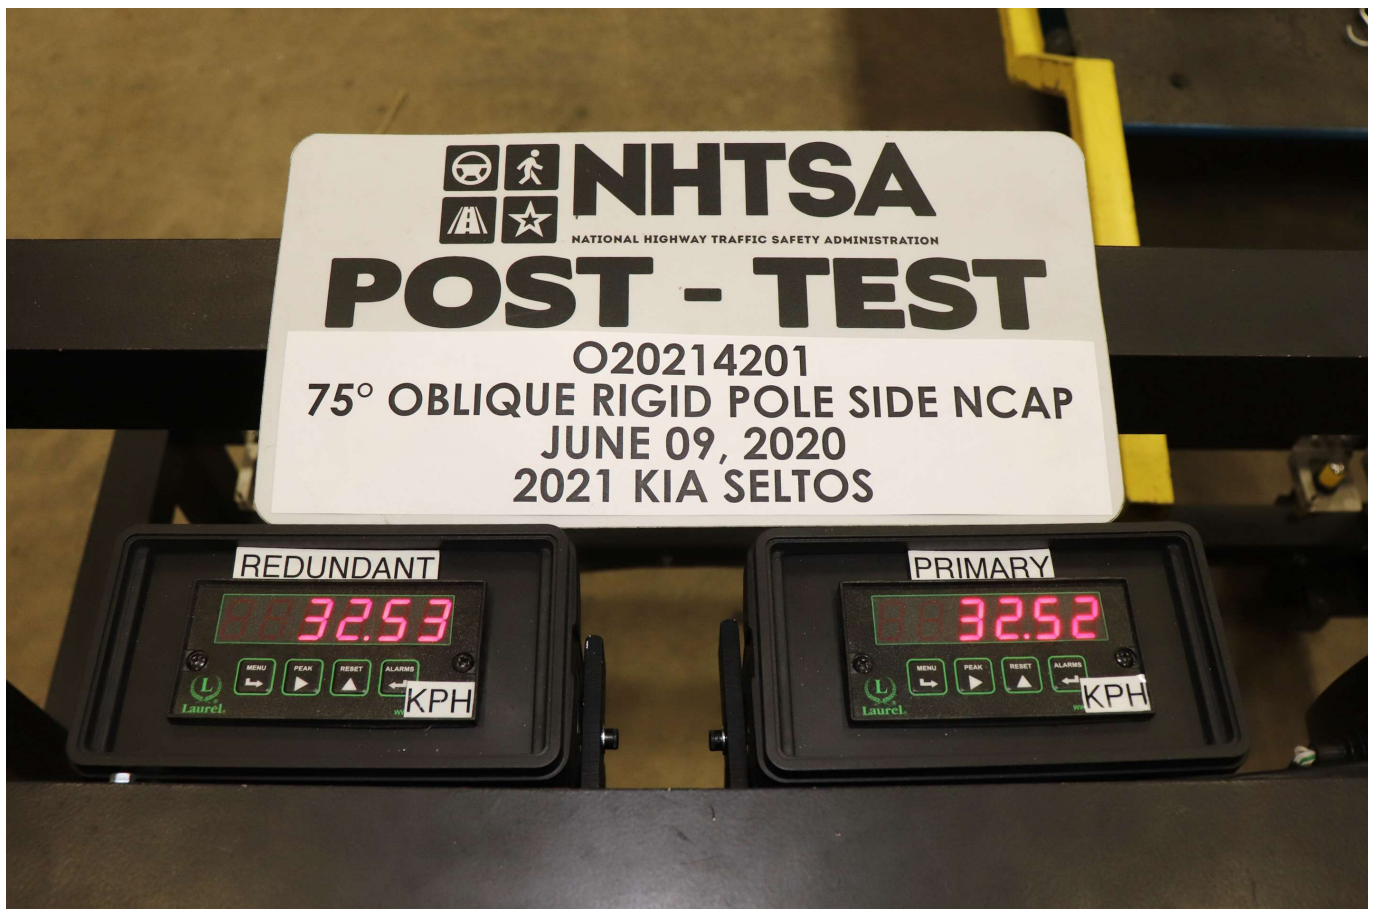
Photo No. 064 - Post-Test Primary and Redundant Speed Trap Read-Out

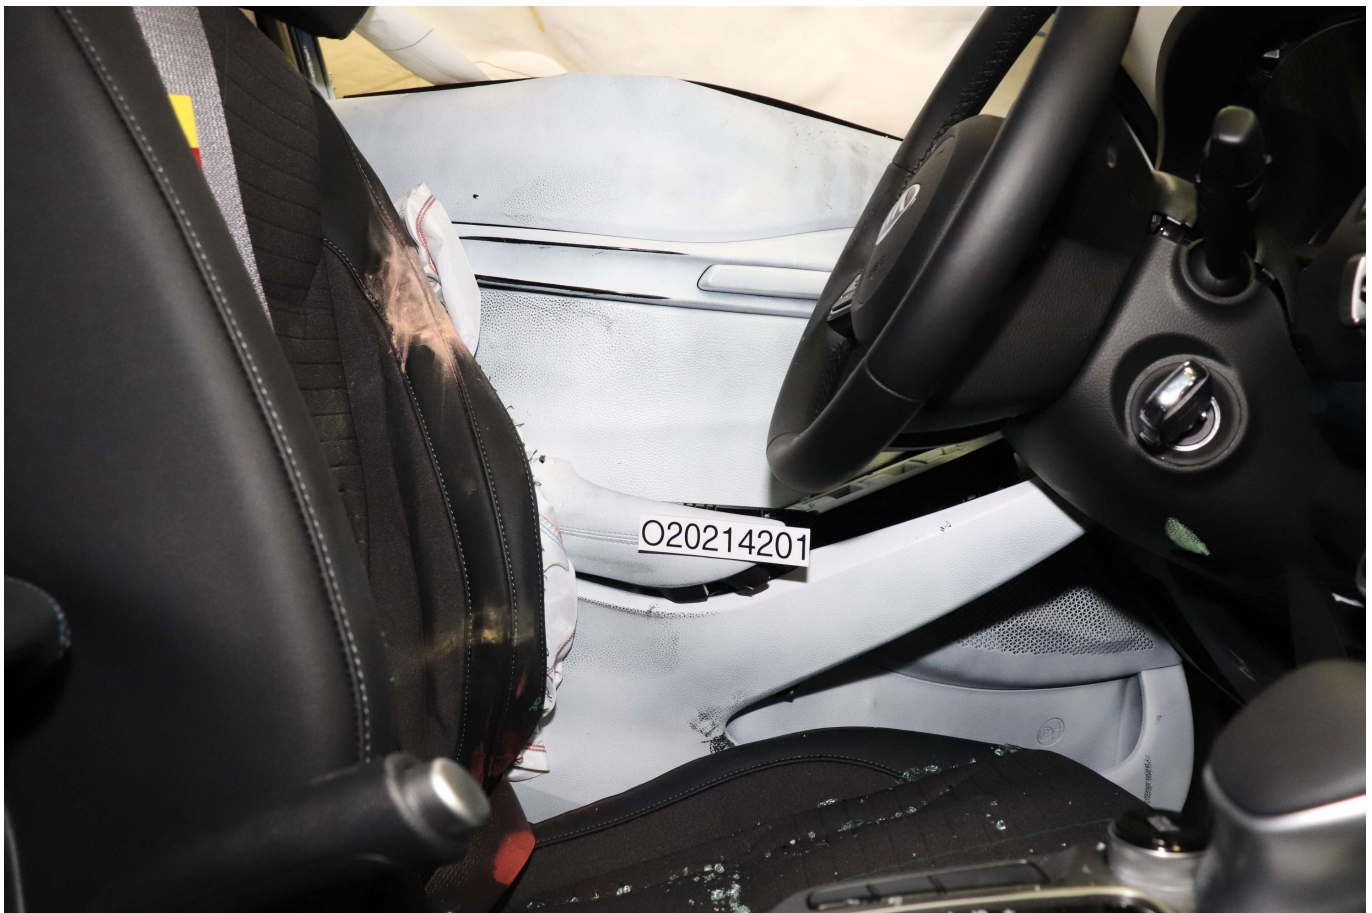
Photo No. 073 - Post-Test View of Shattered Vehicle Inner Door Panel
