**NEW CAR ASSESSMENT PROGRAM
CRASH IMMINENT BRAKING SYSTEM CONFIRMATION TEST
NCAP-DRI-CIB-21-16**

2021 Toyota Highlander LE - V6 FWD

DYNAMIC RESEARCH, INC.
355 Van Ness Avenue, STE 200
Torrance, California 90501

Final Report

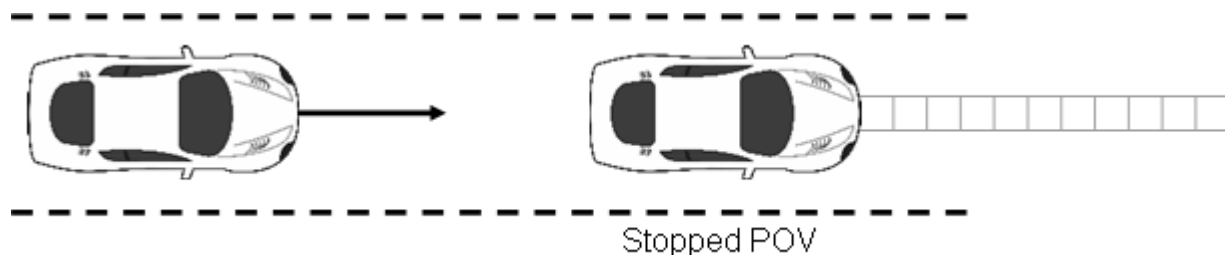
This test evaluates the ability of the CIB system to detect and respond to a stopped lead vehicle in the immediate forward path of the SV, as depicted in Figure 1.

Figure 1. Depiction of Test 1

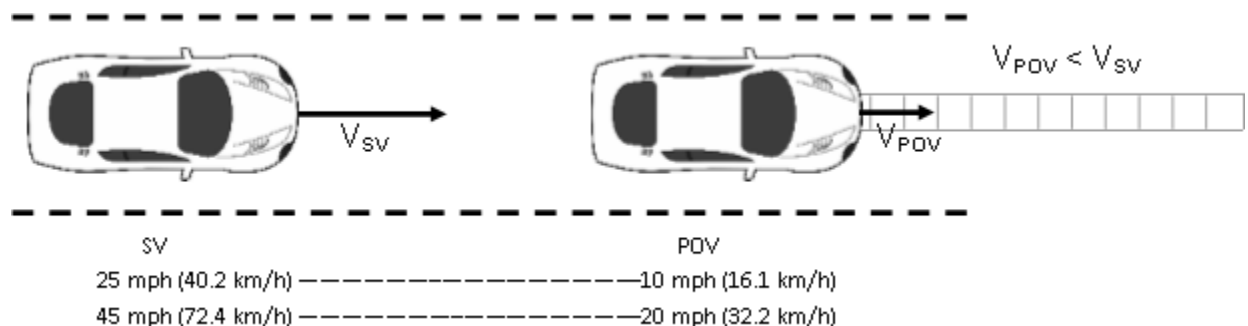
- This test evaluates the ability of the CIB system to detect and respond to a slower-moving lead vehicle traveling at a constant speed in the immediate forward path of the SV, as depicted in Figure 2.

Figure 2. Depiction of Test 2

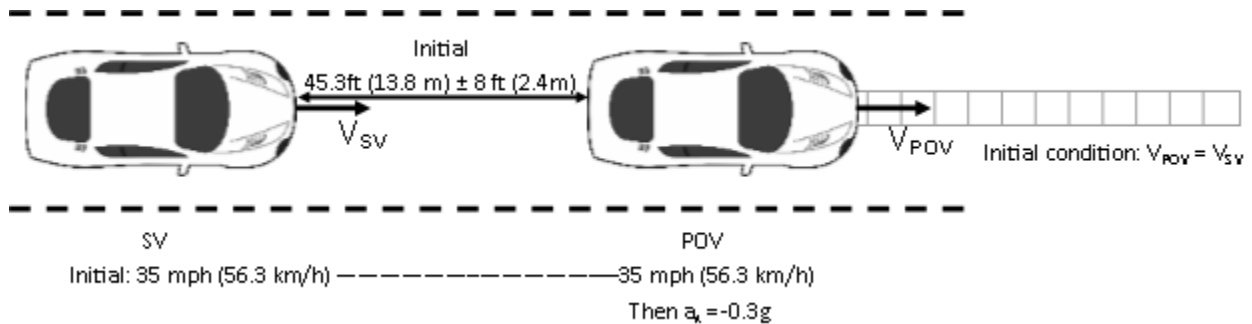
This test evaluates the ability of the CIB system to detect and respond to a lead vehicle slowing with a constant deceleration in the immediate forward path of the SV, as depicted in Figure 3.

Figure 3. Depiction of Test 3

The SV ignition was cycled prior to each test run. For this test scenario, both the POV and SV were driven at a constant 35.0 mph (56.3 km/h) in the center of the lane, with a headway of 45.3 ft (13.8 m) ± 8 ft (2.4 m). Once these conditions were met, the POV tow vehicle brakes were applied to achieve 0.3 ± 0.03 g of deceleration. The test concluded when either:

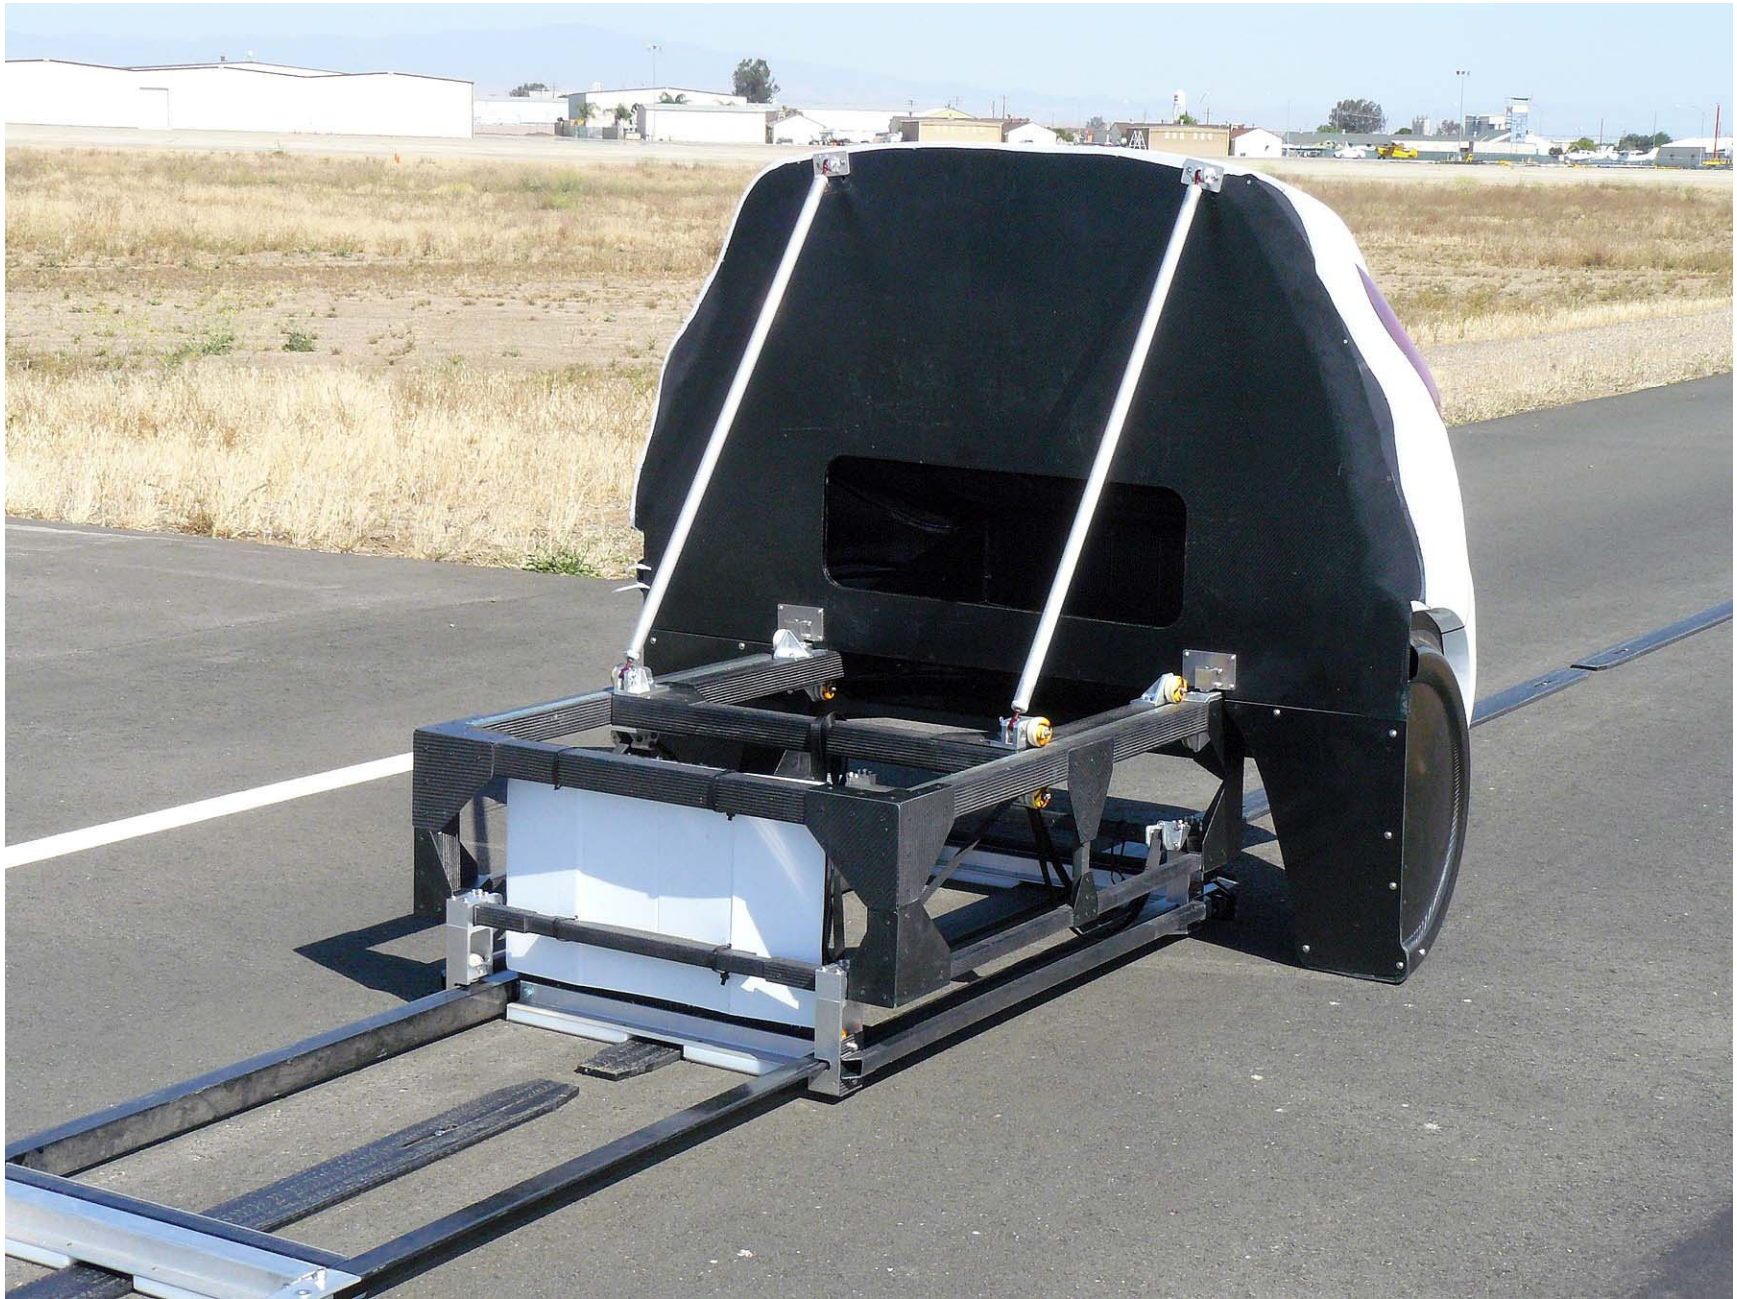
Figure A7. Load Frame/Slider of SSV

CIB testing requires a POV that realistically represents typical vehicles, does not suffer damage or cause damage to a test vehicle in the event of collision, and can be accurately positioned and moved during the tests. The tests reported herein made use of the NHTSA developed Strikeable Surrogate Vehicle (SSV).

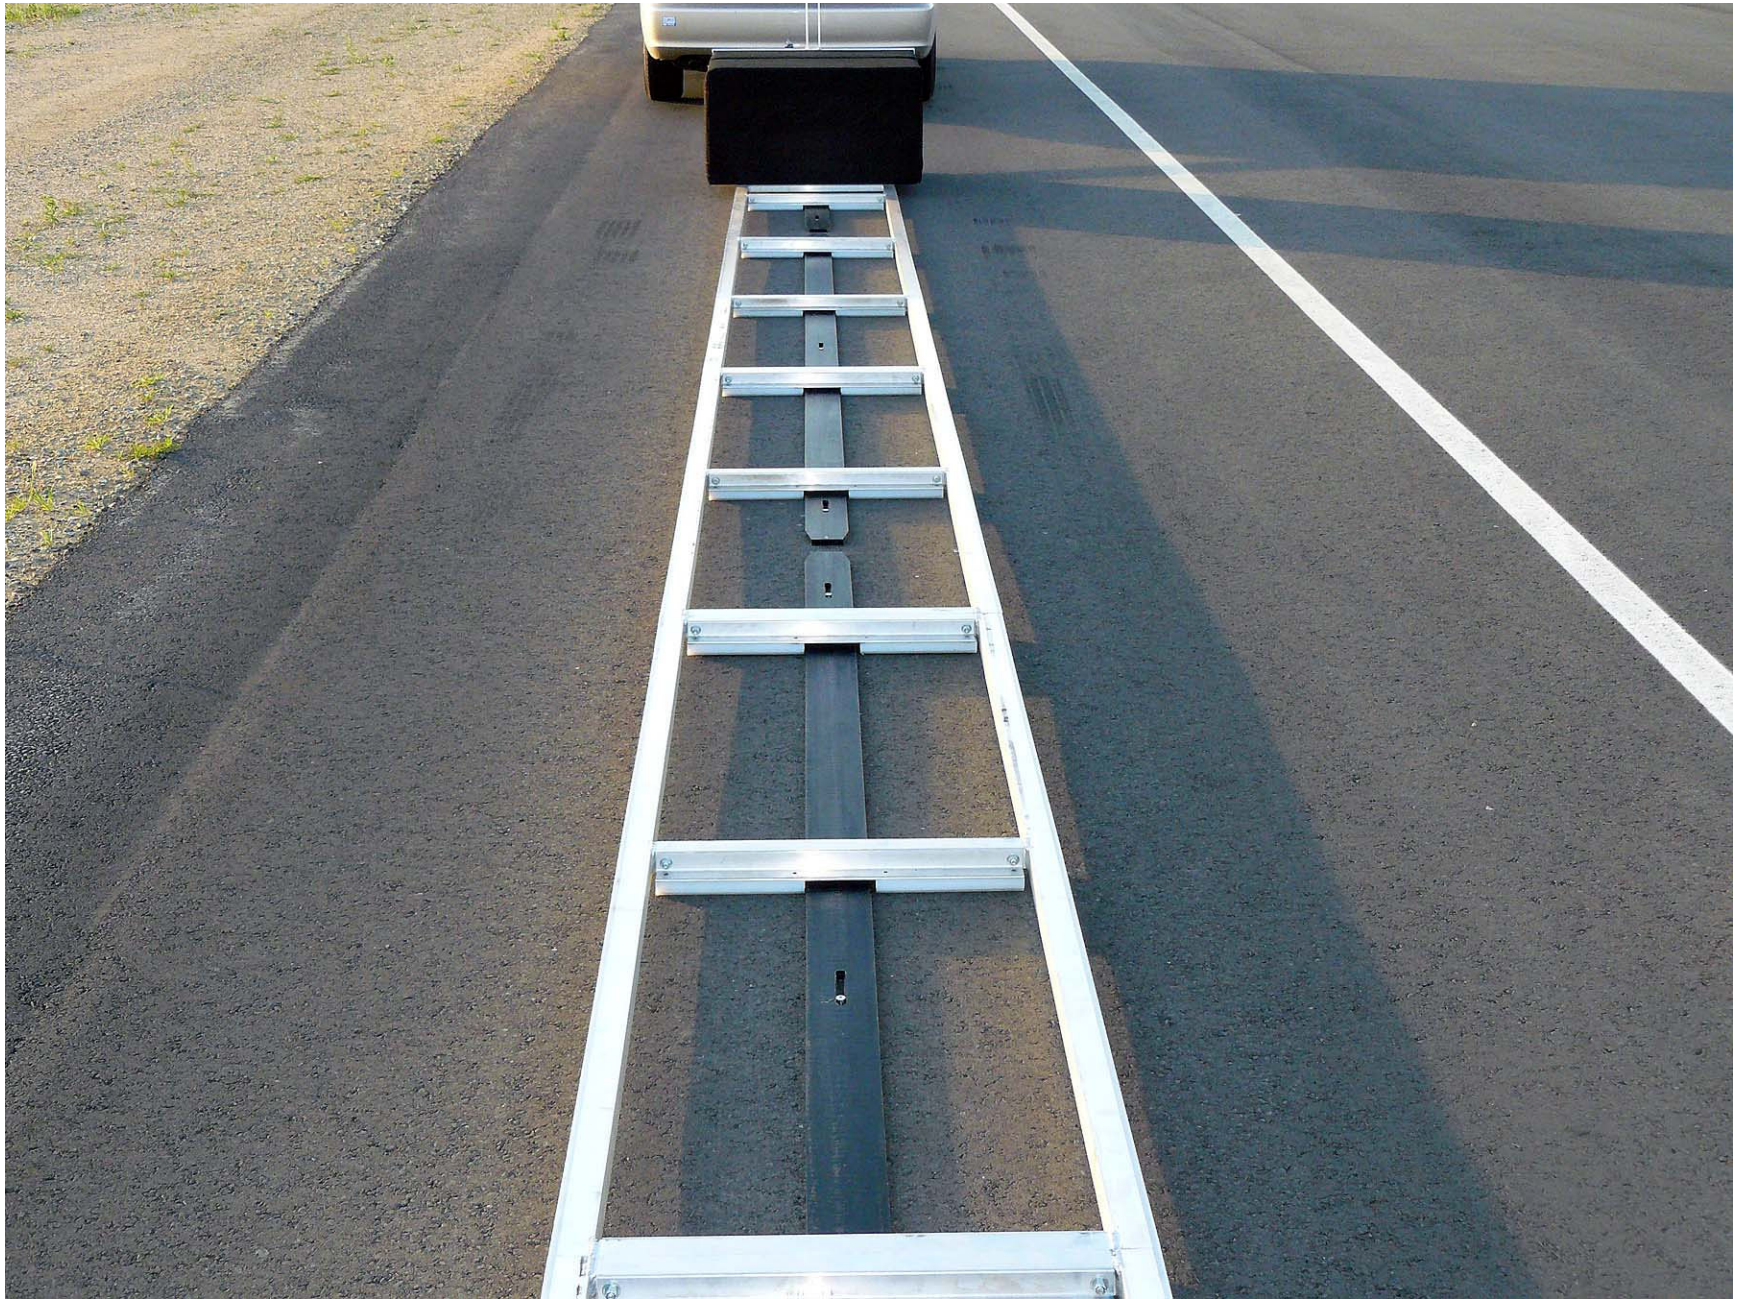
Figure A8. Two-Rail Track and Road-Based Lateral Restraint Track

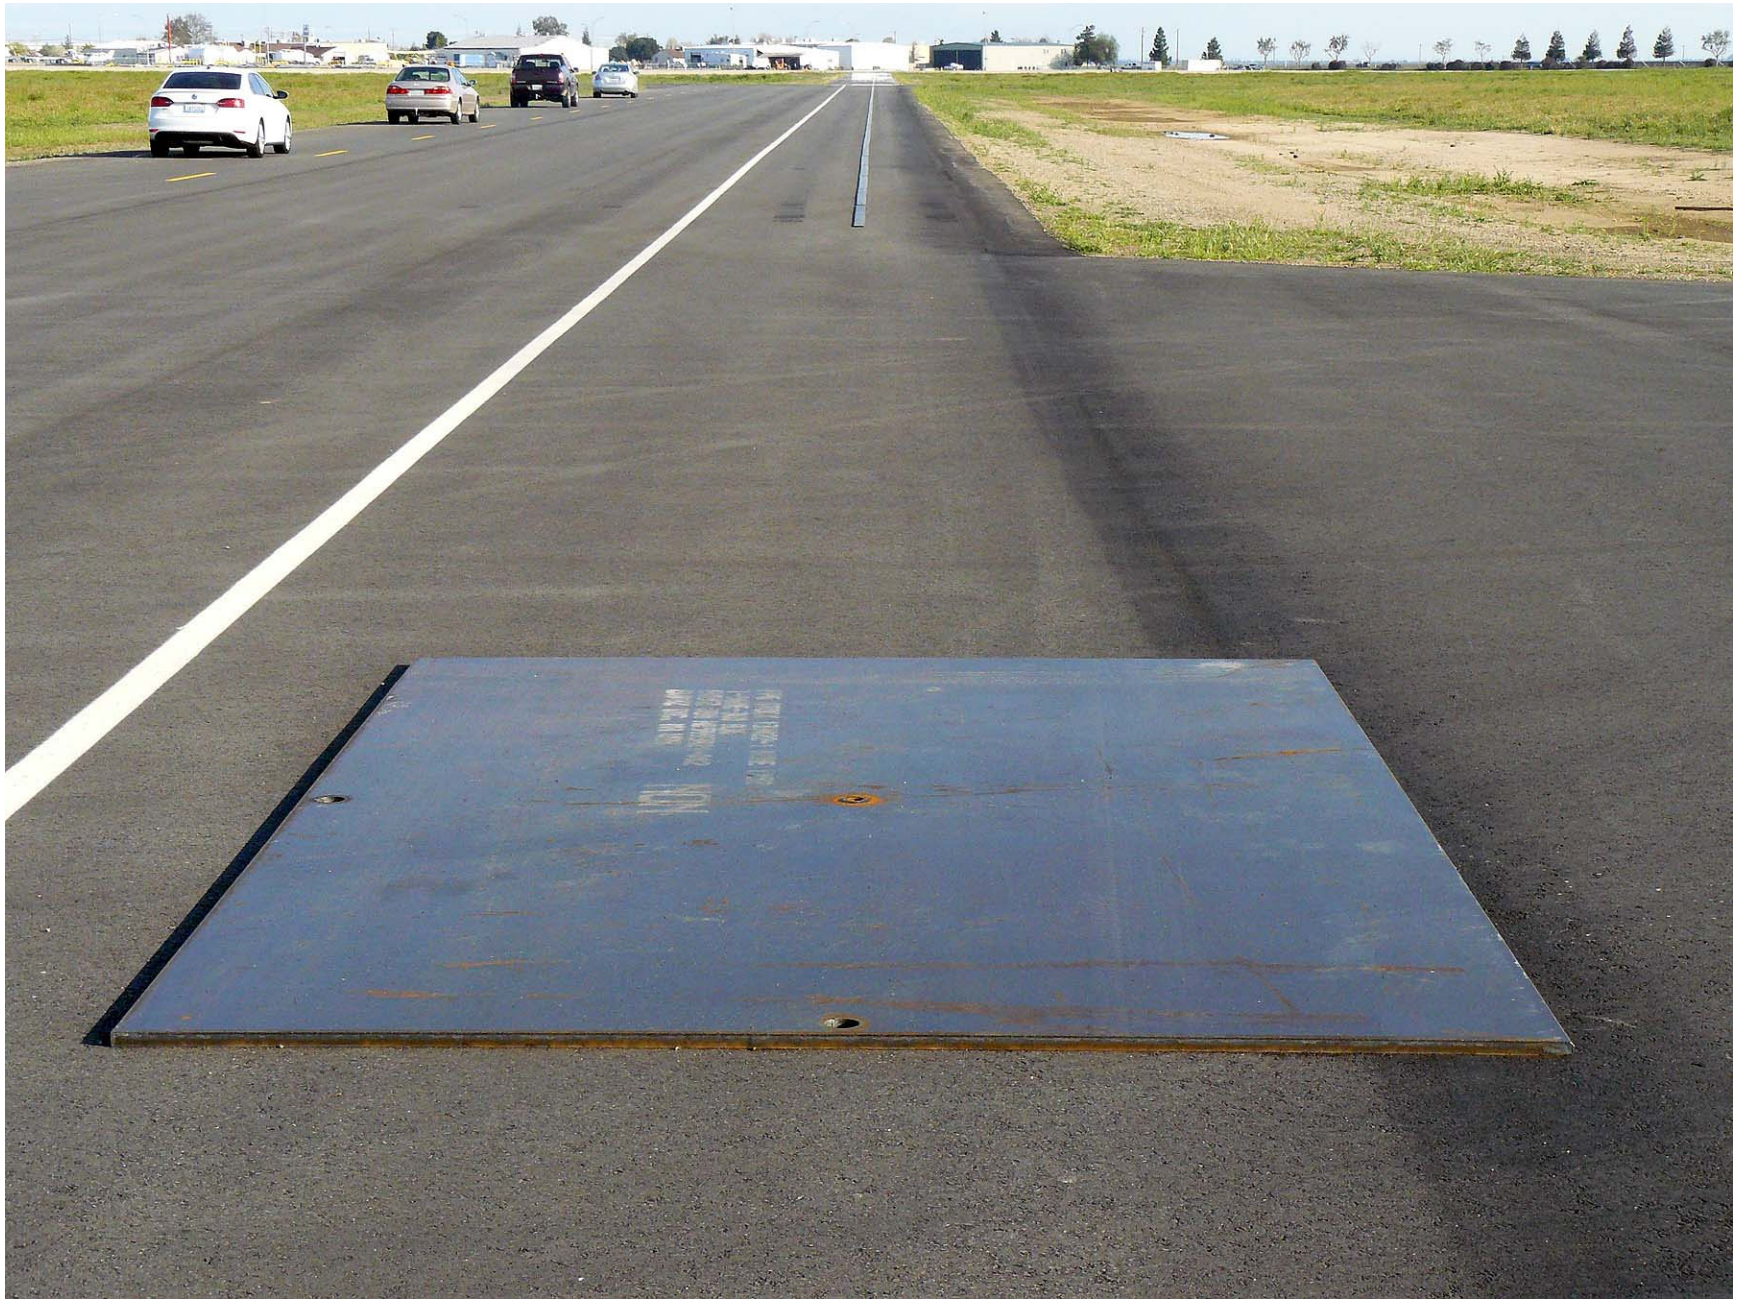
Figure A9. Steel Trench Plate

The false positive suppression test series evaluates the ability of a CIB system to differentiate a steel trench plate (STP) from an object presenting a genuine safety risk to the SV. Although the STP is large and metallic, it is designed to be driven over without risk of injury to the driver or damage to the SV. Therefore, in this scenario, the automatic braking available from CIB is not necessary and should be suppressed. The test condition is nearly equivalent to that previously defined for Test 1, the stopped POV condition, but with an STP in the SV forward path in lieu of a POV.

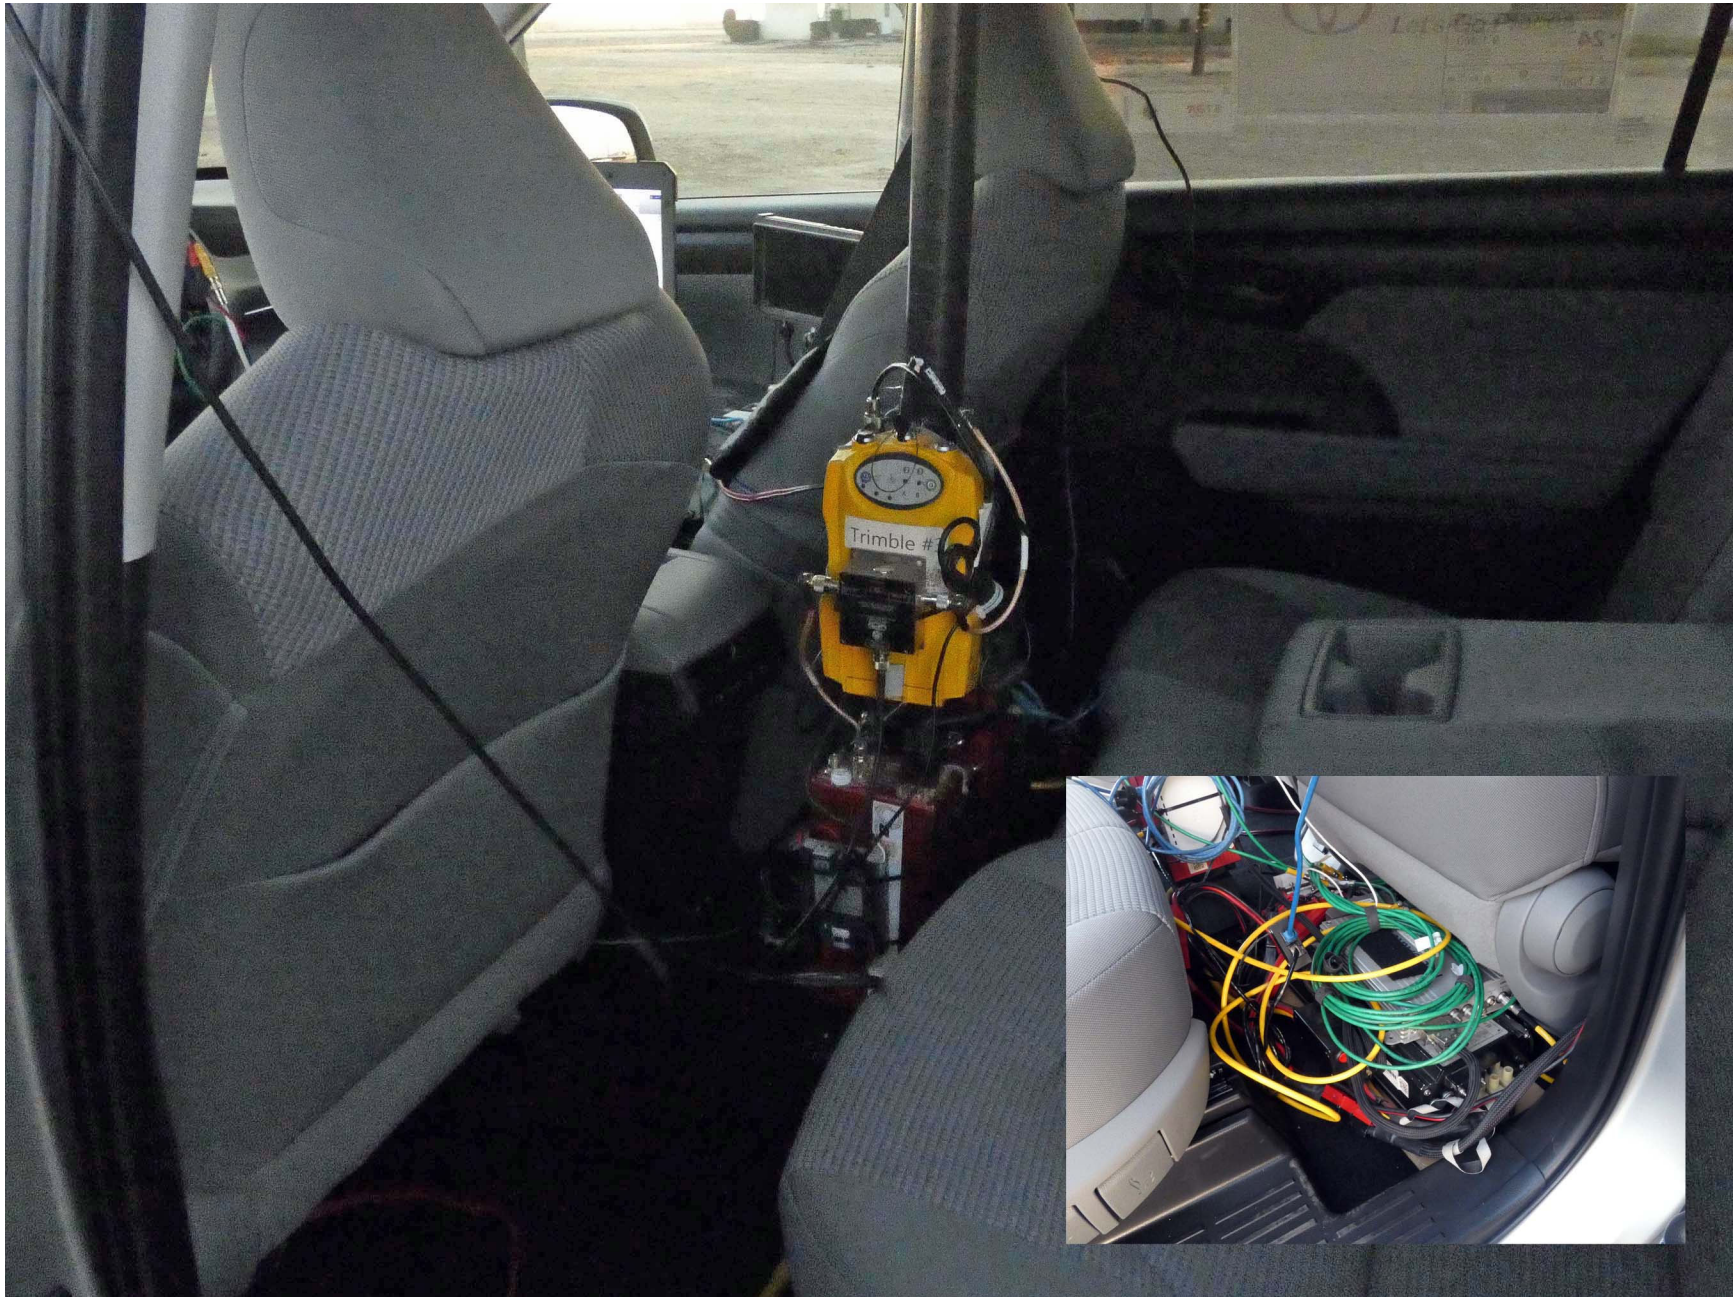
Figure A10. DGPS, Inertial Measurement Unit, and MicroAutoBox Installed in Subject Vehicle

| Type | Output | Range | Accuracy, Other Primary Specs | Mfr, Model | Serial Number | Calibration Dates Last Due |
|--|---|---|--|---|---|--|
| Data Acquisition System | Data acquisition is achieved using a dSPACE MicroAutoBox II. Data from the Oxford IMU, including Longitudinal, Lateral, and Vertical Acceleration, Roll, Yaw, and Pitch Rate, Forward and Lateral Velocity, Roll and Pitch Angle are sent over Ethernet to the MicroAutoBox. The Oxford IMUs are calibrated per the manufacturer's recommended schedule (listed above). | | | dSPACE Micro-Autobox II 1401/1513 | | |

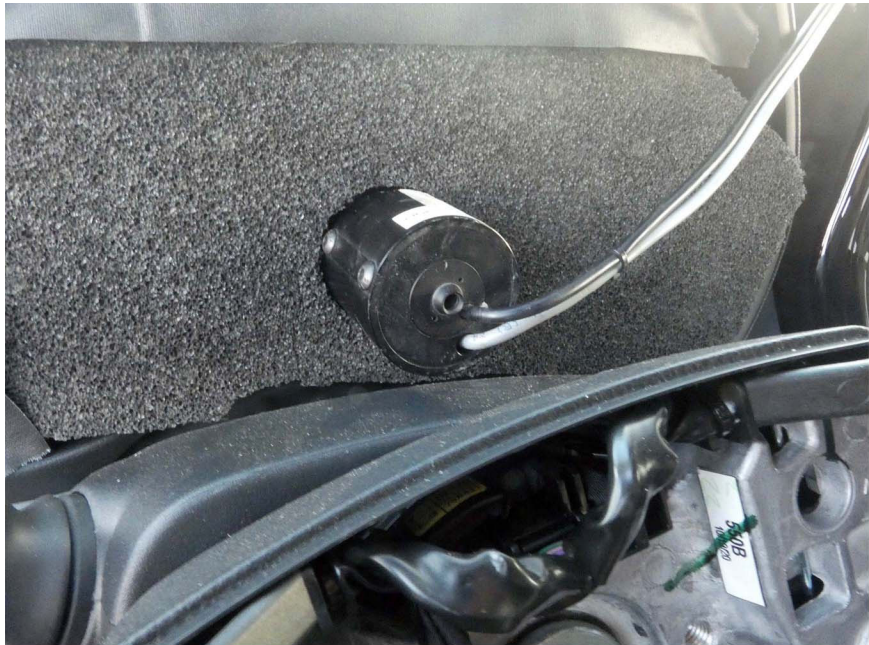
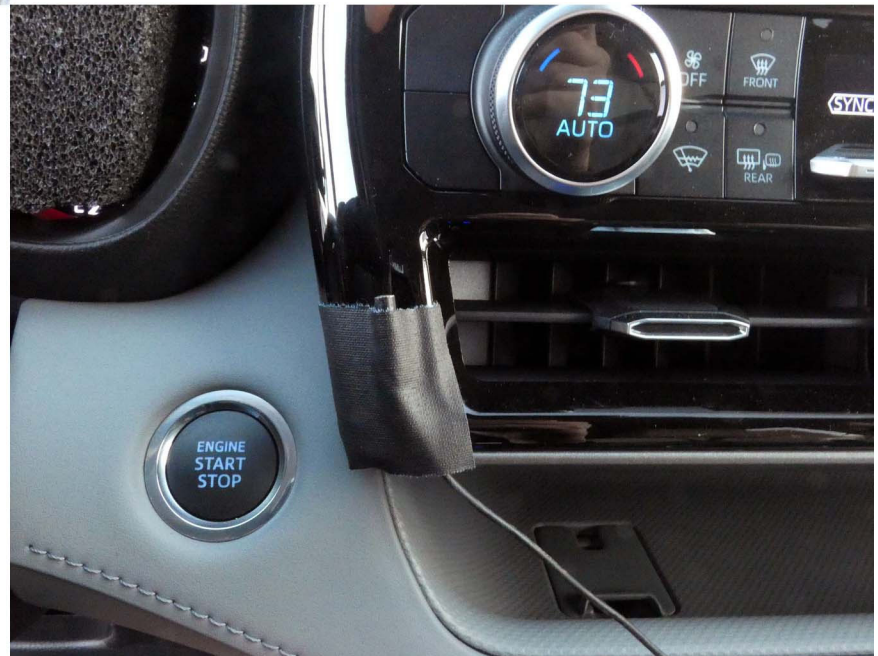
Figure A11. Sensors for Detecting Auditory and Visual Alerts

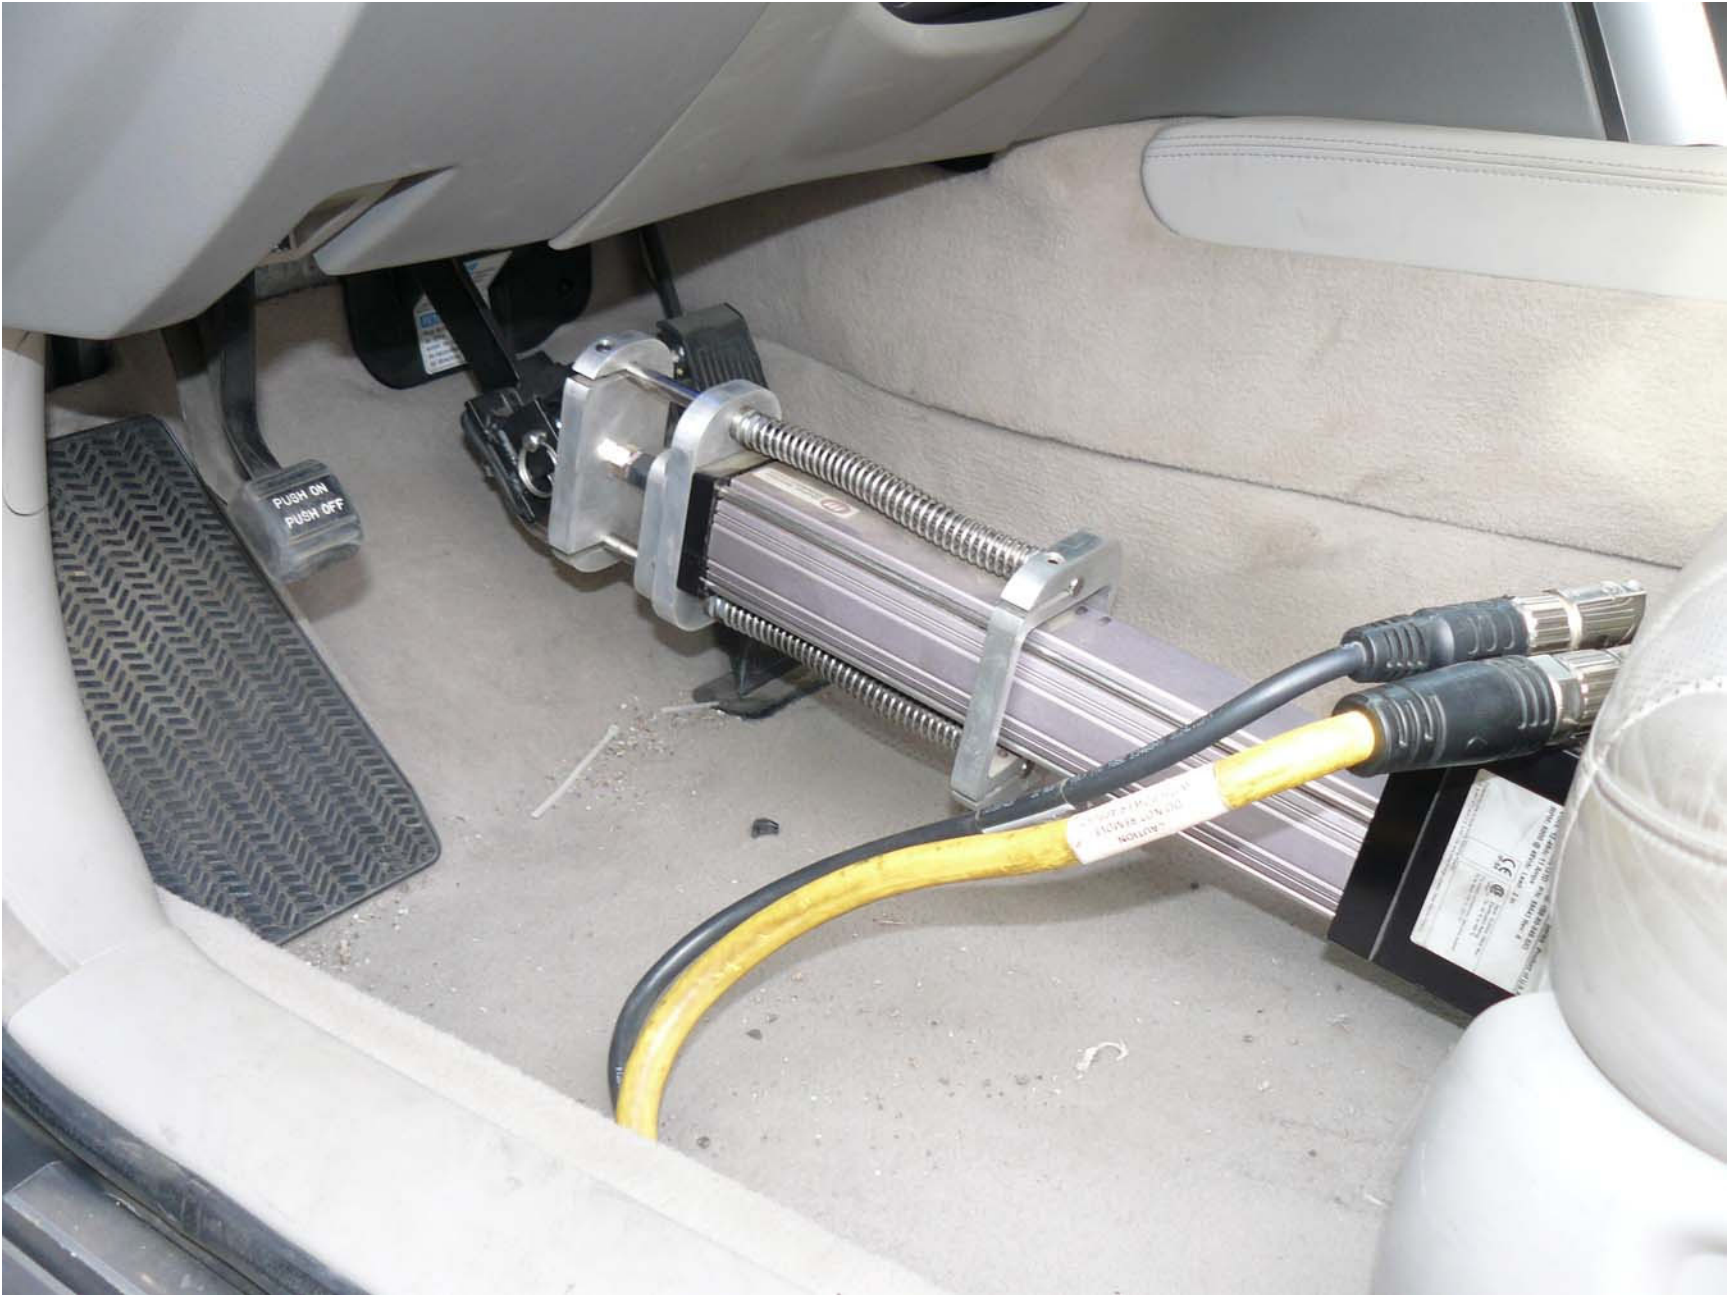
Figure A13. Brake Actuator Installed in POV System

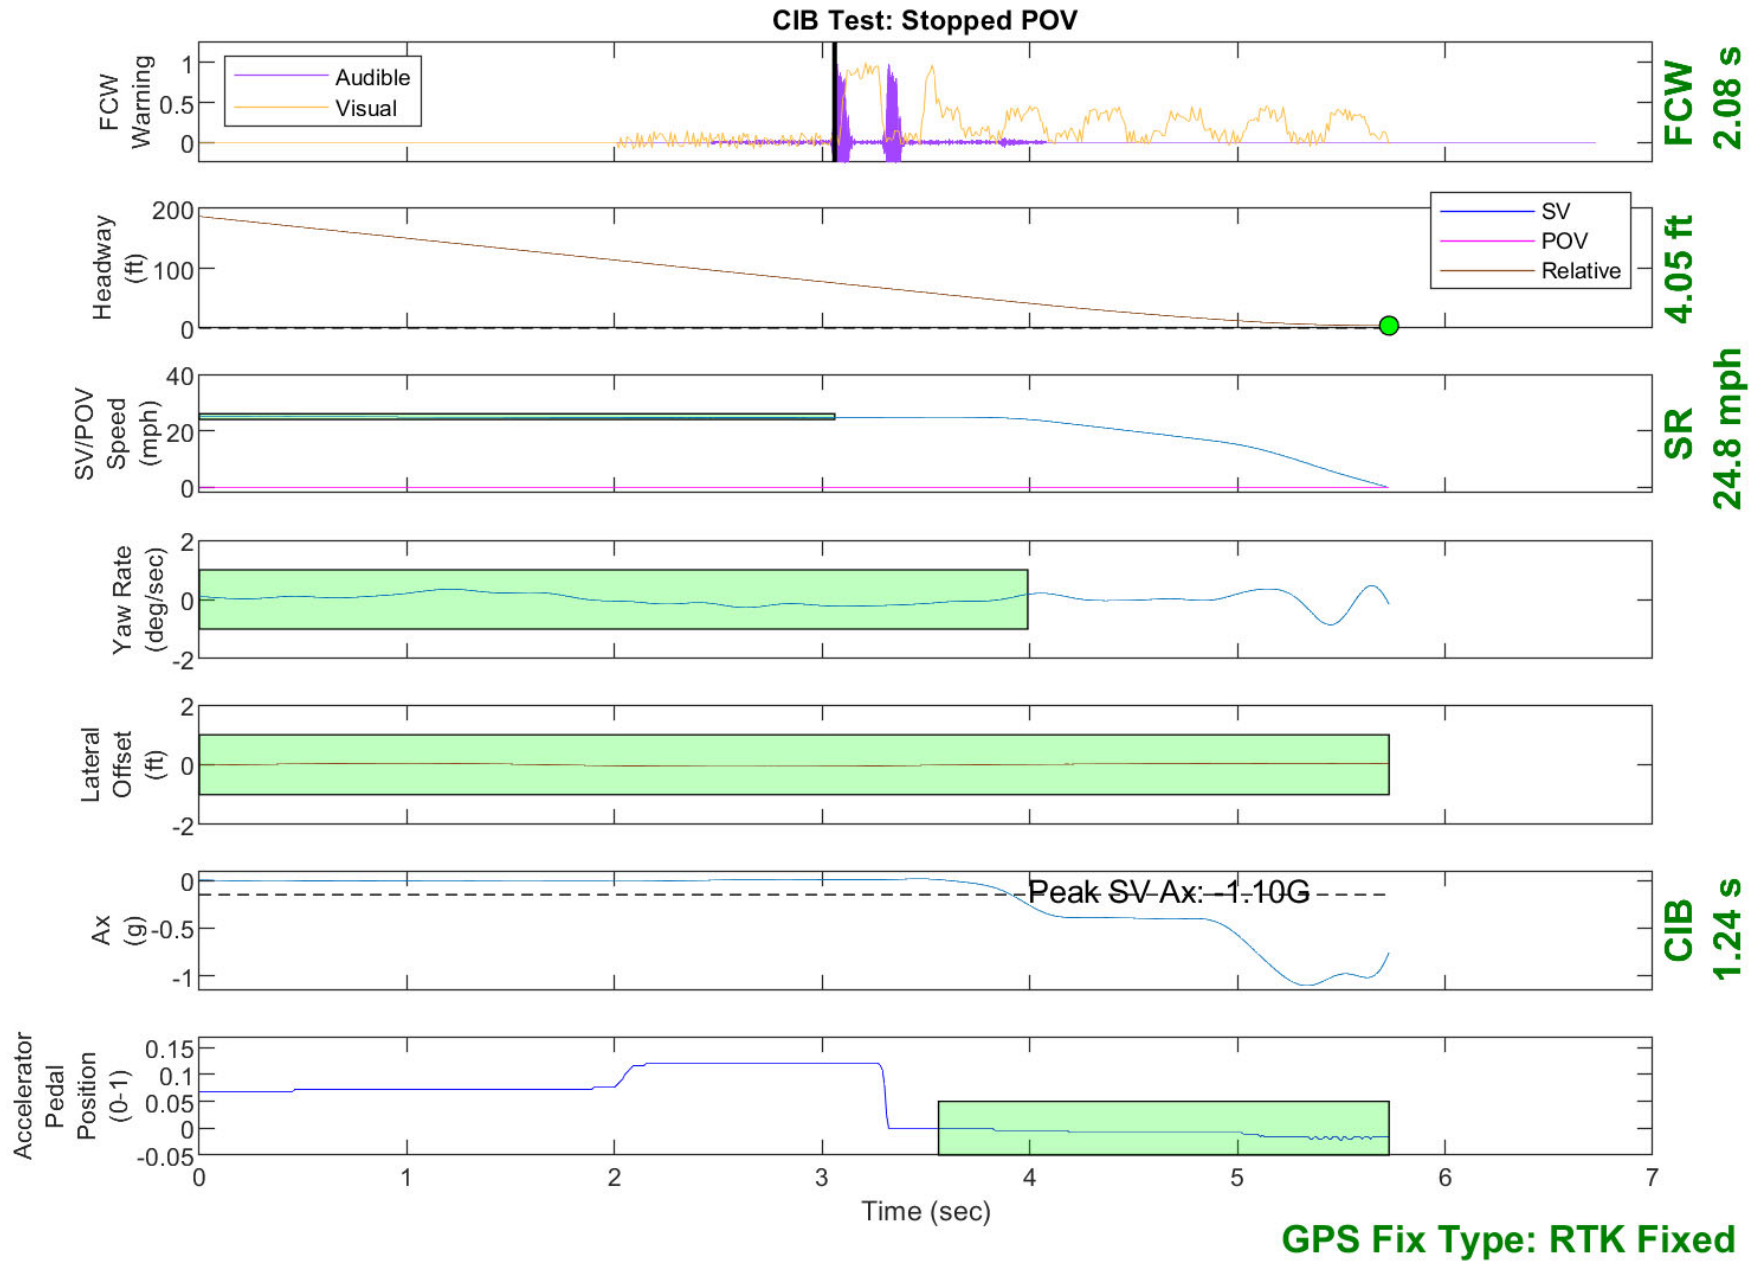
Figure D1. Example Time History for Stopped POV, Passing

Examples of time history plots for each test type (including passing, failing and invalid runs) are shown in Figure D1 through Figure D9. Figures D1 through D6 show passing runs for each of the 6 test types. Figures D7 and D8 show examples of invalid runs. Figure D9 shows an example of a valid test that failed the CIB requirements.

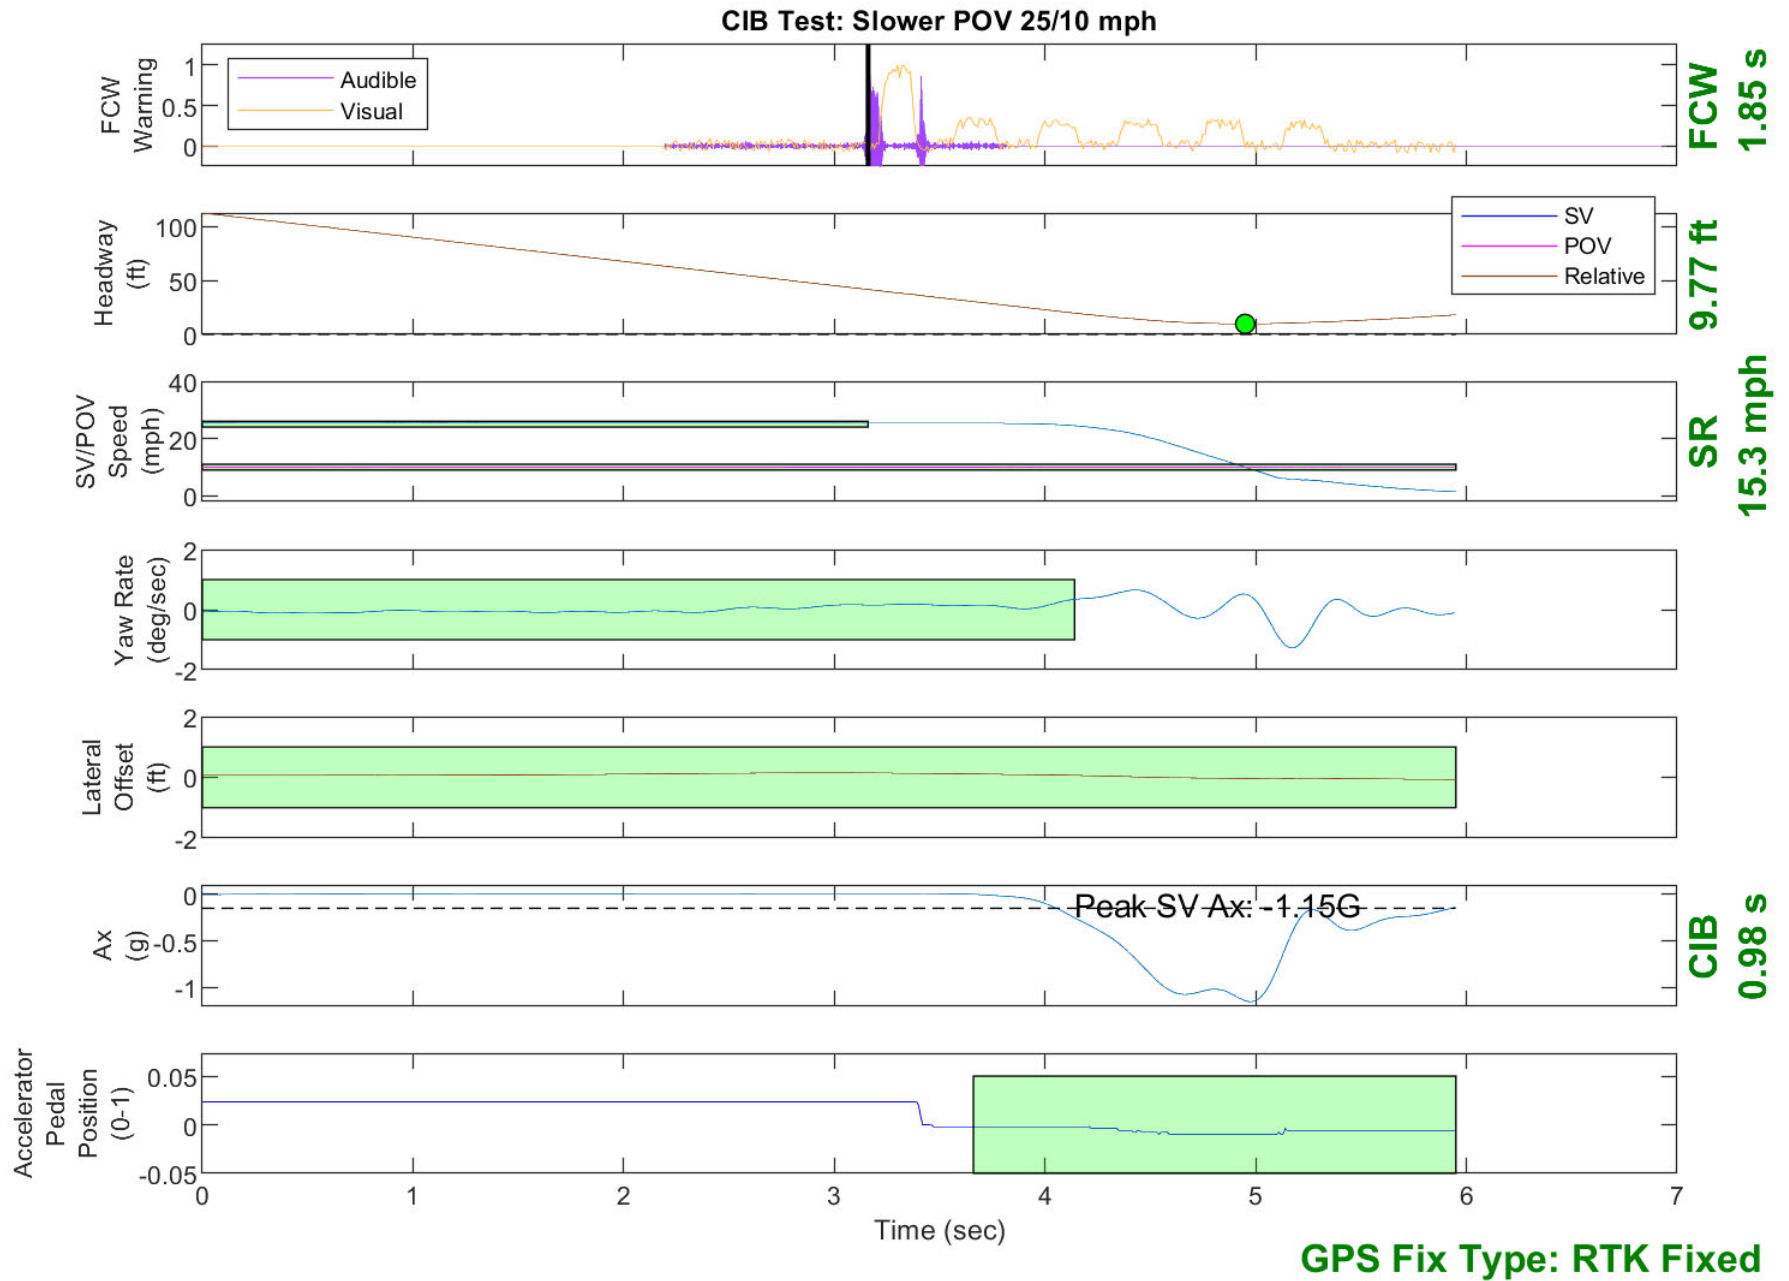
Figure D2. Example Time History for Slower POV 25 vs. 10, Passing

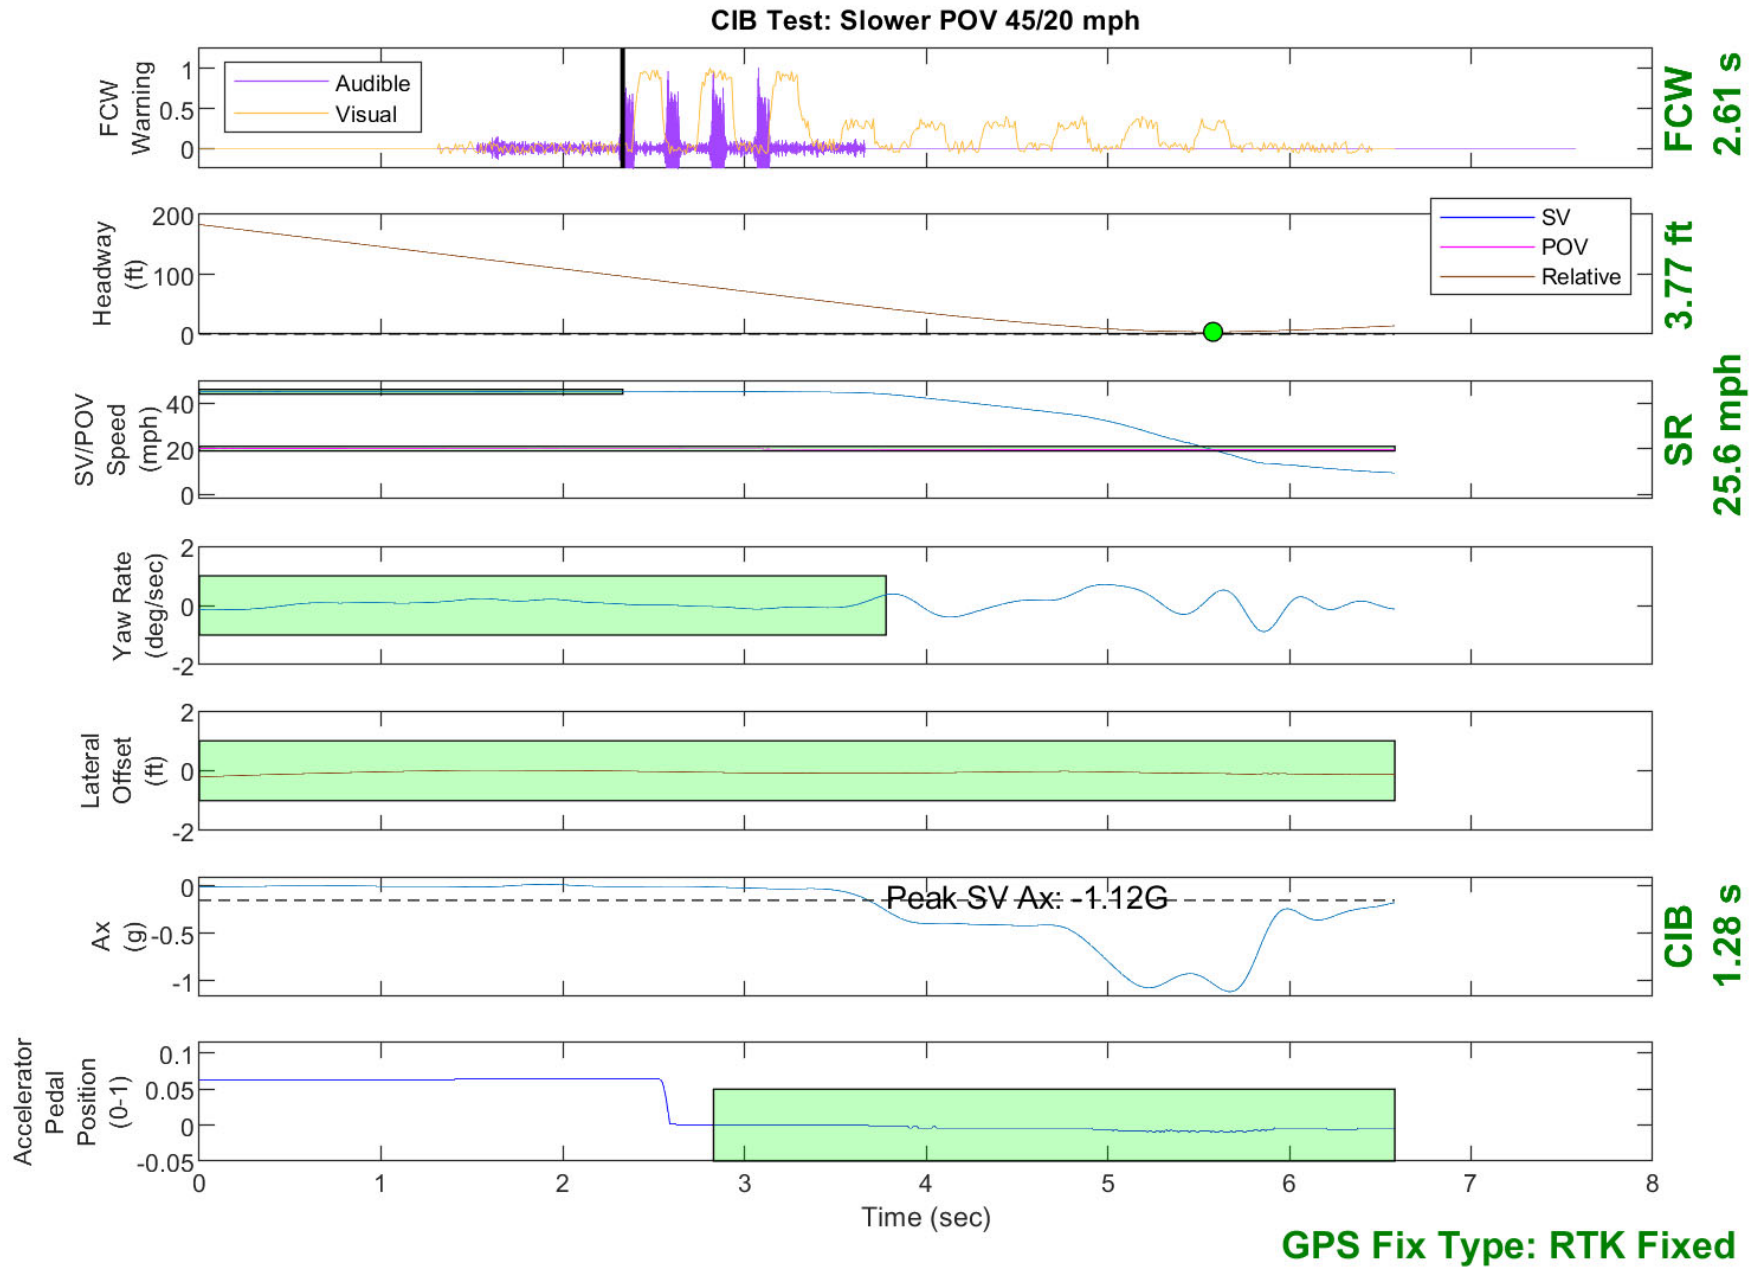
Figure D3. Example Time History for Slower POV 45 vs. 20, Passing
