**NEW CAR ASSESSMENT PROGRAM
CRASH IMMINENT BRAKING SYSTEM CONFIRMATION TEST
NCAP-DRI-CIB-21-16**

2021 Toyota Highlander LE - V6 FWD

DYNAMIC RESEARCH, INC.
355 Van Ness Avenue, STE 200
Torrance, California 90501

Final Report

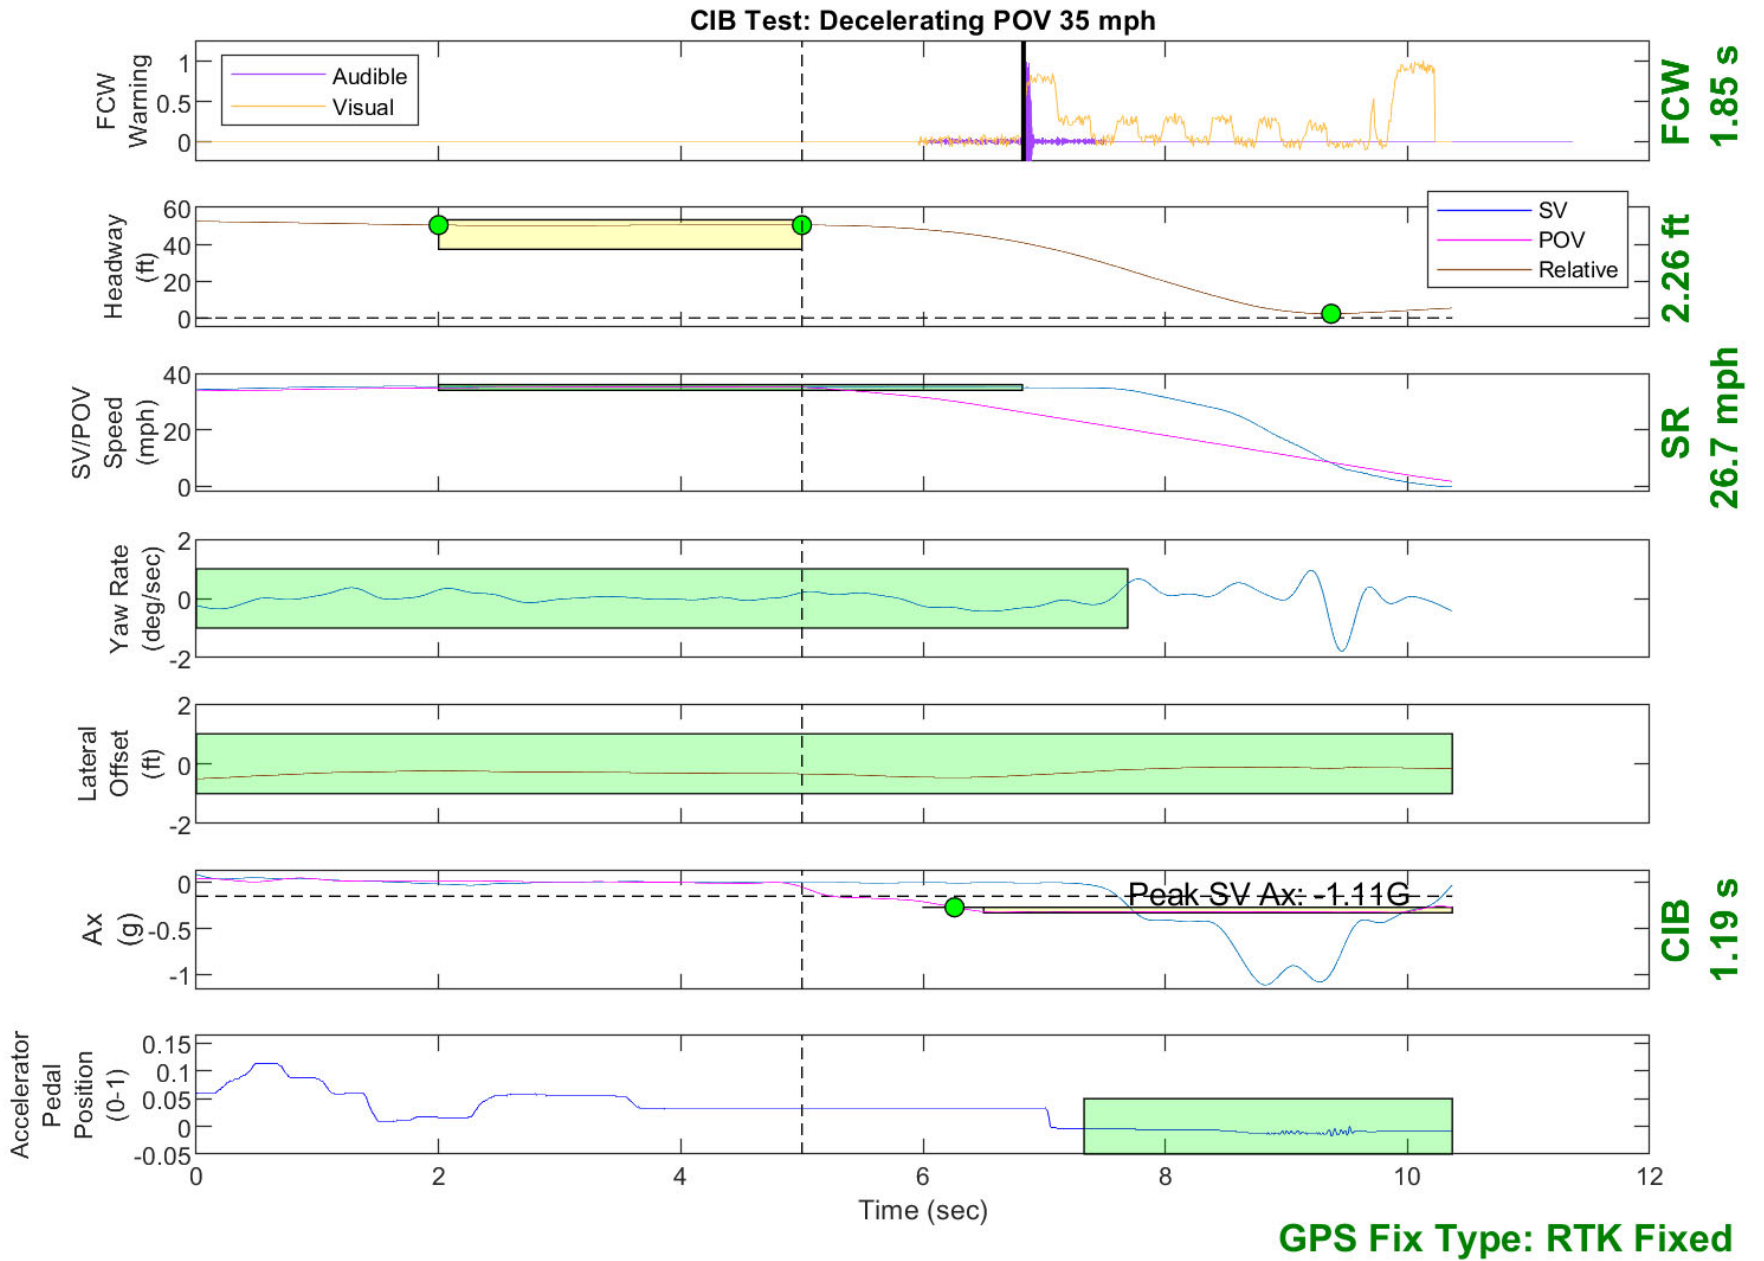
Figure D4. Example Time History for Decelerating POV 35, Passing

Examples of time history plots for each test type (including passing, failing and invalid runs) are shown in Figure D1 through Figure D9. Figures D1 through D6 show passing runs for each of the 6 test types. Figures D7 and D8 show examples of invalid runs. Figure D9 shows an example of a valid test that failed the CIB requirements.

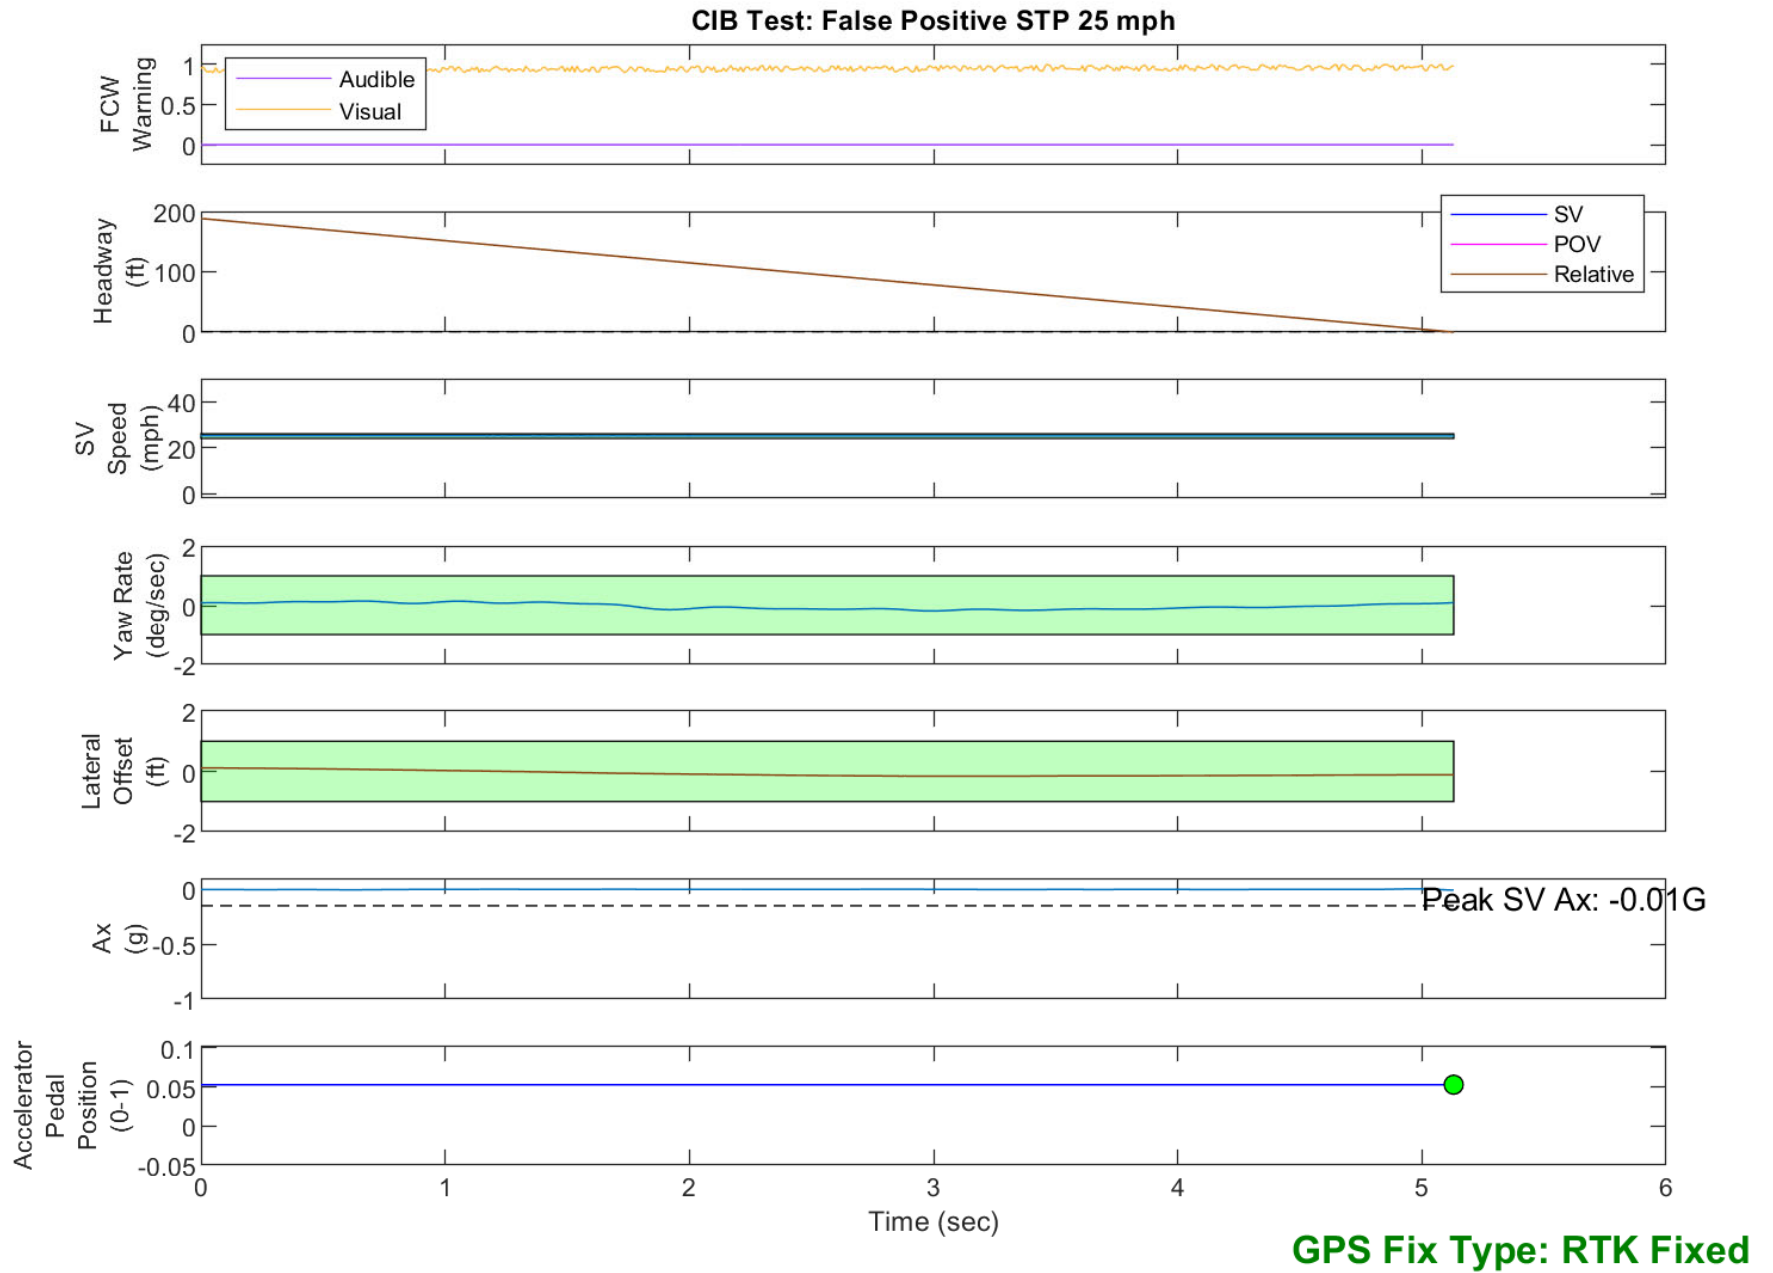
Figure D5. Example Time History for False Positive STP 25, Passing

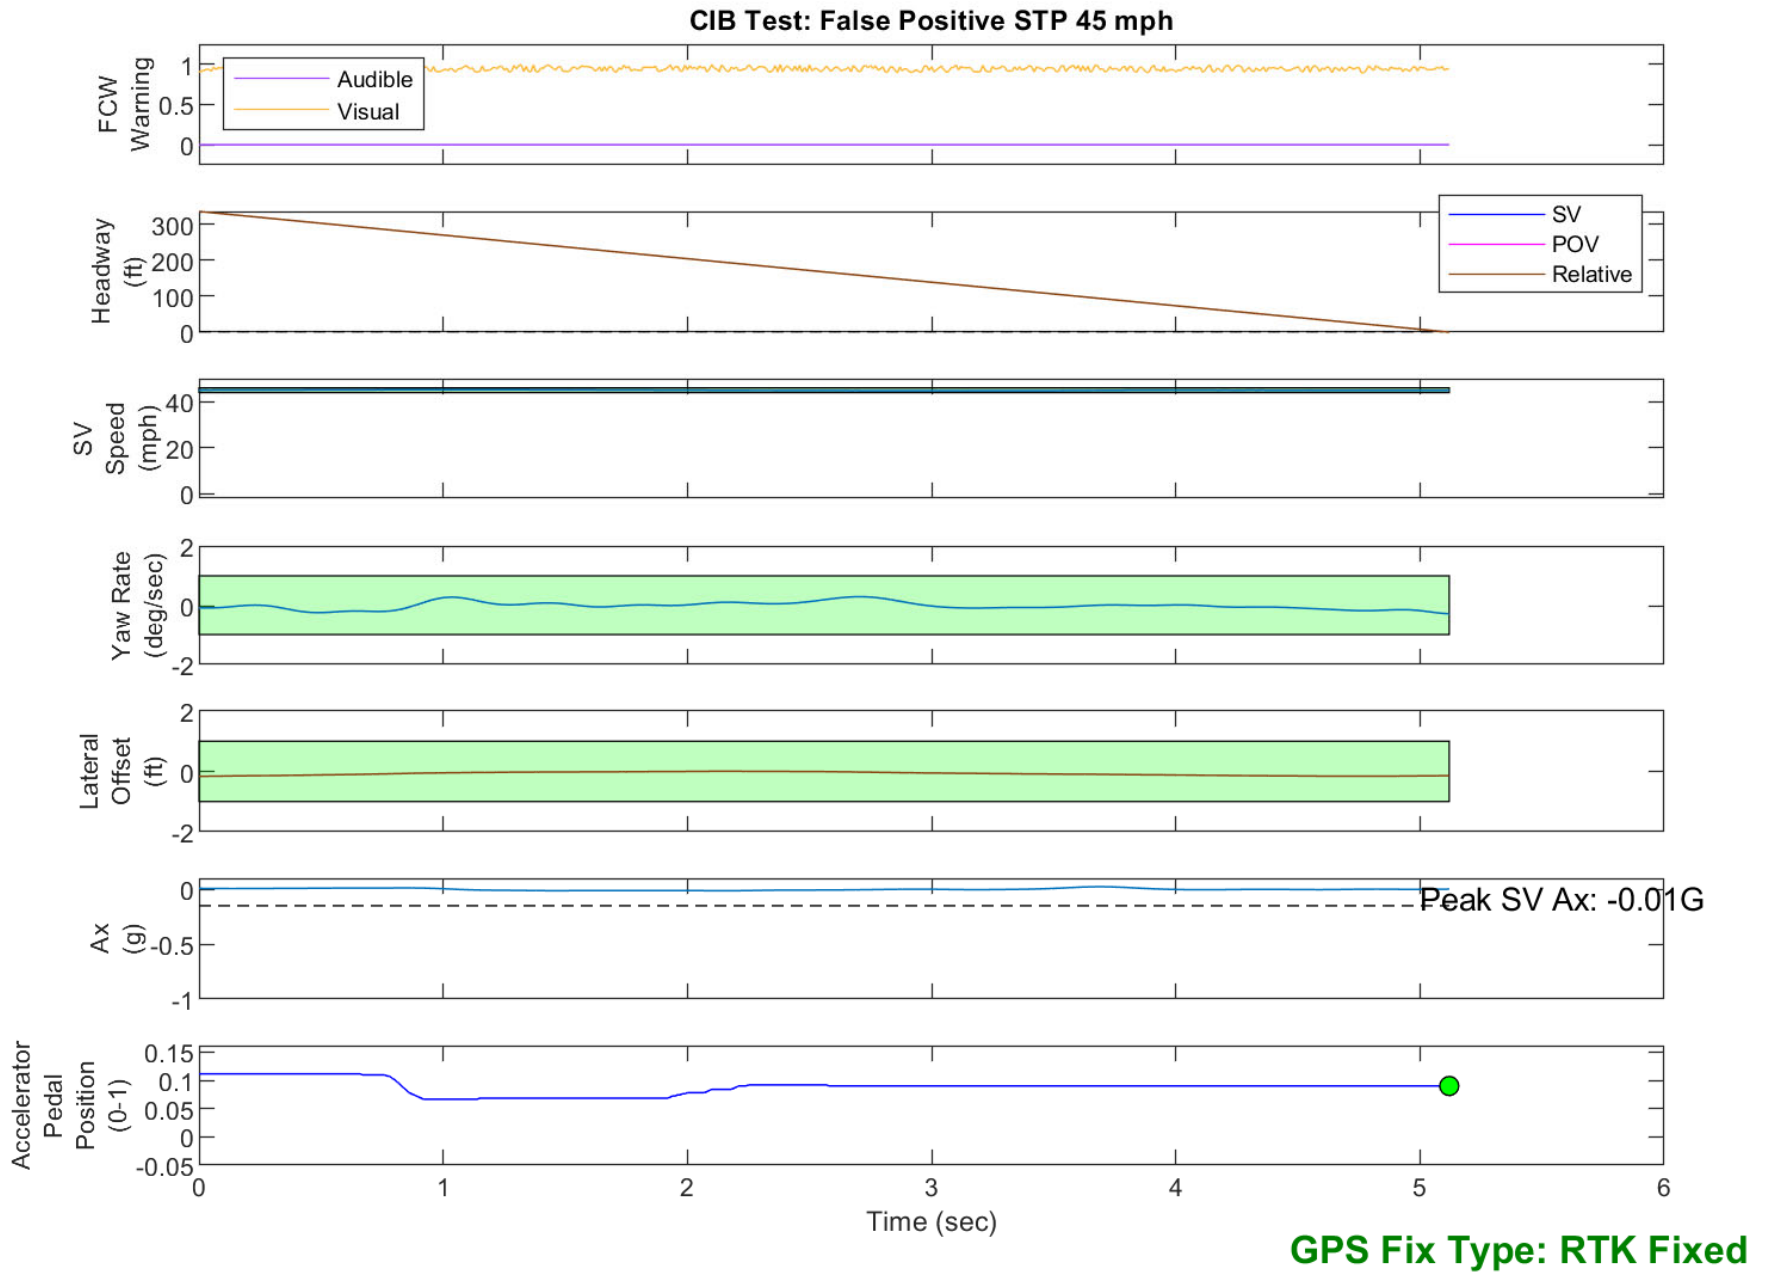
Figure D6. Example Time History for False Positive STP 45, Passing

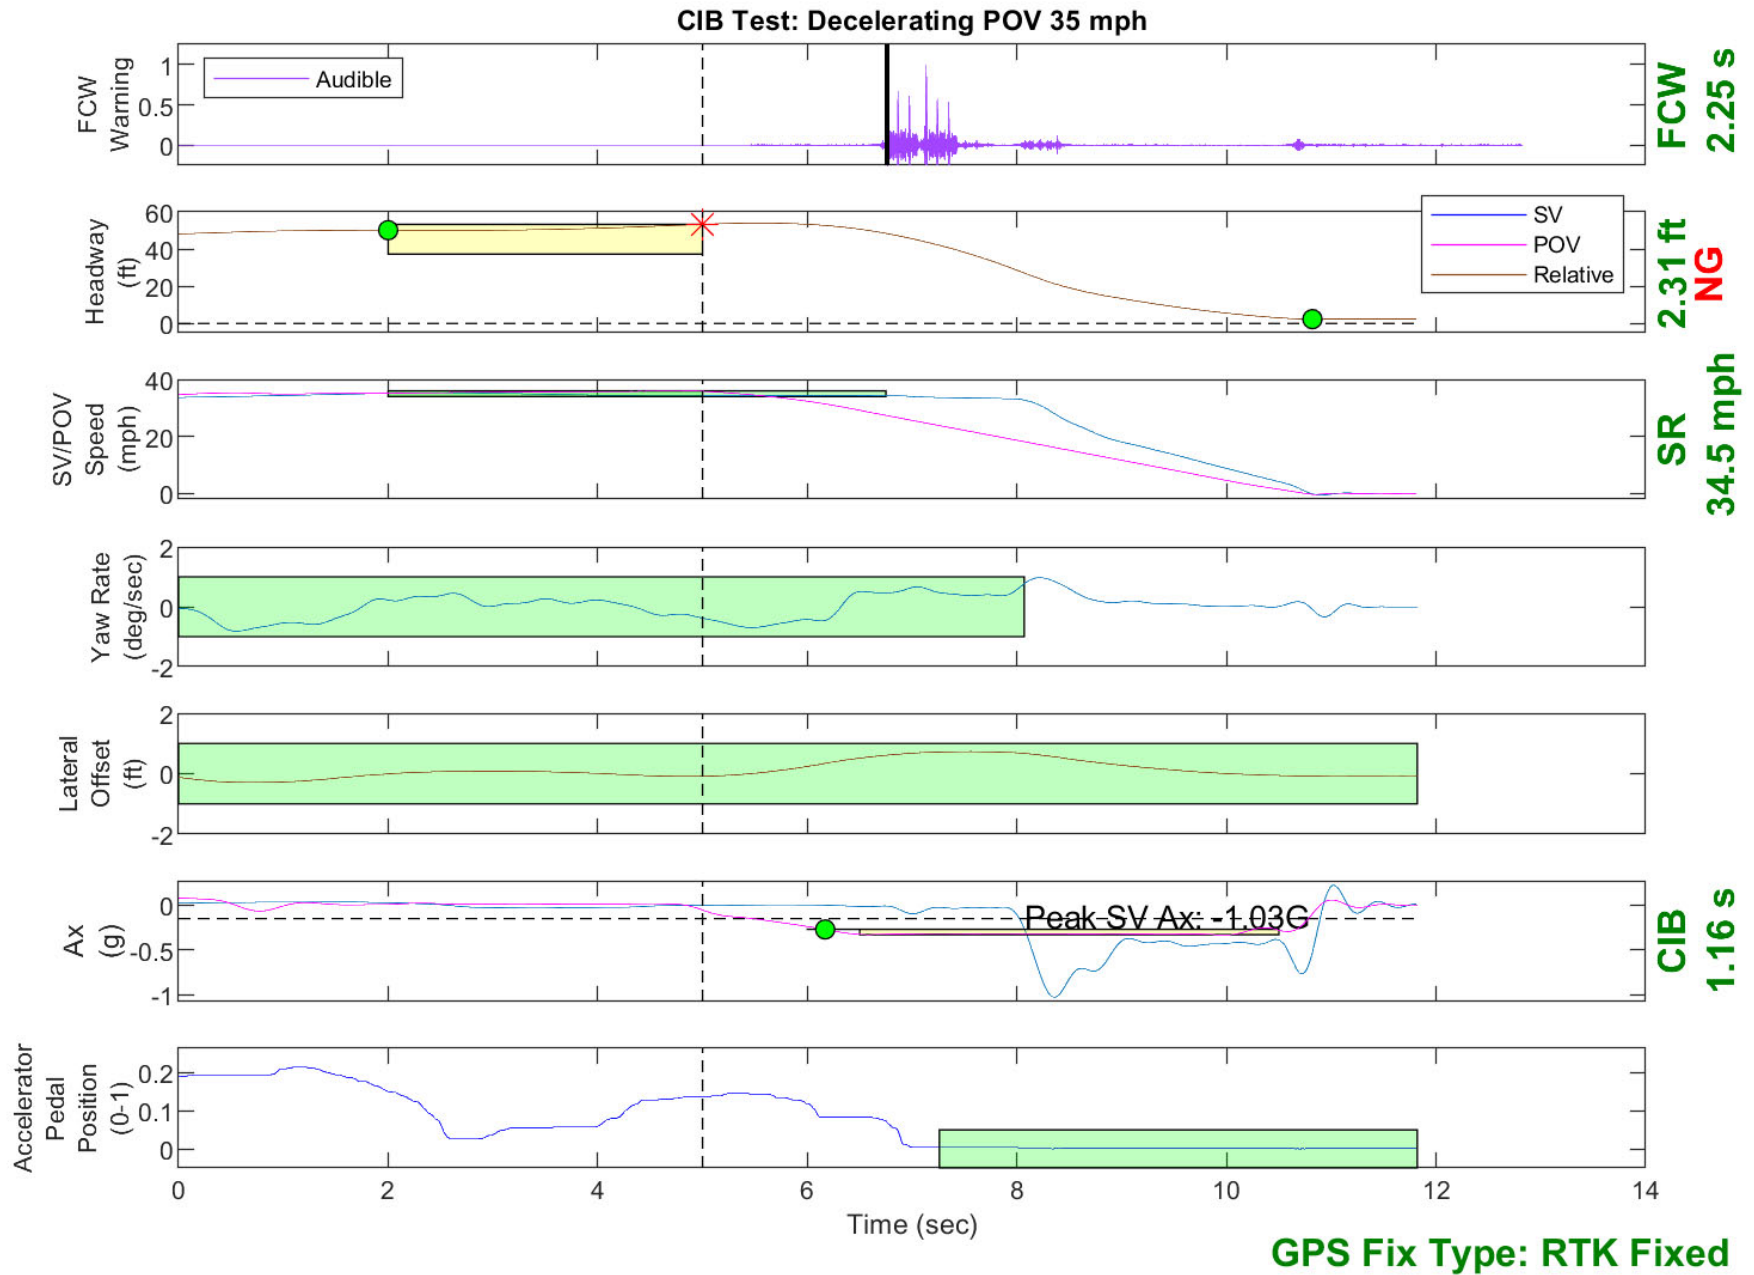
Figure D7. Example Time History Displaying Invalid Headway Criteria

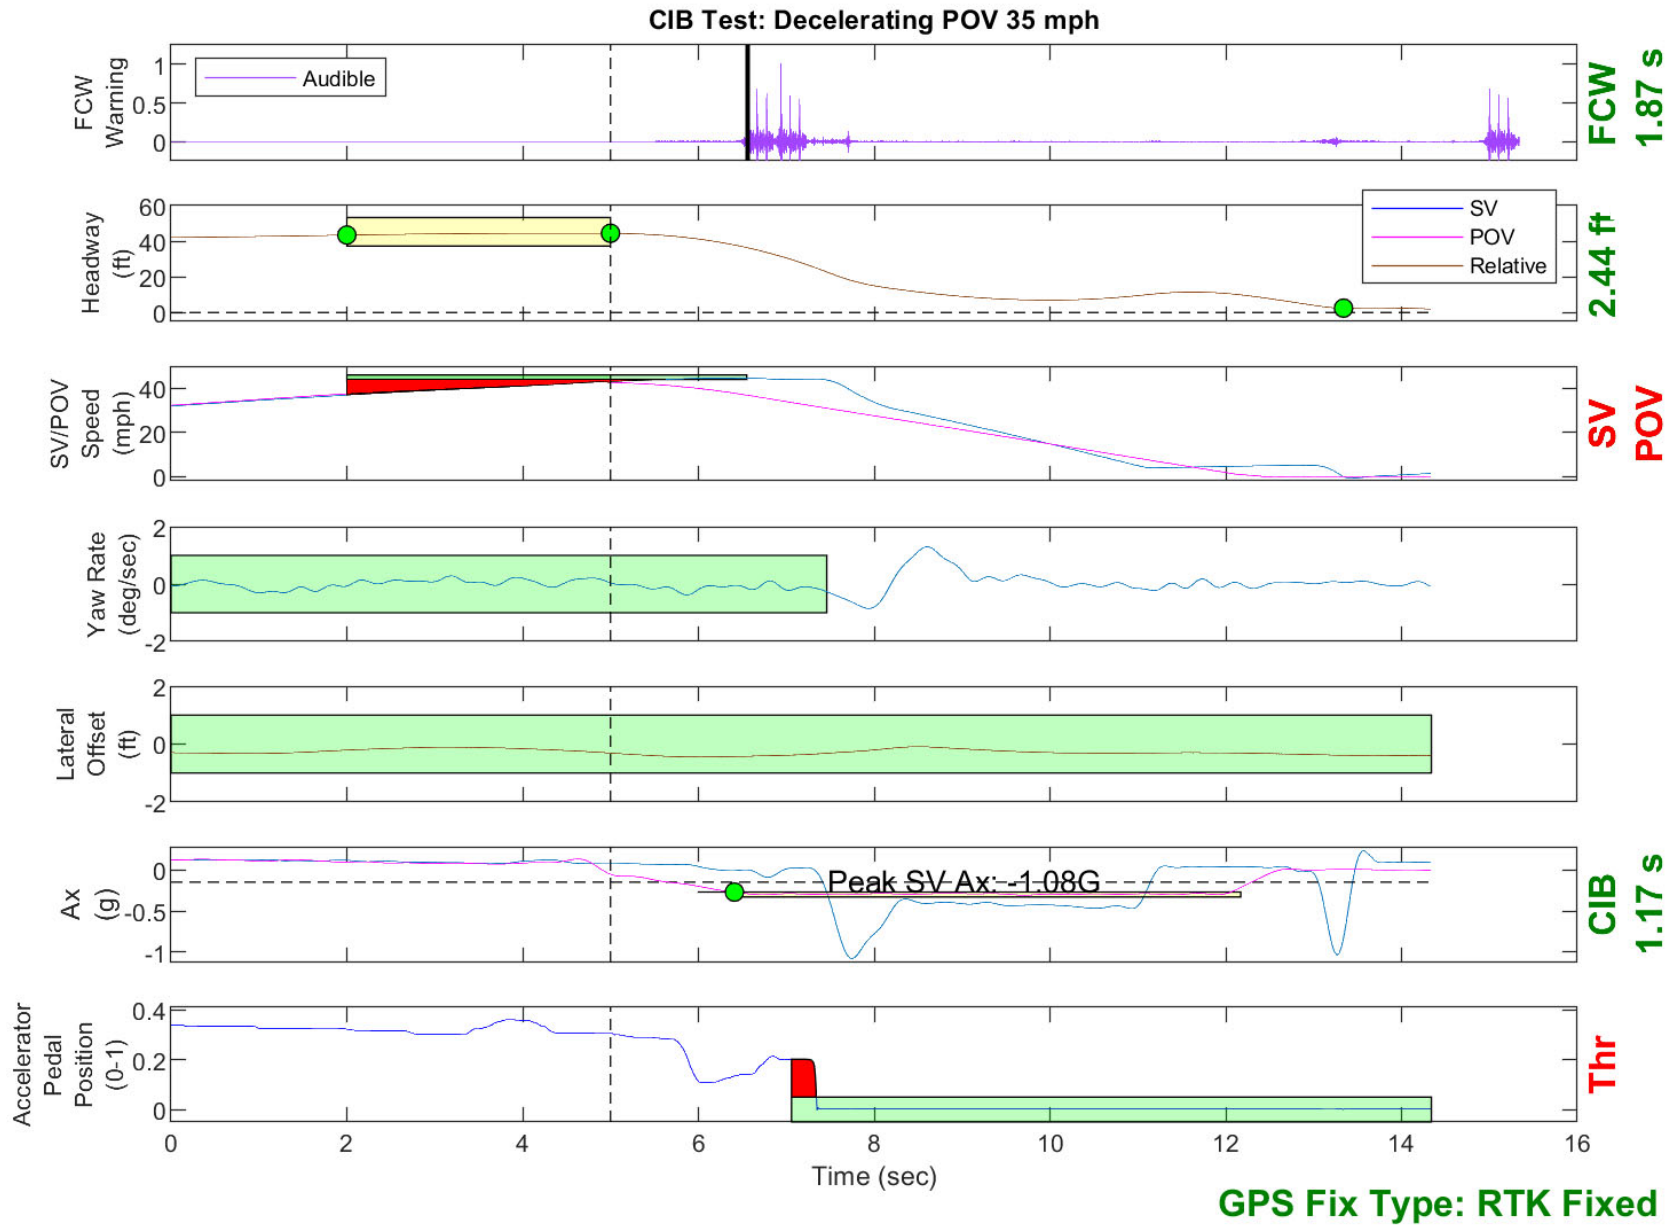
Figure D8. Example Time History Displaying Various Invalid Criteria

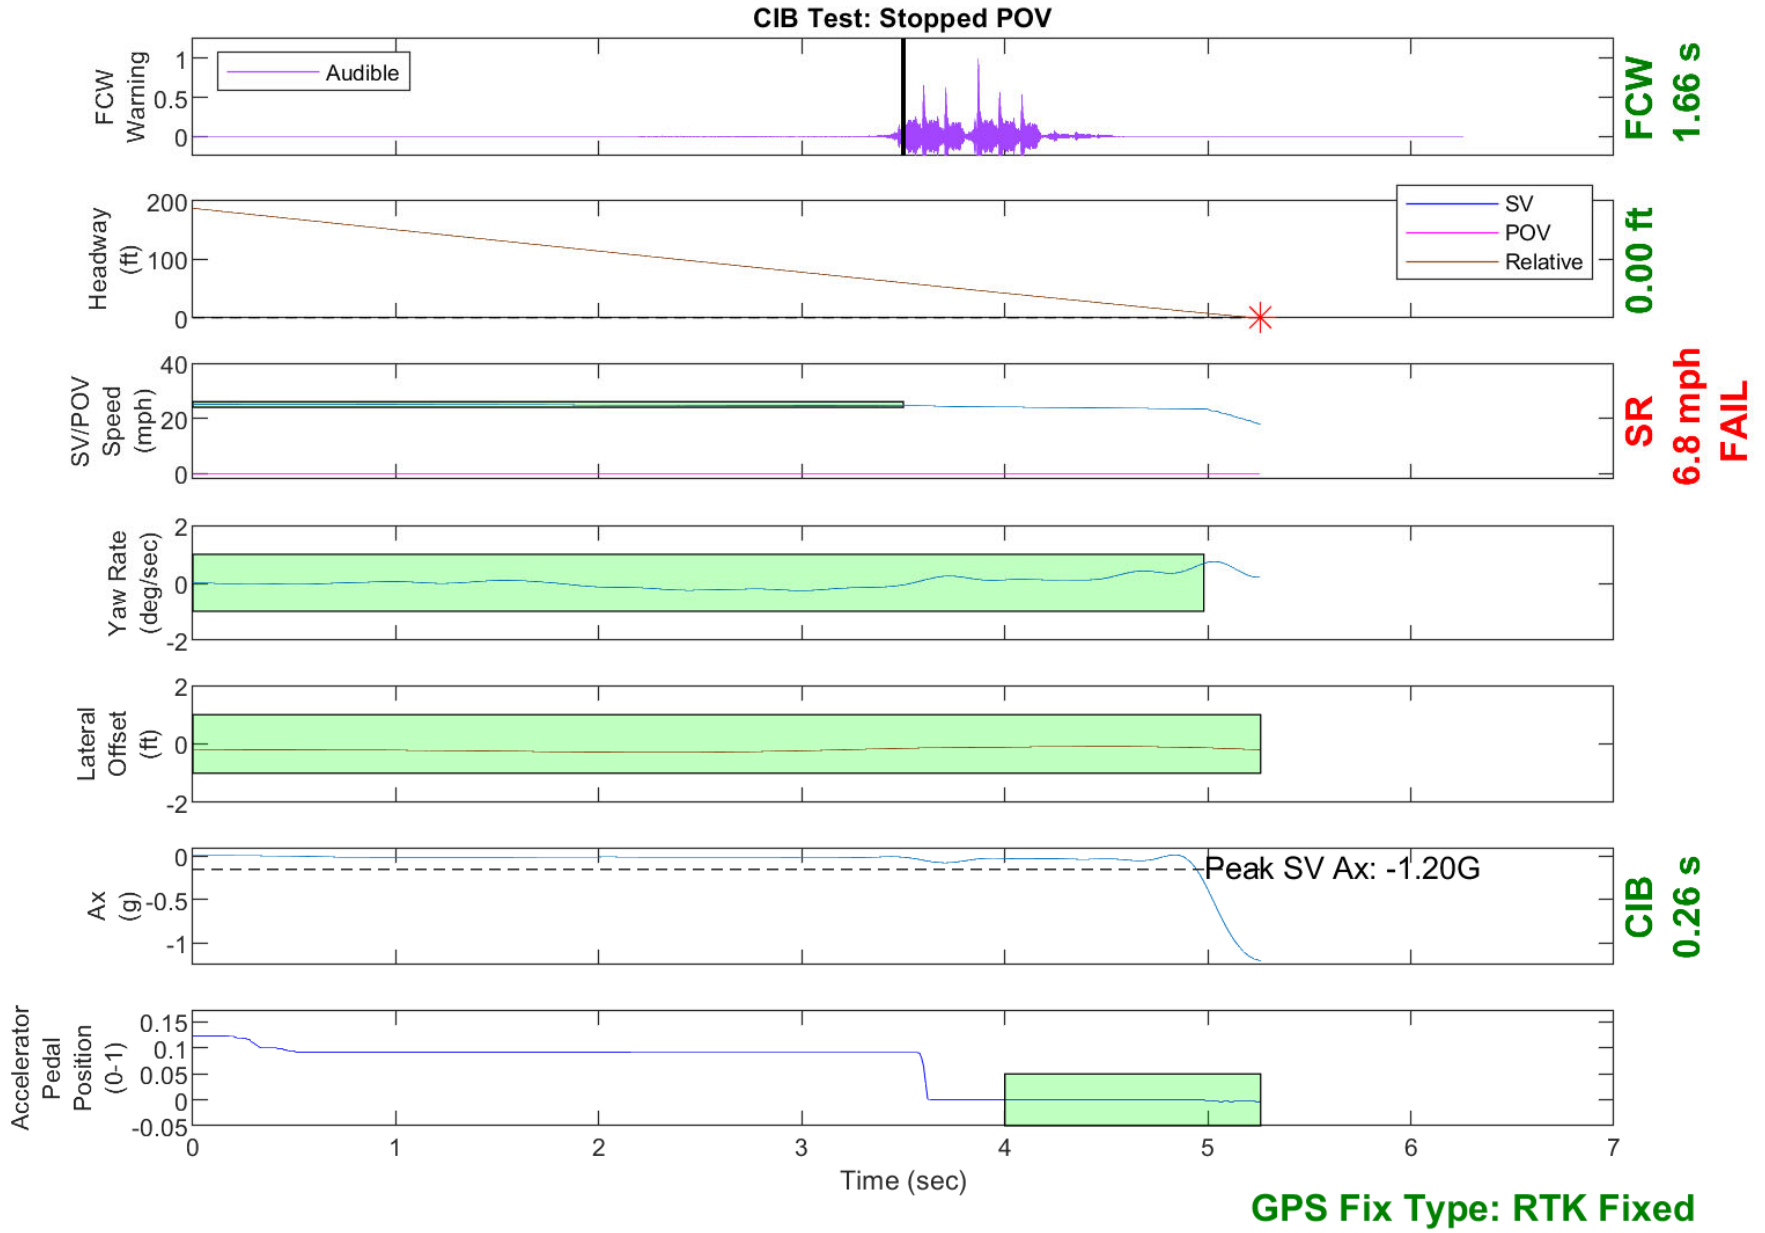
Figure D9. Example Time History for a Failed Run

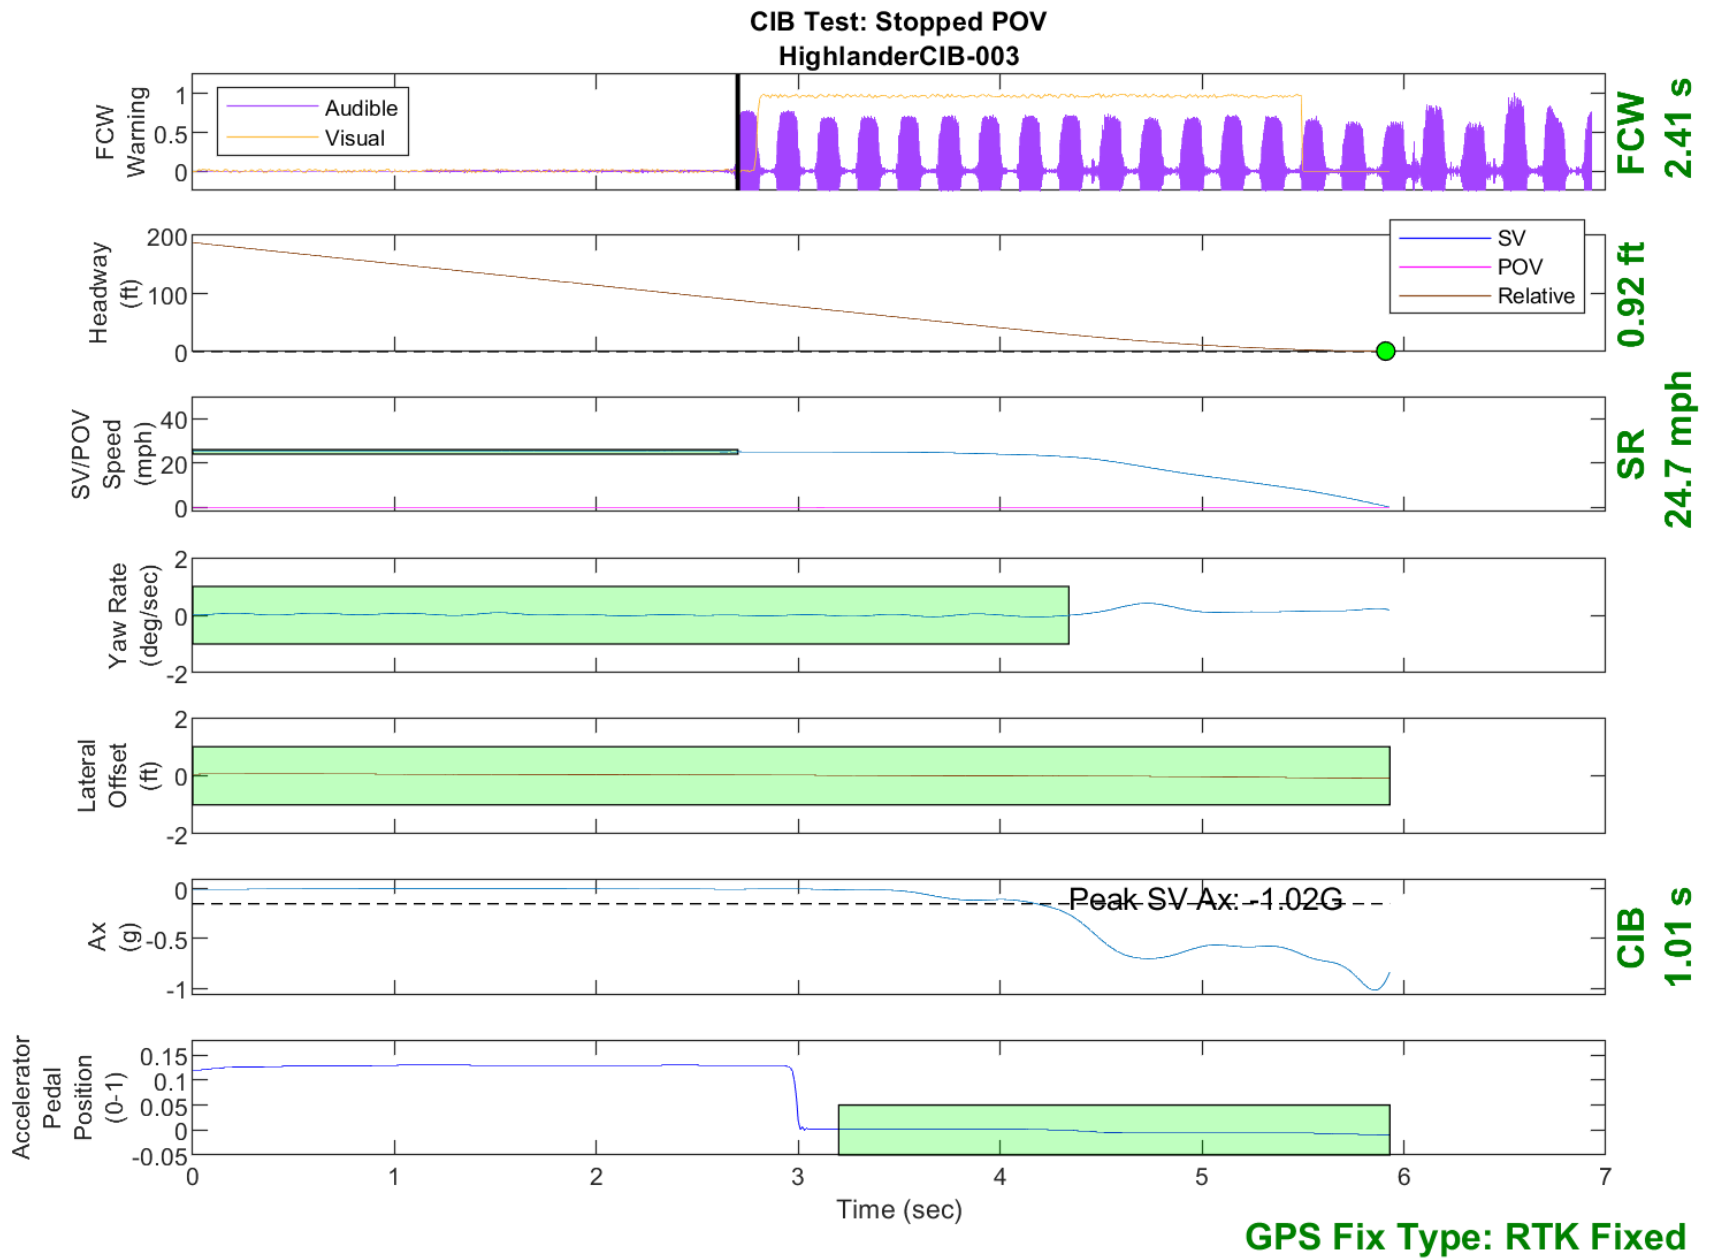
Figure D10. Time History for CIB Run 3, SV Encounters Stopped POV

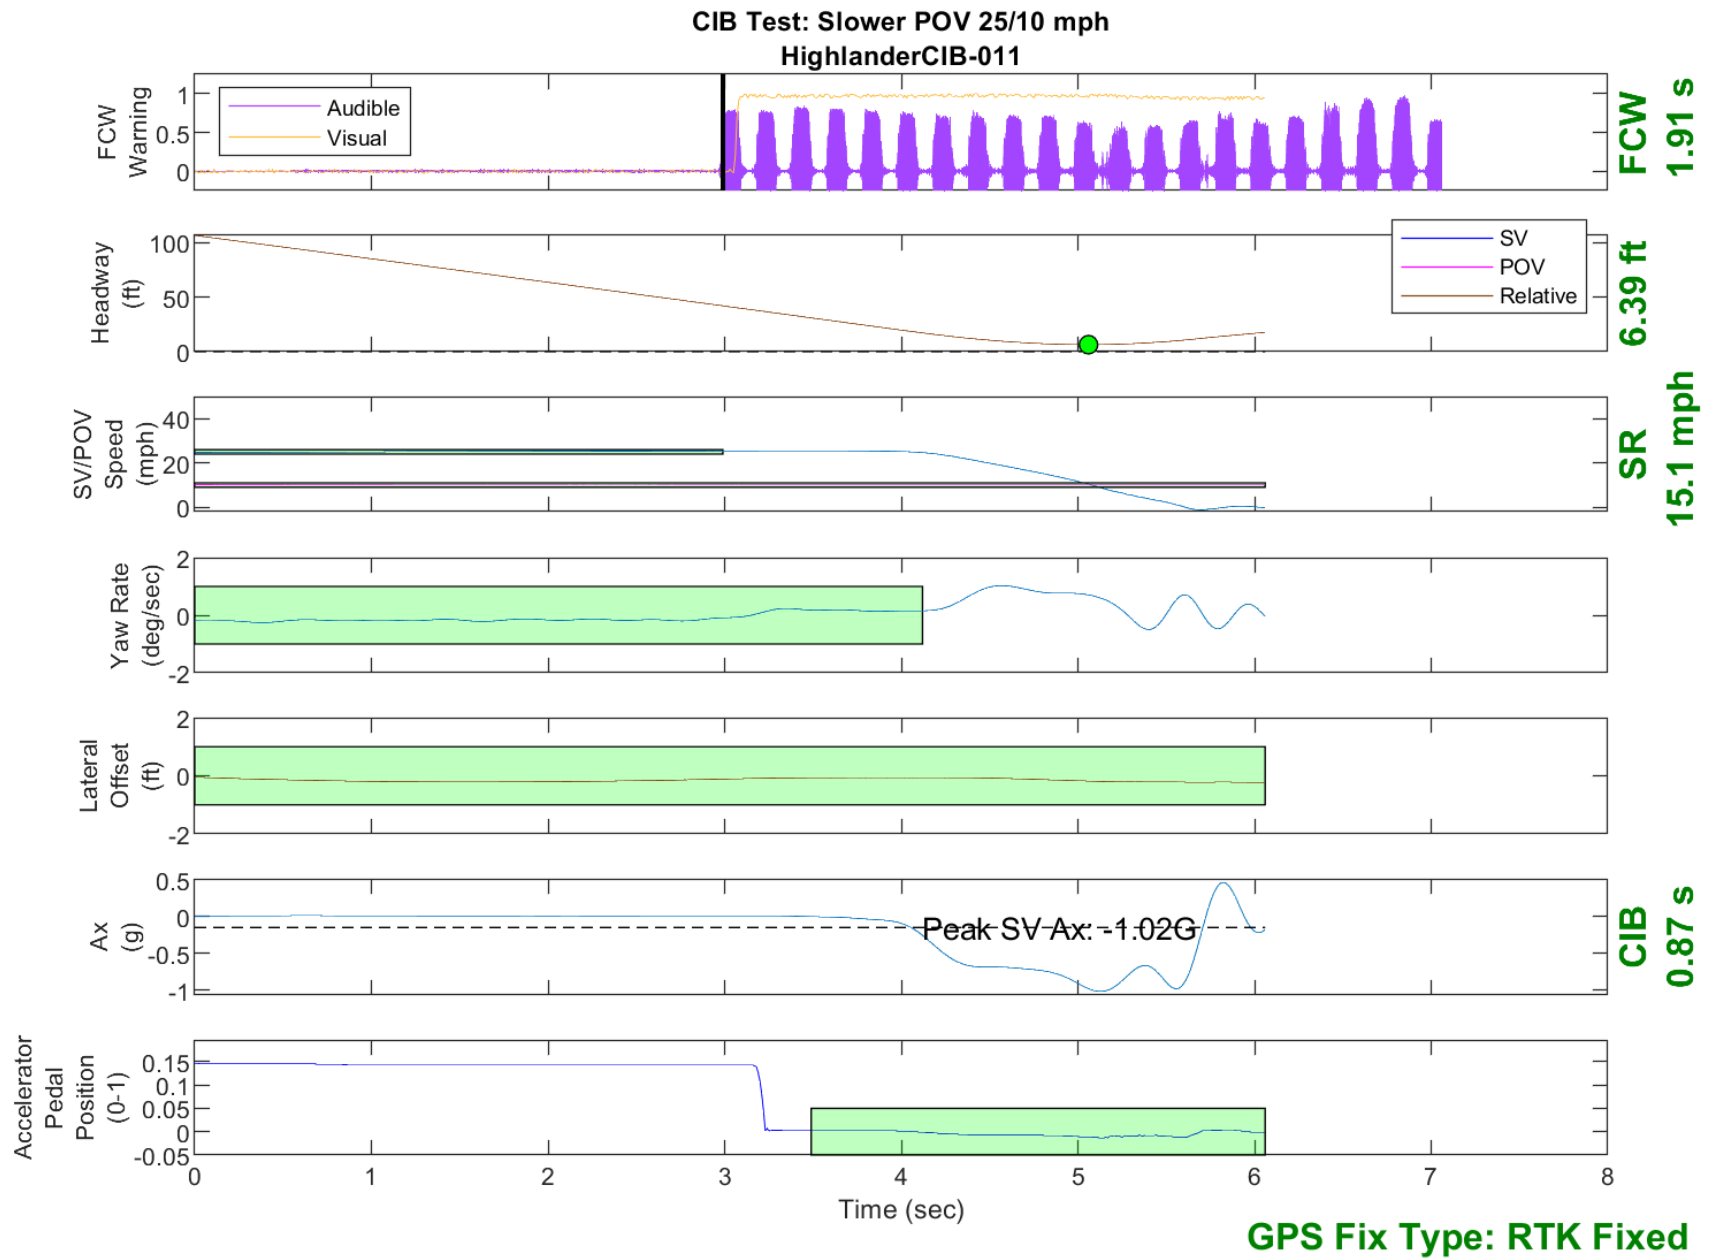
Figure D17. Time History for CIB Run 11, SV Encounters Slower POV, SV 25 mph, POV 10 mph

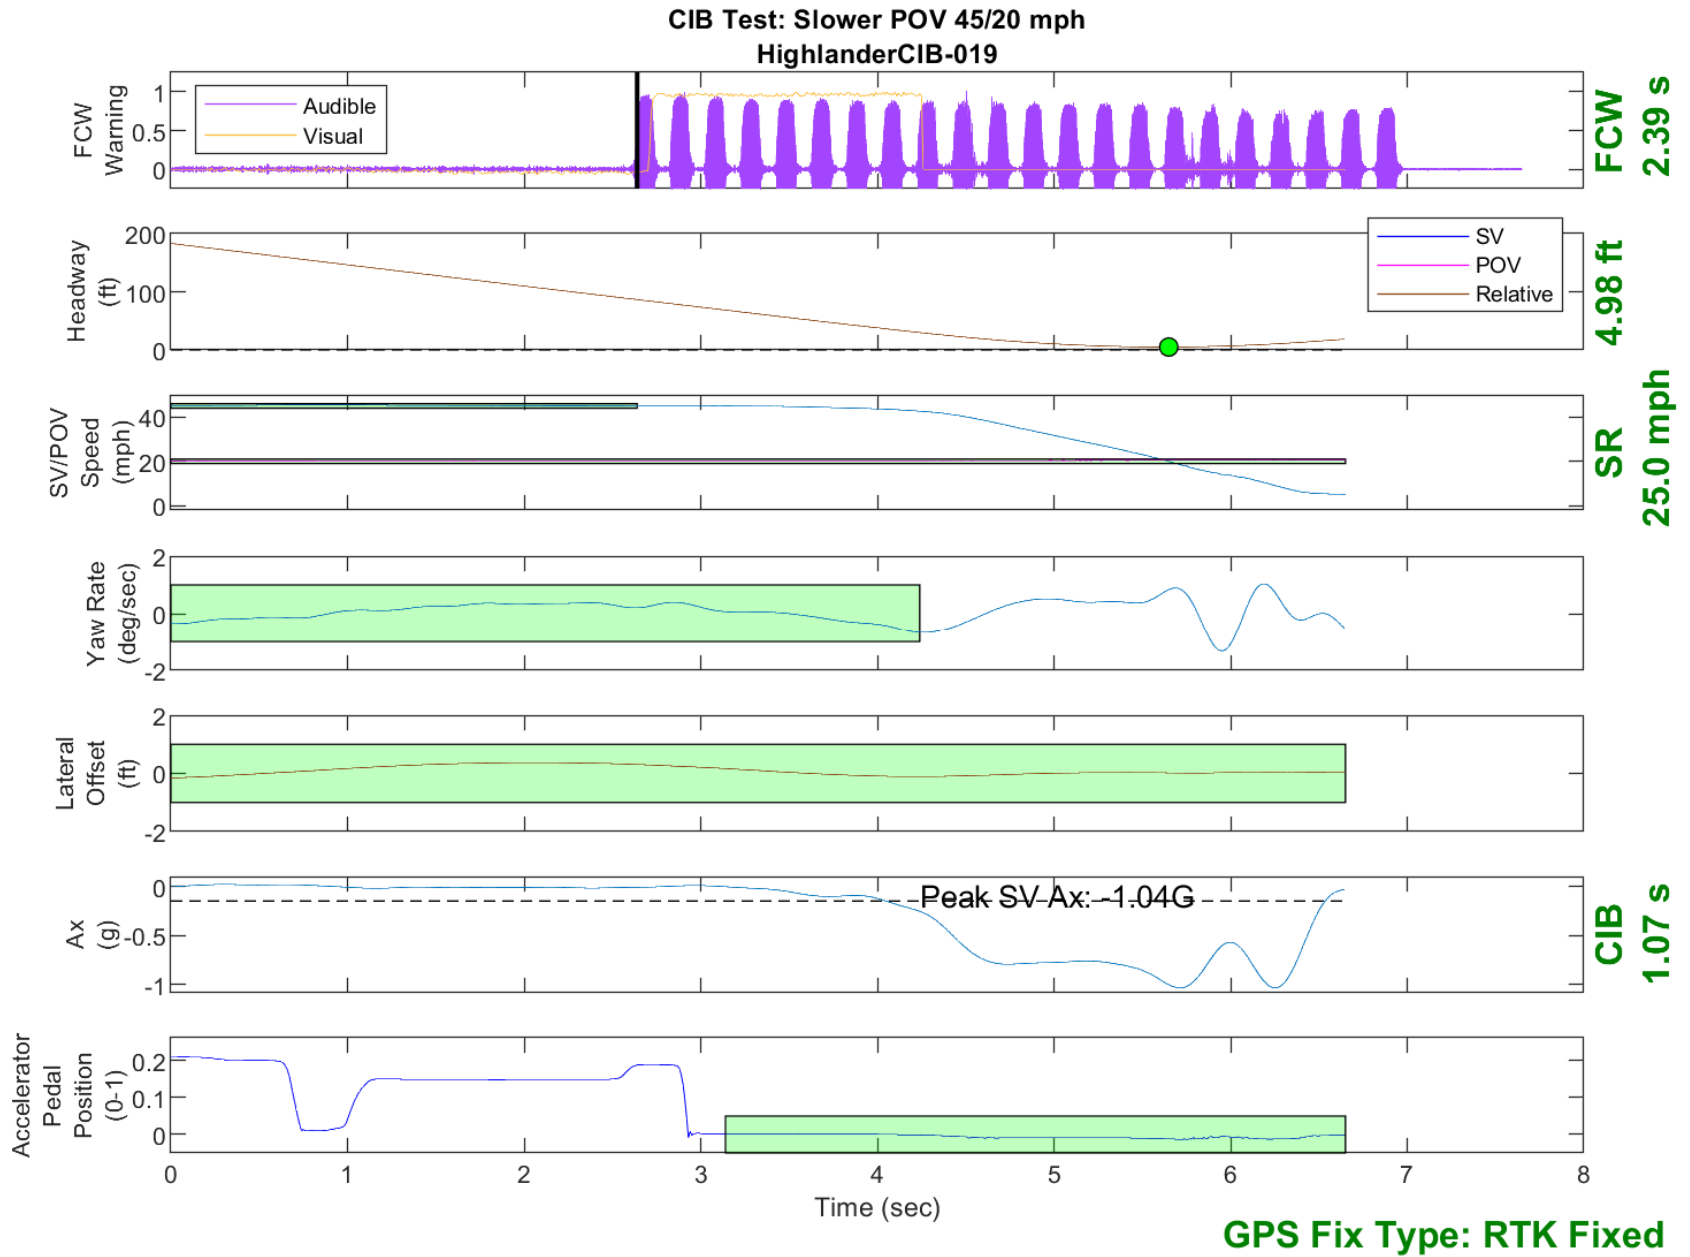
Figure D24. Time History for CIB Run 19, SV Encounters Slower POV, SV 45 mph, POV 20 mph

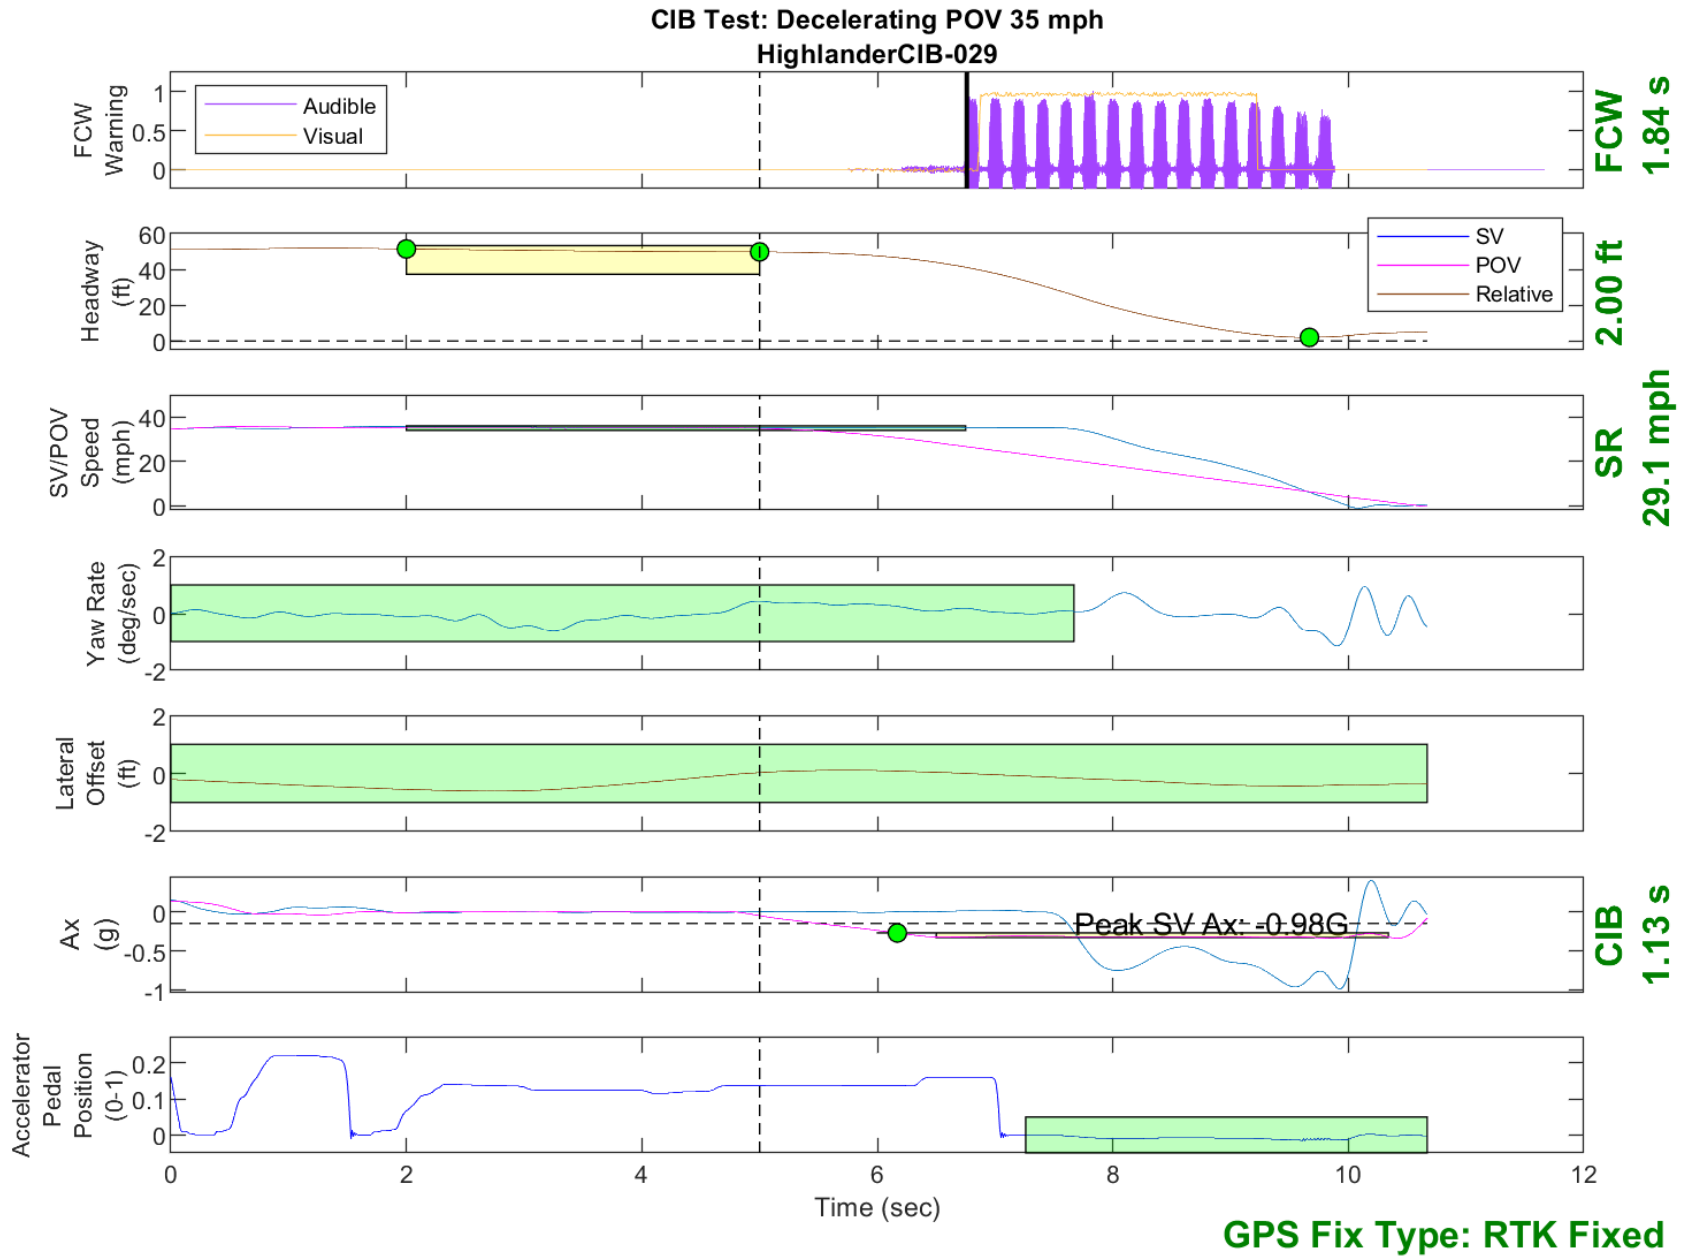
Figure D31. Time History for CIB Run 29, SV Encounters Decelerating POV, SV 35 mph, POV 35 mph
