**NEW CAR ASSESSMENT PROGRAM
CRASH IMMINENT BRAKING SYSTEM CONFIRMATION TEST
NCAP-DRI-CIB-21-16**

2021 Toyota Highlander LE - V6 FWD

DYNAMIC RESEARCH, INC.
355 Van Ness Avenue, STE 200
Torrance, California 90501

Final Report

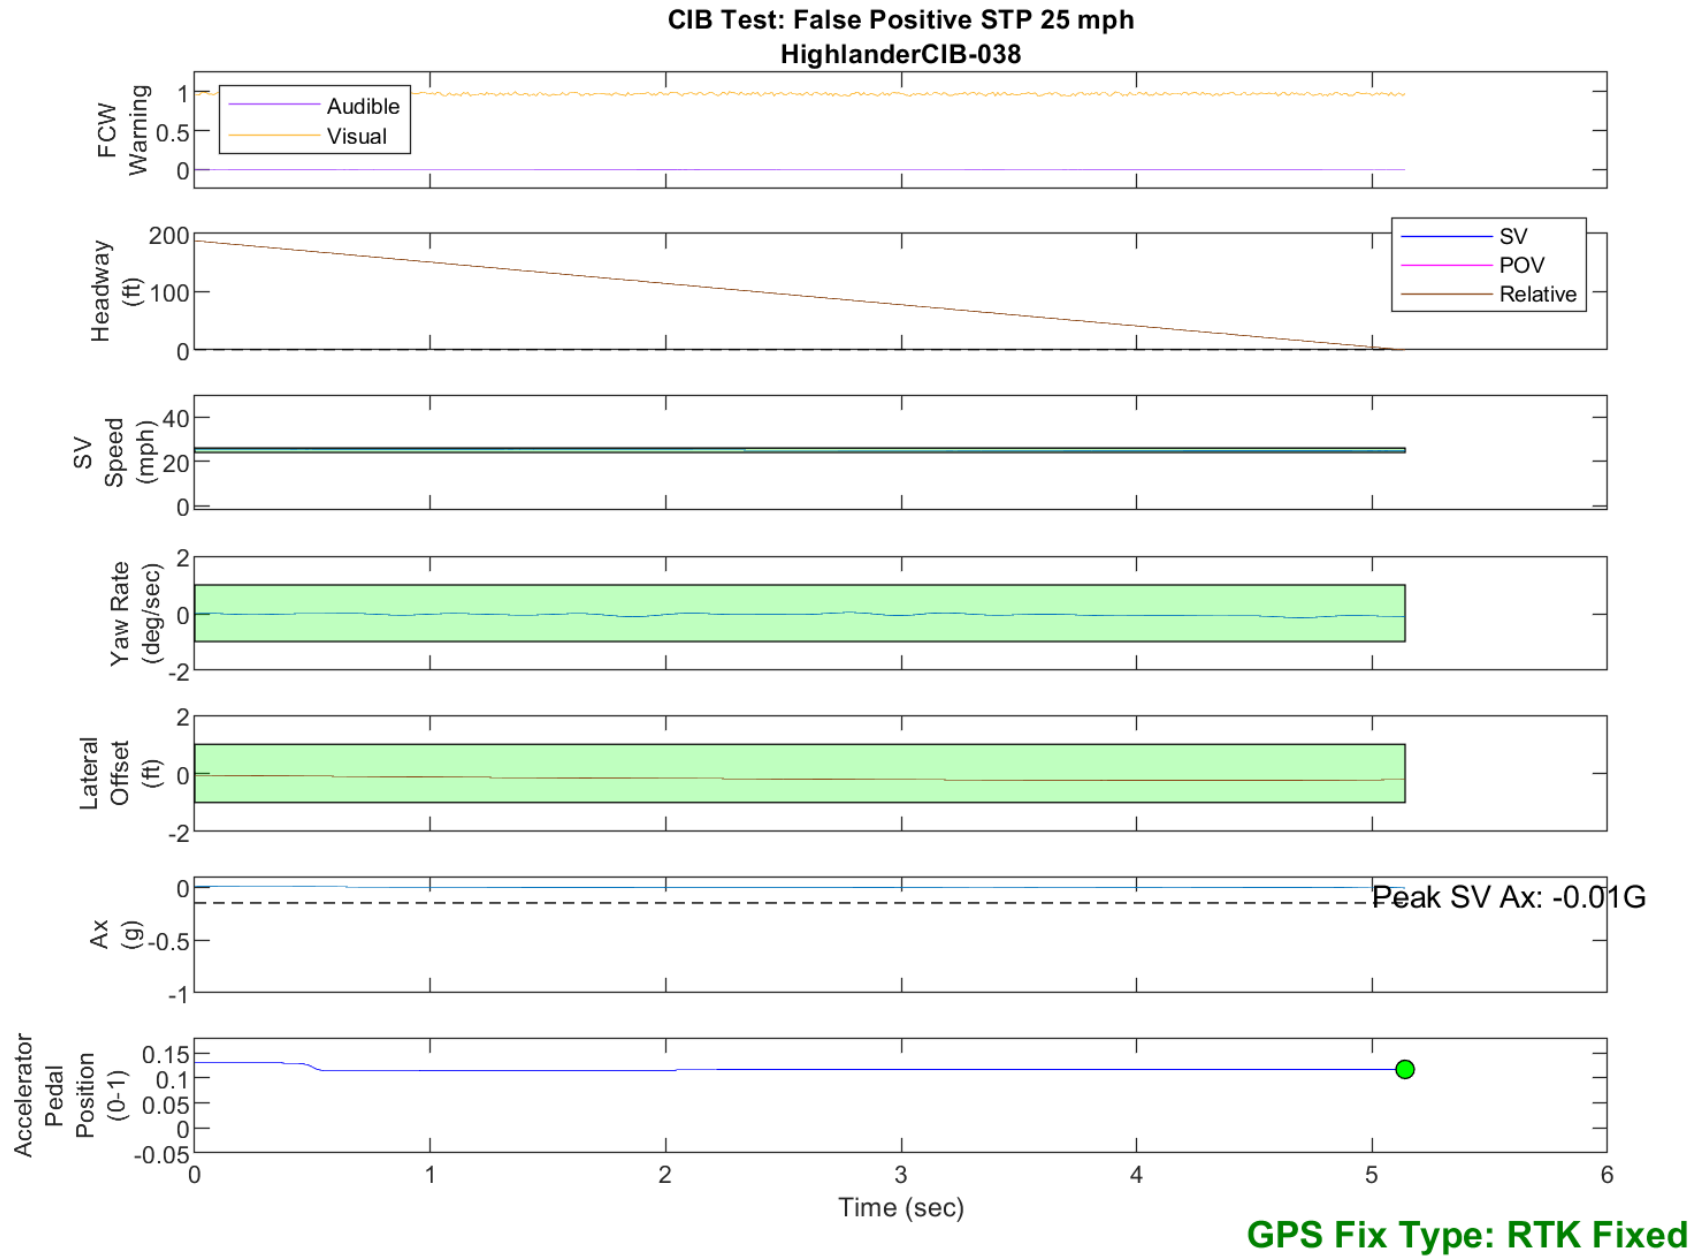
Figure D38. Time History for CIB Run 38, SV Encounters Steel Trench Plate, SV 25 mph

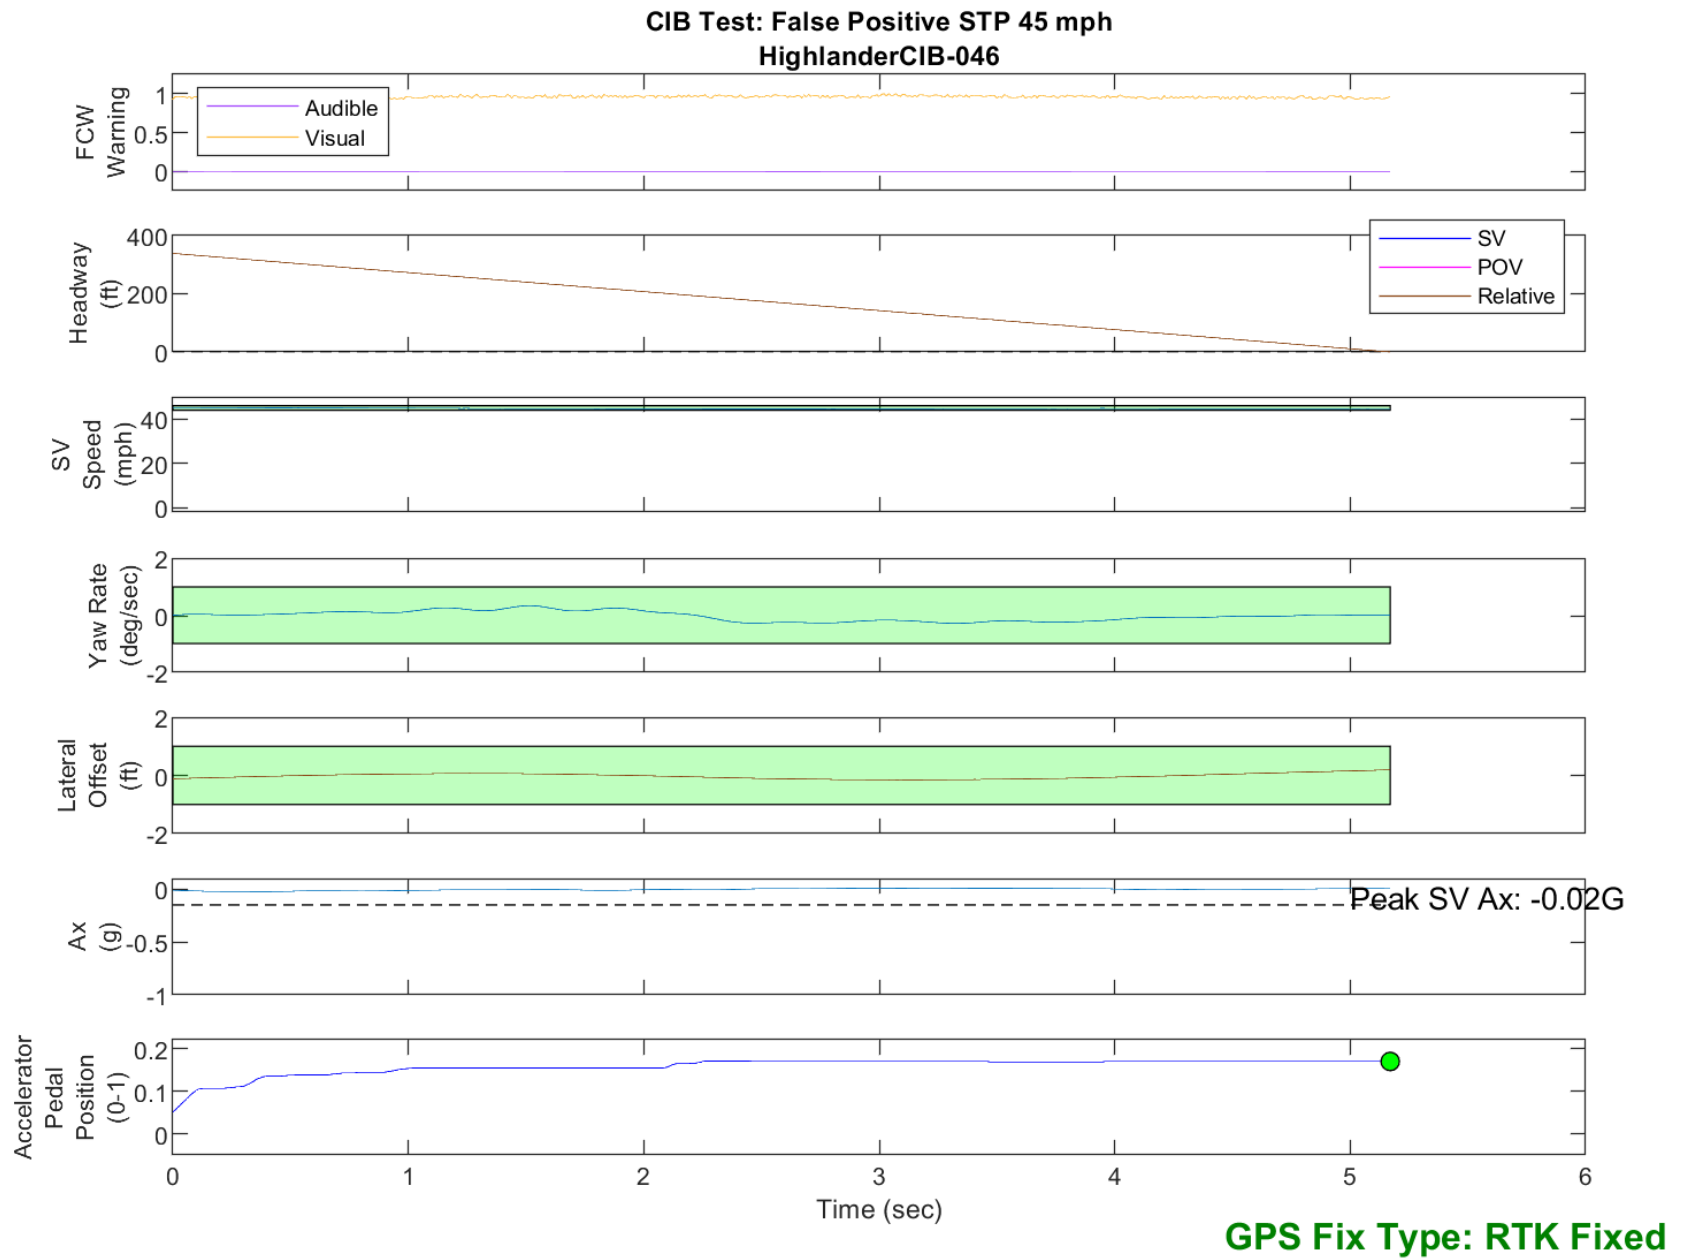
Figure D45. Time History for CIB Run 46, SV Encounters Steel Trench Plate, SV 45 mph
