**NEW CAR ASSESSMENT PROGRAM
CRASH IMMINENT BRAKING SYSTEM CONFIRMATION TEST
NCAP-DRI-CIB-21-03**

2021 Chevrolet Trailblazer FWD 4dr LT

DYNAMIC RESEARCH, INC.

Final Report

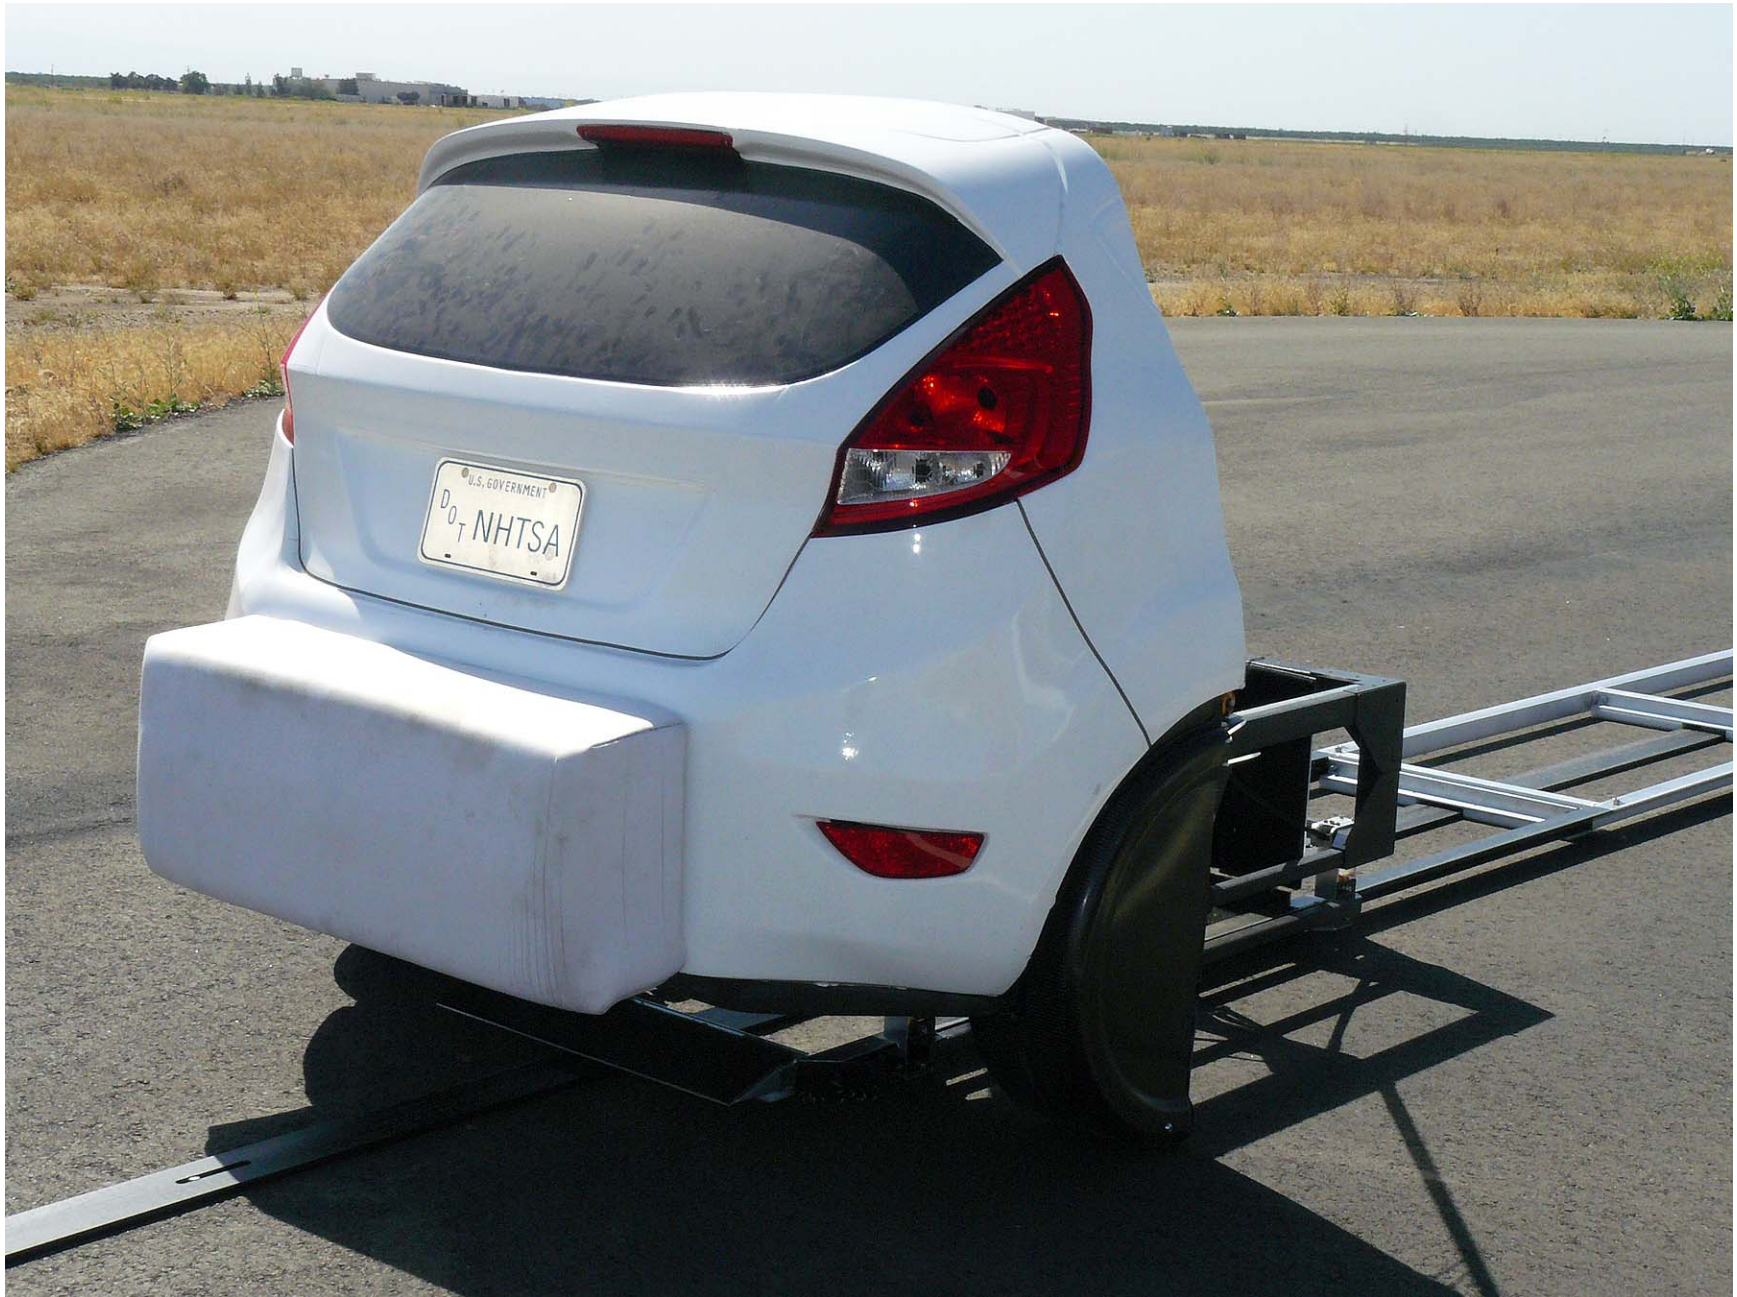
Figure A6. Rear View of Principal Other Vehicle (SSV)

CIB testing requires a POV that realistically represents typical vehicles, does not suffer damage or cause damage to a test vehicle in the event of collision, and can be accurately positioned and moved during the tests. The tests reported herein made use of the NHTSA developed Strikeable Surrogate Vehicle (SSV).

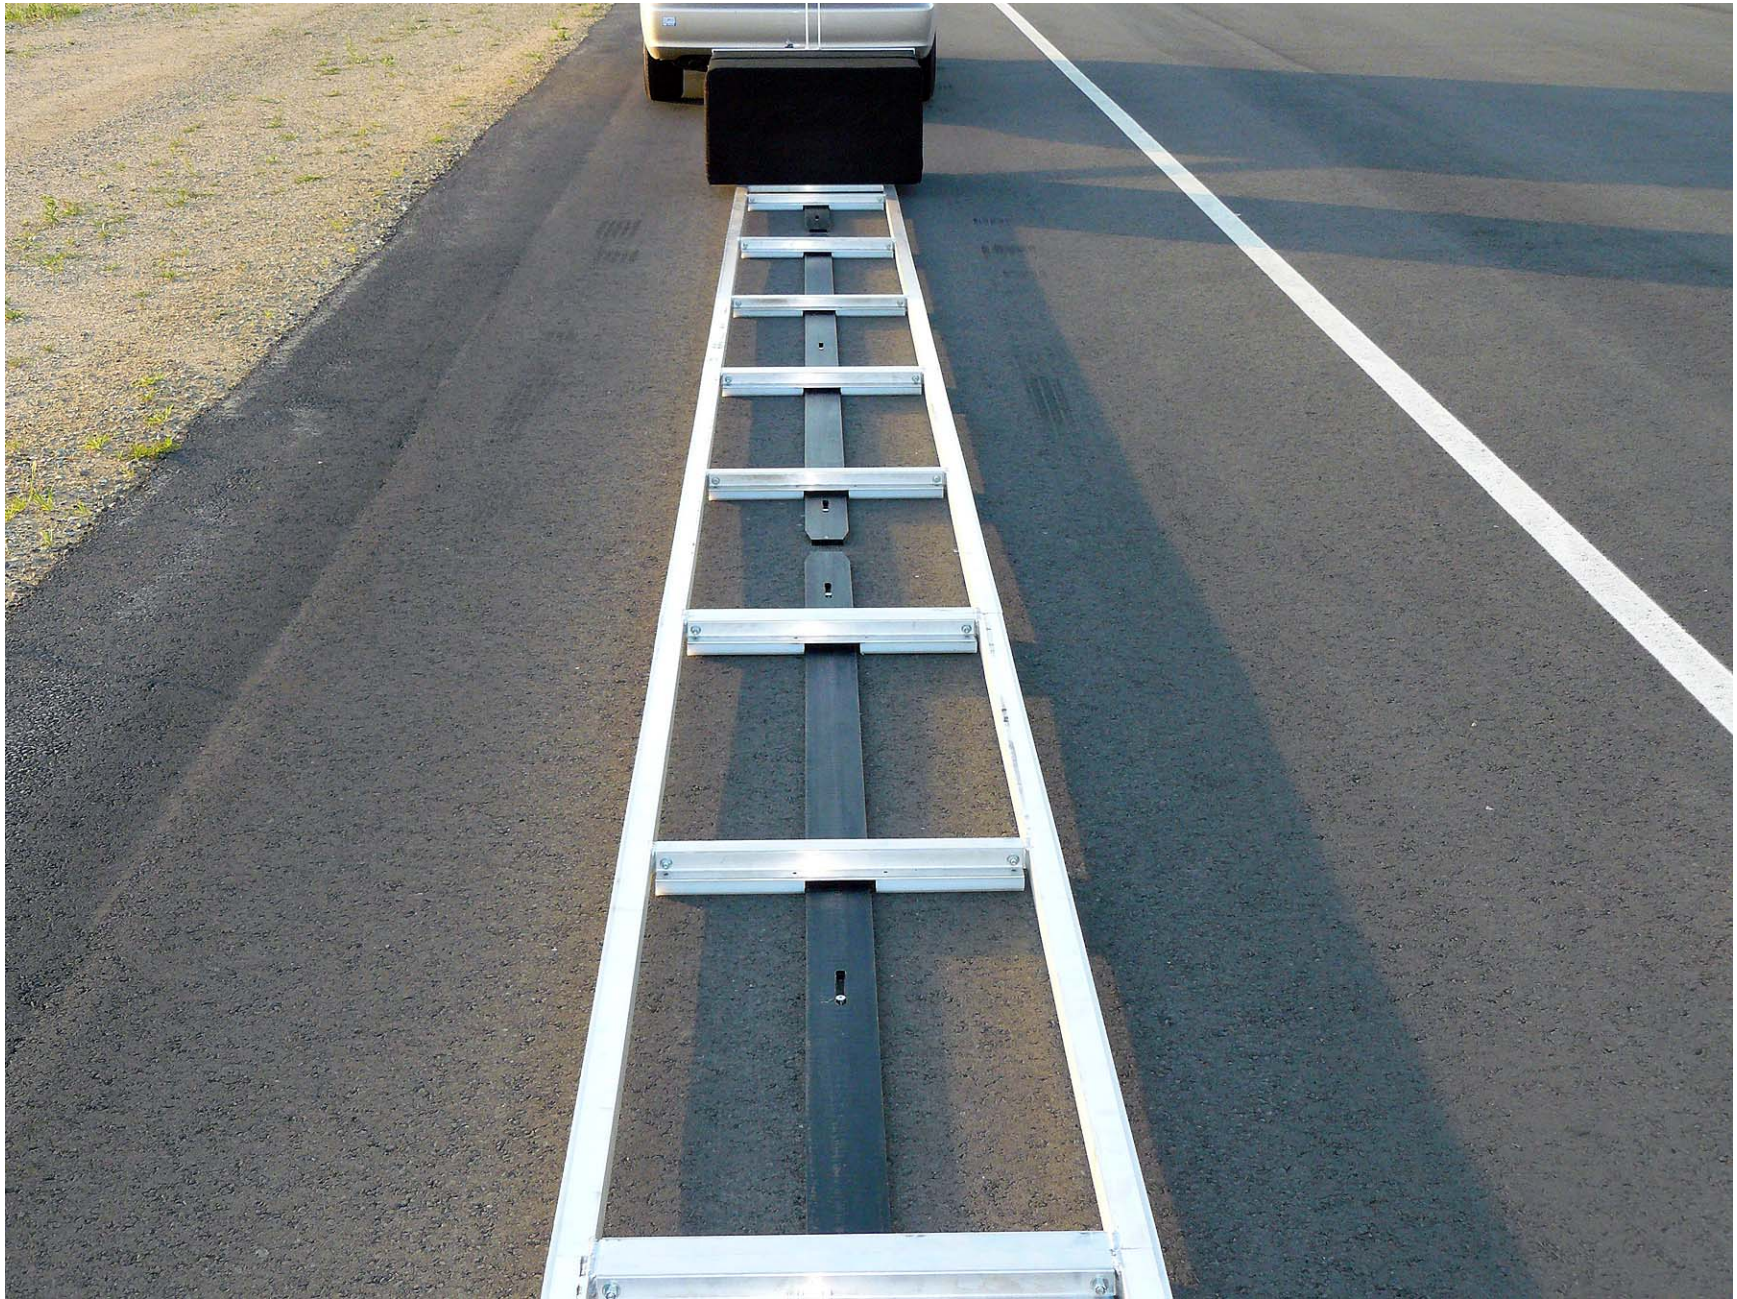
Figure A8. Two-Rail Track and Road-Based Lateral Restraint Track

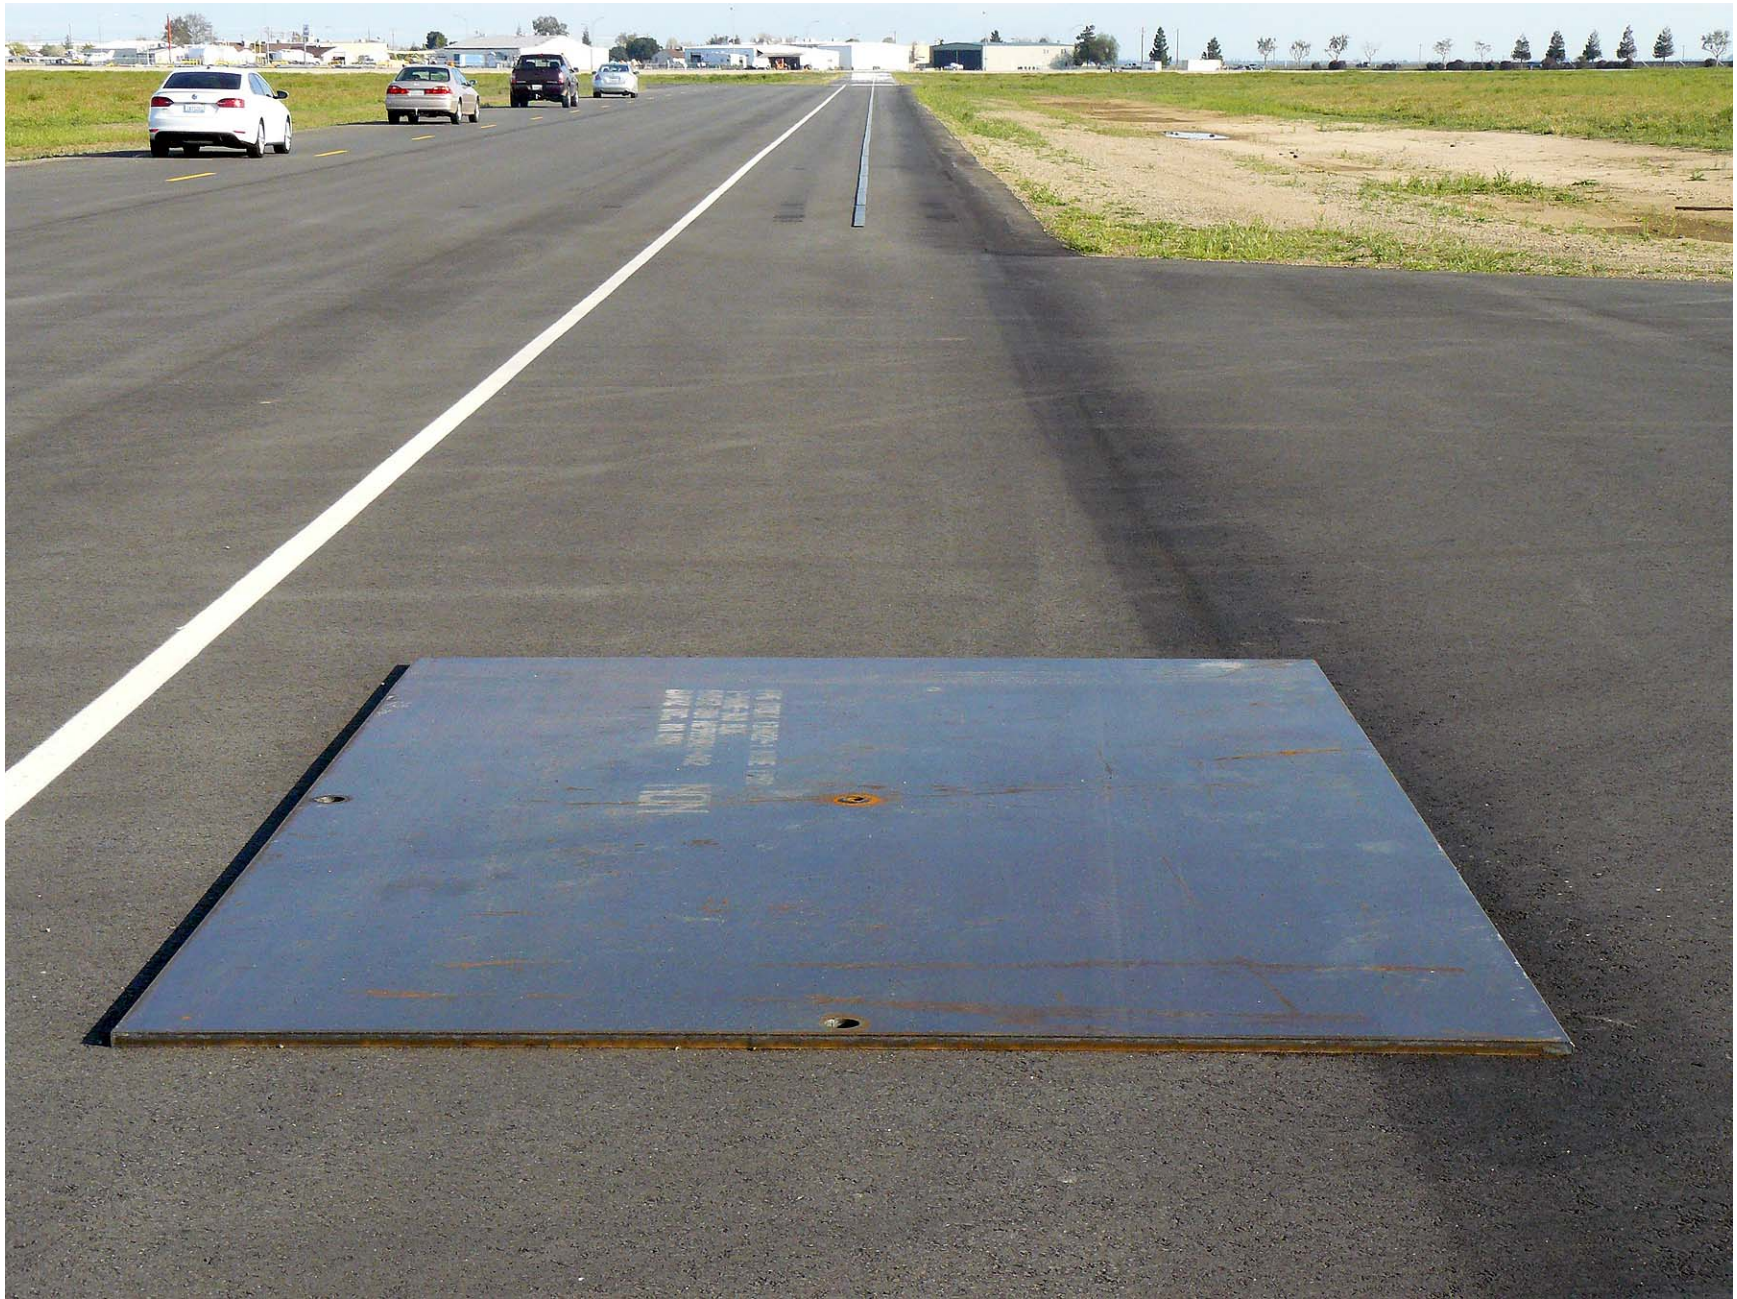
Figure A9. Steel Trench Plate

The false positive suppression test series evaluates the ability of a CIB system to differentiate a steel trench plate (STP) from an object presenting a genuine safety risk to the SV. Although the STP is large and metallic, it is designed to be driven over without risk of injury to the driver or damage to the SV. Therefore, in this scenario, the automatic braking available from CIB is not necessary and should be suppressed. The test condition is nearly equivalent to that previously defined for Test 1, the stopped POV condition, but with an STP in the SV forward path in lieu of a POV.

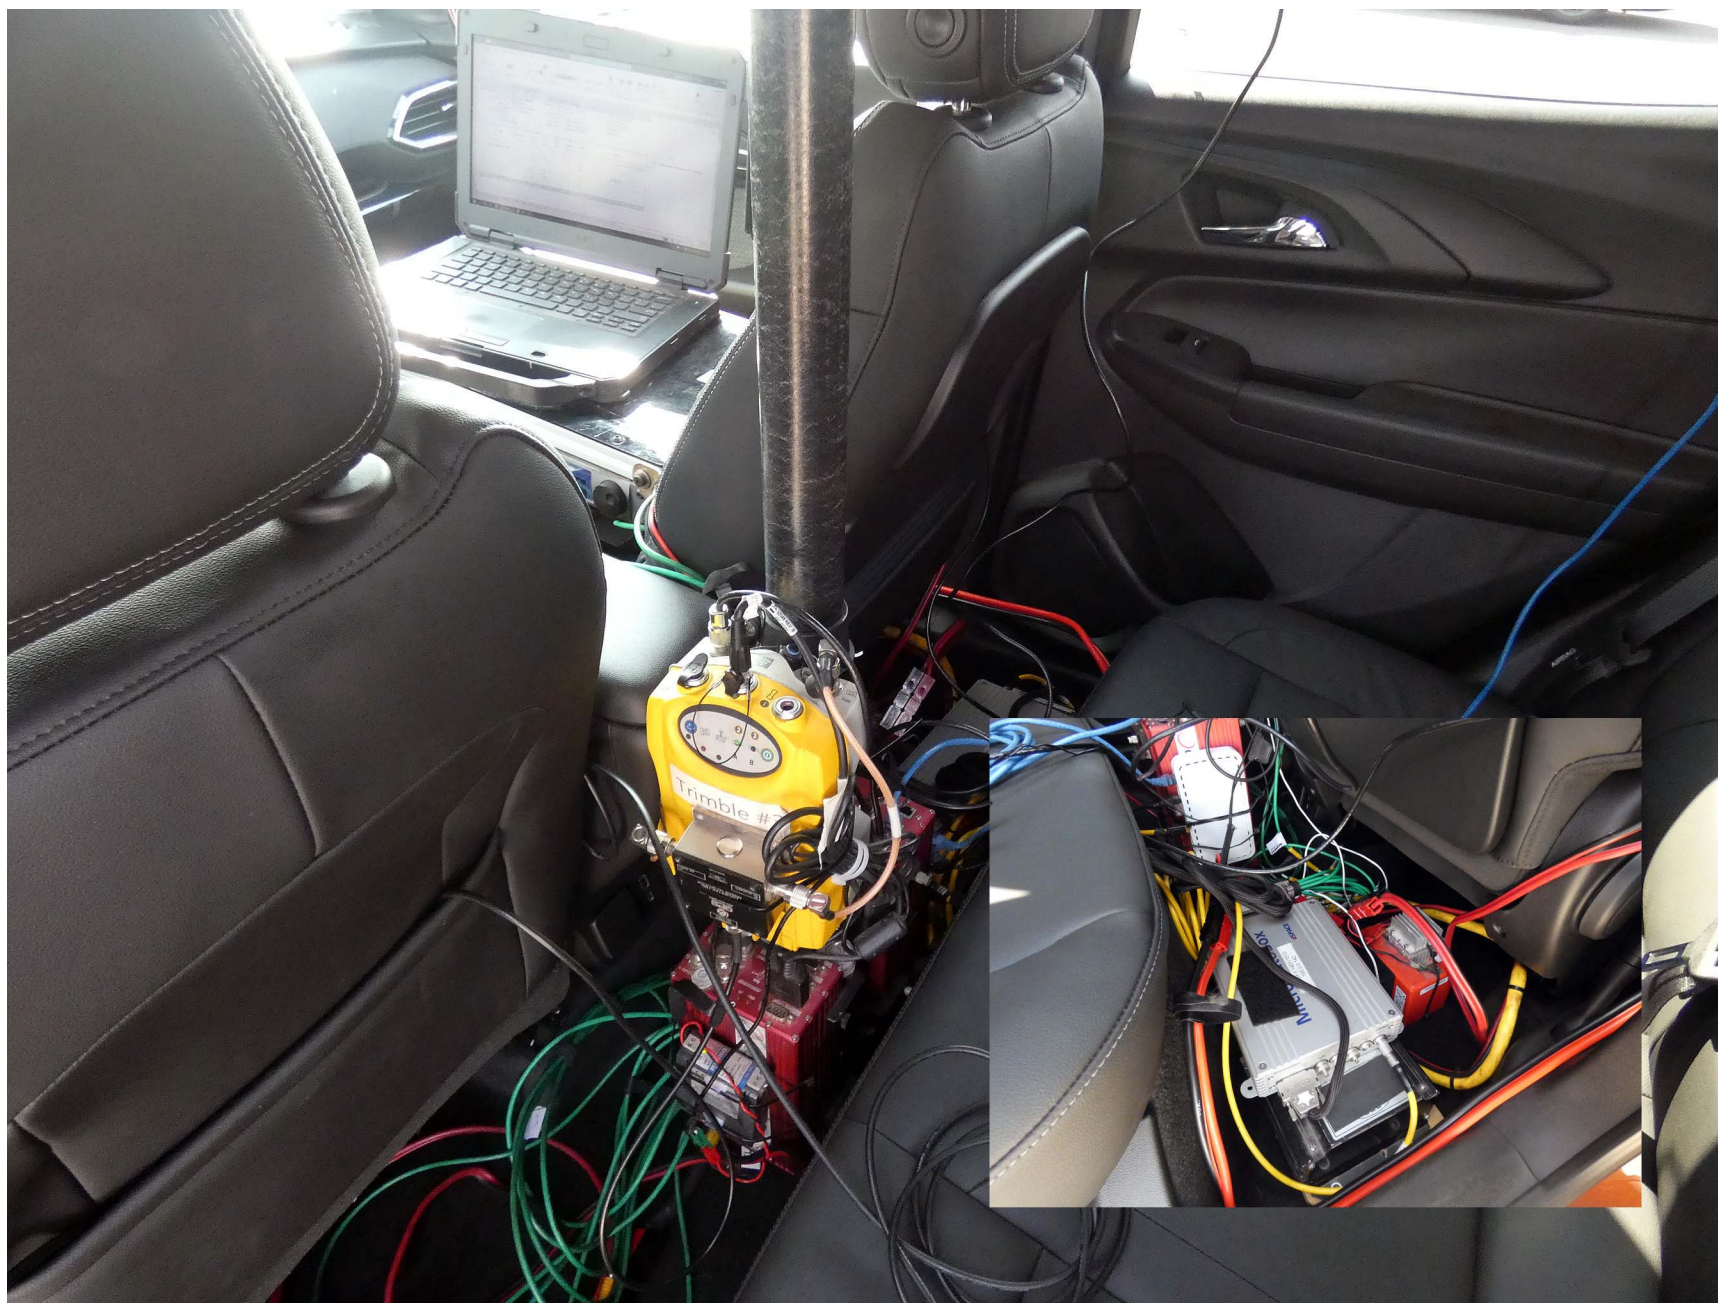
Figure A10. DGPS, Inertial Measurement Unit, and MicroAutoBox Installed in Subject Vehicle

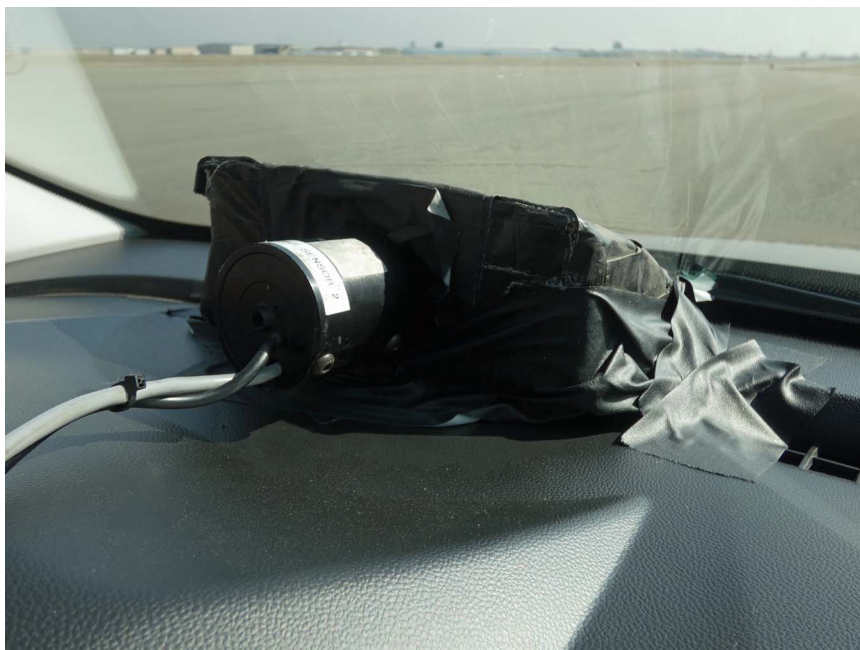
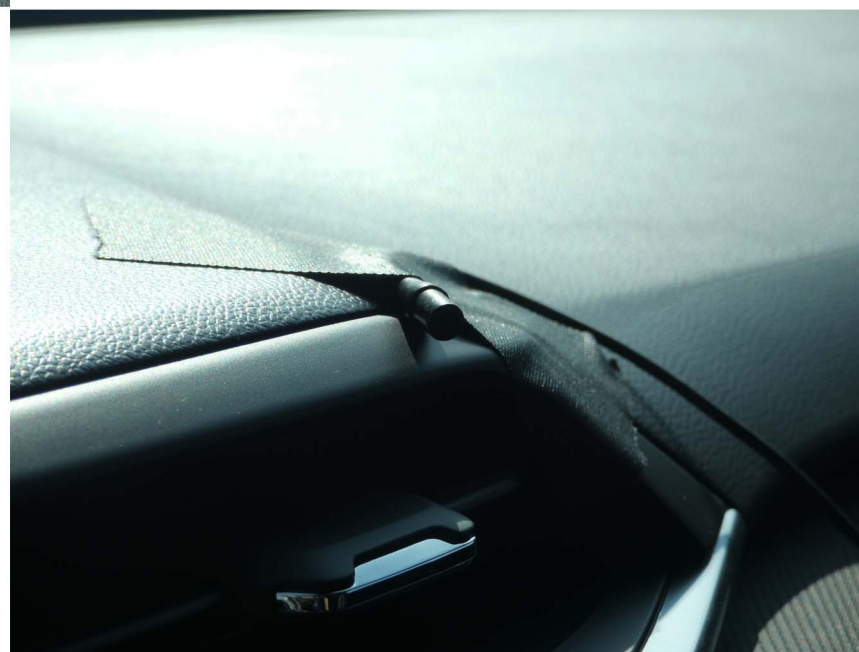
Figure A11. Sensors for Detecting Auditory and Visual Alerts

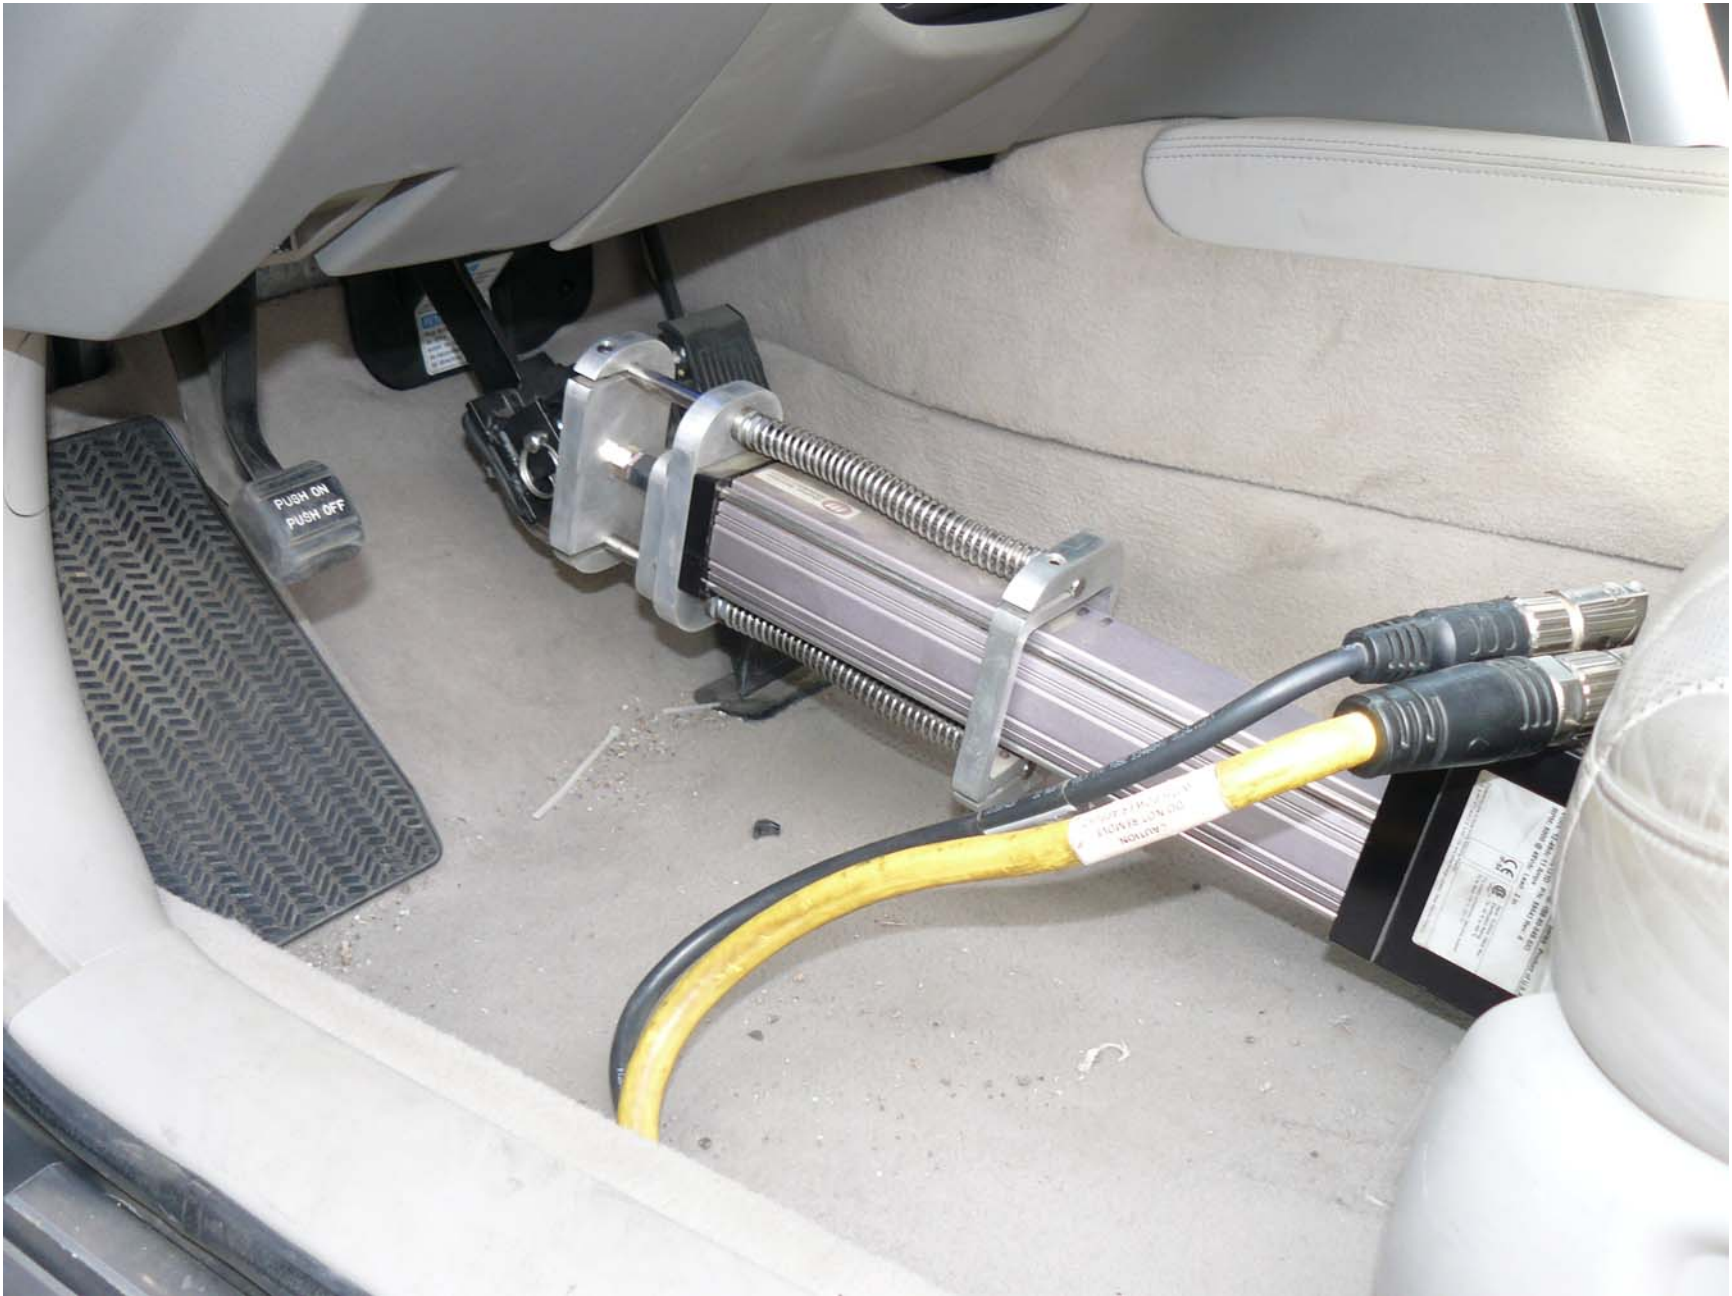
Figure A13. Brake Actuator Installed in POV System

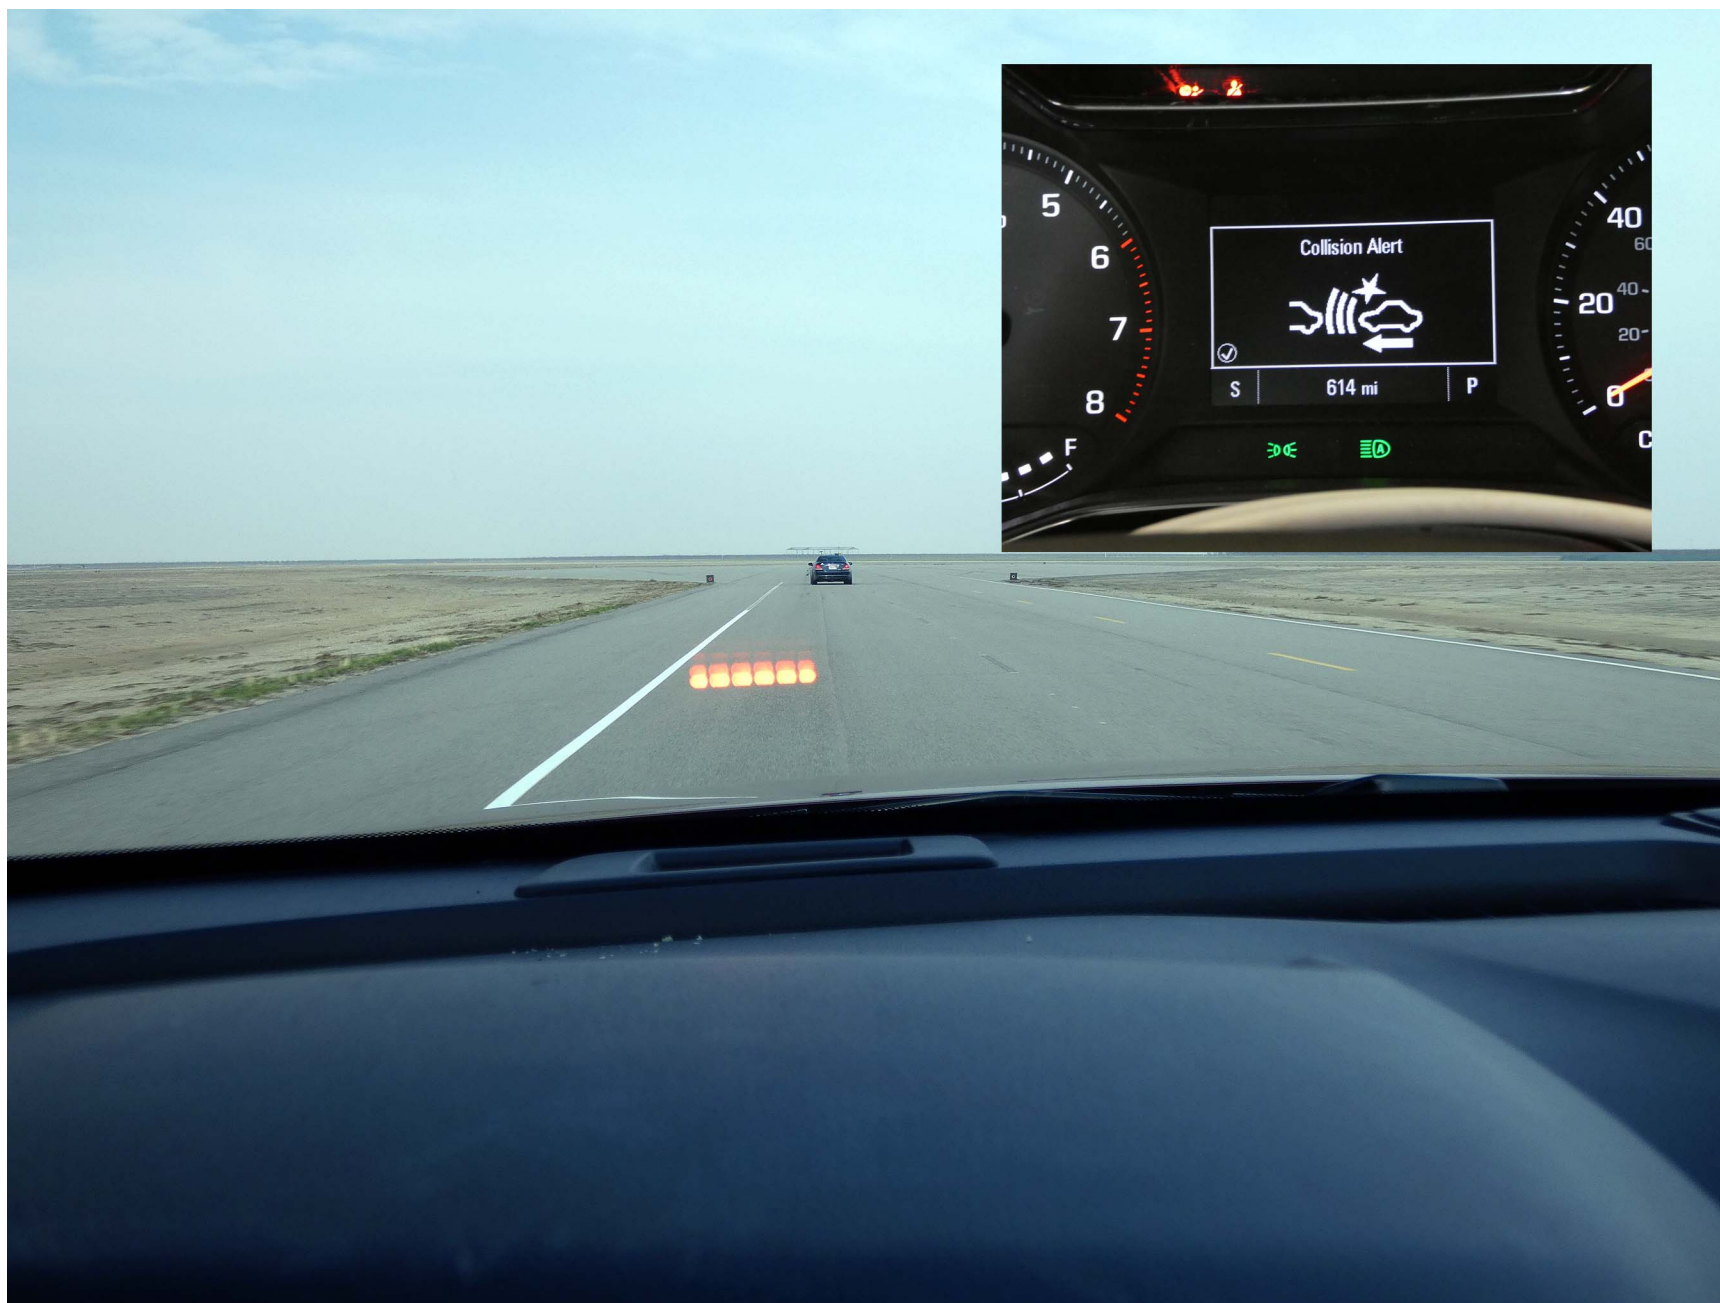
Figure A16. Visual Alerts

When your vehicle approaches another detected vehicle too rapidly, the red FCA (Forward Collision Alert) display will flash on the windshield. The alert is displayed as a series of red dots. When AEB intervention is completed, an additional display appears in the instrument panel. See Appendix A, Figure A16.
